**Flood Control Project Maintenance  
Levee Inspections**

**Fall 2015 Levee Maintenance Deficiency Summary Report**

**Sacramento River Basin**

**Butte County Department of Public Works**

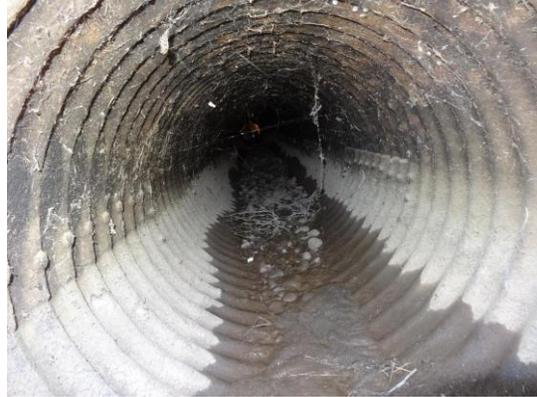
Photo 1 of 3 : UCIP\_FA\_2015\_3168.jpg

LS view: inside view of CMP on levee slope. Needs cleaning and clearing.

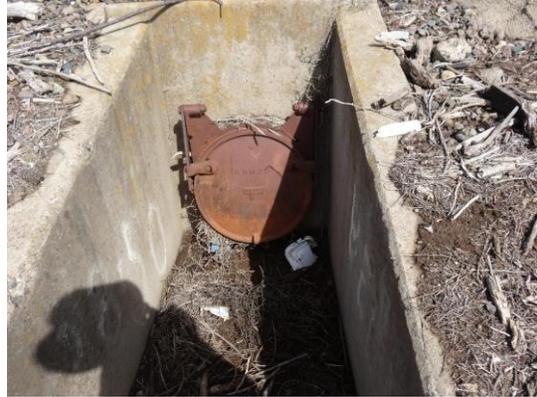
Photo 3 of 3 : UCIP\_FA\_2015\_3170.jpg

WS view: U type concrete headwall, pipe, and flapgate on levee slope. Soil/mud on outlet box. Vegetation debris blocking outlet box.

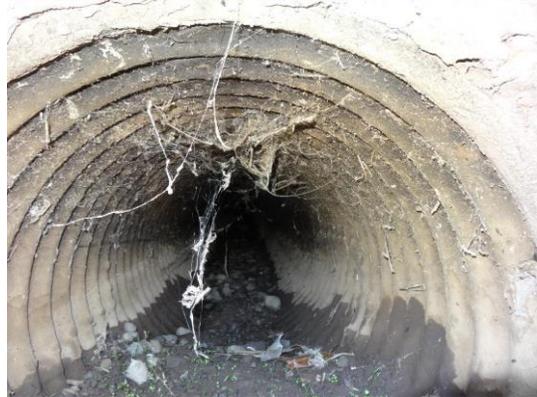
Photo 1 of 3 : UCIP\_FA\_2015\_3279.jpg

LS view: inside view of CMP on levee slope. Needs cleaning and clearing.

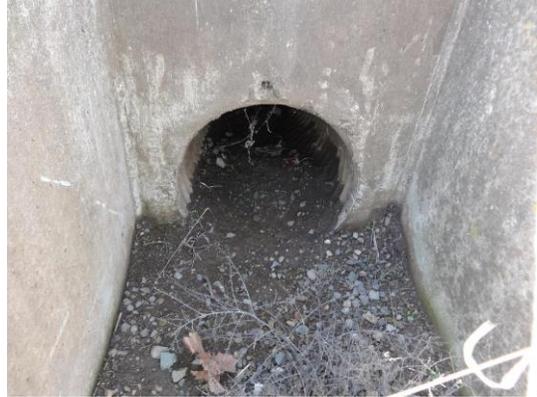
Photo 2 of 3 : UCIP\_FA\_2015\_3280.jpg

LS view: U type concrete headwall and CMP on levee slope. Soil/mud on inlet box.

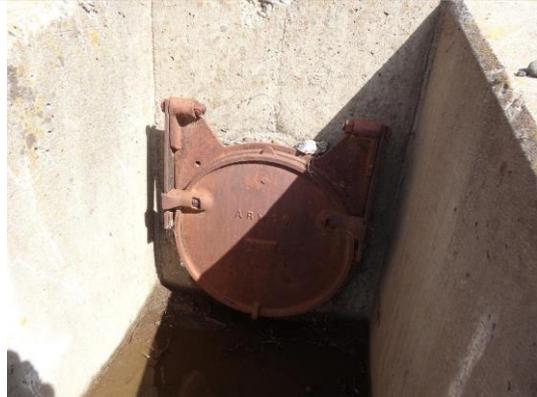
Photo 3 of 3 : UCIP\_FA\_2015\_3281.jpg

WS view: U type concrete headwall, pipe, and flapgate on levee slope. Soil/mud on outlet box.

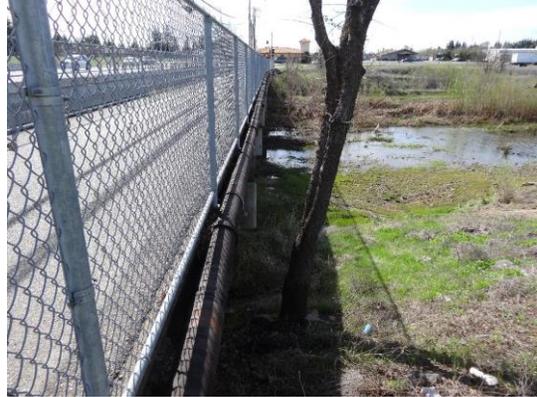
Photo 1 of 1 : UCIP\_FA\_2015\_3269.jpg

WS view: 6-inch steel pipe attached to Cohasset Road Bridge. Needs confirmation from LMA whether this is a gasoline.

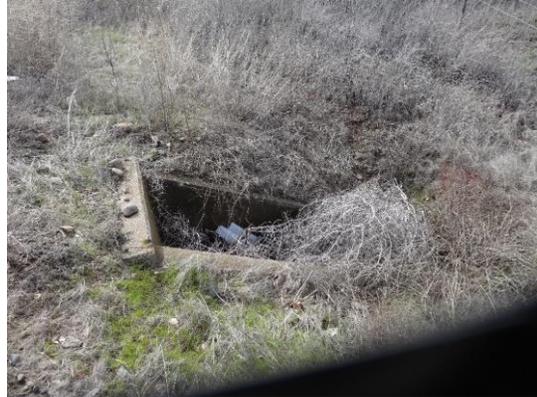
Photo 1 of 2 : UCIP\_FA\_2015\_3952.jpg

LS view: U type concrete headwall and pipe on levee slope. Soil/mud on inlet box. Vegetation debris blocking inlet box.

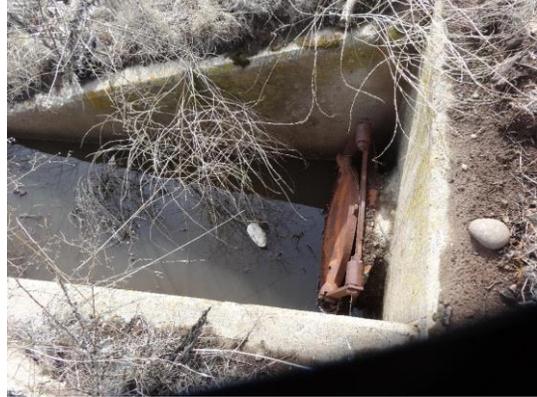
Photo 2 of 2 : UCIP\_FA\_2015\_3953.jpg

**Action/Comments**  
 Inspector Comments: FS\_ID:32125  
 DS\_ID:19275  
 EP\_NO: N/A  
 FS\_HLM: 3.76  
 Repair Type: Non-Urgent  
 Crossing Status: Found  
 UCIP Comments: The culvert was working during the field visit. Needs cleaning and clearing on both ends of the pipe.  
 FIELD\_STRUCT\_DESC: 24-inch CM pipe through the levee, 7.5 feet below the crown. Flap gate on the waterward end. Concrete "U" headwalls on both ends. Grouted riprap apron on the landward end. Grouted riprap spillway on the waterward end. O&M Manual Sac 504, May 1965.  
 FS Date: 03/04/2014

WS view: U type concrete headwall, pipe, and flapgate on levee slope. Soil/mud on outlet box. Vegetation debris blocking outlet box.

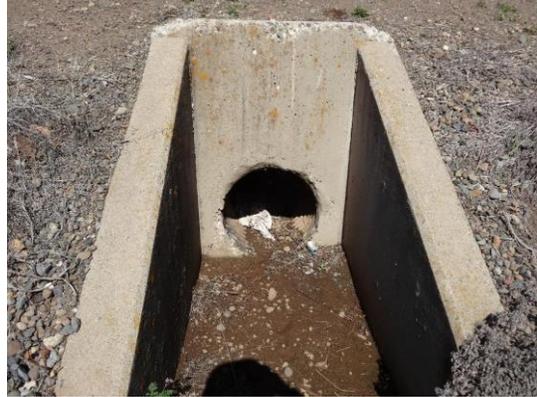
Photo 1 of 3 : UCIP\_FA\_2015\_3530.jpg

**Action/Comments**  
 Inspector Comments: FS\_ID:32026  
 DS\_ID:19279  
 EP\_NO: N/A  
 FS\_HLM: 0.281  
 Repair Type: Non-Urgent  
 Crossing Status: Found  
 UCIP Comments: Needs cleaning and clearing the culvert.  
 FIELD\_STRUCT\_DESC: 24-inch CM pipe through the levee, 10.0 feet below the crown. Flap gate on the waterward end. Concrete "U" headwalls on both ends. Grouted riprap apron on the landward end. Grouted riprap spillway on the waterward end. O&M Manual Sac 504, May 1965.  
 FS Date: 03/07/2014

LS view: U type concrete headwall and CMP on levee slope. Mud and pebbles on inlet box.

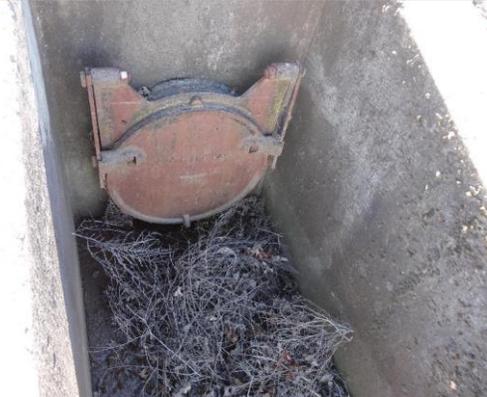
Photo 2 of 3 : UCIP\_FA\_2015\_3531.jpg

WS view: U type concrete headwall and CMP on levee slope. Mud and vegetation debris on outlet box.

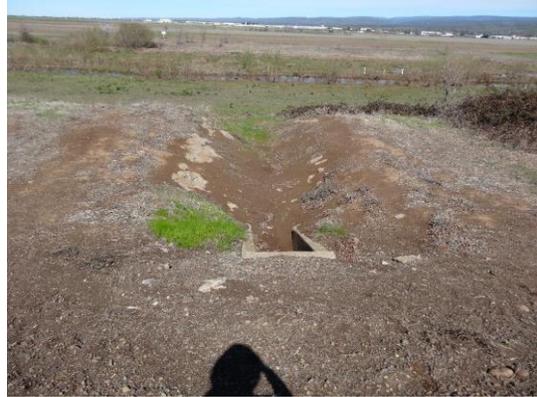
Photo 3 of 3 : UCIP\_FA\_2015\_3532.jpg

WS view: concrete headwall and grouted riprap spillway on levee slope.

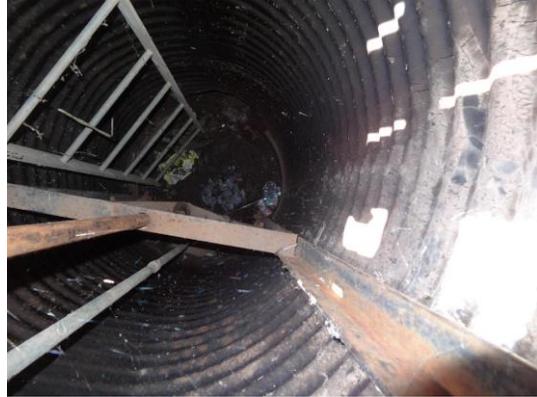
Photo 2 of 3 : UCIP\_FA\_2015\_3528.jpg

Inspector Comments: FS\_ID:32025  
 DS\_ID:19280  
 EP\_NO: N/A  
 FS\_HLM: 0.343  
 Repair Type: Non-Urgent  
 Crossing Status: Found  
 UCIP Comments: Slide gate in a CMP riser. Vegetation debris and mud on inlet box. Needs cleaning and clearing the culvert.  
 FIELD\_STRUCT\_DESC: 24-inch CM pipe through the levee and under the channel, 9.5 feet below the crown. Slide gate in CM pipe riser on the waterward slope. Concrete "U" headwall on the landward end. O&M Manual Sac 504, May 1965.  
 FS Date: 03/07/2014

WS view: inside view of slide gate in CMP riser on waterside shoulder. Debris trapped in the riser.

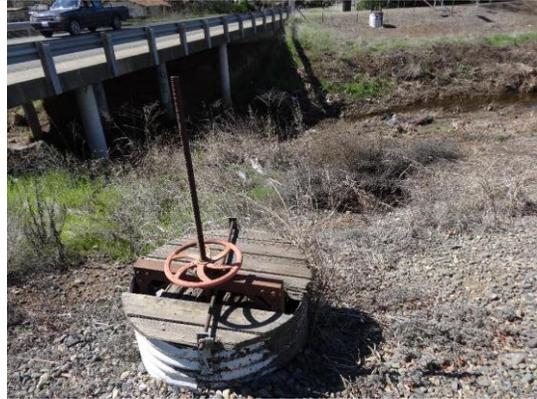
Photo 3 of 3 : UCIP\_FA\_2015\_3529.jpg

WS view: slide gate in CMP riser on waterside shoulder.

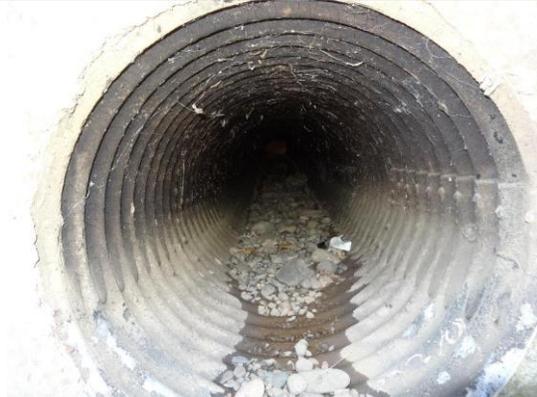
Photo 1 of 3 : UCIP\_FA\_2015\_3524.jpg

LM Start	<b>0.35</b>	Rating **	M	Issue No.	<b>21</b>
LM End	<b>0.35</b>	Issue Type +	En	Location *	LS
Category	Supplemental			GPS Latitude/Longitude	
				Start	End
Item	DWR UCIP Field Study			39.775682 °	39.775682 °
				-121.850375 °	-121.850375 °
DWR ID					
Action/Comments					
Inspector Comments: FS_ID:32023 DS_ID:19281 EP_NO: N/A FS_HLM: 0.366 Repair Type: Non-Urgent Crossing Status: Found

LS view: inside view of the CM pipe. Needs cleaning and clearing the pipe.

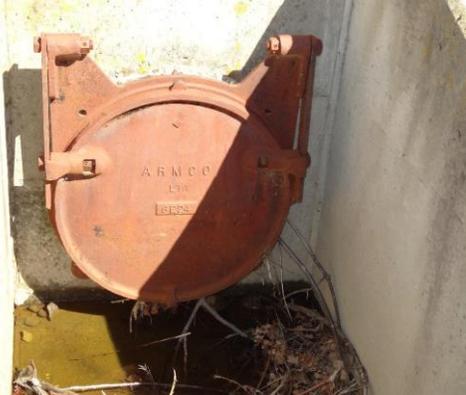
Photo 3 of 3 : UCIP\_FA\_2015\_3526.jpg

WS view: U type concrete headwall and CMP on levee slope. Vegetation debris and mud on outlet box. Needs cleaning and clearing.

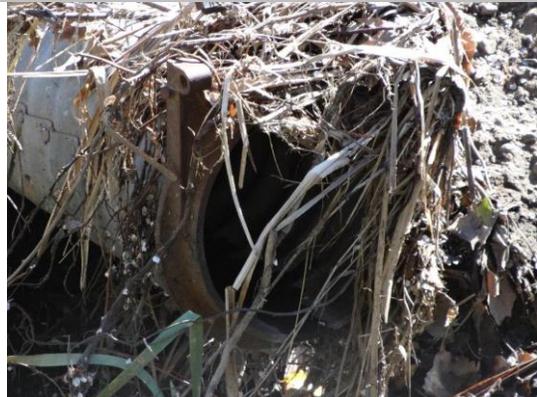
Photo 1 of 3 : UCIP\_FA\_2015\_3495.jpg

LM Start	<b>0.71</b>	Rating **	U	Issue No.	<b>22</b>
LM End	<b>0.71</b>	Issue Type +	En	Location *	LS
Category	Supplemental			GPS Latitude/Longitude	
				Start	End
Item	DWR UCIP Field Study			39.772907 °	39.772907 °
				-121.845949 °	-121.845949 °
DWR ID					
Action/Comments					
Inspector Comments: FS_ID:31968 DS_ID:19284 EP_NO: N/A FS_HLM: 0.749 Repair Type: Urgent Crossing Status: Found UCIP Comments: Flap gate missing. Pipe support needs to be repaired. Needs cleaning and clearing the pipe outlet. FIELD_STRUCT_DESC: 12-inch CM pipe through the patrol road, 4.3 feet below the crown. FS Date: 03/07/2014

WS view: close view of CM outfall drain pipe with vegetation debris covered. Flap gate was missing from the pipe end.

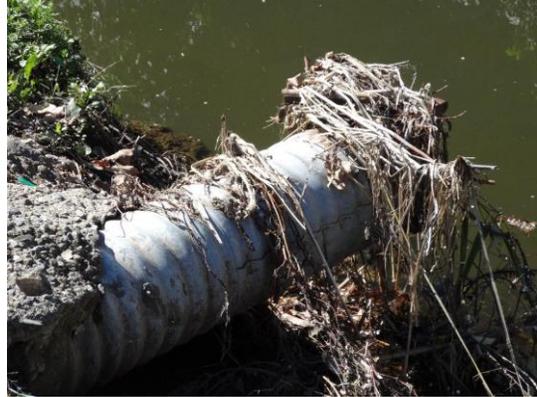
Photo 2 of 3 : UCIP\_FA\_2015\_3496.jpg

WS view: close view of CM outfall drain pipe with vegetation debris covered.

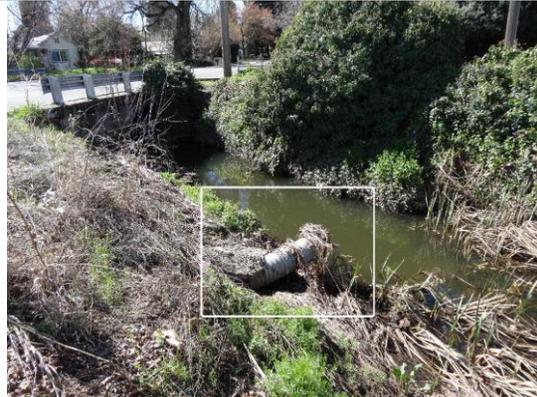
Photo 3 of 3 : UCIP\_FA\_2015\_3497.jpg

WS view: CM outfall drain pipe on levee slope.

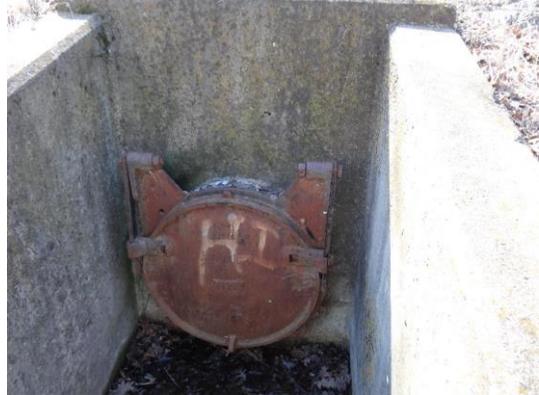
Photo 1 of 2 : UCIP\_FA\_2015\_3951.jpg

WS view: U type concrete headwall and CMP on levee slope. Soil/mud on outlet box. Needs cleaning and clearing.

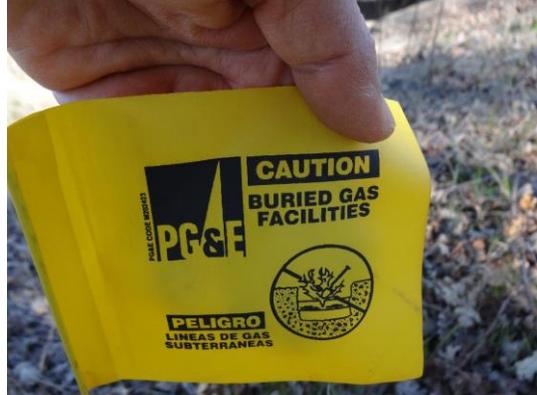
Photo 1 of 2 : UCIP\_FA\_2015\_3992.jpg

WS view: close up view of little gasline indicator.

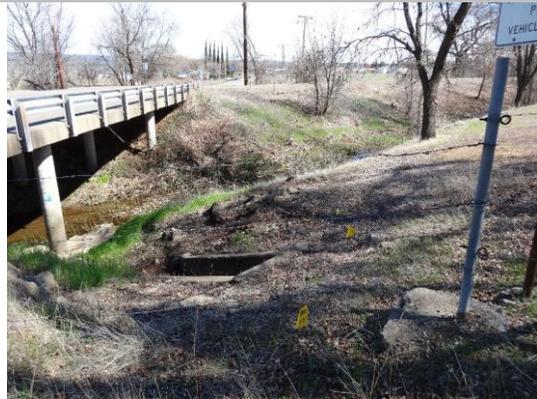
Photo 2 of 2 : UCIP\_FA\_2015\_3993.jpg

WS view: little gasline indicator (yellow flags) on both sides of the levee.

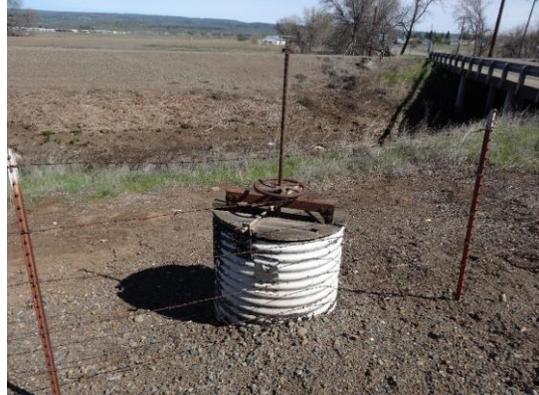
Photo 1 of 3 : UCIP\_FA\_2015\_3955.jpg

WS view: slide gate in CMP riser on waterside. No access to CMP riser.

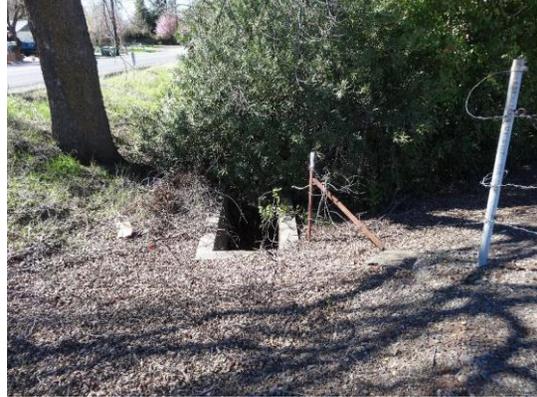
Photo 3 of 3 : UCIP\_FA\_2015\_4073.jpg

LS view: U type concrete headwall of CMP culvert on levee slope. Vegetation debris and mud on inlet box.

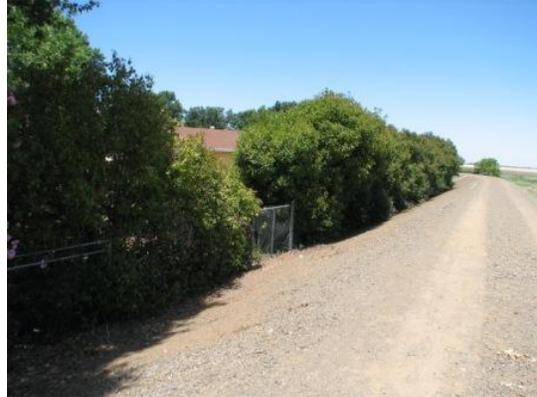
Photo 1 of 1 : FA\_2015\_NA0003\_68\_1\_20150910\_00001.jpg

LM Start	<b>0.94</b>	Rating **	U	Issue No.	<b>1</b>
LM End	<b>1.01</b>	Issue Type +	En	Location *	LS
Category	Earthen Levee			GPS Latitude/Longitude	
				Start	End
Item	Encroachments			39.776013 °	39.776595 °
				-121.851175 °	-121.852005 °
DWR ID	DWR_NA0003_04_s_2012_1				
Action/Comments					
Fence Inspector Comments: Chainlink fences are unpermitted.

View of the fence and trees along the landside toe of the levee.

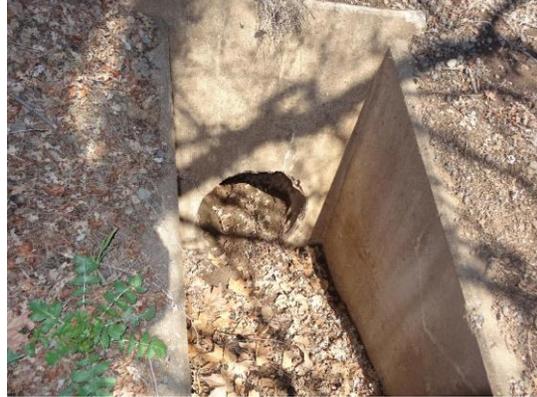
Photo 1 of 2 : UCIP\_FA\_2015\_4015.jpg

**Action/Comments**  
 Inspector Comments: FS\_ID:31963  
 DS\_ID:19289  
 EP\_NO: N/A  
 FS\_HLM: 1.15  
 Repair Type: Non-Urgent  
 Crossing Status: Found  
 UCIP Comments: Needs cleaning and clearing the culvert.  
 FIELD\_STRUCT\_DESC: 24-inch CM pipe through the levee, 11.0 feet below the flap gate on the waterward end. Concrete "U" headwalls on both ends. Grouted riprap apron on the landward end. Grouted riprap spillway on the waterward end. O&M Manual Sac 504, May 1965.  
 FS Date: 03/07/2014

LS view: U type concrete headwall and CMP on levee slope. Vegetation debris and mud on inlet box.

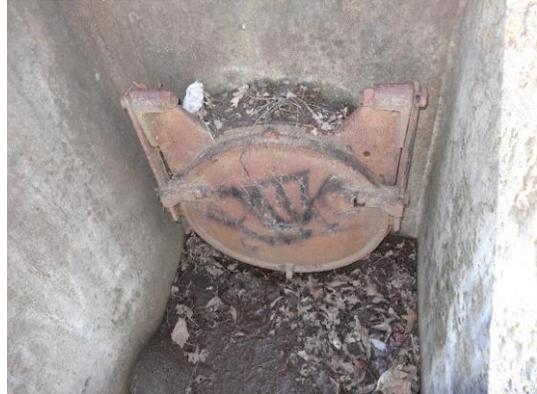
Photo 2 of 2 : UCIP\_FA\_2015\_4016.jpg

WS view: U type concrete headwall and CMP on levee slope. Vegetation debris and mud on outlet box. Needs cleaning and clearing.

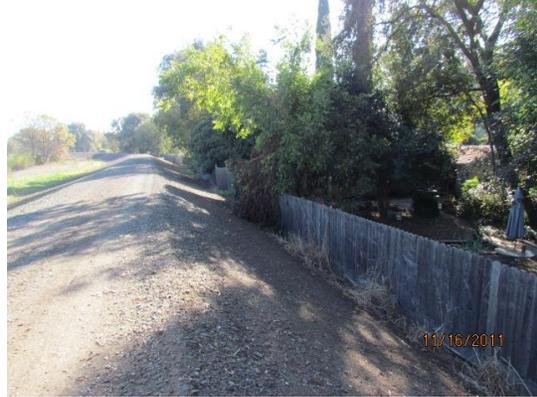
Photo 1 of 1 : FA\_2015\_NA0003\_68\_3\_20150910\_00003.jpg

LM Start	<b>1.11</b>	Rating **	U	Issue No.	<b>3</b>
LM End	<b>1.22</b>	Issue Type +	En	Location *	LS
Category	Earthen Levee		GPS Latitude/Longitude		
			Start	End	
Item	Encroachments		39.7776760 °	39.777650 °	
			-121.854022 °	-121.855687 °	
DWR ID	DWR_NA0003_04_s_2012_3				
Action/Comments					
Fence

View of the fence along the L/S toe.

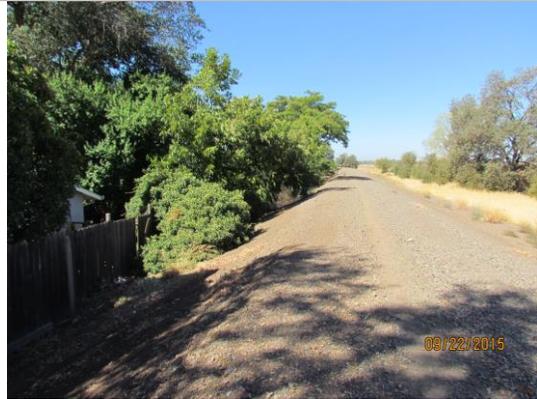
Photo 1 of 1 : FA\_2015\_NA0003\_68\_17\_20151013\_00004.jpg

LM Start	<b>1.16</b>	Rating **	M	Issue No.	<b>17</b>
LM End	<b>1.22</b>	Issue Type +	Ma	Location *	LS
Category	Earthen Levee		GPS Latitude/Longitude		
			Start	End	
Item	Trim / Thin Trees		39.777128 °	39.777580 °	
			-121.854763 °	-121.855612 °	
DWR ID	DWR_NA0003_04_f_2015_17				
Action/Comments					
Trim trees to at least five feet above ground level. Inspector Comments: Remove the trees that are overhanging the levee slope.

View of the trees overhanging the levee slope.

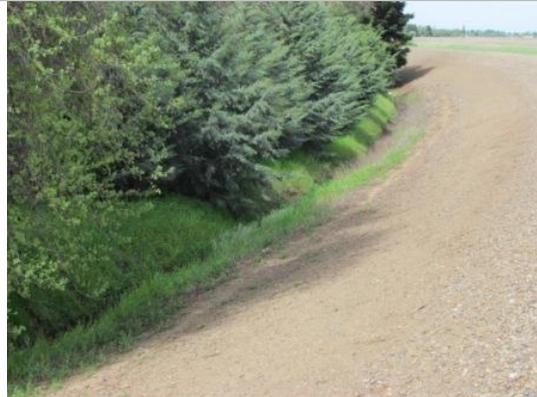
Photo 1 of 1 : FA\_2015\_NA0003\_68\_2\_20150910\_00002.jpg

LM Start	<b>1.27</b>	Rating **	M	Issue No.	<b>2</b>
LM End	<b>1.36</b>	Issue Type +	En	Location *	LS
Category	Earthen Levee		GPS Latitude/Longitude		
			Start	End	
Item	Encroachments		39.778003 °	39.778378 °	
			-121.856403 °	-121.857953 °	
DWR ID	DWR_NA0003_04_s_2012_2				
Action/Comments					
Ditch

View of ditch at the landside toe.

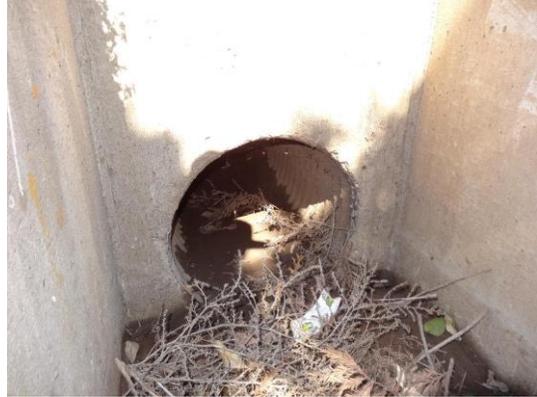
Photo 1 of 2 : UCIP\_FA\_2015\_4017.jpg

Inspector Comments: FS\_ID:31964  
 DS\_ID:19290  
 EP\_NO: N/A  
 FS\_HLM: 1.4  
 Repair Type: Non-Urgent  
 Crossing Status: Found  
 UCIP Comments: Needs cleaning and clearing the culvert.  
 FIELD\_STRUCT\_DESC: 24-inch CM pipe through the levee, 13.0 feet below the crown. Flap gate on the waterward end. Concrete "U" headwalls on both ends. Grouted riprap apron on the landward end. Grouted riprap spillway on the waterward end. O&M Manual Sac 504, May 1965.  
 FS Date: 03/07/2014

LS view: U type concrete headwall and CMP on levee slope. Vegetation debris and mud in inlet box.

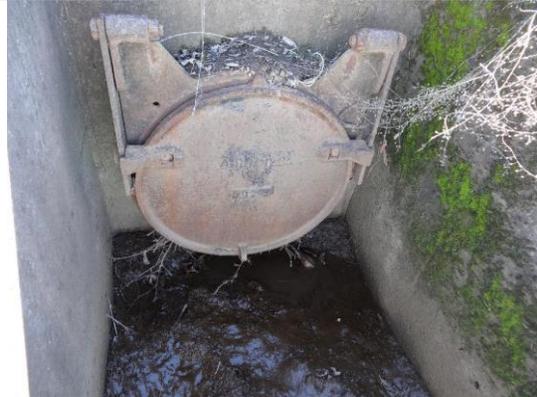
Photo 2 of 2 : UCIP\_FA\_2015\_4018.jpg

WS view: U type concrete headwall and CMP on levee slope. Vegetation debris and mud in outlet box. Needs cleaning and clearing.

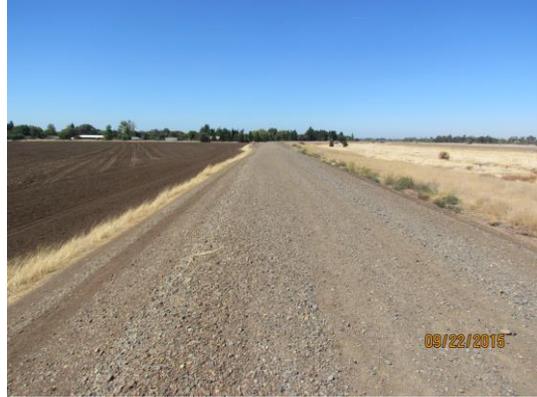
Photo 1 of 1 : FA\_2015\_NA0003\_68\_18\_20151013\_00005.jpg

LM Start	<b>1.62</b>	Rating **	A	Issue No.	<b>18</b>
LM End	<b>1.62</b>	Issue Type +	Ma	Location *	LS
Category	Earthen Levee		GPS Latitude/Longitude		
			Start	End	
Item	Vegetation		39.778842 °	39.778842 °	
			-121.862935 °	-121.862935 °	
DWR ID	DWR_NA0003_04_f_2015_18				
Action/Comments					
Control annual grass and weeds on the levee slopes and easements. Inspector Comments: Butte Co. sprayed and dragged oh slopes.

View of the slope with acceptable vegetation.

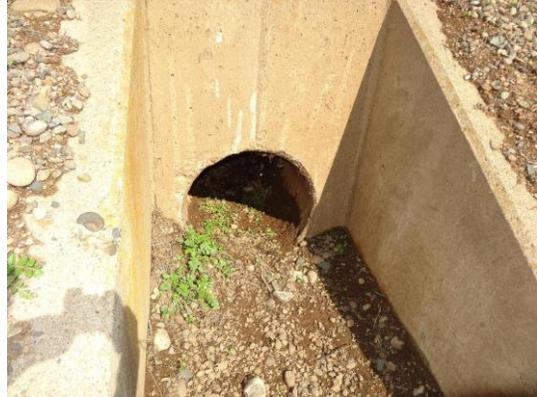
Photo 2 of 3 : UCIP\_FA\_2015\_4020.jpg

Inspector Comments: FS\_ID:31965  
 DS\_ID:19291  
 EP\_NO: N/A  
 FS\_HLM: 2.22  
 Repair Type: Non-Urgent  
 Crossing Status: Found  
 UCIP Comments: Needs cleaning and clearing the culvert.  
 FIELD\_STRUCT\_DESC: 24-inch CM pipe through the levee, 11.0 feet below the crown. Flap gate on the waterward end. Concrete "U" headwall on both ends. Grouted riprap apron on the landward end. Grouted riprap spillway on the waterward end. O&M Manual Sac 504, May 1965.  
 FS Date: 03/07/2014

LS view: U type concrete headwall and CMP on levee slope. Vegetation debris and mud in inlet box.

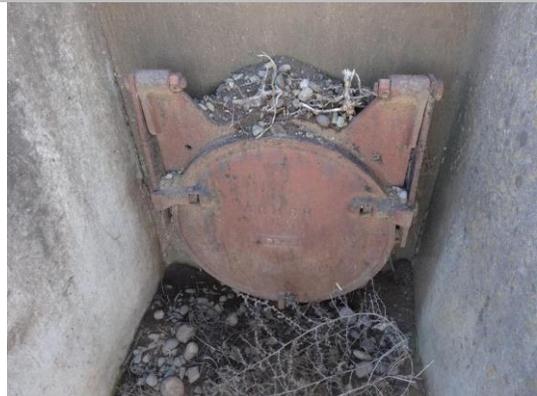
Photo 3 of 3 : UCIP\_FA\_2015\_4021.jpg

WS view: U type concrete headwall and CMP on levee slope. Vegetation debris and mud in outlet box. Needs cleaning and clearing.

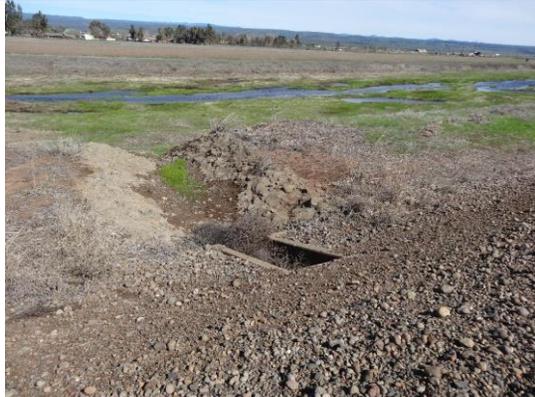
Photo 1 of 3 : UCIP\_FA\_2015\_3494.jpg

WS view: U type concrete headwall and grouted riprap spillway on levee slope.

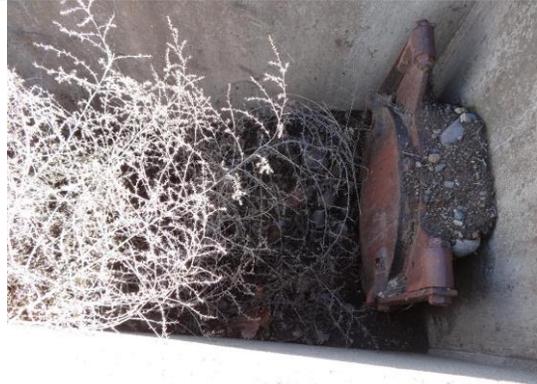
Photo 3 of 3 : UCIP\_FA\_2015\_4023.jpg

WS view: U type concrete headwall and CMP on levee slope. Vegetation debris and mud on outlet box. Needs cleaning and clearing.

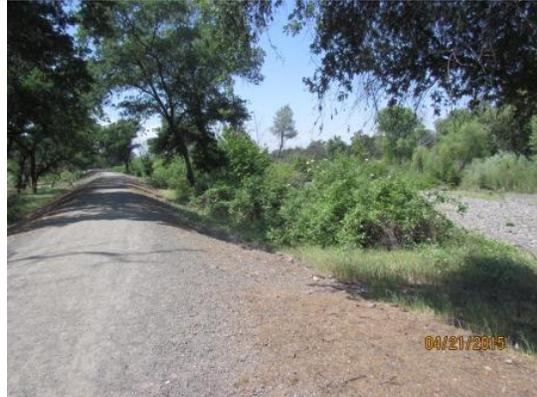
Photo 1 of 2 : FA\_2015\_NA0003\_69\_4\_20150910\_00002.jpg

LM Start	<b>0.21</b>	Rating **	M	Issue No.	<b>4</b>
LM End	<b>0.26</b>	Issue Type +	Ma	Location *	WS
Category	Earthen Levee		GPS Latitude/Longitude		
			Start	End	
Item	Vegetation		39.761957 °	39.761892 °	
			-121.792867 °	-121.793705 °	
DWR ID	DWR_NA0003_05_f_2014_4				
Action/Comments					
Remove the wild growth other than native grasses from the levee slopes. Inspector Comments: Remove the vegetation from the waterside slope.

View of the vegetation along the waterside slope.

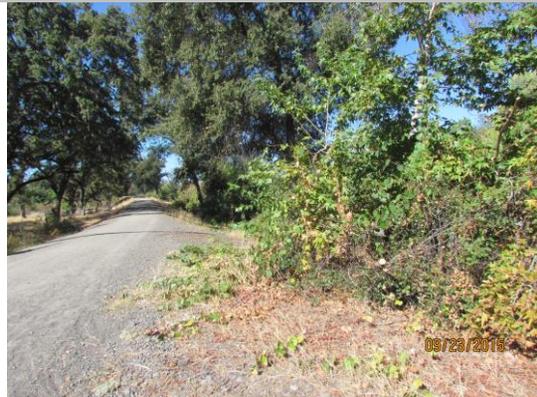
Photo 2 of 2 : FA\_2015\_NA0003\_69\_4\_20151013\_00004.jpg

LM Start	<b>0.21</b>	Rating **	M	Issue No.	<b>4 (cont)</b>
LM End	<b>0.26</b>	Issue Type +	Ma	Location *	WS

View of the vegetation along the waterside slope.

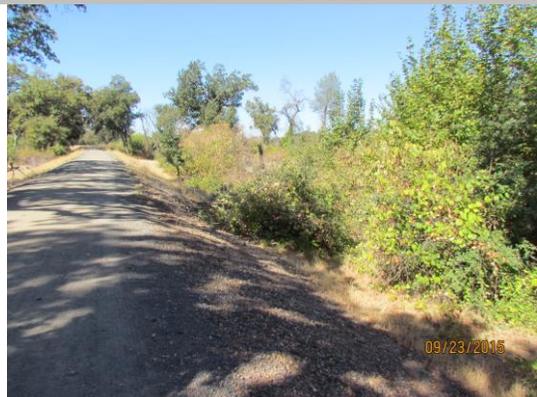
Photo 1 of 1 : FA\_2015\_NA0003\_69\_7\_20151013\_00005.jpg

LM Start	<b>0.25</b>	Rating **	M	Issue No.	<b>7</b>
LM End	<b>0.25</b>	Issue Type +	En	Location *	WS
Category	Earthen Levee		GPS Latitude/Longitude		
			Start	End	
Item	Encroachments		39.761900 °	39.761900 °	
			-121.793635 °	-121.793635 °	
DWR ID	DWR_NA0003_05_f_2015_7				
Action/Comments					
Tree or limb Inspector Comments: Remove the trees overhanging the waterside slope.

View of the trees along the waterside slope.

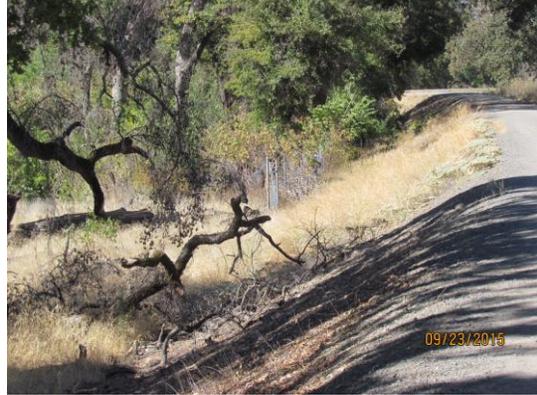
Photo 1 of 1 : FA\_2015\_NA0003\_69\_8\_20151013\_00007.jpg

LM Start	<b>0.26</b>	Rating **	M	Issue No.	<b>8</b>
LM End	<b>0.26</b>	Issue Type +	En	Location *	LS
Category	Earthen Levee		GPS Latitude/Longitude		
			Start	End	
Item	Encroachments		39.761795 °	39.761795 °	
			-121.793790 °	-121.793790 °	
DWR ID	DWR_NA0003_05_f_2015_8				
Action/Comments					
Tree or limb Inspector Comments: Remove the trees from the landside toe.

View of the trees along the landside toe.

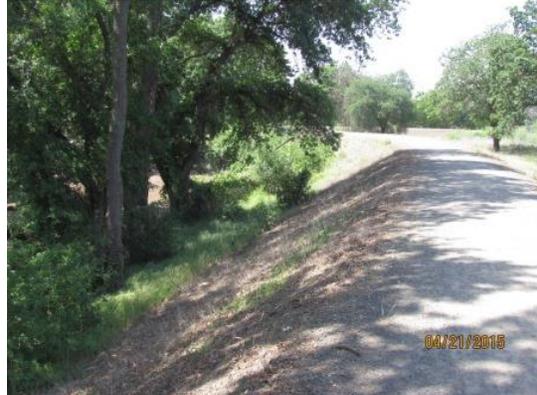
Photo 1 of 2 : FA\_2015\_NA0003\_69\_3\_20150910\_00001.jpg

LM Start	<b>0.34</b>	Rating **	M	Issue No.	<b>3</b>
LM End	<b>0.42</b>	Issue Type +	Ma	Location *	LS
Category	Earthen Levee		GPS Latitude/Longitude		
			Start	End	
Item	Vegetation		39.761633 °	39.761117 °	
			-121.795155 °	-121.796464 °	
DWR ID	DWR_NA0003_05_f_2013_3				
Action/Comments					
Remove the wild growth other than native grasses from the levee slopes. Inspector Comments: Remove the vegetation from the landside slope and toe.

View of the vegetation along the landside slope and toe

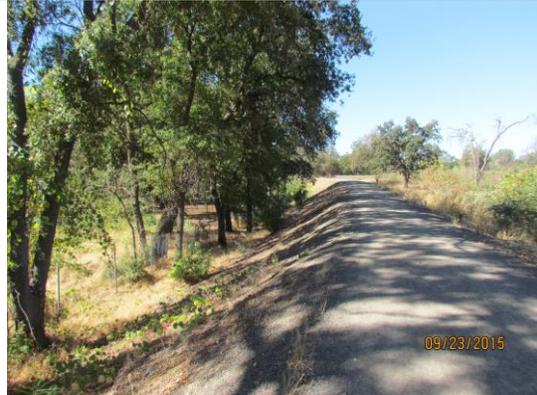
Photo 2 of 2 : FA\_2015\_NA0003\_69\_3\_20151013\_00008.jpg

LM Start	<b>0.34</b>	Rating **	M	Issue No.	<b>3 (cont)</b>
LM End	<b>0.42</b>	Issue Type +	Ma	Location *	LS

View of the vegetation along the landside slope and toe.

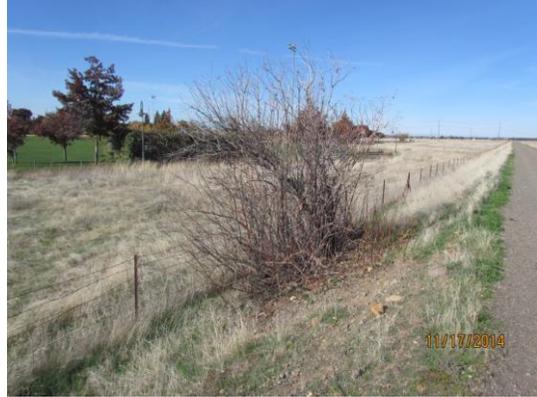
Photo 1 of 1 : FA\_2015\_NA0003\_69\_6\_20150910\_00003.jpg

LM Start	<b>0.89</b>	Rating **	A/W	Issue No.	<b>6</b>
LM End	<b>0.89</b>	Issue Type +	Ma	Location *	LS
Category	Earthen Levee		GPS Latitude/Longitude		
			Start	End	
Item	Vegetation		39.764397 °	39.764397 °	
			-121.803335 °	-121.803335 °	
DWR ID	DWR_NA0003_05_f_2014_6				
Action/Comments					
Elderberries are blocking visibility and flood fight capability. Inspector Comments: Elderberry is not completely blocking the visibility.

View of the elderberry along the landside toe.
