**Flood Control Project Maintenance
Levee Inspections**
LMA District Cover Sheet
Spring 2016 Levee Inspection Results

Butte County Department of Public Works

Spring 2016 Levee Inspection Results

Waterway		Bank	Unit Miles
Unit No. 01 Mud Creek		Right	6.80

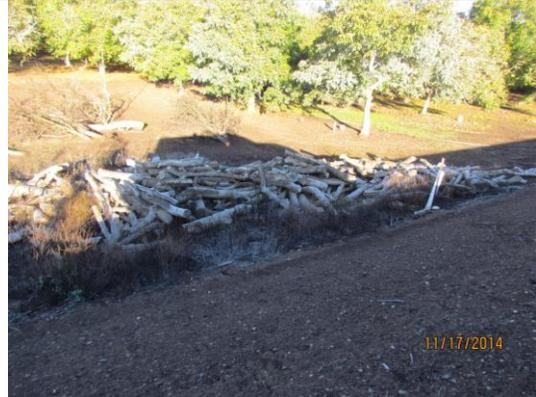
Photo 1 of 2 : SP_2016_NA0003_64_23_20160321_00006.jpg

LM Start	1.29	Rating **	M	Issue No.	23
LM End	1.29	Issue Type +	En	Location *	N/A
Category	Earthen Levee			GPS Latitude/Longitude	
				Start	End
Item	Encroachments			39.741277 °	39.741277 °
				-121.927485 °	-121.927485 °
DWR ID	DWR_NA0003_01_f_2014_23				
Comment Code					
FW : Firewood					
Inspector Comment					
Remove the firewood from the landside toe.

View of the firewood along the landside toe.

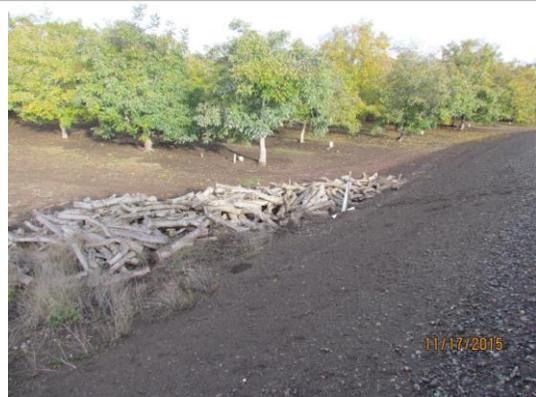
Photo 2 of 2 : SP_2016_NA0003_64_23_20160321_00007.jpg

LM Start	1.29	Rating **	M	Issue No.	23 (cont)
LM End	1.29	Issue Type +	En	Location *	N/A

View of the firewood along the landside toe.

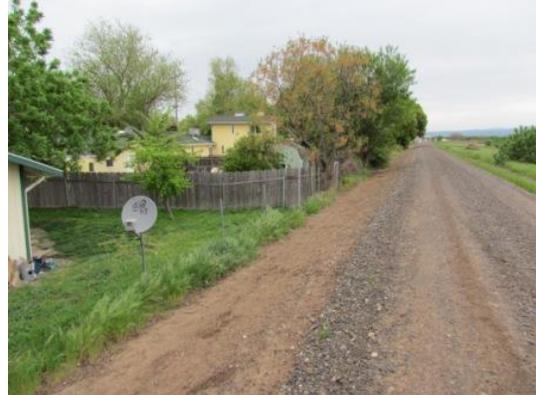
Photo 1 of 1 : SP_2016_NA0003_64_3_20160321_00002.jpg

LM Start	2.00	Rating **	U	Issue No.	3
LM End	2.04	Issue Type +	En	Location *	LS
Category	Earthen Levee		GPS Latitude/Longitude		
			Start	End	
Item	Encroachments		39.748330 °	39.748867 °	
			-121.918685 °	-121.918533 °	
DWR ID	DWR_NA0003_01_s_2012_3				
Comment Code					
FE : Fence					
Inspector Comment

View of the fences along the L/S toe.

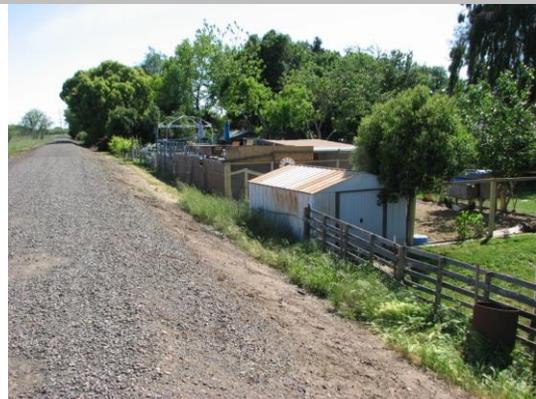
Photo 1 of 1 : SP_2016_NA0003_64_24_20160506_00049.jpg

LM Start	2.10	Rating **	U	Issue No.	24
LM End	2.10	Issue Type +	En	Location *	LS
Category	Earthen Levee			GPS Latitude/Longitude	
				Start	End
Item	Encroachments			39.749732 °	39.749732 °
				-121.918270 °	-121.918270 °
DWR ID	DWR_NA0003_01_s_2012_24				
Comment Code					
BU : Building					
Inspector Comment					
Shed and plank fencing blocking visibility.

04/25/2016: Remove/relocate metal shed at L/S toe.

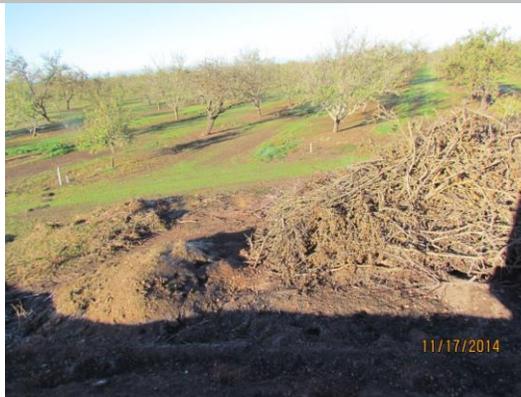
Photo 1 of 1 : SP_2016_NA0003_64_26_20160321_00009.jpg

LM Start	2.60	Rating **	M	Issue No.	26
LM End	2.60	Issue Type +	En	Location *	LS
Category	Earthen Levee		GPS Latitude/Longitude		
			Start	End	
Item	Encroachments		39.756022 °	39.756022 °	
			-121.914788 °	-121.914788 °	
DWR ID	DWR_NA0003_01_f_2014_26				
Comment Code					
PR : Prunings					
Inspector Comment

View of the prunings along the landside toe.

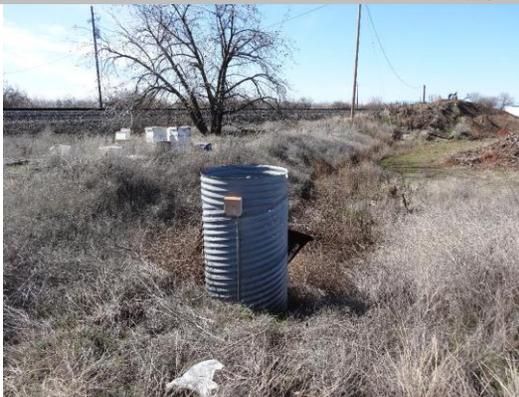
Photo 2 of 2 : UCIP_SP_2016_30291_55699.jpg

Comment Code					
Inspector Comment					
FS_ID:30291 DS_ID:19230 EP_NO: 16633 Repair Type: Non-Urgent Crossing Status: Indicator Found UCIP Comments: A concrete water control box on landside shoulder.It needs confirmation and more info from LMA and/or DWR Inspector. FIELD_STRUCT_DESC: A 2-inch diameter storm water discharge pipeline through the right bank and landward levee toe of Mud Creek. Used a 2-inch coated & wrapped steel pipe. Submerged pump in 36 inch dia CMP casing approx 10 ft from landside toe. Drainage ditch, up to 4 ft wide, runs perpendicular to levee alignment starting at CMP riser and running away from levee. (App. No. 16633) FS Date: 2/20/2014

LS view: CMP riser on levee toe and drainage ditch perpendicular to the levee.

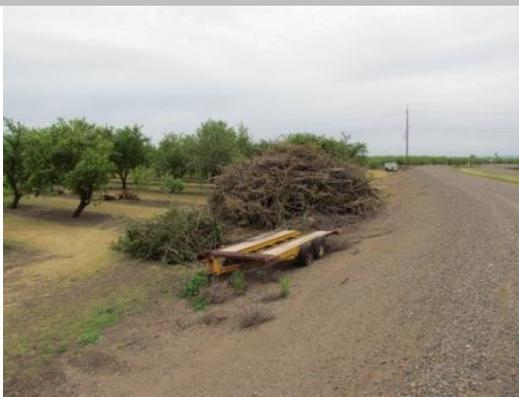
Photo 1 of 1 : SP_2016_NA0003_64_1_20160321_00001.jpg

LM Start	2.93	Rating **	M	Issue No.	1
LM End	2.93	Issue Type +	En	Location *	LS
Category	Earthen Levee			GPS Latitude/Longitude	
				Start	End
Item	Encroachments			39.759755 °	39.759755 °
				-121.911160 °	-121.911160 °
DWR ID	DWR_NA0003_01_s_2012_1				
Comment Code					
PR : Prunings					
Inspector Comment

View of the pruning pile along the L/S toe.

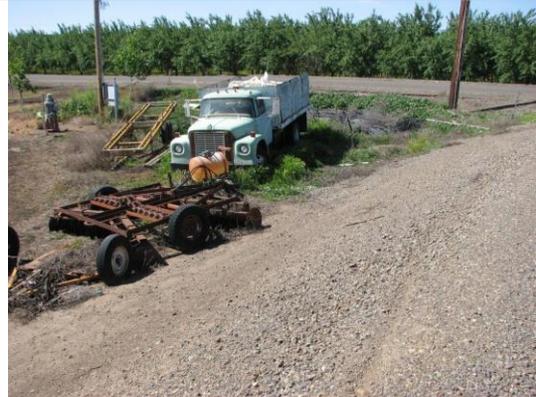
Photo 1 of 1 : SP_2016_NA0003_64_39_20160506_00047.jpg

LM Start	2.98	Rating **	U	Issue No.	39
LM End	2.98	Issue Type +	En	Location *	LS
Category	Earthen Levee		GPS Latitude/Longitude		
			Start	End	
Item	Encroachments		39.760539 °	39.760539 °	
			-121.911376 °	-121.911376 °	
DWR ID	DWR_NA0003_01_s_2016_39				
Comment Code					
AV : Abandoned vehicles					
Inspector Comment					
Truck and farm equipment blocking landside toe.

04/25/2016: Remove equipment/vehicles from L/S toe.

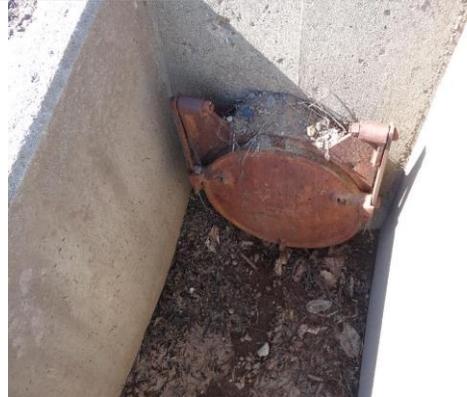
Photo 1 of 2 : UCIP_SP_2016_30294_55704.jpg

LM Start	3.03	Rating **	M	Issue No.	46
LM End	3.03	Issue Type +	En	Location *	LS
Category	Supplemental		GPS Latitude/Longitude		
			Start	End	
Item	DWR UCIP Field Study		39.761224 °	39.761224 °	
			-121.911108 °	-121.911108 °	
DWR ID					
Comment Code					
Inspector Comment					
FS_ID:30294 DS_ID:19216 EP_NO: N/A Repair Type: Non-Urgent Crossing Status: Found UCIP Comments: Inlet and outlet needs cleaning and clearing of debris. FIELD_STRUCT_DESC: 24-inch CM pipe through levee, 8.5 feet below the crown. Flap gate on the waterward end. Concrete "U" headwalls on both ends. Grouted riprap apron on the landward end. Grouted riprap spillway on the waterward end. O&M Manual Sac 504, May 1965. FS Date: 2/20/2014

WS view: U type concrete headwall, flapgate on levee slope.

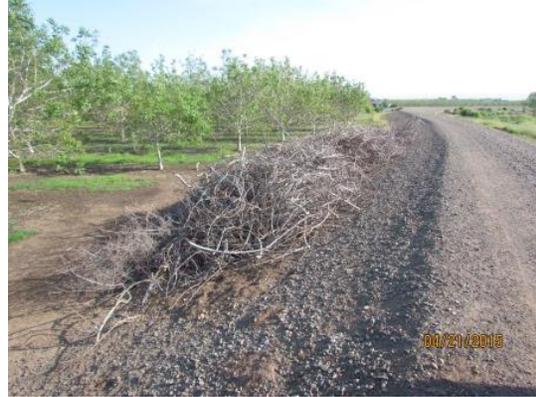
Photo 1 of 2 : SP_2016_NA0003_64_31_20160321_00012.jpg

LM Start	3.15	Rating **	M	Issue No.	31 (cont)
LM End	3.15	Issue Type +	En	Location *	LS

View of the prunings along the landside slope.

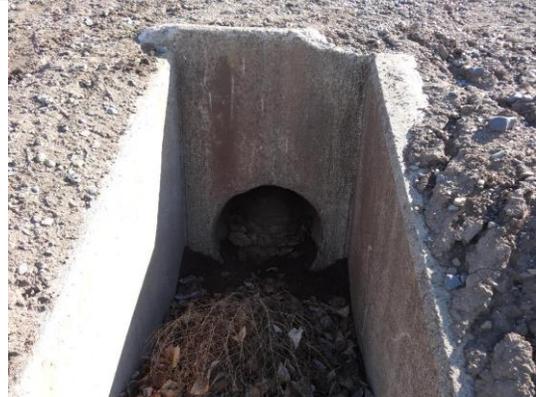
Photo 2 of 2 : UCIP_SP_2016_30310_55740.jpg

LM Start	3.39	Rating **	M	Issue No.	48 (cont)
LM End	3.39	Issue Type +	En	Location *	LS
Category	Supplemental			GPS Latitude/Longitude	
				Start	End
Item	DWR UCIP Field Study			39.765440 °	39.765440 °
				-121.907261 °	-121.907261 °
DWR ID					
Comment Code					
Inspector Comment					
FS_ID:30310 DS_ID:19218 EP_NO: N/A Repair Type: Non-Urgent Crossing Status: Found UCIP Comments: Needs cleaning and clearing of debris. FIELD_STRUCT_DESC: 24-inch CM pipe through the levee, 10.0 feet below the crown. Flap gate on the waterward end. Concrete "U" headwalls on both ends. Grouted riprap apron on the landward end. Grouted riprap spillway on the waterward end. O&M Manual Sac 504, May 1965. FS Date: 2/20/2014

LS view: U type concrete headwall and CMP on levee slope.

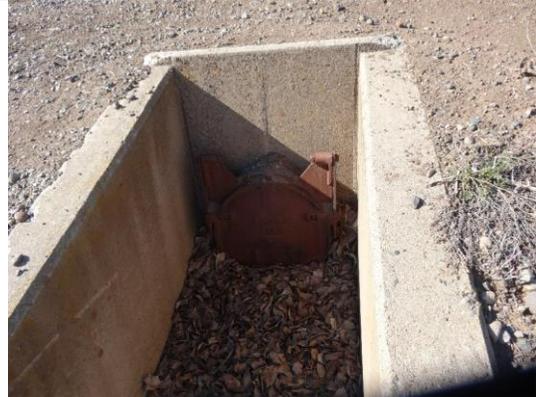
Photo 1 of 2 : UCIP_SP_2016_30311_55743.jpg

LM Start	3.97	Rating **	M	Issue No.	49
LM End	3.97	Issue Type +	En	Location *	LS
Category	Supplemental		GPS Latitude/Longitude		
			Start	End	
Item	DWR UCIP Field Study		39.771293 °	39.771293 °	
			-121.900247 °	-121.900247 °	
DWR ID					
Comment Code					
Inspector Comment					
FS_ID:30311 DS_ID:19219 EP_NO: N/A Repair Type: Non-Urgent Crossing Status: Found UCIP Comments: Needs cleaning and clearing of debris in both ends of the pipe. FIELD_STRUCT_DESC: 24-inch CM pipe through the levee, 9.0 feet below the crown. Flap gate on the waterward end. Concrete "U" headwalls on both ends. Grouted riprap apron on the landward end. Grouted riprap spillway on the waterward end. O&M Manual Sac 504, May 1965. FS Date: 2/20/2014

WS view: U type concrete headwall, pipe, and flapgate on levee slope. Vegetation debris blocking outlet.

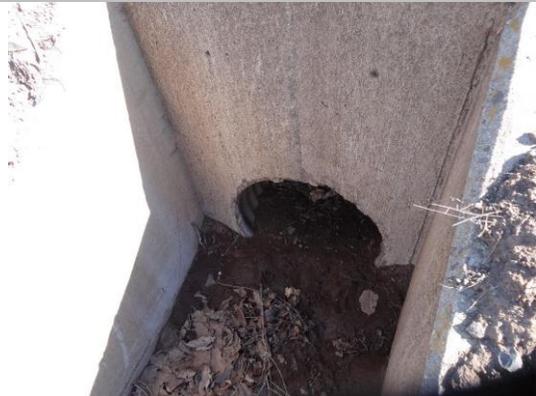
Photo 2 of 2 : UCIP_SP_2016_30311_55742.jpg

LS view: U type concrete headwall and CMP on levee slope.

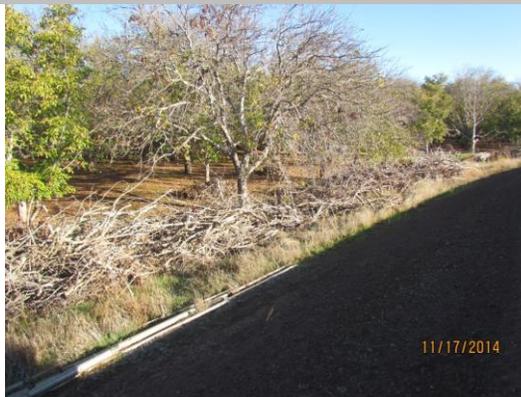
Photo 1 of 1 : SP_2016_NA0003_64_29_20160321_00011.jpg

LM Start	4.03	Rating **	M	Issue No.	29
LM End	4.03	Issue Type +	En	Location *	LS
Category	Earthen Levee		GPS Latitude/Longitude		
			Start	End	
Item	Encroachments		39.771843 °	39.771843 °	
			-121.899437 °	-121.899437 °	
DWR ID	DWR_NA0003_01_f_2014_29				
Comment Code					
PR : Prunings					
Inspector Comment

View of the prunings along the landside toe.

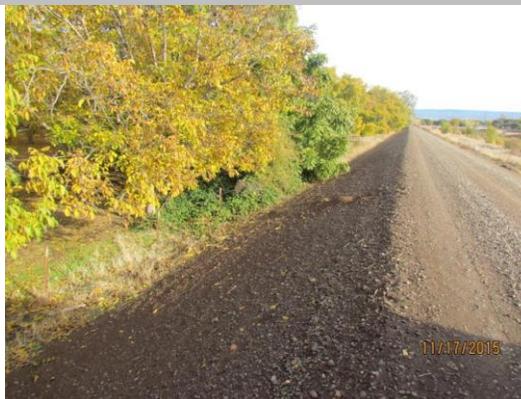
Photo 1 of 1 : SP_2016_NA0003_64_33_20160321_00015.jpg

LM Start	4.27	Rating **	M	Issue No.	33
LM End	4.27	Issue Type +	Ma	Location *	LS
Category	Earthen Levee		GPS Latitude/Longitude		
			Start	End	
Item	Animal Control		39.773398 °	39.773398 °	
			-121.895765 °	-121.895765 °	
DWR ID	DWR_NA0003_01_f_2015_33				
Comment Code					
A1 : Exterminate rodents and backfill and compact or grout burrows.					
Inspector Comment					
Repair the rodent holes along the landside slope.

View of the rodent holes along the landside slope.

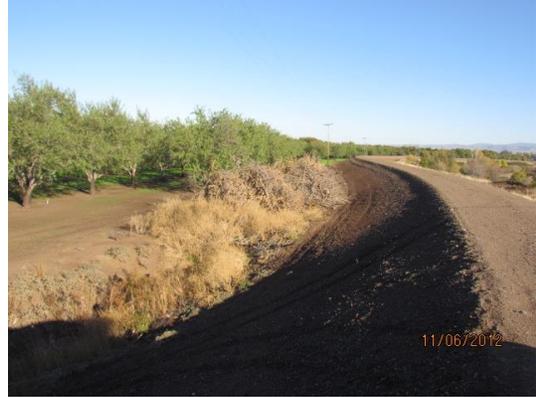
Photo 1 of 1 : SP_2016_NA0003_64_21_20160321_00005.jpg

LM Start	4.46	Rating **	M	Issue No.	21
LM End	4.46	Issue Type +	En	Location *	LS
Category	Earthen Levee		GPS Latitude/Longitude		
			Start	End	
Item	Encroachments		39.775908 °	39.775908 °	
			-121.893947 °	-121.893947 °	
DWR ID	DWR_NA0003_01_s_2012_21				
Comment Code					
PR : Prunings					
Inspector Comment

View of the brush pile along landside toe.

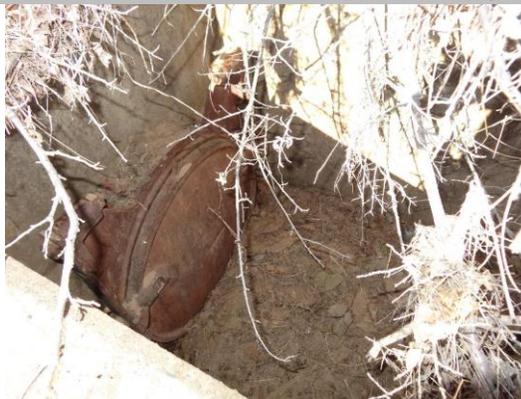
Photo 1 of 2 : UCIP_SP_2016_30388_55891.jpg

Comment Code					
Inspector Comment					
FS_ID:30388 DS_ID:19221 EP_NO: N/A Repair Type: Non-Urgent Crossing Status: Found UCIP Comments: CM Standpipe intake. Intake pipe with air vent. Steel rib-bar grit cover on the standpipe on landside levee toe. Needs cleaning and clearing on both ends of the pipe. FIELD_STRUCT_DESC: 24-inch CM pipe through the levee, 15.0 feet below the crown. Flap gate on the waterward end. Concrete "U" headwalls on waterside ends. Grouted riprap spillway on the waterward end. CM Standpipe intake. Intake pipe with air vent. Steel rib-bar grit cover on the standpipe on landside levee toe. O&M Manual Sac 504, May 1965. FS Date: 2/20/2014

WS view: U type concrete headwall, pipe, and flapgate on levee slope. Vegetation/soil debris blocking outlet.

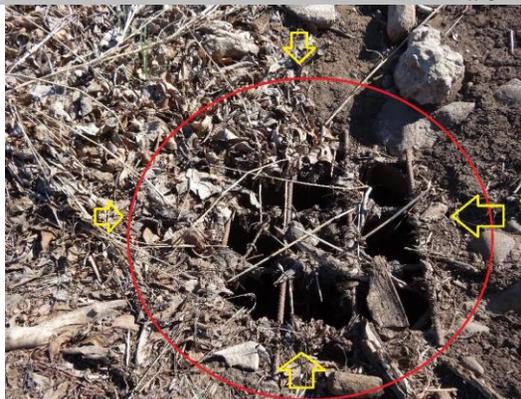
Photo 2 of 2 : UCIP_SP_2016_30388_55890.jpg

LS view: Underground CM standpipe intake with steel grit on levee toe.

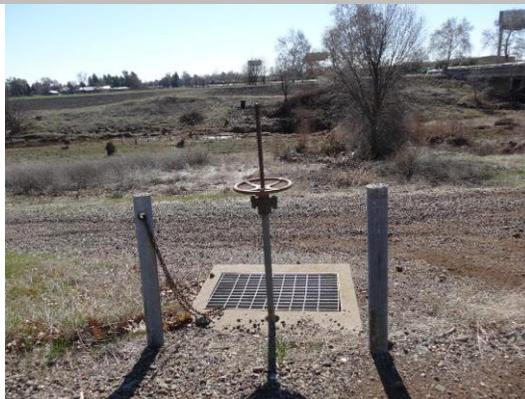
Photo 1 of 2 : UCIP_SP_2016_30368_55861.jpg

LM Start	5.30	Rating **	M	Issue No.	51
LM End	5.30	Issue Type +	En	Location *	LS
Category	Supplemental			GPS Latitude/Longitude	
				Start	End
Item	DWR UCIP Field Study			39.784739 °	39.784739 °
				-121.884860 °	-121.884860 °
DWR ID					
Comment Code					
Inspector Comment					
FS_ID:30368 DS_ID:19223 EP_NO: N/A Repair Type: Non-Urgent Crossing Status: Found UCIP Comments: 12-inch steel pipe about 14 ft below the crown. FIELD_STRUCT_DESC: 12-inch steel pipeline through levee, 14-ft below the crown. Slide gate in concrete box on waterward slope. Flap gate on waterward side. Grouted rock revetment on waterward slope. Three pumps on concrete pad on landside. FS Date: 2/24/2014

WS view: slide gate in concrete box on levee slope.

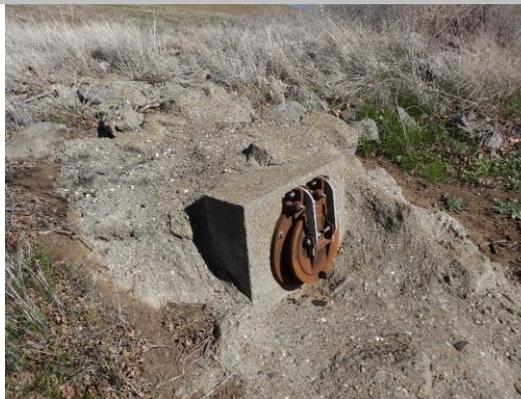
Photo 2 of 2 : UCIP_SP_2016_30368_55860.jpg

LM Start	5.30	Rating **	M	Issue No.	51 (cont)
LM End	5.30	Issue Type +	En	Location *	LS
Category	Supplemental			GPS Latitude/Longitude	
				Start	End
Item	DWR UCIP Field Study			39.784739 °	39.784739 °
				-121.884860 °	-121.884860 °
DWR ID					
Comment Code					
Inspector Comment					
FS_ID:30368 DS_ID:19223 EP_NO: N/A Repair Type: Non-Urgent Crossing Status: Found UCIP Comments: 12-inch steel pipe about 14 ft below the crown. FIELD_STRUCT_DESC: 12-inch steel pipeline through levee, 14-ft below the crown. Slide gate in concrete box on waterward slope. Flap gate on waterward side. Grouted rock revetment on waterward slope. Three pumps on concrete pad on landside. FS Date: 2/24/2014

WS view: concrete headwall and flapgate on levee slope.

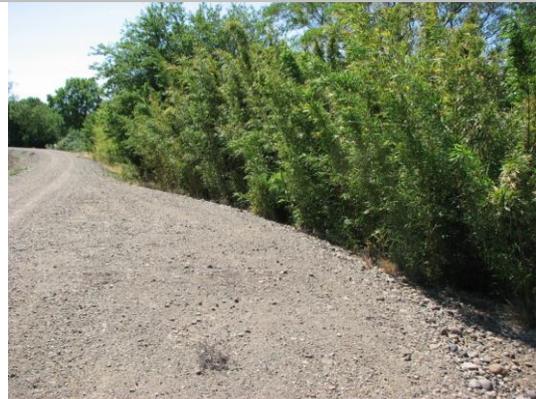
Photo 1 of 1 : SP_2016_NA0003_64_35_20160506_00044.jpg

LM Start	6.09	Rating **	U	Issue No.	35
LM End	6.13	Issue Type +	En	Location *	LS
Category	Earthen Levee		GPS Latitude/Longitude		
			Start	End	
Item	Vegetation		39.794875 °	39.795179 °	
			-121.886394 °	-121.885835 °	
DWR ID	DWR_NA0003_01_s_2016_35				
Comment Code					
V6 : Landscaping					
Inspector Comment					
Bamboo vegetation along landside toe blocking visibility.

04/25/2016: Trim vegetation at L/S toe.

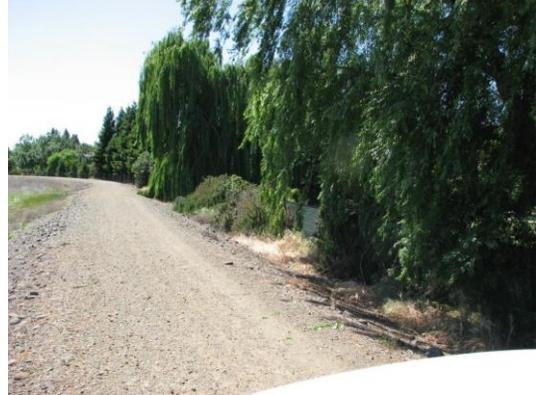
Photo 1 of 1 : SP_2016_NA0003_64_30_20160506_00042.jpg

LM Start	6.36	Rating **	M	Issue No.	30
LM End	6.39	Issue Type +	En	Location *	LS
Category	Earthen Levee		GPS Latitude/Longitude		
			Start	End	
Item	Vegetation		39.797714 °	39.797884 °	
			-121.883384 °	-121.882883 °	
DWR ID	DWR_NA0003_01_s_2016_30				
Comment Code					
V6 : Landscaping					
Inspector Comment					
Willows and rosemary landscaping covering landside toe. Partially blocking visibility.

04/25/2016: Trim vegetation and trees on L/S slope.

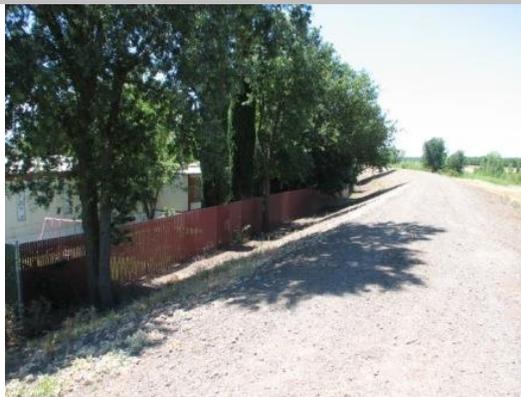
Photo 1 of 1 : SP_2016_NA0003_65_3_20160321_00002.jpg

LM Start	1.49	Rating **	U	Issue No.	3
LM End	1.81	Issue Type +	En	Location *	LS
Category	Earthen Levee		GPS Latitude/Longitude		
			Start	End	
Item	Encroachments		39.782773 °	39.778972 °	
			-121.888178 °	-121.891563 °	
DWR ID	DWR_NA0003_02_s_2012_3				
Comment Code					
FE : Fence					
Inspector Comment					
The fence is within the easement.

View of the fence along the landside toe of the levee.

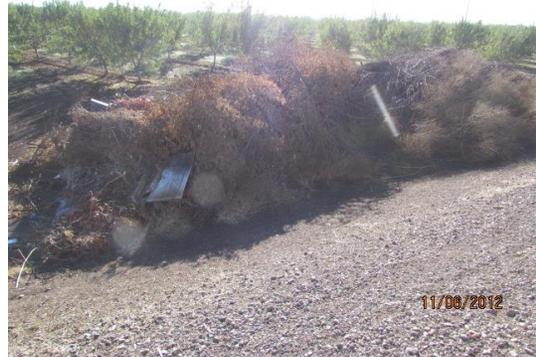
Photo 1 of 1 : SP_2016_NA0003_65_5_20160321_00003.jpg

LM Start	3.31	Rating **	M	Issue No.	5
LM End	3.31	Issue Type +	En	Location *	LS
Category	Earthen Levee		GPS Latitude/Longitude		
			Start	End	
Item	Encroachments		39.763208 °	39.763208 °	
			-121.908517 °	-121.908517 °	
DWR ID	DWR_NA0003_02_f_2012_5				
Comment Code					
PR : Prunings					
Inspector Comment

View of the brush pile along landside toe.

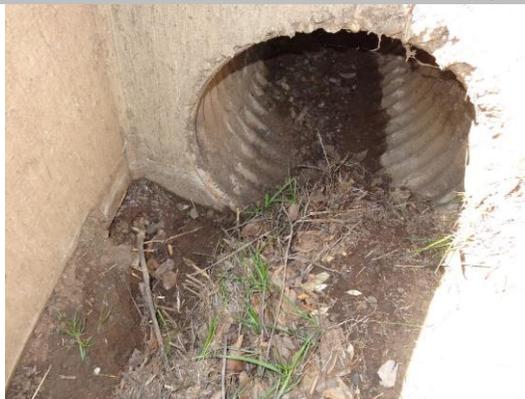
Photo 2 of 2 : UCIP_SP_2016_31028_56912.jpg

LM Start	4.61	Rating **	M	Issue No.	24 (cont)
LM End	4.61	Issue Type +	En	Location *	LS
Category	Supplemental			GPS Latitude/Longitude	
				Start	End
Item	DWR UCIP Field Study			39.748731 °	39.748731 °
				-121.917577 °	-121.917577 °
DWR ID					
Comment Code					
Inspector Comment					
FS_ID:31028 DS_ID:19245 EP_NO: N/A Repair Type: Non-Urgent Crossing Status: Found UCIP Comments: Needs cleaning and clearing of debris. FIELD_STRUCT_DESC: 24-inch CM pipe through the levee, 10.0 feet below the crown. Flap gate on the waterward end. Concrete "U" headwalls on both ends. Grouted riprap apron on the landward end. Grouted riprap spillway on the waterward end. O&M Manual Sac 504, May 1965. FS Date: 2/25/2014

LS view: U type concrete headwall and CMP on levee slope.

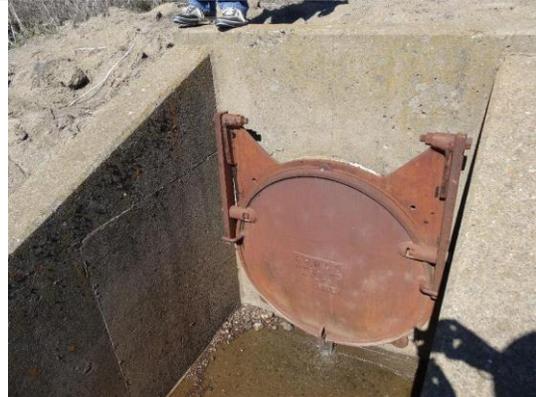
Photo 1 of 2 : UCIP_SP_2016_32103_58602.jpg

LM Start	0.10	Rating **	M	Issue No.	18 (cont)
LM End	0.10	Issue Type +	En	Location *	WS

WS view: U type concrete headwall, pipe, and flapgate on levee slope.

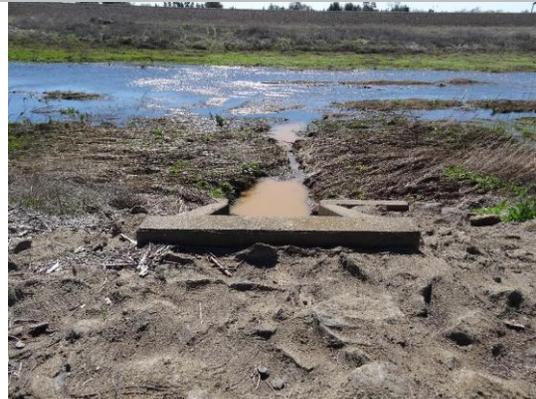
Photo 2 of 2 : UCIP_SP_2016_32103_58601.jpg

WS view: U type concrete headwall of CMP culvert on levee slope. Grouted riprap levee slope and spillway.

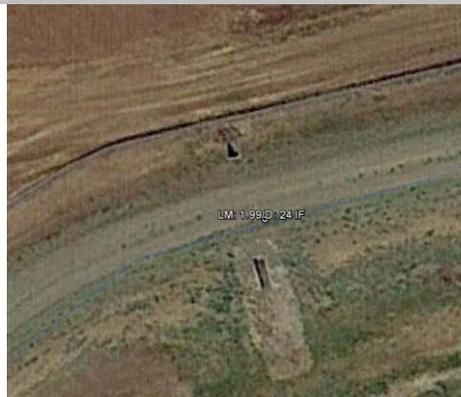
Photo 1 of 1 : UCIP_SP_2016_31900_58189.jpg

LM Start	1.96	Rating **	M	Issue No.	19
LM End	1.96	Issue Type +	En	Location *	WS
Category	Supplemental		GPS Latitude/Longitude		
			Start	End	
Item	DWR UCIP Field Study		39.781714 °	39.781714 °	
			-121.850868 °	-121.850868 °	
DWR ID					
Comment Code					
Inspector Comment					
FS_ID:31900 DS_ID:19266 EP_NO: N/A Repair Type: Non-Urgent Crossing Status: Indicator Found UCIP Comments: Needs location confirmation, GPS reading has not taken due to access problem. FIELD_STRUCT_DESC: 24-inch CM pipe through the levee, 8.0 feet below the crown. Flap gate on the waterward end. Concrete "U" headwalls on both ends. Grouted riprap apron on the landward end. Grouted riprap spillway on the waterward end. O&M Manual Sac 504, May 1965. FS Date: 3/11/2014

Bird's eye view: concrete headwall visible on both sides of the levee. Grouted riprap spillway on waterside.

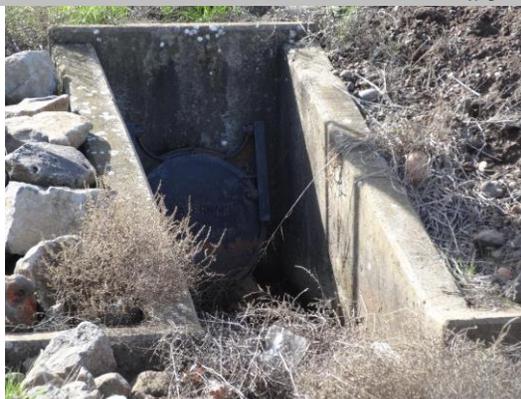
Photo 1 of 2 : UCIP_SP_2016_32124_58625.jpg

LM Start	2.17	Rating **	M	Issue No.	16
LM End	2.17	Issue Type +	En	Location *	WS
Category	Supplemental		GPS Latitude/Longitude		
			Start	End	
Item	DWR UCIP Field Study		39.785290 °	39.785290 °	
			-121.844235 °	-121.844235 °	
DWR ID					
Comment Code					
Inspector Comment					
FS_ID:32124 DS_ID:19267 EP_NO: N/A Repair Type: Non-Urgent Crossing Status: Found UCIP Comments: Pipe is about 4 feet below the crown. Needs cleaning and clearing the culvert. FIELD_STRUCT_DESC: 24-inch CM pipe through the levee, 6.0 feet below the crown. Flap gate on the waterward end. Concrete "U" headwall on each end. O&M Manual Sac 504, May 1965. FS Date: 3/7/2014

WS view: concrete headwall, pipe, and flapgate on levee slope. Vegetation and mud on outlet box.

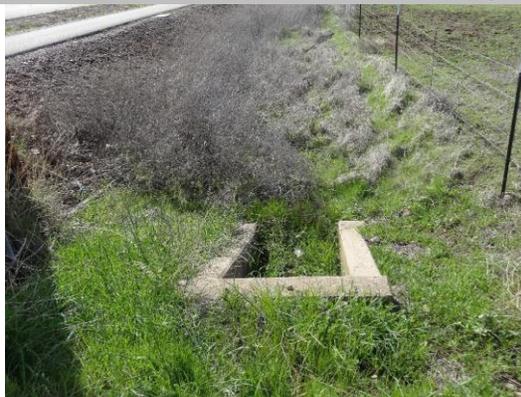
Photo 2 of 2 : UCIP_SP_2016_32124_58624.jpg

LM Start	2.17	Rating **	M	Issue No.	16 (cont)
LM End	2.17	Issue Type +	En	Location *	WS
Category	Supplemental			GPS Latitude/Longitude	
				Start	End
Item	DWR UCIP Field Study			39.785290 °	39.785290 °
				-121.844235 °	-121.844235 °
DWR ID					
Comment Code					
Inspector Comment					
FS_ID:32124 DS_ID:19267 EP_NO: N/A Repair Type: Non-Urgent Crossing Status: Found UCIP Comments: Pipe is about 4 feet below the crown. Needs cleaning and clearing the culvert. FIELD_STRUCT_DESC: 24-inch CM pipe through the levee, 6.0 feet below the crown. Flap gate on the waterward end. Concrete "U" headwall on each end. O&M Manual Sac 504, May 1965. FS Date: 3/7/2014

LS view: U type concrete headwall of CMP culvert on levee slope. Vegetation on inlet box.

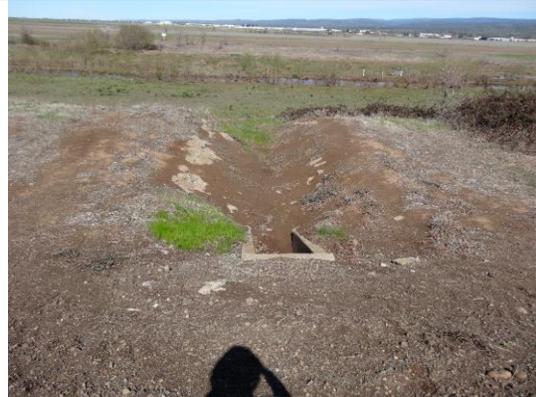
Photo 1 of 2 : UCIP_SP_2016_32026_58520.jpg

LM Start	0.27	Rating **	M	Issue No.	30
LM End	0.27	Issue Type +	En	Location *	LS
Category	Supplemental			GPS Latitude/Longitude	
				Start	End
Item	DWR UCIP Field Study			39.776554 °	39.776554 °
				-121.850730 °	-121.850730 °
DWR ID					
Comment Code					
Inspector Comment					
FS_ID:32026 DS_ID:19279 EP_NO: N/A Repair Type: Non-Urgent Crossing Status: Found UCIP Comments: Needs cleaning and clearing the culvert. FIELD_STRUCT_DESC: 24-inch CM pipe through the levee, 10.0 feet below the crown. Flap gate on the waterward end. Concrete "U" headwalls on both ends. Grouted riprap apron on the landward end. Grouted riprap spillway on the waterward end. O&M Manual Sac 504, May 1965. FS Date: 3/7/2014

WS view: concrete headwall and grouted riprap spillway on levee slope.

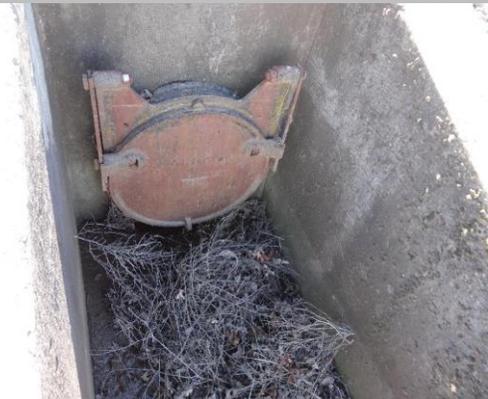
Photo 2 of 2 : UCIP_SP_2016_32026_58519.jpg

WS view: U type concrete headwall and CMP on levee slope. Mud and vegetation debris on outlet box.

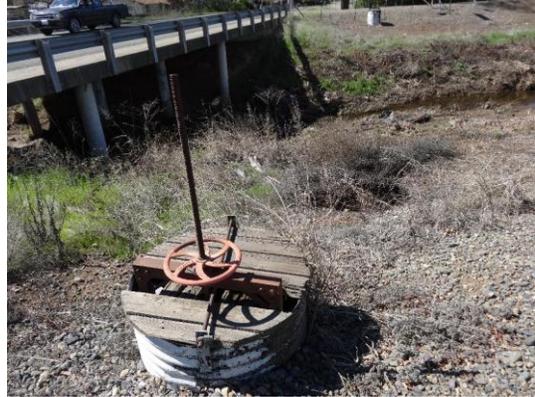
Photo 1 of 2 : UCIP_SP_2016_32025_58512.jpg

LM Start	0.33	Rating **	M	Issue No.	29
LM End	0.33	Issue Type +	En	Location *	LS
Category	Supplemental			GPS Latitude/Longitude	
				Start	End
Item	DWR UCIP Field Study			39.775926°	39.775926°
				-121.850647°	-121.850647°
DWR ID					
Comment Code					
Inspector Comment					
FS_ID:32025 DS_ID:19280 EP_NO: N/A Repair Type: Non-Urgent Crossing Status: Found UCIP Comments: Slide gate in a CMP riser. Vegetation debris and mud on inlet box.Needs cleaning and clearing the culvert. FIELD_STRUCT_DESC: 24-inch CM pipe through the levee and under the channel, 9.5 feet below the crown. Slide gate in CM pipe riser on the waterward slope. Concrete "U" headwall on the landward end. O&M Manual Sac 504, May 1965. FS Date: 3/7/2014

WS view: slide gate in CMP riser on waterside shoulder.

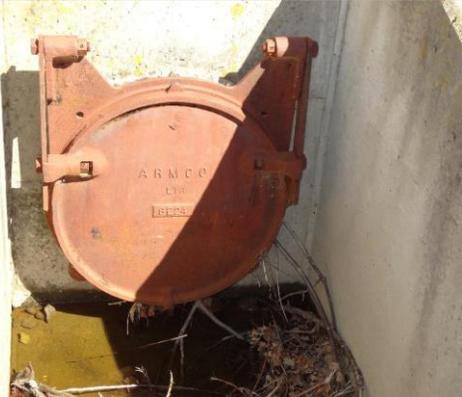
Photo 1 of 2 : UCIP_SP_2016_32023_58505.jpg

LM Start	0.35	Rating **	M	Issue No.	28
LM End	0.35	Issue Type +	En	Location *	LS
Category	Supplemental			GPS Latitude/Longitude	
				Start	End
Item	DWR UCIP Field Study			39.775682°	39.775682°
				-121.850375°	-121.850375°
DWR ID					
Comment Code					
Inspector Comment					
FS_ID:32023 DS_ID:19281 EP_NO: N/A Repair Type: Non-Urgent Crossing Status: Found UCIP Comments: Needs cleaning and clearing the culvert. FIELD_STRUCT_DESC: 24-inch CM pipe through the levee, 8.0 feet below the crown. Flap gate on the waterward end. Concrete "U" headwall on both ends. Grouted riprap apron on the landward end. Grouted riprap spillway on the waterward end. O&M Manual Sac 504, May 1965. FS Date: 3/7/2014

WS view: U type concrete headwall and CMP on levee slope. Vegetation debris and mud on outlet box. Needs cleaning and clearing.

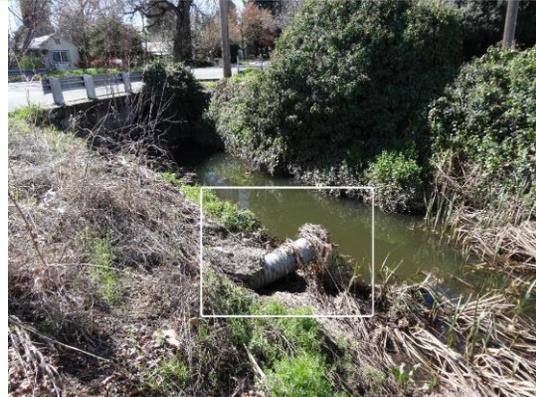
Photo 1 of 2 : UCIP_SP_2016_31968_58407.jpg

LM Start	0.71	Rating **	U	Issue No.	27
LM End	0.71	Issue Type +	En	Location *	LS
Category	Supplemental			GPS Latitude/Longitude	
				Start	End
Item	DWR UCIP Field Study			39.772907 °	39.772907 °
				-121.845949 °	-121.845949 °
DWR ID					
Comment Code					
Inspector Comment					
FS_ID:31968 DS_ID:19284 EP_NO: N/A Repair Type: Urgent Crossing Status: Found UCIP Comments: Flap gate missing. Pipe support needs to be repaired. Needs cleaning and clearing the pipe outlet. FIELD_STRUCT_DESC: 12-inch CM pipe through the patrol road, 4.3 feet below the crown. FS Date: 3/7/2014

WS view: CM outfall drain pipe on levee slope.

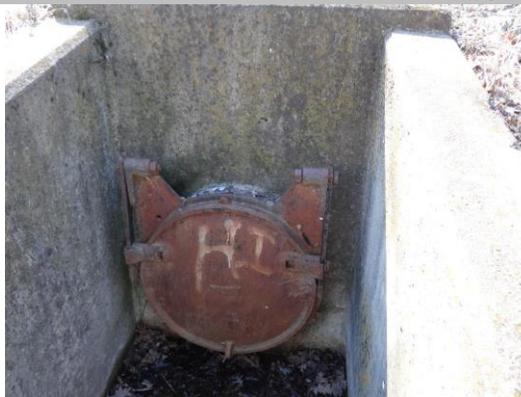
Photo 1 of 2 : UCIP_SP_2016_32143_58641.jpg

LM Start	0.92	Rating **	M	Issue No.	20
LM End	0.92	Issue Type +	En	Location *	LS
Category	Supplemental			GPS Latitude/Longitude	
				Start	End
Item	DWR UCIP Field Study			39.775704 °	39.775704 °
				-121.850901 °	-121.850901 °
DWR ID					
Comment Code					
Inspector Comment					
FS_ID:32143 DS_ID:19287 EP_NO: N/A Repair Type: Non-Urgent Crossing Status: Found UCIP Comments: Needs cleaning and clearing the culvert. FIELD_STRUCT_DESC: 24-inch CM pipe through the levee, 9.0 feet below the crown. Flap gate on the waterward end. Concrete "U" headwalls on both ends. Grouted riprap apron on the landward end. Grouted riprap spillway on the waterward end. O&M Manual Sac 504, May 1965. FS Date: 3/7/2014

WS view: U type concrete headwall and CMP on levee slope. Soil/mud on outlet box. Needs cleaning and clearing.

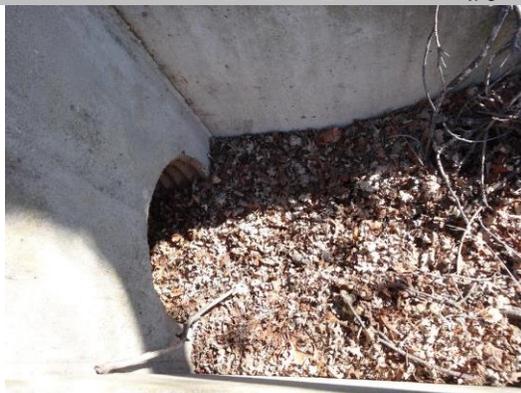
Photo 2 of 2 : UCIP_SP_2016_32143_58640.jpg

LS view: U type concrete headwall and CMP on levee slope. Vegetation and mud on inlet box.

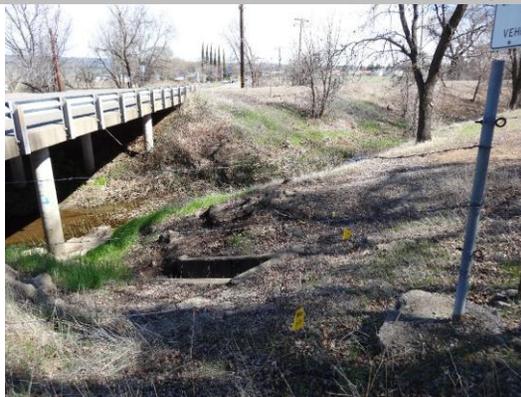
Photo 1 of 2 : UCIP_SP_2016_31946_58357.jpg

LM Start	0.92	Rating **	M	Issue No.	22
LM End	0.92	Issue Type +	En	Location *	LS
Category	Supplemental			GPS Latitude/Longitude	
				Start	End
Item	DWR UCIP Field Study			39.775729 °	39.775729 °
				-121.850950 °	-121.850950 °
DWR ID					
Comment Code					
Inspector Comment					
FS_ID:31946 DS_ID:19293 EP_NO: 15950 Repair Type: Non-Urgent Crossing Status: Indicator Found UCIP Comments: Only little gasline indicator flags found on both sides of the levee and across the creek. FIELD_STRUCT_DESC: 6-inch-diameter high pressure gas main line under both levees and across channel of Dry Creek. 2 feet below the crown. Application No. 15950, 1992. FS Date: 3/7/2014

WS view: little gasline indicator (yellow flags) on both sides of the levee.

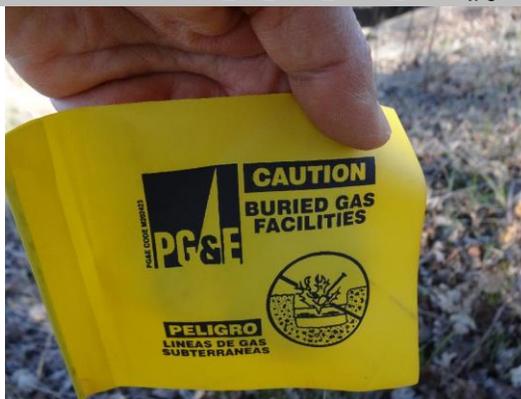
Photo 2 of 2 : UCIP_SP_2016_31946_58356.jpg

WS view: close up view of little gasline indicator.

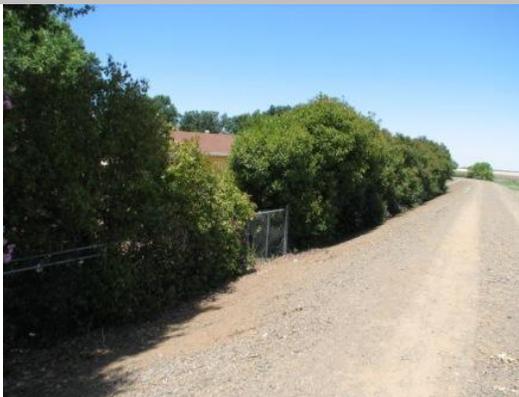
Photo 1 of 1 : SP_2016_NA0003_68_1_20160321_00001.jpg

LM Start	0.94	Rating **	U	Issue No.	1
LM End	1.01	Issue Type +	En	Location *	LS
Category	Earthen Levee		GPS Latitude/Longitude		
			Start	End	
Item	Encroachments		39.776013 °	39.776595 °	
			-121.851175 °	-121.852005 °	
DWR ID	DWR_NA0003_04_s_2012_1				
Comment Code					
FE : Fence					
Inspector Comment					
Chainlink fences are unpermitted.

View of the fence and trees along the landside toe of the levee.

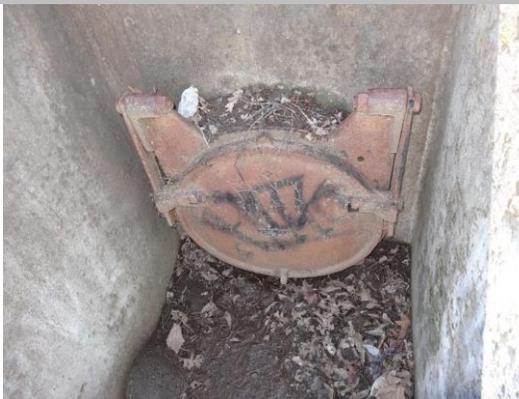
Photo 1 of 2 : UCIP_SP_2016_31963_58384.jpg

LM Start	1.11	Rating **	M	Issue No.	23
LM End	1.11	Issue Type +	En	Location *	LS
Category	Supplemental		GPS Latitude/Longitude		
			Start	End	
Item	DWR UCIP Field Study		39.776709 °	39.776709 °	
			-121.853932 °	-121.853932 °	
DWR ID					
Comment Code					
Inspector Comment					
FS_ID:31963 DS_ID:19289 EP_NO: N/A Repair Type: Non-Urgent Crossing Status: Found UCIP Comments: Needs cleaning and clearing the culvert. FIELD_STRUCT_DESC: 24-inch CM pipe through the levee, 11.0 feet below the flap gate on the waterward end. Concrete "U" headwalls on both ends. Grouted riprap apron on the landward end. Grouted riprap spillway on the waterward end. O&M Manual Sac 504, May 1965. FS Date: 3/7/2014

WS view: U type concrete headwall and CMP on levee slope. Vegetation debris and mud on outlet box. Needs cleaning and clearing.

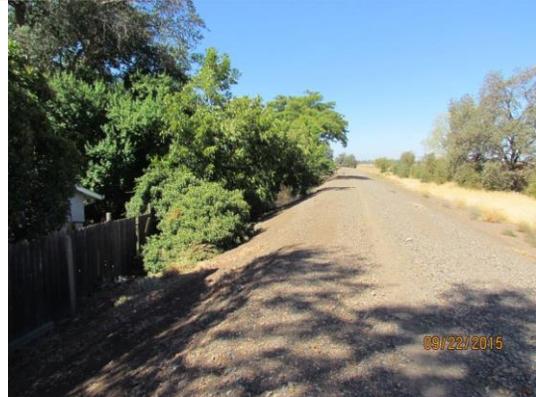
Photo 1 of 1 : SP_2016_NA0003_68_17_20160321_00004.jpg

LM Start	1.16	Rating **	M	Issue No.	17
LM End	1.22	Issue Type +	Ma	Location *	LS
Category	Earthen Levee		GPS Latitude/Longitude		
			Start	End	
Item	Trim / Thin Trees		39.777128 °	39.777580 °	
			-121.854763 °	-121.855612 °	
DWR ID	DWR_NA0003_04_f_2015_17				
Comment Code					
T1 : Trim trees to at least five feet above ground level.					
Inspector Comment					
Remove the trees that are overhanging the levee slope.

View of the trees overhanging the levee slope.

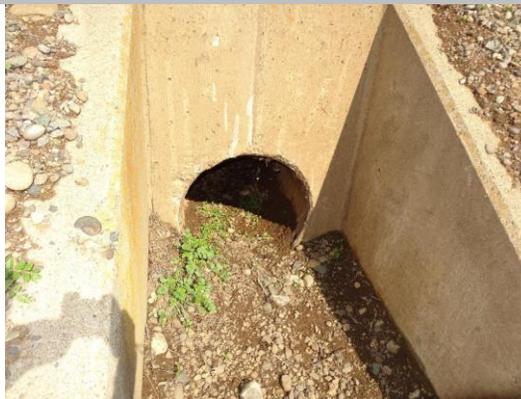
Photo 2 of 2 : UCIP_SP_2016_31965_58394.jpg

LM Start	2.15	Rating **	M	Issue No.	25 (cont)
LM End	2.15	Issue Type +	En	Location *	LS
Category	Supplemental			GPS Latitude/Longitude	
				Start	End
Item	DWR UCIP Field Study			39.782777 °	39.782777 °
				-121.871179 °	-121.871179 °
DWR ID					
Comment Code					
Inspector Comment					
FS_ID:31965 DS_ID:19291 EP_NO: N/A Repair Type: Non-Urgent Crossing Status: Found UCIP Comments: Needs cleaning and clearing the culvert. FIELD_STRUCT_DESC: 24-inch CM pipe through the levee, 11.0 feet below the crown. Flap gate on the waterward end. Concrete "U" headwall on both ends. Grouted riprap apron on the landward end. Grouted riprap spillway on the waterward end. O&M Manual Sac 504, May 1965. FS Date: 3/7/2014

LS view: U type concrete headwall and CMP on levee slope. Vegetation debris and mud in inlet box.

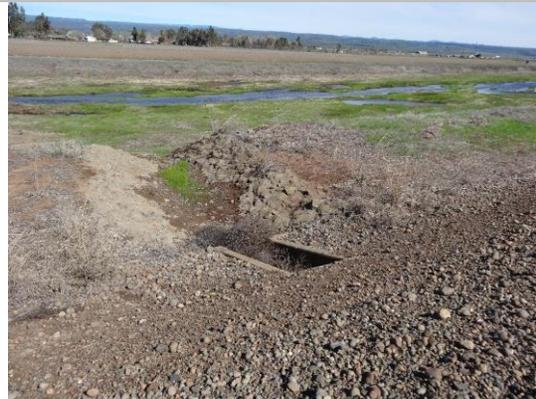
Photo 1 of 2 : UCIP_SP_2016_31966_58401.jpg

LM Start	2.47	Rating **	M	Issue No.	26
LM End	2.47	Issue Type +	En	Location *	LS
Category	Supplemental			GPS Latitude/Longitude	
				Start	End
Item	DWR UCIP Field Study			39.784244 °	39.784244 °
				-121.876810 °	-121.876810 °
DWR ID					
Comment Code					
Inspector Comment					
FS_ID:31966 DS_ID:19292 EP_NO: N/A Repair Type: Non-Urgent Crossing Status: Found UCIP Comments: Needs cleaning and clearing the culvert. FIELD_STRUCT_DESC: 24-inch CM pipe through levee, 11.0 feet below the crown. Flap gate on the waterward end. Concrete "U" headwalls on both ends. Grouted riprap apron on the landward end. Grouted riprap spillway on the waterward end. O&M Manual Sac 504, May 1965. FS Date: 3/7/2014

WS view: U type concrete headwall and grouted riprap spillway on levee slope.

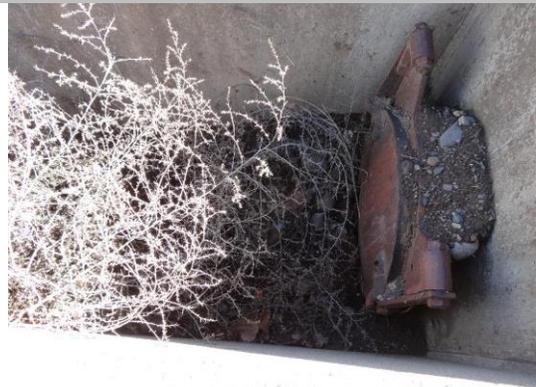
Photo 2 of 2 : UCIP_SP_2016_31966_58400.jpg

WS view: U type concrete headwall and CMP on levee slope. Vegetation debris and mud on outlet box. Needs cleaning and clearing.

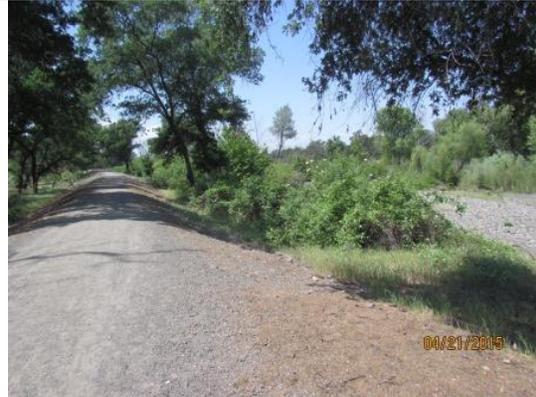
Photo 1 of 2 : SP_2016_NA0003_69_4_20160321_00003.jpg

LM Start	0.21	Rating **	M	Issue No.	4
LM End	0.26	Issue Type +	Ma	Location *	WS
Category	Earthen Levee			GPS Latitude/Longitude	
				Start	End
Item	Vegetation			39.761957 °	39.761892 °
				-121.792867 °	-121.793705 °
DWR ID	DWR_NA0003_05_f_2014_4				
Comment Code					
V2 : Remove the wild growth other than native grasses from the levee slopes.					
Inspector Comment					
Remove the vegetation from the waterside slope.

View of the vegetation along the waterside slope.

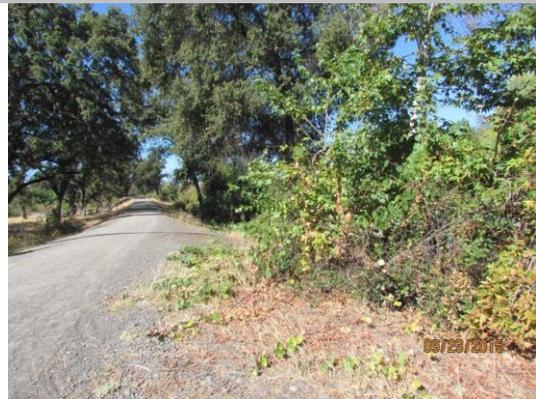
Photo 2 of 2 : SP_2016_NA0003_69_4_20160321_00004.jpg

View of the vegetation along the waterside slope.

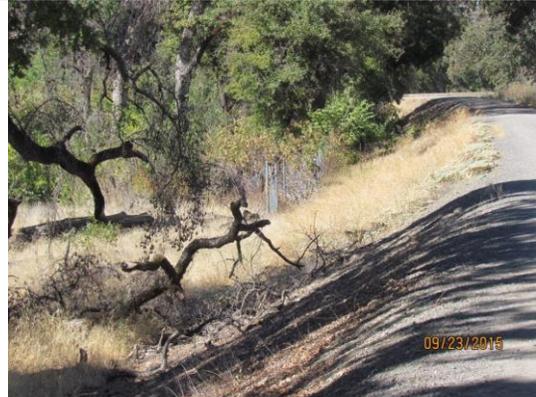
Photo 1 of 1 : SP_2016_NA0003_69_8_20160321_00007.jpg

LM Start	0.26	Rating **	M	Issue No.	8
LM End	0.26	Issue Type +	En	Location *	LS
Category	Earthen Levee		GPS Latitude/Longitude		
			Start	End	
Item	Encroachments		39.761795 °	39.761795 °	
			-121.793790 °	-121.793790 °	
DWR ID	DWR_NA0003_05_f_2015_8				
Comment Code					
TR : Tree or limb					
Inspector Comment					
Remove the trees from the landside toe.

View of the trees along the landside toe.

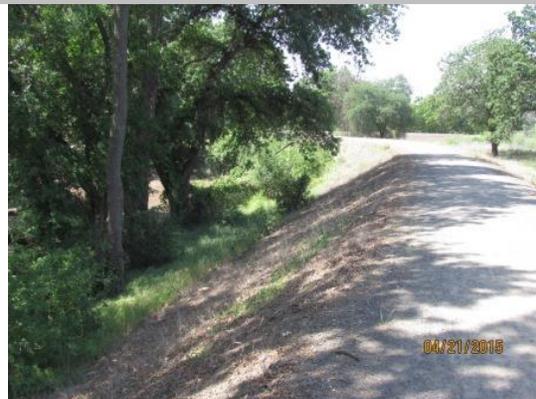
Photo 1 of 2 : SP_2016_NA0003_69_3_20160321_00001.jpg

LM Start	0.34	Rating **	M	Issue No.	3
LM End	0.42	Issue Type +	Ma	Location *	LS
Category	Earthen Levee		GPS Latitude/Longitude		
			Start	End	
Item	Vegetation		39.761633 °	39.761117 °	
			-121.795155 °	-121.796464 °	
DWR ID	DWR_NA0003_05_f_2013_3				
Comment Code					
V2 : Remove the wild growth other than native grasses from the levee slopes.					
Inspector Comment					
Remove the vegetation from the landside slope and toe.

View of the vegetation along the landside slope and toe
