**Flood Control Project Maintenance  
Levee Inspections**

## Maintenance Issue Types Only, Levee Inspection Report By Mile - Fall 2017

### Butte County Department of Public Works

Waterway	Bank	Unit Miles	Inspection Start/End	Inspector
Unit No. 01 Mud Creek	Right	6.80	10/11/2017 10/11/2017	Bob Duffey

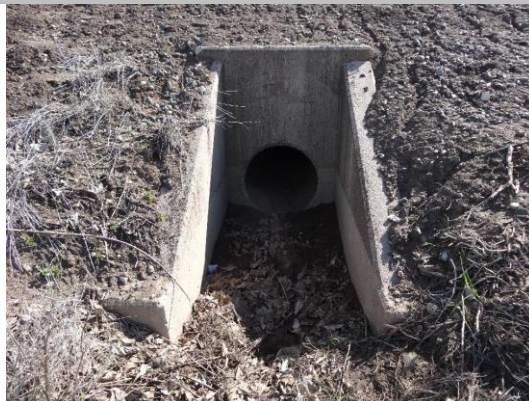
Photo 2 of 3 : UCIP\_FA\_2017\_29705\_54923.jpg

LS view: U typed concrete headwall, CMP on levee slope.

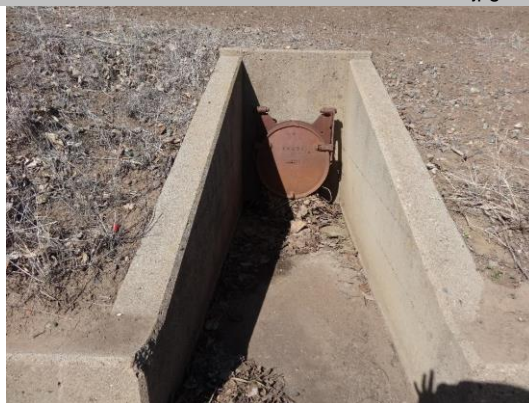
Photo 1 of 3 : UCIP\_FA\_2017\_32044\_58543.jpg

WS view: U typed concrete headwall, pipe, and flapgate on levee slope.

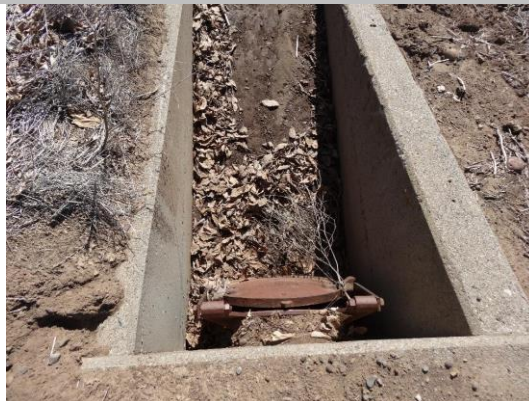
Photo 1 of 3 : UCIP\_FA\_2017\_50142\_55886.jpg

WS view: U type concrete headwall, flapgate on levee slope. Gate was not fully closed.

FS\_ID:50142  
DS\_ID:19212  
EP\_NO: N/A  
Repair Type: No Action Needed  
Crossing Status: Found  
UCIP Comments: 08/29/2016: Shawn Bates of NA0003 has cleared the LS and WS of debris and blockage; WS gate functions properly now. Crossing has been downgraded from Urgent to No Action Needed. (K. Fazel - UCIP)08/11/2016: Same as last inspection. (K. Fazel - UCIP)02/20/2014: No riprap spillway on waterside. Needs cleaning and clearing of debris. Flap gate was not fully closed. (P. Amatya - UCIP)  
FIELD\_STRUCT\_DESC: 24-inch corrugated metal pipe through the levee, 13 feet below the crown. Flap gate on the waterside (WS) end. Concrete "U" headwalls on both ends. Grouted riprap apron on the landside (LS) end. Grouted riprap spillway on the WS end. [Additional Reference(s): DWR Levee Log, 2005. USACE Sacramento O&M Manual 504, May 1965 (HLM 1.95)].  
FS Date: 8/11/2016

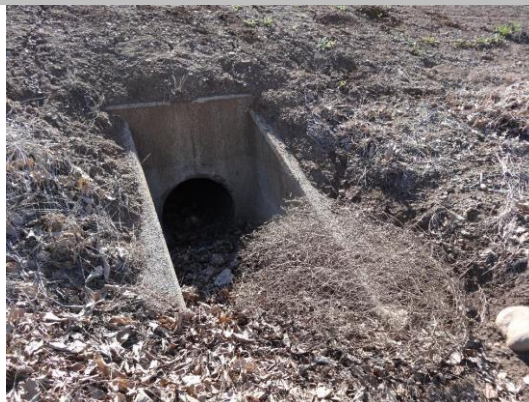
Photo 2 of 3 : UCIP\_FA\_2017\_50142\_55885.jpg

LS view: U type concrete headwall and CMP on levee slope. Vegetation debris blocking inlet.

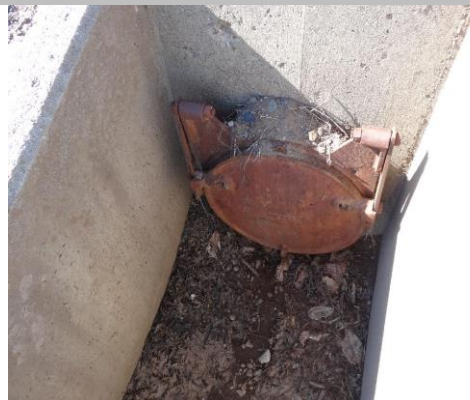
Photo 1 of 2 : UCIP\_FA\_2017\_30294\_55704.jpg

FS\_ID:30294  
DS\_ID:19216  
EP\_NO: N/A  
Repair Type: Non-Urgent  
Crossing Status: Found  
UCIP Comments: Inlet and outlet needs cleaning and clearing of debris.  
FIELD\_STRUCT\_DESC: 24-inch CM pipe through levee, 8.5 feet below the crown. Flap gate on the waterward end. Concrete "U" headwalls on both ends. Grouted riprap apron on the landward end. Grouted riprap spillway on the waterward end. O&M Manual Sac 504, May 1965.  
FS Date: 2/20/2014

WS view: U type concrete headwall, flapgate on levee slope.

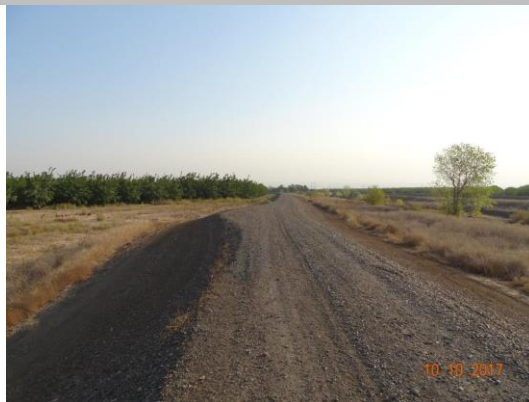
Photo 1 of 1 : FA\_2017\_NA0003\_64\_61\_20171019\_00093.jpg

LM Start	3.39	Rating **	A	Issue No.	61
LM End	3.39	Issue Type +	Ma	Location *	LS
Category	Earthen Levee			GPS Latitude/Longitude	
				Start	End
Item	Vegetation			39.765443 °	39.765443 °
				-121.907288 °	-121.907288 °
DWR ID	DWR_NA0003_01_f_2017_61				
Comment Code					
V1 : Control annual grass and weeds on the levee slopes and easements.					
Inspector Comment					
There is no vegetation on both slopes.

View of no vegetation on both slopes.

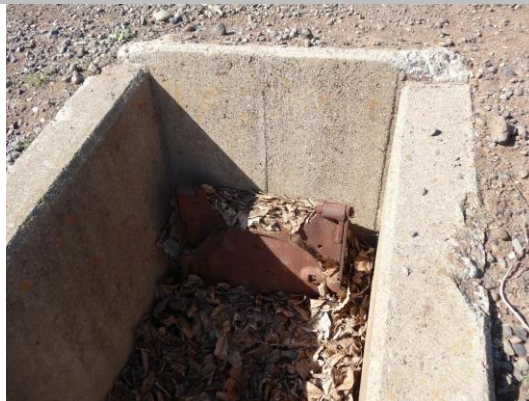
Photo 1 of 3 : UCIP\_FA\_2017\_30310\_55741.jpg

LM Start	3.39	Rating **	M	Issue No.	68
LM End	3.39	Issue Type +	Ma	Location *	
Category	Supplemental			GPS Latitude/Longitude	
				Start	End
Item	DWR UCIP LMA Responsibility			39.765440 °	39.765440 °
				-121.907261 °	-121.907261 °
DWR ID					
Comment Code					
Inspector Comment					
FS_ID:30310 DS_ID:19218 EP_NO: N/A Repair Type: Non-Urgent Crossing Status: Found UCIP Comments: Needs cleaning and clearing of debris. FIELD_STRUCT_DESC: 24-inch CM pipe through the levee, 10.0 feet below the crown. Flap gate on the waterward end. Concrete "U" headwalls on both ends. Grouted riprap apron on the landward end. Grouted riprap spillway on the waterward end. O&M Manual Sac 504, May 1965. FS Date: 2/20/2014

WS view: U type concrete headwall, pipe, and flapgate on levee slope. Vegetation debris blocking outlet.

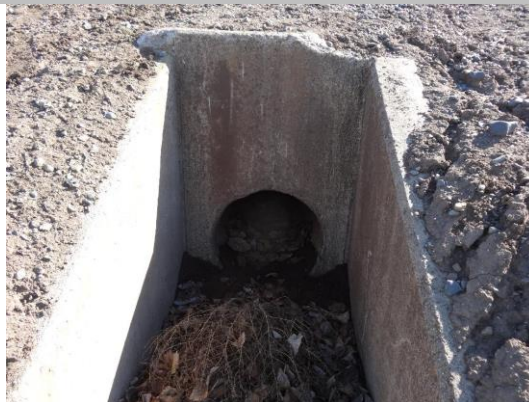
Photo 2 of 3 : UCIP\_FA\_2017\_30310\_55740.jpg

LS view: U type concrete headwall and CMP on levee slope.

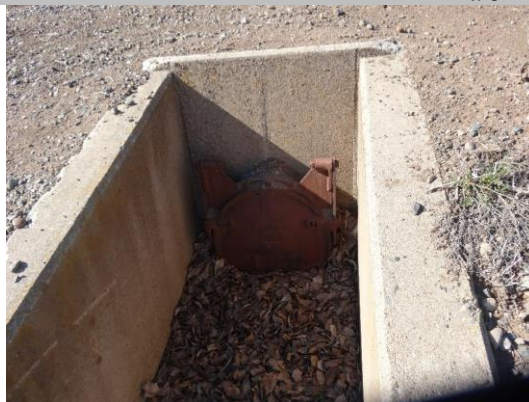
Photo 1 of 2 : UCIP\_FA\_2017\_30311\_55743.jpg

LM Start	3.97	Rating **	M	Issue No.	69
LM End	3.97	Issue Type +	Ma	Location *	
Category	Supplemental			GPS Latitude/Longitude	
				Start	End
Item	DWR UCIP LMA Responsibility			39.771293 °	39.771293 °
				-121.900247 °	-121.900247 °
DWR ID					
Comment Code					
Inspector Comment					
FS_ID:30311 DS_ID:19219 EP_NO: N/A Repair Type: Non-Urgent Crossing Status: Found UCIP Comments: Needs cleaning and clearing of debris in both ends of the pipe. FIELD_STRUCT_DESC: 24-inch CM pipe through the levee, 9.0 feet below the crown. Flap gate on the waterward end. Concrete "U" headwalls on both ends. Grouted riprap apron on the landward end. Grouted riprap spillway on the waterward end. O&M Manual Sac 504, May 1965. FS Date: 2/20/2014

WS view: U type concrete headwall, pipe, and flapgate on levee slope. Vegetation debris blocking outlet.

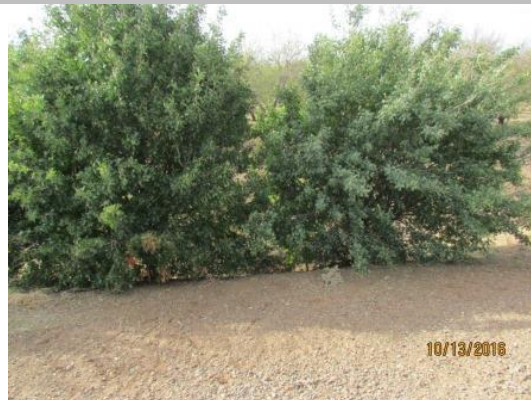
Photo 1 of 1 : FA\_2017\_NA0003\_64\_53\_20170911\_00033.jpg

LM Start	4.45	Rating **	M	Issue No.	53
LM End	4.45	Issue Type +	Ma	Location *	LS
Category	Earthen Levee			GPS Latitude/Longitude	
				Start	End
Item	Trim / Thin Trees			39.775789 °	39.775789 °
				-121.894048 °	-121.894048 °
DWR ID	DWR_NA0003_01_f_2016_53				
Comment Code					
T1 : Trim trees to at least five feet above ground level.					
Inspector Comment

View of the trees along the landside toe.

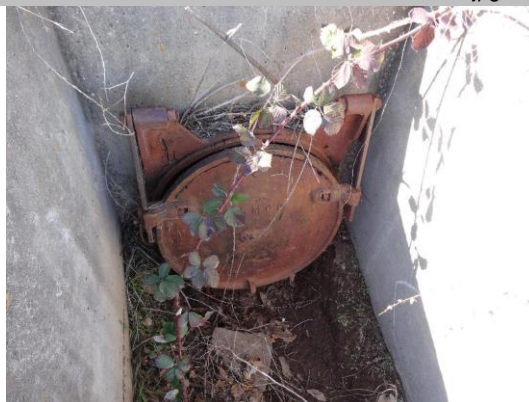
Photo 1 of 2 : UCIP\_FA\_2017\_30312\_55745.jpg

LM Start	4.46	Rating **	M	Issue No.	70
LM End	4.46	Issue Type +	Ma	Location *	
Category	Supplemental			GPS Latitude/Longitude	
				Start	End
Item	DWR UCIP LMA Responsibility			39.775905 °	39.775905 °
				-121.893980 °	-121.893980 °
DWR ID					
Comment Code					
Inspector Comment					
FS_ID:30312					
DS_ID:19220					
EP_NO: N/A					
Repair Type: Non-Urgent					
Crossing Status: Found					
UCIP Comments: Needs cleaning and clearing of debris.					
FIELD_STRUCT_DESC: 24-inch CM pipe through the levee, 13.0 feet below the crown. Flap gate on the waterward end. Concrete "U" headwalls on both ends. Grouted riprap apron on the landward end. Grouted riprap spillway on the waterward end. O&M Manual Sac 504, May 1965.					
FS Date: 2/20/2014

WS view: U type concrete headwall, pipe, and flapgate on levee slope.  
Vegetation debris blocking outlet.

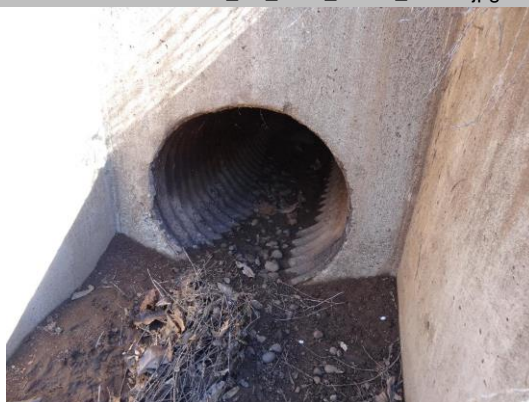
Photo 2 of 2 : UCIP\_FA\_2017\_30312\_55744.jpg

LS view: U type concrete headwall and CMP on levee slope. Needs cleaning and clearing of debris.

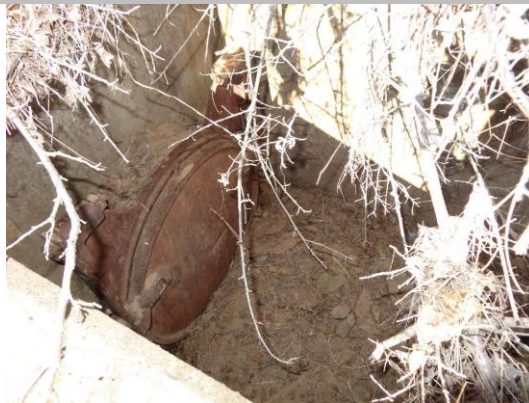
Photo 1 of 2 : UCIP\_FA\_2017\_30388\_55891.jpg

FS\_ID:30388  
DS\_ID:19221  
EP\_NO: N/A  
Repair Type: Non-Urgent  
Crossing Status: Found  
UCIP Comments: CM Standpipe intake. Intake pipe with air vent. Steel rib-bar grit cover on the standpipe on landside levee toe. Needs cleaning and clearing on both ends of the pipe.  
FIELD\_STRUCT\_DESC: 24-inch CM pipe through the levee, 15.0 feet below the crown. Flap gate on the waterward end. Concrete "U" headwalls on waterside ends. Grouted riprap spillway on the waterward end. CM Standpipe intake. Intake pipe with air vent. Steel rib-bar grit cover on the standpipe on landside levee toe. O&M Manual Sac 504, May 1965.  
FS Date: 2/20/2014

WS view: U type concrete headwall, pipe, and flapgate on levee slope. Vegetation/soil debris blocking outlet.

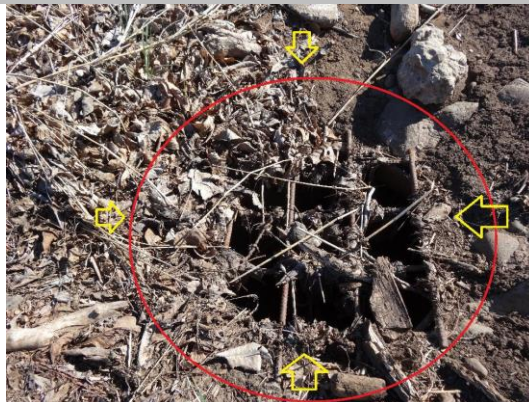
Photo 2 of 2 : UCIP\_FA\_2017\_30388\_55890.jpg

LS view: Underground CM standpipe intake with steel grit on levee toe.

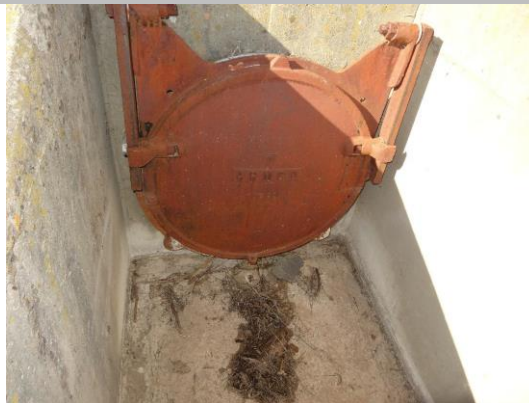
Photo 1 of 3 : UCIP\_FA\_2017\_30327\_55768.jpg

WS view: U type concrete headwall, pipe, and flapgate on levee slope.

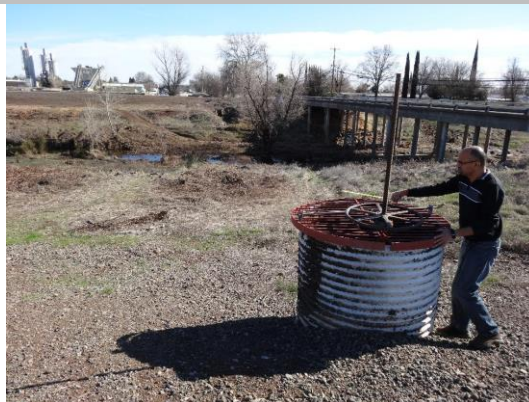
Photo 2 of 3 : UCIP\_FA\_2017\_30327\_55767.jpg

WS view: CM standpipe with slide gate on levee slope.

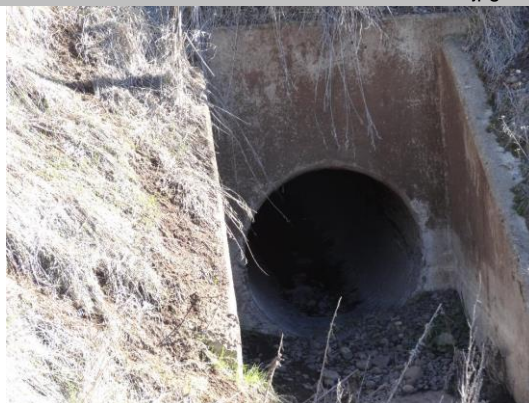
Photo 3 of 3 : UCIP\_FA\_2017\_30327\_55766.jpg

LS view: U type concrete headwall and CMP on levee slope.

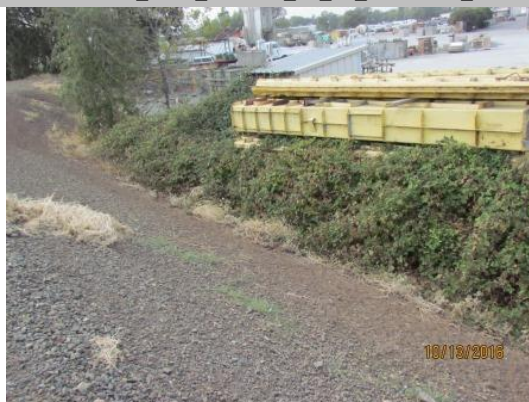
Photo 1 of 1 : FA\_2017\_NA0003\_64\_55\_20170911\_00034.jpg

LM Start	5.20	Rating **	M	Issue No.	55
LM End	5.20	Issue Type +	Ma	Location *	LS
Category	Earthen Levee			GPS Latitude/Longitude	
				Start	End
Item	Vegetation			39.784234 °	39.784234 °
				-121.886589 °	-121.886589 °
DWR ID	DWR_NA0003_01_f_2016_55				
Comment Code					
V2 : Remove the wild growth other than native grasses from the levee slopes.					
Inspector Comment

View of the blackberries blocking visibility and access.

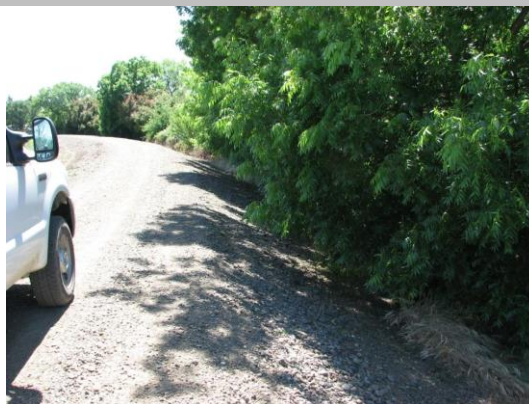
Photo 1 of 1 : FA\_2017\_NA0003\_64\_37\_20170911\_00019.jpg

LM Start	5.98	Rating **	U	Issue No.	37
LM End	6.07	Issue Type +	Ma	Location *	LS
Category	Earthen Levee			GPS Latitude/Longitude	
				Start	End
Item	Vegetation			39.793411 °	39.794580 °
				-121.887310 °	-121.886759 °
DWR ID	DWR_NA0003_01_s _ 2016_37				
Comment Code					
V7 : Trees / Woody Vegetation					
Inspector Comment					
Various overgrown vegetation completely obscuring landside toe visibility.

04/25/2016: Trim trees on L/S slope.

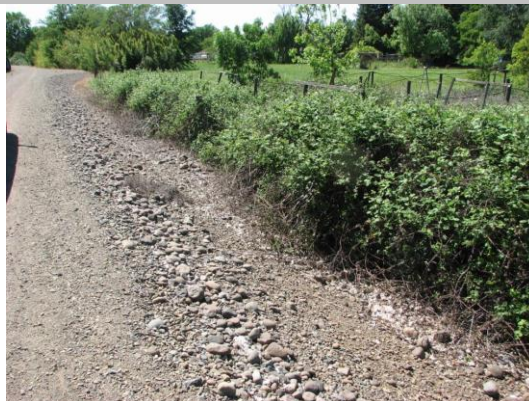
Photo 1 of 1 : FA\_2017\_NA0003\_64\_34\_20170911\_00017.jpg

LM Start	6.16	Rating **	M	Issue No.	34
LM End	6.16	Issue Type +	Ma	Location *	LS
Category	Earthen Levee			GPS Latitude/Longitude	
				Start	End
Item	Vegetation			39.795428 °	39.795428 °
				-121.885306 °	-121.885306 °
DWR ID	DWR_NA0003_01_s_2016_34				
Comment Code					
V2 : Remove the wild growth other than native grasses from the levee slopes.					
Inspector Comment					
Blackberry bramble on landside toe blocking visibility.

Trim vegetation at L/S toe.

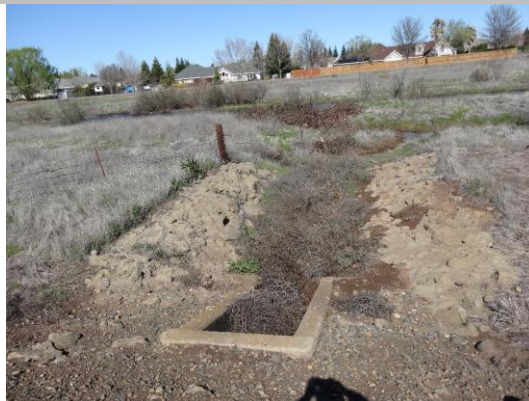
Photo 1 of 3 : UCIP\_FA\_2017\_31667\_57968.jpg

LM Start	0.23	Rating **	M	Issue No.	41
LM End	0.23	Issue Type +	Ma	Location *	
Category	Supplemental			GPS Latitude/Longitude	
				Start	End
Item	DWR UCIP LMA Responsibility			39.797416 °	39.797416 °
				-121.881675 °	-121.881675 °
DWR ID					
Comment Code					
Inspector Comment					
FS_ID:31667 DS_ID:19234 EP_NO: N/A Repair Type: Non-Urgent Crossing Status: Found UCIP Comments: Needs cleaning and clearing the culvert. FIELD_STRUCT_DESC: 24-inch CM pipe through the levee, 6.6 feet below the crown. Flap gate on the waterward end. Concrete "U" headwalls on both ends. Grouted riprap spillway on the waterward end. O&M Manual Sac 504, May 1965. FS Date: 3/11/2014

WS view: CMP culvert with U type concrete headwall. Vegetation debris blocking outlet box.

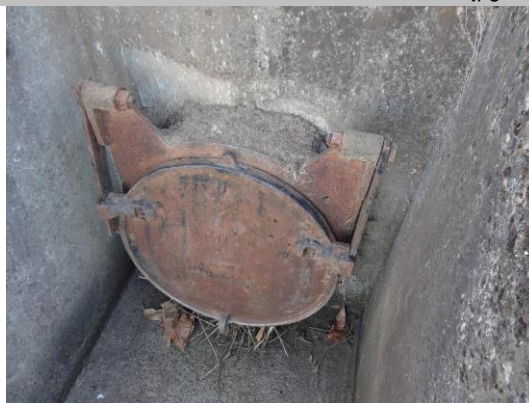
Photo 1 of 3 : UCIP\_FA\_2017\_30403\_55922.jpg

WS view: U type concrete headwall, pipe, and flapgate on levee slope.

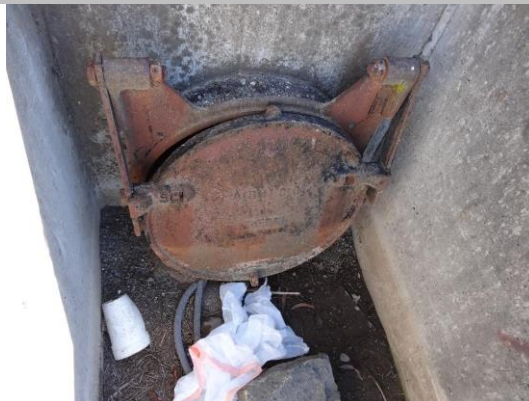
Photo 1 of 2 : UCIP\_FA\_2017\_30743\_56641.jpg

WS view: U type concrete headwall, pipe, and flapgate on levee slope. Debris in outlet box.

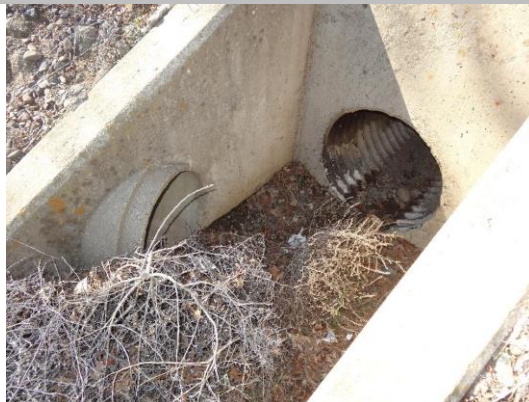
Photo 2 of 2 : UCIP\_FA\_2017\_30743\_56640.jpg

LS view: U type concrete headwall and CMP on levee slope. Vegetation debris and soil in inlet area.

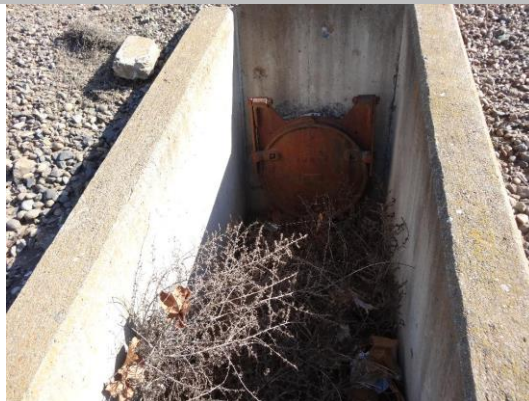
Photo 1 of 3 : UCIP\_FA\_2017\_30763\_56662.jpg

LM Start	2.34	Rating **	M	Issue No.	46	
LM End	2.34	Issue Type +	Ma	Location *		
Category	Supplemental			GPS Latitude/Longitude		
				Start	End	
Item	DWR UCIP LMA Responsibility			39.772185 °	39.772185 °	
				-121.895681 °	-121.895681 °	
DWR ID						
Comment Code						
Inspector Comment						
FS_ID:30763						
DS_ID:19239						
EP_NO: N/A						
Repair Type: Non-Urgent						
Crossing Status: Found						
UCIP Comments: Debris in landside inlet area. Needs cleaning and clearing of debris.						
FIELD_STRUCT_DESC: 24-inch CM pipe through the levee, 10.0 feet below the crown. Flap gate on the waterward end. Concrete "U" headwalls on both ends. Grouted riprap apron on the landward end. Grouted riprap spillway on the waterward end. O&M Manual Sac 504, May 1965.						
FS Date: 2/24/2014

WS view: U type concrete headwall, pipe, and flapgate on levee slope. Vegetation debris blocking outlet.

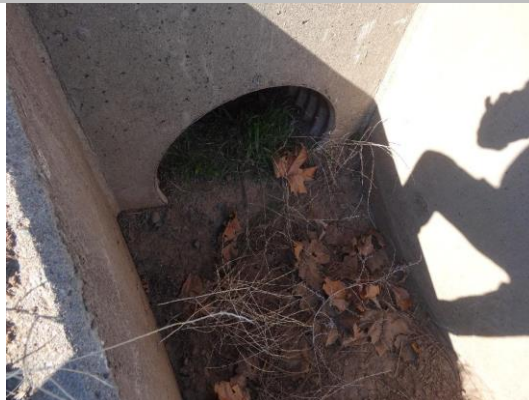
Photo 2 of 3 : UCIP\_FA\_2017\_30763\_56661.jpg

LS view: U type concrete headwall and CMP on levee slope.

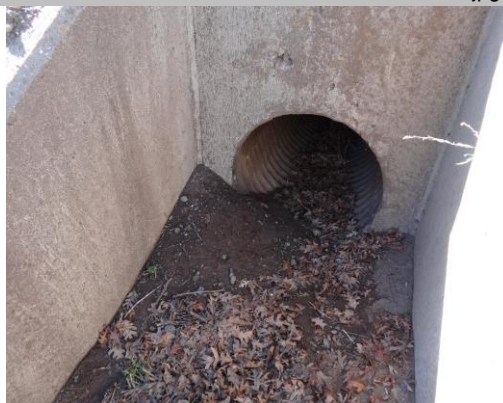
Photo 2 of 3 : UCIP\_FA\_2017\_30783\_56681.jpg

LM Start	2.74	Rating **	M	Issue No.	47 (cont)	
LM End	2.74	Issue Type +	Ma	Location *		
Category	Supplemental			GPS Latitude/Longitude		
				Start	End	
Item	DWR UCIP LMA Responsibility			39.768741 °	39.768741 °	
				-121.901176 °	-121.901176 °	
DWR ID						
Comment Code						
Inspector Comment						
FS_ID:30783						
DS_ID:19240						
EP_NO: N/A						
Repair Type: Non-Urgent						
Crossing Status: Found						
UCIP Comments: Needs cleaning and clearing of debris.						
FIELD_STRUCT_DESC: 24-inch CM pipe through the levee, 10.0 feet below the crown. Flap gate on the waterward end. Concrete "U" headwalls on both ends. Grouted riprap apron on the landward end. Grouted riprap spillway on the waterward end. O&M Manual Sac 504, May 1965.						
FS Date: 2/24/2014

LS view: U type concrete headwall and CMP on levee slope. Debris and soil in inlet box.

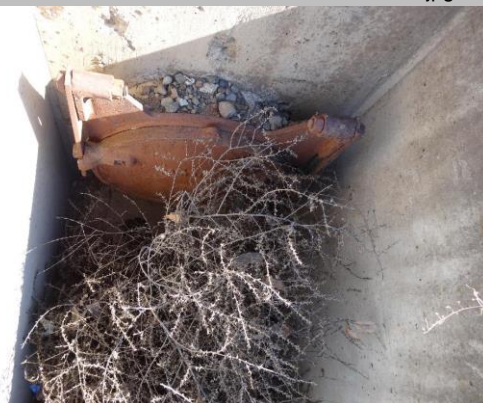
Photo 1 of 3 : UCIP\_FA\_2017\_30803\_56685.jpg

LM Start	3.50	Rating **	M	Issue No.	48
LM End	3.50	Issue Type +	Ma	Location *	
Category	Supplemental			GPS Latitude/Longitude	
				Start	End
Item	DWR UCIP LMA Responsibility			39.760847 °	39.760847 °
				-121.910265 °	-121.910265 °
DWR ID					
Comment Code					
Inspector Comment					
FS_ID:30803					
DS_ID:19241					
EP_NO: N/A					
Repair Type: Non-Urgent					
Crossing Status: Found					
UCIP Comments: Needs cleaning and clearing of debris.					
FIELD_STRUCT_DESC: 24-inch CM pipe through the levee, 6.5 feet below the crown. Flap gate on the waterward end. Concrete "U" headwalls on both ends. Grouted riprap apron on the landward end. Grouted riprap spillway on the waterward end. O&M Manual Sac 504, May 1965.					
FS Date: 2/24/2014

WS view: U type concrete headwall, pipe, and flapgate on levee slope. Vegetation debris and soil blocking outlet.

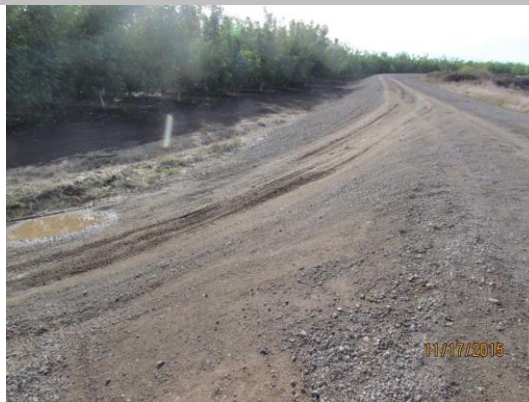
Photo 1 of 1 : FA\_2017\_NA0003\_65\_10\_20170911\_00007.jpg

LM Start	3.52	Rating **	M	Issue No.	10
LM End	3.52	Issue Type +	Ma	Location *	LS
Category	Earthen Levee			GPS Latitude/Longitude	
				Start	End
Item	Slope Stability			39.760582 °	39.760582 °
				-121.910303 °	-121.910303 °
DWR ID	DWR_NA0003_02_f_2015_10				
Comment Code					
S3 : Repair the levee slope damaged by vehicle traffic and prevent access where possible.					
Inspector Comment

View of the vehicle erosion along the landside slope.

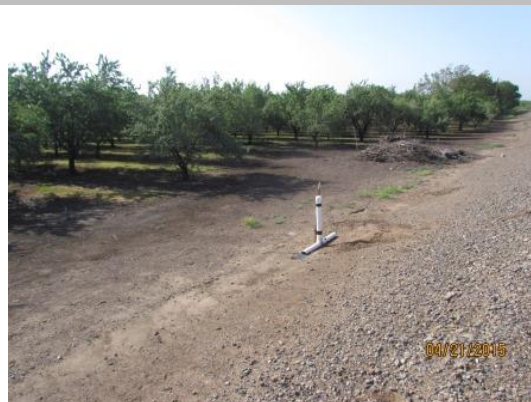
Photo 1 of 2 : FA\_2017\_NA0003\_65\_8\_20170911\_00005.jpg

LM Start	4.55	Rating **	A/W	Issue No.	8
LM End	4.55	Issue Type +	Ma	Location *	LS
Category	Earthen Levee			GPS Latitude/Longitude	
				Start	End
Item	Animal Control			39.749639 °	39.749639 °
				-121.917188 °	-121.917188 °
DWR ID	DWR_NA0003_02_f_2013_8				
Comment Code					
A1 : Exterminate rodents and backfill and compact or grout burrows.					
Inspector Comment					
Butte County has been grouting the rodent holes.

View of the bait station placed by the rodent hole.

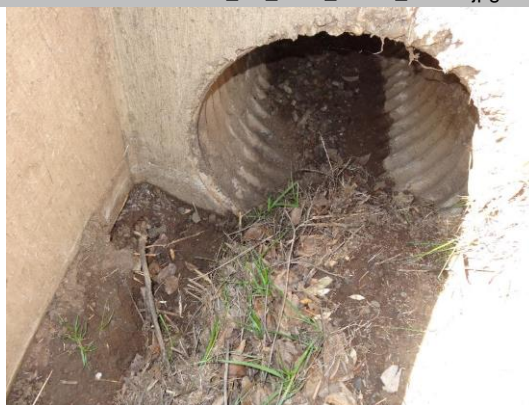
Photo 2 of 3 : UCIP\_FA\_2017\_31028\_56912.jpg

LS view: U type concrete headwall and CMP on levee slope.

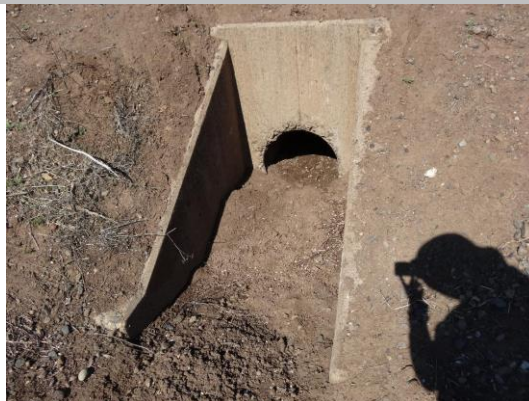
Photo 2 of 3 : UCIP\_FA\_2017\_31031\_56916.jpg

LM Start	5.64	Rating **	M	Issue No.	50 (cont)	
LM End	5.64	Issue Type +	Ma	Location *		
Category	Supplemental			GPS Latitude/Longitude		
				Start	End	
Item	DWR UCIP LMA Responsibility			39.738898 °	39.738898 °	
				-121.930242 °	-121.930242 °	
DWR ID						
Comment Code						
Inspector Comment						
FS_ID:31031						
DS_ID:19247						
EP_NO: N/A						
Repair Type: Non-Urgent						
Crossing Status: Found						
UCIP Comments: Needs cleaning and clearing of debris.						
FIELD_STRUCT_DESC: 24-inch CM pipe through the levee, 11.5 feet below the crown. Flap gate on the waterward end. Concrete "U" headwalls on both ends. Grouted riprap apron on the landward end. Grouted riprap spillway on the waterward end. O&M Manual Sac 504, May 1965.						
FS Date: 2/25/2014

LS view: U type concrete headwall and CMP on levee slope. Soil/mud on inlet box.

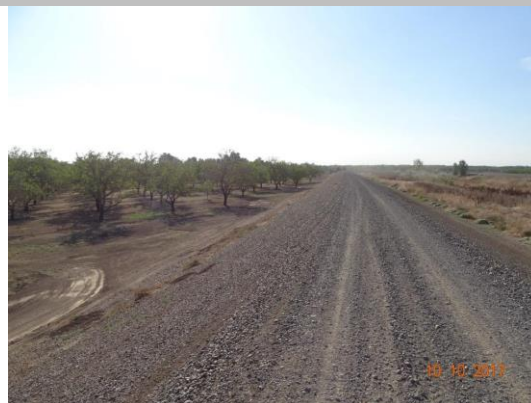
Photo 1 of 1 : FA\_2017\_NA0003\_65\_28\_20171019\_00120.jpg

LM Start	5.87	Rating **	A	Issue No.	28	
LM End	5.87	Issue Type +	Ma	Location *	LS	
Category	Earthen Levee			GPS Latitude/Longitude		
				Start		End
Item	Vegetation			39.736258 °		39.736258 °
				-121.931938 °		-121.931938 °
DWR ID	DWR_NA0003_02_f_2017_28					
Comment Code						
V1 : Control annual grass and weeds on the levee slopes and easements.						
Inspector Comment						
There is no vegetation on both slopes.

View of no vegetation on both slopes.

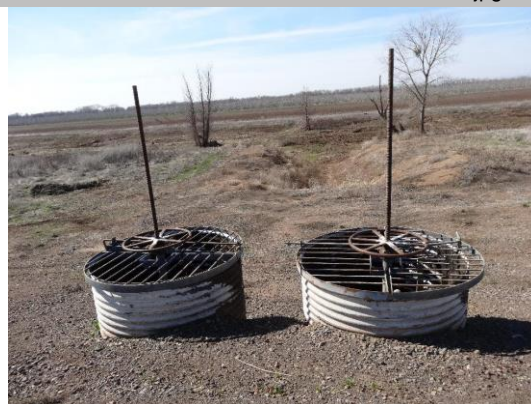
Photo 1 of 3 : UCIP\_FA\_2017\_41376\_56920.jpg

LM Start	6.09	Rating **	M	Issue No.	51
LM End	6.09	Issue Type +	Ma	Location *	
Category	Supplemental			GPS Latitude/Longitude	
				Start	End
Item	DWR UCIP LMA Responsibility			39.733297 °	39.733297 °
				-121.930411 °	-121.930411 °
DWR ID					
Comment Code					
Inspector Comment					
FS_ID:41376 DS_ID:19248 EP_NO: N/A Repair Type: Non-Urgent Crossing Status: Found UCIP Comments: Needs cleaning and clearing of debris. FIELD_STRUCT_DESC: 1 of 2: Two 42-inch CM pipes through the levee, 16.0 feet below the crown. Flap gates on the waterward end. Slide gates in CM pipe riser on the waterward slope. Concrete "U" headwalls on both ends. Grouted riprap apron and rock revetment on the landward end. Channel Slough drainage structure. O&M Manual Sac 504, May 1965. FS Date: 2/25/2014

WS view: slide gates in CMP risers on levee slope.

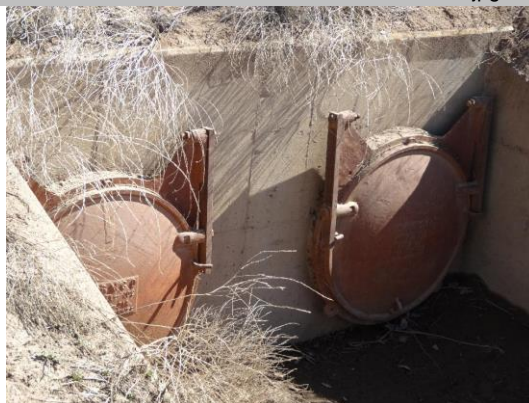
Photo 2 of 3 : UCIP\_FA\_2017\_41376\_56919.jpg

WS view: U type concrete headwall, pipes, and flapgates on levee slope. Vegetation debris on outlet box.

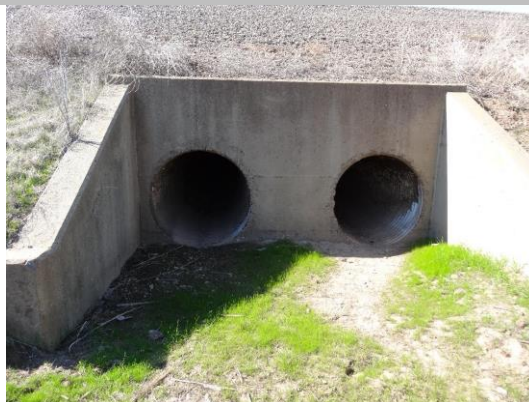
Photo 3 of 3 : UCIP\_FA\_2017\_41376\_56918.jpg

LS view: U type concrete headwall and CMPs on levee slope. Soil/mud on inlet box.

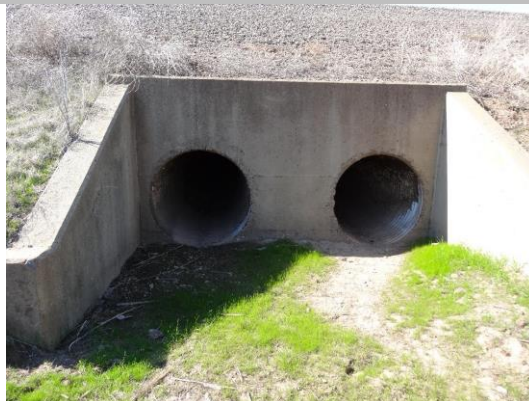
Photo 3 of 3 : UCIP\_FA\_2017\_41377\_56921.jpg

LM Start	6.09	Rating **	M	Issue No.	52 (cont)
LM End	6.09	Issue Type +	Ma	Location *	
Category	Supplemental			GPS Latitude/Longitude	
				Start	End
Item	DWR UCIP LMA Responsibility			39.733280 °	39.733280 °
				-121.930409 °	-121.930409 °
DWR ID					
Comment Code					
Inspector Comment					
FS_ID:41377 DS_ID:19259 EP_NO: N/A Repair Type: Non-Urgent Crossing Status: Found UCIP Comments: Needs cleaning and clearing of debris. FIELD_STRUCT_DESC: 2 of 2: Two 42-inch CM pipes through the levee, 16.0 feet below the crown. Flap gates on the waterward end. Slide gates in CM pipe riser on the waterward slope. Concrete "U" headwalls on both ends. Grouted riprap apron and rock revetment on the landward end. Channel Slough drainage structure. O&M Manual Sac 504, May 1965. FS Date: 2/25/2014

LS view: U type concrete headwall and CMPs on levee slope. Soil/mud on inlet box.

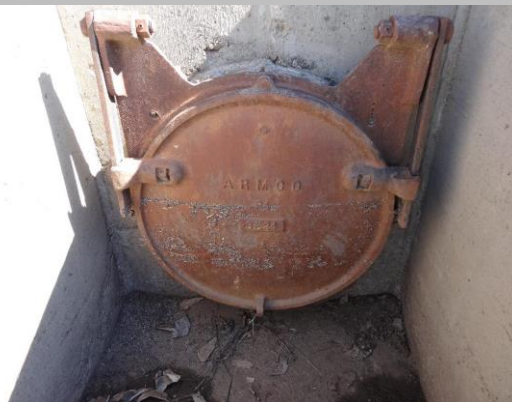
Photo 1 of 3 : UCIP\_FA\_2017\_31034\_56926.jpg

LM Start	6.15	Rating **	M	Issue No.	53
LM End	6.15	Issue Type +	Ma	Location *	
Category	Supplemental			GPS Latitude/Longitude	
				Start	End
Item	DWR UCIP LMA Responsibility			39.732515 °	39.732515 °
				-121.930373 °	-121.930373 °
DWR ID					
Comment Code					
Inspector Comment					
FS_ID:31034 DS_ID:19249 EP_NO: N/A Repair Type: Non-Urgent Crossing Status: Found UCIP Comments: Needs cleaning and clearing of debris. FIELD_STRUCT_DESC: 24-inch CM pipe through the levee, 12.0 feet below the crown. Flap gate on the waterward end. Concrete "U" headwalls on both ends. Grouted riprap apron on the landward end. Grouted riprap spillway on the waterward end. O&M Manual Sac 504, May 1965. FS Date: 2/25/2014

WS view: U type concrete headwall, pipe, and flapgate on levee slope.

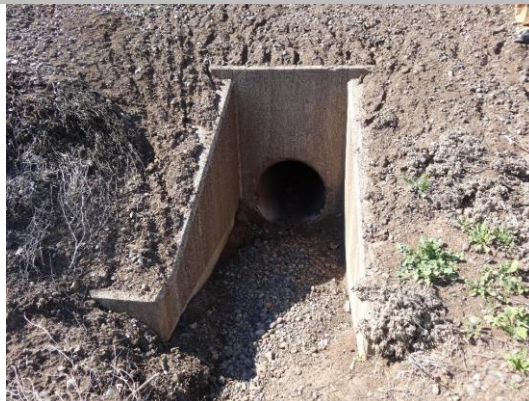
Photo 2 of 3 : UCIP\_FA\_2017\_31034\_56925.jpg

LS view: U type concrete headwall and CMP on levee slope.

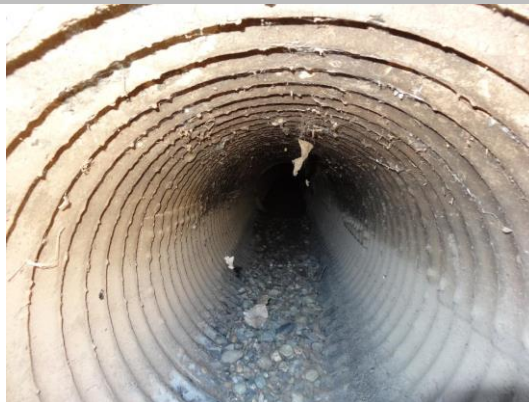
Photo 3 of 3 : UCIP\_FA\_2017\_31034\_56924.jpg

LS view: inside view of CMP on levee slope. Needs cleaning and clearing.

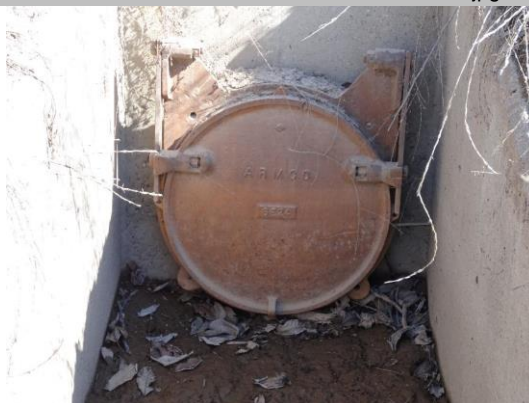
Photo 1 of 3 : UCIP\_FA\_2017\_31085\_56988.jpg

LM Start	6.43	Rating **	M	Issue No.	54
LM End	6.43	Issue Type +	Ma	Location *	
Category	Supplemental			GPS Latitude/Longitude	
				Start	End
Item	DWR UCIP LMA Responsibility			39.728812 °	39.728812 °
				-121.932623 °	-121.932623 °
DWR ID					
Comment Code					
Inspector Comment					
FS_ID:31085					
DS_ID:19251					
EP_NO: N/A					
Repair Type: Non-Urgent					
Crossing Status: Found					
UCIP Comments: Needs cleaning and clearing of debris.					
FIELD_STRUCT_DESC: 24-inch CM pipe through the levee, 15.5 feet below the crown. Flap gate on the waterward end. Concrete "U" headwalls on both ends. Grouted riprap apron on the landward end. Grouted riprap spillway on the waterward end. O&M Manual Sac 504, May 1965.					
FS Date: 2/25/2014

WS view: U type concrete headwall, pipe, and flapgate on levee slope.  
Soil/mud on outlet box.

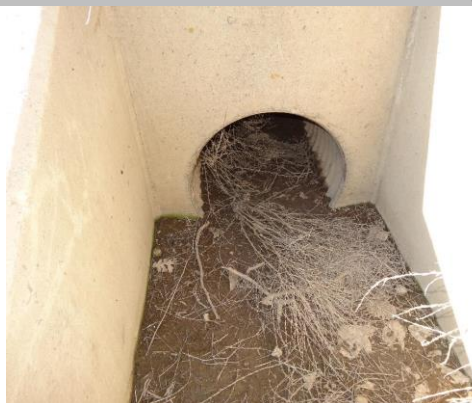
Photo 2 of 3 : UCIP\_FA\_2017\_31103\_57001.jpg

LM Start	6.94	Rating **	M	Issue No.	55 (cont)	
LM End	6.94	Issue Type +	Ma	Location *		
Category	Supplemental			GPS Latitude/Longitude		
				Start	End	
Item	DWR UCIP LMA Responsibility			39.722798 °	39.722798 °	
				-121.937828 °	-121.937828 °	
DWR ID						
Comment Code						
Inspector Comment						
FS_ID:31103						
DS_ID:19252						
EP_NO: N/A						
Repair Type: Non-Urgent						
Crossing Status: Found						
UCIP Comments: Needs cleaning and clearing of debris.						
FIELD_STRUCT_DESC: 24-inch CM pipe through the levee, 15.0 feet below the crown. Flap gate on the waterward end. Concrete "U" headwalls on both ends. Grouted riprap apron on the landward end. Grouted riprap spillway on the waterward end. O&M Manual Sac 504, May 1965.						
FS Date: 2/25/2014

LS view: U type concrete headwall and CMP on levee slope. Soil/mud on inlet box.

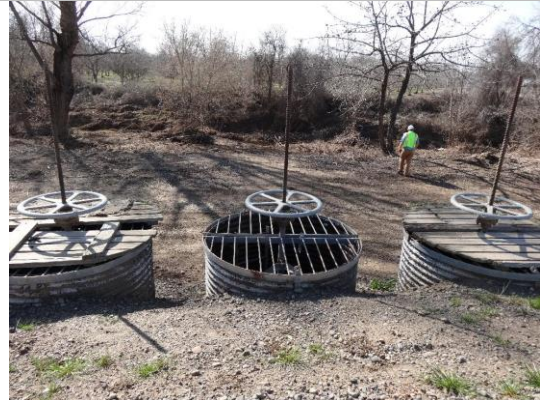
Photo 1 of 3 : UCIP\_FA\_2017\_32085\_58585.jpg

LM Start	7.22	Rating **	M	Issue No.	56
LM End	7.22	Issue Type +	Ma	Location *	
Category	Supplemental			GPS Latitude/Longitude	
				Start	End
Item	DWR UCIP LMA Responsibility			39.718882 °	39.718882 °
				-121.937602 °	-121.937602 °
DWR ID					
Comment Code					
Inspector Comment					
FS_ID:32085 DS_ID:19253 EP_NO: N/A Repair Type: Non-Urgent Crossing Status: Found UCIP Comments: Slide gates in CMP risers on waterside shoulder.Needs cleaning and clearing of debris. FIELD_STRUCT_DESC: 1 of 3: Three 48-inch CM pipes through levee, 18.0 feet below crown. Flap gate on the waterward end. Slide gate in CMP riser on waterside shoulder. Concrete "U" headwalls on both ends. Grouted riprap apron on the landward end. Grouted riprap spillway on the waterward end. O&M Manual Sac 504, May 1965. FS Date: 2/25/2014

WS view: slide gates in CMP risers on waterside shoulder.

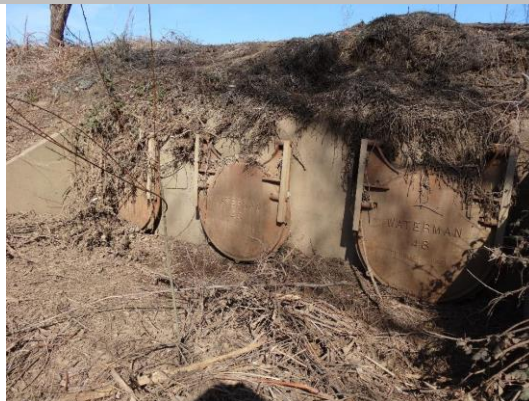
Photo 2 of 3 : UCIP\_FA\_2017\_32085\_58584.jpg

WS view: U type concrete headwall, pipes, and flapgates on levee slope. Soil/mud on outlet box. Vegetation debris blocking outlet box

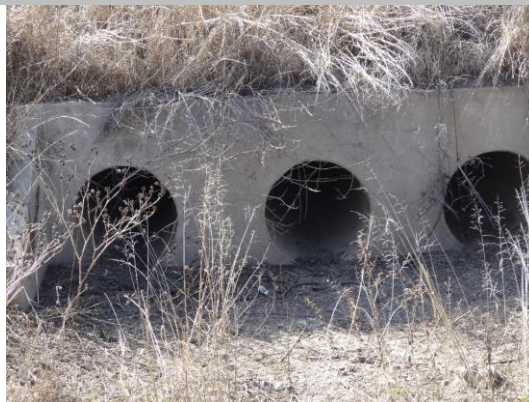
Photo 3 of 3 : UCIP\_FA\_2017\_32085\_58586.jpg

LS view: U type concrete headwall and CMPs on levee slope. Soil/mud on inlet box.

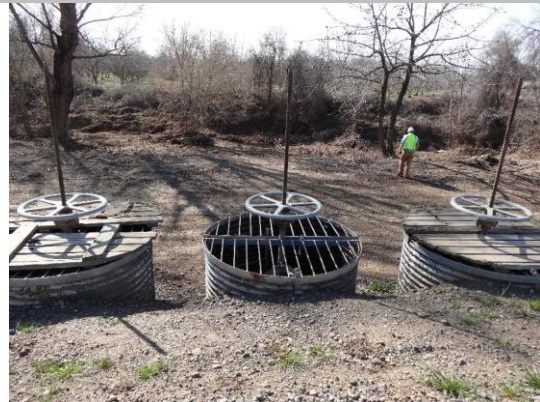
Photo 1 of 3 : UCIP\_FA\_2017\_32086\_58589.jpg

LM Start	7.23	Rating **	M	Issue No.	58
LM End	7.23	Issue Type +	Ma	Location *	
Category	Supplemental			GPS Latitude/Longitude	
				Start	End
Item	DWR UCIP LMA Responsibility			39.718862 °	39.718862 °
				-121.937594 °	-121.937594 °
DWR ID					
Comment Code					
Inspector Comment					
FS_ID:32086 DS_ID:19260 EP_NO: N/A Repair Type: Non-Urgent Crossing Status: Found UCIP Comments: Slide gates in CMP risers on waterside shoulder.Needs cleaning and clearing of debris. FIELD_STRUCT_DESC: 2 of 3: Three 48-inch CM pipes through levee, 18.0 feet below crown Flap gate on the waterward end. Concrete "U" headwalls on both ends. Grouted riprap apron on the landward end. Grouted riprap spillway on the waterward end. O&M Manual Sac 504, May 1965. FS Date: 2/25/2014

WS view: slide gates in CMP risers on waterside shoulder.

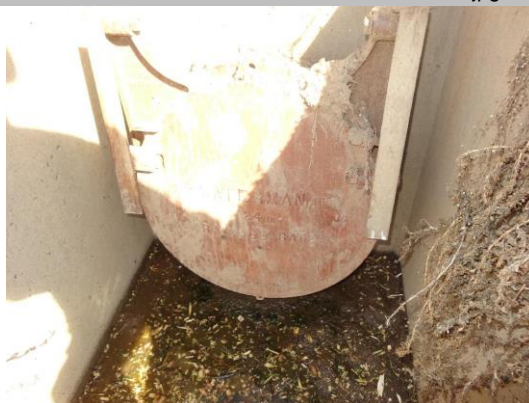
Photo 1 of 2 : UCIP\_FA\_2017\_31129\_57036.jpg

LM Start	7.77	Rating **	M	Issue No.	59
LM End	7.77	Issue Type +	Ma	Location *	
Category	Supplemental			GPS Latitude/Longitude	
				Start	End
Item	DWR UCIP LMA Responsibility			39.711436 °	39.711436 °
				-121.937135 °	-121.937135 °
DWR ID					
Comment Code					
Inspector Comment					
FS_ID:31129					
DS_ID:19254					
EP_NO: N/A					
Repair Type: Non-Urgent					
Crossing Status: Found					
UCIP Comments: Debris in inlet pipe, needs cleaning and clearing.					
FIELD_STRUCT_DESC: 24-inch CM pipe through the levee, 18.0 feet below the crown. Flap gate on the waterward end. Concrete "U" headwalls on both ends. Grouted riprap apron on the landward end. Grouted riprap spillway on the waterward end. O&M Manual Sac 504, May 1965.					
FS Date: 2/25/2014

WS view: U type concrete headwall, pipe, and flapgate on levee slope. Soil/mud on outlet box.

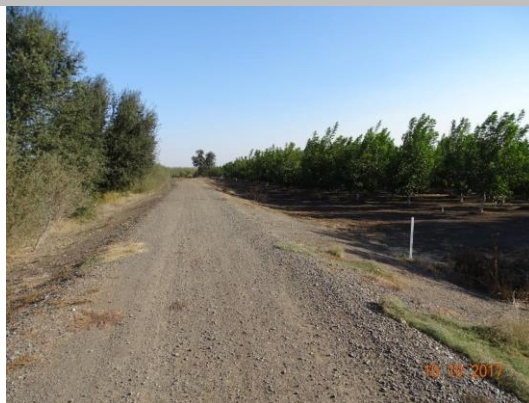
Photo 1 of 1 : FA\_2017\_NA0003\_66\_3\_20171019\_00001.jpg

LM Start	0.18	Rating **	A	Issue No.	3
LM End	0.18	Issue Type +	Ma	Location *	LS
Category	Earthen Levee			GPS Latitude/Longitude	
				Start	End
Item	Vegetation			39.735305 °	39.735305 °
				-121.928998 °	-121.928998 °
DWR ID	DWR_NA0003_02A_f_2017_3				
Comment Code					
V1 : Control annual grass and weeds on the levee slopes and easements.					
Inspector Comment					
There is no vegetation on either slope.

View of no vegetation on both slopes.

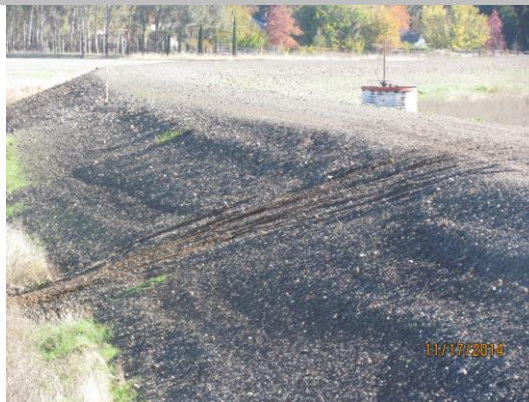
Photo 1 of 1 : FA\_2017\_NA0003\_67\_3\_20170911\_00001.jpg

LM Start	0.07	Rating **	M	Issue No.	3
LM End	0.07	Issue Type +	Ma	Location *	WS
Category	Earthen Levee			GPS Latitude/Longitude	
				Start	End
Item	Slope Stability			39.786068 °	39.786068 °
				-121.881828 °	-121.881828 °
DWR ID	DWR_NA0003_03_s_2012_3				
Comment Code					
S3 : Repair the levee slope damaged by vehicle traffic and prevent access where possible.					
Inspector Comment					
Repair the erosion on landside slope caused by motorcycle traffic.

View of the erosion caused by motorcycles on the land side slope.

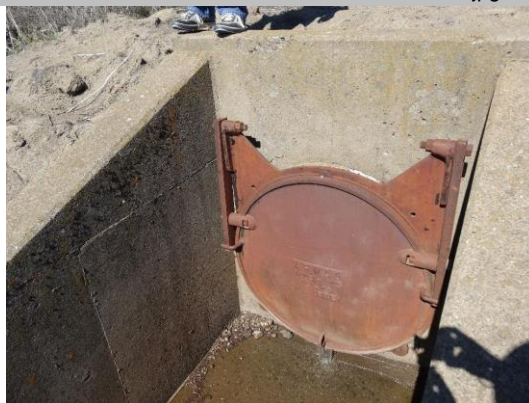
Photo 1 of 3 : UCIP\_FA\_2017\_51844\_58602.jpg

FS\_ID:51844  
DS\_ID:19262  
EP\_NO: N/A  
Repair Type: No Action Needed  
Crossing Status: Found  
UCIP Comments: 05/16/2017 Crossing has been downgraded from Non-Urgent to No Action Needed. The flap gate appears to be in good working order based on the photos, and the small pile of debris not enough to warrant Non-Urgent rating. (K. Fazel - UCIP)03/11/2014:Slide gate in CMP riser on waterside.The culvert was working during field inspection. (P. Amatya - DWR)  
FIELD\_STRUCT\_DESC: 42-inch CM pipe through the levee, 14 feet below the crown. Flap gate on the waterward end. Slid gate in CM riser on the waterward slope. Concrete "U" headwalls on both ends. Grouted riprap apron on the landward end. Grouted riprap spillway on the waterward end. O&M Manual Sac 504, May 1965.  
FS Date: 3/11/2014

WS view: U type concrete headwall, pipe, and flapgate on levee slope.

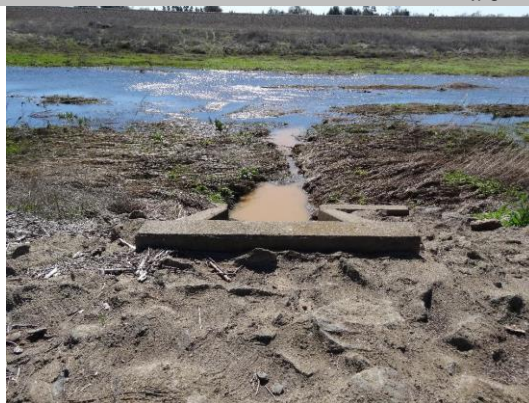
Photo 2 of 3 : UCIP\_FA\_2017\_51844\_58601.jpg

WS view: U type concrete headwall of CMP culvert on levee slope.  
Grouted riprap levee slope and spillway.

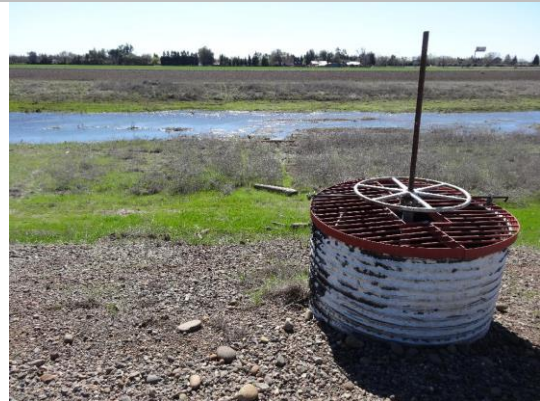
Photo 3 of 3 : UCIP\_FA\_2017\_51844\_58600.jpg

WS view: slide gate in CMP riser on waterside shoulder.

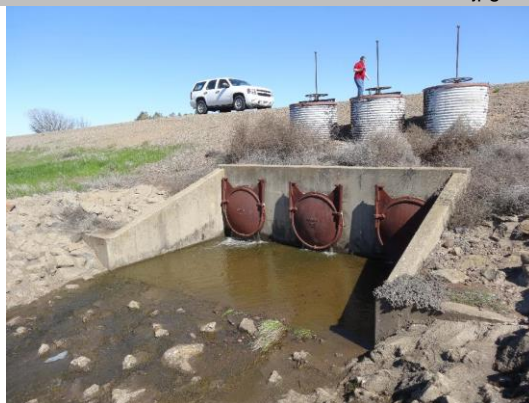
Photo 1 of 2 : UCIP\_FA\_2017\_32104\_58606.jpg

LM Start	0.39	Rating **	A/W	Issue No.	24
LM End	0.39	Issue Type +	Ma	Location *	
Category	Supplemental			GPS Latitude/Longitude	
				Start	End
Item	DWR UCIP LMA Responsibility			39.785262 °	39.785262 °
				-121.876622 °	-121.876622 °
DWR ID					
Comment Code					
Inspector Comment					
FS_ID:32104 DS_ID:19278 EP_NO: N/A Repair Type: No Action Needed Crossing Status: Found UCIP Comments: Slide gate in CMP riser on waterside.The culvert was working during the field visit. FIELD_STRUCT_DESC: 1 of 3: Three 48-inch CM pipes through the levee, 11.7 feet below the crown. Slide gates on each pipe in riser well on the waterward slope. Concrete "U" headwall on both ends. Flap gates on the waterward end. Grouted riprap outlet channel. O&M Manual Sac 504, May 1965. FS Date: 3/11/2014

WS view: U type concrete headwall and three CMPs with slide gates on levee slope. Grouted riprap spillway.

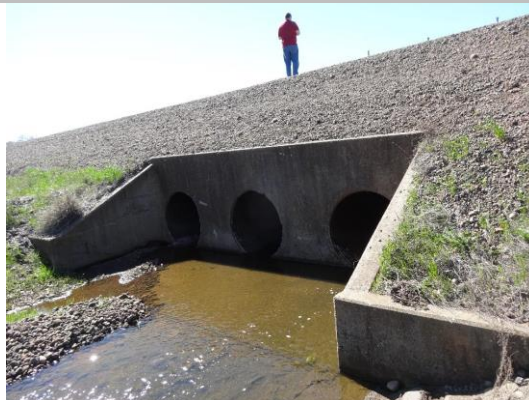
Photo 2 of 2 : UCIP\_FA\_2017\_32104\_58605.jpg

LS view: U type concrete headwall and three CMPs on levee slope. Soil/mud on inlet box.

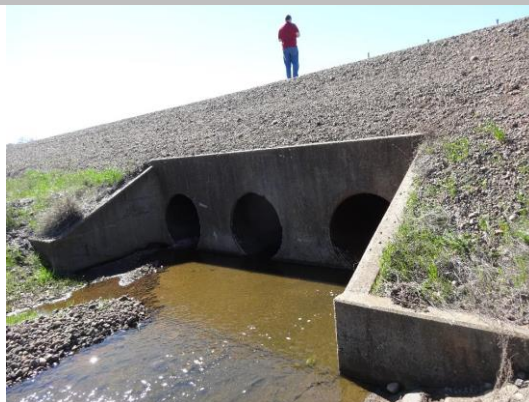
Photo 2 of 2 : UCIP\_FA\_2017\_32105\_58607.jpg

LM Start	0.39	Rating **	A/W	Issue No.	25	
LM End	0.39	Issue Type +	Ma	Location *		
Category	Supplemental			GPS Latitude/Longitude		
				Start		End
Item	DWR UCIP LMA Responsibility			39.785246 °		39.785246 °
				-121.876609 °		-121.876609 °
DWR ID						
Comment Code						
Inspector Comment						
FS_ID:32105 DS_ID:19277 EP_NO: N/A Repair Type: No Action Needed Crossing Status: Found UCIP Comments: Slide gate in CMP riser on waterside.The culvert was working during the field visit. FIELD_STRUCT_DESC: 2 of 3: Three 48-inch CM pipes through the levee, 11.7 feet below the crown. Slide gates on each pipe in riser well on the waterward slope. Concrete "U" headwall on both ends. Flap gates on the waterward end. Grouted riprap outlet channel. O&M Manual Sac 504, May 1965. FS Date: 3/11/2014

LS view: U type concrete headwall and three CMPs on levee slope. Soil/mud on inlet box.

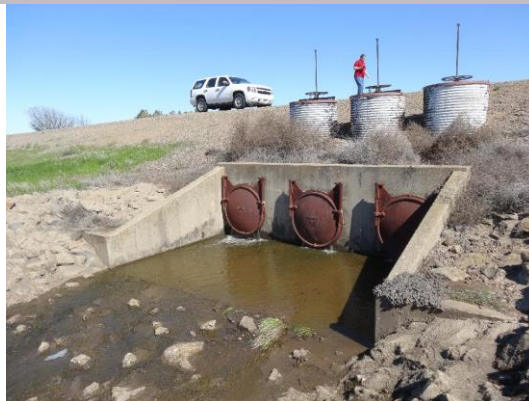
Photo 1 of 2 : UCIP\_FA\_2017\_32106\_58610.jpg

LM Start	0.39	Rating **	A/W	Issue No.	26
LM End	0.39	Issue Type +	Ma	Location *	
Category	Supplemental			GPS Latitude/Longitude	
				Start	End
Item	DWR UCIP LMA Responsibility			39.785230 °	39.785230 °
				-121.876592 °	-121.876592 °
DWR ID					
Comment Code					
Inspector Comment					
FS_ID:32106 DS_ID:19263 EP_NO: N/A Repair Type: No Action Needed Crossing Status: Found UCIP Comments: Slide gate in CMP riser on waterside.The culvert was working during the field visit. FIELD_STRUCT_DESC: 3 of 3: Three 48-inch CM pipes through the levee, 11.7 feet below the crown. Slide gates on each pipe in riser well on the waterward slope. Concrete "U" headwall on both ends. Flap gates on the waterward end. Grouted riprap outlet channel. O&M Manual Sac 504, May 1965. FS Date: 3/11/2014

WS view: U type concrete headwall and three CMPs with slide gates on levee slope. Grouted riprap spillway.

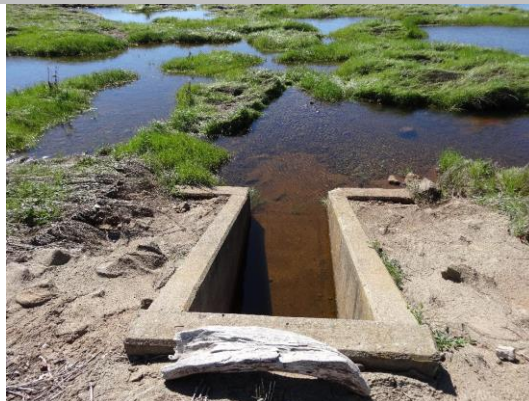
Photo 1 of 3 : UCIP\_FA\_2017\_32107\_58613.jpg

FS\_ID:32107  
DS\_ID:19264  
EP\_NO: N/A  
Repair Type: No Action Needed  
Crossing Status: Found  
UCIP Comments: The culvert was working during the field visit.  
FIELD\_STRUCT\_DESC: 24-inch CM pipe through the levee, 11.7 feet below the crown. Flap gate on the waterward end. Concrete "U" headwall on both ends. O&M Manual Sac 504, May 1965.  
FS Date: 3/11/2014

WS view: U type concrete headwall and grouted riprap on levee slope.

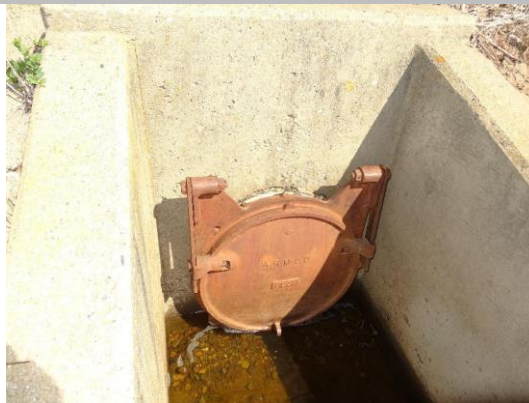
Photo 2 of 3 : UCIP\_FA\_2017\_32107\_58612.jpg

WS view: U type concrete headwall, flapgate, and CMP on levee slope.

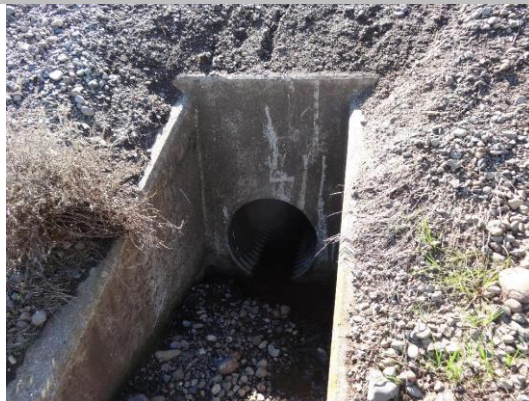
Photo 3 of 3 : UCIP\_FA\_2017\_32107\_58611.jpg

LS view: U type concrete headwall and CMP on levee slope.

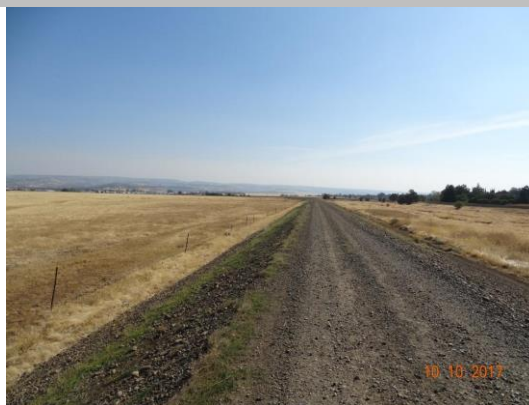
Photo 1 of 1 : FA\_2017\_NA0003\_67\_22\_20171019\_00069.jpg

LM Start	1.34	Rating **	A	Issue No.	22
LM End	1.34	Issue Type +	Ma	Location *	LS
Category	Earthen Levee			GPS Latitude/Longitude	
				Start	End
Item	Vegetation			39.779430 °	39.779430 °
				-121.860978 °	-121.860978 °
DWR ID	DWR_NA0003_03_f_2017_22				
Comment Code					
V1 : Control annual grass and weeds on the levee slopes and easements.					
Inspector Comment					
There is no vegetation on either slope.

View of no vegetation on both slopes.

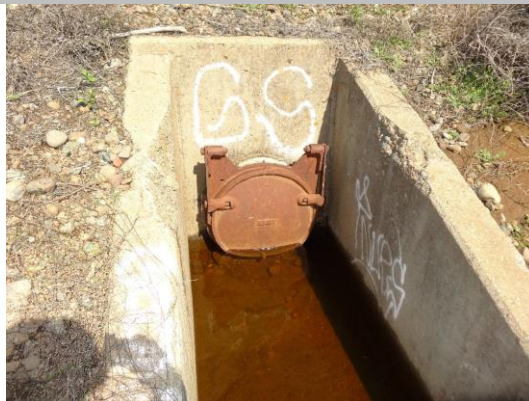
Photo 1 of 2 : UCIP\_FA\_2017\_31899\_58187.jpg

LM Start	1.50	Rating **	A/W	Issue No.	28	
LM End	1.50	Issue Type +	Ma	Location *		
Category	Supplemental			GPS Latitude/Longitude		
				Start	End	
Item	DWR UCIP LMA Responsibility			39.779230°	39.779230°	
				-121.857945°	-121.857945°	
DWR ID						
Comment Code						
Inspector Comment						
FS_ID:31899						
DS_ID:19265						
EP_NO: N/A						
Repair Type: No Action Needed						
Crossing Status: Found						
UCIP Comments: Working during the field visit.						
FIELD_STRUCT_DESC: 24-inch CM pipe through the levee, 11.0 feet below the crown. Flap gate on the waterward end. Concrete "U" headwall on both ends. Grouted riprap apron on both ends. O&M Manual Sac 504, May 1965.						
FS Date: 3/11/2014

WS view: U type concrete headwall, flapgate, and CMP on levee slope. Looks clean and clear.

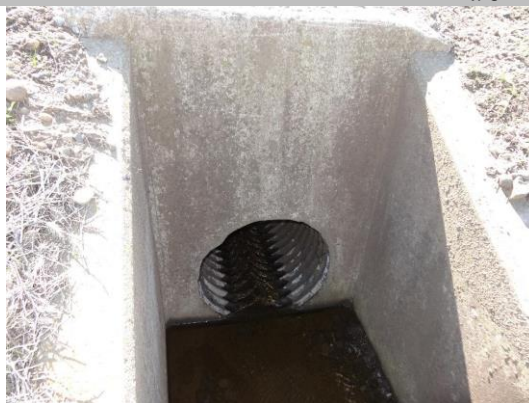
Photo 2 of 2 : UCIP\_FA\_2017\_31899\_58186.jpg

LS view: U type concrete headwall and CMP on levee slope. Looks clean and clear.

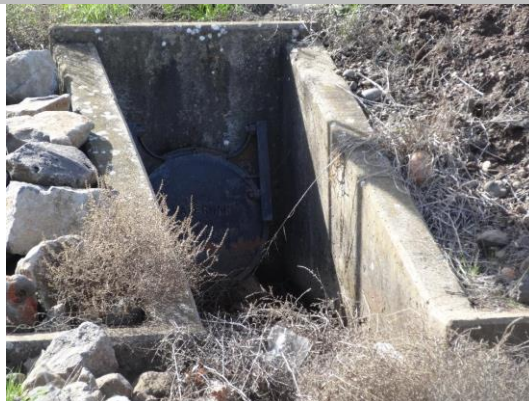
Photo 1 of 3 : UCIP\_FA\_2017\_32124\_58625.jpg

LM Start	2.17	Rating **	M	Issue No.	30	
LM End	2.17	Issue Type +	Ma	Location *		
Category	Supplemental			GPS Latitude/Longitude		
				Start	End	
Item	DWR UCIP LMA Responsibility			39.785290 °	39.785290 °	
				-121.844235 °	-121.844235 °	
DWR ID						
Comment Code						
Inspector Comment						
FS_ID:32124 DS_ID:19267 EP_NO: N/A Repair Type: Non-Urgent Crossing Status: Found UCIP Comments: Pipe is about 4 feet below the crown. Needs cleaning and clearing the culvert. FIELD_STRUCT_DESC: 24-inch CM pipe through the levee, 6.0 feet below the crown. Flap gate on the waterward end. Concrete "U" headwall on each end. O&M Manual Sac 504, May 1965. FS Date: 3/7/2014

WS view: concrete headwall, pipe, and flapgate on levee slope.  
Vegetation and mud on outlet box.
