**Flood Control Project Maintenance  
Levee Inspections**

## Maintenance Issue Types Only, Levee Inspection Report By Mile - Fall 2017

### Butte County Department of Public Works

Waterway	Bank	Unit Miles	Inspection Start/End	Inspector
Unit No. 01 Mud Creek	Right	6.80	10/11/2017 10/11/2017	Bob Duffey

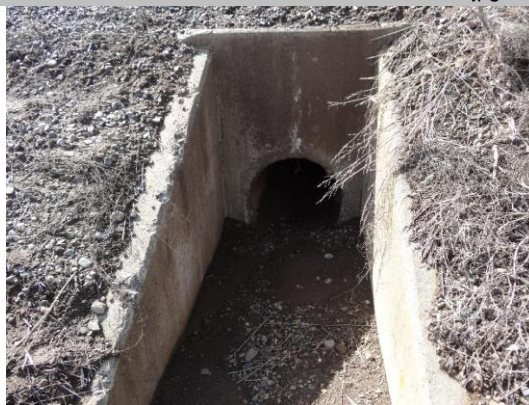
Photo 2 of 3 : UCIP\_FA\_2017\_31901\_58193.jpg

LM Start	3.08	Rating **	M	Issue No.	32 (cont)	
LM End	3.08	Issue Type +	Ma	Location *		
Category	Supplemental			GPS Latitude/Longitude		
				Start	End	
Item	DWR UCIP LMA Responsibility			39.778016°	39.778016°	
				-121.854460°	-121.854460°	
DWR ID						
Comment Code						
Inspector Comment						
FS_ID:31901 DS_ID:19269 EP_NO: N/A Repair Type: Non-Urgent Crossing Status: Found UCIP Comments: Needs cleaning and clearing the culvert. FIELD_STRUCT_DESC: 24-inch CM pipe through the levee, 11.0 feet below the crown. Flap gate on the waterward end. Concrete "U" headwalls on both ends. Grouted riprap apron on the landward end. Grouted riprap spillway on the waterward end. O&M Manual Sac 504, May 1965. FS Date: 3/7/2014

LS view: U type concrete headwall and CMP on levee slope. Soil/mud on inlet box.

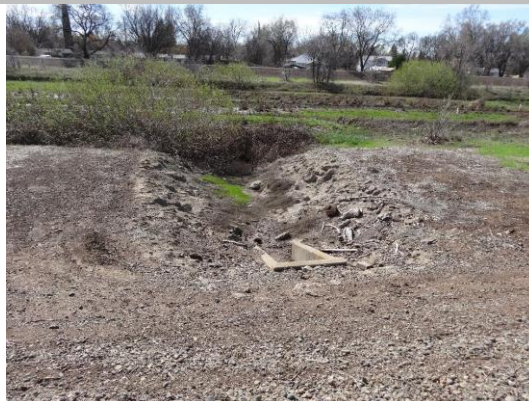
Photo 1 of 3 : UCIP\_FA\_2017\_31902\_58201.jpg

LM Start	3.19	Rating **	A/W	Issue No.	33	
LM End	3.19	Issue Type +	Ma	Location *		
Category	Supplemental			GPS Latitude/Longitude		
				Start	End	
Item	DWR UCIP LMA Responsibility			39.777463 °	39.777463 °	
				-121.852512 °	-121.852512 °	
DWR ID						
Comment Code						
Inspector Comment						
FS_ID:31902						
DS_ID:19270						
EP_NO: N/A						
Repair Type: No Action Needed						
Crossing Status: Found						
UCIP Comments:						
FIELD_STRUCT_DESC: 24-inch CM pipe through the levee, 11.0 feet						
below the crown. Flap gate on the waterward end. Concrete "U"						
headwalls on both ends. Grouted riprap apron on the landward end.						
Grouted riprap spillway on the waterward end. O&M Manual Sac 504,						
May 1965.						
FS Date: 3/7/2014

WS view: U type concrete headwall and grouted riprap spillway on levee slope.

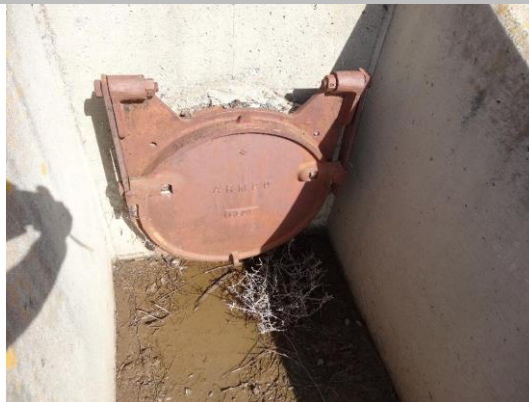
Photo 2 of 3 : UCIP\_FA\_2017\_31902\_58200.jpg

WS view: U type concrete headwall and CMP on levee slope.

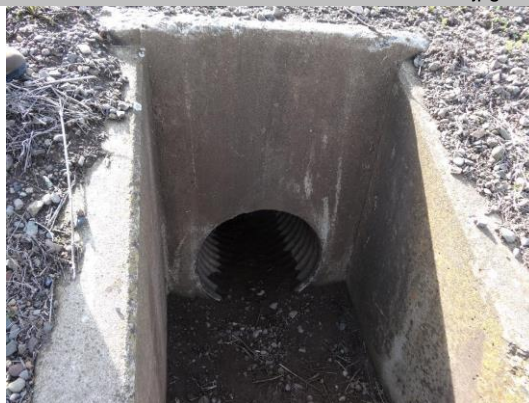
Photo 2 of 3 : UCIP\_FA\_2017\_31864\_58068.jpg

FS\_ID:31864  
DS\_ID:19271  
EP\_NO: N/A  
Repair Type: Non-Urgent  
Crossing Status: Found  
UCIP Comments: Needs cleaning and clearing the culvert.  
FIELD\_STRUCT\_DESC: 24-inch CM pipe through the levee, 10.5 feet below the crown. Flap gate on the waterward end. Concrete "U" headwalls on both ends. Grouted riprap apron on the landward end. Grouted riprap spillway on the waterward end. O&M Manual Sac 504, May 1965.  
FS Date: 3/7/2014

LS view: U type concrete headwall and CMP on levee slope. Soil/mud on inlet box.

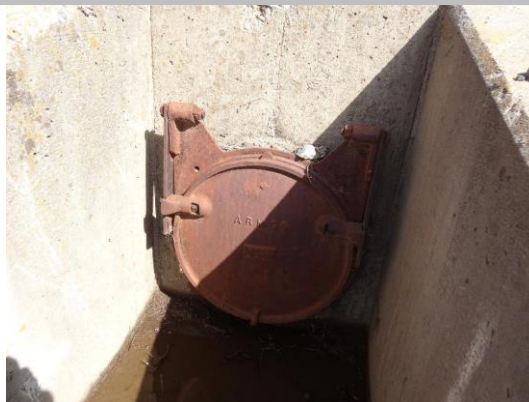
Photo 1 of 3 : UCIP\_FA\_2017\_31856\_58053.jpg

LM Start	3.50	Rating **	M	Issue No.	35	
LM End	3.50	Issue Type +	Ma	Location *		
Category	Supplemental			GPS Latitude/Longitude		
				Start	End	
Item	DWR UCIP LMA Responsibility			39.777139 °	39.777139 °	
				-121.846769 °	-121.846769 °	
DWR ID						
Comment Code						
Inspector Comment						
FS_ID:31856						
DS_ID:19272						
EP_NO: N/A						
Repair Type: Non-Urgent						
Crossing Status: Found						
UCIP Comments: Needs cleaning and clearing the culvert.						
FIELD_STRUCT_DESC: 24-inch CM pipe through the levee, 9.5 feet below the crown. Flap gate on the waterward end. Concrete "U" headwalls on both ends. Grouted riprap apron on the landward end. Grouted riprap spillway on the waterward end. O&M Manual Sac 504, May 1965.						
FS Date: 3/7/2014

WS view: U type concrete headwall, pipe, and flapgate on levee slope.  
Soil/mud on outlet box.

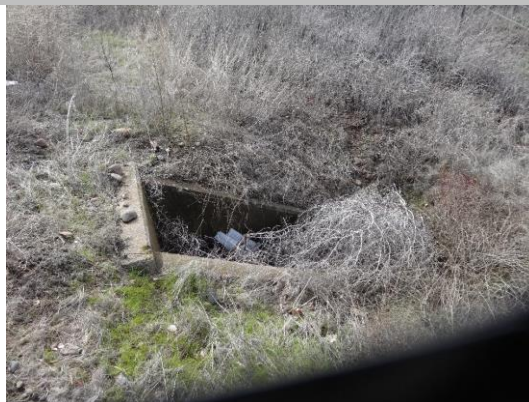
Photo 2 of 2 : UCIP\_FA\_2017\_32125\_58628.jpg

LM Start	3.68	Rating **	M	Issue No.	37
LM End	3.68	Issue Type +	Ma	Location *	
Category	Supplemental			GPS Latitude/Longitude	
				Start	End
Item	DWR UCIP LMA Responsibility			39.777662 °	39.777662 °
				-121.843489 °	-121.843489 °
DWR ID					
Comment Code					
Inspector Comment					
FS_ID:32125 DS_ID:19275 EP_NO: N/A Repair Type: Non-Urgent Crossing Status: Found UCIP Comments: The culvert was working during the field visit.Needs cleaning and clearing on both ends of the pipe. FIELD_STRUCT_DESC: 24-inch CM pipe through the levee, 7.5 feet below the crown. Flap gate on the waterward end. Concrete "U" headwalls on both ends. Grouted riprap apron on the landward end. Grouted riprap spillway on the waterward end. O&M Manual Sac 504, May 1965. FS Date: 3/4/2014

LS view: U type concrete headwall and pipe on levee slope. Soil/mud on inlet box. Vegetation debris blocking inlet box.

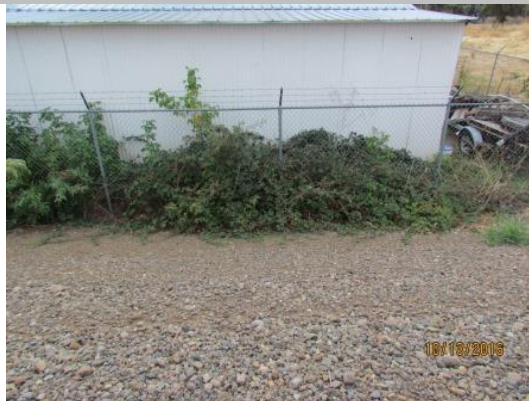
Photo 1 of 1 : FA\_2017\_NA0003\_68\_20\_20170911\_00006.jpg

View of the vegetation along the landside toe blocking visibility.

LM Start	0.16	Rating **	M	Issue No.	20
LM End	0.16	Issue Type +	Ma	Location *	LS
Category	Earthen Levee			GPS Latitude/Longitude	
				Start	End
Item	Vegetation			39.776526 °	39.776526 °
				-121.848727 °	-121.848727 °
DWR ID	DWR_NA0003_04_f_2016_20				
Comment Code					
V2 : Remove the wild growth other than native grasses from the levee slopes.					
Inspector Comment

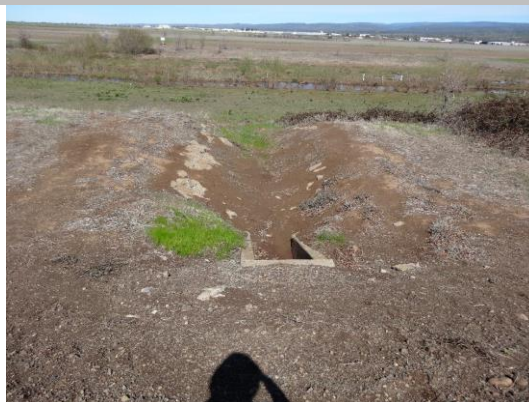
Photo 1 of 3 : UCIP\_FA\_2017\_32026\_58520.jpg

LM Start	0.27	Rating **	M	Issue No.	25
LM End	0.27	Issue Type +	Ma	Location *	
Category	Supplemental			GPS Latitude/Longitude	
				Start	End
Item	DWR UCIP LMA Responsibility			39.776554 °	39.776554 °
				-121.850730 °	-121.850730 °
DWR ID					
Comment Code					
Inspector Comment					
FS_ID:32026					
DS_ID:19279					
EP_NO: N/A					
Repair Type: Non-Urgent					
Crossing Status: Found					
UCIP Comments: Needs cleaning and clearing the culvert.					
FIELD_STRUCT_DESC: 24-inch CM pipe through the levee, 10.0 feet below the crown. Flap gate on the waterward end. Concrete "U" headwalls on both ends. Grouted riprap apron on the landward end. Grouted riprap spillway on the waterward end. O&M Manual Sac 504, May 1965.					
FS Date: 3/7/2014

WS view: concrete headwall and grouted riprap spillway on levee slope.

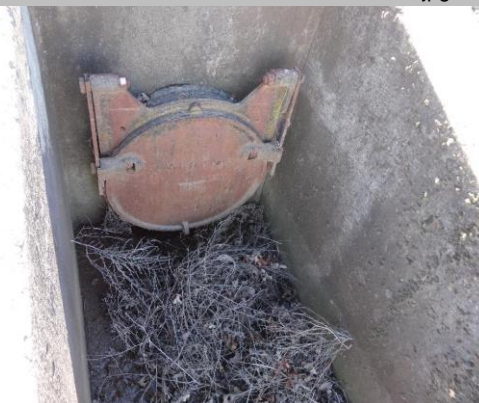
Photo 2 of 3 : UCIP\_FA\_2017\_32026\_58519.jpg

WS view: U type concrete headwall and CMP on levee slope. Mud and vegetation debris on outlet box.

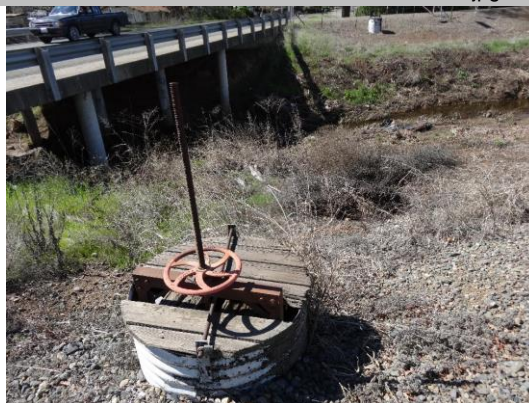
Photo 1 of 3 : UCIP\_FA\_2017\_32025\_58512.jpg

WS view: slide gate in CMP riser on waterside shoulder.

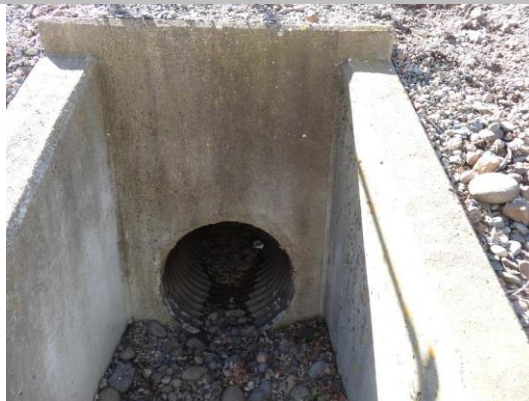
Photo 2 of 3 : UCIP\_FA\_2017\_32023\_58504.jpg

LM Start	0.35	Rating **	M	Issue No.	27 (cont)	
LM End	0.35	Issue Type +	Ma	Location *		
Category	Supplemental			GPS Latitude/Longitude		
				Start	End	
Item	DWR UCIP LMA Responsibility			39.775682 °	39.775682 °	
				-121.850375 °	-121.850375 °	
DWR ID						
Comment Code						
Inspector Comment						
FS_ID:32023						
DS_ID:19281						
EP_NO: N/A						
Repair Type: Non-Urgent						
Crossing Status: Found						
UCIP Comments: Needs cleaning and clearing the culvert.						
FIELD_STRUCT_DESC: 24-inch CM pipe through the levee, 8.0 feet below the crown. Flap gate on the waterward end. Concrete "U" headwall on both ends. Grouted riprap apron on the landward end. Grouted riprap spillway on the waterward end. O&M Manual Sac 504, May 1965.						
FS Date: 3/7/2014

LS view: U type concrete headwall and CMP on levee slope. Pebbles and mud on inlet box.

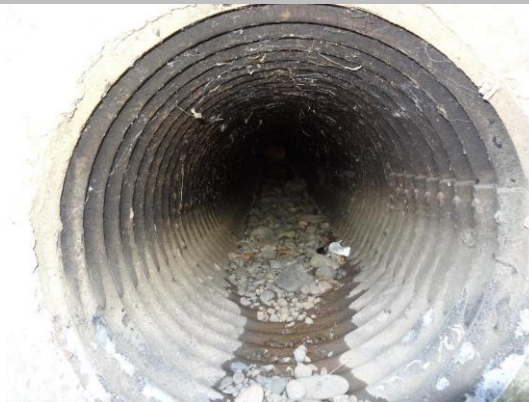
Photo 3 of 3 : UCIP\_FA\_2017\_32023\_58503.jpg

LS view: inside view of the CM pipe. Needs cleaning and clearing the pipe.

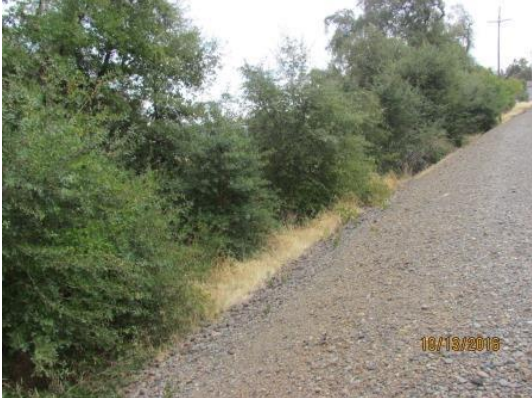
Photo 1 of 1 : FA\_2017\_NA0003\_68\_21\_20170911\_00007.jpg

View of the overgrown trees along the landside toe.

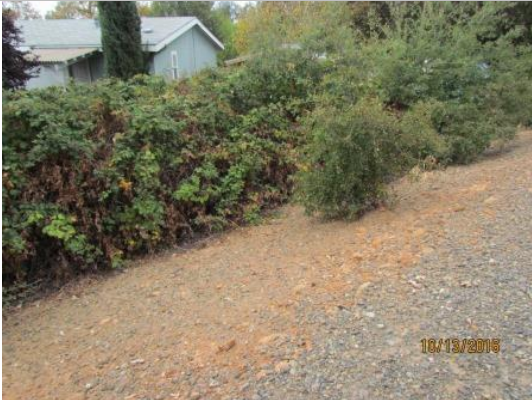
Photo 1 of 1 : FA\_2017\_NA0003\_68\_22\_20170911\_00008.jpg

View of the blackberries blocking visibility and access.

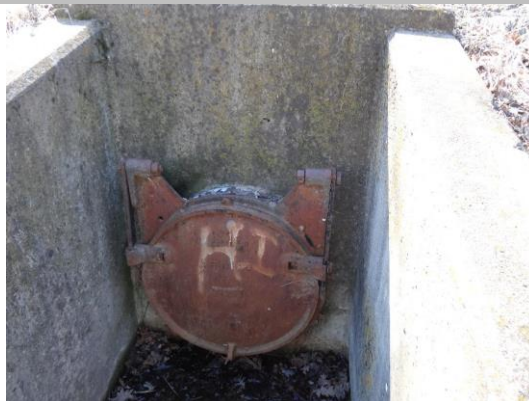
Photo 1 of 2 : UCIP\_FA\_2017\_32143\_58641.jpg

LM Start	0.92	Rating **	M	Issue No.	28
LM End	0.92	Issue Type +	Ma	Location *	
Category	Supplemental			GPS Latitude/Longitude	
				Start	End
Item	DWR UCIP LMA Responsibility			39.775704 °	39.775704 °
				-121.850901 °	-121.850901 °
DWR ID					
Comment Code					
Inspector Comment					
FS_ID:32143					
DS_ID:19287					
EP_NO: N/A					
Repair Type: Non-Urgent					
Crossing Status: Found					
UCIP Comments: Needs cleaning and clearing the culvert.					
FIELD_STRUCT_DESC: 24-inch CM pipe through the levee, 9.0 feet below the crown. Flap gate on the waterward end. Concrete "U" headwalls on both ends. Grouted riprap apron on the landward end. Grouted riprap spillway on the waterward end. O&M Manual Sac 504, May 1965.					
FS Date: 3/7/2014

WS view: U type concrete headwall and CMP on levee slope. Soil/mud on outlet box. Needs cleaning and clearing.

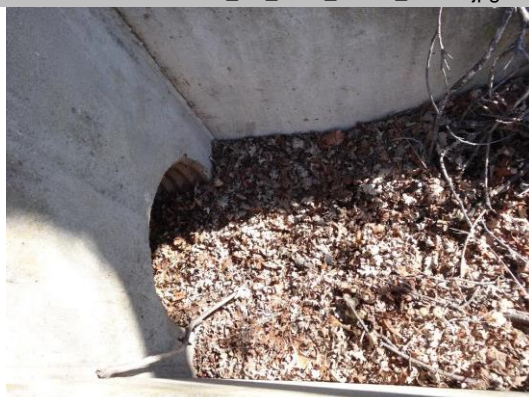
Photo 2 of 2 : UCIP\_FA\_2017\_32143\_58640.jpg

LS view: U type concrete headwall and CMP on levee slope. Vegetation and mud on inlet box.

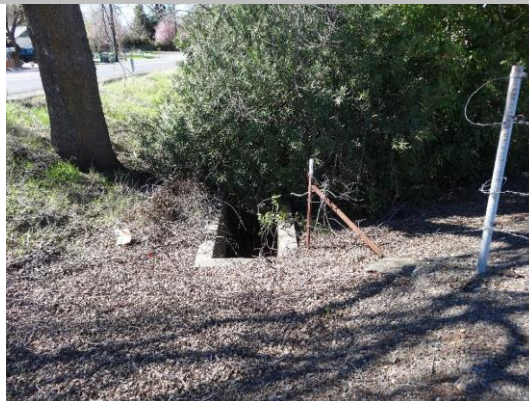
Photo 1 of 3 : UCIP\_FA\_2017\_32144\_58644.jpg

LM Start	0.94	Rating **	M	Issue No.	30
LM End	0.94	Issue Type +	Ma	Location *	
Category	Supplemental			GPS Latitude/Longitude	
				Start	End
Item	DWR UCIP LMA Responsibility			39.775899 °	39.775899 °
				-121.851124 °	-121.851124 °
DWR ID					
Comment Code					
Inspector Comment					
FS_ID:32144					
DS_ID:19288					
EP_NO: N/A					
Repair Type: Non-Urgent					
Crossing Status: Found					
UCIP Comments: Slide gate in CMP riser on waterside. No access to CMP riser.Needs cleaning and clearing the culvert.					
FIELD_STRUCT_DESC: 24-inch CM pipe through the levee and under the channel, 9.5 feet below the crown. Slide gate in pipe riser on the waterward slope. Concrete "U" headwall on the landward end. O&M Manual Sac 504, May 1965.					
FS Date: 3/7/2014

LS view: U type concrete headwall of CMP culvert on levee slope. Vegetation debris and mud on inlet box.

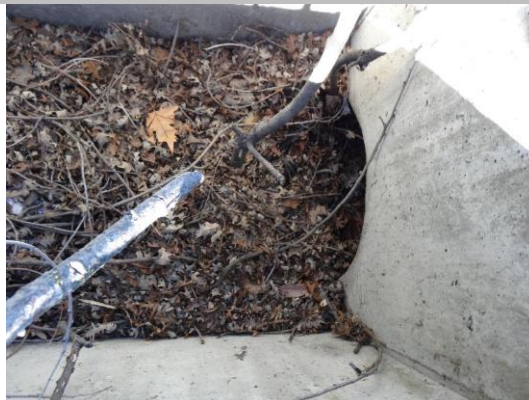
Photo 2 of 3 : UCIP\_FA\_2017\_32144\_58643.jpg

LS view: close view of vegetation debris and mud on inlet box.

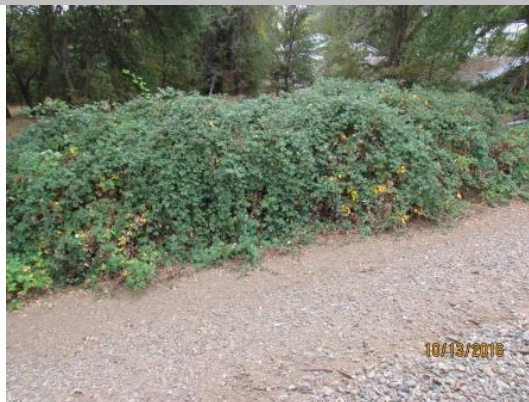
Photo 1 of 1 : FA\_2017\_NA0003\_68\_23\_20170911\_00009.jpg

LM Start	1.04	Rating **	M	Issue No.	23
LM End	1.04	Issue Type +	Ma	Location *	LS
Category	Earthen Levee			GPS Latitude/Longitude	
				Start	End
Item	Vegetation			39.776589 °	39.776589 °
				-121.852600 °	-121.852600 °
DWR ID	DWR_NA0003_04_f_2016_23				
Comment Code					
V2 : Remove the wild growth other than native grasses from the levee slopes.					
Inspector Comment

View of the blackberries blocking visibility and access.

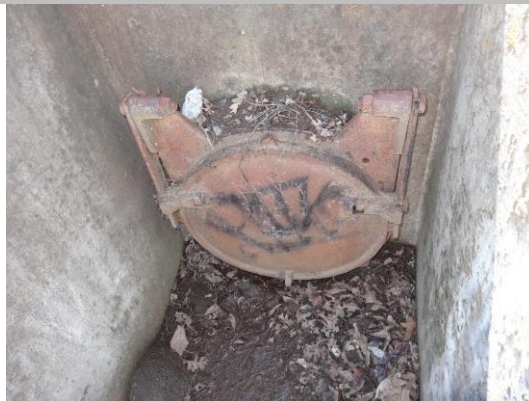
Photo 1 of 3 : UCIP\_FA\_2017\_31963\_58384.jpg

FS\_ID:31963  
DS\_ID:19289  
EP\_NO: N/A  
Repair Type: Non-Urgent  
Crossing Status: Found  
UCIP Comments: Needs cleaning and clearing the culvert.  
FIELD\_STRUCT\_DESC: 24-inch CM pipe through the levee, 11.0 feet below the flap gate on the waterward end. Concrete "U" headwalls on both ends. Grouted riprap apron on the landward end. Grouted riprap spillway on the waterward end. O&M Manual Sac 504, May 1965.  
FS Date: 3/7/2014

WS view: U type concrete headwall and CMP on levee slope. Vegetation debris and mud on outlet box. Needs cleaning and clearing.

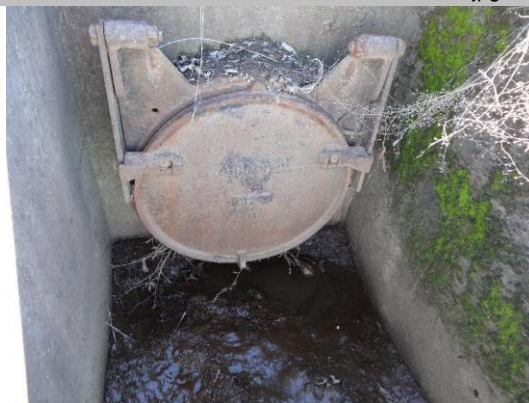
Photo 1 of 2 : UCIP\_FA\_2017\_31964\_58389.jpg

LM Start	1.35	Rating **	M	Issue No.	32	
LM End	1.35	Issue Type +	Ma	Location *		
Category	Supplemental			GPS Latitude/Longitude		
				Start	End	
Item	DWR UCIP LMA Responsibility			39.778370 °	39.778370 °	
				-121.857904 °	-121.857904 °	
DWR ID						
Comment Code						
Inspector Comment						
FS_ID:31964						
DS_ID:19290						
EP_NO: N/A						
Repair Type: Non-Urgent						
Crossing Status: Found						
UCIP Comments: Needs cleaning and clearing the culvert.						
FIELD_STRUCT_DESC: 24-inch CM pipe through the levee, 13.0 feet below the crown. Flap gate on the waterward end. Concrete "U" headwalls on both ends. Grouted riprap apron on the landward end. Grouted riprap spillway on the waterward end. O&M Manual Sac 504, May 1965.						
FS Date: 3/7/2014

WS view: U type concrete headwall and CMP on levee slope. Vegetation debris and mud in outlet box. Needs cleaning and clearing.

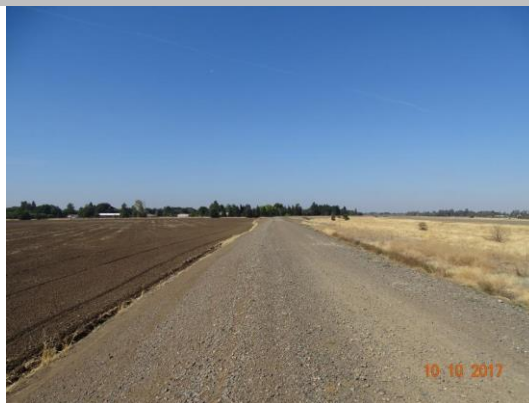
Photo 1 of 1 : FA\_2017\_NA0003\_68\_16\_20171019\_00063.jpg

LM Start	1.61	Rating **	A	Issue No.	16	
LM End	1.61	Issue Type +	Ma	Location *	LS	
Category	Earthen Levee			GPS Latitude/Longitude		
				Start		End
Item	Vegetation			39.778763 °		39.778763 °
				-121.862702 °		-121.862702 °
DWR ID	DWR_NA0003_04_f_2017_16					
Comment Code						
V1 : Control annual grass and weeds on the levee slopes and easements.						
Inspector Comment						
There is no vegetation on either slope.

View of no vegetation on both slopes.

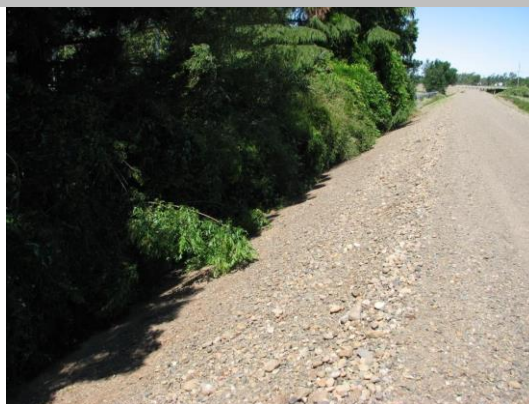
Photo 1 of 1 : FA\_2017\_NA0003\_68\_18\_20170911\_00005.jpg

LM Start	2.04	Rating **	U	Issue No.	18
LM End	2.08	Issue Type +	Ma	Location *	LS
Category	Earthen Levee			GPS Latitude/Longitude	
				Start	End
Item	Trim / Thin Trees			39.781669 °	39.782025 °
				-121.869804 °	-121.870252 °
DWR ID	DWR_NA0003_04_s_2016_18				
Comment Code					
T2 : Thin trees to allow visibility of the ground and room to flood fight.					
Inspector Comment					
Trees and shrubbery obscure visibility on landside toe hinge point.

View of the vegetation on fence at landside toe.

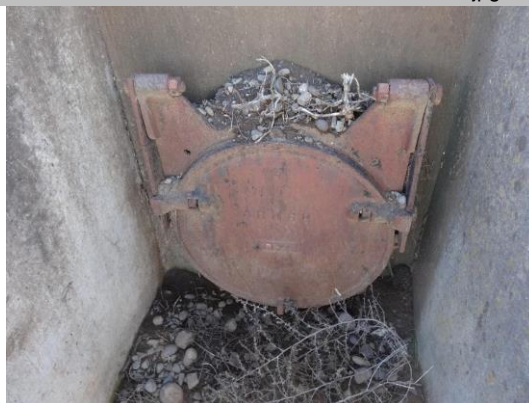
Photo 1 of 3 : UCIP\_FA\_2017\_31965\_58395.jpg

LM Start	2.15	Rating **	M	Issue No.	33
LM End	2.15	Issue Type +	Ma	Location *	
Category	Supplemental			GPS Latitude/Longitude	
				Start	End
Item	DWR UCIP LMA Responsibility			39.782777 °	39.782777 °
				-121.871179 °	-121.871179 °
DWR ID					
Comment Code					
Inspector Comment					
FS_ID:31965 DS_ID:19291 EP_NO: N/A Repair Type: Non-Urgent Crossing Status: Found UCIP Comments: Needs cleaning and clearing the culvert. FIELD_STRUCT_DESC: 24-inch CM pipe through the levee, 11.0 feet below the crown. Flap gate on the waterward end. Concrete "U" headwall on both ends. Grouted riprap apron on the landward end. Grouted riprap spillway on the waterward end. O&M Manual Sac 504, May 1965. FS Date: 3/7/2014

WS view: U type concrete headwall and CMP on levee slope. Vegetation debris and mud in outlet box. Needs cleaning and clearing.

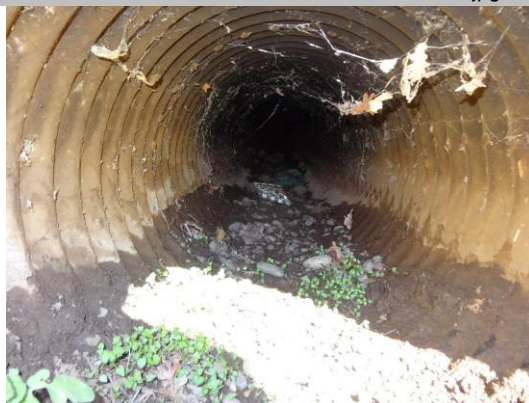
Photo 3 of 3 : UCIP\_FA\_2017\_31965\_58393.jpg

LS view: inside view of CMP on levee slope. Needs cleaning and clearing.

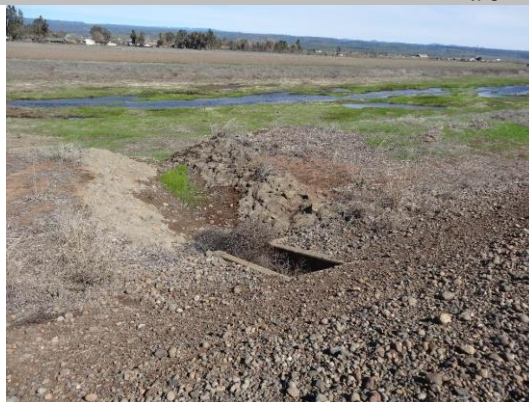
Photo 1 of 3 : UCIP\_FA\_2017\_31966\_58401.jpg

LM Start	2.47	Rating **	M	Issue No.	34
LM End	2.47	Issue Type +	Ma	Location *	
Category	Supplemental			GPS Latitude/Longitude	
				Start	End
Item	DWR UCIP LMA Responsibility			39.784244 °	39.784244 °
				-121.876810 °	-121.876810 °
DWR ID					
Comment Code					
Inspector Comment					
FS_ID:31966					
DS_ID:19292					
EP_NO: N/A					
Repair Type: Non-Urgent					
Crossing Status: Found					
UCIP Comments: Needs cleaning and clearing the culvert.					
FIELD_STRUCT_DESC: 24-inch CM pipe through levee, 11.0 feet below the crown. Flap gate on the waterward end. Concrete "U" headwalls on both ends. Grouted riprap apron on the landward end. Grouted riprap spillway on the waterward end. O&M Manual Sac 504, May 1965.					
FS Date: 3/7/2014

WS view: U type concrete headwall and grouted riprap spillway on levee slope.

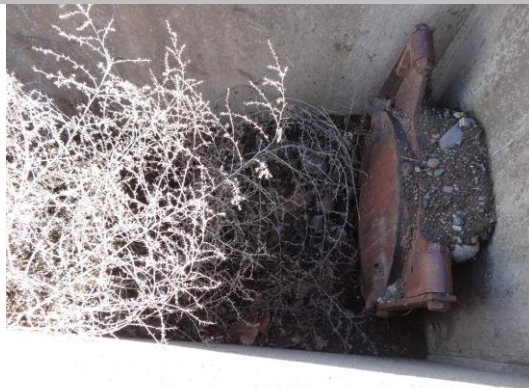
Photo 2 of 3 : UCIP\_FA\_2017\_31966\_58400.jpg

WS view: U type concrete headwall and CMP on levee slope. Vegetation debris and mud on outlet box. Needs cleaning and clearing.

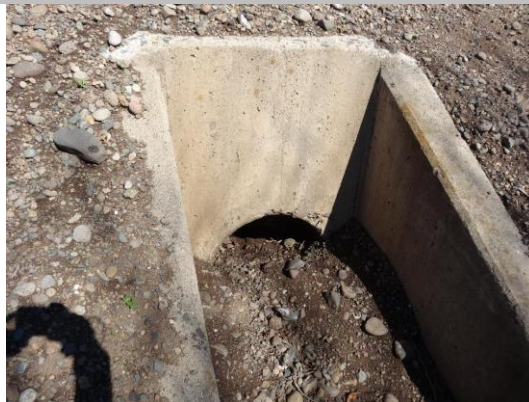
Photo 3 of 3 : UCIP\_FA\_2017\_31966\_58399.jpg

LS view: U type concrete headwall and CMP on levee slope. Vegetation debris and mud in pipe and inlet box.

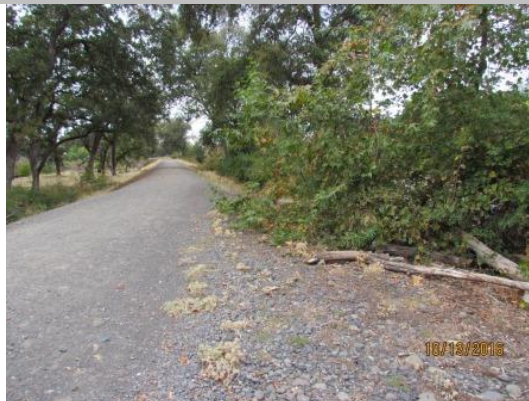
Photo 1 of 1 : FA\_2017\_NA0003\_69\_4\_20170911\_00003.jpg

LM Start	0.21	Rating **	M	Issue No.	4
LM End	0.26	Issue Type +	Ma	Location *	WS
Category	Earthen Levee			GPS Latitude/Longitude	
				Start	End
Item	Vegetation			39.761957 °	39.761892 °
				-121.792867 °	-121.793705 °
DWR ID	DWR_NA0003_05_f_2014_4				
Comment Code					
V2 : Remove the wild growth other than native grasses from the levee slopes.					
Inspector Comment					
Remove the vegetation from the waterside slope.

View of the vegetation along the waterside slope.

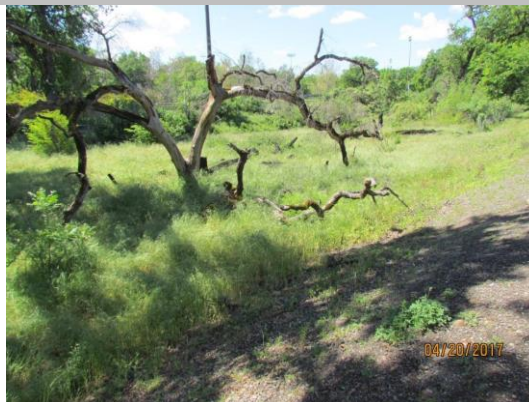
Photo 1 of 2 : FA\_2017\_NA0003\_69\_8\_20170911\_00005.jpg

LM Start	0.26	Rating **	M	Issue No.	8
LM End	0.26	Issue Type +	Ma	Location *	LS
Category	Earthen Levee			GPS Latitude/Longitude	
				Start	End
Item	Encroachments			39.761795 °	39.761795 °
				-121.793790 °	-121.793790 °
DWR ID	DWR_NA0003_05_f_2015_8				
Comment Code					
TR : Tree or limb					
Inspector Comment					
Remove the trees from the landside toe.

View of the tree along the landside toe that has not been removed for over a year.

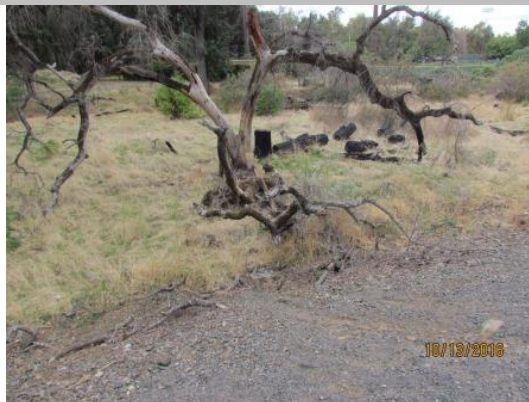
Photo 2 of 2 : FA\_2017\_NA0003\_69\_8\_20170911\_00006.jpg

View of the trees along the landside toe.

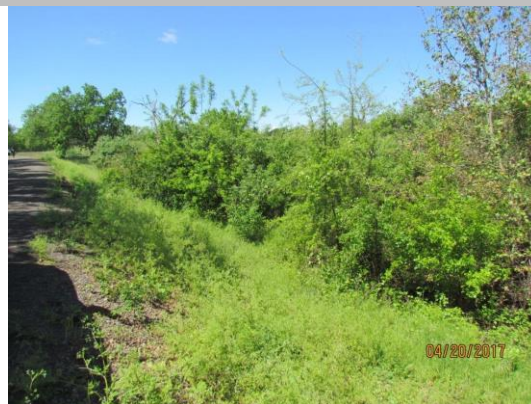
Photo 1 of 1 : FA\_2017\_NA0003\_69\_9\_20170911\_00007.jpg

LM Start	0.33	Rating **	M	Issue No.	9
LM End	0.33	Issue Type +	Ma	Location *	WS
Category	Earthen Levee			GPS Latitude/Longitude	
				Start	End
Item	Vegetation			39.761642 °	39.761642 °
				-121.795008 °	-121.795008 °
DWR ID	DWR_NA0003_05_s_2017_9				
Comment Code					
V2 : Remove the wild growth other than native grasses from the levee slopes.					
Inspector Comment

View of the vegetation along the waterside slope and toe.

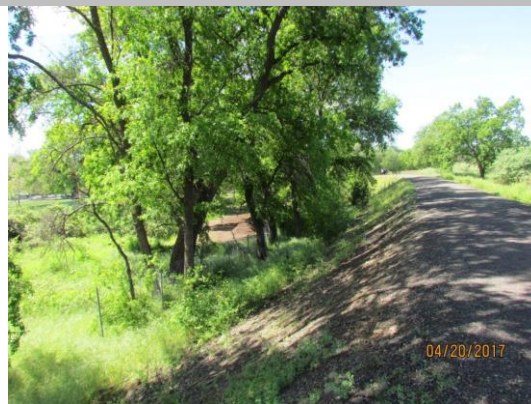
Photo 1 of 2 : FA\_2017\_NA0003\_69\_3\_20170911\_00001.jpg

LM Start	0.34	Rating **	M	Issue No.	3
LM End	0.42	Issue Type +	Ma	Location *	LS
Category	Earthen Levee			GPS Latitude/Longitude	
				Start	End
Item	Vegetation			39.761633 °	39.761117 °
				-121.795155 °	-121.796464 °
DWR ID	DWR_NA0003_05_f_2013_3				
Comment Code					
V2 : Remove the wild growth other than native grasses from the levee slopes.					
Inspector Comment

View of the vegetation along the landside slope and toe.

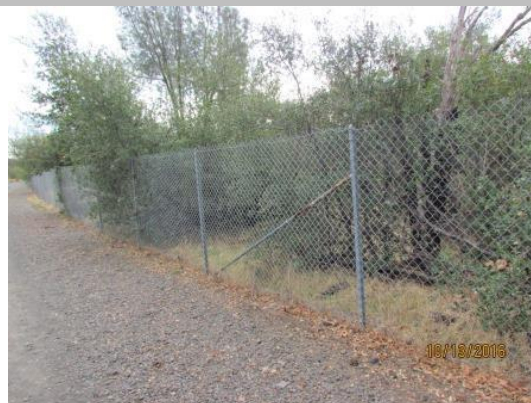
Photo 1 of 1 : FA\_2017\_NA0003\_69\_12\_20170911\_00010.jpg

LM Start	0.50	Rating **	M	Issue No.	12
LM End	0.82	Issue Type +	Ma	Location *	LS
Category	Earthen Levee			GPS Latitude/Longitude	
				Start	End
Item	Trim / Thin Trees			39.761836 °	39.763507 °
				-121.797316 °	-121.802545 °
DWR ID	DWR_NA0003_05_f_2016_12				
Comment Code					
T2 : Thin trees to allow visibility of the ground and room to flood fight.					
Inspector Comment

View of the trees along the landside slope.

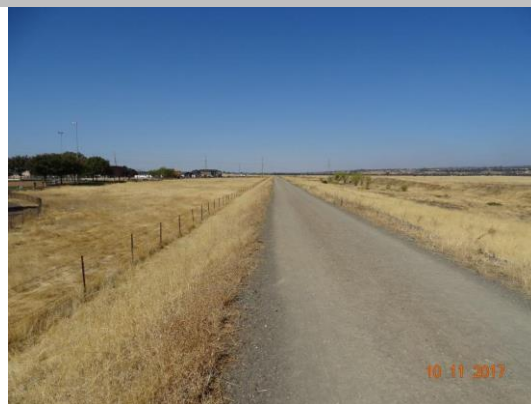
Photo 1 of 1 : FA\_2017\_NA0003\_69\_14\_20171019\_00012.jpg

LM Start	0.85	Rating **	M	Issue No.	14
LM End	1.85	Issue Type +	Ma	Location *	LS
Category	Earthen Levee			GPS Latitude/Longitude	
				Start	End
Item	Vegetation			39.764702 °	39.775426 °
				-121.803562 °	-121.814201 °
DWR ID	DWR_NA0003_05_f_2017_14				
Comment Code					
V2 : Remove the wild growth other than native grasses from the levee slopes.					
Inspector Comment					
Remove the native grasses from both slopes.

View of native grasses on both slopes.
