**Flood Control Project Maintenance
Levee Inspections**

Maintenance Issue Types Only, Levee Inspection Report By Mile - Fall 2018

Butte County Department of Public Works

Waterway	Bank	Unit Miles	Inspection Start/End	Inspector
Unit No. 01 Mud Creek	Right	6.80	09/18/2018 09/18/2018	Bob Duffey

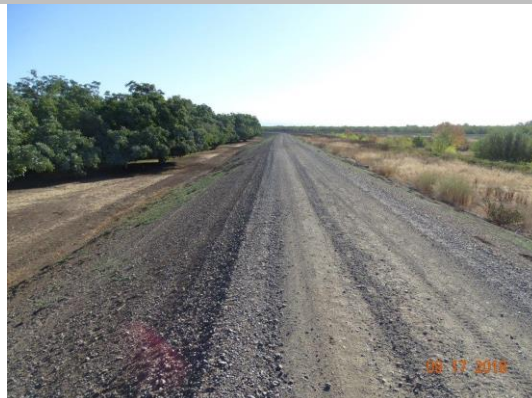
Photo 1 of 1 : FA_2018_NA0003_64_26_20181001_00065.jpg

LM Start	1.06	Rating **	A	Issue No.	26
LM End	1.06	Issue Type +	Ma	Location *	LS
Category	Earthen Levee			GPS Latitude/Longitude	
				Start	End
Item	Vegetation			39.739590 °	39.739590 °
				-121.930827 °	-121.930827 °
DWR ID	DWR_NA0003_01_f_2018_26				
Comment Code					
V1 : Control annual grass and weeds on the levee slopes and easements.					
Inspector Comment					
There is no vegetation on both slopes.

View of the levee with no vegetation on both slopes.

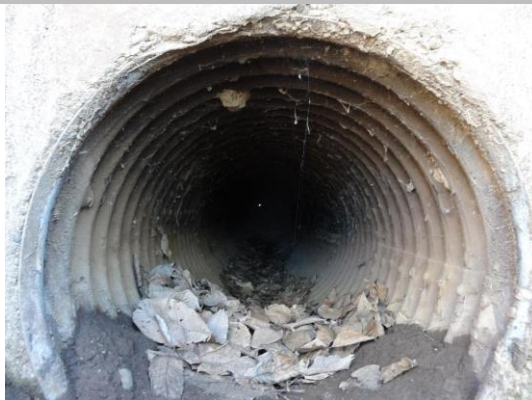
Photo 3 of 3 : UCIP_FA_2018_30310_55739.jpg

LS view: inside view of CMP on levee slope. Needs cleaning and clearing.

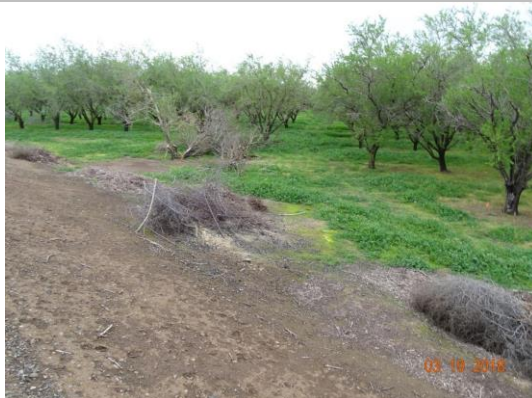
Photo 1 of 1 : FA_2018_NA0003_64_32_20180905_00014.jpg

LM Start	3.89	Rating **	M	Issue No.	32
LM End	3.89	Issue Type +	Ma	Location *	LS
Category	Earthen Levee			GPS Latitude/Longitude	
				Start	End
Item	Encroachments			39.770395 °	39.770395 °
				-121.901305 °	-121.901305 °
DWR ID	DWR_NA0003_01_s_2018_32				
Comment Code					
PR : Prunings					
Inspector Comment					
Remove the prunings from the landside toe

View of the prunings along the landside toe.

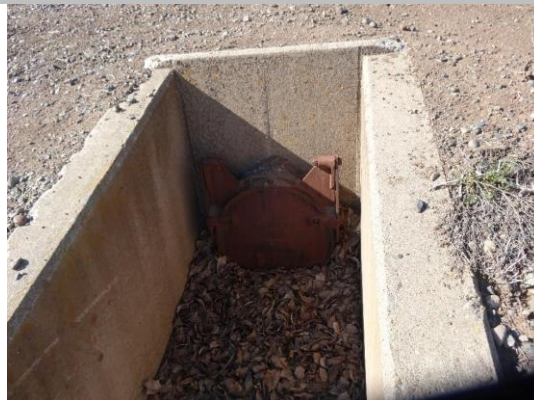
Photo 1 of 2 : UCIP_FA_2018_30311_55743.jpg

Comment Code						
Inspector Comment						
FS_ID:30311						
DS_ID:19219						
EP_NO: N/A						
Repair Type: Non-Urgent						
Crossing Status: Found						
UCIP Comments: Needs cleaning and clearing of debris in both ends of the pipe.						
FIELD_STRUCT_DESC: 24-inch corrugated metal gravity drainage pipe through the levee, 9 feet below the crown. Flap gate on the waterside (WS) end. Concrete U-shaped headwall on each end. Grouted riprap apron on the landside (LS) end. Grouted riprap spillway on the WS end. [Additional Reference(s): DWR Levee Log, 1992. USACE Sacramento O&M Manual 504, May 1965, (HLM 4.08)].						
FS Date: 2/20/2014

WS view: U type concrete headwall, pipe, and flapgate on levee slope. Vegetation debris blocking outlet.

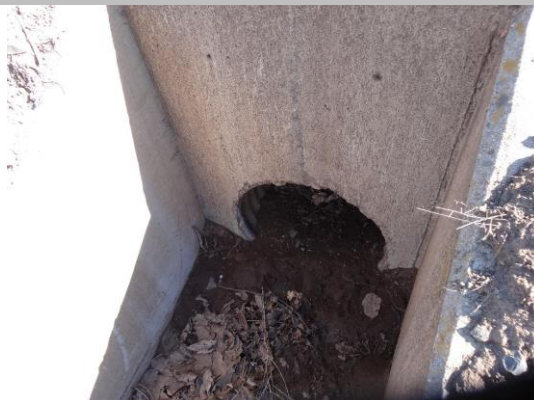
Photo 2 of 2 : UCIP_FA_2018_30311_55742.jpg

LS view: U type concrete headwall and CMP on levee slope.

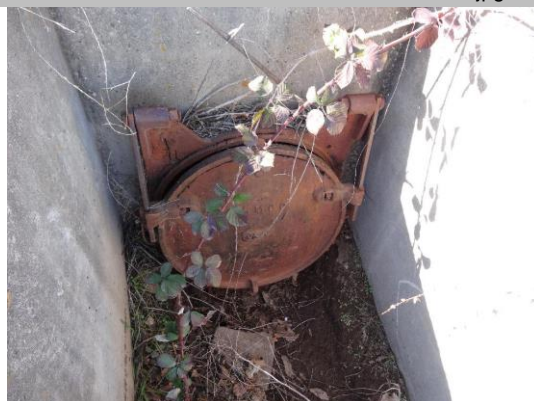
Photo 1 of 2 : UCIP_FA_2018_30312_55745.jpg

WS view: U type concrete headwall, pipe, and flapgate on levee slope. Vegetation debris blocking outlet.

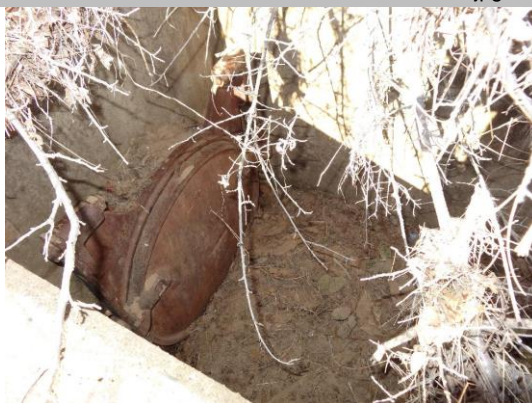
Photo 1 of 2 : UCIP_FA_2018_30388_55891.jpg

WS view: U type concrete headwall, pipe, and flapgate on levee slope. Vegetation/soil debris blocking outlet.

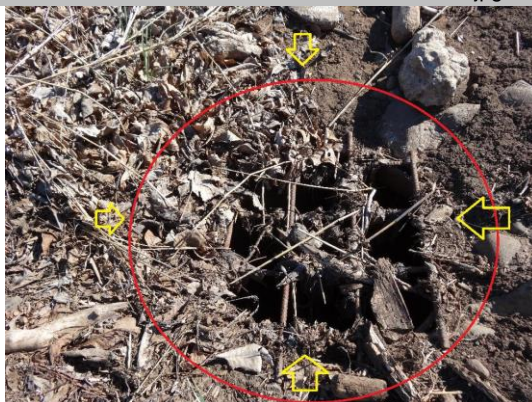
Photo 2 of 2 : UCIP_FA_2018_30388_55890.jpg

LS view: Underground CM standpipe intake with steel grit on levee toe.

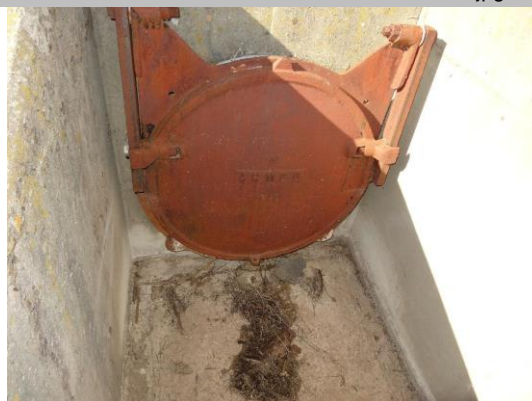
Photo 1 of 3 : UCIP_FA_2018_30327_55768.jpg

WS view: U type concrete headwall, pipe, and flapgate on levee slope.

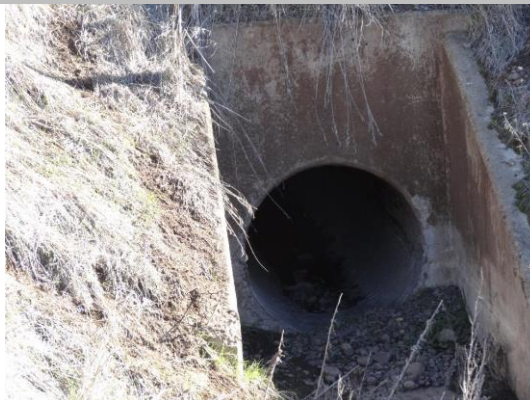
Photo 3 of 3 : UCIP_FA_2018_30327_55766.jpg

LS view: U type concrete headwall and CMP on levee slope.

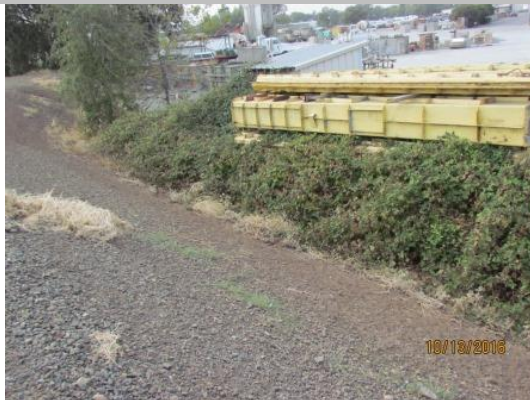
Photo 1 of 1 : FA_2018_NA0003_64_55_20180905_00031.jpg

LM Start	5.20	Rating **	M	Issue No.	55
LM End	5.20	Issue Type +	Ma	Location *	LS
Category	Earthen Levee			GPS Latitude/Longitude	
				Start	End
Item	Vegetation			39.784234 °	39.784234 °
				-121.886589 °	-121.886589 °
DWR ID	DWR_NA0003_01_f_2016_55				
Comment Code					
V2 : Remove the wild growth other than native grasses from the levee slopes.					
Inspector Comment

View of the blackberries blocking visibility and access.

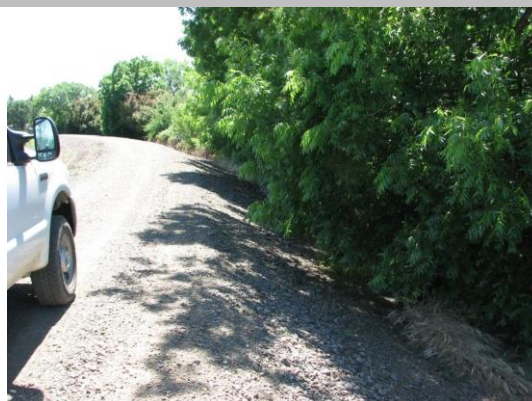
Photo 1 of 1 : FA_2018_NA0003_64_37_20180905_00018.jpg

LM Start	5.98	Rating **	U	Issue No.	37
LM End	6.07	Issue Type +	Ma	Location *	LS
Category	Earthen Levee			GPS Latitude/Longitude	
				Start	End
Item	Vegetation			39.793411 °	39.794580 °
				-121.887310 °	-121.886759 °
DWR ID	DWR_NA0003_01_s_2016_37				
Comment Code					
V7 : Trees / Woody Vegetation					
Inspector Comment					
Various overgrown vegetation completely obscuring landside toe visibility.

04/25/2016: Trim trees on L/S slope.

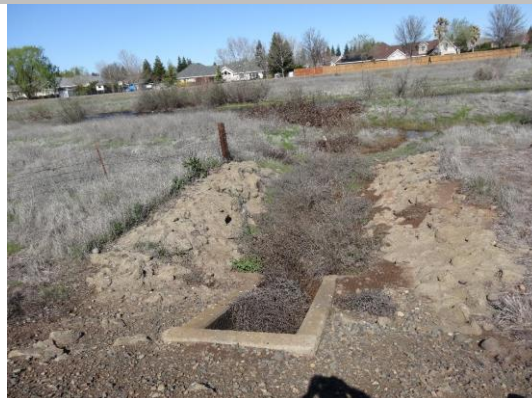
Photo 1 of 3 : UCIP_FA_2018_31667_57968.jpg

WS view: CMP culvert with U type concrete headwall. Vegetation debris blocking outlet box.

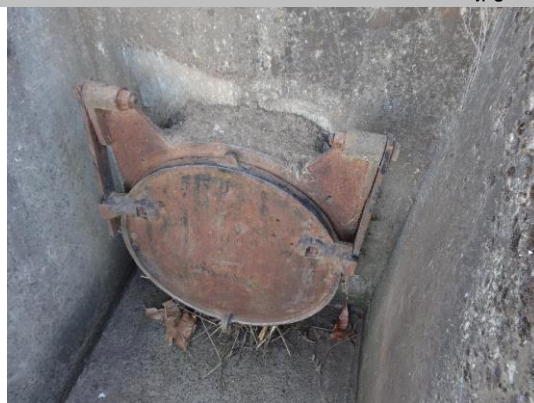
Photo 1 of 3 : UCIP_FA_2018_30403_55922.jpg

WS view: U type concrete headwall, pipe, and flapgate on levee slope.

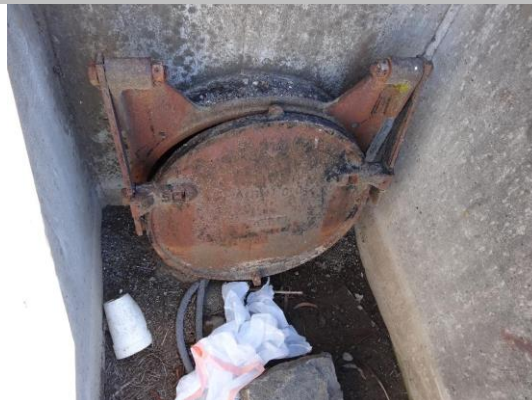
Photo 1 of 2 : UCIP_FA_2018_30743_56641.jpg

WS view: U type concrete headwall, pipe, and flapgate on levee slope. Debris in outlet box.

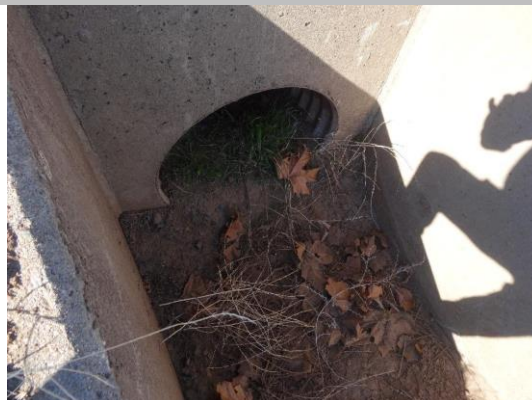
Photo 2 of 3 : UCIP_FA_2018_30763_56661.jpg

LS view: U type concrete headwall and CMP on levee slope.

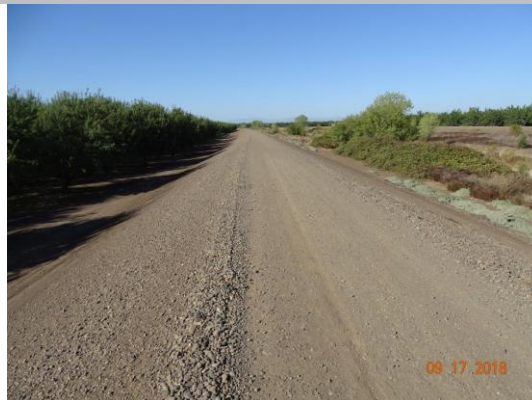
Photo 1 of 1 : FA_2018_NA0003_65_26_20181001_00067.jpg

LM Start	2.91	Rating **	A	Issue No.	26
LM End	2.91	Issue Type +	Ma	Location *	LS
Category	Earthen Levee			GPS Latitude/Longitude	
				Start	End
Item	Vegetation			39.766620 °	39.766620 °
				-121.902605 °	-121.902605 °
DWR ID	DWR_NA0003_02_f_2018_26				
Comment Code					
V1 : Control annual grass and weeds on the levee slopes and easements.					
Inspector Comment					
The vegetation was removed on both slopes.

View of no vegetation on both slopes.

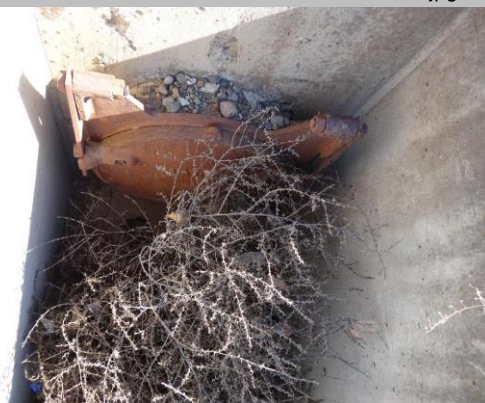
Photo 1 of 3 : UCIP_FA_2018_30803_56685.jpg

WS view: U type concrete headwall, pipe, and flapgate on levee slope.
Vegetation debris and soil blocking outlet.

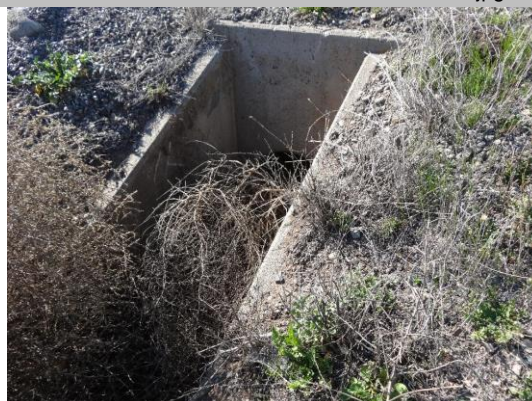
Photo 2 of 3 : UCIP_FA_2018_30803_56684.jpg

LS view: U type concrete headwall and CMP on levee slope. Vegetation debris and soil blocking inlet.

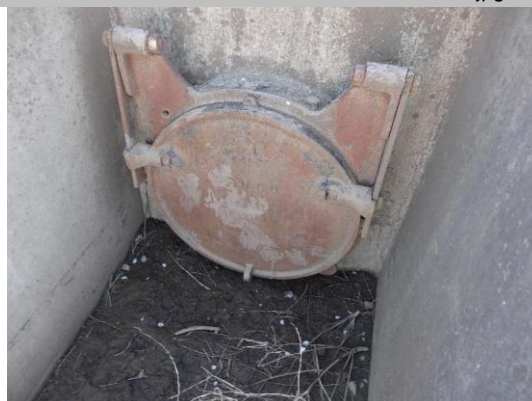
Photo 1 of 3 : UCIP_FA_2018_31031_56917.jpg

WS view: U type concrete headwall, pipe, and flapgate on levee slope. Soil/mud on outlet box.

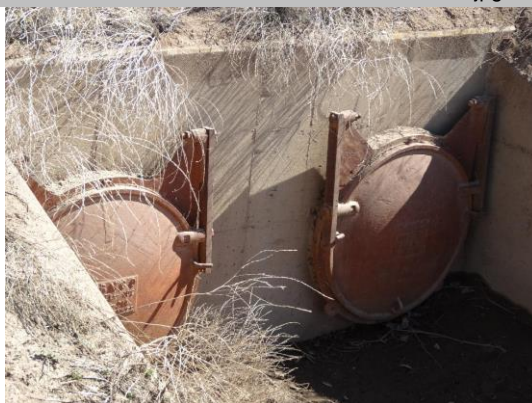
Photo 2 of 3 : UCIP_FA_2018_41376_56919.jpg

Comment Code						
Inspector Comment						
FS_ID:41376 DS_ID:19248 EP_NO: N/A Repair Type: Non-Urgent Crossing Status: Found UCIP Comments: Needs cleaning and clearing of debris. FIELD_STRUCT_DESC: [Channel Slough Drainage Structure] 1 of 2: 42-inch corrugated metal gravity drainage pipe through the levee, 16 feet below the crown. Flap gate on the waterside (WS) end. Slide gate in a corrugated metal pipe (CMP) riser on the WS slope. Concrete U-shaped headwall on each end. Grouted riprap apron and rock revetment on the landside (LS) end. [Additional Reference(s): DWR Levee Log, 1992. USACE Sacramento O&M Manual 504, May 1965, (HLM 6.30)]. FS Date: 2/25/2014

WS view: U type concrete headwall, pipes, and flapgates on levee slope. Vegetation debris on outlet box.

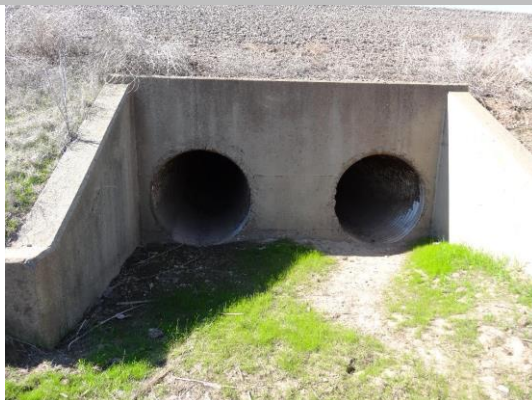
Photo 3 of 3 : UCIP_FA_2018_41376_56918.jpg

LS view: U type concrete headwall and CMPs on levee slope. Soil/mud on inlet box.

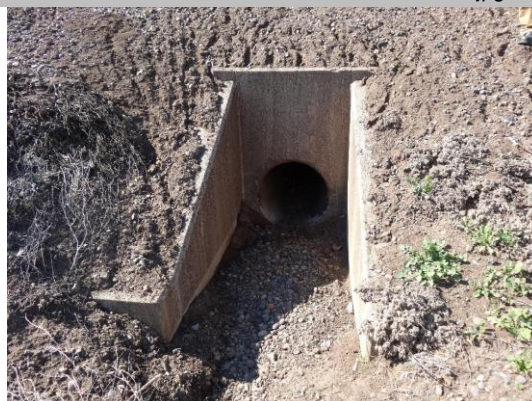
Photo 2 of 3 : UCIP_FA_2018_31034_56925.jpg

LS view: U type concrete headwall and CMP on levee slope.

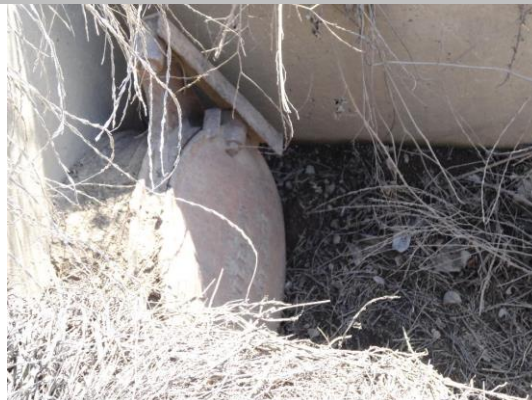
Photo 1 of 3 : UCIP_FA_2018_31103_57002.jpg

LM Start	6.94	Rating **	M	Issue No.	57
LM End	6.94	Issue Type +	Ma	Location *	
Category	Supplemental			GPS Latitude/Longitude	
				Start	End
Item	DWR UCIP LMA Responsibility			39.722798 °	39.722798 °
				-121.937828 °	-121.937828 °
DWR ID	19252				
Comment Code					
Inspector Comment					
FS_ID:31103 DS_ID:19252 EP_NO: N/A Repair Type: Non-Urgent Crossing Status: Found UCIP Comments: Needs cleaning and clearing of debris. FIELD_STRUCT_DESC: 24-inch corrugated metal gravity drainage pipe through the levee, 15 feet below the crown. Flap gate on the waterside (WS) end. Concrete U-shaped headwall on each end. Grouted riprap apron on the landside (LS) end. Grouted riprap spillway on the WS end. [Additional Reference(s): DWR Levee Log, 1992. USACE Sacramento O&M Manual 504, May 1965, (HLM 7.17)]. FS Date: 2/25/2014

WS view: U type concrete headwall, pipe, and flapgate on levee slope. Soil/mud on outlet box. Vegetation debris blocking outlet box

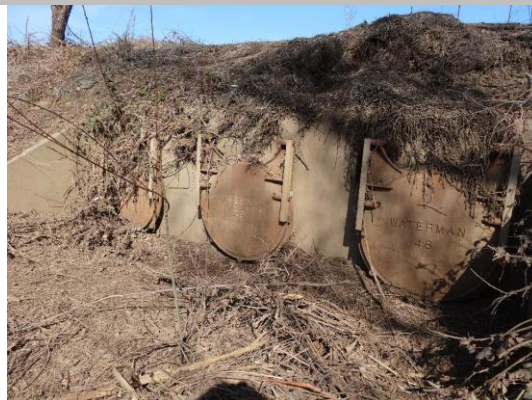
Photo 2 of 3 : UCIP_FA_2018_32087_58591.jpg

WS view: U type concrete headwall, pipes, and flapgates on levee slope.
Soil/mud on outlet box. Vegetation debris on outlet box

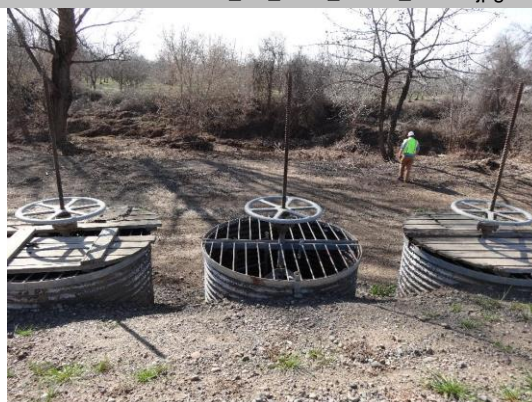
Photo 1 of 3 : UCIP_FA_2018_32086_58589.jpg

Comment Code					
Inspector Comment					
FS_ID:32086 DS_ID:19260 EP_NO: N/A Repair Type: Non-Urgent Crossing Status: Found UCIP Comments: Slide gates in CMP risers on waterside shoulder.Needs cleaning and clearing of debris. FIELD_STRUCT_DESC: 2 of 3: 48-inch corrugated metal gravity drainage pipe through the levee, 18 feet below the crown. Flap gate on the waterside (WS) end. Slide gate in a corrugated metal pipe (CMP) riser on the WS shoulder. Concrete U-shaped headwall on each end. Grouted riprap apron on the landside (LS) end. Grouted riprap spillway on the WS end. [Additional Reference(s): DWR Levee Log, 1992. USACE Sacramento O&M Manual 504, May 1965, (HLM 7.46)]. FS Date: 2/25/2014

WS view: slide gates in CMP risers on waterside shoulder.

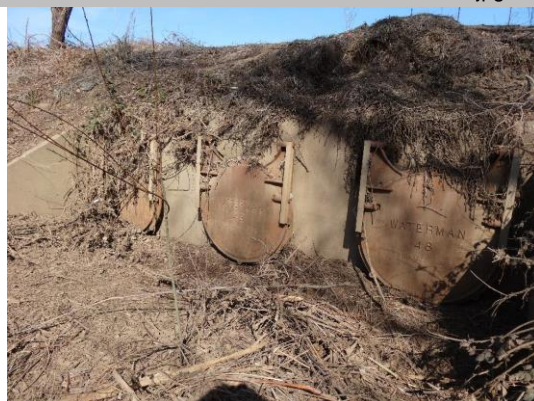
Photo 2 of 3 : UCIP_FA_2018_32086_58588.jpg

Comment Code						
Inspector Comment						
FS_ID:32086 DS_ID:19260 EP_NO: N/A Repair Type: Non-Urgent Crossing Status: Found UCIP Comments: Slide gates in CMP risers on waterside shoulder.Needs cleaning and clearing of debris. FIELD_STRUCT_DESC: 2 of 3: 48-inch corrugated metal gravity drainage pipe through the levee, 18 feet below the crown. Flap gate on the waterside (WS) end. Slide gate in a corrugated metal pipe (CMP) riser on the WS shoulder. Concrete U-shaped headwall on each end. Grouted riprap apron on the landside (LS) end. Grouted riprap spillway on the WS end. [Additional Reference(s): DWR Levee Log, 1992. USACE Sacramento O&M Manual 504, May 1965, (HLM 7.46)]. FS Date: 2/25/2014

WS view: U type concrete headwall, pipes, and flapgates on levee slope. Soil/mud on outlet box. Vegetation debris on outlet box

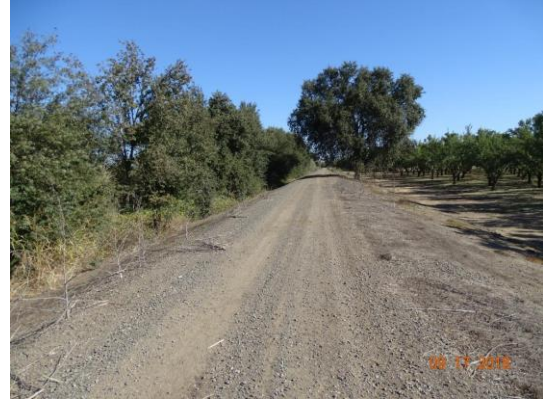
Photo 1 of 1 : FA_2018_NA0003_66_3_20181001_00001.jpg

LM Start	0.05	Rating **	A	Issue No.	3
LM End	0.05	Issue Type +	Ma	Location *	LS
Category	Earthen Levee			GPS Latitude/Longitude	
				Start	End
Item	Vegetation			39.733567 °	39.733567 °
				-121.929850 °	-121.929850 °
DWR ID	DWR_NA0003_02A_f_2018_3				
Comment Code					
V1 : Control annual grass and weeds on the levee slopes and easements.					
Inspector Comment					
The vegetation was removed from both slopes.

View of no vegetation on both slopes.

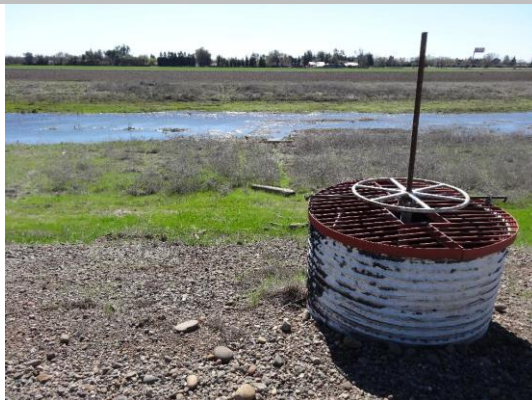
Photo 3 of 3 : UCIP_FA_2018_51844_58600.jpg

Comment Code						
Inspector Comment						
FS_ID:51844 DS_ID:19262 EP_NO: N/A Repair Type: No Action Needed Crossing Status: Found UCIP Comments: 05/16/2017 Crossing has been downgraded from Non-Urgent to No Action Needed. The flap gate appears to be in good working order based on the photos, and the small pile of debris not enough to warrant Non-Urgent rating. (K. Fazel - UCIP)03/11/2014:Slide gate in CMP riser on waterside.The culvert was working during field inspection. (P. Amatya - DWR) FIELD_STRUCT_DESC: 42-inch corrugated metal gravity drainage pipe through the levee, 14 feet below the crown. Flap gate on the waterside (WS) end. Slide gate in a corrugated metal pipe (CMP) riser on the WS slope. Concrete U-shaped headwall on each end. Grouted riprap apron on the landside (LS) end. Grouted riprap spillway on the WS end. [Additional Reference(s): DWR Levee Log, 1992. USACE Sacramento O&M Manual 504, May 1965, (HLM 0.09)]. FS Date: 3/11/2014

WS view: slide gate in CMP riser on waterside shoulder.

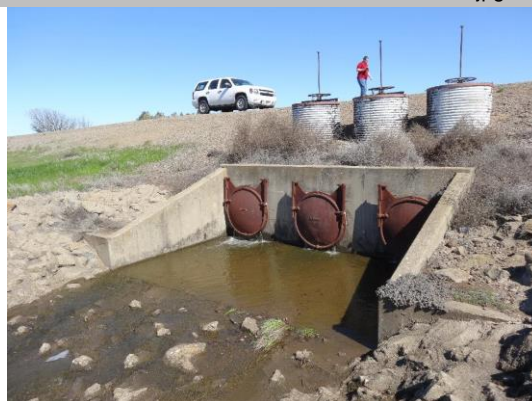
Photo 1 of 2 : UCIP_FA_2018_32105_58608.jpg

Comment Code						
Inspector Comment						
FS_ID:32105						
DS_ID:19277						
EP_NO: N/A						
Repair Type: No Action Needed						
Crossing Status: Found						
UCIP Comments: Slide gate in CMP riser on waterside.The culvert was working during the field visit.						
FIELD_STRUCT_DESC: 2 of 3: 48-inch corrugated metal gravity drainage pipe through the levee, 11.7 feet below the crown. Slide gate in a riser well on the waterside (WS) slope. Concrete U-shaped headwall on each end. Flap gate on the WS end. Grouted riprap outlet channel on the WS. [Additional Reference(s): DWR Levee Log, 1992. USACE Sacramento O&M Manual 504, May 1965, (HLM 0.39)].						
FS Date: 3/11/2014

WS view: U type concrete headwall and three CMPs with slide gates on levee slope. Grouted riprap spillway.

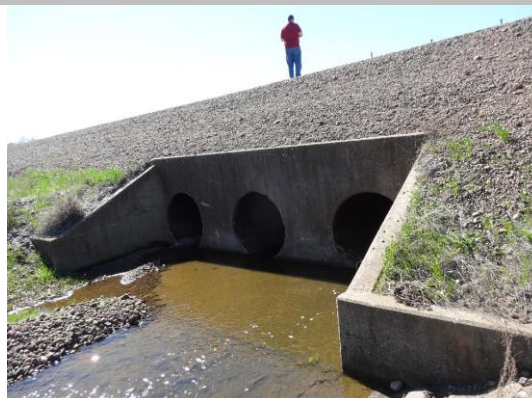
Photo 2 of 2 : UCIP_FA_2018_32105_58607.jpg

LS view: U type concrete headwall and three CMPs on levee slope. Soil/mud on inlet box.

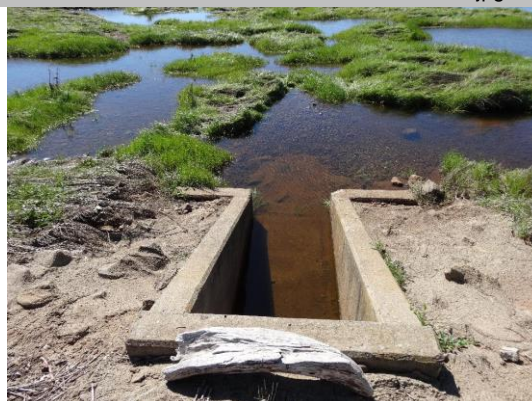
Photo 1 of 3 : UCIP_FA_2018_32107_58613.jpg

WS view: U type concrete headwall and grouted riprap on levee slope.

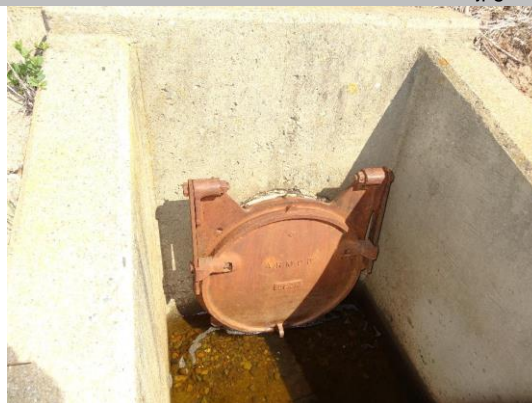
Photo 2 of 3 : UCIP_FA_2018_32107_58612.jpg

WS view: U type concrete headwall, flapgate, and CMP on levee slope.

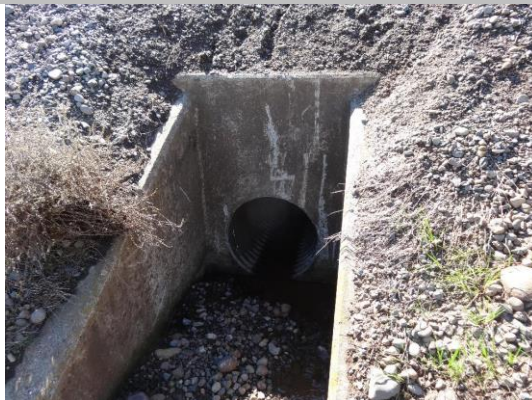
Photo 3 of 3 : UCIP_FA_2018_32107_58611.jpg

LS view: U type concrete headwall and CMP on levee slope.

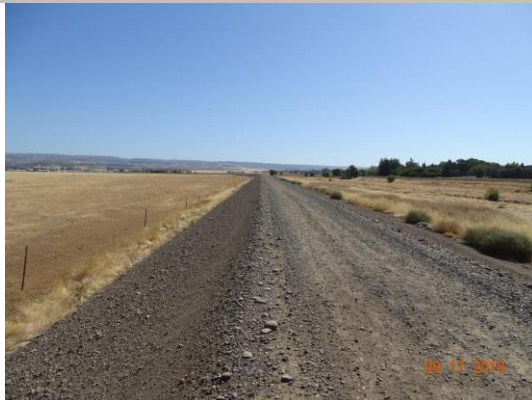
Photo 1 of 1 : FA_2018_NA0003_67_22_20181001_00039.jpg

LM Start	1.33	Rating **	A	Issue No.	22
LM End	1.33	Issue Type +	Ma	Location *	LS
Category	Earthen Levee			GPS Latitude/Longitude	
				Start	End
Item	Vegetation			39.779420 °	39.779420 °
				-121.861140 °	-121.861140 °
DWR ID	DWR_NA0003_03_f_2018_22				
Comment Code					
V1 : Control annual grass and weeds on the levee slopes and easements.					
Inspector Comment					
The vegetation was removed from both slopes.

View of no vegetation on both slopes.

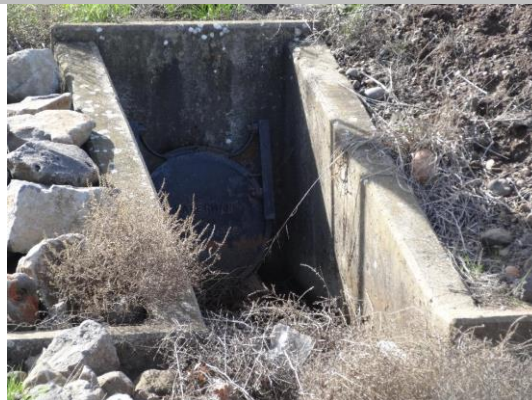
Photo 1 of 3 : UCIP_FA_2018_32124_58625.jpg

WS view: concrete headwall, pipe, and flapgate on levee slope.
Vegetation and mud on outlet box.

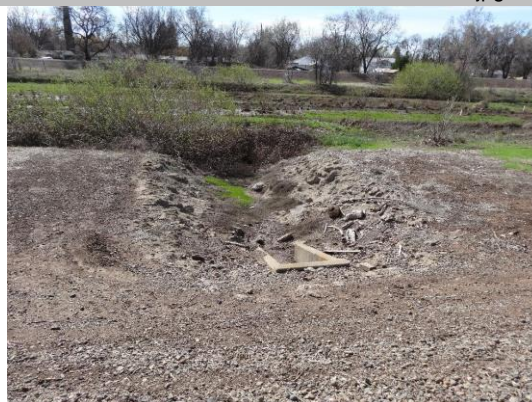
Photo 1 of 3 : UCIP_FA_2018_31902_58201.jpg

WS view: U type concrete headwall and grouted riprap spillway on levee slope.

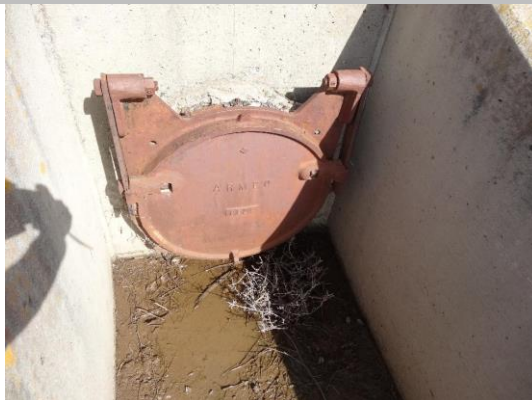
Photo 2 of 3 : UCIP_FA_2018_31902_58200.jpg

WS view: U type concrete headwall and CMP on levee slope.

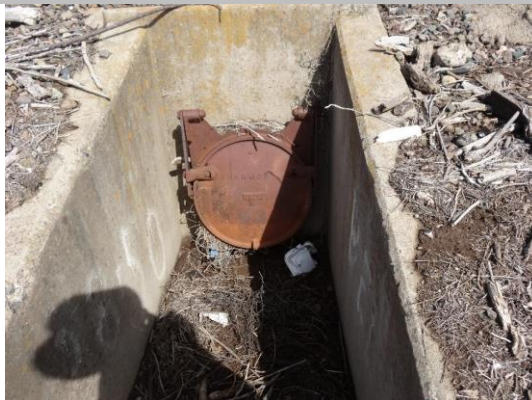
Photo 1 of 3 : UCIP_FA_2018_31864_58069.jpg

WS view: U type concrete headwall, pipe, and flapgate on levee slope. Soil/mud on outlet box. Vegetation debris blocking outlet box.

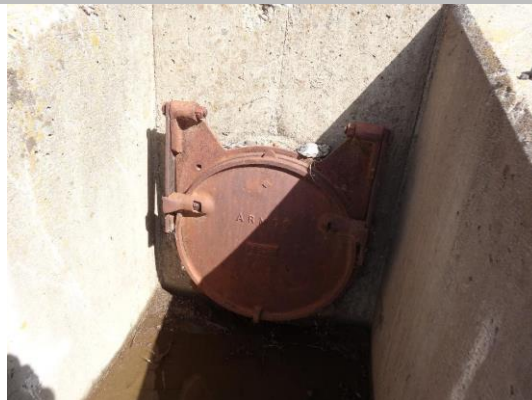
Photo 1 of 3 : UCIP_FA_2018_31856_58053.jpg

WS view: U type concrete headwall, pipe, and flapgate on levee slope.
Soil/mud on outlet box.

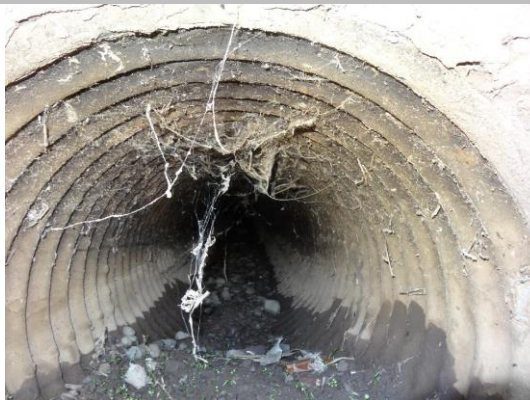
Photo 3 of 3 : UCIP_FA_2018_31856_58051.jpg

LS view: inside view of CMP on levee slope. Needs cleaning and clearing.

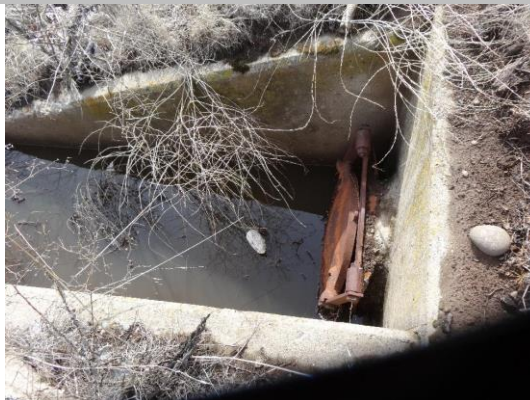
Photo 1 of 2 : UCIP_FA_2018_32125_58629.jpg

Comment Code						
Inspector Comment						
FS_ID:32125						
DS_ID:19275						
EP_NO: N/A						
Repair Type: Non-Urgent						
Crossing Status: Found						
UCIP Comments: The culvert was working during the field visit.Needs cleaning and clearing on both ends of the pipe.						
FIELD_STRUCT_DESC: 24-inch corrugated metal gravity drainage pipe through the levee, 7.5 feet below the crown. Flap gate on the waterside (WS) end. Concrete U-shaped headwall on each end. Grouted riprap apron on the landside (LS) end. Grouted riprap spillway on the WS end. [Additional Reference(s): DWR Levee Log, 1992. USACE Sacramento O&M Manual 504, May 1965, (HLM 3.76)].						
FS Date: 3/4/2014

WS view: U type concrete headwall, pipe, and flapgate on levee slope. Soil/mud on outlet box. Vegetation debris blocking outlet box.

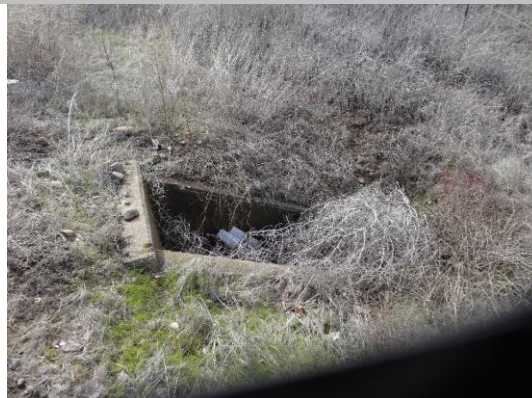
Photo 2 of 2 : UCIP_FA_2018_32125_58628.jpg

Comment Code						
Inspector Comment						
FS_ID:32125 DS_ID:19275 EP_NO: N/A Repair Type: Non-Urgent Crossing Status: Found UCIP Comments: The culvert was working during the field visit.Needs cleaning and clearing on both ends of the pipe. FIELD_STRUCT_DESC: 24-inch corrugated metal gravity drainage pipe through the levee, 7.5 feet below the crown. Flap gate on the waterside (WS) end. Concrete U-shaped headwall on each end. Grouted riprap apron on the landside (LS) end. Grouted riprap spillway on the WS end. [Additional Reference(s): DWR Levee Log, 1992. USACE Sacramento O&M Manual 504, May 1965, (HLM 3.76)]. FS Date: 3/4/2014

LS view: U type concrete headwall and pipe on levee slope. Soil/mud on inlet box. Vegetation debris blocking inlet box.

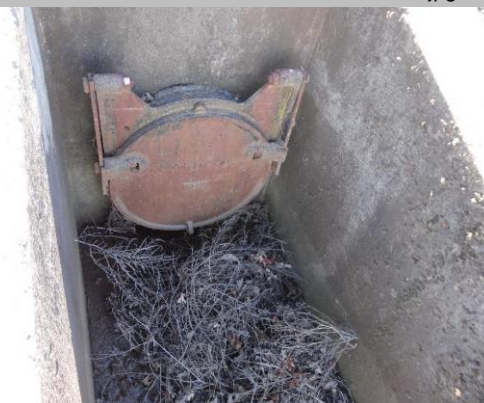
Photo 2 of 3 : UCIP_FA_2018_32026_58519.jpg

WS view: U type concrete headwall and CMP on levee slope. Mud and vegetation debris on outlet box.

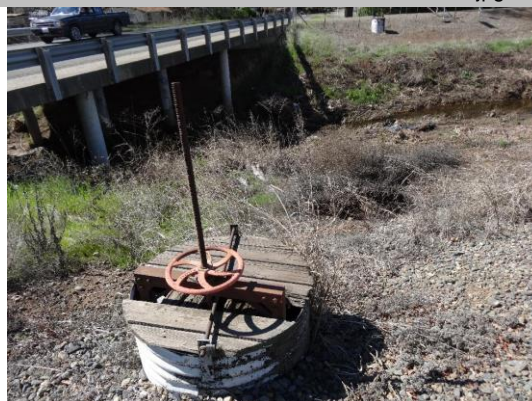
Photo 1 of 3 : UCIP_FA_2018_32025_58512.jpg

Comment Code						
Inspector Comment						
FS_ID:32025						
DS_ID:19280						
EP_NO: N/A						
Repair Type: Non-Urgent						
Crossing Status: Found						
UCIP Comments: Slide gate in a CMP riser. Vegetation debris and mud on inlet box.Needs cleaning and clearing the culvert.						
FIELD_STRUCT_DESC: 24-inch corrugated metal gravity drainage pipe through the levee and under the channel, 9.5 feet below the crown.						
Slide gate in a corrugated metal pipe (CMP) riser on the waterside (WS) slope. Concrete U-shaped headwall on the landside (LS) end.						
[Additional Reference(s): DWR Levee Log, 1992. USACE Sacramento O&M Manual 504, May 1965, (HLM 0.34)].						
FS Date: 3/7/2014

WS view: slide gate in CMP riser on waterside shoulder.

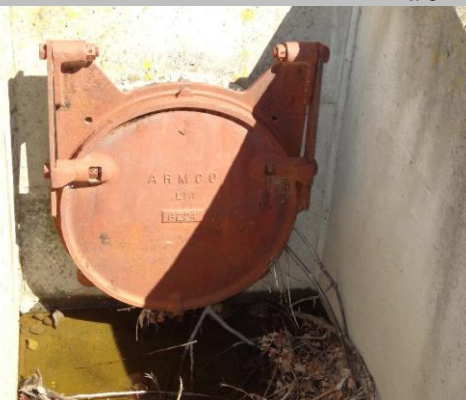
Photo 1 of 3 : UCIP_FA_2018_32023_58505.jpg

WS view: U type concrete headwall and CMP on levee slope. Vegetation debris and mud on outlet box. Needs cleaning and clearing.

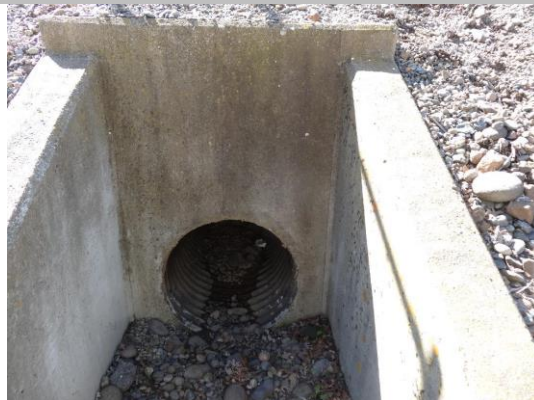
Photo 2 of 3 : UCIP_FA_2018_32023_58504.jpg

LS view: U type concrete headwall and CMP on levee slope. Pebbles and mud on inlet box.

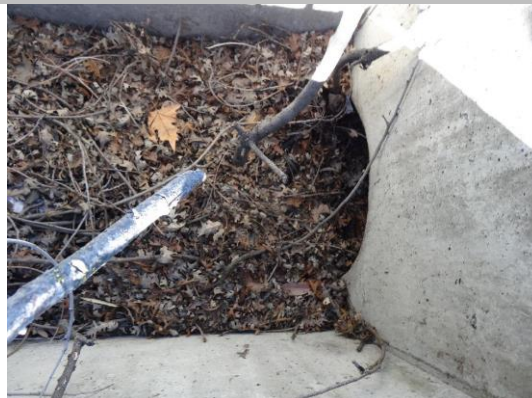
Photo 2 of 3 : UCIP_FA_2018_32144_58643.jpg

LS view: close view of vegetation debris and mud on inlet box.

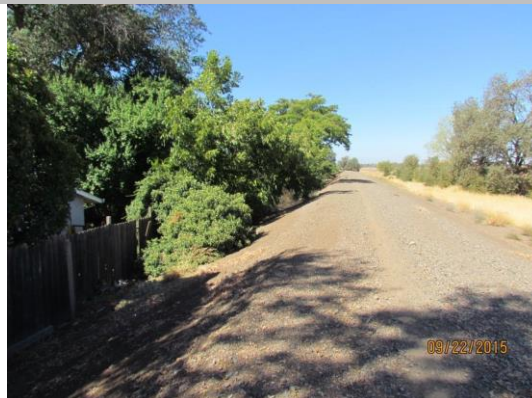
Photo 1 of 1 : FA_2018_NA0003_68_17_20180905_00004.jpg

LM Start	1.16	Rating **	M	Issue No.	17
LM End	1.22	Issue Type +	Ma	Location *	LS
Category	Earthen Levee			GPS Latitude/Longitude	
				Start	End
Item	Trim / Thin Trees			39.777128°	39.777580°
				-121.854763°	-121.855612°
DWR ID	DWR_NA0003_04_f_2015_17				
Comment Code					
T1 : Trim trees to at least five feet above ground level.					
Inspector Comment					
Remove the trees that are overhanging the levee slope.

View of the trees overhanging the levee slope.

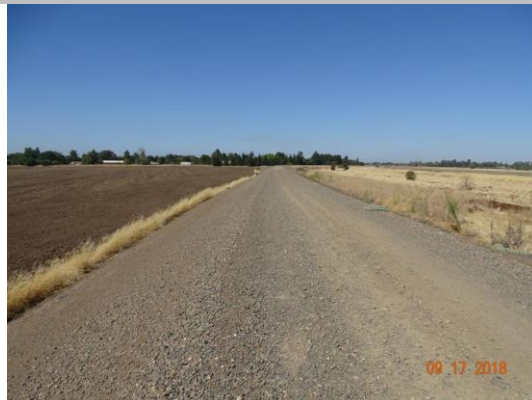
Photo 1 of 1 : FA_2018_NA0003_68_16_20181001_00039.jpg

LM Start	1.60	Rating **	A	Issue No.	16	
LM End	1.60	Issue Type +	Ma	Location *	LS	
Category	Earthen Levee			GPS Latitude/Longitude		
				Start		End
Item	Vegetation			39.778768 °		39.778768 °
				-121.862573 °		-121.862573 °
DWR ID	DWR_NA0003_04_f_2018_16					
Comment Code						
V1 : Control annual grass and weeds on the levee slopes and easements.						
Inspector Comment						
The vegetation has been removed from both slopes.

View of no vegetation on both slopes.

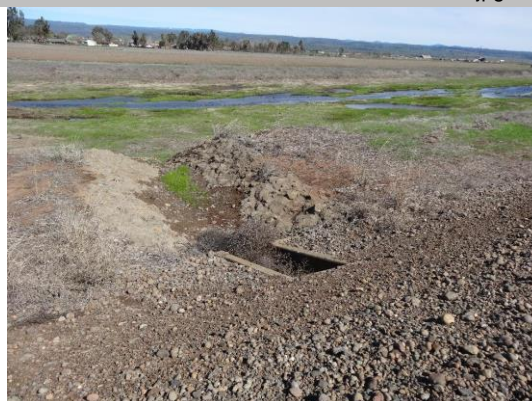
Photo 1 of 3 : UCIP_FA_2018_31966_58401.jpg

WS view: U type concrete headwall and grouted riprap spillway on levee slope.

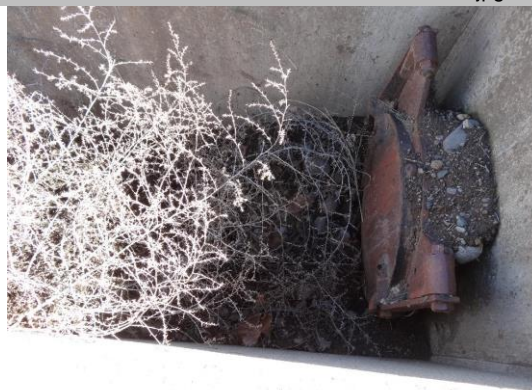
Photo 2 of 3 : UCIP_FA_2018_31966_58400.jpg

WS view: U type concrete headwall and CMP on levee slope. Vegetation debris and mud on outlet box. Needs cleaning and clearing.

Comment Code						
Inspector Comment						
FS_ID:31966						
DS_ID:19292						
EP_NO: N/A						
Repair Type: Non-Urgent						
Crossing Status: Found						
UCIP Comments: Needs cleaning and clearing the culvert.						
FIELD_STRUCT_DESC: 24-inch corrugated metal gravity drainage pipe						
through the levee, 11 feet below the crown. Flap gate on the waterside						
(WS) end. Concrete U-shaped headwall on each end. Grouted riprap						
apron on the landside (LS) end. Grouted riprap spillway on the WS end.						
[Additional Reference(s): DWR Levee Log, 1992. USACE Sacramento						
O&M Manual 504, May 1965, (HLM 2.56)].						
FS Date: 3/7/2014
