**Flood Control Project Maintenance
Levee Inspections**

Maintenance Issue Types Only, Levee Inspection Report By Mile - Fall 2019

Butte County Department of Public Works

Waterway	Bank	Unit Miles	Inspection Start/End	Inspector
Unit No. 01 Mud Creek	Right	6.80	10/22/2019 10/22/2019	Makar Sokol

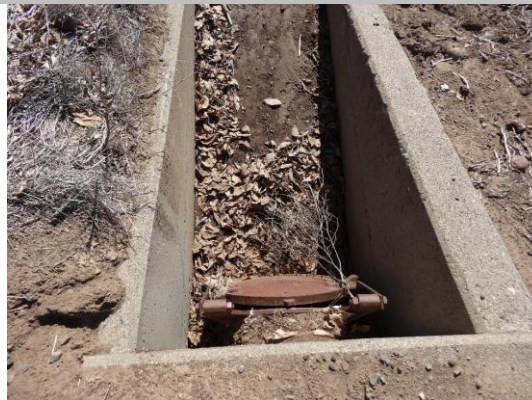
Photo 1 of 3 : UCIP_FA_2019_50142_55886.jpg

WS view: U type concrete headwall, flapgate on levee slope. Gate was not fully closed.

Comment Code						
Inspector Comment						
DS_ID:19212 FS_ID:50142 EP_NO: N/A Repair Type: No Action Needed Crossing Status: Found UCIP Comments: 08/29/2016: Shawn Bates of NA0003 has cleared the LS and WS of debris and blockage; WS gate functions properly now. Crossing has been downgraded from Urgent to No Action Needed. (K. Fazel - UCIP)08/11/2016: Same as last inspection. (K. Fazel - UCIP)02/20/2014:No riprap spillway on waterside. Needs cleaning and clearing of debris. Flap gate was not fully closed. (P. Amatya - UCIP) FIELD_STRUCT_DESC: 24-inch corrugated metal gravity drainage pipe through the levee, 13 feet below the crown. Flap gate on the waterside (WS) end. Concrete U-shaped headwall on each end. Grouted riprap apron on the landside (LS) end. Grouted riprap spillway on the WS end. [Additional Reference(s): DWR Levee Log, 2005. USACE Sacramento O&M Manual 504, May 1965, (HLM 1.95)]. FS Date: 8/11/2016

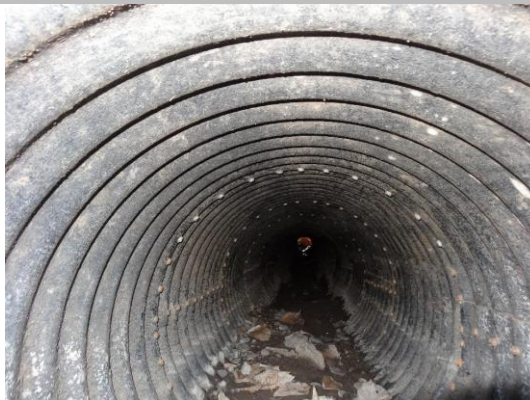
Photo 3 of 3 : UCIP_FA_2019_50142_55884.jpg

LS view: inside view of CMP on levee slope. Needs cleaning and clearing.

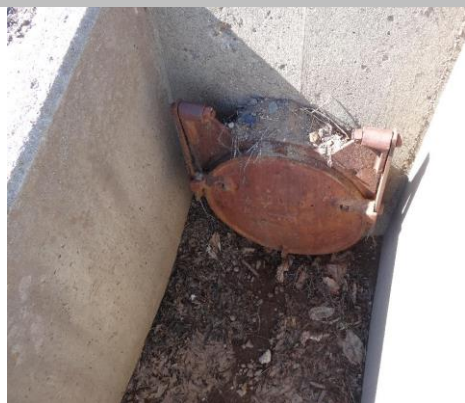
Photo 1 of 2 : UCIP_FA_2019_30294_55704.jpg

LM Start	3.03	Rating **	M	Issue No.	68	
LM End	3.03	Issue Type +	Ma	Location *		
Category	Supplemental			GPS Latitude/Longitude		
				Start	End	
Item	DRAFT DWR UCIP LMA Responsibility			39.761224°	39.761224°	
				-121.911108°	-121.911108°	
DWR ID	19216					
Comment Code						
Inspector Comment						
DS_ID:19216 FS_ID:30294 EP_NO: N/A Repair Type: Non-Urgent Crossing Status: Found UCIP Comments: Inlet and outlet needs cleaning and clearing of debris. FIELD_STRUCT_DESC: 24-inch corrugated metal gravity drainage pipe through the levee, 8.5 feet below the crown. Flap gate on the waterside (WS) end. Concrete U-shaped headwall on each end. Grouted riprap apron on the landside (LS) end. Grouted riprap spillway on the WS end. [Additional Reference(s): DWR Levee Log, 1992. USACE Sacramento O&M Manual 504, May 1965, (HLM 3.11)]. FS Date: 2/20/2014

WS view: U type concrete headwall, flapgate on levee slope.

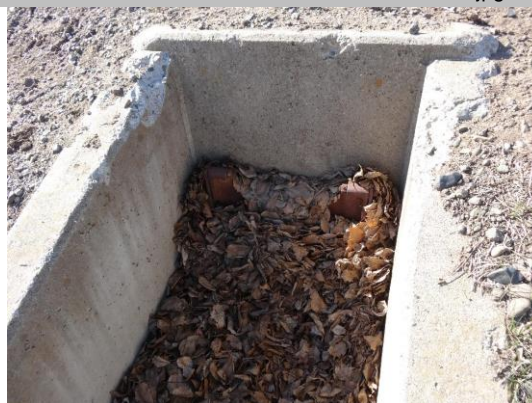
Photo 1 of 2 : UCIP_FA_2019_30295_55706.jpg

WS view: U type concrete headwall, flapgate on levee slope. Vegetation debris blocking the outlet.

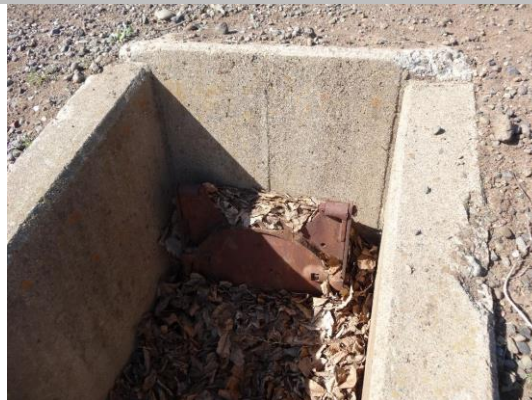
Photo 1 of 3 : UCIP_FA_2019_30310_55741.jpg

WS view: U type concrete headwall, pipe, and flapgate on levee slope.
Vegetation debris blocking outlet.

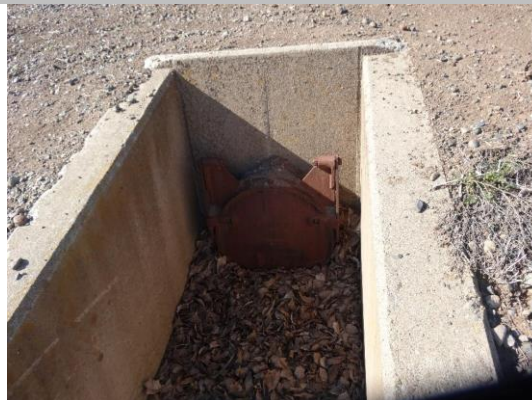
Photo 1 of 2 : UCIP_FA_2019_30311_55743.jpg

WS view: U type concrete headwall, pipe, and flapgate on levee slope. Vegetation debris blocking outlet.

Comment Code						
Inspector Comment						
DS_ID:19219						
FS_ID:30311						
EP_NO: N/A						
Repair Type: Non-Urgent						
Crossing Status: Found						
UCIP Comments: Needs cleaning and clearing of debris in both ends of the pipe.						
FIELD_STRUCT_DESC: 24-inch corrugated metal gravity drainage pipe through the levee, 9 feet below the crown. Flap gate on the waterside (WS) end. Concrete U-shaped headwall on each end. Grouted riprap apron on the landside (LS) end. Grouted riprap spillway on the WS end. [Additional Reference(s): DWR Levee Log, 1992. USACE Sacramento O&M Manual 504, May 1965, (HLM 4.08)].						
FS Date: 2/20/2014

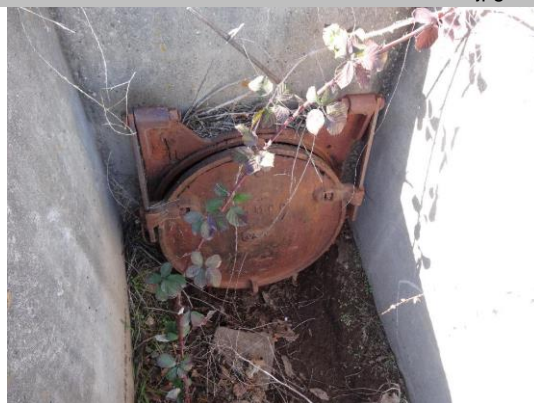
Photo 1 of 2 : UCIP_FA_2019_30312_55745.jpg

WS view: U type concrete headwall, pipe, and flapgate on levee slope. Vegetation debris blocking outlet.

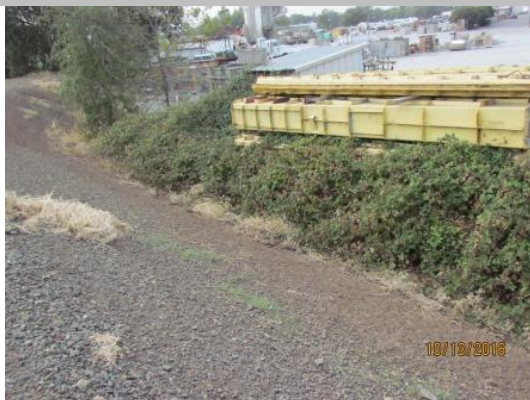
Photo 1 of 1 : FA_2019_NA0003_64_55_20190822_00023.jpg

View of the blackberries blocking visibility and access.

LM Start	5.20	Rating **	M	Issue No.	55
LM End	5.20	Issue Type +	Ma	Location *	LS
Category	Earthen Levee			GPS Latitude/Longitude	
				Start	End
Item	Vegetation			39.784234 °	39.784234 °
				-121.886589 °	-121.886589 °
DWR ID	DWR_NA0003_01_f_2016_55				
Comment Code					
V2 : Remove the wild growth other than native grasses from the levee slopes.					
Inspector Comment

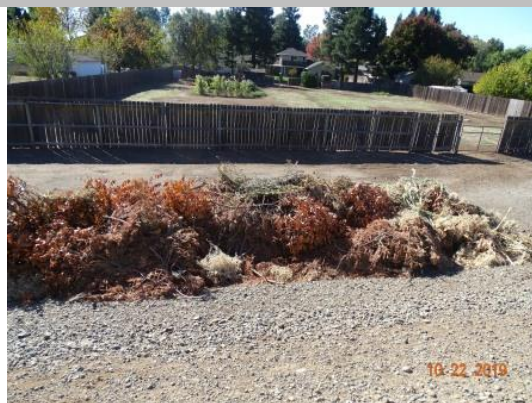
Photo 1 of 1 : FA_2019_NA0003_64_35_20191025_00057.jpg

LM Start	5.65	Rating **	M	Issue No.	35
LM End	5.65	Issue Type +	Ma	Location *	LS
Category	Earthen Levee			GPS Latitude/Longitude	
				Start	End
Item	Encroachments			39.789093 °	39.789093 °
				-121.886500 °	-121.886500 °
DWR ID	DWR_NA0003_01_f_2019_35				
Comment Code					
PR : Prunings					
Inspector Comment					
The pile of prunings should be removed from the landside toe easement.

View of the pile of prunings at the landside toe. Fall 2019.

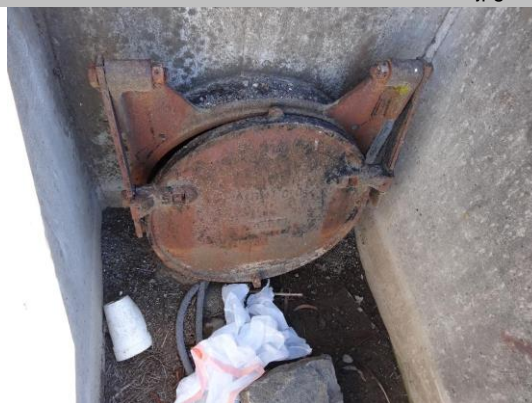
Photo 1 of 2 : UCIP_FA_2019_30743_56641.jpg

WS view: U type concrete headwall, pipe, and flapgate on levee slope. Debris in outlet box.

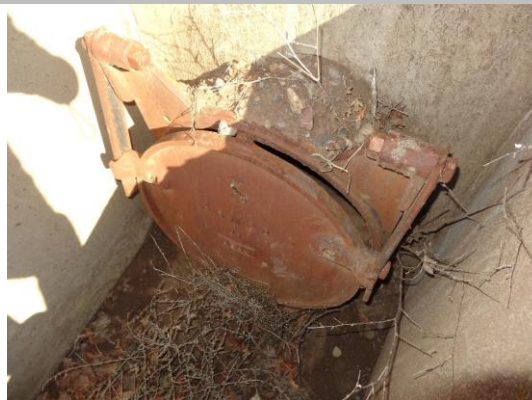
Photo 1 of 3 : UCIP_FA_2019_30783_56682.jpg

WS view: U type concrete headwall, pipe, and flapgate on levee slope. Gate not fully closed. Debris and soil in outlet box.

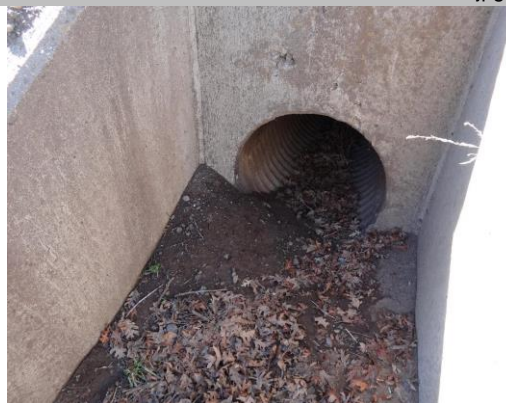
Photo 2 of 3 : UCIP_FA_2019_30783_56681.jpg

LS view: U type concrete headwall and CMP on levee slope. Debris and soil in inlet box.

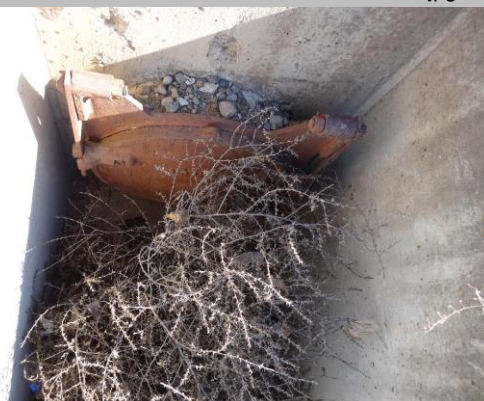
Photo 1 of 3 : UCIP_FA_2019_30803_56685.jpg

WS view: U type concrete headwall, pipe, and flapgate on levee slope. Vegetation debris and soil blocking outlet.

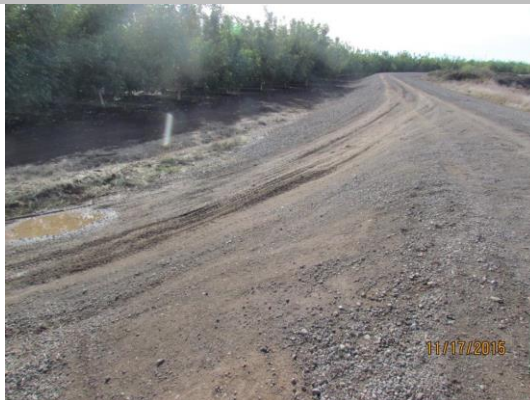
Photo 1 of 1 : FA_2019_NA0003_65_10_20190822_00003.jpg

View of the vehicle erosion along the landside slope.

LM Start	3.52	Rating **	M	Issue No.	10
LM End	3.52	Issue Type +	Ma	Location *	LS
Category	Earthen Levee			GPS Latitude/Longitude	
				Start	End
Item	Slope Stability			39.760582°	39.760582°
				-121.910303°	-121.910303°
DWR ID	DWR_NA0003_02_f_2015_10				
Comment Code					
S3 : Repair the levee slope damaged by vehicle traffic and prevent access where possible.					
Inspector Comment

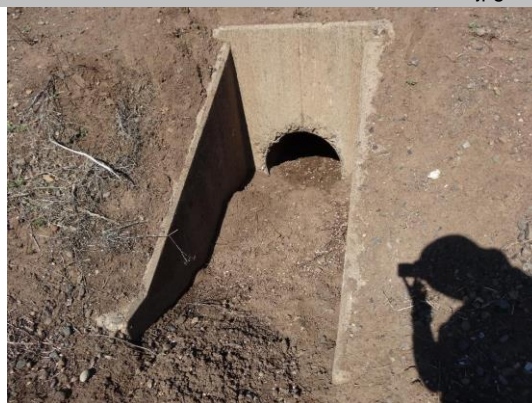
Photo 2 of 3 : UCIP_FA_2019_31031_56916.jpg

LS view: U type concrete headwall and CMP on levee slope. Soil/mud on inlet box.

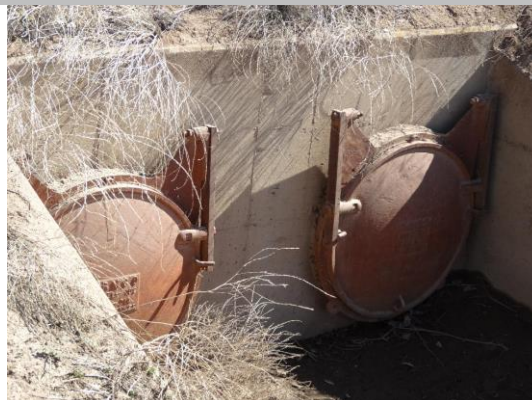
Photo 2 of 3 : UCIP_FA_2019_41376_56919.jpg

WS view: U type concrete headwall, pipes, and flapgates on levee slope. Vegetation debris on outlet box.

Comment Code						
Inspector Comment						
DS_ID:19248 FS_ID:41376 EP_NO: N/A Repair Type: Non-Urgent Crossing Status: Found UCIP Comments: Needs cleaning and clearing of debris. FIELD_STRUCT_DESC: [Channel Slough Drainage Structure] 1 of 2: 42-inch corrugated metal gravity drainage pipe through the levee, 16 feet below the crown. Flap gate on the waterside (WS) end. Slide gate in a corrugated metal pipe (CMP) riser on the WS slope. Concrete U-shaped headwall on each end. Grouted riprap apron and rock revetment on the landside (LS) end. [Additional Reference(s): DWR Levee Log, 1992. USACE Sacramento O&M Manual 504, May 1965, (HLM 6.30)]. FS Date: 2/25/2014

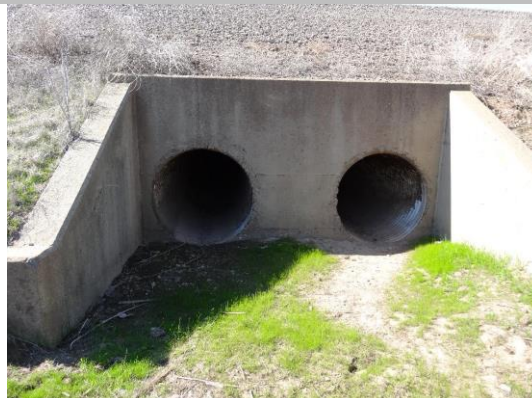
Photo 3 of 3 : UCIP_FA_2019_41376_56918.jpg

LS view: U type concrete headwall and CMPs on levee slope. Soil/mud on inlet box.

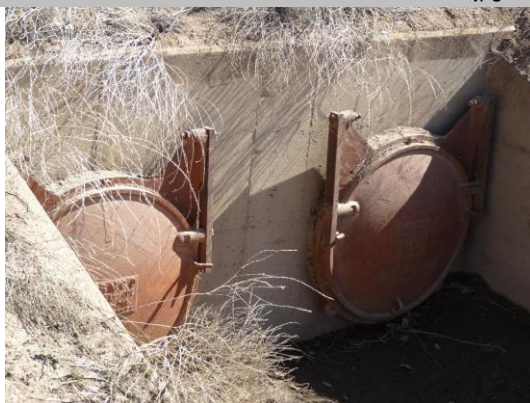
Photo 2 of 3 : UCIP_FA_2019_41377_56922.jpg

LS view: U type concrete headwall and CMPs on levee slope. Vegetation on inlet box.

Comment Code						
Inspector Comment						
DS_ID:19259 FS_ID:41377 EP_NO: N/A Repair Type: Non-Urgent Crossing Status: Found UCIP Comments: Needs cleaning and clearing of debris. FIELD_STRUCT_DESC: [Channel Slough Drainage Structure] 2 of 2: 42-inch corrugated metal gravity drainage pipe through the levee, 16 feet below the crown. Flap gate on the waterside (WS) end. Slide gate in a corrugated metal pipe (CMP) riser on the WS slope. Concrete U-shaped headwall on each end. Grouted riprap apron and rock revetment on the landside (LS) end. [Additional Reference(s): DWR Levee Log, 1992. USACE Sacramento O&M Manual 504, May 1965, (HLM 6.30)]. FS Date: 2/25/2014

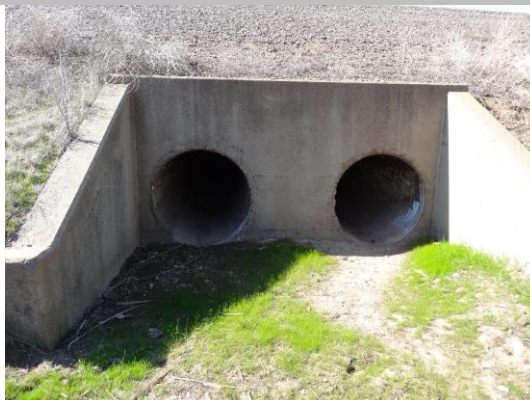
Photo 3 of 3 : UCIP_FA_2019_41377_56921.jpg

LS view: U type concrete headwall and CMPs on levee slope. Soil/mud on inlet box.

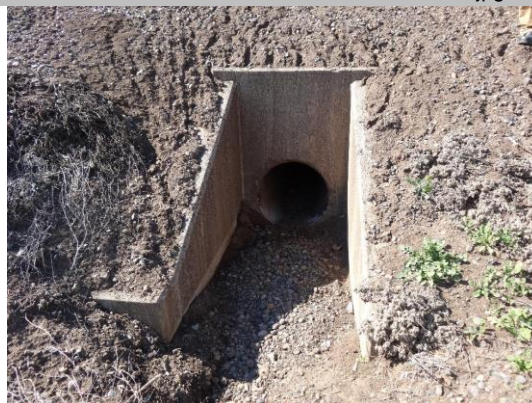
Photo 2 of 3 : UCIP_FA_2019_31034_56925.jpg

LS view: U type concrete headwall and CMP on levee slope.

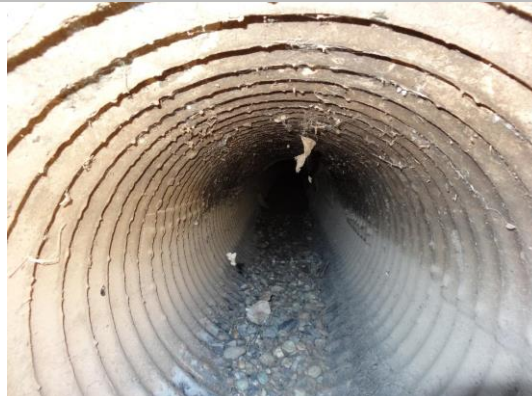
Photo 3 of 3 : UCIP_FA_2019_31034_56924.jpg

LM Start	6.15	Rating **	M	Issue No.	59 (cont)	
LM End	6.15	Issue Type +	Ma	Location *		
Category	Supplemental			GPS Latitude/Longitude		
				Start	End	
Item	DRAFT DWR UCIP LMA Responsibility			39.732515 °	39.732515 °	
				-121.930373 °	-121.930373 °	
DWR ID	19249					
Comment Code						
Inspector Comment						
DS_ID:19249 FS_ID:31034 EP_NO: N/A Repair Type: Non-Urgent Crossing Status: Found UCIP Comments: Needs cleaning and clearing of debris. FIELD_STRUCT_DESC: 24-inch corrugated metal gravity drainage pipe through the levee, 12 feet below the crown. Flap gate on the waterside (WS) end. Concrete U-shaped headwall on each end. Grouted riprap apron on the landside (LS) end. Grouted riprap spillway on the WS end. [Additional Reference(s): DWR Levee Log, 1992. USACE Sacramento O&M Manual 504, May 1965, (HLM 6.35)]. FS Date: 2/25/2014

LS view: inside view of CMP on levee slope. Needs cleaning and clearing.

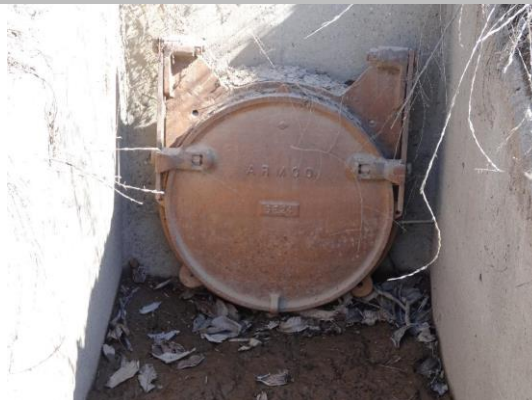
Photo 1 of 3 : UCIP_FA_2019_31085_56988.jpg

LM Start	6.43	Rating **	M	Issue No.	60	
LM End	6.43	Issue Type +	Ma	Location *		
Category	Supplemental			GPS Latitude/Longitude		
				Start		End
Item	DRAFT DWR UCIP LMA Responsibility			39.728812 °		39.728812 °
				-121.932623 °		-121.932623 °
DWR ID	19251					
Comment Code						
Inspector Comment						
DS_ID:19251 FS_ID:31085 EP_NO: N/A Repair Type: Non-Urgent Crossing Status: Found UCIP Comments: Needs cleaning and clearing of debris. FIELD_STRUCT_DESC: 24-inch corrugated metal gravity drainage pipe through the levee, 15.5 feet below the crown. Flap gate on the waterside (WS) end. Concrete U-shaped headwall on each end. Grouted riprap apron on the landside (LS) end. Grouted riprap spillway on the WS end. [Additional Reference(s): DWR Levee Log, 1992. USACE Sacramento O&M Manual 504, May 1965, (HLM 6.65)]. FS Date: 2/25/2014

WS view: U type concrete headwall, pipe, and flapgate on levee slope. Soil/mud on outlet box.

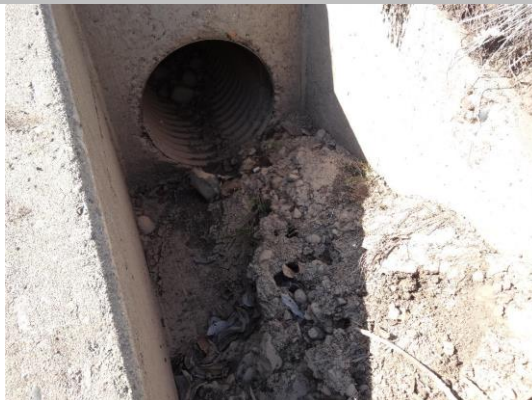
Photo 2 of 3 : UCIP_FA_2019_31085_56987.jpg

LS view: U type concrete headwall and CMP on levee slope. Soil/mud on inlet box.

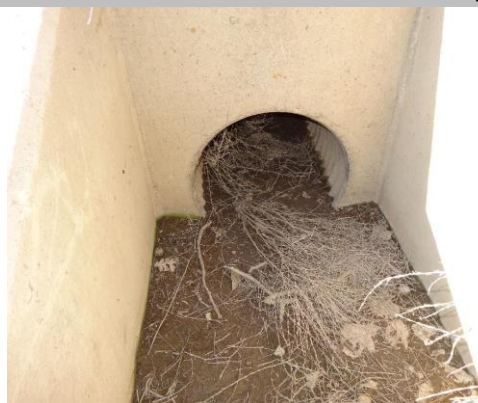
Photo 2 of 3 : UCIP_FA_2019_31103_57001.jpg

LS view: U type concrete headwall and CMP on levee slope. Soil/mud on inlet box.

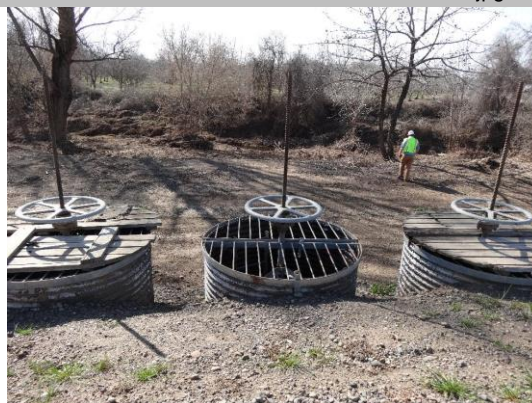
Photo 1 of 3 : UCIP_FA_2019_32085_58585.jpg

Comment Code						
Inspector Comment						
DS_ID:19253 FS_ID:32085 EP_NO: N/A Repair Type: Non-Urgent Crossing Status: Found UCIP Comments: Slide gates in CMP risers on waterside shoulder.Needs cleaning and clearing of debris. FIELD_STRUCT_DESC: 1 of 3: 48-inch corrugated metal gravity drainage pipe through the levee, 18 feet below the crown. Flap gate on the waterside (WS) end. Slide gate in a corrugated metal pipe (CMP) riser on the WS shoulder. Concrete U-shaped headwall on each end. Grouted riprap apron on the landside (LS) end. Grouted riprap spillway on the WS end. [Additional Reference(s): DWR Levee Log, 1992. USACE Sacramento O&M Manual 504, May 1965, (HLM 7.46)]. FS Date: 2/25/2014

WS view: slide gates in CMP risers on waterside shoulder.

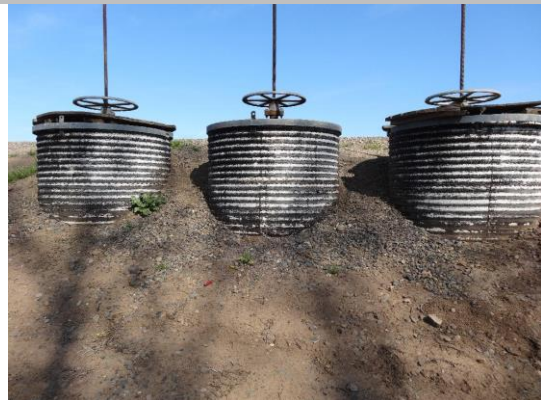
Photo 1 of 3 : UCIP_FA_2019_32087_58592.jpg

Comment Code						
Inspector Comment						
DS_ID:19261 FS_ID:32087 EP_NO: N/A Repair Type: Non-Urgent Crossing Status: Found UCIP Comments: Slide gates in CMP risers on waterside shoulder.Needs cleaning and clearing on both pipe ends. FIELD_STRUCT_DESC: 3 of 3: 48-inch corrugated metal gravity drainage pipe through the levee, 18 feet below the crown. Flap gate on the waterside (WS) end. Slide gate in a corrugated metal pipe (CMP) riser on the WS shoulder. Concrete U-shaped headwall on each end. Grouted riprap apron on the landside (LS) end. Grouted riprap spillway on the WS end. [Additional Reference(s): DWR Levee Log, 1992. USACE Sacramento O&M Manual 504, May 1965, (HLM 7.46)]. FS Date: 2/25/2014

WS view: slide gates in CMP risers on waterside shoulder.

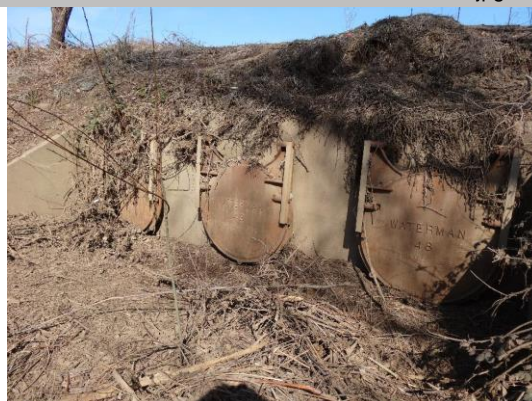
Photo 2 of 3 : UCIP_FA_2019_32087_58591.jpg

WS view: U type concrete headwall, pipes, and flapgates on levee slope. Soil/mud on outlet box. Vegetation debris on outlet box

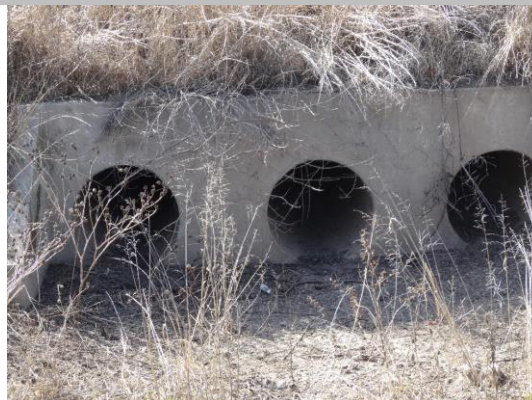
Photo 3 of 3 : UCIP_FA_2019_32087_58590.jpg

LS view: U type concrete headwall and CMPs on levee slope. Soil/mud on inlet box.

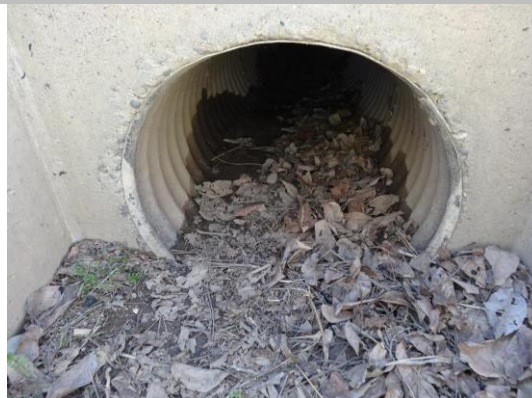
Photo 2 of 2 : UCIP_FA_2019_31129_57035.jpg

Comment Code						
Inspector Comment						
DS_ID:19254						
FS_ID:31129						
EP_NO: N/A						
Repair Type: Non-Urgent						
Crossing Status: Found						
UCIP Comments: Debris in inlet pipe, needs cleaning and clearing.						
FIELD_STRUCT_DESC: 24-inch corrugated metal gravity drainage pipe through the levee, 18 feet below the crown. Flap gate on the waterside (WS) end. Concrete U-shaped headwall on each end. Grouted riprap apron on the landside (LS) end. Grouted riprap spillway on the WS end.						
[Additional Reference(s): DWR Levee Log, 1992. USACE Sacramento O&M Manual 504, May 1965, (HLM 8.09)].						
FS Date: 2/25/2014

LS view: U type concrete headwall and CMP on levee slope. Soil/mud and vegetation on inlet box.

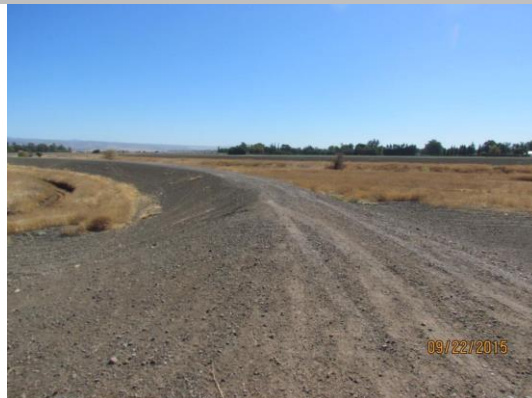
Photo 1 of 1 : FA_2019_NA0003_67_12_20190822_00002.jpg

LM Start	0.02	Rating **	M	Issue No.	12
LM End	0.02	Issue Type +	Ma	Location *	LS
Category	Earthen Levee			GPS Latitude/Longitude	
				Start	End
Item	Slope Stability			39.785970 °	39.785970 °
				-121.882797 °	-121.882797 °
DWR ID	DWR_NA0003_03_f_2015_12				
Comment Code					
S3 : Repair the levee slope damaged by vehicle traffic and prevent access where possible.					
Inspector Comment					
Repair the erosion on both slopes caused by motorcycle traffic.

View of the erosion on both slopes caused by motorcycle traffic.

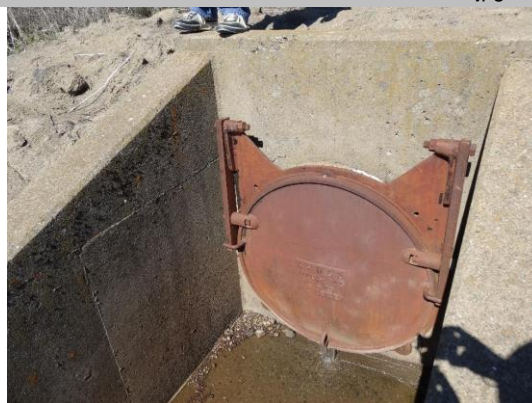
Photo 1 of 3 : UCIP_FA_2019_51844_58602.jpg

Comment Code						
Inspector Comment						
DS_ID:19262 FS_ID:51844 EP_NO: N/A Repair Type: No Action Needed Crossing Status: Found UCIP Comments: 05/16/2017 Crossing has been downgraded from Non-Urgent to No Action Needed. The flap gate appears to be in good working order based on the photos, and the small pile of debris not enough to warrant Non-Urgent rating. (K. Fazel - UCIP)03/11/2014:Slide gate in CMP riser on waterside.The culvert was working during field inspection. (P. Amatya - DWR) FIELD_STRUCT_DESC: 42-inch corrugated metal gravity drainage pipe through the levee, 14 feet below the crown. Flap gate on the waterside (WS) end. Slide gate in a corrugated metal pipe (CMP) riser on the WS slope. Concrete U-shaped headwall on each end. Grouted riprap apron on the landside (LS) end. Grouted riprap spillway on the WS end. [Additional Reference(s): DWR Levee Log, 1992. USACE Sacramento O&M Manual 504, May 1965, (HLM 0.09)]. FS Date: 3/11/2014

WS view: U type concrete headwall, pipe, and flapgate on levee slope.

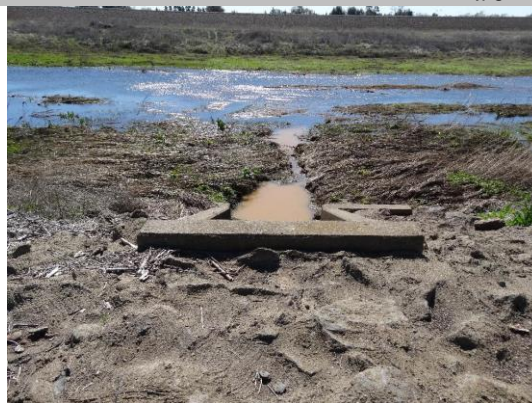
Photo 2 of 3 : UCIP_FA_2019_51844_58601.jpg

WS view: U type concrete headwall of CMP culvert on levee slope.
Grouted riprap levee slope and spillway.

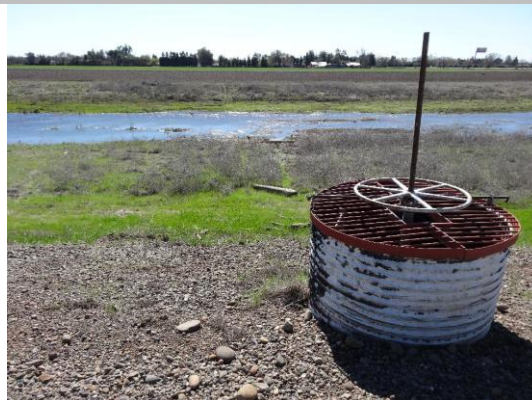
Photo 3 of 3 : UCIP_FA_2019_51844_58600.jpg

Comment Code						
Inspector Comment						
DS_ID:19262 FS_ID:51844 EP_NO: N/A Repair Type: No Action Needed Crossing Status: Found UCIP Comments: 05/16/2017 Crossing has been downgraded from Non-Urgent to No Action Needed. The flap gate appears to be in good working order based on the photos, and the small pile of debris not enough to warrant Non-Urgent rating. (K. Fazel - UCIP)03/11/2014:Slide gate in CMP riser on waterside.The culvert was working during field inspection. (P. Amatya - DWR) FIELD_STRUCT_DESC: 42-inch corrugated metal gravity drainage pipe through the levee, 14 feet below the crown. Flap gate on the waterside (WS) end. Slide gate in a corrugated metal pipe (CMP) riser on the WS slope. Concrete U-shaped headwall on each end. Grouted riprap apron on the landside (LS) end. Grouted riprap spillway on the WS end. [Additional Reference(s): DWR Levee Log, 1992. USACE Sacramento O&M Manual 504, May 1965, (HLM 0.09)]. FS Date: 3/11/2014

WS view: slide gate in CMP riser on waterside shoulder.

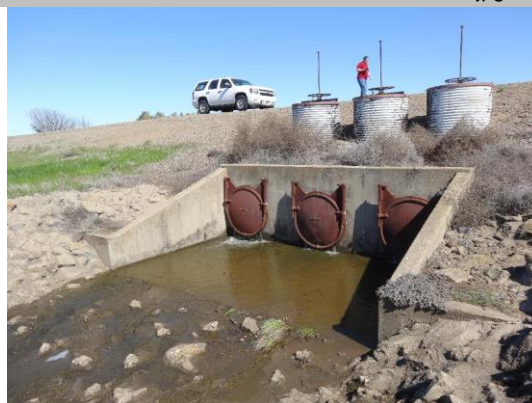
Photo 1 of 2 : UCIP_FA_2019_32104_58606.jpg

Comment Code						
Inspector Comment						
DS_ID:19278						
FS_ID:32104						
EP_NO: N/A						
Repair Type: No Action Needed						
Crossing Status: Found						
UCIP Comments: Slide gate in CMP riser on waterside.The culvert was working during the field visit.						
FIELD_STRUCT_DESC: 1 of 3: 48-inch corrugated metal gravity drainage pipe through the levee, 11.7 feet below the crown. Slide gate in a riser well on the waterside (WS) slope. Concrete U-shaped headwall on each end. Flap gate on the WS end. Grouted riprap outlet channel on the WS. [Additional Reference(s): DWR Levee Log, 1992. USACE Sacramento O&M Manual 504, May 1965, (HLM 0.39)].						
FS Date: 3/11/2014

WS view: U type concrete headwall and three CMPs with slide gates on levee slope. Grouted riprap spillway.

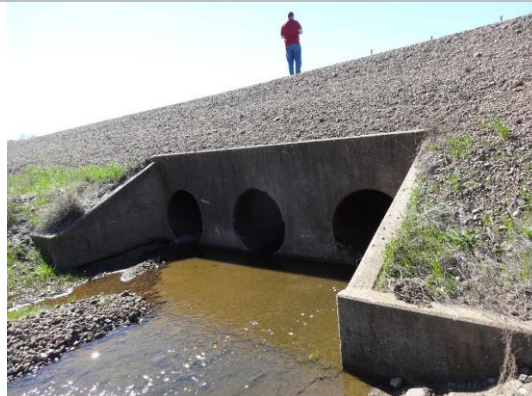
Photo 2 of 2 : UCIP_FA_2019_32104_58605.jpg

LS view: U type concrete headwall and three CMPs on levee slope. Soil/mud on inlet box.

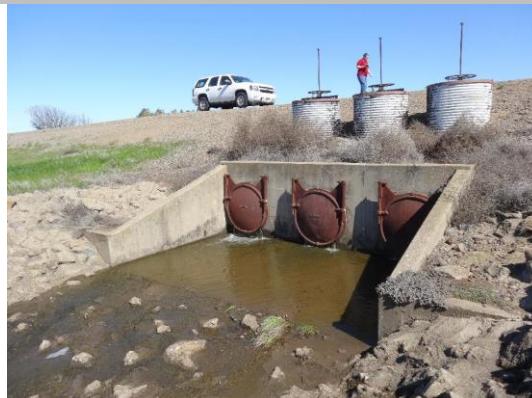
Photo 1 of 2 : UCIP_FA_2019_32105_58608.jpg

Comment Code						
Inspector Comment						
DS_ID:19277						
FS_ID:32105						
EP_NO: N/A						
Repair Type: No Action Needed						
Crossing Status: Found						
UCIP Comments: Slide gate in CMP riser on waterside.The culvert was working during the field visit.						
FIELD_STRUCT_DESC: 2 of 3: 48-inch corrugated metal gravity drainage pipe through the levee, 11.7 feet below the crown. Slide gate in a riser well on the waterside (WS) slope. Concrete U-shaped headwall on each end. Flap gate on the WS end. Grouted riprap outlet channel on the WS. [Additional Reference(s): DWR Levee Log, 1992. USACE Sacramento O&M Manual 504, May 1965, (HLM 0.39)].						
FS Date: 3/11/2014

WS view: U type concrete headwall and three CMPs with slide gates on levee slope. Grouted riprap spillway.

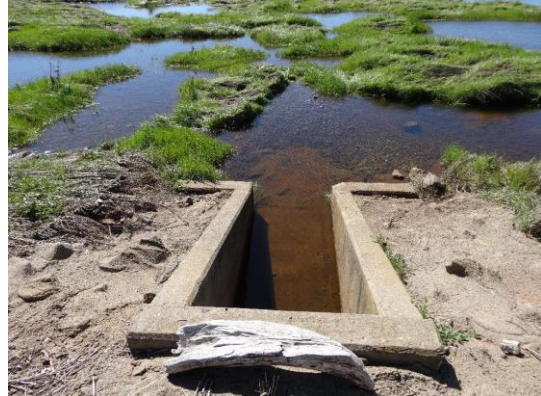
Photo 1 of 3 : UCIP_FA_2019_32107_58613.jpg

LM Start	1.25	Rating **	A/W	Issue No.	33
LM End	1.25	Issue Type +	Ma	Location *	
Category	Supplemental			GPS Latitude/Longitude	
				Start	End
Item	DRAFT DWR UCIP LMA Responsibility			39.779678 °	39.779678 °
				-121.862632 °	-121.862632 °
DWR ID	19264				
Comment Code					
Inspector Comment					
DS_ID:19264					
FS_ID:32107					
EP_NO: N/A					
Repair Type: No Action Needed					
Crossing Status: Found					
UCIP Comments: The culvert was working during the field visit.					
FIELD_STRUCT_DESC: 24-inch corrugated metal gravity drainage pipe through the levee, 11.7 feet below the crown. Flap gate on the waterside (WS) end. Concrete U-shaped headwall on each end.					
[Additional Reference(s): DWR Levee Log, 1992. USACE Sacramento O&M Manual 504, May 1965, (HLM 1.28)].					
FS Date: 3/11/2014

WS view: U type concrete headwall and grouted riprap on levee slope.

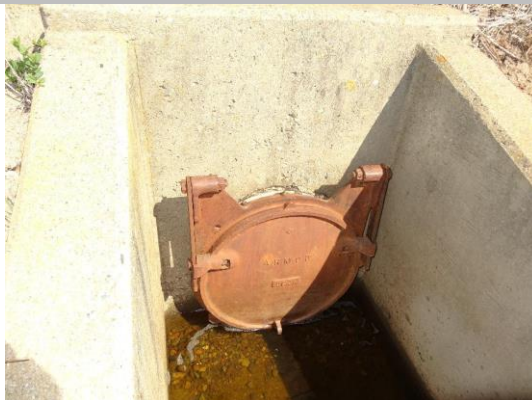
Photo 2 of 3 : UCIP_FA_2019_32107_58612.jpg

WS view: U type concrete headwall, flapgate, and CMP on levee slope.

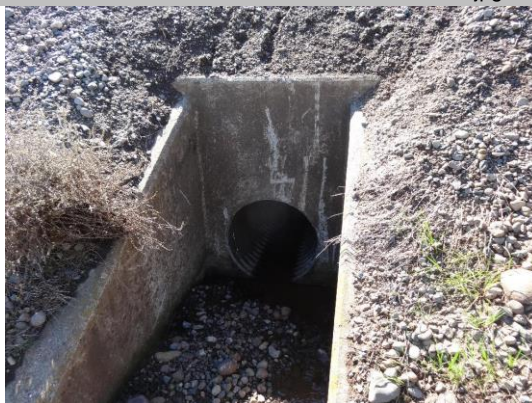
Photo 3 of 3 : UCIP_FA_2019_32107_58611.jpg

LS view: U type concrete headwall and CMP on levee slope.

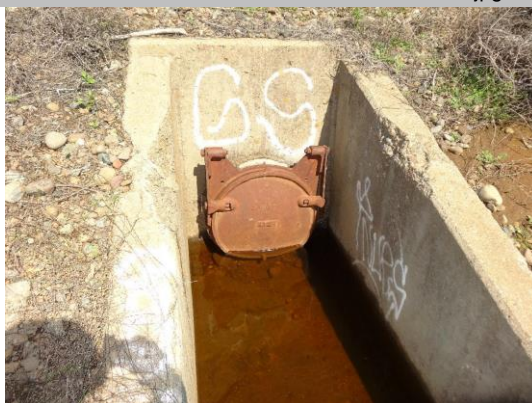
Photo 1 of 2 : UCIP_FA_2019_31899_58187.jpg

LM Start	1.50	Rating **	A/W	Issue No.	34
LM End	1.50	Issue Type +	Ma	Location *	
Category	Supplemental			GPS Latitude/Longitude	
				Start	End
Item	DRAFT DWR UCIP LMA Responsibility			39.779230 °	39.779230 °
				-121.857945 °	-121.857945 °
DWR ID	19265				
Comment Code					
Inspector Comment					
DS_ID:19265 FS_ID:31899 EP_NO: N/A Repair Type: No Action Needed Crossing Status: Found UCIP Comments: Working during the field visit. FIELD_STRUCT_DESC: 24-inch corrugated metal gravity drainage pipe through the levee, 11 feet below the crown. Flap gate on the waterside (WS) end. Concrete U-shaped headwall on each end. Grouted riprap apron on each end. [Additional Reference(s): DWR Levee Log, 1992. USACE Sacramento O&M Manual 504, May 1965, (HLM 1.53)]. FS Date: 3/11/2014

WS view: U type concrete headwall, flapgate, and CMP on levee slope. Looks clean and clear.

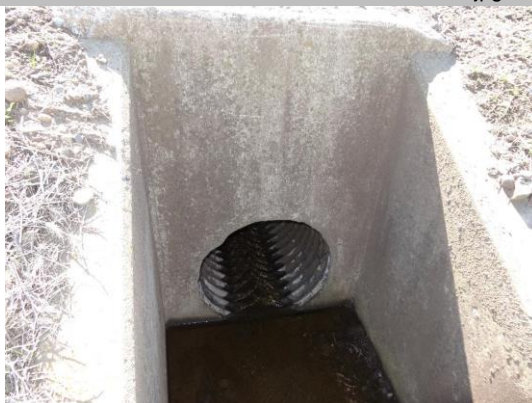
Photo 2 of 2 : UCIP_FA_2019_31899_58186.jpg

LS view: U type concrete headwall and CMP on levee slope. Looks clean and clear.

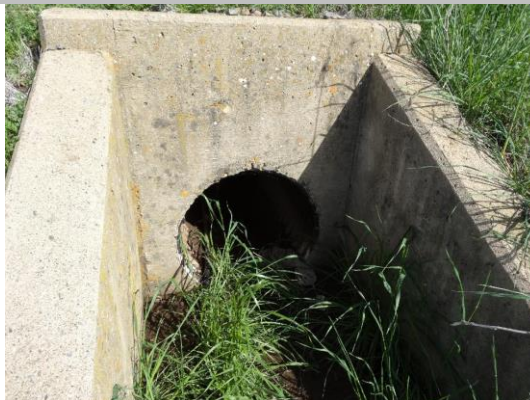
Photo 3 of 3 : UCIP_FA_2019_32124_58627.jpg

LS view: inside view of CMP on levee slope. Needs cleaning and clearing.

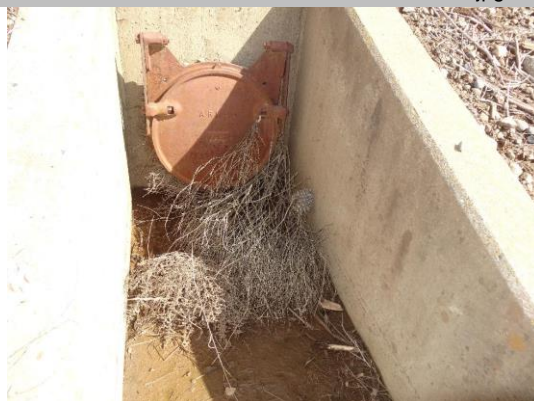
Photo 1 of 3 : UCIP_FA_2019_31901_58194.jpg

WS view: U type concrete headwall, flapgate, and CMP on levee slope. Needs cleaning and clearing.

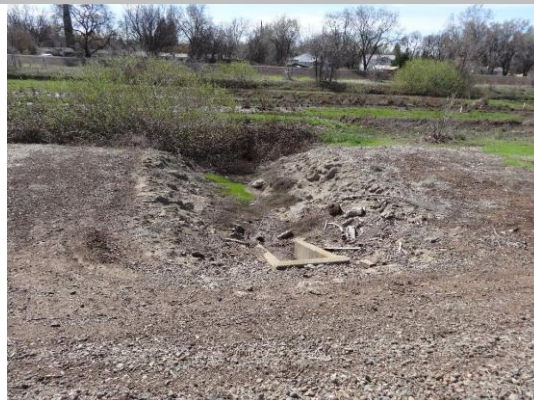
Photo 1 of 3 : UCIP_FA_2019_31902_58201.jpg

WS view: U type concrete headwall and grouted riprap spillway on levee slope.

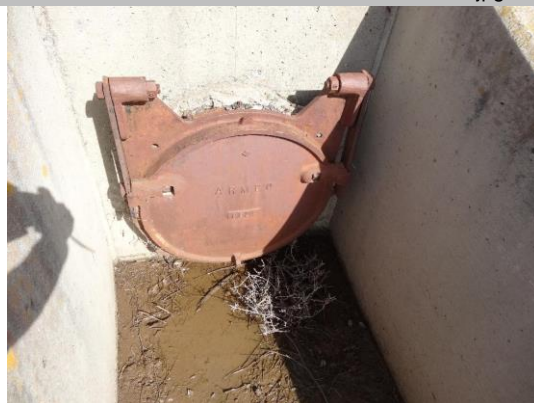
Photo 2 of 3 : UCIP_FA_2019_31902_58200.jpg

WS view: U type concrete headwall and CMP on levee slope.

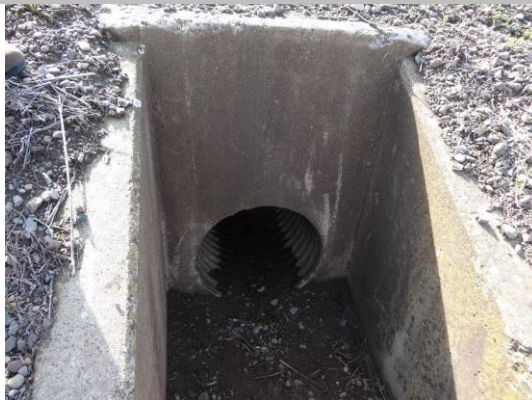
Photo 2 of 3 : UCIP_FA_2019_31864_58068.jpg

LS view: U type concrete headwall and CMP on levee slope. Soil/mud on inlet box.

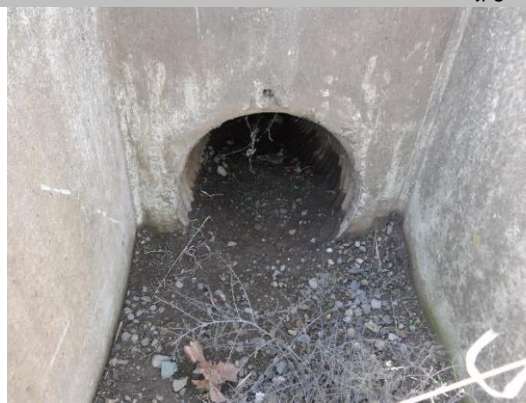
Photo 2 of 3 : UCIP_FA_2019_31856_58052.jpg

LS view: U type concrete headwall and CMP on levee slope. Soil/mud on inlet box.

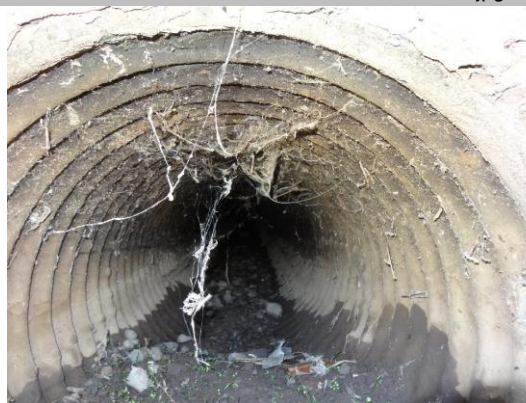
Photo 3 of 3 : UCIP_FA_2019_31856_58051.jpg

LS view: inside view of CMP on levee slope. Needs cleaning and clearing.

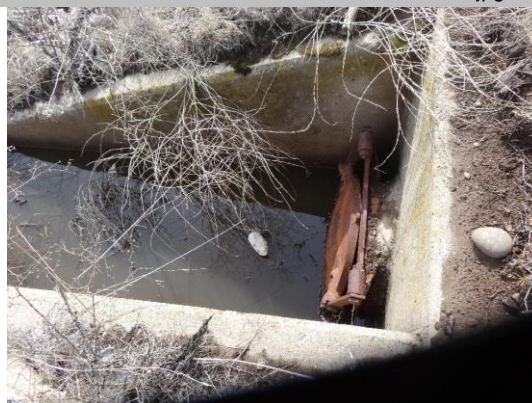
Photo 1 of 2 : UCIP_FA_2019_32125_58629.jpg

Comment Code						
Inspector Comment						
DS_ID:19275						
FS_ID:32125						
EP_NO: N/A						
Repair Type: Non-Urgent						
Crossing Status: Found						
UCIP Comments: The culvert was working during the field visit.Needs cleaning and clearing on both ends of the pipe.						
FIELD_STRUCT_DESC: 24-inch corrugated metal gravity drainage pipe through the levee, 7.5 feet below the crown. Flap gate on the waterside (WS) end. Concrete U-shaped headwall on each end. Grouted riprap apron on the landside (LS) end. Grouted riprap spillway on the WS end. [Additional Reference(s): DWR Levee Log, 1992. USACE Sacramento O&M Manual 504, May 1965, (HLM 3.76)].						
FS Date: 3/4/2014

WS view: U type concrete headwall, pipe, and flapgate on levee slope. Soil/mud on outlet box. Vegetation debris blocking outlet box.

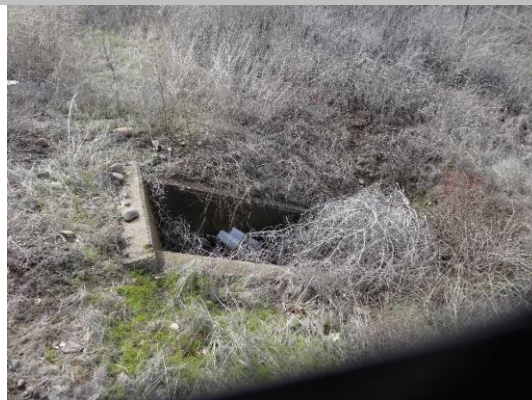
Photo 2 of 2 : UCIP_FA_2019_32125_58628.jpg

LS view: U type concrete headwall and pipe on levee slope. Soil/mud on inlet box. Vegetation debris blocking inlet box.

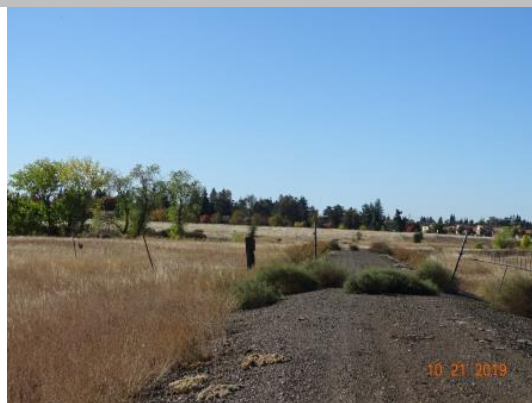
Photo 1 of 1 : FA_2019_NA0003_67_21_20191028_00039.jpg

LM Start	3.96	Rating **	M	Issue No.	21							
LM End	3.96	Issue Type +	Ma	Location *	CR							
Category	Earthen Levee		GPS Latitude/Longitude									
			Start	End								
Item	Vegetation		39.780606°	39.780606°								
			-121.840048°	-121.840048°								
DWR ID	DWR_NA0003_03_f_2019_21											
Comment Code												
V9 : Keep the crown roadway free of vegetation.												
Inspector Comment

View of the brush on top of crown. Fall 2019.

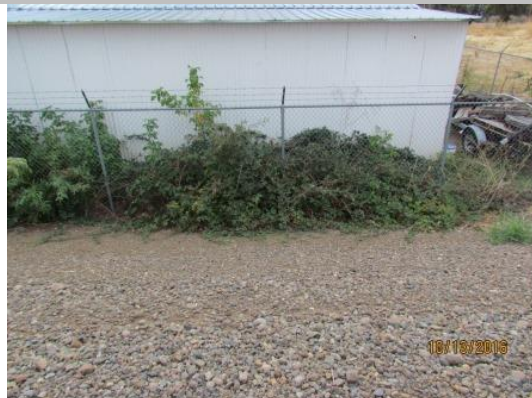
Photo 1 of 1 : FA_2019_NA0003_68_20_20190822_00005.jpg

LM Start	0.16	Rating **	M	Issue No.	20
LM End	0.16	Issue Type +	Ma	Location *	LS
Category	Earthen Levee			GPS Latitude/Longitude	
				Start	End
Item	Vegetation			39.776526 °	39.776526 °
				-121.848727 °	-121.848727 °
DWR ID	DWR_NA0003_04_f_2016_20				
Comment Code					
V2 : Remove the wild growth other than native grasses from the levee slopes.					
Inspector Comment

View of the vegetation along the landside toe.

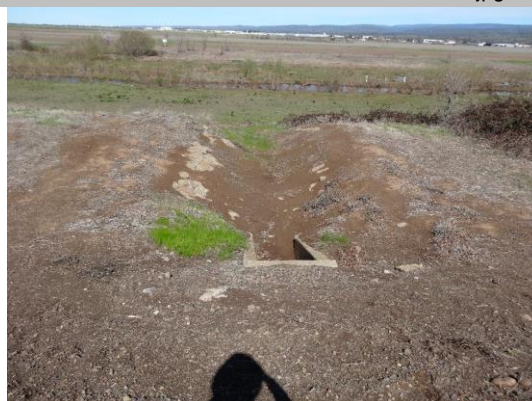
Photo 1 of 3 : UCIP_FA_2019_32026_58520.jpg

WS view: concrete headwall and grouted riprap spillway on levee slope.

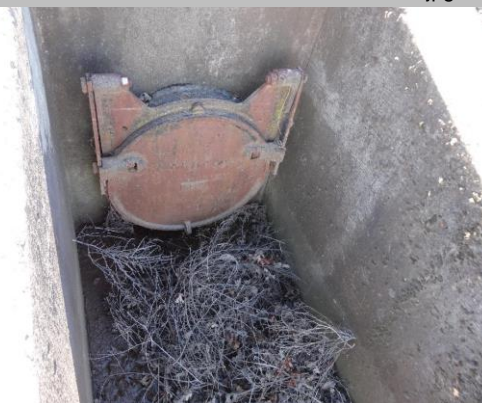
Photo 2 of 3 : UCIP_FA_2019_32026_58519.jpg

WS view: U type concrete headwall and CMP on levee slope. Mud and vegetation debris on outlet box.

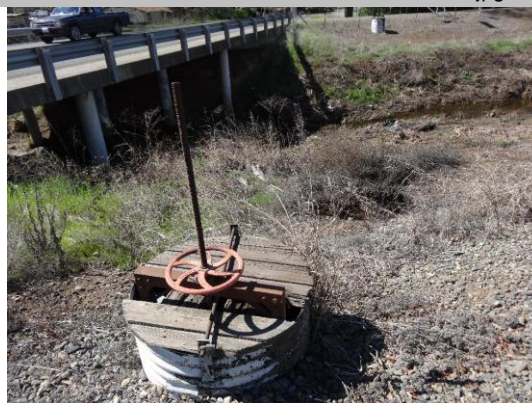
Photo 1 of 3 : UCIP_FA_2019_32025_58512.jpg

WS view: slide gate in CMP riser on waterside shoulder.

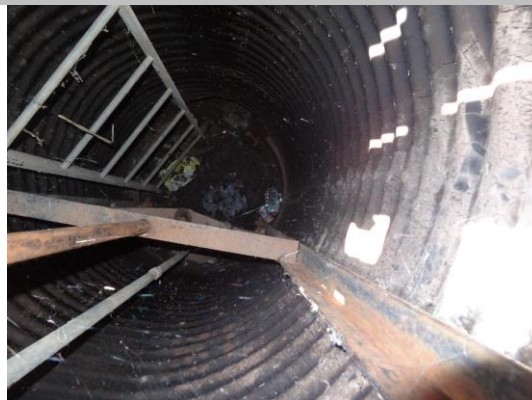
Photo 2 of 3 : UCIP_FA_2019_32025_58511.jpg

WS view: inside view of slide gate in CMP riser on waterside shoulder.
Debris trapped in the riser.

Comment Code						
Inspector Comment						
DS_ID:19280						
FS_ID:32025						
EP_NO: N/A						
Repair Type: Non-Urgent						
Crossing Status: Found						
UCIP Comments: Slide gate in a CMP riser. Vegetation debris and mud on inlet box.Needs cleaning and clearing the culvert.						
FIELD_STRUCT_DESC: 24-inch corrugated metal gravity drainage pipe through the levee and under the channel, 9.5 feet below the crown.						
Slide gate in a corrugated metal pipe (CMP) riser on the waterside (WS) slope. Concrete U-shaped headwall on the landside (LS) end.						
[Additional Reference(s): DWR Levee Log, 1992. USACE Sacramento O&M Manual 504, May 1965, (HLM 0.34)].						
FS Date: 3/7/2014

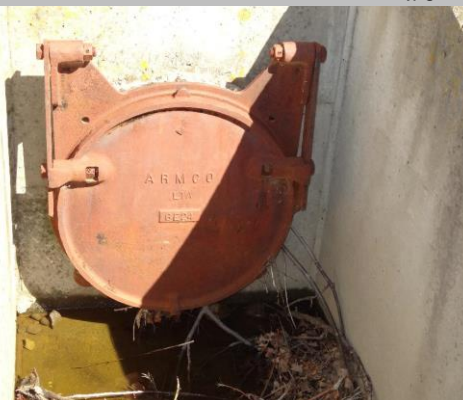
Photo 1 of 3 : UCIP_FA_2019_32023_58505.jpg

WS view: U type concrete headwall and CMP on levee slope. Vegetation debris and mud on outlet box. Needs cleaning and clearing.

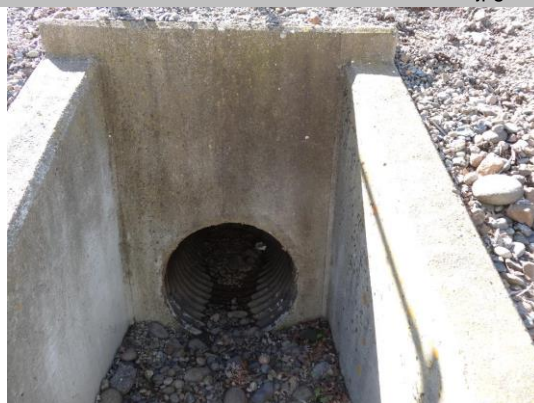
Photo 2 of 3 : UCIP_FA_2019_32023_58504.jpg

LS view: U type concrete headwall and CMP on levee slope. Pebbles and mud on inlet box.

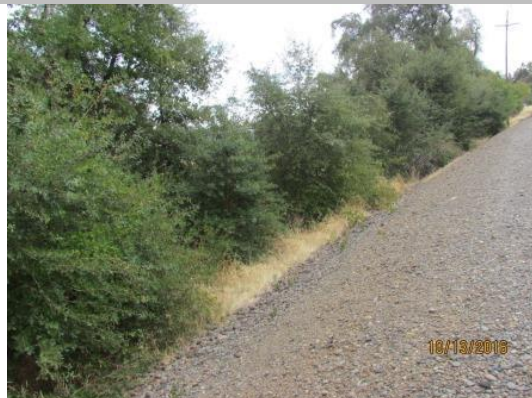
Photo 1 of 1 : FA_2019_NA0003_68_21_20190822_00006.jpg

LM Start	0.35	Rating **	M	Issue No.	21
LM End	0.39	Issue Type +	Ma	Location *	LS
Category	Earthen Levee			GPS Latitude/Longitude	
				Start	End
Item	Vegetation			39.775672°	39.775220°
				-121.850301°	-121.849805°
DWR ID	DWR_NA0003_04_f_2016_21				
Comment Code					
V2 : Remove the wild growth other than native grasses from the levee slopes.					
Inspector Comment

View of the overgrown trees along the landside toe.

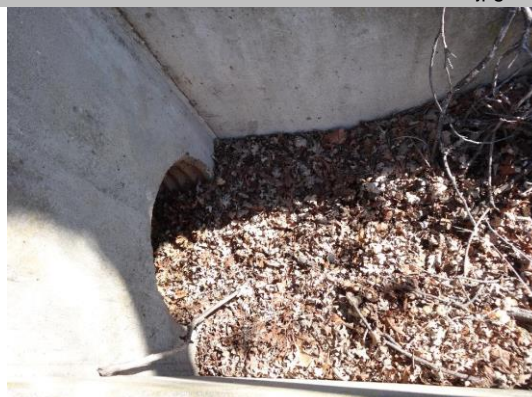
Photo 2 of 2 : UCIP_FA_2019_32143_58640.jpg

LS view: U type concrete headwall and CMP on levee slope. Vegetation and mud on inlet box.

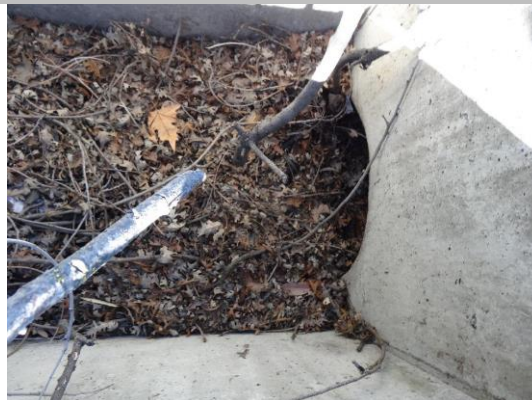
Photo 2 of 3 : UCIP_FA_2019_32144_58643.jpg

LS view: close view of vegetation debris and mud on inlet box.

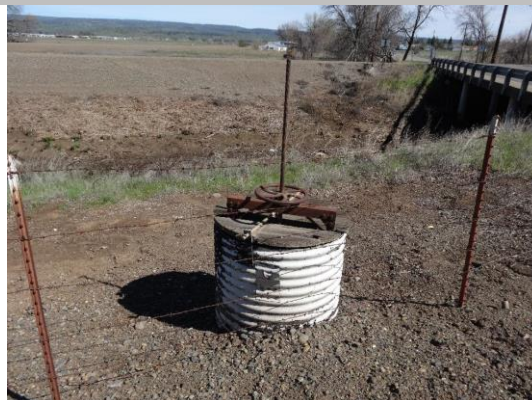
Photo 3 of 3 : UCIP_FA_2019_32144_58642.jpg

WS view: slide gate in CMP riser on waterside. No access to CMP riser.

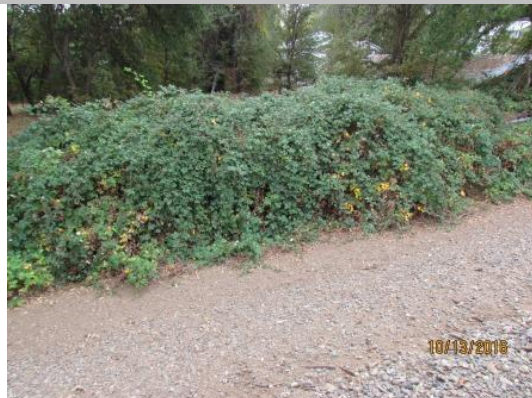
Photo 1 of 1 : FA_2019_NA0003_68_23_20190822_00007.jpg

LM Start	1.04	Rating **	M	Issue No.	23
LM End	1.04	Issue Type +	Ma	Location *	LS
Category	Earthen Levee			GPS Latitude/Longitude	
				Start	End
Item	Vegetation			39.776589 °	39.776589 °
				-121.852600 °	-121.852600 °
DWR ID	DWR_NA0003_04_f_2016_23				
Comment Code					
V2 : Remove the wild growth other than native grasses from the levee slopes.					
Inspector Comment

View of the blackberries blocking visibility and access.

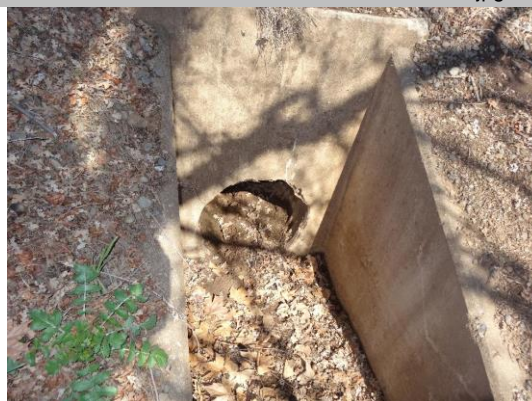
Photo 2 of 3 : UCIP_FA_2019_31963_58383.jpg

LS view: U type concrete headwall and CMP on levee slope. Vegetation debris and mud on inlet box.

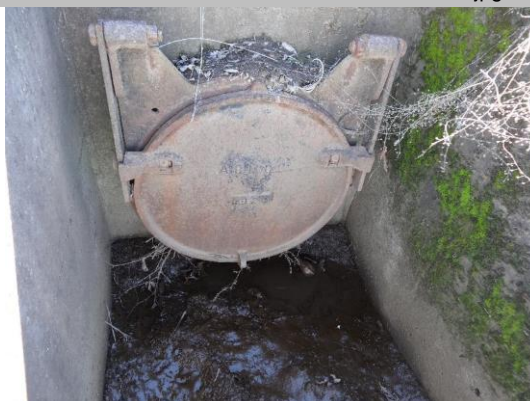
Photo 1 of 2 : UCIP_FA_2019_31964_58389.jpg

WS view: U type concrete headwall and CMP on levee slope. Vegetation debris and mud in outlet box. Needs cleaning and clearing.

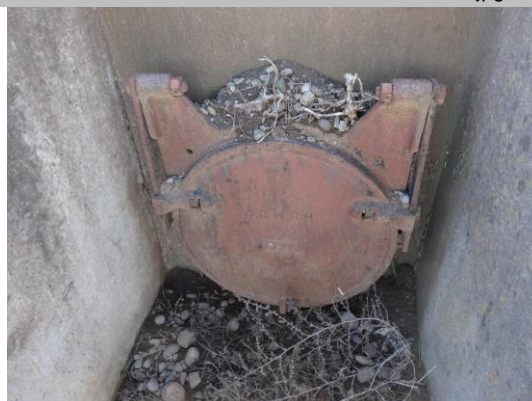
Photo 1 of 3 : UCIP_FA_2019_31965_58395.jpg

WS view: U type concrete headwall and CMP on levee slope. Vegetation debris and mud in outlet box. Needs cleaning and clearing.

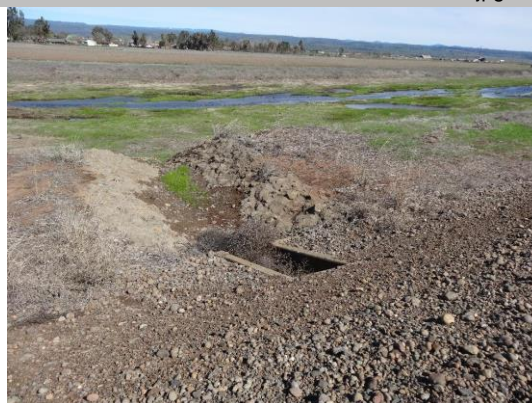
Photo 1 of 3 : UCIP_FA_2019_31966_58401.jpg

LM Start	2.47	Rating **	M	Issue No.	51	
LM End	2.47	Issue Type +	Ma	Location *		
Category	Supplemental			GPS Latitude/Longitude		
				Start		End
Item	DRAFT DWR UCIP LMA Responsibility			39.784244 °		39.784244 °
				-121.876810 °		-121.876810 °
DWR ID	19292					
Comment Code						
Inspector Comment						
DS_ID:19292						
FS_ID:31966						
EP_NO: N/A						
Repair Type: Non-Urgent						
Crossing Status: Found						
UCIP Comments: Needs cleaning and clearing the culvert.						
FIELD_STRUCT_DESC: 24-inch corrugated metal gravity drainage pipe through the levee, 11 feet below the crown. Flap gate on the waterside (WS) end. Concrete U-shaped headwall on each end. Grouted riprap apron on the landside (LS) end. Grouted riprap spillway on the WS end.						
[Additional Reference(s): DWR Levee Log, 1992. USACE Sacramento O&M Manual 504, May 1965, (HLM 2.56)].						
FS Date: 3/7/2014

WS view: U type concrete headwall and grouted riprap spillway on levee slope.

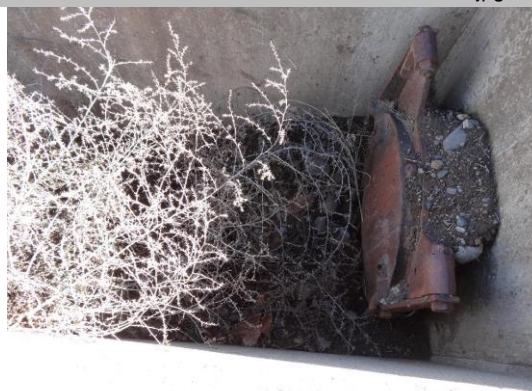
Photo 2 of 3 : UCIP_FA_2019_31966_58400.jpg

WS view: U type concrete headwall and CMP on levee slope. Vegetation debris and mud on outlet box. Needs cleaning and clearing.

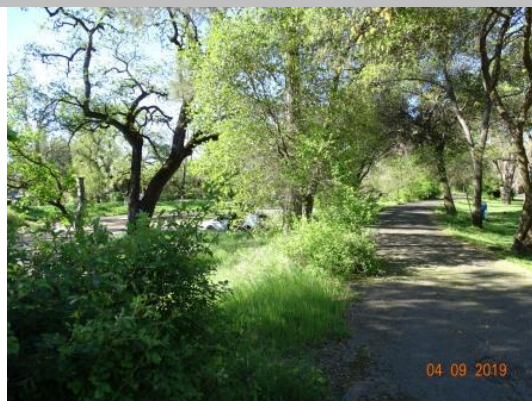
Photo 1 of 1 : FA_2019_NA0003_69_1_20190822_00001.jpg

LM Start	0.03	Rating **	M	Issue No.	1
LM End	0.20	Issue Type +	Ma	Location *	LS
Category	Earthen Levee			GPS Latitude/Longitude	
				Start	End
Item	Vegetation			39.763164 °	39.761860 °
				-121.790335 °	-121.792635 °
DWR ID	DWR_NA0003_05_s_2012_1				
Comment Code					
V2 : Remove the wild growth other than native grasses from the levee slopes.					
Inspector Comment

View of the wild growth on the landside slope. Spring 2019.
