**Flood Control Project Maintenance
Levee Inspections**

Maintenance Issue Types Only, Levee Inspection Report By Mile - Fall 2019

Butte County Department of Public Works

Waterway	Bank	Unit Miles	Inspection Start/End	Inspector
Unit No. 01 Mud Creek	Right	6.80	10/22/2019 10/22/2019	Makar Sokol

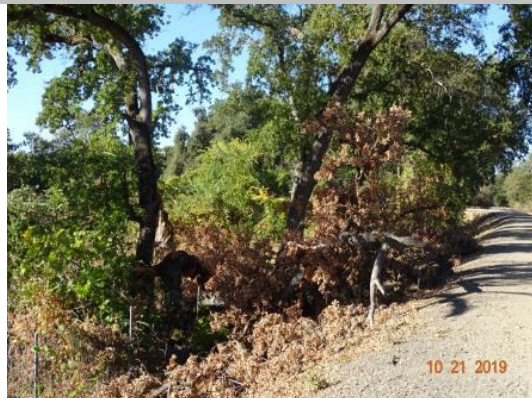
Photo 1 of 1 : FA_2019_NA0003_69_3_20191028_00006.jpg

LM Start	0.30	Rating **	M	Issue No.	3
LM End	0.30	Issue Type +	Ma	Location *	LS
Category	Earthen Levee			GPS Latitude/Longitude	
				Start	End
Item	Encroachments			39.761743 °	39.761743 °
				-121.794447 °	-121.794447 °
DWR ID	DWR_NA0003_05_f_2019_3				
Comment Code					
TR : Tree or limb					
Inspector Comment					
The fallen tree should be removed from the landside slope and toe.

View of the fallen tree on the landside slope. Fall 2019.

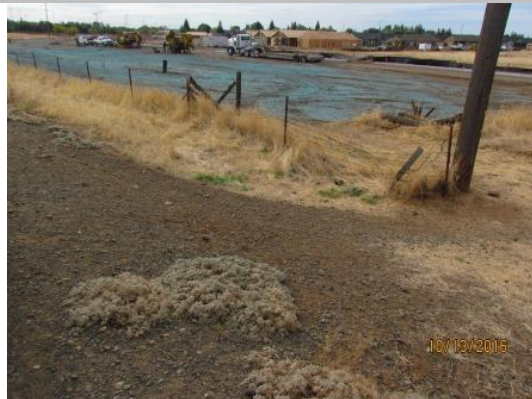
Photo 1 of 1 : FA_2019_NA0003_69_13_20190822_00003.jpg

LM Start	1.25	Rating **	M	Issue No.	13
LM End	1.25	Issue Type +	Ma	Location *	LS
Category	Earthen Levee			GPS Latitude/Longitude	
				Start	End
Item	Slope Stability			39.768621 °	39.768621 °
				-121.807052 °	-121.807052 °
DWR ID	DWR_NA0003_05_f_2016_13				
Comment Code					
S2 : Repair the levee slope damaged by foot traffic and prevent access where possible.					
Inspector Comment

View of the damaged slope by foot traffic.
