**Flood Control Project Maintenance
Levee Inspections**

Maintenance Issue Types Only, Levee Inspection Report By Mile - Fall 2020

Butte County Department of Public Works

Waterway	Bank	Unit Miles	Inspection Start/End	Inspector
Unit No. 01 Mud Creek	Right	6.80	10/27/2020 10/27/2020	Makar Sokol

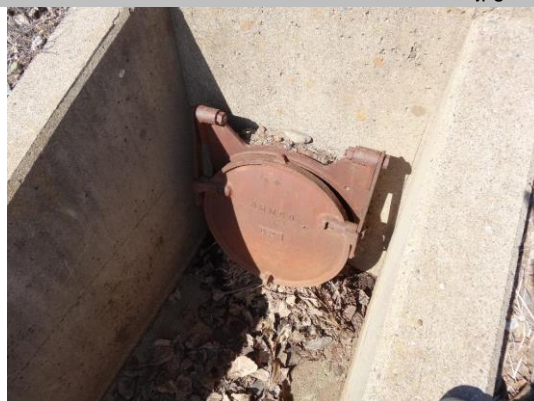
Photo 2 of 3 : UCIP_FA_2020_32044_58542.jpg

WS view: vegetation debris blocking outlet.

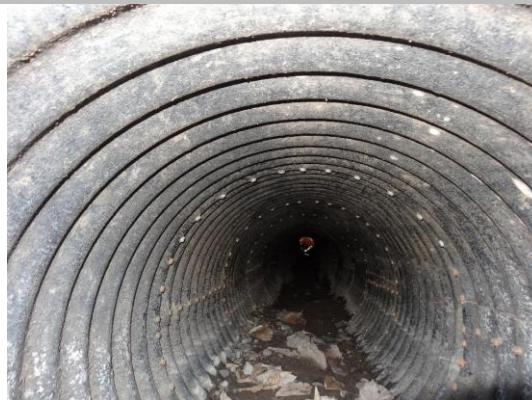
Photo 3 of 3 : UCIP_FA_2020_50142_55884.jpg

LS view: inside view of CMP on levee slope. Needs cleaning and clearing.

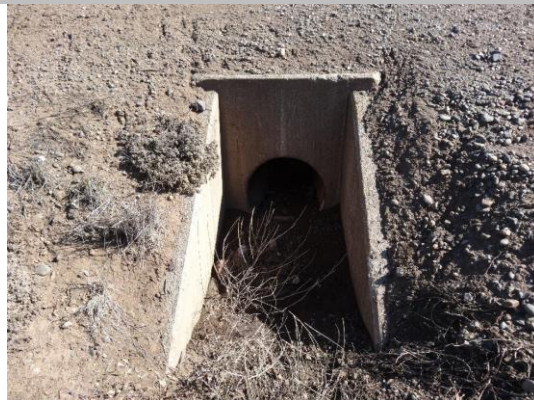
Photo 2 of 2 : UCIP_FA_2020_30294_55703.jpg

LS view: U type concrete headwall and CMP on levee slope. Debris blocking the inlet pipe.

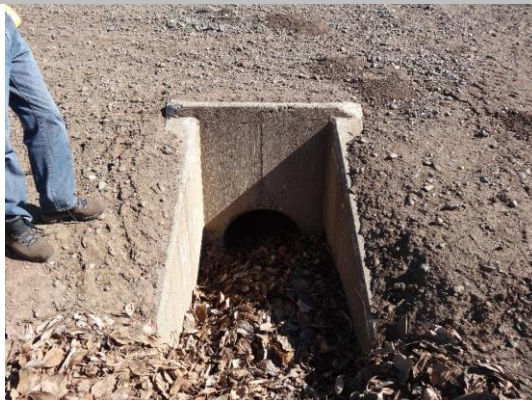
Photo 2 of 2 : UCIP_FA_2020_30295_55705.jpg

DS_ID:19217
FS_ID:30295
EP_NO: N/A
Repair Type: Non-Urgent
EVAL Issue:
Crossing Status: Found
UCIP Comments: It needs cleaning and clearing in inlet and outlet ends.
FIELD_STRUCT_DESC: 24-inch corrugated metal gravity drainage pipe through the levee, 9 feet below the crown. Flap gate on the waterside (WS) end. Concrete U-shaped headwall on each end. Grouted riprap apron on the landside (LS) end. Grouted riprap spillway on the WS end. [Additional Reference(s): DWR Levee Log, 1992. USACE Sacramento O&M Manual 504, May 1965, (HLM 3.27)].
FS Date: 2/20/2014

LS view: U type concrete headwall and CMP on levee slope. Vegetation debris blocking the inlet.

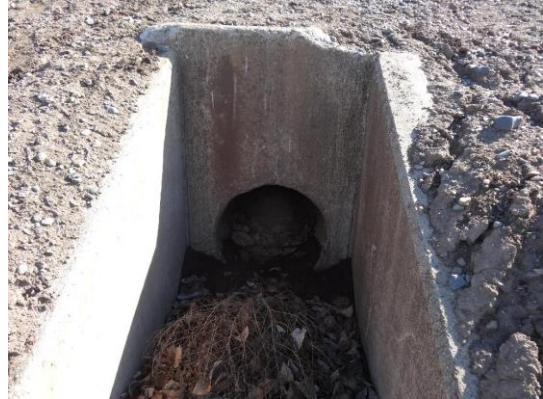
Photo 2 of 3 : UCIP_FA_2020_30310_55740.jpg

DS_ID:19218
 FS_ID:30310
 EP_NO: N/A
 Repair Type: Non-Urgent
 EVAL Issue:
 Crossing Status: Found
 UCIP Comments: Needs cleaning and clearing of debris.
 FIELD_STRUCT_DESC: 24-inch corrugated metal gravity drainage pipe through the levee, 10 feet below the crown. Flap gate on the waterside (WS) end. Concrete U-shaped headwall on each end. Grouted riprap apron on the landside (LS) end. Grouted riprap spillway on the WS end. [Additional Reference(s): DWR Levee Log, 1992. USACE Sacramento O&M Manual 504, May 1965, (HLM 3.48)].
 FS Date: 2/20/2014

LS view: U type concrete headwall and CMP on levee slope.

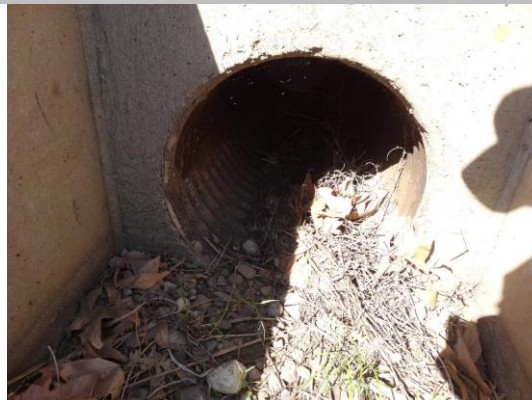
Photo 2 of 3 : UCIP_FA_2020_30403_55921.jpg

LS view: U type concrete headwall and CMP on levee slope. Vegetation debris in inlet pipe.

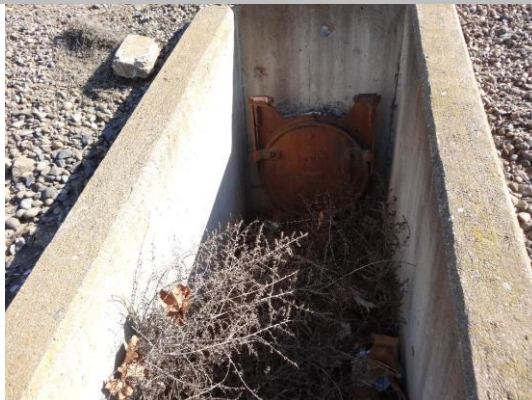
Photo 1 of 3 : UCIP_FA_2020_30763_56662.jpg

WS view: U type concrete headwall, pipe, and flapgate on levee slope. Vegetation debris blocking outlet.

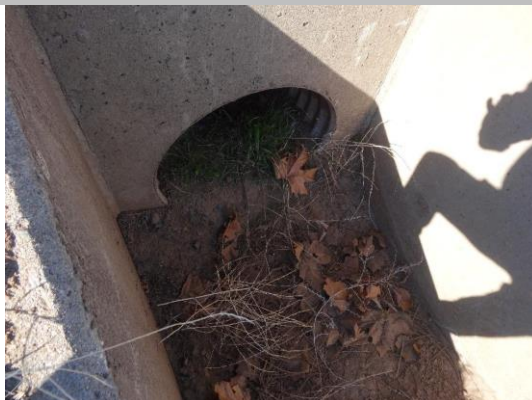
Photo 2 of 3 : UCIP_FA_2020_30763_56661.jpg

LS view: U type concrete headwall and CMP on levee slope.

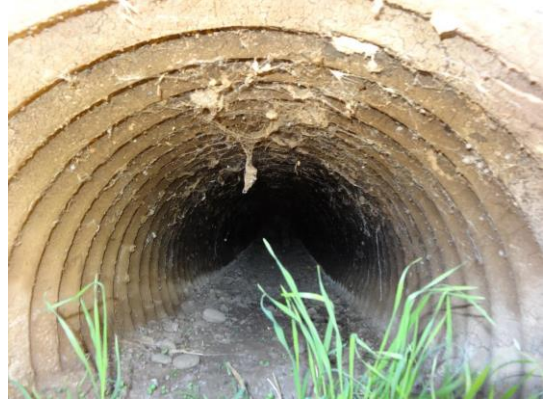
Photo 3 of 3 : UCIP_FA_2020_30763_56660.jpg

LS view: inside view of CMP on levee slope. Needs cleaning and clearing.

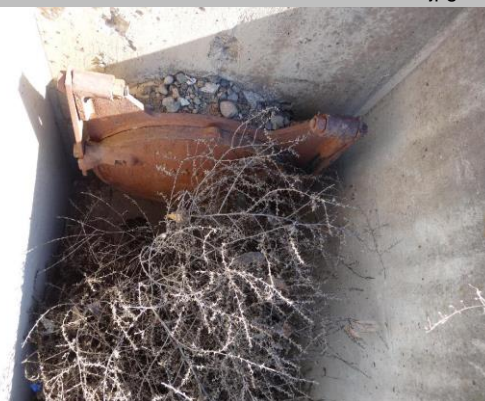
Photo 1 of 3 : UCIP_FA_2020_30803_56685.jpg

WS view: U type concrete headwall, pipe, and flapgate on levee slope. Vegetation debris and soil blocking outlet.

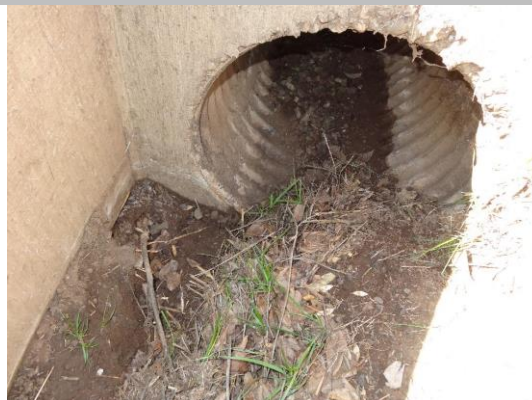
Photo 2 of 3 : UCIP_FA_2020_31028_56912.jpg

LS view: U type concrete headwall and CMP on levee slope.

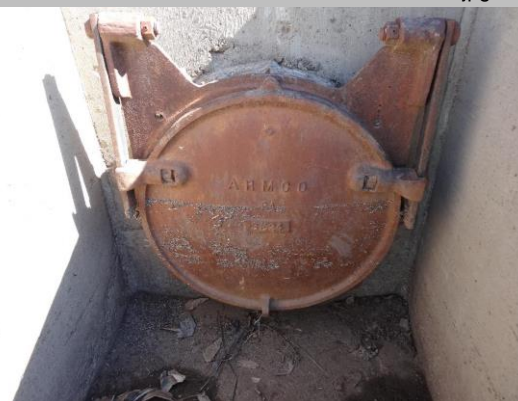
Photo 1 of 3 : UCIP_FA_2020_31034_56926.jpg

WS view: U type concrete headwall, pipe, and flapgate on levee slope.

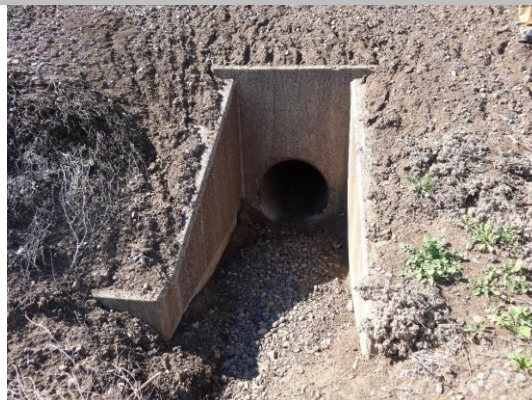
Photo 2 of 3 : UCIP_FA_2020_31034_56925.jpg

LS view: U type concrete headwall and CMP on levee slope.

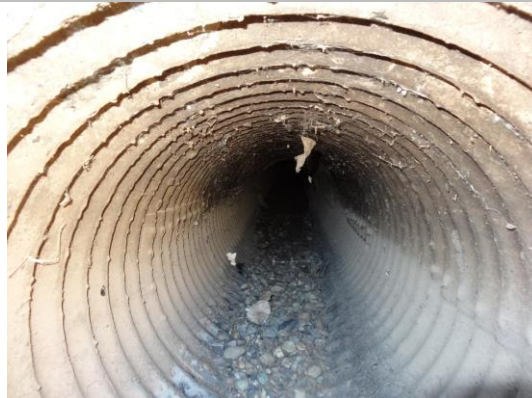
Photo 3 of 3 : UCIP_FA_2020_31034_56924.jpg

LS view: inside view of CMP on levee slope. Needs cleaning and clearing.

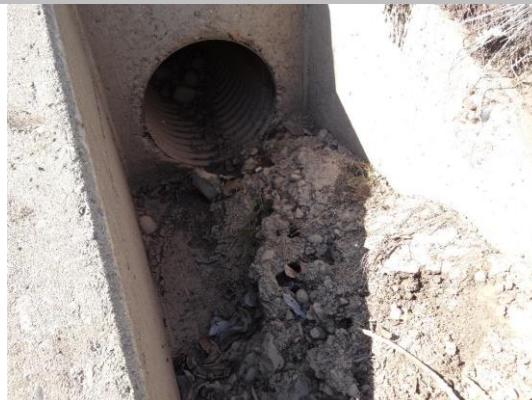
Photo 2 of 3 : UCIP_FA_2020_31085_56987.jpg

LS view: U type concrete headwall and CMP on levee slope. Soil/mud on inlet box.

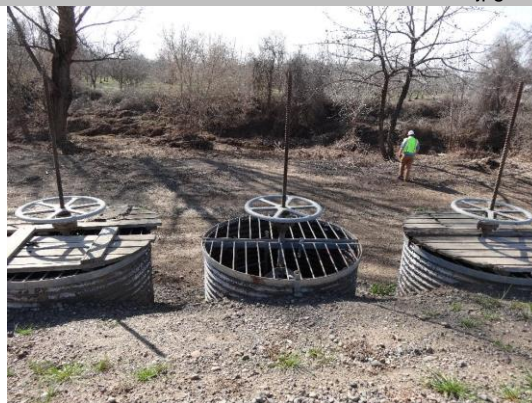
Photo 1 of 3 : UCIP_FA_2020_32085_58585.jpg

DS_ID:19253
 FS_ID:32085
 EP_NO: N/A
 Repair Type: Non-Urgent
 EVAL Issue:
 Crossing Status: Found
 UCIP Comments: Slide gates in CMP risers on waterside shoulder. Needs cleaning and clearing of debris.
 FIELD_STRUCT_DESC: 1 of 3: 48-inch corrugated metal gravity drainage pipe through the levee, 18 feet below the crown. Flap gate on the waterside (WS) end. Slide gate in a corrugated metal pipe (CMP) riser on the WS shoulder. Concrete U-shaped headwall on each end. Grouted riprap apron on the landside (LS) end. Grouted riprap spillway on the WS end. [Additional Reference(s): DWR Levee Log, 1992. USACE Sacramento O&M Manual 504, May 1965, (HLM 7.46)].
 FS Date: 2/25/2014

WS view: slide gates in CMP risers on waterside shoulder.

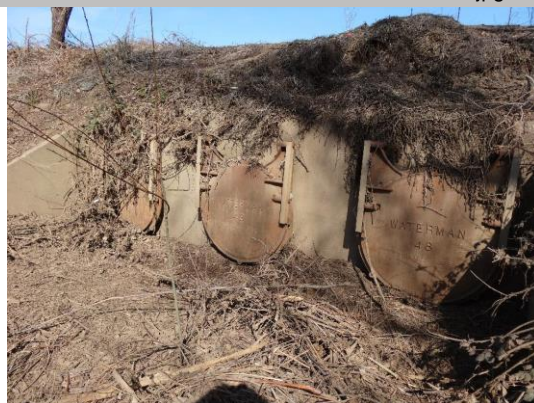
Photo 2 of 3 : UCIP_FA_2020_32085_58584.jpg

WS view: U type concrete headwall, pipes, and flapgates on levee slope. Soil/mud on outlet box. Vegetation debris blocking outlet box

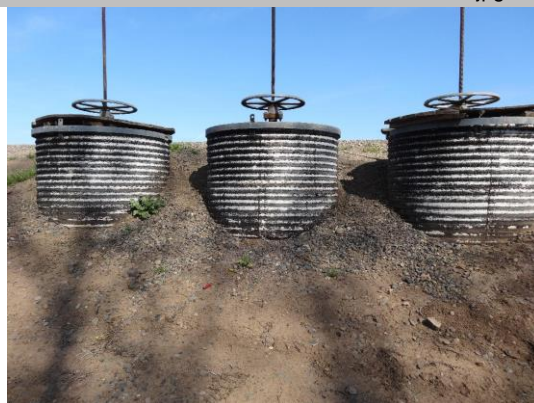
Photo 1 of 3 : UCIP_FA_2020_32087_58592.jpg

WS view: slide gates in CMP risers on waterside shoulder.

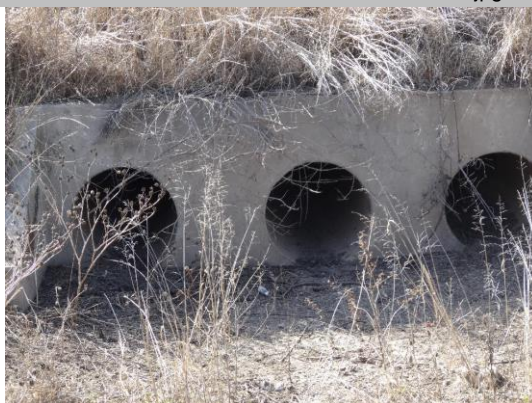
Photo 3 of 3 : UCIP_FA_2020_32087_58590.jpg

LS view: U type concrete headwall and CMPs on levee slope. Soil/mud on inlet box.

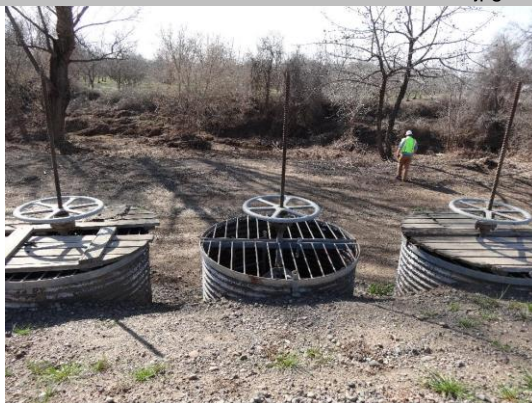
Photo 1 of 3 : UCIP_FA_2020_32086_58589.jpg

DS_ID:19260
 FS_ID:32086
 EP_NO: N/A
 Repair Type: Non-Urgent
 EVAL Issue:
 Crossing Status: Found
 UCIP Comments: Slide gates in CMP risers on waterside shoulder. Needs cleaning and clearing of debris.
 FIELD_STRUCT_DESC: 2 of 3: 48-inch corrugated metal gravity drainage pipe through the levee, 18 feet below the crown. Flap gate on the waterside (WS) end. Slide gate in a corrugated metal pipe (CMP) riser on the WS shoulder. Concrete U-shaped headwall on each end. Grouted riprap apron on the landside (LS) end. Grouted riprap spillway on the WS end. [Additional Reference(s): DWR Levee Log, 1992. USACE Sacramento O&M Manual 504, May 1965, (HLM 7.46)].
 FS Date: 2/25/2014

WS view: slide gates in CMP risers on waterside shoulder.

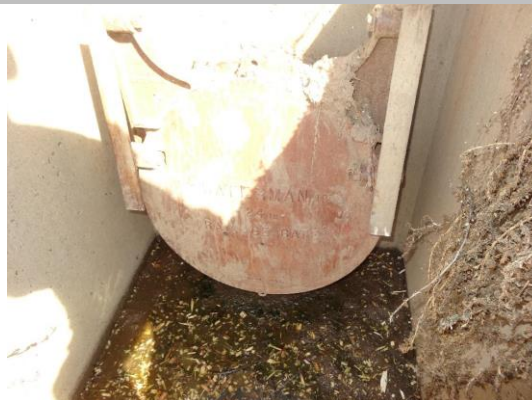
Photo 1 of 2 : UCIP_FA_2020_31129_57036.jpg

WS view: U type concrete headwall, pipe, and flapgate on levee slope. Soil/mud on outlet box.

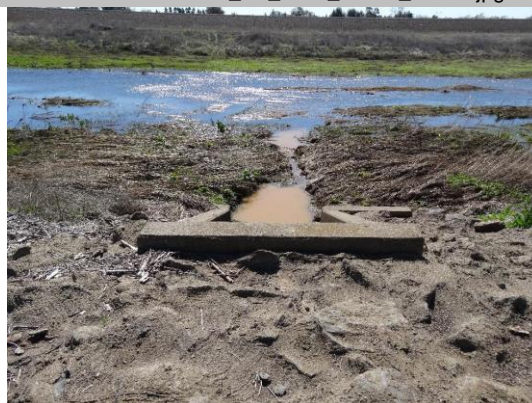
Photo 2 of 3 : UCIP_FA_2020_51844_58601.jpg

WS view: U type concrete headwall of CMP culvert on levee slope.
Grouted riprap levee slope and spillway.

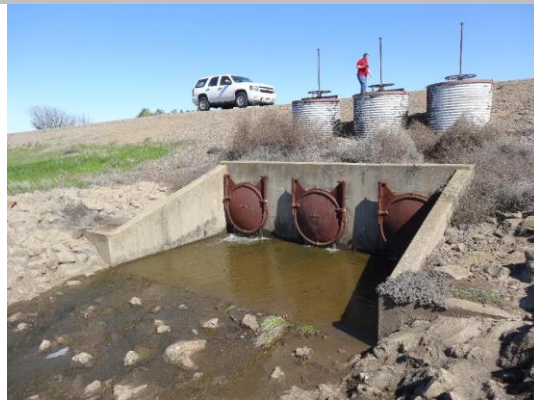
Photo 1 of 2 : UCIP_FA_2020_32105_58608.jpg

Comment Code					
Inspector Comment					
DS_ID:19277					
FS_ID:32105					
EP_NO: N/A					
Repair Type: No Action Needed					
EVAL Issue:					
Crossing Status: Found					
UCIP Comments: Slide gate in CMP riser on waterside.The culvert was working during the field visit.					
FIELD_STRUCT_DESC: 2 of 3: 48-inch corrugated metal gravity drainage pipe through the levee, 11.7 feet below the crown. Slide gate in a riser well on the waterside (WS) slope. Concrete U-shaped headwall on each end. Flap gate on the WS end. Grouted riprap outlet channel on the WS. [Additional Reference(s): DWR Levee Log, 1992. USACE Sacramento O&M Manual 504, May 1965, (HLM 0.39)].					
FS Date: 3/11/2014

WS view: U type concrete headwall and three CMPs with slide gates on levee slope. Grouted riprap spillway.

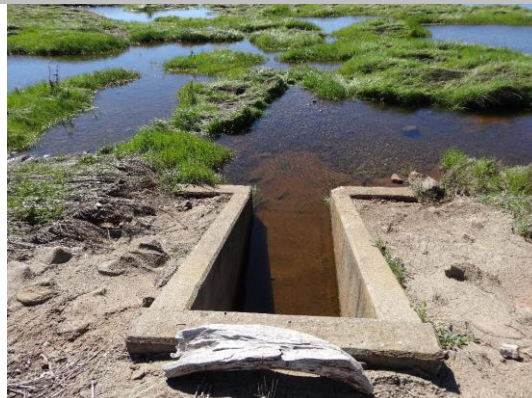
Photo 1 of 3 : UCIP_FA_2020_32107_58613.jpg

WS view: U type concrete headwall and grouted riprap on levee slope.

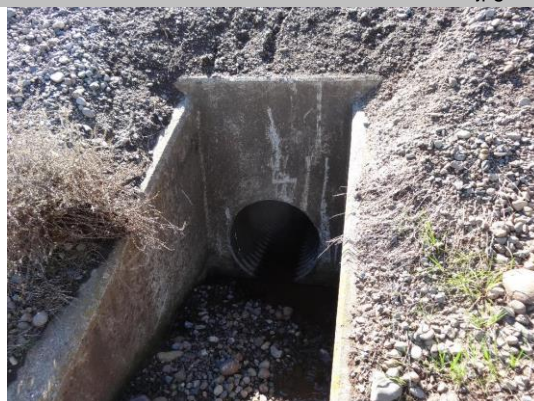
Photo 3 of 3 : UCIP_FA_2020_32107_58611.jpg

LS view: U type concrete headwall and CMP on levee slope.

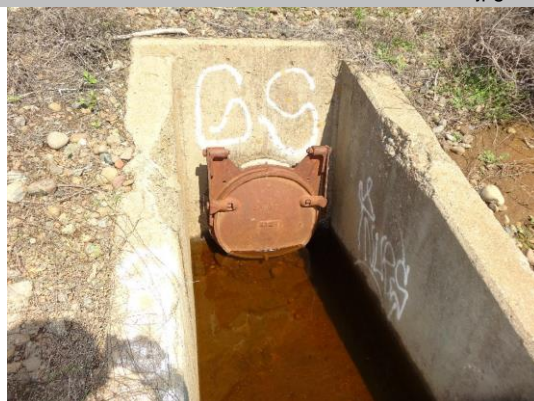
Photo 1 of 2 : UCIP_FA_2020_31899_58187.jpg

DS_ID:19265
 FS_ID:31899
 EP_NO: N/A
 Repair Type: No Action Needed
 EVAL Issue:
 Crossing Status: Found
 UCIP Comments: Working during the field visit.
 FIELD_STRUCT_DESC: 24-inch corrugated metal gravity drainage pipe through the levee, 11 feet below the crown. Flap gate on the waterside (WS) end. Concrete U-shaped headwall on each end. Grouted riprap apron on each end. [Additional Reference(s): DWR Levee Log, 1992. USACE Sacramento O&M Manual 504, May 1965, (HLM 1.53)].
 FS Date: 3/11/2014

WS view: U type concrete headwall, flapgate, and CMP on levee slope.
Looks clean and clear.

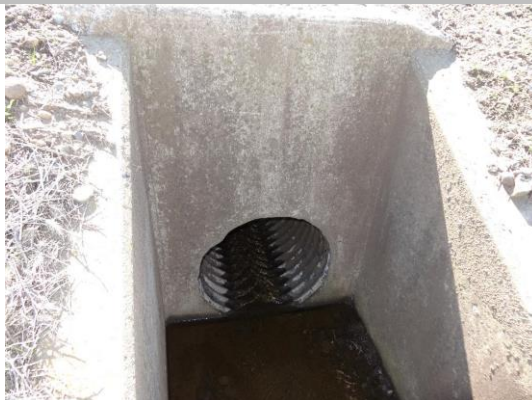
Photo 2 of 2 : UCIP_FA_2020_31899_58186.jpg

LS view: U type concrete headwall and CMP on levee slope. Looks clean and clear.

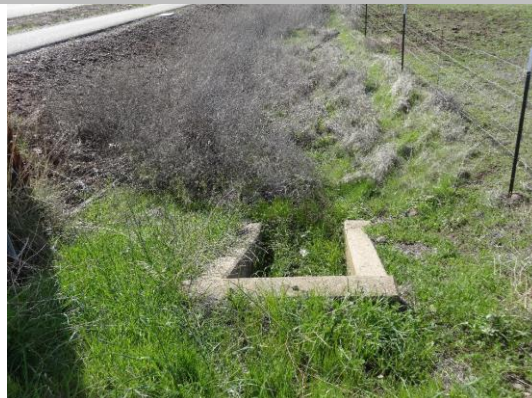
Photo 2 of 3 : UCIP_FA_2020_32124_58624.jpg

DS_ID:19267
 FS_ID:32124
 EP_NO: N/A
 Repair Type: Non-Urgent
 EVAL Issue:
 Crossing Status: Found
 UCIP Comments: Pipe is about 4 feet below the crown. Needs cleaning and clearing the culvert.
 FIELD_STRUCT_DESC: 24-inch corrugated metal gravity drainage pipe through the levee, 6 feet below the crown. Flap gate on the waterside (WS) end. Concrete U-shaped headwall on each end.
 [Additional Reference(s): DWR Levee Log, 1992. USACE Sacramento O&M Manual 504, May 1965, (HLM 2.23)].
 FS Date: 3/7/2014

LS view: U type concrete headwall of CMP culvert on levee slope.
Vegetation on inlet box.

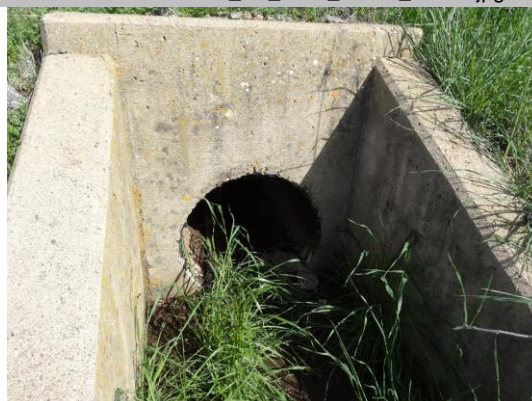
Photo 3 of 3 : UCIP_FA_2020_32124_58627.jpg

LS view: inside view of CMP on levee slope. Needs cleaning and clearing.

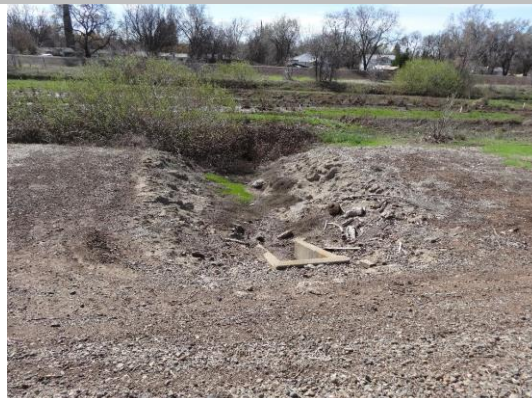
Photo 1 of 3 : UCIP_FA_2020_31902_58201.jpg

WS view: U type concrete headwall and grouted riprap spillway on levee slope.

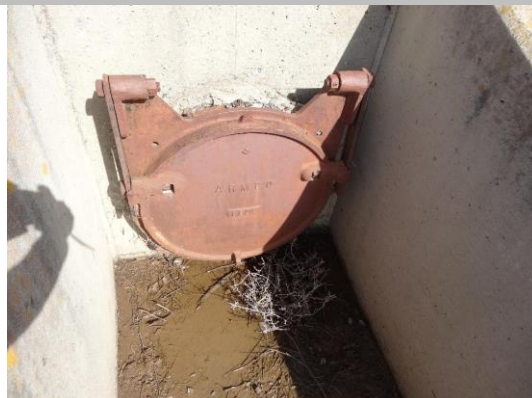
Photo 2 of 3 : UCIP_FA_2020_31902_58200.jpg

WS view: U type concrete headwall and CMP on levee slope.

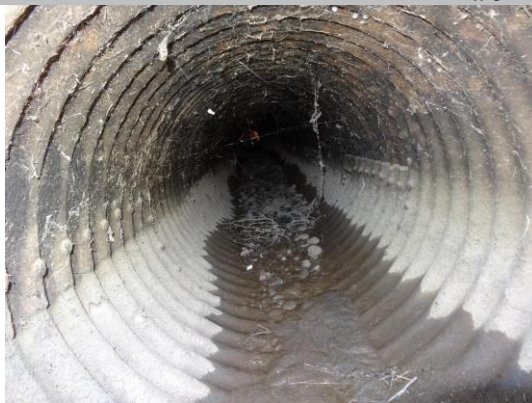
Photo 3 of 3 : UCIP_FA_2020_31864_58067.jpg

LS view: inside view of CMP on levee slope. Needs cleaning and clearing.

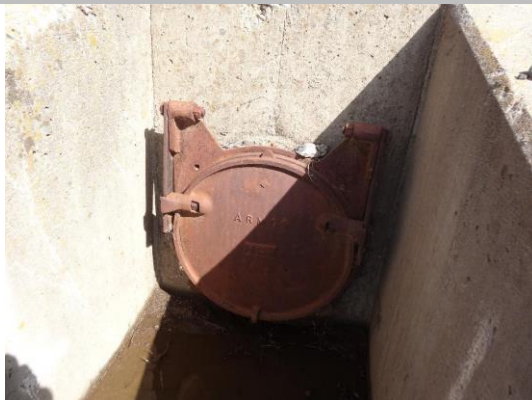
Photo 1 of 3 : UCIP_FA_2020_31856_58053.jpg

WS view: U type concrete headwall, pipe, and flapgate on levee slope. Soil/mud on outlet box.

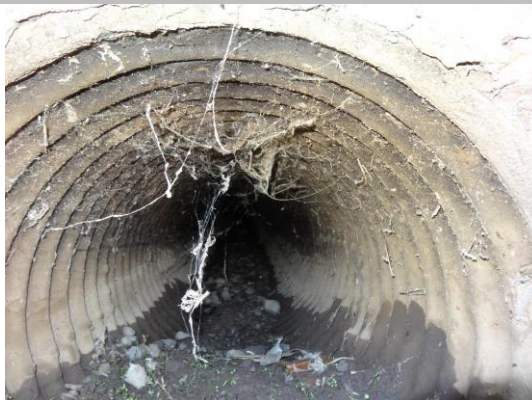
Photo 3 of 3 : UCIP_FA_2020_31856_58051.jpg

LS view: inside view of CMP on levee slope. Needs cleaning and clearing.

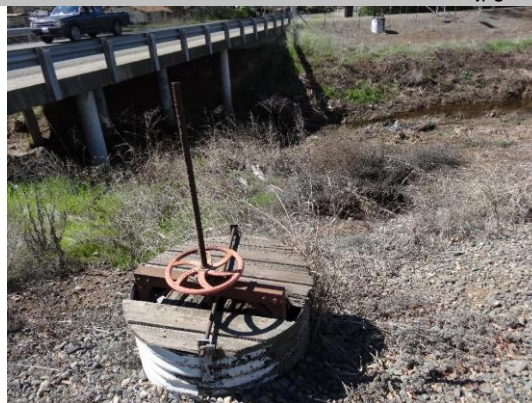
Photo 1 of 3 : UCIP_FA_2020_32025_58512.jpg

DS_ID:19280
 FS_ID:32025
 EP_NO: N/A
 Repair Type: Non-Urgent
 EVAL Issue:
 Crossing Status: Found
 UCIP Comments: Slide gate in a CMP riser. Vegetation debris and mud on inlet box. Needs cleaning and clearing the culvert.
 FIELD_STRUCT_DESC: 24-inch corrugated metal gravity drainage pipe through the levee and under the channel, 9.5 feet below the crown. Slide gate in a corrugated metal pipe (CMP) riser on the waterside (WS) slope. Concrete U-shaped headwall on the landside (LS) end.
 [Additional Reference(s): DWR Levee Log, 1992. USACE Sacramento O&M Manual 504, May 1965, (HLM 0.34)].
 FS Date: 3/7/2014

WS view: slide gate in CMP riser on waterside shoulder.

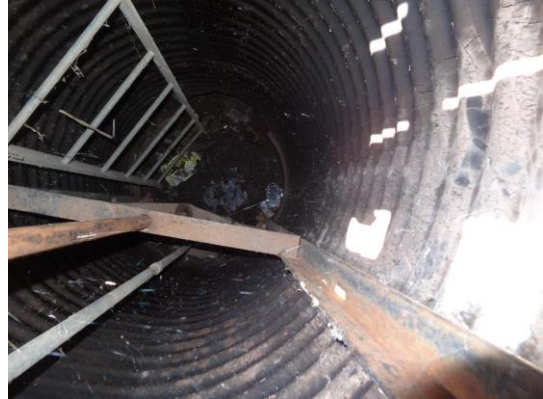
Photo 2 of 3 : UCIP_FA_2020_32025_58511.jpg

WS view: inside view of slide gate in CMP riser on waterside shoulder. Debris trapped in the riser.

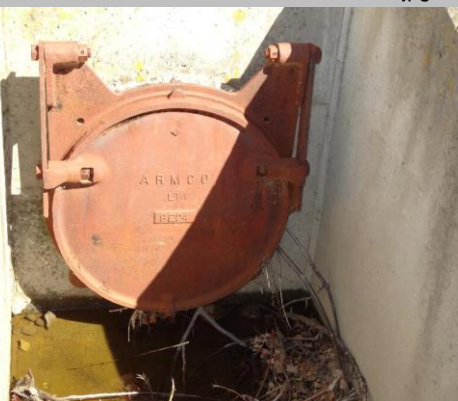
Photo 1 of 3 : UCIP_FA_2020_32023_58505.jpg

WS view: U type concrete headwall and CMP on levee slope. Vegetation debris and mud on outlet box. Needs cleaning and clearing.

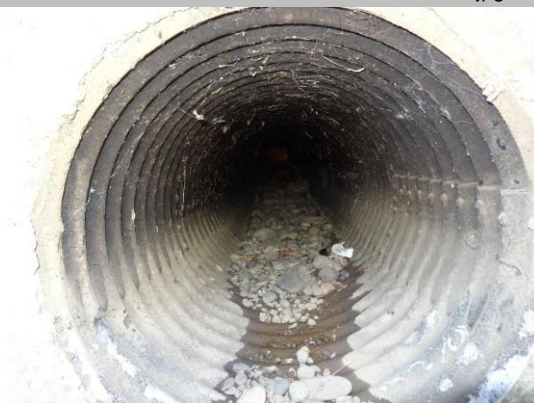
Photo 3 of 3 : UCIP_FA_2020_32023_58503.jpg

LS view: inside view of the CM pipe. Needs cleaning and clearing the pipe.

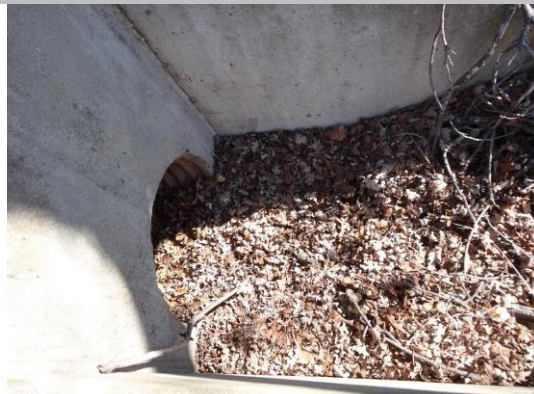
Photo 2 of 2 : UCIP_FA_2020_32143_58640.jpg

LS view: U type concrete headwall and CMP on levee slope. Vegetation and mud on inlet box.

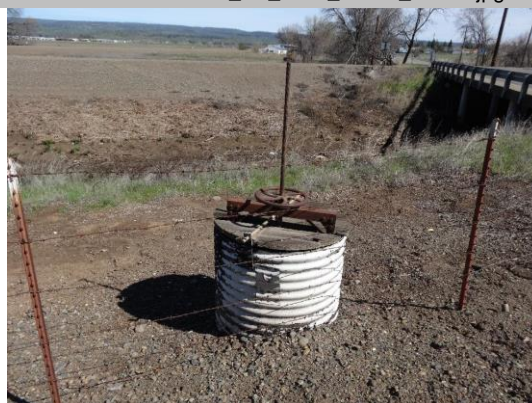
Photo 3 of 3 : UCIP_FA_2020_32144_58642.jpg

DS_ID:19288
 FS_ID:32144
 EP_NO: N/A
 Repair Type: Non-Urgent
 EVAL Issue:
 Crossing Status: Found
 UCIP Comments: Slide gate in CMP riser on waterside. No access to CMP riser. Needs cleaning and clearing the culvert.
 FIELD_STRUCT_DESC: 24-inch corrugated metal gravity drainage pipe through the levee and under the channel, 9.5 feet below the crown. Slide gate in a pipe riser on the waterside (WS) slope. Concrete U-shaped headwall on the landside (LS) end. [Additional Reference(s): DWR Levee Log, 1992. USACE Sacramento O&M Manual 504, May 1965, (HLM 0.98)].
 FS Date: 3/7/2014

WS view: slide gate in CMP riser on waterside. No access to CMP riser.

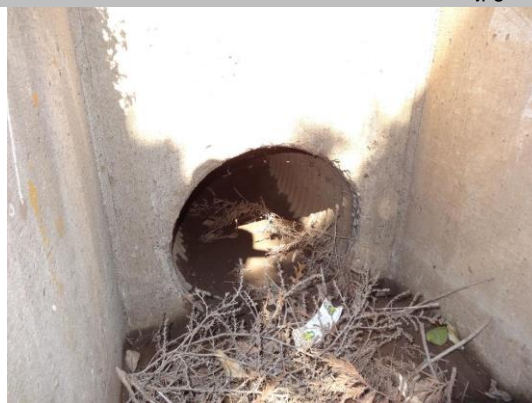
Photo 2 of 2 : UCIP_FA_2020_31964_58388.jpg

DS_ID:19290
 FS_ID:31964
 EP_NO: N/A
 Repair Type: Non-Urgent
 EVAL Issue:
 Crossing Status: Found
 UCIP Comments: Needs cleaning and clearing the culvert.
 FIELD_STRUCT_DESC: 24-inch corrugated metal gravity drainage pipe through the levee, 13 feet below the crown. Flap gate on the waterside (WS) end. Concrete U-shaped headwall on each end. Grouted riprap apron on the landside (LS) end. Grouted riprap spillway on the WS end. [Additional Reference(s): DWR Levee Log, 1992. USACE Sacramento O&M Manual 504, May 1965, (HLM 1.41)].
 FS Date: 3/7/2014

LS view: U type concrete headwall and CMP on levee slope. Vegetation debris and mud in inlet box.

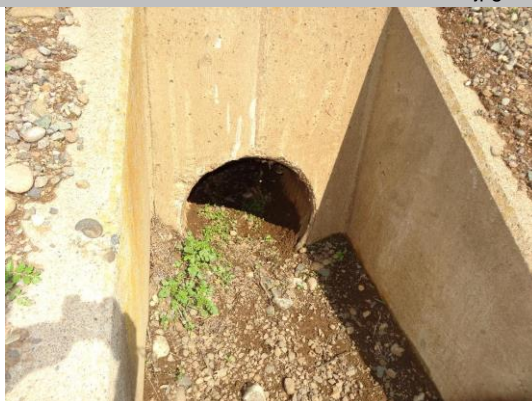
Photo 2 of 3 : UCIP_FA_2020_31965_58394.jpg

DS_ID:19291
 FS_ID:31965
 EP_NO: N/A
 Repair Type: Non-Urgent
 EVAL Issue:
 Crossing Status: Found
 UCIP Comments: Needs cleaning and clearing the culvert.
 FIELD_STRUCT_DESC: 24-inch corrugated metal gravity drainage pipe through the levee, 11 feet below the crown. Flap gate on the waterside (WS) end. Concrete U-shaped headwall on each end. Grouted riprap apron on the landside (LS) end. Grouted riprap spillway on the WS end. [Additional Reference(s): DWR Levee Log, 1992. USACE Sacramento O&M Manual 504, May 1965, (HLM 2.22)].
 FS Date: 3/7/2014

LS view: U type concrete headwall and CMP on levee slope. Vegetation debris and mud in inlet box.

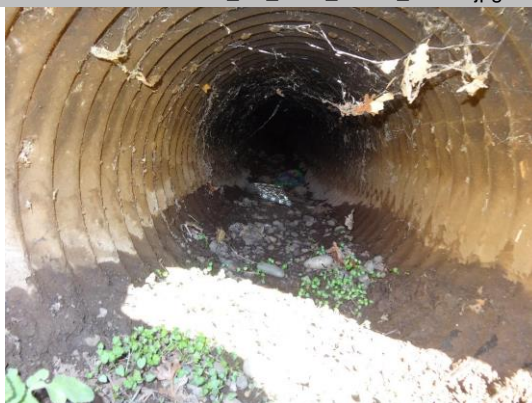
Photo 3 of 3 : UCIP_FA_2020_31965_58393.jpg

LS view: inside view of CMP on levee slope. Needs cleaning and clearing.
