**Flood Control Project Maintenance  
Levee Inspections**

**Fall 2012 Levee Maintenance Deficiency Summary Report**

**City of Sacramento**

**Levee Inspection Report By Mile - Fall 2012**

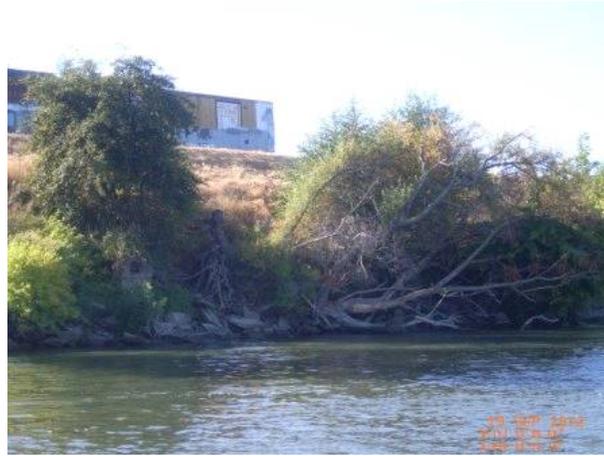
USACE 2012 Photo #2

Levee Mile Report Line	10
Start Levee Mile	1.32
End Levee Mile	1.39
Location	Water Side
Category	Supplemental
Item	USACE Erosion Survey
