**Flood Control Project Maintenance
Levee Inspections**

**Fall 2013 Levee Maintenance Deficiency Summary Report
Overall LMA & Unit Ratings, including USACE Erosion Survey**

**Flood Control Project Maintenance
Levee Inspections
LMA District Cover Sheet
Fall 2013 Levee Inspection Results**

City of Sacramento

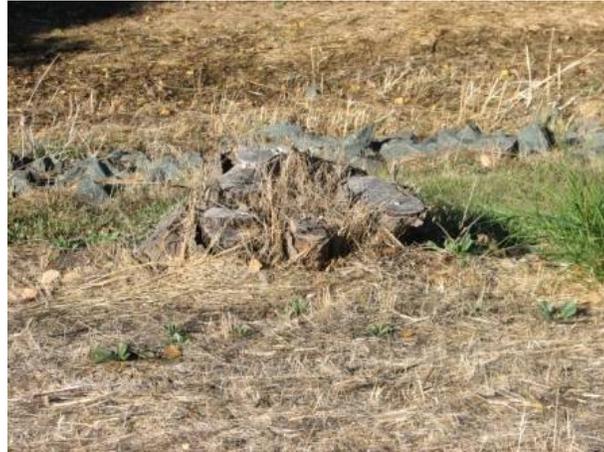
johngw_f_20130924_976.jpg

There are several tree stumps in this area. The district have been monitoring and spraying the stumps. Photo fall 2012.

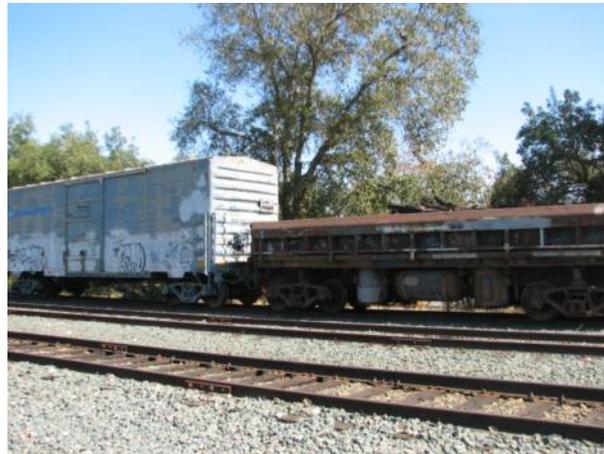
johngw_f_20131021_170.JPG

Levee Mile Report Line	43
Start Levee Mile	3.29
End Levee Mile	3.29
Location	Crown
Category	Earthen Levee
Item	Encroachments

Trains cars are stored on the crown of the levee. Fall 2013
