**Flood Control Project Maintenance  
Levee Inspections**

## Maintenance Issue Types Only, Levee Inspection Report By Mile - Fall 2021

### Knights Landing Ridge Drainage District

Waterway	Bank	Unit Miles	Inspection Start/End	Inspector
Unit No. 01 Knights Landing Ridge Cut	Right	6.36	09/07/2021 09/07/2021	Zach Jojola

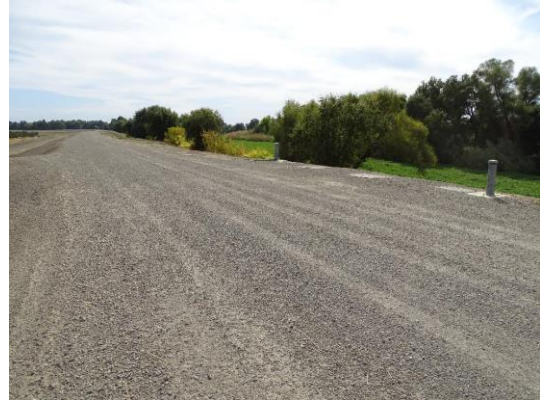
Photo 1 of 3 : UCIP\_FA\_2021\_55749\_82670.jpg

Comment Code						
Inspector Comment						
DS_ID:25571 FS_ID:55749 EP_NO: N/A Repair Type: No Action Needed EVAL Issue: Compliant Crossing Status: Found UCIP Comments: 10/08/2019 No issues recorded during inspection (O.Yakimov - DWR UCIP) FIELD_STRUCT_DESC: 16-inch steel discharge pipe through the levee, 3-feet below the crown. Pump house on pile structure in drainage ditch on the landward side. Siphon breaker and positive closure device butterfly valve with handwheel operator on the pipe on the waterward side. Pipe replaces a section of pipe through the levee butt welded to the original pipe approximately 35-feet from levee centerline on both levee slopes. Service pole on pump house (16-inch pipe authorized under Permit No. 9317-1, 2014, RD730, issued 07/10/2014, previous 16-inch pipe removed, see DSID 19374) FS Date: 10/8/2019 12:32:09 PM

View of levee crown at the crossing

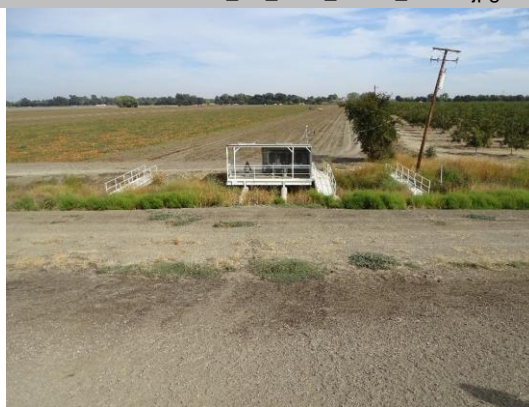
Photo 3 of 3 : UCIP\_FA\_2021\_55749\_82672.jpg

View of LS looking from levee crown

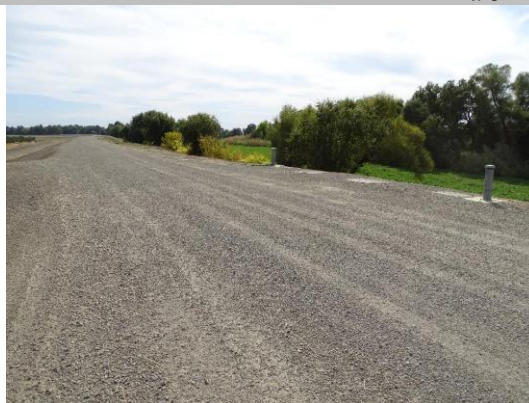
Photo 1 of 3 : UCIP\_FA\_2021\_54351\_82677.jpg

Comment Code					
Inspector Comment					
DS_ID:25572 FS_ID:54351 EP_NO: N/A Repair Type: No Action Needed EVAL Issue: Compliant Crossing Status: Found UCIP Comments: 10/08/2019 No issues recorded during inspection (O.Yakimov - DWR UCIP) FIELD_STRUCT_DESC: 24-inch steel discharge pipe through the levee, 6.5-feet below the crown. Pump house on pile structure in drainage ditch on the landward side. Siphon breaker and positive closure device butterfly valve with handwheel operator on the pipe on the waterward side. Pipe replaces a section of pipe through the levee butt welded to the original pipe approximately 37-feet from levee centerline on both levee slopes. Service pole on pump house. (Permit No. 9317-1, applicant - RD730, issued 07/10/2014 gives authorization of emergency removal and replacement of the pipe in September 2012.) FS Date: 10/8/2019

View of levee crown at the crossing

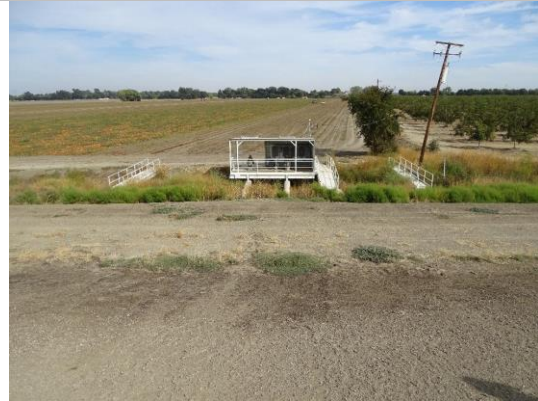
Photo 3 of 3 : UCIP\_FA\_2021\_54351\_82679.jpg

View of LS looking from levee crown

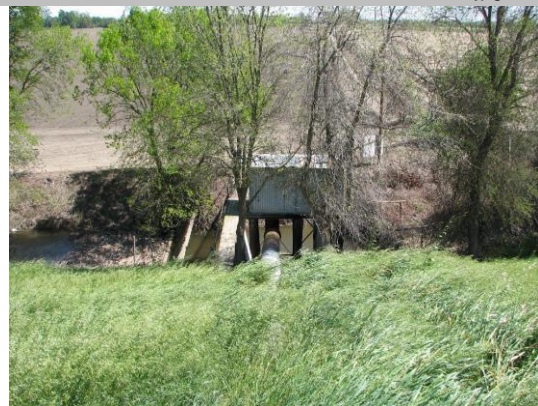
Photo 1 of 3 : UCIP\_FA\_2021\_11293\_18675.jpg

DS\_ID:19374  
 FS\_ID:11293  
 EP\_NO: 9317  
 Repair Type: No Action Needed  
 EVAL Issue:  
 Crossing Status: Found  
 UCIP Comments: 01/14/2019 Pipe has been replaved with a 16-inch pipe under permit 9317-1; new DS-ID 25571. (O.Yakimov - DWR UCIP)  
 FIELD\_STRUCT\_DESC: \*REMOVED\* 1 of 2: 16-inch steel discharge pipe through the levee, 3 feet below the crown. Pump house on pile structure in drainage ditch on the landside (LS). Siphon breaker on the pipe on the waterside (WS). Service pole at the pump house. (16-inch pipe [HLM 3.97] authorized under Automatic Board Order (ABO) issued as Permit No. 9317, 1974 - Reclamation District No. 819). [Additional Reference(s): DWR Levee Log, 1990. USACE Sacramento O&M Manual 127, June 1953, (Station 211+05) (15-inch pipe listed)].  
 FS Date: 4/9/2013

Pump on LS toe.

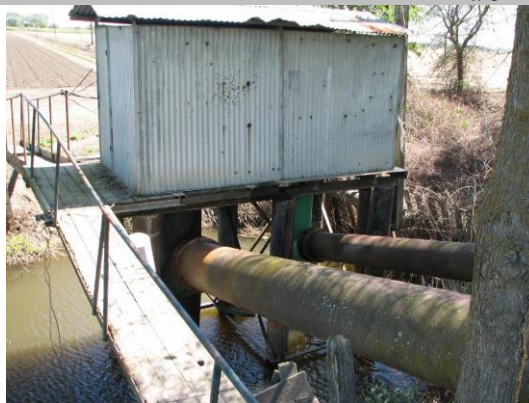
Photo 2 of 3 : UCIP\_FA\_2021\_11293\_18674.jpg

Pump and pipes on LS toe.

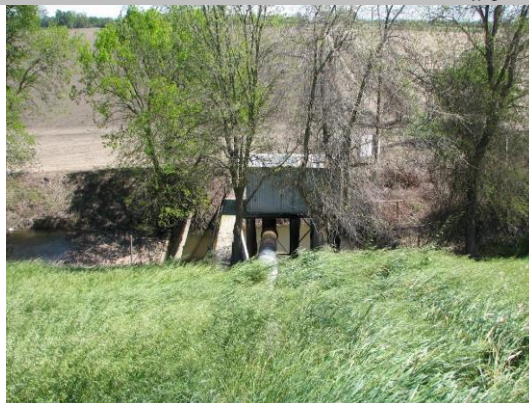
Photo 1 of 3 : UCIP\_FA\_2021\_11291\_18669.jpg

Comment Code						
Inspector Comment						
DS_ID:19401 FS_ID:11291 EP_NO: 9317 Repair Type: No Action Needed EVAL Issue: Crossing Status: Found UCIP Comments: 01/14/2019 Pipe was removed replaced with a new 24-inch pipe through the levee. Permit 9317-1 issues authorization of emergency removal and replacement of the pipe in September 2012. New DS-ID 25572. (O.Yakimov - DWR UCIP) FIELD_STRUCT_DESC: *REMOVED* 2 of 2: 24-inch steel discharge pipe through the levee, 9 feet below the crown. Pump house on pile structure in drainage ditch on the landside (LS). Siphon breaker on the pipe on the waterside (WS) with a butterfly shutoff valve. Service pole at the pump house. (Permit No. 9317, 1974 - Reclamation District No. 819). Pipe replaced in 2012. [Additional Reference(s): DWR Levee Log, 1990. USACE Sacramento O&M Manual 127, June 1953, (Station 210+99)]. FS Date: 4/9/2013

Pumphouse at LS toe.
