**Flood Control Project Maintenance  
Levee Inspections**

## Maintenance Issue Types Only, Levee Inspection Report By Mile - Fall 2024

### Knights Landing Ridge Drainage District

Waterway	Bank	Unit Miles	Inspection Start/End	Inspector
Unit No. 01 Knights Landing Ridge Cut	Right	6.36	09/23/2024 09/23/2024	Zach Jojola

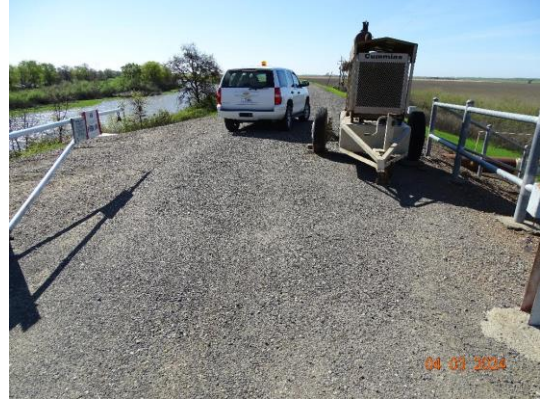
Photo 1 of 3 : UCIP\_FA\_2024\_83884\_123285.jpg

Comment Code					
Inspector Comment					
DS_ID:19365 FS_ID:83884 EP_NO: 9301 Repair Type: No Action Needed EVAL Issue: Crossing Status: Found UCIP Comments: 04/03/2024 Record updated from Non-Urgent to No Action Needed. No issues observed during inspection. (O. Yakimov - DWR UCIP) 10/8/2019 Record updated from No Action Needed to Non-Urgent. Need to have CVFPB review ABO and determine current owner. (O.Yakimov - DWR UCIP) FIELD_STRUCT_DESC: 1 of 2: 18-inch steel drainage pipe through the levee, 6.4 feet below the crown. Siphon breaker on the waterside (WS) slope. Pump house mounted on concrete box in irrigation ditch at the landside (LS) toe. (18-inch and 24-inch pipes [HLM 2.70] authorized under Automatic Board Order (ABO) issued as Permit No. 9301, 1974 - Reclamation District No. 730). [Additional Reference(s): DWR Levee Log, 1990 (HLM 2.70). USACE Sacramento O&M Manual, Unit 127, June 1953, Revised 23 November 2021, (Station 128+00), listed as 18-inch pipe. USACE As-Built Drawing No. 50-04-2848, 3 March 1953, Sheet 3, STA 128+00]. FS Date: 4/3/2024 1:51:40 PM

Top of Levee: View of levee crown looking downstream

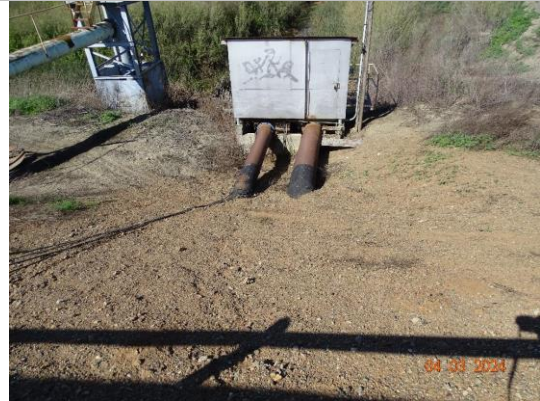
Photo 3 of 3 : UCIP\_FA\_2024\_83884\_123284.jpg

Land-Side: View of levee slope looking from crown. Pumping structure in drainage ditch at levee toe

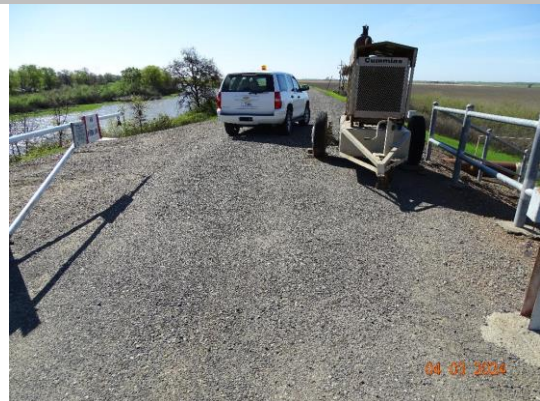
Photo 1 of 3 : UCIP\_FA\_2024\_83885\_123291.jpg

DS\_ID:19392  
FS\_ID:83885  
EP\_NO: 9301  
Repair Type: No Action Needed  
EVAL Issue:  
Crossing Status: Found  
UCIP Comments: 04/03/2024 Record updated from Non-Urgent to No Action Needed. No issues observed during inspection. (O. Yakimov - DWR UCIP)  
10/8/2019 Record updated from No Action Needed to Non-Urgent. Need to have CVFPB review ABO and determine current owner. (O.Yakimov - DWR UCIP)  
FIELD\_STRUCT\_DESC: 2 of 2: 24-inch steel drainage pipe through the levee, 7.3 feet below the crown. Pump house mounted on concrete box in irrigation ditch at the landside (LS) toe. Siphon breaker in riser on the waterside (WS) slope. (24-inch and 18-inch pipes [HLM 2.70] authorized under Automatic Board Order (ABO) issued as Permit No. 9301, 1974 - Reclamation District No. 730). [Additional Reference(s): DWR Levee Log, 1990 (HLM 2.70). USACE Sacramento O&M Manual, Unit 127, June 1953, Revised 23 November 2021, (Station 128+00), listed as 24-inch pipe. USACE As-Built Drawing No. 50-04-2848, 3 March 1953, Sheet 3, STA 128+00].

Top of Levee: View of levee crown looking downstream

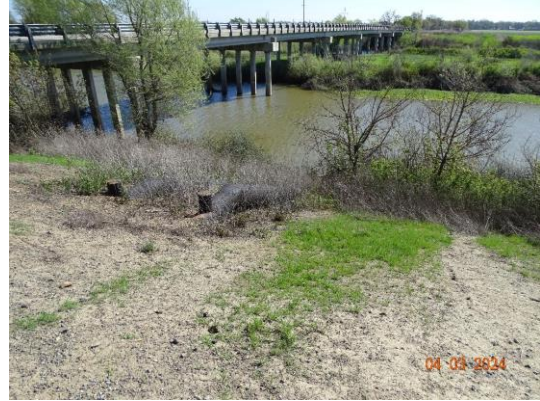
Photo 2 of 3 : UCIP\_FA\_2024\_83885\_123289.jpg

Water-Side: View of levee slope looking from crown. Pipes daylight on the slope

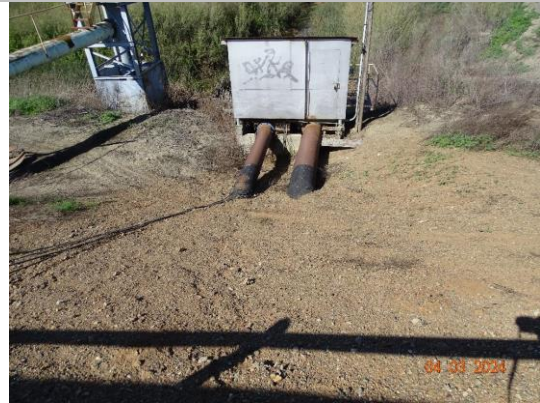
Photo 3 of 3 : UCIP\_FA\_2024\_83885\_123290.jpg

Land-Side: View of levee slope looking from crown. Pumping structure in drainage ditch at levee toe

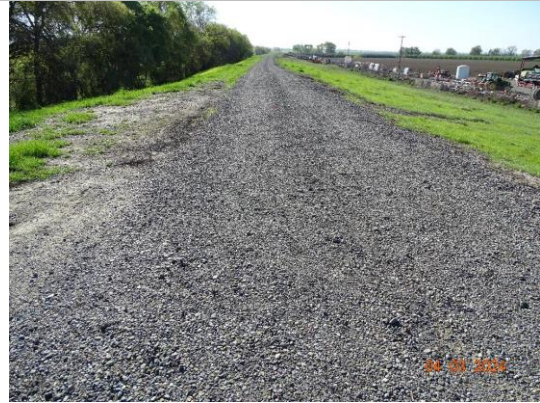
Photo 1 of 3 : UCIP\_FA\_2024\_84641\_123370.jpg

Comment Code					
Inspector Comment					
DS_ID:19389 FS_ID:84641 EP_NO: N/A Repair Type: Non-Urgent EVAL Issue: Crossing Status: Not Found UCIP Comments: 08/19/2024 Coordinates of this cross were updated after review of O&M Manual and As-Built drawings. (O. Yakimov - DWR UCIP) 04/03/2024 Record remains Non-Urgent. Crossing not found. Geophysical results did not confirm presence of pipe through levee. Record will remain in UCIP's inspection records until future Levee Improvement Project can confirm no crossing was found through the levee. (O. Yakimov - DWR UCIP) 0/8/2019 Record updated from No Action Needed to Non-Urgent. Crossing not found. (O.Yakimov - DWR UCIP) FIELD_STRUCT_DESC: 48-inch corrugated metal drainage pipe partially through the levee, approximately 4 feet below the crown. Pipe crossing waterside slope and partially goes through levee crown according to as-built drawings. [Additional Reference(s): USACE Sacramento O&M Manual, Unit 127, June 1953, Revised 23 November 2021, (Station 323+00), listed as 48-inch pipe not going entirely through levee. USACE As-Built Drawing No. 50-04-2848, 3 March 1953, Sheet 5, STA 323+00]. FS Date: 4/3/2024 3:03:22 PM

Top of Levee: View of levee crown looking downstream

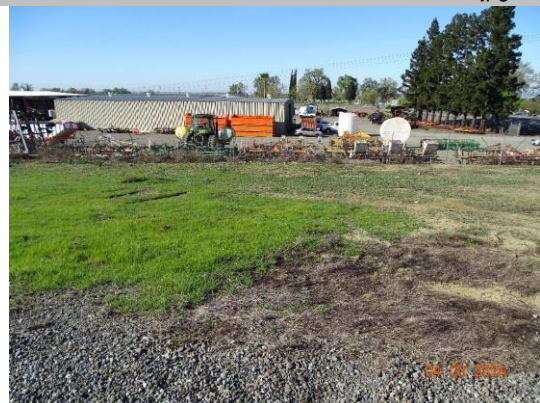
Photo 2 of 3 : UCIP\_FA\_2024\_84641\_123371.jpg

Land-Side: View of levee slope looking from crown

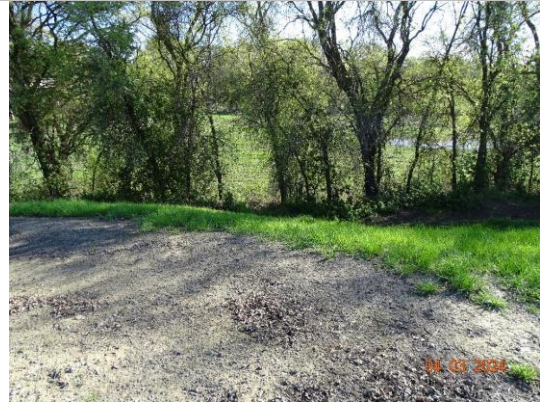
Photo 3 of 3 : UCIP\_FA\_2024\_84641\_123372.jpg

Water-Side: View of levee slope looking from crown

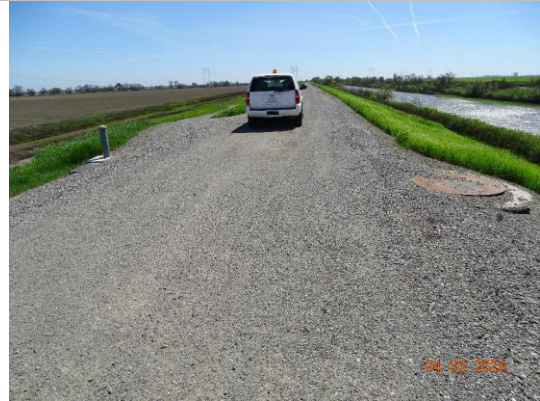
Photo 1 of 3 : UCIP\_FA\_2024\_83912\_123414.jpg

Comment Code					
Inspector Comment					
DS_ID:25471 FS_ID:83912 EP_NO: N/A Repair Type: Non-Urgent EVAL Issue: Crossing Status: Found UCIP Comments: 04/03/2024 Record remains Non-Urgent. Requested CVFPB to evaluate this crossing for a possibility to issue a separate permit. No other issues observed during inspection. (O. Yakimov - DWR UCIP) 10/08/2019 Record remains Non-Urgent. Encroachment permit is missing. No details provided from Levee Improvement Project. (O. Yakimov - DWR UCIP) 09/27/2017 Previous 12-inch pipe (see DSID 19371) was replaced with new 18-inch steel pipe as part of the Knights Landing 2015 Levee Repair Project. No integrity issues were recorded by DWR levee inspector Zachary Jojola. Inspector located the concrete headwall, flap gate, and manual operator for the 12-inch pipe. No as-builts have been received to confirm the details of the new pipe or the abandoned structures allowed to remain from the previous structure. UCIP staff will need to follow-up with LMA to obtain as-built records and authorizing permit. (DWR UCIP - O. Magana) 09/01/2016 - pipe was replaced as part of the knights landing 2015 levee repair project. UCIP has requested the As-builts from the LMA and will update the record when those are received. (T. Hatch/UCIP) FIELD_STRUCT_DESC: 1 of 2: 18-inch steel drainage pipe through the levee, at an unknown depth. Pump in a metal pumphouse on the landside (LS) toe in a drainage canal. Diesel generator on concrete pad at LS toe with wired connection to electrical panel at the same location. Electrical conduit buried on LS berm to the pumphouse. Concrete headwall on the waterside (WS) toe. Flap gate on the WS at the headwall. Manhole labeled storm drain at the WS shoulder, air vent on LS shoulder. This crossing replaces 12-inch pipe (see DSID 19371). (Replacement of pump station discharge lines as a part of Levee Improvement Project authorized under Permit No. 18905, 2014 - Knights Landing Ridge Drainage District, 18-inch pipe installed). FS Date: 4/3/2024 10:35:21 AM

Top of Levee: View of levee crown looking downstream

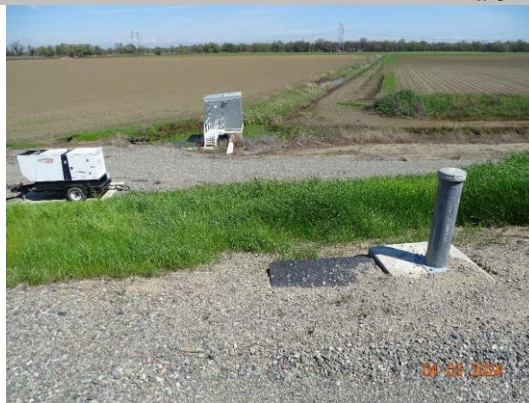
Photo 2 of 3 : UCIP\_FA\_2024\_83912\_123410.jpg

Land-Side: View of levee slope looking from crown. Pump house in drainage ditch off levee toe

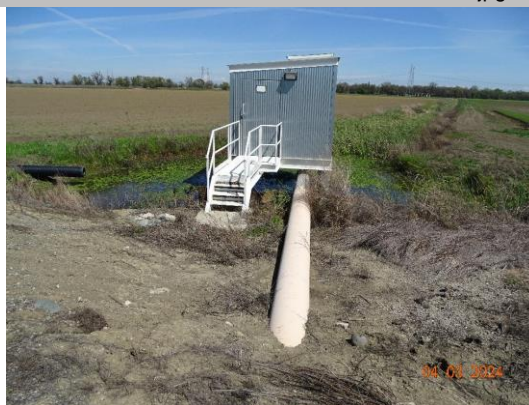
Photo 3 of 3 : UCIP\_FA\_2024\_83912\_123411.jpg

Land-Side: View of a pump house in drainage ditch off levee toe

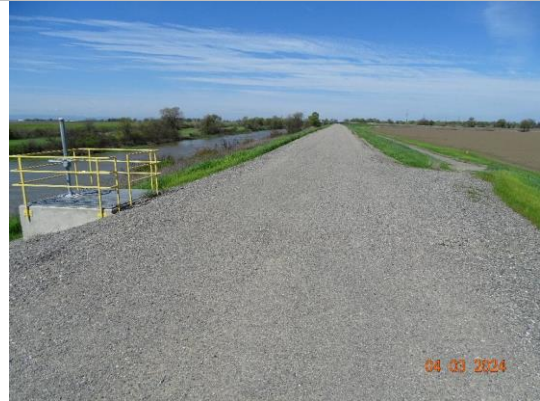
Photo 1 of 3 : UCIP\_FA\_2024\_79242\_123417.jpg

Comment Code						
Inspector Comment						
DS_ID:25597						
FS_ID:79242						
EP_NO: N/A						
Repair Type: No Action Needed						
EVAL Issue:						
Crossing Status: Found						
UCIP Comments: 04/03/2024 Record is No Action Needed. No issues observed during inspection. (O. Yakimov - DWR UCIP)						
FIELD_STRUCT_DESC: 2 of 2: 24-inch steel drainage pipe through the levee, 18.5 feet below the crown. Concrete box with slide gate on WS shoulder. Flap gate on the waterside (WS) end. Open on the landside (LS) end. LS toe cobble revetted. This crossing replaces 24-inch pipe (see DSID 19399). (24-inch pipe authorized under Permit No. 18905-1, 2019 - Knights Landing Ridge Drainage District).						
FS Date: 4/3/2024

Top of Levee: View of levee crown looking upstream

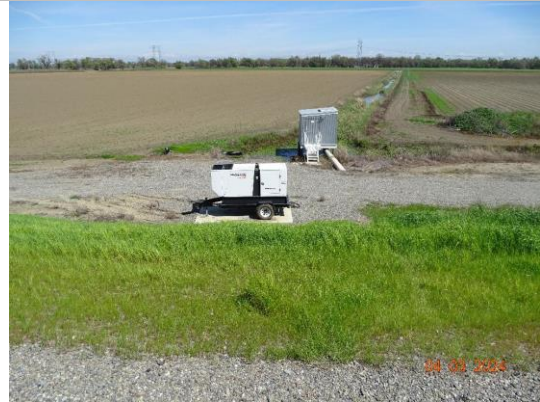
Photo 2 of 3 : UCIP\_FA\_2024\_79242\_123418.jpg

Land-Side: View of levee slope looking from crown. Drainage ditch off levee toe

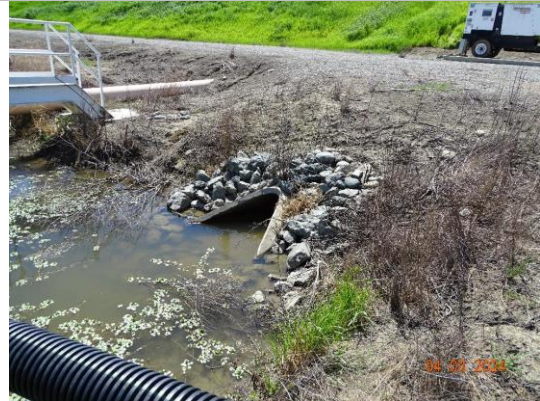
Photo 3 of 3 : UCIP\_FA\_2024\_79242\_123421.jpg

Land-Side: Pipe inlet in drainage ditch off levee toe
