**Flood Control Project Maintenance  
Levee Inspections**

**Fall 2011 Levee Maintenance Deficiency Summary Report**

**Overall LMA & Unit Ratings, including DWR Erosion Survey**

**San Joaquin River Basin**

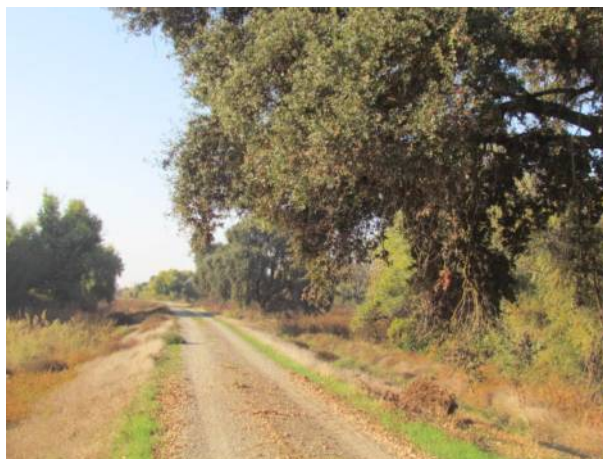
richard\_f\_20111114\_396.jpg

Looking south at tree limbs over roadway.

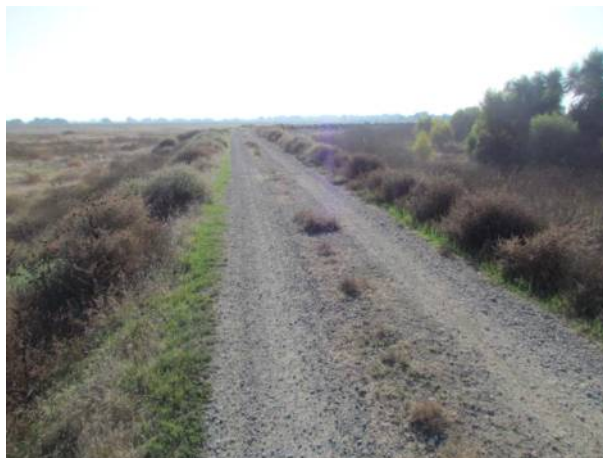
richard\_f\_20111114\_397.jpg

Levee Mile Report Line	5
Start Levee Mile	0.66
End Levee Mile	2.52
Location	Water Side
Category	Earthen Levee
Item	Vegetation

Looking south at typical view of vegetation on waterside and landside slopes.

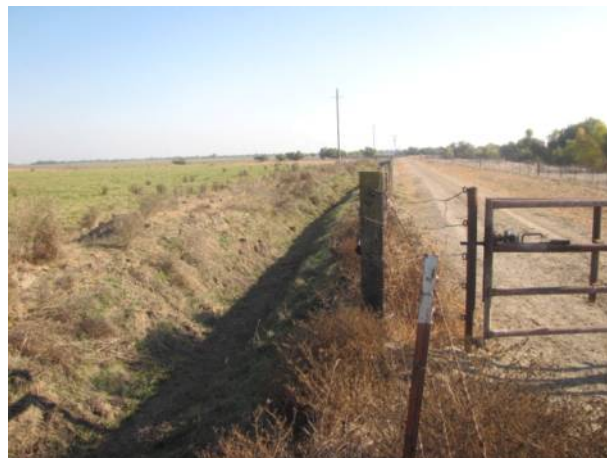
richard\_f\_20110922\_113.jpg

Looking south at irrigation ditch along landside toe.

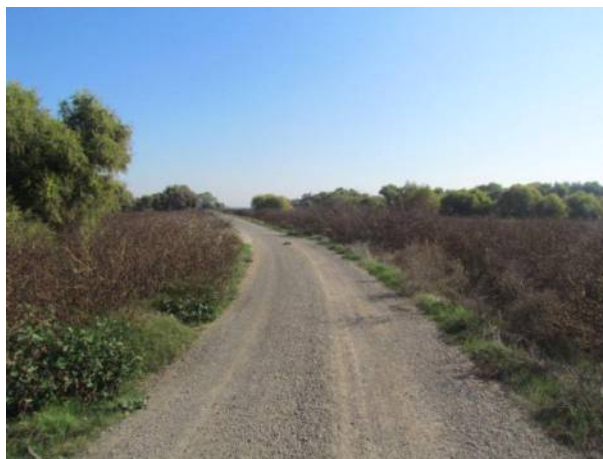
richard\_f\_20111114\_398.jpg

Looking south at dense vegetation on waterside and landside slopes.

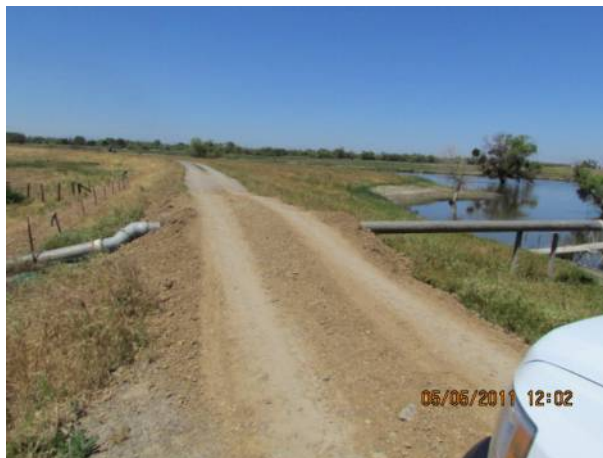
richard\_f\_20110922\_115.jpg

Levee Mile Report Line	16
Start Levee Mile	19.33
End Levee Mile	19.33
Location	Crown
Category	Earthen Levee
Item	Encroachments

Looking north at unauthorized pipe across crown of levee with a ramp.

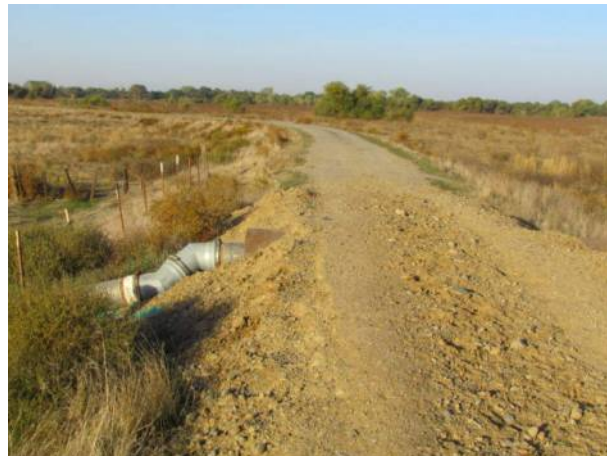
richard\_f\_20111114\_399.jpg

Looking south at unauthorized pipe across levee and ramp.

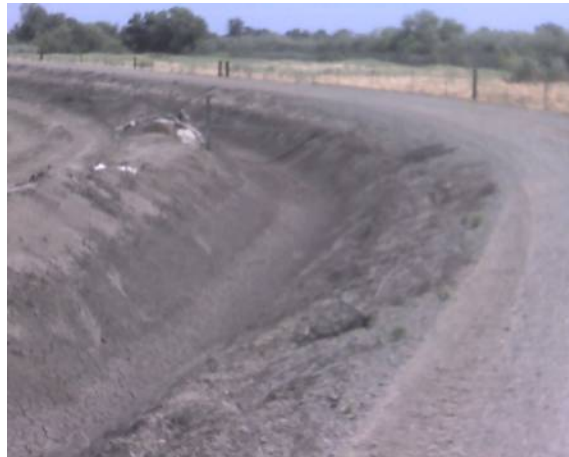
richard\_f\_20110922\_119.jpg

Looking southeast at ditch along landside toe.

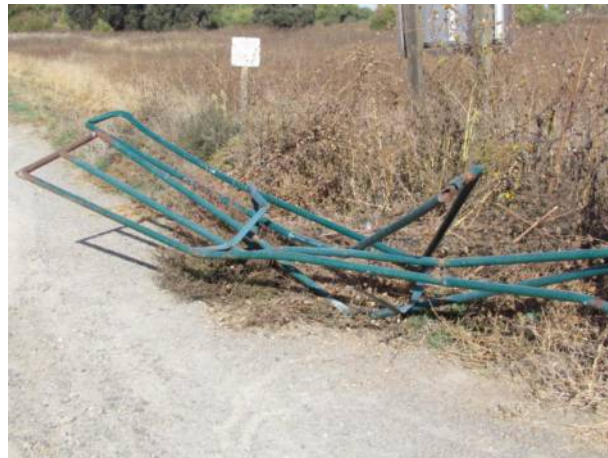
richard\_f\_20111114\_444.jpg

Levee Mile Report Line	2
Start Levee Mile	2.30
End Levee Mile	2.30
Location	Crown
Category	Earthen Levee
Item	Repair Gates

Looking at damaged gate.

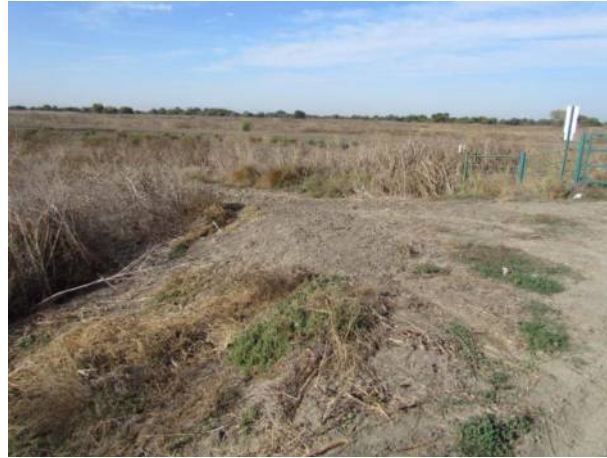
richard\_f\_20111114\_442.jpg

Looking northwest at unauthorized ramp on landside slope.

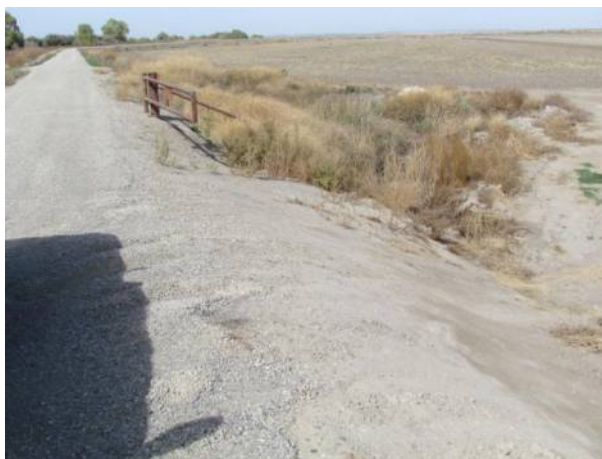
richard\_f\_20111114\_434.jpg

Looking southwest at levee damage cause by vehicle traffic on landside slope.

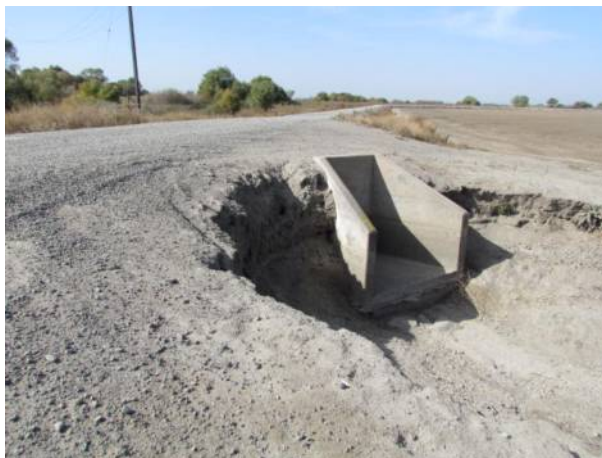
richard\_f\_20111114\_435.jpg

Levee Mile Report Line	3
Start Levee Mile	2.06
End Levee Mile	2.06
Location	Land Side
Category	Earthen Levee
Item	Erosion / Bank Caving

Looking northeast at erosion around pipe outlet on landside slope.

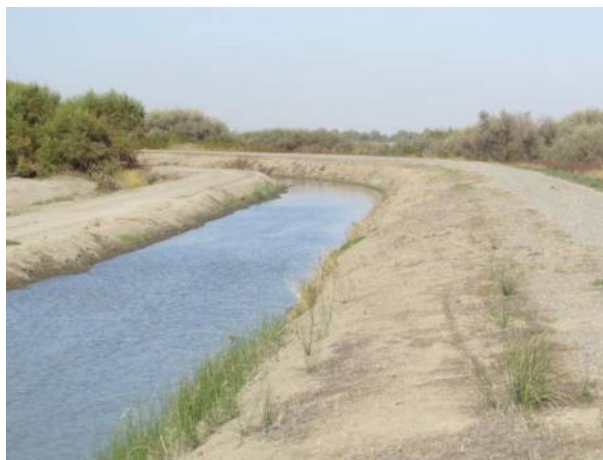
richard\_f\_20111114\_437.jpg

Looking northeast at irrigation canal along landside toe.

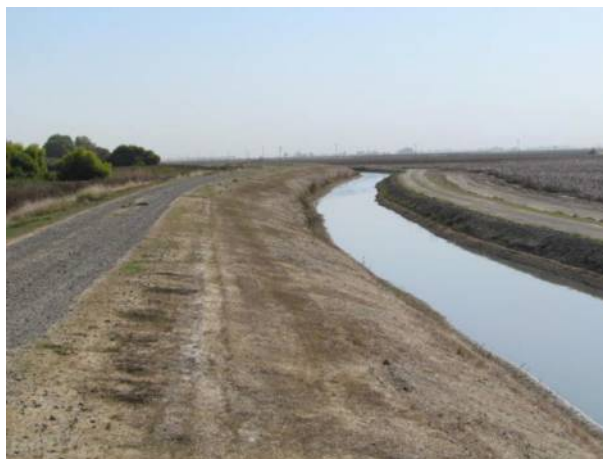
richard\_f\_20111114\_438.jpg

Levee Mile Report Line	1
Start Levee Mile	0.32
End Levee Mile	1.49
Location	Crown
Category	Earthen Levee
Item	Encroachments

Looking north at irrigation canal along landside toe.

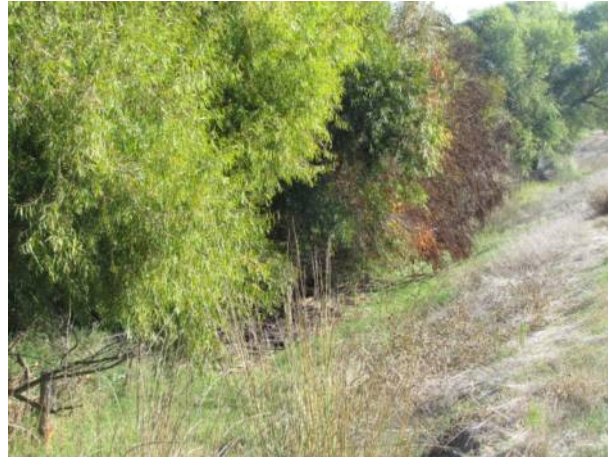
richard\_f\_20111114\_400.jpg

Looking south at dense trees on landside slope.

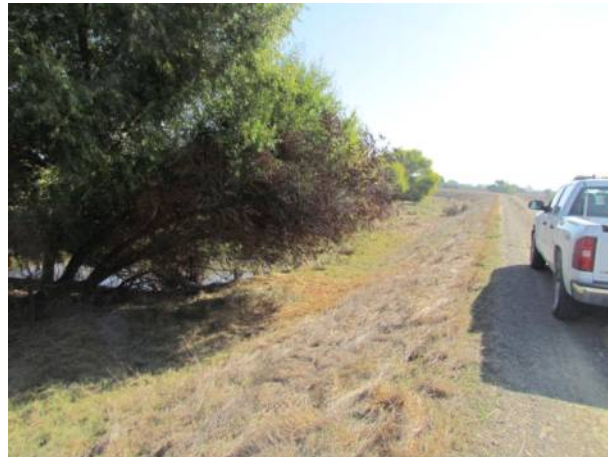
richard\_f\_20111114\_401.jpg

Levee Mile Report Line	2
Start Levee Mile	3.32
End Levee Mile	3.32
Location	Land Side
Category	Earthen Levee
Item	Trim / Thin Trees

Looking south at trees on landside toe

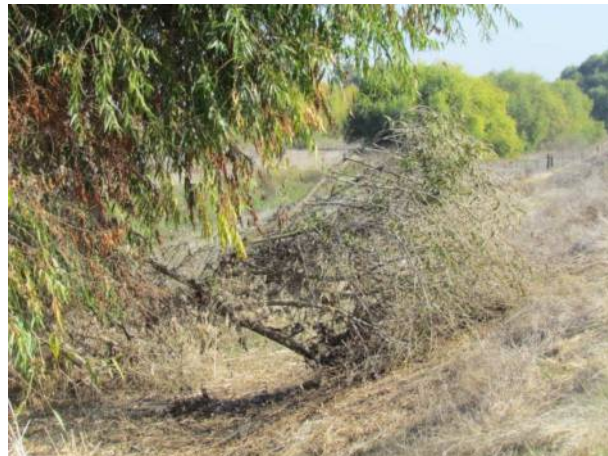
richard\_f\_20111114\_402.jpg

Levee Mile Report Line	3
Start Levee Mile	3.54
End Levee Mile	3.54
Location	Land Side
Category	Earthen Levee
Item	Encroachments

Looking south at downed tree limb on landside toe.

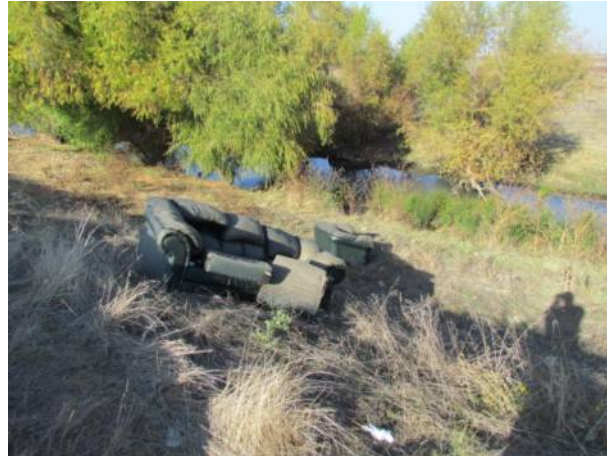
richard\_f\_20111114\_403.jpg

Looking southwest at garbage on landside slope.

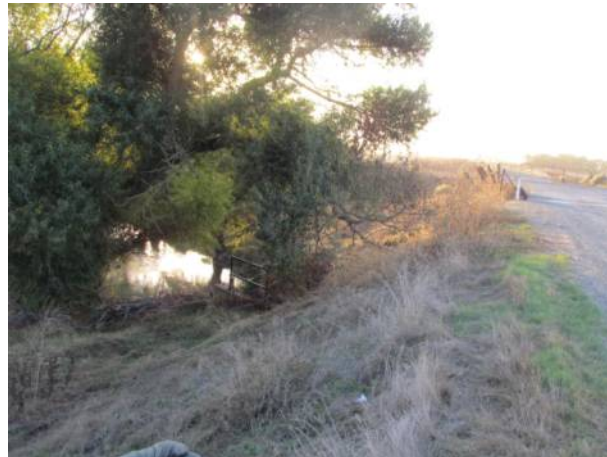
richard\_f\_20111114\_404.jpg

Levee Mile Report Line	11
Start Levee Mile	11.49
End Levee Mile	11.49
Location	Land Side
Category	Earthen Levee
Item	Trim / Thin Trees

Looking south at downed tree limb on landside slope and toe.

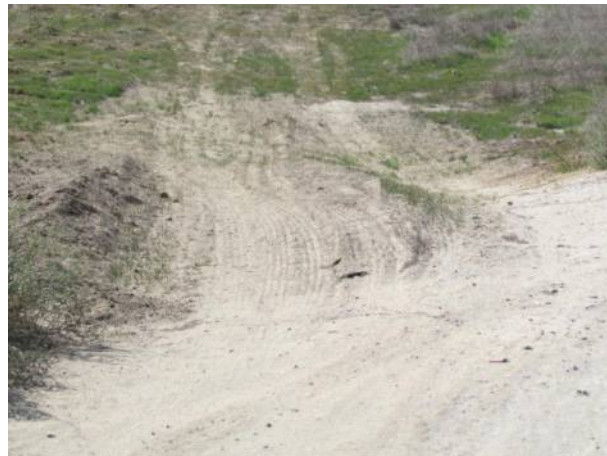
richard\_f\_20111114\_405.jpg

Levee Mile Report Line	14
Start Levee Mile	34.50
End Levee Mile	34.50
Location	Water Side
Category	Earthen Levee
Item	Encroachments

Looking south at unauthorized ramp on landside slope.

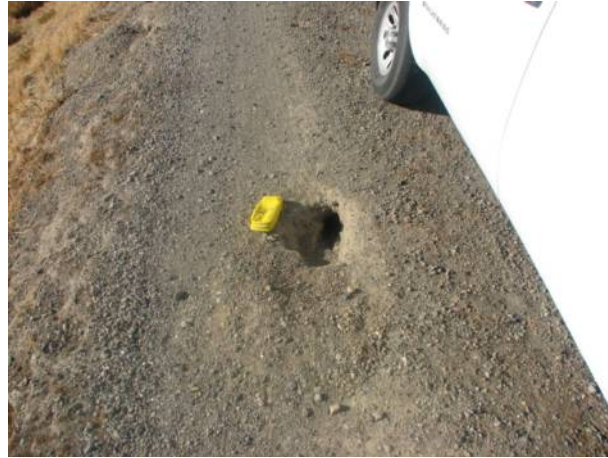
richard\_f\_20110922\_124.jpg

Looking at squirrel hole on crown of levee.

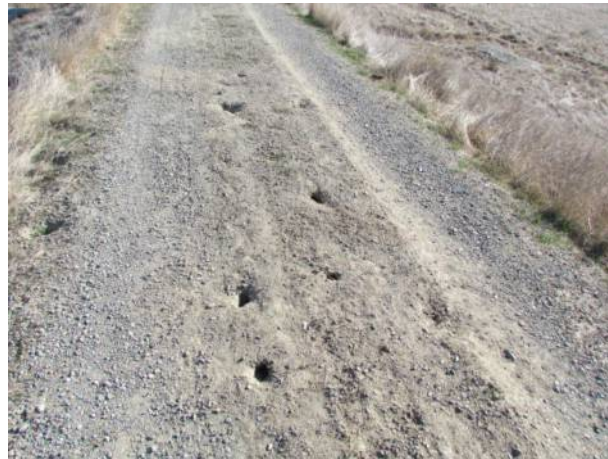
richard\_f\_20111114\_432.jpg

Levee Mile Report Line	1
Start Levee Mile	4.67
End Levee Mile	4.67
Location	Crown
Category	Earthen Levee
Item	Animal Control

Looking north at several rodent holes on levee crown.

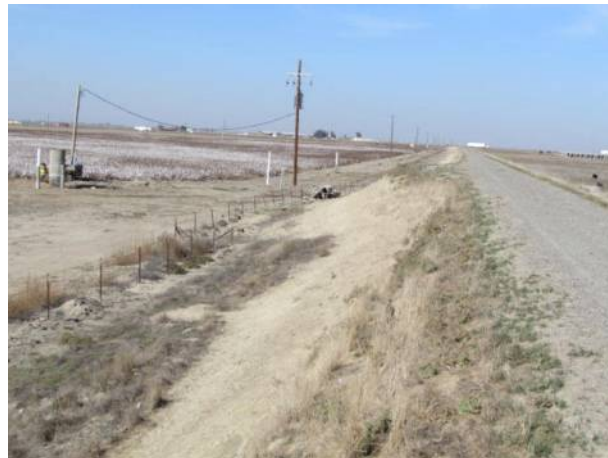
richard\_f\_20111114\_430.jpg

Levee Mile Report Line	10
Start Levee Mile	24.50
End Levee Mile	24.93
Location	Land Side
Category	Earthen Levee
Item	Slope Stability

Looking north at livestock traffic along landside slope.

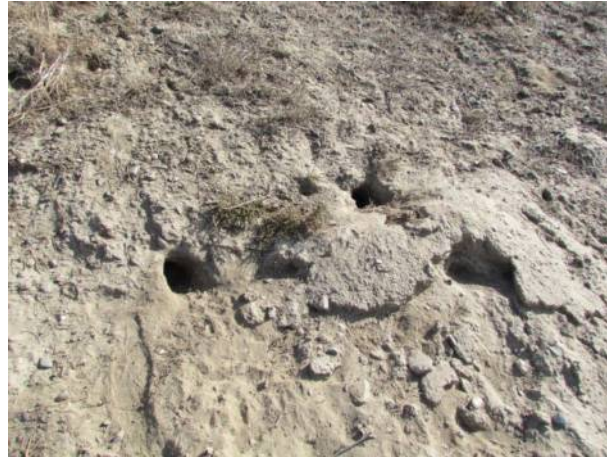
richard\_f\_20111114\_427.jpg

Looking at typical rodent holes on landside slope.

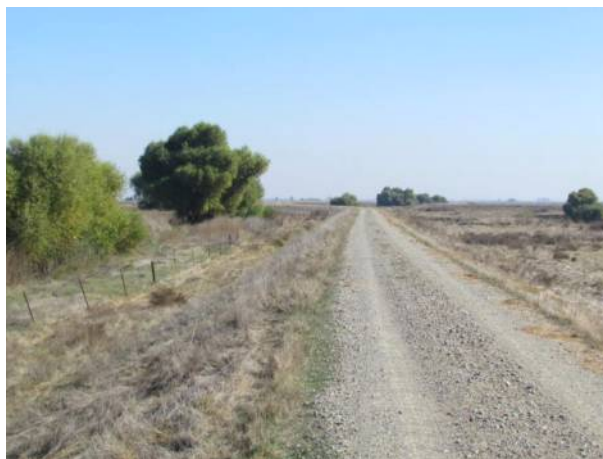
richard\_f\_20111107\_380.jpg

Levee Mile Report Line	2
Start Levee Mile	0.78
End Levee Mile	3.62
Location	Land Side
Category	Earthen Levee
Item	Vegetation

Looking east at typical view of landside slope.

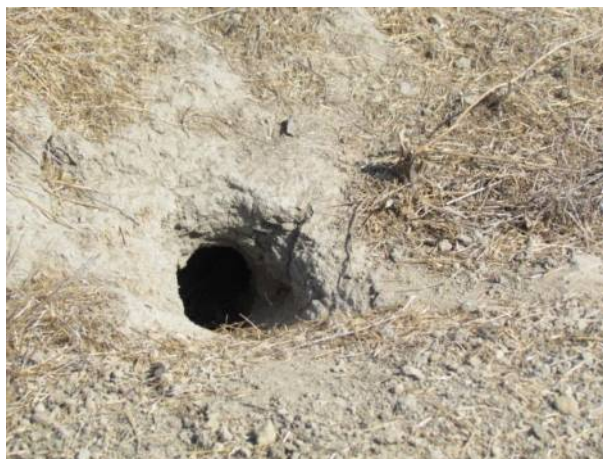
richard\_f\_20111107\_384.jpg

Levee Mile Report Line	4
Start Levee Mile	2.12
End Levee Mile	2.12
Location	Land Side
Category	Earthen Levee
Item	Animal Control

Looking at typical view of rodent holes on landside slope and toe.

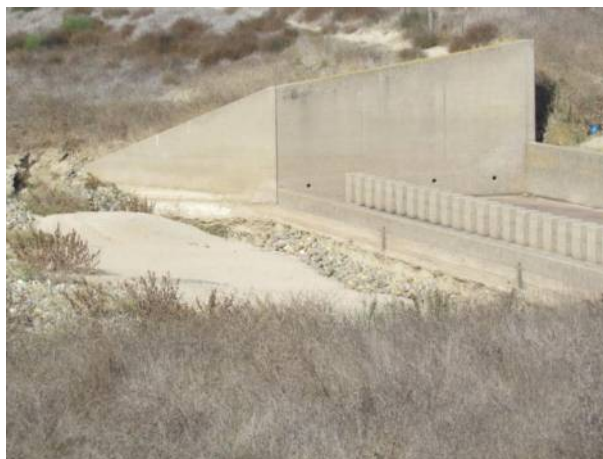
richard\_f\_20111107\_389.jpg

Levee Mile Report Line	3
Start Levee Mile	0.08
End Levee Mile	0.08
Location	Water Side
Category	Channels
Item	Concrete Foundations

Looking at erosion on downstream side of structure.

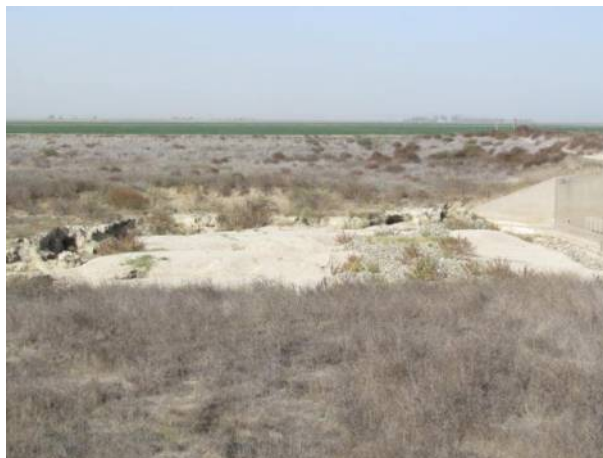
richard\_f\_20111107\_390.jpg

Levee Mile Report Line	3
Start Levee Mile	0.08
End Levee Mile	0.08
Location	Water Side
Category	Channels
Item	Concrete Foundations

Looking south at erosion at and near structure in the channel.

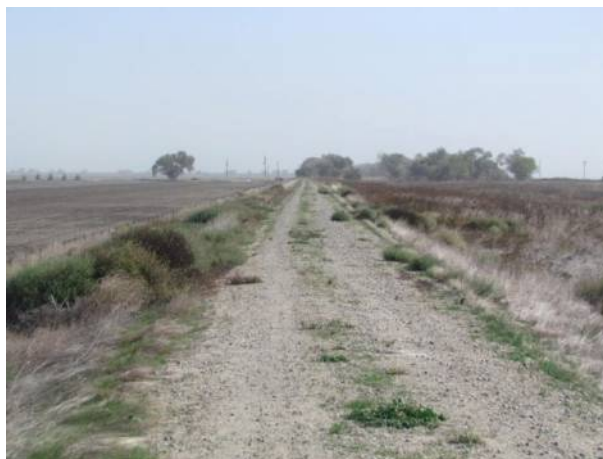
richard\_f\_20111107\_392.jpg

Levee Mile Report Line	2
Start Levee Mile	1.52
End Levee Mile	1.99
Location	Water Side
Category	Earthen Levee
Item	Vegetation

Looking at dense vegetation on landside and waterside slope.

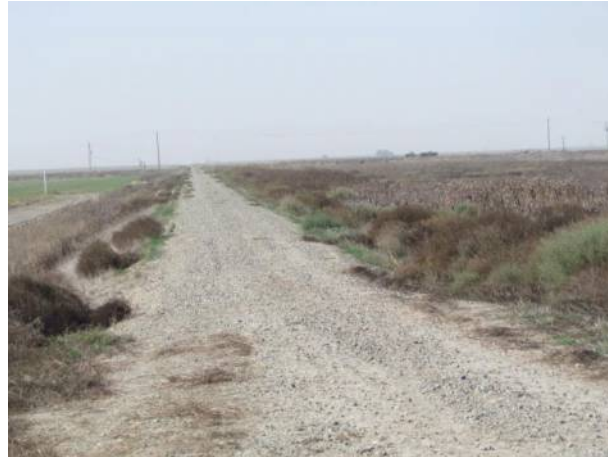
richard\_f\_20111107\_393.jpg

Looking at dense tumble weeds on landside and waterside slope.

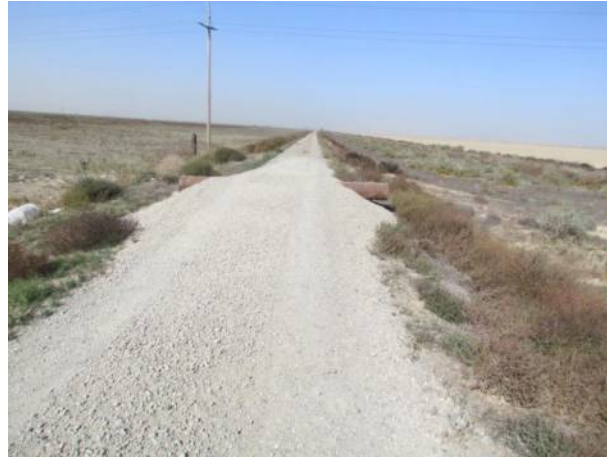
richard\_f\_20111114\_413.jpg

Looking south at unauthorized pipe across levee crown.

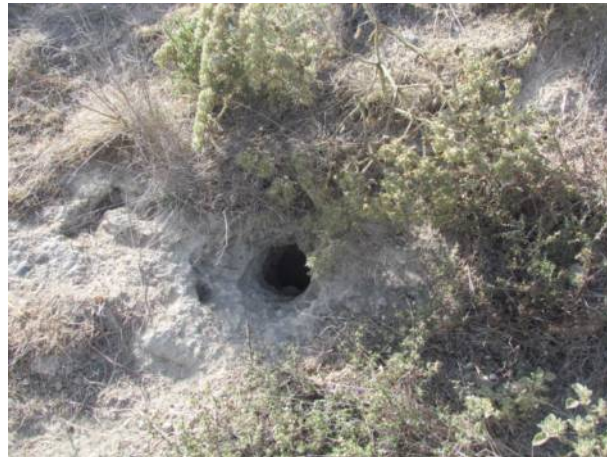
richard\_f\_20111114\_414.jpg

Levee Mile Report Line	2
Start Levee Mile	6.51
End Levee Mile	6.60
Location	Land Side
Category	Earthen Levee
Item	Animal Control

Looking west at typical rodent holes on landside slope.

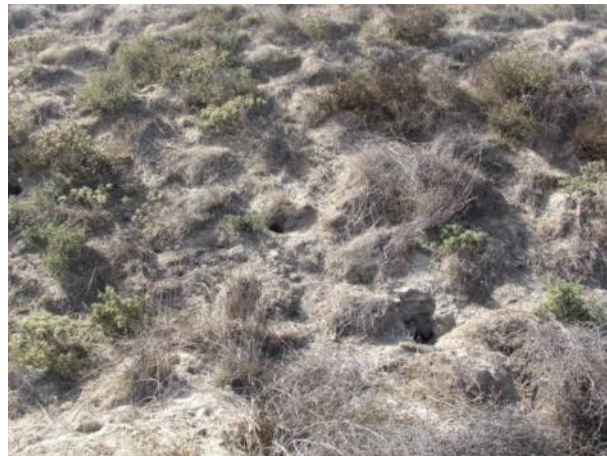
richard\_f\_20111114\_415.jpg

Looking west at typical view of rodent holes on landside slope.

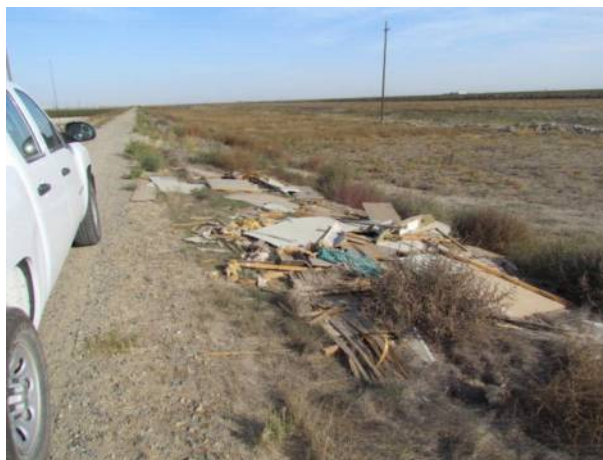
richard\_f\_20111114\_426.jpg

Looking northeast at garbage on waterside slope.

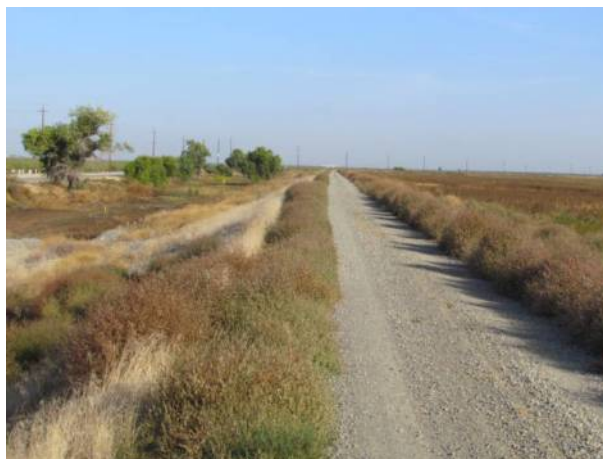
richard\_f\_20111114\_425.jpg

Levee Mile Report Line	3
Start Levee Mile	11.86
End Levee Mile	13.15
Location	Land Side
Category	Earthen Levee
Item	Vegetation

Looking north at tumble weed along landside and waterside shoulders.

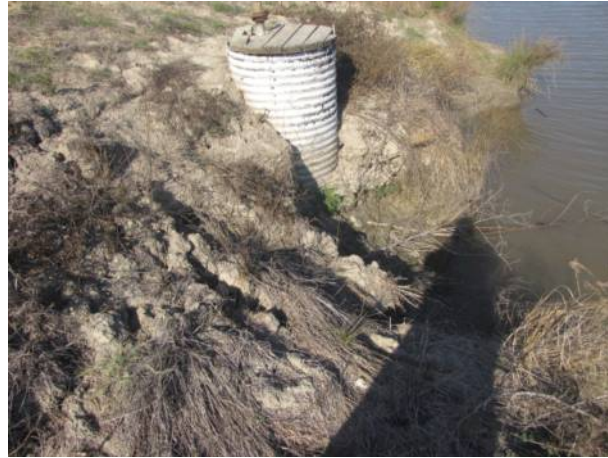
richard\_f\_20110922\_133.jpg

Looking downstream at erosion around screw gate can on waterside slope.

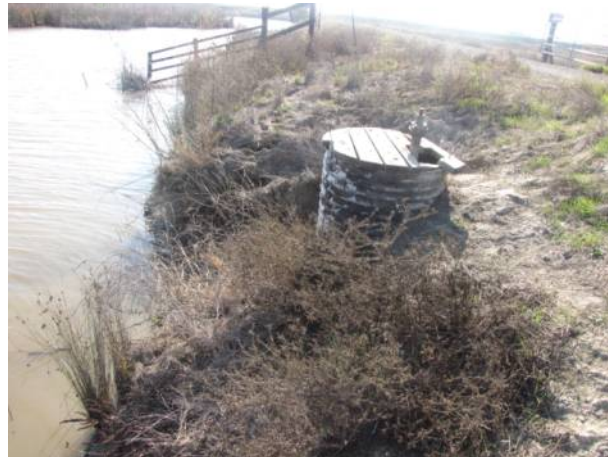
richard\_f\_20110922\_134.jpg

Levee Mile Report Line	1
Start Levee Mile	0.10
End Levee Mile	0.10
Location	Water Side
Category	Earthen Levee
Item	Erosion / Bank Caving

Looking upstream at erosion around screw gate can.

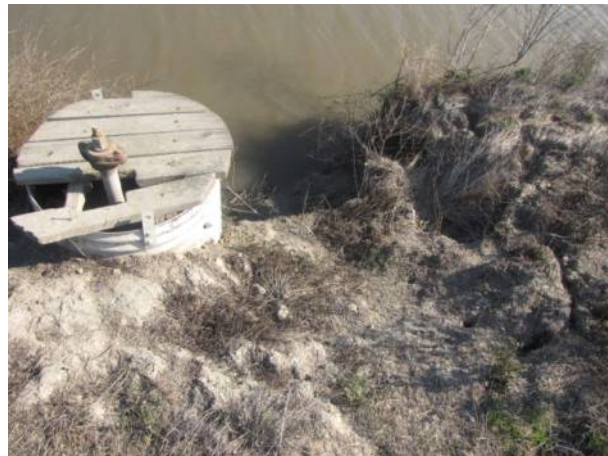
richard\_f\_20110922\_135.jpg

Levee Mile Report Line	1
Start Levee Mile	0.10
End Levee Mile	0.10
Location	Water Side
Category	Earthen Levee
Item	Erosion / Bank Caving

Looking at erosion near and around screw gate can.

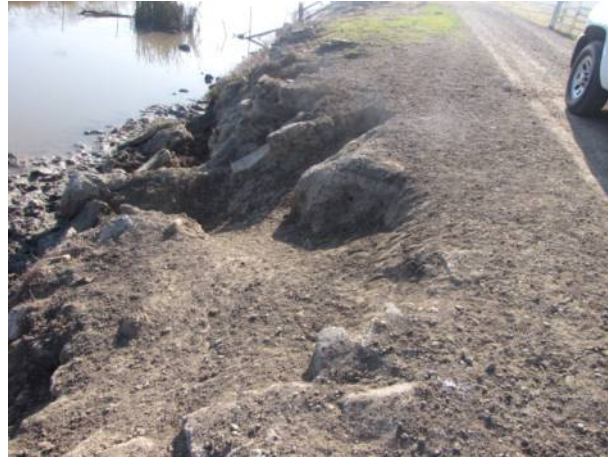
richard\_f\_20110922\_125.jpg

Looking upstream at one of several slope stability along canal.

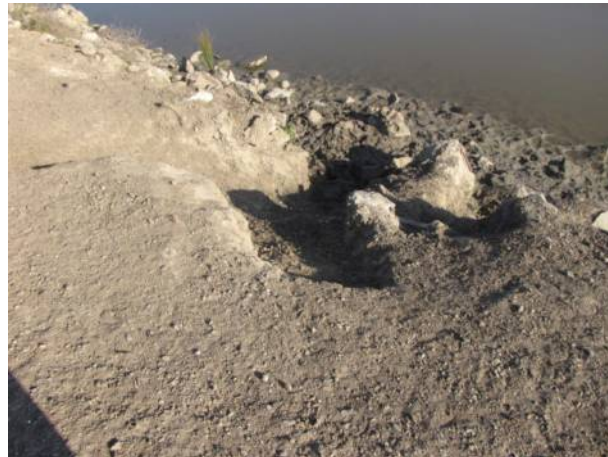
richard\_f\_20110922\_126.jpg

Levee Mile Report Line	4
Start Levee Mile	3.65
End Levee Mile	3.65
Location	Water Side
Category	Earthen Levee
Item	Animal Control

Looking at one of several slope stability along canal.

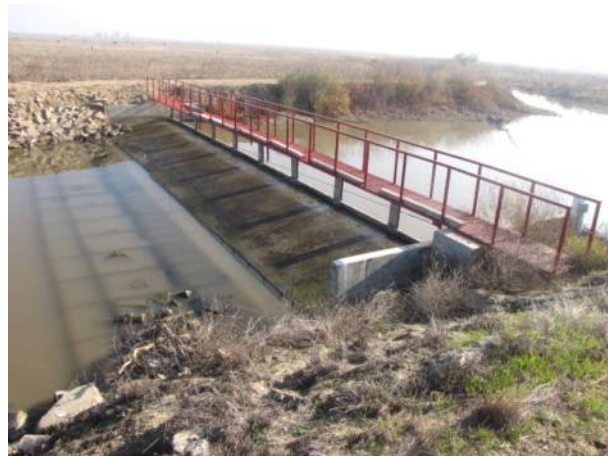
richard\_f\_20110922\_130.jpg

5	3.85	3.85	Channels	Encroachments	WS	M	Inspector Comments: Stevenson Irrigation District constructed a concrete weir across channel without a permit. Still waiting for permit.	37.255568 ° -120.720551 °	37.255568 ° -120.720551 °	4 Y
6	4.68	4.68	Channels	Encroachments	WS	M	Inspector Comments: Old wooden bridge in channel should be removed.	37.264250 ° -120.731280 °	37.264250 ° -120.731280 °	3 Y
7	4.80	4.86	Earthen Levee	Animal Control	WS	M	Repair the levee slope damaged by livestock and prevent large animal access. Inspector Comments: Erosion caused by livestock on waterside toe.	37.265180 ° -120.732745 °	37.265743 ° -120.733602 °	5 Y
8	4.81	4.84	Earthen Levee	Crown Surface / Depressions / Rutting	CR	M	Add appropriate gravel or road base. Grade and compact.	37.265330 ° -120.732960 °	37.265705 ° -120.733553 °	10
9	5.07	5.10	Earthen Levee	Crown Surface / Depressions / Rutting	CR	M	Regrade the crown roadway for proper drainage. Inspector Comments: Minor rutting on levee crown.	37.267682 ° -120.736597 °	37.267967 ° -120.736913 °	9 Y

Levee Mile Report Line	5
Start Levee Mile	3.85
End Levee Mile	3.85
Location	Water Side
Category	Channels
Item	Encroachments

Looking northeast at weir in channel.

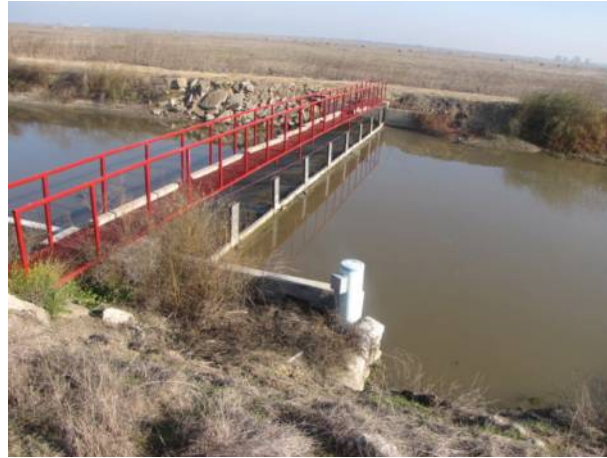
richard\_f\_20110922\_131.jpg

Looking at upstream side of weir.

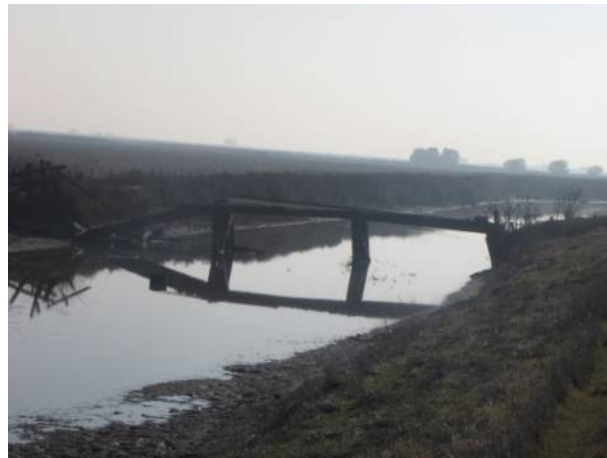
richard\_f\_20110922\_127.jpg

Looking downstream at dilapidated bridge in channel.

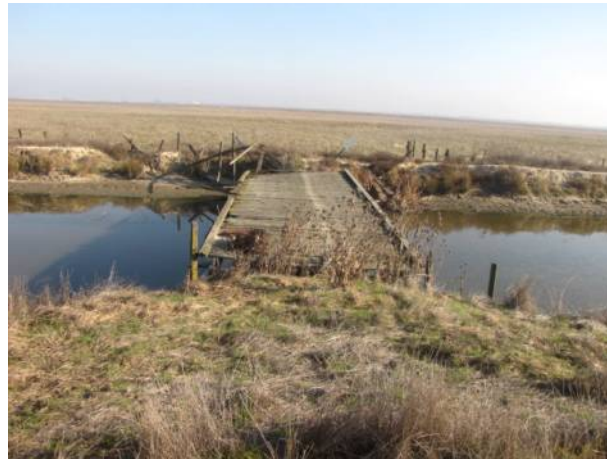
richard\_f\_20110922\_128.jpg

Looking southeast at dilapidated bridge in channel.

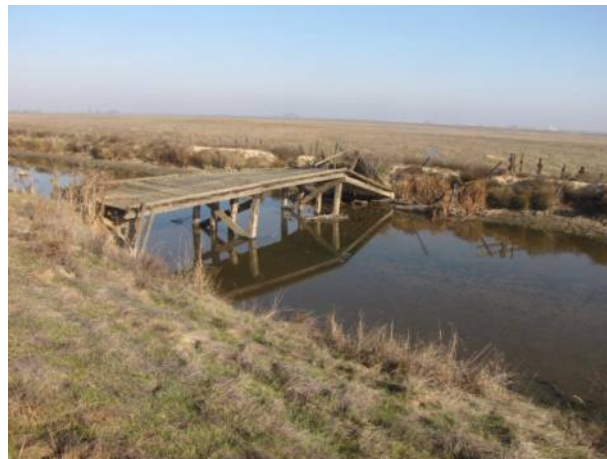
richard\_f\_20110922\_129.jpg

Levee Mile Report Line	6
Start Levee Mile	4.68
End Levee Mile	4.68
Location	Water Side
Category	Channels
Item	Encroachments

Looking northeast at dilapidated bridge in channel.

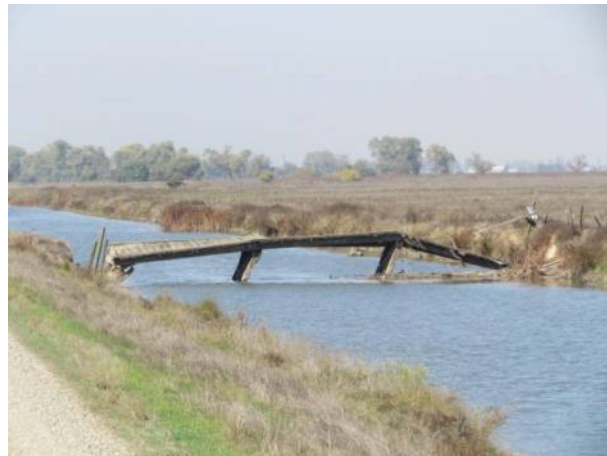
richard\_f\_20111114\_406.jpg

Levee Mile Report Line	6
Start Levee Mile	4.68
End Levee Mile	4.68
Location	Water Side
Category	Channels
Item	Encroachments

Looking north at dilapidated bridge in canal.

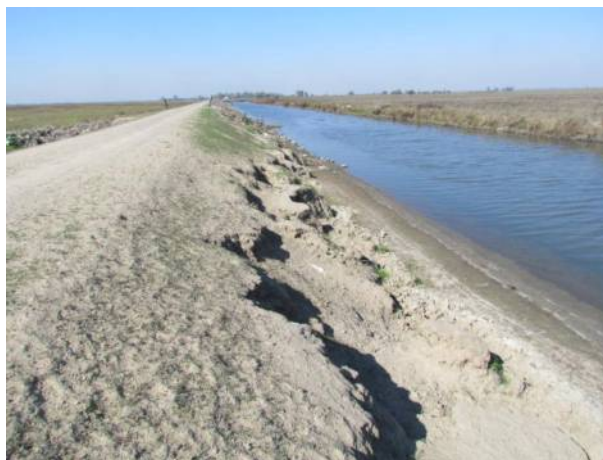
richard\_f\_20111114\_407.jpg

Looking north at erosion on waterward slope caused by livestock.

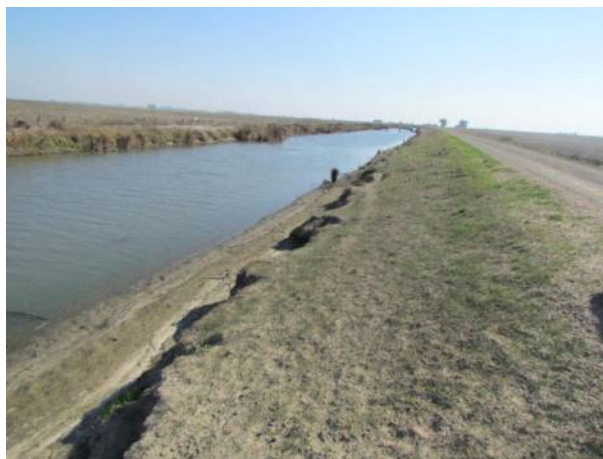
richard\_f\_20111114\_408.jpg

Levee Mile Report Line	7
Start Levee Mile	4.80
End Levee Mile	4.86
Location	Water Side
Category	Earthen Levee
Item	Animal Control

Looking southwest at erosion on waterward toe caused by livestock.

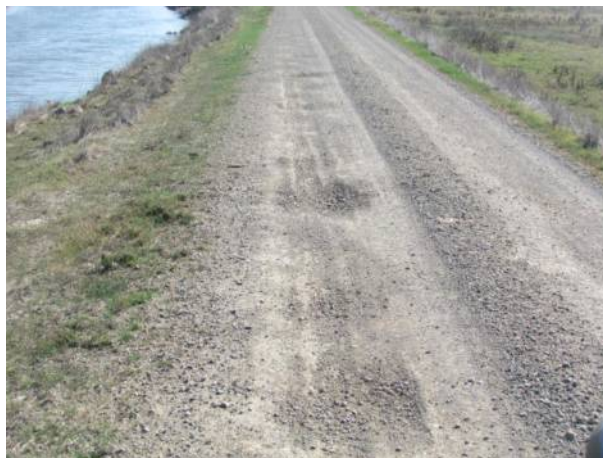
richard\_f\_20111114\_410.jpg

Levee Mile Report Line	9
Start Levee Mile	5.07
End Levee Mile	5.10
Location	Crown
Category	Earthen Levee
Item	Crown Surface / Depressions / Rutting

Looking south at rutting on levee crown.

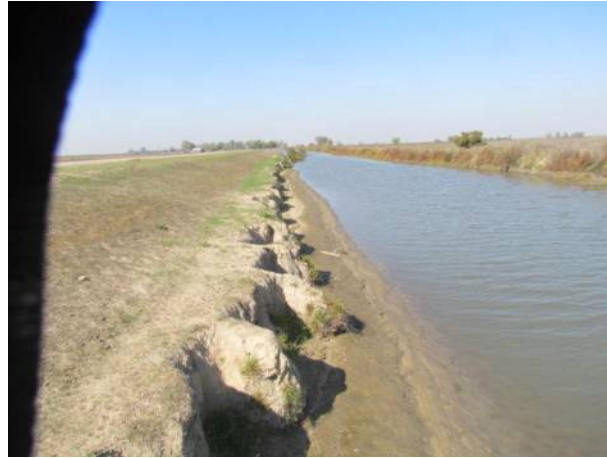
richard\_f\_20111114\_409.jpg

Looking north at erosion caused by livestock.

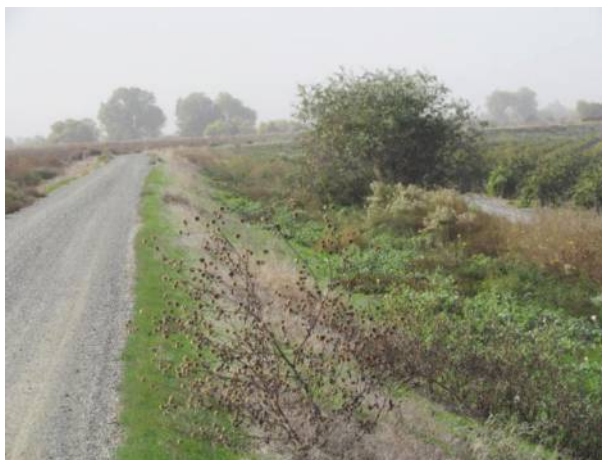
richard\_f\_20111114\_421.jpg

Looking south wild roses on landside toe.

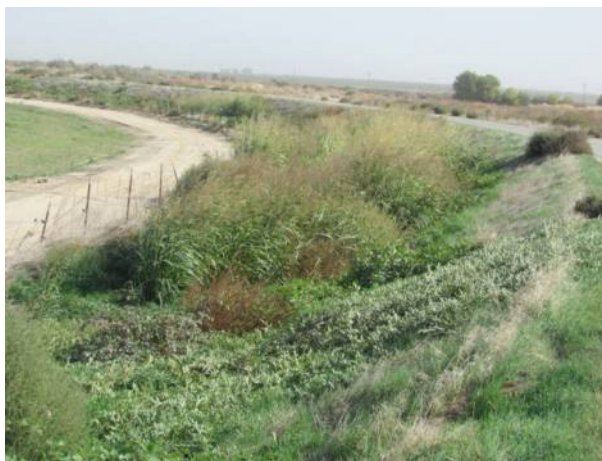
richard\_f\_20111114\_422.jpg

Levee Mile Report Line	2
Start Levee Mile	1.56
End Levee Mile	1.75
Location	Land Side
Category	Earthen Levee
Item	Vegetation

Looking south at Johnson grass along landside toe.

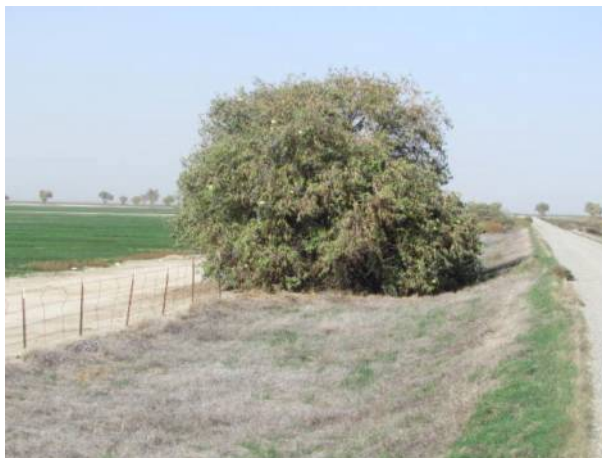
richard\_f\_20111114\_423.jpg

Levee Mile Report Line	3
Start Levee Mile	3.30
End Levee Mile	3.30
Location	Land Side
Category	Earthen Levee
Item	Vegetation

Looking south at elderberry on landside toe.

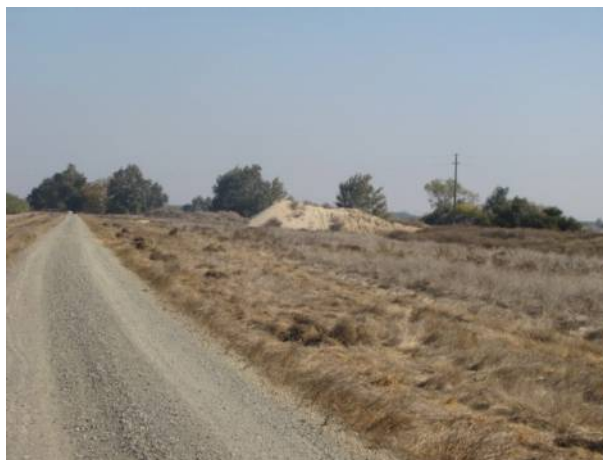
richard\_f\_20110922\_136.jpg

Looking upstream (south) at sand pile within 100' of waterside levee toe.

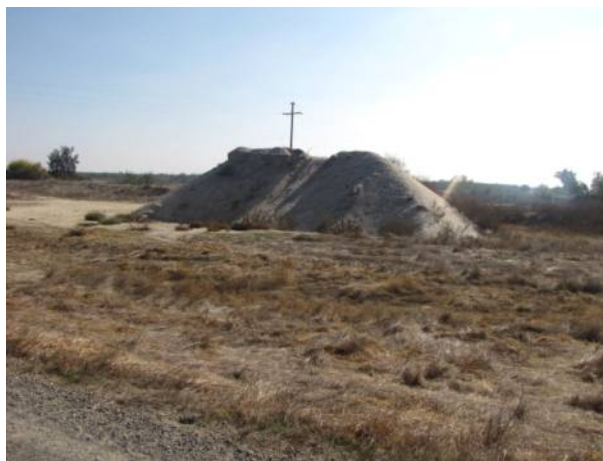
richard\_f\_20110922\_137.jpg

Levee Mile Report Line	7
Start Levee Mile	5.23
End Levee Mile	5.23
Location	Water Side
Category	Earthen Levee
Item	Encroachments

Looking southwest at sand pile within 100' of waterside levee toe.

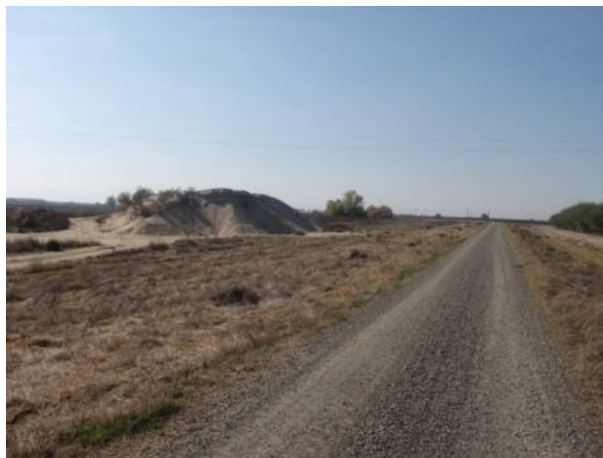
richard\_f\_20110922\_138.jpg

Levee Mile Report Line	7
Start Levee Mile	5.23
End Levee Mile	5.23
Location	Water Side
Category	Earthen Levee
Item	Encroachments

Looking downstream (north) at sandpile within 100' of waterside levee toe.

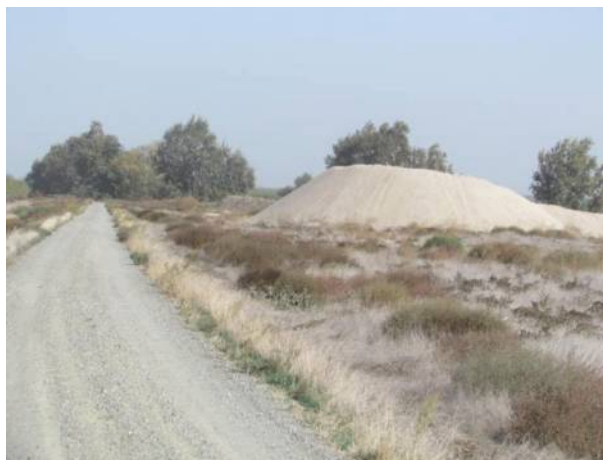
richard\_f\_20111114\_424.jpg

Looking south at sand pile on channel.

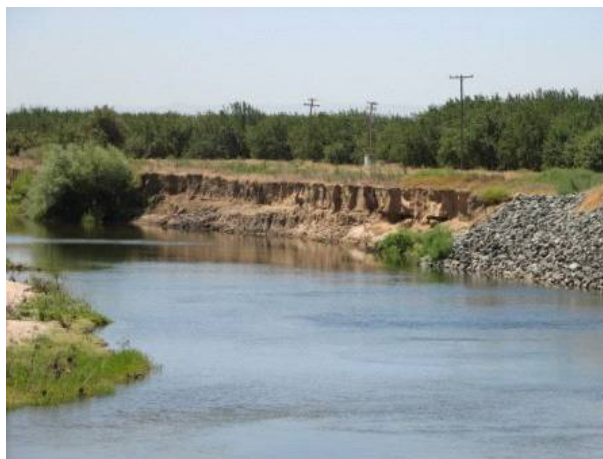
SJR2011\_NA0010U23RM224.27\_1.jpg

Levee Mile Report Line	11
Start Levee Mile	9.10
End Levee Mile	9.21
Location	Water Side
Category	Supplemental
Item	DWR Erosion Survey

Looking downstream at the downstream erosion site from the upstream site location. The boulders shows the riparian protection.

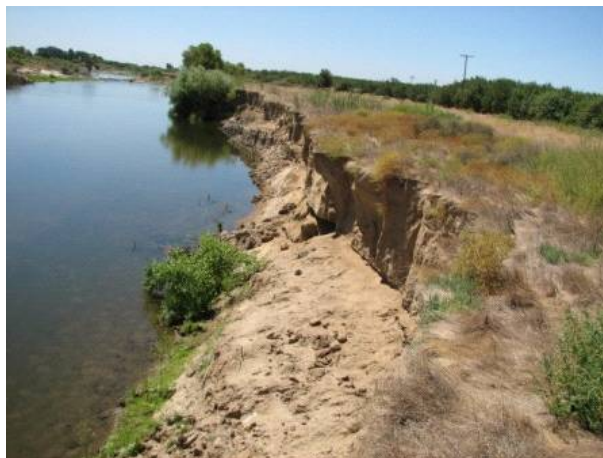
SJR2011\_NA0010U23RM224.27\_2.jpg

Levee Mile Report Line	11
Start Levee Mile	9.10
End Levee Mile	9.21
Location	Water Side
Category	Supplemental
Item	DWR Erosion Survey

Looking downstream standing at the middle of the erosion site.

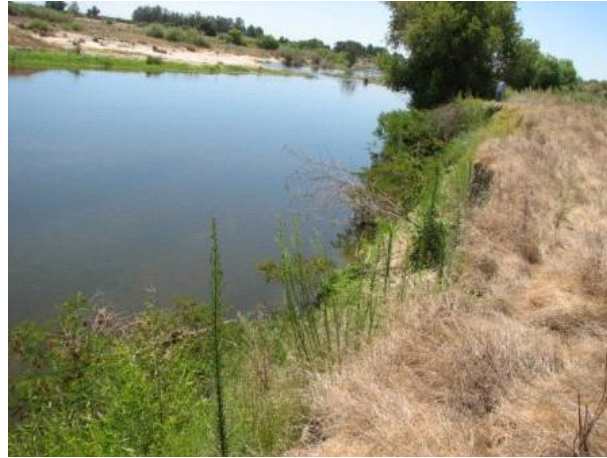
SJR2011\_NA0010U23RM224.27\_3.jpg

Close look at the site. Dense vegetation is visible.

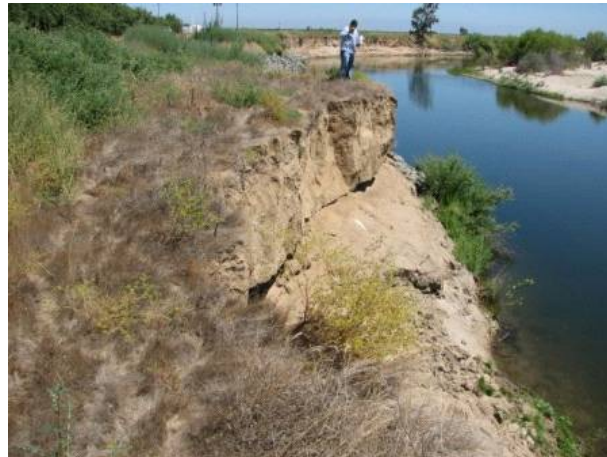
SJR2011\_NA0010U23RM224.27\_4.jpg

Levee Mile Report Line	11
Start Levee Mile	9.10
End Levee Mile	9.21
Location	Water Side
Category	Supplemental
Item	DWR Erosion Survey

Looking upstream. This image shows the ending point of the riparian protection.

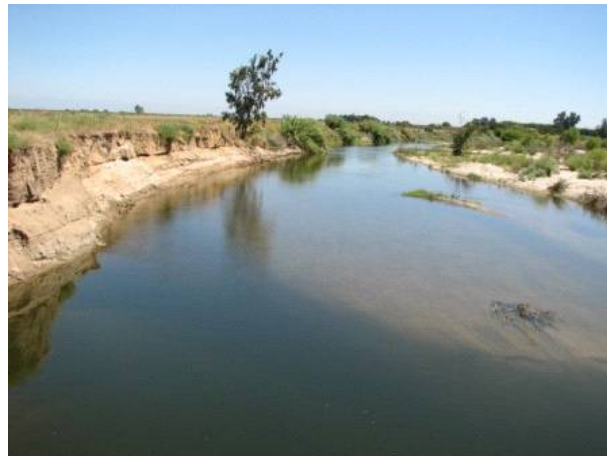
SJR2011\_NA0010U23RM224.33\_1.jpg

Levee Mile Report Line	12
Start Levee Mile	9.21
End Levee Mile	9.26
Location	Water Side
Category	Supplemental
Item	DWR Erosion Survey

The tree in the image marks the starting point of this erosion site.

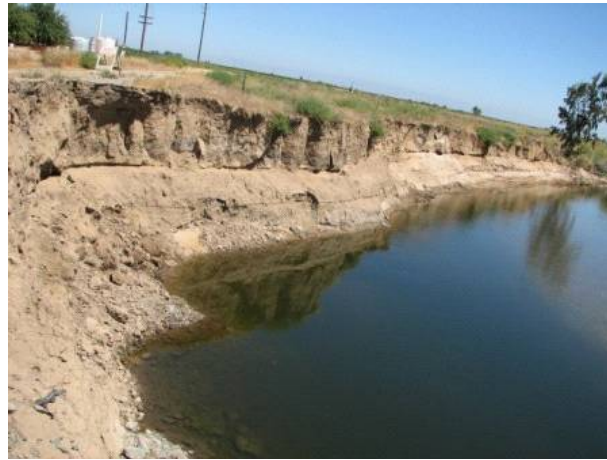
SJR2011\_NA0010U23RM224.33\_2.jpg

Standing next to the erosion point cutting into the levee.

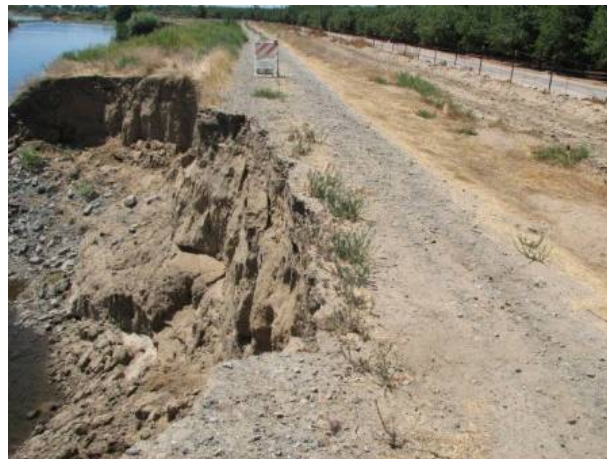
SJR2011\_NA0010U23RM224.33\_3.jpg

Levee Mile Report Line	12
Start Levee Mile	9.21
End Levee Mile	9.26
Location	Water Side
Category	Supplemental
Item	DWR Erosion Survey

Looking downstream. The image shows the point where the erosion is cutting into the levee.

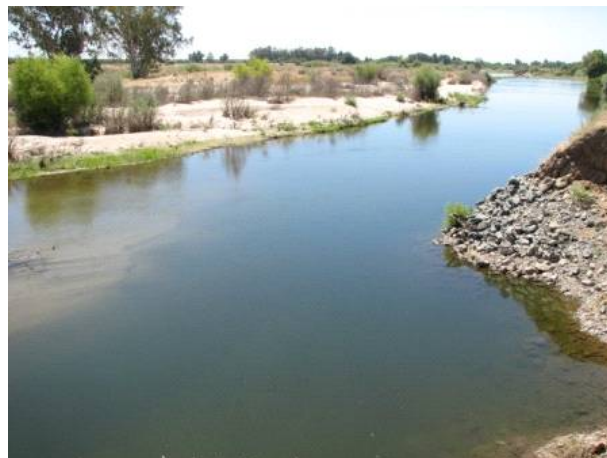
SJR2011\_NA0010U23RM224.33\_4.jpg

Levee Mile Report Line	12
Start Levee Mile	9.21
End Levee Mile	9.26
Location	Water Side
Category	Supplemental
Item	DWR Erosion Survey

Looking downstream. The image shows the starting point of the riparian protection.

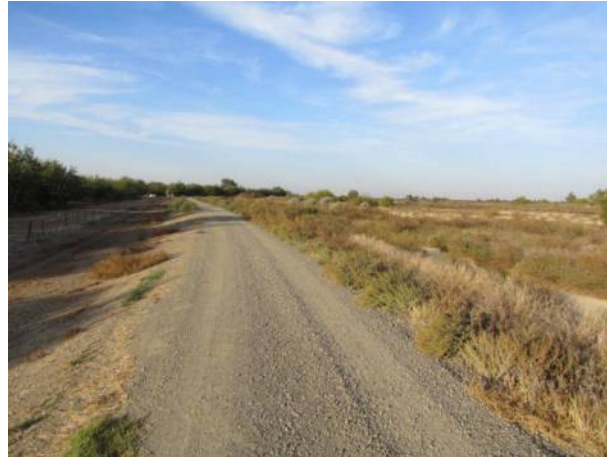
richard\_f\_20111114\_416.jpg

Looking south at dense vegetation on waterside slope.

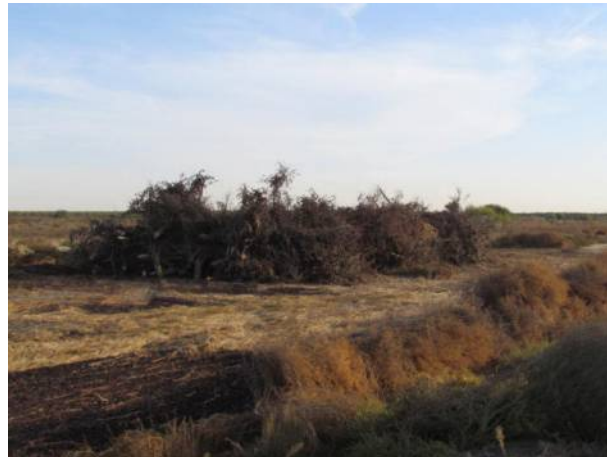
richard\_f\_20111114\_417.jpg

Levee Mile Report Line	5
Start Levee Mile	6.33
End Levee Mile	6.33
Location	Water Side
Category	Earthen Levee
Item	Encroachments

Looking east at large pruning pile in channel.

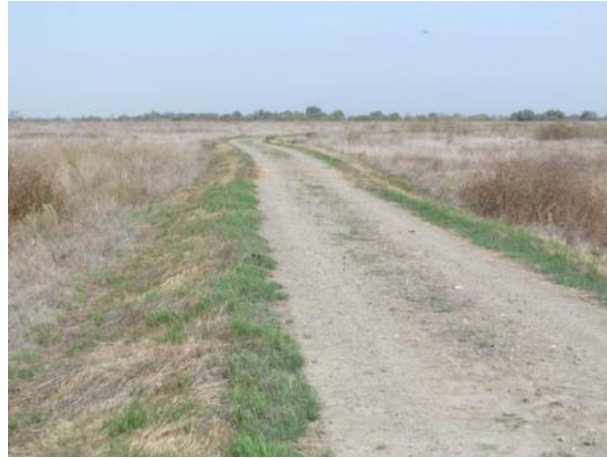
richard\_f\_20111114\_446.jpg

Looking at typical view of levee slopes.
