**Flood Control Project Maintenance
Levee Inspections**

Fall 2013 Levee Maintenance Deficiency Summary Report

San Joaquin River Basin

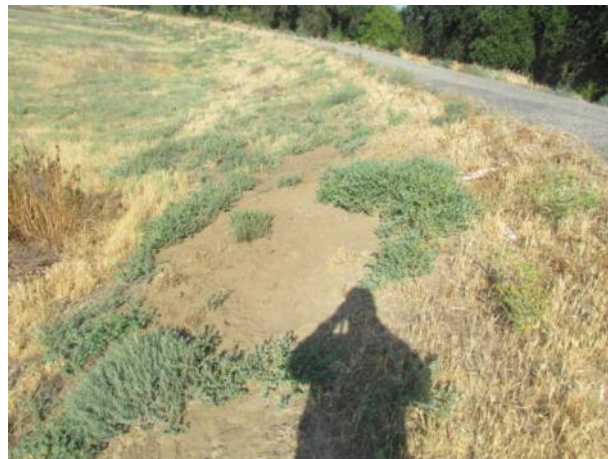
richard_f_20131112_177.JPG

Looking south at repaired site on landward slope.
(Spring 2013)

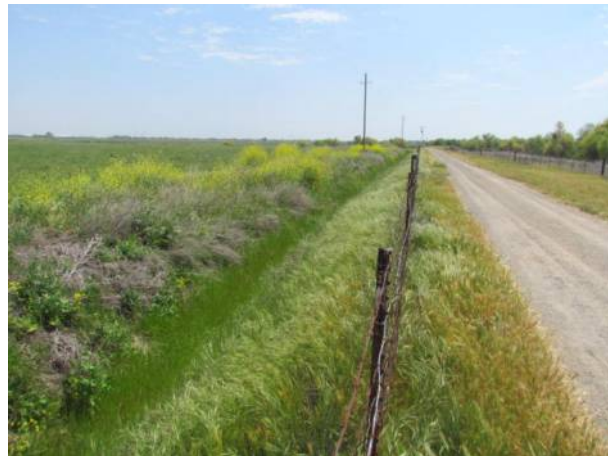
Levee Mile Report Line	12
Start Levee Mile	4.00
End Levee Mile	4.08
Location	Land Side
Category	Earthen Levee
Item	Encroachments

Looking south at irrigation ditch at landside toe.

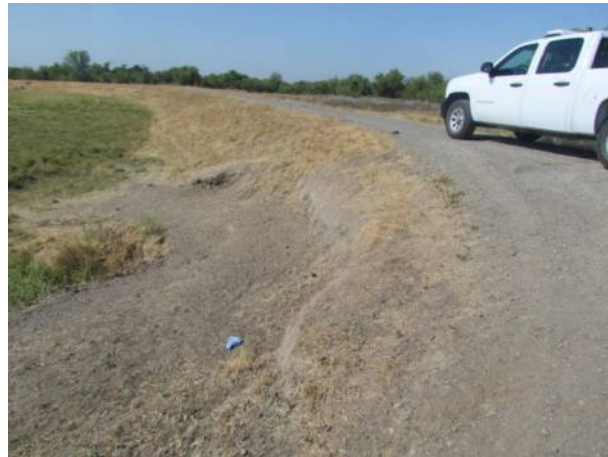
richard_f_20131112_168.JPG

Looking south at damage slope by livestock on landward slope.

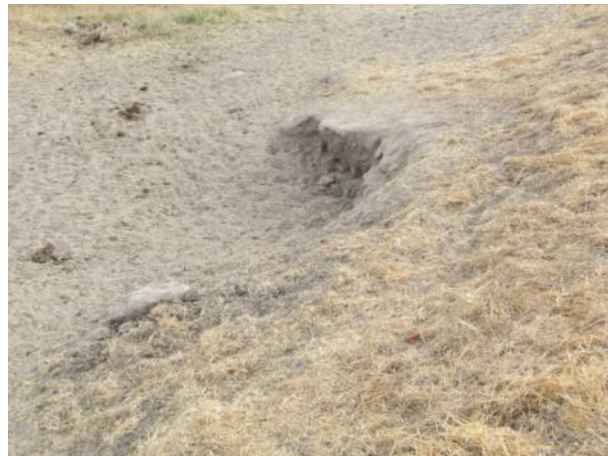
Levee Mile Report Line	14
Start Levee Mile	4.72
End Levee Mile	4.72
Location	Land Side
Category	Earthen Levee
Item	Animal Control

Looking southeast at erosion on landward toe.

LMR No.	Levee Mile		Category	Item	Location	Rating	Action/Comment	GPS Latitude/Longitude		Issue No.
	Start	End						Start	End	
14	4.72	4.72	Earthen Levee	Animal Control	LS	M Ma	A2 : Repair the levee slope damaged by livestock and prevent large animal access. Inspector Comments: Levee landward toe damaged by live stock.	37.302398 ° -120.920920 °	37.302398 ° -120.920920 °	9 Y
DWR ID: DWR_NA0010_01_s_2013_9										
15	5.75	5.75	Earthen Levee	Animal Control	LS A/W	Ma	A3 : No rodents visible, but rodent burrows visible; need to backfill and compact or grout burrows. Inspector Comments: Large rodent holes on landside slope near fence pole.	37.304057 ° -120.907200 °	37.304057 ° -120.907200 °	116 Y
DWR ID: DWR_NA0010_01_s_2012_116										
16	6.04	6.46	Earthen Levee	Vegetation	WSA/W	Ma	V9 : Keep the crown roadway free of vegetation.	37.303715 ° -120.902115 °	37.303838 ° -120.891912 °	13
DWR ID: DWR_NA0010_01_s_2012_13

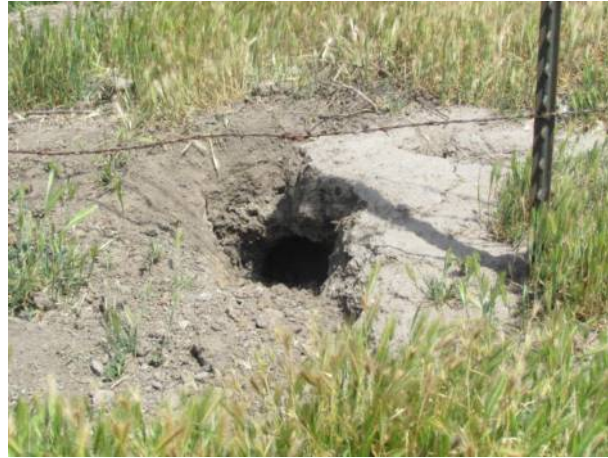
richard_f_20131112_178.jpg

Looking east at one of several rodent holes on landside shoulder and slope.

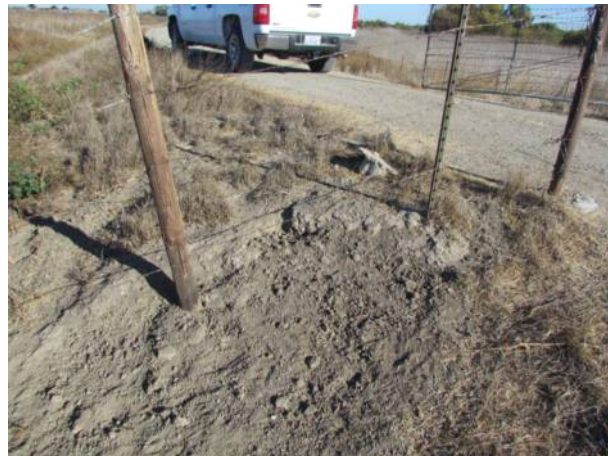
richard_f_20131112_180.JPG

Looking south at repaired rodent site on landside slope. (Fall 2012)

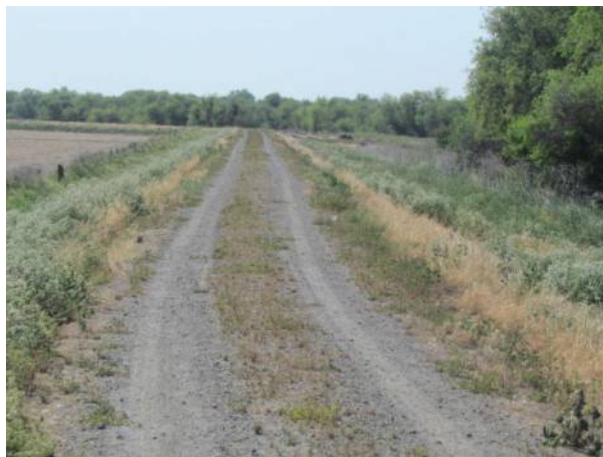
Levee Mile Report Line	22
Start Levee Mile	9.21
End Levee Mile	10.76
Location	Crown
Category	Earthen Levee
Item	Crown Surface / Depressions / Rutting

Looking south at vegetation on levee crown.
(Spring 2013)

DWR ID: DWR_NA0010_01_s_2012_15										
22	9.21	10.76	Earthen Levee	Crown Surface / Depressions / Rutting	CR A/W	Ma	C1 : Add appropriate material and re-grade the levee to bring the crown above the design elevation. Inspector Comments: District re-graded levee crown and control vegetation on levee crown.	37.296145 ° -120.848588 °	37.293077 ° -120.839170 °	117 Y
DWR ID: DWR_NA0010_01_s_2012_117										
23	9.67	9.67	Earthen Levee	Repair Gates	CR	M Ma	Inspector Comments: Need to replace hinges.	37.294984 ° -120.840680 °	37.294984 ° -120.840680 °	18 Y
DWR ID: DWR_NA0010_01_f_2013_18										
24	10.88	11.41	Earthen Levee	Crown Surface / Depressions / Rutting	CR A/W	Ma	C3 : Add appropriate gravel or road base. Grade and compact.	37.283153 ° -120.830870 °	37.278878 ° -120.824165 °	28 Y
DWR ID: DWR_NA0010_01_s_2013_28										
25	12.62	12.62	Earthen Levee	Animal Control	LS A/W	Ma	A3 : No rodents visible, but rodent burrows visible; need to backfill and compact or grout burrows. Inspector Comments: Rodent holes along fence line on landward slope.	37.258970 ° -120.826388 °	37.258970 ° -120.826388 °	29

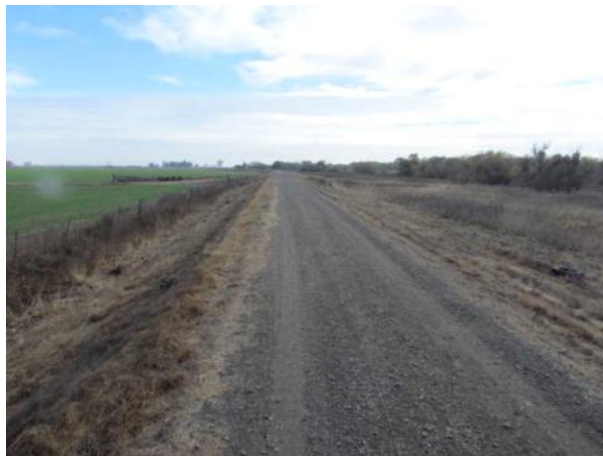
Levee Mile Report Line	22
Start Levee Mile	9.21
End Levee Mile	10.76
Location	Crown
Category	Earthen Levee
Item	Crown Surface / Depressions / Rutting

Looking south at levee crown. (Fall 2013)

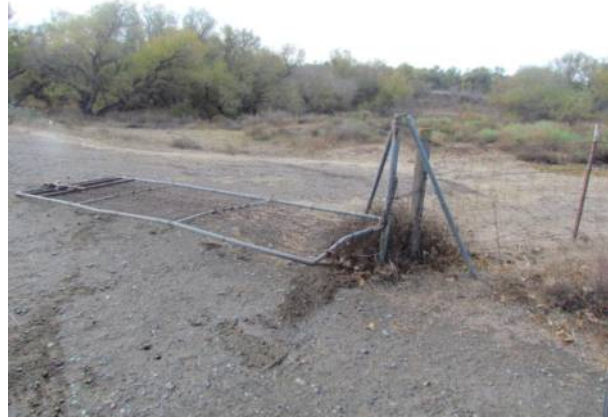
Levee Mile Report Line	23
Start Levee Mile	9.67
End Levee Mile	9.67
Location	Crown
Category	Earthen Levee
Item	Repair Gates

Looking at damaged gate across levee crown.

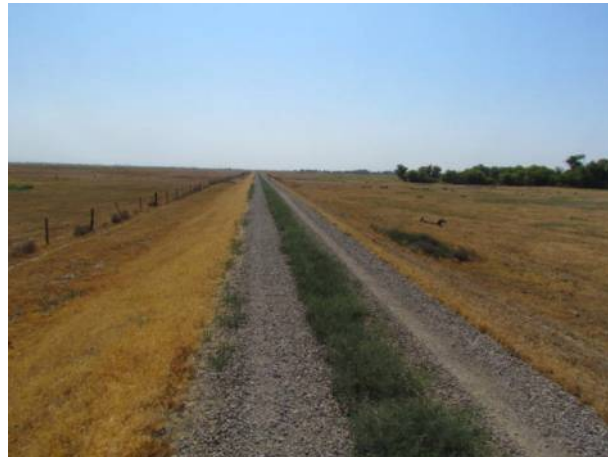
Levee Mile Report Line	24
Start Levee Mile	10.88
End Levee Mile	11.41
Location	Crown
Category	Earthen Levee
Item	Crown Surface / Depressions / Rutting

Looking south at vegetation on levee crown.

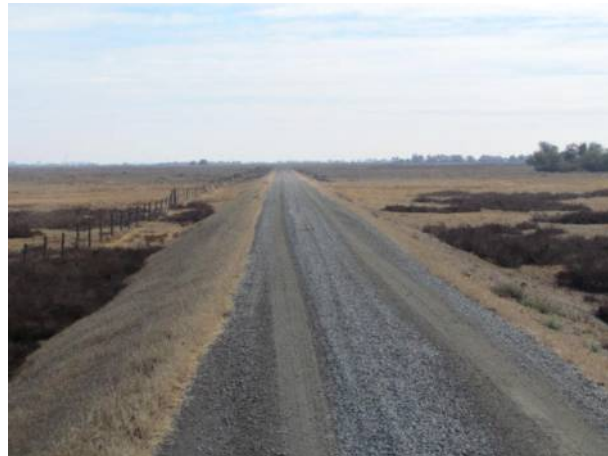
Levee Mile Report Line	24
Start Levee Mile	10.88
End Levee Mile	11.41
Location	Crown
Category	Earthen Levee
Item	Crown Surface / Depressions / Rutting

Looking south at re-graded levee and added road base on levee crown.

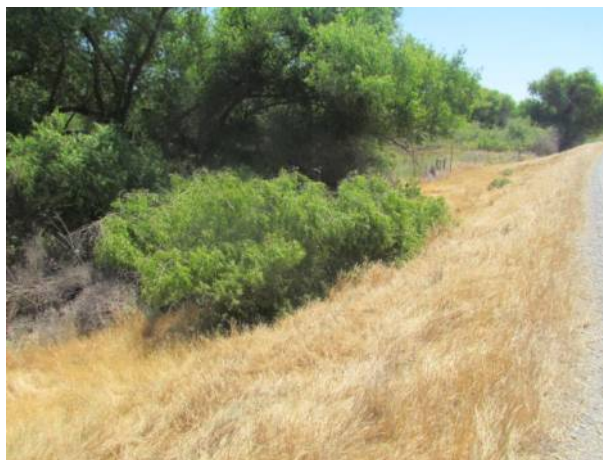
richard_f_20131112_174.JPG

Looking north at a downed tree limb on landward slope and toe.

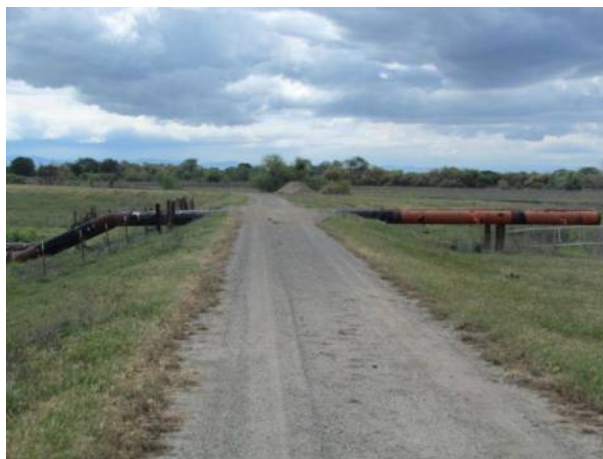
Levee Mile Report Line	29
Start Levee Mile	19.33
End Levee Mile	19.33
Location	Crown
Category	Earthen Levee
Item	Encroachments

Looking south at pipe across levee crown.

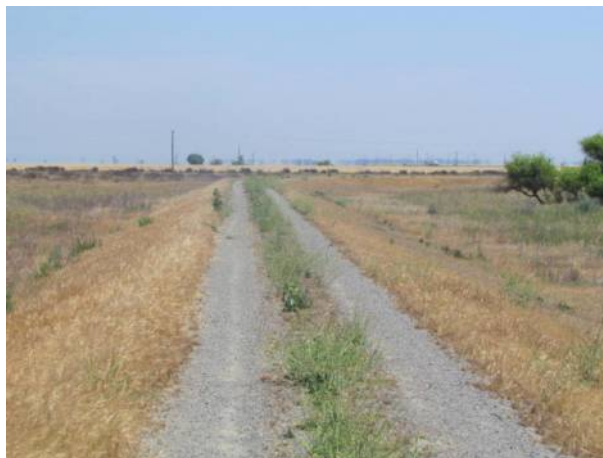
Levee Mile Report Line	30
Start Levee Mile	19.95
End Levee Mile	20.23
Location	Crown
Category	Earthen Levee
Item	Vegetation

Looking north at vegetation on levee crown,

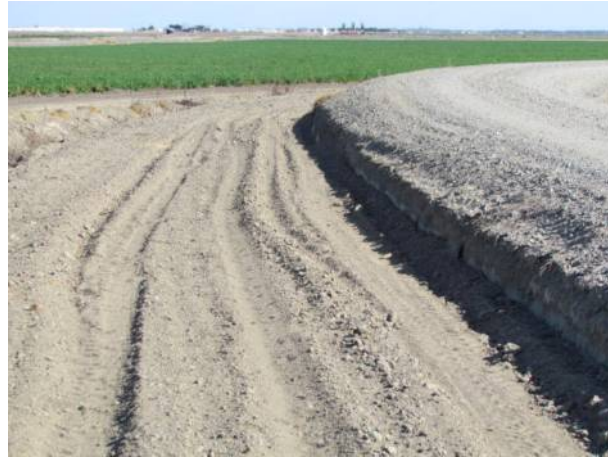
richard_f_20131112_169.JPG

Looking west at farmer discing landside slope.

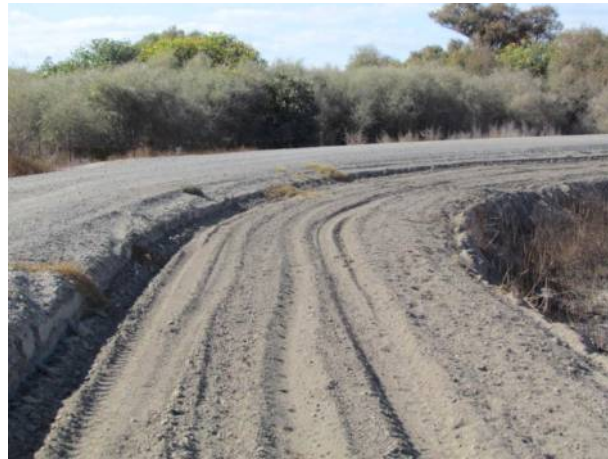
Levee Mile Report Line	31
Start Levee Mile	21.46
End Levee Mile	22.02
Location	Land Side
Category	Earthen Levee
Item	Encroachments

Looking east at farmer discing into landside slope.

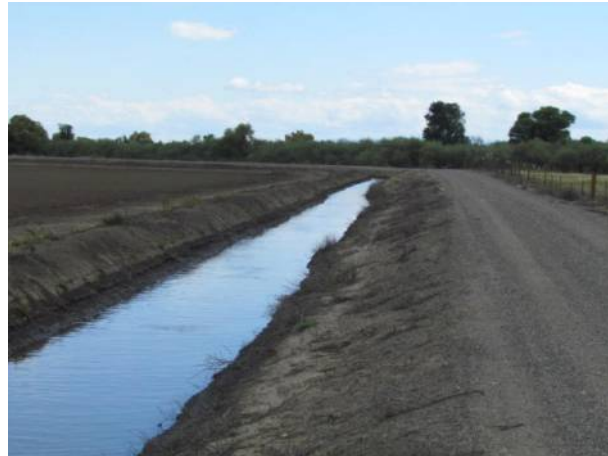
Levee Mile Report Line	32
Start Levee Mile	22.09
End Levee Mile	22.56
Location	Land Side
Category	Earthen Levee
Item	Encroachments

Looking upstream at irrigation at landside toe.

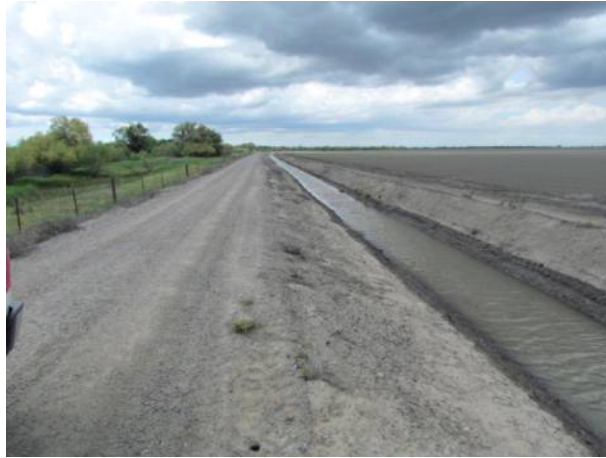
richard_f_20131112_172.jpg

Looking downstream at irrigation ditch at landside toe.

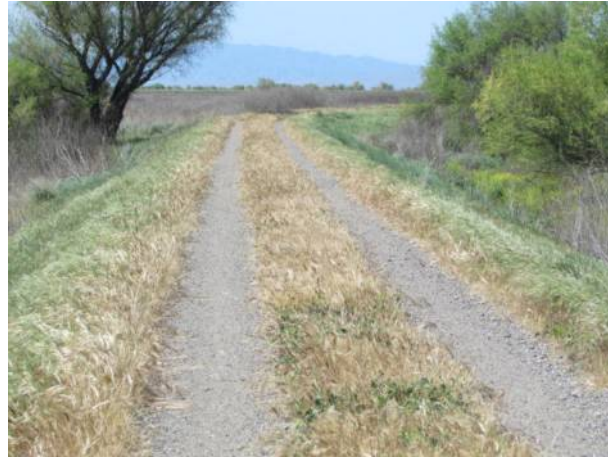
richard_f_20131112_185.jpg

Looking north at vegetation on levee crown.

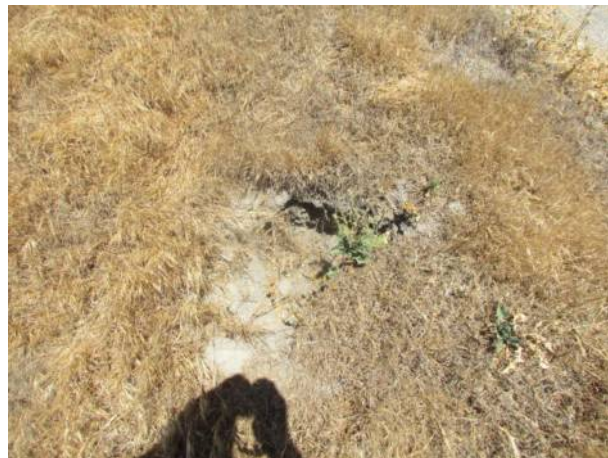
Levee Mile Report Line	3
Start Levee Mile	0.13
End Levee Mile	0.13
Location	Land Side
Category	Earthen Levee
Item	Animal Control

Looking at large rodent hole on landward slope.

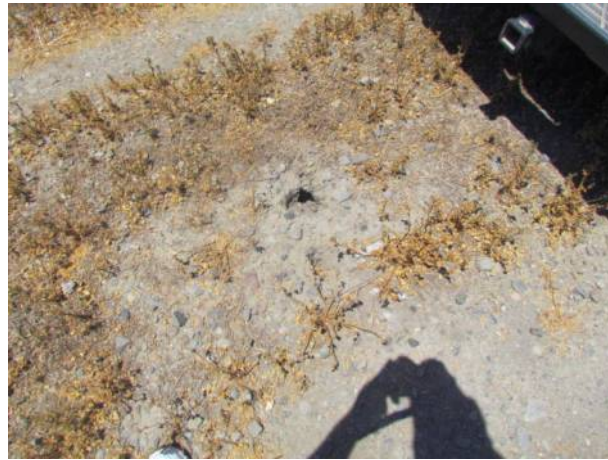
richard_f_20131112_187.JPG

Looking at rodent hole on levee crown.

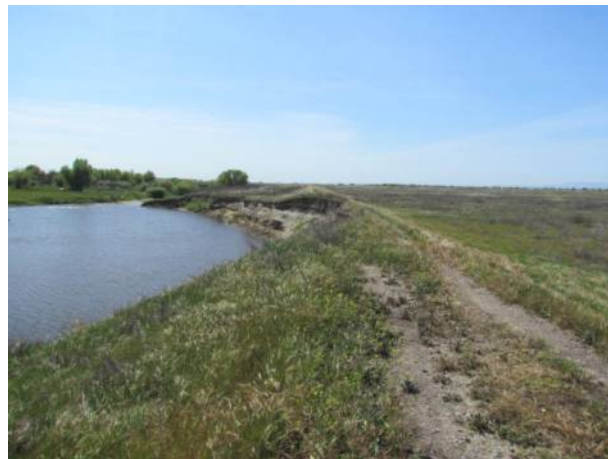
Levee Mile Report Line	5
Start Levee Mile	0.77
End Levee Mile	0.77
Location	Water Side
Category	Earthen Levee
Item	Erosion / Bank Caving

Looking south at large erosion on waterside slope. (Spring 2012)

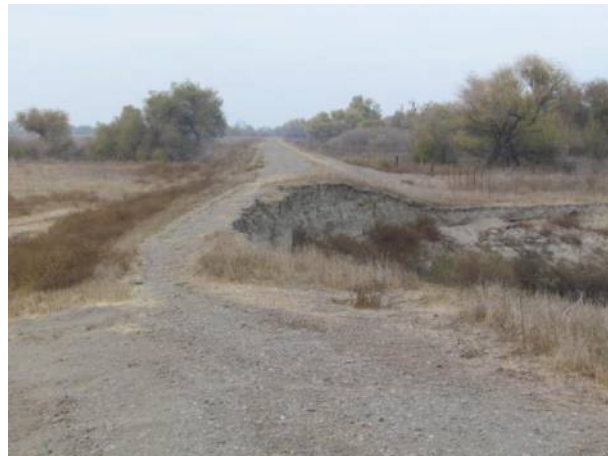
Levee Mile Report Line	5
Start Levee Mile	0.77
End Levee Mile	0.77
Location	Water Side
Category	Earthen Levee
Item	Erosion / Bank Caving

Looking north at large erosion on waterward slope. (Fall 2013)

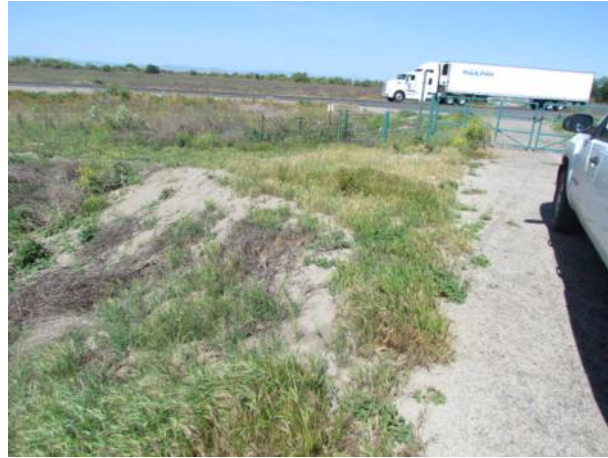
richard_f_20131112_183.jpg

Looking northwest at ramp on landside slope near Hwy 140.

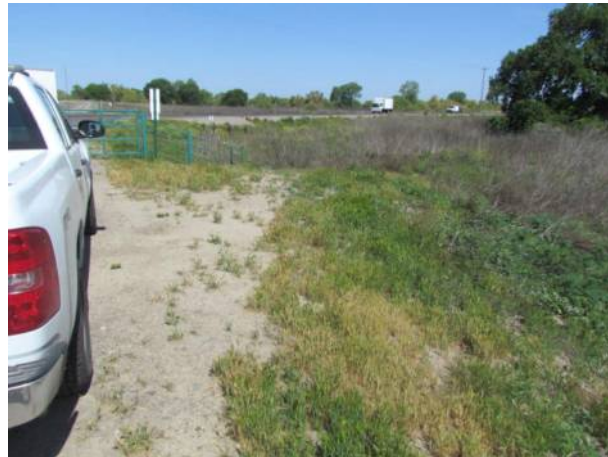
Levee Mile Report Line	6
Start Levee Mile	2.33
End Levee Mile	2.33
Location	Land Side
Category	Earthen Levee
Item	Encroachments

Looking northeast at ramp on waterside slope near Hwy 140.

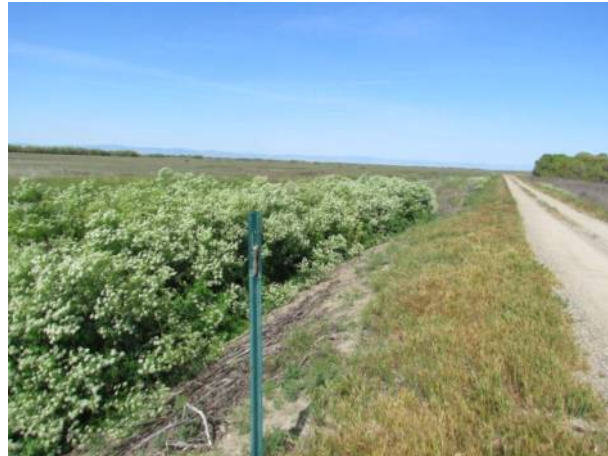
Levee Mile Report Line	8
Start Levee Mile	7.76
End Levee Mile	7.76
Location	Land Side
Category	Earthen Levee
Item	Vegetation

Looking north dense vegetation at landside slope and toe.

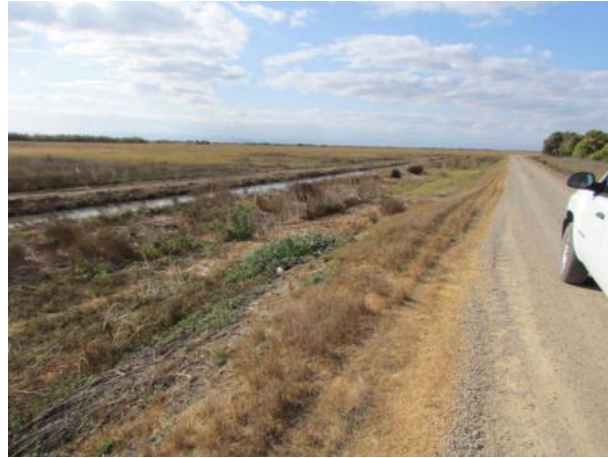
richard_f_20131112_190.JPG

Looking north at removed vegetation on landside berm. (Fall 2012)

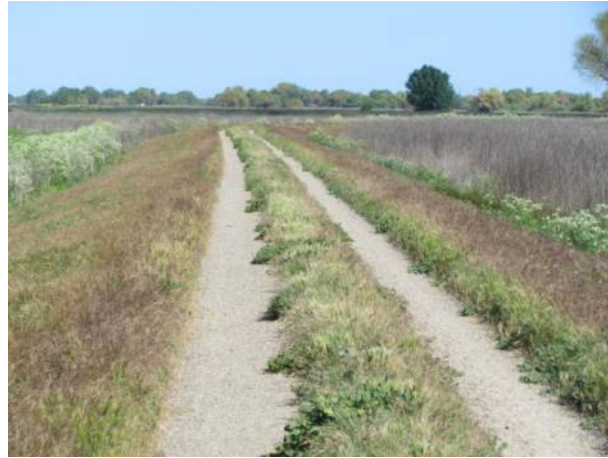
richard_f_20131112_192.jpg

Looking north at vegetation on levee crown.

LMR No.	Levee Mile		Category	Item	Location * + Rating	Action/Comment	GPS Latitude/Longitude		Issue No. Photo
	Start	End					Start	End	
1	7.87	13.45	Earthen Levee	Crown Surface / Depressions / Rutting	CR M Ma	C2 : Repair depressions or ruts in the crown or slope. Inspector Comments: Regrade levee crown excess rutting.	37.231279 ° -120.811852 °	37.176608 ° -120.762619 °	3 Y
DWR ID: DWR_NA0010_02B_s_2012_3									
2	8.78	13.79	Earthen Levee	Vegetation	LS A Ma	V1 : Control annual grass and weeds on the levee slopes and easements.	37.231428 ° -120.811993 °	° °	1 Y
DWR ID: DWR_NA0010_02B_f_2013_1									
3	9.46	9.46	Earthen Levee	Encroachments	LS A/W Ma	TR : Tree or limb Inspector Comments: Broken tree limb on landside slope.	37.220212 ° -120.788637 °	37.220212 ° -120.788637 °	2 Y
DWR ID: DWR_NA0010_02B_f_2012_2									
4	9.50	9.98	Earthen Levee	Vegetation	LS A/W Ma	V2 : Remove the wild growth other than native grasses from the levee slopes.	37.220463 ° -120.787837 °	37.216298 ° -120.783906 °	6 Y

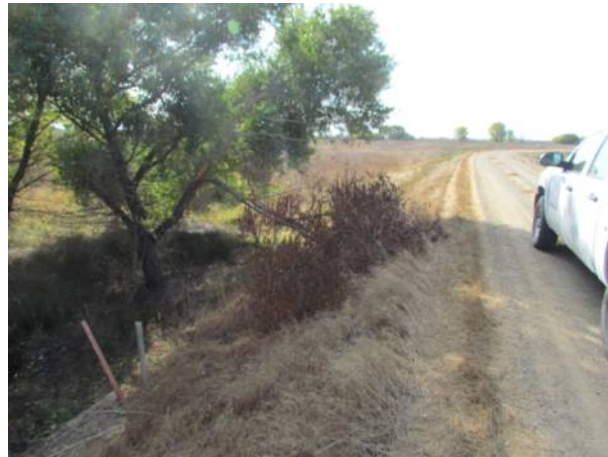
richard_f_20131112_191.JPG

Looking north at broken tree limb on landside slope.

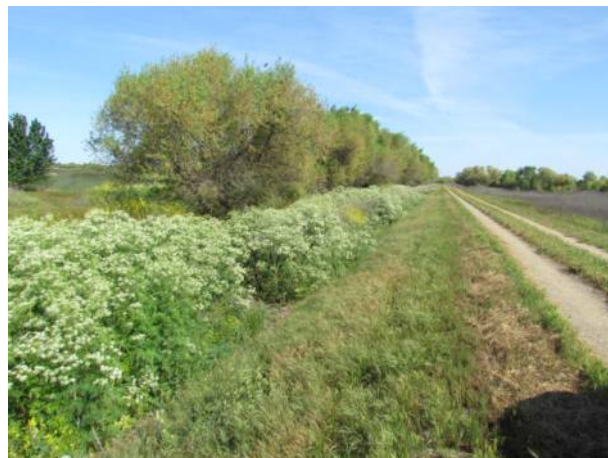
Levee Mile Report Line	4
Start Levee Mile	9.50
End Levee Mile	9.98
Location	Land Side
Category	Earthen Levee
Item	Vegetation

Looking northwest at dense vegetation on landside slope and toe.

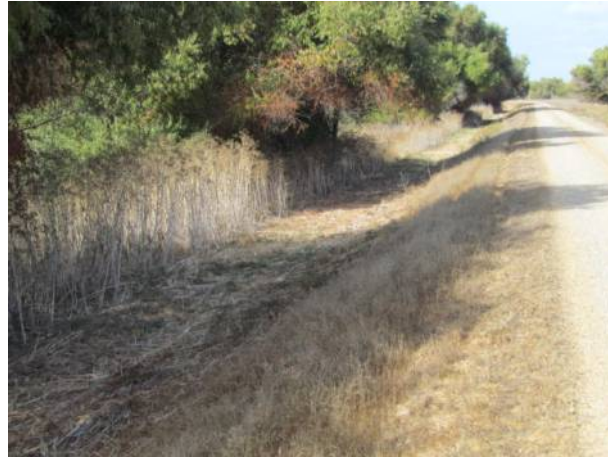
richard_f_20131112_196.JPG

Looking north at removed wild growth on landside toe. (Fall 2012)

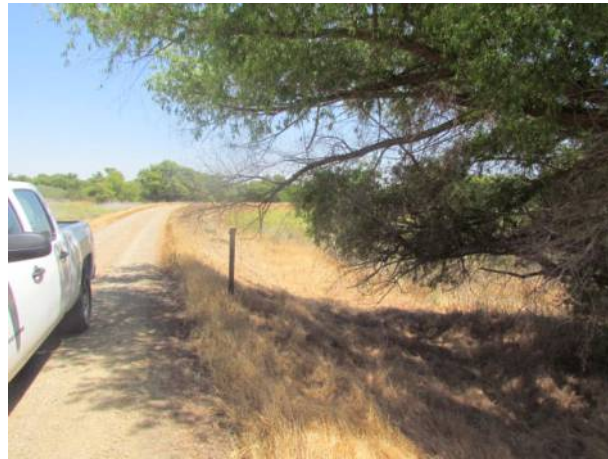
Levee Mile Report Line	5
Start Levee Mile	9.66
End Levee Mile	9.66
Location	Land Side
Category	Earthen Levee
Item	Trim / Thin Trees

Looking south at tree on landward toe.

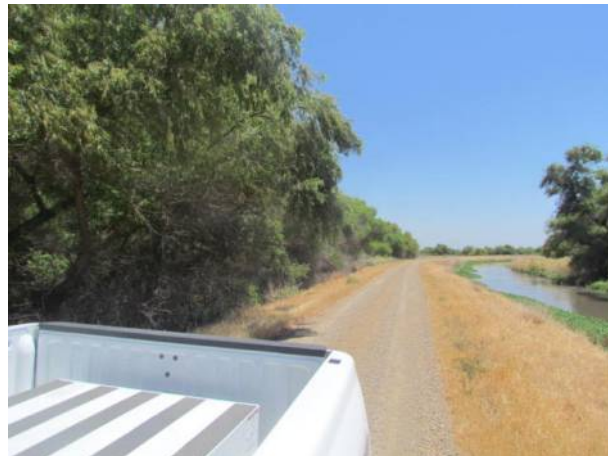
Levee Mile Report Line	8
Start Levee Mile	13.47
End Levee Mile	13.47
Location	Water Side
Category	Earthen Levee
Item	Trim / Thin Trees

Looking south at overhanging tree limb on landward slope.

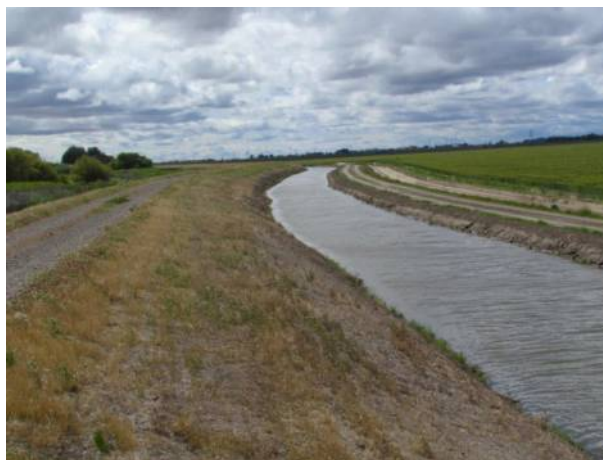
richard_f_20131112_199.jpg

Looking north at irrigation ditch at landside toe.

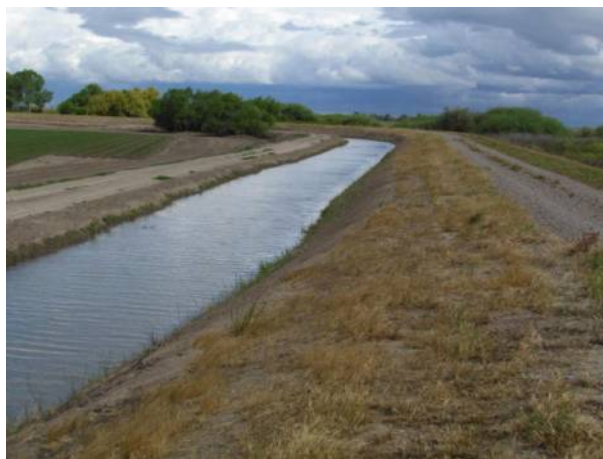
Levee Mile Report Line	1
Start Levee Mile	0.32
End Levee Mile	1.49
Location	Crown
Category	Earthen Levee
Item	Encroachments

Looking north at irrigation ditch at landside toe.

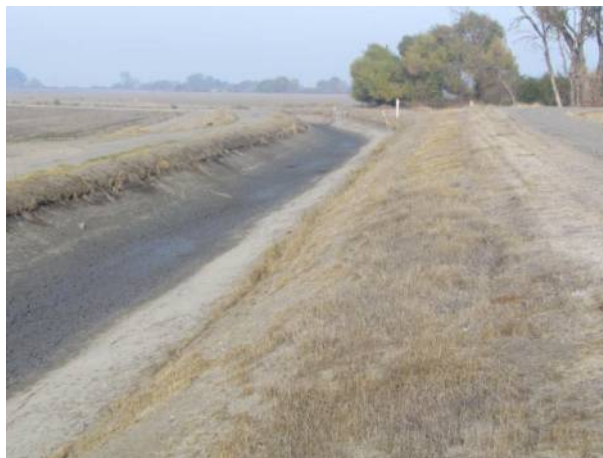
richard_f_20131127_304.JPG

Looking north at irrigation ditch at landward toe.
(Fall 2013)

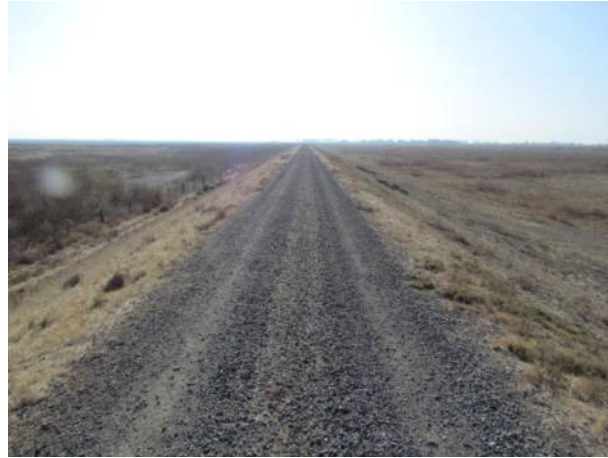
richard_f_20131127_295.JPG

Looking south at typical view of levee.

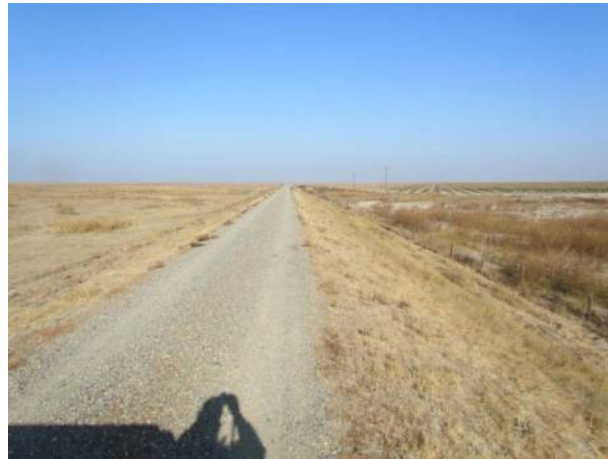
richard_f_20131127_296.JPG

Looking north at typical view of levee.

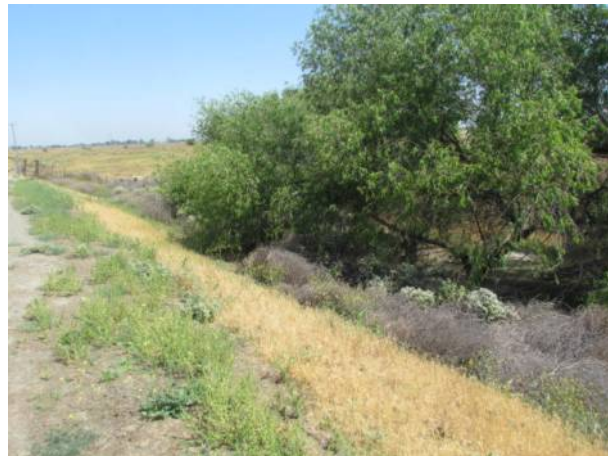
richard_f_20131112_209.JPG

Levee Mile Report Line	2
Start Levee Mile	0.64
End Levee Mile	0.64
Location	Land Side
Category	Earthen Levee
Item	Trim / Thin Trees

Looking east at untrimmed trees on landward toe.

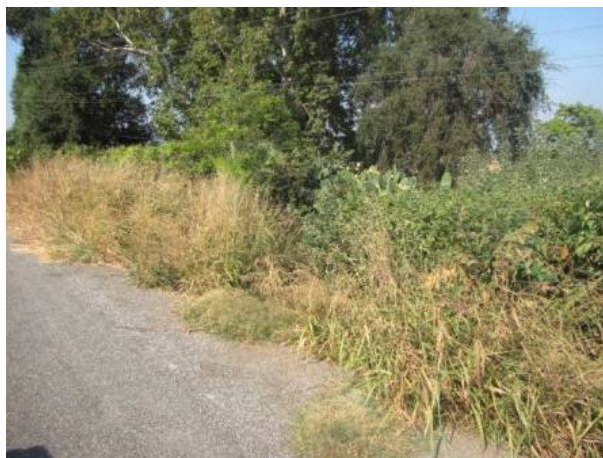
richard_f_20131112_202.jpg

Looking south at dense trees on landside slope.

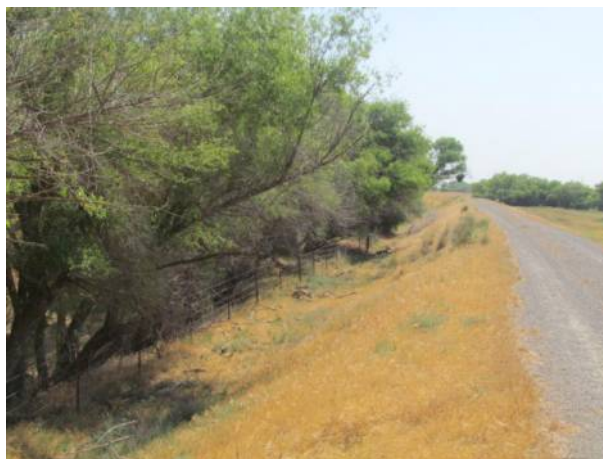
richard_f_20131112_203.JPG

Levee Mile Report Line	4
Start Levee Mile	2.81
End Levee Mile	2.86
Location	Land Side
Category	Earthen Levee
Item	Trim / Thin Trees

Looking south at trimmed trees on landward slope and toe.

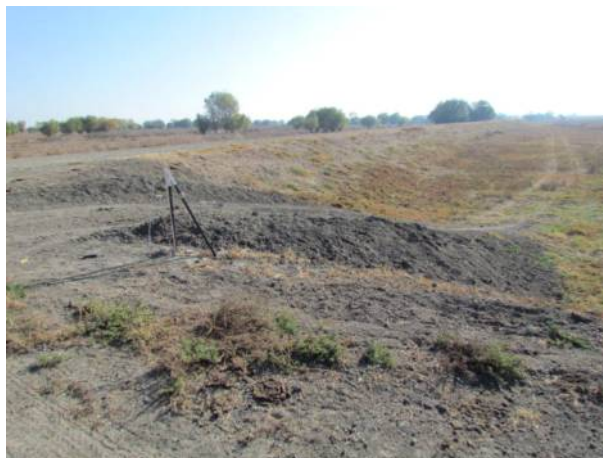
richard_f_20131112_204.JPG

Levee Mile Report Line	5
Start Levee Mile	3.19
End Levee Mile	3.19
Location	Water Side
Category	Earthen Levee
Item	Encroachments

Looking south at unauthorized ramp on waterside slope.

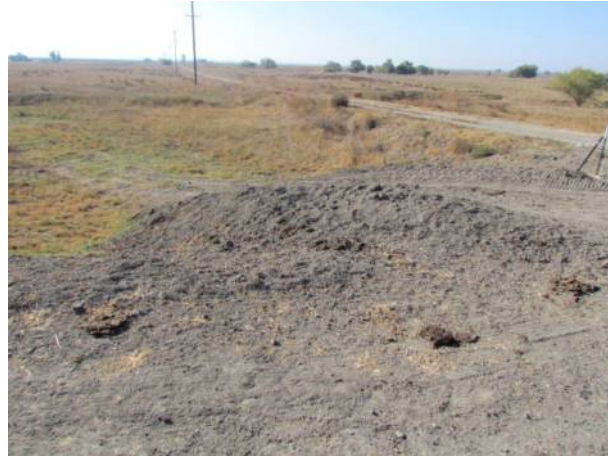
Levee Mile Report Line	5
Start Levee Mile	3.19
End Levee Mile	3.19
Location	Water Side
Category	Earthen Levee
Item	Encroachments
Looking northwest at unauthorized ramp on waterside slope.	
richard_f_20131112_205.JPG

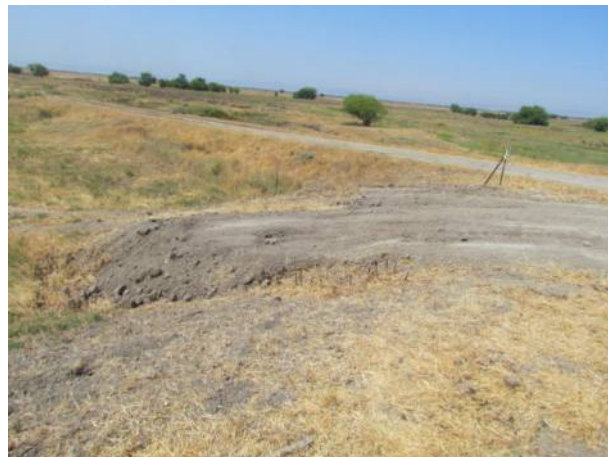
Levee Mile Report Line	5
Start Levee Mile	3.19
End Levee Mile	3.19
Location	Water Side
Category	Earthen Levee
Item	Encroachments
Looking northwest at unauthorized ramp on waterward slope.	
richard_f_20131112_206.JPG

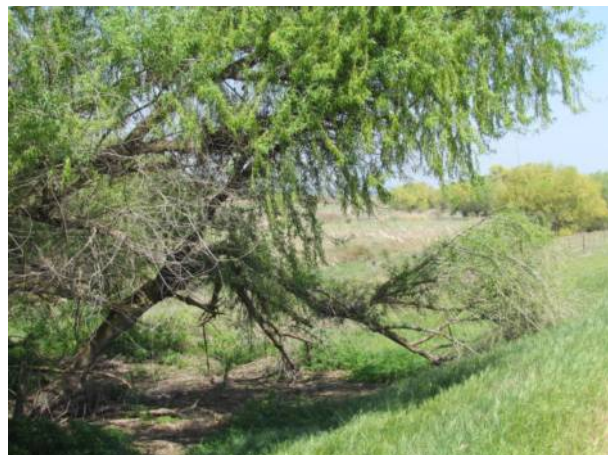
Levee Mile Report Line	7
Start Levee Mile	3.54
End Levee Mile	3.54
Location	Land Side
Category	Earthen Levee
Item	Encroachments
Looking south at down tree limb on landside slope and toe.	
richard_f_20131112_201.jpg

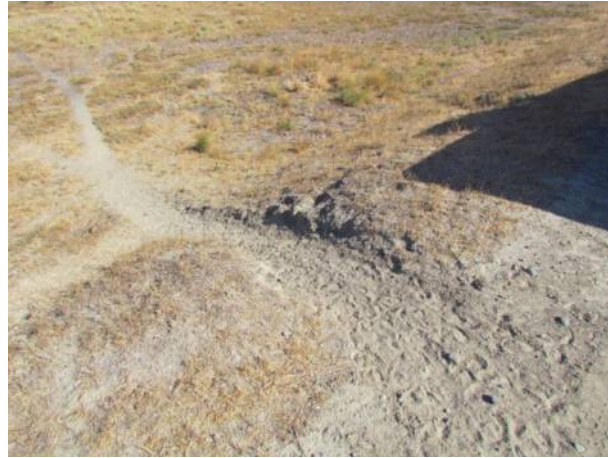
richard_f_20131112_207.JPG

Looking east at levee damage by livestock on landside slope.

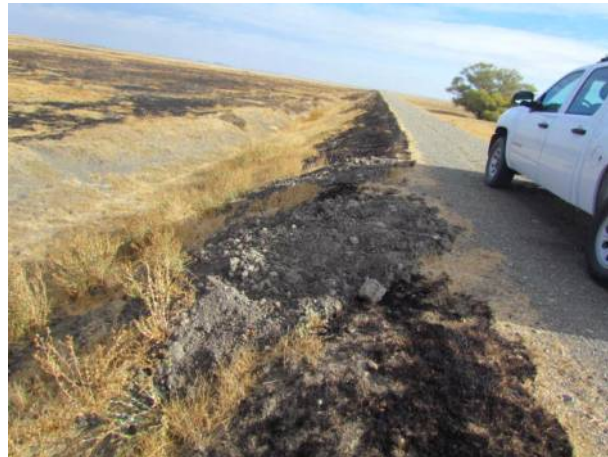
richard_f_20131121_291.JPG

Levee Mile Report Line	8
Start Levee Mile	4.99
End Levee Mile	4.99
Location	Land Side
Category	Earthen Levee
Item	Animal Control

Looking south at repaired livestock erosion on landward slope.

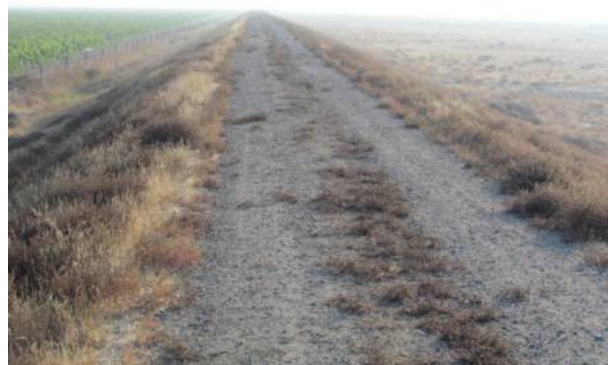
richard_f_20131112_208.JPG

Levee Mile Report Line	19
Start Levee Mile	26.88
End Levee Mile	27.90
Location	Crown
Category	Earthen Levee
Item	Crown Surface / Depressions / Rutting

Looking south at typical view of levee crown.

DWR ID: DWR_NA0010_05_f_2012_19										
19	26.88	27.90	Earthen Levee	Crown Surface / Depressions / Rutting	CR A/W	Ma	C1 : Add appropriate material and re-grade the levee to bring the crown above the design elevation.	37.032681 ° -120.473370 °	37.032573 ° -120.454938 °	20 Y
DWR ID: DWR_NA0010_05_f_2012_20										
20	29.58	29.70	Earthen Levee	Erosion / Bank Caving	LS	M Ma	E1 : Note and monitor erosion site. Inspector Comments: Landside erosion caused by livestock.	37.020272 ° -120.433737 °	37.018712 ° -120.432682 °	171 Y
DWR ID: DWR_NA0010_05_s_2012_171										
21	29.76	31.66	Earthen Levee	Vegetation	WSA/W	Ma	V2 : Remove the wild growth other than native grasses from the levee slopes.	37.017953 ° -120.432132 °	36.996773 ° -120.410739 °	21
DWR ID: DWR_NA0010_05_f_2012_21										
22	29.80	29.80	Earthen Levee	Animal Control	LS	M Ma	A3 : No rodents visible, but rodent burrows visible; need to backfill and compact or grout burrows.	37.017540 ° -120.431955 °	37.017540 ° -120.431955 °	16

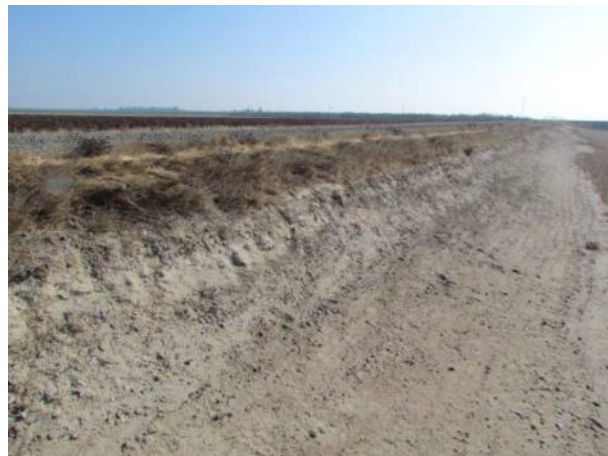
Levee Mile Report Line	20
Start Levee Mile	29.58
End Levee Mile	29.70
Location	Land Side
Category	Earthen Levee
Item	Erosion / Bank Caving
Looking east at livestock erosion on landward slope.	
richard_f_20131127_298.JPG

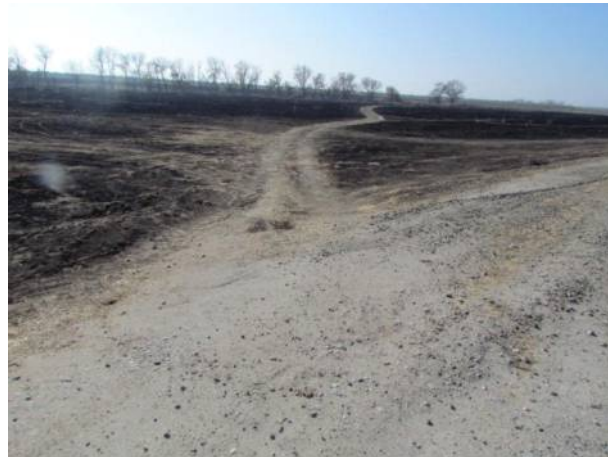
Levee Mile Report Line	24
Start Levee Mile	34.50
End Levee Mile	34.50
Location	Water Side
Category	Earthen Levee
Item	Encroachments
Looking west at unauthorized ramp on waterward slope.	
richard_f_20131127_300.JPG

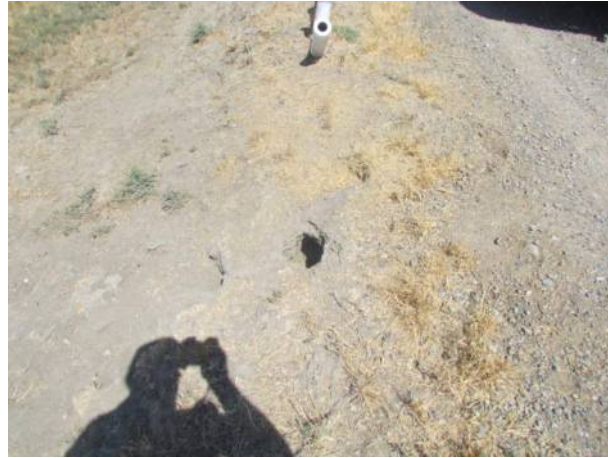
richard_f_20131112_221.JPG

Looking north at rodent hole on landward slope.

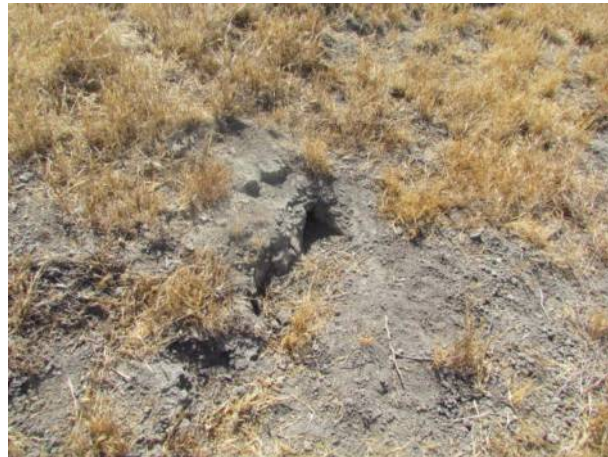
richard_f_20131112_218.JPG

Levee Mile Report Line	4
Start Levee Mile	4.72
End Levee Mile	4.72
Location	Land Side
Category	Earthen Levee
Item	Animal Control

Looking at typical rodent holes on landward slope.

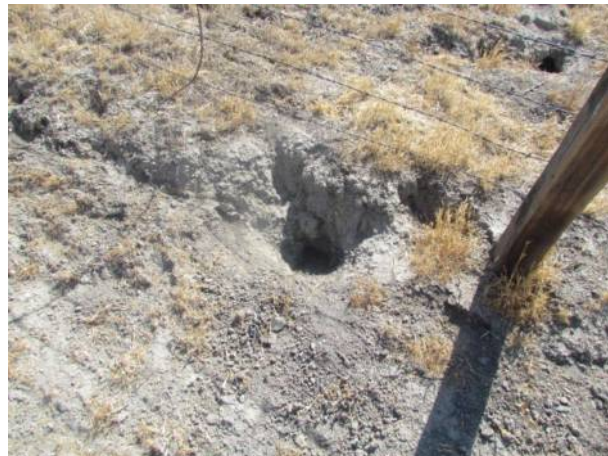
richard_f_20131112_219.JPG

Levee Mile Report Line	4
Start Levee Mile	4.72
End Levee Mile	4.72
Location	Land Side
Category	Earthen Levee
Item	Animal Control

Looking at rodent hole along fence line on landward slope.

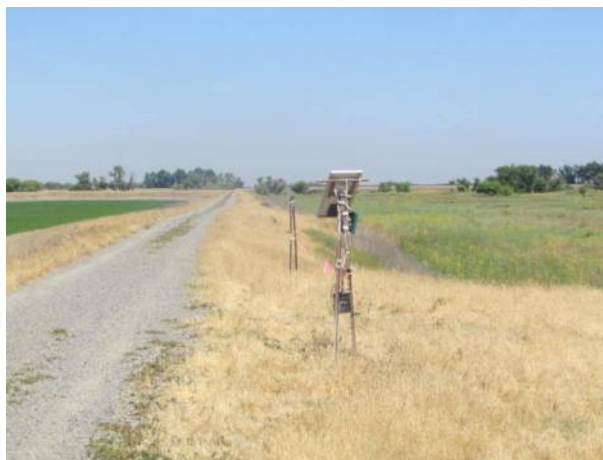
richard_f_20131112_220.JPG

Looking north at electric fence on waterward shoulder.

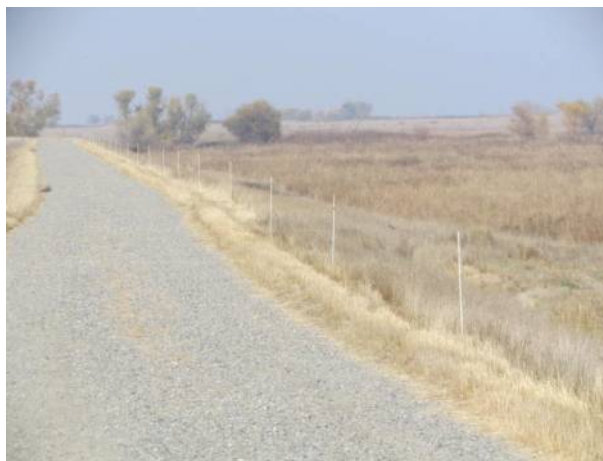
richard_f_20131127_301.JPG

Levee Mile Report Line	10
Start Levee Mile	13.56
End Levee Mile	14.45
Location	Water Side
Category	Earthen Levee
Item	Encroachments

Looking north at electric fence on waterward shoulder.

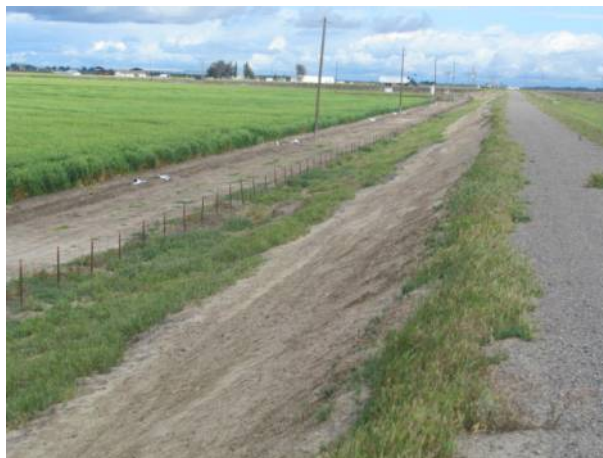
richard_f_20131112_216.jpg

Levee Mile Report Line	14
Start Levee Mile	24.50
End Levee Mile	24.93
Location	Land Side
Category	Earthen Levee
Item	Slope Stability

Looking north at livestock erosion on landside slope.

LMR No.	Levee Mile		Category	Item	Location	Rating	Action/Comment	GPS Latitude/Longitude		Issue No.
	Start	End						Start	End	Photo
14	24.50	24.93	Earthen Levee	Slope Stability	LS	M _{Ma}	S2 : Repair the levee slope damaged by foot traffic and prevent access where possible. Inspector Comments: Landside erosion caused by livestock.	37.071198 ° -120.519220 °	° °	5 Y
DWR ID: DWR_NA0010_06_s_2012_5										
15	27.56	27.87	Earthen Levee	Slope Stability	LS	M _{Ma}	S2 : Repair the levee slope damaged by foot traffic and prevent access where possible. Inspector Comments: Landside erosion caused by livestock.	37.036955 ° -120.484395 °	37.032887 ° -120.481225 °	3 Y
DWR ID: DWR_NA0010_06_s_2012_3										
16	28.62	28.62	Earthen Levee	Animal Control	LS	M _{Ma}	A3 : No rodents visible, but rodent burrows visible; need to backfill and compact or grout burrows.	37.030102 ° -120.469122 °	37.030102 ° -120.469122 °	19

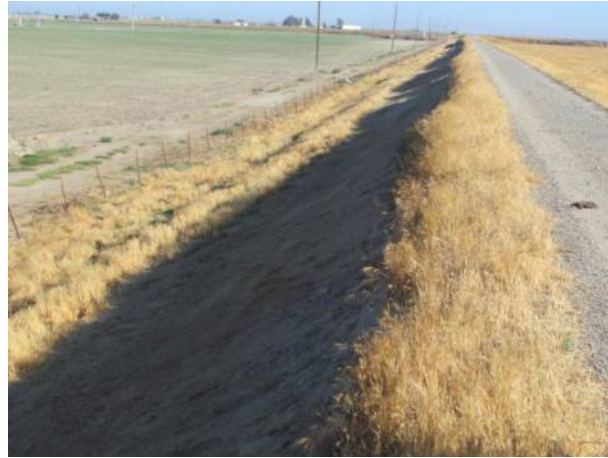
richard_f_20131112_217.JPG

Looking north at livestock erosion on landward slope.

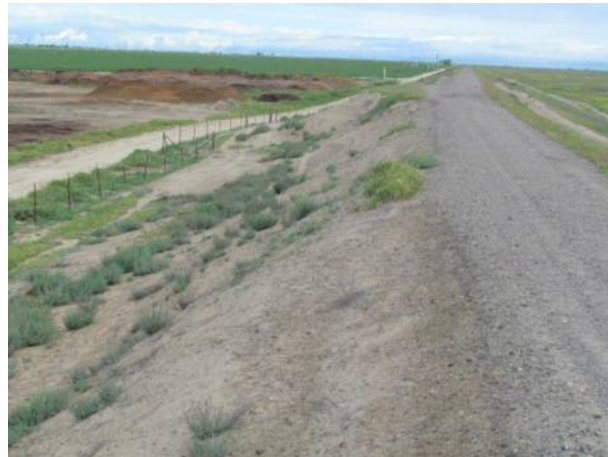
richard_f_20131112_213.jpg

Levee Mile Report Line	15
Start Levee Mile	27.56
End Levee Mile	27.87
Location	Land Side
Category	Earthen Levee
Item	Slope Stability

Looking north at livestock erosion on landside shoulder and slope.

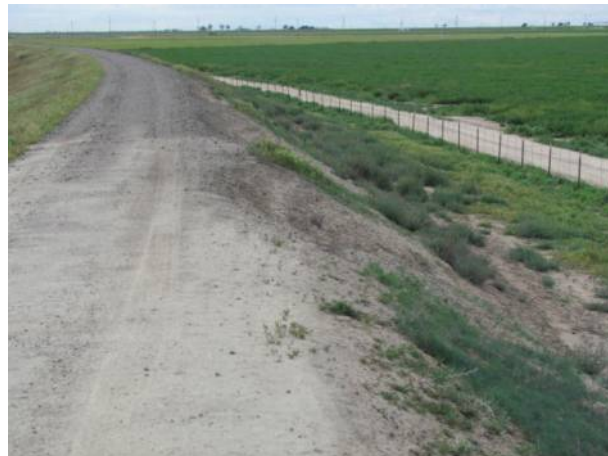
richard_f_20131112_214.jpg

Levee Mile Report Line	15
Start Levee Mile	27.56
End Levee Mile	27.87
Location	Land Side
Category	Earthen Levee
Item	Slope Stability

Looking south at livestock erosion on landside shoulder and slope.

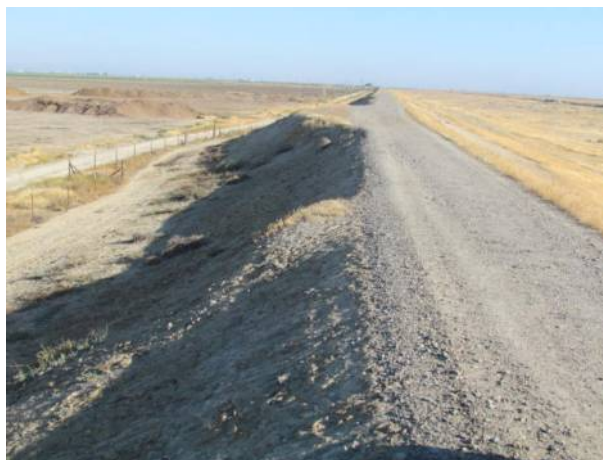
richard_f_20131112_215.JPG

Looking north at livestock erosion on landward slope. (Spring 2013)

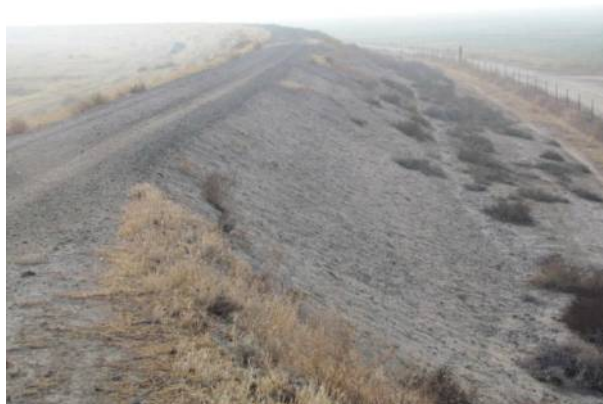
richard_f_20131127_302.JPG

Levee Mile Report Line	15
Start Levee Mile	27.56
End Levee Mile	27.87
Location	Land Side
Category	Earthen Levee
Item	Slope Stability

Looking south at livestock erosion on landward slope. (Fall 2013)

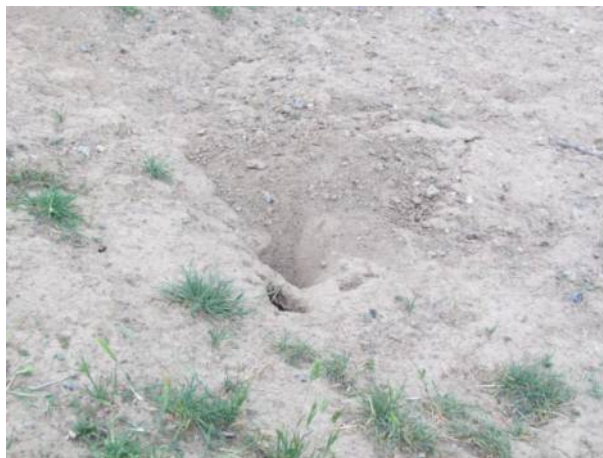
richard_f_20131112_211.jpg

Levee Mile Report Line	17
Start Levee Mile	31.01
End Levee Mile	31.01
Location	Land Side
Category	Earthen Levee
Item	Animal Control

Looking at typical rodent hole on landside slope.

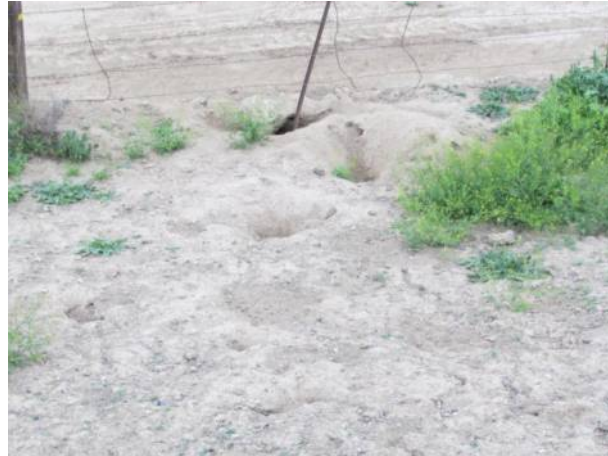
richard_f_20131112_212.jpg

Looking west at rodent holes on landside slope and toe near fence line.

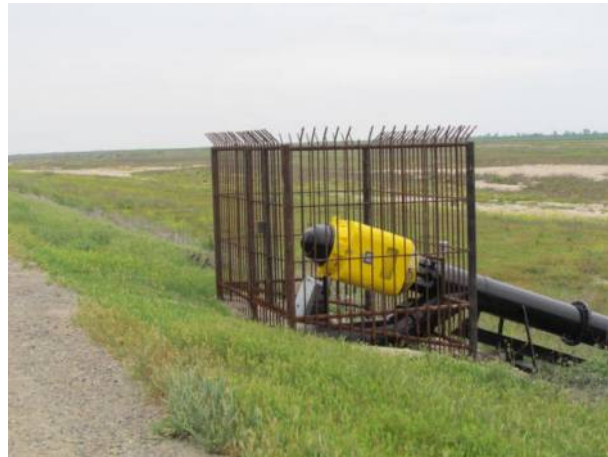
richard_f_20131112_222.jpg

Levee Mile Report Line	18
Start Levee Mile	32.99
End Levee Mile	32.99
Location	Water Side
Category	Earthen Levee
Item	Encroachments

Looking northeast at new metal fence around slant pump on waterside slope.

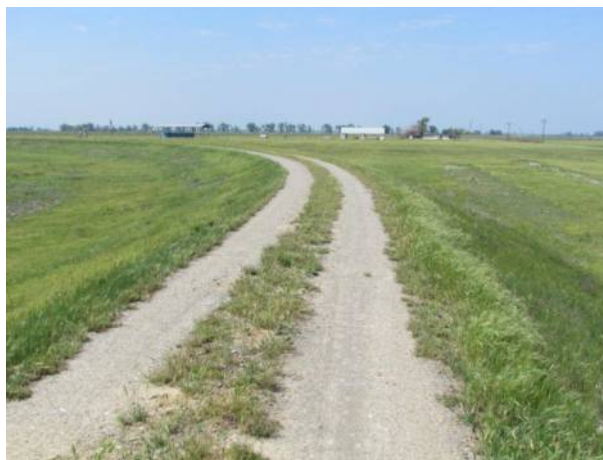
richard_f_20131112_229.jpg

Looking east at vegetation on levee crown.

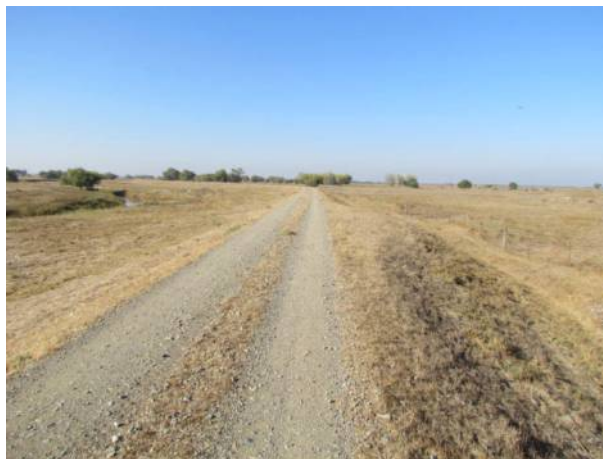
richard_f_20131112_230.JPG

Levee Mile Report Line	1
Start Levee Mile	0.11
End Levee Mile	2.57
Location	Crown
Category	Earthen Levee
Item	Crown Surface / Depressions / Rutting

Looking east at un-regraded levee crown. (Fall 2012)

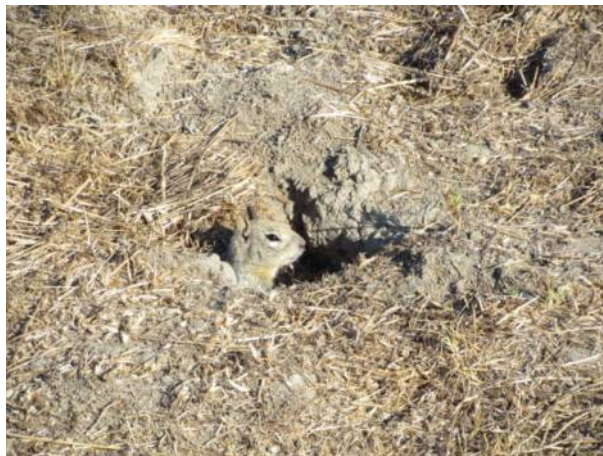
richard_f_20131112_223.JPG

Levee Mile Report Line	3
Start Levee Mile	1.22
End Levee Mile	1.22
Location	Land Side
Category	Earthen Levee
Item	Animal Control

Looking at east at active rodent holes on landside berm.
