**Flood Control Project Maintenance
Levee Inspections**

Fall 2013 Levee Maintenance Deficiency Summary Report

San Joaquin River Basin

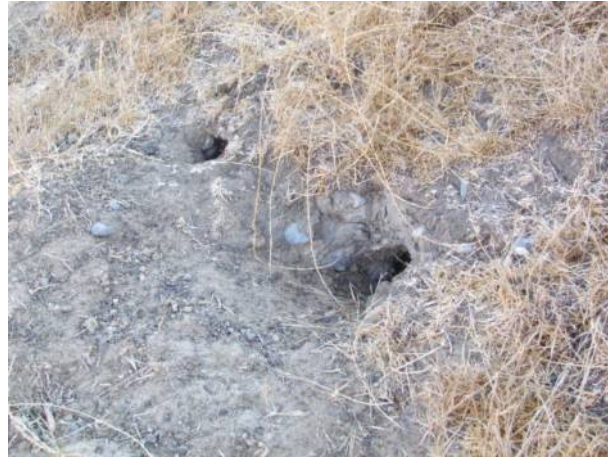
richard_f_20131121_282.JPG

Looking north at several rodent holes on landward slope.

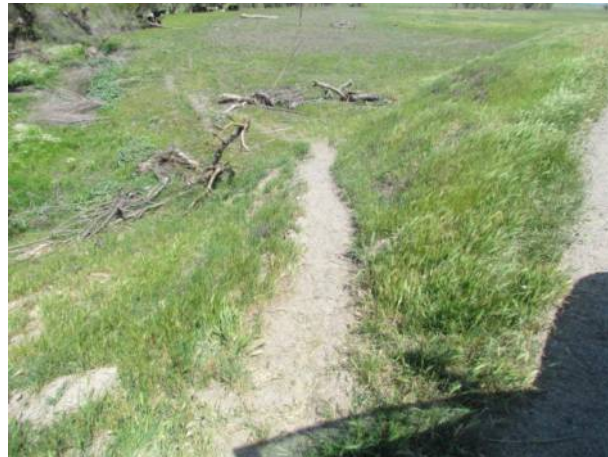
richard_f_20131112_224.jpg

Levee Mile Report Line	4
Start Levee Mile	1.51
End Levee Mile	1.51
Location	Land Side
Category	Earthen Levee
Item	Animal Control

Looking northeast at landside slope damaged by livestock.

DWR ID: DWR_NA0010_07_f_2012_1										
4	1.51	1.51	Earthen Levee	Animal Control	LS M Ma		A2 : Repair the levee slope damaged by livestock and prevent large animal access. Inspector Comments: Erosion on landward slope has been repaired by district. Landward toe erosion not repaired.	37.263930 ° -120.750680 °	37.263930 ° -120.750680 °	3 Y
DWR ID: DWR_NA0010_07_s_2012_3										
5	1.71	1.72	Earthen Levee	Animal Control	LS M Ma		A1 : Exterminate rodents and backfill and compact or grout burrows.	37.262570 ° -120.747453 °	37.262467 ° -120.747180 °	5 Y
DWR ID: DWR_NA0010_07_s_2013_5										
6	1.86	1.86	Earthen Levee	Animal Control	CR A/W Ma		A3 : No rodents visible, but rodent burrows visible; need to backfill and compact or grout burrows. Inspector Comments: Large rodent holes on crown of levee and landside shoulder of levee.	37.261670 ° -120.745010 °	37.261670 ° -120.745010 °	31 Y
DWR ID: DWR_NA0010_07_s_2012_31

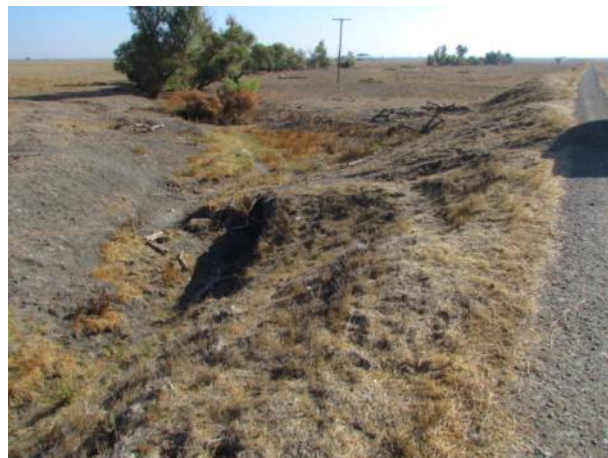
richard_f_20131112_225.JPG

Levee Mile Report Line	4
Start Levee Mile	1.51
End Levee Mile	1.51
Location	Land Side
Category	Earthen Levee
Item	Animal Control

Looking southeast at landside slope and toe damage by livestock.

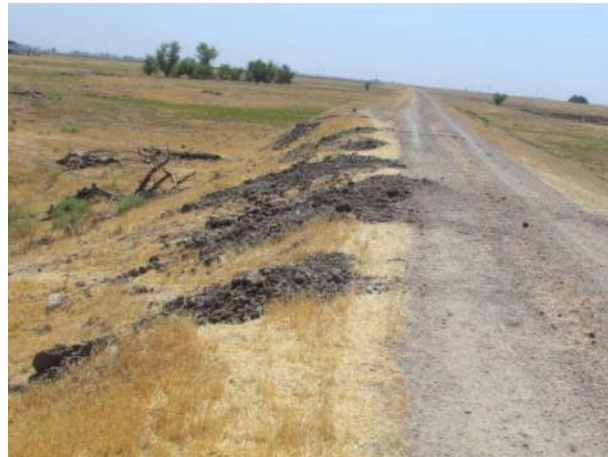
Levee Mile Report Line	4
Start Levee Mile	1.51
End Levee Mile	1.51
Location	Land Side
Category	Earthen Levee
Item	Animal Control
Looking south at landward slope.	
richard_f_20131112_227.JPG

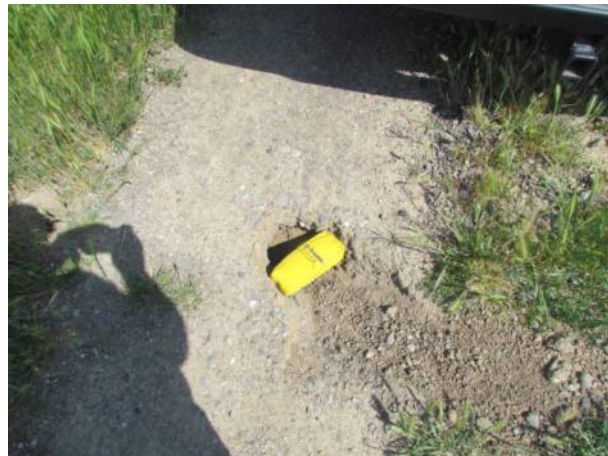
Levee Mile Report Line	6
Start Levee Mile	1.86
End Levee Mile	1.86
Location	Crown
Category	Earthen Levee
Item	Animal Control
Looking at rodent hole on levee crown.	
richard_f_20131112_231.jpg

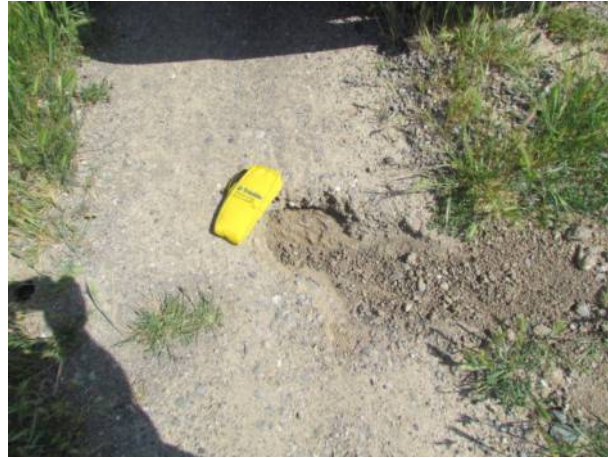
richard_f_20131112_232.jpg

Looking at rodent hole on levee crown.

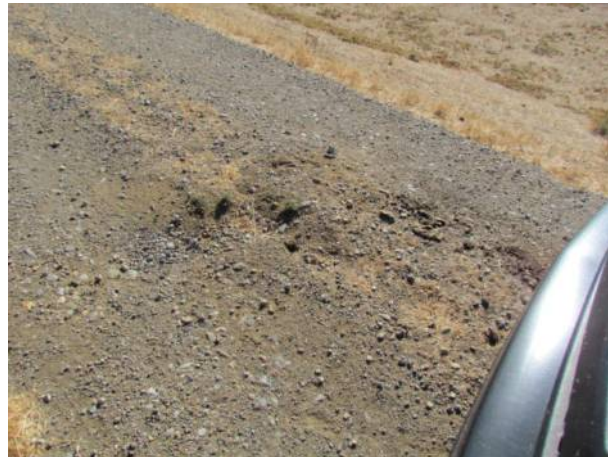
richard_f_20131121_283.JPG

Levee Mile Report Line	6
Start Levee Mile	1.86
End Levee Mile	1.86
Location	Crown
Category	Earthen Levee
Item	Animal Control

Looking north a repaired rodent hole on levee crown.

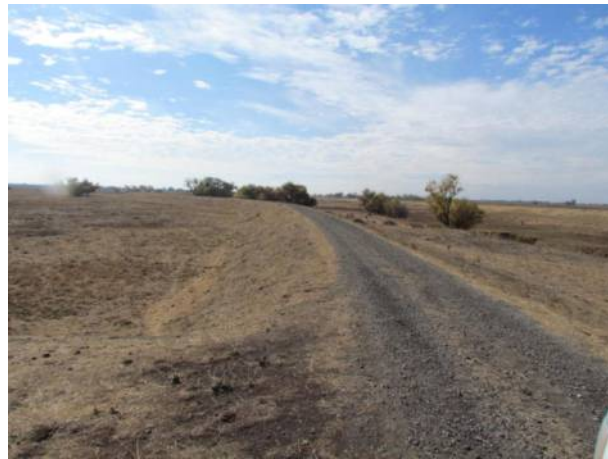
richard_f_20131121_287.JPG

Looking west at typical view of levee.

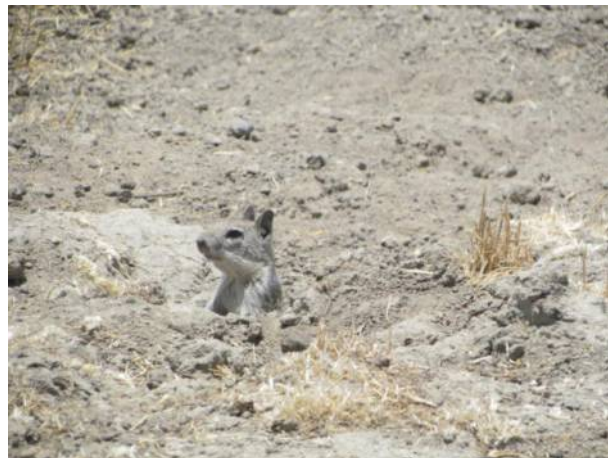
richard_f_20131112_236.JPG

Looking west at rodent holes on landward slope.

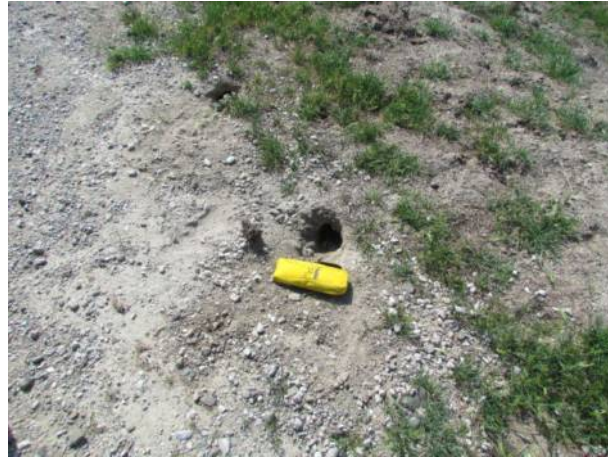
richard_f_20131112_234.jpg

Looking at typical rodent hole along the section.

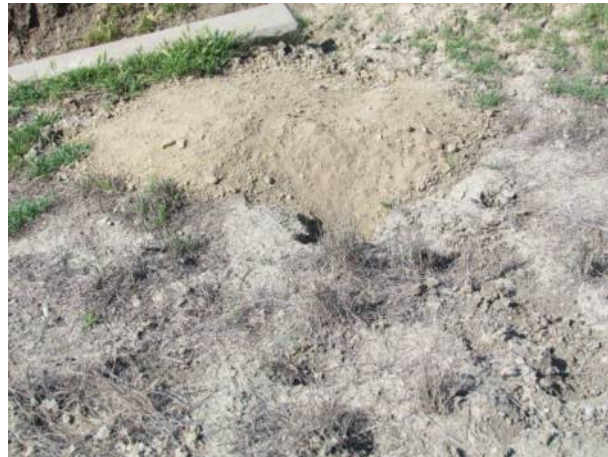
richard_f_20131112_235.jpg

Levee Mile Report Line	6
Start Levee Mile	2.07
End Levee Mile	2.12
Location	Land Side
Category	Earthen Levee
Item	Animal Control

Looking at typical rodent hole on landside slope near headwall.

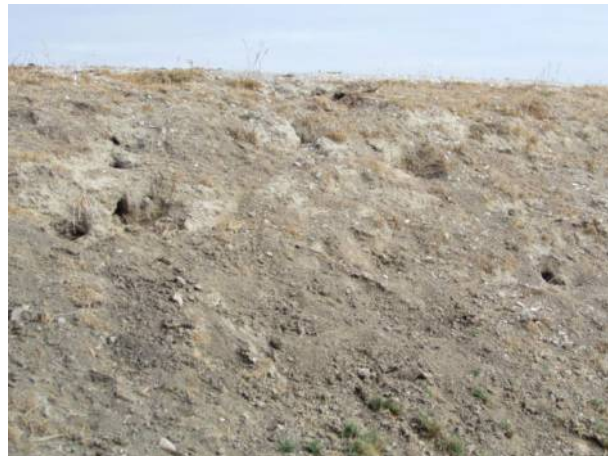
richard_f_20131121_288.JPG

Levee Mile Report Line	6
Start Levee Mile	2.07
End Levee Mile	2.12
Location	Land Side
Category	Earthen Levee
Item	Animal Control

Looking south at several rodent holes on landward slope.

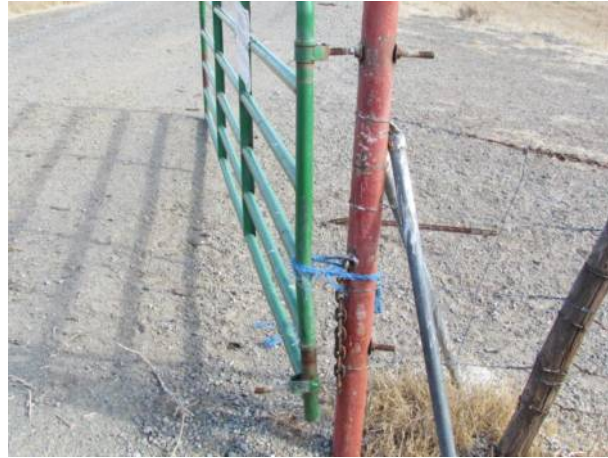
LMR No.	Levee Mile		Category	Item	Location *	Rating **	Action/Comment	GPS Latitude/Longitude		Issue No.
	Start	End						Start	End	
1	0.67	0.67	Earthen Levee	Repair Gates	WS	M	Inspector Comments: Bottom hinge broken on gate across levee crown.	37.202725 ° -120.743028 °	37.202725 ° -120.743028 °	2 Y
DWR ID: DWR_NA0010_11_f_2013_2										
2	1.77	1.77	Earthen Levee	Animal Control	LS	M	A3 : No rodents visible, but rodent burrows visible; need to backfill and compact or grout burrows.	37.202743 ° -120.723187 °	37.202743 ° -120.723187 °	1
DWR ID: DWR_NA0010_11_s_2012_1

Levee Mile Report Line	1
Start Levee Mile	0.67
End Levee Mile	0.67
Location	Water Side
Category	Earthen Levee
Item	Repair Gates
Looking at bottom hinge broken on gate across levee crown.	
richard_f_20131127_305.JPG

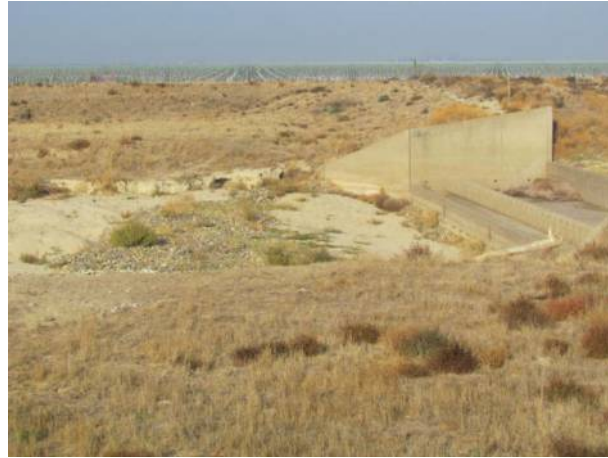
richard_f_20131112_243.JPG

Levee Mile Report Line	2
Start Levee Mile	0.08
End Levee Mile	0.08
Location	Water Side
Category	Channels
Item	Concrete Foundations

Looking south at erosion in channel near drop structure.

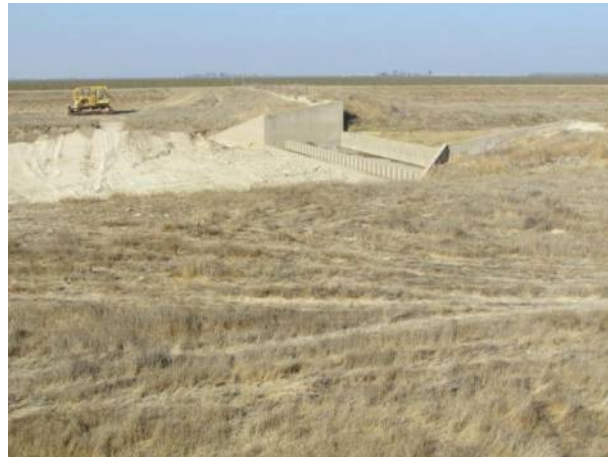
richard_f_20131127_309.JPG

Levee Mile Report Line	2
Start Levee Mile	0.08
End Levee Mile	0.08
Location	Water Side
Category	Channels
Item	Concrete Foundations

Looking south at repaired erosion on downstream side of drop structure.

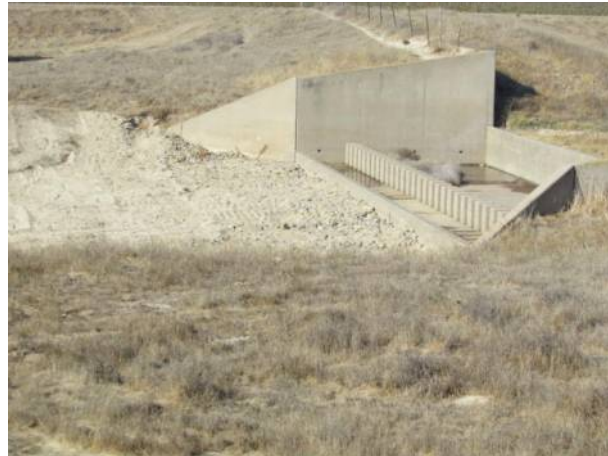
richard_f_20131127_310.JPG

Levee Mile Report Line	2
Start Levee Mile	0.08
End Levee Mile	0.08
Location	Water Side
Category	Channels
Item	Concrete Foundations

Looking south at repaired erosion site on downstream side of structure.

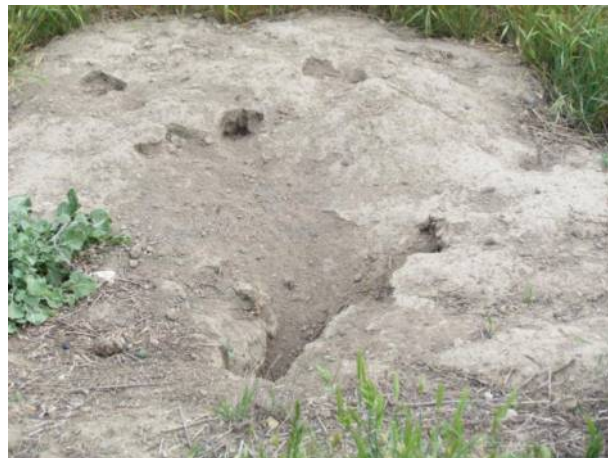
richard_f_20131112_249.jpg

Levee Mile Report Line	4
Start Levee Mile	5.75
End Levee Mile	5.90
Location	Land Side
Category	Earthen Levee
Item	Animal Control

Looking at several rodent holes on landside slope.

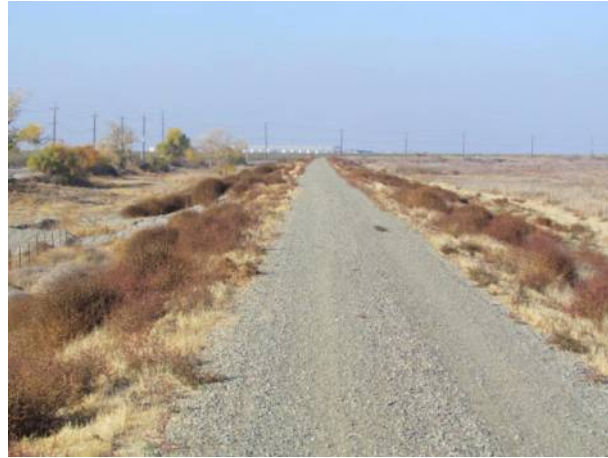
richard_f_20131127_315.JPG

Looking north at controlled tumble weeds on landward and waterward slope. (Fall 2013)

LMR No.	Levee Mile		Category	Item	Location *	Rating ** +	Action/Comment	GPS Latitude/Longitude		Issue No. Photo
	Start	End						Start	End	
1	11.86	13.15	Earthen Levee	Vegetation	LS A/W	Ma	V2 : Remove the wild growth other than native grasses from the levee slopes. Inspector Comments: Dense tumble weed on landside and waterside shoulder and slope.	36.815400 ° -120.305080 °	36.797353 ° -120.308560 °	1 Y
DWR ID: DWR_NA0010_18_s_2012_1										
2	13.55	15.12	Earthen Levee	Crown Surface / Depressions / Rutting	LS A/W	Ma	C2 : Repair depressions or ruts in the crown or slope.	36.792861 ° -120.304907 °	36.776058 ° -120.287111 °	3
DWR ID: DWR_NA0010_18_f_2012_3

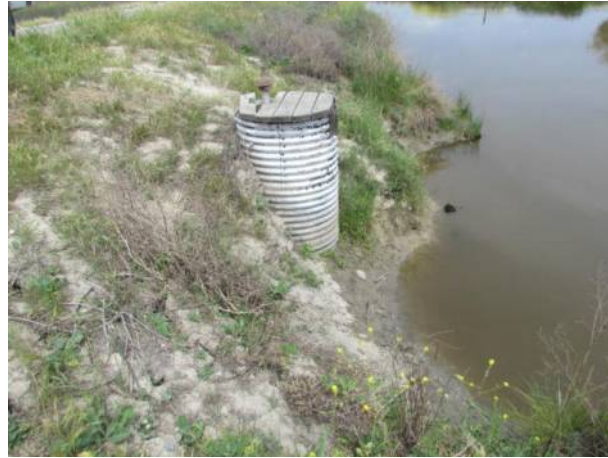
richard_f_20131112_257.jpg

Looking north at erosion on waterside toe near screw gate.

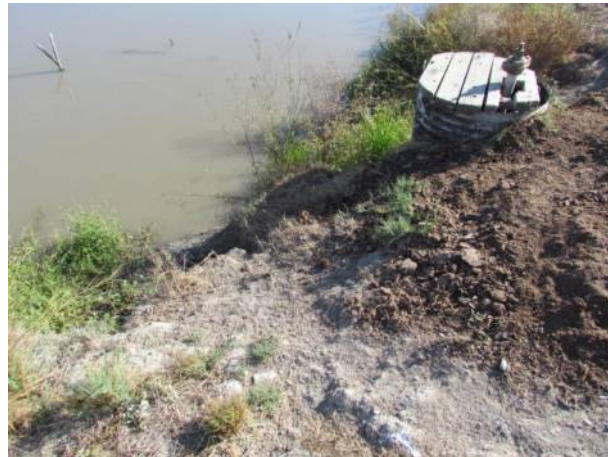
richard_f_20131112_258.JPG

Levee Mile Report Line	1
Start Levee Mile	0.10
End Levee Mile	0.10
Location	Water Side
Category	Earthen Levee
Item	Erosion / Bank Caving

Looking south at erosion near screw gate. (Fall 2012)

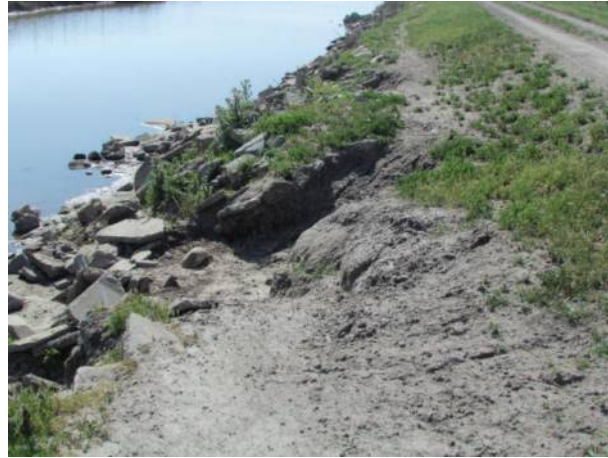
richard_f_20131112_251.jpg

Looking northeast at erosion caused by animals on waterside slope.

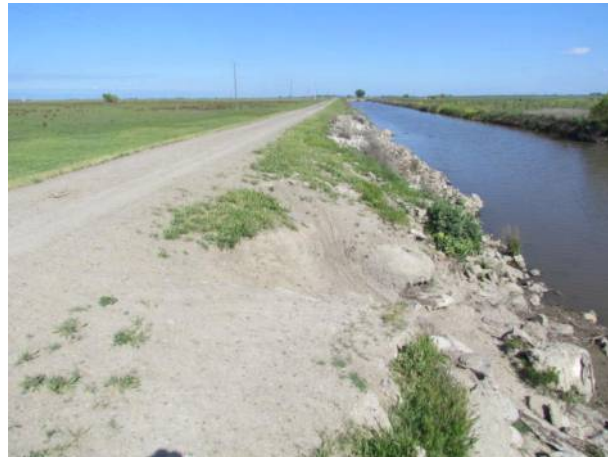
richard_f_20131112_252.jpg

Levee Mile Report Line	3
Start Levee Mile	2.65
End Levee Mile	3.65
Location	Water Side
Category	Earthen Levee
Item	Animal Control

Looking south at erosion caused by animals on waterside slope.

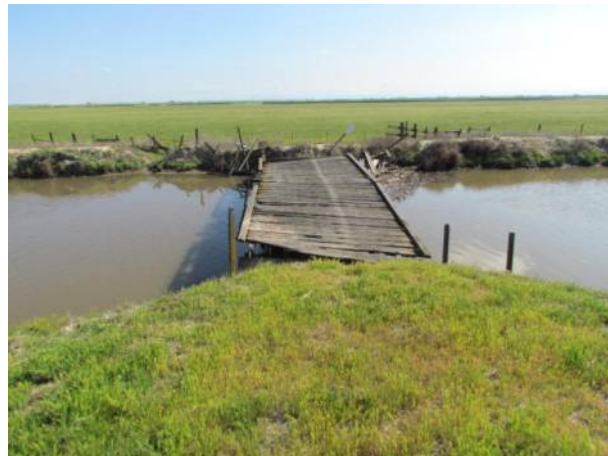
richard_f_20131112_253.jpg

Levee Mile Report Line	6
Start Levee Mile	4.68
End Levee Mile	4.68
Location	Water Side
Category	Channels
Item	Encroachments

Looking east at dilapidated bridge across canal.

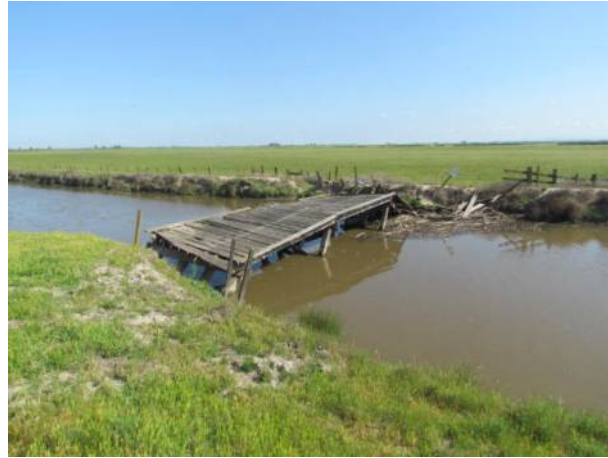
richard_f_20131112_254.jpg

Looking northeast at dilapidated bridge across canal.

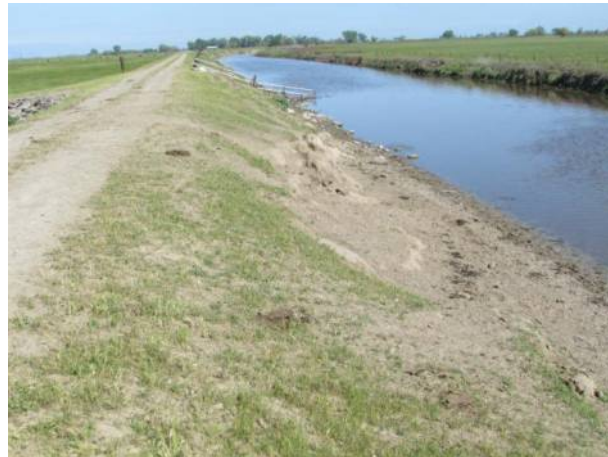
richard_f_20131112_255.jpg

Levee Mile Report Line	7
Start Levee Mile	4.80
End Levee Mile	4.86
Location	Water Side
Category	Earthen Levee
Item	Animal Control

Looking north at waterside erosion from livestock.

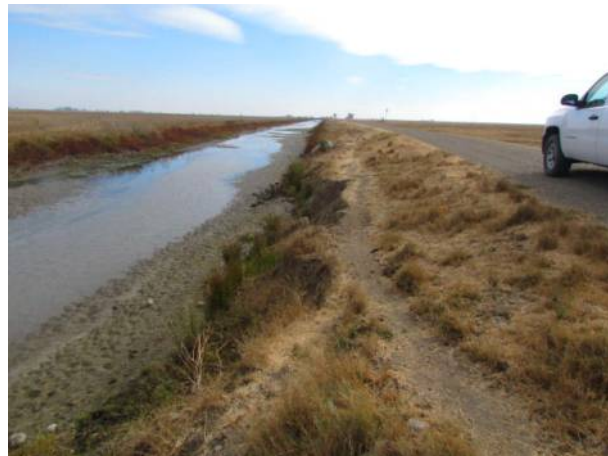
richard_f_20131121_285.JPG

Levee Mile Report Line	9
Start Levee Mile	5.02
End Levee Mile	5.05
Location	Water Side
Category	Earthen Levee
Item	Erosion / Bank Caving

Looking south livestock erosion on waterward toe.

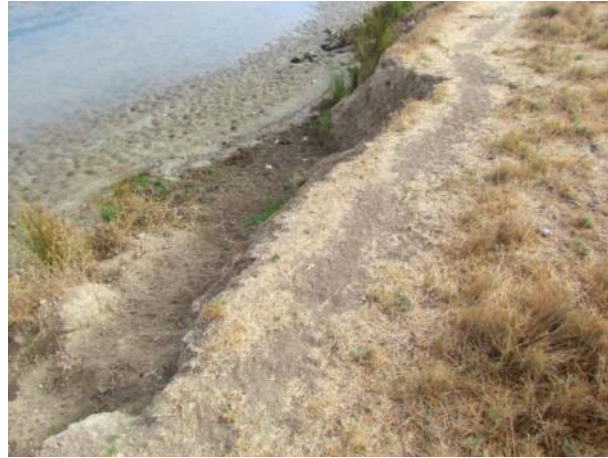
richard_f_20131121_286.JPG

Looking southeast at livestock erosion on waterward toe.

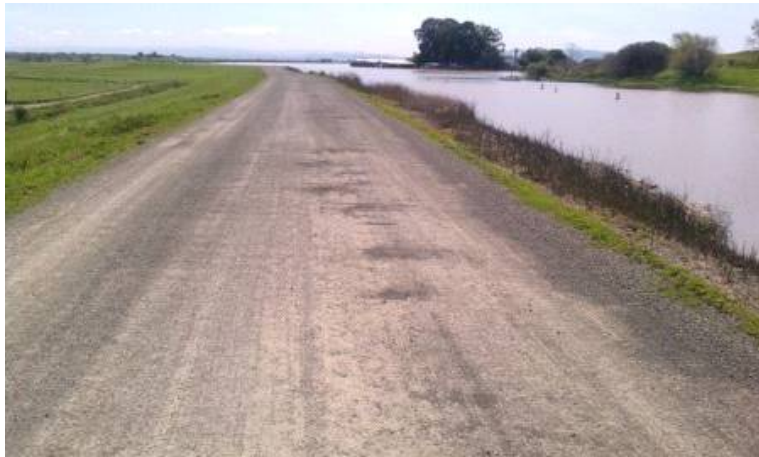
richard_f_20131112_260.jpg

Levee Mile Report Line	10
Start Levee Mile	5.07
End Levee Mile	5.10
Location	Crown
Category	Earthen Levee
Item	Crown Surface / Depressions / Rutting

Looking south at rutting on levee crown.

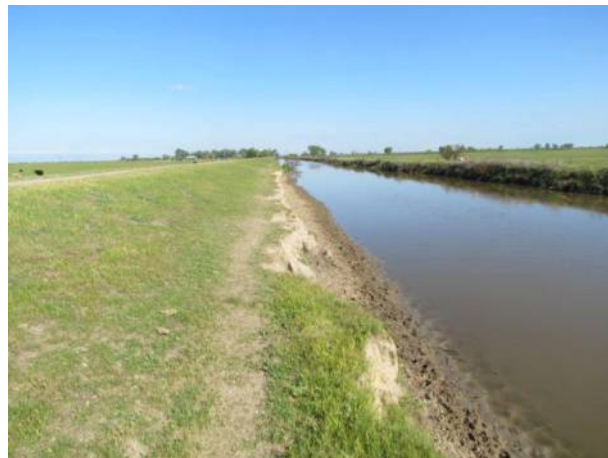
richard_f_20131112_256.jpg

Levee Mile Report Line	12
Start Levee Mile	5.15
End Levee Mile	5.20
Location	Water Side
Category	Earthen Levee
Item	Animal Control

Looking north at livestock erosion along waterside slope and toe.

LMR No.	Levee Mile		Category	Item	Location *	Rating ** +	Action/Comment	GPS Latitude/Longitude		Issue No. Photo
	Start	End						Start	End	
12	5.15	5.20	Earthen Levee	Animal Control	WS	M	A2 : Repair the levee slope damaged by livestock and prevent large animal access. Inspector Comments: Erosion caused by livestock on waterside toe.	37.268492 ° -120.737493 °	37.269133 ° -120.738208 °	6 Y

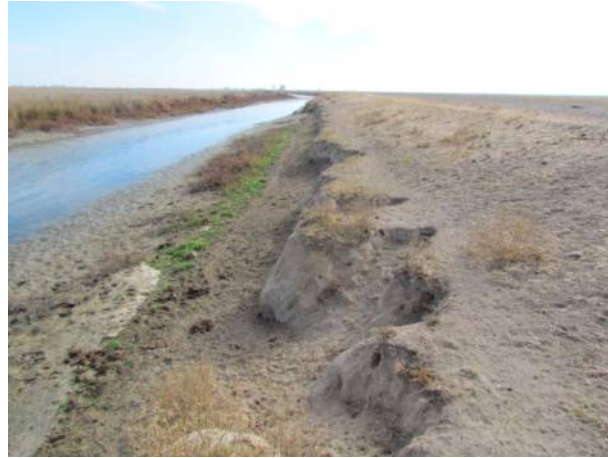
richard_f_20131121_284.JPG

Looking south at livestock erosion on waterward toe.

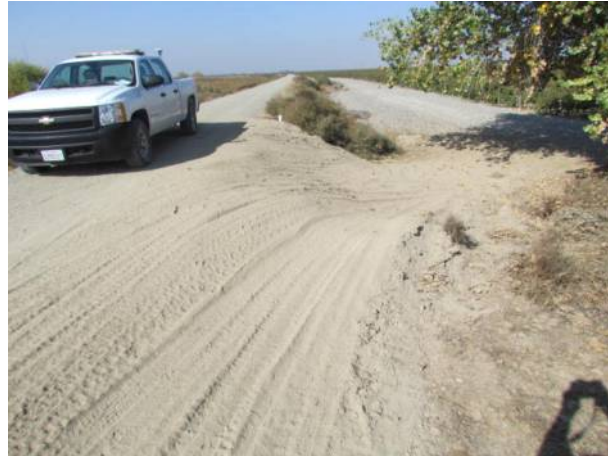
richard_f_20131112_270.JPG

Looking north at slope damaged by vehicle traffic.

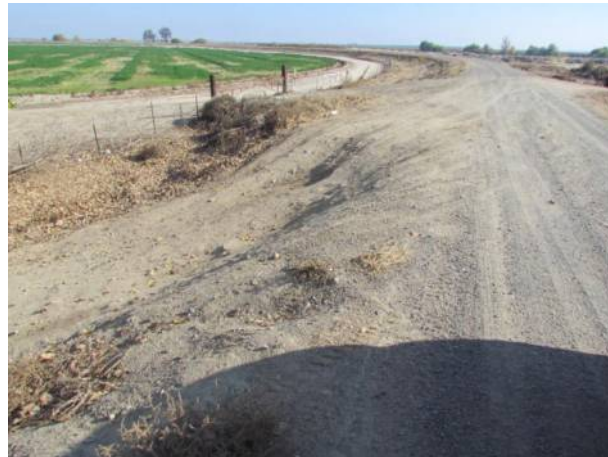
richard_f_20131127_316.JPG

Levee Mile Report Line	3
Start Levee Mile	1.53
End Levee Mile	1.53
Location	Land Side
Category	Earthen Levee
Item	Slope Stability

Looking south at slope damaged by vehicle traffic. (Fall 2013)

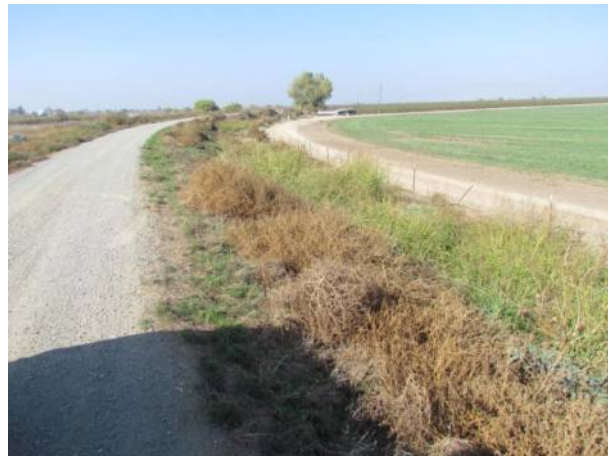
richard_f_20131112_261.JPG

Levee Mile Report Line	4
Start Levee Mile	1.56
End Levee Mile	1.75
Location	Land Side
Category	Earthen Levee
Item	Vegetation

Looking south at dense vegetation on landside slope.

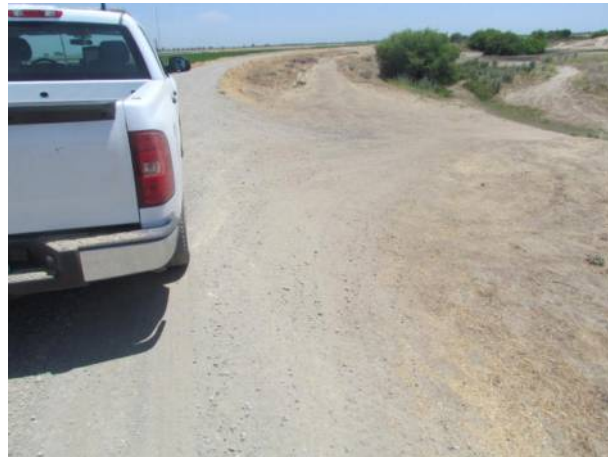
richard_f_20131112_272.JPG

DWR ID: DWR_NA0010_23_s_2012_2									
5	2.13	2.42	Earthen Levee	Slope Stability	WS M Ma	S3 : Repair the levee slope damaged by vehicle traffic and prevent access where possible. Inspector Comments: Several damaged sites within this reach.	36.775507 ° -120.251672 °	36.774423 ° -120.246993 °	16 Y
DWR ID: DWR_NA0010_23_s_2013_16									
6	2.85	2.85	Earthen Levee	Vegetation	LS M Ma	V4 : Elderberries are blocking visibility and flood fight capability.	36.771537 ° -120.240917 °	36.771537 ° -120.240917 °	15 Y
DWR ID: DWR_NA0010_23_s_2012_15									
7	3.30	3.30	Earthen Levee	Vegetation	LS M Ma	V4 : Elderberries are blocking visibility and flood fight capability.	36.774403 ° -120.234705 °	36.774403 ° -120.234705 °	3 Y
DWR ID: DWR_NA0010_23_s_2012_3									
8	3.45	3.45	Earthen Levee	Vegetation	LS M Ma	V4 : Elderberries are blocking visibility and flood fight capability.	36.776537 ° -120.234573 °	36.776537 ° -120.234573 °	9 Y

Levee Mile Report Line	5
Start Levee Mile	2.13
End Levee Mile	2.42
Location	Water Side
Category	Earthen Levee
Item	Slope Stability

Looking south at waterward slope damaged by vehicle traffic

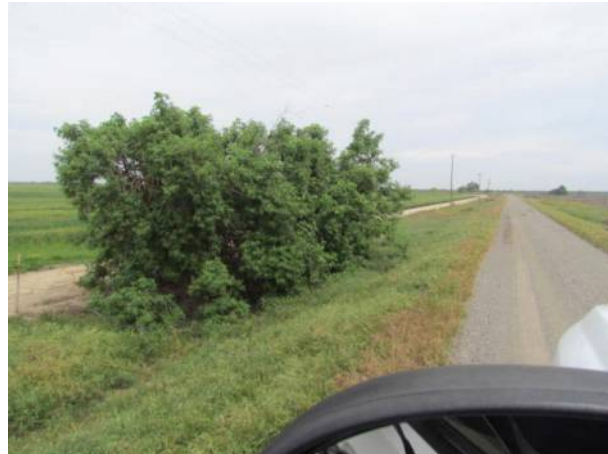
richard_f_20131112_271.jpg

Levee Mile Report Line	6
Start Levee Mile	2.85
End Levee Mile	2.85
Location	Land Side
Category	Earthen Levee
Item	Vegetation

Looking south at elderberry on landside toe and berm.

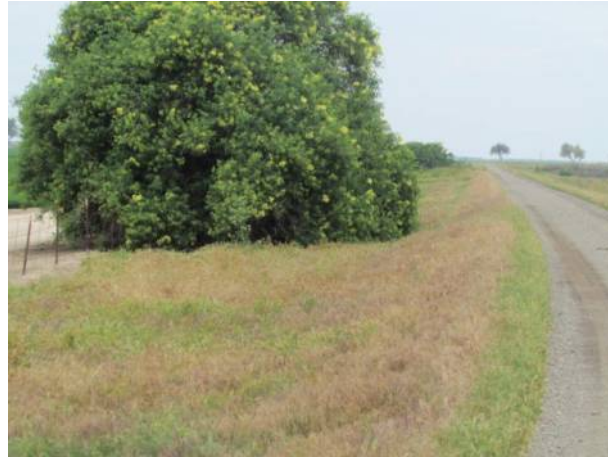
richard_f_20131112_263.jpg

Looking south at elderberry on landside toe and berm.

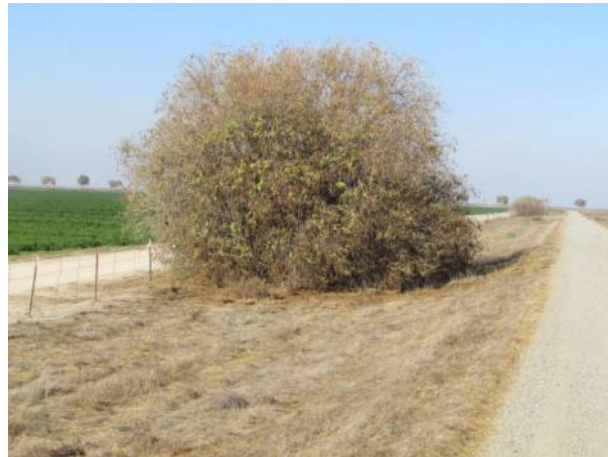
richard_f_20131127_317.JPG

Levee Mile Report Line	7
Start Levee Mile	3.30
End Levee Mile	3.30
Location	Land Side
Category	Earthen Levee
Item	Vegetation

Looking south at elderberry bush on landward toe. (Fall 2013)

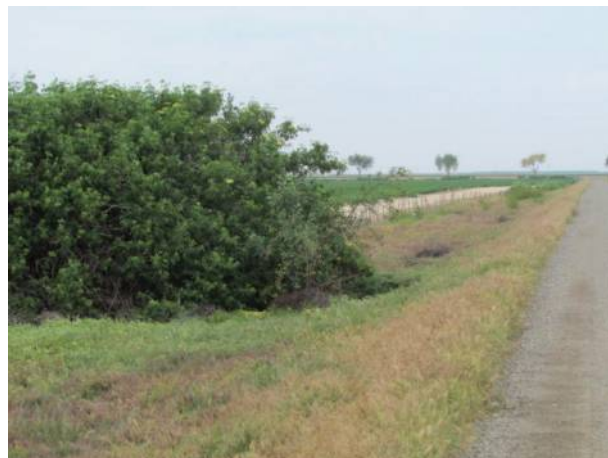
richard_f_20131112_267.jpg

Looking south at elderberry on landside toe and berm.

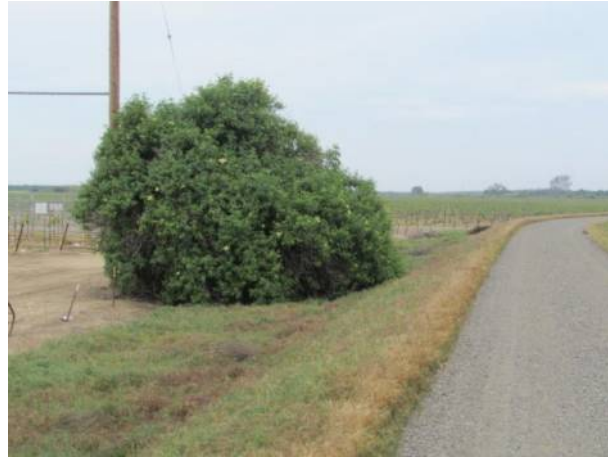
Levee Mile Report Line	9
Start Levee Mile	4.14
End Levee Mile	4.14
Location	Land Side
Category	Earthen Levee
Item	Vegetation
Looking south at elderberry on landside toe and berm.	
richard_f_20131112_268.jpg

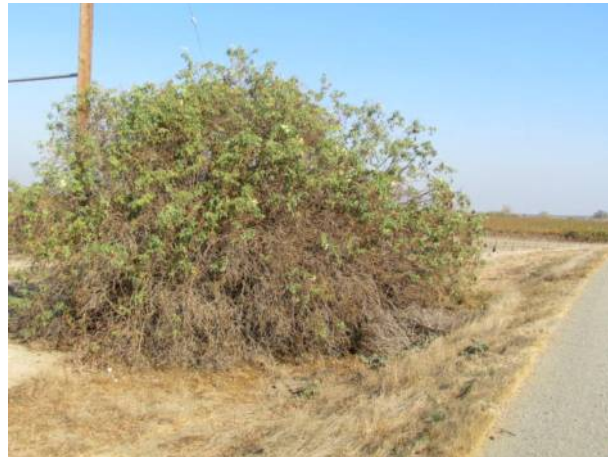
Levee Mile Report Line	9
Start Levee Mile	4.14
End Levee Mile	4.14
Location	Land Side
Category	Earthen Levee
Item	Vegetation
Looking south at elderberry bush on landward toe. (Fall 2013)	
richard_f_20131127_318.JPG

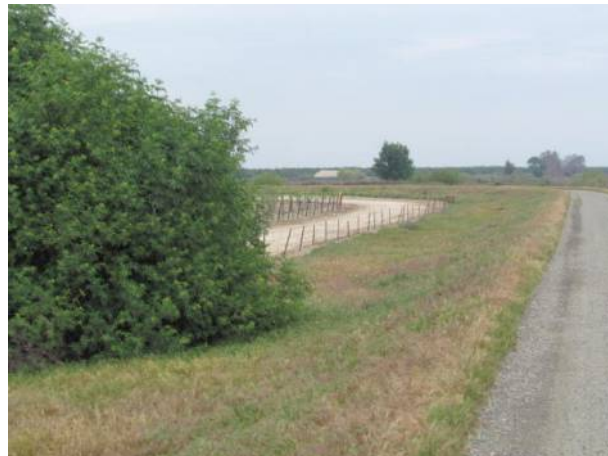
Levee Mile Report Line	10
Start Levee Mile	4.46
End Levee Mile	4.46
Location	Land Side
Category	Earthen Levee
Item	Vegetation
Looking south at elderberry on landside toe and berm.	
richard_f_20131112_269.jpg

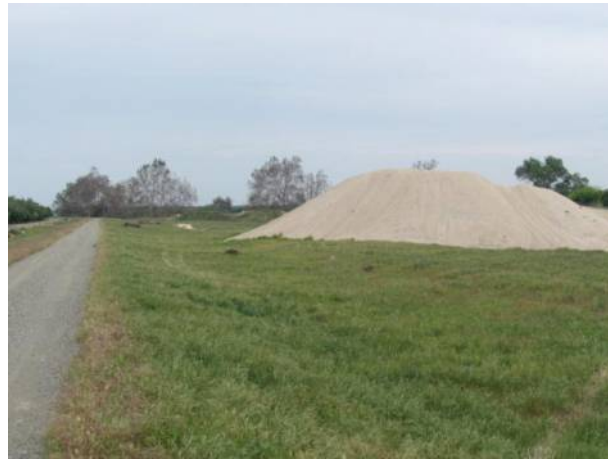
richard_f_20131112_265.jpg

Looking south at sand pile 20-30 feet away from waterside slope.

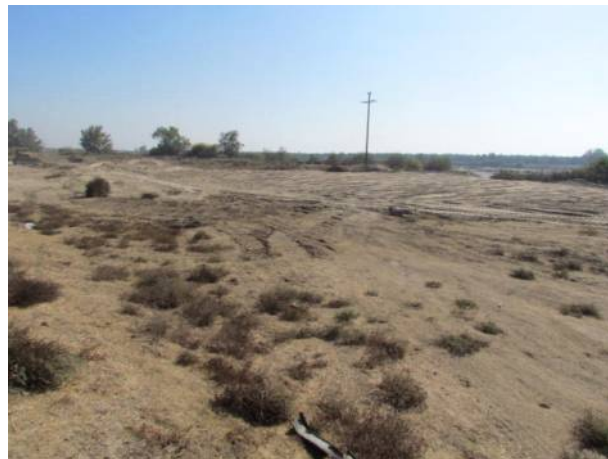
richard_f_20131112_266.JPG

Levee Mile Report Line	11
Start Levee Mile	5.23
End Levee Mile	5.23
Location	Water Side
Category	Earthen Levee
Item	Encroachments

Looking southwest at de-graded sandpile in channel.

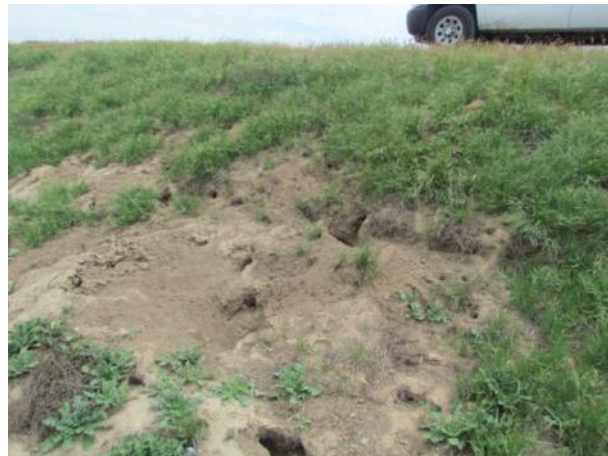
richard_f_20131112_264.jpg

Levee Mile Report Line	12
Start Levee Mile	5.69
End Levee Mile	5.90
Location	Water Side
Category	Earthen Levee
Item	Animal Control

Looking at several rodent holes on landside slope.

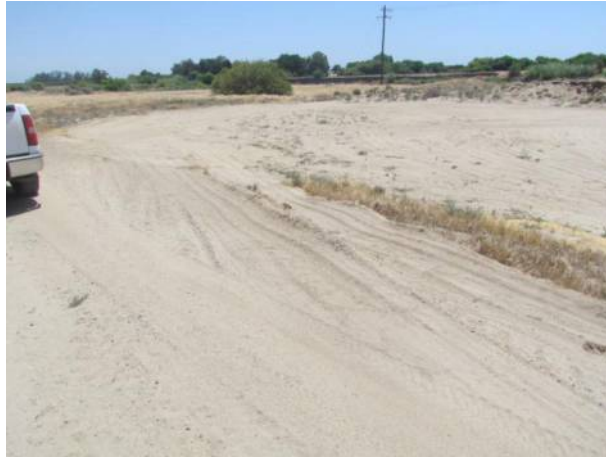
richard_f_20131112_273.JPG

Looking southwest at waterward slope damaged due to vehicle traffic.

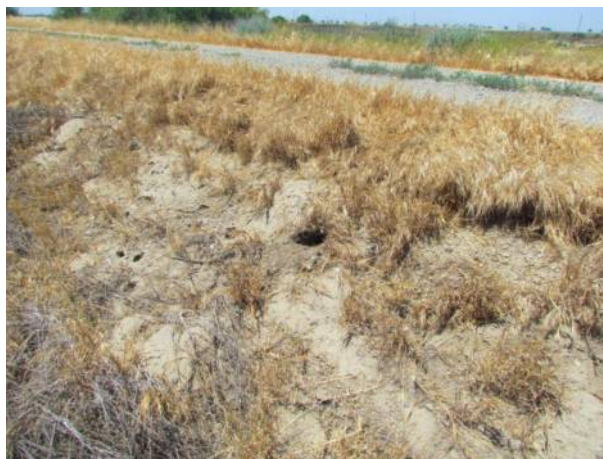
richard_f_20131112_275.JPG

Levee Mile Report Line	3
Start Levee Mile	3.46
End Levee Mile	3.46
Location	Land Side
Category	Earthen Levee
Item	Animal Control

Looking east at one of several rodent holes on landward slope.

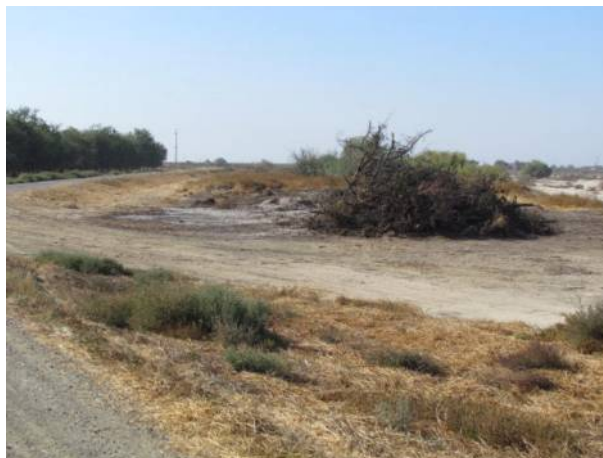
richard_f_20131112_274.JPG

Levee Mile Report Line	5
Start Levee Mile	6.33
End Levee Mile	6.33
Location	Water Side
Category	Earthen Levee
Item	Encroachments

Looking north at prunings on waterside berm.
