**Flood Control Project Maintenance  
Levee Inspections**

**Fall 2014 Levee Maintenance Deficiency Summary Report**

**San Joaquin River Basin**

<b>NA0010</b>	Overall LMA Rating	Total LMA Miles						
<b>Lower San Joaquin Levee District</b>	<b>U</b>	<b>191.11</b>						
Rated Item	Maintenance Deficiency				Enforcement		Design & System Obsolescence	
	M Miles	U Miles	M + 4U Miles	Threshold %	M Miles	U Miles	M Miles	U Miles
<i>Earthen Levee</i>								
Vegetation	58.64	1.91	66.28	34.68%				
Trim / Thin Trees	0.03		0.03	0.02%				
Encroachments	1.83		1.83	0.96%	1.82			
Animal Control	2.70		2.70	1.41%				
Slope Stability	1.08		1.08	0.57%				
Erosion / Bank Caving	0.13	0.01	0.17	0.09%				
Crown Surface / Depressions / Rutting	10.46		10.46	5.47%				
<i>Interior Drainage &amp; Piping Systems</i>								
Erosion Areas		0.01	0.04	0.02%				
<i>Rivers, Channels &amp; Designated Floodways</i>								
Encroachments						0.01		
<i>Supplemental</i>								
DWR UCIP Field Study					2.78	0.17		
<b>LMA Totals:</b>	<b>74.87</b>	<b>1.93</b>	<b>82.59</b>	<b>43.21%</b>	<b>4.60</b>	<b>0.18</b>	<b>0.00</b>	<b>0.00</b>

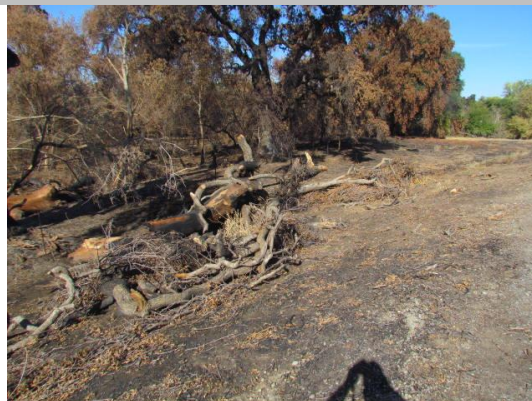
Photo 1 of 2 : FA\_2014\_NA0010\_118\_98\_20141110\_00022.jpg

LM Start	0.07	Rating **	M	Issue No.	98
LM End	0.07	Issue Type +	Ma	Location *	WS
Category	Earthen Levee			GPS Latitude/Longitude	
				Start	End
Item	Encroachments			37.348157 °	37.348157 °
				-120.959658 °	-120.959658 °
DWR ID	DWR_NA0010_01_f_2014_98				
Action/Comments					
Tree or limb					
Inspector Comments: Downed tree limbs due to fire along levee slope.

Looking north at tree limbs on waterward toe.

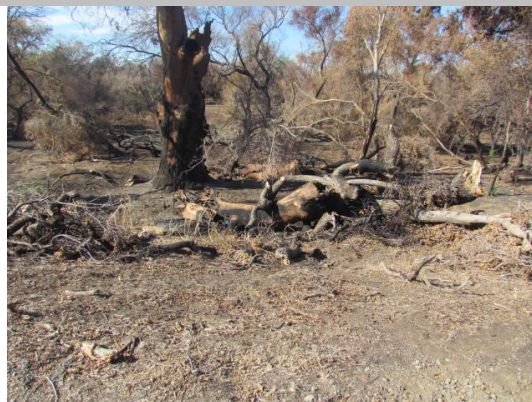
Photo 2 of 2 : FA\_2014\_NA0010\_118\_98\_20141110\_00021.jpg

Looking southwest at tree limbs on waterwater toe.

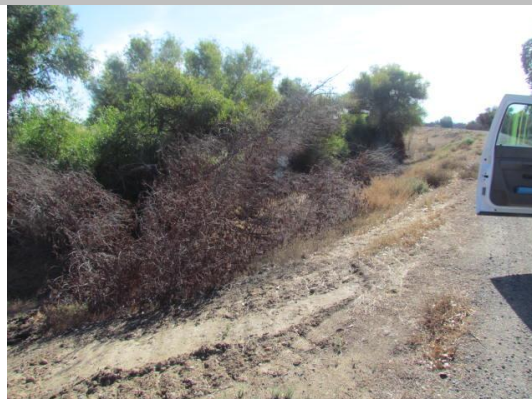
Photo 1 of 1 : FA\_2014\_NA0010\_118\_99\_20141110\_00023.jpg

LM Start	0.21	Rating **	M	Issue No.	99
LM End	0.21	Issue Type +	Ma	Location *	LS
Category	Earthen Levee			GPS Latitude/Longitude	
				Start	End
Item	Encroachments			37.346582 °	37.346582 °
				-120.961052 °	-120.961052 °
DWR ID	DWR_NA0010_01_f_2014_99				
Action/Comments					
Tree or limb					
Inspector Comments: Downed tree limbs on landward slope.

Looking south at tree limbs on landward slope and toe.

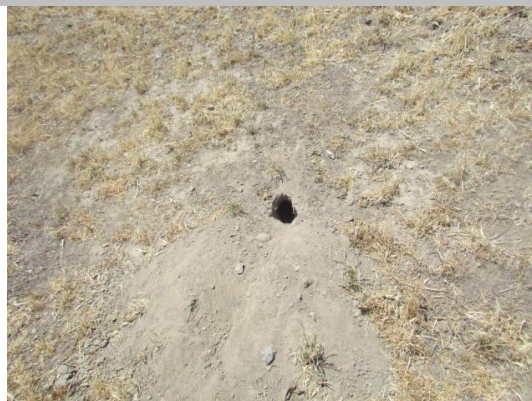
Photo 1 of 1 : FA\_2014\_NA0010\_118\_1\_20141103\_00001.jpg

LM Start	0.24	Rating **	M	Issue No.	1
LM End	0.41	Issue Type +	Ma	Location *	LS
Category	Earthen Levee			GPS Latitude/Longitude	
				Start	End
Item	Animal Control			37.346152 °	37.343935 °
				-120.961402 °	-120.962536 °
DWR ID	DWR_NA0010_01_s_2012_1				
Action/Comments					
Exterminate rodents and backfill and compact or grout burrows. Inspector Comments: Typical view of several rodent holes on landward slope.

Looking at typical rodent holes on landward slope.

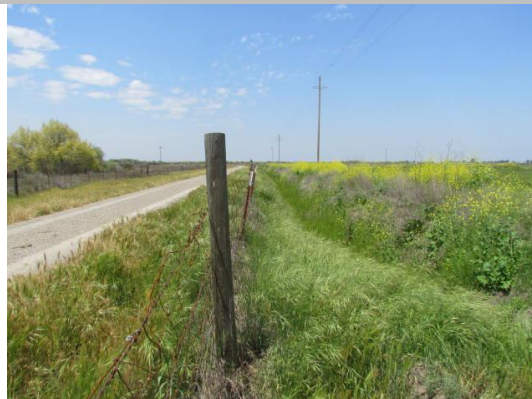
Photo 1 of 2 : FA\_2014\_NA0010\_118\_5\_20141103\_00002.jpg

LM Start	4.00	Rating **	M	Issue No.	5
LM End	4.08	Issue Type +	En	Location *	LS
Category	Earthen Levee			GPS Latitude/Longitude	
				Start	End
Item	Encroachments			37.310837 °	37.310003 °
				-120.926182 °	-120.925313 °
DWR ID	DWR_NA0010_01_s_2012_5				
Action/Comments					
Ditch					
Inspector Comments: Irrigation ditch at landside toe

Looking north at irrigation ditch at landside toe.

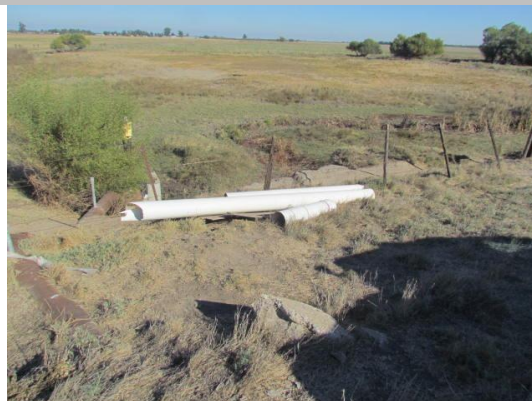
Photo 1 of 1 : FA\_2014\_NA0010\_118\_100\_20141110\_00024.jpg

LM Start	4.16	Rating **	M	Issue No.	100
LM End	4.16	Issue Type +	Ma	Location *	N/A
Category	Earthen Levee			GPS Latitude/Longitude	
				Start	End
Item	Encroachments			37.309049 °	37.309049 °
				-120.924421 °	-120.924421 °
DWR ID	DWR_NA0010_01_f_2014_100				
Action/Comments					
Garbage Inspector Comments: Old PVC pipes left on landward slope.

Looking east at old pvc pipes on landward slope.

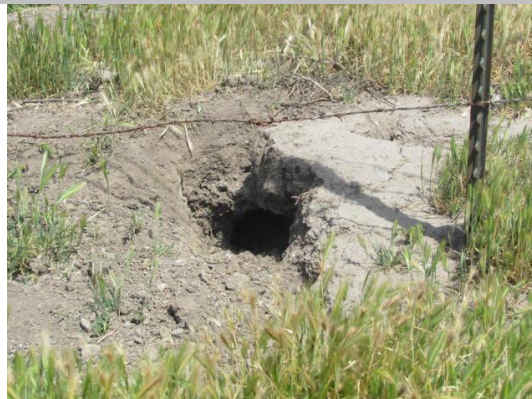
Photo 1 of 3 : FA\_2014\_NA0010\_118\_116\_20141103\_00015.jpg

LM Start	5.75	Rating **	A/W	Issue No.	116
LM End	5.75	Issue Type +	Ma	Location *	LS
Category	Earthen Levee			GPS Latitude/Longitude	
				Start	End
Item	Animal Control			37.304057 °	37.304057 °
				-120.907200 °	-120.907200 °
DWR ID	DWR_NA0010_01_s_2012_116				
Action/Comments					
No rodents visible, but rodent burrows visible; need to backfill and compact or grout burrows.					
Inspector Comments: Large rodent holes on landside slope near fence pole.

Looking east at one of several rodent holes on landside shoulder and slope.

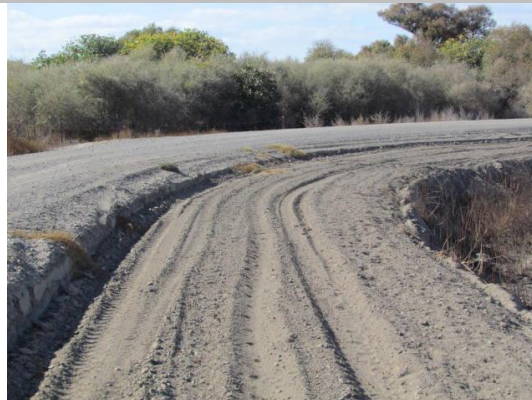
Photo 1 of 2 : FA\_2014\_NA0010\_118\_20\_20141103\_00007.jpg

LM Start	20.28	Rating **	M	Issue No.	20
LM End	22.02	Issue Type +	Ma	Location *	LS
Category	Earthen Levee			GPS Latitude/Longitude	
				Start	End
Item	Encroachments			37.193426 °	37.172663 °
				-120.760419 °	-120.754894 °
DWR ID	DWR_NA0010_01_f_2012_20				
Action/Comments					
Agricultural tilling					
Inspector Comments: Farmer cutting into landside toe and slope.

Looking east at farmer discing into landside slope.

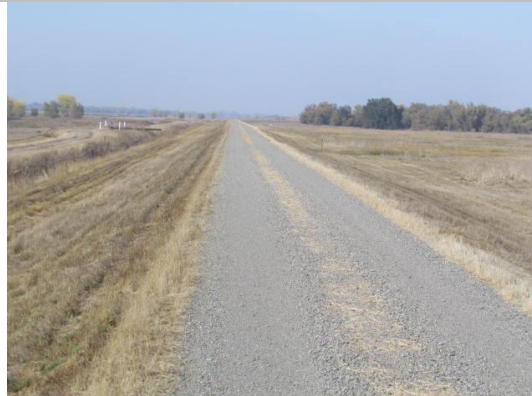
Photo 1 of 2 : FA\_2014\_NA0010\_119\_9\_20141110\_00007.jpg

LM Start	0.00	Rating **	A/W	Issue No.	9
LM End	5.30	Issue Type +	Ma	Location *	CR
Category	Earthen Levee			GPS Latitude/Longitude	
				Start	End
Item	Vegetation			37.296229 °	37.261893 °
				-120.880732 °	-120.832390 °
DWR ID	DWR_NA0010_02A_s _ 2014_9				
Action/Comments					
Remove the wild growth other than native grasses from the levee slopes.					
Inspector Comments: Control vegetation on levee crown.

Looking north at levee crown complies with standards.

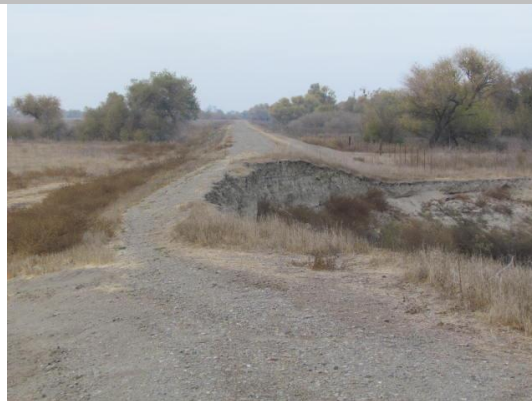
Photo 2 of 3 : FA\_2014\_NA0010\_119\_5\_20141103\_00004.jpg

Looking north at large erosion on waterward slope. (Fall 2013)

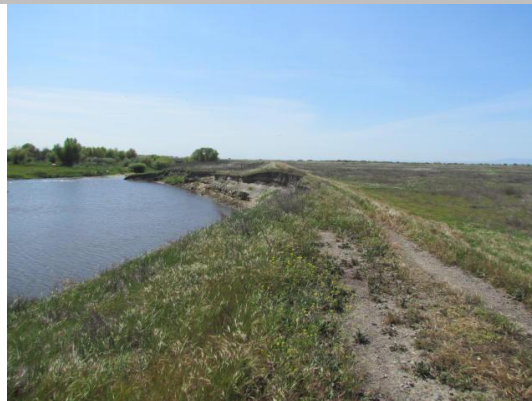
Photo 3 of 3 : FA\_2014\_NA0010\_119\_5\_20141103\_00005.jpg

Looking south at large erosion on waterside slope. (Spring 2012)

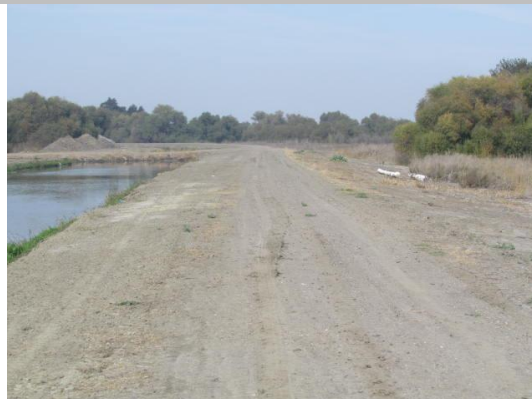
Photo 1 of 2 : FA\_2014\_NA0010\_120\_3\_20141110\_00007.jpg

LM Start	7.87	Rating **	A/W	Issue No.	3
LM End	13.45	Issue Type +	Ma	Location *	LS
Category	Earthen Levee			GPS Latitude/Longitude	
				Start	End
Item	Vegetation			37.231279 °	37.176608 °
				-120.811852 °	-120.762619 °
DWR ID	DWR_NA0010_02B_f_2014_3				
Action/Comments					
Keep the crown roadway free of vegetation. Inspector Comments: Control vegetation growth on levee crown.

Looking north at levee crown complies with standards. (Fall 2014)

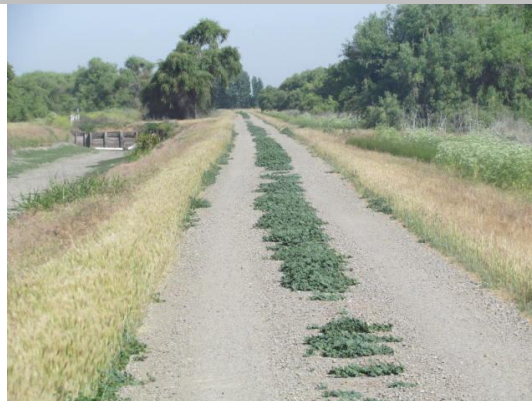
Photo 2 of 2 : FA\_2014\_NA0010\_120\_3\_20141103\_00001.jpg

Looking north at vegetation on levee crown. (Spring 2014)

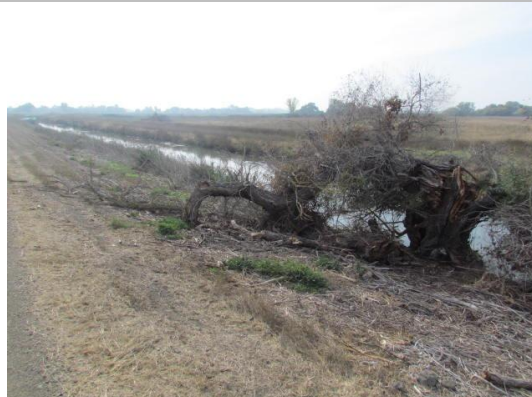
Photo 2 of 2 : FA\_2014\_NA0010\_120\_1\_20141110\_00008.jpg

LM Start	12.25	Rating **	M	Issue No.	1 (cont)	
LM End	12.25	Issue Type +	Ma	Location *	LS	
Category	Earthen Levee			GPS Latitude/Longitude		
				Start		End
Item	Encroachments			37.191500 °		37.191500 °
				-120.764521 °		-120.764521 °
DWR ID	DWR_NA0010_02B_f_2014_1					
Action/Comments						
Tree or limb						
Inspector Comments: Fallen tree limbs on landward slope.

Looking southwest at tree limb on waterward slope.

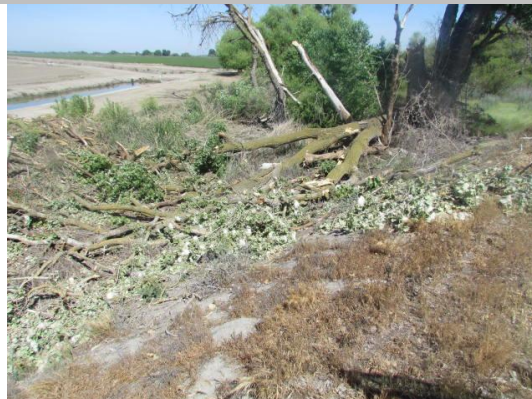
Photo 1 of 1 : FA\_2014\_NA0010\_122\_4\_20141103\_00004.jpg

LM Start	0.30	Rating **	M	Issue No.	4
LM End	0.30	Issue Type +	En	Location *	LS
Category	Earthen Levee			GPS Latitude/Longitude	
				Start	End
Item	Encroachments			37.109052 °	37.109052 °
				-120.590800 °	-120.590800 °
DWR ID	DWR_NA0010_04_s_2014_4				
Action/Comments					
Tree or limb					
Inspector Comments: Downed tree on landward slope and toe.

Looking east at downed tree and prunings on landward slope and toe.

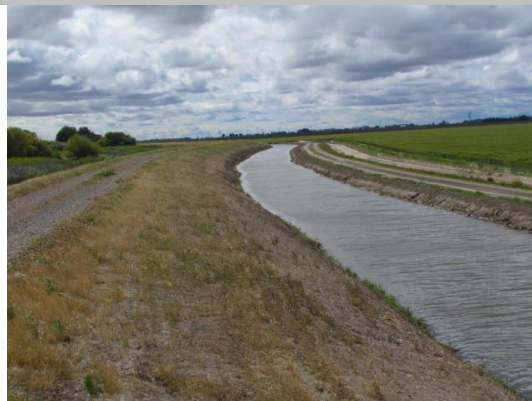
Photo 1 of 3 : FA\_2014\_NA0010\_122\_3\_20141103\_00001.jpg

LM Start	0.32	Rating **	M	Issue No.	3
LM End	1.49	Issue Type +	En	Location *	CR
Category	Earthen Levee			GPS Latitude/Longitude	
				Start	End
Item	Encroachments			37.108822 °	37.096532 °
				-120.590718 °	-120.578027 °
DWR ID	DWR_NA0010_04_s_2012_3				
Action/Comments					
Ditch					
Inspector Comments: Agricultural Ditch within 10' easement.

Looking north at irrigation ditch at landside toe.

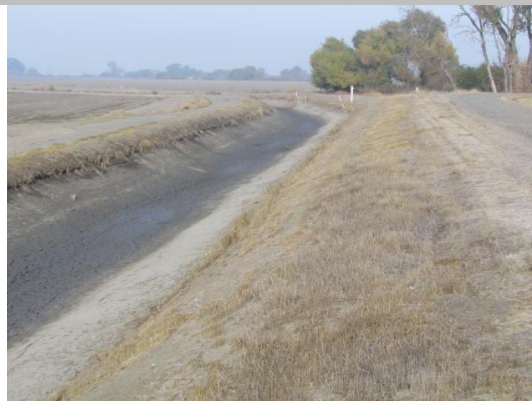
Photo 2 of 3 : FA\_2014\_NA0010\_122\_3\_20141103\_00002.jpg

Looking north at irrigation ditch at landward toe. (Fall 2013)

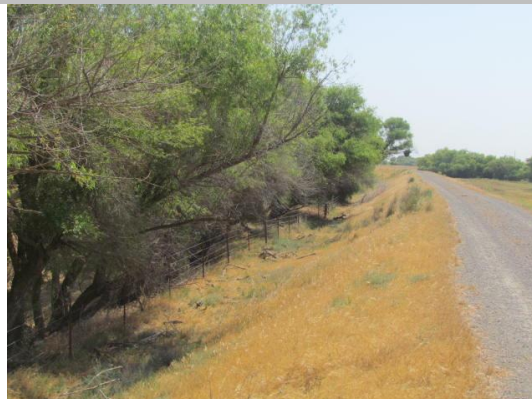
Photo 1 of 2 : FA\_2014\_NA0010\_123\_3\_20141103\_00002.jpg

LM Start	2.81	Rating **	A/W	Issue No.	3
LM End	2.86	Issue Type +	Ma	Location *	LS
Category	Earthen Levee			GPS Latitude/Longitude	
				Start	End
Item	Trim / Thin Trees			37.256803 °	37.256835 °
				-120.785407 °	-120.784528 °
DWR ID	DWR_NA0010_05_s_2012_3				
Action/Comments					
Thin trees to allow visibility of the ground and room to flood fight.

Looking south at trimmed trees on landward slope and toe.

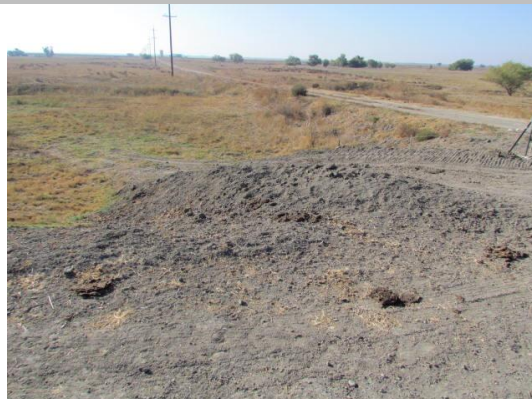
Photo 3 of 3 : FA\_2014\_NA0010\_123\_7\_20141103\_00006.jpg

LM Start	3.19	Rating **	M	Issue No.	7 (cont)	
LM End	3.19	Issue Type +	En	Location *	WS	
Category	Earthen Levee			GPS Latitude/Longitude		
				Start		End
Item	Encroachments			37.256554 °	37.256554 °	
				-120.778847 °	-120.778847 °	
DWR ID	DWR_NA0010_05_f_2012_7					
Action/Comments						
Ramp						
Inspector Comments: Unauthorized ramp on waterside slope.

Looking northwest at unauthorized ramp on waterside slope.

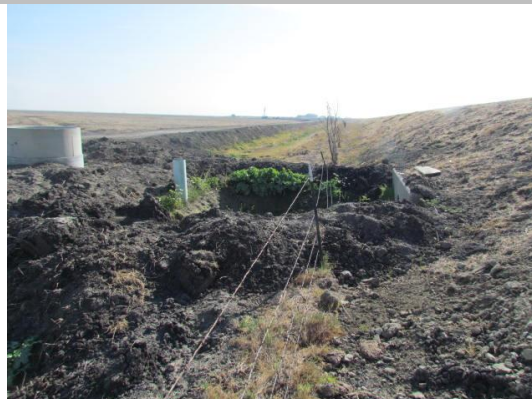
Photo 2 of 2 : FA\_2014\_NA0010\_123\_8\_20141110\_00017.jpg

LM Start	5.56	Rating **	M	Issue No.	8 (cont)	
LM End	5.56	Issue Type +	En	Location *	LS	
Category	Earthen Levee			GPS Latitude/Longitude		
				Start		End
Item	Encroachments			37.238970 °		37.238970 °
				-120.739688 °		-120.739688 °
DWR ID	DWR_NA0010_05_s_2014_8					
Action/Comments						
Pipe Inspector Comments: Landowner installed 18" pvc pipe to 24" drain pipe. Eighteen inch pipe has a water meter installed. It appears that dike around drainage structure will prevent proper drainage.

Looking south at drain structure on landward toe.

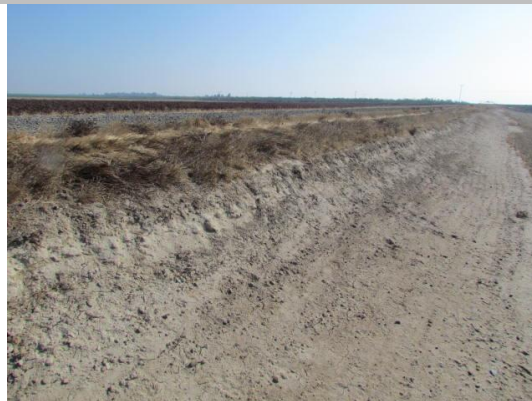
Photo 3 of 3 : FA\_2014\_NA0010\_123\_171\_20141103\_00014.jpg

Looking east at livestock erosion on landward slope.

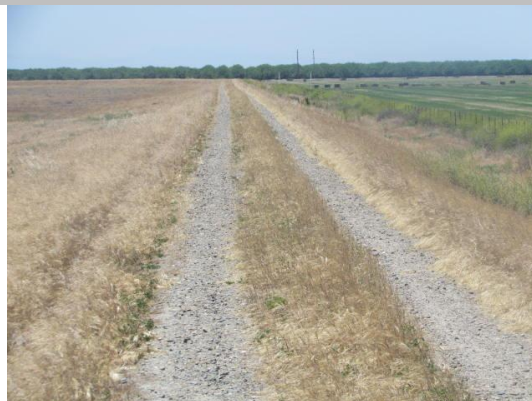
Photo 1 of 1 : FA\_2014\_NA0010\_123\_22\_20141103\_00010.jpg

LM Start	30.36	Rating **	A/W	Issue No.	22
LM End	34.51	Issue Type +	Ma	Location *	LS
Category	Earthen Levee			GPS Latitude/Longitude	
				Start	End
Item	Vegetation			37.010443 °	36.978581 °
				-120.426820 °	-120.368381 °
DWR ID	DWR_NA0010_05_f_2012_22				
Action/Comments					
Keep the crown roadway free of vegetation. Inspector Comments: Control wild growth on levee crown.

Looking at vegetation on levee crown.

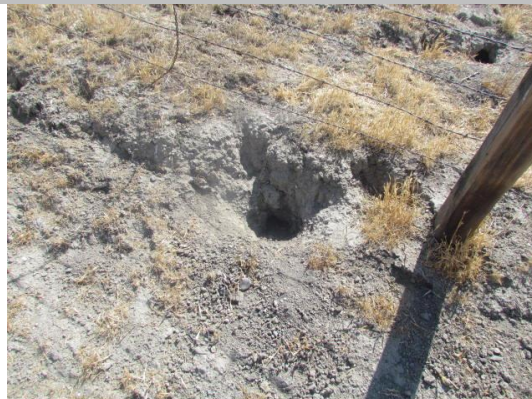
Photo 1 of 2 : FA\_2014\_NA0010\_124\_10\_20141103\_00010.jpg

LM Start	4.72	Rating **	M	Issue No.	10
LM End	4.72	Issue Type +	Ma	Location *	LS
Category	Earthen Levee			GPS Latitude/Longitude	
				Start	End
Item	Animal Control			37.243540 °	37.243540 °
				-120.760782 °	-120.760782 °
DWR ID	DWR_NA0010_06_s_2012_10				
Action/Comments					
No rodents visible, but rodent burrows visible; need to backfill and compact or grout burrows.					
Inspector Comments: Rodent holes next to fence post on landward slope.

Looking at rodent hole along fence line on landward slope.

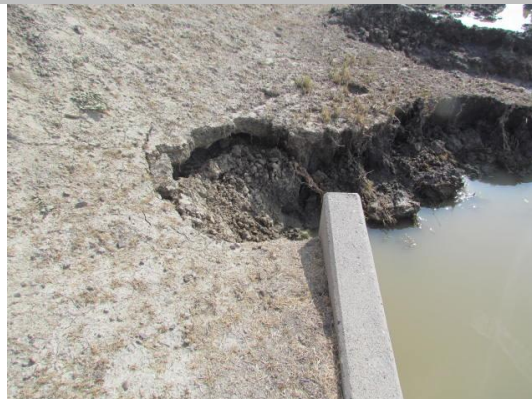
Photo 1 of 2 : FA\_2014\_NA0010\_124\_65\_20141110\_00015.jpg

LM Start	6.05	Rating **	U	Issue No.	65
LM End	6.05	Issue Type +	Ma	Location *	LS
Category	Interior Drainage & Piping Systems			GPS Latitude/Longitude	
				Start	End
Item	Erosion Areas			37.236372 °	37.236372 °
				-120.739706 °	-120.739706 °
DWR ID	DWR_NA0010_06_f_2014_65				
Action/Comments					
Inspector Comments: Erosion on right side of drain structure headwall at landward toe.

Looking northwest at erosion around headwall of drainage structure on landward toe.

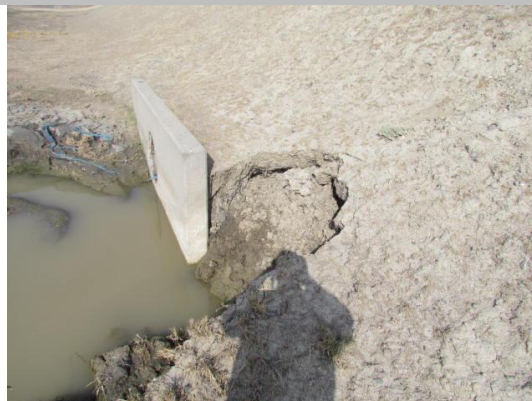
Photo 2 of 2 : FA\_2014\_NA0010\_124\_65\_20141110\_00016.jpg

Looking south erosion around headwall of drainage structure on landward toe.

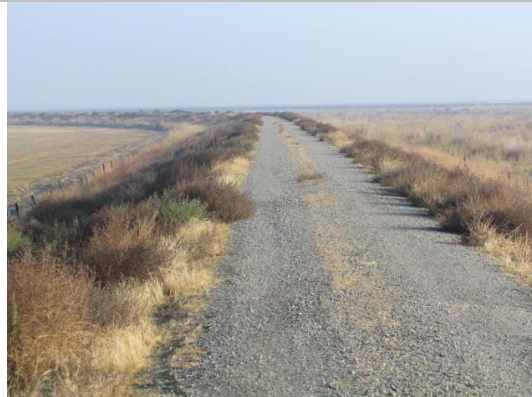
Photo 1 of 1 : FA\_2014\_NA0010\_124\_63\_20141110\_00018.jpg

LM Start	16.98	Rating **	M	Issue No.	63
LM End	19.32	Issue Type +	Ma	Location *	LS
Category	Earthen Levee			GPS Latitude/Longitude	
				Start	End
Item	Vegetation			37.144129 °	37.113644 °
				-120.602479 °	-120.588271 °
DWR ID	DWR_NA0010_06_f_2014_63				
Action/Comments					
Remove the wild growth other than native grasses from the levee slopes.					
Inspector Comments: Control tumble weeds on landward and waterward slopes.

Looking north at tumble weeds on levee slopes.

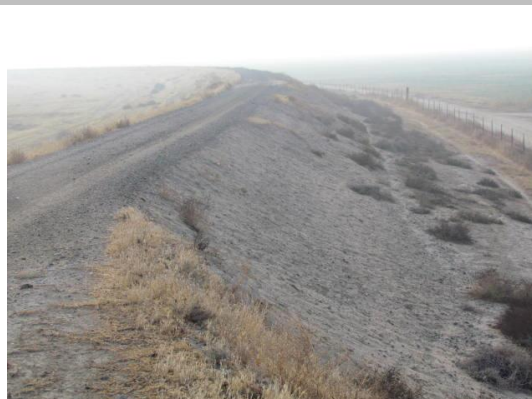
Photo 2 of 4 : FA\_2014\_NA0010\_124\_3\_20141103\_00004.jpg

Looking south at livestock erosion on landward slope. (Fall 2013)

LM Start	27.56	Rating **	M	Issue No.	3 (cont)	
LM End	27.87	Issue Type +	Ma	Location *	LS	
Category	Earthen Levee			GPS Latitude/Longitude		
				Start		End
Item	Slope Stability			37.036955 °		37.032887 °
				-120.484395 °		-120.481225 °
DWR ID	DWR_NA0010_06_s _ 2012_3					
Action/Comments						
Repair the levee slope damaged by foot traffic and prevent access where possible.						
Inspector Comments: Landside erosion caused by livestock.

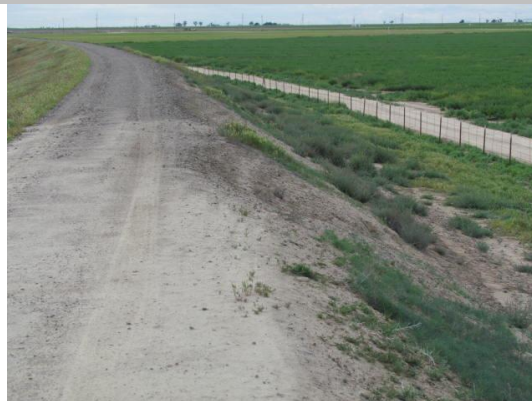
Photo 4 of 4 : FA\_2014\_NA0010\_124\_3\_20141103\_00006.jpg

Looking south at livestock erosion on landside shoulder and slope.

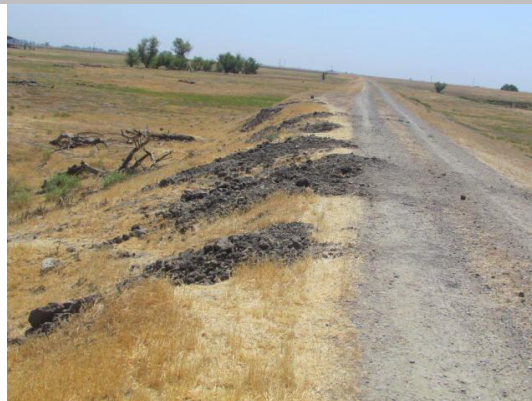
Photo 2 of 4 : FA\_2014\_NA0010\_125\_3\_20141103\_00004.jpg

Looking south at landward slope.

LM Start	1.51	Rating **	M	Issue No.	3 (cont)	
LM End	1.51	Issue Type +	Ma	Location *	LS	
Category	Earthen Levee			GPS Latitude/Longitude		
				Start		End
Item	Animal Control			37.263930 °		37.263930 °
				-120.750680 °		-120.750680 °
DWR ID	DWR_NA0010_07_s _ 2012_3					
Action/Comments						
Repair the levee slope damaged by livestock and prevent large animal access.						
Inspector Comments: Erosion on landward slope has been repaired by district. Landward toe erosion not repaired.

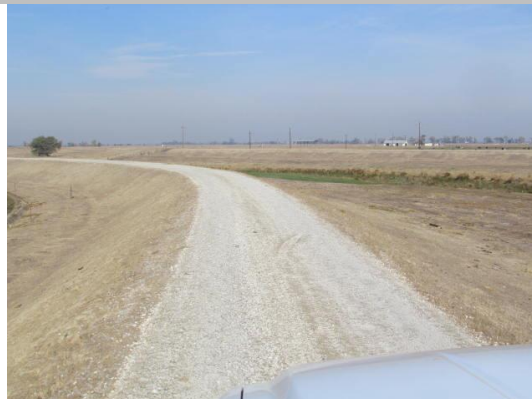
Photo 1 of 2 : FA\_2014\_NA0010\_126\_28\_20141110\_00012.jpg

Looking west at levee crown in complies with standards.

LM Start	0.00	Rating **	A/W	Issue No.	28
LM End	2.22	Issue Type +	Ma	Location *	LS
Category	Earthen Levee			GPS Latitude/Longitude	
				Start	End
Item	Vegetation			37.253178 °	37.256802 °
				-120.768513 °	-120.740452 °
DWR ID	DWR_NA0010_08_s_2012_28				
Action/Comments					
Keep the crown roadway free of vegetation.

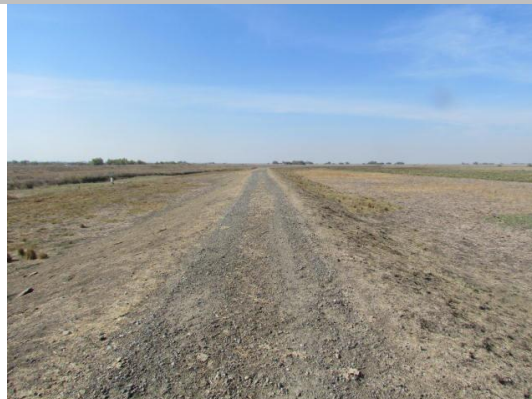
Photo 1 of 3 : FA\_2014\_NA0010\_127\_3\_20141110\_00001.jpg

LM Start	0.87	Rating **	A	Issue No.	3
LM End	0.87	Issue Type +	Ma	Location *	LS
Category	Earthen Levee			GPS Latitude/Longitude	
				Start	End
Item	Vegetation			37.220039 °	37.220039 °
				-120.698444 °	-120.698444 °
DWR ID	DWR_NA0010_09_f_2014_3				
Action/Comments					
Control annual grass and weeds on the levee slopes and easements. Inspector Comments: Levee is well maintained.

Looking south at levee crown in compliance with standards.

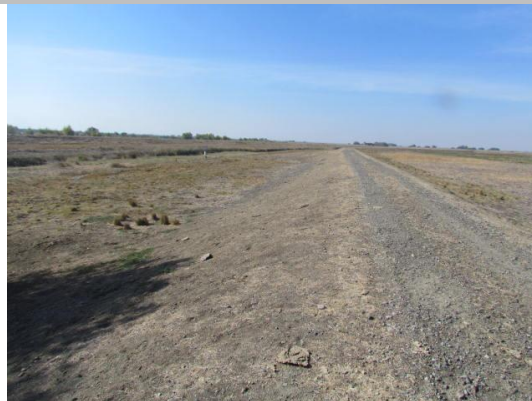
Photo 2 of 3 : FA\_2014\_NA0010\_127\_3\_20141110\_00002.jpg

Looking south at waterward slope in compliance with standards.

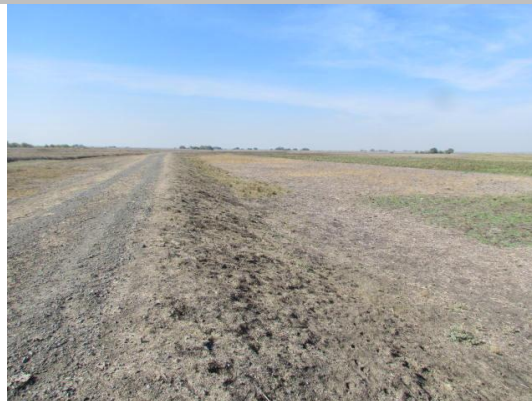
Photo 3 of 3 : FA\_2014\_NA0010\_127\_3\_20141110\_00003.jpg

Looking south at landward slope in compliance with standards.

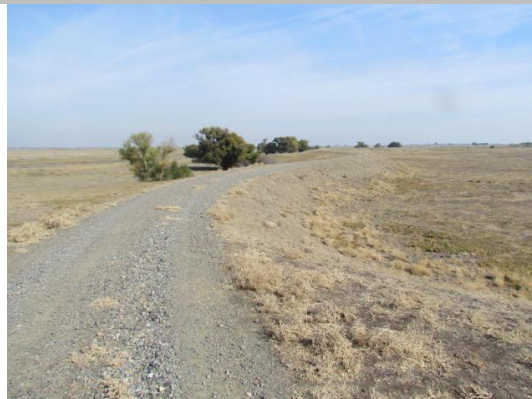
Photo 1 of 2 : FA\_2014\_NA0010\_128\_2\_20141110\_00001.jpg

LM Start	0.00	Rating **	A	Issue No.	2
LM End	0.82	Issue Type +	Ma	Location *	LS
Category	Earthen Levee			GPS Latitude/Longitude	
				Start	End
Item	Vegetation			37.217971 °	37.217971 °
				-120.711415 °	-120.711415 °
DWR ID	DWR_NA0010_10_f_2014_2				
Action/Comments					
Control annual grass and weeds on the levee slopes and easements. Inspector Comments: Levee is well maintained.

Looking waterward slope in compliance with standards.

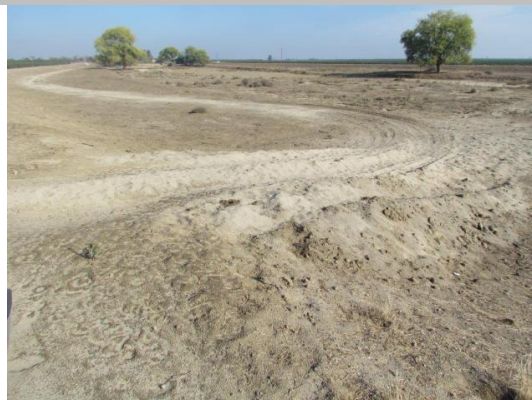
Photo 1 of 3 : FA\_2014\_NA0010\_131\_5\_20141110\_00003.jpg

LM Start	0.90	Rating **	M	Issue No.	5
LM End	0.90	Issue Type +	En	Location *	WS
Category	Earthen Levee			GPS Latitude/Longitude	
				Start	End
Item	Encroachments			37.044855 °	37.044855 °
				-120.434106 °	-120.434106 °
DWR ID	DWR_NA0010_13_s_2014_5				
Action/Comments					
Ramp					
Inspector Comments: Unauthorized ramp on waterward slope.

Looking east at unauthorized ramp on waterward slope. (Fall 2014)

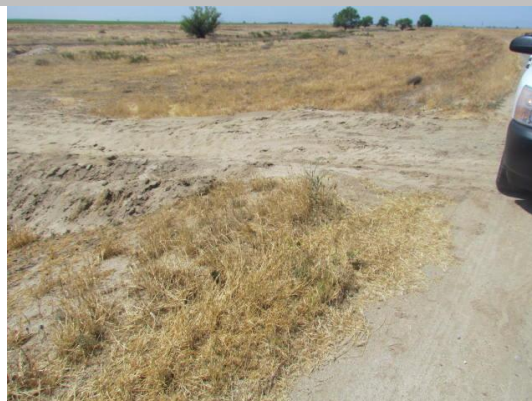
Photo 2 of 3 : FA\_2014\_NA0010\_131\_5\_20141103\_00001.jpg

LM Start	0.90	Rating **	M	Issue No.	5 (cont)	
LM End	0.90	Issue Type +	En	Location *	WS	
Category	Earthen Levee			GPS Latitude/Longitude		
				Start		End
Item	Encroachments			37.044855 °		37.044855 °
				-120.434106 °		-120.434106 °
DWR ID	DWR_NA0010_13_s_2014_5					
Action/Comments						
Ramp						
Inspector Comments: Unauthorized ramp on waterward slope.

Looking west at unauthorized ramp on waterward slope.

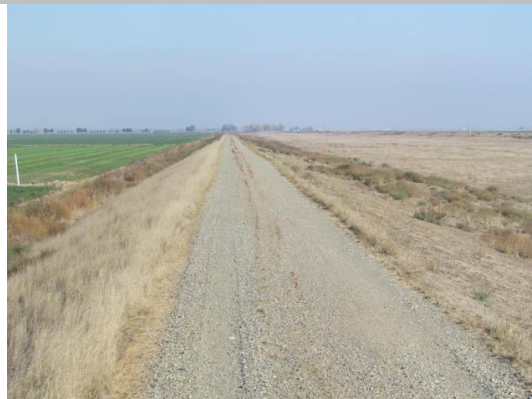
Photo 1 of 2 : FA\_2014\_NA0010\_133\_11\_20141110\_00002.jpg

Looking east at typical view of levee in complies with standards

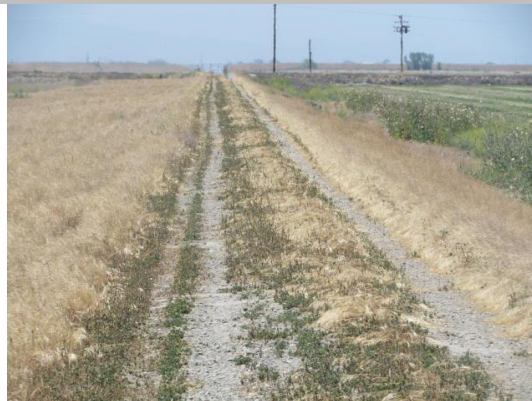
Photo 2 of 2 : FA\_2014\_NA0010\_133\_11\_20141103\_00001.jpg

LM Start	0.00	Rating **	A/W	Issue No.	11
LM End	1.99	Issue Type +	Ma	Location *	CR
Category	Earthen Levee			GPS Latitude/Longitude	
				Start	End
Item	Crown Surface / Depressions / Rutting			36.996547 °	36.996587 °
				-120.410220 °	-120.374503 °
DWR ID	DWR_NA0010_15_s_2012_11				
Action/Comments					
Add appropriate material and re-grade the levee to bring the crown above the design elevation.					
Inspector Comments: Control vegetation on levee crown.

Looking east at vegetation on levee crown.

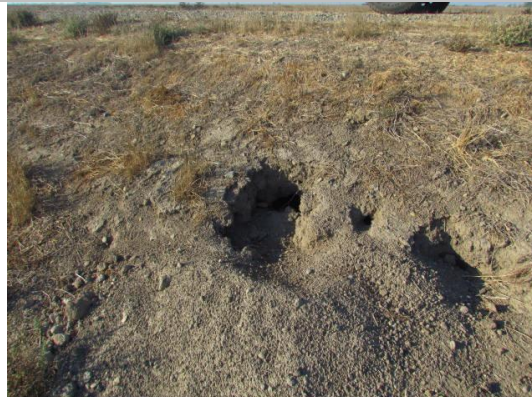
Photo 1 of 2 : FA\_2014\_NA0010\_134\_2\_20141110\_00002.jpg

LM Start	1.78	Rating **	M	Issue No.	2
LM End	1.78	Issue Type +	Ma	Location *	LS
Category	Earthen Levee			GPS Latitude/Longitude	
				Start	End
Item	Animal Control			36.995487 °	36.995487 °
				-120.377054 °	-120.377054 °
DWR ID	DWR_NA0010_16_f_2014_2				
Action/Comments					
No rodents visible, but rodent burrows visible; need to backfill and compact or grout burrows.					
Inspector Comments: Large rodent holes on landward slope.

Looking at large rodent holes on landward slope.

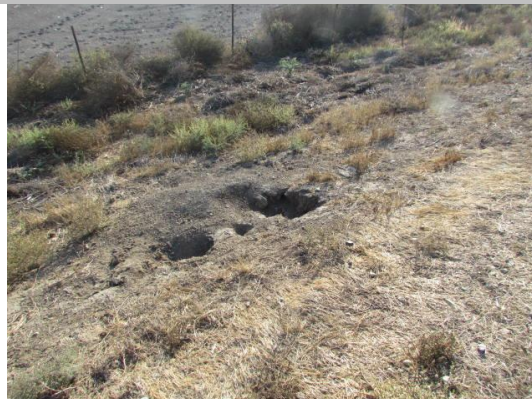
Photo 2 of 2 : FA\_2014\_NA0010\_134\_2\_20141110\_00003.jpg

Looking southwest at several rodent holes on landward slope.

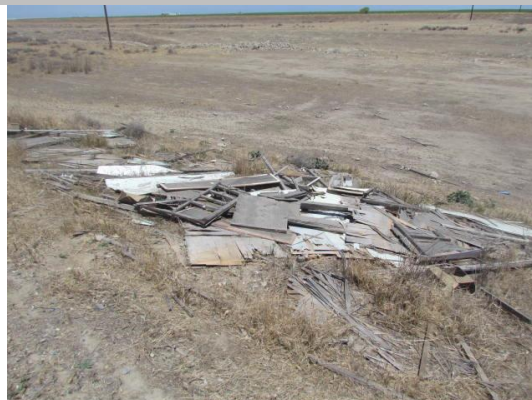
Photo 1 of 1 : FA\_2014\_NA0010\_137\_5\_20141103\_00002.jpg

LM Start	8.04	Rating **	M	Issue No.	5
LM End	8.04	Issue Type +	En	Location *	WS
Category	Earthen Levee			GPS Latitude/Longitude	
				Start	End
Item	Encroachments			36.865074 °	36.865074 °
				-120.317996 °	-120.317996 °
DWR ID	DWR_NA0010_18_s_2014_5				
Action/Comments					
Garbage					
Inspector Comments: Trash on waterward slope.

Looking west at trash on waterward slope.

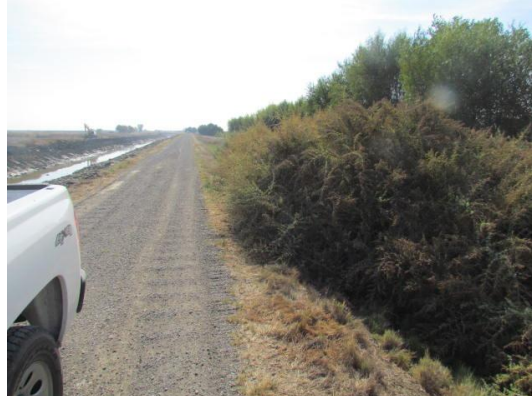
Photo 1 of 1 : FA\_2014\_NA0010\_138\_21\_20141110\_00014.jpg

LM Start	0.53	Rating **	M	Issue No.	21
LM End	0.53	Issue Type +	Ma	Location *	LS
Category	Earthen Levee			GPS Latitude/Longitude	
				Start	End
Item	Vegetation			37.213006 °	37.213006 °
				-120.698019 °	-120.698019 °
DWR ID	DWR_NA0010_22A_f_2014_21				
Action/Comments					
Remove the wild growth other than native grasses from the levee slopes.					
Inspector Comments: Dense brush on landward slope.

Looking south at dense brushes on landward slope.

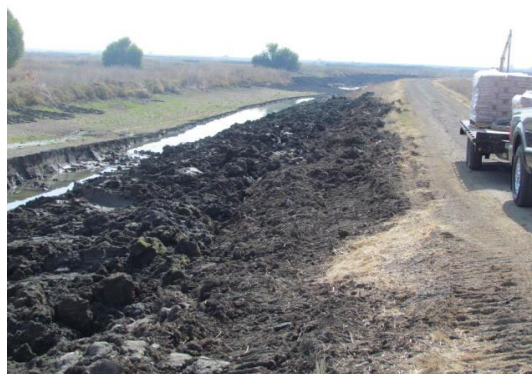
Photo 2 of 3 : FA\_2014\_NA0010\_138\_22\_20141110\_00017.jpg

Looking southeast at excavated waterward slope.

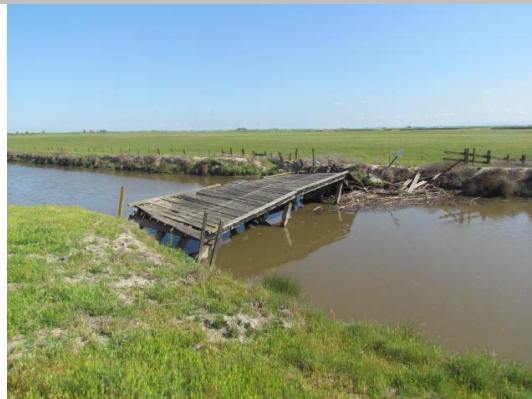
Photo 3 of 4 : FA\_2014\_NA0010\_138\_3\_20141103\_00003.jpg

Looking northeast at dilapidated bridge across canal.

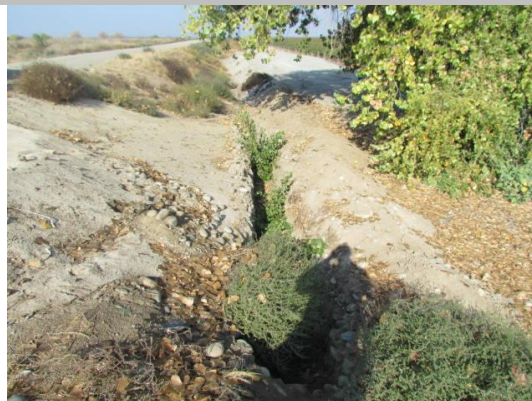
Photo 2 of 2 : FA\_2014\_NA0010\_139\_29\_20141110\_00019.jpg

Looking north at trench at landward toe.

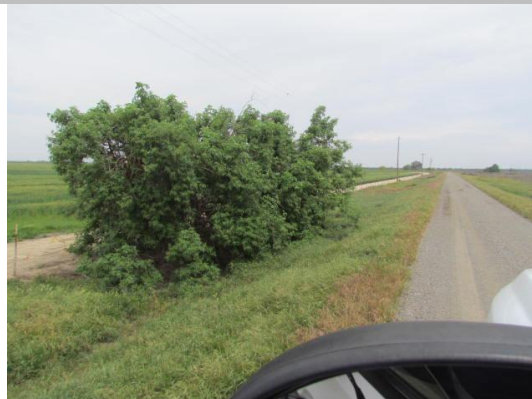
Photo 1 of 1 : FA\_2014\_NA0010\_139\_15\_20141103\_00014.jpg

LM Start	2.85	Rating **	M	Issue No.	15
LM End	2.85	Issue Type +	Ma	Location *	LS
Category	Earthen Levee			GPS Latitude/Longitude	
				Start	End
Item	Vegetation			36.771537 °	36.771537 °
				-120.240917 °	-120.240917 °
DWR ID	DWR_NA0010_23_s_2012_15				
Action/Comments					
Elderberries are blocking visibility and flood fight capability.

Looking south at elderberry on landside toe and berm.

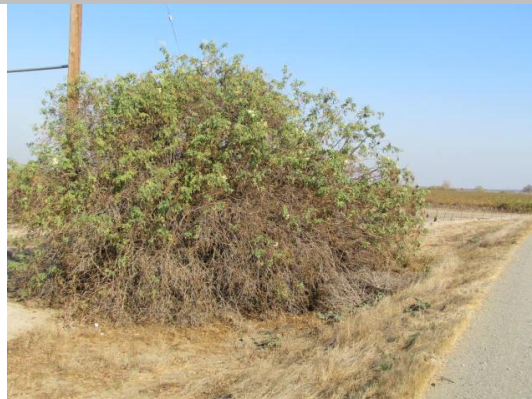
Photo 1 of 2 : FA\_2014\_NA0010\_139\_10\_20141103\_00009.jpg

LM Start	4.14	Rating **	M	Issue No.	10
LM End	4.14	Issue Type +	Ma	Location *	LS
Category	Earthen Levee			GPS Latitude/Longitude	
				Start	End
Item	Vegetation			36.784212 °	36.784212 °
				-120.228815 °	-120.228815 °
DWR ID	DWR_NA0010_23_s_2012_10				
Action/Comments					
Elderberries are blocking visibility and flood fight capability.

Looking south at elderberry bush on landward toe. (Fall 2013)

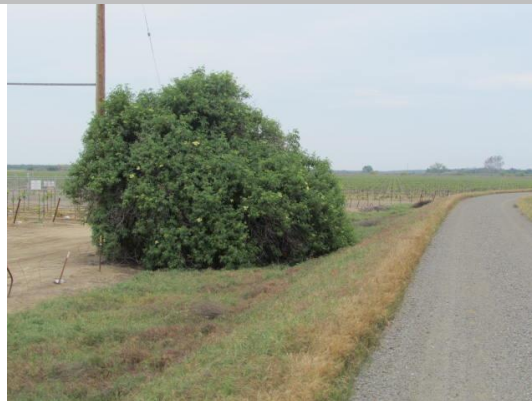
Photo 2 of 2 : FA\_2014\_NA0010\_139\_10\_20141103\_00010.jpg

Looking south at elderberry on landside toe and berm.

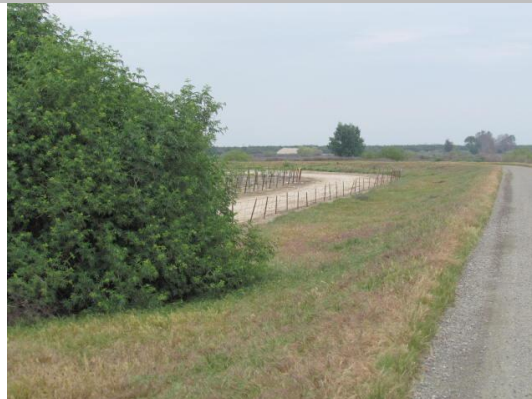
Photo 1 of 1 : FA\_2014\_NA0010\_139\_11\_20141103\_00011.jpg

LM Start	4.46	Rating **	M	Issue No.	11
LM End	4.46	Issue Type +	Ma	Location *	LS
Category	Earthen Levee			GPS Latitude/Longitude	
				Start	End
Item	Vegetation			36.784523 °	36.784523 °
				-120.223292 °	-120.223292 °
DWR ID	DWR_NA0010_23_s_2012_11				
Action/Comments					
Elderberries are blocking visibility and flood fight capability.

Looking south at elderberry on landside toe and berm.

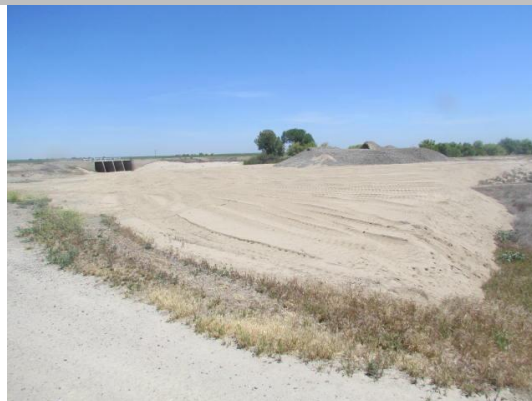
Photo 1 of 2 : FA\_2014\_NA0010\_140\_47\_20141103\_00003.jpg

LM Start	0.06	Rating **	M	Issue No.	47
LM End	0.06	Issue Type +	En	Location *	LS
Category	Earthen Levee			GPS Latitude/Longitude	
				Start	End
Item	Encroachments			36.772328 °	36.772328 °
				-120.285117 °	-120.285117 °
DWR ID	DWR_NA0010_24_s_2014_47				
Action/Comments					
Material					
Inspector Comments: District constructed a berm on waterward slope.					
Berm is being used for staging of earthen material.

Looking south at berm on waterward slope.

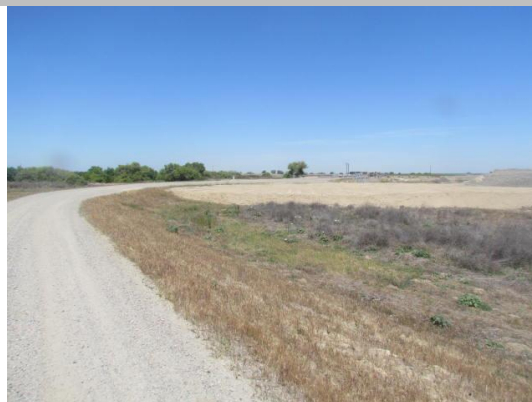
Photo 2 of 2 : FA\_2014\_NA0010\_140\_47\_20141103\_00004.jpg

Looking north at berm on waterward slope.

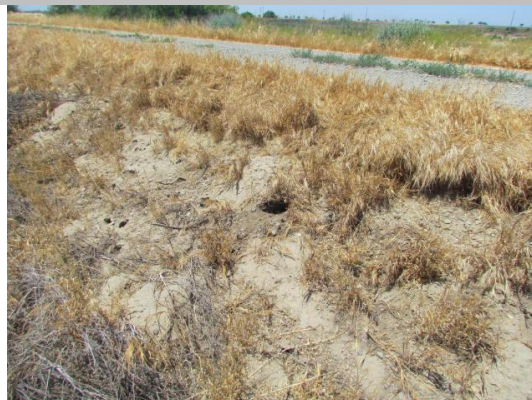
Photo 1 of 1 : FA\_2014\_NA0010\_140\_7\_20141103\_00002.jpg

LM Start	3.46	Rating **	M	Issue No.	7
LM End	3.46	Issue Type +	Ma	Location *	LS
Category	Earthen Levee			GPS Latitude/Longitude	
				Start	End
Item	Animal Control			36.769345 °	36.769345 °
				-120.238370 °	-120.238370 °
DWR ID	DWR_NA0010_24_s_2012_7				
Action/Comments					
No rodents visible, but rodent burrows visible; need to backfill and compact or grout burrows.					
Inspector Comments: One of several rodent holes on landward slope.

Looking east at one of several rodent holes on landward slope.

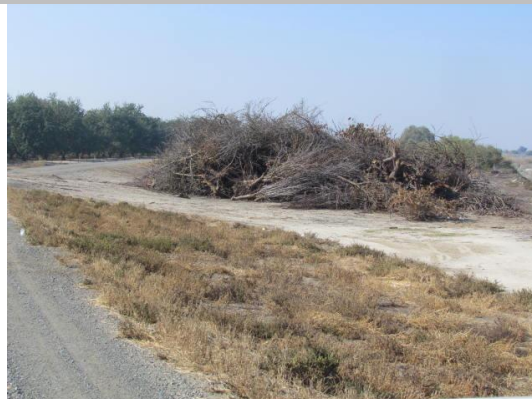
Photo 1 of 2 : FA\_2014\_NA0010\_140\_3\_20141110\_00006.jpg

LM Start	6.33	Rating **	M	Issue No.	3
LM End	6.33	Issue Type +	Ma	Location *	WS
Category	Earthen Levee			GPS Latitude/Longitude	
				Start	End
Item	Encroachments			36.788155 °	36.788155 °
				-120.209655 °	-120.209655 °
DWR ID	DWR_NA0010_24_s_2012_3				
Action/Comments					
Prunings					
Inspector Comments: Large pruning pile in channel.

Looking north at large pruning pile in channel.

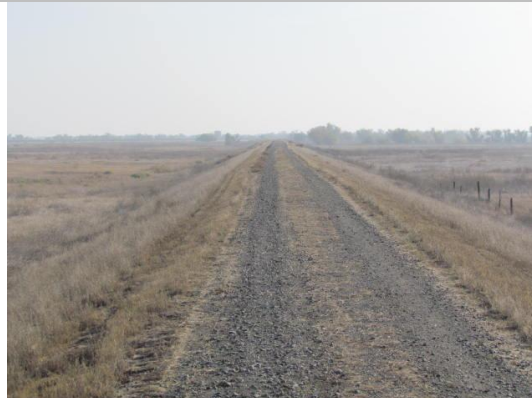
Photo 1 of 2 : FA\_2014\_NA0010\_141\_8\_20141110\_00002.jpg

Looking north at typical view of levee crown in complies with standards.
