**Flood Control Project Maintenance
Levee Inspections**

Fall 2016 Levee Maintenance Deficiency Summary Report

San Joaquin River Basin

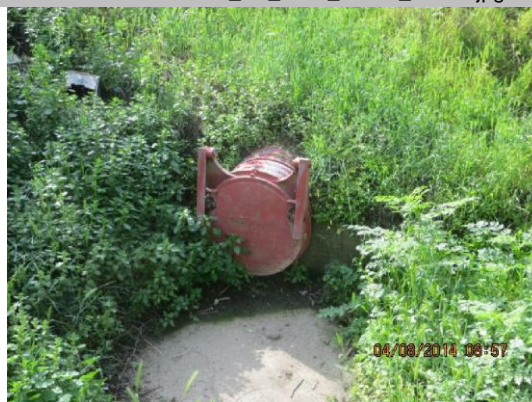
Photo 1 of 2 : UCIP_FA_2016_39091_60601.jpg

FS_ID:39091
DS_ID:19650
EP_NO: N/A
Repair Type: Non-Urgent
Crossing Status: Found
UCIP Comments: Dense vegetation limits the inspector's visibility to identify signs of pipe failure (leaks) along the waterward slope and landward toe. Recommend removing vegetation along pipe alignment and landward toe to conduct proper inspection of structure and appurtenances.
FIELD_STRUCT_DESC: 24-inch CM stormdrain pipe through the levee, 10.5 feet below the crown. Flap gate on the waterward end. Brass cap No. 108 BM on headwall on the landward side. (USACE-1967). This entry matches the Drainage or Irrigation Structure referenced in O&M manual (HLM 0.02).
FS Date: 4/8/2014 7:34:00 AM

Flapgate on WS toe.

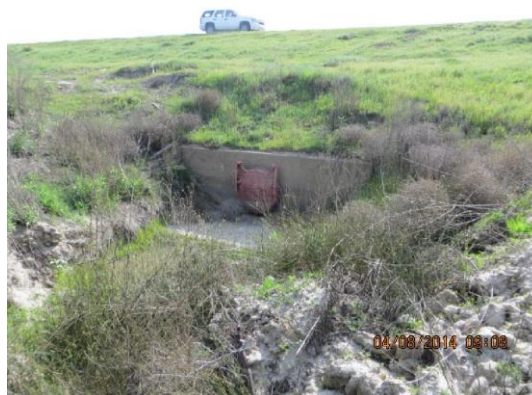
Photo 1 of 2 : UCIP_FA_2016_39092_60611.jpg

LM Start	0.34	Rating **	M	Issue No.	1213
LM End	0.34	Issue Type +	En	Location *	LS
Category	Supplemental			GPS Latitude/Longitude	
				Start	End
Item	DWR UCIP Field Study			37.344705 °	37.344705 °
				-120.962176 °	-120.962176 °
DWR ID					
Comment Code					
Inspector Comment					
FS_ID:39092 DS_ID:19651 EP_NO: N/A Repair Type: Non-Urgent Crossing Status: Found UCIP Comments: Pipe has significant sediment buildup and shows some signs of corrosion at landward toe. Recommend cleaning sediment from inside pipe and check wall integrity. FIELD_STRUCT_DESC: 36-inch CM stormdrain pipe through the levee, 18.5 feet below the crown. Flap gate on the waterward end. Brass cap No. 108 BM on headwall on the landward side. (USACE-1967). This entry matches the Drainage or Irrigation Structure referenced in O&M manual (HLM 0.35). FS Date: 4/8/2014

Flapgate and headwall visible off WS toe.

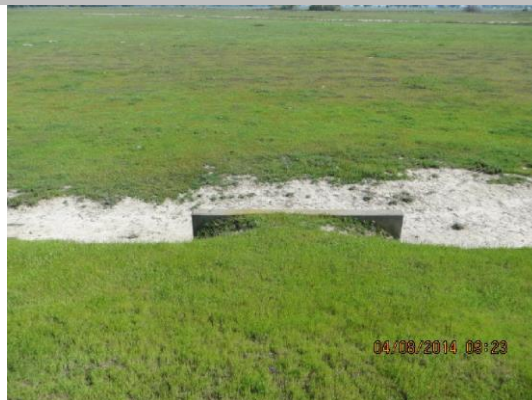
Photo 1 of 2 : UCIP_FA_2016_39096_60632.jpg

Comment Code						
Inspector Comment						
FS_ID:39096						
DS_ID:19585						
EP_NO: N/A						
Repair Type: Non-Urgent						
Crossing Status: Found						
UCIP Comments: Moderate erosion around headwall on landward toe.						
May or may not be an issue. Need to contact owner to determine status						
of crossing and to address erosion issue on landward side.						
FIELD_STRUCT_DESC: 24-inch CM pipe through the levee, 7-feet						
below the crown. Flap gate on the waterward end. Brass cap No. 108						
BM on headwall on the landward side. (USACE-1967). This entry						
matches the Drainage or Irrigation Structure referenced in O&M manual						
(HLM 0.95).						
FS Date: 4/8/2014

Flapgate, pipe, and headwall on WS toe.

Concrete headwall and pipe visible at LS toe.

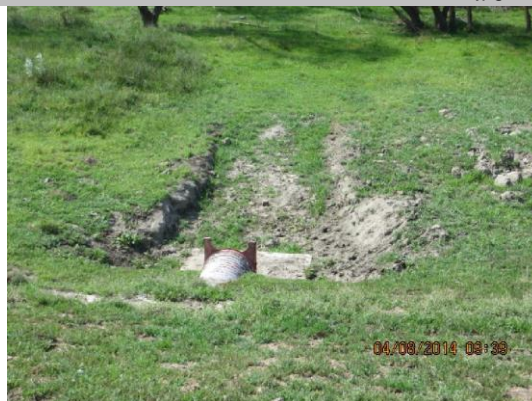
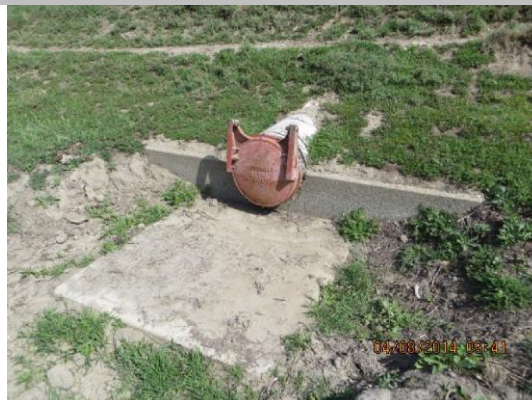
Photo 1 of 2 : UCIP_FA_2016_39099_60652.jpg

LM Start	1.46	Rating **	M	Issue No.	1216
LM End	1.46	Issue Type +	En	Location *	LS
Category	Supplemental			GPS Latitude/Longitude	
				Start	End
Item	DWR UCIP Field Study			37.336866 °	37.336866 °
				-120.948520 °	-120.948520 °
DWR ID					
Comment Code					
Inspector Comment					
FS_ID:39099					
DS_ID:19588					
EP_NO: N/A					
Repair Type: Non-Urgent					
Crossing Status: Found					
UCIP Comments: Some sediment buildup inside pipe at LS toe.					
Recommend contacting owner to clear sediment buildup and check wall integrity through pipe section.					
FIELD_STRUCT_DESC: 24-inch CM stormdrain pipe through the levee, 11.0 feet below the crown. Flap gate on the waterward end. Brass cap No. 108 BM on headwall on the landward side. (USACE-1967). This entry matches the Drainage or Irrigation Structure referenced in O&M manual (HLM 1.48).					
FS Date: 4/8/2014

Pipe, flapgate, and concrete headwall visible on WS toe.

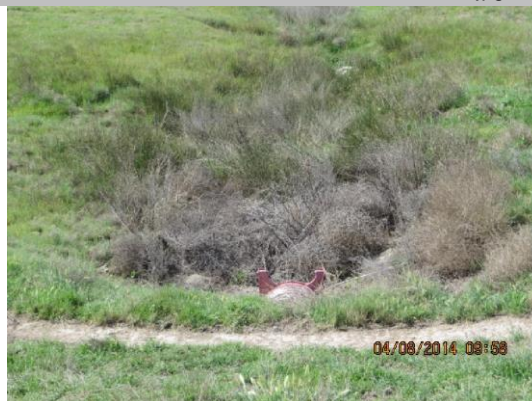
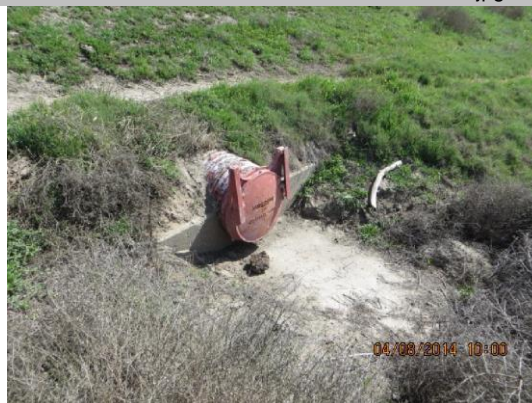
Photo 1 of 2 : UCIP_FA_2016_39100_60670.jpg

LM Start	1.95	Rating **	M	Issue No.	1217
LM End	1.95	Issue Type +	En	Location *	LS
Category	Supplemental			GPS Latitude/Longitude	
				Start	End
Item	DWR UCIP Field Study			37.334377 °	37.334377 °
				-120.940397 °	-120.940397 °
DWR ID					
Comment Code					
Inspector Comment					
FS_ID:39100 DS_ID:19591 EP_NO: N/A Repair Type: Non-Urgent Crossing Status: Found UCIP Comments: Need to contact owner to determine crossing status. Inlet drop box silted in and needs to be cleaned out. FIELD_STRUCT_DESC: 24-inch CM stormdrain pipe through the levee, 9.7 feet below the crown. Flap gate on the waterward end. Brass cap No. 100 BM on headwall on the landward side. (USACE-1967). Wooden barrier around drop inlet on LS toe. This entry matches the Drainage or Irrigation Structure referenced in O&M manual (HLM 1.98). FS Date: 4/8/2014

Concrete headwall and flapgate on WS toe.

Pipe, flapgate, and headwall on WS toe.

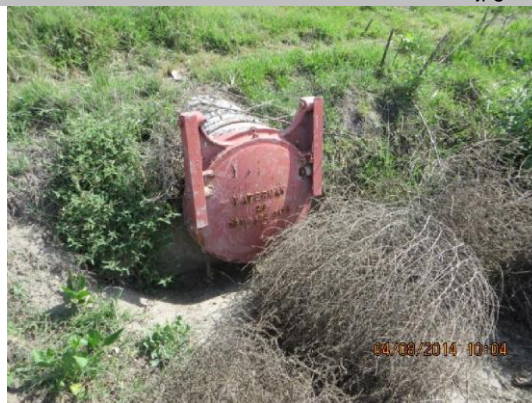
Photo 1 of 2 : UCIP_FA_2016_39123_60675.jpg

LM Start	2.06	Rating **	M	Issue No.	1218
LM End	2.06	Issue Type +	En	Location *	LS
Category	Supplemental			GPS Latitude/Longitude	
				Start	End
Item	DWR UCIP Field Study			37.333653 °	37.333653 °
				-120.938770 °	-120.938770 °
DWR ID					
Comment Code					
Inspector Comment					
FS_ID:39123 DS_ID:19570 EP_NO: N/A Repair Type: Non-Urgent Crossing Status: Found UCIP Comments: Unable to find inlet on landward toe. Recommend clearing vegetation on landward side to properly inspect inlet. FIELD_STRUCT_DESC: 24-inch CM stormdrain pipe through the levee, 9.8 feet below the crown. Flap gate on waterward end. Brass cap No. 100 BM on headwall on the landward side. (USACE-1967). This entry matches the Drainage or Irrigation Structure referenced in O&M manual (HLM 2.08). FS Date: 4/8/2014

Pipe and flapgate visible on WS toe.

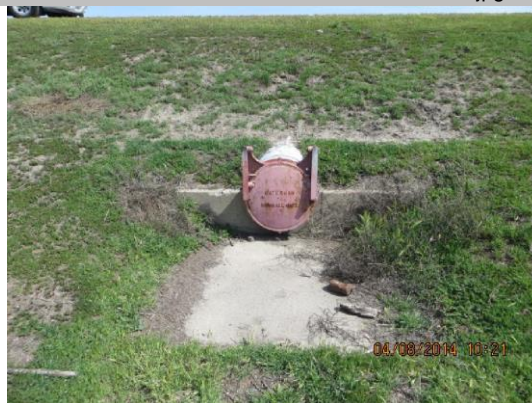
Photo 1 of 2 : UCIP_FA_2016_39127_60688.jpg

LM Start	2.67	Rating **	M	Issue No.	1219
LM End	2.67	Issue Type +	En	Location *	LS
Category	Supplemental			GPS Latitude/Longitude	
				Start	End
Item	DWR UCIP Field Study			37.327362 °	37.327362 °
				-120.931591 °	-120.931591 °
DWR ID					
Comment Code					
Inspector Comment					
FS_ID:39127					
DS_ID:19573					
EP_NO: N/A					
Repair Type: Non-Urgent					
Crossing Status: Found					
UCIP Comments: Sedimentation in pipe at landward toe.					
FIELD_STRUCT_DESC: 24-inch CM stormdrain pipe through the levee,					
7.3 feet below the crown. Flap gate on the waterward end. Brass cap					
No. 100 BM on headwall on the landward side. (USACE-1967). This					
entry matches the Drainage or Irrigation Structure referenced in O&M					
manual (HLM 2.70).					
FS Date: 4/8/2014

Pipe, flapgate, and headwall on WS toe.

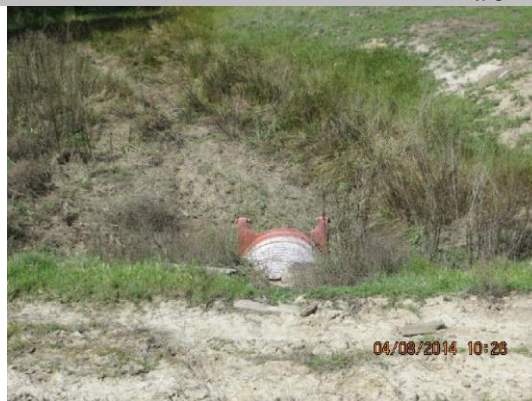
Photo 1 of 2 : UCIP_FA_2016_39128_60702.jpg

LM Start	3.13	Rating **	M	Issue No.	1220
LM End	3.13	Issue Type +	En	Location *	LS
Category	Supplemental			GPS Latitude/Longitude	
				Start	End
Item	DWR UCIP Field Study			37.321444 °	37.321444 °
				-120.928764 °	-120.928764 °
DWR ID					
Comment Code					
Inspector Comment					
FS_ID:39128					
DS_ID:19574					
EP_NO: N/A					
Repair Type: Non-Urgent					
Crossing Status: Found					
UCIP Comments: Some minor erosion around headwall on LS toe.					
FIELD_STRUCT_DESC: 36-inch CM pipe through the levee, 8-feet below the crown. Flap gate on the waterward end. Brass cap No. 100					
BM on headwall on the landward side. (USACE-1967). This entry matches the Drainage or Irrigation Structure referenced in O&M manual (HLM 3.16).					
FS Date: 4/8/2014

Pipe, Flapgate, and headwall on WS toe.

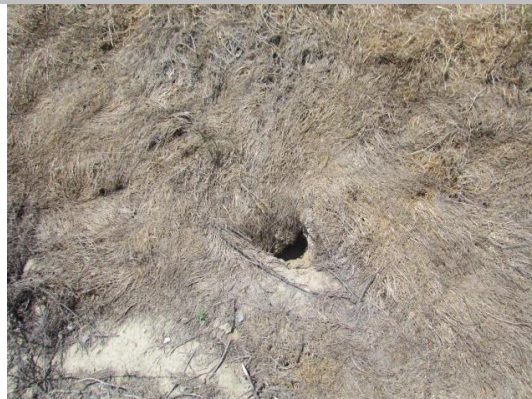
Photo 1 of 2 : FA_2016_NA0010_118_10_20161007_00007.jpg

LM Start	3.16	Rating **	M	Issue No.	10
LM End	3.16	Issue Type +	Ma	Location *	LS
Category	Earthen Levee			GPS Latitude/Longitude	
				Start	End
Item	Animal Control			37.321053 °	37.321053 °
				-120.928785 °	-120.928785 °
DWR ID	DWR_NA0010_01_s_2012_10				
Comment Code					
A3 : No rodents visible, but rodent burrows visible; need to backfill and compact or grout burrows.					
Inspector Comment					
Several rodent holes noted within this section. Rodent hole noted on waterward shoulder next to fence pole.

Looking at typical view of rodent holes on landward slope.

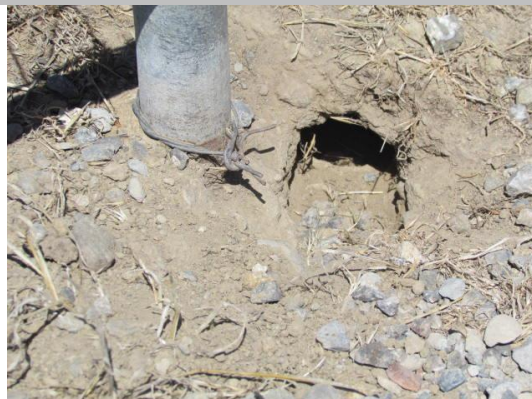
Photo 2 of 2 : FA_2016_NA0010_118_10_20161007_00008.jpg

Looking at rodent hole next to fence pole on landward shoulder.

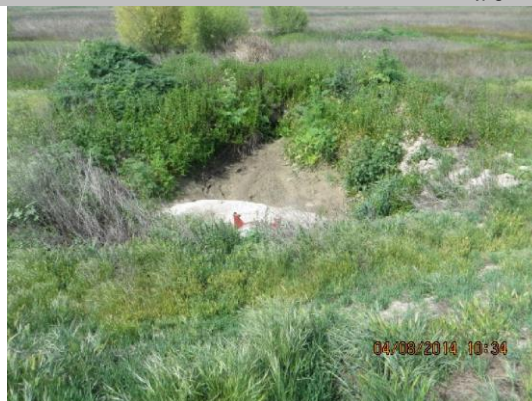
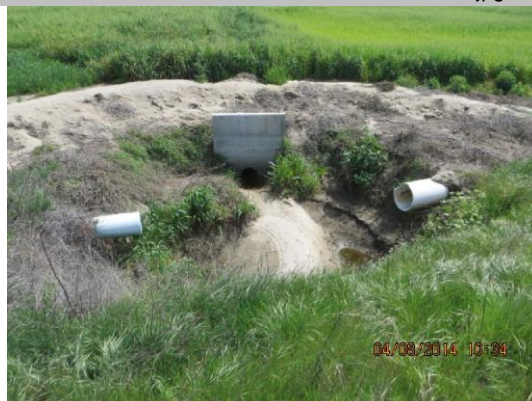
Photo 1 of 2 : UCIP_FA_2016_50054_60707.jpg

Comment Code					
Inspector Comment					
FS_ID:50054 DS_ID:19575 EP_NO: N/A Repair Type: Urgent Crossing Status: Found UCIP Comments: 7/19/2016 Same as previous inspection. Erosion present on LS slope. (DWR UCIP - omagana)4/08/2014 Pipe rusted through at Springline on LS toe. Flapgate blocked by sediment on WS toe. Heavy sediment on both ends of pipe. Need to contact owner to address issues. (DWR UCIP - omagana) FIELD_STRUCT_DESC: 36-inch corrugated metal drainage pipe through the levee, 9.7 feet below the crown. Flap gate located on the waterside (WS) end. Brass cap No. 100 BM on headwall located on the landside (LS). [Additional Reference(s): DWR Levee Log, 2002. USACE San Joaquin O&M Manuals: Unit No. 601, 1967, (HLM 3.50), Unit No. 601 Part I, 1967 (Amended in 1978), Unit No. 601 Part II, 1969, and Unit No. 601 Part III, 1969]. FS Date: 7/19/2016

Pipe, headwall, and flapgate on WS toe.

Pipe and headwall on LS toe.

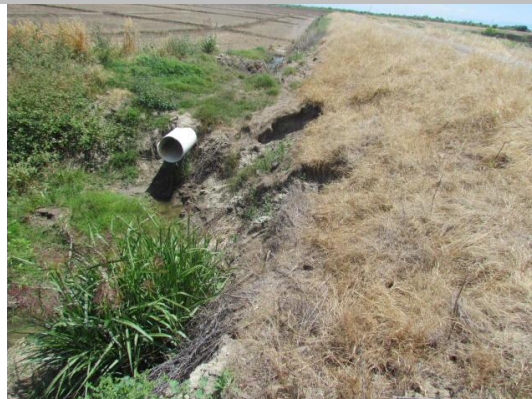
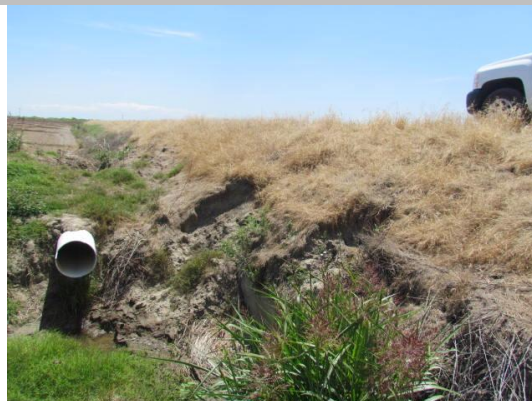
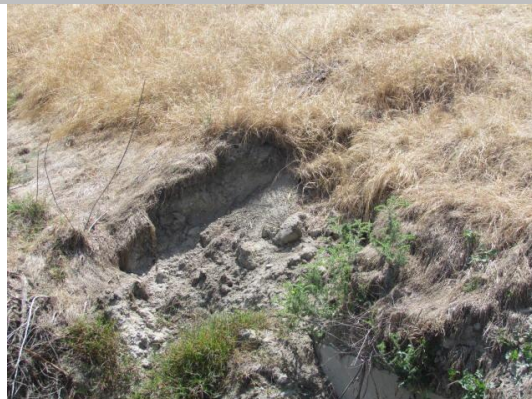
Photo 1 of 3 : FA_2016_NA0010_118_1179_20161007_00022.jpg

LM Start	3.47	Rating **	U	Issue No.	1179
LM End	3.47	Issue Type +	Ma	Location *	LS
Category	Earthen Levee			GPS Latitude/Longitude	
				Start	End
Item	Erosion / Bank Caving			37.317057 °	37.317057 °
				-120.926443 °	-120.926443 °
DWR ID	DWR_NA0010_01_s_2015_1179				
Comment Code					
E1 : Note and monitor erosion site.					
Inspector Comment					
Several erosions greater than three inches on landward slope.

Looking south at erosion on landward slope and toe.

Looking southwest at erosion on landward slope and toe.

Looking west at erosion on landward slope and toe.

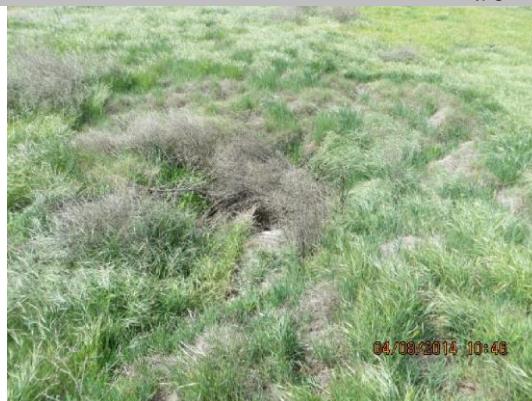
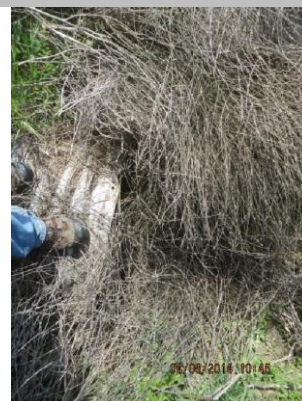
Photo 1 of 2 : UCIP_FA_2016_39132_60723.jpg

FS_ID:39132
DS_ID:19576
EP_NO: N/A
Repair Type: Non-Urgent
Crossing Status: Found
UCIP Comments: Slide gate missing from WS. No closure device, but degrading of levee at Highway 140 is lower than pipe, so this does not appear to be a critical issue. Also dense vegetation limits the inspector's visibility to identify signs of pipe failure (leaks) along the slope. Recommend removing vegetation along pipe alignment to conduct proper inspection of structure and appurtenances.
FIELD_STRUCT_DESC: 30-inch CM irrigation pipe through the levee, 3.5 feet below the crown. Slidegate on the waterward end. Brass cap No. 100 BM on headwall on the landward side. (USACE-1967). This entry matches the Drainage or Irrigation Structure referenced in O&M manual (HLM 3.95).
FS Date: 4/8/2014

Slide gate missing on WS toe with heavy vegetation camouflaging pipe

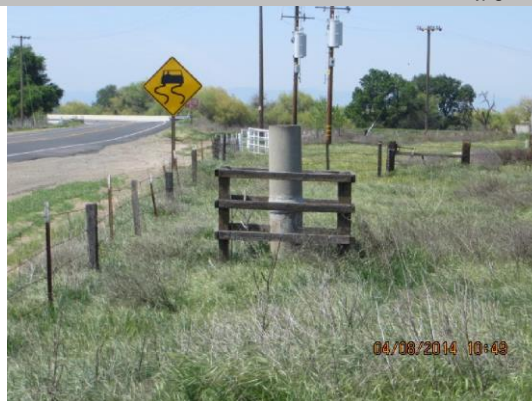
Photo 1 of 2 : UCIP_FA_2016_39133_60725.jpg

FS_ID:39133
DS_ID:19606
EP_NO: N/A
Repair Type: Non-Urgent
Crossing Status: Indicator Found
UCIP Comments: Need to contact owner to determine status of crossing inlet and outlet not found.
FIELD_STRUCT_DESC: 12-inch concrete irrigation pipe through the levee, 3.5 feet below the crown. 12-inch Concrete standpipes off both sides of levee.
FS Date: 4/8/2014

12-inch concrete standpipe off WS toe.

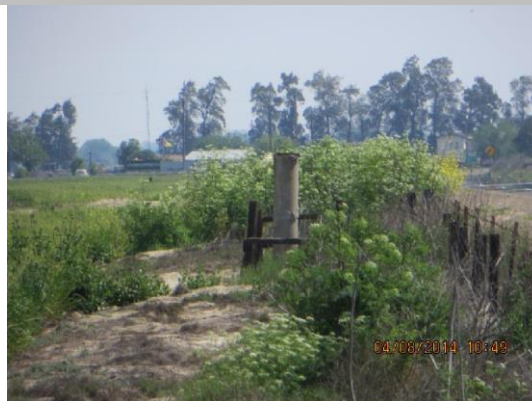
Photo 2 of 2 : UCIP_FA_2016_39133_60724.jpg

12-inch concrete standpipe off LS toe.

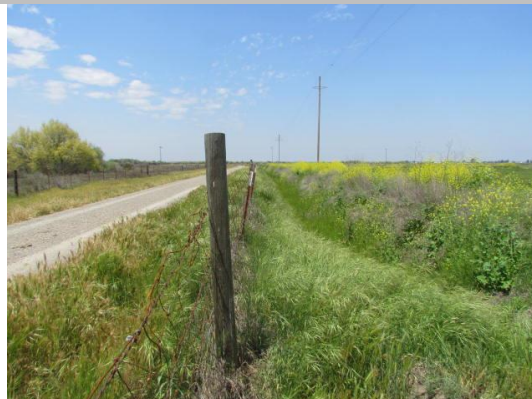
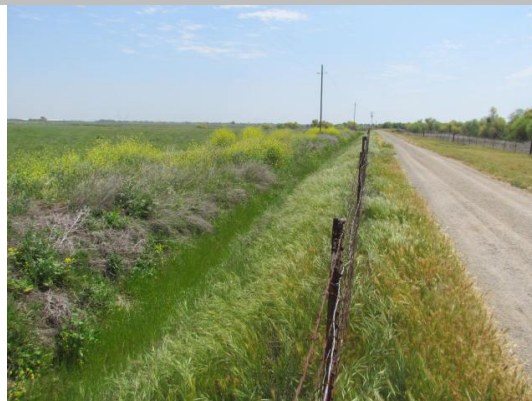
Photo 1 of 2 : FA_2016_NA0010_118_5_20161007_00003.jpg

LM Start	3.98	Rating **	U	Issue No.	5
LM End	4.05	Issue Type +	En	Location *	LS
Category	Earthen Levee			GPS Latitude/Longitude	
				Start	End
Item	Encroachments			37.310837 °	37.310003 °
				-120.926182 °	-120.925313 °
DWR ID	DWR_NA0010_01_s_2012_5				
Comment Code					
DT : Ditch					
Inspector Comment					
Irrigation ditch at landside toe

Looking north at irrigation ditch at landside toe.

Looking south at irrigation ditch at landside toe.

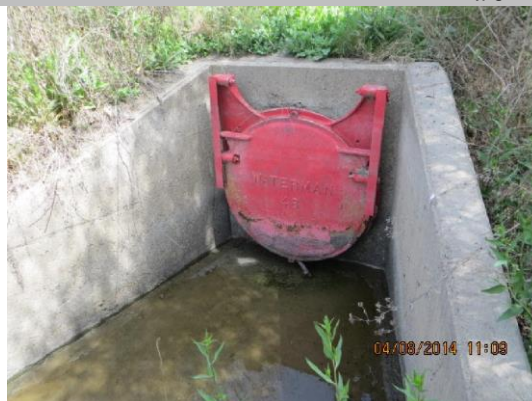
Photo 1 of 2 : UCIP_FA_2016_39134_60730.jpg

FS_ID:39134
DS_ID:19607
EP_NO: N/A
Repair Type: Non-Urgent
Crossing Status: Found
UCIP Comments: Pipe appears sleeved with a 12-inch steel pipe with a slide gate at the LS toe. No identified authorization for changes to this crossing. Need to contact owner to obtain additional information about the modifications to crossing.
FIELD_STRUCT_DESC: 48-inch CM stormdrain pipe through the levee, 14.0 feet below the crown. Flap gate on the waterward end. Brass cap No. 90 BM on headwall on the landward side. (USACE-1967). This entry matches the Drainage or Irrigation Structure referenced in O&M manual (HLM 4.16).
FS Date: 4/8/2014

Concrete headwall and 48-inch flapgate visible on WS toe.

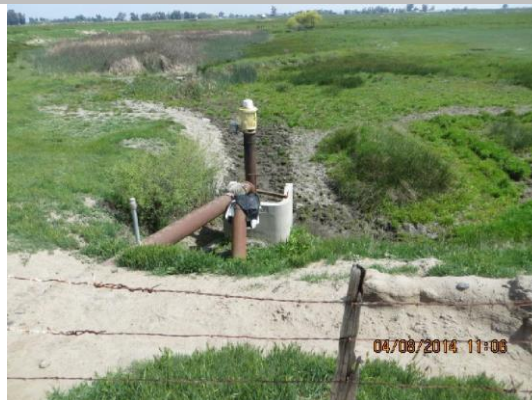
Photo 2 of 2 : UCIP_FA_2016_39134_60731.jpg

Assumed pipe exists under pump at LS toe.

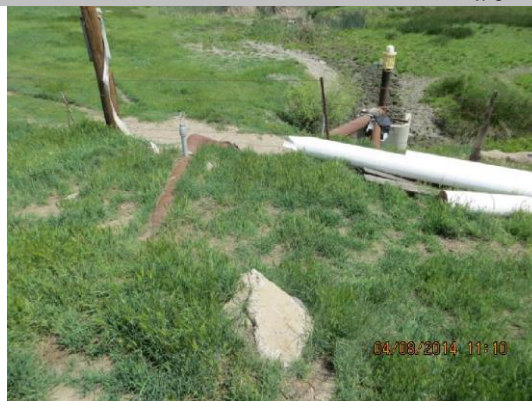
Photo 1 of 2 : UCIP_FA_2016_39138_71320.jpg

FS_ID:39138
DS_ID:24866
EP_NO: N/A
Repair Type: Non-Urgent
Crossing Status: Found
UCIP Comments: Need to contact owner to get details of crossing.
FIELD_STRUCT_DESC: 12-inch steel stormdrain pipe through the levee 2.5-feet below the crown. 12-inch steel pipe, vent, and pump on stand visible on LS slope. 10-inch PVC pipe visible on WS slope.
FS Date: 4/8/2014

View of pipe visible on landward side.

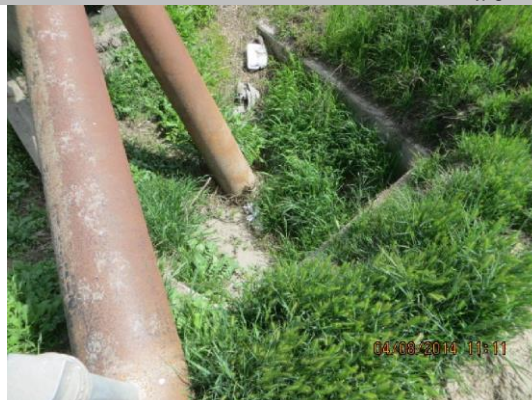
Photo 2 of 2 : UCIP_FA_2016_39138_71319.jpg

Pipe through existing 48 inch pipe.

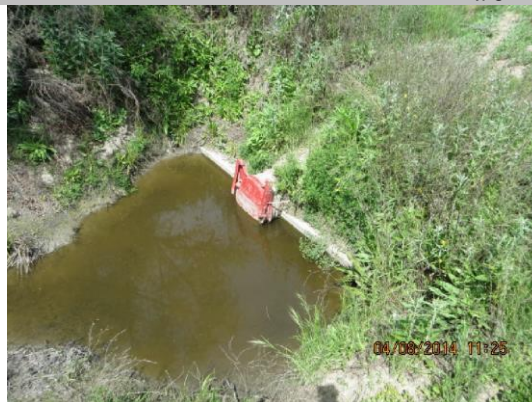
Photo 2 of 2 : UCIP_FA_2016_39140_60732.jpg

Pipe, flapgate, and headwall visible at WS toe.

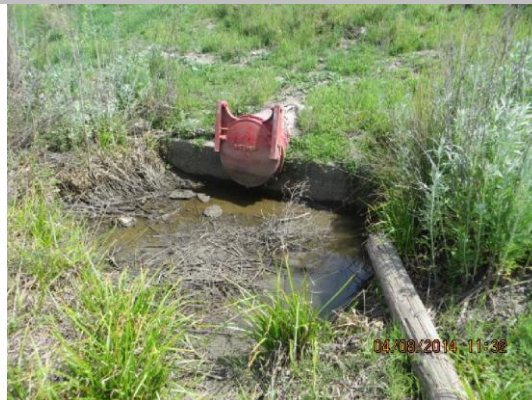
Photo 2 of 2 : UCIP_FA_2016_39141_60738.jpg

Pipe, flapgate, and headwall on WS toe.

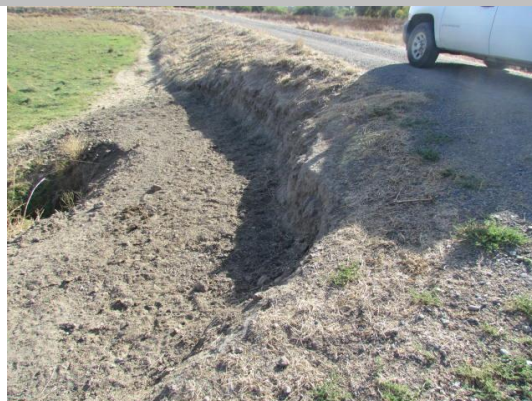
Photo 1 of 1 : FA_2016_NA0010_118_9_20161007_00006.jpg

LM Start	4.69	Rating **	U	Issue No.	9
LM End	4.69	Issue Type +	Ma	Location *	LS
Category	Earthen Levee			GPS Latitude/Longitude	
				Start	End
Item	Animal Control			37.302398 °	37.302398 °
				-120.920920 °	-120.920920 °
DWR ID	DWR_NA0010_01_s_2013_9				
Comment Code					
A2 : Repair the levee slope damaged by livestock and prevent large animal access.					
Inspector Comment					
Levee landward toe damaged by livestock.

Looking at landward slope damaged by livestock.

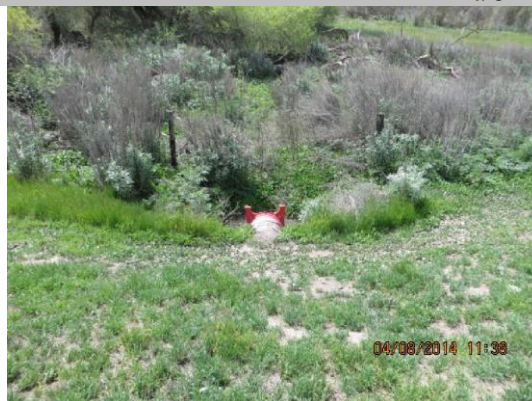
Photo 1 of 2 : UCIP_FA_2016_39143_60740.jpg

LM Start	5.02	Rating **	M	Issue No.	1190
LM End	5.02	Issue Type +	En	Location *	LS
Category	Supplemental			GPS Latitude/Longitude	
				Start	End
Item	DWR UCIP Field Study			37.298917 °	37.298917 °
				-120.917262 °	-120.917262 °
DWR ID					
Comment Code					
Inspector Comment					
FS_ID:39143 DS_ID:19610 EP_NO: N/A Repair Type: Non-Urgent Crossing Status: Found UCIP Comments: Non-functional -- sediment buildup against flapgate and inlet buried at landward side. FIELD_STRUCT_DESC: 24-inch CM stormdrain pipe through the levee, 8.0 feet below the crown. Flap gate on the waterward end. Brass cap No. 90 BM on headwall on the landward side. (USACE-1967). This entry matches the Drainage or Irrigation Structure referenced in O&M manual (HLM 5.05). FS Date: 4/8/2014

Flapgate and headwall visible at WS toe.

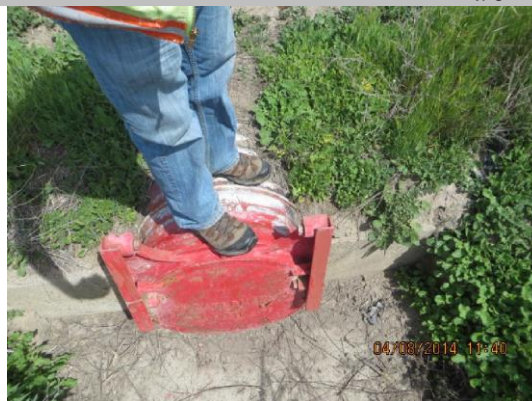
Photo 2 of 2 : UCIP_FA_2016_39143_60739.jpg

Flapgate and headwall visible at WS toe.

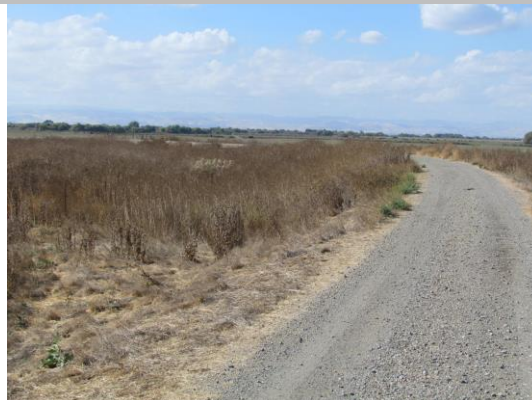
Photo 1 of 2 : FA_2016_NA0010_118_93_20161024_00233.jpg

LM Start	5.87	Rating **	U	Issue No.	93
LM End	6.86	Issue Type +	Ma	Location *	WS
Category	Earthen Levee			GPS Latitude/Longitude	
				Start	End
Item	Vegetation			37.303584 °	37.302118 °
				-120.904614 °	-120.887957 °
DWR ID	DWR_NA0010_01_f_2015_93				
Comment Code					
V2 : Remove the wild growth other than native grasses from the levee slopes.					
Inspector Comment

Looking at dense veg on waterward slope. (Fall 2016)

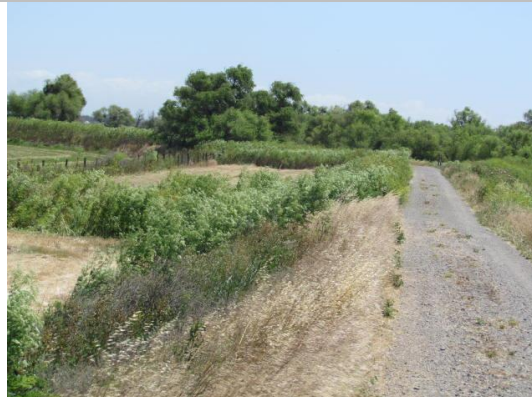
Photo 2 of 2 : FA_2016_NA0010_118_93_20161007_00018.jpg

Looking at dense veg on waterward slope. (Spring 2016)

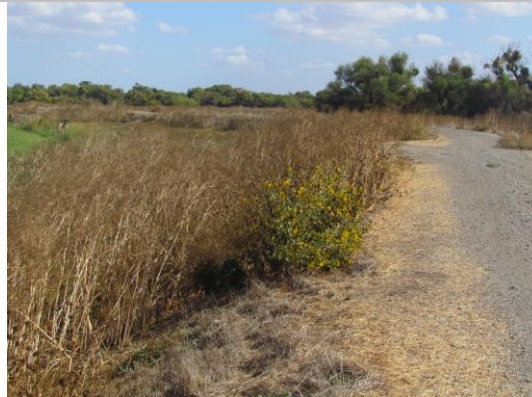
Photo 1 of 2 : FA_2016_NA0010_118_92_20161024_00234.jpg

LM Start	5.87	Rating **	U	Issue No.	92
LM End	6.86	Issue Type +	Ma	Location *	LS
Category	Earthen Levee			GPS Latitude/Longitude	
				Start	End
Item	Vegetation			37.303555 °	37.302118 °
				-120.904541 °	-120.887957 °
DWR ID	DWR_NA0010_01_f_2015_92				
Comment Code					
V2 : Remove the wild growth other than native grasses from the levee slopes.					
Inspector Comment

Looking south at dense veg on landward slope. (Fall 2016)

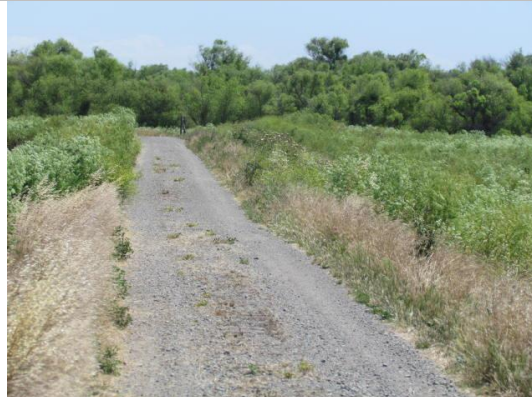
Photo 2 of 2 : FA_2016_NA0010_118_92_20161007_00017.jpg

Looking south at dense veg on landward slope. (Spring 2016)

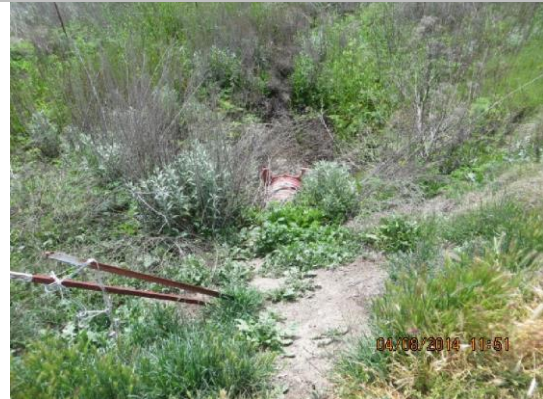
Photo 1 of 2 : UCIP_FA_2016_39151_60742.jpg

Comment Code					
Inspector Comment					
FS_ID:39151 DS_ID:19611 EP_NO: N/A Repair Type: Non-Urgent Crossing Status: Found UCIP Comments: Dense vegetation limits the inspector's visibility to identify signs of pipe failure (leaks) along waterward and landward slopes. Recommend removing vegetation along pipe alignment to conduct proper inspection of structure and appurtenances. Landward side filled in with soil. Need to contact owner. If crossing is no longer used need to coordinate with CVFPB for proper abandonment. FIELD_STRUCT_DESC: 24-inch CM stormdrain pipe through the levee, 8.6 feet below the crown. Flap gate on the waterward end. Brass cap No. 90 BM on headwall on the landward side. (USACE-1967). This entry matches the Drainage or Irrigation Structure referenced in O&M manual (HLM 5.95). FS Date: 4/8/2014

Pipe, concrete headwall, and flapgate visible on WS toe.

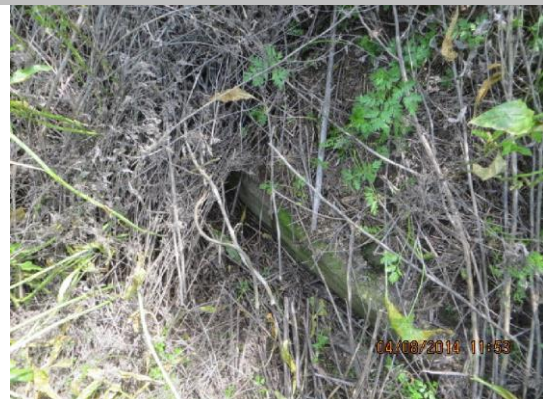
Photo 2 of 2 : UCIP_FA_2016_39151_60741.jpg

Top of concrete headwall just visible on LS toe.

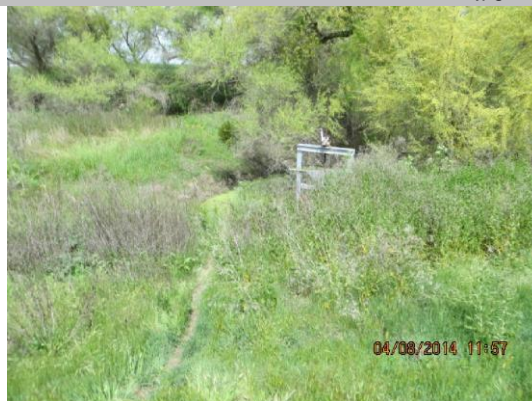
Photo 1 of 2 : UCIP_FA_2016_39152_60745.jpg

Comment Code					
Inspector Comment					
FS_ID:39152 DS_ID:19612 EP_NO: N/A Repair Type: Non-Urgent Crossing Status: Found UCIP Comments: Dense vegetation limits the inspector's visibility to identify signs of pipe failure (leaks) along waterward and landward slopes. Recommend removing vegetation along pipe alignment to conduct proper inspection of structure and appurtenances. Pipe completely blocked by soil on LS toe due to animal activity. Slide gate blocked open. FIELD_STRUCT_DESC: 48-inch CM pipe through the levee, 13.1 feet below the crown. Walkway to slidegate on LS toe at concrete headwall. Flap gate at concrete headwall on the WS toe. Brass cap No. 90 BM on headwall on the landward side. (USACE-1967). Pipe crosses levee at an angle to levee alignment. This entry matches the Drainage or Irrigation Structure referenced in O&M manual (HLM 6.13). FS Date: 4/8/2014

Slidegate at LS toe.

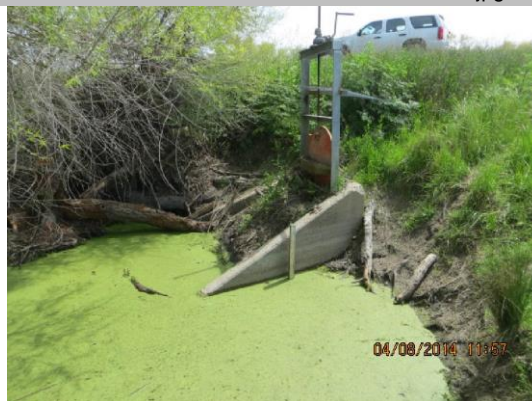
Photo 2 of 2 : UCIP_FA_2016_39152_60744.jpg

Pipe, concrete headwall, slidegate, and metal walkway on LS toe.

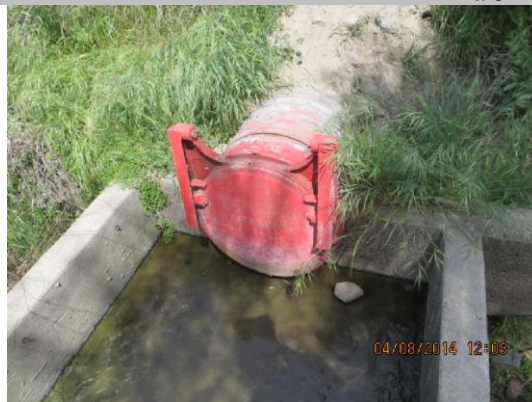
Photo 2 of 2 : UCIP_FA_2016_39154_60760.jpg

Pipe, flapgate, and concrete headwall on WS toe.

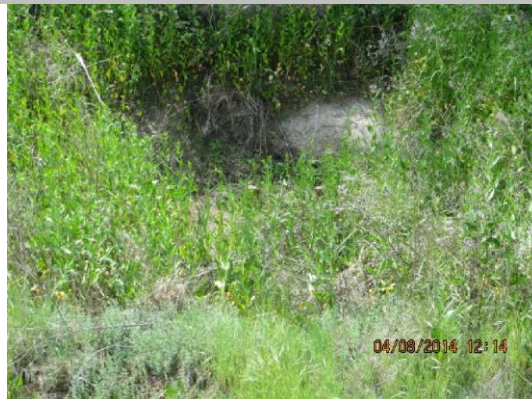
Photo 1 of 2 : UCIP_FA_2016_49962_60764.jpg

FS_ID:49962
DS_ID:19614
EP_NO: N/A
Repair Type: Non-Urgent
Crossing Status: Found
UCIP Comments: 7/19/2016 Same as previous inspection. Outlet and inlet are under water. (DWR UCIP - omagana)4/08/2014 Flapgate blocked by sedimentation at WS toe. Dense vegetation limits the inspector's visibility to identify signs of pipe failure (leaks) along the slope. Recommend removing vegetation along pipe alignment to conduct proper inspection of structure and appurtenances. Also recommend clearing vegetation from both waterward and landward toe. (DWR UCIP - omagana)
FIELD_STRUCT_DESC: 24-inch corrugated metal drainage pipe through the levee, 9.8 feet below the crown. Wooden fence around 4-foot by 4-foot drop inlet located on the landside (LS) toe. Flap gate located on the waterside (WS) end. Brass cap No. 90 BM on headwall located on the LS. [Additional Reference(s): DWR Levee Log, 2002. USACE San Joaquin O&M Manuals: Unit No. 601, 1967, (HLM 6.64), Unit No. 601 Part I, 1967 (Amended in 1978), Unit No. 601 Part II, 1969, and Unit No. 601 Part III, 1969]

Pipe and flapgate visible on WS toe.

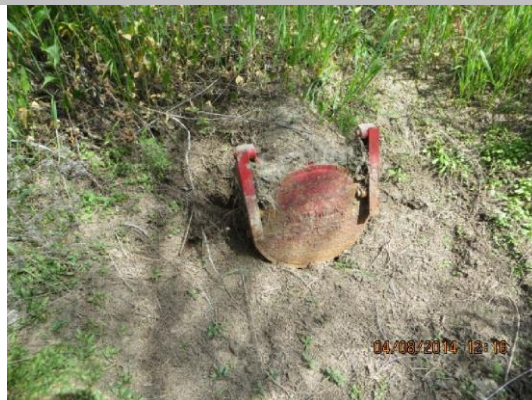
Photo 2 of 2 : UCIP_FA_2016_49962_60766.jpg

Pipe and flapgate visible at WS toe. Flapgate blocked by sedimentation on WS toe.

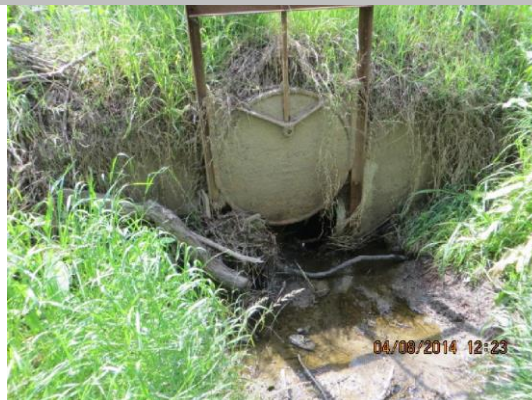
Photo 2 of 2 : UCIP_FA_2016_50077_60767.jpg

Pipe, concrete headwall, and slidegate on LS toe. Debris blocking closure of slidegate.

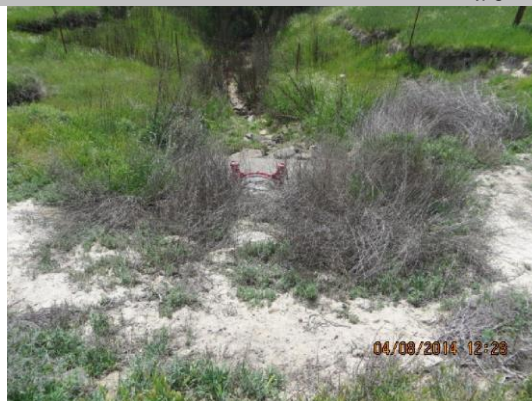
Photo 1 of 2 : UCIP_FA_2016_42851_60770.jpg

Comment Code					
Inspector Comment					
FS_ID:42851					
DS_ID:19616					
EP_NO: N/A					
Repair Type: Non-Urgent					
Crossing Status: Found					
UCIP Comments: Pipe failing and corroded through at LS toe. Need to contact owner to determine status of crossing. Also dense vegetation limits the inspector's visibility to identify signs of pipe failure (leaks) along the landward slope. Recommend removing vegetation along pipe alignment to conduct proper inspection of structure.					
FIELD_STRUCT_DESC: 24-inch CM stormdrain pipe through the levee, 5.1 feet below the crown. Flap gate on the waterward end. Brass cap No. 90 BM on headwall on the landward side. (USACE-1967). This entry matches the Drainage or Irrigation Structure referenced in O&M manual (HLM 7.21).					
FS Date: 4/8/2014

Pipe, concrete headwall, and flapgate on WS toe.

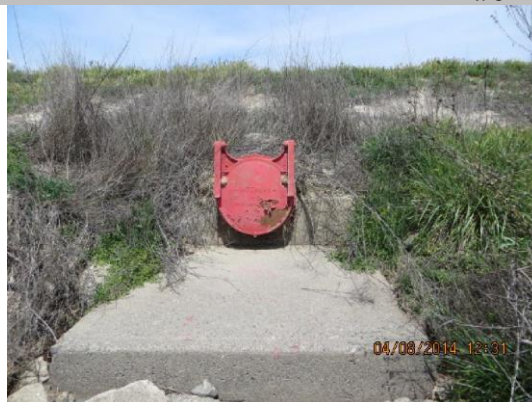
Photo 2 of 2 : UCIP_FA_2016_42851_60772.jpg

Flapgate and concrete headwall on WS toe.

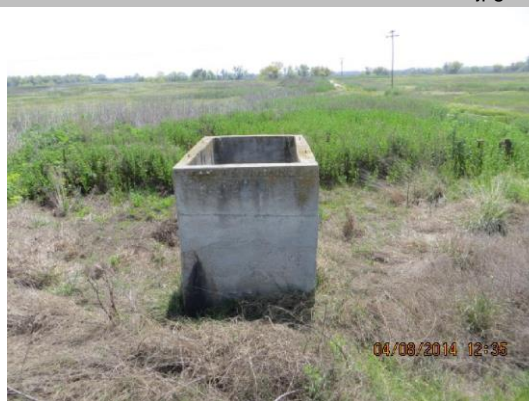
Photo 2 of 2 : UCIP_FA_2016_39160_60775.jpg

5'X7' concrete box riser on WS toe.

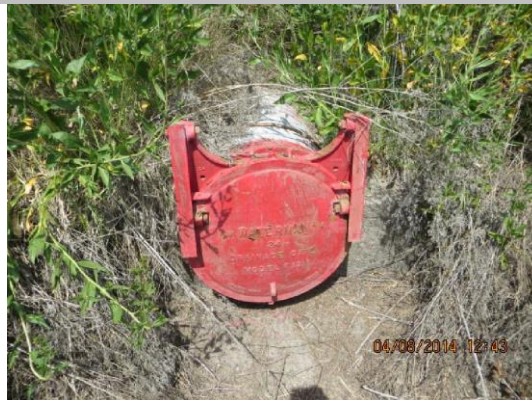
Photo 2 of 2 : UCIP_FA_2016_39161_60780.jpg

Pipe and flapgate visible on WS toe.

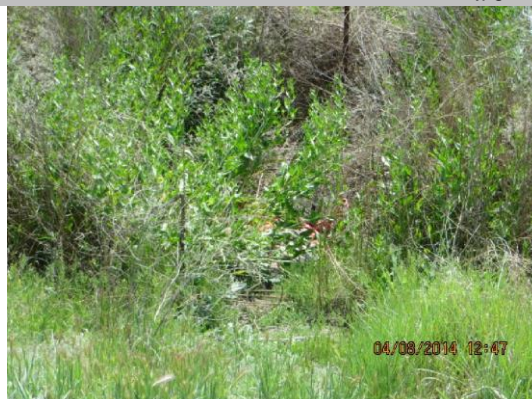
Photo 1 of 2 : UCIP_FA_2016_39243_60842.jpg

LM Start	7.65	Rating **	M	Issue No.	1191
LM End	7.65	Issue Type +	En	Location *	LS
Category	Supplemental			GPS Latitude/Longitude	
				Start	End
Item	DWR UCIP Field Study			37.299211 °	37.299211 °
				-120.874415 °	-120.874415 °
DWR ID					
Comment Code					
Inspector Comment					
FS_ID:39243 DS_ID:19619 EP_NO: N/A Repair Type: Non-Urgent Crossing Status: Found UCIP Comments: Dense vegetation limits the inspector's visibility to identify signs of pipe failure (leaks) along the slope. Recommend removing vegetation along pipe alignment to conduct proper inspection of structure. FIELD_STRUCT_DESC: 24-inch CM pipe through the levee, 10.0 feet below the crown. Flap gate on the waterward end. Brass cap No. 80 BM on headwall on the landward side. (USACE-1967). This entry matches the Drainage or Irrigation Structure referenced in O&M manual (HLM 7.69). FS Date: 4/8/2014

Flapgate and headwall at WS toe. Heavy vegetation on slopes.

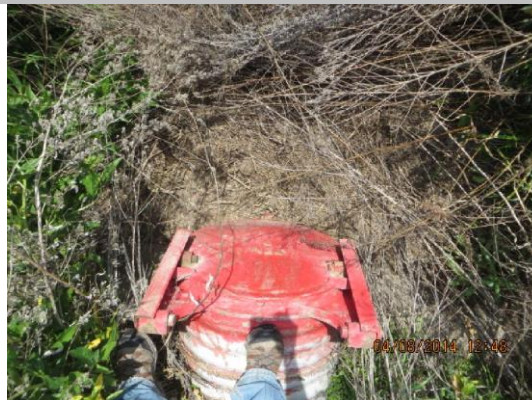
Photo 2 of 2 : UCIP_FA_2016_39243_60840.jpg

Flapgate and headwall at WS toe.

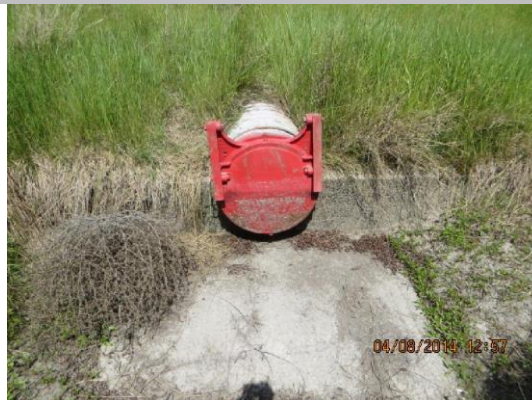
Photo 1 of 2 : UCIP_FA_2016_39244_60844.jpg

FS_ID:39244
DS_ID:19620
EP_NO: N/A
Repair Type: Non-Urgent
Crossing Status: Found
UCIP Comments: Dense vegetation limits the inspector's visibility to identify signs of pipe failure (leaks) along the slope. Recommend removing vegetation along pipe alignment to conduct proper inspection of structure.
FIELD_STRUCT_DESC: 24-inch CM stormdrain pipe through the levee, 8.0 feet below the crown. Flap gate on the waterward end. Brass cap No. 80 BM on headwall on the landward side. (USACE-1967). This entry matches the Drainage or Irrigation Structure referenced in O&M manual (HLM 8.07).
FS Date: 4/9/2014

LM Start	8.03	Rating **	M	Issue No.	1192 (cont)
LM End	8.03	Issue Type +	En	Location *	LS

Pipe, Headwall, and flapgate at WS toe.

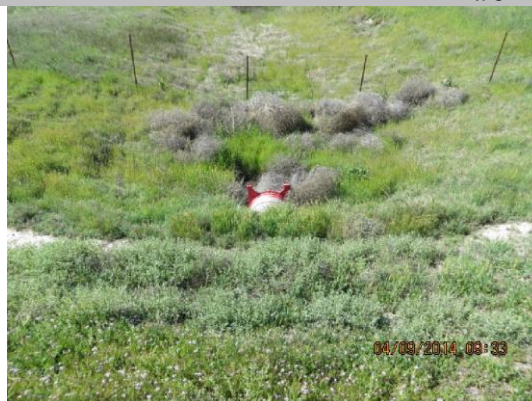
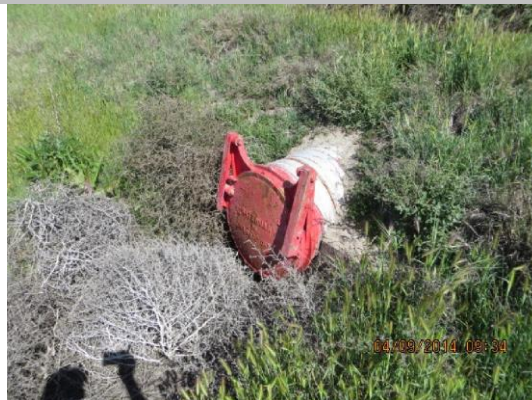
Photo 1 of 2 : UCIP_FA_2016_39245_60850.jpg

FS_ID:39245
DS_ID:19621
EP_NO: N/A
Repair Type: Non-Urgent
Crossing Status: Found
UCIP Comments: Dense vegetation limits the inspector's visibility to identify signs of pipe failure (leaks) along the slope. Recommend removing vegetation along pipe alignment to conduct proper inspection of structure. Sediment buildup at landward toe.
FIELD_STRUCT_DESC: 24-inch CM pipe through the levee, 9.5 feet below the crown. Flap gate on the waterward end. Brass cap No. 80 BM on headwall on the landward side. (USACE-1967). This entry matches the Drainage or Irrigation Structure referenced in O&M manual (HLM 8.41).
FS Date: 4/9/2014

LM Start	8.38	Rating **	M	Issue No.	1193 (cont)
LM End	8.38	Issue Type +	En	Location *	LS

Concrete headwall, pipe, and flapgate at WS toe.

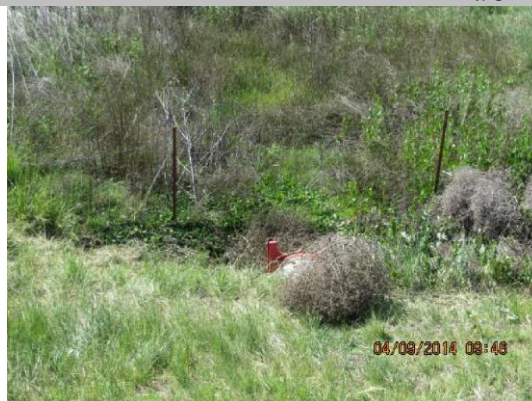
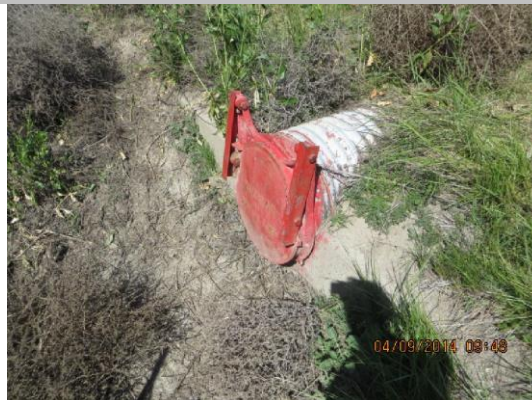
Photo 1 of 2 : UCIP_FA_2016_39247_60859.jpg

LM Start	8.89	Rating **	M	Issue No.	1194
LM End	8.89	Issue Type +	En	Location *	LS
Category	Supplemental			GPS Latitude/Longitude	
				Start	End
Item	DWR UCIP Field Study			37.297296 °	37.297296 °
				-120.852871 °	-120.852871 °
DWR ID					
Comment Code					
Inspector Comment					
FS_ID:39247 DS_ID:19623 EP_NO: N/A Repair Type: Non-Urgent Crossing Status: Found UCIP Comments: Dense vegetation limits the inspector's visibility to identify signs of pipe failure (leaks) along the slope. Recommend removing vegetation along pipe alignment to conduct proper inspection of structure. FIELD_STRUCT_DESC: 24-inch CM stormdrain pipe through the levee, 9.1 feet below the crown. Flap gate on the waterward end. Brass cap No. 80 BM on headwall on the landward side. (USACE-1967). This entry matches the Drainage or Irrigation Structure referenced in O&M manual (HLM 8.93). FS Date: 4/9/2014

Pipe, flapgate, and headwall on WS toe.

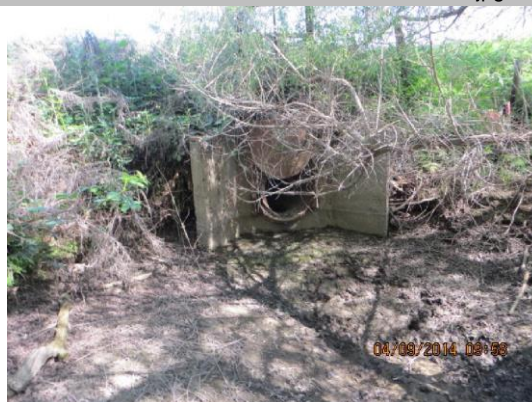
Photo 2 of 2 : UCIP_FA_2016_49964_60862.jpg

Slidegate and headwall at WS toe.

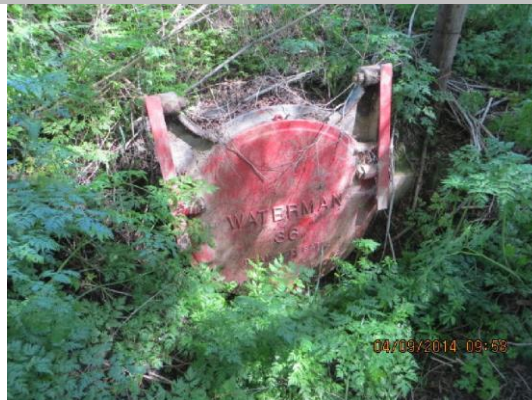
Photo 1 of 2 : UCIP_FA_2016_39249_60870.jpg

Comment Code					
Inspector Comment					
FS_ID:39249 DS_ID:19625 EP_NO: N/A Repair Type: Non-Urgent Crossing Status: Found UCIP Comments: Dense vegetation limits the inspector's visibility to identify signs of pipe failure (leaks) along the slope. Recommend removing vegetation along pipe alignment to conduct proper inspection of structure. Some sediment buildup in pipe. FIELD_STRUCT_DESC: 36-inch CM stormdrain pipe through the levee, 10.0 feet below the crown. Flap gate on the waterward end. Brass cap No. 80 BM on headwall on the landward side. (USACE-1967). This entry matches the Drainage or Irrigation Structure referenced in O&M manual (HLM 9.00). FS Date: 4/9/2014

Pipe and flapgate visible on WS toe.

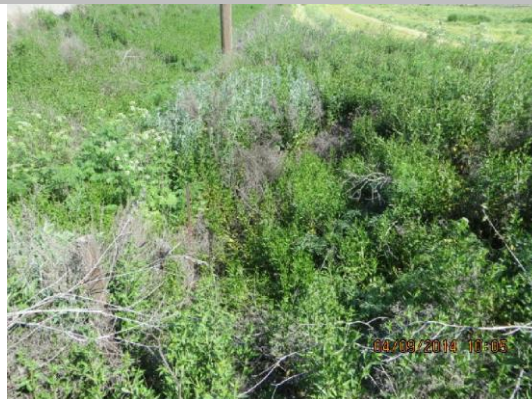
Photo 1 of 2 : UCIP_FA_2016_39250_60872.jpg

LM Start	8.99	Rating **	M	Issue No.	1196
LM End	8.99	Issue Type +	En	Location *	LS
Category	Supplemental			GPS Latitude/Longitude	
				Start	End
Item	DWR UCIP Field Study			37.297488 °	37.297488 °
				-120.851157 °	-120.851157 °
DWR ID					
Comment Code					
Inspector Comment					
FS_ID:39250 DS_ID:19626 EP_NO: N/A Repair Type: Non-Urgent Crossing Status: Found UCIP Comments: Dense vegetation limits the inspector's visibility to identify signs of pipe failure (leaks) along the slope. Recommend removing vegetation along pipe alignment to conduct proper inspection of structure. FIELD_STRUCT_DESC: 24-inch CM stormdrain pipe through the levee, 10.0 feet below the crown. Flap gate on the waterward end. Brass cap No. 80 BM on headwall on the landward side. (USACE-1967). This entry matches the Drainage or Irrigation Structure referenced in O&M manual (HLM 9.03). FS Date: 4/9/2014

Heavy vegetation on LS toe.

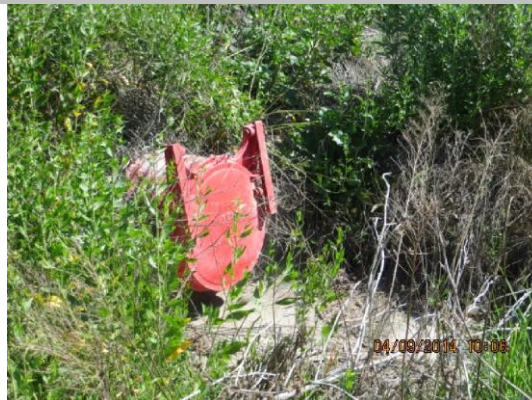
Photo 2 of 2 : UCIP_FA_2016_39250_60871.jpg

Pipe, concrete headwall, and flapgate at WS toe.

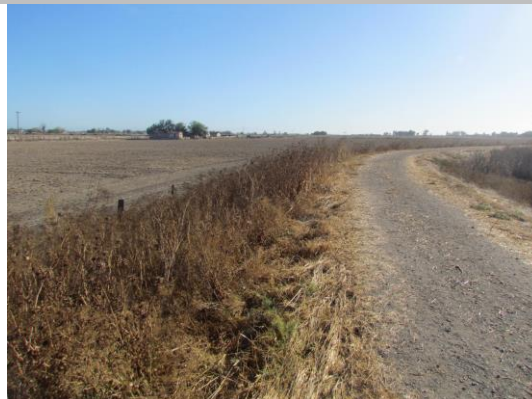
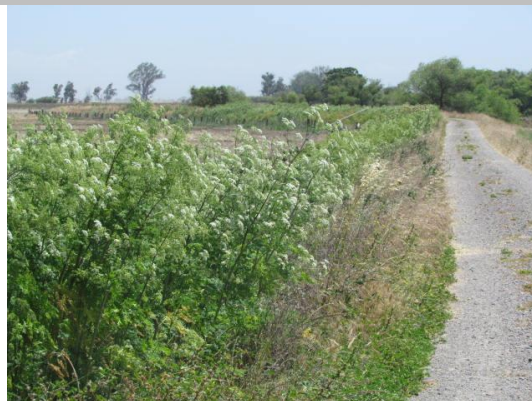
Photo 1 of 2 : FA_2016_NA0010_118_12_20161024_00235.jpg

LM Start	8.99	Rating **	U	Issue No.	12 (cont)
LM End	9.72	Issue Type +	Ma	Location *	LS

Looking east at dense veg on landward slope. (Fall 2016)

Looking southeast at dense veg on landward slope. (Spring 2016)

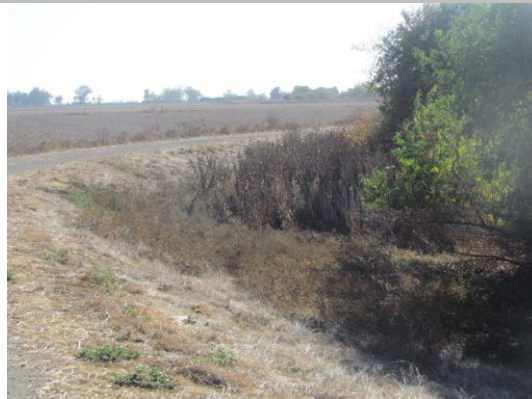
Photo 1 of 2 : FA_2016_NA0010_118_94_20161024_00236.jpg

LM Start	9.03	Rating **	U	Issue No.	94
LM End	9.72	Issue Type +	Ma	Location *	WS
Category	Earthen Levee			GPS Latitude/Longitude	
				Start	End
Item	Vegetation			37.297380 °	37.293801 °
				-120.850388 °	-120.839759 °
DWR ID	DWR_NA0010_01_f_2015_94				
Comment Code					
V2 : Remove the wild growth other than native grasses from the levee slopes.					
Inspector Comment

Looking south at dense veg on waterward slope. (Fall 2016)

Looking southwest at dense veg on waterward slope. (Spring 2016)

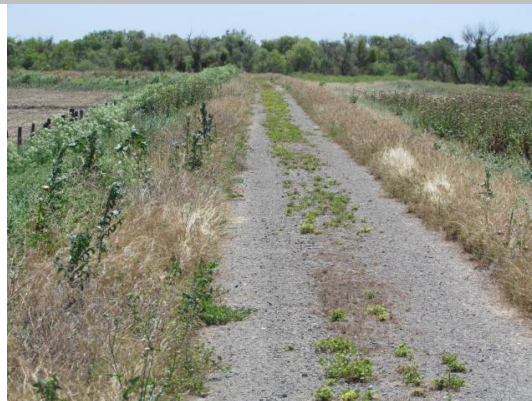
Photo 1 of 1 : FA_2016_NA0010_118_117_20161007_00021.jpg

LM Start	9.16	Rating **	M	Issue No.	117
LM End	9.78	Issue Type +	Ma	Location *	CR
Category	Earthen Levee			GPS Latitude/Longitude	
				Start	End
Item	Crown Surface / Depressions / Rutting			37.296145 °	37.293077 °
				-120.848588 °	-120.839170 °
DWR ID	DWR_NA0010_01_s_2012_117				
Comment Code					
C1 : Add appropriate material and re-grade the levee to bring the crown above the design elevation.					
Inspector Comment					
Control vegetation on levee crown.

Looking south at veg on levee crown.

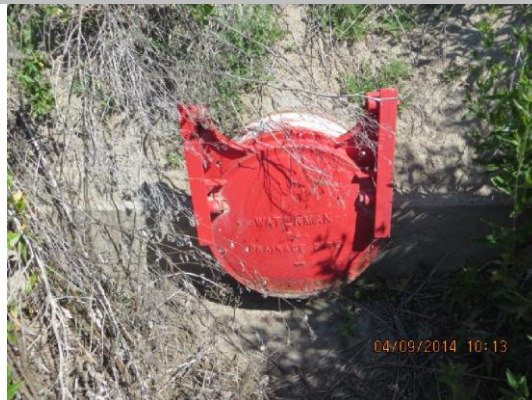
Photo 1 of 2 : UCIP_FA_2016_39251_60875.jpg

Comment Code					
Inspector Comment					
FS_ID:39251 DS_ID:19627 EP_NO: N/A Repair Type: Non-Urgent Crossing Status: Found UCIP Comments: Dense vegetation limits the inspector's visibility to identify signs of pipe failure (leaks) along the slope. Recommend removing vegetation along pipe alignment to conduct proper inspection of structure. FIELD_STRUCT_DESC: 24-inch CM stormdrain pipe through the levee, 8.6 feet below the crown. Concrete drop-inlet installed at LS toe. Flap gate on the waterward end. Brass cap No. 80 BM on headwall on the landward side. (USACE-1967). This entry matches the Drainage or Irrigation Structure referenced in O&M manual (HLM 9.37). FS Date: 4/9/2014

Pipe and flapgate on WS toe.

Headwall, Pipe, and flapgate on WS toe.

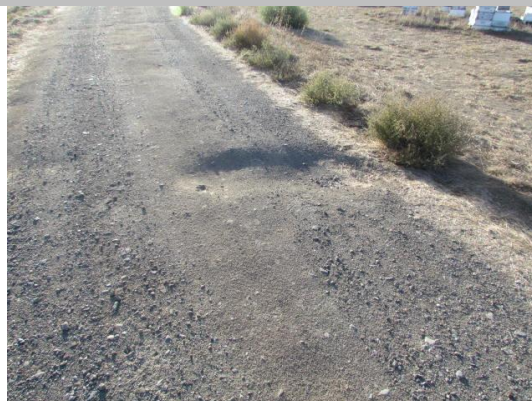
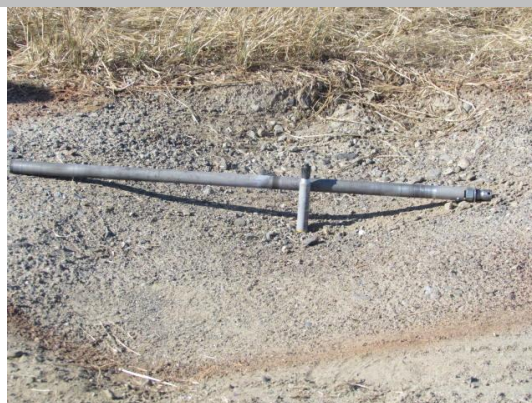
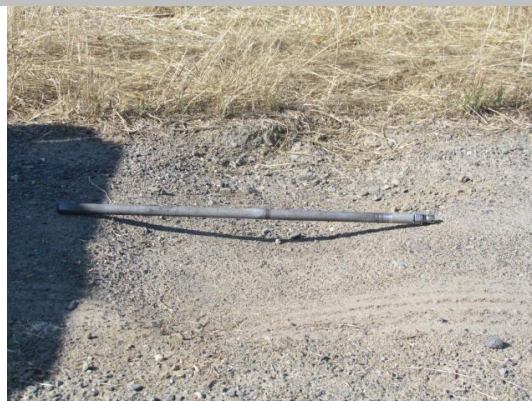
Photo 1 of 3 : FA_2016_NA0010_118_14_20161007_00010.jpg

LM Start	9.57	Rating **	M	Issue No.	14
LM End	9.57	Issue Type +	Ma	Location *	CR
Category	Earthen Levee			GPS Latitude/Longitude	
				Start	End
Item	Crown Surface / Depressions / Rutting			37.295517 °	37.295517 °
				-120.841452 °	-120.841452 °
DWR ID	DWR_NA0010_01_s_ 2015_14				
Comment Code					
C2 : Repair depressions or ruts in the crown or slope.					
Inspector Comment					
Depression greater than 3" deep by 18" wide by 18" long on levee crown

Looking at depression on levee crown. (Fall 2015)

Looking west at depression greater than three inches on levee crown.

Looking west at depression on levee crown.
