**Flood Control Project Maintenance
Levee Inspections**

Fall 2016 Levee Maintenance Deficiency Summary Report

San Joaquin River Basin

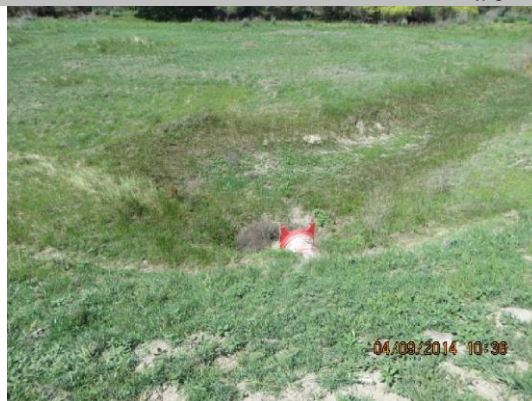
Photo 1 of 2 : UCIP_FA_2016_39253_60884.jpg

LM Start	10.20	Rating **	M	Issue No.	1203
LM End	10.20	Issue Type +	En	Location *	CR
Category	Supplemental			GPS Latitude/Longitude	
				Start	End
Item	DWR UCIP Field Study			37.287511 °	37.287511 °
				-120.840251 °	-120.840251 °
DWR ID					
Comment Code					
Inspector Comment					
FS_ID:39253					
DS_ID:19629					
EP_NO: N/A					
Repair Type: Non-Urgent					
Crossing Status: Found					
UCIP Comments: Dense vegetation blocks waterward and landward toes Recommend removing vegetation from both toes. Also sediment buildup in pipe visible from landward side.					
FIELD_STRUCT_DESC: 24-inch CM stormdrain pipe through the levee, 9.0 feet below the crown. Flap gate on the waterward end. Brass cap No. 69 BM on headwall on the landward side. (USACE-1967). This entry matches the Drainage or Irrigation Structure referenced in O&M manual (HLM 10.23).					
FS Date: 4/9/2014

Pipe, headwall, and flapgate on WS toe.

Pipe, headwall, and flapgate at WS toe.

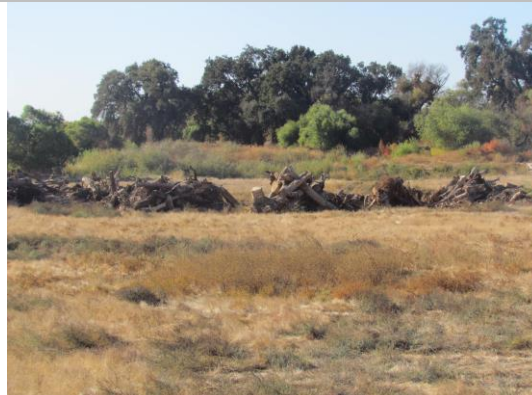
Photo 1 of 1 : FA_2016_NA0010_118_91_20161024_00237.jpg

LM Start	10.73	Rating **	U	Issue No.	91
LM End	10.73	Issue Type +	En	Location *	WS
Category	Earthen Levee			GPS Latitude/Longitude	
				Start	End
Item	Encroachments			37.283543 °	37.283543 °
				-120.832665 °	-120.832665 °
DWR ID	DWR_NA0010_01_f_2016_91				
Comment Code					
PR : Prunings					
Inspector Comment					
Large pruning piles in the middle of channel 100 ft from waterward slope should be removed or burned.

Looking west at pruning piles in channel 100ft from waterward slope.

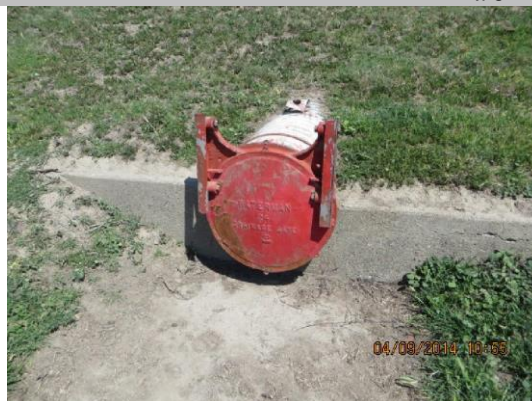
Photo 1 of 2 : UCIP_FA_2016_39255_60897.jpg

LM Start	10.98	Rating **	M	Issue No.	1204
LM End	10.98	Issue Type +	En	Location *	WS
Category	Supplemental			GPS Latitude/Longitude	
				Start	End
Item	DWR UCIP Field Study			37.282627 °	37.282627 °
				-120.828233 °	-120.828233 °
DWR ID					
Comment Code					
Inspector Comment					
FS_ID:39255 DS_ID:19632 EP_NO: N/A Repair Type: Non-Urgent Crossing Status: Found UCIP Comments: Dense vegetation blocks landward headwall. Recommend removing excess vegetation on landward toe. FIELD_STRUCT_DESC: 24-inch CM stormdrain pipe through the levee, 6.0 feet below the crown. Flap gate on the waterward end. Brass cap No. 66 BM on headwall on the landward side. (USACE-1967). This entry matches the Drainage or Irrigation Structure referenced in O&M manual (HLM 11.00). FS Date: 4/9/2014

Pipe, headwall, and flapgate on WS toe.

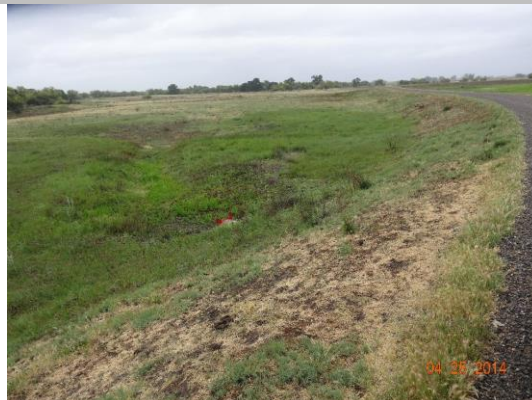
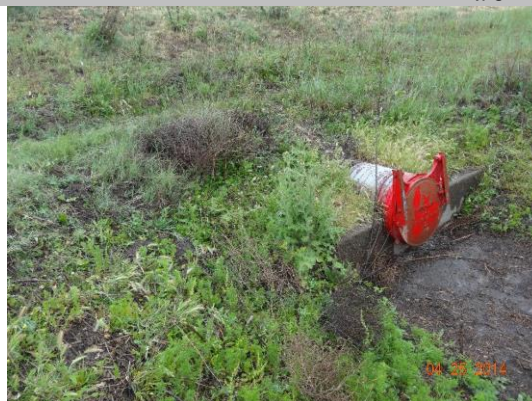
Photo 1 of 2 : UCIP_FA_2016_36103_65362.jpg

View of waterward side.

Item	DWR UCIP Field Study			37.273787 °	37.273787 °	
				-120.825519 °	-120.825519 °	
DWR ID						
Comment Code						
Inspector Comment						
FS_ID:36103						
DS_ID:19634						
EP_NO: N/A						
Repair Type: Non-Urgent						
Crossing Status: Found						
UCIP Comments: Need to contact owner--landward side has been buried. It appears that soil was removed from levee toe, immediately upstream, and used to pile soil at landward side at crossing.						
FIELD_STRUCT_DESC: 24-inch CM pipe through the levee, 10.0 feet below the crown. Flap gate on the waterward end. Brass cap No. 62 BM on headwall on the landward side. (USACE-1967). This entry matches the Drainage or Irrigation Structure referenced in O&M manual (HLM 11.48).						
FS Date: 4/25/2014

View of concrete headwall and flap gate visible on waterward side.

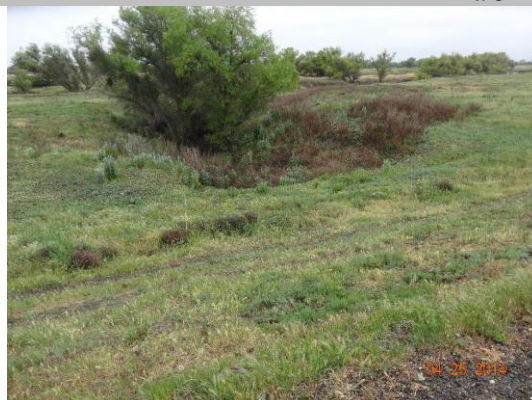
Photo 1 of 2 : UCIP_FA_2016_36105_65372.jpg

Comment Code					
Inspector Comment					
FS_ID:36105					
DS_ID:19635					
EP_NO: N/A					
Repair Type: Non-Urgent					
Crossing Status: Found					
UCIP Comments: Crossing is non-functional --landward side is buried.					
Debris found on landward side (channel). Dense vegetation found on waterward slope. Recommend contacting owner to determine status of crossing. If crossing is no longer used need to coordinate with CVFPB for proper abandonment.					
FIELD_STRUCT_DESC: 24-inch CM pipe through the levee, 17.0 feet below the crown. Flap gate on the waterward end. Brass cap No. 61 BM on headwall on the landward side. (USACE-1967). This entry matches the Drainage or Irrigation Structure referenced in O&M manual (HLM 11.76).					
FS Date: 4/25/2014

View of waterward side.

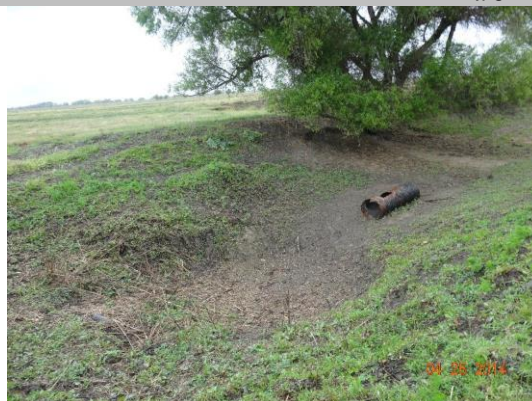
Photo 2 of 2 : UCIP_FA_2016_36105_65371.jpg

Item	DWR UCIP Field Study			37.269701 °	37.269701 °	
				-120.826450 °	-120.826450 °	
DWR ID						
Comment Code						
Inspector Comment						
FS_ID:36105						
DS_ID:19635						
EP_NO: N/A						
Repair Type: Non-Urgent						
Crossing Status: Found						
UCIP Comments: Crossing is non-functional --landward side is buried.						
Debris found on landward side (channel). Dense vegetation found on						
waterward slope. Recommend contacting owner to determine status of						
crossing. If crossing is no longer used need to coordinate with CVFPB						
for proper abandonment.						
FIELD_STRUCT_DESC: 24-inch CM pipe through the levee, 17.0 feet						
below the crown. Flap gate on the waterward end. Brass cap No. 61 BM						
on headwall on the landward side. (USACE-1967). This entry matches the						
Drainage or Irrigation Structure referenced in O&M manual (HLM

Landward side of crossing buried--damage pipe section visible on landward side.

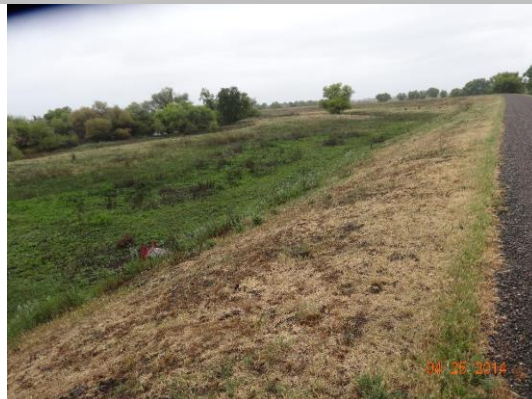
Photo 1 of 2 : UCIP_FA_2016_36106_65378.jpg

Item	DWR UCIP Field Study			37.265336	°	37.265336	°
				-120.826591		°	-120.826591
DWR ID							
Comment Code							
Inspector Comment							
FS_ID:36106 DS_ID:19636 EP_NO: N/A Repair Type: Non-Urgent Crossing Status: Found UCIP Comments: Crossing is non-functional --landward side is buried. Dense vegetation found on waterward slope. Recommend contacting owner to determine status of crossing. If crossing is no longer used need to coordinate with CVFPB for proper abandonment. FIELD_STRUCT_DESC: 24-inch CM pipe through the levee, 12.4 feet below the crown. Flap gate on the waterward end. Brass cap No. 60 BM on headwall on the landward side. (USACE-1967). This entry matches the Drainage or Irrigation Structure referenced in O&M manual (HLM 12.11). FS Date: 4/25/2014

View of waterward side--flap gate visible on waterward toe.

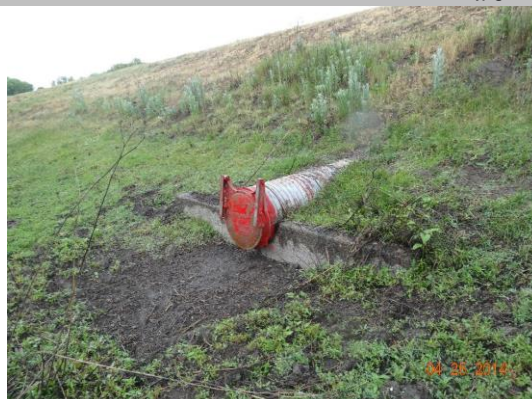
Photo 2 of 2 : UCIP_FA_2016_36106_65379.jpg

Item	DWR UCIP Field Study			37.265336 °	37.265336 °	
				-120.826591 °	-120.826591 °	
DWR ID						
Comment Code						
Inspector Comment						
FS_ID:36106 DS_ID:19636 EP_NO: N/A Repair Type: Non-Urgent Crossing Status: Found UCIP Comments: Crossing is non-functional --landward side is buried. Dense vegetation found on waterward slope. Recommend contacting owner to determine status of crossing. If crossing is no longer used need to coordinate with CVFPB for proper abandonment. FIELD_STRUCT_DESC: 24-inch CM pipe through the levee, 12.4 feet below the crown. Flap gate on the waterward end. Brass cap No. 60 BM on headwall on the landward side. (USACE-1967). This entry matches the Drainage or Irrigation Structure referenced in O&M manual (HLM 12.11). FS Date: 4/25/2014

Flap gate and concrete headwall visible on waterward side.

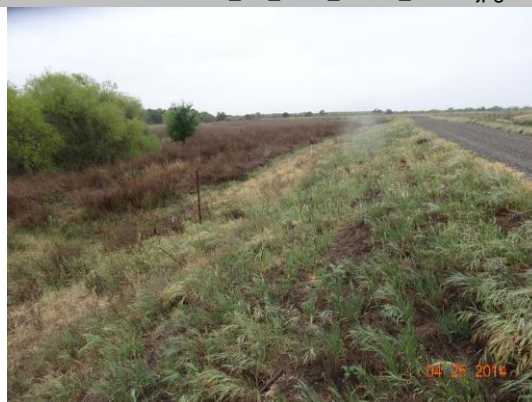
Photo 1 of 2 : UCIP_FA_2016_36146_65412.jpg

Comment Code					
Inspector Comment					
FS_ID:36146 DS_ID:19637 EP_NO: N/A Repair Type: Non-Urgent Crossing Status: Found UCIP Comments: Concrete headwall on landward side blocked by debris. Dense vegetation limits the inspector's visibility to identify signs of pipe failure (leaks) along the landward slope. Recommend removing vegetation along pipe alignment to conduct proper inspection of crossing. FIELD_STRUCT_DESC: 24-inch CM pipe through the levee, 9.5 feet below the crown. Flap gate on the waterward end. Brass cap No. 60 BM on headwall on the landward side. (USACE-1967). This entry matches the Drainage or Irrigation Structure referenced in O&M manual (HLM 12.94). FS Date: 4/25/2014

View of waterward side.

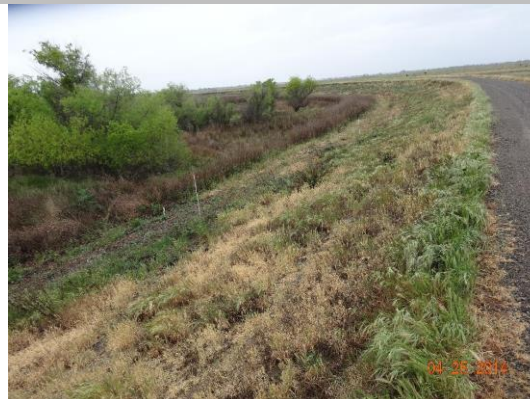
Photo 1 of 2 : UCIP_FA_2016_36109_65389.jpg

Comment Code					
Inspector Comment					
FS_ID:36109 DS_ID:19638 EP_NO: N/A Repair Type: Non-Urgent Crossing Status: Found UCIP Comments: Dense vegetation limits the inspector's visibility to identify signs of pipe failure (leaks) along the landward slope. Concrete headwall blocked by debris located on landward toe. Recommend clearing debris from landward slope and toe. FIELD_STRUCT_DESC: 24-inch CM pipe through the levee, 14.2 feet below the crown. Flap gate on the waterward end. Brass cap No. 60 BM on headwall on the landward side. (USACE-1967). This entry matches the Drainage or Irrigation Structure referenced in O&M manual (HLM 13.48). FS Date: 4/25/2014

View of waterward side.

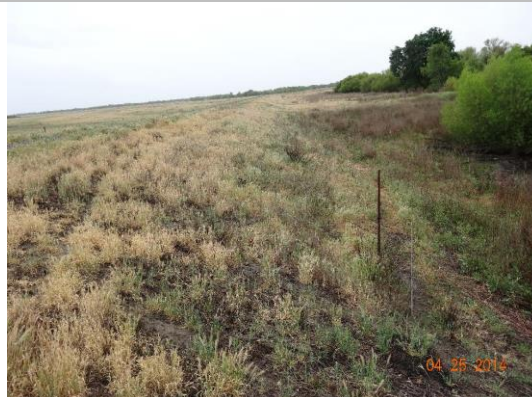
Photo 1 of 2 : UCIP_FA_2016_39256_65418.jpg

FS_ID:39256
DS_ID:19639
EP_NO: N/A
Repair Type: Non-Urgent
Crossing Status: Found
UCIP Comments: No access to waterward toe due to fence. Unable to find the concrete headwall and flap gate on waterward side past fence. Also dense vegetation limits the inspector's visibility to identify signs of pipe failure (leaks) along the waterward slope. Recommend removing vegetation along pipe alignment to conduct proper inspection of structure. Also need access past fence on waterward side.
FIELD_STRUCT_DESC: 24-inch CM pipe through the levee, 14.5 feet below the crown. Flap gate on the waterward end. Brass cap No. 60 BM on headwall on the landward side. (USACE-1967). This entry matches the Drainage or Irrigation Structure referenced in O&M manual (HLM 13.58).
FS Date: 4/25/2014

View of waterward side.

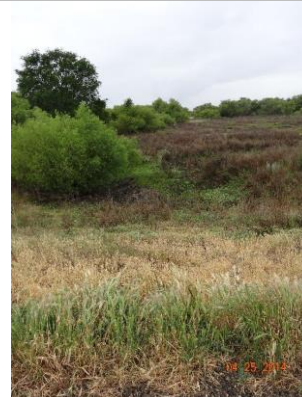
Photo 2 of 2 : UCIP_FA_2016_39256_65417.jpg

Dense vegetation on waterward side.

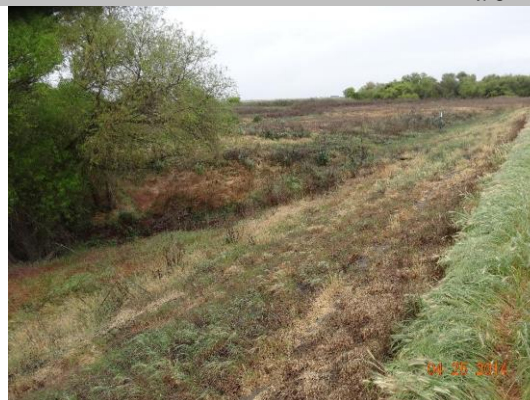
Photo 1 of 2 : UCIP_FA_2016_36166_65449.jpg

LM Start	14.22	Rating **	M	Issue No.	1224
LM End	14.22	Issue Type +	En	Location *	WS
Category	Supplemental			GPS Latitude/Longitude	
				Start	End
Item	DWR UCIP Field Study			37.242225 °	37.242225 °
				-120.817665 °	-120.817665 °
DWR ID					
Comment Code					
Inspector Comment					
FS_ID:36166 DS_ID:19641 EP_NO: N/A Repair Type: Non-Urgent Crossing Status: Found UCIP Comments: Dense vegetation limits the inspector's visibility to identify signs of pipe failure (leaks) along the slopes. Recommend removing vegetation along pipe alignment to conduct proper inspection of structure. FIELD_STRUCT_DESC: 24-inch CM pipe through the levee, 13.0 feet below the crown. Flap gate on the waterward end. Brass cap No. 60 BM on headwall on the landward side. (USACE-1967). This entry matches the Drainage or Irrigation Structure referenced in O&M manual (HLM 14.21). FS Date: 4/25/2014

View of waterward side.

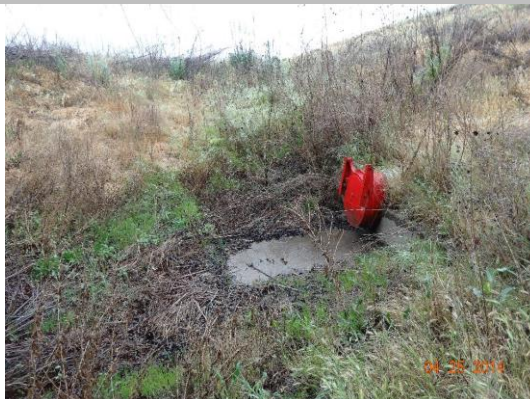
Photo 2 of 2 : UCIP_FA_2016_36166_65452.jpg

LM Start	14.22	Rating **	M	Issue No.	1224 (cont)
LM End	14.22	Issue Type +	En	Location *	WS
Category	Supplemental			GPS Latitude/Longitude	
				Start	End
Item	DWR UCIP Field Study			37.242225 °	37.242225 °
				-120.817665 °	-120.817665 °
DWR ID					
Comment Code					
Inspector Comment					
FS_ID:36166 DS_ID:19641 EP_NO: N/A Repair Type: Non-Urgent Crossing Status: Found UCIP Comments: Dense vegetation limits the inspector's visibility to identify signs of pipe failure (leaks) along the slopes. Recommend removing vegetation along pipe alignment to conduct proper inspection of structure. FIELD_STRUCT_DESC: 24-inch CM pipe through the levee, 13.0 feet below the crown. Flap gate on the waterward end. Brass cap No. 60 BM on headwall on the landward side. (USACE-1967). This entry matches the Drainage or Irrigation Structure referenced in O&M manual (HLM 14.21). FS Date: 4/25/2014

View of concrete headwall, concrete apron, and flap gate on waterward side.

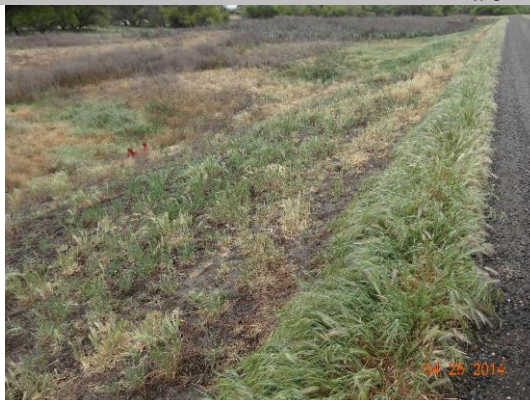
Photo 1 of 2 : UCIP_FA_2016_36167_65455.jpg

LM Start	14.65	Rating **	M	Issue No.	1225
LM End	14.65	Issue Type +	En	Location *	WS
Category	Supplemental			GPS Latitude/Longitude	
				Start	End
Item	DWR UCIP Field Study			37.237584 °	37.237584 °
				-120.812967 °	-120.812967 °
DWR ID					
Comment Code					
Inspector Comment					
FS_ID:36167 DS_ID:19642 EP_NO: N/A Repair Type: Non-Urgent Crossing Status: Found UCIP Comments: Dense vegetation limits the inspector's visibility to identify signs of pipe failure (leaks) along the landward slope and toe. Recommend removing vegetation along pipe alignment to conduct proper inspection of structure. FIELD_STRUCT_DESC: 24-inch CM pipe through the levee, 9.7 feet below the crown. Flap gate on the waterward end. Brass cap No. 60 BM on headwall on the landward side. (USACE-1967). This entry matches the Drainage or Irrigation Structure referenced in O&M manual (HLM 14.65). FS Date: 4/25/2014

View of waterward side.

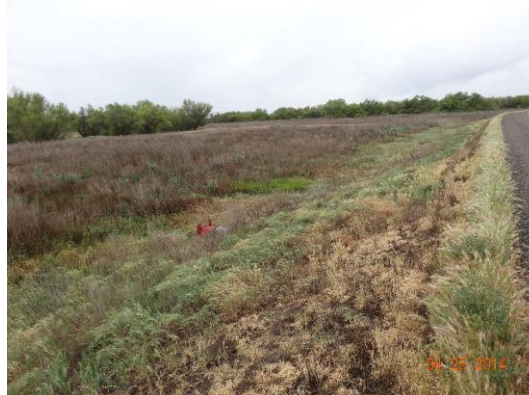
Photo 1 of 2 : UCIP_FA_2016_36168_65459.jpg

LM Start	15.29	Rating **	M	Issue No.	1226
LM End	15.29	Issue Type +	En	Location *	WS
Category	Supplemental			GPS Latitude/Longitude	
				Start	End
Item	DWR UCIP Field Study			37.231428 °	37.231428 °
				-120.805543 °	-120.805543 °
DWR ID					
Comment Code					
Inspector Comment					
FS_ID:36168 DS_ID:19643 EP_NO: N/A Repair Type: Non-Urgent Crossing Status: Found UCIP Comments: Dense vegetation limits the inspector's visibility to identify signs of pipe failure (leaks) along the landward slope. Recommend removing vegetation along pipe alignment to conduct proper inspection of structure. FIELD_STRUCT_DESC: 24-inch CM pipe through the levee, 9.2 feet below the crown. Flap gate on the waterward end. Brass cap No. 60 BM on headwall on the landward side. (USACE-1967). This entry matches the Drainage or Irrigation Structure referenced in O&M manual (HLM 15.29). FS Date: 4/25/2014

View of waterward side.

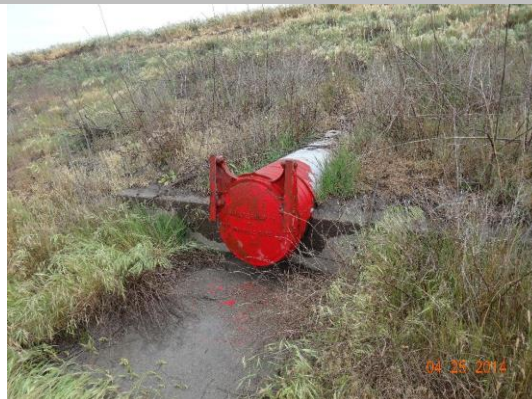
Photo 2 of 2 : UCIP_FA_2016_36168_65457.jpg

Item	DWR UCIP Field Study			37.231428 °		37.231428 °
				-120.805543 °		-120.805543 °
DWR ID						
Comment Code						
Inspector Comment						
FS_ID:36168						
DS_ID:19643						
EP_NO: N/A						
Repair Type: Non-Urgent						
Crossing Status: Found						
UCIP Comments: Dense vegetation limits the inspector's visibility to identify signs of pipe failure (leaks) along the landward slope.						
Recommend removing vegetation along pipe alignment to conduct proper inspection of structure.						
FIELD_STRUCT_DESC: 24-inch CM pipe through the levee, 9.2 feet below the crown. Flap gate on the waterward end. Brass cap No. 60 BM on headwall on the landward side. (USACE-1967). This entry matches the Drainage or Irrigation Structure referenced in O&M manual (HLM 15.29).						
FS Date: 4/25/2014

Concrete headwall, flap gate, and concrete apron located on waterward side.

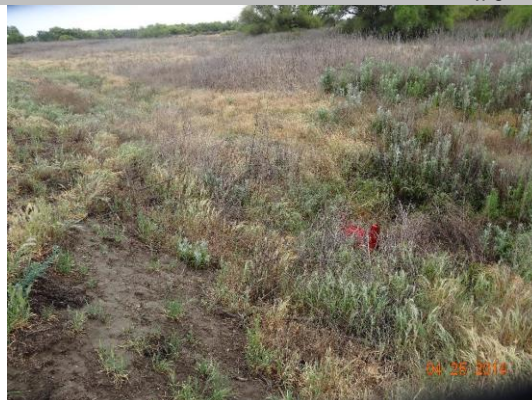
Photo 1 of 2 : UCIP_FA_2016_36169_65464.jpg

Comment Code					
Inspector Comment					
FS_ID:36169 DS_ID:19644 EP_NO: N/A Repair Type: Non-Urgent Crossing Status: Found UCIP Comments: Dense vegetation limits the inspector's visibility to identify signs of pipe failure (leaks) along the waterward and landward slopes. Recommend removing vegetation along pipe alignment to conduct proper inspection of structure. FIELD_STRUCT_DESC: 24-inch CM pipe through the levee, 8.5 feet below the crown. Flap gate on the waterward end. Brass cap No. 60 BM on headwall on the landward side. (USACE-1967). This entry matches the Drainage or Irrigation Structure referenced in O&M manual (HLM 15.57). FS Date: 4/25/2014

View of waterward side--flap gate visible through dense vegetation.

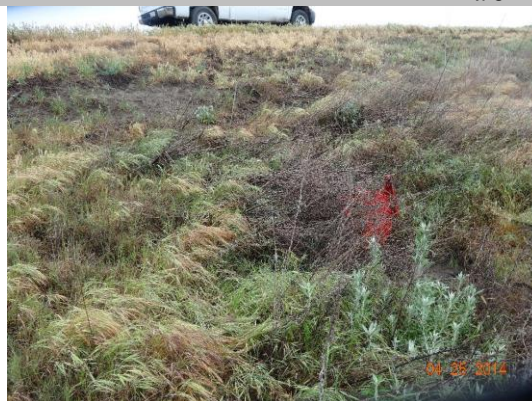
Photo 2 of 2 : UCIP_FA_2016_36169_65463.jpg

Item	DWR UCIP Field Study			37.228155 °	37.228155 °	
				-120.802645 °	-120.802645 °	
DWR ID						
Comment Code						
Inspector Comment						
FS_ID:36169						
DS_ID:19644						
EP_NO: N/A						
Repair Type: Non-Urgent						
Crossing Status: Found						
UCIP Comments: Dense vegetation limits the inspector's visibility to identify signs of pipe failure (leaks) along the waterward and landward slopes. Recommend removing vegetation along pipe alignment to conduct proper inspection of structure.						
FIELD_STRUCT_DESC: 24-inch CM pipe through the levee, 8.5 feet below the crown. Flap gate on the waterward end. Brass cap No. 60 BM on headwall on the landward side. (USACE-1967). This entry matches the Drainage or Irrigation Structure referenced in O&M manual (HLM 15.57).						
FS Date: 4/25/2014

View of waterward slope covered by dense vegetation.

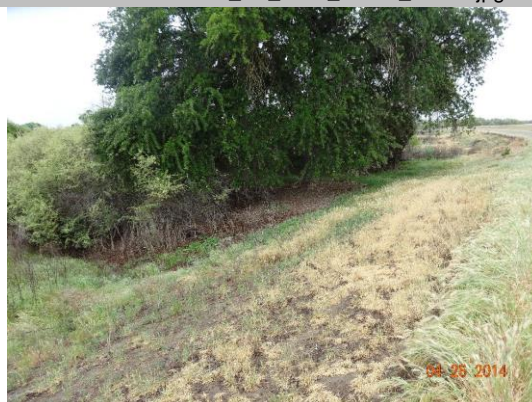
Photo 1 of 2 : UCIP_FA_2016_36171_65471.jpg

Comment Code					
Inspector Comment					
FS_ID:36171 DS_ID:19645 EP_NO: N/A Repair Type: Non-Urgent Crossing Status: Found UCIP Comments: Dense vegetation limits the inspector's visibility to identify signs of pipe failure (leaks) along the waterward and landward slope. Recommend removing vegetation along pipe alignment to conduct proper inspection of structure. FIELD_STRUCT_DESC: 24-inch CM pipe through the levee, 11.0 feet below the crown. Flap gate on the waterward end. Brass cap No. 60 BM on headwall on the landward side. (USACE-1967). This entry matches the Drainage or Irrigation Structure referenced in O&M manual (HLM 15.81). FS Date: 4/25/2014

View of waterward side.

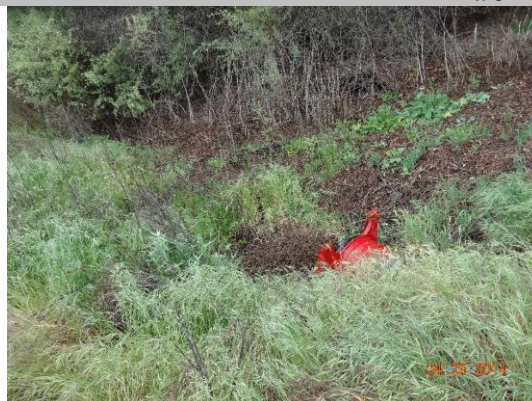
Photo 2 of 2 : UCIP_FA_2016_36171_65470.jpg

Item	DWR UCIP Field Study			37.226099 °		37.226099 °
				-120.799125 °		-120.799125 °
DWR ID						
Comment Code						
Inspector Comment						
FS_ID:36171						
DS_ID:19645						
EP_NO: N/A						
Repair Type: Non-Urgent						
Crossing Status: Found						
UCIP Comments: Dense vegetation limits the inspector's visibility to identify signs of pipe failure (leaks) along the waterward and landward slope. Recommend removing vegetation along pipe alignment to conduct proper inspection of structure.						
FIELD_STRUCT_DESC: 24-inch CM pipe through the levee, 11.0 feet below the crown. Flap gate on the waterward end. Brass cap No. 60 BM on headwall on the landward side. (USACE-1967). This entry matches the Drainage or Irrigation Structure referenced in O&M manual (HLM 15.81).						
FS Date: 4/25/2014

Flap gate visible on waterward side.

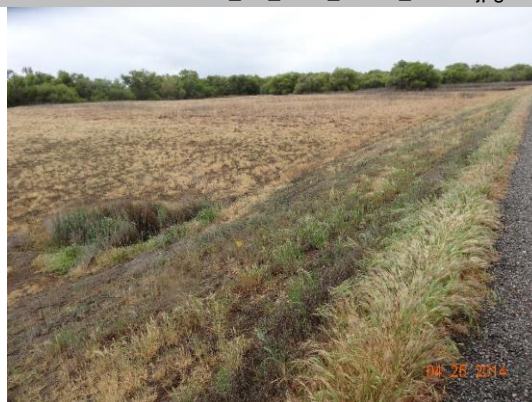
Photo 1 of 2 : UCIP_FA_2016_36172_65476.jpg

Comment Code					
Inspector Comment					
FS_ID:36172 DS_ID:19646 EP_NO: N/A Repair Type: Non-Urgent Crossing Status: Found UCIP Comments: Dense vegetation limits the inspector's visibility to identify signs of pipe failure (leaks) along the waterward and landward slopes. Recommend removing vegetation along pipe alignment to conduct proper inspection of structure and appurtenances. FIELD_STRUCT_DESC: 24-inch CM pipe through the levee, 11.3 feet below the crown. Flap gate on the waterward end. Brass cap No. 50 BM on headwall on the landward side. (USACE-1967). This entry matches the Drainage or Irrigation Structure referenced in O&M manual (HLM 16.09). FS Date: 4/25/2014

View of waterward side.

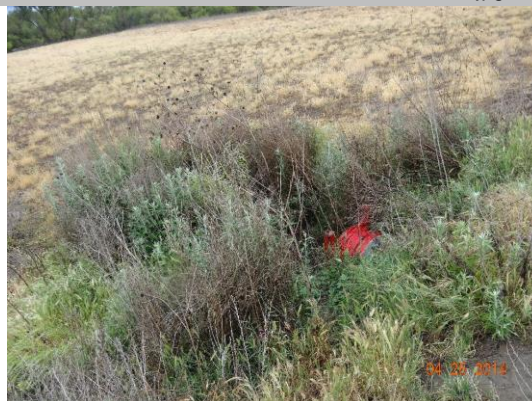
Photo 2 of 2 : UCIP_FA_2016_36172_65475.jpg

Item	DWR UCIP Field Study			37.224157 °		37.224157 °
				-120.795250 °		-120.795250 °
DWR ID						
Comment Code						
Inspector Comment						
FS_ID:36172 DS_ID:19646 EP_NO: N/A Repair Type: Non-Urgent Crossing Status: Found UCIP Comments: Dense vegetation limits the inspector's visibility to identify signs of pipe failure (leaks) along the waterward and landward slopes. Recommend removing vegetation along pipe alignment to conduct proper inspection of structure and appurtenances. FIELD_STRUCT_DESC: 24-inch CM pipe through the levee, 11.3 feet below the crown. Flap gate on the waterward end. Brass cap No. 50 BM on headwall on the landward side. (USACE-1967). This entry matches the Drainage or Irrigation Structure referenced in O&M manual (HLM 16.09). FS Date: 4/25/2014

Flap gate visible on waterward toe.

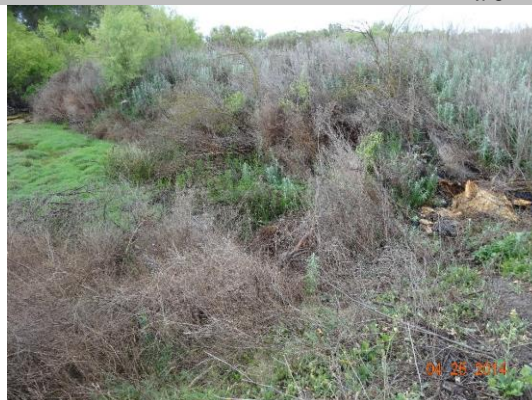
Photo 1 of 2 : UCIP_FA_2016_39257_65480.jpg

Comment Code					
Inspector Comment					
FS_ID:39257					
DS_ID:19647					
EP_NO: N/A					
Repair Type: Non-Urgent					
Crossing Status: Found					
UCIP Comments: Dense vegetation limits the inspector's visibility to identify signs of pipe failure (leaks) along the waterward and landward slopes. Recommend removing vegetation along pipe alignment to conduct proper inspection of structure. Unable to find pipe on landward side.					
FIELD_STRUCT_DESC: 24-inch CM pipe through the levee, 14.7 feet below the crown. Flap gate on the waterward end. Brass cap No. 50 BM on headwall on the landward side. (USACE-1967). This entry matches the Drainage or Irrigation Structure referenced in O&M manual (HLM 16.15).					
FS Date: 4/25/2014

View of waterward side.

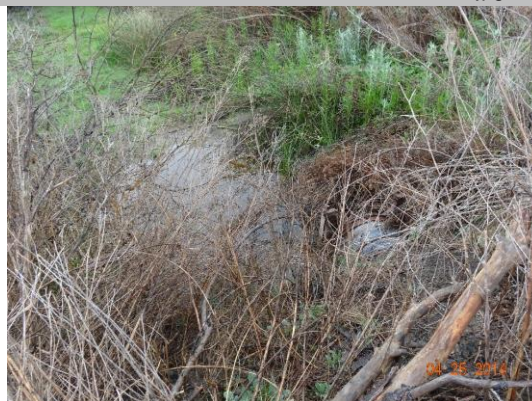
Photo 2 of 2 : UCIP_FA_2016_39257_65479.jpg

Comment Code					
Inspector Comment					
FS_ID:39257 DS_ID:19647 EP_NO: N/A Repair Type: Non-Urgent Crossing Status: Found UCIP Comments: Dense vegetation limits the inspector's visibility to identify signs of pipe failure (leaks) along the waterward and landward slopes. Recommend removing vegetation along pipe alignment to conduct proper inspection of structure. Unable to find pipe on landward side. FIELD_STRUCT_DESC: 24-inch CM pipe through the levee, 14.7 feet below the crown. Flap gate on the waterward end. Brass cap No. 50 BM on headwall on the landward side. (USACE-1967). This entry matches the Drainage or Irrigation Structure referenced in O&M manual (HLM 16.15). FS Date: 4/25/2014

Crossing visible on waterward side under dense vegetation.

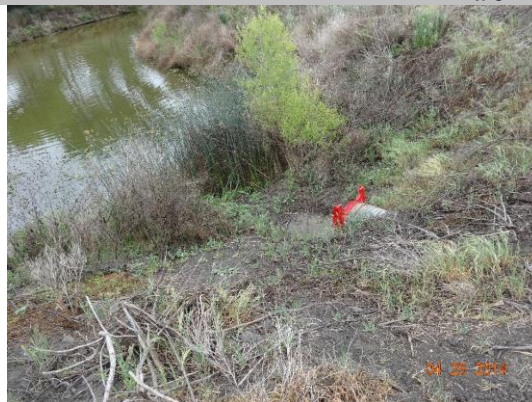
Photo 2 of 2 : UCIP_FA_2016_39258_66289.jpg

View of waterward side.

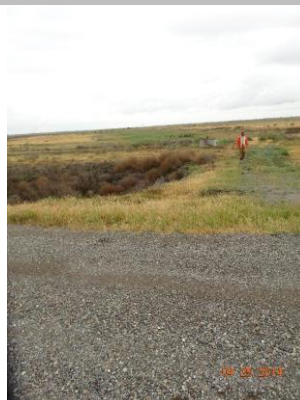
Photo 2 of 2 : UCIP_FA_2016_39360_71486.jpg

View of landward side.

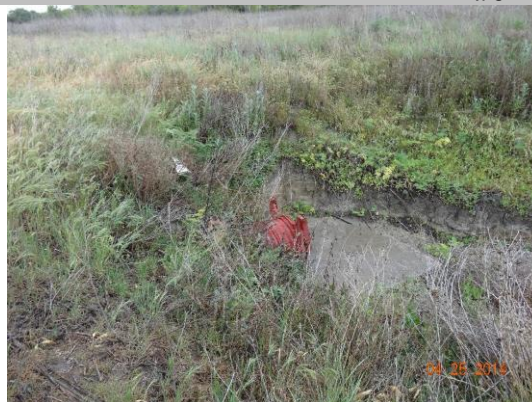
Photo 2 of 2 : UCIP_FA_2016_39259_65519.jpg

Flap gate visible on waterward side.

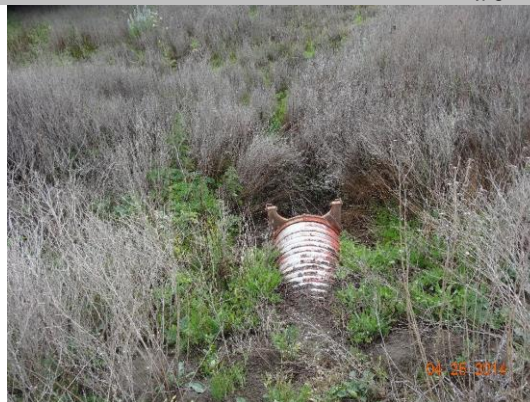
Photo 2 of 2 : UCIP_FA_2016_39260_65521.jpg

Pipe visible on waterward side.

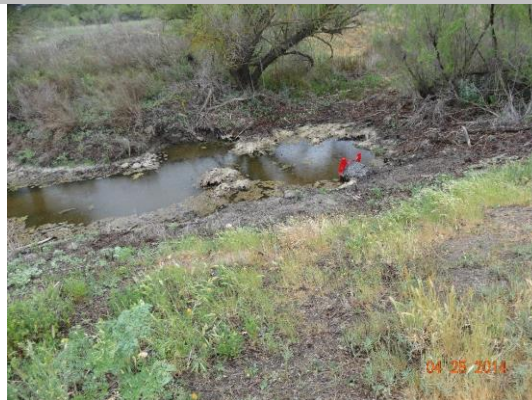
Photo 2 of 2 : UCIP_FA_2016_36203_65552.jpg

Pipe visible on waterward side.

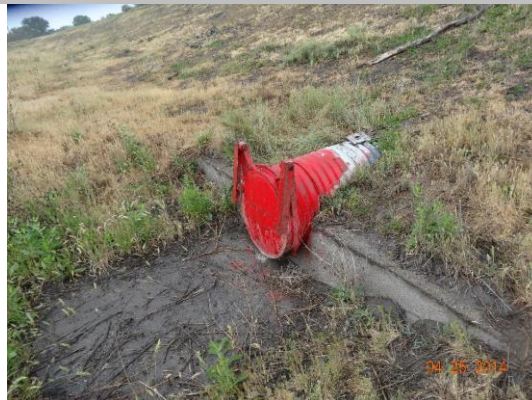
Photo 2 of 2 : UCIP_FA_2016_36204_65546.jpg

Flap gate visible on waterward side.

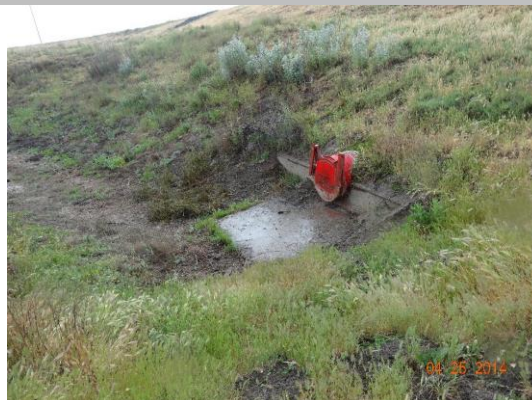
Photo 2 of 2 : UCIP_FA_2016_39261_65556.jpg

Flap gate visible on waterward side.

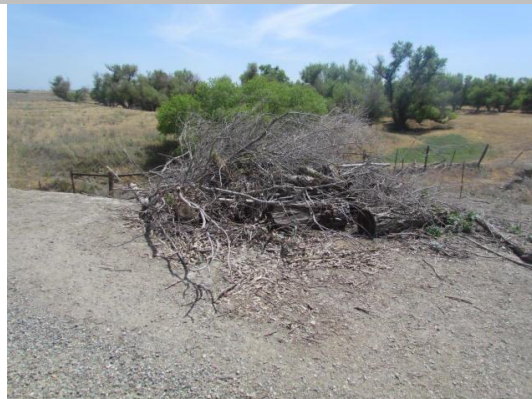
Photo 1 of 1 : FA_2016_NA0010_118_27_20161007_00016.jpg

LM Start	18.77	Rating **	M	Issue No.	27
LM End	18.77	Issue Type +	En	Location *	WS
Category	Earthen Levee			GPS Latitude/Longitude	
				Start	End
Item	Encroachments			37.205080 °	37.205080 °
				-120.762655 °	-120.762655 °
DWR ID	DWR_NA0010_01_s_2014_27				
Comment Code					
PR : Prunings					
Inspector Comment

Looking at prunings on waterward shoulder and slope.

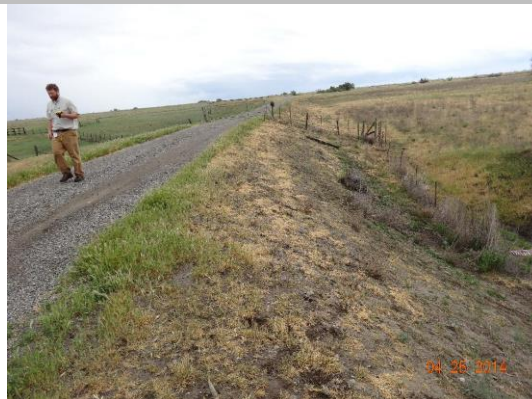
Photo 1 of 2 : UCIP_FA_2016_36246_65627.jpg

LM Start	18.79	Rating **	M	Issue No.	1242
LM End	18.79	Issue Type +	En	Location *	WS
Category	Supplemental			GPS Latitude/Longitude	
				Start	End
Item	DWR UCIP Field Study			37.204966 °	37.204966 °
				-120.762511 °	-120.762511 °
DWR ID					
Comment Code					
Inspector Comment					
FS_ID:36246 DS_ID:19593 EP_NO: N/A Repair Type: Non-Urgent Crossing Status: Found UCIP Comments: Dense vegetation limits the inspector's visibility to identify signs of pipe failure (leaks) along the landward slope. Recommend removing vegetation along pipe alignment to conduct proper inspection of structure. FIELD_STRUCT_DESC: 24-inch CM pipe through the levee, 12.0 feet below the crown. Flap gate on the waterward end. Brass cap No. 50 BM on headwall on the landward side. (USACE-1967). This entry matches the Drainage or Irrigation Structure referenced in O&M manual (HLM 18.79). FS Date: 4/25/2014

Overview of levee crown and waterward slope.

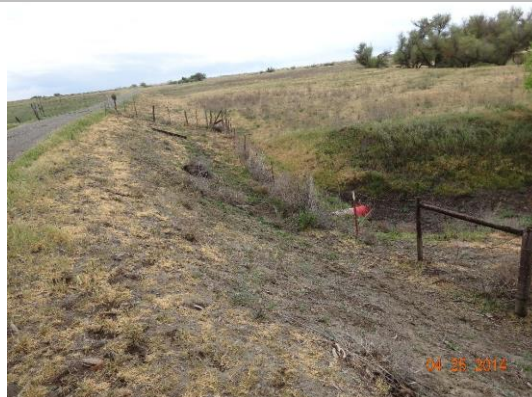
Photo 2 of 2 : UCIP_FA_2016_36246_65623.jpg

Item	DWR UCIP Field Study			37.204966 °	37.204966 °	
				-120.762511 °	-120.762511 °	
DWR ID						
Comment Code						
Inspector Comment						
FS_ID:36246						
DS_ID:19593						
EP_NO: N/A						
Repair Type: Non-Urgent						
Crossing Status: Found						
UCIP Comments: Dense vegetation limits the inspector's visibility to identify signs of pipe failure (leaks) along the landward slope.						
Recommend removing vegetation along pipe alignment to conduct proper inspection of structure.						
FIELD_STRUCT_DESC: 24-inch CM pipe through the levee, 12.0 feet below the crown. Flap gate on the waterward end. Brass cap No. 50 BM on headwall on the landward side. (USACE-1967). This entry matches the Drainage or Irrigation Structure referenced in O&M manual (HLM 18.79).						
FS Date: 4/25/2014

View of waterward side.

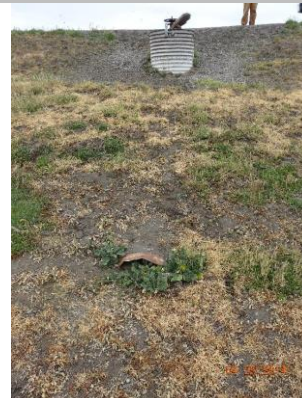
Photo 1 of 2 : UCIP_FA_2016_39263_65631.jpg

Comment Code					
Inspector Comment					
FS_ID:39263					
DS_ID:19594					
EP_NO: N/A					
Repair Type: Non-Urgent					
Crossing Status: Found					
UCIP Comments: Non-functional crossing--pipe is buried on waterward side. Sediment buildup in pipe visible from landward side. Need to coordinate with owner to determine status. If crossing is no longer in use, owner will need to coordinate with DWR Inspector and CVFPB to properly abandon.					
FIELD_STRUCT_DESC: 24-inch CM pipe through the levee, 13.0 feet below the crown. Slide gate on the waterward slope. Brass cap No. 40 BM on headwall on the landward side. (USACE-1967). This entry matches the Drainage or Irrigation Structure referenced in O&M manual (HLM 19.17).					
FS Date: 4/25/2014

View of waterward slope. CMP riser and pipe visible.

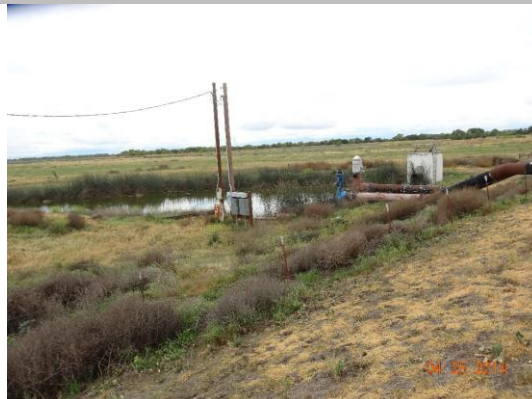
Photo 1 of 2 : UCIP_FA_2016_39266_71421.jpg

LM Start	19.32	Rating **	M	Issue No.	1227
LM End	19.32	Issue Type +	En	Location *	WS
Category	Supplemental			GPS Latitude/Longitude	
				Start	End
Item	DWR UCIP Field Study			37.200921 °	37.200921 °
				-120.756901 °	-120.756901 °
DWR ID					
Comment Code					
Inspector Comment					
FS_ID:39266 DS_ID:24871 EP_NO: N/A Repair Type: Non-Urgent Crossing Status: Found UCIP Comments: New crossing found during field inspection--Need to contact owner to obtain additional information about crossing. FIELD_STRUCT_DESC: 1 of 2: 20-inch steel pipe through levee at an unknown depth. Pump station located on landward side. Electrical panel located on landward side. FS Date: 4/25/2014

View of landward side.

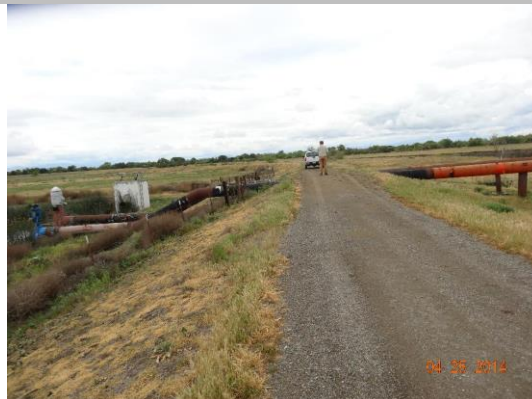
Photo 2 of 2 : UCIP_FA_2016_39266_71420.jpg

LM Start	19.32	Rating **	M	Issue No.	1227 (cont)	
LM End	19.32	Issue Type +	En	Location *	WS	
Category	Supplemental			GPS Latitude/Longitude		
				Start	End	
Item	DWR UCIP Field Study			37.200921 °	37.200921 °	
				-120.756901 °	-120.756901 °	
DWR ID						
Comment Code						
Inspector Comment						
FS_ID:39266						
DS_ID:24871						
EP_NO: N/A						
Repair Type: Non-Urgent						
Crossing Status: Found						
UCIP Comments: New crossing found during field inspection--Need to contact owner to obtain additional information about crossing.						
FIELD_STRUCT_DESC: 1 of 2: 20-inch steel pipe through levee at an unknown depth. Pump station located on landward side. Electrical panel located on landward side.						
FS Date: 4/25/2014

Overview of levee crown at crossing.

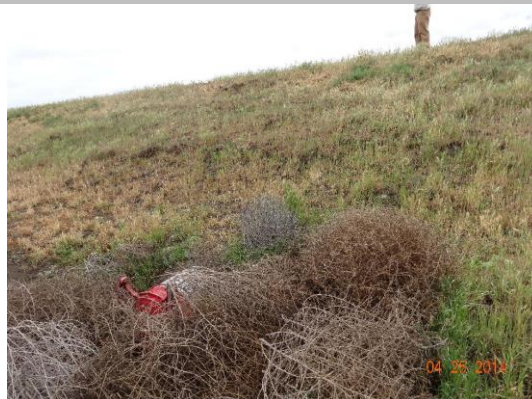
Photo 2 of 2 : UCIP_FA_2016_39268_65640.jpg

Item	DWR UCIP Field Study			37.199427 °	37.199427 °	
				-120.760235 °	-120.760235 °	
DWR ID						
Comment Code						
Inspector Comment						
FS_ID:39268 DS_ID:19596 EP_NO: N/A Repair Type: Non-Urgent Crossing Status: Found UCIP Comments: Dense vegetation limits the inspector's visibility to identify signs of pipe failure (leaks) along the waterward slope. Recommend removing vegetation along pipe alignment to conduct proper inspection of structure. Dense vegetation blocks both waterward and landward headwalls. Sediment buildup in pipe visible from landward side. FIELD_STRUCT_DESC: 24-inch CM pipe through the levee, 8.0 feet below the crown. Flap gate on the waterward end. Brass cap No. 40 BM on headwall on the landward side. (USACE-1967). This entry matches the Drainage or Irrigation Structure referenced in O&M manual (HLM 19.54). FS Date: 4/25/2014

Flap gate visible on waterward side--potential erosion present on slope.

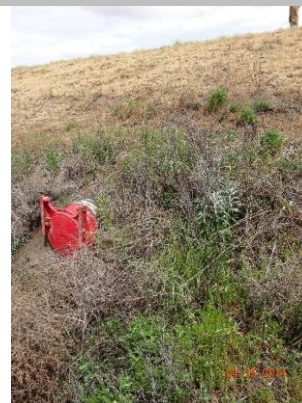
LM Start	20.18	Rating **	M	Issue No.	1230
LM End	20.18	Issue Type +	En	Location *	WS
Category	Supplemental			GPS Latitude/Longitude	
				Start	End
Item	DWR UCIP Field Study			37.194669 °	37.194669 °
				-120.759736 °	-120.759736 °
DWR ID					
Comment Code					
Inspector Comment					
FS_ID:39269 DS_ID:19598 EP_NO: N/A Repair Type: Non-Urgent Crossing Status: Found UCIP Comments: Recommend removing vegetation and sediment buildup from both waterward and landward concrete headwalls. FIELD_STRUCT_DESC: 24-inch CM pipe through the levee, 8.5 feet below the crown. Flap gate on the waterward end. Brass cap No. 40 BM on headwall on the landward side. (USACE-1967). This entry matches the Drainage or Irrigation Structure referenced in O&M manual (HLM 20.18). FS Date: 4/25/2014

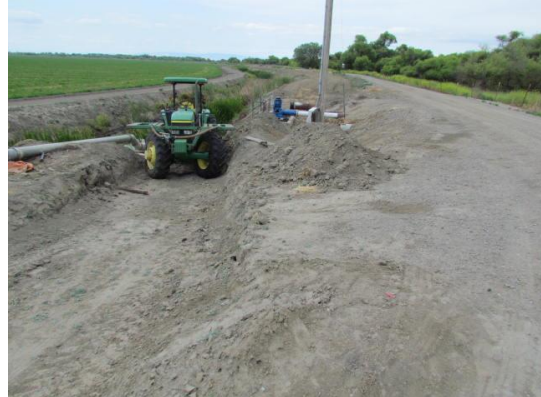
Photo 1 of 2 : FA_2016_NA0010_118_1184_20161007_00025.jpg

LM Start	20.25	Rating **	U	Issue No.	1184 (cont)
LM End	20.25	Issue Type +	En	Location *	LS

Looking north at ramp cut into landward slope.

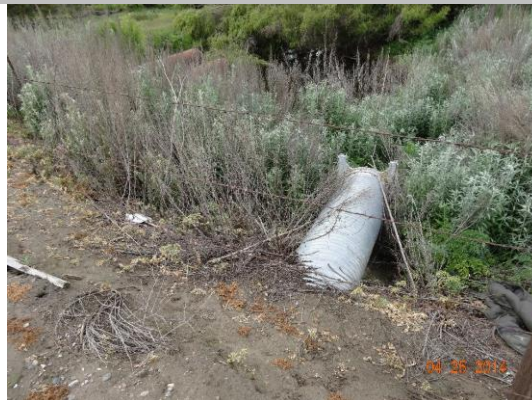
Photo 2 of 2 : UCIP_FA_2016_49965_66304.jpg

View of WS.

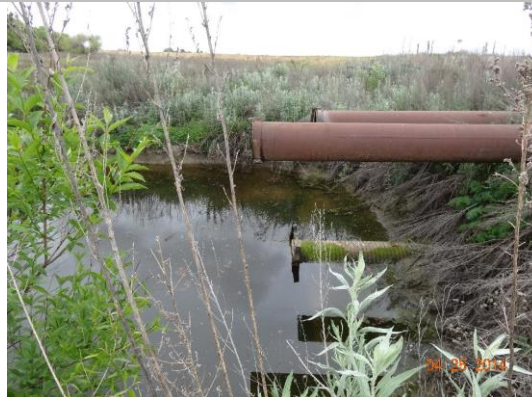
Photo 2 of 2 : UCIP_FA_2016_39878_66309.jpg

Multiple crossings visible on waterward side--36 inch CMP is submersed in water.

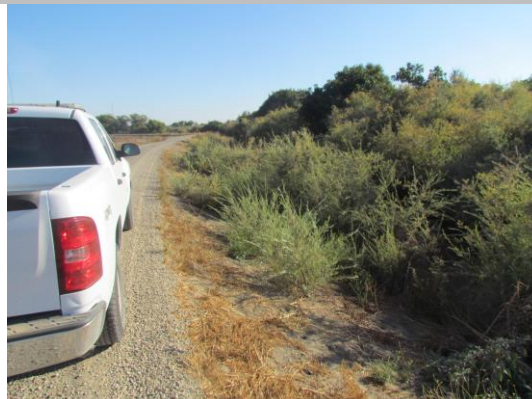
Photo 1 of 1 : FA_2016_NA0010_118_8_20161024_00238.jpg

LM Start	21.32	Rating **	U	Issue No.	8
LM End	22.46	Issue Type +	Ma	Location *	WS
Category	Earthen Levee			GPS Latitude/Longitude	
				Start	End
Item	Vegetation			37.180109 °	37.167498 °
				-120.762154 °	-120.750862 °
DWR ID	DWR_NA0010_01_f_2015_8				
Comment Code					
V2 : Remove the wild growth other than native grasses from the levee slopes.					
Inspector Comment					
Dense vegetation on waterward slope.

Looking downstream at dense veg on waterward slope.

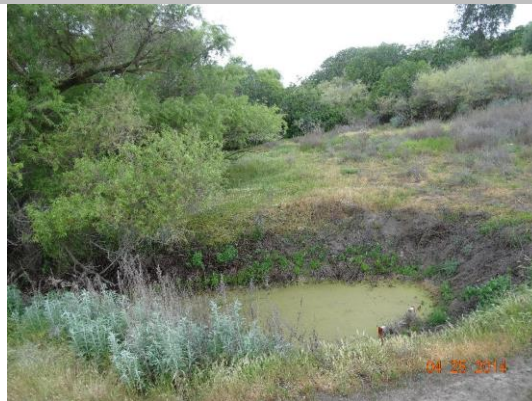
Photo 1 of 2 : UCIP_FA_2016_39271_66312.jpg

LM Start	21.40	Rating **	M	Issue No.	1231
LM End	21.40	Issue Type +	En	Location *	WS
Category	Supplemental			GPS Latitude/Longitude	
				Start	End
Item	DWR UCIP Field Study			37.179065 °	37.179065 °
				-120.761567 °	-120.761567 °
DWR ID					
Comment Code					
Inspector Comment					
FS_ID:39271 DS_ID:19603 EP_NO: N/A Repair Type: Non-Urgent Crossing Status: Found UCIP Comments: Crossing is non-functional--crossing buried on landward side. Need to contact owner to determine status of crossing. If crossing is no longer used need to coordinate with CVFPB for proper abandonment. FIELD_STRUCT_DESC: 36-inch CM pipe through the levee, 11.5 feet below the crown. Flap gate on the waterward end. Brass cap No. 40 BM on headwall on the landward side. (USACE-1967). This entry matches the Drainage or Irrigation Structure referenced in O&M manual (HLM 21.40). FS Date: 4/25/2014

View of waterward side.

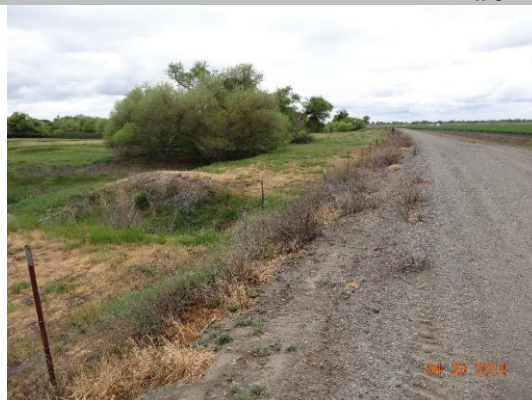
Photo 1 of 2 : UCIP_FA_2016_39272_65697.jpg

LM Start	21.75	Rating **	M	Issue No.	1236
LM End	21.75	Issue Type +	En	Location *	WS
Category	Supplemental			GPS Latitude/Longitude	
				Start	End
Item	DWR UCIP Field Study			37.176106 °	37.176106 °
				-120.756768 °	-120.756768 °
DWR ID					
Comment Code					
Inspector Comment					
FS_ID:39272 DS_ID:19604 EP_NO: N/A Repair Type: Non-Urgent Crossing Status: Found UCIP Comments: Non-functional crossing-landward side is buried. Need to contact owner to determine status of crossing. If crossing is no longer used need to coordinate with CVFPB for proper abandonment. FIELD_STRUCT_DESC: 24-inch CM pipe through the levee, 9.0 feet below the crown. Flap gate on the waterward end. Brass cap No. 40 BM on headwall on the landward side. (USACE-1967). This entry matches the Drainage or Irrigation Structure referenced in O&M manual (HLM 21.76). FS Date: 4/25/2014

View of waterward side.

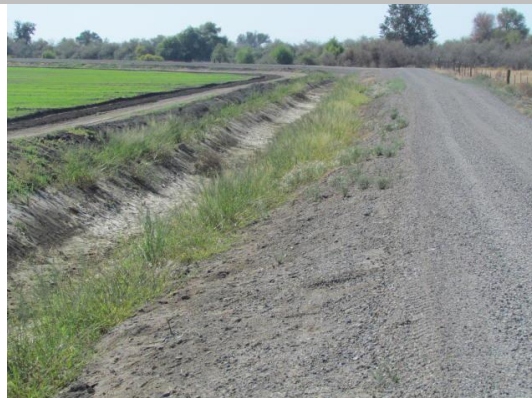
Photo 1 of 3 : FA_2016_NA0010_118_22_20161007_00013.jpg

LM Start	22.06	Rating **	U	Issue No.	22
LM End	22.51	Issue Type +	En	Location *	LS
Category	Earthen Levee			GPS Latitude/Longitude	
				Start	End
Item	Encroachments			37.172074 °	37.166983 °
				-120.754628 °	-120.750127 °
DWR ID	DWR_NA0010_01_s_2012_22				
Comment Code					
DT : Ditch					
Inspector Comment					
Ditch has encroach into landward toe and slope.

Looking downstream at irrigation ditch at LM 22.06

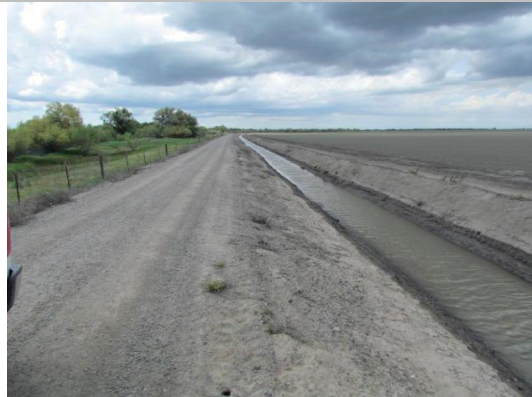
Photo 2 of 3 : FA_2016_NA0010_118_22_20161007_00014.jpg

LM Start	22.06	Rating **	U	Issue No.	22 (cont)
LM End	22.51	Issue Type +	En	Location *	LS
Category	Earthen Levee			GPS Latitude/Longitude	
				Start	End
Item	Encroachments			37.172074 °	37.166983 °
				-120.754628 °	-120.750127 °
DWR ID	DWR_NA0010_01_s_2012_22				
Comment Code					
DT : Ditch					
Inspector Comment					
Ditch has encroach into landward toe and slope.

Looking downstream at irrigation ditch at landside toe.

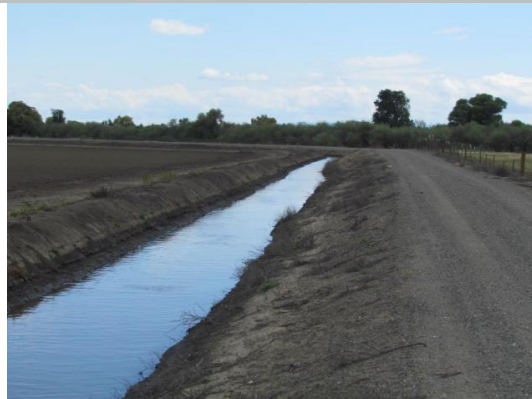
Photo 3 of 3 : FA_2016_NA0010_118_22_20161007_00015.jpg

Looking upstream at irrigation at landside toe.

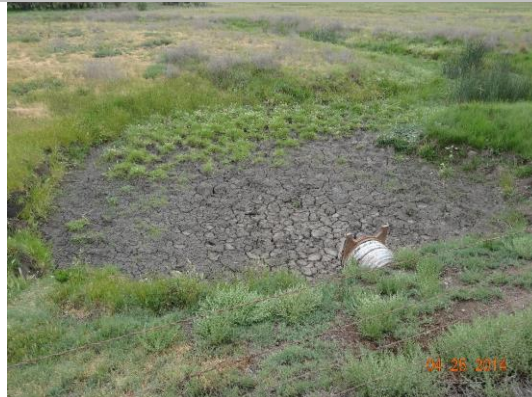
Photo 2 of 2 : UCIP_FA_2016_39273_65707.jpg

Flap gate visible on waterward side.

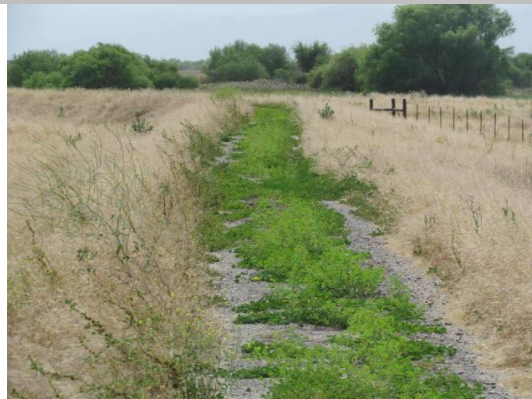
Photo 1 of 1 : FA_2016_NA0010_119_24_20161007_00006.jpg

LM Start	0.00	Rating **	M	Issue No.	24
LM End	2.30	Issue Type +	Ma	Location *	CR
Category	Earthen Levee			GPS Latitude/Longitude	
				Start	End
Item	Crown Surface / Depressions / Rutting			37.296313 °	37.291556 °
				-120.880576 °	-120.851252 °
DWR ID	DWR_NA0010_02A_s_2016_24				
Comment Code					
C1 : Add appropriate material and re-grade the levee to bring the crown above the design elevation.					
Inspector Comment					
Control annual weeds and regrade levee crown.

Looking northeast at veg on levee crown.

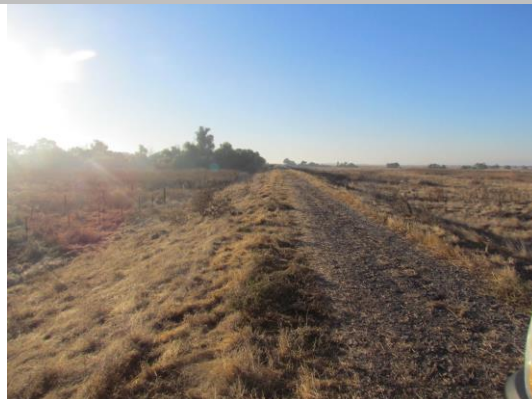
Photo 1 of 2 : FA_2016_NA0010_119_27_20161024_00065.jpg

LM Start	0.00	Rating **	M	Issue No.	27
LM End	1.33	Issue Type +	Ma	Location *	LS
Category	Earthen Levee			GPS Latitude/Longitude	
				Start	End
Item	Vegetation			37.296305 °	37.286489 °
				-120.880567 °	-120.865966 °
DWR ID	DWR_NA0010_02A_f_2015_27				
Comment Code					
V2 : Remove the wild growth other than native grasses from the levee slopes.					
Inspector Comment

Looking at dense veg on landward slope. (Fall 2016)

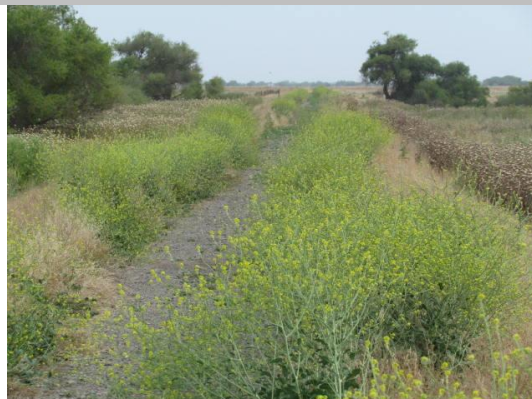
Photo 2 of 2 : FA_2016_NA0010_119_27_20161007_00007.jpg

Looking at dense veg on landward slope. (Spring 2016)

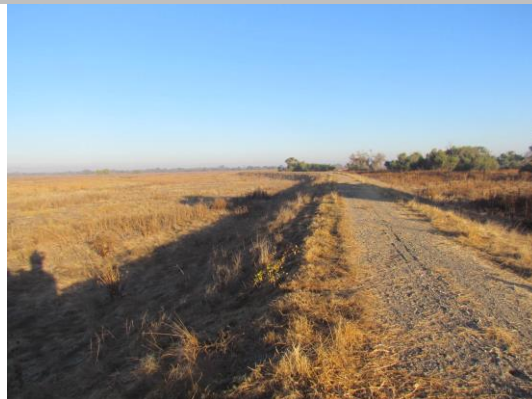
Photo 1 of 2 : FA_2016_NA0010_119_28_20161024_00066.jpg

LM Start	0.00	Rating **	M	Issue No.	28
LM End	1.33	Issue Type +	Ma	Location *	WS
Category	Earthen Levee			GPS Latitude/Longitude	
				Start	End
Item	Vegetation			37.296305 °	37.286489 °
				-120.880567 °	-120.865966 °
DWR ID	DWR_NA0010_02A_f _ 2015_28				
Comment Code					
V2 : Remove the wild growth other than native grasses from the levee slopes.					
Inspector Comment

Looking north at dense veg on waterward slope. (Fall 2016)

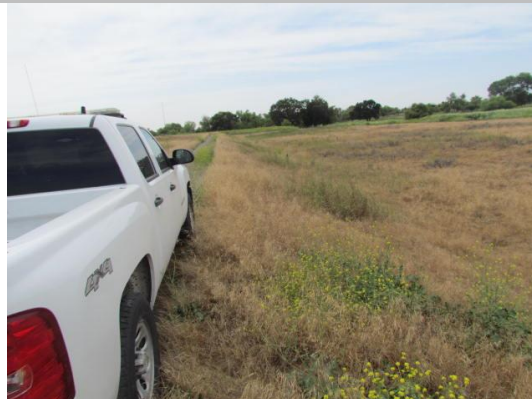
Photo 2 of 2 : FA_2016_NA0010_119_28_20161007_00008.jpg

Looking north at dense veg on waterward slope. (Spring 2016)

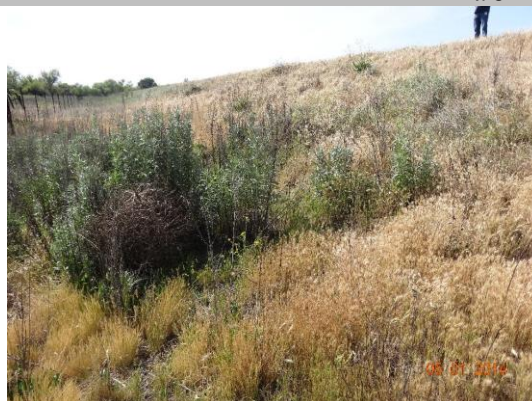
Photo 1 of 2 : UCIP_FA_2016_36503_66102.jpg

Comment Code					
Inspector Comment					
FS_ID:36503					
DS_ID:19652					
EP_NO: N/A					
Repair Type: Non-Urgent					
Crossing Status: Found					
UCIP Comments: Dense vegetation limits the inspector's visibility to identify signs of pipe failure (leaks) along the slope. Recommend removing vegetation along pipe alignment to conduct proper inspection of structure.					
FIELD_STRUCT_DESC: 24-inch CM pipe through the levee, 11.0 feet below the crown. Flap gate on the waterward end. Brass cap No. 139 BM on headwall on the landward side. (USACE-1967). This entry matches the Drainage or Irrigation Structure referenced in O&M manual (HLM 0.24).					
FS Date: 5/1/2014

View of waterward side.

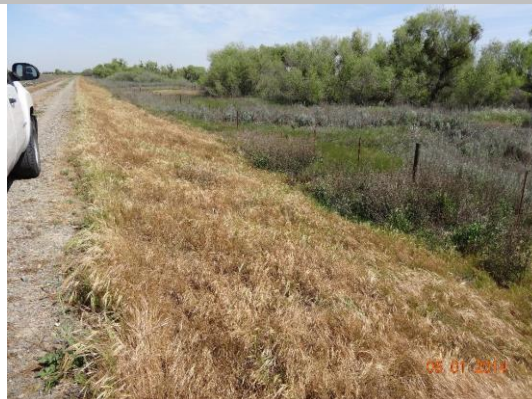
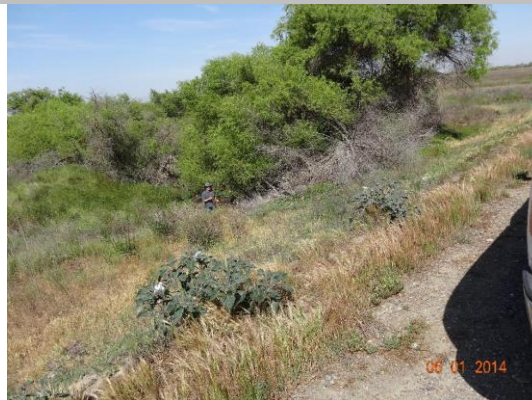
LM Start	0.66	Rating **	M	Issue No.	35
LM End	0.66	Issue Type +	En	Location *	WS
Category	Supplemental			GPS Latitude/Longitude	
				Start	End
Item	DWR UCIP Field Study			37.288087 °	37.288087 °
				-120.874919 °	-120.874919 °
DWR ID					
Comment Code					
Inspector Comment					
FS_ID:36504 DS_ID:19653 EP_NO: N/A Repair Type: Non-Urgent Crossing Status: Found UCIP Comments: Dense vegetation limits the inspector's visibility to identify signs of pipe failure (leaks) along the slope. Recommend removing vegetation along pipe alignment to conduct proper inspection of structure. FIELD_STRUCT_DESC: 24-inch CM pipe through the levee, 14.8 feet below the crown. Flap gate on the waterward end. Brass cap No. 138 BM on headwall on the landward side. (USACE-1967). This entry matches the Drainage or Irrigation Structure referenced in O&M manual (HLM 0.67). FS Date: 5/1/2014

View of waterward side.

View of landward side.
