**Flood Control Project Maintenance
Levee Inspections**

Fall 2016 Levee Maintenance Deficiency Summary Report

San Joaquin River Basin

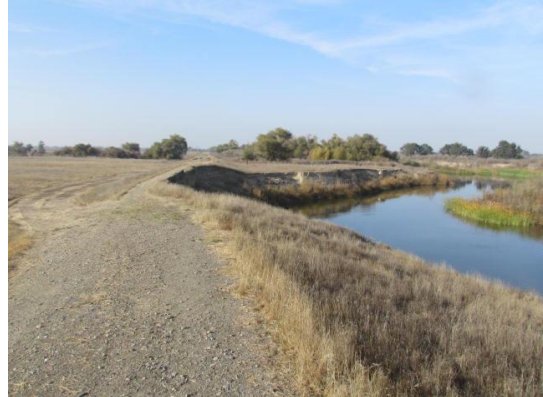
Photo 1 of 3 : FA_2016_NA0010_119_5_20161007_00003.jpg

LM Start	0.75	Rating **	U	Issue No.	5
LM End	0.75	Issue Type +	Ma	Location *	WS
Category	Earthen Levee			GPS Latitude/Longitude	
				Start	End
Item	Erosion / Bank Caving			37.286877 °	37.286877 °
				-120.874222 °	-120.874222 °
DWR ID	DWR_NA0010_02A_s_2012_5				
Comment Code					
E2 : Schedule repair of erosion site prior to the next inspection.					
Inspector Comment					
A field investigation report in on file. For more information and pictures see field investigation report #4301.

Looking north at erosion on waterward slope. (Fall 2014)

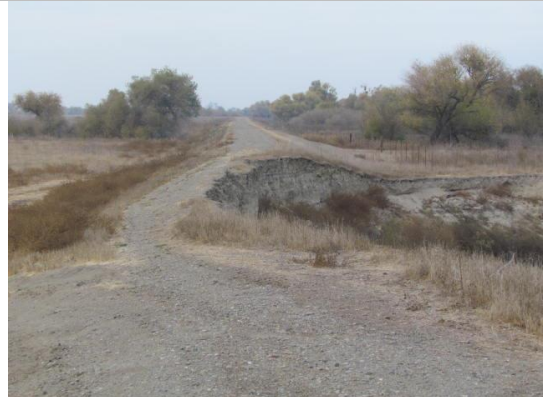
Photo 2 of 3 : FA_2016_NA0010_119_5_20161007_00004.jpg

Looking north at large erosion on waterward slope. (Fall 2013)

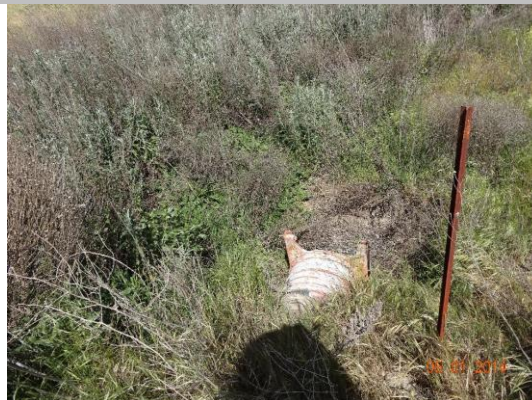
Photo 2 of 2 : UCIP_FA_2016_39363_66112.jpg

Pipe visible on waterward side.

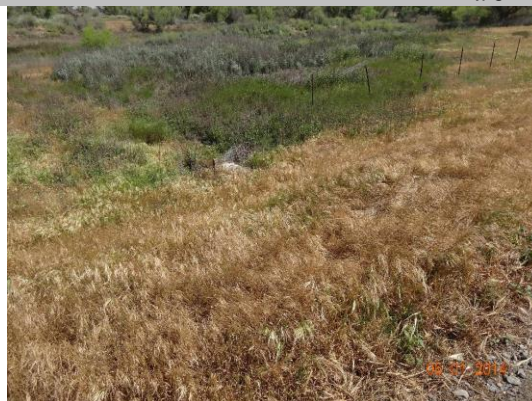
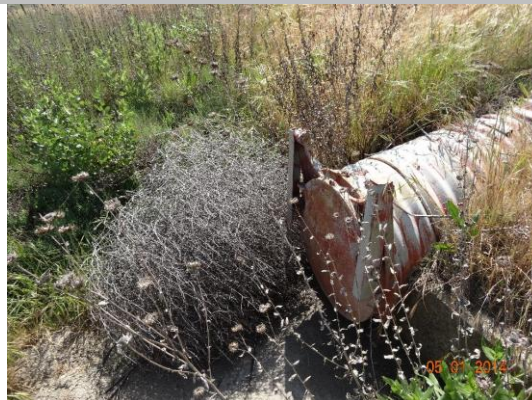
LM Start	1.21	Rating **	M	Issue No.	36
LM End	1.21	Issue Type +	En	Location *	WS
Category	Supplemental			GPS Latitude/Longitude	
				Start	End
Item	DWR UCIP Field Study			37.286118 °	37.286118 °
				-120.868167 °	-120.868167 °
DWR ID					
Comment Code					
Inspector Comment					
FS_ID:36506 DS_ID:19655 EP_NO: N/A Repair Type: Non-Urgent Crossing Status: Found UCIP Comments: Dense vegetation limits the inspector's visibility to identify signs of pipe failure (leaks) along the slope. Recommend removing vegetation along pipe alignment to conduct proper inspection of structure. FIELD_STRUCT_DESC: 24-inch CM pipe through the levee, 8.6 feet below the crown. Flap gate on the waterward end. Brass cap No. 136 BM on headwall on the landward side. (USACE-1967). This entry matches the Drainage or Irrigation Structure referenced in O&M manual (HLM 1.22). FS Date: 5/1/2014

Overview of waterward side.

Flap gate visible on waterward side.

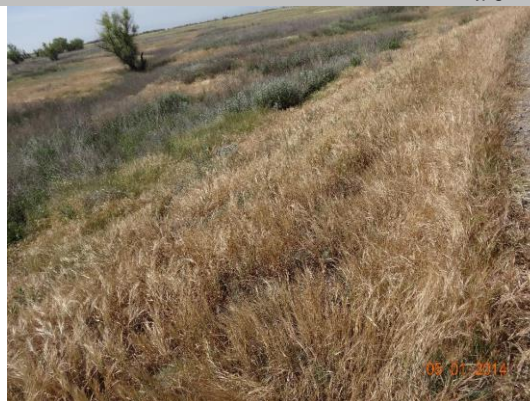
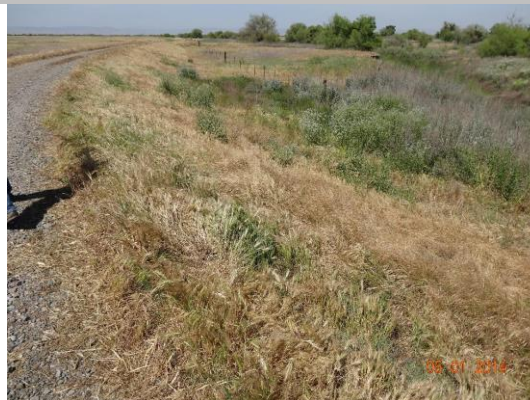
LM Start	1.33	Rating **	M	Issue No.	37
LM End	1.33	Issue Type +	En	Location *	WS
Category	Supplemental			GPS Latitude/Longitude	
				Start	End
Item	DWR UCIP Field Study			37.286463 °	37.286463 °
				-120.865997 °	-120.865997 °
DWR ID					
Comment Code					
Inspector Comment					
FS_ID:36507 DS_ID:19656 EP_NO: N/A Repair Type: Non-Urgent Crossing Status: Found UCIP Comments: Dense vegetation limits the inspector's visibility to identify signs of pipe failure (leaks) along the slope. Recommend removing vegetation along pipe alignment to conduct proper inspection of structure. FIELD_STRUCT_DESC: 36-inch CM pipe through the levee, 14.6 feet below the crown. Flap gate on the waterward end. Brass cap No. 135 BM on headwall on the landward side. (USACE-1967). This entry matches the Drainage or Irrigation Structure referenced in O&M manual (HLM 1.34). FS Date: 5/1/2014

View of landward side.

View of waterward side.

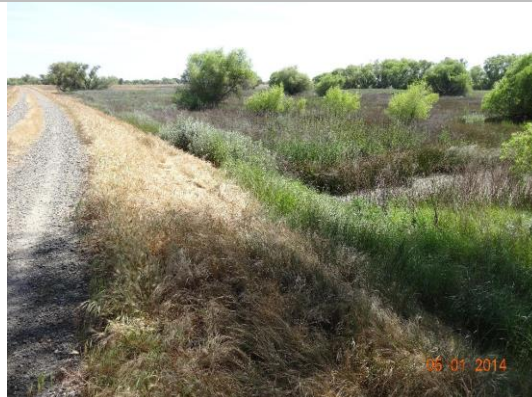
Photo 1 of 2 : UCIP_FA_2016_36508_66124.jpg

FS_ID:36508
DS_ID:19657
EP_NO: N/A
Repair Type: Non-Urgent
Crossing Status: Found
UCIP Comments: Dense vegetation limits the inspector's visibility to identify signs of pipe failure (leaks) along the slope. Recommend removing vegetation along pipe alignment to conduct proper inspection of structure.
FIELD_STRUCT_DESC: 24-inch CM pipe through the levee, 10.2 feet below the crown. Flap gate on the waterward end. Brass cap No. 135 BM on headwall on the landward side. (USACE-1967). This entry matches the Drainage or Irrigation Structure referenced in O&M manual (HLM 1.62).
FS Date: 5/1/2014

Overview of landward side.

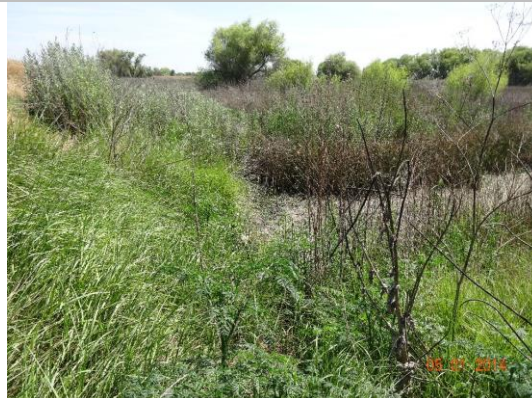
Photo 2 of 2 : UCIP_FA_2016_36508_66123.jpg

Dense vegetation along levee slope and toe.

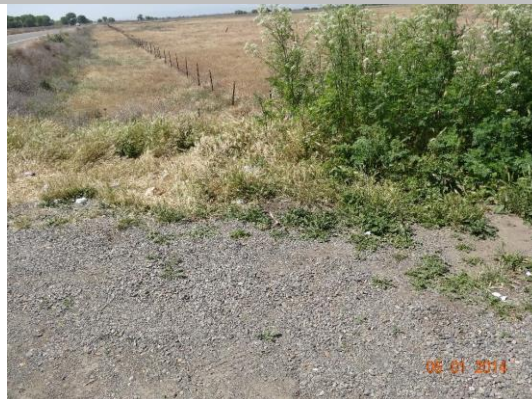
Photo 1 of 2 : UCIP_FA_2016_36510_66133.jpg

FS_ID:36510
DS_ID:19659
EP_NO: N/A
Repair Type: Non-Urgent
Crossing Status: Found
UCIP Comments: Dense vegetation limits the inspector's visibility to identify signs of pipe failure (leaks) along the slope. Recommend removing vegetation along pipe alignment to conduct proper inspection of structure.
FIELD_STRUCT_DESC: 24-inch CM pipe through the levee, 7.0 feet below the crown. Flap gate on the waterward end. Brass cap No. 135 BM on headwall on the landward side. (USACE-1967). This entry matches the Drainage or Irrigation Structure referenced in O&M manual (HLM 2.30).
FS Date: 5/1/2014

View of landward side.

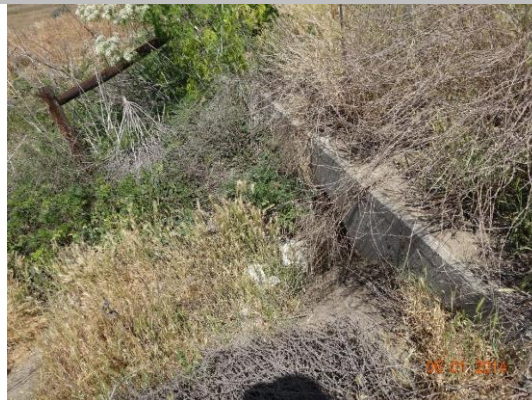
Photo 2 of 2 : UCIP_FA_2016_36510_66132.jpg

Concrete headwall visible on landward side.

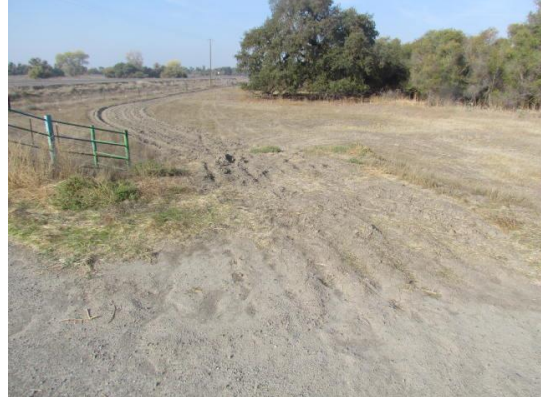
Photo 1 of 4 : FA_2016_NA0010_119_2_20161007_00001.jpg

Looking northeast at unauthorized ramp on landward slope.

LM Start	2.32	Rating **	M	Issue No.	2 (cont)	
LM End	2.32	Issue Type +	En	Location *	LS	
Category	Earthen Levee			GPS Latitude/Longitude		
				Start		End
Item	Encroachments			37.291433 °		37.291433 °
				-120.850917 °		-120.850917 °
DWR ID	DWR_NA0010_02A_s_2012_2					
Comment Code						
RA : Ramp						
Inspector Comment						
Unauthorized ramp on landside and waterside slope.

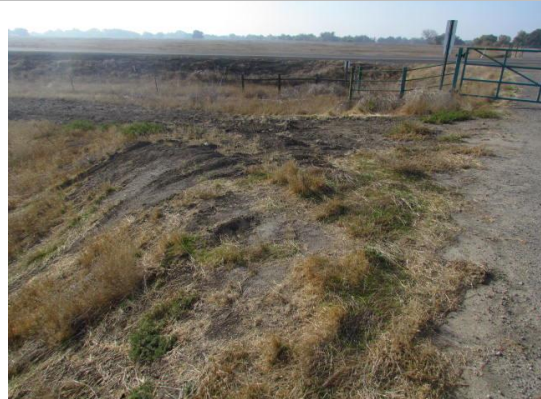
Photo 2 of 4 : FA_2016_NA0010_119_2_20161007_00002.jpg

Looking northwest at unauthorized ramp on waterward slope.

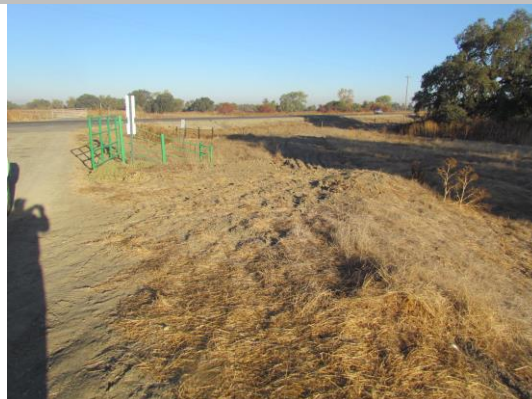
Photo 4 of 4 : FA_2016_NA0010_119_2_20161024_00067.jpg

Looking at ramp on landward slope. (Fall 2016)

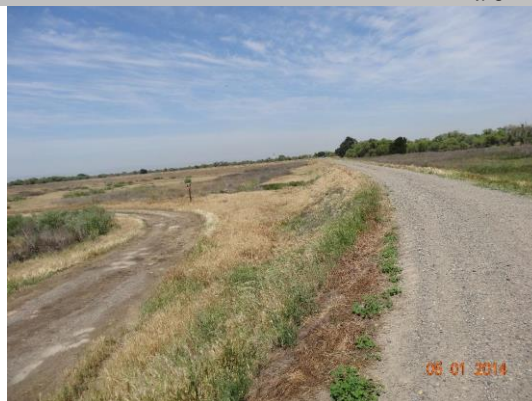
Photo 1 of 2 : UCIP_FA_2016_36512_66142.jpg

Comment Code					
Inspector Comment					
FS_ID:36512					
DS_ID:19661					
EP_NO: N/A					
Repair Type: Non-Urgent					
Crossing Status: Found					
UCIP Comments: Dense vegetation limits the inspector's visibility to identify signs of pipe failure (leaks) along the slope. Recommend removing vegetation along pipe alignment to conduct proper inspection of structure.					
FIELD_STRUCT_DESC: 24-inch CM pipe through the levee, 10.0 feet below the crown. Flap gate on the waterward end. Brass cap No. 130 BM on headwall on the landward side. (USACE-1967). This entry matches the Drainage or Irrigation Structure referenced in O&M manual (HLM 2.59).					
FS Date: 5/1/2014

View of landward side.

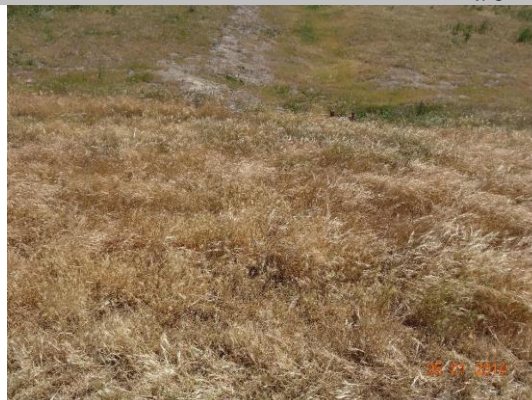
Photo 1 of 2 : UCIP_FA_2016_36513_66145.jpg

LM Start	2.95	Rating **	M	Issue No.	43
LM End	2.95	Issue Type +	En	Location *	LS
Category	Supplemental			GPS Latitude/Longitude	
				Start	End
Item	DWR UCIP Field Study			37.284326 °	37.284326 °
				-120.845157 °	-120.845157 °
DWR ID					
Comment Code					
Inspector Comment					
FS_ID:36513 DS_ID:19662 EP_NO: N/A Repair Type: Non-Urgent Crossing Status: Found UCIP Comments: Dense vegetation limits the inspector's visibility to identify signs of pipe failure (leaks) along the slope. Recommend removing vegetation along pipe alignment to conduct proper inspection of structure. FIELD_STRUCT_DESC: 24-inch CM pipe through the levee, 10.0 feet below the crown. Flap gate on the waterward end. Brass cap No. 130 BM on headwall on the landward side. (USACE-1967). This entry matches the Drainage or Irrigation Structure referenced in O&M manual (HLM 2.96). FS Date: 5/1/2014

View of waterward side.

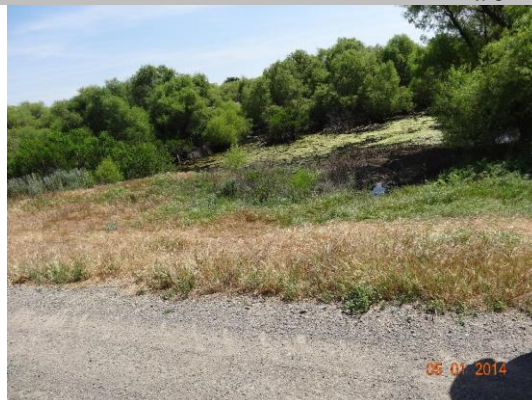
Photo 1 of 2 : UCIP_FA_2016_36514_66151.jpg

LM Start	3.28	Rating **	M	Issue No.	44
LM End	3.28	Issue Type +	En	Location *	LS
Category	Supplemental			GPS Latitude/Longitude	
				Start	End
Item	DWR UCIP Field Study			37.279656 °	37.279656 °
				-120.844795 °	-120.844795 °
DWR ID					
Comment Code					
Inspector Comment					
FS_ID:36514 DS_ID:19665 EP_NO: N/A Repair Type: Non-Urgent Crossing Status: Found UCIP Comments: Dense vegetation limits the inspector's visibility to identify signs of pipe failure (leaks) along the slope. Recommend removing vegetation along pipe alignment to conduct proper inspection of structure. FIELD_STRUCT_DESC: 24-inch CM pipe through the levee, 12.4 feet below the crown. Flap gate on the waterward end. Brass cap No. 130 BM on headwall on the landward side. (USACE-1967). This entry matches the Drainage or Irrigation Structure referenced in O&M manual (HLM 3.29). FS Date: 5/1/2014

View of waterward side.

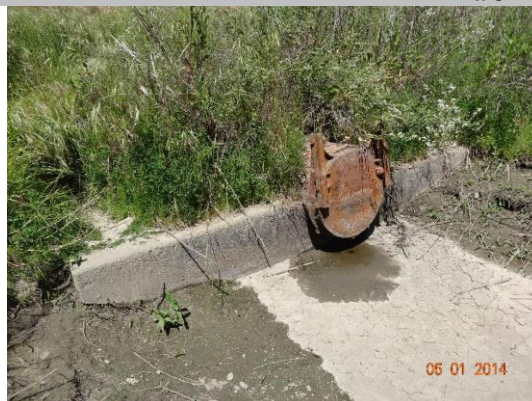
Photo 2 of 2 : UCIP_FA_2016_36514_66153.jpg

LM Start	3.28	Rating **	M	Issue No.	44 (cont)	
LM End	3.28	Issue Type +	En	Location *	LS	
Category	Supplemental			GPS Latitude/Longitude		
				Start		End
Item	DWR UCIP Field Study			37.279656 °		37.279656 °
				-120.844795 °		-120.844795 °
DWR ID						
Comment Code						
Inspector Comment						
FS_ID:36514 DS_ID:19665 EP_NO: N/A Repair Type: Non-Urgent Crossing Status: Found UCIP Comments: Dense vegetation limits the inspector's visibility to identify signs of pipe failure (leaks) along the slope. Recommend removing vegetation along pipe alignment to conduct proper inspection of structure. FIELD_STRUCT_DESC: 24-inch CM pipe through the levee, 12.4 feet below the crown. Flap gate on the waterward end. Brass cap No. 130 BM on headwall on the landward side. (USACE-1967). This entry matches the Drainage or Irrigation Structure referenced in O&M manual (HLM 3.29). FS Date: 5/1/2014

Flap gate visible on waterward side.

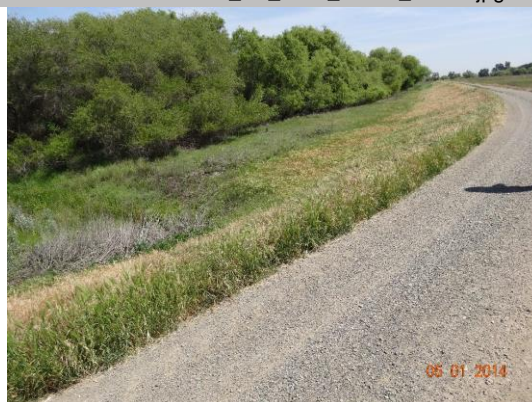
Photo 1 of 2 : UCIP_FA_2016_36515_66155.jpg

Comment Code					
Inspector Comment					
FS_ID:36515					
DS_ID:19666					
EP_NO: N/A					
Repair Type: Non-Urgent					
Crossing Status: Found					
UCIP Comments: Dense vegetation limits the inspector's visibility to identify signs of pipe failure (leaks) along the slope. Recommend removing vegetation along pipe alignment to conduct proper inspection of structure.					
FIELD_STRUCT_DESC: 24-inch CM pipe through the levee, 10.0 feet below the crown. Flap gate on the waterward end. Brass cap No. 130 BM on headwall on the landward side. (USACE-1967). This entry matches the Drainage or Irrigation Structure referenced in O&M manual (HLM 3.62).					
FS Date: 5/1/2014

View of waterward side.

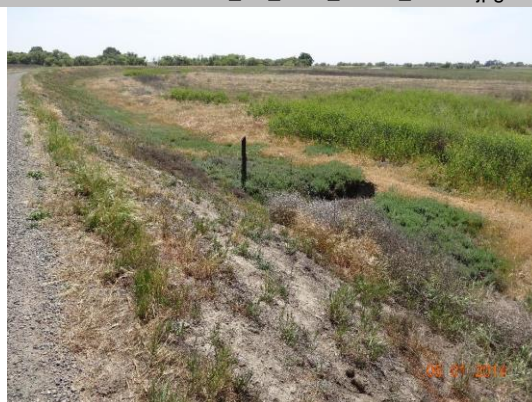
Photo 1 of 2 : UCIP_FA_2016_39364_66161.jpg

Comment Code					
Inspector Comment					
FS_ID:39364					
DS_ID:19667					
EP_NO: N/A					
Repair Type: Non-Urgent					
Crossing Status: Found					
UCIP Comments: Signs of erosion or sink hole present on landward toe--Need to contact owner. Dense vegetation limits the inspector's visibility to identify signs of pipe failure (leaks) along the slope. Recommend removing vegetation along pipe alignment to conduct proper inspection of structure.					
FIELD_STRUCT_DESC: 24-inch CM pipe through the levee, 8.6 feet below the crown. Flap gate on the waterward end. Brass cap No. 130 BM on headwall on the landward side. (USACE-1967). This entry matches the Drainage or Irrigation Structure referenced in O&M manual (HLM 3.95).					
FS Date: 5/1/2014

View of landward side.

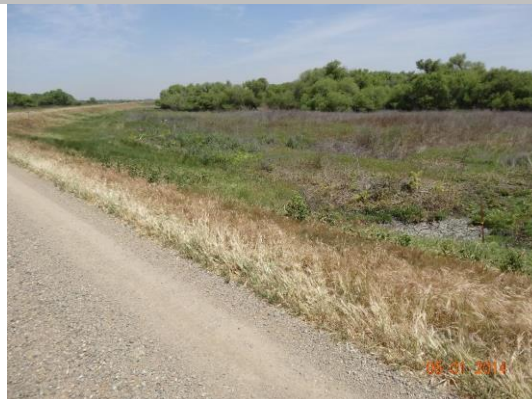
Photo 1 of 2 : UCIP_FA_2016_36517_66167.jpg

Comment Code					
Inspector Comment					
FS_ID:36517					
DS_ID:19668					
EP_NO: N/A					
Repair Type: Non-Urgent					
Crossing Status: Found					
UCIP Comments: Dense vegetation limits the inspector's visibility to identify signs of pipe failure (leaks) along the slope. Recommend removing vegetation along pipe alignment to conduct proper inspection of structure.					
FIELD_STRUCT_DESC: 24-inch CM pipe through the levee, 8.0 feet below the crown. Flap gate on the waterward end. Brass cap No. 125 BM on headwall on the landward side. (USACE-1967). This entry matches the Drainage or Irrigation Structure referenced in O&M manual (HLM 5.43).					
FS Date: 5/1/2014

View of waterward side.

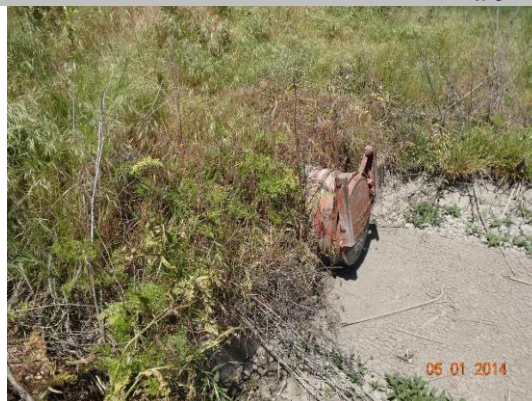
Photo 2 of 2 : UCIP_FA_2016_36517_66166.jpg

Comment Code						
Inspector Comment						
FS_ID:36517						
DS_ID:19668						
EP_NO: N/A						
Repair Type: Non-Urgent						
Crossing Status: Found						
UCIP Comments: Dense vegetation limits the inspector's visibility to identify signs of pipe failure (leaks) along the slope. Recommend removing vegetation along pipe alignment to conduct proper inspection of structure.						
FIELD_STRUCT_DESC: 24-inch CM pipe through the levee, 8.0 feet below the crown. Flap gate on the waterward end. Brass cap No. 125 BM on headwall on the landward side. (USACE-1967). This entry matches the Drainage or Irrigation Structure referenced in O&M manual (HLM 5.43).						
FS Date: 5/1/2014

Flap gate visible on waterward side.

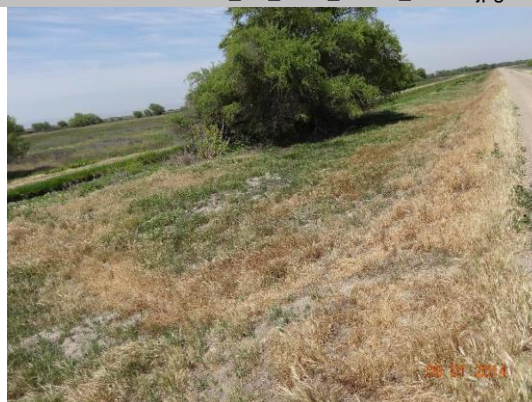
Photo 1 of 2 : UCIP_FA_2016_36518_66171.jpg

LM Start	6.03	Rating **	M	Issue No.	47
LM End	6.03	Issue Type +	En	Location *	LS
Category	Supplemental			GPS Latitude/Longitude	
				Start	End
Item	DWR UCIP Field Study			37.253527 °	37.253527 °
				-120.823991 °	-120.823991 °
DWR ID					
Comment Code					
Inspector Comment					
FS_ID:36518 DS_ID:19669 EP_NO: N/A Repair Type: Non-Urgent Crossing Status: Found UCIP Comments: Dense vegetation limits the inspector's visibility to identify signs of pipe failure (leaks) along the slope. Recommend removing vegetation along pipe alignment to conduct proper inspection of structure. FIELD_STRUCT_DESC: 24-inch CM pipe through the levee, 7.7 feet below the crown. Flap gate on the waterward end. Brass cap No. 125 BM on headwall on the landward side. (USACE-1967). This entry matches the Drainage or Irrigation Structure referenced in O&M manual (HLM 6.06). FS Date: 5/1/2014

View of landward side.

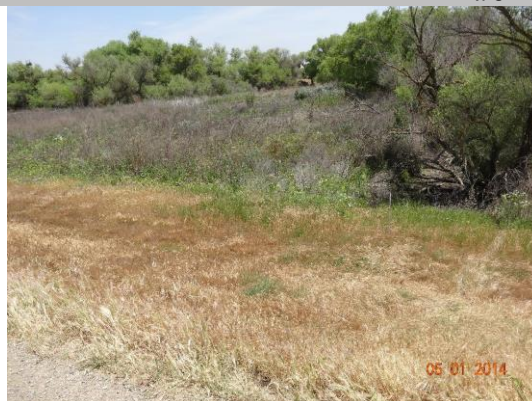
Photo 2 of 2 : UCIP_FA_2016_36518_66170.jpg

LM Start	6.03	Rating **	M	Issue No.	47 (cont)	
LM End	6.03	Issue Type +	En	Location *	LS	
Category	Supplemental			GPS Latitude/Longitude		
				Start		End
Item	DWR UCIP Field Study			37.253527 °		37.253527 °
				-120.823991 °		-120.823991 °
DWR ID						
Comment Code						
Inspector Comment						
FS_ID:36518 DS_ID:19669 EP_NO: N/A Repair Type: Non-Urgent Crossing Status: Found UCIP Comments: Dense vegetation limits the inspector's visibility to identify signs of pipe failure (leaks) along the slope. Recommend removing vegetation along pipe alignment to conduct proper inspection of structure. FIELD_STRUCT_DESC: 24-inch CM pipe through the levee, 7.7 feet below the crown. Flap gate on the waterward end. Brass cap No. 125 BM on headwall on the landward side. (USACE-1967). This entry matches the Drainage or Irrigation Structure referenced in O&M manual (HLM 6.06). FS Date: 5/1/2014

View of waterward side.

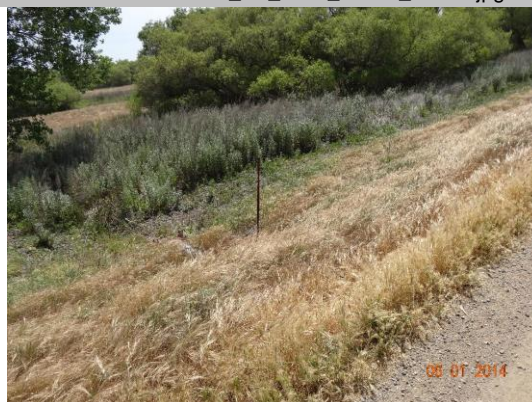
Photo 1 of 2 : UCIP_FA_2016_36519_66173.jpg

LM Start	6.47	Rating **	M	Issue No.	29
LM End	6.47	Issue Type +	En	Location *	LS
Category	Supplemental			GPS Latitude/Longitude	
				Start	End
Item	DWR UCIP Field Study			37.248210 °	37.248210 °
				-120.823120 °	-120.823120 °
DWR ID					
Comment Code					
Inspector Comment					
FS_ID:36519 DS_ID:19670 EP_NO: N/A Repair Type: Non-Urgent Crossing Status: Found UCIP Comments: Dense vegetation limits the inspector's visibility to identify signs of pipe failure (leaks) along the slope. Recommend removing vegetation along pipe alignment to conduct proper inspection of structure. FIELD_STRUCT_DESC: 24-inch CM pipe through the levee, 7.7 feet below the crown. Flap gate on the waterward end. Brass cap No. 125 BM on headwall on the landward side. (USACE-1967). This entry matches the Drainage or Irrigation Structure referenced in O&M manual (HLM 6.50). FS Date: 5/1/2014

View of waterward side.

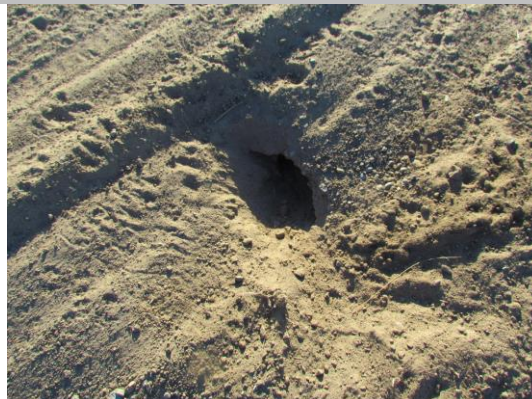
Photo 2 of 2 : FA_2016_NA0010_119_22_20161024_00071.jpg

LM Start	6.85	Rating **	M	Issue No.	22 (cont)	
LM End	6.85	Issue Type +	Ma	Location *	CR	
Category	Earthen Levee			GPS Latitude/Longitude		
				Start		End
Item	Animal Control			37.242833 °		37.242833 °
				-120.822270 °		-120.822270 °
DWR ID	DWR_NA0010_02A_f _ 2016_22					
Comment Code						
A1 : Exterminate rodents and backfill and compact or grout burrows.						
Inspector Comment						
Noticed several burrow holes on the levee crown. It does not seem to be rodent holes or gopher holes. It could be moles.

Looking at close-up of rodent hole on levee crown.

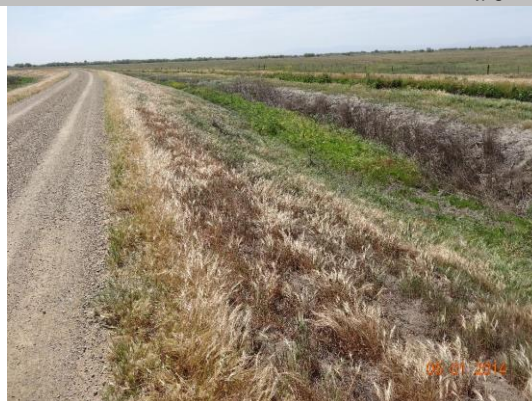
Photo 1 of 2 : UCIP_FA_2016_39365_66178.jpg

Comment Code					
Inspector Comment					
FS_ID:39365					
DS_ID:19671					
EP_NO: N/A					
Repair Type: Non-Urgent					
Crossing Status: Found					
UCIP Comments: Dense vegetation limits the inspector's visibility to identify signs of pipe failure (leaks) along the slope. Recommend removing vegetation along pipe alignment to conduct proper inspection of structure. Pipe extension visible on landward side--need to contact owner for additional information about extension/modification.					
FIELD_STRUCT_DESC: 24-inch CM pipe through the levee, 12.6 feet below the crown. Flap gate on the waterward end. Brass cap No. 125 BM on headwall on the landward side. (USACE-1967). This entry matches the Drainage or Irrigation Structure referenced in O&M manual (HLM 7.05).					
FS Date: 5/1/2014

View of landward side.

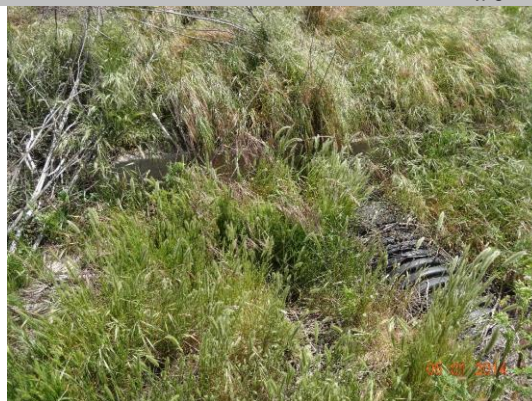
Photo 2 of 2 : UCIP_FA_2016_39365_66177.jpg

Comment Code					
Inspector Comment					
FS_ID:39365 DS_ID:19671 EP_NO: N/A Repair Type: Non-Urgent Crossing Status: Found UCIP Comments: Dense vegetation limits the inspector's visibility to identify signs of pipe failure (leaks) along the slope. Recommend removing vegetation along pipe alignment to conduct proper inspection of structure. Pipe extension visible on landward side--need to contact owner for additional information about extension/modification. FIELD_STRUCT_DESC: 24-inch CM pipe through the levee, 12.6 feet below the crown. Flap gate on the waterward end. Brass cap No. 125 BM on headwall on the landward side. (USACE-1967). This entry matches the Drainage or Irrigation Structure referenced in O&M manual (HLM 7.05). FS Date: 5/1/2014

Pipe extension visible on landward side attached to inlet at concrete headwall.

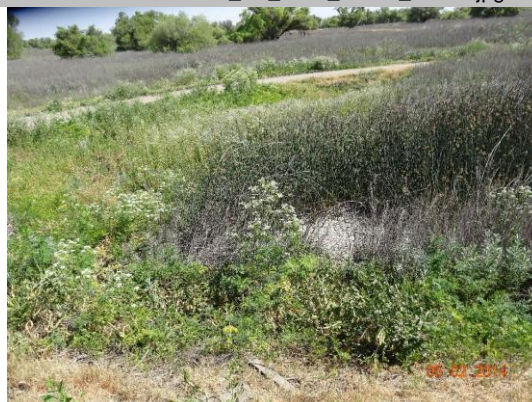
Photo 1 of 2 : UCIP_FA_2016_36521_66183.jpg

Comment Code					
Inspector Comment					
FS_ID:36521					
DS_ID:19673					
EP_NO: N/A					
Repair Type: Non-Urgent					
Crossing Status: Found					
UCIP Comments: Dense vegetation limits the inspector's visibility to identify signs of pipe failure (leaks) along the slope. Recommend removing vegetation along pipe alignment to conduct proper inspection of structure.					
FIELD_STRUCT_DESC: 24-inch CM pipe through the levee, 8.0 feet below the crown. Flap gate on the waterward end. Brass cap No. 125 BM on headwall on the landward side. (USACE-1967). This entry matches the Drainage or Irrigation Structure referenced in O&M manual (HLM 7.77).					
FS Date: 5/1/2014

View of waterward side.

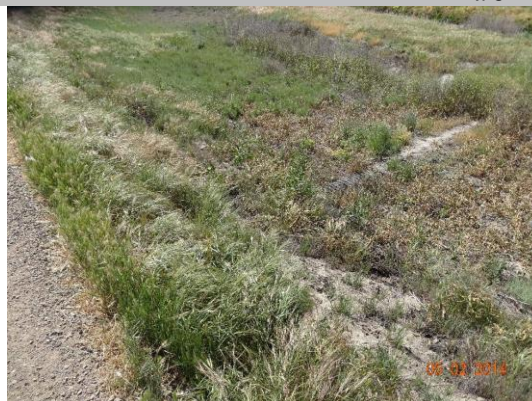
Photo 2 of 2 : UCIP_FA_2016_36521_66182.jpg

Comment Code						
Inspector Comment						
FS_ID:36521						
DS_ID:19673						
EP_NO: N/A						
Repair Type: Non-Urgent						
Crossing Status: Found						
UCIP Comments: Dense vegetation limits the inspector's visibility to identify signs of pipe failure (leaks) along the slope. Recommend removing vegetation along pipe alignment to conduct proper inspection of structure.						
FIELD_STRUCT_DESC: 24-inch CM pipe through the levee, 8.0 feet below the crown. Flap gate on the waterward end. Brass cap No. 125 BM on headwall on the landward side. (USACE-1967). This entry matches the Drainage or Irrigation Structure referenced in O&M manual (HLM 7.77).						
FS Date: 5/1/2014

View of landward side.

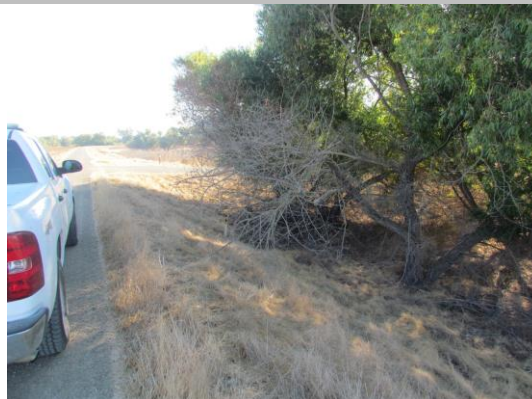
Photo 1 of 1 : FA_2016_NA0010_120_17_20161024_00005.jpg

LM Start	9.42	Rating **	M	Issue No.	17
LM End	9.42	Issue Type +	Ma	Location *	LS
Category	Earthen Levee			GPS Latitude/Longitude	
				Start	End
Item	Trim / Thin Trees			37.220199 °	37.220199 °
				-120.788748 °	-120.788748 °
DWR ID	DWR_NA0010_02B_f_2016_17				
Comment Code					
T1 : Trim trees to at least five feet above ground level.					
Inspector Comment					
Trim back dead tree limb on landward toe.

Looking at dead tree limb on landward slope.

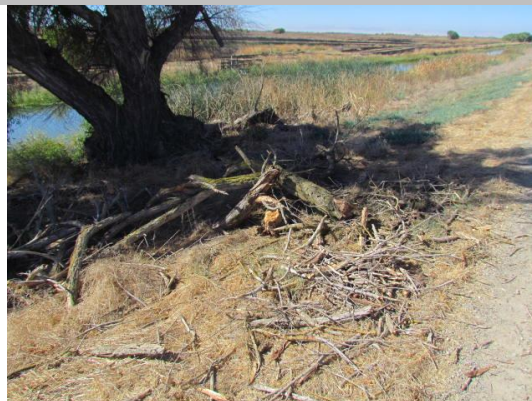
Photo 1 of 1 : FA_2016_NA0010_120_14_20161007_00004.jpg

LM Start	10.94	Rating **	M	Issue No.	14
LM End	10.94	Issue Type +	Ma	Location *	LS
Category	Earthen Levee			GPS Latitude/Longitude	
				Start	End
Item	Encroachments			37.205711 °	37.205711 °
				-120.774741 °	-120.774741 °
DWR ID	DWR_NA0010_02B_f_2015_14				
Comment Code					
PR : Prunings					
Inspector Comment					
Prunings on landward slope.

Looking at prunings on landward slope.

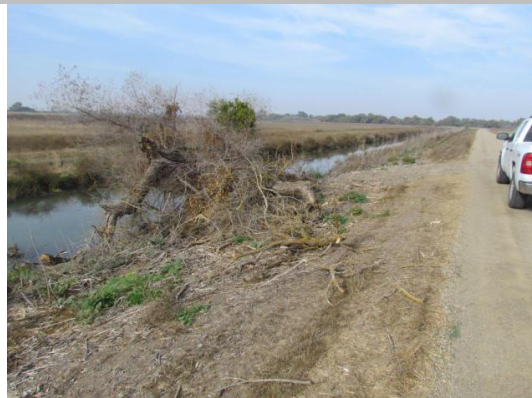
Photo 1 of 2 : FA_2016_NA0010_120_1_20161007_00001.jpg

LM Start	12.21	Rating **	M	Issue No.	1
LM End	12.21	Issue Type +	Ma	Location *	LS
Category	Earthen Levee			GPS Latitude/Longitude	
				Start	End
Item	Encroachments			37.191528 °	37.191528 °
				-120.764541 °	-120.764541 °
DWR ID	DWR_NA0010_02B_f_2014_1				
Comment Code					
TR : Tree or limb					
Inspector Comment					
Fallen tree limbs on landward slope.

Looking northwest at tree limb on waterward slope.

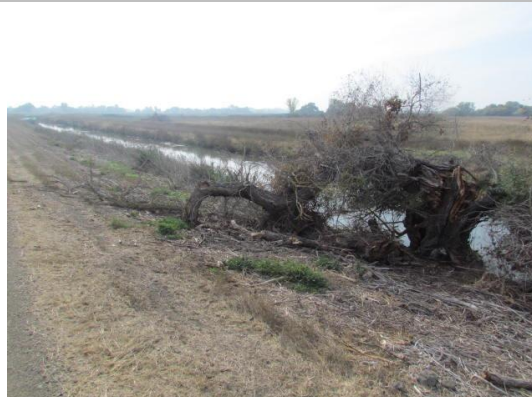
Photo 2 of 2 : FA_2016_NA0010_120_1_20161007_00002.jpg

LM Start	12.21	Rating **	M	Issue No.	1 (cont)	
LM End	12.21	Issue Type +	Ma	Location *	LS	
Category	Earthen Levee			GPS Latitude/Longitude		
				Start		End
Item	Encroachments			37.191528 °	37.191528 °	
				-120.764541 °	-120.764541 °	
DWR ID	DWR_NA0010_02B_f_2014_1					
Comment Code						
TR : Tree or limb						
Inspector Comment						
Fallen tree limbs on landward slope.

Looking southwest at tree limb on waterward slope.

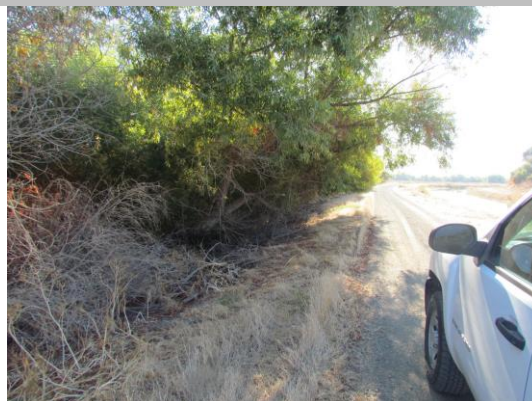
Photo 1 of 1 : FA_2016_NA0010_120_167_20161024_00009.jpg

LM Start	13.42	Rating **	U	Issue No.	167
LM End	13.42	Issue Type +	Ma	Location *	WS
Category	Earthen Levee			GPS Latitude/Longitude	
				Start	End
Item	Trim / Thin Trees			37.176379 °	37.176379 °
				-120.762255 °	-120.762255 °
DWR ID	DWR_NA0010_02B_s_2015_167				
Comment Code					
T3 : Trim and thin trees to allow visibility of the ground and room to flood fight.					
Inspector Comment					
Dense trees on waterward slope.

Looking south at untrimmed trees on waterward slope.

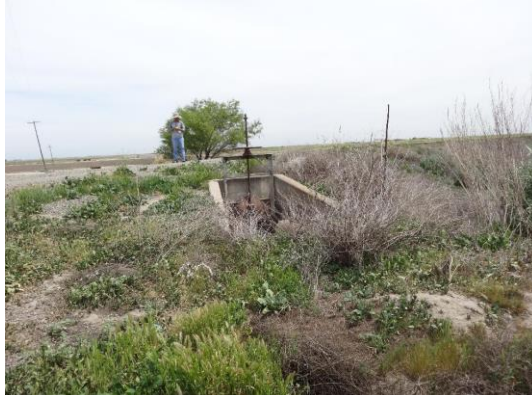
Photo 1 of 2 : UCIP_FA_2016_36543_66281.jpg

LM Start	2.04	Rating **	M	Issue No.	70
LM End	2.04	Issue Type +	En	Location *	LS
Category	Supplemental			GPS Latitude/Longitude	
				Start	End
Item	DWR UCIP Field Study			37.089394 °	37.089394 °
				-120.567731 °	-120.567731 °
DWR ID					
Comment Code					
Inspector Comment					
FS_ID:36543 DS_ID:19694 EP_NO: N/A Repair Type: Non-Urgent Crossing Status: Found UCIP Comments: Need to contact owner--additional appurtenances found on waterward side not part of original description. Unable to determine if walkway, pump, and pipe through waterward berm is if part of original crossing. FIELD_STRUCT_DESC: 36-inch CM pipe through the levee, 6.6 feet below the crown. Slide gate on the waterward end. Pump on the waterward bank. (USACE-1967). This entry matches the Drainage or Irrigation Structure referenced in O&M manual (HLM 2.05). FS Date: 4/17/2014

Slide gate and concrete structure located on waterward slope.

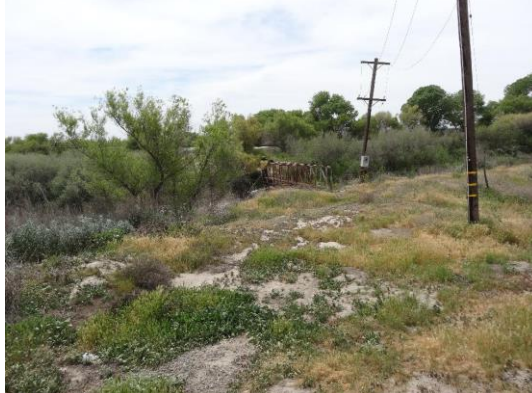
Photo 2 of 2 : UCIP_FA_2016_36543_66282.jpg

View of walkway and berm on waterward side.

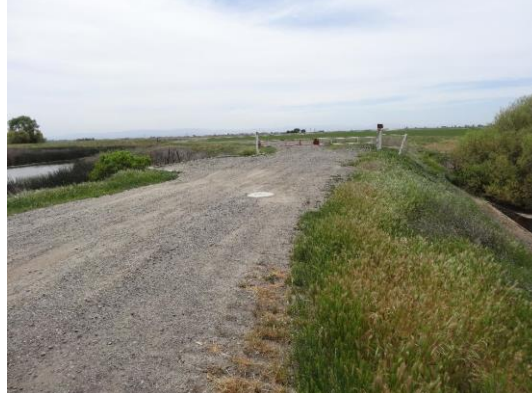
Photo 2 of 2 : UCIP_FA_2016_40529_61968.jpg

View of levee crown.

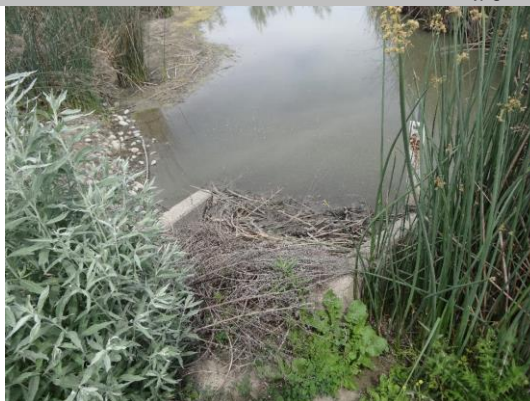
Photo 1 of 2 : UCIP_FA_2016_34093_61982.jpg

LM Start	0.24	Rating **	M	Issue No.	7
LM End	0.24	Issue Type +	En	Location *	LS
Category	Supplemental			GPS Latitude/Longitude	
				Start	End
Item	DWR UCIP Field Study			37.109933 °	37.109933 °
				-120.590689 °	-120.590689 °
DWR ID					
Comment Code					
Inspector Comment					
FS_ID:34093 DS_ID:19695 EP_NO: N/A Repair Type: Non-Urgent Crossing Status: Found UCIP Comments: Sediment and debris blocking concrete headwall located on waterward side. During inspection water was flowing from landward side to waterward side. Recommend removing sediment to confirm condition of flap gate and pipe. FIELD_STRUCT_DESC: 36-inch CM pipe through the levee, 18.0 feet below the crown. Flap gate on the waterward end. Concrete headwalls on both sides. (USACE-1967). This entry matches the Drainage or Irrigation Structure referenced in O&M manual (HLM 0.27). FS Date: 4/17/2014

View of dense vegetation near concrete headwall located on waterward side.

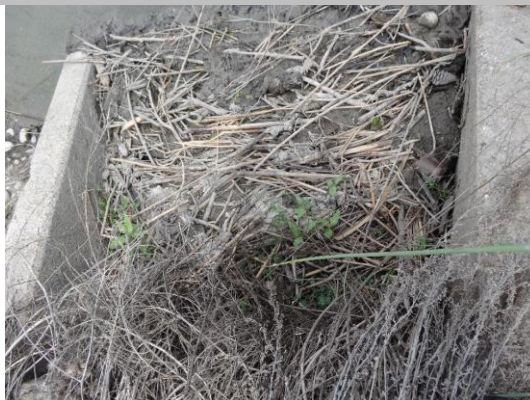
Photo 2 of 2 : UCIP_FA_2016_34093_61981.jpg

Sediment blocking flap gate located on waterward side.

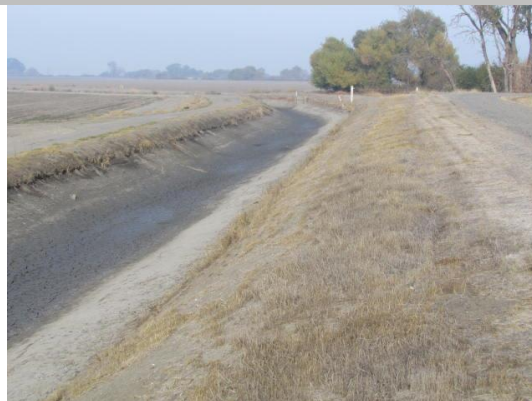
Photo 2 of 3 : FA_2016_NA0010_122_3_20161007_00002.jpg

Looking north at irrigation ditch at landward toe. (Fall 2013)

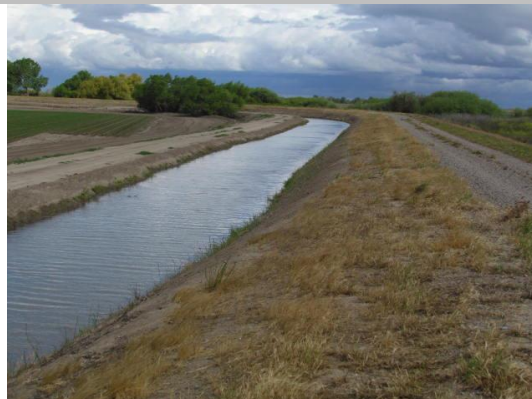
Photo 3 of 3 : FA_2016_NA0010_122_3_20161007_00003.jpg

Looking north at irrigation ditch at landside toe.

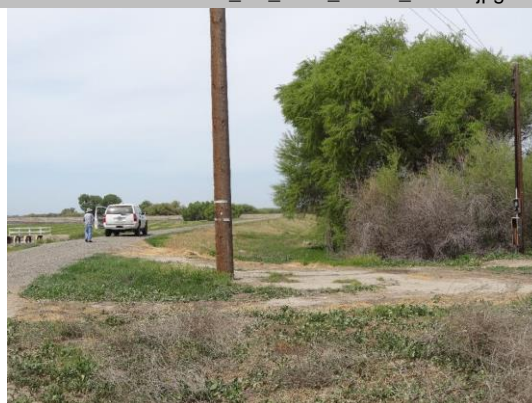
Photo 2 of 2 : UCIP_FA_2016_40530_61988.jpg

Overview of waterward side and levee crown at crossing.

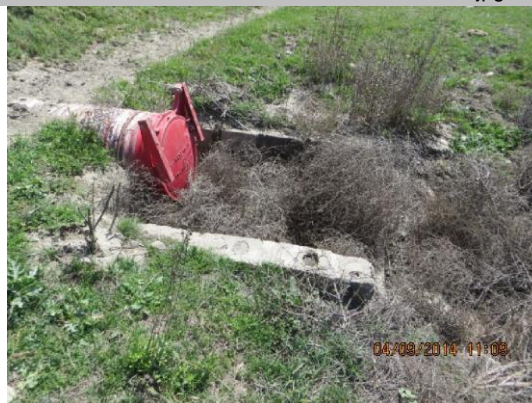
Photo 2 of 2 : UCIP_FA_2016_39563_60920.jpg

Pipe, flapgate, and concrete headwall on WS toe.

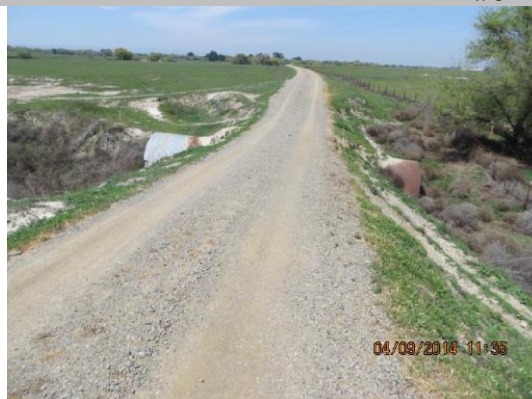
Photo 1 of 2 : UCIP_FA_2016_49967_71469.jpg

FS_ID:49967
DS_ID:24867
EP_NO: N/A
Repair Type: Urgent
Crossing Status: Found
UCIP Comments: 07/20/2016 same as previous inspection. Levee section at crossing has been degraded. According to LMA representative, Rick, the low point at crossing has been present for over 10 years when the pipe was replaced. (DWR UCIP - omagana)04/09/2014 Pipe is open on both ends and levee has been degraded at this location. No permit identified for this crossing. (DWR UCIP - omagana)
FIELD_STRUCT_DESC: 96-inch corrugated metal drainage pipe through the levee, 4.5 feet below the crown. Pipe is composed of two materials, corrugated metal pipe (CMP) on the WS and steel pipe on the LS. This section of the levee is a degraded section that drops approximately 4 feet within 100 feet in length. This section of the levee is the site of the 1960's levee breach. [Additional Reference(s): USACE Periodic Inspection Report 2014, USACE_CESPK_L05A_2014_p_0014]

Pipe through levee where levee has been degraded.

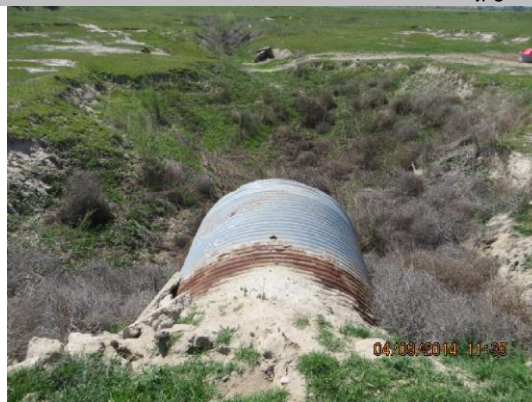
Photo 2 of 2 : UCIP_FA_2016_49967_71467.jpg

Pipe on WS toe.

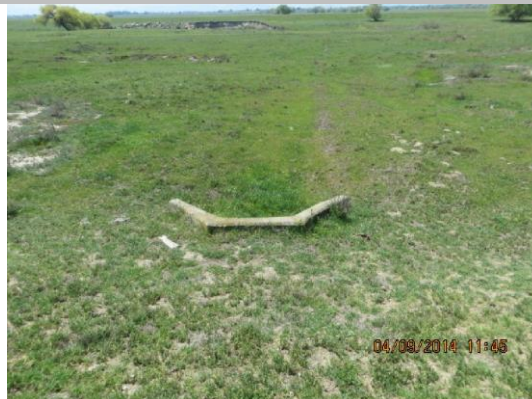
Photo 1 of 2 : UCIP_FA_2016_39584_60926.jpg

LM Start	0.60	Rating **	M	Issue No.	1326
LM End	0.60	Issue Type +	En	Location *	WS
Category	Supplemental			GPS Latitude/Longitude	
				Start	End
Item	DWR UCIP Field Study			37.273945 °	37.273945 °
				-120.815835 °	-120.815835 °
DWR ID					
Comment Code					
Inspector Comment					
FS_ID:39584 DS_ID:19757 EP_NO: N/A Repair Type: Non-Urgent Crossing Status: Found UCIP Comments: Excess debris on landward headwall--recommend clearing. FIELD_STRUCT_DESC: 30-inch C.M. stormdrain pipe through the levee, 7.5 feet below the crown. Flap gate on the waterward end. Concrete headwall on the landward end. Concrete "U" headwall on the waterward end. (USACE-1967). This entry matches the Drainage or Irrigation Structure referenced in O&M manual (HLM 0.59). FS Date: 4/9/2014

Concrete headwall, pipe, and flapgate on WS toe.

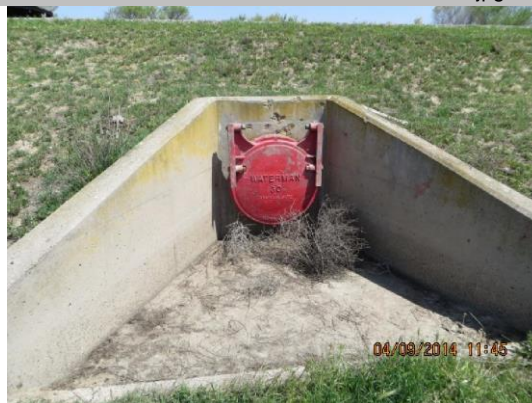
Photo 2 of 2 : UCIP_FA_2016_39584_60925.jpg

Concrete headwall, pipe, and flapgate on WS toe.

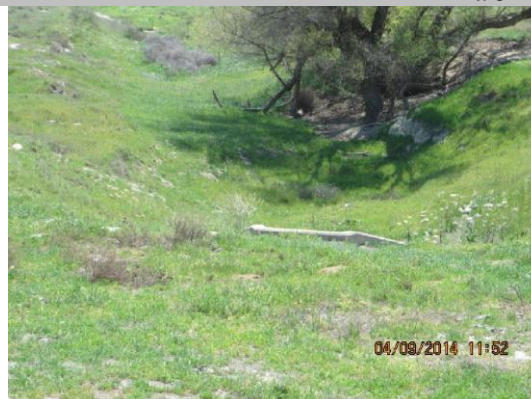
Photo 1 of 2 : UCIP_FA_2016_39585_60931.jpg

Comment Code					
Inspector Comment					
FS_ID:39585 DS_ID:19758 EP_NO: N/A Repair Type: Non-Urgent Crossing Status: Found UCIP Comments: Dense vegetation limits the inspector's visibility to identify signs of pipe failure (leaks) along the landward slope. Recommend removing vegetation along pipe alignment to conduct proper inspection of structure. FIELD_STRUCT_DESC: 36-inch C.M. stormdrain pipe through the levee, 13.2 feet below the crown. Flap gate on the waterward end. Concrete headwall on the landward end. Concrete "U" headwall on the waterward end. Cobble revetment around both ends. (USACE-1967). This entry matches the Drainage or Irrigation Structure referenced in O&M manual (HLM 0.65). FS Date: 4/9/2014

Concrete headwall visible off WS toe.

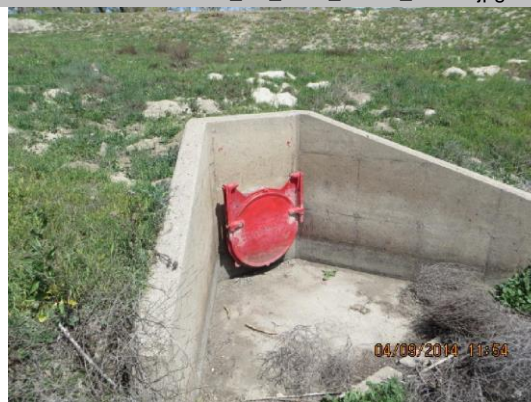
Photo 2 of 2 : UCIP_FA_2016_39585_60929.jpg

Pipe, flapgate, and headwall at WS toe.

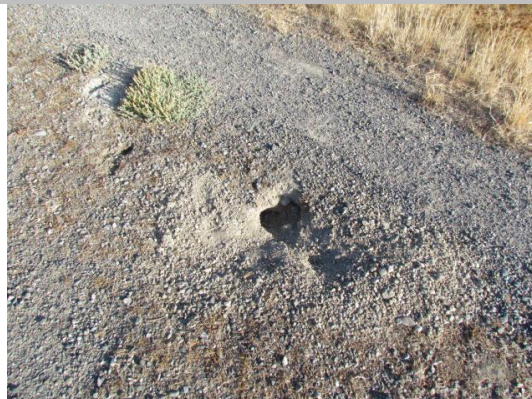
Photo 1 of 1 : FA_2016_NA0010_123_80_20161007_00011.jpg

LM Start	1.66	Rating **	M	Issue No.	80
LM End	1.75	Issue Type +	Ma	Location *	LS
Category	Earthen Levee			GPS Latitude/Longitude	
				Start	End
Item	Animal Control			37.263448 °	37.262225 °
				-120.802715 °	-120.802296 °
DWR ID	DWR_NA0010_05_f_2015_80				
Comment Code					
A3 : No rodents visible, but rodent burrows visible; need to backfill and compact or grout burrows.					
Inspector Comment					
Several rodent holes on levee crown within this section.

Looking at typical view of rodent holes within this section on landward slope.

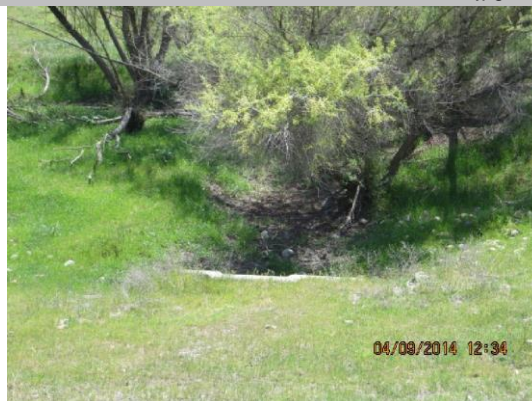
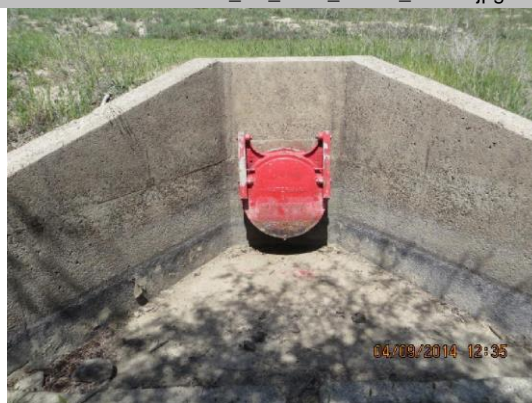
LM Start	2.84	Rating **	M	Issue No.	1318
LM End	2.84	Issue Type +	En	Location *	LS
Category	Supplemental			GPS Latitude/Longitude	
				Start	End
Item	DWR UCIP Field Study			37.256810 °	37.256810 °
				-120.785113 °	-120.785113 °
DWR ID					
Comment Code					
Inspector Comment					
FS_ID:33709					
DS_ID:19809					
EP_NO: N/A					
Repair Type: Non-Urgent					
Crossing Status: Found					
UCIP Comments: Log partially blocking inlet at LS toe.					
FIELD_STRUCT_DESC: 24-inch C.M. stormdrain pipe through the					
levee, 15.0 feet below the crown. Flap gate on the waterward end.					
Concrete "U" headwalls on both ends. (USACE-1967). This entry					
matches the Drainage or Irrigation Structure referenced in O&M manual					
(HLM 2.85).					
FS Date: 4/9/2014

Concrete headwall at outlet on WS toe.

Headwall, pipe, and flapgate on WS toe.

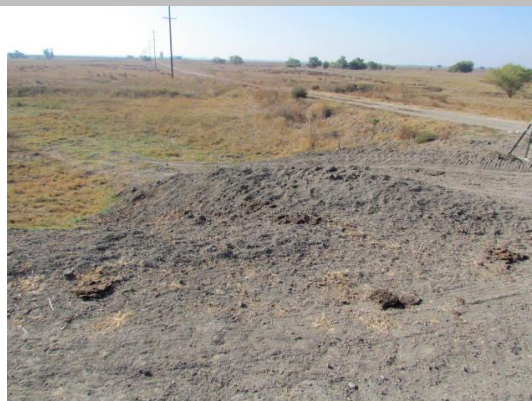
Photo 3 of 3 : FA_2016_NA0010_123_7_20161007_00006.jpg

LM Start	3.20	Rating **	M	Issue No.	7 (cont)	
LM End	3.20	Issue Type +	En	Location *	WS	
Category	Earthen Levee			GPS Latitude/Longitude		
				Start	End	
Item	Encroachments			37.256554 °	37.256554 °	
				-120.778847 °	-120.778847 °	
DWR ID	DWR_NA0010_05_f_2012_7					
Comment Code						
RA : Ramp						
Inspector Comment						
Unauthorized ramp on waterside slope.

Looking northwest at unauthorized ramp on waterside slope.

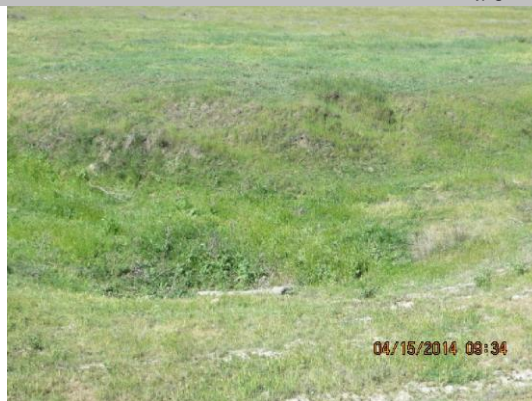
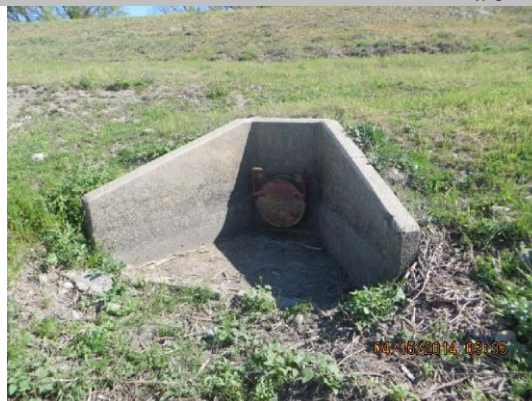
LM Start	3.34	Rating **	M	Issue No.	1335
LM End	3.34	Issue Type +	En	Location *	WS
Category	Supplemental			GPS Latitude/Longitude	
				Start	End
Item	DWR UCIP Field Study			37.255258 °	37.255258 °
				-120.776996 °	-120.776996 °
DWR ID					
Comment Code					
Inspector Comment					
FS_ID:43055 DS_ID:19810 EP_NO: N/A Repair Type: Non-Urgent Crossing Status: Found UCIP Comments: Pipe corroded through at flapgate on WS toe. FIELD_STRUCT_DESC: 24-inch C.M. stormdrain pipe through the levee, 14.7 feet below the crown. Flap gate on the waterward end. Concrete "U" headwalls on both ends. (USACE-1967). This entry matches the Drainage or Irrigation Structure referenced in O&M manual (HLM 3.33). FS Date: 4/15/2014

Concrete headwall at WS toe.

Flapgate and Concrete headwall at WS toe.

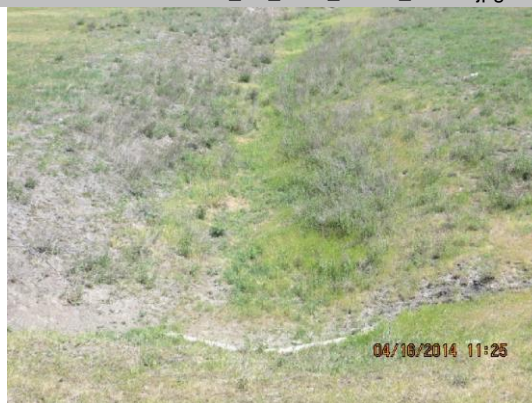
Photo 1 of 2 : UCIP_FA_2016_39586_61137.jpg

LM Start	3.68	Rating **	M	Issue No.	1328
LM End	3.68	Issue Type +	En	Location *	WS
Category	Supplemental			GPS Latitude/Longitude	
				Start	End
Item	DWR UCIP Field Study			37.252308 °	37.252308 °
				-120.768038 °	-120.768038 °
DWR ID					
Comment Code					
Inspector Comment					
FS_ID:39586 DS_ID:19811 EP_NO: N/A Repair Type: Non-Urgent Crossing Status: Found UCIP Comments: Sediment buildup in pipe visible from landward side-- recommend contacting owner to clear pipe. FIELD_STRUCT_DESC: 24-inch C.M. stormdrain pipe through the levee, 15.0 feet below the crown. Flap gate on the waterward end. Concrete headwall on the landward end. Concrete "U" headwall on the waterward end. (USACE-1967). This entry matches the Drainage or Irrigation Structure referenced in O&M manual (HLM 3.67). FS Date: 4/16/2014

Pipe, headwall, and flapgate on WS toe.

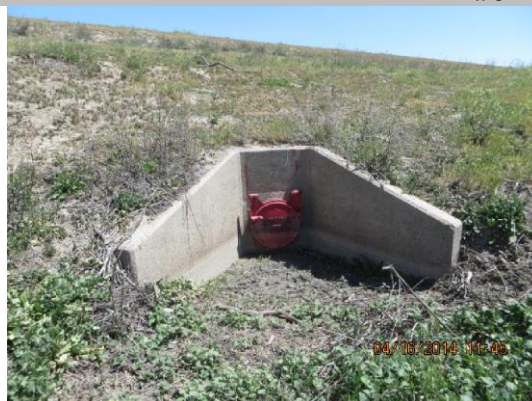
Photo 2 of 2 : UCIP_FA_2016_39880_61143.jpg

LM Start	4.02	Rating **	M	Issue No.	1336 (cont)
LM End	4.02	Issue Type +	En	Location *	WS
Category	Supplemental			GPS Latitude/Longitude	
				Start	End
Item	DWR UCIP Field Study			37.248432 °	37.248432 °
				-120.764066 °	-120.764066 °
DWR ID					
Comment Code					
Inspector Comment					
FS_ID:39880 DS_ID:19769 EP_NO: N/A Repair Type: Non-Urgent Crossing Status: Found UCIP Comments: Sediment buildup in pipe visible from landward side--recommend contacting owner to clear pipe. FIELD_STRUCT_DESC: 24-inch C.M. stormdrain pipe through the levee, 16.0 feet below the crown. Flap gate on the waterward end. Concrete "U" headwalls on both ends. (USACE-1967). This entry matches the Drainage or Irrigation Structure referenced in O&M manual (HLM 4.02). FS Date: 4/16/2014

Pipe, headwall, and flapgate on WS toe.

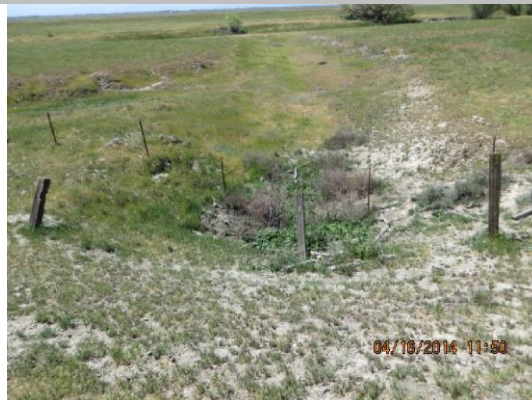
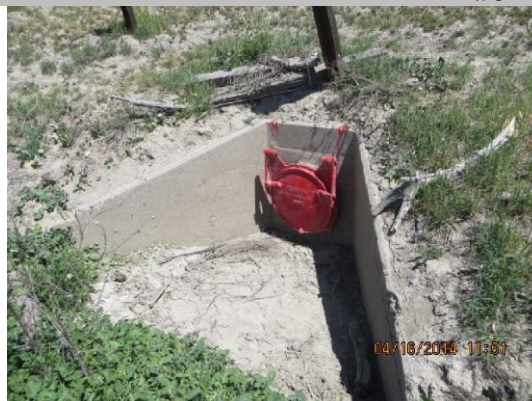
LM Start	4.27	Rating **	M	Issue No.	1329
LM End	4.27	Issue Type +	En	Location *	WS
Category	Supplemental			GPS Latitude/Longitude	
				Start	End
Item	DWR UCIP Field Study			37.246008 °	37.246008 °
				-120.760706 °	-120.760706 °
DWR ID					
Comment Code					
Inspector Comment					
FS_ID:39588 DS_ID:19770 EP_NO: N/A Repair Type: Non-Urgent Crossing Status: Found UCIP Comments: Sediment buildup in pipe visible from landward side--recommend contacting owner to clear pipe. FIELD_STRUCT_DESC: 24-inch C.M. stormdrain pipe through the levee, 11.6-feet below the crown. Flap gate on the waterward end. Concrete head wall on the landward end. Concrete "U" headwall on the waterward end. (USACE-1967). This entry matches the Drainage or Irrigation Structure referenced in O&M manual (HLM 4.27). FS Date: 4/16/2014

Pipe, headwall, and flapgate on WS toe.

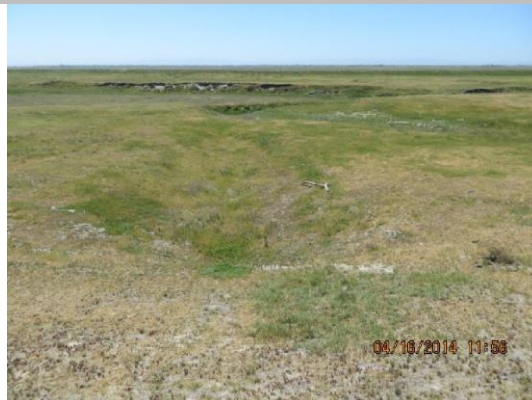
LM Start	4.55	Rating **	M	Issue No.	1330
LM End	4.55	Issue Type +	En	Location *	WS
Category	Supplemental			GPS Latitude/Longitude	
				Start	End
Item	DWR UCIP Field Study			37.243668 °	37.243668 °
				-120.756812 °	-120.756812 °
DWR ID					
Comment Code					
Inspector Comment					
FS_ID:39589 DS_ID:19771 EP_NO: N/A Repair Type: Non-Urgent Crossing Status: Found UCIP Comments: Sediment buildup in pipe visible from landward side--recommend contacting owner to clear pipe. FIELD_STRUCT_DESC: 24-inch C.M. stormdrain pipe through the levee, 12.0-feet below the crown. Flap gate on the waterward end. Concrete headwall on the landward end. Concrete "U" headwall on the waterward end. (USACE-1967). This entry matches the Drainage or Irrigation Structure referenced in O&M manual (HLM 4.54). FS Date: 4/16/2014 8:16:00 AM

Pipe, flapgate, and headwall on WS toe.
