**Flood Control Project Maintenance
Levee Inspections**

Fall 2016 Levee Maintenance Deficiency Summary Report

San Joaquin River Basin

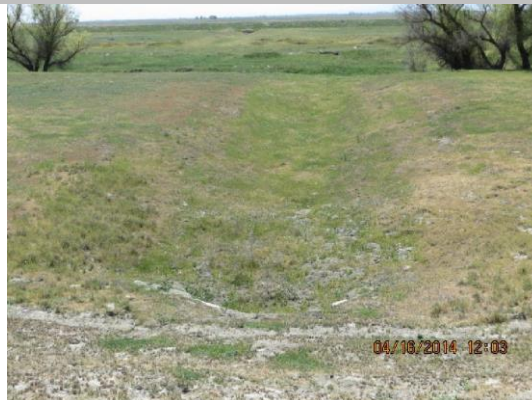
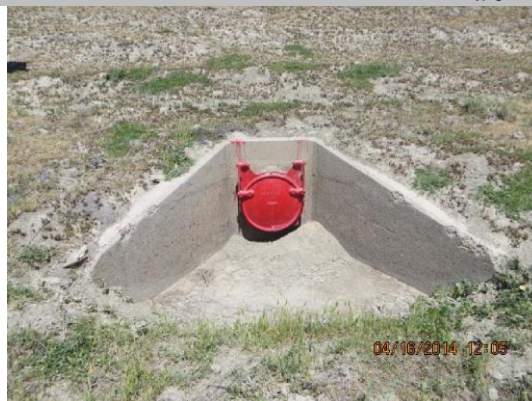
LM Start	4.89	Rating **	M	Issue No.	1331
LM End	4.89	Issue Type +	En	Location *	WS
Category	Supplemental			GPS Latitude/Longitude	
				Start	End
Item	DWR UCIP Field Study			37.240978 °	37.240978 °
				-120.751613 °	-120.751613 °
DWR ID					
Comment Code					
Inspector Comment					
FS_ID:39590 DS_ID:19772 EP_NO: N/A Repair Type: Non-Urgent Crossing Status: Found UCIP Comments: Heavy sediment buildup in pipe visible from landward side--recommend contacting owner to clear pipe. FIELD_STRUCT_DESC: 24-inch C.M. stormdrain pipe through the levee, 12.3-feet below the crown. Flap gate on the waterward end. Concrete headwall on the landward end. Concrete "U" headwall on the waterward end. (USACE-1967). This entry matches the Drainage or Irrigation Structure referenced in O&M manual (HLM 4.89). FS Date: 4/16/2014

Headwall, flapgate, and pipe on WS toe.

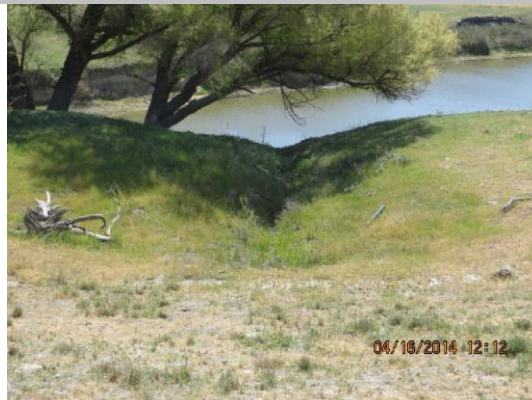
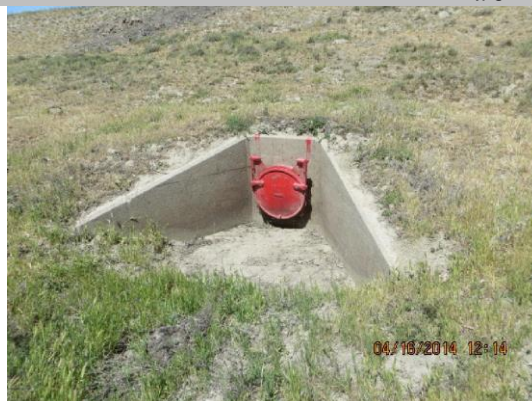
LM Start	5.15	Rating **	M	Issue No.	1332
LM End	5.15	Issue Type +	En	Location *	WS
Category	Supplemental			GPS Latitude/Longitude	
				Start	End
Item	DWR UCIP Field Study			37.240607 °	37.240607 °
				-120.746916 °	-120.746916 °
DWR ID					
Comment Code					
Inspector Comment					
FS_ID:39591 DS_ID:19773 EP_NO: N/A Repair Type: Non-Urgent Crossing Status: Found UCIP Comments: Heavy sediment buildup in pipe visible from landward side--recommend contacting owner to clear pipe. FIELD_STRUCT_DESC: 24-inch C.M. stormdrain pipe through the levee, 12.2-feet below the crown. Flap gate on the waterward end. Concrete headwall on the landward end. Concrete "U" headwall on the waterward end. (USACE-1967). This entry matches the Drainage or Irrigation Structure referenced in O&M manual (HLM 5.15). FS Date: 4/16/2014

Headwall, flapgate, and pipe on WS toe.

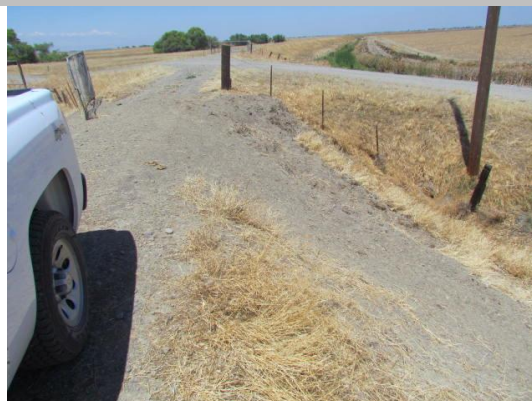
Photo 1 of 2 : FA_2016_NA0010_123_1309_20161007_00015.jpg

LM Start	6.59	Rating **	M	Issue No.	1309
LM End	6.59	Issue Type +	Ma	Location *	LS
Category	Earthen Levee			GPS Latitude/Longitude	
				Start	End
Item	Slope Stability			37.229682 °	37.229682 °
				-120.726305 °	-120.726305 °
DWR ID	DWR_NA0010_05_s_ 2015_1309				
Comment Code					
S2 : Repair the levee slope damaged by foot traffic and prevent access where possible.					
Inspector Comment					
Landward slope damage caused by animal foot traffic.

Looking north at damaged landward slope.

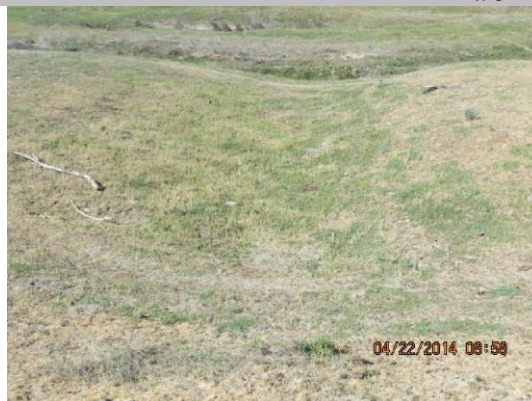
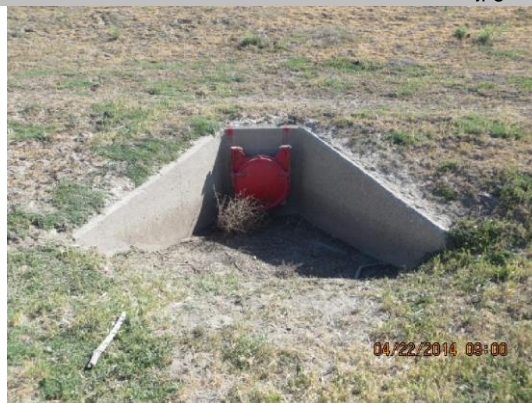
LM Start	7.36	Rating **	M	Issue No.	1348
LM End	7.36	Issue Type +	En	Location *	LS
Category	Supplemental			GPS Latitude/Longitude	
				Start	End
Item	DWR UCIP Field Study			37.224560 °	37.224560 °
				-120.714057 °	-120.714057 °
DWR ID					
Comment Code					
Inspector Comment					
FS_ID:39592 DS_ID:19761 EP_NO: N/A Repair Type: Non-Urgent Crossing Status: Found UCIP Comments: Sediment buildup in pipe visible from landward side--recommend contacting owner to clear pipe. FIELD_STRUCT_DESC: 24-inch C.M. stormdrain pipe through the levee, 12.0-feet below the crown. Flap gate on the waterward end. Concrete headwall on the landward end. Concrete "U" headwall on the waterward end. (USACE-1967). This entry matches the Drainage or Irrigation Structure referenced in O&M manual (HLM 7.36). FS Date: 4/22/2014

Headwall, flapgate, and pipe on WS toe.

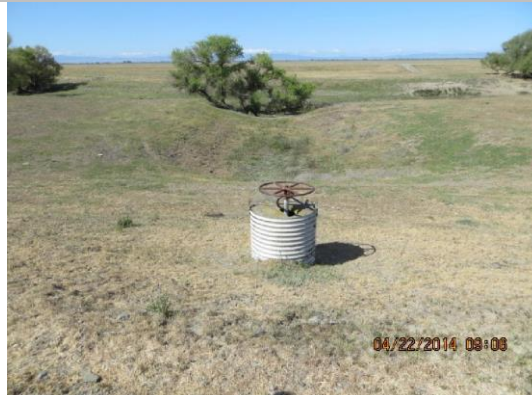
Photo 2 of 2 : UCIP_FA_2016_34170_62115.jpg

Slide gate in CMP riser on WS slope. No outlet or pipe found on WS toe.

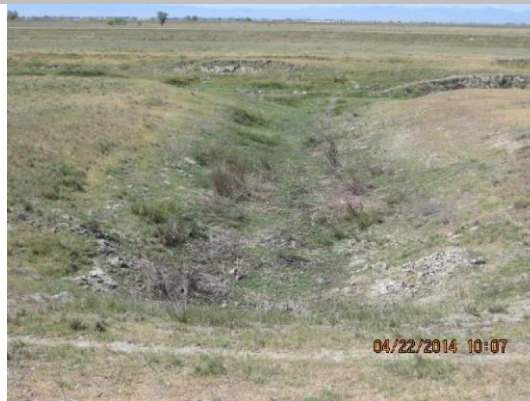
Photo 1 of 2 : UCIP_FA_2016_34265_62182.jpg

LM Start	8.46	Rating **	M	Issue No.	1316	
LM End	8.46	Issue Type +	En	Location *	LS	
Category	Supplemental			GPS Latitude/Longitude		
				Start	End	
Item	DWR UCIP Field Study			37.209606 °	37.209606 °	
				-120.702069 °	-120.702069 °	
DWR ID						
Comment Code						
Inspector Comment						
FS_ID:34265						
DS_ID:19763						
EP_NO: N/A						
Repair Type: Non-Urgent						
Crossing Status: Found						
UCIP Comments: Pipe filled with silt on LS toe and should be cleared.						
FIELD_STRUCT_DESC: 24-inch CM stormdrain pipe through the levee,						
16.0-feet below the crown. Flap gate on the waterward end. Concrete						
headwall on the landward end. Concrete "U" headwalls on the						
waterward end. (USACE-1967). This entry matches the Drainage or						
Irrigation Structure referenced in O&M manual (HLM 8.44).						
FS Date: 4/22/2014

Headwall, flapgate, and pipe on WS toe

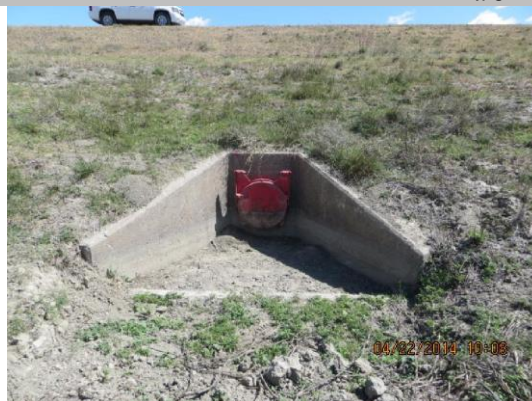
Photo 2 of 2 : UCIP_FA_2016_34265_62183.jpg

LM Start	8.46	Rating **	M	Issue No.	1316 (cont)	
LM End	8.46	Issue Type +	En	Location *	LS	
Category	Supplemental			GPS Latitude/Longitude		
				Start	End	
Item	DWR UCIP Field Study			37.209606 °	37.209606 °	
				-120.702069 °	-120.702069 °	
DWR ID						
Comment Code						
Inspector Comment						
FS_ID:34265						
DS_ID:19763						
EP_NO: N/A						
Repair Type: Non-Urgent						
Crossing Status: Found						
UCIP Comments: Pipe filled with silt on LS toe and should be cleared.						
FIELD_STRUCT_DESC: 24-inch CM stormdrain pipe through the levee,						
16.0-feet below the crown. Flap gate on the waterward end. Concrete						
headwall on the landward end. Concrete "U" headwalls on the						
waterward end. (USACE-1967). This entry matches the Drainage or						
Irrigation Structure referenced in O&M manual (HLM 8.44).						
FS Date: 4/22/2014

Headwall, flapgate, and pipe on WS toe

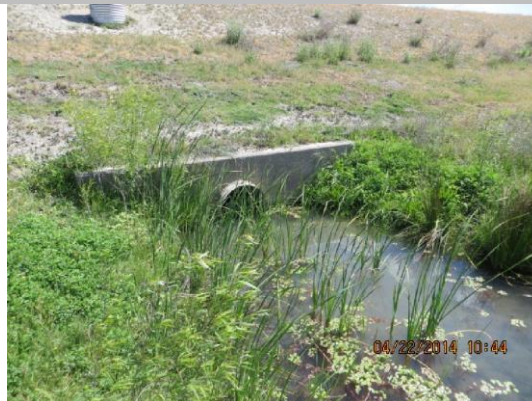
Photo 2 of 2 : UCIP_FA_2016_34273_62202.jpg

Concrete headwall and pipe on WS toe.

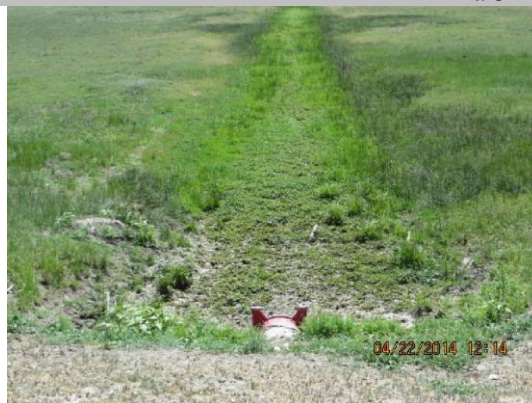
Photo 1 of 2 : UCIP_FA_2016_39593_62240.jpg

LM Start	12.89	Rating **	M	Issue No.	1349
LM End	12.89	Issue Type +	En	Location *	LS
Category	Supplemental			GPS Latitude/Longitude	
				Start	End
Item	DWR UCIP Field Study			37.175816 °	37.175816 °
				-120.640865 °	-120.640865 °
DWR ID					
Comment Code					
Inspector Comment					
FS_ID:39593 DS_ID:19707 EP_NO: N/A Repair Type: Non-Urgent Crossing Status: Found UCIP Comments: Sediment buildup in pipe visible from landward side--recommend contacting owner to clear pipe. FIELD_STRUCT_DESC: 24-inch CM stormdrain pipe through the levee, 10.2-feet below the crown. Flap gate on the waterward end. Concrete headwalls on the landward end with flashboards. Concrete saddle and apron on the waterward end with a flapgate. Metal screen at LS toe inlet (USACE-1967). This entry matches the Drainage or Irrigation Structure referenced in O&M manual (HLM 12.87). FS Date: 4/22/2014

Headwall, flapgate, and pipe on WS toe.

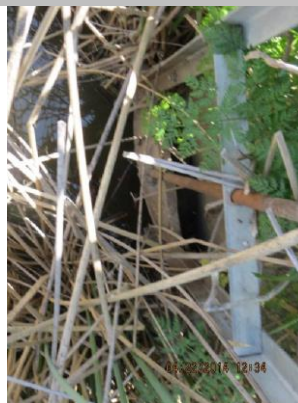
Photo 1 of 2 : UCIP_FA_2016_34824_62624.jpg

LM Start	13.72	Rating **	M	Issue No.	1324
LM End	13.72	Issue Type +	En	Location *	LS
Category	Supplemental			GPS Latitude/Longitude	
				Start	End
Item	DWR UCIP Field Study			37.168202 °	37.168202 °
				-120.629886 °	-120.629886 °
DWR ID					
Comment Code					
Inspector Comment					
FS_ID:34824 DS_ID:19709 EP_NO: N/A Repair Type: Non-Urgent Crossing Status: Found UCIP Comments: Pipe not visible and may need to have silt removed from outlet on WS toe. FIELD_STRUCT_DESC: 24-inch C.M. stormdrain pipe through the levee, 16-feet below the crown. Flap gate on the waterward end. Slidegate on concrete headwall at LS toe. Concrete saddle and apron on the waterward end. (USACE-1967). This entry matches the Drainage or Irrigation Structure referenced in O&M manual (HLM 13.72). FS Date: 4/22/2014

Slide gate at concrete headwall on LS toe.

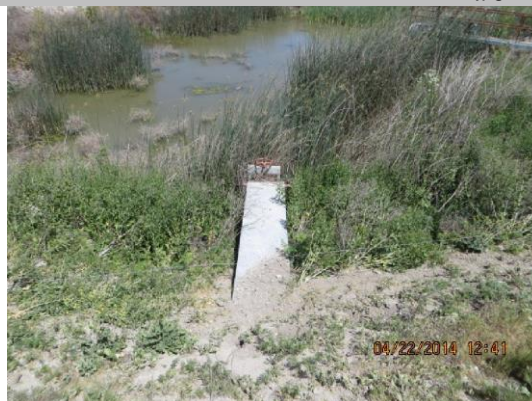
Photo 2 of 2 : UCIP_FA_2016_34824_62623.jpg

LM Start	13.72	Rating **	M	Issue No.	1324 (cont)
LM End	13.72	Issue Type +	En	Location *	LS
Category	Supplemental			GPS Latitude/Longitude	
				Start	End
Item	DWR UCIP Field Study			37.168202 °	37.168202 °
				-120.629886 °	-120.629886 °
DWR ID					
Comment Code					
Inspector Comment					
FS_ID:34824 DS_ID:19709 EP_NO: N/A Repair Type: Non-Urgent Crossing Status: Found UCIP Comments: Pipe not visible and may need to have silt removed from outlet on WS toe. FIELD_STRUCT_DESC: 24-inch C.M. stormdrain pipe through the levee, 16-feet below the crown. Flap gate on the waterward end. Slidegate on concrete headwall at LS toe. Concrete saddle and apron on the waterward end. (USACE-1967). This entry matches the Drainage or Irrigation Structure referenced in O&M manual (HLM 13.72). FS Date: 4/22/2014

Walkway to gatevalve on LS shoulder.

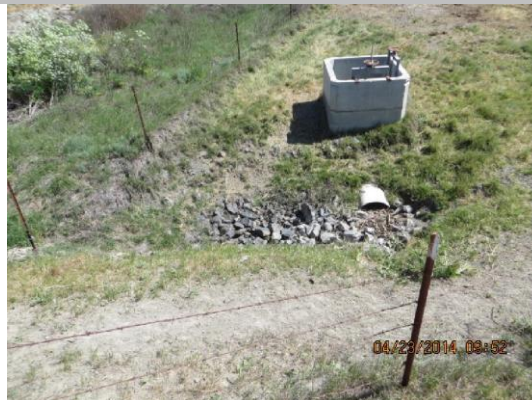
Photo 1 of 2 : UCIP_FA_2016_34664_62454.jpg

LM Start	15.11	Rating **	M	Issue No.	1319
LM End	15.11	Issue Type +	En	Location *	LS
Category	Supplemental			GPS Latitude/Longitude	
				Start	End
Item	DWR UCIP Field Study			37.156805 °	37.156805 °
				-120.609513 °	-120.609513 °
DWR ID					
Comment Code					
Inspector Comment					
FS_ID:34664 DS_ID:19712 EP_NO: N/A Repair Type: Non-Urgent Crossing Status: Found UCIP Comments: Minor erosion at headwall on WS toe. FIELD_STRUCT_DESC: 36-inch C.M. stormdrain pipe through the levee, 11.9 feet below the crown. Flap gate on the waterward end. Concrete headwall on both ends. (USACE-1967). This entry matches the Drainage or Irrigation Structure referenced in O&M manual (HLM 15.09). FS Date: 4/23/2014

Headwall and inlet on LS toe.

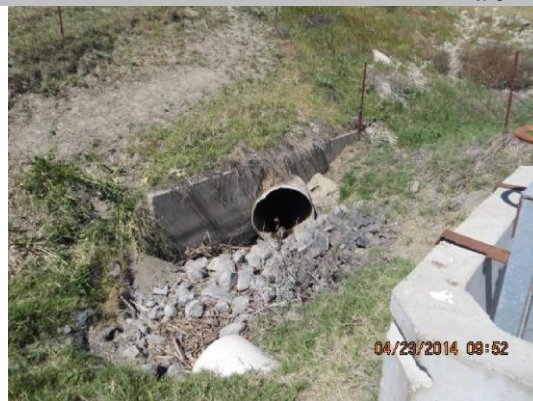
Photo 2 of 2 : UCIP_FA_2016_34664_62453.jpg

LM Start	15.11	Rating **	M	Issue No.	1319 (cont)	
LM End	15.11	Issue Type +	En	Location *	LS	
Category	Supplemental			GPS Latitude/Longitude		
				Start	End	
Item	DWR UCIP Field Study			37.156805 °	37.156805 °	
				-120.609513 °	-120.609513 °	
DWR ID						
Comment Code						
Inspector Comment						
FS_ID:34664						
DS_ID:19712						
EP_NO: N/A						
Repair Type: Non-Urgent						
Crossing Status: Found						
UCIP Comments: Minor erosion at headwall on WS toe.						
FIELD_STRUCT_DESC: 36-inch C.M. stormdrain pipe through the						
levee, 11.9 feet below the crown. Flap gate on the waterward end.						
Concrete headwall on both ends. (USACE-1967). This entry matches						
the Drainage or Irrigation Structure referenced in O&M manual (HLM						
15.09).						
FS Date: 4/23/2014

Headwall and inlet on LS toe.

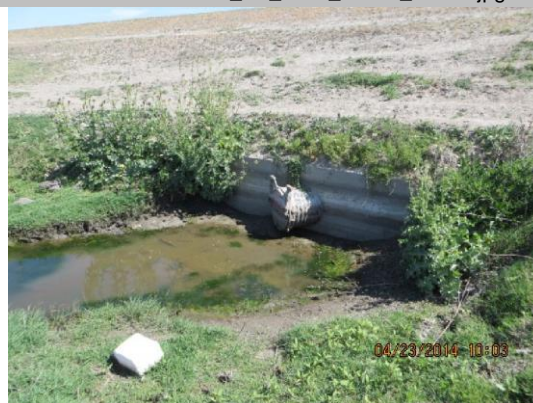
Photo 1 of 2 : UCIP_FA_2016_39595_62459.jpg

LM Start	15.76	Rating **	M	Issue No.	1350
LM End	15.76	Issue Type +	En	Location *	LS
Category	Supplemental			GPS Latitude/Longitude	
				Start	End
Item	DWR UCIP Field Study			37.150012 °	37.150012 °
				-120.601330 °	-120.601330 °
DWR ID					
Comment Code					
Inspector Comment					
FS_ID:39595 DS_ID:19713 EP_NO: N/A Repair Type: Non-Urgent Crossing Status: Found UCIP Comments: Sediment buildup in pipe visible from landward side-- recommend contacting owner to clear pipe. FIELD_STRUCT_DESC: 24-inch C.M. Stormdrain pipe through the levee, 11.0 feet below the crown. Flap gate on the waterward end. Concrete headwalls on both ends. (USACE-1967). This entry matches the Drainage or Irrigation Structure referenced in O&M manual (HLM 15.74). FS Date: 4/23/2014

Headwall, pipe, and flapgate on WS toe.

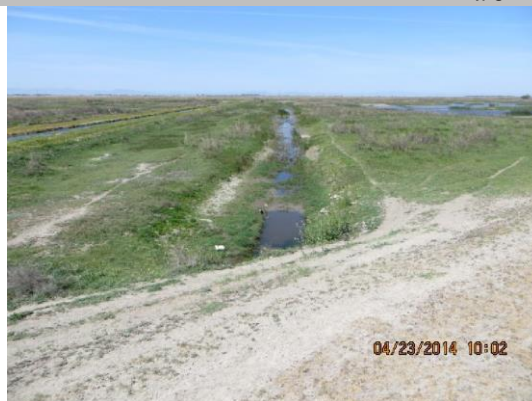
Photo 2 of 2 : UCIP_FA_2016_39595_62456.jpg

LM Start	15.76	Rating **	M	Issue No.	1350 (cont)	
LM End	15.76	Issue Type +	En	Location *	LS	
Category	Supplemental			GPS Latitude/Longitude		
				Start		End
Item	DWR UCIP Field Study			37.150012 °		37.150012 °
				-120.601330 °		-120.601330 °
DWR ID						
Comment Code						
Inspector Comment						
FS_ID:39595 DS_ID:19713 EP_NO: N/A Repair Type: Non-Urgent Crossing Status: Found UCIP Comments: Sediment buildup in pipe visible from landward side--recommend contacting owner to clear pipe. FIELD_STRUCT_DESC: 24-inch C.M. Stormdrain pipe through the levee, 11.0 feet below the crown. Flap gate on the waterward end. Concrete headwalls on both ends. (USACE-1967). This entry matches the Drainage or Irrigation Structure referenced in O&M manual (HLM 15.74). FS Date: 4/23/2014

Headwall, pipe, and flapgate on WS toe.

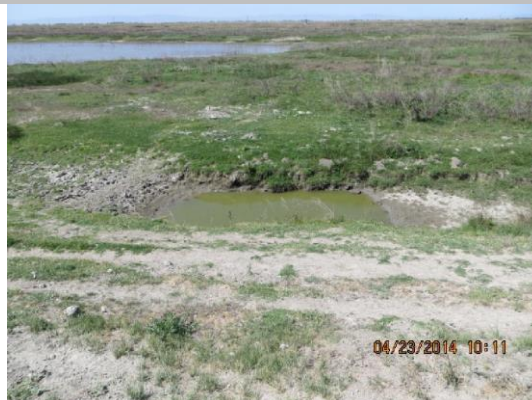
Photo 1 of 2 : UCIP_FA_2016_39596_62464.jpg

LM Start	15.81	Rating **	M	Issue No.	1351
LM End	15.81	Issue Type +	En	Location *	LS
Category	Supplemental			GPS Latitude/Longitude	
				Start	End
Item	DWR UCIP Field Study			37.149381 °	37.149381 °
				-120.600761 °	-120.600761 °
DWR ID					
Comment Code					
Inspector Comment					
FS_ID:39596 DS_ID:19715 EP_NO: N/A Repair Type: Non-Urgent Crossing Status: Found UCIP Comments: Excess vegetation at inlet on LS toe should be cleared. FIELD_STRUCT_DESC: 24-inch C.M. stormdrain pipe through the levee, 12-feet below the crown. Flap gate on the waterward end. Concrete head wall on the landward end. Concrete saddle and apron on the waterward end. (USACE-1967). This entry matches the Drainage or Irrigation Structure referenced in O&M manual (HLM 15.80). FS Date: 4/23/2014

Headwall, pipe, and flapgate on WS toe.

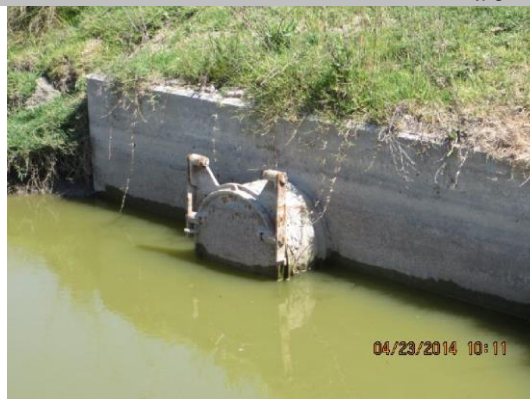
Photo 2 of 2 : UCIP_FA_2016_39596_62467.jpg

LM Start	15.81	Rating **	M	Issue No.	1351 (cont)
LM End	15.81	Issue Type +	En	Location *	LS
Category	Supplemental			GPS Latitude/Longitude	
				Start	End
Item	DWR UCIP Field Study			37.149381 °	37.149381 °
				-120.600761 °	-120.600761 °
DWR ID					
Comment Code					
Inspector Comment					
FS_ID:39596 DS_ID:19715 EP_NO: N/A Repair Type: Non-Urgent Crossing Status: Found UCIP Comments: Excess vegetation at inlet on LS toe should be cleared. FIELD_STRUCT_DESC: 24-inch C.M. stormdrain pipe through the levee, 12-feet below the crown. Flap gate on the waterward end. Concrete head wall on the landward end. Concrete saddle and apron on the waterward end. (USACE-1967). This entry matches the Drainage or Irrigation Structure referenced in O&M manual (HLM 15.80). FS Date: 4/23/2014

Headwall, pipe, and flapgate on WS toe.

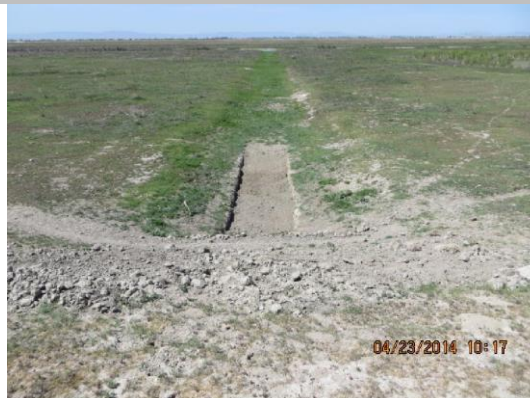
Photo 1 of 2 : UCIP_FA_2016_34725_62469.jpg

LM Start	16.68	Rating **	M	Issue No.	1321
LM End	16.68	Issue Type +	En	Location *	LS
Category	Supplemental			GPS Latitude/Longitude	
				Start	End
Item	DWR UCIP Field Study			37.138760 °	37.138760 °
				-120.592393 °	-120.592393 °
DWR ID					
Comment Code					
Inspector Comment					
FS_ID:34725 DS_ID:19716 EP_NO: N/A Repair Type: Non-Urgent Crossing Status: Found UCIP Comments: Pipe heavily silted on LS toe. FIELD_STRUCT_DESC: 24-inch C.M. stormdrain pipe through the levee, 10.5-feet below the crown. Flap gate on the waterward end. Concrete headwall on both ends. (USACE-1967). This entry matches the Drainage or Irrigation Structure referenced in O&M manual (HLM 16.67). FS Date: 4/23/2014

Headwall, flapgate, and pipe visible on WS toe.

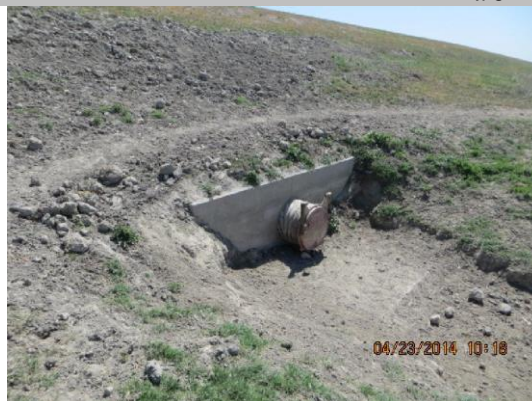
Photo 2 of 2 : UCIP_FA_2016_34725_62471.jpg

LM Start	16.68	Rating **	M	Issue No.	1321 (cont)
LM End	16.68	Issue Type +	En	Location *	LS
Category	Supplemental			GPS Latitude/Longitude	
				Start	End
Item	DWR UCIP Field Study			37.138760 °	37.138760 °
				-120.592393 °	-120.592393 °
DWR ID					
Comment Code					
Inspector Comment					
FS_ID:34725					
DS_ID:19716					
EP_NO: N/A					
Repair Type: Non-Urgent					
Crossing Status: Found					
UCIP Comments: Pipe heavily silted on LS toe.					
FIELD_STRUCT_DESC: 24-inch C.M. stormdrain pipe through the					
levee, 10.5-feet below the crown. Flap gate on the waterward end.					
Concrete headwall on both ends. (USACE-1967). This entry matches					
the Drainage or Irrigation Structure referenced in O&M manual (HLM					
16.67).					
FS Date: 4/23/2014

Headwall, flapgate, and pipe visible on WS toe.

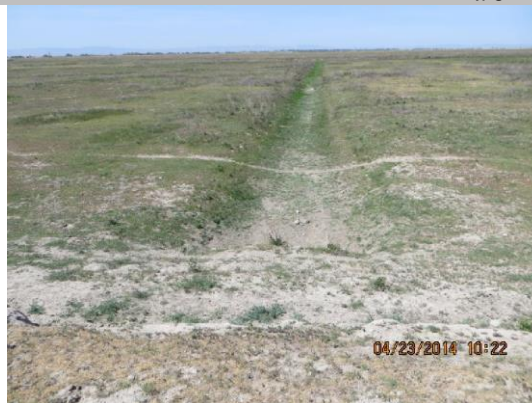
Photo 1 of 2 : UCIP_FA_2016_39597_62481.jpg

LM Start	17.22	Rating **	M	Issue No.	1352
LM End	17.22	Issue Type +	En	Location *	LS
Category	Supplemental			GPS Latitude/Longitude	
				Start	End
Item	DWR UCIP Field Study			37.132211 °	37.132211 °
				-120.587106 °	-120.587106 °
DWR ID					
Comment Code					
Inspector Comment					
FS_ID:39597					
DS_ID:19717					
EP_NO: N/A					
Repair Type: Non-Urgent					
Crossing Status: Found					
UCIP Comments: Sediment buildup in pipe visible from landward side--recommend contacting owner to clear pipe.					
FIELD_STRUCT_DESC: 24-inch CM stormdrain pipe through the levee, 12-feet below the crown. Flap gate on the waterward end. Concrete headwall on both ends. (USACE-1967). This entry matches the Drainage or Irrigation Structure referenced in O&M manual (HLM 17.20).					
FS Date: 4/23/2014

Headwall, flapgate, and pipe visible on WS toe.

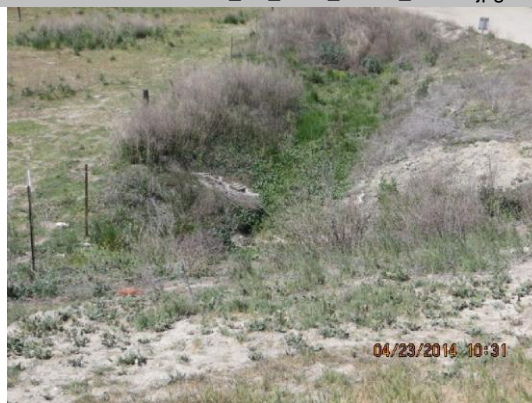
Photo 1 of 2 : UCIP_FA_2016_39599_62485.jpg

LM Start	17.54	Rating **	M	Issue No.	1353
LM End	17.54	Issue Type +	En	Location *	LS
Category	Supplemental			GPS Latitude/Longitude	
				Start	End
Item	DWR UCIP Field Study			37.127843 °	37.127843 °
				-120.585245 °	-120.585245 °
DWR ID					
Comment Code					
Inspector Comment					
FS_ID:39599					
DS_ID:19743					
EP_NO: N/A					
Repair Type: Non-Urgent					
Crossing Status: Found					
UCIP Comments: Sediment buildup in pipe visible from landward side--recommend contacting owner to clear pipe.					
FIELD_STRUCT_DESC: 24-inch CM stormdrain pipe through the levee, 9.8-feet below the crown. Flap gate on the waterward end. Concrete headwall on both ends. (USACE-1967). This entry matches the Drainage or Irrigation Structure referenced in O&M manual (HLM 17.52).					
FS Date: 4/23/2014

Headwall, pipe, and flapgate visible on WS toe.

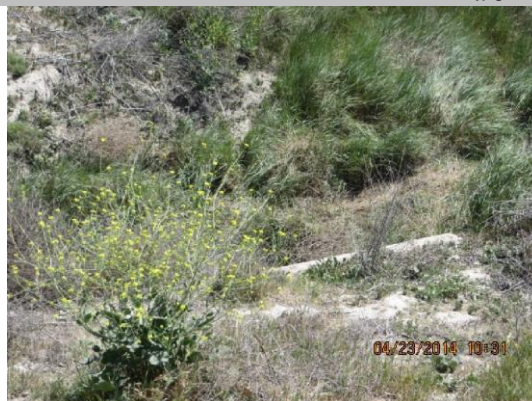
Photo 2 of 2 : UCIP_FA_2016_39599_62486.jpg

LM Start	17.54	Rating **	M	Issue No.	1353 (cont)
LM End	17.54	Issue Type +	En	Location *	LS
Category	Supplemental			GPS Latitude/Longitude	
				Start	End
Item	DWR UCIP Field Study			37.127843 °	37.127843 °
				-120.585245 °	-120.585245 °
DWR ID					
Comment Code					
Inspector Comment					
FS_ID:39599					
DS_ID:19743					
EP_NO: N/A					
Repair Type: Non-Urgent					
Crossing Status: Found					
UCIP Comments: Sediment buildup in pipe visible from landward side--recommend contacting owner to clear pipe.					
FIELD_STRUCT_DESC: 24-inch CM stormdrain pipe through the levee, 9.8-feet below the crown. Flap gate on the waterward end. Concrete headwall on both ends. (USACE-1967). This entry matches the Drainage or Irrigation Structure referenced in O&M manual (HLM 17.52).					
FS Date: 4/23/2014

Pipe and headwall visible on LS toe.

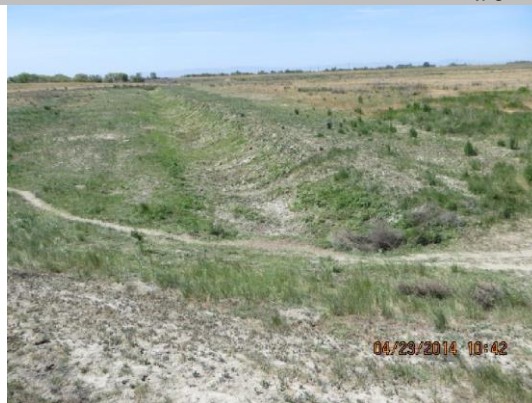
Photo 1 of 2 : UCIP_FA_2016_34747_62494.jpg

LM Start	18.09	Rating **	M	Issue No.	1322
LM End	18.09	Issue Type +	En	Location *	LS
Category	Supplemental			GPS Latitude/Longitude	
				Start	End
Item	DWR UCIP Field Study			37.120309 °	37.120309 °
				-120.582041 °	-120.582041 °
DWR ID					
Comment Code					
Inspector Comment					
FS_ID:34747					
DS_ID:19745					
EP_NO: N/A					
Repair Type: Non-Urgent					
Crossing Status: Found					
UCIP Comments: Animal burrows in levee on both slopes.					
FIELD_STRUCT_DESC: 24-inch C.M. stormdrain pipe through the					
levee, 12.4-feet below the crown. Flap gate on the waterward end.					
Concrete headwall on both ends. (USACE-1967). This entry matches					
the Drainage or Irrigation Structure referenced in O&M manual (HLM					
18.07).					
FS Date: 4/23/2014

Headwall, pipe, and flapgate on WS toe.

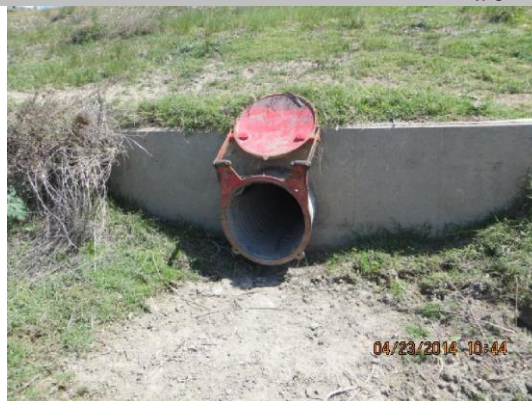
Photo 2 of 2 : UCIP_FA_2016_34747_62495.jpg

LM Start	18.09	Rating **	M	Issue No.	1322 (cont)
LM End	18.09	Issue Type +	En	Location *	LS
Category	Supplemental			GPS Latitude/Longitude	
				Start	End
Item	DWR UCIP Field Study			37.120309 °	37.120309 °
				-120.582041 °	-120.582041 °
DWR ID					
Comment Code					
Inspector Comment					
FS_ID:34747					
DS_ID:19745					
EP_NO: N/A					
Repair Type: Non-Urgent					
Crossing Status: Found					
UCIP Comments: Animal burrows in levee on both slopes.					
FIELD_STRUCT_DESC: 24-inch C.M. stormdrain pipe through the					
levee, 12.4-feet below the crown. Flap gate on the waterward end.					
Concrete headwall on both ends. (USACE-1967). This entry matches					
the Drainage or Irrigation Structure referenced in O&M manual (HLM					
18.07).					
FS Date: 4/23/2014

Headwall, pipe, and flapgate on WS toe.

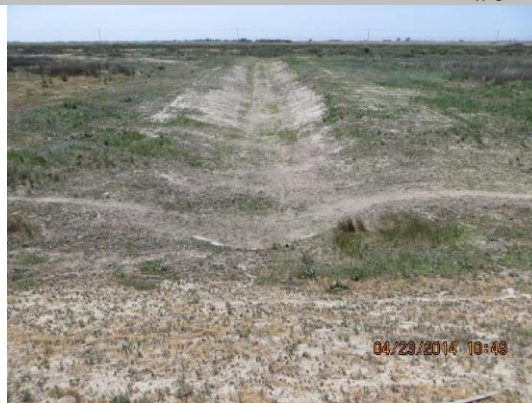
Photo 1 of 2 : UCIP_FA_2016_39600_62499.jpg

Comment Code					
Inspector Comment					
FS_ID:39600 DS_ID:19746 EP_NO: N/A Repair Type: Non-Urgent Crossing Status: Found UCIP Comments: Dense vegetation limits the inspector's visibility to identify signs of pipe failure (leaks) along the landward slope. Recommend removing vegetation along pipe alignment to conduct proper inspection of structure. FIELD_STRUCT_DESC: 24-inch C.M. stormdrain pipe through the levee, 10.0-feet below the crown. Flap gate on the waterward end. Concrete headwall on the landward end. Concrete "U" headwall on the waterward end. (USACE-1967). This entry matches the Drainage or Irrigation Structure referenced in O&M manual (HLM 18.68). FS Date: 4/23/2014

Headwall, pipe and flapgate visible on WS toe.

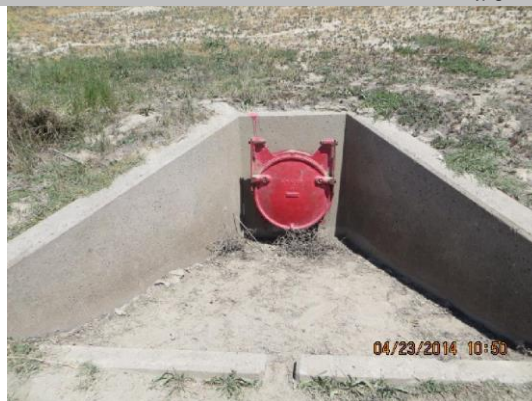
Photo 2 of 2 : UCIP_FA_2016_39600_62498.jpg

Item	DWR UCIP Field Study			37.115472 °	37.115472 °	
				-120.573628 °	-120.573628 °	
DWR ID						
Comment Code						
Inspector Comment						
FS_ID:39600						
DS_ID:19746						
EP_NO: N/A						
Repair Type: Non-Urgent						
Crossing Status: Found						
UCIP Comments: Dense vegetation limits the inspector's visibility to identify signs of pipe failure (leaks) along the landward slope.						
Recommend removing vegetation along pipe alignment to conduct proper inspection of structure.						
FIELD_STRUCT_DESC: 24-inch C.M. stormdrain pipe through the levee, 10.0-feet below the crown. Flap gate on the waterward end. Concrete headwall on the landward end. Concrete "U" headwall on the waterward end. (USACE-1967). This entry matches the Drainage or Irrigation Structure referenced in O&M manual (HLM 18.68).						
FS Date: 4/23/2014

Headwall, pipe and flapgate visible on WS toe.

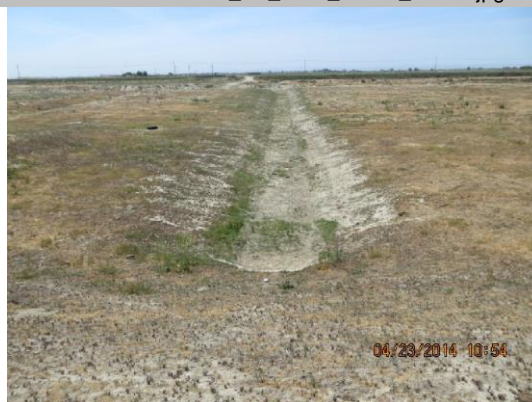
Photo 1 of 2 : UCIP_FA_2016_39601_62504.jpg

LM Start	19.15	Rating **	M	Issue No.	1355
LM End	19.15	Issue Type +	En	Location *	LS
Category	Supplemental			GPS Latitude/Longitude	
				Start	End
Item	DWR UCIP Field Study			37.115466 °	37.115466 °
				-120.565467 °	-120.565467 °
DWR ID					
Comment Code					
Inspector Comment					
FS_ID:39601 DS_ID:19747 EP_NO: N/A Repair Type: Non-Urgent Crossing Status: Found UCIP Comments: Sediment buildup in pipe visible from landward side--recommend contacting owner to clear pipe. FIELD_STRUCT_DESC: 24-inch C.M. stormdrain pipe through the levee, 10.0-feet below the crown. Flap gate on the waterward end. Concrete headwall on the landward end. Concrete "U" headwall on the waterward end. (USACE-1967). This entry matches the Drainage or Irrigation Structure referenced in O&M manual (HLM 19.11). FS Date: 4/23/2014

Headwall, pipe, and flapgate visible on WS toe.

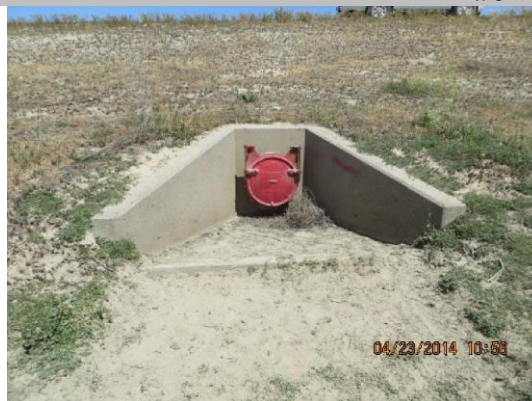
Photo 2 of 2 : UCIP_FA_2016_39601_62506.jpg

LM Start	19.15	Rating **	M	Issue No.	1355 (cont)
LM End	19.15	Issue Type +	En	Location *	LS
Category	Supplemental			GPS Latitude/Longitude	
				Start	End
Item	DWR UCIP Field Study			37.115466 °	37.115466 °
				-120.565467 °	-120.565467 °
DWR ID					
Comment Code					
Inspector Comment					
FS_ID:39601 DS_ID:19747 EP_NO: N/A Repair Type: Non-Urgent Crossing Status: Found UCIP Comments: Sediment buildup in pipe visible from landward side--recommend contacting owner to clear pipe. FIELD_STRUCT_DESC: 24-inch C.M. stormdrain pipe through the levee, 10.0-feet below the crown. Flap gate on the waterward end. Concrete headwall on the landward end. Concrete "U" headwall on the waterward end. (USACE-1967). This entry matches the Drainage or Irrigation Structure referenced in O&M manual (HLM 19.11). FS Date: 4/23/2014

Headwall, pipe, and flapgate visible on WS toe.

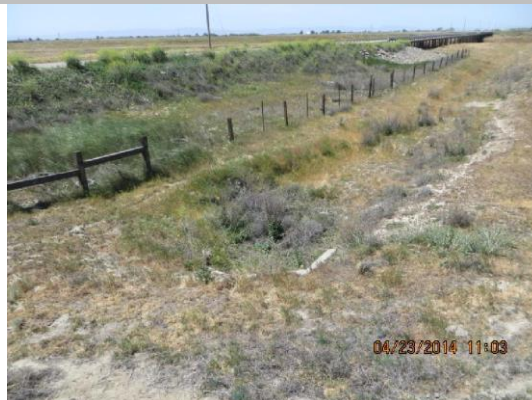
Photo 1 of 2 : UCIP_FA_2016_39602_62514.jpg

LM Start	19.48	Rating **	M	Issue No.	1356
LM End	19.48	Issue Type +	En	Location *	LS
Category	Supplemental			GPS Latitude/Longitude	
				Start	End
Item	DWR UCIP Field Study			37.113542 °	37.113542 °
				-120.560389 °	-120.560389 °
DWR ID					
Comment Code					
Inspector Comment					
FS_ID:39602 DS_ID:19777 EP_NO: N/A Repair Type: Non-Urgent Crossing Status: Found UCIP Comments: Sediment buildup in pipe visible from landward side--recommend contacting owner to clear pipe. FIELD_STRUCT_DESC: 24-inch C.M. stormdrain pipe through the levee, 9.0-feet below the crown. Flap gate on the waterward end. Concrete headwall on the landward end. Concrete "U" headwall on the waterward end. (USACE-1967). This entry matches the Drainage or Irrigation Structure referenced in O&M manual (HLM 19.46). FS Date: 4/23/2014

Headwall, pipe, and flapgate visible on WS toe.

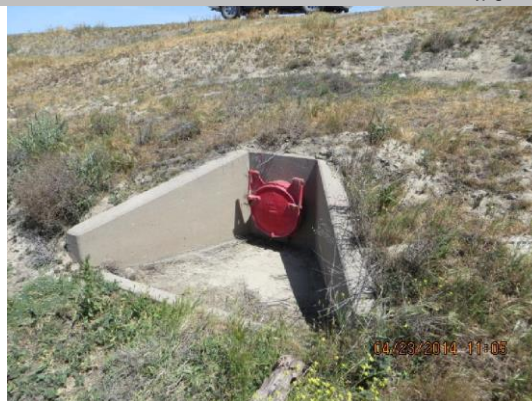
Photo 2 of 2 : UCIP_FA_2016_39602_62516.jpg

LM Start	19.48	Rating **	M	Issue No.	1356 (cont)
LM End	19.48	Issue Type +	En	Location *	LS
Category	Supplemental			GPS Latitude/Longitude	
				Start	End
Item	DWR UCIP Field Study			37.113542 °	37.113542 °
				-120.560389 °	-120.560389 °
DWR ID					
Comment Code					
Inspector Comment					
FS_ID:39602 DS_ID:19777 EP_NO: N/A Repair Type: Non-Urgent Crossing Status: Found UCIP Comments: Sediment buildup in pipe visible from landward side--recommend contacting owner to clear pipe. FIELD_STRUCT_DESC: 24-inch C.M. stormdrain pipe through the levee, 9.0-feet below the crown. Flap gate on the waterward end. Concrete headwall on the landward end. Concrete "U" headwall on the waterward end. (USACE-1967). This entry matches the Drainage or Irrigation Structure referenced in O&M manual (HLM 19.46). FS Date: 4/23/2014

Headwall, pipe, and flapgate visible on WS toe.

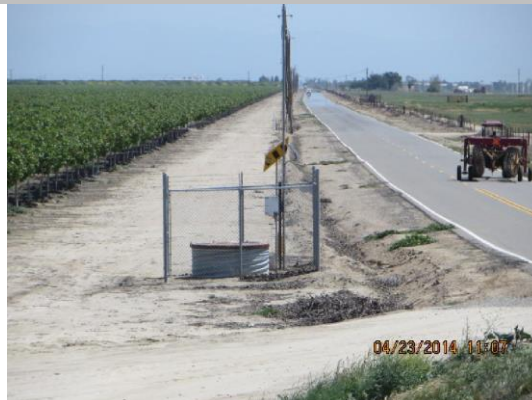
Photo 1 of 2 : UCIP_FA_2016_39345_71477.jpg

LM Start	19.51	Rating **	M	Issue No.	1333
LM End	19.51	Issue Type +	En	Location *	LS
Category	Supplemental			GPS Latitude/Longitude	
				Start	End
Item	DWR UCIP Field Study			37.113172 °	37.113172 °
				-120.560014 °	-120.560014 °
DWR ID					
Comment Code					
Inspector Comment					
FS_ID:39345 DS_ID:24868 EP_NO: N/A Repair Type: Non-Urgent Crossing Status: Indicator Found UCIP Comments: Markers closer to the levee may be necessary to properly mark pipe crossing location. FIELD_STRUCT_DESC: Gasline of unknown diameter at unknown depth below the crown. CMP riser and gasline marker off LS toe. FS Date: 4/22/2014

Gasline marker off LS toe.

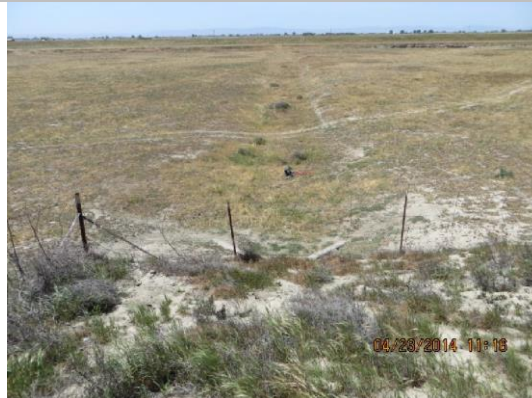
Photo 1 of 2 : UCIP_FA_2016_39603_62519.jpg

Comment Code					
Inspector Comment					
FS_ID:39603					
DS_ID:19778					
EP_NO: N/A					
Repair Type: Non-Urgent					
Crossing Status: Found					
UCIP Comments: Dense vegetation limits the inspector's visibility to identify signs of pipe failure (leaks) along the landward slope. Recommend removing vegetation along pipe alignment to conduct proper inspection of structure. Sediment buildup in pipe visible from landward side--recommend contacting owner to clear pipe.					
FIELD_STRUCT_DESC: 24-inch C.M. stormdrain pipe through the levee, 9.7 feet below the crown. Flap gate on the waterward end. Concrete headwall on the landward end. Concrete "U" headwall on the waterward end. (USACE-1967). This entry matches the Drainage or Irrigation Structure referenced in O&M manual (HLM 19.50).					
FS Date: 4/23/2014

Headwall, pipe, and flapgate visible on WS toe.

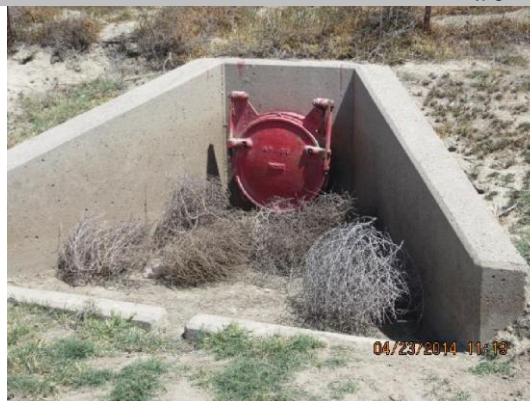
Photo 2 of 2 : UCIP_FA_2016_39603_62521.jpg

FS_ID:39603
DS_ID:19778
EP_NO: N/A
Repair Type: Non-Urgent
Crossing Status: Found
UCIP Comments: Dense vegetation limits the inspector's visibility to identify signs of pipe failure (leaks) along the landward slope. Recommend removing vegetation along pipe alignment to conduct proper inspection of structure. Sediment buildup in pipe visible from landward side--recommend contacting owner to clear pipe.
FIELD_STRUCT_DESC: 24-inch C.M. stormdrain pipe through the levee, 9.7 feet below the crown. Flap gate on the waterward end. Concrete headwall on the landward end. Concrete "U" headwall on the waterward end. (USACE-1967). This entry matches the Drainage or Irrigation Structure referenced in O&M manual (HLM 19.50).
FS Date: 4/23/2014

Headwall, pipe, and flapgate visible on WS toe.

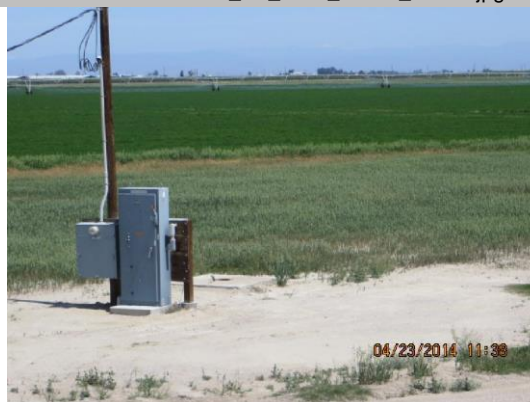
Photo 1 of 1 : UCIP_FA_2016_34759_62537.jpg

FS_ID:34759
DS_ID:19782
EP_NO: 13828
Repair Type: Non-Urgent
Crossing Status: Not Found
UCIP Comments:
FIELD_STRUCT_DESC: *DELETE* NOT INSTALLED THROUGH THE LEVEE. 24-inch steel irrigation pipe through the levee, 4.0 feet below the crown. Pump missing from pad on the landward side. Steel cutoff wall around pipe at center of levee. Siphon breaker on apex of pipe on landward shoulder. Pre-existing ditch runs from waterward toe to channel. Pipe extends from pump to the channel. Rock revetment on the cut slopes of the inlet channel. (Permit No. 13828-1988)
FS Date: 4/23/2014

Well head visible off LS toe.

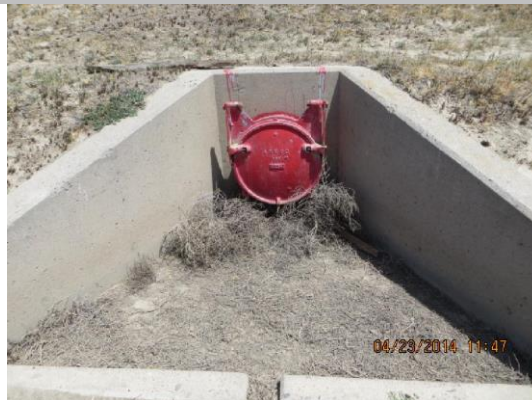
Photo 2 of 2 : UCIP_FA_2016_39605_62543.jpg

FS_ID:39605
DS_ID:19784
EP_NO: N/A
Repair Type: Non-Urgent
Crossing Status: Found
UCIP Comments: Dense vegetation limits the inspector's visibility to identify signs of pipe failure (leaks) along the landward slope. Recommend removing vegetation along pipe alignment to conduct proper inspection of structure.
FIELD_STRUCT_DESC: 24-inch C.M. pipe through the levee, 10.5 feet below the crown. Flap gate on the waterward end. Concrete headwall on the landward end. Concrete "U" headwall on the waterward end. (USACE-1967). This entry matches the Drainage or Irrigation Structure referenced in O&M manual (HLM 20.59).
FS Date: 4/23/2014

Headwall, pipe, and flapgate visible on WS toe.

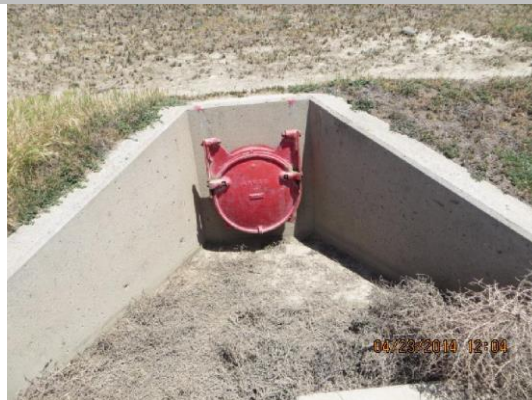
Photo 2 of 2 : UCIP_FA_2016_39606_62551.jpg

FS_ID:39606
DS_ID:19785
EP_NO: N/A
Repair Type: Non-Urgent
Crossing Status: Found
UCIP Comments: Dense vegetation limits the inspector's visibility to identify signs of pipe failure (leaks) along the landward slope. Recommend removing vegetation along pipe alignment to conduct proper inspection of structure.
FIELD_STRUCT_DESC: 24-inch C.M. stormdrain pipe through the levee, 11.8-feet below the crown. Flap gate on the waterward end. Concrete headwall on the landward end. Concrete "U" headwall on the waterward end. (USACE-1967). This entry matches the Drainage or Irrigation Structure referenced in O&M manual (HLM 21.08).
FS Date: 4/23/2014

Headwall, pipe, and flapgate visible on WS toe.

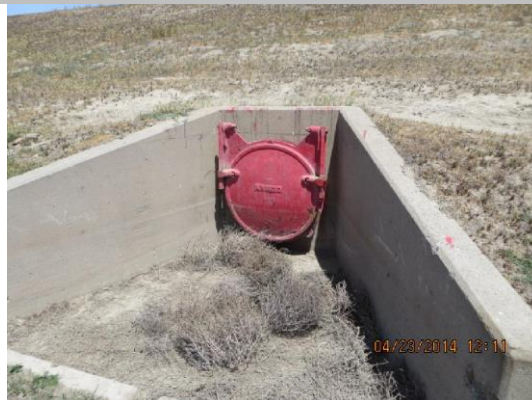
Photo 2 of 2 : UCIP_FA_2016_39614_62556.jpg

FS_ID:39614
DS_ID:19786
EP_NO: N/A
Repair Type: Non-Urgent
Crossing Status: Found
UCIP Comments: Dense vegetation limits the inspector's visibility to identify signs of pipe failure (leaks) along the landward slope. Recommend removing vegetation along pipe alignment to conduct proper inspection of structure.
FIELD_STRUCT_DESC: 36-inch C.M. stormdrain pipe through the levee, 12.7-feet below the crown. Flap gate on the waterward end. Concrete headwall on the landward end. Concrete "U" headwall on the waterward end. (USACE-1967). This entry matches the Drainage or Irrigation Structure referenced in O&M manual (HLM 21.42).
FS Date: 4/23/2014

Headwall, pipe, and flapgate visible on WS toe.

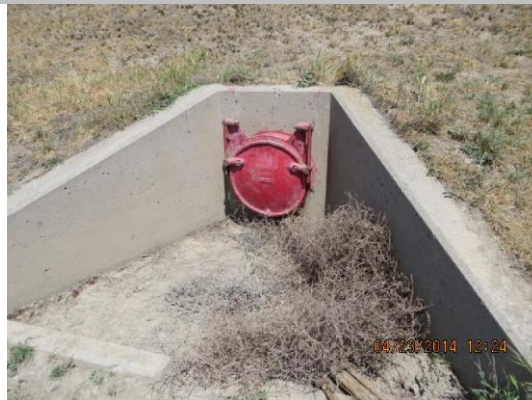
Photo 2 of 2 : UCIP_FA_2016_39883_62558.jpg

Comment Code					
Inspector Comment					
FS_ID:39883					
DS_ID:19787					
EP_NO: N/A					
Repair Type: Non-Urgent					
Crossing Status: Found					
UCIP Comments: Dense vegetation limits the inspector's visibility to					
identify signs of pipe failure (leaks) along the landward slope.					
Recommend removing vegetation along pipe alignment to conduct					
proper inspection of structure.					
FIELD_STRUCT_DESC: 24-inch C.M. stormdrain pipe through the					
levee, 12.4-feet below the crown. Flap gate on the waterward end.					
Concrete headwall on the landward end. Concrete "U" headwall on the					
waterward end. (USACE-1967). This entry matches the Drainage or					
Irrigation Structure referenced in O&M manual (HLM 21.81).					
FS Date: 4/23/2014

Headwall, pipe, and flapgate visible on WS toe.

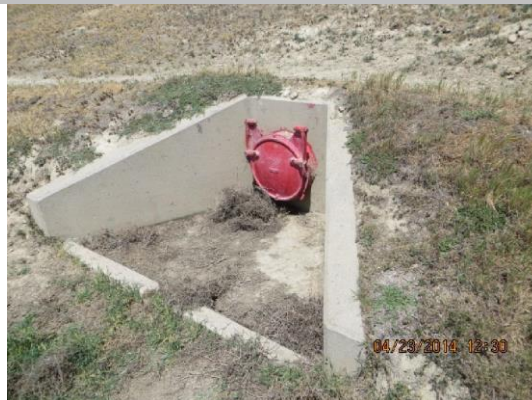
Photo 2 of 2 : UCIP_FA_2016_39610_62588.jpg

Comment Code						
Inspector Comment						
FS_ID:39610 DS_ID:19788 EP_NO: N/A Repair Type: Non-Urgent Crossing Status: Found UCIP Comments: Dense vegetation limits the inspector's visibility to identify signs of pipe failure (leaks) along the landward slope. Recommend removing vegetation along pipe alignment to conduct proper inspection of structure. FIELD_STRUCT_DESC: 24-inch C.M. stormdrain pipe through the levee, 10.7-feet below the crown. Flap gate on the waterward end. Concrete headwall on the landward end. Concrete "U" headwall on the waterward end. (USACE-1967). This entry matches the Drainage or Irrigation Structure referenced in O&M manual (HLM 21.85). FS Date: 4/23/2014

Headwall, pipe, and flapgate visible on WS toe.

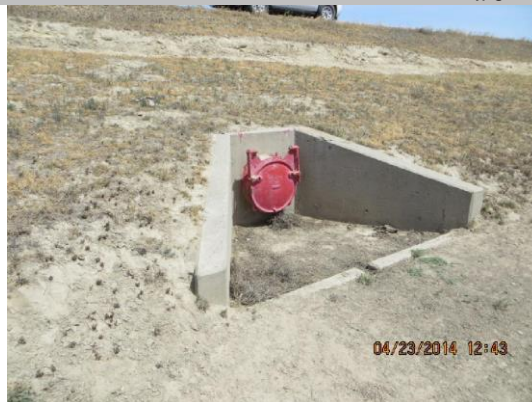
Photo 2 of 2 : UCIP_FA_2016_39611_62593.jpg

FS_ID:39611
DS_ID:19789
EP_NO: N/A
Repair Type: Non-Urgent
Crossing Status: Found
UCIP Comments: Dense vegetation limits the inspector's visibility to identify signs of pipe failure (leaks) along the landward slope. Recommend removing vegetation along pipe alignment to conduct proper inspection of structure. Sediment buildup in pipe visible from landward side--recommend contacting owner to clear pipe.
FIELD_STRUCT_DESC: 24-inch C.M. stormdrain pipe through the levee, 10.2-feet below the crown. Flap gate on the waterward end. Concrete headwall on the landward end. Concrete "U" headwall on the waterward end. (USACE-1967). This entry matches the Drainage or Irrigation Structure referenced in O&M manual (HLM 22.19).
FS Date: 4/23/2014

Headwall, pipe, and flapgate visible on WS toe.

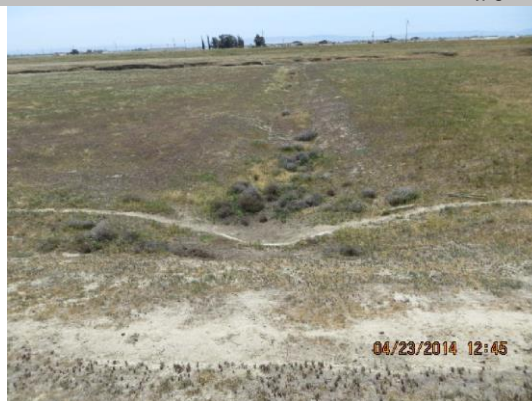
Photo 1 of 2 : UCIP_FA_2016_39613_62596.jpg

Comment Code					
Inspector Comment					
FS_ID:39613					
DS_ID:19790					
EP_NO: N/A					
Repair Type: Non-Urgent					
Crossing Status: Found					
UCIP Comments: Dense vegetation limits the inspector's visibility to identify signs of pipe failure (leaks) along the landward slope.					
Recommend removing vegetation along pipe alignment to conduct proper inspection of structure. Sediment buildup in pipe visible from landward side--recommend contacting owner to clear pipe.					
FIELD_STRUCT_DESC: 24-inch C.M. stormdrain pipe through the levee, 10.4-feet below the crown. Flap gate on the waterward end.					
Concrete headwall on the landward end. Concrete "U" headwall on the waterward end. (USACE-1967). This entry matches the Drainage or Irrigation Structure referenced in O&M manual (HLM 22.79).					
FS Date: 4/23/2014

Headwall, pipe, and flapgate visible on WS toe.

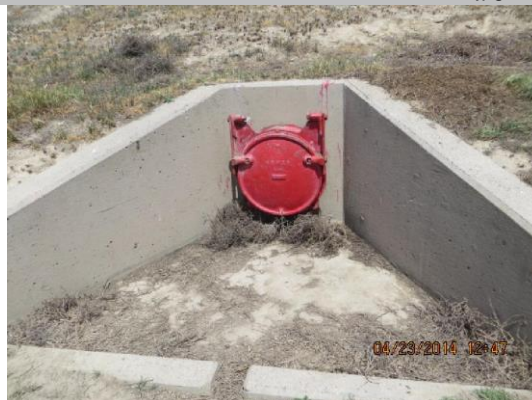
Photo 2 of 2 : UCIP_FA_2016_39613_62598.jpg

Headwall, pipe, and flapgate visible on WS toe.

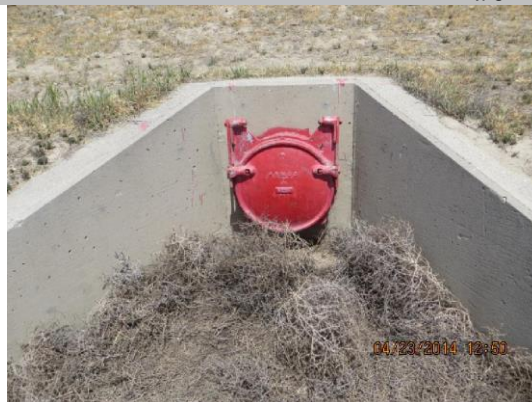
Photo 2 of 2 : UCIP_FA_2016_39616_62600.jpg

Comment Code					
Inspector Comment					
FS_ID:39616					
DS_ID:19791					
EP_NO: N/A					
Repair Type: Non-Urgent					
Crossing Status: Found					
UCIP Comments: Dense vegetation limits the inspector's visibility to identify signs of pipe failure (leaks) along the landward slope. Recommend removing vegetation along pipe alignment to conduct proper inspection of structure. Sediment buildup in pipe visible from landward side--recommend contacting owner to clear pipe.					
FIELD_STRUCT_DESC: 24-inch C.M. stormdrain pipe through the levee, 12.2-feet below the crown. Flap gate on the waterward end. Concrete headwall on the landward end. Concrete "U" headwall on the waterward end. (USACE-1967). This entry matches the Drainage or Irrigation Structure referenced in O&M manual (HLM 22.94).					
FS Date: 4/23/2014

Headwall, pipe, and flapgate visible on WS toe.

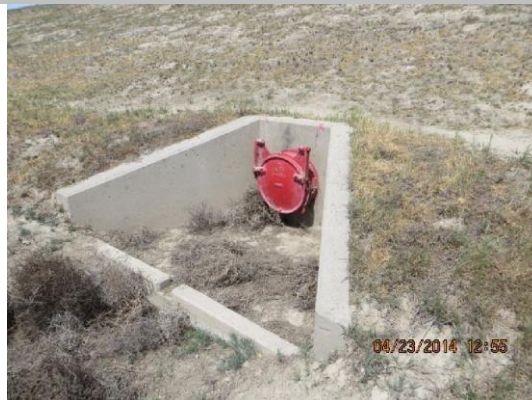
Photo 2 of 2 : UCIP_FA_2016_39617_62608.jpg

FS_ID:39617
DS_ID:19792
EP_NO: N/A
Repair Type: Non-Urgent
Crossing Status: Found
UCIP Comments: Dense vegetation limits the inspector's visibility to identify signs of pipe failure (leaks) along the landward slope. Recommend removing vegetation along pipe alignment to conduct proper inspection of structure.
FIELD_STRUCT_DESC: 24-inch C.M. stormdrain pipe through the levee, 11.1-feet below the crown. Flap gate on the waterward end. Concrete headwall on the landward end. Concrete "U" headwall on the waterward end. (USACE-1967). This entry matches the Drainage or Irrigation Structure referenced in O&M manual (HLM 22.79).
FS Date: 4/23/2014

Headwall, pipe, and flapgate visible on WS toe.

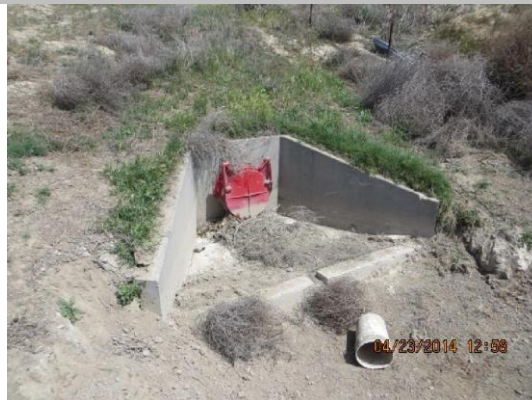
Photo 2 of 2 : UCIP_FA_2016_39618_62610.jpg

FS_ID:39618
DS_ID:19793
EP_NO: N/A
Repair Type: Non-Urgent
Crossing Status: Found
UCIP Comments: Debris blocking closure of outlet. Dense vegetation limits the inspector's visibility to identify signs of pipe failure (leaks) along the waterward and landward slopes. Recommend removing vegetation along pipe alignment to conduct proper inspection of structure.
FIELD_STRUCT_DESC: 24-inch C.M. stormdrain pipe through the levee, 11.5-feet below the crown. Flap gate on the waterward end. Concrete headwall on the landward end. Concrete "U" headwall on the waterward end.
FS Date: 4/23/2014

Headwall, pipe, and flapgate visible on WS toe.

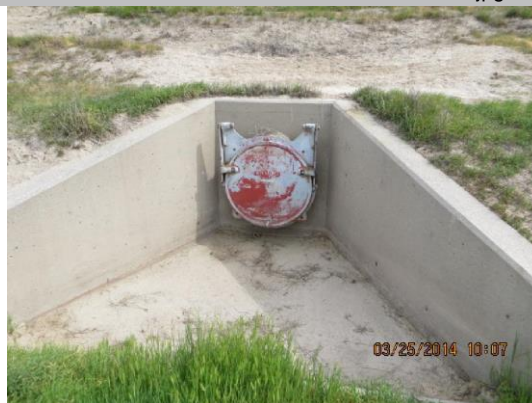
Photo 2 of 2 : UCIP_FA_2016_39621_59270.jpg

LM Start	23.72	Rating **	M	Issue No.	1368
LM End	23.72	Issue Type +	En	Location *	LS
Category	Supplemental			GPS Latitude/Longitude	
				Start	End
Item	DWR UCIP Field Study			37.067799 °	37.067799 °
				-120.511093 °	-120.511093 °
DWR ID					
Comment Code					
Inspector Comment					
FS_ID:39621					
DS_ID:19796					
EP_NO: N/A					
Repair Type: Non-Urgent					
Crossing Status: Found					
UCIP Comments: Sediment buildup in pipe visible from landward side--recommend contacting owner to clear pipe.					
FIELD_STRUCT_DESC: 30-inch C.M. pipe through the levee, 12.1 feet below the crown. Flap gate on the waterward end. Concrete "U" headwall on the waterward end. (USACE-1967). This entry matches the Drainage or Irrigation Structure referenced in O&M manual (HLM 23.62).					
FS Date: 3/25/2014

Flapgate on Concrete headwall on WS toe.

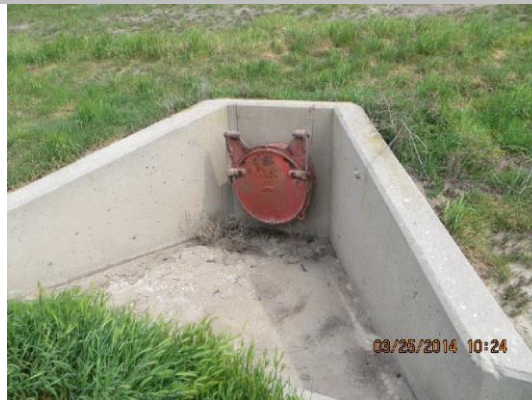
Photo 2 of 2 : UCIP_FA_2016_46850_59285.jpg

FS_ID:46850
DS_ID:19798
EP_NO: N/A
Repair Type: Non-Urgent
Crossing Status: Found
UCIP Comments: Dense vegetation limits the inspector's visibility to identify signs of pipe failure (leaks) along the landward slope. Recommend removing vegetation along pipe alignment to conduct proper inspection of structure.
FIELD_STRUCT_DESC: 24-inch C.M. stormdrain pipe through the levee, 11.2 feet below the crown. Flap gate on the waterward end. Concrete headwall on the landward end. Concrete "U" headwall on the waterward end. (USACE-1967). This entry matches the Drainage or Irrigation Structure referenced in O&M manual (HLM 24.18).
FS Date: 3/25/2014

Flapgate at concrete headwall at WS toe.

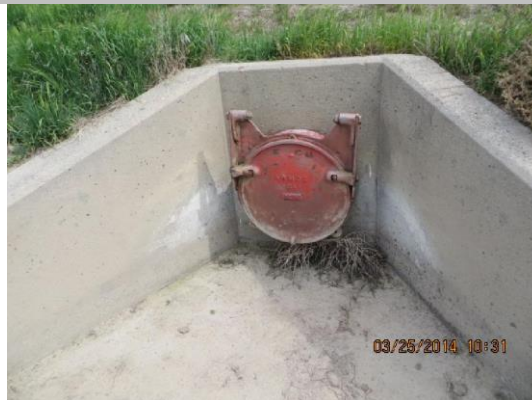
Photo 2 of 2 : UCIP_FA_2016_39623_59290.jpg

Comment Code					
Inspector Comment					
FS_ID:39623					
DS_ID:19799					
EP_NO: N/A					
Repair Type: Non-Urgent					
Crossing Status: Found					
UCIP Comments: Dense vegetation limits the inspector's visibility to identify signs of pipe failure (leaks) along the landward slope.					
Recommend removing vegetation along pipe alignment to conduct proper inspection of structure.					
FIELD_STRUCT_DESC: 24-inch C.M. stormdrain pipe through the levee, 11.2 feet below the crown. Flap gate on the waterward end. Concrete headwall on the landward end. Concrete "U" headwall on the waterward end. (USACE-1967). This entry matches the Drainage or Irrigation Structure referenced in O&M manual (HLM 24.46).					
FS Date: 3/25/2014

Flapgate at Concrete headwall on WS toe.

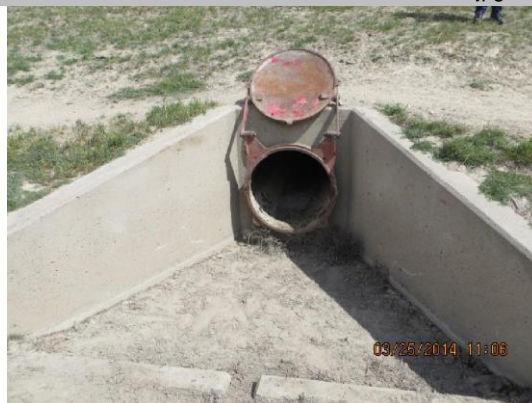
Photo 2 of 2 : UCIP_FA_2016_32789_59312.jpg

LM Start	25.24	Rating **	M	Issue No.	1312
LM End	25.24	Issue Type +	En	Location *	LS
Category	Supplemental			GPS Latitude/Longitude	
				Start	End
Item	DWR UCIP Field Study			37.051477 °	37.051477 °
				-120.492650 °	-120.492650 °
DWR ID					
Comment Code					
Inspector Comment					
FS_ID:32789					
DS_ID:19803					
EP_NO: N/A					
Repair Type: Non-Urgent					
Crossing Status: Found					
UCIP Comments: Flapgate propped open during flood season.					
FIELD_STRUCT_DESC: 30-inch C.M. stormdrain pipe through the					
levee, 11.3 feet below the crown. Flap gate on the waterward end.					
Concrete headwall on the landward end. Concrete "U" headwall on the					
waterward end. (USACE-1967). This entry matches the Drainage or					
Irrigation Structure referenced in O&M manual (HLM 25.13).					
FS Date: 3/25/2014

Concrete headwall and flapgate on WS toe.
