**Flood Control Project Maintenance
Levee Inspections**

Fall 2016 Levee Maintenance Deficiency Summary Report

San Joaquin River Basin

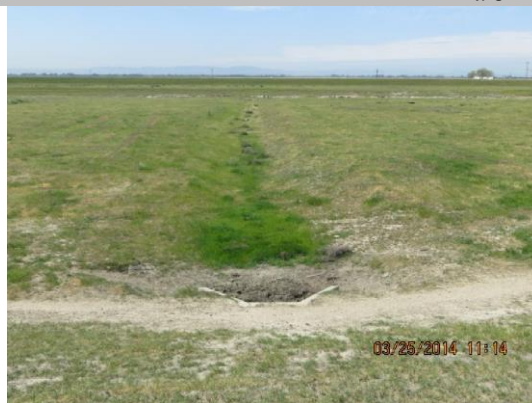
Photo 1 of 2 : UCIP_FA_2016_39625_59316.jpg

Comment Code					
Inspector Comment					
FS_ID:39625 DS_ID:19804 EP_NO: N/A Repair Type: Non-Urgent Crossing Status: Found UCIP Comments: Dense vegetation limits the inspector's visibility to identify signs of pipe failure (leaks) along the landward slope. Recommend removing vegetation along pipe alignment to conduct proper inspection of structure. Sediment buildup in pipe visible from landward side--recommend contacting owner to clear pipe. FIELD_STRUCT_DESC: 30-inch C.M. pipe through the levee, 12.0 feet below the crown. Flap gate on the waterward end. Concrete headwall on the landward end. Concrete "U" headwall on the waterward end. (USACE-1967). This entry matches the Drainage or Irrigation Structure referenced in O&M manual (HLM 25.51). FS Date: 3/25/2014

Concrete headwall on WS toe.

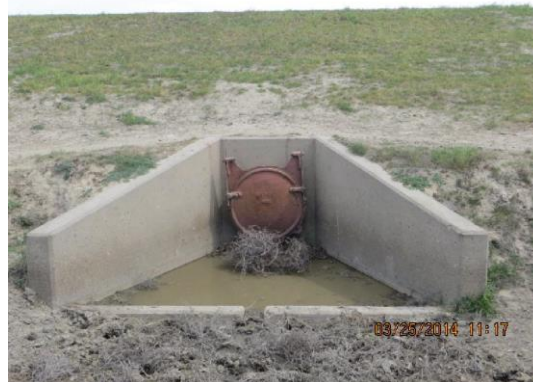
Photo 2 of 2 : UCIP_FA_2016_39625_59317.jpg

Item	DWR UCIP Field Study			37.047455 °	37.047455 °	
				-120.488443 °	-120.488443 °	
DWR ID						
Comment Code						
Inspector Comment						
FS_ID:39625 DS_ID:19804 EP_NO: N/A Repair Type: Non-Urgent Crossing Status: Found UCIP Comments: Dense vegetation limits the inspector's visibility to identify signs of pipe failure (leaks) along the landward slope. Recommend removing vegetation along pipe alignment to conduct proper inspection of structure. Sediment buildup in pipe visible from landward side--recommend contacting owner to clear pipe. FIELD_STRUCT_DESC: 30-inch C.M. pipe through the levee, 12.0 feet below the crown. Flap gate on the waterward end. Concrete headwall on the landward end. Concrete "U" headwall on the waterward end. (USACE-1967). This entry matches the Drainage or Irrigation Structure referenced in O&M manual (HLM 25.51). FS Date: 3/25/2014

Flapgate on concrete headwall at WS toe.

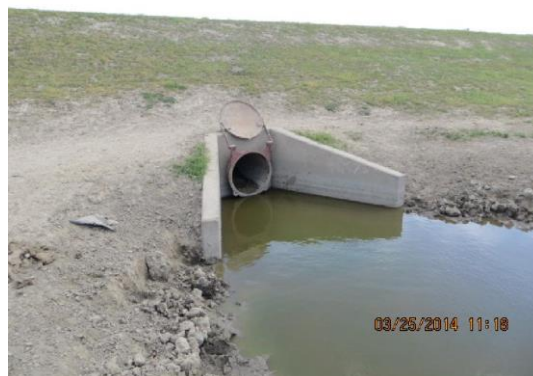
Photo 1 of 2 : UCIP_FA_2016_39626_59321.jpg

LM Start	25.63	Rating **	M	Issue No.	1371
LM End	25.63	Issue Type +	En	Location *	LS
Category	Supplemental			GPS Latitude/Longitude	
				Start	End
Item	DWR UCIP Field Study			37.047170 °	37.047170 °
				-120.488222 °	-120.488222 °
DWR ID					
Comment Code					
Inspector Comment					
FS_ID:39626 DS_ID:19805 EP_NO: N/A Repair Type: Non-Urgent Crossing Status: Found UCIP Comments: Sediment buildup in pipe visible from landward side--recommend contacting owner to clear pipe. FIELD_STRUCT_DESC: 30-inch C.M. stormdrain pipe through the levee, 12.1 feet below the crown. Flap gate on the waterward end. Concrete headwall on the landward end. Concrete "U" headwall on the waterward end. (USACE-1967). This entry matches the Drainage or Irrigation Structure referenced in O&M manual (HLM 25.53). FS Date: 3/25/2014

Flapgate on headwall at WS toe.

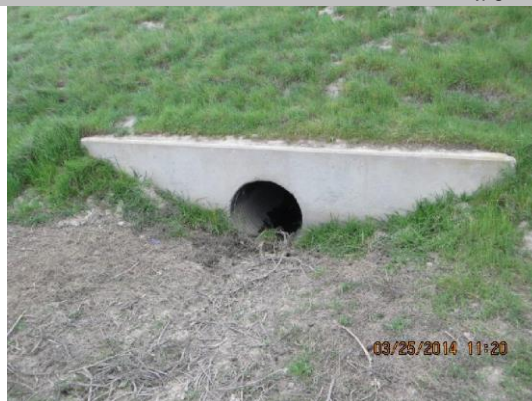
Photo 2 of 2 : UCIP_FA_2016_39626_59320.jpg

LM Start	25.63	Rating **	M	Issue No.	1371 (cont)
LM End	25.63	Issue Type +	En	Location *	LS
Category	Supplemental			GPS Latitude/Longitude	
				Start	End
Item	DWR UCIP Field Study			37.047170 °	37.047170 °
				-120.488222 °	-120.488222 °
DWR ID					
Comment Code					
Inspector Comment					
FS_ID:39626 DS_ID:19805 EP_NO: N/A Repair Type: Non-Urgent Crossing Status: Found UCIP Comments: Sediment buildup in pipe visible from landward side--recommend contacting owner to clear pipe. FIELD_STRUCT_DESC: 30-inch C.M. stormdrain pipe through the levee, 12.1 feet below the crown. Flap gate on the waterward end. Concrete headwall on the landward end. Concrete "U" headwall on the waterward end. (USACE-1967). This entry matches the Drainage or Irrigation Structure referenced in O&M manual (HLM 25.53). FS Date: 3/25/2014

Concrete headwall on LS toe.

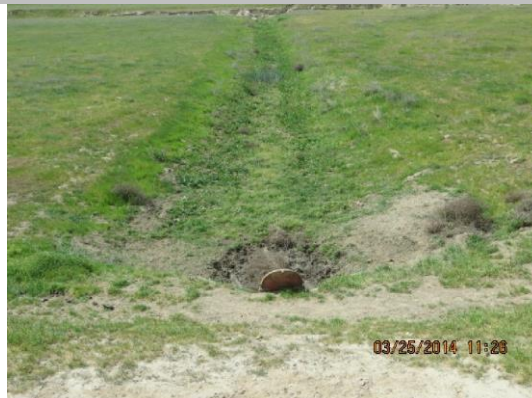
Photo 1 of 2 : UCIP_FA_2016_39627_59341.jpg

LM Start	26.20	Rating **	M	Issue No.	1372
LM End	26.20	Issue Type +	En	Location *	LS
Category	Supplemental			GPS Latitude/Longitude	
				Start	End
Item	DWR UCIP Field Study			37.040070 °	37.040070 °
				-120.482796 °	-120.482796 °
DWR ID					
Comment Code					
Inspector Comment					
FS_ID:39627					
DS_ID:19806					
EP_NO: N/A					
Repair Type: Non-Urgent					
Crossing Status: Found					
UCIP Comments: Sediment buildup in pipe visible from landward side--recommend contacting owner to clear pipe.					
FIELD_STRUCT_DESC: 24-inch C.M. stormdrain pipe through the levee, 10.0 feet below the crown. Flap gate on the waterward end. Concrete headwall on the landward end. Concrete "U" headwall on the waterward end. (USACE-1967). This entry matches the Drainage or Irrigation Structure referenced in O&M manual (HLM 26.11).					
FS Date: 3/25/2014

Concrete headwall on WS toe.

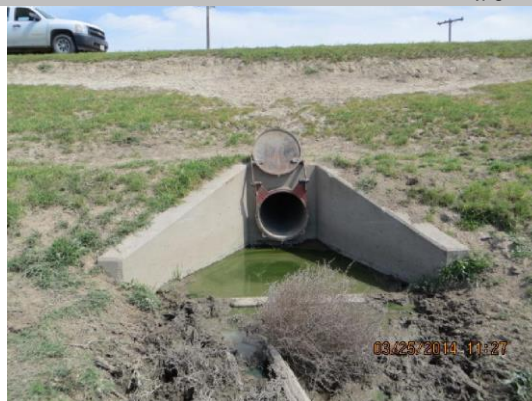
Photo 2 of 2 : UCIP_FA_2016_39627_59340.jpg

LM Start	26.20	Rating **	M	Issue No.	1372 (cont)
LM End	26.20	Issue Type +	En	Location *	LS
Category	Supplemental			GPS Latitude/Longitude	
				Start	End
Item	DWR UCIP Field Study			37.040070 °	37.040070 °
				-120.482796 °	-120.482796 °
DWR ID					
Comment Code					
Inspector Comment					
FS_ID:39627 DS_ID:19806 EP_NO: N/A Repair Type: Non-Urgent Crossing Status: Found UCIP Comments: Sediment buildup in pipe visible from landward side--recommend contacting owner to clear pipe. FIELD_STRUCT_DESC: 24-inch C.M. stormdrain pipe through the levee, 10.0 feet below the crown. Flap gate on the waterward end. Concrete headwall on the landward end. Concrete "U" headwall on the waterward end. (USACE-1967). This entry matches the Drainage or Irrigation Structure referenced in O&M manual (HLM 26.11). FS Date: 3/25/2014

Flapgate on Concrete headwall at WS toe.

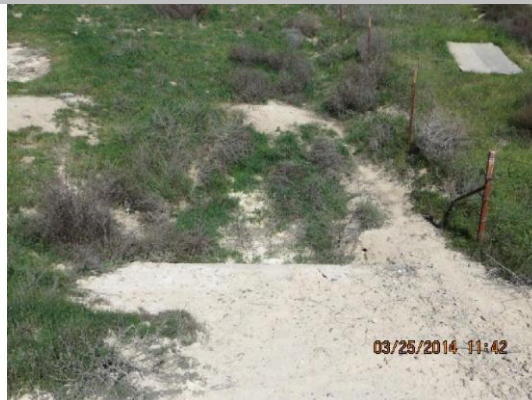
Photo 1 of 2 : UCIP_FA_2016_39628_59350.jpg

LM Start	26.95	Rating **	M	Issue No.	1373
LM End	26.95	Issue Type +	En	Location *	LS
Category	Supplemental			GPS Latitude/Longitude	
				Start	End
Item	DWR UCIP Field Study			37.032669 °	37.032669 °
				-120.473901 °	-120.473901 °
DWR ID					
Comment Code					
Inspector Comment					
FS_ID:39628 DS_ID:19808 EP_NO: N/A Repair Type: Non-Urgent Crossing Status: Found UCIP Comments: Pipe has heavy silt buildup visible from landward side--recommend contacting owner to clear pipe. FIELD_STRUCT_DESC: 24-inch C.M. stormdrain pipe through the levee, 11.4 feet below the crown. Flap gate on the waterward end. Concrete headwall on the landward end. Concrete "U" headwall on the waterward end. (USACE-1967). This entry matches the Drainage or Irrigation Structure referenced in O&M manual (HLM 26.85). FS Date: 3/25/2014

Concrete headwall on LS toe.

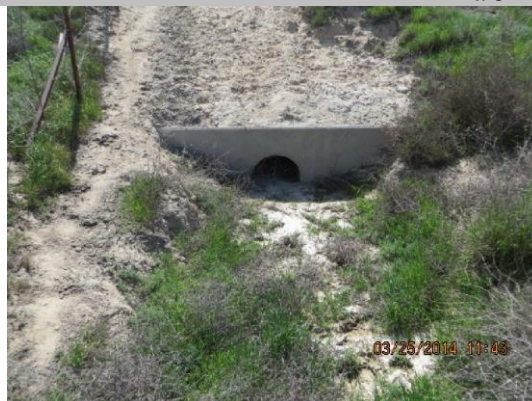
Photo 2 of 2 : UCIP_FA_2016_39628_59349.jpg

LM Start	26.95	Rating **	M	Issue No.	1373 (cont)
LM End	26.95	Issue Type +	En	Location *	LS
Category	Supplemental			GPS Latitude/Longitude	
				Start	End
Item	DWR UCIP Field Study			37.032669 °	37.032669 °
				-120.473901 °	-120.473901 °
DWR ID					
Comment Code					
Inspector Comment					
FS_ID:39628 DS_ID:19808 EP_NO: N/A Repair Type: Non-Urgent Crossing Status: Found UCIP Comments: Pipe has heavy silt buildup visible from landward side--recommend contacting owner to clear pipe. FIELD_STRUCT_DESC: 24-inch C.M. stormdrain pipe through the levee, 11.4 feet below the crown. Flap gate on the waterward end. Concrete headwall on the landward end. Concrete "U" headwall on the waterward end. (USACE-1967). This entry matches the Drainage or Irrigation Structure referenced in O&M manual (HLM 26.85). FS Date: 3/25/2014

Concrete headwall on LS toe.

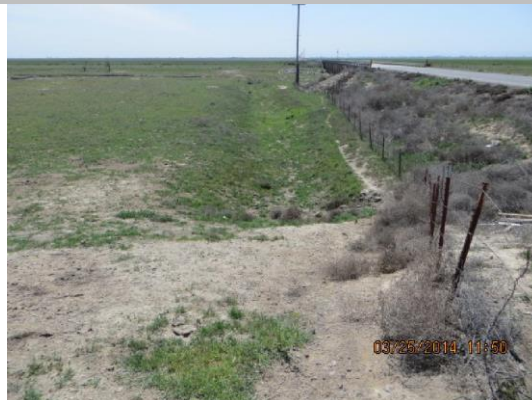
Photo 1 of 2 : UCIP_FA_2016_32806_59353.jpg

LM Start	26.97	Rating **	M	Issue No.	1313
LM End	26.97	Issue Type +	En	Location *	LS
Category	Supplemental			GPS Latitude/Longitude	
				Start	End
Item	DWR UCIP Field Study			37.032680 °	37.032680 °
				-120.473454 °	-120.473454 °
DWR ID					
Comment Code					
Inspector Comment					
FS_ID:32806 DS_ID:19748 EP_NO: N/A Repair Type: Non-Urgent Crossing Status: Found UCIP Comments: Tumble weed buildup at inlet mat create blockage and should be removed. FIELD_STRUCT_DESC: 24-inch C.M. stormdrain pipe through the levee, 11.3 feet below the crown. Flap gate on the waterward end. Concrete headwall on the landward end. Concrete "U" headwall on the waterward end. (USACE-1967). This entry matches the Drainage or Irrigation Structure referenced in O&M manual (HLM 26.87). FS Date: 3/25/2014

Concrete headwall at WS toe.

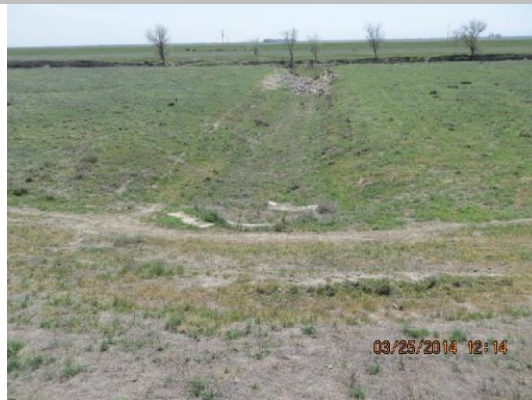
Photo 1 of 2 : UCIP_FA_2016_32823_59382.jpg

LM Start	28.27	Rating **	M	Issue No.	1314
LM End	28.27	Issue Type +	En	Location *	LS
Category	Supplemental			GPS Latitude/Longitude	
				Start	End
Item	DWR UCIP Field Study			37.032623 °	37.032623 °
				-120.450108 °	-120.450108 °
DWR ID					
Comment Code					
Inspector Comment					
FS_ID:32823 DS_ID:19750 EP_NO: N/A Repair Type: Non-Urgent Crossing Status: Found UCIP Comments: Animal Burrowing activity at LS toe may undermine headwall. FIELD_STRUCT_DESC: 24-inch C.M. stormdrain pipe through the levee, 10.8 feet below the crown. Flap gate on the waterward end. Concrete headwall on the landward end. Concrete "U" headwall on the waterward end. (USACE-1967). This entry matches the Drainage or Irrigation Structure referenced in O&M manual (HLM 28.17). FS Date: 3/25/2014

Concrete headwall on WS toe.

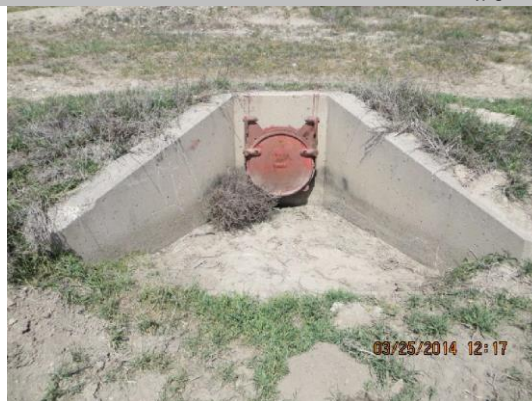
Photo 2 of 2 : UCIP_FA_2016_32823_59383.jpg

LM Start	28.27	Rating **	M	Issue No.	1314 (cont)
LM End	28.27	Issue Type +	En	Location *	LS
Category	Supplemental			GPS Latitude/Longitude	
				Start	End
Item	DWR UCIP Field Study			37.032623 °	37.032623 °
				-120.450108 °	-120.450108 °
DWR ID					
Comment Code					
Inspector Comment					
FS_ID:32823 DS_ID:19750 EP_NO: N/A Repair Type: Non-Urgent Crossing Status: Found UCIP Comments: Animal Burrowing activity at LS toe may undermine headwall. FIELD_STRUCT_DESC: 24-inch C.M. stormdrain pipe through the levee, 10.8 feet below the crown. Flap gate on the waterward end. Concrete headwall on the landward end. Concrete "U" headwall on the waterward end. (USACE-1967). This entry matches the Drainage or Irrigation Structure referenced in O&M manual (HLM 28.17). FS Date: 3/25/2014

Flapgate on Concrete headwall at WS toe.

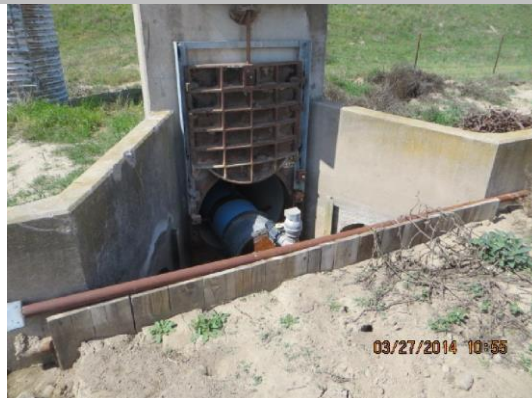
Photo 2 of 2 : UCIP_FA_2016_50055_59409.jpg

FS_ID:50055
DS_ID:19752
EP_NO: N/A
Repair Type: Non-Urgent
Crossing Status: Found
UCIP Comments: 7/20/2016 same as previous inspection. Crossing has been downgraded from Urgent to Non-Urgent slide gate is on LS. Pipe is buried through WS. Need to coordinate with owner to determine permit used to authorized sleeved pipe. (DWR UCIP - omagana)3/27/2014 Slide gate will not close due to 24-inch PVC pipe sleeved through pipe. Also slide gate rails rusted beyond use. (DWR UCIP - omagana)
FIELD_STRUCT_DESC: [Rodunder Siphon Structure] 48-inch concrete irrigation siphon pipe through the levee, 12.1 feet below the crown. Concrete "U" headwall on inlet structure located on the landside (LS) end. Slide gate mounted on concrete headwall located on the LS. 36-inch corrugated metal pipe (CMP) riser unit with slide gate, 8 feet upstream from siphon, located on the LS. 24-inch pipe from this unit enters siphon behind inlet structure. [Additional Reference(s): DWR Levee Log, 2002. USACE San Joaquin O&M Manuals: Unit No. 601, 1967, (HLM 28.95), Unit No. 601 Part I, 1967 (Amended in 1978), Unit No. 601 Part II, 1969, and Unit No. 601 Part III, 1969]

24-inch PVC pipe sleeved through 48-inch concrete pipe.

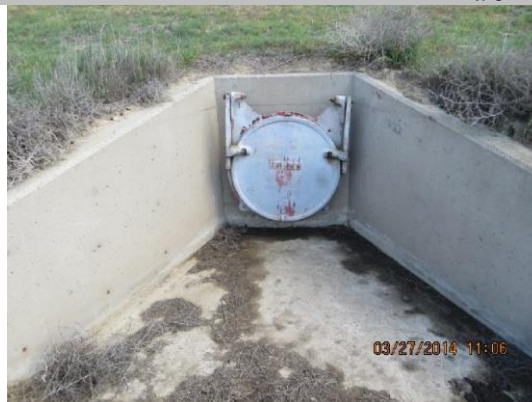
Photo 2 of 2 : UCIP_FA_2016_39884_59413.jpg

FS_ID:39884
DS_ID:19753
EP_NO: N/A
Repair Type: Non-Urgent
Crossing Status: Found
UCIP Comments: Dense vegetation limits the inspector's visibility to identify signs of pipe failure (leaks) along the landward slope. Recommend removing vegetation along pipe alignment to conduct proper inspection of structure. Sediment buildup in pipe visible from landward side--recommend contacting owner to clear pipe.
FIELD_STRUCT_DESC: 36-inch C.M. pipe through the levee, 10.2 feet below the crown. Flap gate on the waterward end. Concrete headwall on the landward end. Concrete "U" headwall on the waterward end. (USACE-1967). This entry matches the Drainage or Irrigation Structure referenced in O&M manual (HLM 29.49).
FS Date: 3/27/2014

Flapgate on Concrete headwall at WS toe.

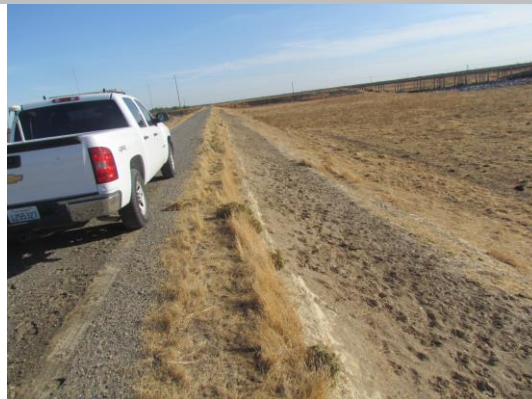
Photo 1 of 2 : FA_2016_NA0010_123_171_20161024_00208.jpg

LM Start	29.68	Rating **	M	Issue No.	171
LM End	29.80	Issue Type +	Ma	Location *	WS
Category	Earthen Levee			GPS Latitude/Longitude	
				Start	End
Item	Erosion / Bank Caving			37.020272 °	37.018712 °
				-120.433737 °	-120.432682 °
DWR ID	DWR_NA0010_05_s_ 2014_171				
Comment Code					
E1 : Note and monitor erosion site.					
Inspector Comment					
Waterside erosion caused by livestock.

Looking south at animal erosion on waterward slope.

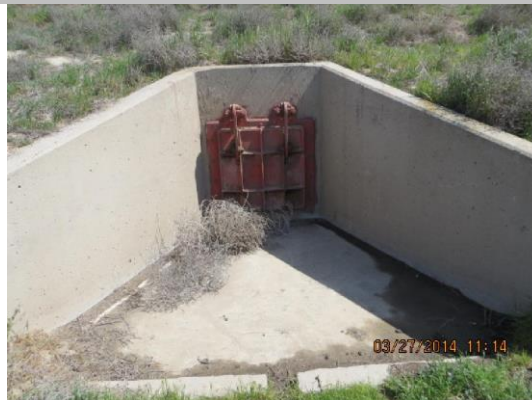
Photo 2 of 2 : UCIP_FA_2016_39631_59426.jpg

FS_ID:39631
DS_ID:19754
EP_NO: N/A
Repair Type: Non-Urgent
Crossing Status: Found
UCIP Comments: Dense vegetation limits the inspector's visibility to identify signs of pipe failure (leaks) along the landward slope. Recommend removing vegetation along pipe alignment to conduct proper inspection of structure.
FIELD_STRUCT_DESC: 30-inch square R.C.B.C. through the levee, 12.0 feet below the crown. Concrete "U" headwall on the waterward end. Flap gate on the waterward end. Concrete headwall on the landward end. (USACE-1967). This entry matches the Drainage or Irrigation Structure referenced in O&M manual (HLM 29.72).
FS Date: 3/27/2014

Flapgate on Concrete headwall at WS toe.

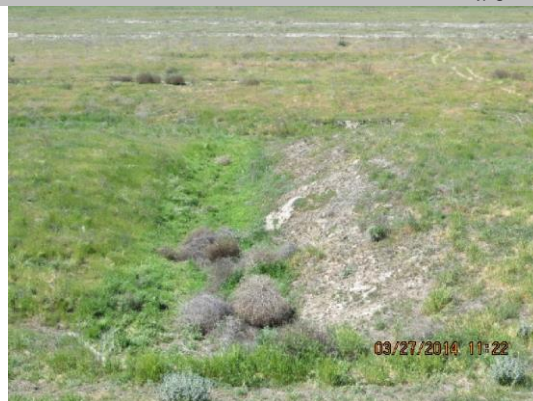
Photo 1 of 2 : UCIP_FA_2016_39632_59430.jpg

Comment Code					
Inspector Comment					
FS_ID:39632					
DS_ID:19696					
EP_NO: N/A					
Repair Type: Non-Urgent					
Crossing Status: Found					
UCIP Comments: Dense vegetation limits the inspector's visibility to identify signs of pipe failure (leaks) along the landward slope.					
Recommend removing vegetation along pipe alignment to conduct proper inspection of structure.					
FIELD_STRUCT_DESC: 30-inch square stormdrain R.C.B.C. through the levee, 13.1 feet below the crown. Concrete "U", headwall on the waterward end. Flap gate on the waterward end. Concrete headwall on the landward end. (USACE-1967). This entry matches the Drainage or Irrigation Structure referenced in O&M manual (HLM 30.04).					
FS Date: 3/27/2014

Concrete headwall on WS toe.

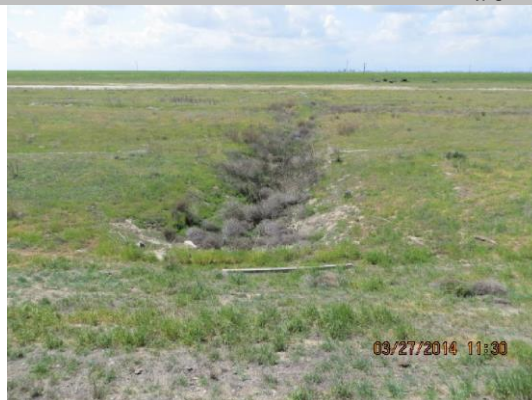
Photo 1 of 2 : UCIP_FA_2016_39633_59435.jpg

Comment Code						
Inspector Comment						
FS_ID:39633						
DS_ID:19697						
EP_NO: N/A						
Repair Type: Non-Urgent						
Crossing Status: Found						
UCIP Comments: Some debris buildup at LS toe. Dense vegetation limits the inspector's visibility to identify signs of pipe failure (leaks) along the landward slope. Recommend removing vegetation along pipe alignment to conduct proper inspection of structure.						
FIELD_STRUCT_DESC: 30-inch square R.C.B.C. stormdrain through the levee, 13.3 feet below the crown. Concrete "U" headwall on the waterward end. Flap gate on the waterward end. Concrete headwall on the landward end. (USACE-1967). This entry matches the Drainage or Irrigation Structure referenced in O&M manual (HLM 30.96).						
FS Date: 3/27/2014

Concrete headwall on WS toe.

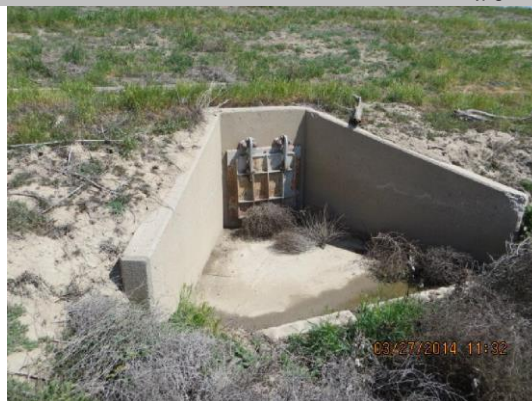
Photo 2 of 2 : UCIP_FA_2016_39633_59436.jpg

Item	DWR UCIP Field Study			37.004212 °	37.004212 °	
				-120.419178 °	-120.419178 °	
DWR ID						
Comment Code						
Inspector Comment						
FS_ID:39633						
DS_ID:19697						
EP_NO: N/A						
Repair Type: Non-Urgent						
Crossing Status: Found						
UCIP Comments: Some debris buildup at LS toe. Dense vegetation limits the inspector's visibility to identify signs of pipe failure (leaks) along the landward slope. Recommend removing vegetation along pipe alignment to conduct proper inspection of structure.						
FIELD_STRUCT_DESC: 30-inch square R.C.B.C. stormdrain through the levee, 13.3 feet below the crown. Concrete "U" headwall on the waterward end. Flap gate on the waterward end. Concrete headwall on the landward end. (USACE-1967). This entry matches the Drainage or Irrigation Structure referenced in O&M manual (HLM 30.96).						
FS Date: 3/27/2014

Flapgate on Concrete headwall at WS toe.

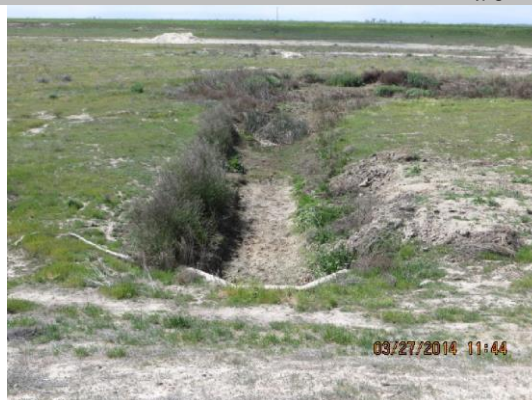
Photo 1 of 2 : UCIP_FA_2016_39643_59439.jpg

Comment Code					
Inspector Comment					
FS_ID:39643					
DS_ID:19698					
EP_NO: N/A					
Repair Type: Non-Urgent					
Crossing Status: Found					
UCIP Comments: Excess vegetation buildup at inlet on LS toe. Dense vegetation limits the inspector's visibility to identify signs of pipe failure (leaks) along the landward slope. Recommend removing vegetation along pipe alignment to conduct proper inspection of structure.					
FIELD_STRUCT_DESC: 30-inch square R.C.B.C. stormdrain through levee, 13.4 feet below crown. Concrete "U" headwall on waterward end. Flap gate on waterward end. Concrete headwall on landward end. (USACE-1967). This entry matches the Drainage or Irrigation Structure referenced in O&M manual (HLM 31.19).					
FS Date: 3/27/2014

Concrete headwall on WS toe.

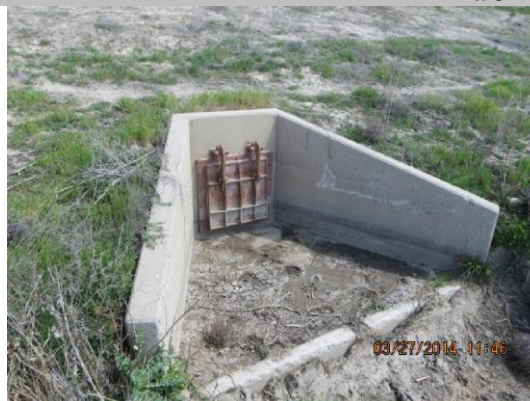
Photo 2 of 2 : UCIP_FA_2016_39643_59440.jpg

Item	DWR UCIP Field Study			37.001754 °	37.001754 °	
				-120.416254 °	-120.416254 °	
DWR ID						
Comment Code						
Inspector Comment						
FS_ID:39643 DS_ID:19698 EP_NO: N/A Repair Type: Non-Urgent Crossing Status: Found UCIP Comments: Excess vegetation buildup at inlet on LS toe. Dense vegetation limits the inspector's visibility to identify signs of pipe failure (leaks) along the landward slope. Recommend removing vegetation along pipe alignment to conduct proper inspection of structure. FIELD_STRUCT_DESC: 30-inch square R.C.B.C. stormdrain through levee, 13.4 feet below crown. Concrete "U" headwall on waterward end. Flap gate on waterward end. Concrete headwall on landward end. (USACE-1967). This entry matches the Drainage or Irrigation Structure referenced in O&M manual (HLM 31.19). FS Date: 3/27/2014

Flapgate at concrete headwall on WS toe.

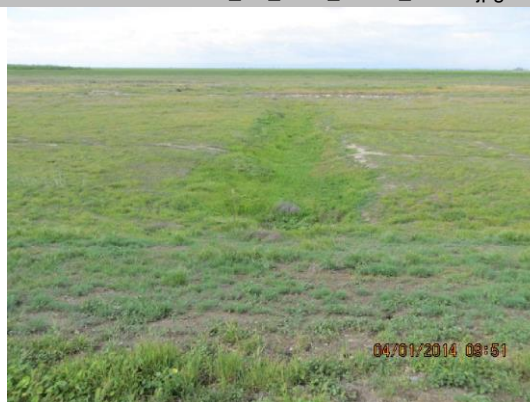
Photo 1 of 2 : UCIP_FA_2016_39645_59686.jpg

Comment Code					
Inspector Comment					
FS_ID:39645 DS_ID:19700 EP_NO: N/A Repair Type: Non-Urgent Crossing Status: Found UCIP Comments: Dense vegetation limits the inspector's visibility to identify signs of pipe failure (leaks) along the landward slope. Recommend removing vegetation along pipe alignment to conduct proper inspection of structure. FIELD_STRUCT_DESC: 30-inch square R.C.B.C. through the levee, 13.0 feet below the crown. Concrete "U" headwall on the waterward end. Flap gate on the waterward end. Concrete headwall on the landward end with flashboard attachment. (USACE-1967). This entry matches the Drainage or Irrigation Structure referenced in O&M manual (HLM 31.71). FS Date: 4/1/2014

Concrete headwall at channel on WS toe.

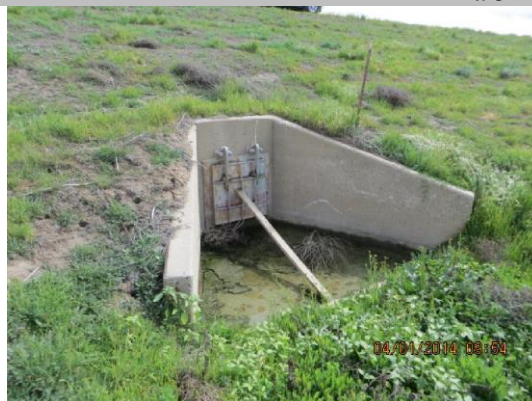
Photo 2 of 2 : UCIP_FA_2016_39645_59687.jpg

Comment Code					
Inspector Comment					
FS_ID:39645					
DS_ID:19700					
EP_NO: N/A					
Repair Type: Non-Urgent					
Crossing Status: Found					
UCIP Comments: Dense vegetation limits the inspector's visibility to identify signs of pipe failure (leaks) along the landward slope.					
Recommend removing vegetation along pipe alignment to conduct proper inspection of structure.					
FIELD_STRUCT_DESC: 30-inch square R.C.B.C. through the levee, 13.0 feet below the crown. Concrete "U" headwall on the waterward end. Flap gate on the waterward end. Concrete headwall on the landward end with flashboard attachment. (USACE-1967). This entry matches the Drainage or Irrigation Structure referenced in O&M manual (HLM 31.71).					
FS Date: 4/1/2014

Flapgate on Concrete headwall at channel on WS toe.

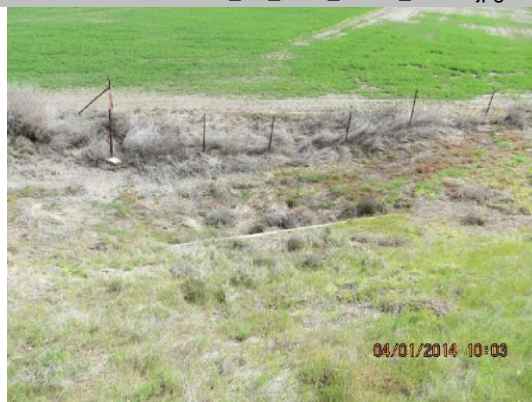
Photo 1 of 2 : UCIP_FA_2016_39646_59690.jpg

LM Start	32.32	Rating **	M	Issue No.	1344
LM End	32.32	Issue Type +	En	Location *	LS
Category	Supplemental			GPS Latitude/Longitude	
				Start	End
Item	DWR UCIP Field Study			36.989435 °	36.989435 °
				-120.402626 °	-120.402626 °
DWR ID					
Comment Code					
Inspector Comment					
FS_ID:39646 DS_ID:19701 EP_NO: N/A Repair Type: Non-Urgent Crossing Status: Found UCIP Comments: Some silt buildup inside culvert. FIELD_STRUCT_DESC: 30-inch square R.C.B.C. through the levee, 14.2 feet below the crown. Concrete "U" headwall on the waterward end. Flap gate on the waterward end. Concrete headwall on the landward end with flashboard attachment. (USACE-1967). This entry matches the Drainage or Irrigation Structure referenced in O&M manual (HLM 32.22). FS Date: 4/1/2014

Concrete headwall at inlet on LS toe.

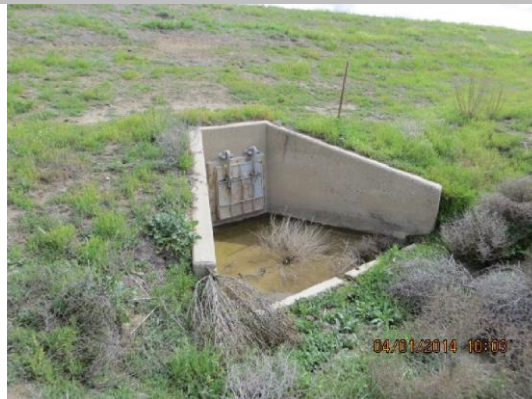
Photo 2 of 2 : UCIP_FA_2016_39646_59688.jpg

LM Start	32.32	Rating **	M	Issue No.	1344 (cont)
LM End	32.32	Issue Type +	En	Location *	LS
Category	Supplemental	GPS Latitude/Longitude			
		Start	End		
Item	DWR UCIP Field Study	36.989435 °	36.989435 °		
		-120.402626 °	-120.402626 °		
DWR ID					
Comment Code					
Inspector Comment					
FS_ID:39646 DS_ID:19701 EP_NO: N/A Repair Type: Non-Urgent Crossing Status: Found UCIP Comments: Some silt buildup inside culvert. FIELD_STRUCT_DESC: 30-inch square R.C.B.C. through the levee, 14.2 feet below the crown. Concrete "U" headwall on the waterward end. Flap gate on the waterward end. Concrete headwall on the landward end with flashboard attachment. (USACE-1967). This entry matches the Drainage or Irrigation Structure referenced in O&M manual (HLM 32.22). FS Date: 4/1/2014

Flapgate on Concrete headwall at WS toe.

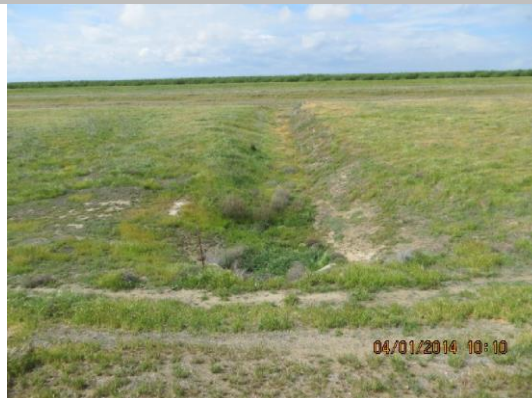
Photo 1 of 2 : UCIP_FA_2016_39647_59697.jpg

Comment Code					
Inspector Comment					
FS_ID:39647 DS_ID:19702 EP_NO: N/A Repair Type: Non-Urgent Crossing Status: Found UCIP Comments: Dense vegetation limits the inspector's visibility to identify signs of pipe failure (leaks) along the landward slope. Recommend removing vegetation along pipe alignment to conduct proper inspection of structure. Debris buildup blocking landward headwall--recommend contacting owner to clear debris. FIELD_STRUCT_DESC: 30-inch square R.C.B.C. through the levee, 12.2 feet below the crown. Concrete "U" headwall on the waterward end. Flap gate on the waterward end. Concrete headwall on the landward end. (USACE-1967). This entry matches the Drainage or Irrigation Structure referenced in O&M manual (HLM 33.01). FS Date: 4/1/2014

Concrete headwall at WS toe.

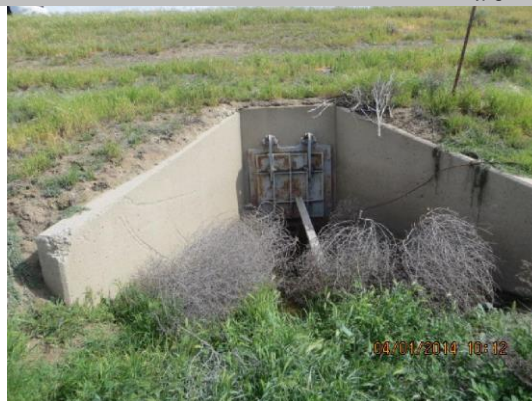
Photo 2 of 2 : UCIP_FA_2016_39647_59699.jpg

Comment Code					
Inspector Comment					
FS_ID:39647 DS_ID:19702 EP_NO: N/A Repair Type: Non-Urgent Crossing Status: Found UCIP Comments: Dense vegetation limits the inspector's visibility to identify signs of pipe failure (leaks) along the landward slope. Recommend removing vegetation along pipe alignment to conduct proper inspection of structure. Debris buildup blocking landward headwall--recommend contacting owner to clear debris. FIELD_STRUCT_DESC: 30-inch square R.C.B.C. through the levee, 12.2 feet below the crown. Concrete "U" headwall on the waterward end. Flap gate on the waterward end. Concrete headwall on the landward end. (USACE-1967). This entry matches the Drainage or Irrigation Structure referenced in O&M manual (HLM 33.01). FS Date: 4/1/2014

Flapgate on Concrete headwall at WS toe.

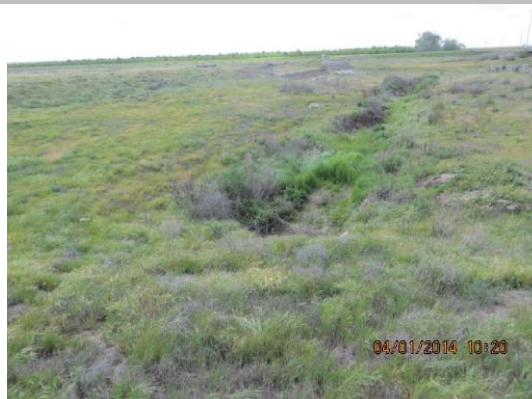
Photo 1 of 2 : UCIP_FA_2016_39648_59701.jpg

Comment Code					
Inspector Comment					
FS_ID:39648					
DS_ID:19703					
EP_NO: N/A					
Repair Type: Non-Urgent					
Crossing Status: Found					
UCIP Comments: Dense vegetation limits the inspector's visibility to identify signs of pipe failure (leaks) along the slopes. Recommend removing vegetation along pipe alignment to conduct proper inspection of structure.					
FIELD_STRUCT_DESC: 30-inch square R.C.B.C. through the levee, 13.9 feet below the crown. Concrete "U" headwall on the waterward end. Flap gate on the waterward end. Concrete headwall on the landward end. (USACE-1967). This entry matches the Drainage or Irrigation Structure referenced in O&M manual (HLM 33.72).					
FS Date: 4/1/2014

Concrete headwall at WS toe.

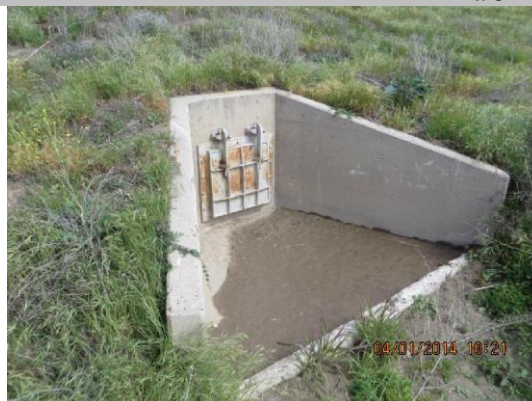
Photo 2 of 2 : UCIP_FA_2016_39648_59700.jpg

Item	DWR UCIP Field Study			36.976808 °		36.976808 °
				-120.382593 °		-120.382593 °
DWR ID						
Comment Code						
Inspector Comment						
FS_ID:39648 DS_ID:19703 EP_NO: N/A Repair Type: Non-Urgent Crossing Status: Found UCIP Comments: Dense vegetation limits the inspector's visibility to identify signs of pipe failure (leaks) along the slopes. Recommend removing vegetation along pipe alignment to conduct proper inspection of structure. FIELD_STRUCT_DESC: 30-inch square R.C.B.C. through the levee, 13.9 feet below the crown. Concrete "U" headwall on the waterward end. Flap gate on the waterward end. Concrete headwall on the landward end. (USACE-1967). This entry matches the Drainage or Irrigation Structure referenced in O&M manual (HLM 33.72). FS Date: 4/1/2014

Flapgate on Concrete headwall at WS toe.

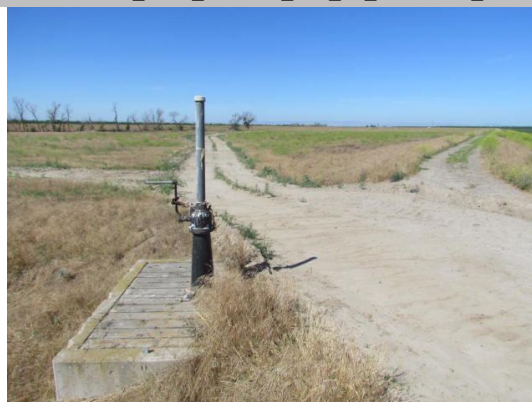
Photo 1 of 4 : FA_2016_NA0010_123_11_20161007_00007.jpg

LM Start	34.61	Rating **	M	Issue No.	11
LM End	34.61	Issue Type +	En	Location *	WS
Category	Earthen Levee			GPS Latitude/Longitude	
				Start	End
Item	Encroachments			36.978555 °	36.978555 °
				-120.368467 °	-120.368467 °
DWR ID	DWR_NA0010_05_s_2012_11				
Comment Code					
RA : Ramp					
Inspector Comment					
Unauthorized ramp on waterside slope. Landowner cut unauthorized ramp on waterside slope and levee crown.

Looking west at ramp on waterward slope.

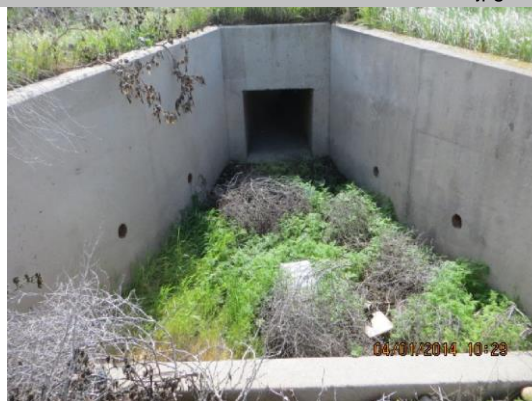
Photo 2 of 2 : UCIP_FA_2016_39649_59704.jpg

FS_ID:39649
DS_ID:19755
EP_NO: N/A
Repair Type: Non-Urgent
Crossing Status: Found
UCIP Comments: Dense vegetation limits the inspector's visibility to identify signs of pipe failure (leaks) along the landward slope. Recommend removing vegetation along pipe alignment to conduct proper inspection of structure. Debris buildup visible on waterward headwall--recommend contacting owner to clear pipe.
FIELD_STRUCT_DESC: 36-inch square R.C.B.C. through the levee, 9.7 feet below the crown. Slide gate in 56"X91" concrete riser unit on the waterward slope. Concrete "U" headwalls on both ends. Landside channel cobble revetted for 8.0 feet. (USACE-1967). [Chowchilla Canal Irrigation Structure] This entry matches the Drainage or Irrigation Structure referenced in O&M manual (HLM 34.51).
FS Date: 4/1/2014

Concrete headwall at LS toe.

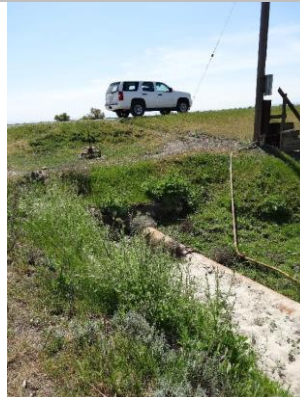
Photo 2 of 2 : UCIP_FA_2016_39463_66343.jpg

LM Start	0.66	Rating **	M	Issue No.	1239
LM End	0.66	Issue Type +	En	Location *	LS
Category	Supplemental			GPS Latitude/Longitude	
				Start	End
Item	DWR UCIP Field Study			37.271444 °	37.271444 °
				-120.815835 °	-120.815835 °
DWR ID					
Comment Code					
Inspector Comment					
FS_ID:39463 DS_ID:19815 EP_NO: N/A Repair Type: Non-Urgent Crossing Status: Found UCIP Comments: Need to contact owner. Sediment buildup on landward side. Recommend removing sediment buildup on landward toe. FIELD_STRUCT_DESC: 24-inch CM pipe through levee, 7.2 feet below crown. Slide gate inside 36-inch CM pipe riser in the waterward slope. Pump on concrete structure in channel. Concrete headwall on both ends. (USACE-1967). This entry matches the Drainage or Irrigation Structure referenced in O&M manual (HLM 0.74). FS Date: 4/18/2014

View of slope on waterward side.

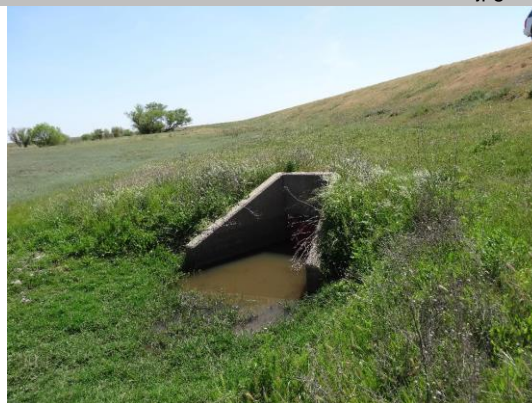
Photo 2 of 2 : UCIP_FA_2016_36565_66345.jpg

LM Start	0.78	Rating **	M	Issue No.	1228
LM End	0.78	Issue Type +	En	Location *	LS
Category	Supplemental			GPS Latitude/Longitude	
				Start	End
Item	DWR UCIP Field Study			37.270460 °	37.270460 °
				-120.814290 °	-120.814290 °
DWR ID					
Comment Code					
Inspector Comment					
FS_ID:36565 DS_ID:19816 EP_NO: N/A Repair Type: Non-Urgent Crossing Status: Found UCIP Comments: Landward side blocked--need to contact owner to determine status of crossing. FIELD_STRUCT_DESC: 24-inch CM pipe through levee, 16.2 feet below crown. Flap gate on the waterward end. Concrete "U" headwall on both ends. (USACE-1967). This entry matches the Drainage or Irrigation Structure referenced in O&M manual (HLM 0.86). FS Date: 4/18/2014

Concrete structure located on waterward toe.

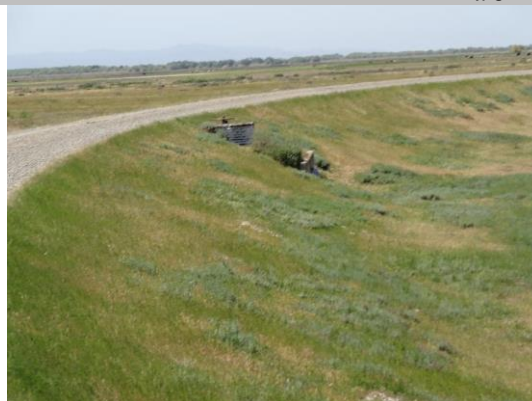
Photo 1 of 2 : UCIP_FA_2016_39464_66354.jpg

LM Start	2.53	Rating **	M	Issue No.	1240
LM End	2.53	Issue Type +	En	Location *	LS
Category	Supplemental			GPS Latitude/Longitude	
				Start	End
Item	DWR UCIP Field Study			37.252948 °	37.252948 °
				-120.794352 °	-120.794352 °
DWR ID					
Comment Code					
Inspector Comment					
FS_ID:39464 DS_ID:19818 EP_NO: N/A Repair Type: Non-Urgent Crossing Status: Found UCIP Comments: Need to contact owner. Sediment buildup in pipe visible on landward side. FIELD_STRUCT_DESC: 36-inch CM pipe through levee, 6.9 feet below crown. Slide gate in 48-inch CM pipe riser in the waterward slope. Concrete headwall on both ends. (USACE-1967). This entry matches the Drainage or Irrigation Structure referenced in O&M manual (HLM 2.61). FS Date: 4/18/2014

View of waterward side.

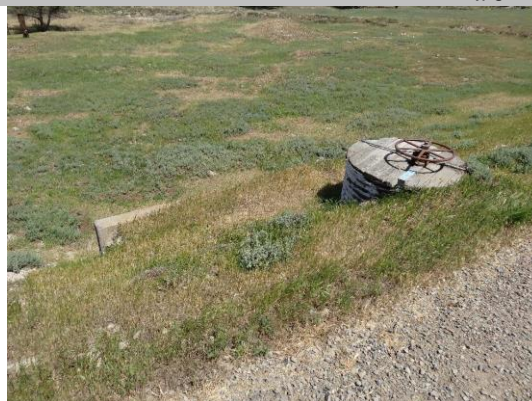
Photo 2 of 2 : UCIP_FA_2016_39464_66357.jpg

LM Start	2.53	Rating **	M	Issue No.	1240 (cont)	
LM End	2.53	Issue Type +	En	Location *	LS	
Category	Supplemental			GPS Latitude/Longitude		
				Start		End
Item	DWR UCIP Field Study			37.252948 °		37.252948 °
				-120.794352 °		-120.794352 °
DWR ID						
Comment Code						
Inspector Comment						
FS_ID:39464 DS_ID:19818 EP_NO: N/A Repair Type: Non-Urgent Crossing Status: Found UCIP Comments: Need to contact owner. Sediment buildup in pipe visible on landward side. FIELD_STRUCT_DESC: 36-inch CM pipe through levee, 6.9 feet below crown. Slide gate in 48-inch CM pipe riser in the waterward slope. Concrete headwall on both ends. (USACE-1967). This entry matches the Drainage or Irrigation Structure referenced in O&M manual (HLM 2.61). FS Date: 4/18/2014

View of waterward side.

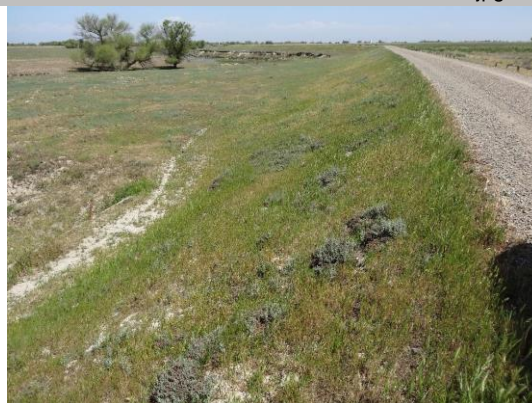
Photo 2 of 2 : UCIP_FA_2016_36568_66360.jpg

LM Start	2.57	Rating **	M	Issue No.	1230
LM End	2.57	Issue Type +	En	Location *	WS
Category	Supplemental			GPS Latitude/Longitude	
				Start	End
Item	DWR UCIP Field Study			37.252743 °	37.252743 °
				-120.793756 °	-120.793756 °
DWR ID					
Comment Code					
Inspector Comment					
FS_ID:36568 DS_ID:19819 EP_NO: N/A Repair Type: Non-Urgent Crossing Status: Found UCIP Comments: Dense vegetation limits the inspector's visibility to identify signs of pipe condition on landward toe--headwall blocked by dense vegetation. Recommend removing vegetation from landward toe. FIELD_STRUCT_DESC: 24-inch CM pipe through levee, 9.2 feet below crown. Flap gate on the waterward end. Concrete headwall on both ends. (USACE-1967). This entry matches the Drainage or Irrigation Structure referenced in O&M manual (HLM 2.65). FS Date: 4/18/2014

View of waterward side.

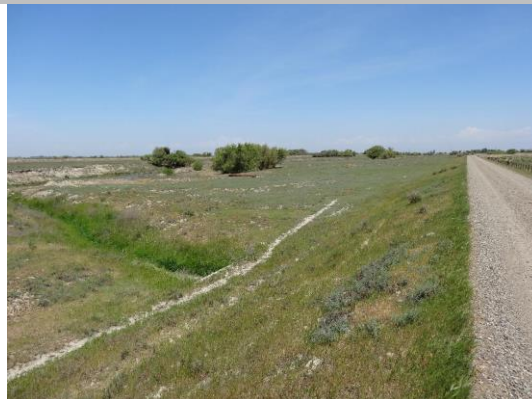
Photo 1 of 2 : UCIP_FA_2016_36569_66369.jpg

LM Start	2.77	Rating **	M	Issue No.	1231
LM End	2.77	Issue Type +	En	Location *	WS
Category	Supplemental			GPS Latitude/Longitude	
				Start	End
Item	DWR UCIP Field Study			37.253020 °	37.253020 °
				-120.790219 °	-120.790219 °
DWR ID					
Comment Code					
Inspector Comment					
FS_ID:36569 DS_ID:19820 EP_NO: N/A Repair Type: Non-Urgent Crossing Status: Found UCIP Comments: Dense vegetation limits the inspector's visibility to identify signs of pipe condition on landward toe--headwall blocked by dense vegetation. Recommend removing vegetation from landward toe. FIELD_STRUCT_DESC: 24-inch CM pipe through levee, 10.5 feet below crown. Flap gate on the waterward end. Concrete headwall on both ends. (USACE-1967). This entry matches the Drainage or Irrigation Structure referenced in O&M manual (HLM 2.85). FS Date: 4/18/2014

View of waterward side.

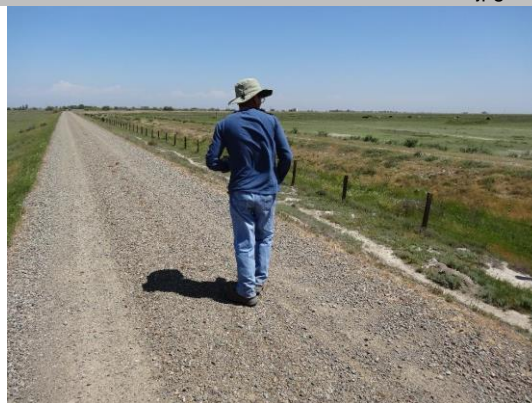
Photo 2 of 2 : UCIP_FA_2016_36569_66368.jpg

Overview of levee crown at crossing.

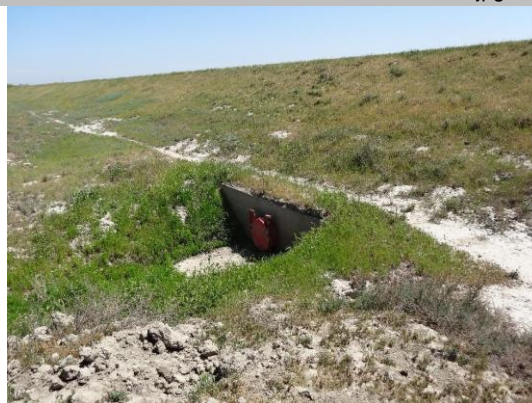
Photo 2 of 2 : UCIP_FA_2016_36583_66380.jpg

LM Start	3.01	Rating **	M	Issue No.	1232
LM End	3.01	Issue Type +	En	Location *	WS
Category	Supplemental			GPS Latitude/Longitude	
				Start	End
Item	DWR UCIP Field Study			37.253811 °	37.253811 °
				-120.786059 °	-120.786059 °
DWR ID					
Comment Code					
Inspector Comment					
FS_ID:36583 DS_ID:19821 EP_NO: N/A Repair Type: Non-Urgent Crossing Status: Found UCIP Comments: Dense vegetation limits the inspector's visibility to identify signs of pipe condition on landward toe--headwall blocked by dense vegetation. Recommend removing vegetation from landward toe. FIELD_STRUCT_DESC: 24 inch CM pipe through levee, 11.2 feet below crown. Flap gate on the waterward end. Concrete headwall on both ends. (USACE-1967). This entry matches the Drainage or Irrigation Structure referenced in O&M manual (HLM 3.09). FS Date: 4/18/2014

Flap gate and concrete headwall visible on waterward side.

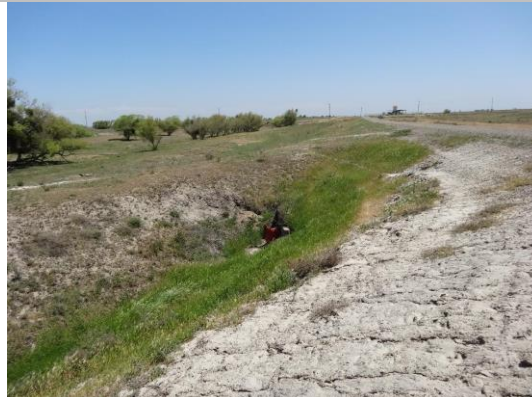
Photo 2 of 2 : UCIP_FA_2016_36584_66386.jpg

LM Start	3.21	Rating **	M	Issue No.	1233
LM End	3.21	Issue Type +	En	Location *	WS
Category	Supplemental			GPS Latitude/Longitude	
				Start	End
Item	DWR UCIP Field Study			37.253513 °	37.253513 °
				-120.782509 °	-120.782509 °
DWR ID					
Comment Code					
Inspector Comment					
FS_ID:36584 DS_ID:19822 EP_NO: N/A Repair Type: Non-Urgent Crossing Status: Found UCIP Comments: Dense vegetation limits the inspector's visibility to identify signs of pipe condition on waterward slope and landward toe (headwall blocked by dense vegetation). Recommend removing vegetation from landward toe. FIELD_STRUCT_DESC: 24-inch CM pipe through levee, 10.4 feet below crown. Flap gate on the waterward end. Concrete headwall on both ends. (USACE-1967). This entry matches the Drainage or Irrigation Structure referenced in O&M manual (HLM 3.29). FS Date: 4/18/2014

View of waterward side.

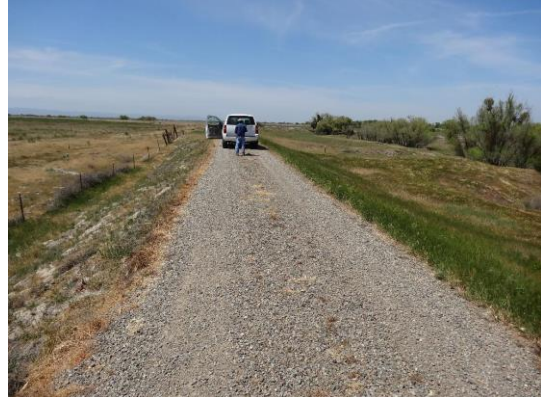
Photo 1 of 2 : UCIP_FA_2016_36585_66389.jpg

Comment Code					
Inspector Comment					
FS_ID:36585 DS_ID:19823 EP_NO: N/A Repair Type: Non-Urgent Crossing Status: Found UCIP Comments: Alignment of crossing unknown--altered crossing. No headwall found on landward side only siphon breaker found a short distance from landward toe. Tall grass observed on waterward slope and some burrow activity also noticed. Need to contact owner to determine alignment of crossing and status of crossing. FIELD_STRUCT_DESC: 36-inch CM pipe through levee, 15.7 feet below crown. Flap gate on the waterward end. Concrete "U" headwall on both ends. BM stamped 9770-152 on top of the headwall on the waterward side. (USACE-1967). This entry matches the Drainage or Irrigation Structure referenced in O&M manual (HLM 3.43). FS Date: 4/18/2014

Overview of levee crown at crossing.

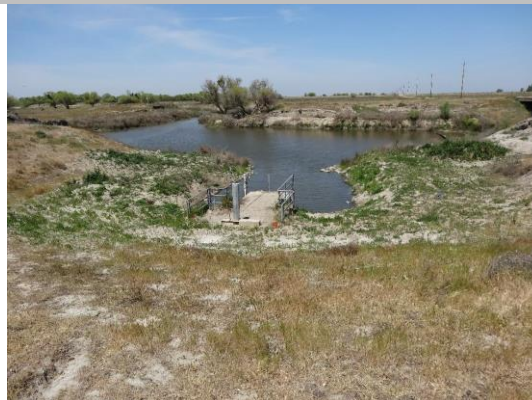
LM Start	0.60	Rating **	M	Issue No.	1214 (cont)
LM End	0.60	Issue Type +	En	Location *	LS

Flapgate and headwall visible on WS toe.

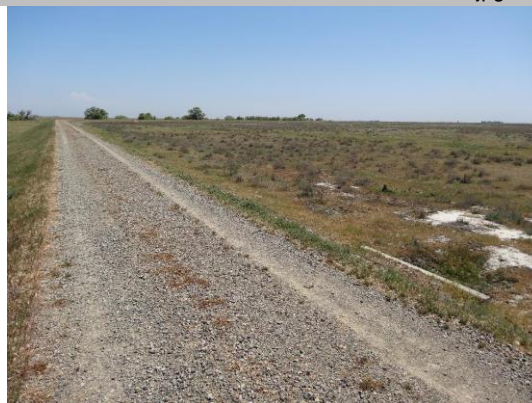
Photo 2 of 2 : UCIP_FA_2016_39099_60653.jpg

* Location LS : Land Side N/A : Not Applicable WS : Water Side CR : Crown	** Rating A : Acceptable M : Minimally Acceptable U : Unacceptable	N : Not Inspected/Rated C : Corrected A/W : Acceptable but Monitor & Maintain	+ Issue Type Ma : Maintenance Deficiency Ob : Design & System Obsolescence En : Enforcement
--	--	---	---

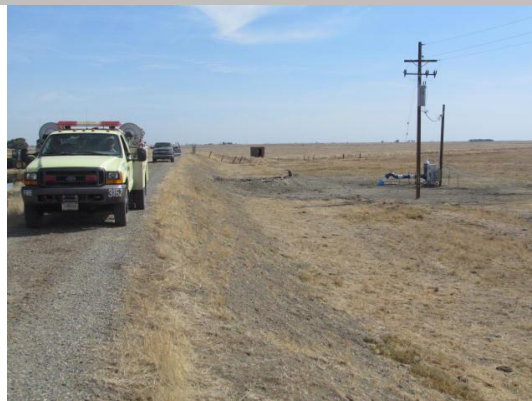
Pipe, flapgate, and headwall on WS toe.

Levee Inspection Report By Mile - Fall 2016

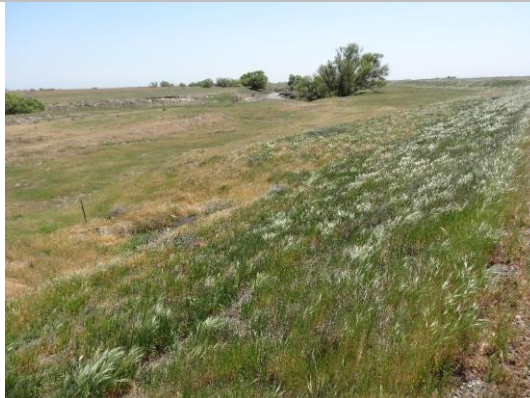
Photo 3 of 3 : FA_2016_NA0010_118_1179_20161007_00024.jpg

LM Start	3.47	Rating **	U	Issue No.	1179 (cont)
LM End	3.47	Issue Type +	Ma	Location *	LS

Looking west at erosion on landward slope and toe.

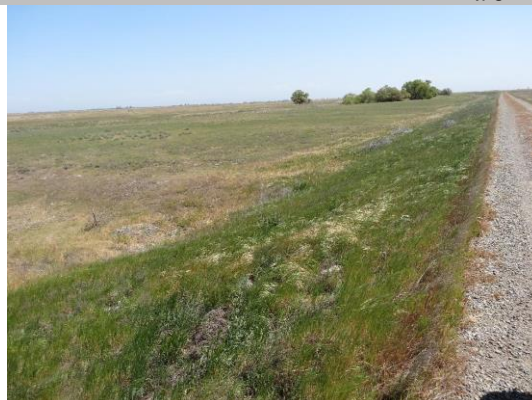
Photo 1 of 2 : UCIP_FA_2016_39875_61599.jpg

LM Start	5.26	Rating **	M	Issue No.	1250	
LM End	5.26	Issue Type +	En	Location *	LS	
Category	Supplemental			GPS Latitude/Longitude		
				Start	End	
Item	DWR UCIP Field Study			37.239098 °	37.239098 °	
				-120.751774 °	-120.751774 °	
DWR ID						
Comment Code						
Inspector Comment						
FS_ID:39875						
DS_ID:19863						
EP_NO: N/A						
Repair Type: Non-Urgent						
Crossing Status: Found						
UCIP Comments: Clear vegetation from waterward slope and landward headwall.						
FIELD_STRUCT_DESC: 24-inch CM pipe through levee, 10.9 feet below crown. Flap gate on the waterward end. Concrete headwall on both ends. (USACE-1967). This entry matches the Drainage or Irrigation Structure referenced in O&M manual (HLM 5.34).						
FS Date: 4/18/2014

View of waterward side.

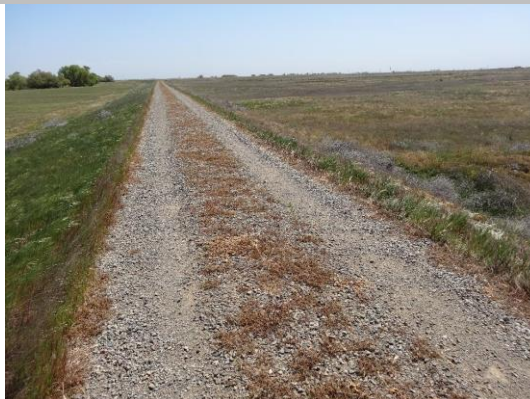
Photo 2 of 2 : UCIP_FA_2016_39875_61598.jpg

LM Start	5.26	Rating **	M	Issue No.	1250 (cont)	
LM End	5.26	Issue Type +	En	Location *	LS	
Category	Supplemental			GPS Latitude/Longitude		
				Start	End	
Item	DWR UCIP Field Study			37.239098 °	37.239098 °	
				-120.751774 °	-120.751774 °	
DWR ID						
Comment Code						
Inspector Comment						
FS_ID:39875						
DS_ID:19863						
EP_NO: N/A						
Repair Type: Non-Urgent						
Crossing Status: Found						
UCIP Comments: Clear vegetation from waterward slope and landward headwall.						
FIELD_STRUCT_DESC: 24-inch CM pipe through levee, 10.9 feet below crown. Flap gate on the waterward end. Concrete headwall on both ends. (USACE-1967). This entry matches the Drainage or Irrigation Structure referenced in O&M manual (HLM 5.34).						
FS Date: 4/18/2014

Overview of levee crown at crossing.

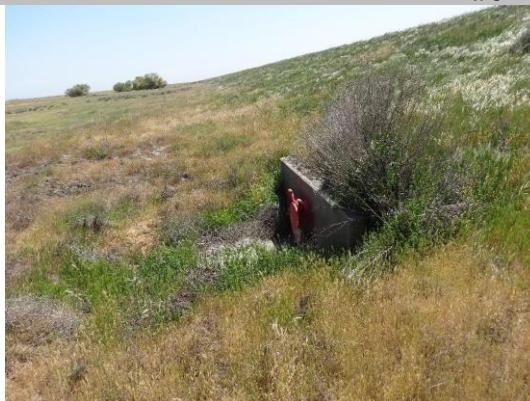
Photo 1 of 2 : UCIP_FA_2016_36611_66441.jpg

Comment Code					
Inspector Comment					
FS_ID:36611					
DS_ID:19864					
EP_NO: N/A					
Repair Type: Non-Urgent					
Crossing Status: Found					
UCIP Comments: Dense vegetation limits the inspector's visibility to identify signs of pipe failure (leaks) along the waterward slope.					
Recommend removing vegetation along pipe alignment to conduct proper inspection of structure. Also recommend removing excess vegetation at landward headwall.					
FIELD_STRUCT_DESC: 24-inch CM pipe through levee, 11.0 feet below crown. Flap gate on the waterward end. Concrete headwall on both ends. (USACE-1967). This entry matches the Drainage or Irrigation Structure referenced in O&M manual (HLM 5.63).					
FS Date: 4/18/2014

Concrete headwall and flap gate visible on waterward toe.

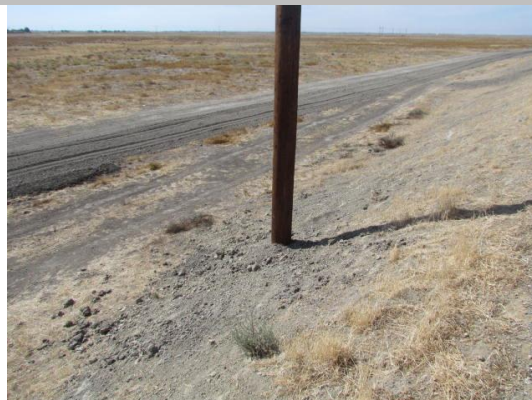
Photo 1 of 2 : FA_2016_NA0010_124_69_20161007_00020.jpg

LM Start	5.93	Rating **	U	Issue No.	69
LM End	6.25	Issue Type +	En	Location *	LS
Category	Earthen Levee			GPS Latitude/Longitude	
				Start	End
Item	Encroachments			37.236936 °	37.235487 °
				-120.740384 °	-120.737685 °
DWR ID	DWR_NA0010_06_f_2015_69				
Comment Code					
PO : Pole					
Inspector Comment					
Several PG& E poles within this section at the landward toe and slope.

Looking at power pole on landward slope.

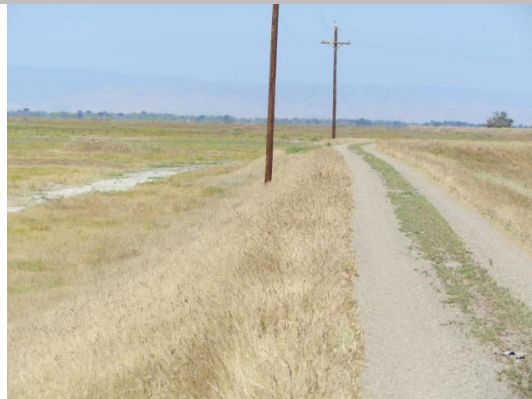
Photo 2 of 2 : FA_2016_NA0010_124_69_20161007_00021.jpg

LM Start	5.93	Rating **	U	Issue No.	69 (cont)	
LM End	6.25	Issue Type +	En	Location *	LS	
Category	Earthen Levee			GPS Latitude/Longitude		
				Start		End
Item	Encroachments			37.236936 °		37.235487 °
				-120.740384 °		-120.737685 °
DWR ID	DWR_NA0010_06_f_2015_69					
Comment Code						
PO : Pole						
Inspector Comment						
Several PG& E poles within this section at the landward toe and slope.

Looking west at several PG&E poles on landward slope.

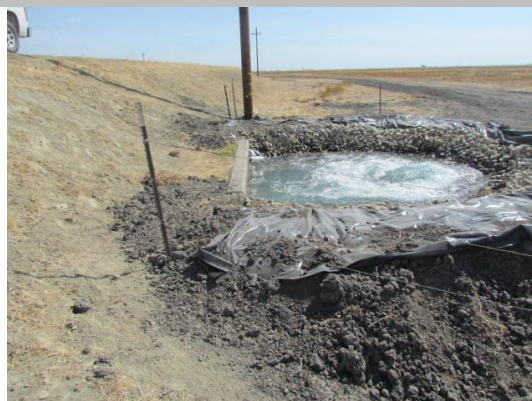
Photo 1 of 5 : FA_2016_NA0010_124_70_20161007_00022.jpg

LM Start	5.98	Rating **	U	Issue No.	70
LM End	5.98	Issue Type +	En	Location *	LS
Category	Earthen Levee			GPS Latitude/Longitude	
				Start	End
Item	Encroachments			37.236382 °	37.236382 °
				-120.739709 °	-120.739709 °
DWR ID	DWR_NA0010_06_f_2015_70				
Comment Code					
PI : Pipe					
Inspector Comment					
Pipe from well at 15ft line with dyke around pipe to close to landward toe.

Looking south at dyke connected to drainage structure at landward toe.

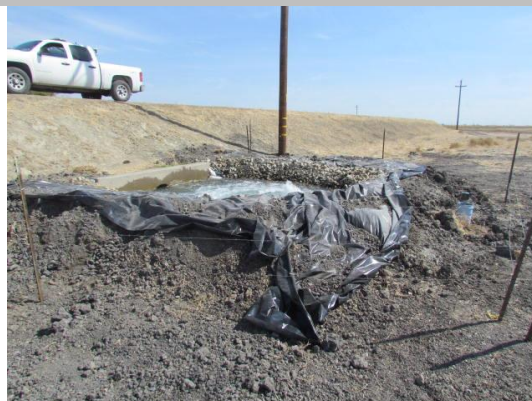
Photo 2 of 5 : FA_2016_NA0010_124_70_20161007_00023.jpg

Looking southwest at dyke connected to drainage structure at landward toe.

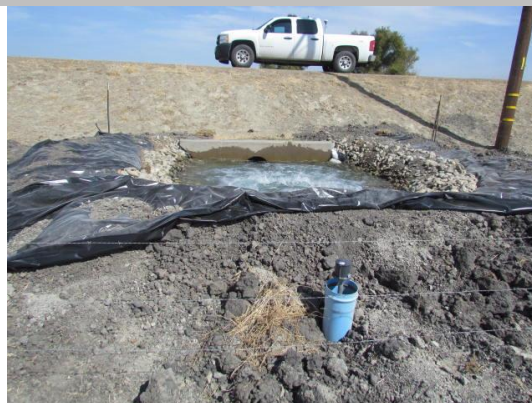
Photo 3 of 5 : FA_2016_NA0010_124_70_20161007_00024.jpg

Looking west at dyke connected to drainage structure at landward toe.

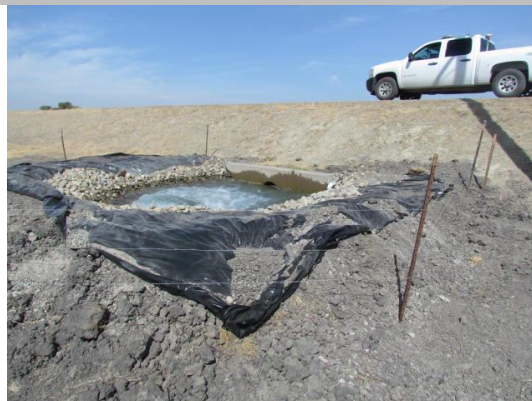
Photo 4 of 5 : FA_2016_NA0010_124_70_20161007_00025.jpg

Looking northwest at dyke connected to drainage structure at landward toe.
