**Flood Control Project Maintenance
Levee Inspections**

Fall 2016 Levee Maintenance Deficiency Summary Report

San Joaquin River Basin

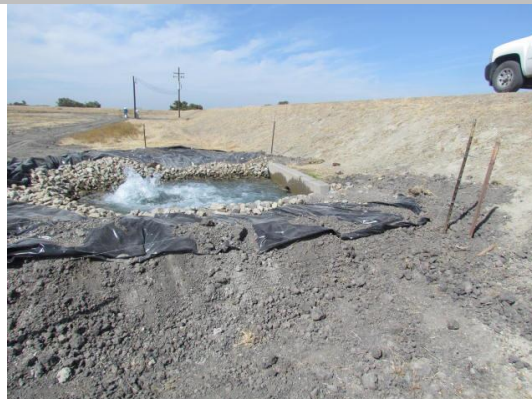
Photo 5 of 5 : FA_2016_NA0010_124_70_20161007_00026.jpg

LM Start	5.98	Rating **	U	Issue No.	70 (cont)	
LM End	5.98	Issue Type +	En	Location *	LS	
Category	Earthen Levee			GPS Latitude/Longitude		
				Start	End	
Item	Encroachments			37.236382 °	37.236382 °	
				-120.739709 °	-120.739709 °	
DWR ID	DWR_NA0010_06_f_2015_70					
Comment Code						
PI : Pipe						
Inspector Comment						
Pipe from well at 15ft line with dyke around pipe to close to landward toe.

Looking north at dyke connected to drainage structure at landward toe.

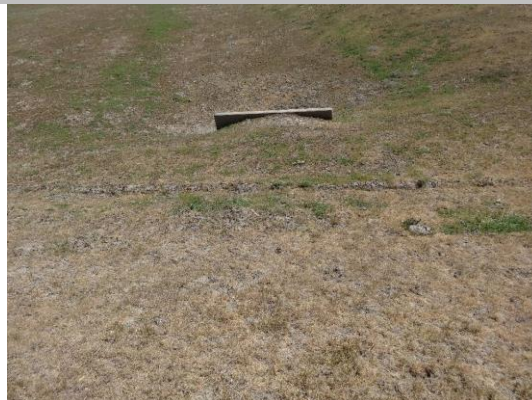
Photo 1 of 2 : UCIP_FA_2016_39472_66462.jpg

LM Start	7.66	Rating **	M	Issue No.	1220
LM End	7.66	Issue Type +	En	Location *	LS
Category	Supplemental			GPS Latitude/Longitude	
				Start	End
Item	DWR UCIP Field Study			37.222743 °	37.222743 °
				-120.716416 °	-120.716416 °
DWR ID					
Comment Code					
Inspector Comment					
FS_ID:39472 DS_ID:19869 EP_NO: N/A Repair Type: Non-Urgent Crossing Status: Found UCIP Comments: Some sediment buildup in pipe visible on landward side--recommend clearing. FIELD_STRUCT_DESC: 24-inch CM pipe through levee, 11.8 feet below crown. Flap gate on the waterward end. Concrete headwall on both ends. (USACE-1967). This entry matches the Drainage or Irrigation Structure referenced in O&M manual (HLM 7.74). Skewed crossing FS Date: 4/18/2014

View of waterward side.

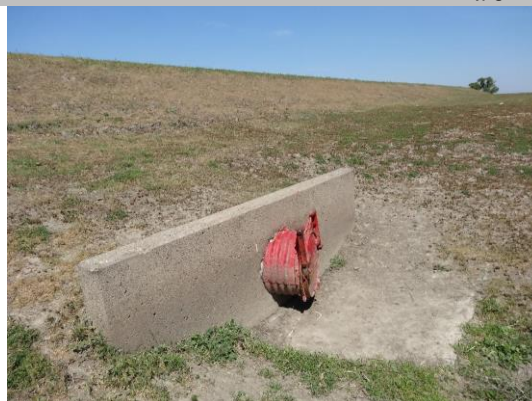
Photo 2 of 2 : UCIP_FA_2016_39472_66461.jpg

LM Start	7.66	Rating **	M	Issue No.	1220 (cont)
LM End	7.66	Issue Type +	En	Location *	LS
Category	Supplemental			GPS Latitude/Longitude	
				Start	End
Item	DWR UCIP Field Study			37.222743 °	37.222743 °
				-120.716416 °	-120.716416 °
DWR ID					
Comment Code					
Inspector Comment					
FS_ID:39472 DS_ID:19869 EP_NO: N/A Repair Type: Non-Urgent Crossing Status: Found UCIP Comments: Some sediment buildup in pipe visible on landward side--recommend clearing. FIELD_STRUCT_DESC: 24-inch CM pipe through levee, 11.8 feet below crown. Flap gate on the waterward end. Concrete headwall on both ends. (USACE-1967). This entry matches the Drainage or Irrigation Structure referenced in O&M manual (HLM 7.74). Skewed crossing FS Date: 4/18/2014

Pipe crosses levee at an angle.

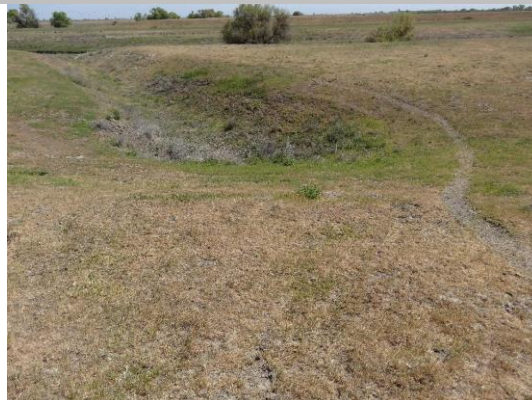
Photo 1 of 2 : UCIP_FA_2016_39473_61674.jpg

LM Start	8.13	Rating **	M	Issue No.	1221
LM End	8.13	Issue Type +	En	Location *	LS
Category	Supplemental			GPS Latitude/Longitude	
				Start	End
Item	DWR UCIP Field Study			37.216547 °	37.216547 °
				-120.713000 °	-120.713000 °
DWR ID					
Comment Code					
Inspector Comment					
FS_ID:39473 DS_ID:19870 EP_NO: N/A Repair Type: Non-Urgent Crossing Status: Found UCIP Comments: Sediment buildup in pipe--recommend contacting owner to clear sediment. FIELD_STRUCT_DESC: 24-inch CM pipe through levee, 16.5 feet below crown. Flap gate on the waterward end. Concrete headwall on both ends. (USACE-1967). This entry matches the Drainage or Irrigation Structure referenced in O&M manual (HLM 8.21). FS Date: 4/18/2014

View of waterward side.

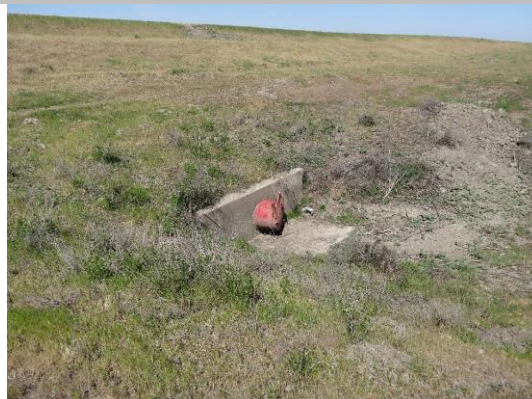
Photo 2 of 2 : UCIP_FA_2016_39473_61673.jpg

LM Start	8.13	Rating **	M	Issue No.	1221 (cont)	
LM End	8.13	Issue Type +	En	Location *	LS	
Category	Supplemental			GPS Latitude/Longitude		
				Start	End	
Item	DWR UCIP Field Study			37.216547 °	37.216547 °	
				-120.713000 °	-120.713000 °	
DWR ID						
Comment Code						
Inspector Comment						
FS_ID:39473						
DS_ID:19870						
EP_NO: N/A						
Repair Type: Non-Urgent						
Crossing Status: Found						
UCIP Comments: Sediment buildup in pipe--recommend contacting owner to clear sediment.						
FIELD_STRUCT_DESC: 24-inch CM pipe through levee, 16.5 feet below crown. Flap gate on the waterward end. Concrete headwall on both ends. (USACE-1967). This entry matches the Drainage or Irrigation Structure referenced in O&M manual (HLM 8.21).						
FS Date: 4/18/2014

Pipe crosses levee at an angle.

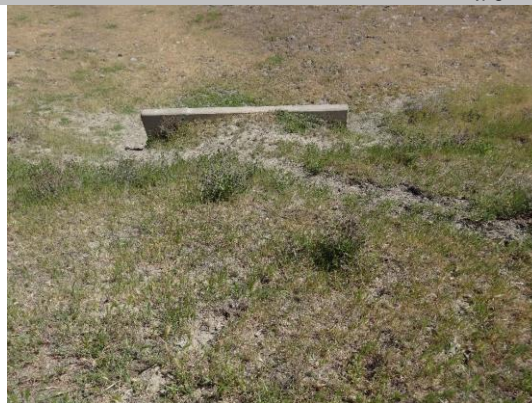
Photo 1 of 2 : UCIP_FA_2016_39474_61685.jpg

Comment Code					
Inspector Comment					
FS_ID:39474					
DS_ID:19871					
EP_NO: N/A					
Repair Type: Non-Urgent					
Crossing Status: Found					
UCIP Comments: Need to contact owner. Sediment buildup in pipe visible on landward side--recommend clearing. Good candidate for pressure test or video inspection due to signs of heavy corrosion. If no leaks after tests this crossing would be a good candidate for rehabilitation.					
FIELD_STRUCT_DESC: 24-inch CM pipe through levee, 9.2 feet below crown. Flap gate on the waterward end. Concrete headwall on both ends. (USACE-1967). This entry matches the Drainage or Irrigation Structure referenced in O&M manual (HLM 8.51).					
FS Date: 4/18/2014

View of waterward side.

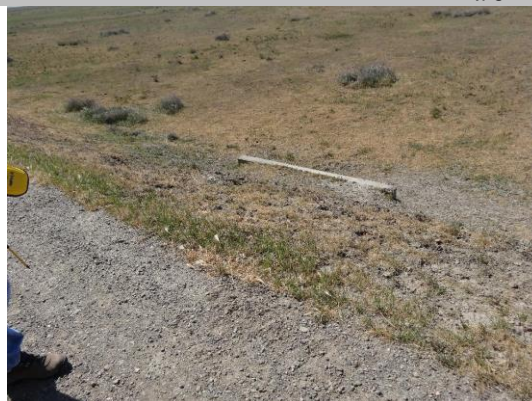
Photo 2 of 2 : UCIP_FA_2016_39474_61684.jpg

Item	DWR UCIP Field Study			37.213288 °	37.213288 °	
				-120.709503 °	-120.709503 °	
DWR ID						
Comment Code						
Inspector Comment						
FS_ID:39474						
DS_ID:19871						
EP_NO: N/A						
Repair Type: Non-Urgent						
Crossing Status: Found						
UCIP Comments: Need to contact owner. Sediment buildup in pipe visible on landward side--recommend clearing. Good candidate for pressure test or video inspection due to signs of heavy corrosion. If no leaks after tests this crossing would be a good candidate for rehabilitation.						
FIELD_STRUCT_DESC: 24-inch CM pipe through levee, 9.2 feet below crown. Flap gate on the waterward end. Concrete headwall on both ends. (USACE-1967). This entry matches the Drainage or Irrigation Structure referenced in O&M manual (HLM 8.51).						
FS Date: 4/18/2014

View of landward side.

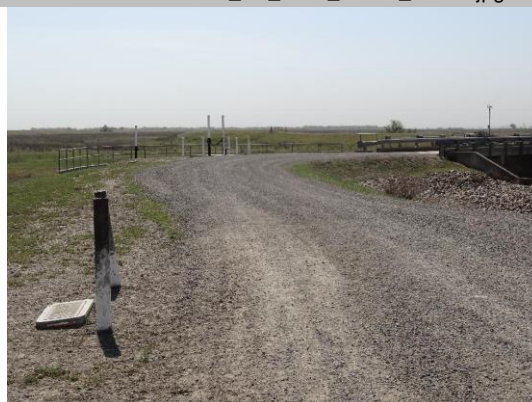
Photo 1 of 2 : UCIP_FA_2016_42525_72925.jpg

LM Start	9.52	Rating **	M	Issue No.	1255
LM End	9.52	Issue Type +	En	Location *	LS
Category	Supplemental			GPS Latitude/Longitude	
				Start	End
Item	DWR UCIP Field Study			37.202481 °	37.202481 °
				-120.695303 °	-120.695303 °
DWR ID					
Comment Code					
Inspector Comment					
FS_ID:42525 DS_ID:19872 EP_NO: N/A Repair Type: Non-Urgent Crossing Status: Indicator Found UCIP Comments: 12/5/14 Accidently missed updating record. Photos have been added and coordinates have been updated. Unable to confirm if crossing is the same cable line originally identified in desk study at levee mile 6.43. Recommend contacting owner to confirm alignment, size of conduit, and permit issued. FIELD_STRUCT_DESC: Buried telephone cable under crown of roadway. FS Date: 4/18/2014

Service box located on waterward levee shoulder.

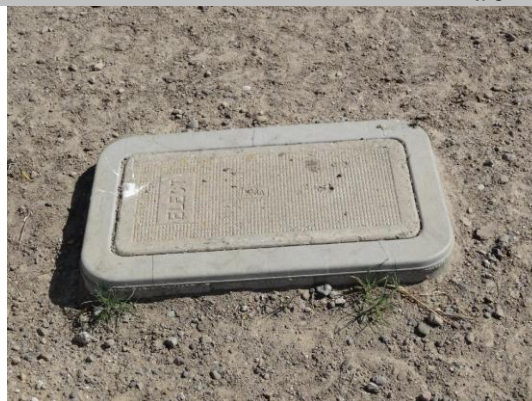
Photo 2 of 2 : UCIP_FA_2016_42525_72924.jpg

LM Start	9.52	Rating **	M	Issue No.	1255 (cont)
LM End	9.52	Issue Type +	En	Location *	LS
Category	Supplemental			GPS Latitude/Longitude	
				Start	End
Item	DWR UCIP Field Study			37.202481 °	37.202481 °
				-120.695303 °	-120.695303 °
DWR ID					
Comment Code					
Inspector Comment					
FS_ID:42525 DS_ID:19872 EP_NO: N/A Repair Type: Non-Urgent Crossing Status: Indicator Found UCIP Comments: 12/5/14 Accidently missed updating record. Photos have been added and coordinates have been updated. Unable to confirm if crossing is the same cable line originally identified in desk study at levee mile 6.43. Recommend contacting owner to confirm alignment, size of conduit, and permit issued. FIELD_STRUCT_DESC: Buried telephone cable under crown of roadway. FS Date: 4/18/2014

Service box is for electrical conduit.

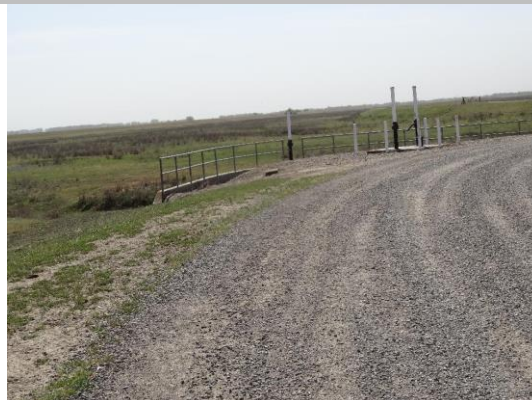
Photo 1 of 2 : UCIP_FA_2016_42524_72922.jpg

LM Start	9.56	Rating **	M	Issue No.	1254
LM End	9.56	Issue Type +	En	Location *	LS
Category	Supplemental			GPS Latitude/Longitude	
				Start	End
Item	DWR UCIP Field Study			37.202014 °	37.202014 °
				-120.694820 °	-120.694820 °
DWR ID					
Comment Code					
Inspector Comment					
FS_ID:42524 DS_ID:19873 EP_NO: N/A Repair Type: Non-Urgent Crossing Status: Found UCIP Comments: 12/5/14 Accidently missed entry. Photos have been added and coordinates have been updated by Olivia Magana. Unable to determine condition of crossing due to limited access. Recommend contacting owner to provide condition of crossing. FIELD_STRUCT_DESC: 36-inch CM pipe through levee, 14.0 feet below crown. Slide gate in concrete diversion box on the waterward shoulder. FS Date: 4/18/2014

Overview of levee crown looking upstream.

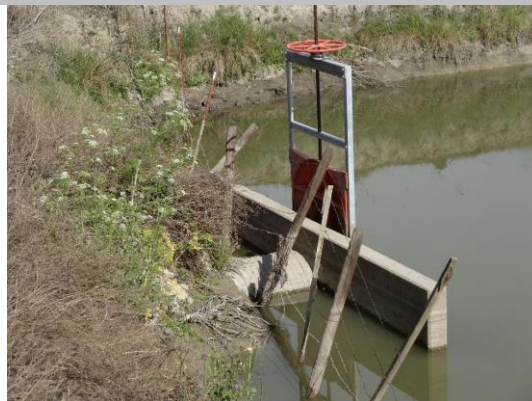
Photo 2 of 2 : UCIP_FA_2016_39475_61690.jpg

Pipe, slide gate, and concrete headwall visible on landward side.

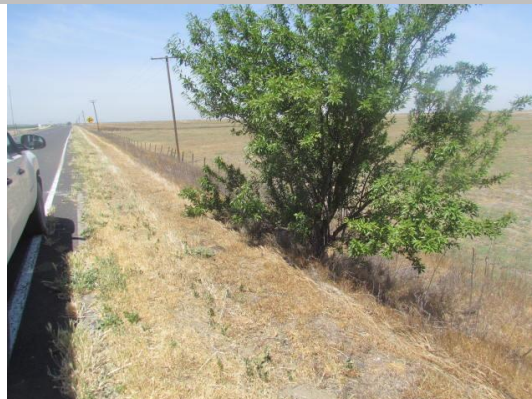
Photo 1 of 1 : FA_2016_NA0010_124_14_20161007_00018.jpg

LM Start	11.49	Rating **	M	Issue No.	14
LM End	11.49	Issue Type +	Ma	Location *	WS
Category	Earthen Levee			GPS Latitude/Longitude	
				Start	End
Item	Trim / Thin Trees			37.186189 °	37.186189 °
				-120.668476 °	-120.668476 °
DWR ID	DWR_NA0010_06_s_2015_14				
Comment Code					
T1 : Trim trees to at least five feet above ground level.					
Inspector Comment					
Almond tree located along Sandy Mush Rd. on waterward slope.

Looking west at tree on waterward slope.

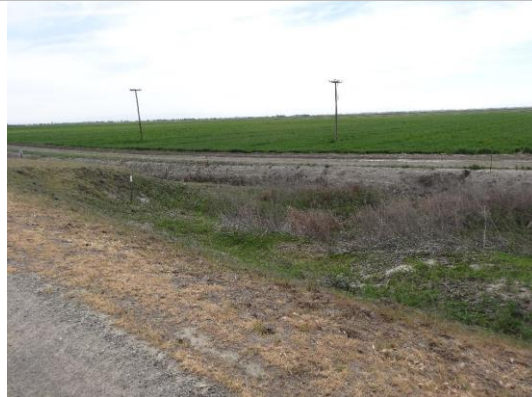
Photo 2 of 2 : UCIP_FA_2016_39476_66487.jpg

View of landward side.

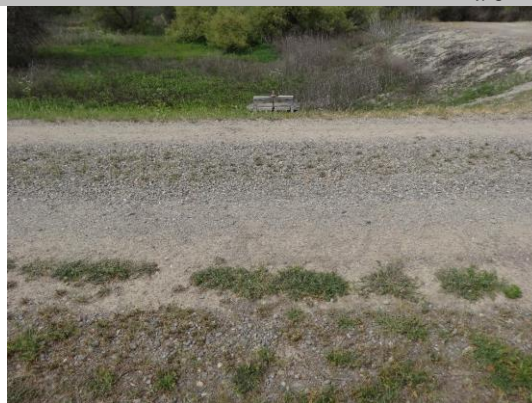
Photo 1 of 2 : UCIP_FA_2016_39477_66492.jpg

LM Start	13.22	Rating **	M	Issue No.	1225
LM End	13.22	Issue Type +	En	Location *	WS
Category	Supplemental			GPS Latitude/Longitude	
				Start	End
Item	DWR UCIP Field Study			37.171675 °	37.171675 °
				-120.655064 °	-120.655064 °
DWR ID					
Comment Code					
Inspector Comment					
FS_ID:39477					
DS_ID:19877					
EP_NO: N/A					
Repair Type: Non-Urgent					
Crossing Status: Found					
UCIP Comments: Not accessible--crossing is buried on landward side.					
Need to contact owner to determine status.					
FIELD_STRUCT_DESC: 24-inch CM pipe through levee, 10.8 feet below crown. Flap gate on the waterward end. (USACE-1967). This entry matches the Drainage or Irrigation Structure referenced in O&M manual (HLM 13.30).					
FS Date: 4/17/2014

View of levee crown at crossing.

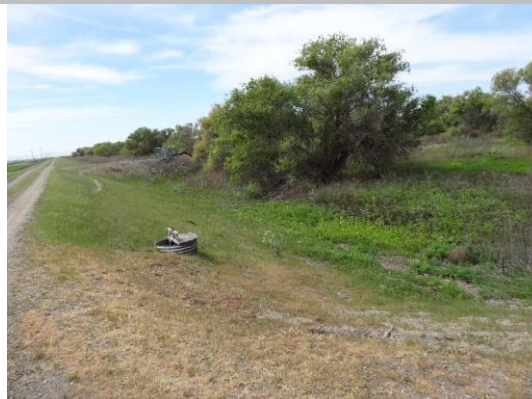
Photo 2 of 2 : UCIP_FA_2016_39477_66494.jpg

LM Start	13.22	Rating **	M	Issue No.	1225 (cont)
LM End	13.22	Issue Type +	En	Location *	WS
Category	Supplemental			GPS Latitude/Longitude	
				Start	End
Item	DWR UCIP Field Study			37.171675 °	37.171675 °
				-120.655064 °	-120.655064 °
DWR ID					
Comment Code					
Inspector Comment					
FS_ID:39477					
DS_ID:19877					
EP_NO: N/A					
Repair Type: Non-Urgent					
Crossing Status: Found					
UCIP Comments: Not accessible--crossing is buried on landward side.					
Need to contact owner to determine status.					
FIELD_STRUCT_DESC: 24-inch CM pipe through levee, 10.8 feet below crown. Flap gate on the waterward end. (USACE-1967). This entry matches the Drainage or Irrigation Structure referenced in O&M manual (HLM 13.30).					
FS Date: 4/17/2014

View of waterward slope.

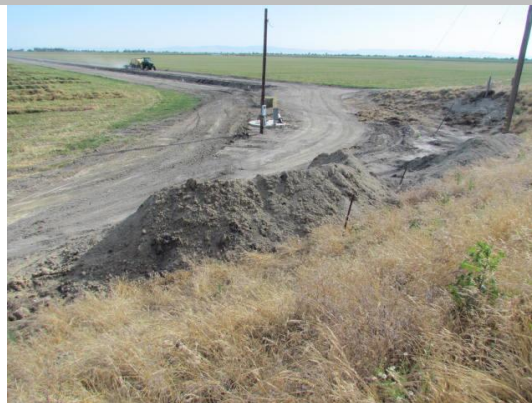
Photo 1 of 1 : FA_2016_NA0010_124_68_20161007_00019.jpg

LM Start	13.24	Rating **	M	Issue No.	68
LM End	13.24	Issue Type +	En	Location *	LS
Category	Earthen Levee			GPS Latitude/Longitude	
				Start	End
Item	Encroachments			37.171686 °	37.171686 °
				-120.654562 °	-120.654562 °
DWR ID	DWR_NA0010_06_f_2015_68				
Comment Code					
MA : Material					
Inspector Comment					
Landowner stockpile dirt at landward toe.

Looking west at dirt stockpile at landward toe.

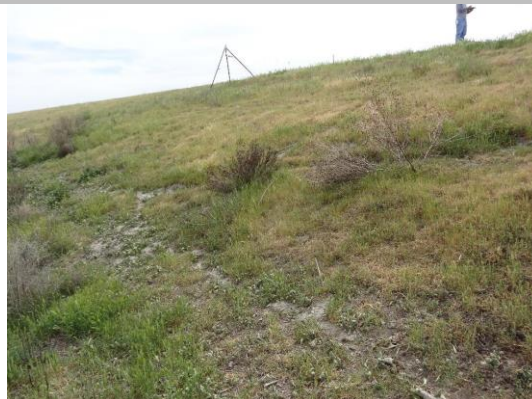
Photo 1 of 2 : UCIP_FA_2016_39478_66496.jpg

LM Start	14.36	Rating **	M	Issue No.	1226
LM End	14.36	Issue Type +	En	Location *	LS
Category	Supplemental			GPS Latitude/Longitude	
				Start	End
Item	DWR UCIP Field Study			37.167888 °	37.167888 °
				-120.636419 °	-120.636419 °
DWR ID					
Comment Code					
Inspector Comment					
FS_ID:39478 DS_ID:19878 EP_NO: N/A Repair Type: Non-Urgent Crossing Status: Found UCIP Comments: Not accessible--crossing is buried on landward side. Need to contact owner to determine status. FIELD_STRUCT_DESC: 24-inch CM pipe through levee, 12.3 feet below crown. Flap gate on the waterward end. (USACE-1967). This entry matches the Drainage or Irrigation Structure referenced in O&M manual (HLM 14.44). FS Date: 4/17/2014

View of waterward slope.

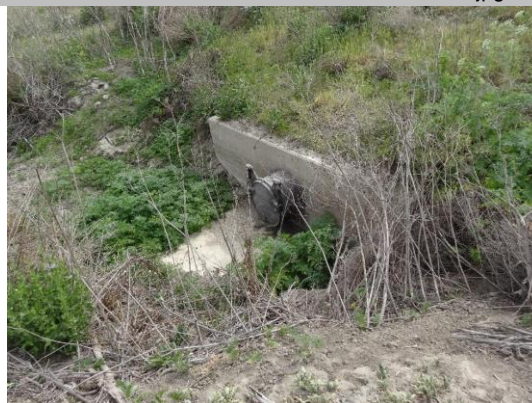
Photo 2 of 2 : UCIP_FA_2016_39478_66497.jpg

View of pipe daylight, flap gate, and concrete headwall visible on waterward toe.

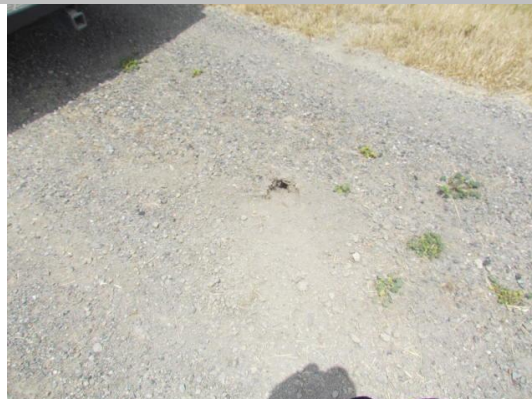
Photo 1 of 1 : FA_2016_NA0010_124_1212_20161007_00040.jpg

LM Start	14.94	Rating **	M	Issue No.	1212
LM End	14.94	Issue Type +	Ma	Location *	CR
Category	Earthen Levee			GPS Latitude/Longitude	
				Start	End
Item	Animal Control			37.162287 °	37.162287 °
				-120.628791 °	-120.628791 °
DWR ID	DWR_NA0010_06_s_2015_1212				
Comment Code					
A3 : No rodents visible, but rodent burrows visible; need to backfill and compact or grout burrows.					
Inspector Comment					
Several rodent holes noted on levee crown and landside and waterside slopes.

Looking at rodent hole on levee crown.

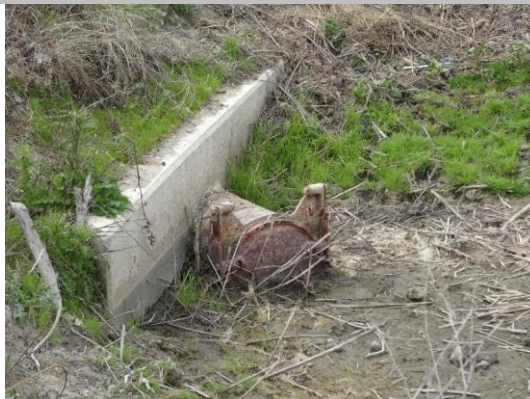
Photo 1 of 2 : UCIP_FA_2016_39480_66507.jpg

LM Start	15.68	Rating **	M	Issue No.	1227
LM End	15.68	Issue Type +	En	Location *	LS
Category	Supplemental			GPS Latitude/Longitude	
				Start	End
Item	DWR UCIP Field Study			37.156934 °	37.156934 °
				-120.617210 °	-120.617210 °
DWR ID					
Comment Code					
Inspector Comment					
FS_ID:39480 DS_ID:19884 EP_NO: N/A Repair Type: Non-Urgent Crossing Status: Found UCIP Comments: Need to contact owner. Sediment buildup on both the waterward and landward side. Recommend removing sediment buildup from both side. Also recommend clearing excess sediment inside crossing. FIELD_STRUCT_DESC: 24-inch CM pipe through levee, 14.0 feet below crown. Flap gate on the waterward end. (USACE-1967). This entry matches the Drainage or Irrigation Structure referenced in O&M manual (HLM 15.76). FS Date: 4/17/2014

Flap gate buried halfway on waterward side.

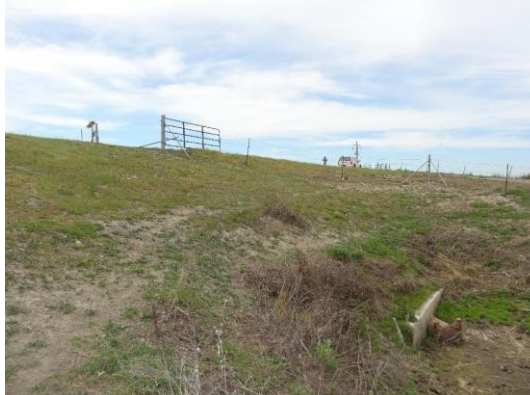
Photo 2 of 2 : UCIP_FA_2016_39480_66506.jpg

View of waterward side.

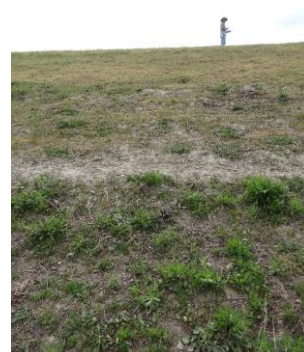
Photo 1 of 2 : UCIP_FA_2016_36663_66530.jpg

LM Start	15.82	Rating **	M	Issue No.	1242
LM End	15.82	Issue Type +	En	Location *	LS
Category	Supplemental			GPS Latitude/Longitude	
				Start	End
Item	DWR UCIP Field Study			37.155539 °	37.155539 °
				-120.615303 °	-120.615303 °
DWR ID					
Comment Code					
Inspector Comment					
FS_ID:36663 DS_ID:19885 EP_NO: N/A Repair Type: Non-Urgent Crossing Status: Found UCIP Comments: Need to contact owner to determine status of crossing. Waterward side is buried and not accessible. Landward side headwall is blocked by dense vegetation. Recommend confirming status of flap gate on waterward side and removing dense vegetation form landward side. FIELD_STRUCT_DESC: 36-inch CM pipe through levee, 16.6 feet below crown. Flap gate on the waterward end. (USACE-1967). This entry matches the Drainage or Irrigation Structure referenced in O&M manual (HLM 15.91). FS Date: 4/17/2014

View of waterward side, Photo 1 of 3.

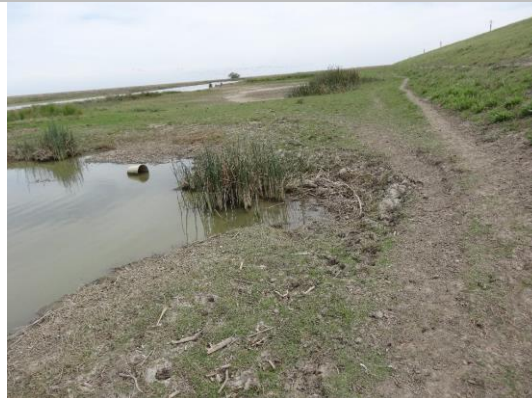
Photo 2 of 2 : UCIP_FA_2016_36663_66526.jpg

View of waterward side, photo 2 of 3.

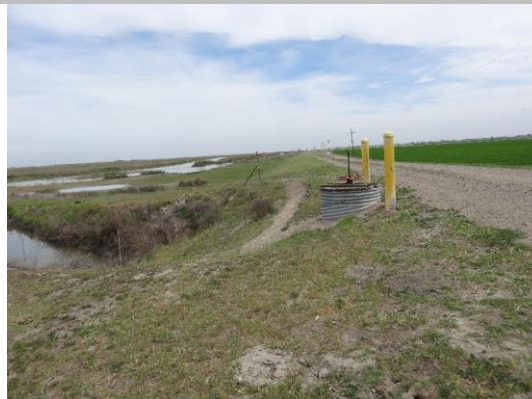
Photo 1 of 2 : UCIP_FA_2016_36665_66541.jpg

LM Start	16.40	Rating **	M	Issue No.	1243
LM End	16.40	Issue Type +	En	Location *	LS
Category	Supplemental			GPS Latitude/Longitude	
				Start	End
Item	DWR UCIP Field Study			37.149747 °	37.149747 °
				-120.607702 °	-120.607702 °
DWR ID					
Comment Code					
Inspector Comment					
FS_ID:36665					
DS_ID:19559					
EP_NO: N/A					
Repair Type: Non-Urgent					
Crossing Status: Found					
UCIP Comments: Need to contact owner to determine status of crossing. Unable to confirm pipe diameter.					
FIELD_STRUCT_DESC: 36-inch CM pipe through the levee, 5.9 feet below the crown. Slide gate on the waterward side. Siphon extends under channel. (USACE-1967). This entry matches the Drainage or Irrigation Structure referenced in O&M manual (HLM 16.49).					
FS Date: 4/17/2014

View of waterward side.

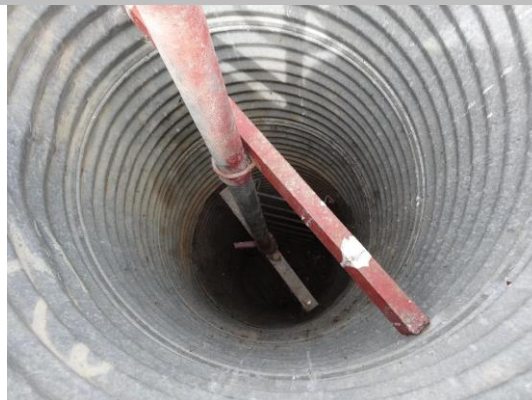
Photo 2 of 2 : UCIP_FA_2016_36687_66582.jpg

Inside view of CMP riser located on waterward slope.

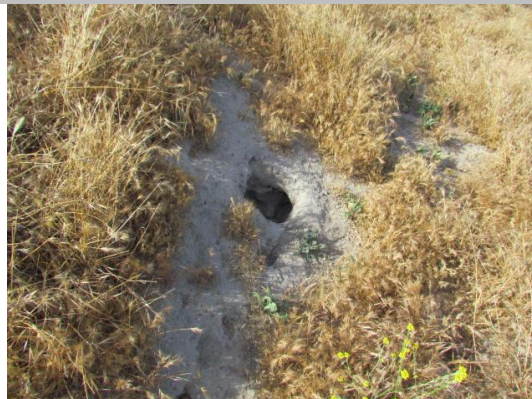
Photo 1 of 5 : FA_2016_NA0010_124_1211_20161007_00035.jpg

LM Start	19.14	Rating **	U	Issue No.	1211
LM End	19.14	Issue Type +	Ma	Location *	WS
Category	Earthen Levee			GPS Latitude/Longitude	
				Start	End
Item	Animal Control			37.114793 °	37.114793 °
				-120.587582 °	-120.587582 °
DWR ID	DWR_NA0010_06_s_ 2015_1211				
Comment Code					
A1 : Exterminate rodents and backfill and compact or grout burrows.					
Inspector Comment					
Several large rodent holes with more than 2 cubic feet of material was noted on waterward slope

Looking at rodent hole on waterward slope. Spring 2016

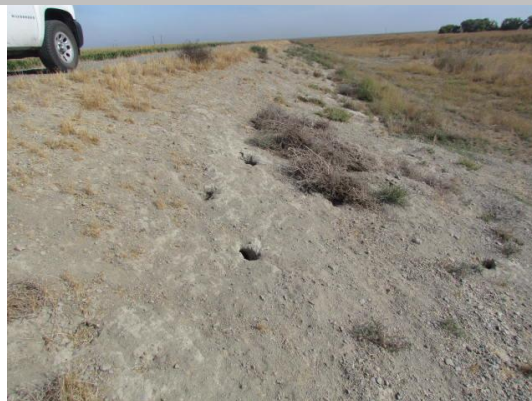
Photo 2 of 5 : FA_2016_NA0010_124_1211_20161007_00036.jpg

Looking at several rodent holes on waterward slope. (Fall 2015)

LM Start	19.14	Rating **	U	Issue No.	1211 (cont)
LM End	19.14	Issue Type +	Ma	Location *	WS
Category	Earthen Levee			GPS Latitude/Longitude	
				Start	End
Item	Animal Control			37.114793 °	37.114793 °
				-120.587582 °	-120.587582 °
DWR ID	DWR_NA0010_06_s_ 2015_1211				
Comment Code					
A1 : Exterminate rodents and backfill and compact or grout burrows.					
Inspector Comment					
Several large rodent holes with more than 2 cubic feet of material was noted on waterward slope

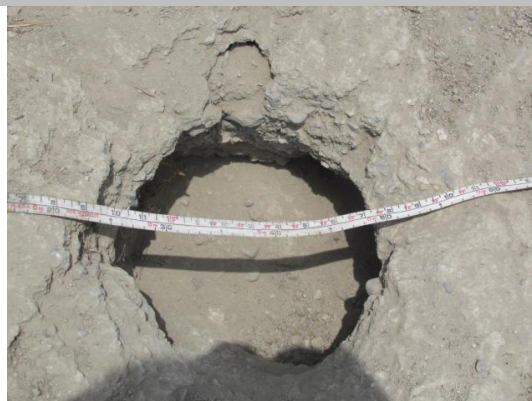
Photo 3 of 5 : FA_2016_NA0010_124_1211_20161007_00037.jpg

Looking at close-up view of large rodent hole on waterward slope.
(Spring 2015)

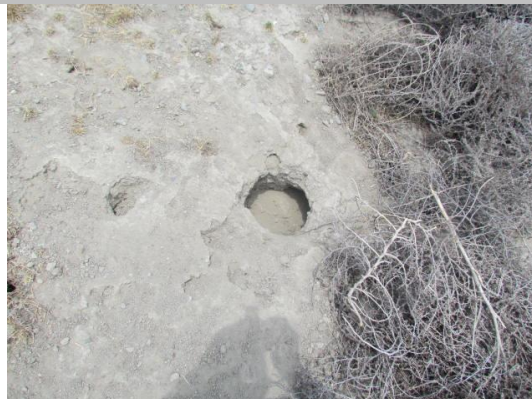
Photo 4 of 5 : FA_2016_NA0010_124_1211_20161007_00038.jpg

Looking at large rodent hole on waterward slope. Spring 2015

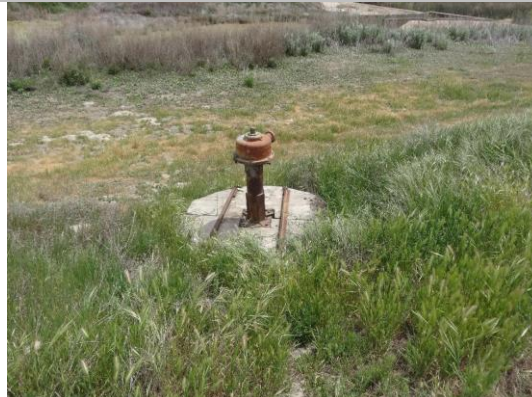
Photo 2 of 2 : UCIP_FA_2016_36688_66584.jpg

Riser located on waterward slope.

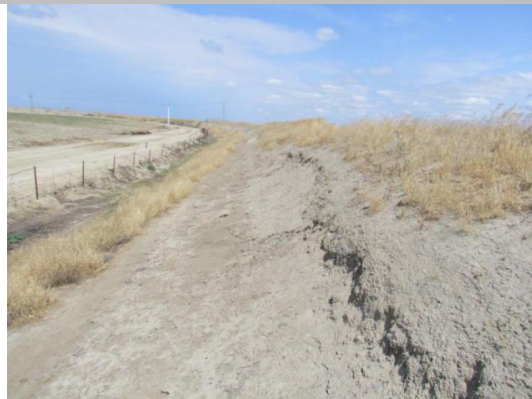
Photo 1 of 2 : FA_2016_NA0010_124_1209_20161007_00033.jpg

LM Start	20.79	Rating **	U	Issue No.	1209
LM End	20.88	Issue Type +	Ma	Location *	LS
Category	Earthen Levee			GPS Latitude/Longitude	
				Start	End
Item	Erosion / Bank Caving			37.113107 °	37.112176 °
				-120.563782 °	-120.562516 °
DWR ID	DWR_NA0010_06_s_ 2015_1209				
Comment Code					
E1 : Note and monitor erosion site.					
Inspector Comment					
Erosion on landward slope greater than 3 inches. Erosion caused by livestock.

Looking north at livestock erosion on landward slope.

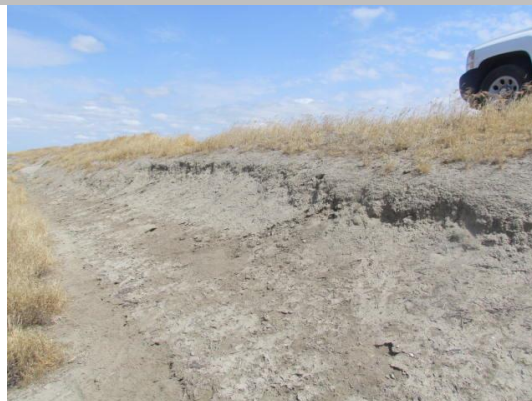
Photo 2 of 2 : FA_2016_NA0010_124_1209_20161007_00034.jpg

Looking northeast at livestock erosion on landward slope.

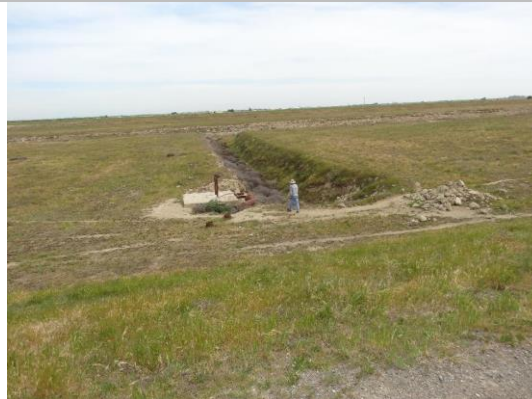
Photo 2 of 2 : UCIP_FA_2016_34010_61870.jpg

View of waterward side.

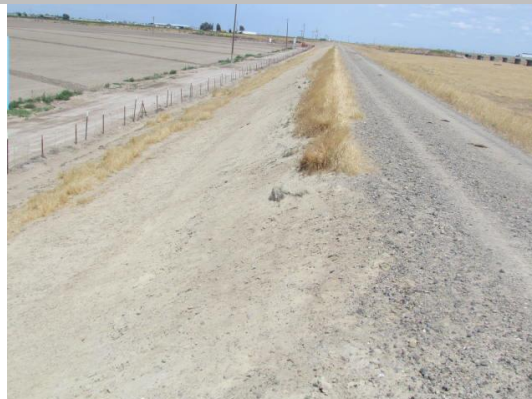
Photo 1 of 3 : FA_2016_NA0010_124_5_20161007_00013.jpg

LM Start	24.58	Rating **	M	Issue No.	5	
LM End	24.93	Issue Type +	Ma	Location *	LS	
Category	Earthen Levee			GPS Latitude/Longitude		
				Start		End
Item	Slope Stability			37.071198 °		°
				-120.519220 °		°
DWR ID	DWR_NA0010_06_s_2012_5					
Comment Code						
S2 : Repair the levee slope damaged by foot traffic and prevent access where possible.						
Inspector Comment						
Landside erosion caused by livestock.

Looking north at livestock erosion on landward slope. (Spring 2015)

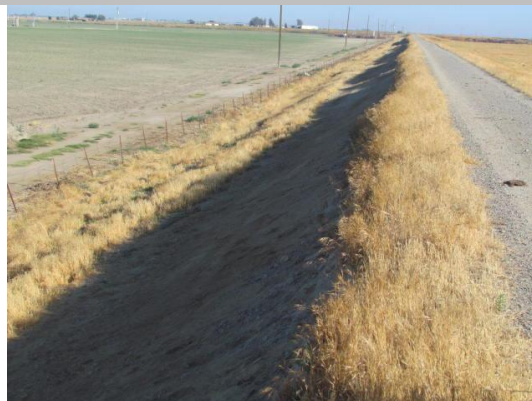
Photo 2 of 3 : FA_2016_NA0010_124_5_20161007_00014.jpg

Looking north at livestock erosion on landward slope. (Spring 2014)

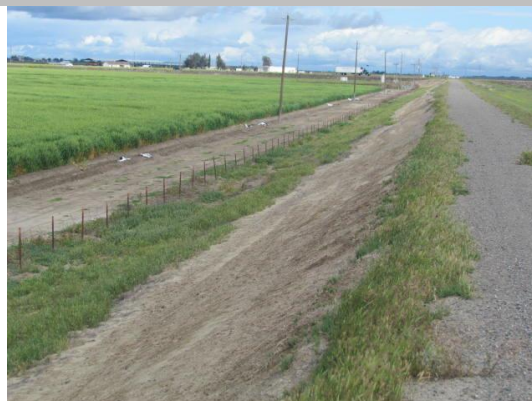
Photo 3 of 3 : FA_2016_NA0010_124_5_20161007_00015.jpg

Looking north at livestock erosion on landside slope. (Fall 2014)

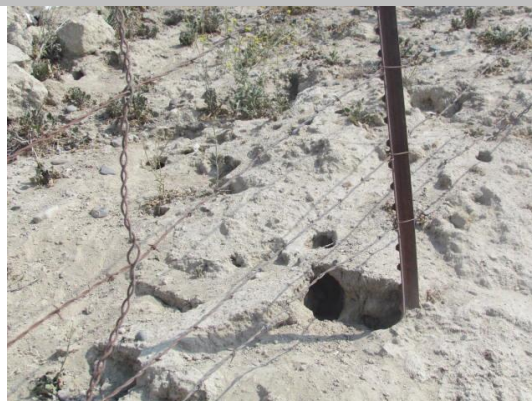
Photo 1 of 1 : FA_2016_NA0010_124_1208_20161007_00032.jpg

LM Start	26.13	Rating **	M	Issue No.	1208
LM End	26.13	Issue Type +	Ma	Location *	LS
Category	Earthen Levee			GPS Latitude/Longitude	
				Start	End
Item	Animal Control			37.054222 °	37.054222 °
				-120.500862 °	-120.500862 °
DWR ID	DWR_NA0010_06_s_2015_1208				
Comment Code					
A1 : Exterminate rodents and backfill and compact or grout burrows.					
Inspector Comment					
Noted several rodent holes next to and within rock revetment on landward slope.

Rodent holes on landward slope.

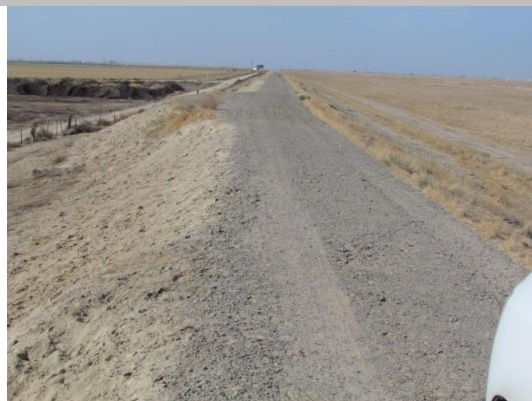
Photo 1 of 4 : FA_2016_NA0010_124_3_20161007_00009.jpg

LM Start	27.64	Rating **	M	Issue No.	3
LM End	27.97	Issue Type +	Ma	Location *	LS
Category	Earthen Levee			GPS Latitude/Longitude	
				Start	End
Item	Slope Stability			37.036955 °	37.032887 °
				-120.484395 °	-120.481225 °
DWR ID	DWR_NA0010_06_s_2012_3				
Comment Code					
S2 : Repair the levee slope damaged by foot traffic and prevent access where possible.					
Inspector Comment					
Landside erosion caused by livestock. Erosion greater than 3" in depth on landward slope. Levee crown has narrowed within this reach.

Looking north at livestock erosion on landward slope. Fall 2015

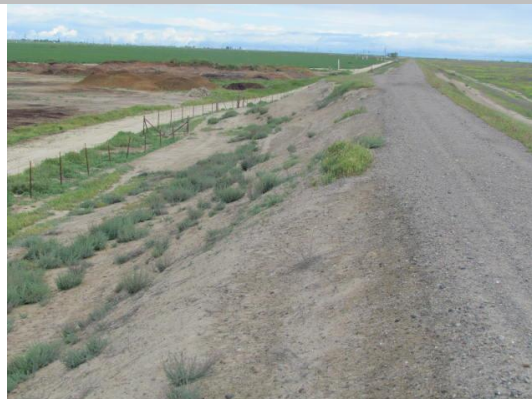
Photo 3 of 4 : FA_2016_NA0010_124_3_20161007_00011.jpg

LM Start	27.64	Rating **	M	Issue No.	3 (cont)	
LM End	27.97	Issue Type +	Ma	Location *	LS	
Category	Earthen Levee			GPS Latitude/Longitude		
				Start		End
Item	Slope Stability			37.036955 °		37.032887 °
				-120.484395 °		-120.481225 °
DWR ID	DWR_NA0010_06_s_2012_3					
Comment Code						
S2 : Repair the levee slope damaged by foot traffic and prevent access where possible.						
Inspector Comment						
Landside erosion caused by livestock. Erosion greater than 3" in depth on landward slope. Levee crown has narrowed within this reach.

Looking north at livestock erosion on landside shoulder and slope. (Fall 2014)

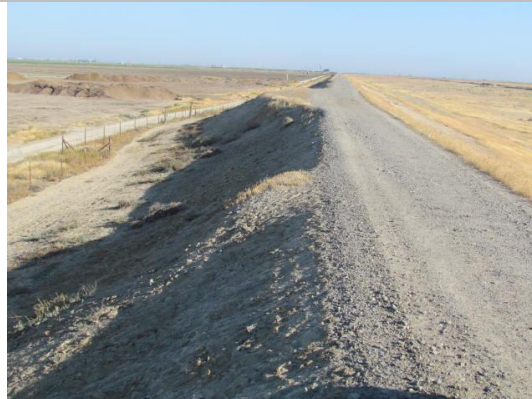
Photo 4 of 4 : FA_2016_NA0010_124_3_20161007_00012.jpg

Looking north at livestock erosion on landward slope. (Spring 2013)

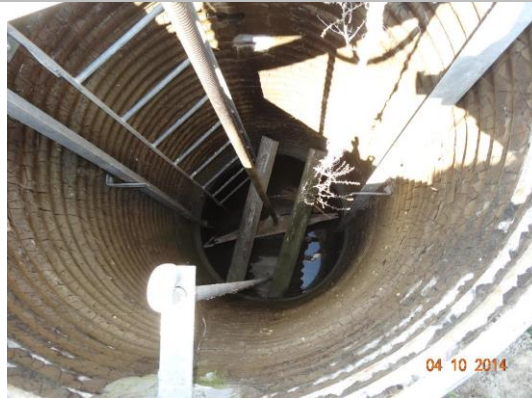
Photo 2 of 2 : UCIP_FA_2016_39886_66603.jpg

Inside view of CMP riser located on waterward slope.

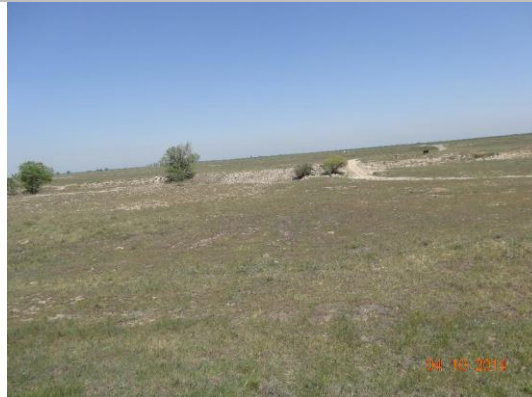
Photo 2 of 2 : UCIP_FA_2016_36693_66604.jpg

Overview of Eastside Bypass at crossing.

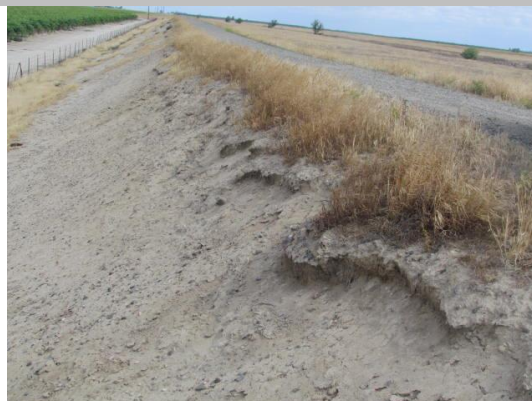
Photo 1 of 2 : FA_2016_NA0010_124_1207_20161007_00030.jpg

LM Start	30.81	Rating **	U	Issue No.	1207
LM End	31.06	Issue Type +	Ma	Location *	LS
Category	Earthen Levee			GPS Latitude/Longitude	
				Start	End
Item	Erosion / Bank Caving			37.021615 °	37.018428 °
				-120.437587 °	-120.435378 °
DWR ID	DWR_NA0010_06_s_ 2015_1207				
Comment Code					
E1 : Note and monitor erosion site.					
Inspector Comment					
Landward erosion greater than 1" in depth and greater than 3" in length.					
Erosion caused by livestock traffic.

Looking northeast at livestock erosion on landward slope.

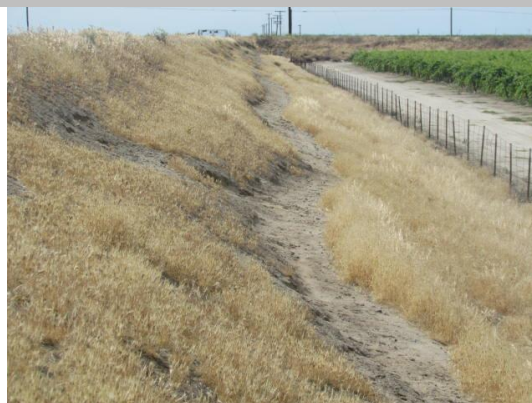
Photo 2 of 2 : FA_2016_NA0010_124_1207_20161007_00031.jpg

Looking south at livestock erosion on landward slope.

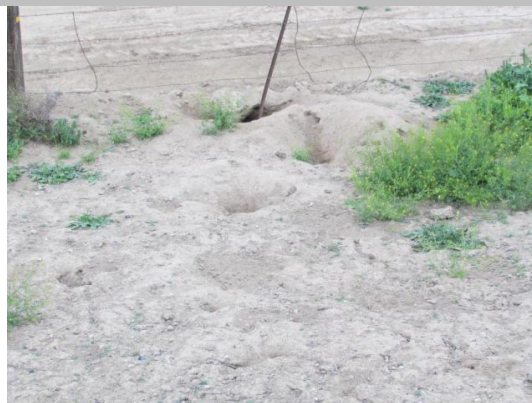
Photo 1 of 2 : FA_2016_NA0010_124_2_20161007_00007.jpg

LM Start	31.10	Rating **	U	Issue No.	2
LM End	31.10	Issue Type +	Ma	Location *	LS
Category	Earthen Levee			GPS Latitude/Longitude	
				Start	End
Item	Animal Control			37.017955 °	37.017955 °
				-120.435017 °	-120.435017 °
DWR ID	DWR_NA0010_06_s_2012_2				
Comment Code					
A1 : Exterminate rodents and backfill and compact or grout burrows.					
Inspector Comment

Looking west at rodent holes on landside slope and toe near fence line.

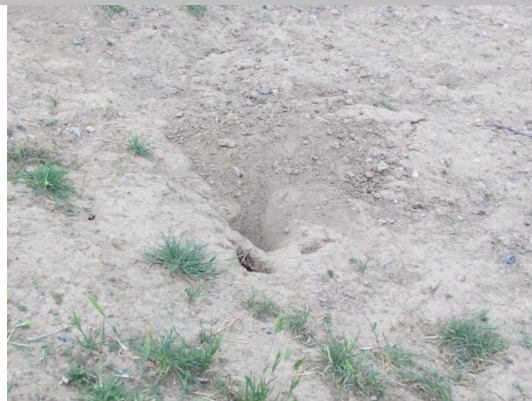
Photo 2 of 2 : FA_2016_NA0010_124_2_20161007_00008.jpg

Looking at typical rodent hole on landside slope.

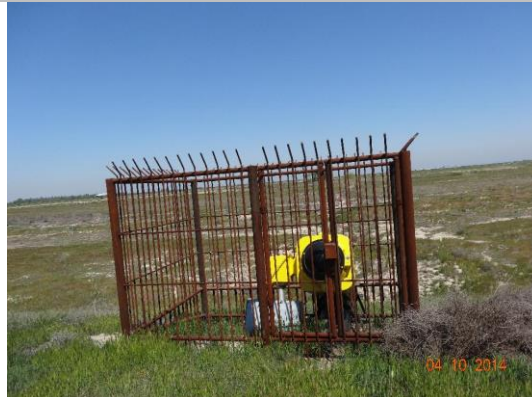
Photo 2 of 2 : UCIP_FA_2016_46183_61902.jpg

Electrical conduit visible on waterward slope.

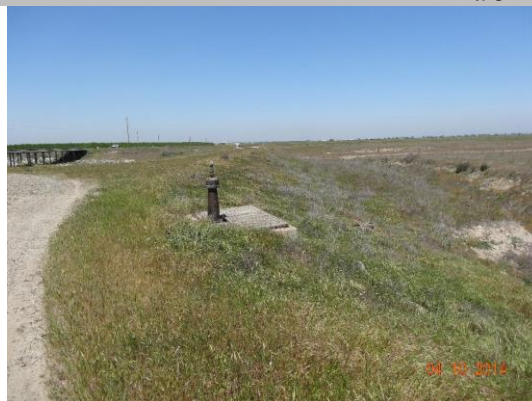
Photo 1 of 2 : UCIP_FA_2016_39481_66628.jpg

Comment Code					
Inspector Comment					
FS_ID:39481 DS_ID:19813 EP_NO: N/A Repair Type: Non-Urgent Crossing Status: Found UCIP Comments: Dense vegetation limits the inspector's visibility to identify signs of pipe failure (leaks) along the slope. Recommend removing vegetation along pipe alignment to conduct proper inspection of structure and appurtenances. High vegetation along crossing alignment--recommend removing vegetation along pipe crossing. FIELD_STRUCT_DESC: 48x72-inch through the levee, 15.1 feet below the crown. Slide gate in concrete riser in the waterward slope. Concrete "U" headwall on both ends. Landside channel cobble revetted for 8.0 feet. (USACE-1967). This entry matches the Drainage or Irrigation Structure referenced in O&M manual (HLM 35.33). FS Date: 4/10/2014

View of waterward side--slide gate inside concrete box.

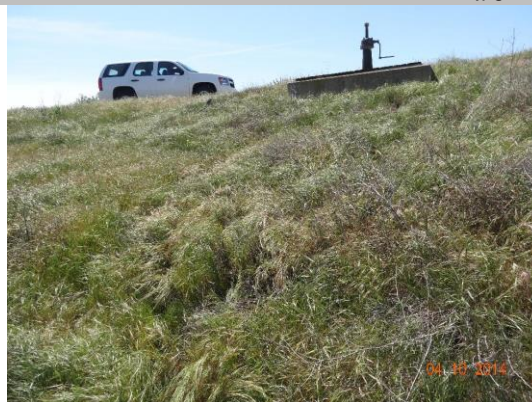
Photo 2 of 2 : UCIP_FA_2016_39481_66632.jpg

View of waterward slope covered by dense vegetation.

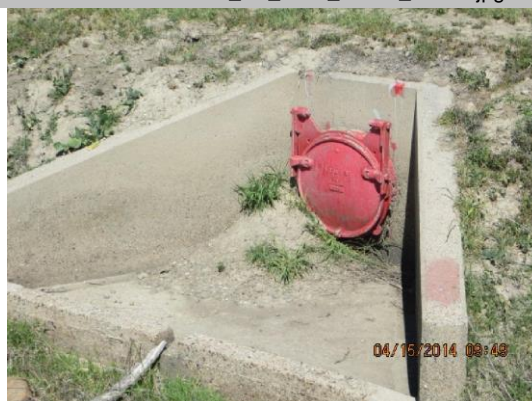
Photo 2 of 2 : UCIP_FA_2016_49966_60955.jpg

Pipe, headwall, and flapgate at WS toe. Soil buildup partially blocking flapgate.

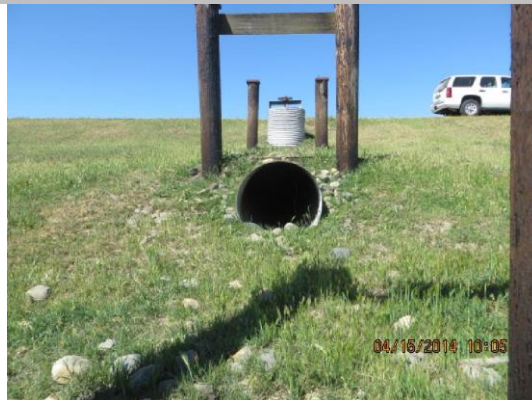
Photo 2 of 2 : UCIP_FA_2016_33713_60965.jpg

Outlet on WS slope.

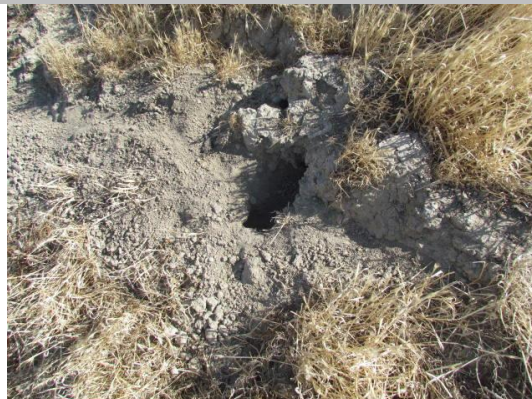
Photo 1 of 1 : FA_2016_NA0010_125_29_20161007_00005.jpg

LM Start	0.50	Rating **	M	Issue No.	29
LM End	0.50	Issue Type +	Ma	Location *	LS
Category	Earthen Levee			GPS Latitude/Longitude	
				Start	End
Item	Animal Control			37.258722 °	37.258722 °
				-120.764867 °	-120.764867 °
DWR ID	DWR_NA0010_07_s_2012_29				
Comment Code					
A3 : No rodents visible, but rodent burrows visible; need to backfill and compact or grout burrows.					
Inspector Comment					
Several rodent holes noted on landward and waterward slope and shoulder.

Looking at typical view of rodent holes on landward slope.

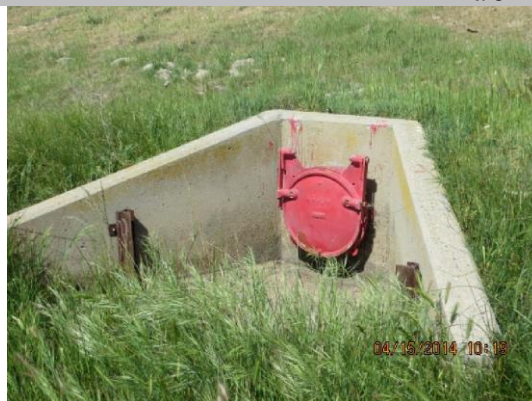
Photo 2 of 2 : UCIP_FA_2016_39507_60988.jpg

Headwall and flapgate on WS toe.

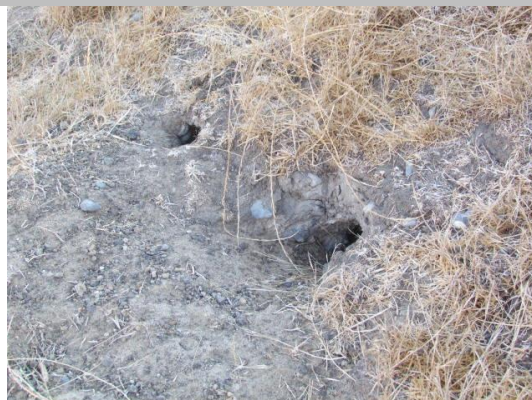
Photo 1 of 2 : FA_2016_NA0010_125_1_20161007_00001.jpg

Looking north at several rodent holes on landward slope.

LM Start	1.22	Rating **	M	Issue No.	1
LM End	1.22	Issue Type +	Ma	Location *	LS
Category	Earthen Levee			GPS Latitude/Longitude	
				Start	End
Item	Animal Control			37.264387 °	37.264387 °
				-120.755805 °	-120.755805 °
DWR ID	DWR_NA0010_07_f_2012_1				
Comment Code					
A1 : Exterminate rodents and backfill and compact or grout burrows.					
Inspector Comment

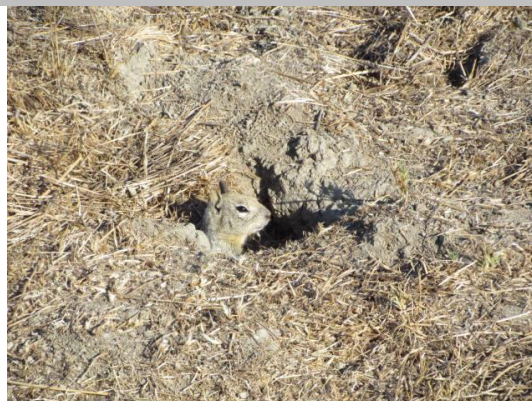
Photo 2 of 2 : FA_2016_NA0010_125_1_20161007_00002.jpg

Looking at east at active rodent holes on landside berm.

LM Start	1.22	Rating **	M	Issue No.	1 (cont)	
LM End	1.22	Issue Type +	Ma	Location *	LS	
Category	Earthen Levee			GPS Latitude/Longitude		
				Start		End
Item	Animal Control			37.264387 °		37.264387 °
				-120.755805 °		-120.755805 °
DWR ID	DWR_NA0010_07_f_2012_1					
Comment Code						
A1 : Exterminate rodents and backfill and compact or grout burrows.						
Inspector Comment

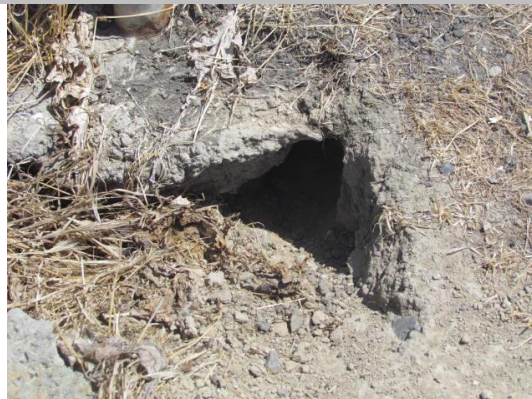
Photo 2 of 2 : FA_2016_NA0010_125_12_20161007_00004.jpg

LM Start	2.09	Rating **	M	Issue No.	12 (cont)	
LM End	2.09	Issue Type +	Ma	Location *	LS	
Category	Earthen Levee			GPS Latitude/Longitude		
				Start		End
Item	Animal Control			37.259187 °		37.259187 °
				-120.742551 °		-120.742551 °
DWR ID	DWR_NA0010_07_f_2014_12					
Comment Code						
A3 : No rodents visible, but rodent burrows visible; need to backfill and compact or grout burrows.						
Inspector Comment						
Rodent activity noted next to fence post.

Looking at rodent activity next to fence post

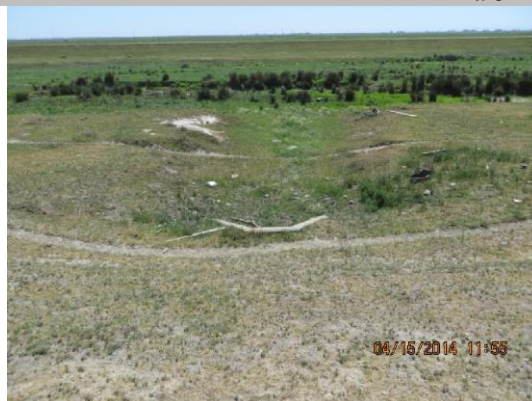
Photo 1 of 2 : UCIP_FA_2016_39508_61016.jpg

LM Start	3.09	Rating **	M	Issue No.	190
LM End	3.09	Issue Type +	En	Location *	LS
Category	Supplemental			GPS Latitude/Longitude	
				Start	End
Item	DWR UCIP Field Study			37.251883 °	37.251883 °
				-120.728264 °	-120.728264 °
DWR ID					
Comment Code					
Inspector Comment					
FS_ID:39508 DS_ID:19901 EP_NO: N/A Repair Type: Non-Urgent Crossing Status: Found UCIP Comments: Some sediment buildup at landward toe and inside pipe--recommend clearing. FIELD_STRUCT_DESC: 24-inch C.M. stormdrain pipe through the levee, 10.4-feet below the crown. Flap gate on the waterward end. Concrete headwall on the landward end. Concrete "U" headwall on the waterward end. (USACE-1967). This entry matches the Drainage or Irrigation Structure referenced in O&M manual (HLM 3.09). FS Date: 4/15/2014

Headwall, pipe, and flapgate on WS toe.

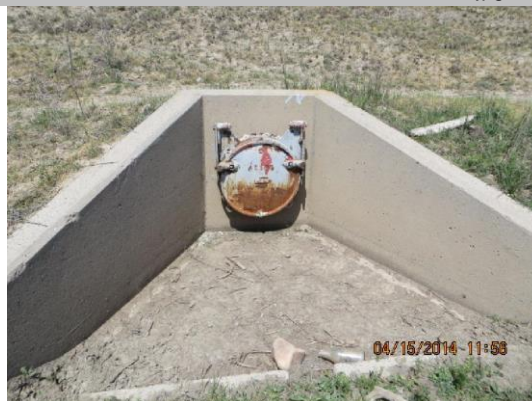
Photo 2 of 2 : UCIP_FA_2016_39508_61015.jpg

Headwall, pipe, and flapgate on WS toe.

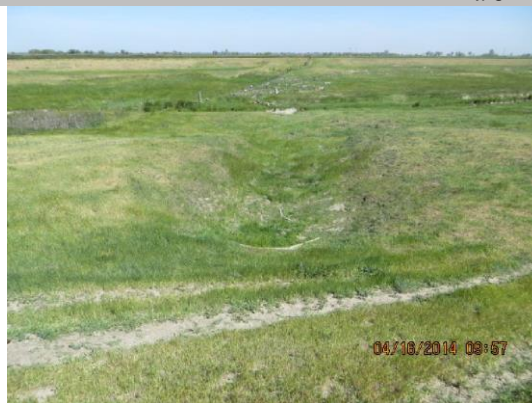
Photo 1 of 2 : UCIP_FA_2016_39887_61084.jpg

LM Start	0.90	Rating **	M	Issue No.	21
LM End	0.90	Issue Type +	En	Location *	WS
Category	Supplemental			GPS Latitude/Longitude	
				Start	End
Item	DWR UCIP Field Study			37.262384 °	37.262384 °
				-120.760528 °	-120.760528 °
DWR ID					
Comment Code					
Inspector Comment					
FS_ID:39887 DS_ID:19832 EP_NO: N/A Repair Type: Non-Urgent Crossing Status: Found UCIP Comments: Some sediment buildup at inlet on LS toe. FIELD_STRUCT_DESC: 24-inch CM stormdrain pipe through levee, 11.5 feet below crown. Flap gate on the waterward end. Concrete headwalls. (USACE-1967). This entry matches the Drainage or Irrigation Structure referenced in O&M manual (HLM 0.89). FS Date: 4/16/2014

Headwall, pipe, and flapgate on WS toe.

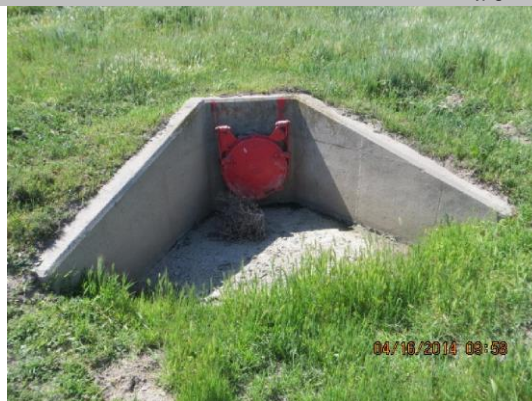
Photo 2 of 2 : UCIP_FA_2016_39887_61083.jpg

Headwall, pipe, and flapgate on WS toe.

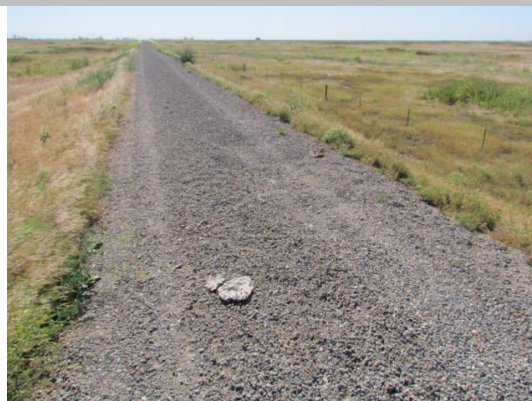
Photo 1 of 1 : FA_2016_NA0010_126_5_20161007_00002.jpg

LM Start	1.16	Rating **	M	Issue No.	5
LM End	1.16	Issue Type +	Ma	Location *	CR
Category	Earthen Levee			GPS Latitude/Longitude	
				Start	End
Item	Crown Surface / Depressions / Rutting			37.263243 °	37.263243 °
				-120.756372 °	-120.756372 °
DWR ID	DWR_NA0010_08_s_2016_5				
Comment Code					
C2 : Repair depressions or ruts in the crown or slope.					
Inspector Comment					
Depression noted on levee crown.

Looking west at depression on toward landward shoulder.

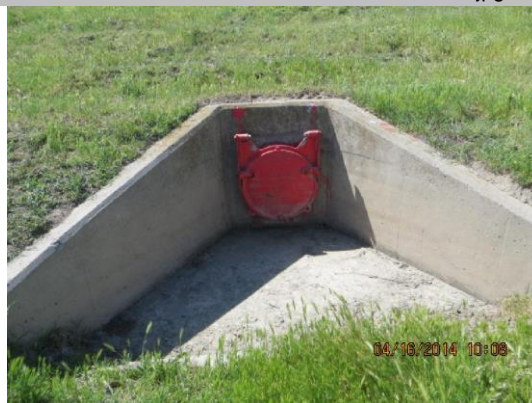
Photo 2 of 2 : UCIP_FA_2016_39510_61093.jpg

Pipe, headwall, and flapgate on WS toe.

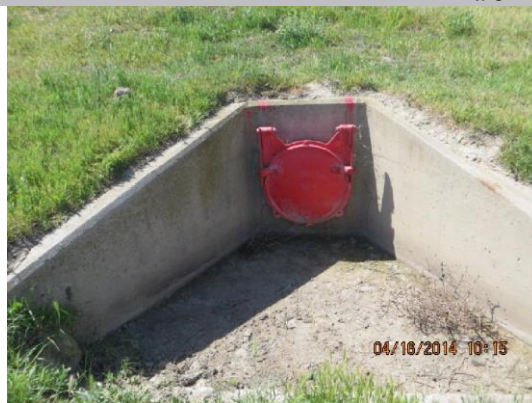
Photo 1 of 2 : UCIP_FA_2016_39511_61098.jpg

LM Start	2.05	Rating **	M	Issue No.	18
LM End	2.05	Issue Type +	En	Location *	WS
Category	Supplemental			GPS Latitude/Longitude	
				Start	End
Item	DWR UCIP Field Study			37.258220 °	37.258220 °
				-120.742868 °	-120.742868 °
DWR ID					
Comment Code					
Inspector Comment					
FS_ID:39511					
DS_ID:19835					
EP_NO: N/A					
Repair Type: Non-Urgent					
Crossing Status: Found					
UCIP Comments: Non-functional landward inlet is buried in sediment.					
Need to contact owner to determine status.					
FIELD_STRUCT_DESC: 24-inch CM stormdrain pipe through levee,					
12.0 feet below crown. Flap gate on the waterward end. Concrete					
headwall on both ends. (USACE-1967). This entry matches the					
Drainage or Irrigation Structure referenced in O&M manual (HLM 2.05).					
FS Date: 4/16/2014

Pipe, headwall, and flapgate on Ws toe.

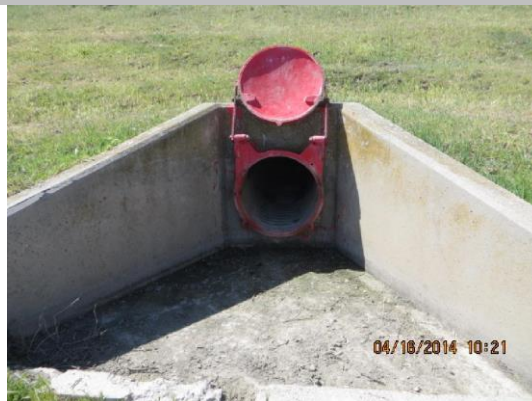
Photo 2 of 2 : UCIP_FA_2016_39512_61100.jpg

Pipe, headwall, and flapgate on WS toe.

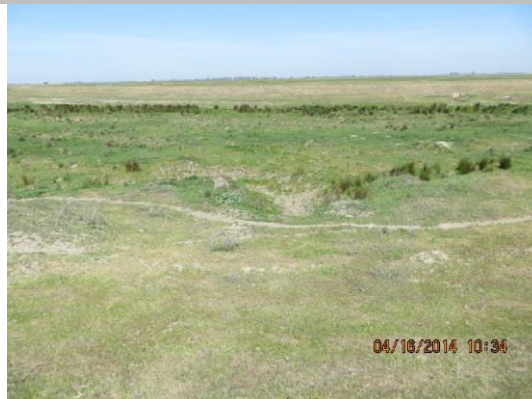
Photo 1 of 2 : UCIP_FA_2016_49969_61112.jpg

FS_ID:49969
DS_ID:19838
EP_NO: N/A
Repair Type: Non-Urgent
Crossing Status: Found
UCIP Comments: 7/20/2016 LS inlet buried under dense vegetation. Dense vegetation limits the inspector's visibility to identify signs of pipe failure (leaks) along the WS and LS slope. Recommend removing vegetation along pipe alignment to conduct proper inspection of structure and appurtenances. (DWR UCIP - omagana)4/16/2014 Pipe blocked by silt on LS toe. Flapgate rusty and does not operate correctly. (DWR UCIP - omagana)
FIELD_STRUCT_DESC: 36-inch corrugated metal drainage pipe through levee, 13.4 feet below crown. Flap gate located on the waterside (WS) end. Concrete headwall located on the landside (LS).
[Additional Reference(s): DWR Levee Log, 2002. USACE San Joaquin O&M Manuals: Unit No. 601, 1967, (HLM 3.06), Unit No. 601 Part I, 1967 (Amended in 1978), Unit No. 601 Part II, 1969, and Unit No. 601 Part III, 1969]

Pipe, headwall, and flapgate on WS toe.

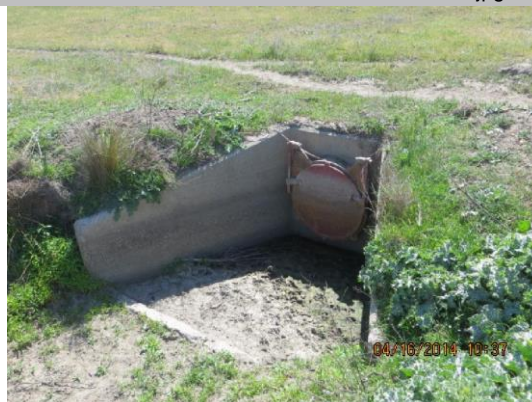
Photo 2 of 2 : UCIP_FA_2016_49969_61113.jpg

Pipe, headwall, and flapgate on WS toe.
