**Flood Control Project Maintenance
Levee Inspections**

Fall 2016 Levee Maintenance Deficiency Summary Report

San Joaquin River Basin

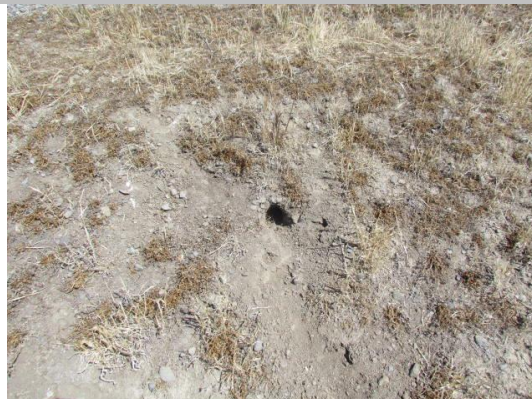
Photo 1 of 1 : FA_2016_NA0010_126_3_20161007_00001.jpg

LM Start	3.40	Rating **	M	Issue No.	3
LM End	3.54	Issue Type +	Ma	Location *	LS
Category	Earthen Levee			GPS Latitude/Longitude	
				Start	End
Item	Animal Control			37.253052 °	37.253600 °
				-120.722647 °	-120.720198 °
DWR ID	DWR_NA0010_08_s_2012_3				
Comment Code					
A3 : No rodents visible, but rodent burrows visible; need to backfill and compact or grout burrows.					
Inspector Comment					
Noted several rodent holes on landward slope within this reach.

Looking at typical view of rodent holes on landward slope.

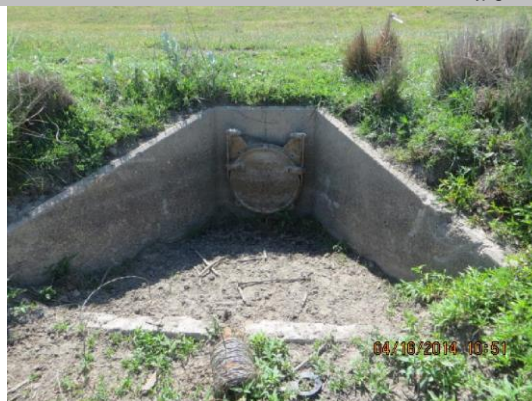
Photo 2 of 2 : UCIP_FA_2016_39513_61133.jpg

LM Start	3.43	Rating **	M	Issue No.	20 (cont)
LM End	3.43	Issue Type +	En	Location *	LS
Category	Supplemental			GPS Latitude/Longitude	
				Start	End
Item	DWR UCIP Field Study			37.253151 °	37.253151 °
				-120.722182 °	-120.722182 °
DWR ID					
Comment Code					
Inspector Comment					
FS_ID:39513 DS_ID:19840 EP_NO: N/A Repair Type: Non-Urgent Crossing Status: Found UCIP Comments: No access available on landward side. Need to confirm status of crossing. FIELD_STRUCT_DESC: 24-inch CM stormdrain pipe through levee, 13.0 feet below crown. Flap gate on the waterward end. Concrete headwall on both ends. (USACE-1967). This entry matches the Drainage or Irrigation Structure referenced in O&M manual (HLM 3.43). FS Date: 4/16/2014

Pipe, headwall, and flapgate on WS toe.

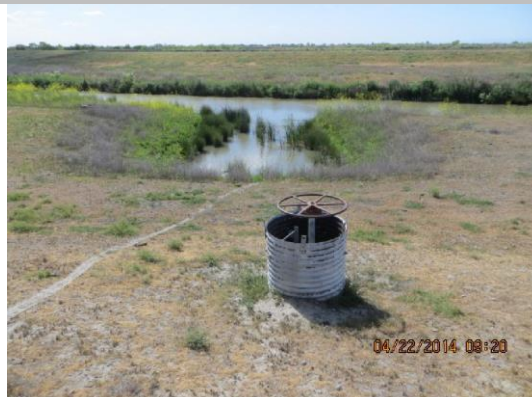
Photo 1 of 2 : UCIP_FA_2016_39888_62119.jpg

LM Start	0.47	Rating **	M	Issue No.	7
LM End	0.47	Issue Type +	En	Location *	CR
Category	Supplemental			GPS Latitude/Longitude	
				Start	End
Item	DWR UCIP Field Study			37.220416 °	37.220416 °
				-120.705248 °	-120.705248 °
DWR ID					
Comment Code					
Inspector Comment					
FS_ID:39888					
DS_ID:19841					
EP_NO: N/A					
Repair Type: Non-Urgent					
Crossing Status: Found					
UCIP Comments: Concrete headwalls on landward and waterward under water. Need photo to confirm condition of concrete headwalls, pipe, and gate on both toes.					
FIELD_STRUCT_DESC: 24-inch C.M. stormdrain pipe through the levee, 18.7-feet below the crown. Slide gate inside 36-inch C.M. pipe riser on the waterward slope. Concrete "U" headwalls on both ends. (USACE-1967). This entry matches the Drainage or Irrigation Structure referenced in O&M manual (HLM 0.47).					
FS Date: 4/22/2014

Slide gate in CMP riser on WS slope with outlet visible in background.

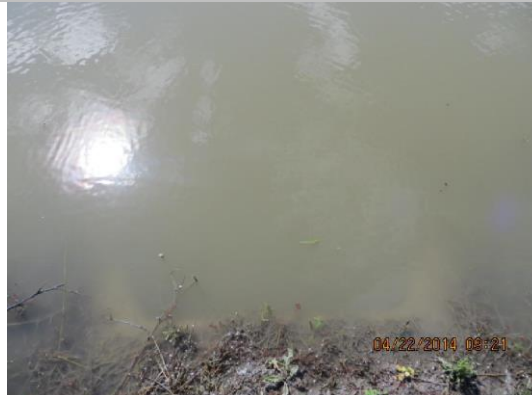
Photo 2 of 2 : UCIP_FA_2016_39888_62117.jpg

Concrete headwall visible under water on WS toe.

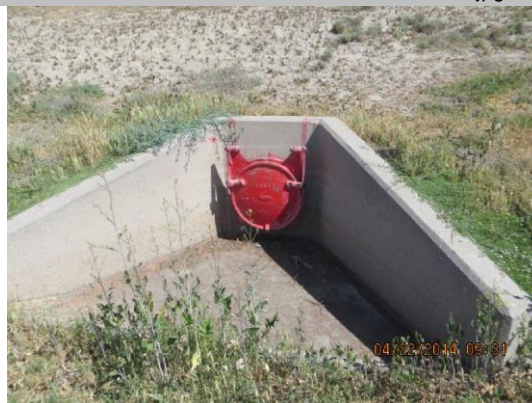
Photo 2 of 2 : UCIP_FA_2016_39515_62132.jpg

Headwall, flapgate, and pipe on WS toe.

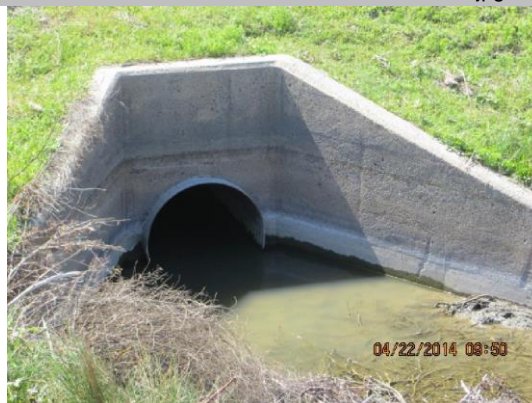
Photo 2 of 2 : UCIP_FA_2016_39516_62146.jpg

Headwall and pipe on WS toe.

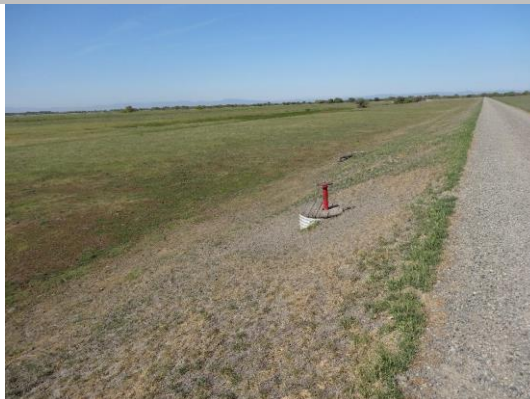
Photo 1 of 2 : UCIP_FA_2016_39517_66644.jpg

LM Start	0.42	Rating **	M	Issue No.	2
LM End	0.42	Issue Type +	En	Location *	LS
Category	Supplemental			GPS Latitude/Longitude	
				Start	End
Item	DWR UCIP Field Study			37.202754 °	37.202754 °
				-120.747689 °	-120.747689 °
DWR ID					
Comment Code					
Inspector Comment					
FS_ID:39517					
DS_ID:19846					
EP_NO: N/A					
Repair Type: Non-Urgent					
Crossing Status: Found					
UCIP Comments: Need to contact owner. Recommend clearing sediment deposit inside pipe.					
FIELD_STRUCT_DESC: 24-inch C.M. pipe through the levee, 11.0 feet below the crown. Slide gate inside CMP riser located on the waterward end. (USACE-1967). This entry matches the Drainage or Irrigation Structure referenced in O&M manual (HLM 0.42).					
FS Date: 4/18/2014

View of slide gate inside CMP riser located on waterward slope.

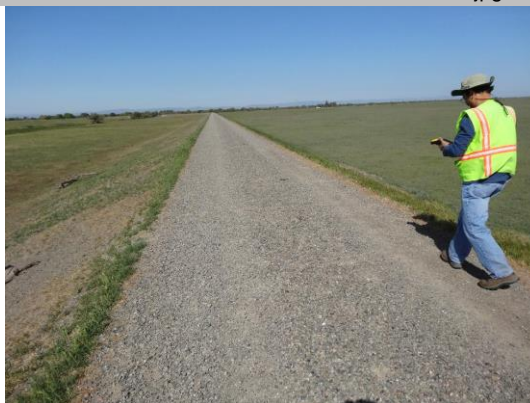
Photo 2 of 2 : UCIP_FA_2016_39517_66643.jpg

View of levee crown at crossing.

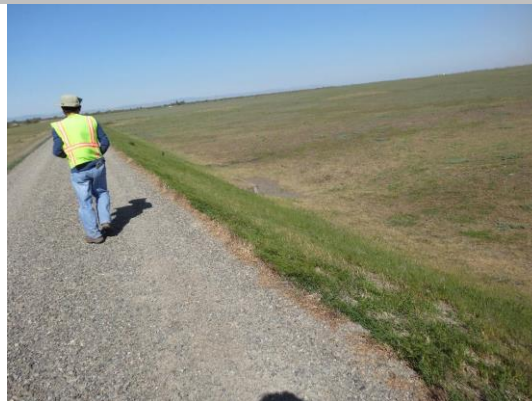
Photo 2 of 2 : UCIP_FA_2016_39518_61996.jpg

View of landward side.

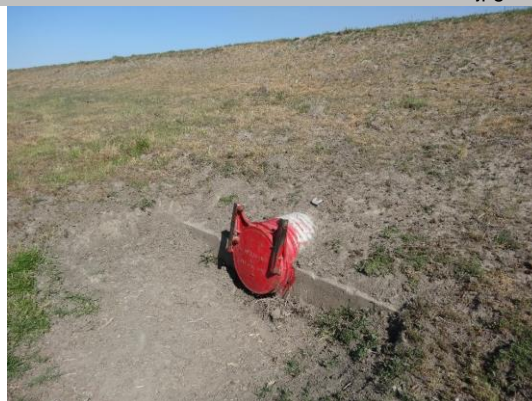
Photo 2 of 2 : UCIP_FA_2016_39519_62002.jpg

Concrete headwall and flap gate visible on waterward side.

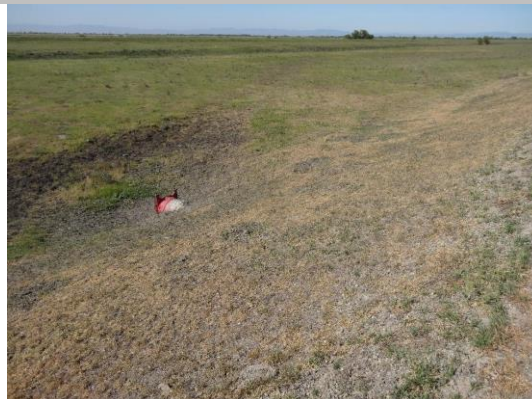
Photo 1 of 2 : UCIP_FA_2016_39520_62008.jpg

LM Start	1.13	Rating **	M	Issue No.	5
LM End	1.13	Issue Type +	En	Location *	LS
Category	Supplemental			GPS Latitude/Longitude	
				Start	End
Item	DWR UCIP Field Study			37.202748 °	37.202748 °
				-120.734796 °	-120.734796 °
DWR ID					
Comment Code					
Inspector Comment					
FS_ID:39520 DS_ID:19849 EP_NO: N/A Repair Type: Non-Urgent Crossing Status: Found UCIP Comments: Need to contact owner. Recommend clearing sediment deposit inside pipe. FIELD_STRUCT_DESC: 24-inch C.M. pipe through the levee, 9.0 feet below the crown. Flap gate on the waterward end. (USACE-1967). This entry matches the Drainage or Irrigation Structure referenced in O&M manual (HLM 1.13). FS Date: 4/18/2014

View of waterward side--flap gate visible at levee toe.

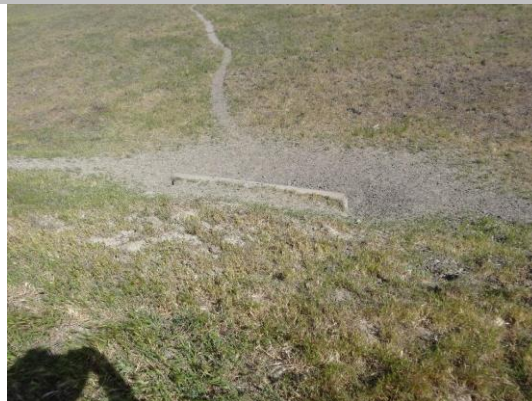
Photo 2 of 2 : UCIP_FA_2016_39520_62007.jpg

View of landward side.

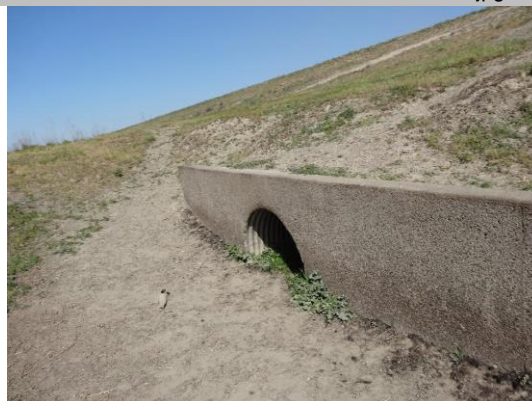
Photo 2 of 2 : UCIP_FA_2016_39521_62017.jpg

View of concrete headwall located on waterward side.

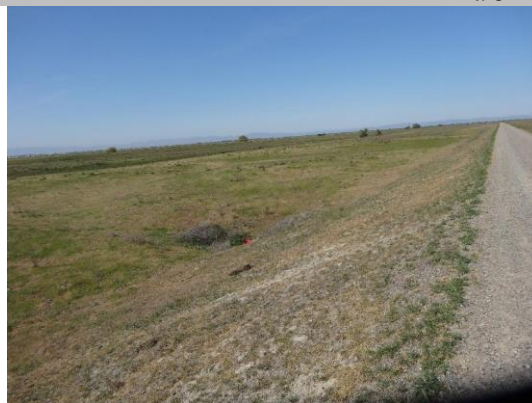
Photo 1 of 2 : UCIP_FA_2016_39522_62024.jpg

LM Start	1.98	Rating **	M	Issue No.	7
LM End	1.98	Issue Type +	En	Location *	LS
Category	Supplemental			GPS Latitude/Longitude	
				Start	End
Item	DWR UCIP Field Study			37.202740 °	37.202740 °
				-120.719247 °	-120.719247 °
DWR ID					
Comment Code					
Inspector Comment					
FS_ID:39522					
DS_ID:19851					
EP_NO: N/A					
Repair Type: Non-Urgent					
Crossing Status: Found					
UCIP Comments: Need to contact owner. Recommend clearing sediment deposit inside pipe.					
FIELD_STRUCT_DESC: 24-inch C.M. pipe through the levee, 12.8 feet below the crown. Flap gate on the waterward end. (USACE-1967). This entry matches the Drainage or Irrigation Structure referenced in O&M manual (HLM 1.99).					
FS Date: 4/18/2014

View of waterward side.

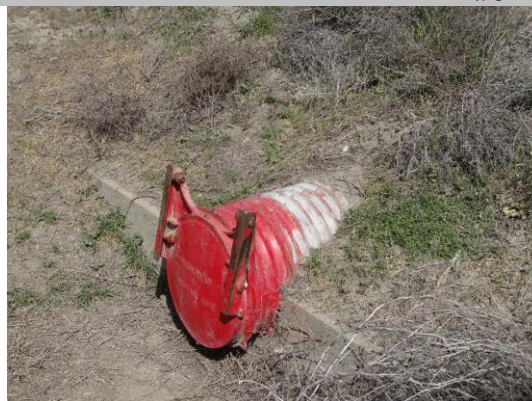
Photo 2 of 2 : UCIP_FA_2016_39522_62025.jpg

LM Start	1.98	Rating **	M	Issue No.	7 (cont)	
LM End	1.98	Issue Type +	En	Location *	LS	
Category	Supplemental			GPS Latitude/Longitude		
				Start	End	
Item	DWR UCIP Field Study			37.202740 °	37.202740 °	
				-120.719247 °	-120.719247 °	
DWR ID						
Comment Code						
Inspector Comment						
FS_ID:39522						
DS_ID:19851						
EP_NO: N/A						
Repair Type: Non-Urgent						
Crossing Status: Found						
UCIP Comments: Need to contact owner. Recommend clearing sediment deposit inside pipe.						
FIELD_STRUCT_DESC: 24-inch C.M. pipe through the levee, 12.8 feet below the crown. Flap gate on the waterward end. (USACE-1967). This entry matches the Drainage or Irrigation Structure referenced in O&M manual (HLM 1.99).						
FS Date: 4/18/2014

Flap gate located on waterward side.

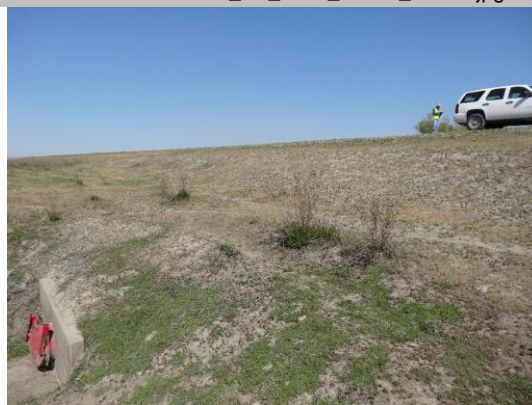
Photo 1 of 2 : UCIP_FA_2016_39523_62028.jpg

LM Start	3.04	Rating **	M	Issue No.	8
LM End	3.04	Issue Type +	En	Location *	LS
Category	Supplemental			GPS Latitude/Longitude	
				Start	End
Item	DWR UCIP Field Study			37.202494 °	37.202494 °
				-120.700153 °	-120.700153 °
DWR ID					
Comment Code					
Inspector Comment					
FS_ID:39523					
DS_ID:19852					
EP_NO: N/A					
Repair Type: Non-Urgent					
Crossing Status: Found					
UCIP Comments: Need to contact owner. Recommend clearing sediment deposit inside pipe.					
FIELD_STRUCT_DESC: 24-inch C.M. pipe through the levee, 15.0 feet below the crown. Flap gate on the waterward end. (USACE-1967). This entry matches the Drainage or Irrigation Structure referenced in O&M manual (HLM 3.04).					
FS Date: 4/18/2014

Overview of waterward side--flap gate, concrete headwall and apron visible on levee toe.

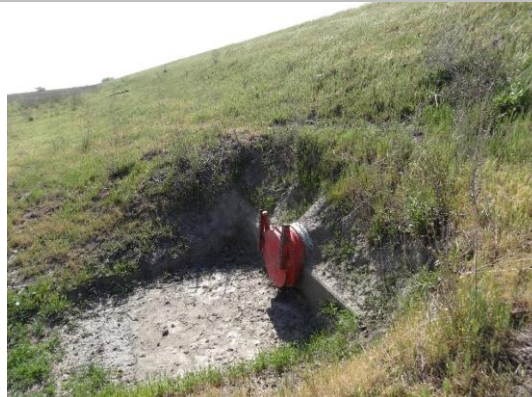
Photo 2 of 2 : UCIP_FA_2016_36704_66649.jpg

Concrete headwall and flap gate visible on waterward side.

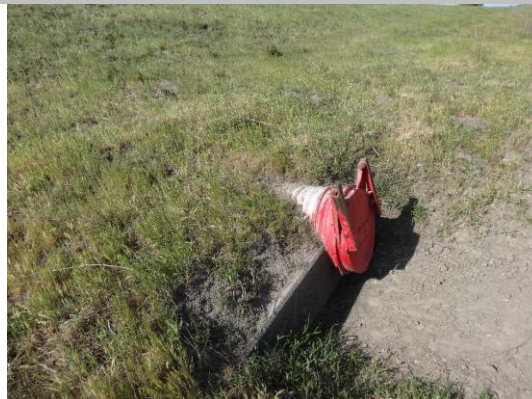
Photo 2 of 2 : UCIP_FA_2016_39889_62049.jpg

Concrete headwall and flap gate visible on waterward side.

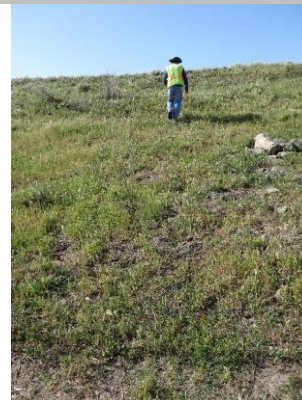
Photo 2 of 2 : UCIP_FA_2016_36705_66652.jpg

View of waterward slope.

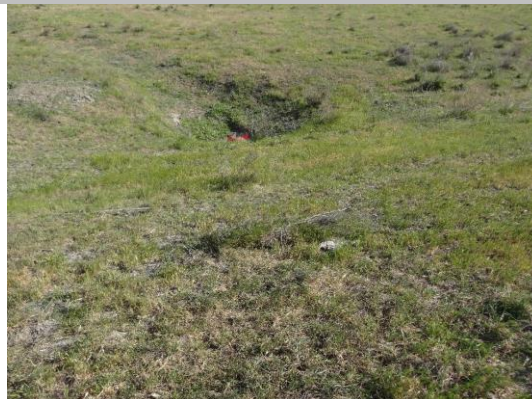
Photo 1 of 2 : UCIP_FA_2016_34126_62060.jpg

LM Start	1.53	Rating **	M	Issue No.	2
LM End	1.53	Issue Type +	En	Location *	LS
Category	Supplemental			GPS Latitude/Longitude	
				Start	End
Item	DWR UCIP Field Study			37.200913 °	37.200913 °
				-120.727496 °	-120.727496 °
DWR ID					
Comment Code					
Inspector Comment					
FS_ID:34126 DS_ID:19858 EP_NO: N/A Repair Type: Non-Urgent Crossing Status: Found UCIP Comments: Limited access on landward side due to fence and dense vegetation. Recommend obtaining access to landward side and clear vegetation on landward side. FIELD_STRUCT_DESC: 24-inch CM pipe through levee, 10.7 feet below crown. Flap gate on the waterward end. (USACE-1967). This entry matches the Drainage or Irrigation Structure referenced in O&M manual (HLM 1.53). FS Date: 4/18/2014

View of waterward side.

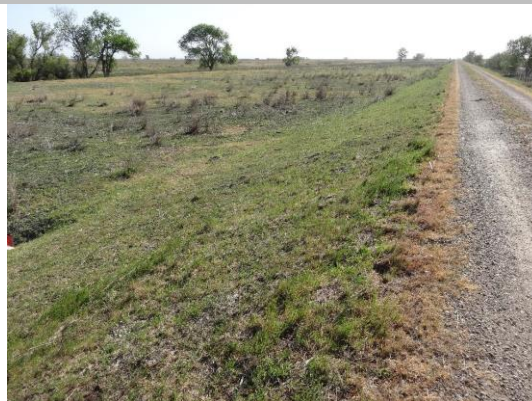
Photo 1 of 2 : UCIP_FA_2016_39890_62069.jpg

LM Start	2.70	Rating **	M	Issue No.	7
LM End	2.70	Issue Type +	En	Location *	LS
Category	Supplemental			GPS Latitude/Longitude	
				Start	End
Item	DWR UCIP Field Study			37.200906 °	37.200906 °
				-120.706316 °	-120.706316 °
DWR ID					
Comment Code					
Inspector Comment					
FS_ID:39890					
DS_ID:19860					
EP_NO: N/A					
Repair Type: Non-Urgent					
Crossing Status: Found					
UCIP Comments: Need to contact owner. Recommend clearing sediment deposit inside pipe.					
FIELD_STRUCT_DESC: 24-inch CM pipe through levee, 10.7 feet below crown. Flap gate on the waterward end. (USACE-1967). This entry matches the Drainage or Irrigation Structure referenced in O&M manual (HLM 2.70).					
FS Date: 4/18/2014

View of waterward side.

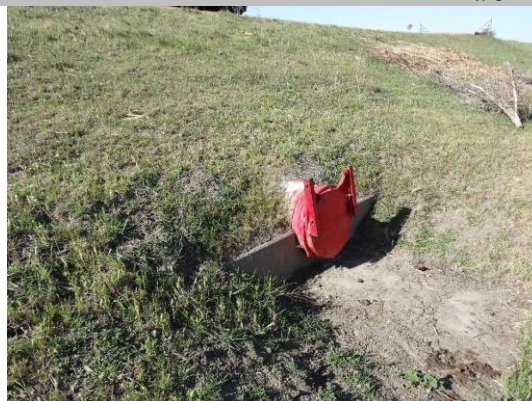
Photo 2 of 2 : UCIP_FA_2016_39890_62070.jpg

Concrete headwall and flat gate located on waterward side.

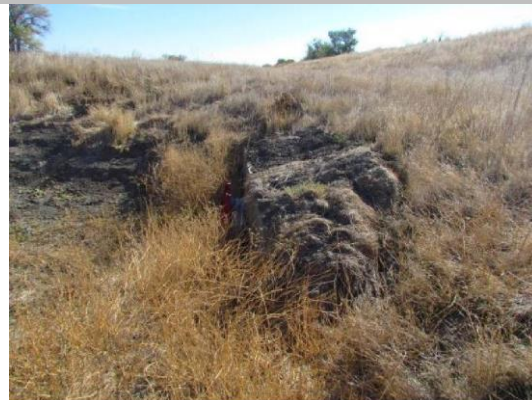
Photo 2 of 2 : UCIP_FA_2016_46786_74729.jpg

Repair to headwall located on waterward side has been addressed.

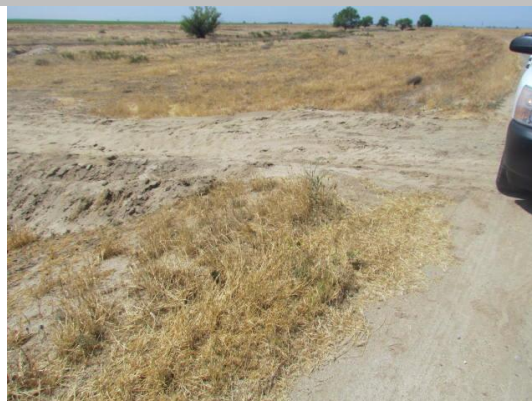
Photo 2 of 3 : FA_2016_NA0010_131_5_20161007_00002.jpg

LM Start	0.91	Rating **	M	Issue No.	5 (cont)	
LM End	0.91	Issue Type +	En	Location *	WS	
Category	Earthen Levee			GPS Latitude/Longitude		
				Start		End
Item	Encroachments			37.044855 °		37.044855 °
				-120.434106 °		-120.434106 °
DWR ID	DWR_NA0010_13_s_ 2014_5					
Comment Code						
RA : Ramp						
Inspector Comment						
Unauthorized ramp on waterward slope.

Looking west at unauthorized ramp on waterward slope.

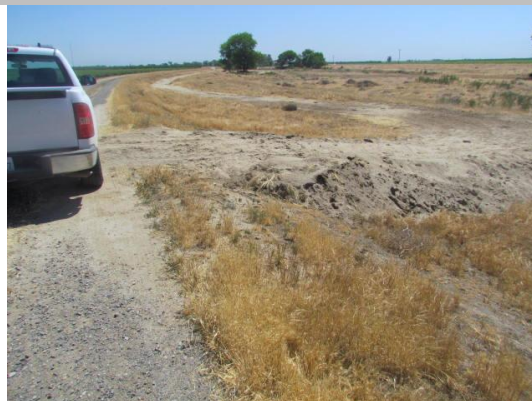
Photo 3 of 3 : FA_2016_NA0010_131_5_20161007_00003.jpg

Looking east at unauthorized ramp on waterward slope.

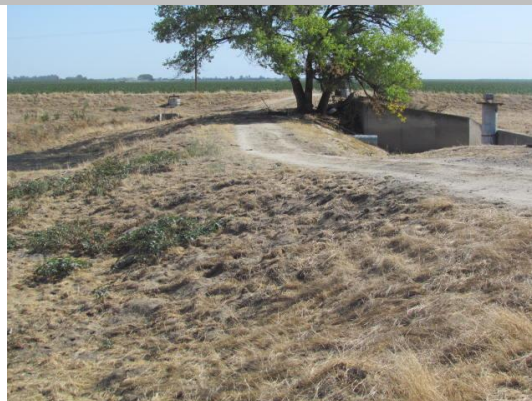
Photo 1 of 6 : FA_2016_NA0010_131_6_20161007_00004.jpg

LM Start	1.14	Rating **	U	Issue No.	6
LM End	1.14	Issue Type +	En	Location *	WS
Category	Earthen Levee			GPS Latitude/Longitude	
				Start	End
Item	Encroachments			37.045541 °	37.045541 °
				-120.430014 °	-120.430014 °
DWR ID	DWR_NA0010_13_f_ 2015_6				
Comment Code					
WL : Wall					
Inspector Comment					
Landowner built sand dam on upstream side of drop structure.

Looking overview of sand dam.

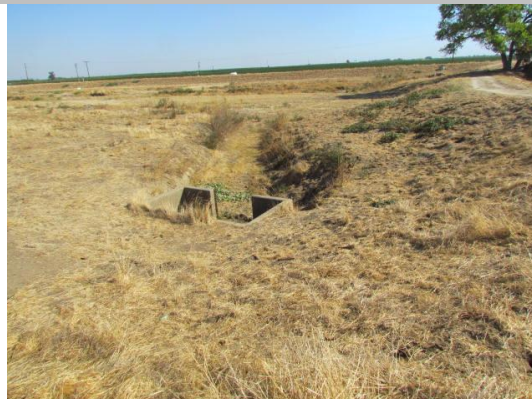
Photo 2 of 6 : FA_2016_NA0010_131_6_20161110_00015.jpg

LM Start	1.14	Rating **	U	Issue No.	6 (cont)	
LM End	1.14	Issue Type +	En	Location *	WS	
Category	Earthen Levee			GPS Latitude/Longitude		
				Start		End
Item	Encroachments			37.045541 °		37.045541 °
				-120.430014 °		-120.430014 °
DWR ID	DWR_NA0010_13_f_2015_6					
Comment Code						
WL : Wall						
Inspector Comment						
Landowner built sand dam on upstream side of drop structure.

Looking west at upstream side of sand dam on the southside of the Drop structure.

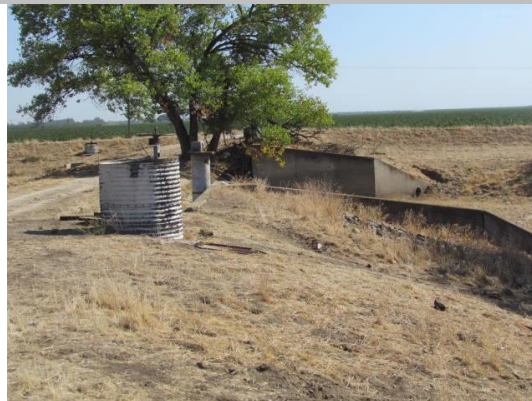
Photo 3 of 6 : FA_2016_NA0010_131_6_20161007_00005.jpg

Looking south at downstream side of structure.

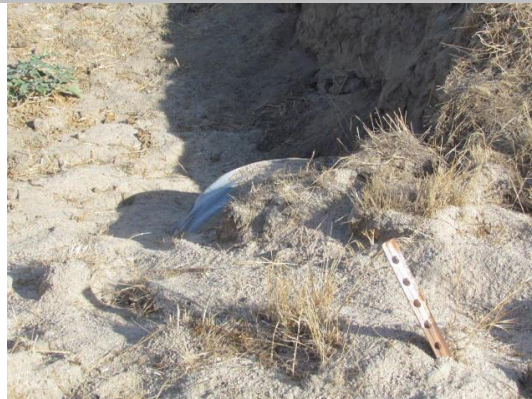
Photo 4 of 6 : FA_2016_NA0010_131_6_20161007_00006.jpg

Looking at corrugated pipe on north end on upstream side of structure.

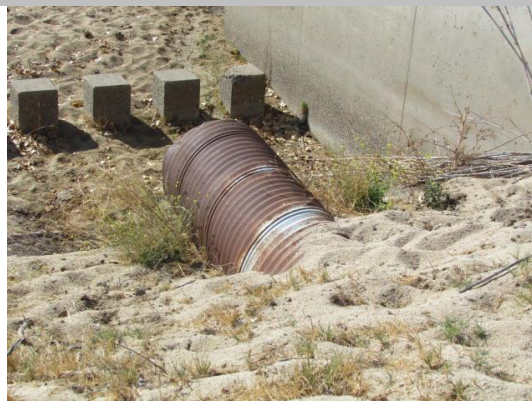
Photo 5 of 6 : FA_2016_NA0010_131_6_20161007_00007.jpg

Looking at corrugated pipe on north end on downstream side of structure.

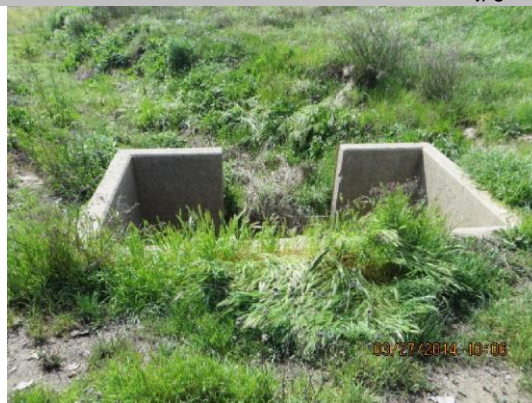
Photo 2 of 2 : UCIP_FA_2016_39524_59392.jpg

Concrete distribution box on WS toe.

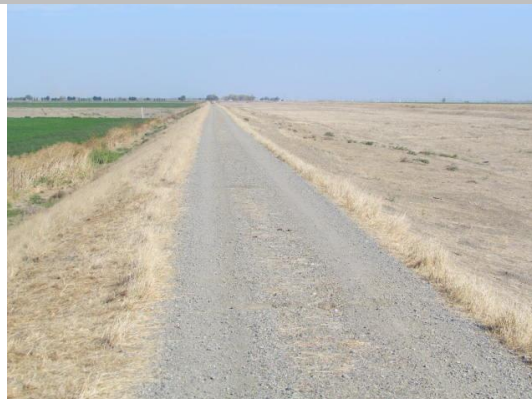
Photo 1 of 1 : FA_2016_NA0010_132_2_20161110_00006.jpg

LM Start	0.00	Rating **	A/W	Issue No.	2
LM End	1.26	Issue Type +	Ma	Location *	CR
Category	Earthen Levee			GPS Latitude/Longitude	
				Start	End
Item	Crown Surface / Depressions / Rutting			37.032379 °	37.045404 °
				-120.441265 °	-120.427749 °
DWR ID	DWR_NA0010_14_f_2012_2				
Comment Code					
C3 : Add appropriate gravel or road base. Grade and compact.					
Inspector Comment					
Control vegetation on levee crown.

Looking at typical view of levee crown.

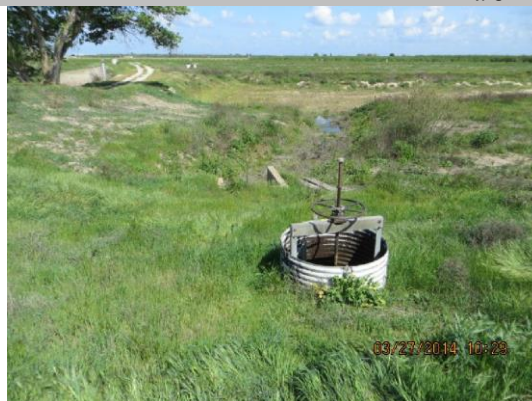
Photo 1 of 2 : UCIP_FA_2016_39526_59398.jpg

Comment Code					
Inspector Comment					
FS_ID:39526 DS_ID:19909 EP_NO: N/A Repair Type: Non-Urgent Crossing Status: Found UCIP Comments: Lid should be installed on CMP riser on WS slope, could be a safety hazard. Also dense vegetation limits the inspector's visibility to identify signs of pipe failure (leaks) along the slope. Recommend removing vegetation along pipe alignment to conduct proper inspection of structure. FIELD_STRUCT_DESC: 36-inch CM pipe through levee, 10-feet below crown. Slide gate inside 48-inch CM pipe riser in waterward slope. Concrete distribution box (6'X7') at toe of waterward slope. Slots for wooden flashboard on waterward side of box. 7'X9' Concrete distribution box on the landward side 20-feet from toe. (USACE-1967). This entry matches the Drainage or Irrigation Structure referenced in O&M manual (HLM 1.15). FS Date: 3/27/2014

Slide gate in CMP riser and outlet/inlet structure visible in background at WS toe.

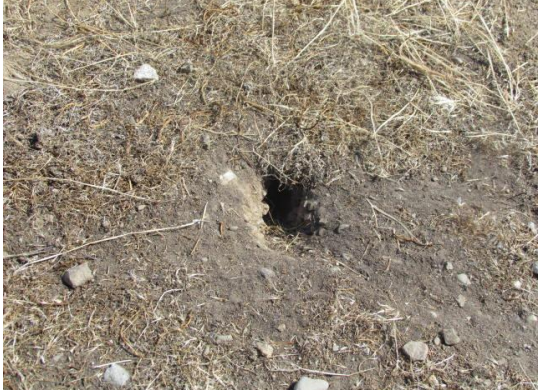
Photo 1 of 1 : FA_2016_NA0010_132_79_20161007_00002.jpg

Looking at typical view of rodent holes on landward slope.

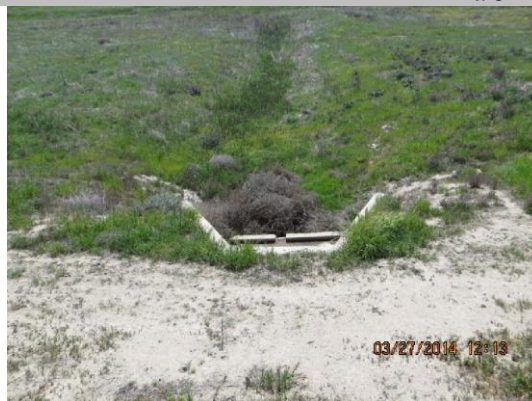
Photo 1 of 2 : UCIP_FA_2016_39527_59452.jpg

Comment Code					
Inspector Comment					
FS_ID:39527					
DS_ID:19912					
EP_NO: N/A					
Repair Type: Non-Urgent					
Crossing Status: Found					
UCIP Comments: Dense vegetation limits the inspector's visibility to identify signs of pipe failure (leaks) along the landward slope.					
Recommend removing vegetation along pipe alignment to conduct proper inspection of structure.					
FIELD_STRUCT_DESC: 30-inch square R.C.B.C. through the levee, 8.5 feet below the crown. Concrete "U" headwall on the waterward end. Flap gate on the waterward end. Concrete headwall on the landward end. (USACE-1967). This entry matches the Drainage or Irrigation Structure referenced in O&M manual (HLM 1.01).					
FS Date: 3/27/2014

Concrete headwall on WS toe.

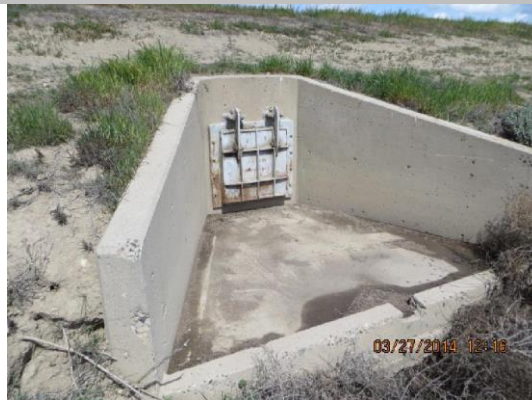
Photo 2 of 2 : UCIP_FA_2016_39527_59453.jpg

Flapgate on concrete headwall at WS toe.

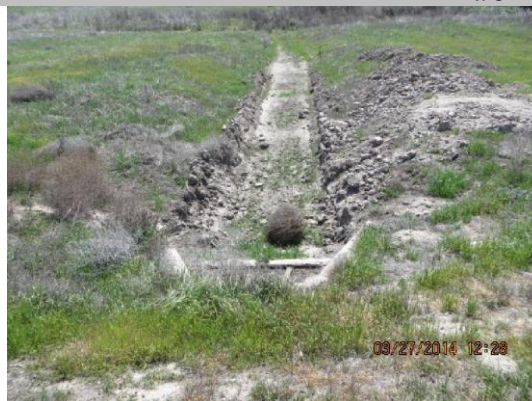
Photo 1 of 2 : UCIP_FA_2016_32840_59456.jpg

LM Start	1.53	Rating **	M	Issue No.	12
LM End	1.53	Issue Type +	En	Location *	CR
Category	Supplemental			GPS Latitude/Longitude	
				Start	End
Item	DWR UCIP Field Study			36.996582 °	36.996582 °
				-120.382757 °	-120.382757 °
DWR ID					
Comment Code					
Inspector Comment					
FS_ID:32840 DS_ID:19913 EP_NO: N/A Repair Type: Non-Urgent Crossing Status: Found UCIP Comments: Excessive vegetation at inlet on LS toe. FIELD_STRUCT_DESC: 30-inch square R.C.B.C. stormdrain through the levee, 8.9 feet below the crown. Concrete "U" headwall on the waterward end. Flap gate on the waterward end. Concrete headwall on the landward end. (USACE-1967). This entry matches the Drainage or Irrigation Structure referenced in O&M manual (HLM 1.53). FS Date: 3/27/2014

Concrete headwall on WS toe.

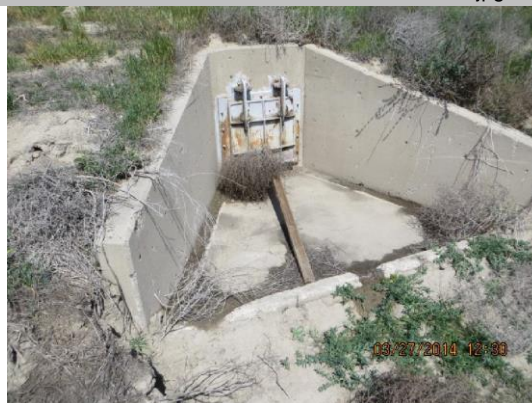
Photo 2 of 2 : UCIP_FA_2016_32840_59457.jpg

Flapgate on concrete headwall at WS toe.

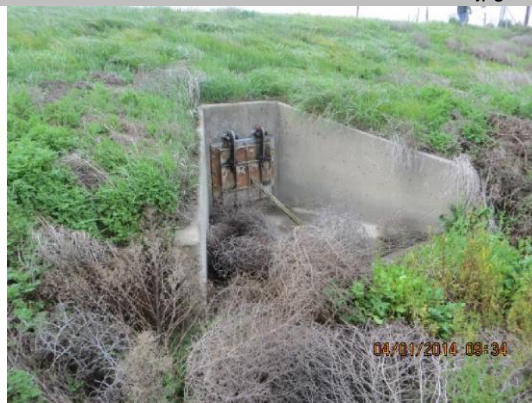
Photo 2 of 2 : UCIP_FA_2016_39529_59680.jpg

Flapgate on headwall at WS toe.

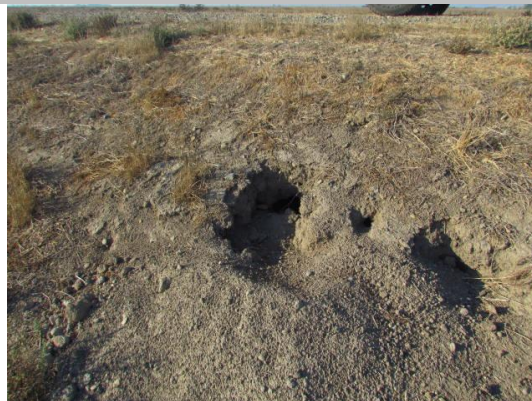
Photo 1 of 2 : FA_2016_NA0010_134_2_20161007_00001.jpg

LM Start	1.77	Rating **	U	Issue No.	2
LM End	1.77	Issue Type +	Ma	Location *	LS
Category	Earthen Levee			GPS Latitude/Longitude	
				Start	End
Item	Animal Control			36.995487 °	36.995487 °
				-120.377054 °	-120.377054 °
DWR ID	DWR_NA0010_16_f_2014_2				
Comment Code					
A3 : No rodents visible, but rodent burrows visible; need to backfill and compact or grout burrows.					
Inspector Comment					
Large rodent holes on landward slope.

Looking at large rodent holes on landward slope.

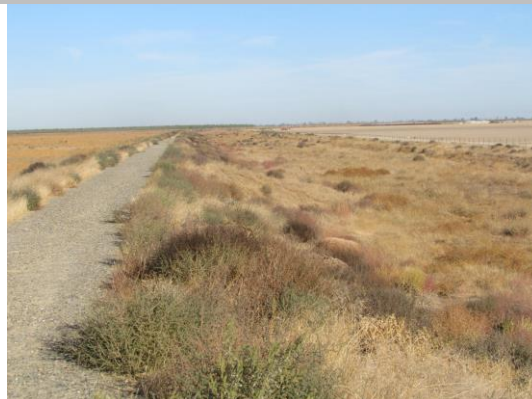
Photo 1 of 1 : FA_2016_NA0010_135_11_20161024_00025.jpg

LM Start	0.00	Rating **	U	Issue No.	11
LM End	2.54	Issue Type +	Ma	Location *	LS
Category	Earthen Levee			GPS Latitude/Longitude	
				Start	End
Item	Vegetation			36.976445 °	36.952745 °
				-120.374700 °	-120.349100 °
DWR ID	DWR_NA0010_17_f_2016_11				
Comment Code					
V1 : Control annual grass and weeds on the levee slopes and easements.					
Inspector Comment					
Dense vegetation (tumble weeds) on levee slope.

Looking south at typical view of dense veg on landward slope.

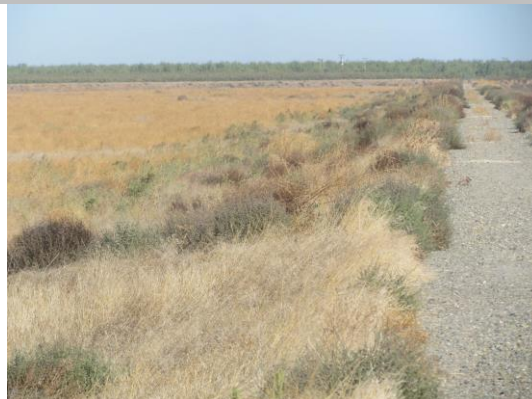
Photo 1 of 1 : FA_2016_NA0010_135_12_20161024_00026.jpg

LM Start	0.00	Rating **	U	Issue No.	12
LM End	2.60	Issue Type +	Ma	Location *	WS
Category	Earthen Levee			GPS Latitude/Longitude	
				Start	End
Item	Vegetation			36.976445 °	36.951928 °
				-120.374700 °	-120.348605 °
DWR ID	DWR_NA0010_17_f_2016_12				
Comment Code					
V1 : Control annual grass and weeds on the levee slopes and easements.					
Inspector Comment					
Dense vegetation (Tumble weeds) on levee slope.

Looking at typical view of dense veg on waterward slope.

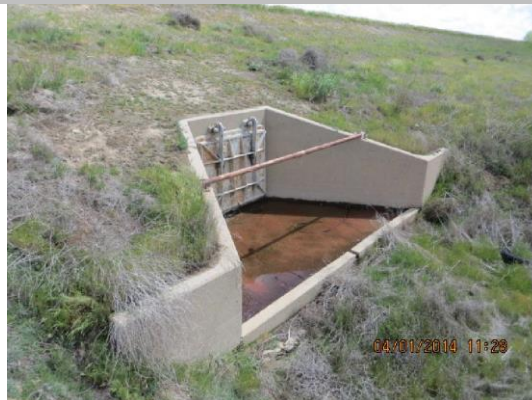
Photo 2 of 2 : UCIP_FA_2016_39531_59711.jpg

Flapgate on Concrete headwall at WS toe.

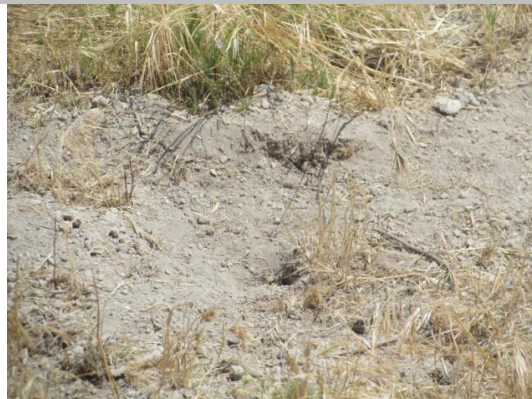
Photo 1 of 1 : FA_2016_NA0010_135_5_20161007_00004.jpg

LM Start	7.27	Rating **	M	Issue No.	5
LM End	7.38	Issue Type +	Ma	Location *	LS
Category	Earthen Levee			GPS Latitude/Longitude	
				Start	End
Item	Animal Control			36.887869 °	36.886341 °
				-120.321697 °	-120.320940 °
DWR ID	DWR_NA0010_17_s_2012_5				
Comment Code					
A3 : No rodents visible, but rodent burrows visible; need to backfill and compact or grout burrows.					
Inspector Comment					
Notice several rodent holes within this reach.

Looking at typical view of rodent holes on landward slope.

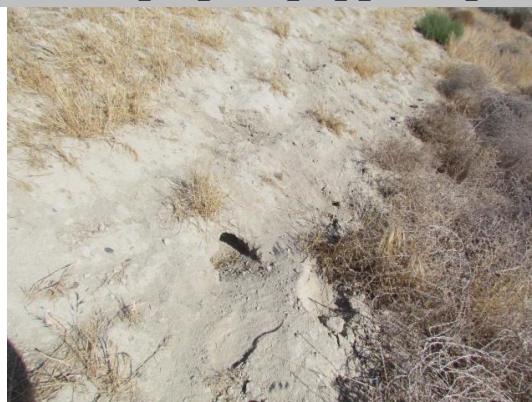
Photo 1 of 2 : FA_2016_NA0010_135_3_20161007_00001.jpg

LM Start	12.34	Rating **	M	Issue No.	3
LM End	12.38	Issue Type +	Ma	Location *	LS
Category	Earthen Levee			GPS Latitude/Longitude	
				Start	End
Item	Animal Control			36.820558 °	36.820000 °
				-120.300616 °	-120.300831 °
DWR ID	DWR_NA0010_17_s_2014_3				
Comment Code					
A3 : No rodents visible, but rodent burrows visible; need to backfill and compact or grout burrows.					
Inspector Comment					
Noted several rodent holes with this reach.

Looking at typical view of rodent holes on landward slope. Fall 2015

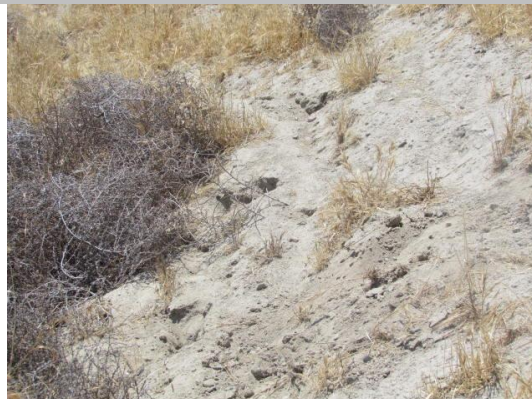
Photo 2 of 2 : FA_2016_NA0010_135_3_20161007_00002.jpg

Looking at several rodent holes on landward slope. Spring 2015

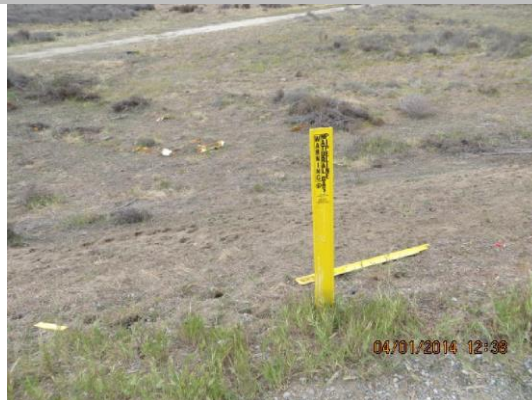
Photo 1 of 2 : UCIP_FA_2016_41406_71490.jpg

LM Start	14.38	Rating **	M	Issue No.	17
LM End	14.38	Issue Type +	En	Location *	LS
Category	Supplemental			GPS Latitude/Longitude	
				Start	End
Item	DWR UCIP Field Study			36.793318 °	36.793318 °
				-120.302138 °	-120.302138 °
DWR ID					
Comment Code					
Inspector Comment					
FS_ID:41406					
DS_ID:24850					
EP_NO: N/A					
Repair Type: Non-Urgent					
Crossing Status: Indicator Found					
UCIP Comments: No permit identified for this crossing.					
FIELD_STRUCT_DESC: Gas line through the levee at an unknown depth. Gas line markers on both shoulders.					
FS Date: 4/1/2014

Gasline marker on WS slope..

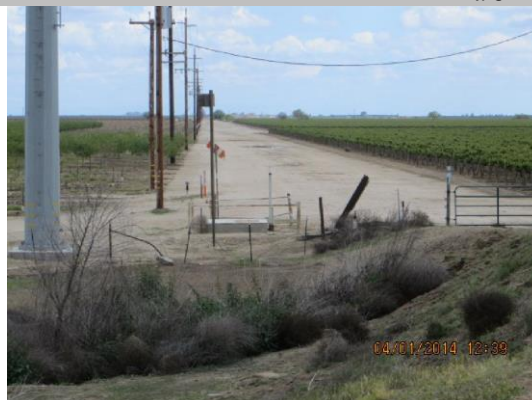
Photo 1 of 2 : UCIP_FA_2016_50067_59742.jpg

Comment Code					
Inspector Comment					
FS_ID:50067 DS_ID:19562 EP_NO: 18568 Repair Type: Non-Urgent Crossing Status: Indicator Found UCIP Comments: 7/20/2016 Marker visible on LS. WS marker missing. (DWR UCIP - omagana)4/01/2014 Need to contact owner to confirm and obtain status of crossing. Markers misleading--unable to confirm if markers correspond to this crossing. Need markers at levee. (DWR UCIP - omagana) FIELD_STRUCT_DESC: 30-inch steel gas pipeline through the levee, approximately 60 feet below the crown. Location markers are visible on the waterside (WS) and landside (LS). (Permit No. 18568, 2010 - Gill Ranch Storage LLC) FS Date: 7/20/2016

Gasline marker and concrete sump off LS toe.

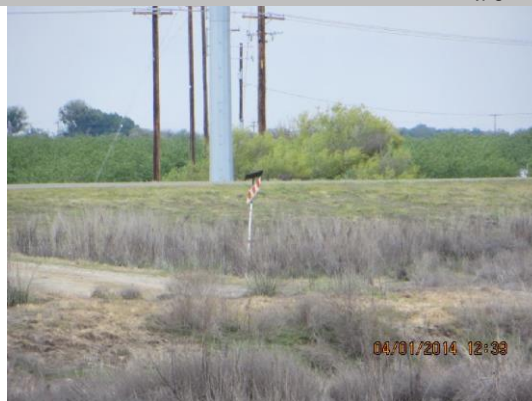
Photo 2 of 2 : UCIP_FA_2016_50067_59741.jpg

Gasline marker visible in channell off WS toe.

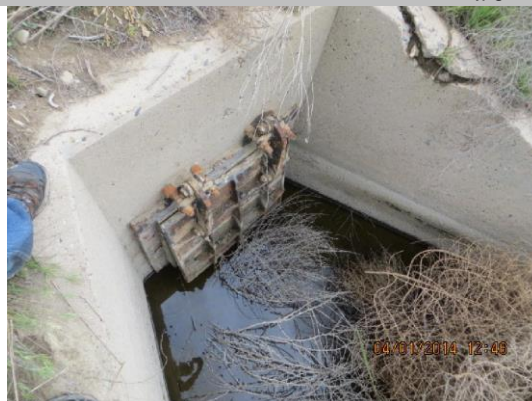
Photo 2 of 2 : UCIP_FA_2016_39535_59747.jpg

Flapgate on Concrete headwall at WS toe.

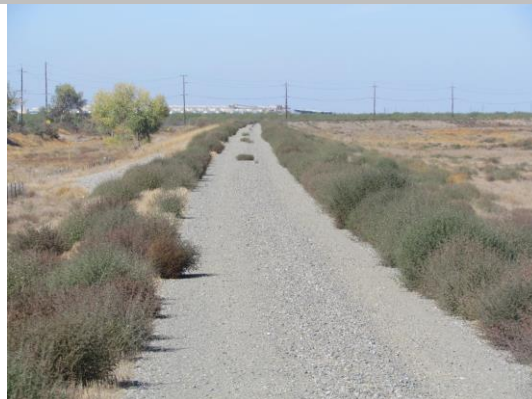
Photo 1 of 1 : FA_2016_NA0010_137_10_20161024_00019.jpg

LM Start	0.00	Rating **	U	Issue No.	10
LM End	13.24	Issue Type +	Ma	Location *	LS
Category	Earthen Levee			GPS Latitude/Longitude	
				Start	End
Item	Vegetation			36.974113 °	36.796253 °
				-120.363258 °	-120.308384 °
DWR ID	DWR_NA0010_18_f_2016_10				
Comment Code					
V1 : Control annual grass and weeds on the levee slopes and easements.					
Inspector Comment					
Control tumble weeds on levee shoulder and slope.

Looking downstream at typical view of dense veg on landward and waterward shoulders.

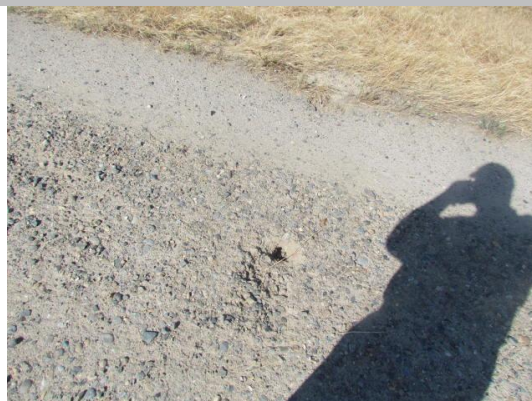
Photo 1 of 1 : FA_2016_NA0010_137_7_20161007_00003.jpg

LM Start	1.44	Rating **	M	Issue No.	7
LM End	1.44	Issue Type +	Ma	Location *	LS
Category	Earthen Levee			GPS Latitude/Longitude	
				Start	End
Item	Animal Control			36.956163 °	36.956163 °
				-120.353672 °	-120.353672 °
DWR ID	DWR_NA0010_18_s_2014_7				
Comment Code					
A3 : No rodents visible, but rodent burrows visible; need to backfill and compact or grout burrows.					
Inspector Comment					
Several noted on landward slope and on levee crown.

Looking at typical view of rodent holes within this section on landward slope.

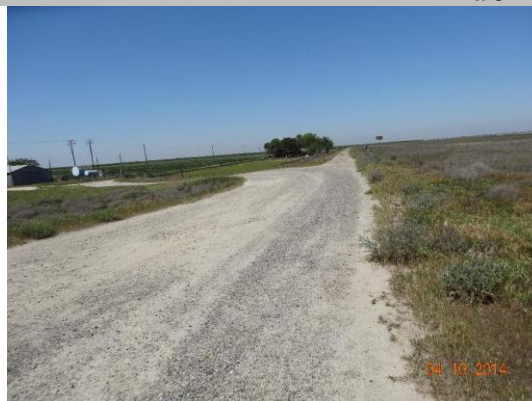
Photo 1 of 2 : UCIP_FA_2016_39503_66660.jpg

FS_ID:39503
DS_ID:19925
EP_NO: 6603
Repair Type: Non-Urgent
Crossing Status: Found
UCIP Comments: Need to contact owner. Appears abandoned--good candidate for video or pressure inspection. This crossings is the same age as the pipe that has failed immediately upstream.
FIELD_STRUCT_DESC: 15-inch steel pipe through the levee, 4.3 feet below the crown. Electrical conduit through the levee, 4.3 feet below the crown. Siphon breaker on landward shoulder. 36-inch concrete standpipe on landward berm. Inlet facility on waterward bank consisting of pump, 42-inch concrete standpipe, and 20-inch concrete channel intake pipe with cutoff wall. (Permit No. 6603-1970)
FS Date: 4/10/2014

Overview of levee crown at crossing.

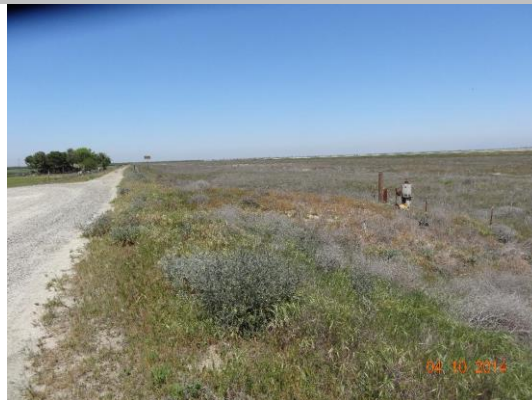
Photo 2 of 2 : UCIP_FA_2016_39503_66657.jpg

View of waterward side.

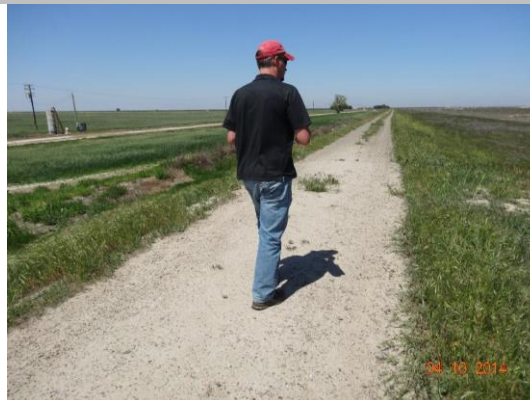
Photo 2 of 2 : UCIP_FA_2016_49968_60559.jpg

View of levee crown at crossing.

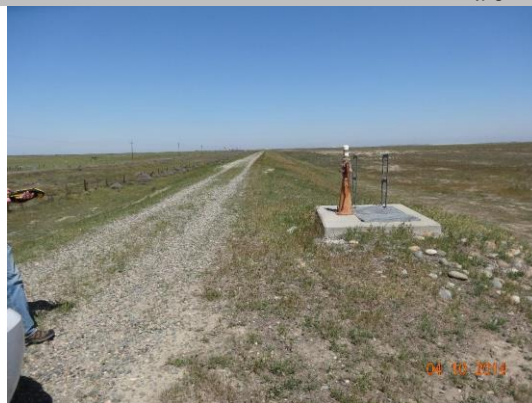
Photo 1 of 2 : UCIP_FA_2016_36843_67202.jpg

Comment Code					
Inspector Comment					
FS_ID:36843					
DS_ID:19930					
EP_NO: N/A					
Repair Type: Non-Urgent					
Crossing Status: Found					
UCIP Comments: CMP crossing is distorted on waterward side. Debris scattered on landward side. Sediment deposit inside crossing visible from landward side. Recommend removing debris from landward side.					
FIELD_STRUCT_DESC: 42-inch concrete pipe through the levee, 19.0 feet below the crown. Gate structure on waterward shoulder. Pipe section on waterward side is corrugated metal and pipe section on lanward side is reinforced concrete. (Permit No. 13548-1984, New Stone Water District)					
FS Date: 4/10/2014

Overview of levee crown at crossing--slide gate inside concrete box located on waterward shoulder.

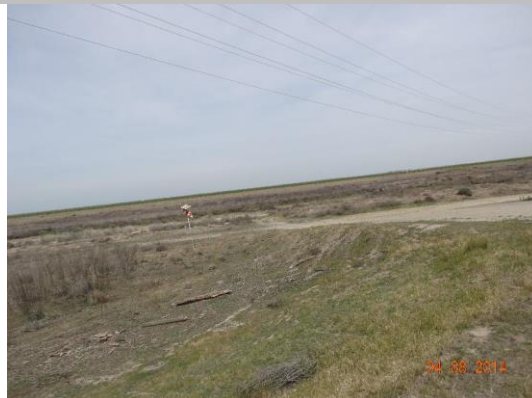
Photo 1 of 2 : UCIP_FA_2016_39505_67226.jpg

LM Start	13.59	Rating **	M	Issue No.	15
LM End	13.59	Issue Type +	En	Location *	WS
Category	Supplemental			GPS Latitude/Longitude	
				Start	End
Item	DWR UCIP Field Study			36.792684 °	36.792684 °
				-120.304542 °	-120.304542 °
DWR ID					
Comment Code					
Inspector Comment					
FS_ID:39505					
DS_ID:19932					
EP_NO: N/A					
Repair Type: Non-Urgent					
Crossing Status: Indicator Found					
UCIP Comments: Multiple markers visible along waterward and					
landward sides unable to confirm how many crossings go through					
levee. Need to contact owner to obtain additional details on crossings.					
FIELD_STRUCT_DESC: 6-inch gas line through the levee. Extends					
underneath the channel.					
FS Date: 4/8/2014

Markers visible on waterward side.

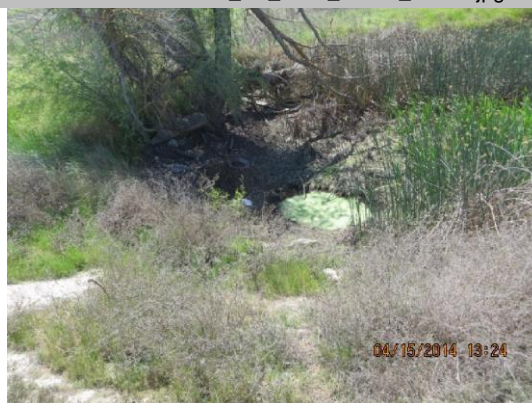
Photo 2 of 2 : UCIP_FA_2016_49959_61061.jpg

Concrete headwall at toe of LS slope.

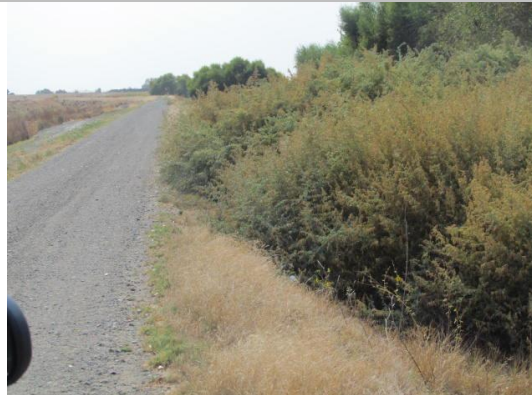
Photo 1 of 2 : FA_2016_NA0010_138_21_20161007_00008.jpg

Looking at dense vegetation on landward slope. Fall 2015

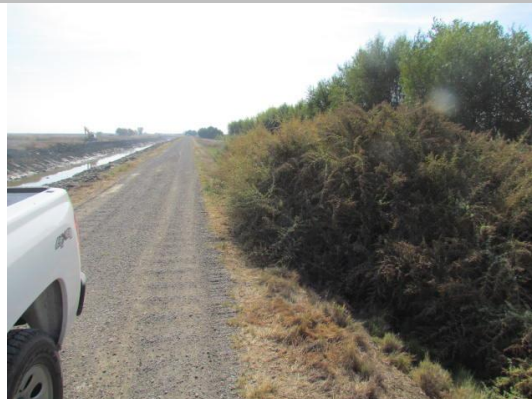
Photo 2 of 2 : FA_2016_NA0010_138_21_20161007_00009.jpg

Looking south at dense vegetation on landward slope. Spring 2015

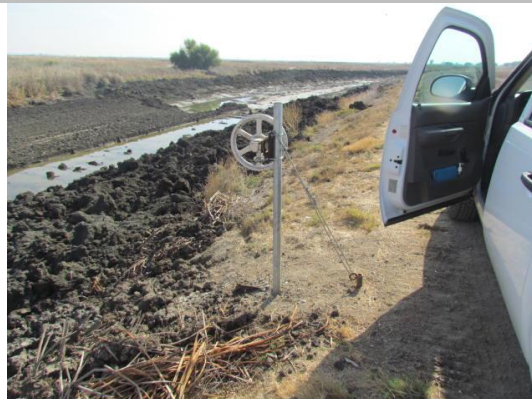
Photo 1 of 1 : FA_2016_NA0010_138_23_20161007_00010.jpg

LM Start	0.87	Rating **	M	Issue No.	23
LM End	0.87	Issue Type +	En	Location *	WS
Category	Earthen Levee			GPS Latitude/Longitude	
				Start	End
Item	Encroachments			37.217802 °	37.217802 °
				-120.697416 °	-120.697416 °
DWR ID	DWR_NA0010_22A_f_2014_23				
Comment Code					
SI : Sign					
Inspector Comment					
Pulley on waterward shouder without board permit.

Looking south at pulley on waterward shoulder.

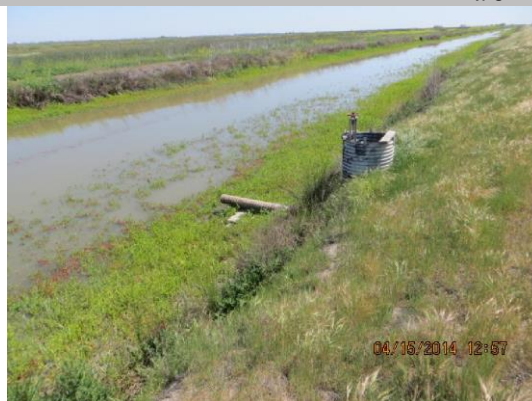
Photo 1 of 2 : UCIP_FA_2016_33733_61030.jpg

LM Start	1.57	Rating **	M	Issue No.	261
LM End	1.57	Issue Type +	En	Location *	WS
Category	Supplemental			GPS Latitude/Longitude	
				Start	End
Item	DWR UCIP Field Study			37.227588 °	37.227588 °
				-120.700945 °	-120.700945 °
DWR ID					
Comment Code					
Inspector Comment					
FS_ID:33733 DS_ID:19936 EP_NO: N/A Repair Type: Non-Urgent Crossing Status: Found UCIP Comments: Slide gate rusted and does not function. Headwall buried at LS toe. Pipe appears abandoned and if so should be done so properly. FIELD_STRUCT_DESC: 8-inch CM irrigation pipe through levee, 7.0-feet below the crown. Slide gate inside 36-inch CM pipe riser in the waterward slope. Concrete headwall on the landward end. (USACE-1967). This entry matches the Drainage or Irrigation Structure referenced in O&M manual (HLM 1.57). FS Date: 4/15/2014

Pipe and CMP riser with slide gate visible on WS slope.

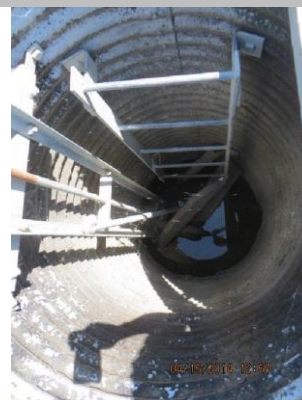
Photo 2 of 2 : UCIP_FA_2016_33733_61029.jpg

Inside CMP riser on WS shoulder.

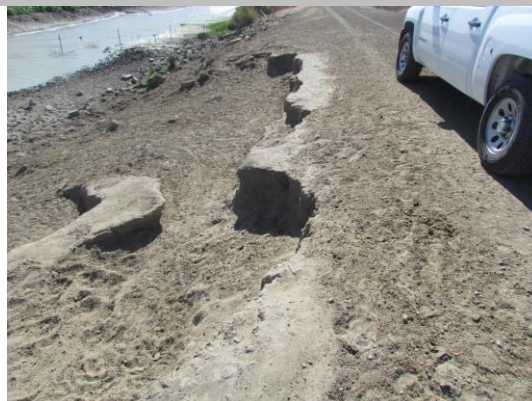
Photo 1 of 1 : FA_2016_NA0010_138_13_20161024_00024.jpg

LM Start	2.65	Rating **	U	Issue No.	13
LM End	2.65	Issue Type +	Ma	Location *	WS
Category	Earthen Levee			GPS Latitude/Longitude	
				Start	End
Item	Erosion / Bank Caving			37.242572 °	37.242572 °
				-120.706472 °	-120.706472 °
DWR ID	DWR_NA0010_22A_f _ 2016_13				
Comment Code					
E1 : Note and monitor erosion site.					
Inspector Comment					
Erosion caused by animal traffic.

Looking at animal erosion on waterwater slope.

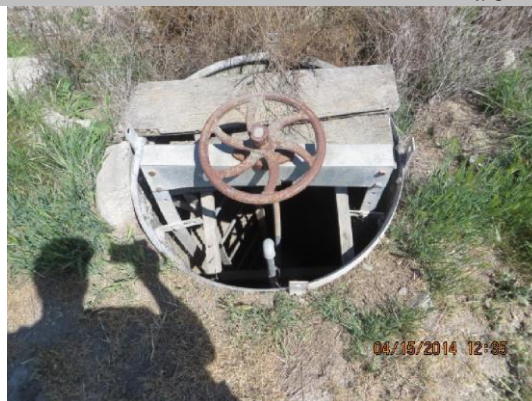
Photo 1 of 2 : UCIP_FA_2016_33732_61026.jpg

LM Start	2.71	Rating **	M	Issue No.	260
LM End	2.71	Issue Type +	En	Location *	WS
Category	Supplemental			GPS Latitude/Longitude	
				Start	End
Item	DWR UCIP Field Study			37.243501 °	37.243501 °
				-120.706773 °	-120.706773 °
DWR ID					
Comment Code					
Inspector Comment					
FS_ID:33732 DS_ID:19937 EP_NO: N/A Repair Type: Non-Urgent Crossing Status: Found UCIP Comments: Slide gate does not function and should be repaired. Headwall at LS toe not found. FIELD_STRUCT_DESC: 24-inch CM irrigation pipe through the levee, 7.5-feet below the crown. Slide gate inside 36-inch CM pipe riser in the waterward slope. Concrete "U" headwall on the landward end. (USACE-1967). This entry matches the Drainage or Irrigation Structure referenced in O&M manual (HLM 2.72). FS Date: 4/15/2014

Slidegate in CMP riser on WS shoulder. (Note: actuator does not work).

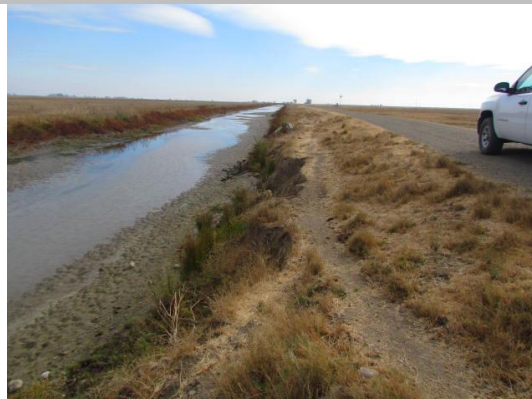
Photo 2 of 2 : FA_2016_NA0010_138_4_20161007_00002.jpg

LM Start	5.05	Rating **	M	Issue No.	4 (cont)	
LM End	5.05	Issue Type +	Ma	Location *	WS	
Category	Earthen Levee			GPS Latitude/Longitude		
				Start		End
Item	Erosion / Bank Caving			37.267516 °		37.267516 °
				-120.736401 °		-120.736401 °
DWR ID	DWR_NA0010_22A_f_2013_4					
Comment Code						
E2 : Schedule repair of erosion site prior to the next inspection.						
Inspector Comment						
Erosion caused by animal traffic.

Looking southeast at livestock erosion on waterward toe.

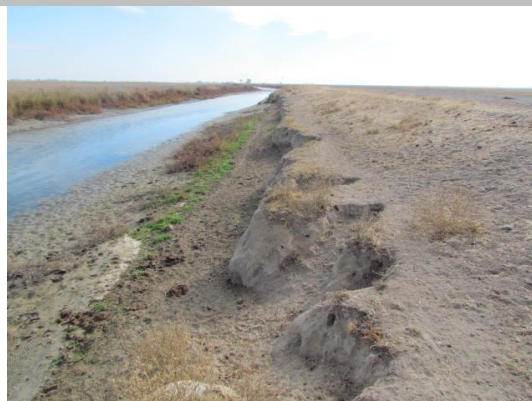
Photo 1 of 2 : FA_2016_NA0010_138_6_20161007_00003.jpg

LM Start	5.14	Rating **	M	Issue No.	6
LM End	5.20	Issue Type +	Ma	Location *	WS
Category	Earthen Levee			GPS Latitude/Longitude	
				Start	End
Item	Animal Control			37.268492 °	37.269133 °
				-120.737493 °	-120.738208 °
DWR ID	DWR_NA0010_22A_s_2012_6				
Comment Code					
A2 : Repair the levee slope damaged by livestock and prevent large animal access.					
Inspector Comment					
Slope damage caused by livestock on waterside toe.

Looking southeast at livestock erosion on waterward toe.

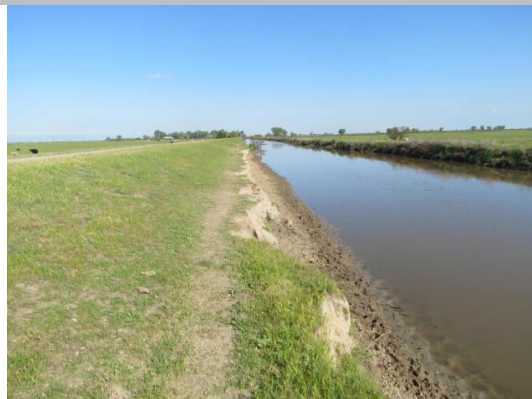
Photo 2 of 2 : FA_2016_NA0010_138_6_20161007_00004.jpg

Looking northwest at livestock erosion along waterside slope and toe.

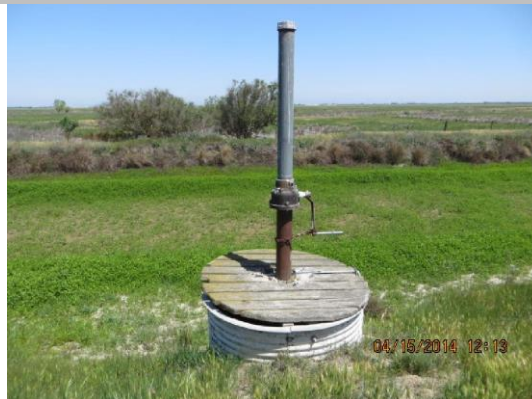
Photo 1 of 2 : UCIP_FA_2016_39536_61022.jpg

LM Start	5.48	Rating **	M	Issue No.	262
LM End	5.48	Issue Type +	En	Location *	WS
Category	Supplemental			GPS Latitude/Longitude	
				Start	End
Item	DWR UCIP Field Study			37.272079 °	37.272079 °
				-120.741575 °	-120.741575 °
DWR ID					
Comment Code					
Inspector Comment					
FS_ID:39536 DS_ID:19938 EP_NO: N/A Repair Type: Non-Urgent Crossing Status: Found UCIP Comments: Need to contact owner. Pipe silted in on LS toe. Appears abandoned and if so should be done so properly. FIELD_STRUCT_DESC: 48-inch CM irrigation pipe through the levee, 10 feet below the crown. Slide gate inside 60-inch CM pipe riser in the waterward slope. Concrete headwall on the landward end. Waterward end capped with 1/4-inch steel plate. (USACE-1967). This entry matches the Drainage or Irrigation Structure referenced in O&M manual (HLM 5.48). FS Date: 4/15/2014

Slidegate inside riser on WS shoulder.
