**Flood Control Project Maintenance
Levee Inspections**

Fall 2016 Levee Maintenance Deficiency Summary Report

San Joaquin River Basin

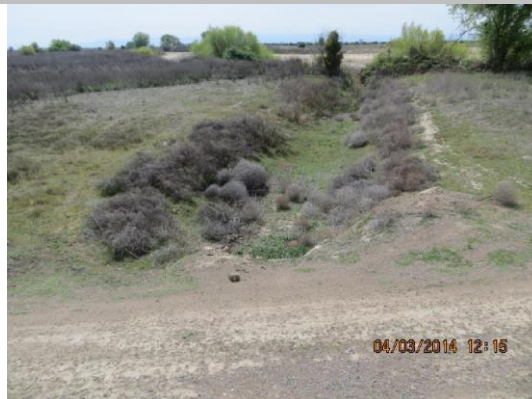
Photo 1 of 2 : UCIP_FA_2016_39537_59860.jpg

LM Start	0.21	Rating **	M	Issue No.	34
LM End	0.21	Issue Type +	En	Location *	WS
Category	Supplemental			GPS Latitude/Longitude	
				Start	End
Item	DWR UCIP Field Study			36.772713 °	36.772713 °
				-120.280670 °	-120.280670 °
DWR ID					
Comment Code					
Inspector Comment					
FS_ID:39537 DS_ID:19945 EP_NO: N/A Repair Type: Non-Urgent Crossing Status: Found UCIP Comments: Excessive vegetation at inlet--recommend clearing. FIELD_STRUCT_DESC: 30-inch square R.C.B.C. through the levee 13.0 feet below the crown. Concrete "U" headwall on the waterward end. Flap gate on the waterward end. Concrete headwall on the landward end. (USACE-1967). This entry matches the Drainage or Irrigation Structure referenced in O&M manual (HLM 0.21). Cleaned and rehabilitated under Permit No. 13085 (1981). FS Date: 4/3/2014

Concrete headwall on WS toe at channel.

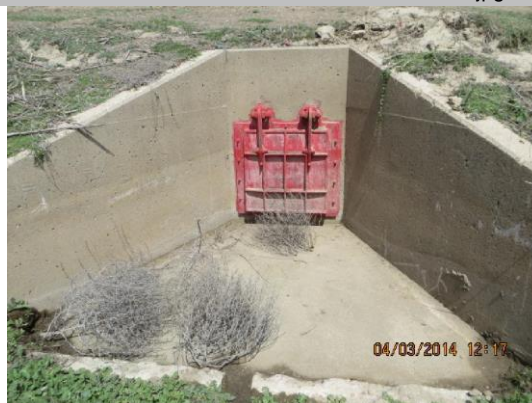
Photo 2 of 2 : UCIP_FA_2016_39537_59859.jpg

Flapgate on Concrete headwall at WS toe.

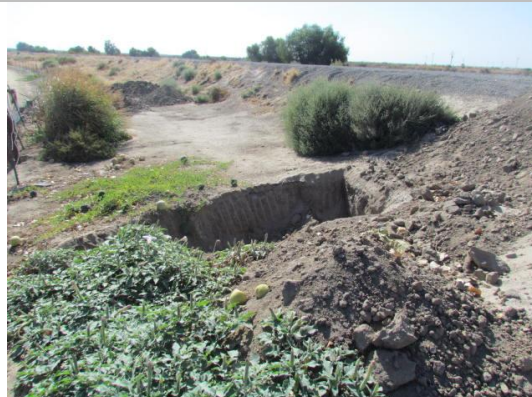
Photo 2 of 3 : FA_2016_NA0010_139_24_20161007_00019.jpg

LM Start	1.54	Rating **	U	Issue No.	24 (cont)	
LM End	1.54	Issue Type +	En	Location *	LS	
Category	Earthen Levee			GPS Latitude/Longitude		
				Start		End
Item	Encroachments			36.771922 °		36.771922 °
				-120.259321 °		-120.259321 °
DWR ID	DWR_NA0010_23_f_2015_24					
Comment Code						
DT : Ditch						
Inspector Comment						
Landowner digging at landward berm.

Looking southeast at large pot hole on landward berm.

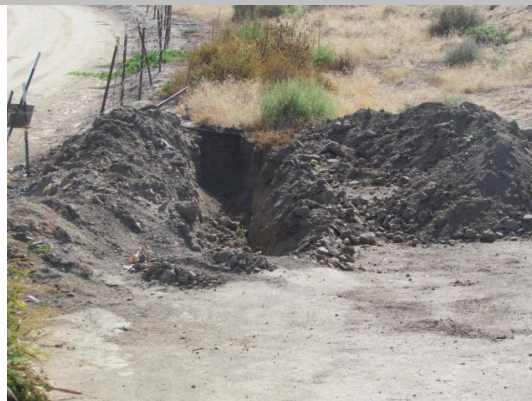
Photo 3 of 3 : FA_2016_NA0010_139_24_20161007_00020.jpg

Looking southeast at trench on landward berm.

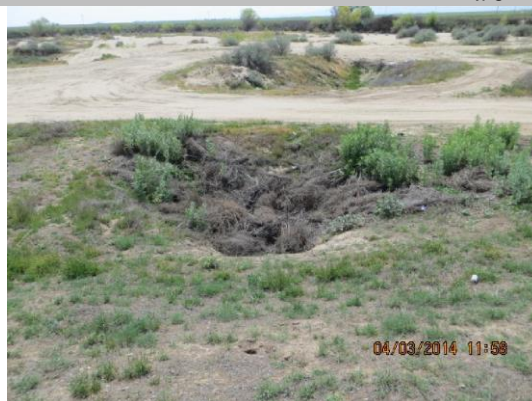
Photo 1 of 2 : UCIP_FA_2016_39538_59855.jpg

LM Start	1.63	Rating **	M	Issue No.	35
LM End	1.63	Issue Type +	En	Location *	LS
Category	Supplemental			GPS Latitude/Longitude	
				Start	End
Item	DWR UCIP Field Study			36.771408 °	36.771408 °
				-120.257899 °	-120.257899 °
DWR ID					
Comment Code					
Inspector Comment					
FS_ID:39538 DS_ID:19948 EP_NO: N/A Repair Type: Non-Urgent Crossing Status: Found UCIP Comments: Appears abandoned and if so should be done properly. Discharge channel is blocked by sand and soil making drain ineffective. Soil buildup at inlet on LS toe. Need to contact owner. FIELD_STRUCT_DESC: 30-inch square R.C.B.C. through the levee, 11.0 feet below the crown. Concrete "U" headwall on the waterward end. Flap gate on the waterward end. Concrete headwall on the landward end. FS Date: 4/3/2014

Concrete headwall on WS toe.

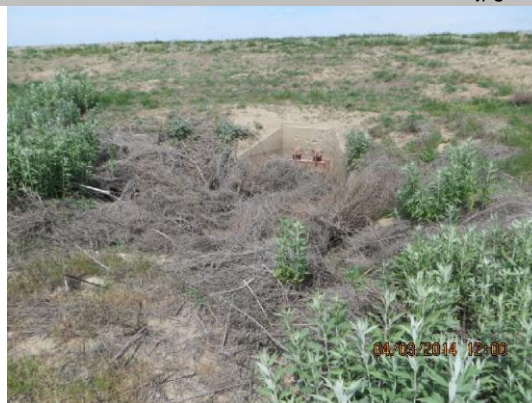
Photo 2 of 2 : UCIP_FA_2016_39538_59857.jpg

Flapgate on Concrete headwall at WS toe.

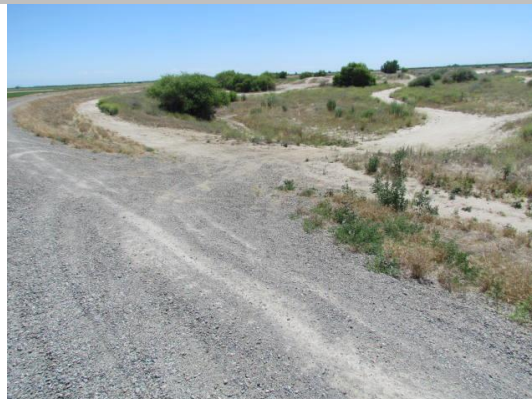
Photo 1 of 1 : FA_2016_NA0010_139_16_20161007_00017.jpg

LM Start	2.12	Rating **	M	Issue No.	16
LM End	2.42	Issue Type +	Ma	Location *	WS
Category	Earthen Levee			GPS Latitude/Longitude	
				Start	End
Item	Slope Stability			36.775507 °	36.774423 °
				-120.251672 °	-120.246993 °
DWR ID	DWR_NA0010_23_s_ 2013_16				
Comment Code					
S3 : Repair the levee slope damaged by vehicle traffic and prevent access where possible.					
Inspector Comment					
Several damaged sites within this reach. Damage caused by vehicle traffic. At. LM. 2.12, 2.21, 2.37, & 2.41

Looking west at one of several slope damaged cause by vehicle traffic.

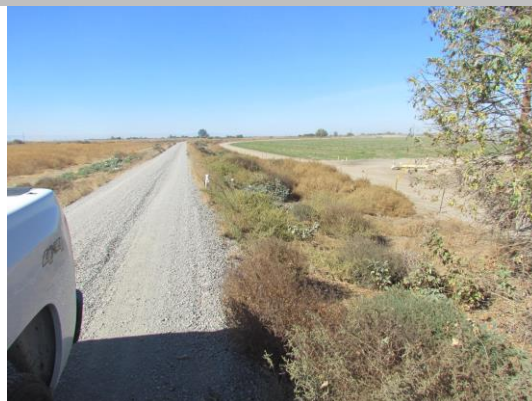
Photo 1 of 2 : FA_2016_NA0010_139_23_20161024_00053.jpg

LM Start	2.83	Rating **	U	Issue No.	23
LM End	3.02	Issue Type +	Ma	Location *	LS
Category	Earthen Levee			GPS Latitude/Longitude	
				Start	End
Item	Vegetation			36.771560 °	36.771554 °
				-120.241248 °	-120.237788 °
DWR ID	DWR_NA0010_23_f_ 2016_23				
Comment Code					
V1 : Control annual grass and weeds on the levee slopes and easements.					
Inspector Comment					
Dense veg (Tumble weeds) on levee slope.

Looking downstream at dense veg on landward slope.

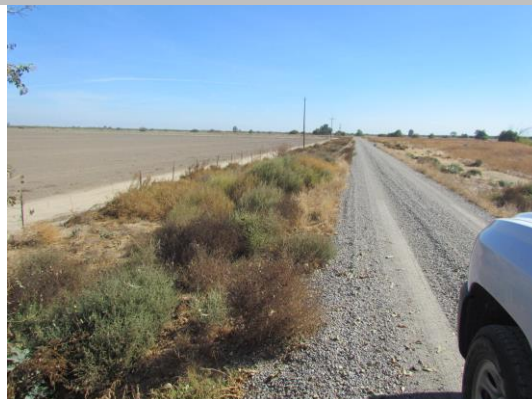
Photo 2 of 2 : FA_2016_NA0010_139_23_20161024_00054.jpg

Looking upstream at dense veg on landward slope.

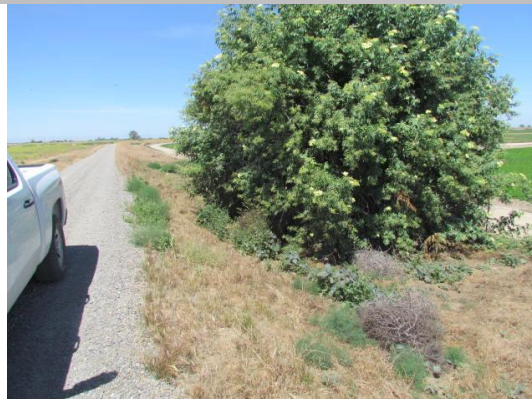
Photo 1 of 3 : FA_2016_NA0010_139_15_20161007_00014.jpg

Looking west at elderberry at landward toe. (Spring 2016)

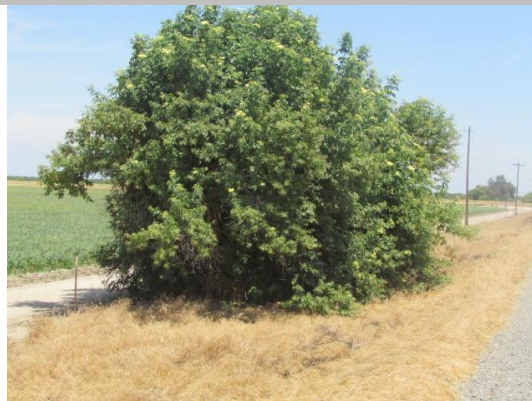
Photo 2 of 3 : FA_2016_NA0010_139_15_20161007_00015.jpg

Looking east at elderberry at landward toe. (Spring 2015)

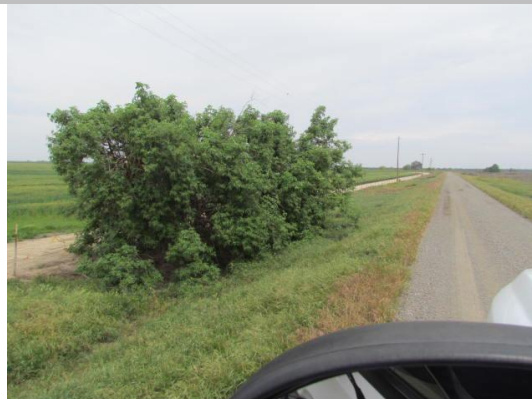
Photo 3 of 3 : FA_2016_NA0010_139_15_20161007_00016.jpg

Looking east at elderberry on landside toe and berm. (Fall 2014)

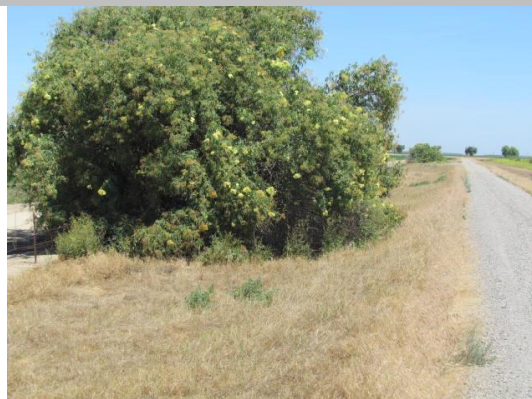
Photo 1 of 4 : FA_2016_NA0010_139_3_20161007_00002.jpg

Looking North at elderberry on landward toe and berm. (Spring 2016)

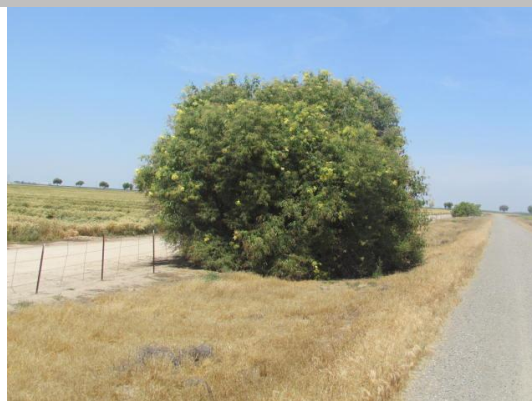
Photo 2 of 4 : FA_2016_NA0010_139_3_20161007_00003.jpg

Looking north at elderberry on landward toe and berm. (Spring 2015)

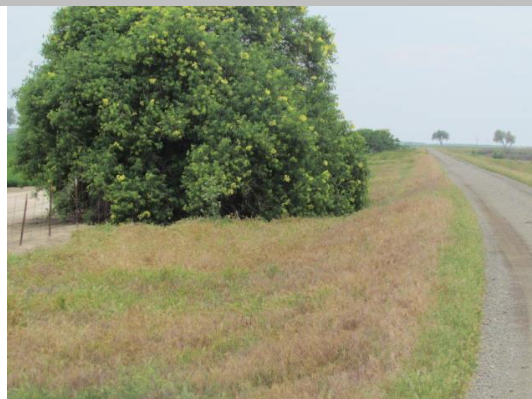
Photo 3 of 4 : FA_2016_NA0010_139_3_20161007_00004.jpg

Looking north at elderberry on landside toe and berm. (Fall 2014)

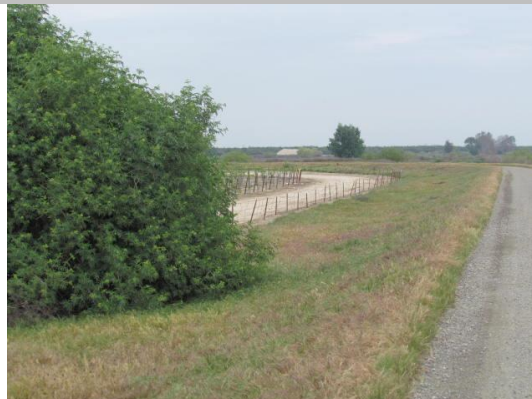
Photo 2 of 2 : FA_2016_NA0010_139_11_20161007_00013.jpg

LM Start	4.45	Rating **	M	Issue No.	11 (cont)	
LM End	4.45	Issue Type +	Ma	Location *	LS	
Category	Earthen Levee			GPS Latitude/Longitude		
				Start		End
Item	Vegetation			36.784523 °		36.784523 °
				-120.223292 °		-120.223292 °
DWR ID	DWR_NA0010_23_s_2012_11					
Comment Code						
V4 : Elderberries are blocking visibility and flood fight capability.						
Inspector Comment						
Control growth of elderberry on landward toe and berm.

Looking northeast at elderberry on landside toe and berm.

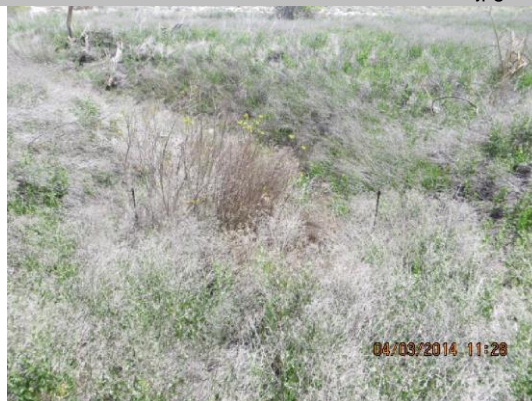
Photo 2 of 2 : UCIP_FA_2016_39540_59847.jpg

Heavy vegetation in outlet/channel on WS toe.

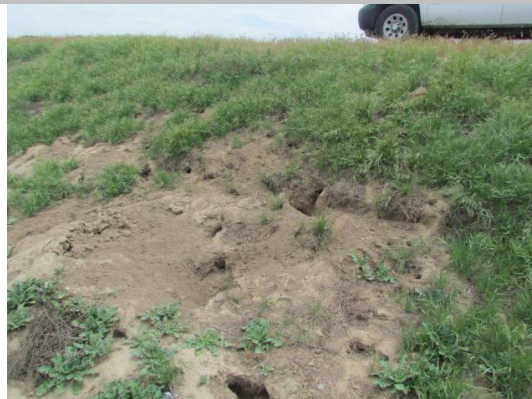
Photo 1 of 1 : FA_2016_NA0010_139_5_20161007_00006.jpg

LM Start	5.68	Rating **	U	Issue No.	5
LM End	5.68	Issue Type +	Ma	Location *	WS
Category	Earthen Levee			GPS Latitude/Longitude	
				Start	End
Item	Animal Control			36.791981 °	36.791981 °
				-120.206274 °	-120.206274 °
DWR ID	DWR_NA0010_23_s_2012_5				
Comment Code					
A1 : Exterminate rodents and backfill and compact or grout burrows.					
Inspector Comment					
Several large rodent holes in this area.

Looking at several rodent holes on landside slope.

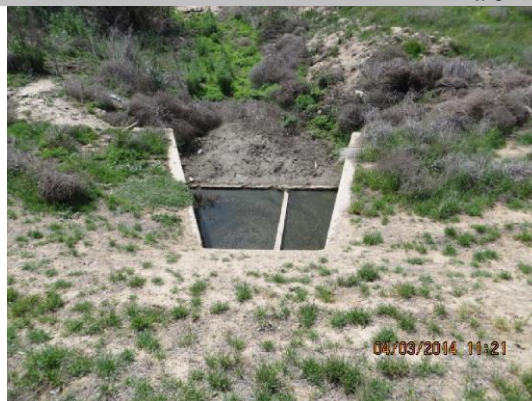
Photo 1 of 2 : UCIP_FA_2016_39542_59830.jpg

Comment Code					
Inspector Comment					
FS_ID:39542 DS_ID:19954 EP_NO: N/A Repair Type: Non-Urgent Crossing Status: Found UCIP Comments: Dense vegetation limits the inspector's visibility to identify signs of pipe failure (leaks) along the landward slope. Recommend removing vegetation along pipe alignment to conduct proper inspection of structure. FIELD_STRUCT_DESC: 36-inch square R.C.B.C through the levee 9.0 feet below the crown. Concrete "U" headwalls on both ends. Flap gate on the waterward end. Outlet channel cobble revetted 5.0 feet long. (USACE-1967). This entry matches the Drainage or Irrigation Structure referenced in O&M manual (HLM 5.71). FS Date: 4/3/2014

Concrete headwall on WS toe.

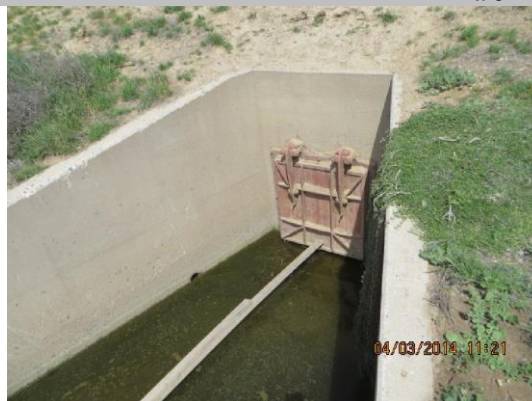
Photo 2 of 2 : UCIP_FA_2016_39542_59829.jpg

Comment Code						
Inspector Comment						
FS_ID:39542						
DS_ID:19954						
EP_NO: N/A						
Repair Type: Non-Urgent						
Crossing Status: Found						
UCIP Comments: Dense vegetation limits the inspector's visibility to identify signs of pipe failure (leaks) along the landward slope.						
Recommend removing vegetation along pipe alignment to conduct proper inspection of structure.						
FIELD_STRUCT_DESC: 36-inch square R.C.B.C through the levee 9.0 feet below the crown. Concrete "U" headwalls on both ends. Flap gate on the waterward end. Outlet channel cobble revetted 5.0 feet long. (USACE-1967). This entry matches the Drainage or Irrigation Structure referenced in O&M manual (HLM 5.71).						
FS Date: 4/3/2014

Flapgate on Concrete headwall on WS toe.

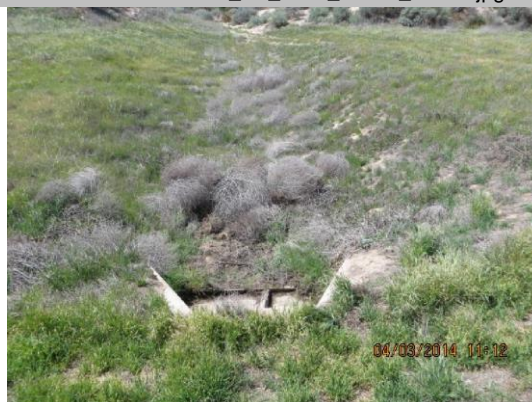
Photo 1 of 2 : UCIP_FA_2016_39543_59826.jpg

LM Start	7.06	Rating **	M	Issue No.	31
LM End	7.06	Issue Type +	En	Location *	WS
Category	Supplemental			GPS Latitude/Longitude	
				Start	End
Item	DWR UCIP Field Study			36.778783 °	36.778783 °
				-120.192447 °	-120.192447 °
DWR ID					
Comment Code					
Inspector Comment					
FS_ID:39543 DS_ID:19939 EP_NO: N/A Repair Type: Non-Urgent Crossing Status: Found UCIP Comments: Dense vegetation limits the inspector's visibility to identify signs of pipe failure (leaks) along the landward slope. Recommend removing vegetation along pipe alignment to conduct proper inspection of structure. FIELD_STRUCT_DESC: 30-inch square R.C.B.C. through the levee 8.5 feet below the crown. Concrete "U" headwall on the waterward end. Flap gate on the waterward end. Concrete headwall on the landward end. FS Date: 4/3/2014

Concrete headwall on WS toe.

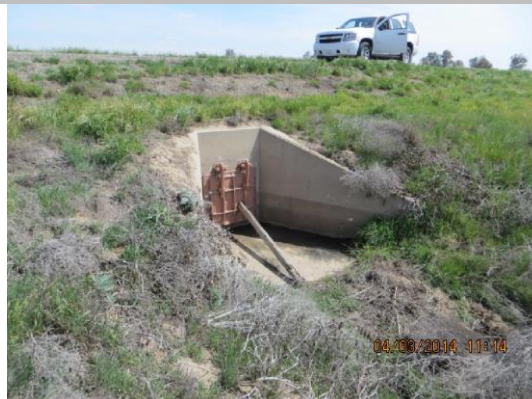
Photo 2 of 2 : UCIP_FA_2016_39543_59828.jpg

LM Start	7.06	Rating **	M	Issue No.	31 (cont)	
LM End	7.06	Issue Type +	En	Location *	WS	
Category	Supplemental			GPS Latitude/Longitude		
				Start		End
Item	DWR UCIP Field Study			36.778783 °	36.778783 °	
				-120.192447 °	-120.192447 °	
DWR ID						
Comment Code						
Inspector Comment						
FS_ID:39543 DS_ID:19939 EP_NO: N/A Repair Type: Non-Urgent Crossing Status: Found UCIP Comments: Dense vegetation limits the inspector's visibility to identify signs of pipe failure (leaks) along the landward slope. Recommend removing vegetation along pipe alignment to conduct proper inspection of structure. FIELD_STRUCT_DESC: 30-inch square R.C.B.C. through the levee 8.5 feet below the crown. Concrete "U" headwall on the waterward end. Flap gate on the waterward end. Concrete headwall on the landward end. FS Date: 4/3/2014

Flapgate on Concrete headwall at WS toe.

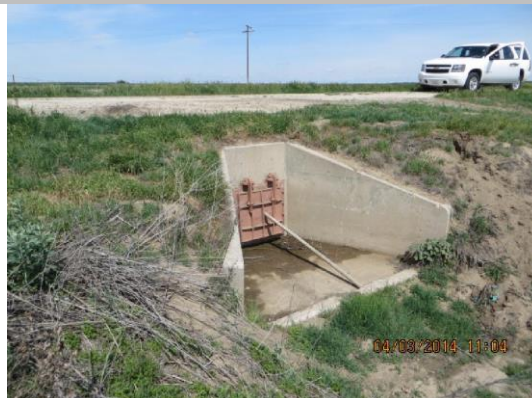
Photo 1 of 2 : UCIP_FA_2016_39544_59823.jpg

Comment Code					
Inspector Comment					
FS_ID:39544					
DS_ID:19940					
EP_NO: N/A					
Repair Type: Non-Urgent					
Crossing Status: Found					
UCIP Comments: Some sediment buildup at inlet at LS toe. Also dense vegetation limits the inspector's visibility to identify signs of pipe failure (leaks) along the landward slope. Recommend removing vegetation along pipe alignment to conduct proper inspection of structure.					
FIELD_STRUCT_DESC: 30-inch square R.C.B.C. through the levee, 5.2 feet below the crown. Concrete "U" headwall on the waterward end. Flap gate on the waterward end. Concrete headwalls on the landward end. (USACE-1967). This entry matches the Drainage or Irrigation Structure referenced in O&M manual (HLM 8.33).					
FS Date: 4/3/2014

Flapgate on WS toe.

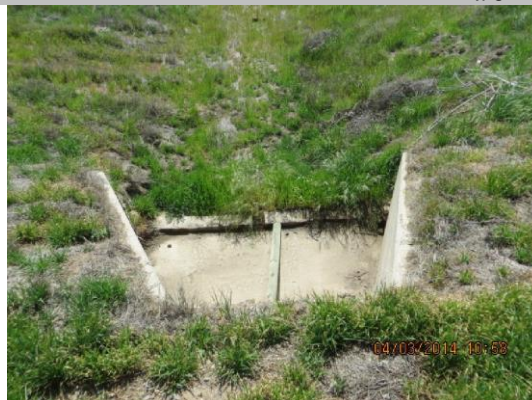
Photo 1 of 2 : UCIP_FA_2016_39545_59817.jpg

Comment Code					
Inspector Comment					
FS_ID:39545					
DS_ID:19941					
EP_NO: N/A					
Repair Type: Non-Urgent					
Crossing Status: Found					
UCIP Comments: Dense vegetation limits the inspector's visibility to identify signs of pipe failure (leaks) along the landward slope.					
Recommend removing vegetation along pipe alignment to conduct proper inspection of structure.					
FIELD_STRUCT_DESC: 30-inch square R.C.B.C. through the levee, 5.6 feet below the crown. Concrete "U" headwall on the waterward end.					
Flap gate on the waterward end. Concrete headwall on the landward end. (USACE-1967). This entry matches the Drainage or Irrigation Structure referenced in O&M manual (HLM 8.54).					
FS Date: 4/3/2014

Concrete headwall on WS toe.

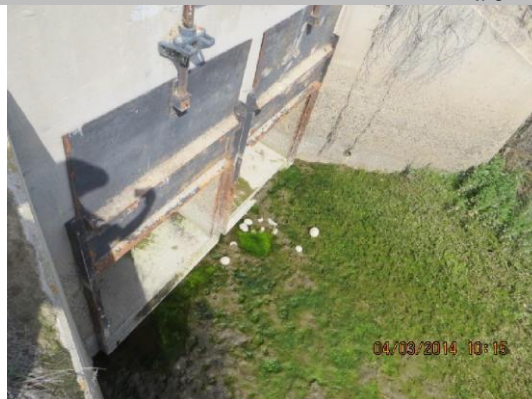
Photo 2 of 2 : UCIP_FA_2016_49971_59809.jpg

Slide gate on concrete headwall at WS toe.

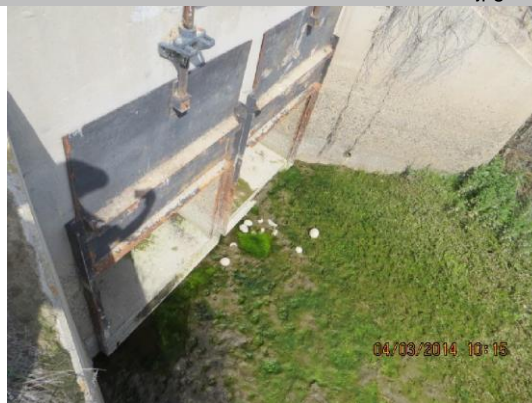
Photo 2 of 2 : UCIP_FA_2016_49972_59801.jpg

FS_ID:49972
DS_ID:19980
EP_NO: N/A
Repair Type: Urgent
Crossing Status: Found
UCIP Comments: 7/20/2016 No change--same as previous inspection.
(DWR UCIP - omagana)4/03/2014 Slide gate not functional. Slide gate channels heavily corroded (exfoliated) and likely impact functionality/structural integrity of gate. (DWR UCIP - omagana)
FIELD_STRUCT_DESC: [Gravelly Ford Canal Irrigation Structure] 2 of 2: 48-inch by 63-inch reinforced concrete box culvert (RCBC) through the levee, 10 feet below the crown. Concrete "U" headwall is located on the waterside (WS) end. Gear pedestal slide gate with wall bracket is located on the WS headwall. Concrete "U" headwall is located on the landside (LS) end. Outlet channel cobble revetted 10 feet long. Guardrails are located on both shoulders. [Additional Reference(s): DWR Levee Log, 2002]
FS Date: 7/20/2016

Slide gates on WS toe.

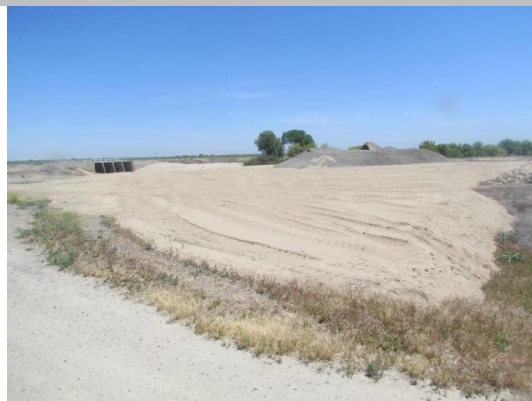
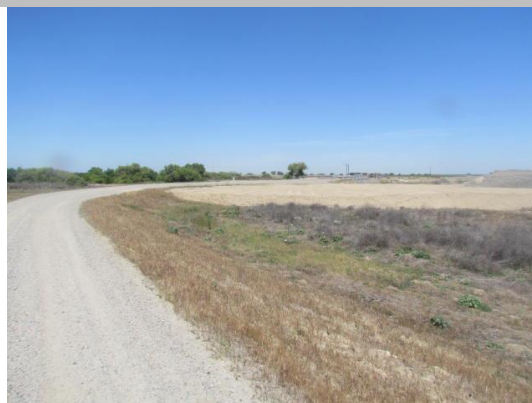
LM Start	0.06	Rating **	M	Issue No.	47
LM End	0.06	Issue Type +	En	Location *	LS
Category	Earthen Levee			GPS Latitude/Longitude	
				Start	End
Item	Encroachments			36.772328 °	36.772328 °
				-120.285117 °	-120.285117 °
DWR ID	DWR_NA0010_24_s_2014_47				
Comment Code					
MA : Material					
Inspector Comment					
District constructed a berm on waterward slope. Berm is being used for staging of earthen material.

Looking northeast at berm on waterward slope.

Looking north at berm on waterward slope.

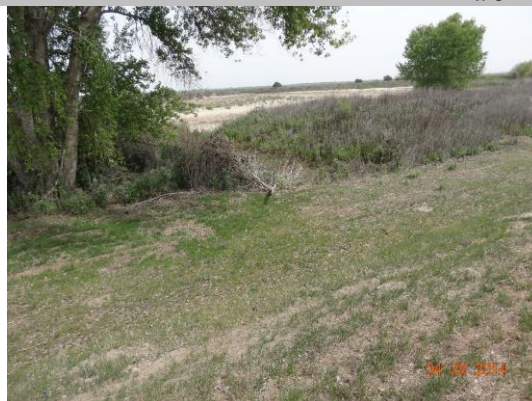
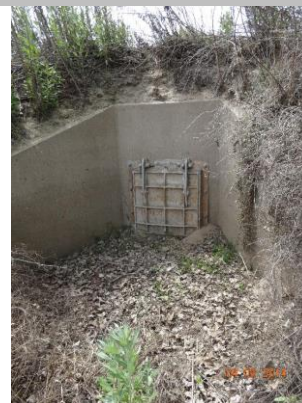
LM Start	0.50	Rating **	M	Issue No.	268
LM End	0.50	Issue Type +	En	Location *	LS
Category	Supplemental			GPS Latitude/Longitude	
				Start	End
Item	DWR UCIP Field Study			36.766872 °	36.766872 °
				-120.283212 °	-120.283212 °
DWR ID					
Comment Code					
Inspector Comment					
FS_ID:33264					
DS_ID:19955					
EP_NO: N/A					
Repair Type: Non-Urgent					
Crossing Status: Found					
UCIP Comments: No access available to confirm condition of landward side headwall. Recommend clearing debris along fence. Surface erosion near concrete headwall on landward side was present.					
FIELD_STRUCT_DESC: 30-inch square R.C.B.C. through the levee, 13.5 feet below the crown. Concrete headwalls on both ends. Flap gate on the waterward end.					
FS Date: 4/8/2014

View of waterward side.

Square gate visible on waterward side.

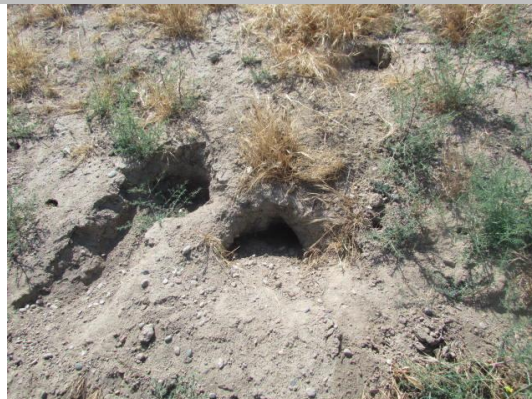
LM Start	0.82	Rating **	M	Issue No.	6
LM End	0.82	Issue Type +	Ma	Location *	LS
Category	Earthen Levee			GPS Latitude/Longitude	
				Start	End
Item	Animal Control			36.766775 °	36.766775 °
				-120.278757 °	-120.278757 °
DWR ID	DWR_NA0010_24_s_2013_6				
Comment Code					
A1 : Exterminate rodents and backfill and compact or grout burrows.					
Inspector Comment					
Noted several rodent holes within this section.

Looking at several rodent holes on landward slope.

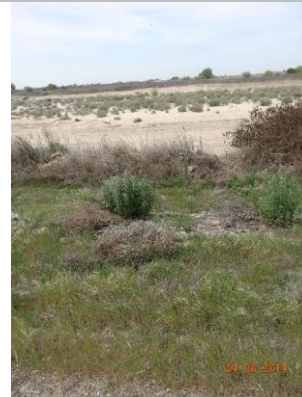
LM Start	1.06	Rating **	M	Issue No.	269
LM End	1.06	Issue Type +	En	Location *	LS
Category	Supplemental			GPS Latitude/Longitude	
				Start	End
Item	DWR UCIP Field Study			36.769574 °	36.769574 °
				-120.276253 °	-120.276253 °
DWR ID					
Comment Code					
Inspector Comment					
FS_ID:33265 DS_ID:19961 EP_NO: 13735 Repair Type: Non-Urgent Crossing Status: Found UCIP Comments: Unable to determine status of crossing. Need to contact owner to determine status of crossing. FIELD_STRUCT_DESC: 24-inch steel discharge pipe through the levee, 2-feet below the crown. Roadway on crown has been padded 1-foot. Siphon breaker on the apex of pipeline on landward shoulder. Galvanized siphon vent pipe on the landward shoulder. Steel cutoff wall around the pipeline at centerline of levee. Pump on landward side. (Permit No. 13735-1984). FS Date: 4/8/2014

View of landward side.

View of waterward side.

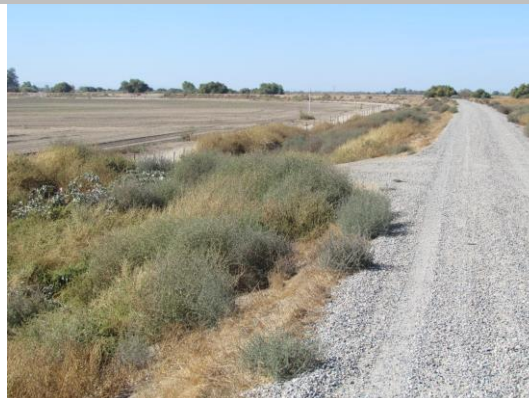
LM Start	1.34	Rating **	U	Issue No.	13
LM End	2.17	Issue Type +	Ma	Location *	LS
Category	Earthen Levee			GPS Latitude/Longitude	
				Start	End
Item	Vegetation			36.772360 °	36.769993 °
				-120.272798 °	-120.259236 °
DWR ID	DWR_NA0010_24_f_2016_13				
Comment Code					
V1 : Control annual grass and weeds on the levee slopes and easements.					
Inspector Comment

Looking at typical view of dense veg on landward slope.

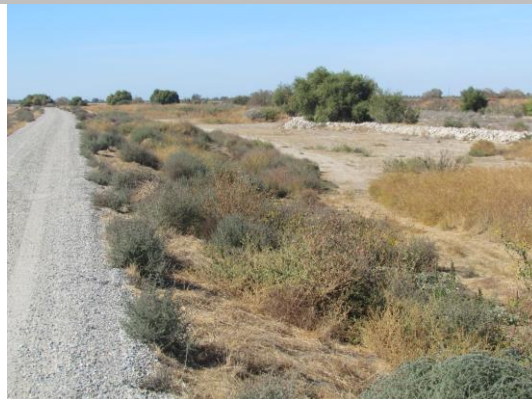
LM Start	1.56	Rating **	U	Issue No.	12
LM End	2.17	Issue Type +	Ma	Location *	WS
Category	Earthen Levee			GPS Latitude/Longitude	
				Start	End
Item	Vegetation			36.770759 °	36.769993 °
				-120.269522 °	-120.259236 °
DWR ID	DWR_NA0010_24_f_2016_12				
Comment Code					
V1 : Control annual grass and weeds on the levee slopes and easements.					
Inspector Comment

Looking at typical view of dense veg on waterward slope.

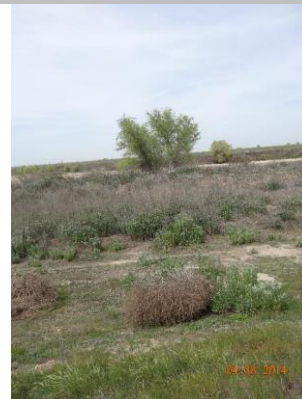
LM Start	1.75	Rating **	M	Issue No.	270
LM End	1.75	Issue Type +	En	Location *	WS
Category	Supplemental			GPS Latitude/Longitude	
				Start	End
Item	DWR UCIP Field Study			36.771065 °	36.771065 °
				-120.266294 °	-120.266294 °
DWR ID					
Comment Code					
Inspector Comment					
FS_ID:33266 DS_ID:19962 EP_NO: 13085 Repair Type: Non-Urgent Crossing Status: Indicator Found UCIP Comments: Need to contact owner to determine status. FIELD_STRUCT_DESC: 20-inch steel discharge pipe through the levee, 2-feet below the crown. Siphon breaker installed on apex of pipe on the landward shoulder. Steel cutoff wall placed around pipeline at each shoulder. Pipeline encased through the levee crown in concrete. Vent pipe on landward side. Rock riprap on the waterward levee slope. (Permit No. 13085-1981). FS Date: 4/8/2014

Overview of levee crown at crossing.

View of waterward side.

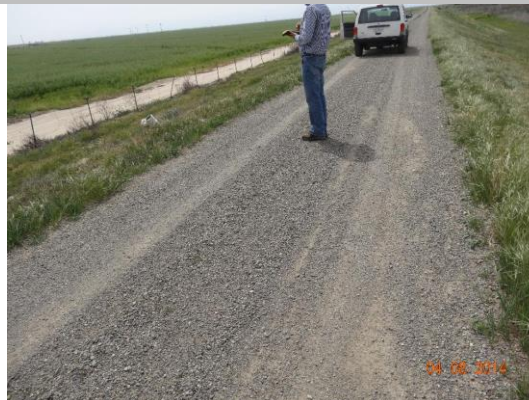
LM Start	2.69	Rating **	M	Issue No.	271
LM End	2.69	Issue Type +	En	Location *	WS
Category	Supplemental			GPS Latitude/Longitude	
				Start	End
Item	DWR UCIP Field Study			36.771742 °	36.771742 °
				-120.250929 °	-120.250929 °
DWR ID					
Comment Code					
Inspector Comment					
FS_ID:33267 DS_ID:19963 EP_NO: 13735 Repair Type: Non-Urgent Crossing Status: Found UCIP Comments: Unable to confirm status of crossing. FIELD_STRUCT_DESC: 24-inch steel discharge pipe through the levee, 2-feet below the crown. Roadway on crown has been padded 1- foot. Siphon breaker on the apex of pipeline on landward shoulder. Galvanized siphon vent pipe on the landward shoulder. Steel cutoff wall around the pipeline at centerline of levee. Pump on landward side. (Permit No. 13735-1984). FS Date: 4/8/2014

Overview of levee crown at crossing.

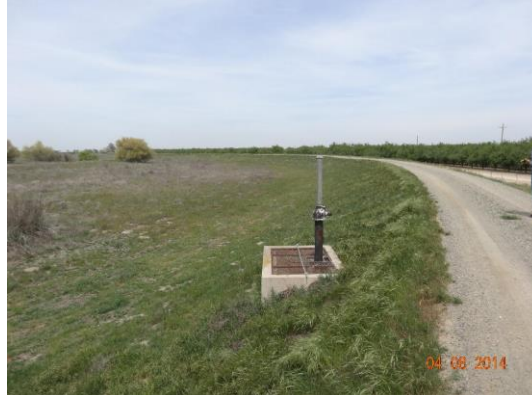
LM Start	4.06	Rating **	M	Issue No.	267
LM End	4.06	Issue Type +	En	Location *	LS
Category	Supplemental			GPS Latitude/Longitude	
				Start	End
Item	DWR UCIP Field Study			36.769238 °	36.769238 °
				-120.228588 °	-120.228588 °
DWR ID					
Comment Code					
Inspector Comment					
FS_ID:36849 DS_ID:19964 EP_NO: N/A Repair Type: Non-Urgent Crossing Status: Found UCIP Comments: Unable to confirm crossing alignment and appurtenances associated with this crossing. Multiple stand pipes visible on landward side. Need to contact owner to determine status of crossing and alignment. FIELD_STRUCT_DESC: 30-inch square R.C.B.C. through the levee 12.5 feet below the crown. Concrete riser unit with slide gate on the waterward slope. Screw gate on landward shoulder. Pump on landward side. Rehabilitation of crossing under Permit No. 13085 (1981). FS Date: 4/8/2014

View of waterward side.

Slide gate inside concrete box located on waterward side.

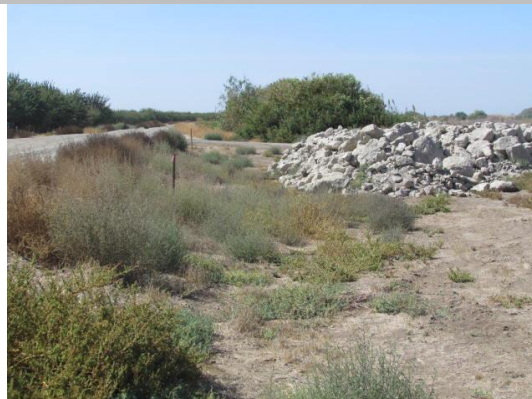
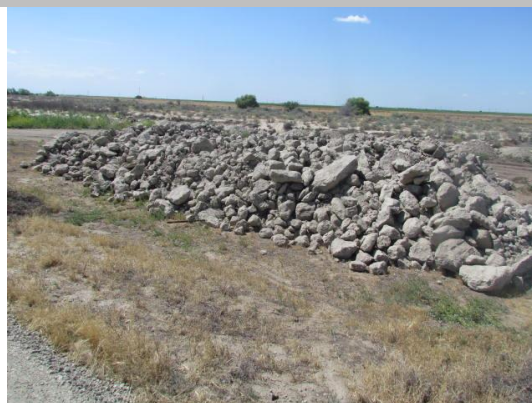
LM Start	5.40	Rating **	M	Issue No.	266
LM End	5.40	Issue Type +	En	Location *	WS
Category	Earthen Levee			GPS Latitude/Longitude	
				Start	End
Item	Encroachments			36.782405 °	36.782405 °
				-120.222763 °	-120.222763 °
DWR ID	DWR_NA0010_24_s_2015_266				
Comment Code					
MA : Material					
Inspector Comment					
Rocks stockpile near waterward toe.

Looking at rock stockpile on waterward berm. Fall 2015

Looking north at rock pile on waterward berm.

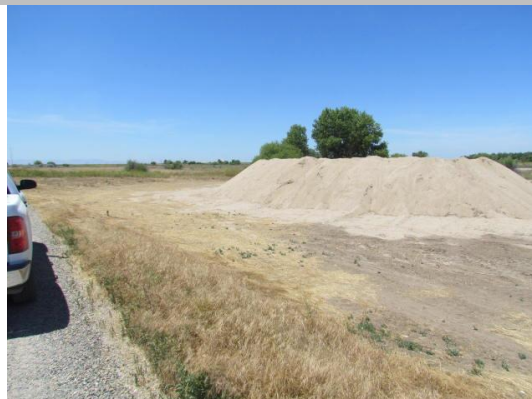
LM Start	6.15	Rating **	U	Issue No.	2
LM End	6.15	Issue Type +	En	Location *	WS
Category	Earthen Levee			GPS Latitude/Longitude	
				Start	End
Item	Encroachments			36.788088 °	36.788088 °
				-120.212827 °	-120.212827 °
DWR ID	DWR_NA0010_24_s_2016_2				
Comment Code					
MA : Material					
Inspector Comment					
Sand pile on waterward berm over three feet high and 25 feet away from waterward toe should be removed.

Looking northeast at sandpile over three on waterward berm.

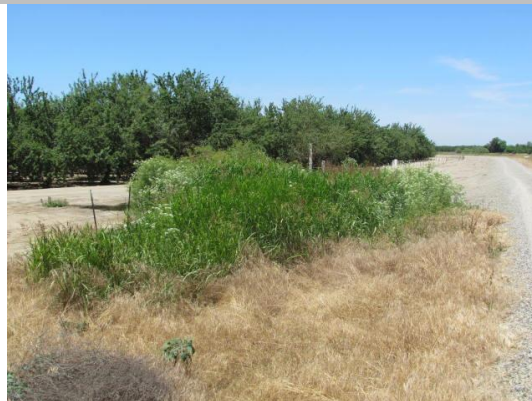
LM Start	6.72	Rating **	U	Issue No.	15
LM End	6.91	Issue Type +	Ma	Location *	LS
Category	Earthen Levee			GPS Latitude/Longitude	
				Start	End
Item	Vegetation			36.786678 °	36.783993 °
				-120.204741 °	-120.203779 °
DWR ID	DWR_NA0010_24_f_2015_15				
Comment Code					
V2 : Remove the wild growth other than native grasses from the levee slopes.					
Inspector Comment					
Dense vegetation on landward slope

Looking northwest at dense veg on landward slope and toe.

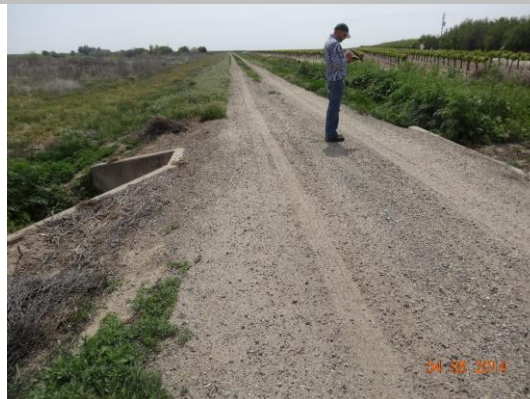
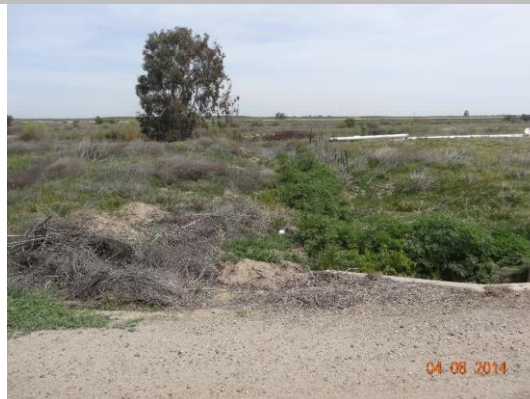
LM Start	6.73	Rating **	M	Issue No.	273 (cont)
LM End	6.73	Issue Type +	En	Location *	LS

FS_ID:50056
DS_ID:19957
EP_NO: N/A
Repair Type: Non-Urgent
Crossing Status: Found
UCIP Comments: 7/20/2016 same as previous inspection. Crossing has been downgraded from Urgent to Non-Urgent PVC does not prevent WS flap gate from closing. (DWR UCIP - omagana)4/08/2014 Unauthorized PVC pipe through existing crossing. PVC distorted inside--Need to contact owner to correct issue. If crossing was allowed need to contact owner for permit number issue for crossing variance. (DWR UCIP - omagana)
FIELD_STRUCT_DESC: 24-inch corrugated metal drainage pipe through the levee, 3.6 feet below the crown. Concrete "U" headwall located on the waterside (WS) end. Flap gate is located on the WS end. Concrete headwall is located on the landside (LS) end. [Additional Reference(s): DWR Levee Log, 2002]
FS Date: 7/20/2016

Overview of levee crown at crossing.

View of WS--debris (pipe sections) located on waterward side.

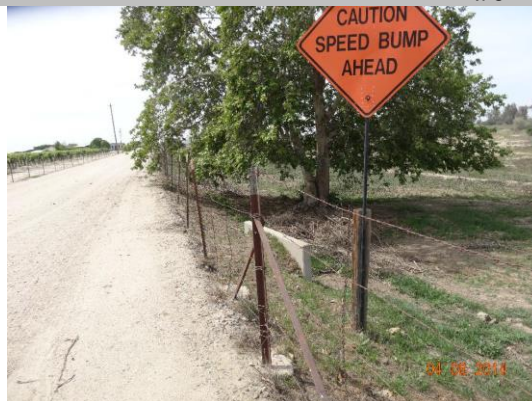
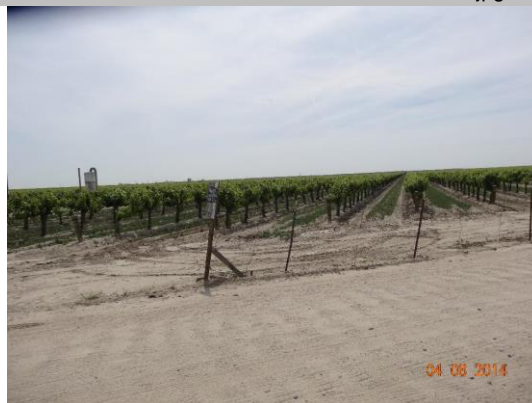
LM Start	8.33	Rating **	M	Issue No.	272
LM End	8.33	Issue Type +	En	Location *	LS
Category	Supplemental			GPS Latitude/Longitude	
				Start	End
Item	DWR UCIP Field Study			36.778084 °	36.778084 °
				-120.184454 °	-120.184454 °
DWR ID					
Comment Code					
Inspector Comment					
FS_ID:33272					
DS_ID:19960					
EP_NO: N/A					
Repair Type: Non-Urgent					
Crossing Status: Found					
UCIP Comments: Barbed wire along levee shoulder--no access. Need to confirm crossing size and condition of crossing.					
FIELD_STRUCT_DESC: 12-inch concrete pipe through the levee, 3.0 feet below the crown. Concrete headwall on the waterward end. Flap gate on the waterward end. (USACE-1967). This entry matches the Drainage or Irrigation Structure referenced in O&M manual (HLM 8.32).					
FS Date: 4/8/2014

View of waterward side.

View of landward side.

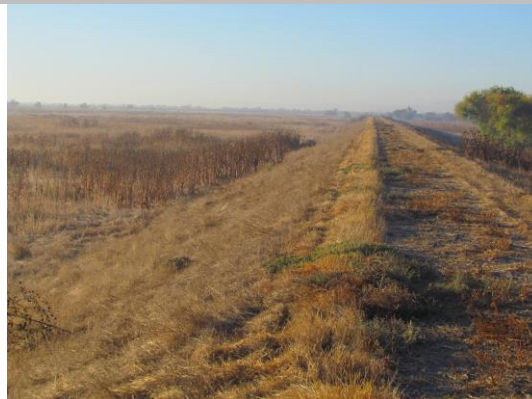
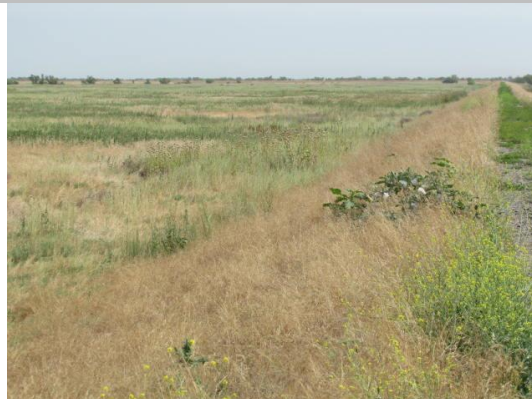
LM Start	0.00	Rating **	U	Issue No.	7
LM End	2.48	Issue Type +	Ma	Location *	LS
Category	Earthen Levee			GPS Latitude/Longitude	
				Start	End
Item	Vegetation			37.296261 °	37.271165 °
				-120.880678 °	-120.866629 °
DWR ID	DWR_NA0010_25_f_2015_7				
Comment Code					
V2 : Remove the wild growth other than native grasses from the levee slopes.					
Inspector Comment

Looking at typical view of dense veg on landward slope. (Fall 2016)

Looking at typical view of landward slope. (Spring 2016)

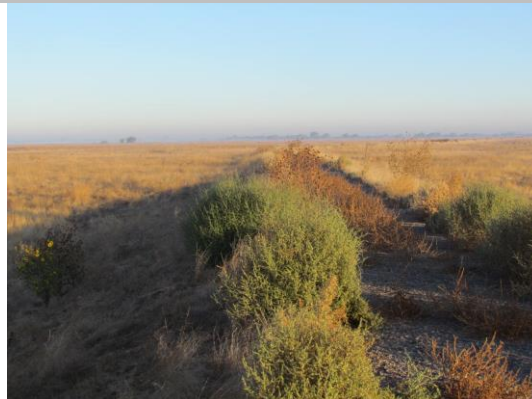
LM Start	0.00	Rating **	U	Issue No.	9
LM End	2.49	Issue Type +	Ma	Location *	WS
Category	Earthen Levee			GPS Latitude/Longitude	
				Start	End
Item	Vegetation			37.296261 °	37.271117 °
				-120.880678 °	-120.866599 °
DWR ID	DWR_NA0010_25_f_2015_9				
Comment Code					
V2 : Remove the wild growth other than native grasses from the levee slopes.					
Inspector Comment

Looking at typical view of dense veg on waterward slope. (Fall 2016)

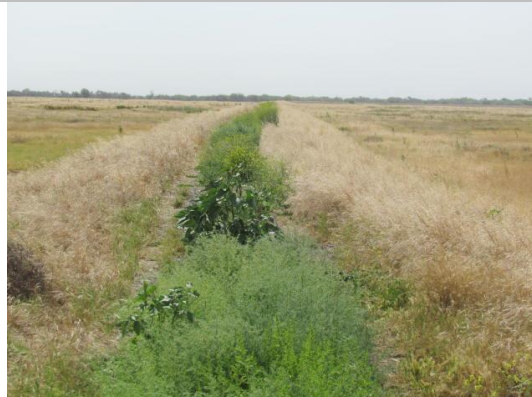
Photo 2 of 2 : FA_2016_NA0010_141_9_20161007_00003.jpg

LM Start	0.00	Rating **	U	Issue No.	9 (cont)	
LM End	2.49	Issue Type +	Ma	Location *	WS	
Category	Earthen Levee			GPS Latitude/Longitude		
				Start		End
Item	Vegetation			37.296261 °		37.271117 °
				-120.880678 °		-120.866599 °
DWR ID	DWR_NA0010_25_f_2015_9					
Comment Code						
V2 : Remove the wild growth other than native grasses from the levee slopes.						
Inspector Comment

Looking at typical view of waterward slope.

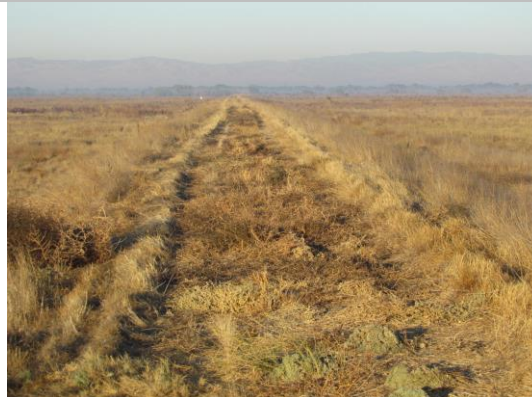
Photo 1 of 2 : FA_2016_NA0010_141_8_20161024_00024.jpg

LM Start	0.01	Rating **	U	Issue No.	8
LM End	2.49	Issue Type +	Ma	Location *	CR
Category	Earthen Levee			GPS Latitude/Longitude	
				Start	End
Item	Vegetation			37.296117 °	37.271117 °
				-120.880724 °	-120.866599 °
DWR ID	DWR_NA0010_25_s_2012_8				
Comment Code					
V2 : Remove the wild growth other than native grasses from the levee slopes.					
Inspector Comment					
Control weeds on levee crown.

Looking at typical view of dense veg on levee crown. (Fall 2016)

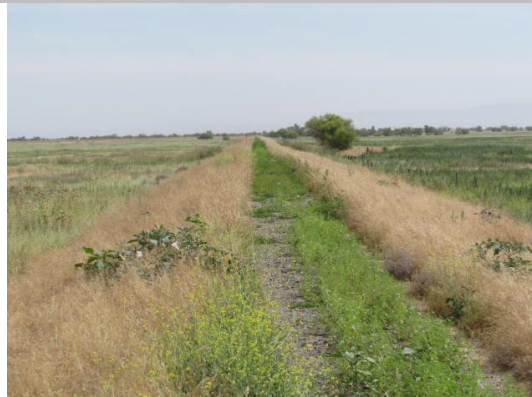
Photo 2 of 2 : FA_2016_NA0010_141_8_20161007_00002.jpg

LM Start	0.01	Rating **	U	Issue No.	8 (cont)
LM End	2.49	Issue Type +	Ma	Location *	CR

Looking at typical view of levee crown. (Spring 2016)

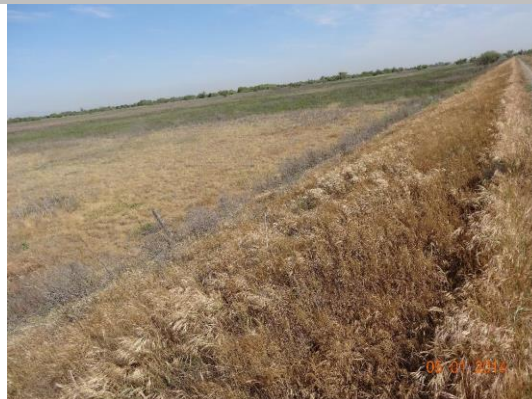
Photo 1 of 2 : UCIP_FA_2016_36851_67249.jpg

LM Start	0.36	Rating **	M	Issue No.	10
LM End	0.36	Issue Type +	En	Location *	CR
Category	Supplemental			GPS Latitude/Longitude	
				Start	End
Item	DWR UCIP Field Study			37.291173 °	37.291173 °
				-120.880731 °	-120.880731 °
DWR ID					
Comment Code					
Inspector Comment					
FS_ID:36851 DS_ID:19966 EP_NO: N/A Repair Type: Non-Urgent Crossing Status: Found UCIP Comments: Dense vegetation limits the inspectors visibility to identify signs of pipe failure (leaks) along the slope. Recommend removing vegetation along pipe alignment to conduct proper inspection of structure. FIELD_STRUCT_DESC: 24-inch CM pipe through the levee, 11.6 feet below the crown. Flap gate on the waterward end. (USACE-1967). This entry matches the Drainage or Irrigation Structure referenced in O&M manual (HLM 0.35). FS Date: 5/1/2014

View of waterward side.

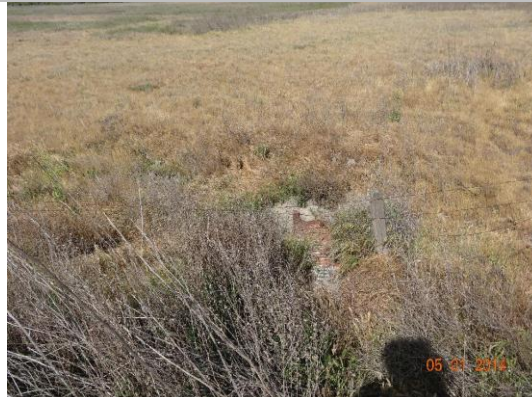
Photo 2 of 2 : UCIP_FA_2016_36851_67248.jpg

Pipe outlet visible on waterward side.

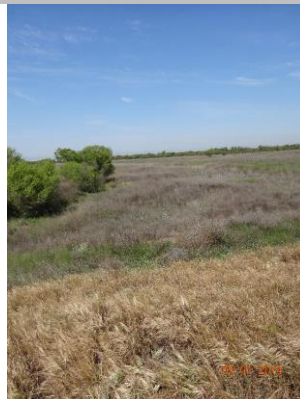
Photo 1 of 2 : UCIP_FA_2016_36852_67250.jpg

LM Start	0.59	Rating **	M	Issue No.	11
LM End	0.59	Issue Type +	En	Location *	CR
Category	Supplemental			GPS Latitude/Longitude	
				Start	End
Item	DWR UCIP Field Study			37.287744 °	37.287744 °
				-120.880645 °	-120.880645 °
DWR ID					
Comment Code					
Inspector Comment					
FS_ID:36852 DS_ID:19967 EP_NO: N/A Repair Type: Non-Urgent Crossing Status: Found UCIP Comments: Dense vegetation limits the inspectors visibility to identify signs of pipe failure (leaks) along the slope. Recommend removing vegetation along pipe alignment to conduct proper inspection of structure. FIELD_STRUCT_DESC: 24-inch CM pipe through the levee, 14.7 feet below the crown. Flap gate on the waterward end. (USACE-1967). This entry matches the Drainage or Irrigation Structure referenced in O&M manual (HLM 0.59). FS Date: 5/1/2014

Overview of waterward side--Salt Slough.

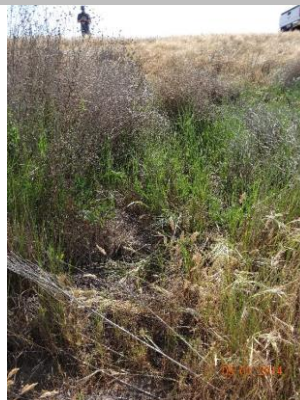
Photo 2 of 2 : UCIP_FA_2016_36852_67251.jpg

View of waterward slope covered by dense vegetation.

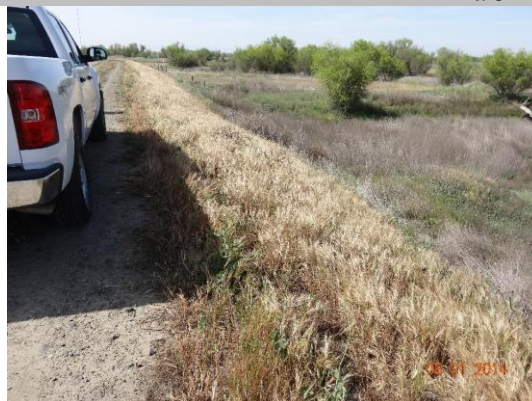
Photo 1 of 2 : UCIP_FA_2016_36853_67256.jpg

LM Start	0.97	Rating **	M	Issue No.	12
LM End	0.97	Issue Type +	En	Location *	CR
Category	Supplemental			GPS Latitude/Longitude	
				Start	End
Item	DWR UCIP Field Study			37.282252 °	37.282252 °
				-120.880738 °	-120.880738 °
DWR ID					
Comment Code					
Inspector Comment					
FS_ID:36853 DS_ID:19968 EP_NO: N/A Repair Type: Non-Urgent Crossing Status: Found UCIP Comments: Dense vegetation limits the inspectors visibility to identify signs of pipe failure (leaks) along the slope. Recommend removing vegetation along pipe alignment to conduct proper inspection of structure. FIELD_STRUCT_DESC: 24-inch CM pipe through the levee, 11.4 feet below the crown. Flap gate on the waterward end. (USACE-1967). This entry matches the Drainage or Irrigation Structure referenced in O&M manual (HLM 0.97). FS Date: 5/1/2014

View of waterward side.

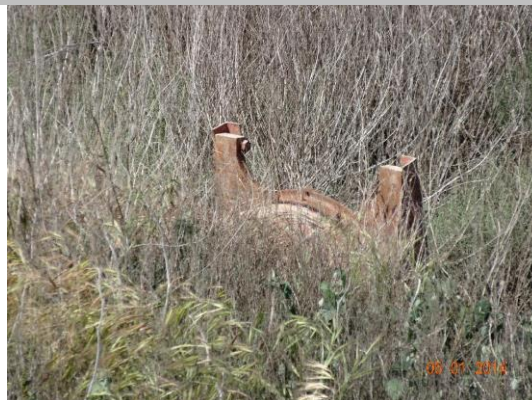
Photo 2 of 2 : UCIP_FA_2016_36853_67255.jpg

Pipe and evidence of flap gate visible on waterward side.

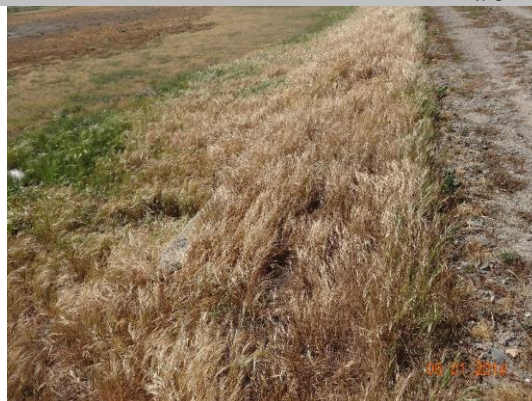
Photo 1 of 2 : UCIP_FA_2016_36854_67259.jpg

LM Start	2.05	Rating **	M	Issue No.	13
LM End	2.05	Issue Type +	En	Location *	CR
Category	Supplemental			GPS Latitude/Longitude	
				Start	End
Item	DWR UCIP Field Study			37.277390 °	37.277390 °
				-120.867184 °	-120.867184 °
DWR ID					
Comment Code					
Inspector Comment					
FS_ID:36854 DS_ID:19969 EP_NO: N/A Repair Type: Non-Urgent Crossing Status: Found UCIP Comments: Dense vegetation limits the inspectors visibility to identify signs of pipe failure (leaks) along the slope. Recommend removing vegetation along pipe alignment to conduct proper inspection of structure. FIELD_STRUCT_DESC: 24-inch CM pipe through the levee, 4.0 feet below the crown. Flap gate on the waterward end. (USACE-1967). This entry matches the Drainage or Irrigation Structure referenced in O&M manual (HLM 2.05). FS Date: 5/1/2014

View of landward side.

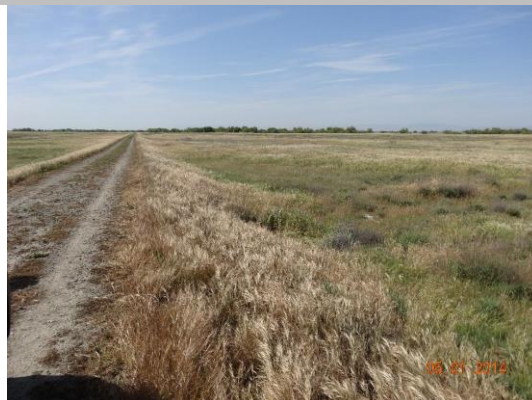
Photo 2 of 2 : UCIP_FA_2016_36854_67260.jpg

View of waterward side.

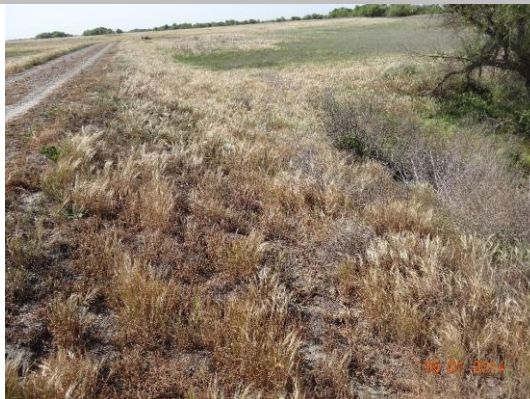
Photo 1 of 2 : UCIP_FA_2016_39502_67270.jpg

Comment Code					
Inspector Comment					
FS_ID:39502					
DS_ID:19970					
EP_NO: N/A					
Repair Type: Non-Urgent					
Crossing Status: Found					
UCIP Comments: Dense vegetation limits the inspectors visibility to identify signs of pipe failure (leaks) along the slope. Recommend removing vegetation along pipe alignment to conduct proper inspection of structure. Sediment buildup in pipe visible on landward side--recommend clearing.					
FIELD_STRUCT_DESC: 24-inch CM pipe through the levee, 11.2 feet below the crown. Flap gate on the waterward end. (USACE-1967). This entry matches the Drainage or Irrigation Structure referenced in O&M manual (HLM 2.45).					
FS Date: 5/1/2014 4:04:00 PM

View of waterward side.

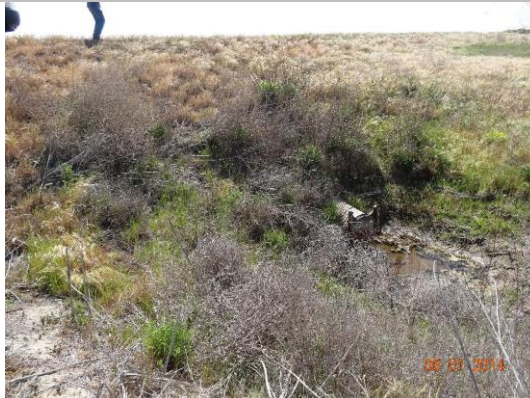
Photo 2 of 2 : UCIP_FA_2016_39502_67269.jpg

Pipe daylights at waterward toe.
