**Flood Control Project Maintenance
Levee Inspections**

Fall 2018 Levee Maintenance Deficiency Summary Report

San Joaquin River Basin

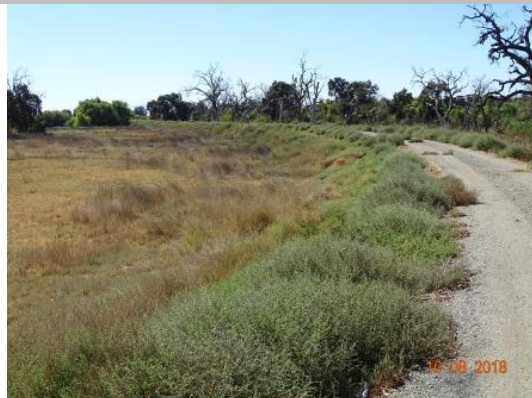
Photo 1 of 1 : FA_2018_NA0010_118_101_20181019_00271.jpg

LM Start	0.00	Rating **	U	Issue No.	101
LM End	0.33	Issue Type +	Ma	Location *	LS
Category	Earthen Levee			GPS Latitude/Longitude	
				Start	End
Item	Vegetation			37.348627 °	37.344775 °
				-120.958830 °	-120.962151 °
DWR ID	DWR_NA0010_01_f_2018_101				
Comment Code					
V1 : Control annual grass and weeds on the levee slopes and easements.					
Inspector Comment					
Dense vegetation on landside slope an toe

Dense vegetation obstructing view of landside slope. (Fall 2018)

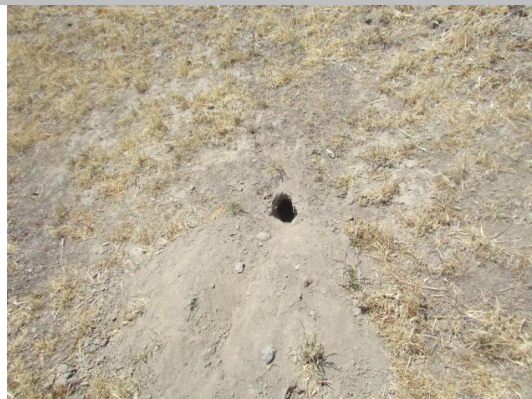
Photo 1 of 1 : FA_2018_NA0010_118_1_20180911_00001.jpg

LM Start	0.07	Rating **	M	Issue No.	1
LM End	0.23	Issue Type +	Ma	Location *	LS
Category	Earthen Levee			GPS Latitude/Longitude	
				Start	End
Item	Animal Control			37.347999 °	37.346096 °
				-120.959840 °	-120.961455 °
DWR ID	DWR_NA0010_01_s_2012_1				
Comment Code					
A1 : Exterminate rodents and backfill and compact or grout burrows.					
Inspector Comment					
Typical view of several rodent holes on landward slope.Could not see rodent holes due to dense vegetation.

Looking at typical rodent holes on landward slope. (Spring 2018)

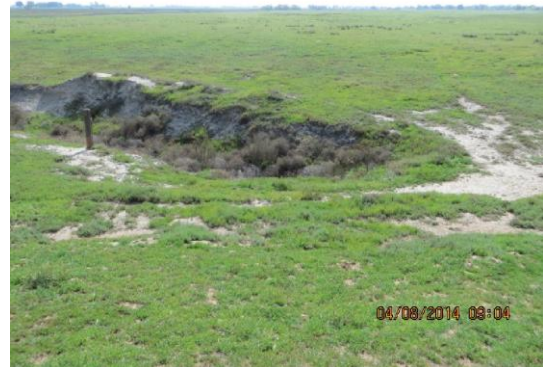
Comment Code						
Inspector Comment						
FS_ID:39092						
DS_ID:19651						
EP_NO: N/A						
Repair Type: Non-Urgent						
Crossing Status: Found						
UCIP Comments: 04/08/2014 Pipe has significant sediment buildup and shows some signs of corrosion at landward toe. Recommend cleaning sediment from inside pipe and check wall integrity. (DWR UCIP - W. Wylie)						
FIELD_STRUCT_DESC: 36-inch corrugated metal gravity drainage pipe through the levee, 18.5 feet below the crown. Flap gate on the waterside (WS) end. Brass cap No. 108 bench mark (BM) on the headwall on the landside (LS). [Additional Reference(s): DWR Levee Log, 2002. USACE San Joaquin O&M Manual 601.1, 1967, (HLM 0.35)].						
FS Date: 4/8/2014

Flapgate and headwall visible off WS toe.

Pipe and headwall visible off LS toe.

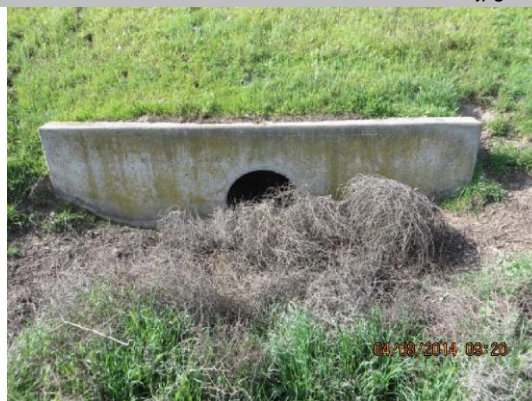
LM Start	0.85	Rating **	A/W	Issue No.	1188
LM End	0.85	Issue Type +	Ma	Location *	
Category	Supplemental			GPS Latitude/Longitude	
				Start	End
Item	DWR UCIP LMA Responsibility			37.339829 °	37.339829 °
				-120.958621 °	-120.958621 °
DWR ID	19584				
Comment Code					
Inspector Comment					
FS_ID:33524					
DS_ID:19584					
EP_NO: N/A					
Repair Type: No Action Needed					
Crossing Status: Found					
UCIP Comments:					
FIELD_STRUCT_DESC: 24-inch corrugated metal gravity drainage pipe through the levee, 7 feet below the crown. Flap gate on the waterside (WS) end. Brass cap No. 108 bench mark (BM) on the headwall on the landside (LS). [Additional Reference(s): DWR Levee Log, 2002. USACE San Joaquin O&M Manual 601.1, 1967, (HLM 0.87)].					
FS Date: 4/8/2014

Pipe, flapgate, and headwall visible on WS toe.

Pipe and headwall visible on LS toe.

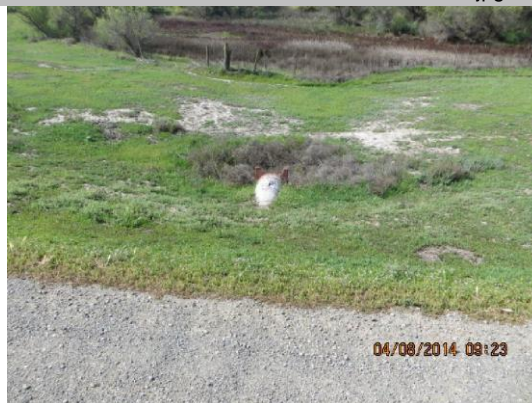
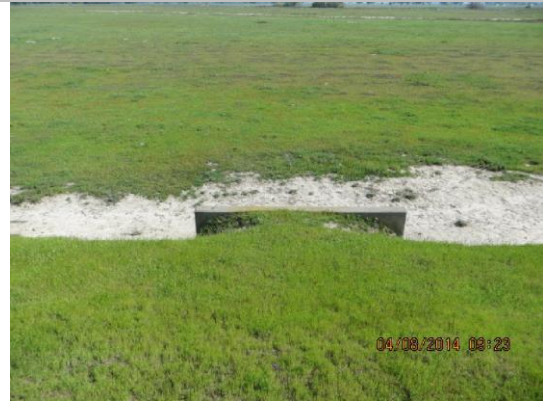
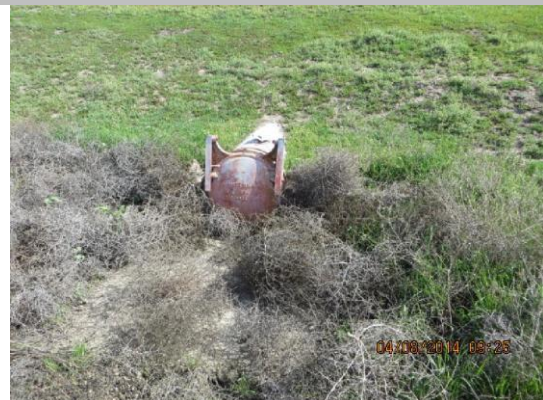
Comment Code						
Inspector Comment						
FS_ID:39096						
DS_ID:19585						
EP_NO: N/A						
Repair Type: Non-Urgent						
Crossing Status: Found						
UCIP Comments: 04/08/2014 Moderate erosion around headwall on landward toe. May or may not be an issue. Need to contact owner to determine status of crossing and to address erosion issue on landward side. (DWR UCIP - W. Wylie)						
FIELD_STRUCT_DESC: 24-inch corrugated metal gravity drainage pipe through the levee, 7 feet below the crown. Flap gate on the waterside (WS) end. Brass cap No. 108 bench mark (BM) on the headwall on the landside (LS). [Additional Reference(s): DWR Levee Log, 2002. USACE San Joaquin O&M Manual 601.1, 1967, (HLM 0.95)].						
FS Date: 4/8/2014

Flapgate, pipe, and headwall on WS toe.

Concrete headwall and pipe visible at LS toe.

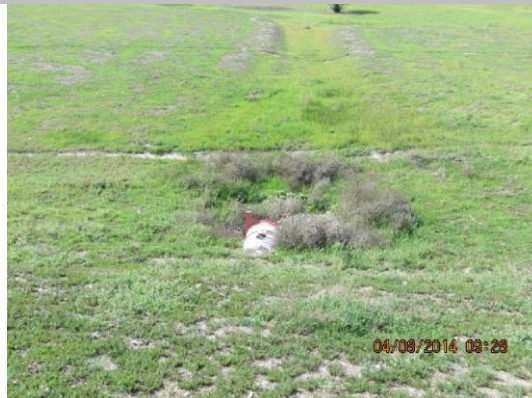
LM Start	1.15	Rating **	A/W	Issue No.	1190	
LM End	1.15	Issue Type +	Ma	Location *		
Category	Supplemental			GPS Latitude/Longitude		
				Start	End	
Item	DWR UCIP LMA Responsibility			37.338005 °	37.338005 °	
				-120.953921 °	-120.953921 °	
DWR ID	19586					
Comment Code						
Inspector Comment						
FS_ID:33543						
DS_ID:19586						
EP_NO: N/A						
Repair Type: No Action Needed						
Crossing Status: Found						
UCIP Comments:						
FIELD_STRUCT_DESC: 24-inch corrugated metal gravity drainage pipe through the levee, 7.5 feet below the crown. Flap gate on the waterside (WS) end. Brass cap No. 108 bench mark (BM) on the headwall on the landside (LS). [Additional Reference(s): DWR Levee Log, 2002. USACE San Joaquin O&M Manual 601.1, 1967, (HLM 1.17)].						
FS Date: 4/8/2014

Pipe, headwall, and flapgate visible on WS toe.

Headwall and pipe visible on LS toe.

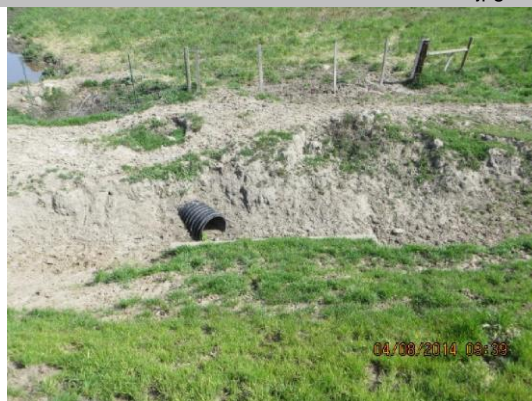
Comment Code						
Inspector Comment						
FS_ID:39099						
DS_ID:19588						
EP_NO: N/A						
Repair Type: Non-Urgent						
Crossing Status: Found						
UCIP Comments: 04/08/2014 Some sediment buildup inside pipe at LS toe. Recommend contacting owner to clear sediment buildup and check wall integrity through pipe section. (DWR UCIP - W. Wylie)						
FIELD_STRUCT_DESC: 24-inch corrugated metal gravity drainage pipe through the levee, 11 feet below the crown. Flap gate on the waterside (WS) end. Brass cap No. 108 bench mark (BM) on the headwall on the landside (LS). [Additional Reference(s): DWR Levee Log, 2002. USACE San Joaquin O&M Manual 601.1, 1967, (HLM 1.48)].						
FS Date: 4/8/2014

Pipe, flapgate, and concrete headwall visible on WS toe.

Pipe and concrete headwall visible on LS toe.

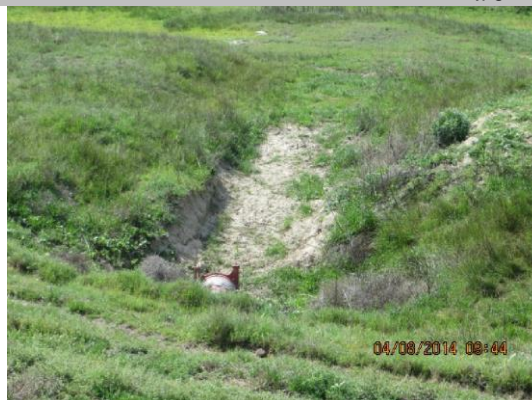
Photo 1 of 3 : UCIP_FA_2018_33563_60661.jpg

LM Start	1.67	Rating **	M	Issue No.	1193	
LM End	1.67	Issue Type +	Ma	Location *		
Category	Supplemental			GPS Latitude/Longitude		
				Start	End	
Item	DWR UCIP LMA Responsibility			37.336459 °	37.336459 °	
				-120.944803 °	-120.944803 °	
DWR ID	19589					
Comment Code						
Inspector Comment						
FS_ID:33563						
DS_ID:19589						
EP_NO: N/A						
Repair Type: Non-Urgent						
Crossing Status: Found						
UCIP Comments: 04/08/2014 Heavy sediment buildup in pipe at LS toe. (DWR UCIP - W. Wylie)						
FIELD_STRUCT_DESC: 24-inch corrugated metal gravity drainage pipe through the levee, 13.6 feet below the crown. Flap gate on the waterside (WS) end. Brass cap No. 108 bench mark (BM) on the headwall on the landside (LS). [Additional Reference(s): DWR Levee Log, 2002. USACE San Joaquin O&M Manual 601.1, 1967, (HLM 1.69)].						
FS Date: 4/8/2014

Pipe, headwall, and flapgate visible on WS toe.

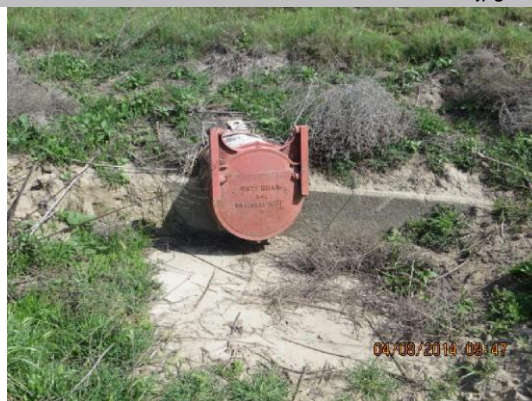
Photo 2 of 3 : UCIP_FA_2018_33563_60663.jpg

Pipe, headwall, and flapgate visible on WS toe.

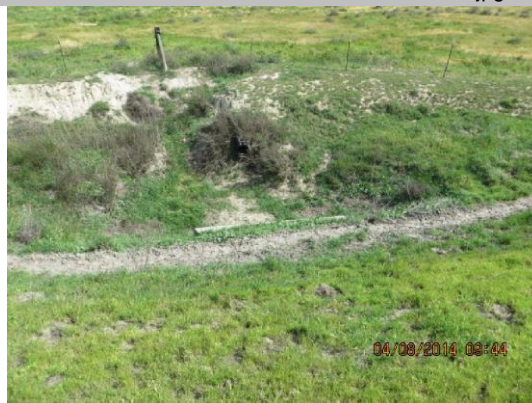
Photo 3 of 3 : UCIP_FA_2018_33563_60662.jpg

Pipe and headwall visible on LS toe.

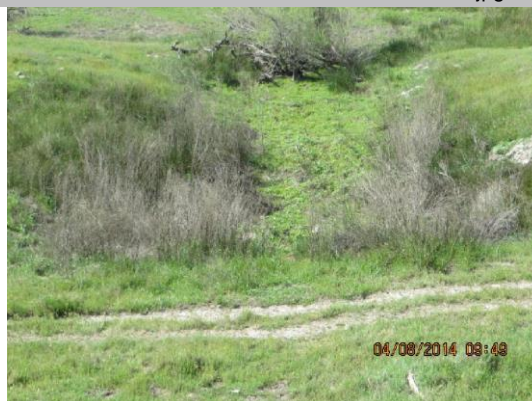
Photo 1 of 3 : UCIP_FA_2018_33564_60666.jpg

LM Start	1.81	Rating **	A/W	Issue No.	1194
LM End	1.81	Issue Type +	Ma	Location *	
Category	Supplemental			GPS Latitude/Longitude	
				Start	End
Item	DWR UCIP LMA Responsibility			37.335612 °	37.335612 °
				-120.942532 °	-120.942532 °
DWR ID	19590				
Comment Code					
Inspector Comment					
FS_ID:33564					
DS_ID:19590					
EP_NO: N/A					
Repair Type: No Action Needed					
Crossing Status: Found					
UCIP Comments:					
FIELD_STRUCT_DESC: 36-inch corrugated metal gravity drainage pipe through the levee, 14.2 feet below the crown. Flap gate on the waterside (WS) end. Brass cap No. 100 bench mark (BM) on the headwall on the landside (LS). [Additional Reference(s): DWR Levee Log, 2002. USACE San Joaquin O&M Manual 601.1, 1967, (HLM 1.83)].					
FS Date: 4/8/2014

Pipe, flapgate, and headwall visible at WS toe.

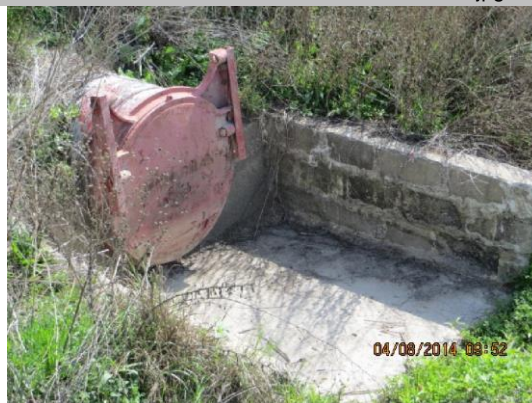
Photo 2 of 3 : UCIP_FA_2018_33564_60667.jpg

Pipe, flapgate, and headwall visible at WS toe.

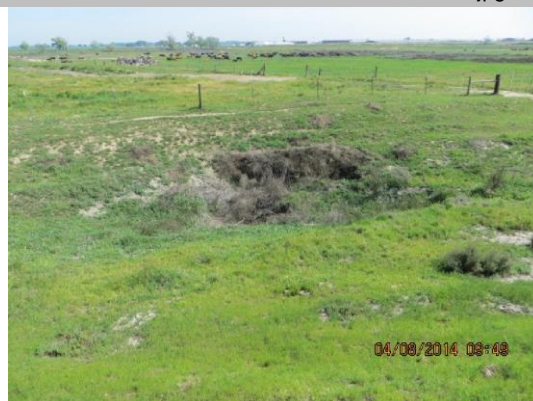
Photo 3 of 3 : UCIP_FA_2018_33564_60665.jpg

Pipe and concrete headwall visible at LS toe.

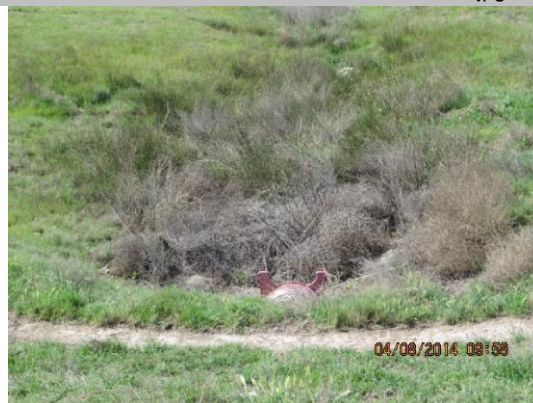
Photo 1 of 3 : UCIP_FA_2018_39100_60670.jpg

Comment Code					
Inspector Comment					
FS_ID:39100 DS_ID:19591 EP_NO: N/A Repair Type: Non-Urgent Crossing Status: Found UCIP Comments: 04/08/2014 Need to contact owner to determine crossing status. Inlet drop box silted in and needs to be cleaned out. (DWR UCIP - W. Wylie) FIELD_STRUCT_DESC: 24-inch corrugated metal gravity drainage pipe through the levee, 9.7 feet below the crown. Flap gate on the waterside (WS) end. Brass cap No. 100 bench mark (BM) on the headwall on the landside (LS). Wooden barrier around drop inlet on the LS toe. [Additional Reference(s): DWR Levee Log, 2002. USACE San Joaquin O&M Manual 601.1, 1967, (HLM 1.98)]. FS Date: 4/8/2014

Concrete headwall and flapgate on WS toe.

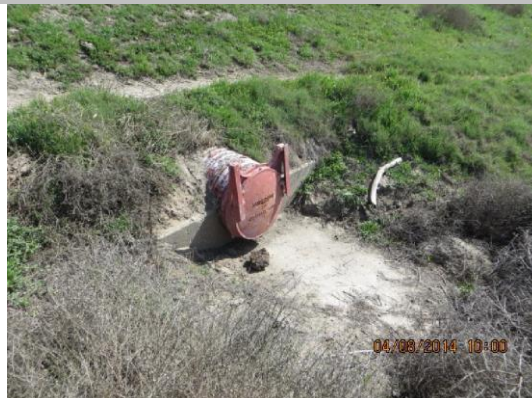
Photo 2 of 3 : UCIP_FA_2018_39100_60672.jpg

Pipe, flapgate, and headwall on WS toe.

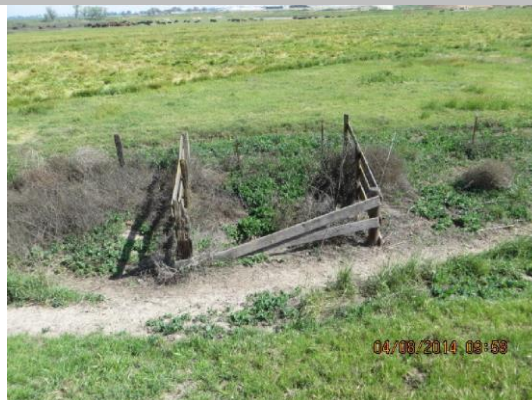
Photo 3 of 3 : UCIP_FA_2018_39100_60671.jpg

Wooded barrier around drop-inlet on LS toe.

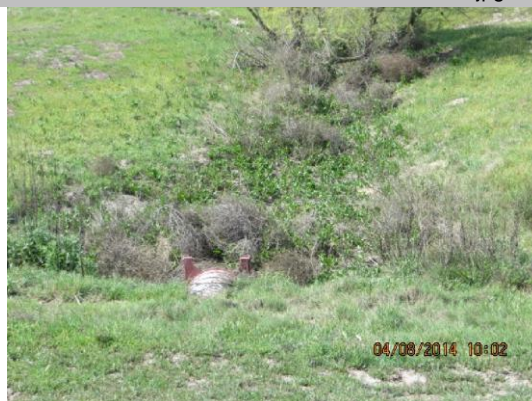
Photo 1 of 3 : UCIP_FA_2018_39123_60675.jpg

LM Start	2.06	Rating **	M	Issue No.	1196	
LM End	2.06	Issue Type +	Ma	Location *		
Category	Supplemental			GPS Latitude/Longitude		
				Start	End	
Item	DWR UCIP LMA Responsibility			37.333653 °	37.333653 °	
				-120.938770 °	-120.938770 °	
DWR ID	19570					
Comment Code						
Inspector Comment						
FS_ID:39123 DS_ID:19570 EP_NO: N/A Repair Type: Non-Urgent Crossing Status: Found UCIP Comments: 04/08/2014 Unable to find inlet on landward toe. Recommend clearing vegetation on landward side to properly inspect inlet. (DWR UCIP - W. Wylie) FIELD_STRUCT_DESC: 24-inch corrugated metal gravity drainage pipe through the levee, 9.8 feet below the crown. Flap gate on the waterside (WS) end. Brass cap No. 100 bench mark (BM) on the headwall on the landside (LS). [Additional Reference(s): DWR Levee Log, 2002. USACE San Joaquin O&M Manual 601.1, 1967, (HLM 2.08)]. FS Date: 4/8/2014

Pipe and flapgate visible on WS toe.

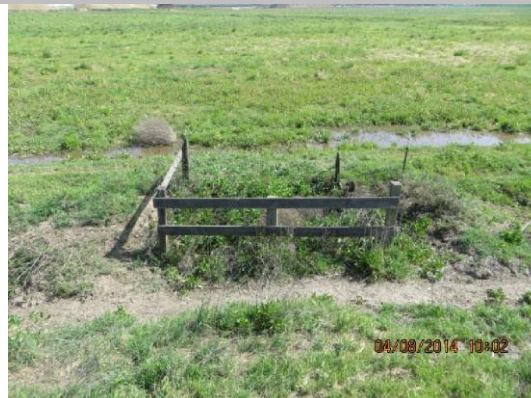
Photo 3 of 3 : UCIP_FA_2018_39123_60674.jpg

Wooded barrier around drop-inlet on LS toe.

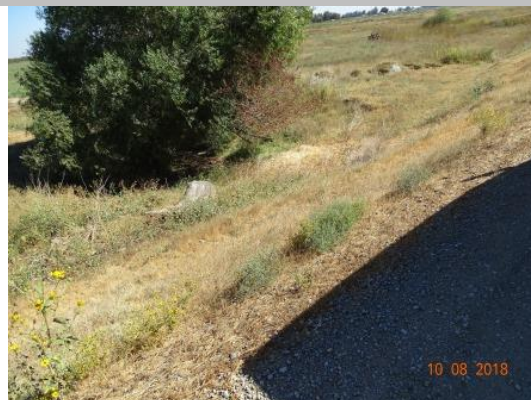
Photo 1 of 2 : FA_2018_NA0010_118_110_20181019_00272.jpg

LM Start	2.20	Rating **	N	Issue No.	110
LM End	2.20	Issue Type +	Ma	Location *	LS
Category	Earthen Levee			GPS Latitude/Longitude	
				Start	End
Item	Trim / Thin Trees			37.331820 °	37.331820 °
				-120.937605 °	-120.937605 °
DWR ID	DWR_NA0010_01_f_2018_110				
Comment Code					
T5 : Tree stumps.					
Inspector Comment					
Tree stump on landside slope should be removed

View of tree stump on landside slope. (Fall 2018)

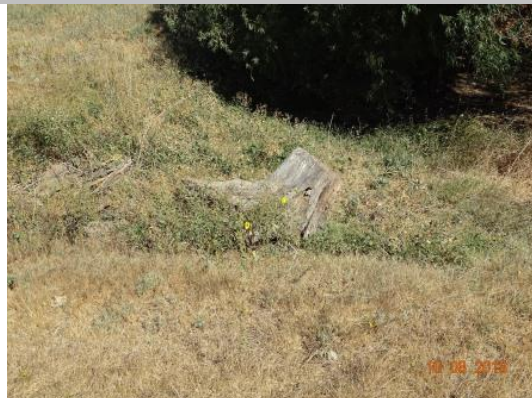
Photo 2 of 2 : FA_2018_NA0010_118_110_20181019_00273.jpg

LM Start	2.20	Rating **	N	Issue No.	110 (cont)	
LM End	2.20	Issue Type +	Ma	Location *	LS	
Category	Earthen Levee			GPS Latitude/Longitude		
				Start	End	
Item	Trim / Thin Trees			37.331820 °	37.331820 °	
				-120.937605 °	-120.937605 °	
DWR ID	DWR_NA0010_01_f_2018_110					
Comment Code						
T5 : Tree stumps.						
Inspector Comment						
Tree stump on landside slope should be removed

View of tree stump on landside slope. (Fall 2018)

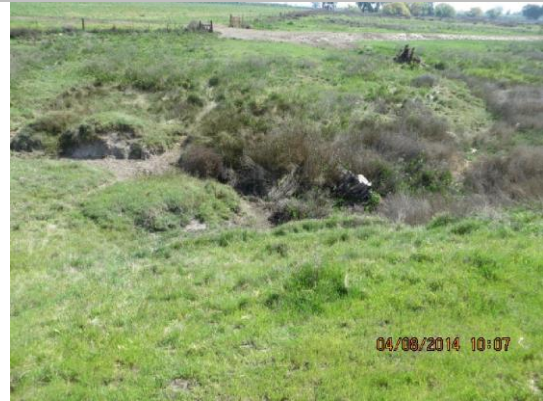
Photo 2 of 3 : UCIP_FA_2018_39125_71308.jpg

Pipe and headwall on LS toe.

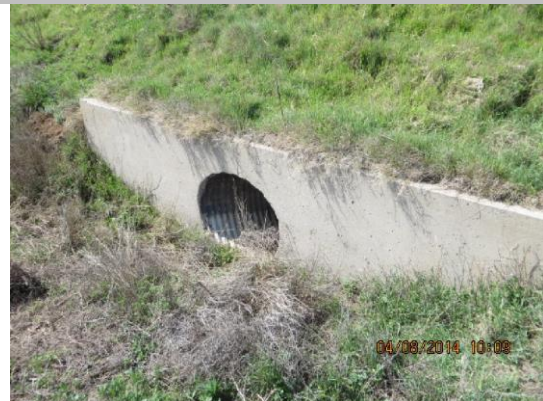
Photo 3 of 3 : UCIP_FA_2018_39125_71307.jpg

Pipe and headwall on LS toe.

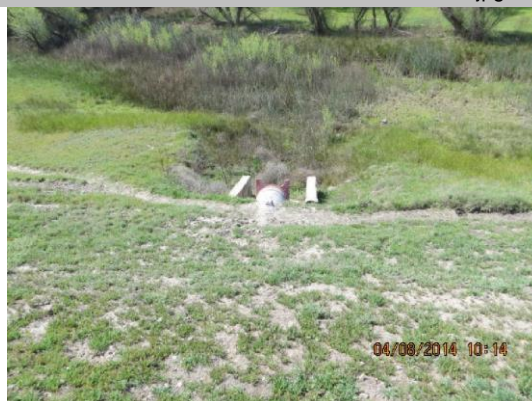
Photo 1 of 3 : UCIP_FA_2018_33568_60679.jpg

LM Start	2.50	Rating **	A/W	Issue No.	1198
LM End	2.50	Issue Type +	Ma	Location *	
Category	Supplemental			GPS Latitude/Longitude	
				Start	End
Item	DWR UCIP LMA Responsibility			37.328619 °	37.328619 °
				-120.934369 °	-120.934369 °
DWR ID	19572				
Comment Code					
Inspector Comment					
FS_ID:33568					
DS_ID:19572					
EP_NO: N/A					
Repair Type: No Action Needed					
Crossing Status: Found					
UCIP Comments:					
FIELD_STRUCT_DESC: 24-inch corrugated metal gravity drainage pipe through the levee, 8 feet below the crown. Flap gate on the waterside (WS) end. Brass cap No. 100 bench mark (BM) on the headwall on the landside (LS). [Additional Reference(s): DWR Levee Log, 2002. USACE San Joaquin O&M Manual 601.1, 1967, (HLM 2.52)].					
FS Date: 4/8/2014

Pipe, headwall, and flapgate on WS toe.

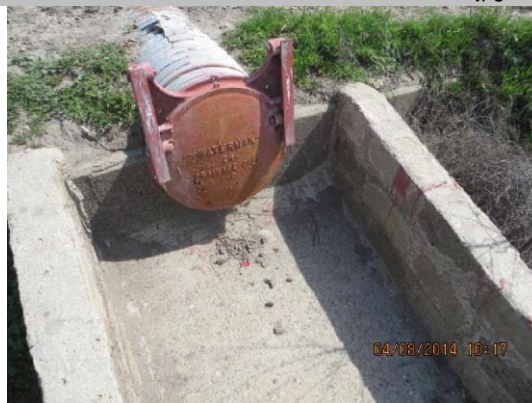
Photo 2 of 3 : UCIP_FA_2018_33568_60680.jpg

Pipe, headwall, and flapgate on WS toe.

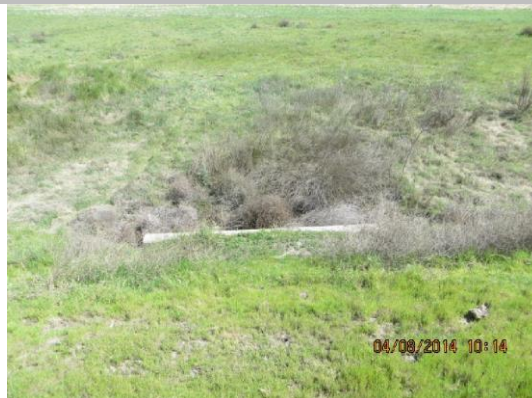
Photo 3 of 3 : UCIP_FA_2018_33568_60678.jpg

Pipe and headwall on LS toe.

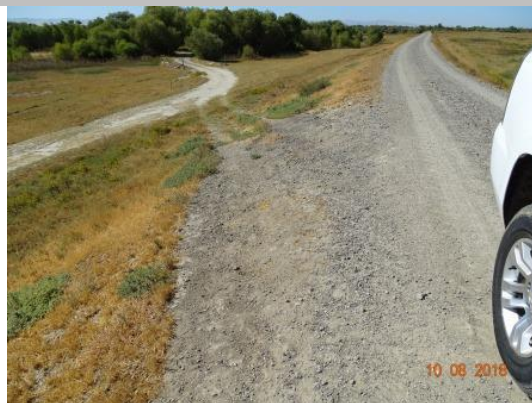
Photo 1 of 1 : FA_2018_NA0010_118_113_20181022_00274.jpg

LM Start	2.58	Rating **	A/W	Issue No.	113
LM End	2.58	Issue Type +	Ma	Location *	WS
Category	Earthen Levee			GPS Latitude/Longitude	
				Start	End
Item	Slope Stability			37.327936 °	37.327936 °
				-120.933013 °	-120.933013 °
DWR ID	DWR_NA0010_01_f_2018_113				
Comment Code					
S3 : Repair the levee slope damaged by vehicle traffic and prevent access where possible.					
Inspector Comment					
damage caused by vehicle traffic over the levee.

Erosion caused by vehicle traffic. (Fall 2018)

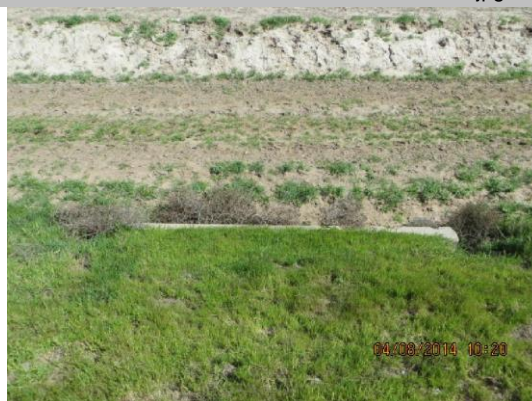
Photo 3 of 3 : UCIP_FA_2018_39127_60687.jpg

Pipe and headwall on LS toe.

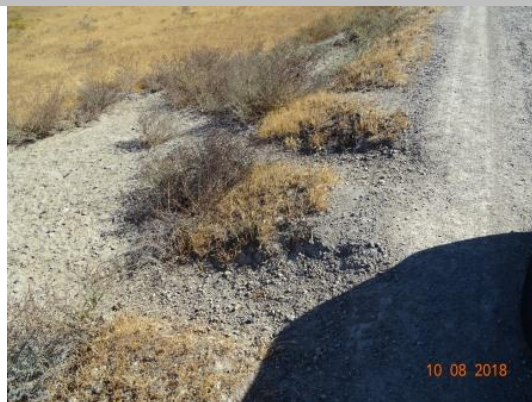
Photo 1 of 1 : FA_2018_NA0010_118_114_20181022_00275.jpg

LM Start	2.99	Rating **	M	Issue No.	114
LM End	2.99	Issue Type +	Ma	Location *	LS
Category	Earthen Levee			GPS Latitude/Longitude	
				Start	End
Item	Slope Stability			37.323328 °	37.323328 °
				-120.929521 °	-120.929521 °
DWR ID	DWR_NA0010_01_f_2018_114				
Comment Code					
S2 : Repair the levee slope damaged by foot traffic and prevent access where possible.					
Inspector Comment					
Slope damage cause by livestock

View of slope damage caused by livestock. (Fall 2018)

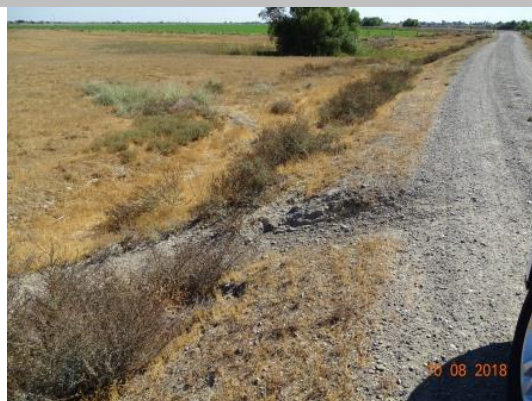
Photo 1 of 2 : FA_2018_NA0010_118_115_20181022_00276.jpg

LM Start	3.10	Rating **	M	Issue No.	115
LM End	3.10	Issue Type +	Ma	Location *	LS
Category	Earthen Levee			GPS Latitude/Longitude	
				Start	End
Item	Slope Stability			37.321903 °	37.321903 °
				-120.928748 °	-120.928748 °
DWR ID	DWR_NA0010_01_f_2018_115				
Comment Code					
S2 : Repair the levee slope damaged by foot traffic and prevent access where possible.					
Inspector Comment					
damage cause by foot traffic.

View of erosion path looking downstream. (Fall 2018)

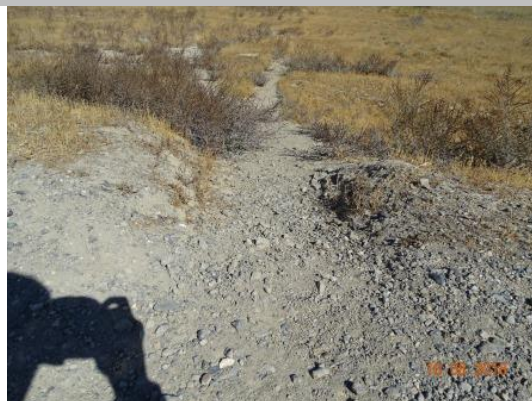
Photo 2 of 2 : FA_2018_NA0010_118_115_20181022_00277.jpg

View of erosion path looking down landside slope. (Fall 2018)

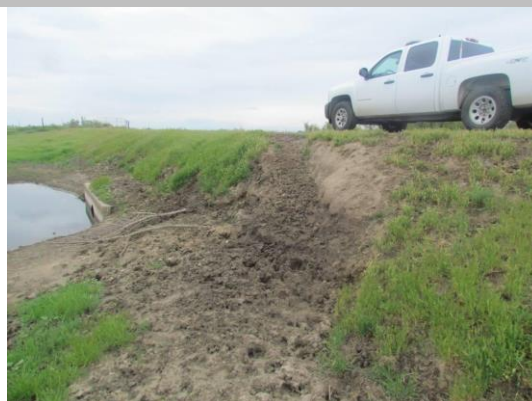
Photo 1 of 1 : FA_2018_NA0010_118_108_20180911_00025.jpg

LM Start	3.11	Rating **	M	Issue No.	108
LM End	3.11	Issue Type +	Ma	Location *	LS
Category	Earthen Levee			GPS Latitude/Longitude	
				Start	End
Item	Slope Stability			37.321704 °	37.321704 °
				-120.928749 °	-120.928749 °
DWR ID	DWR_NA0010_01_s_2017_108				
Comment Code					
S2 : Repair the levee slope damaged by foot traffic and prevent access where possible.					
Inspector Comment					
Slope damage caused by animal traffic on landside toe.

Looking west at slope damage caused by animal traffic.

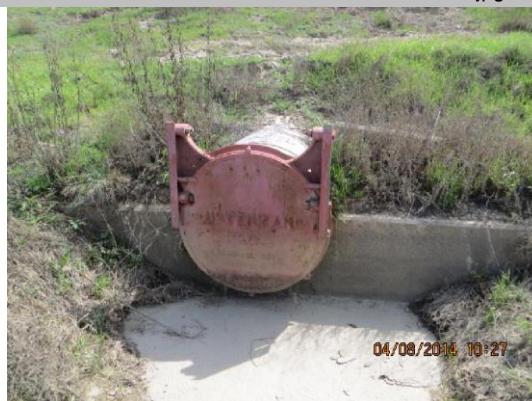
Photo 2 of 3 : UCIP_FA_2018_39128_60700.jpg

Pipe, Flapgate, and headwall on WS toe.

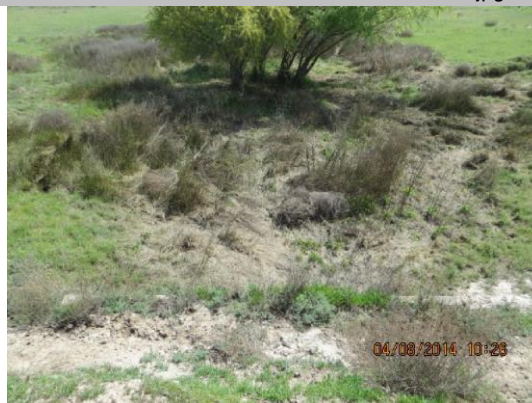
Photo 3 of 3 : UCIP_FA_2018_39128_60701.jpg

Pipe and headwall on LS toe.

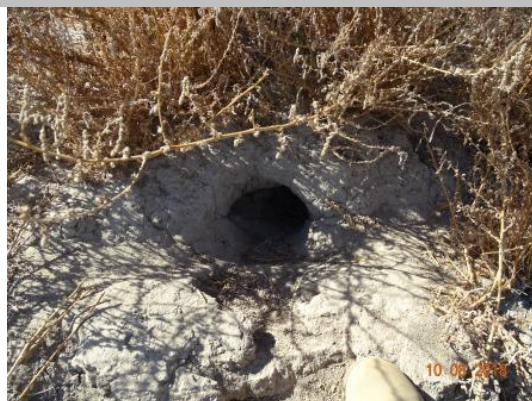
Photo 2 of 2 : FA_2018_NA0010_118_116_20181022_00279.jpg

LM Start	3.18	Rating **	M	Issue No.	116 (cont)	
LM End	3.18	Issue Type +	Ma	Location *	LS	
Category	Earthen Levee			GPS Latitude/Longitude		
				Start		End
Item	Animal Control			37.320725 °		37.320725 °
				-120.928837 °		-120.928837 °
DWR ID	DWR_NA0010_01_f_2018_116					
Comment Code						
A3 : No rodents visible, but rodent burrows visible; need to backfill and compact or grout burrows.						
Inspector Comment						
Several rodent holes noted in this section.

Representative view of rodent holes in this section. (Fall 2018)

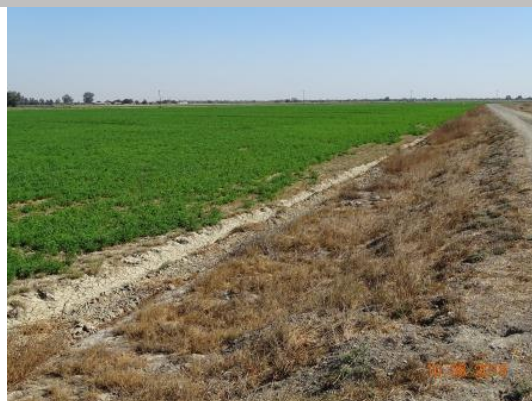
Photo 1 of 1 : FA_2018_NA0010_118_117_20181022_00280.jpg

LM Start	3.23	Rating **	M	Issue No.	117
LM End	3.90	Issue Type +	En	Location *	LS
Category	Earthen Levee			GPS Latitude/Longitude	
				Start	End
Item	Encroachments			37.320029 °	37.311311 °
				-120.928556 °	-120.927310 °
DWR ID	DWR_NA0010_01_f_2018_117				
Comment Code					
DT : Ditch					
Inspector Comment					
Earthen ditch along landside toe.

Earthen ditch along landside toe. (Fall 2018)

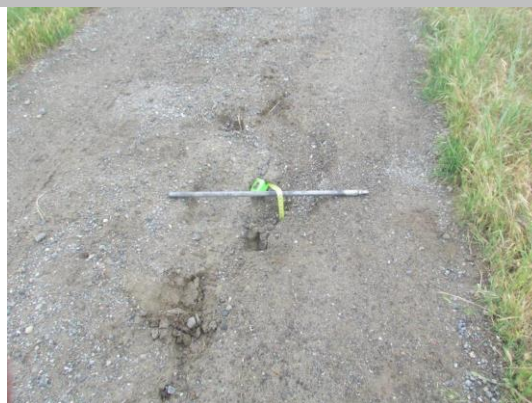
Photo 1 of 4 : FA_2018_NA0010_118_109_20180911_00026.jpg

LM Start	3.26	Rating **	A/W	Issue No.	109
LM End	3.29	Issue Type +	Ma	Location *	CR
Category	Earthen Levee			GPS Latitude/Longitude	
				Start	End
Item	Crown Surface / Depressions / Rutting			37.319740 °	37.319300 °
				-120.928308 °	-120.927903 °
DWR ID	DWR_NA0010_01_s_2017_109				
Comment Code					
C2 : Repair depressions or ruts in the crown or slope.					
Inspector Comment					
Depression (sinkhole) on levee crown and other depressions

Looking south at sinkhole on levee crown

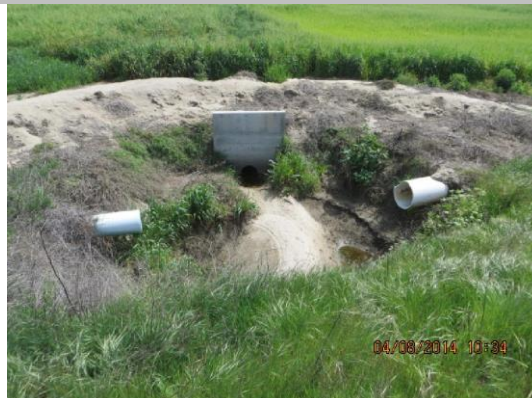
Photo 2 of 3 : UCIP_FA_2018_53188_60706.jpg

Pipe and headwall on LS toe.

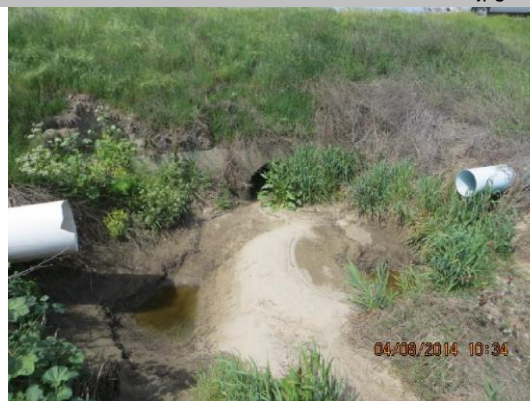
Photo 3 of 3 : UCIP_FA_2018_53188_60705.jpg

Comment Code						
Inspector Comment						
FS_ID:53188 DS_ID:19575 EP_NO: N/A Repair Type: Urgent Crossing Status: Found UCIP Comments: 11/01/2018 Pipe continues to rust through, causing the pipe to collapse on the LS. Sediment buildup visible from the LS inlet. Loss of soil just above the LS concrete headwall and along the LS slope. Crossing remains Urgent due to the levee slope issues and pipe failure through the levee. (O. Magana - DWR UCIP)07/19/2016 Same as previous inspection. Erosion present on LS slope. (DWR UCIP - O. Magana)04/08/2014 Pipe rusted through at Springline on LS toe. Flapgate blocked by sediment on WS toe. Heavy sediment on both ends of pipe. Need to contact owner to address issues. (DWR UCIP - W. Wylie) FIELD_STRUCT_DESC: 36-inch corrugated metal gravity drainage pipe through the levee, 9.7 feet below the crown. Flap gate on the waterside (WS) end. Brass cap No. 100 bench mark (BM) on the headwall on the landside (LS). [Additional Reference(s): DWR Levee Log, 2002. USACE San Joaquin O&M Manual 601.1, 1967, (HLM 3.50)]. FS Date: 11/1/2018 12:49:00 PM

Pipe and headwall on LS toe.

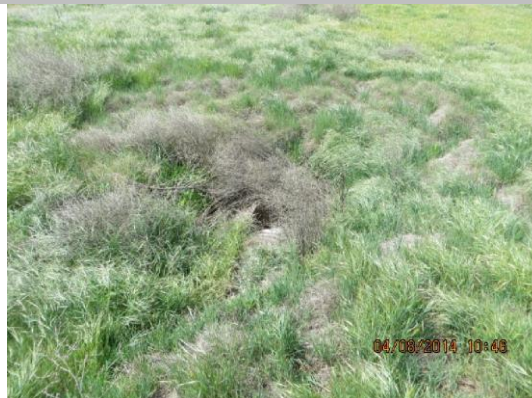
Photo 1 of 3 : UCIP_FA_2018_39132_60723.jpg

UCIP Comments: 04/08/2014 Slide gate missing from WS. No closure device, but degrading of levee at Highway 140 is lower than pipe, so this does not appear to be a critical issue. Also dense vegetation limits the inspector's visibility to identify signs of pipe failure (leaks) along the slope. Recommend removing vegetation along pipe alignment to conduct proper inspection of structure and appurtenances. (DWR UCIP - W. Wylie)

Slide gate missing on WS toe with heavy vegetation camouflaging pipe

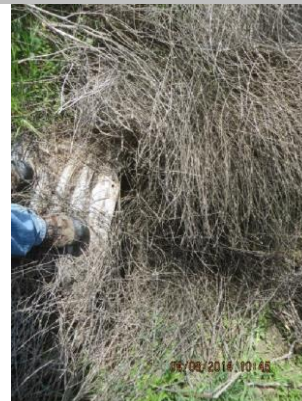
Photo 2 of 3 : UCIP_FA_2018_39132_60720.jpg

Slide gate missing on WS toe with heavy vegetation camouflaging pipe

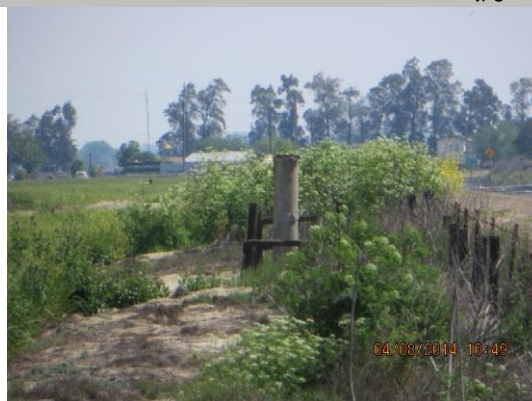
Photo 2 of 2 : UCIP_FA_2018_39133_60724.jpg

12-inch concrete standpipe off LS toe.

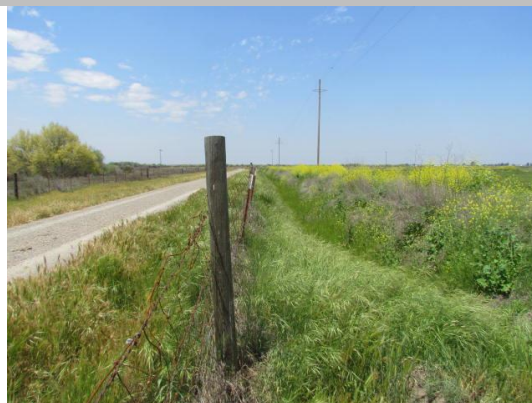
Photo 1 of 2 : FA_2018_NA0010_118_5_20180911_00002.jpg

LM Start	3.98	Rating **	U	Issue No.	5
LM End	4.05	Issue Type +	En	Location *	LS
Category	Earthen Levee			GPS Latitude/Longitude	
				Start	End
Item	Encroachments			37.310837°	37.310003°
				-120.926182°	-120.925313°
DWR ID	DWR_NA0010_01_s_2012_5				
Comment Code					
DT : Ditch					
Inspector Comment					
Irrigation ditch at landside toe

Looking north at irrigation ditch at landside toe.

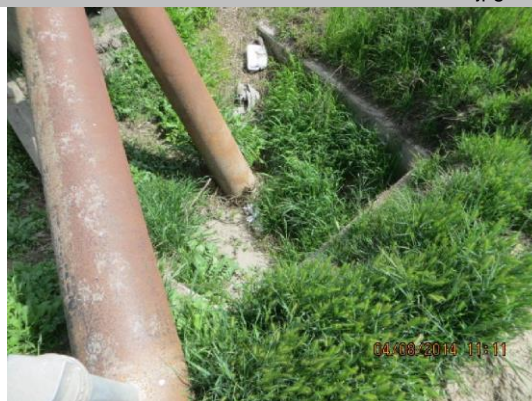
Photo 2 of 2 : UCIP_FA_2018_39138_71319.jpg

LM Start	4.13	Rating **	M	Issue No.	1205 (cont)	
LM End	4.13	Issue Type +	En	Location *		
Category	Supplemental			GPS Latitude/Longitude		
				Start	End	
Item	DWR UCIP Field Study			37.309063 °	37.309063 °	
				-120.924449 °	-120.924449 °	
DWR ID	24866					
Comment Code						
Inspector Comment						
FS_ID:39138						
DS_ID:24866						
EP_NO: N/A						
Repair Type: Non-Urgent						
Crossing Status: Found						
UCIP Comments: 04/08/2014 Need to contact owner to get details of crossing. (DWR UCIP - W. Wylie)						
FIELD_STRUCT_DESC: 12-inch steel drainage discharge pipe through the levee, 2.5 feet below the crown. 12-inch steel pipe, vent, and pump on stand visible on the landside (LS) slope. 10-inch polyvinyl chloride (PVC) pipe visible on the waterside (WS) slope.						
FS Date: 4/8/2014

Pipe through existing 48 inch pipe.

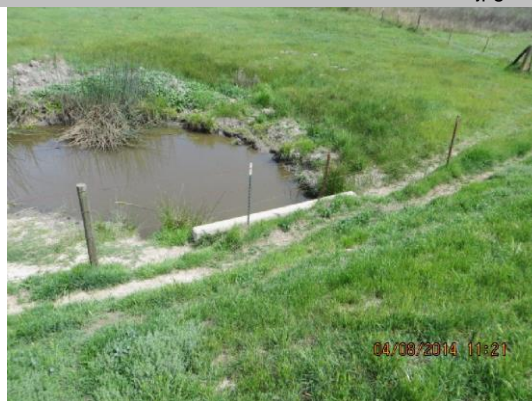
Photo 3 of 3 : UCIP_FA_2018_39140_60734.jpg

Comment Code					
Inspector Comment					
FS_ID:39140 DS_ID:19608 EP_NO: N/A Repair Type: Non-Urgent Crossing Status: Found UCIP Comments: 04/08/2014 Dense vegetation and fence limits the inspector's visibility to identify signs of pipe failure (leaks) along the landward side. Recommend obtaining access to landward toe and removing vegetation along pipe alignment to conduct proper inspection of structure and appurtenances. (DWR UCIP - W. Wylie) FIELD_STRUCT_DESC: 24-inch corrugated metal gravity drainage pipe through the levee, 11.9 feet below the crown. Flap gate on the waterside (WS) end. Brass cap No. 90 bench mark (BM) on the headwall on the landside (LS). [Additional Reference(s): DWR Levee Log, 2002. USACE San Joaquin O&M Manual 601.1, 1967, (HLM 4.27)]. FS Date: 4/8/2014

Concrete headwall at LS toe.

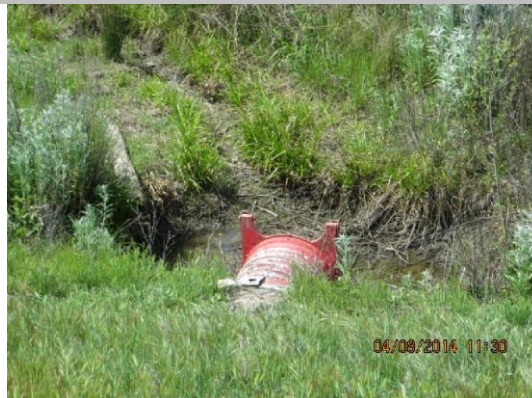
Comment Code						
Inspector Comment						
FS_ID:39141						
DS_ID:19609						
EP_NO: N/A						
Repair Type: Non-Urgent						
Crossing Status: Found						
UCIP Comments: 04/08/2014 Dense vegetation limits the inspector's visibility to identify signs of pipe failure (leaks) along the waterward side. Recommend removing vegetation along pipe alignment to conduct proper inspection of structure and appurtenances. (DWR UCIP - W. Wylie)						
FIELD_STRUCT_DESC: 24-inch corrugated metal gravity drainage pipe through the levee, 10 feet below the crown. Flap gate on the waterside (WS) end. Brass cap No. 90 bench mark (BM) on the headwall on the landside (LS). [Additional Reference(s): DWR Levee Log, 2002. USACE San Joaquin O&M Manual 601.1, 1967, (HLM 4.72)].						
FS Date: 4/8/2014

Pipe, flapgate, and headwall on WS toe.

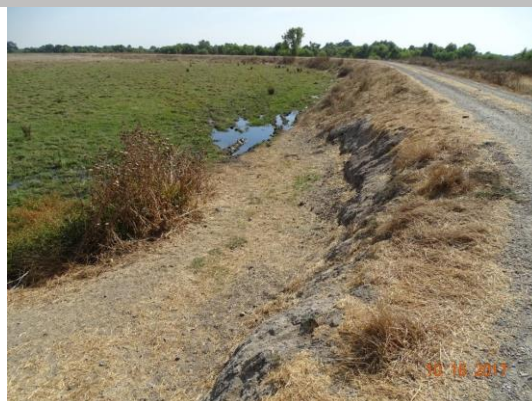
Photo 2 of 3 : FA_2018_NA0010_118_9_20180911_00007.jpg

LM Start	4.69	Rating **	A/W	Issue No.	9 (cont)	
LM End	4.69	Issue Type +	Ma	Location *	LS	
Category	Earthen Levee			GPS Latitude/Longitude		
				Start		End
Item	Erosion / Bank Caving			37.302398°	37.302398°	
				-120.920920°	-120.920920°	
DWR ID	DWR_NA0010_01_s_2013_9					
Comment Code						
Inspector Comment						
Levee landside toe damaged by livestock.

Looking south at landside.

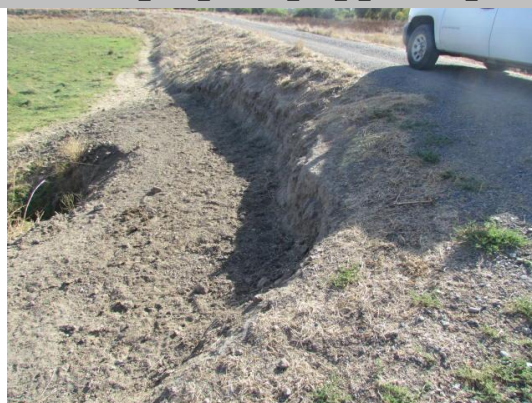
Photo 3 of 3 : FA_2018_NA0010_118_9_20180911_00008.jpg

Looking at landward slope damaged by livestock.

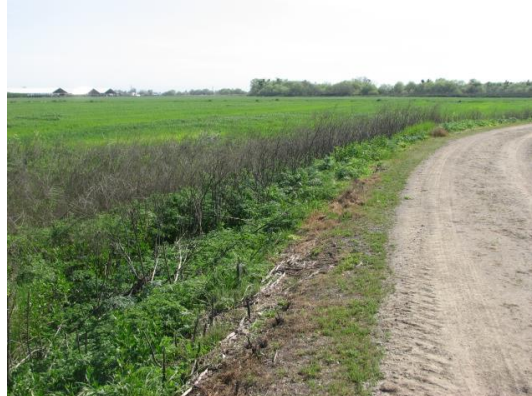
Photo 1 of 1 : FA_2018_NA0010_118_106_20180911_00023.jpg

LM Start	5.74	Rating **	U	Issue No.	106
LM End	6.20	Issue Type +	Ma	Location *	LS
Category	Earthen Levee			GPS Latitude/Longitude	
				Start	End
Item	Vegetation			37.304180 °	37.304911 °
				-120.906860 °	-120.899001 °
DWR ID	DWR_NA0010_01_f_2017_106				
Comment Code					
V2 : Remove the wild growth other than native grasses from the levee slopes.					
Inspector Comment					
Dense vegetation on landside slope.

Looking south at dense veg on landward slope. (Spring 2018)

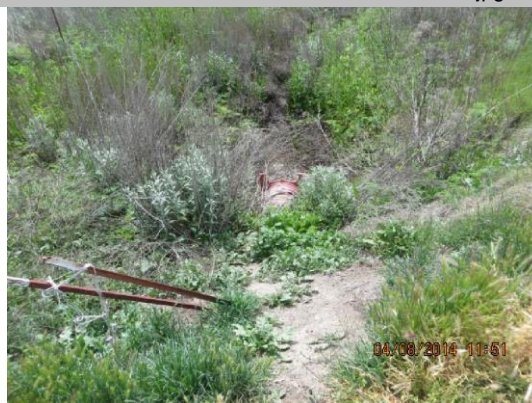
Photo 1 of 2 : UCIP_FA_2018_39151_60742.jpg

Comment Code					
Inspector Comment					
FS_ID:39151 DS_ID:19611 EP_NO: N/A Repair Type: Non-Urgent Crossing Status: Found UCIP Comments: 04/08/2014 Dense vegetation limits the inspector's visibility to identify signs of pipe failure (leaks) along waterward and landward slopes. Recommend removing vegetation along pipe alignment to conduct proper inspection of structure and appurtenances. Landward side filled in with soil. Need to contact owner. If crossing is no longer used need to coordinate with CVFPB for proper abandonment. (DWR UCIP - W. Wylie) FIELD_STRUCT_DESC: 24-inch corrugated metal gravity drainage pipe through the levee, 8.6 feet below the crown. Flap gate on the waterside (WS) end. Brass cap No. 90 bench mark (BM) on the headwall on the landside (LS). [Additional Reference(s): DWR Levee Log, 2002. USACE San Joaquin O&M Manual 601.1, 1967, (HLM 5.95)]. FS Date: 4/8/2014

Pipe, concrete headwall, and flapgate visible on WS toe.

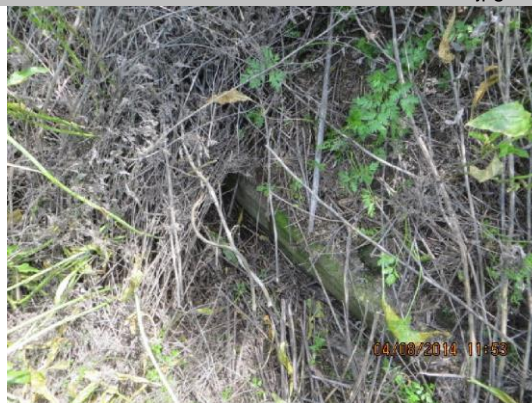
Photo 2 of 2 : UCIP_FA_2018_39151_60741.jpg

Top of concrete headwall just visible on LS toe.

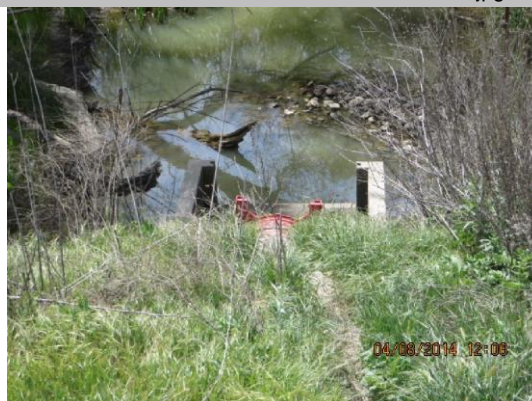
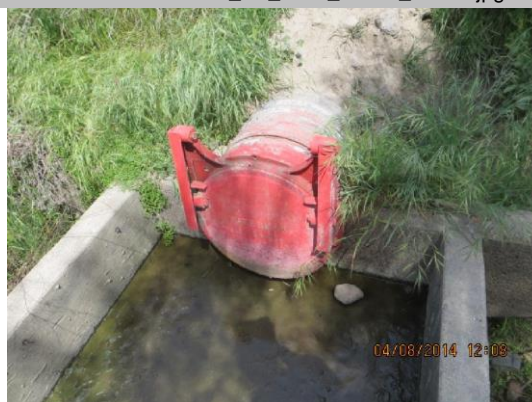
Comment Code						
Inspector Comment						
FS_ID:39154 DS_ID:19613 EP_NO: N/A Repair Type: Non-Urgent Crossing Status: Found UCIP Comments: 04/08/2014 Dense vegetation limits the inspector's visibility to identify signs of pipe failure (leaks) along the slope. Recommend removing vegetation along pipe alignment to conduct proper inspection of structure and appurtenances. (DWR UCIP - W. Wylie) FIELD_STRUCT_DESC: 24-inch corrugated metal gravity drainage pipe through the levee, 9.5 feet below the crown. Flap gate on the waterside (WS) end. Slide gate on the landside (LS) end next to a 48-inch concrete riser with walkway over the top. Brass cap No. 90 bench mark (BM) on the headwall on the LS. [Additional Reference(s): DWR Levee Log, 2002. USACE San Joaquin O&M Manual 601.1, 1967, (HLM 6.40)]. FS Date: 4/8/2014

Pipe, flapgate, and concrete headwall on WS toe.

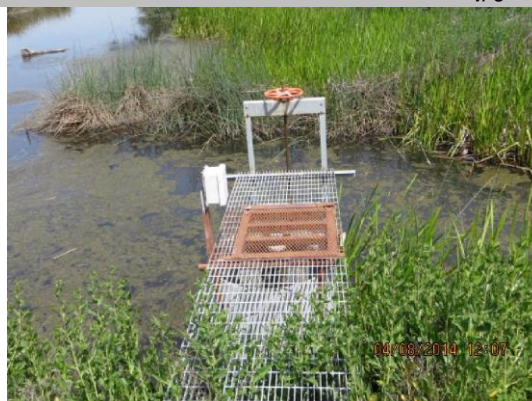
Photo 3 of 3 : UCIP_FA_2018_39154_60761.jpg

Comment Code						
Inspector Comment						
FS_ID:39154 DS_ID:19613 EP_NO: N/A Repair Type: Non-Urgent Crossing Status: Found UCIP Comments: 04/08/2014 Dense vegetation limits the inspector's visibility to identify signs of pipe failure (leaks) along the slope. Recommend removing vegetation along pipe alignment to conduct proper inspection of structure and appurtenances. (DWR UCIP - W. Wylie) FIELD_STRUCT_DESC: 24-inch corrugated metal gravity drainage pipe through the levee, 9.5 feet below the crown. Flap gate on the waterside (WS) end. Slide gate on the landside (LS) end next to a 48-inch concrete riser with walkway over the top. Brass cap No. 90 bench mark (BM) on the headwall on the LS. [Additional Reference(s): DWR Levee Log, 2002. USACE San Joaquin O&M Manual 601.1, 1967, (HLM 6.40)]. FS Date: 4/8/2014

Metal walkway over concrete standpipe next to slide gate on LS toe.

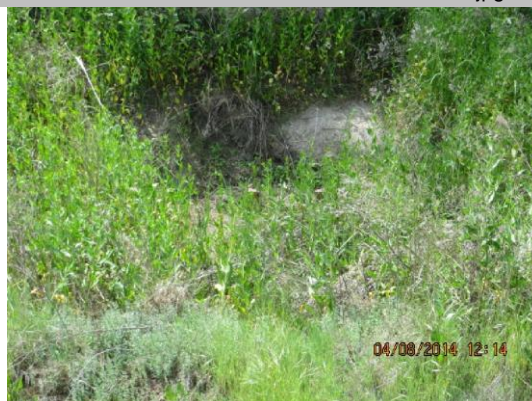
Photo 1 of 3 : UCIP_FA_2018_49962_60764.jpg

Comment Code						
Inspector Comment						
FS_ID:49962 DS_ID:19614 EP_NO: N/A Repair Type: Non-Urgent Crossing Status: Found UCIP Comments: 7/19/2016 Same as previous inspection. Outlet and inlet are under water. (DWR UCIP - O. Magana)4/08/2014 Flapgate blocked by sedimentation at WS toe. Dense vegetation limits the inspector's visibility to identify signs of pipe failure (leaks) along the slope. Recommend removing vegetation along pipe alignment to conduct proper inspection of structure and appurtenances. Also recommend clearing vegetation from both waterward and landward toe. (DWR UCIP - W. Wylie) FIELD_STRUCT_DESC: 24-inch corrugated metal gravity drainage pipe through the levee, 9.8 feet below the crown. Wooden fence around a 4-foot by 4-foot drop inlet on the landside (LS) toe. Flap gate on the waterside (WS) end. Brass cap No. 90 bench mark (BM) on the headwall on the LS. [Additional Reference(s): DWR Levee Log, 2002. USACE San Joaquin O&M Manual 601.1, 1967, (HLM 6.64)]. FS Date: 7/19/2016

Pipe and flapgate visible on WS toe.

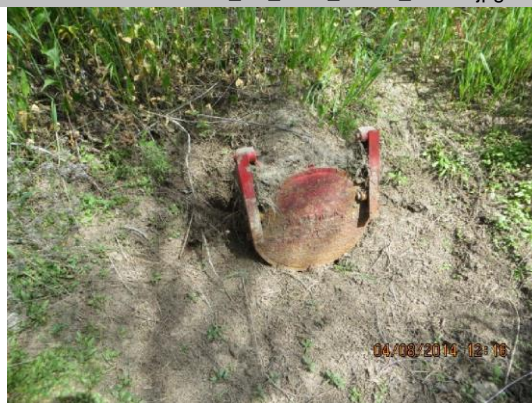
Photo 2 of 3 : UCIP_FA_2018_49962_60766.jpg

Pipe and flapgate visible at WS toe. Flapgate blocked by sedimentation on WS toe.

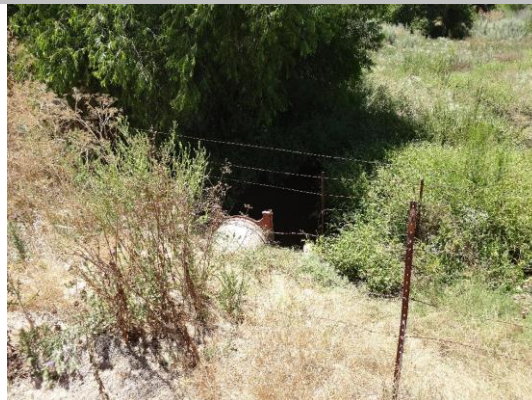
Photo 3 of 3 : UCIP_FA_2018_50077_75470.jpg

View of WS--fence limits access to flap gate.

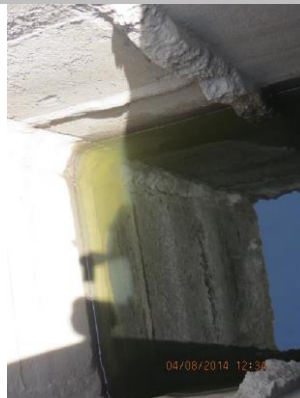
Photo 1 of 3 : UCIP_FA_2018_39160_60776.jpg

FS_ID:39160
DS_ID:19617
EP_NO: 4425
Repair Type: Non-Urgent
Crossing Status: Found
UCIP Comments: 04/08/2014 Recommend contacting owner to determine status of crossing. No pump was found on waterward side (riverbank). If crossing is no longer used need to coordinate with CVFPB for proper abandonment. (DWR UCIP - W. Wylie)
FIELD_STRUCT_DESC: 24-inch concrete encased steel irrigation discharge pipe through the levee, 13.6 feet below the crown. Pipe encased in 6-inches of concrete through the levee. 5-foot by 7-foot concrete distribution box on the waterside (WS). 20-inch concrete standpipe at the landside (LS) toe. Pump on the riverbank, accessible by walkway platform, pump not found. Concrete cutoff walls around pipe in line with the levee shoulders. Pipe extends to 36-inch concrete pipes on both sides of the levee. (Plans to install an irrigation pipeline through the levee authorized under Permit No. 4425, 1964 - James J. Stevinson, a Corporation). [Additional Reference(s): DWR Levee Log, 2002].

Pipe visible under water in concrete box riser on WS toe.

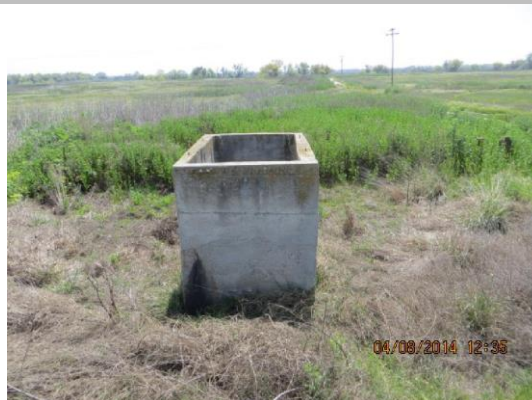
Photo 2 of 3 : UCIP_FA_2018_39160_60775.jpg

5'X7' concrete box riser on WS toe.

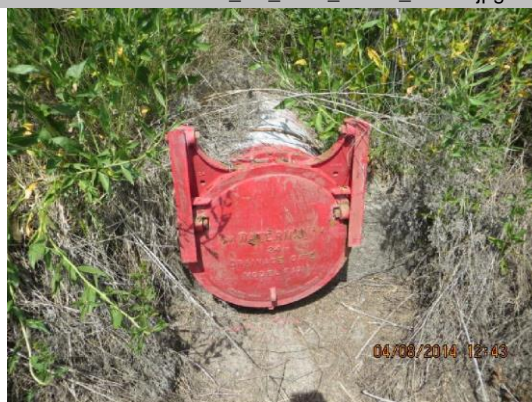
Photo 2 of 3 : UCIP_FA_2018_39161_60780.jpg

Pipe and flapgate visible on WS toe.

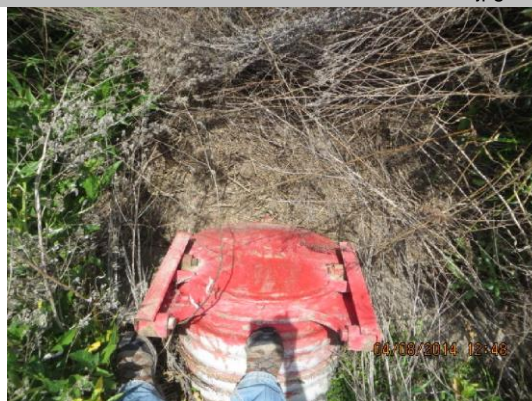
Photo 2 of 3 : UCIP_FA_2018_39243_60840.jpg

Flapgate and headwall at WS toe.

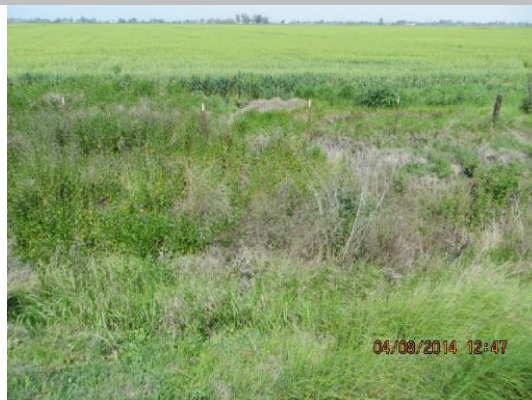
Photo 3 of 3 : UCIP_FA_2018_39243_60841.jpg

Comment Code						
Inspector Comment						
FS_ID:39243						
DS_ID:19619						
EP_NO: N/A						
Repair Type: Non-Urgent						
Crossing Status: Found						
UCIP Comments: 04/08/2014 Dense vegetation limits the inspector's visibility to identify signs of pipe failure (leaks) along the slope. Recommend removing vegetation along pipe alignment to conduct proper inspection of structure. (DWR UCIP - W. Wylie)						
FIELD_STRUCT_DESC: 24-inch corrugated metal gravity drainage pipe through the levee, 10 feet below the crown. Flap gate on the waterside (WS) end. Brass cap No. 80 bench mark (BM) on the headwall on the landside (LS). [Additional Reference(s): DWR Levee Log, 2002. USACE San Joaquin O&M Manual 601.1, 1967, (HLM 7.69)].						
FS Date: 4/8/2014

Concrete headwall at LS toe. Heavy vegetation on both slopes.

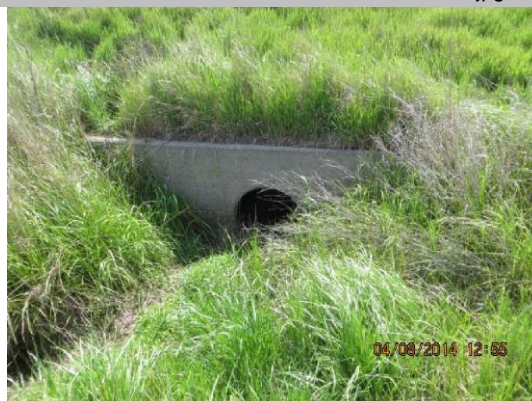
Photo 3 of 3 : UCIP_FA_2018_39244_60846.jpg

Comment Code						
Inspector Comment						
FS_ID:39244						
DS_ID:19620						
EP_NO: N/A						
Repair Type: Non-Urgent						
Crossing Status: Found						
UCIP Comments: 04/09/2014 Dense vegetation limits the inspector's visibility to identify signs of pipe failure (leaks) along the slope. Recommend removing vegetation along pipe alignment to conduct proper inspection of structure. (DWR UCIP - W. Wylie)						
FIELD_STRUCT_DESC: 24-inch corrugated metal gravity drainage pipe through the levee, 8 feet below the crown. Flap gate on the waterside (WS) end. Brass cap No. 80 bench mark (BM) on the headwall on the landside (LS). [Additional Reference(s): DWR Levee Log, 2002. USACE San Joaquin O&M Manual 601.1, 1967, (HLM 8.07)].						
FS Date: 4/9/2014

Pipe and concrete headwall on LS toe.

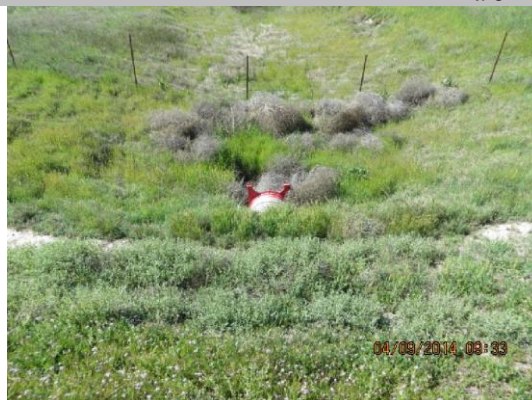
Photo 1 of 3 : UCIP_FA_2018_39245_60850.jpg

Comment Code					
Inspector Comment					
FS_ID:39245 DS_ID:19621 EP_NO: N/A Repair Type: Non-Urgent Crossing Status: Found UCIP Comments: 04/09/2014 Dense vegetation limits the inspector's visibility to identify signs of pipe failure (leaks) along the slope. Recommend removing vegetation along pipe alignment to conduct proper inspection of structure. Sediment buildup at landward toe. (DWR UCIP - W. Wylie) FIELD_STRUCT_DESC: 24-inch corrugated metal gravity drainage pipe through the levee, 9.5 feet below the crown. Flap gate on the waterside (WS) end. Brass cap No. 80 bench mark (BM) on the headwall on the landside (LS). [Additional Reference(s): DWR Levee Log, 2002. USACE San Joaquin O&M Manual 601.1, 1967, (HLM 8.41)]. FS Date: 4/9/2014

Concrete headwall, pipe, and flapgate at WS toe.

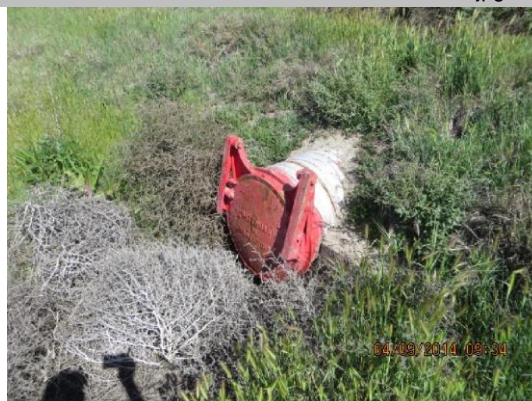
Photo 2 of 3 : UCIP_FA_2018_39245_60848.jpg

Concrete headwall, pipe, and flapgate at WS toe.
