**Flood Control Project Maintenance
Levee Inspections**

Fall 2018 Levee Maintenance Deficiency Summary Report

San Joaquin River Basin

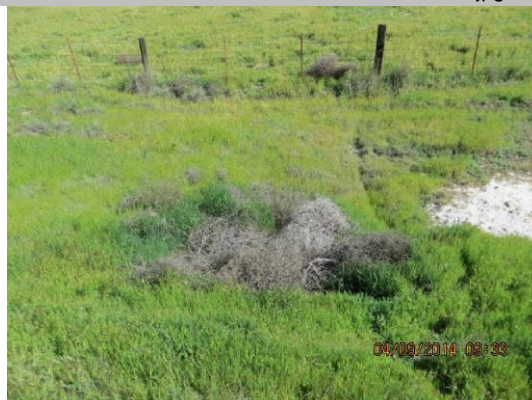
Photo 3 of 3 : UCIP_FA_2018_39245_60849.jpg

Comment Code						
Inspector Comment						
FS_ID:39245						
DS_ID:19621						
EP_NO: N/A						
Repair Type: Non-Urgent						
Crossing Status: Found						
UCIP Comments: 04/09/2014 Dense vegetation limits the inspector's visibility to identify signs of pipe failure (leaks) along the slope.						
Recommend removing vegetation along pipe alignment to conduct proper inspection of structure. Sediment buildup at landward toe. (DWR UCIP - W. Wylie)						
FIELD_STRUCT_DESC: 24-inch corrugated metal gravity drainage pipe through the levee, 9.5 feet below the crown. Flap gate on the waterside (WS) end. Brass cap No. 80 bench mark (BM) on the headwall on the landside (LS). [Additional Reference(s): DWR Levee Log, 2002. USACE San Joaquin O&M Manual 601.1, 1967, (HLM 8.41)].						
FS Date: 4/9/2014

Pipe and concrete headwall at LS toe. Note heavy vegetation.

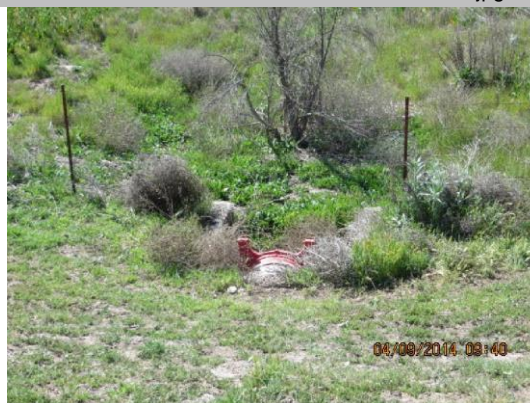
Photo 1 of 3 : UCIP_FA_2018_39246_60854.jpg

LM Start	8.57	Rating **	A/W	Issue No.	1220
LM End	8.57	Issue Type +	Ma	Location *	
Category	Supplemental			GPS Latitude/Longitude	
				Start	End
Item	DWR UCIP LMA Responsibility			37.296552 °	37.296552 °
				-120.858596 °	-120.858596 °
DWR ID	19622				
Comment Code					
Inspector Comment					
FS_ID:39246					
DS_ID:19622					
EP_NO: N/A					
Repair Type: No Action Needed					
Crossing Status: Found					
UCIP Comments:					
FIELD_STRUCT_DESC: 24-inch corrugated metal gravity drainage pipe					
through the levee, 9 feet below the crown. Flap gate on the waterside					
(WS) end. Brass cap No. 80 bench mark (BM) on the headwall on the					
landside (LS). [Additional Reference(s): DWR Levee Log, 2002. USACE					
San Joaquin O&M Manual 601.1, 1967, (HLM 8.61)].					
FS Date: 4/9/2014

Pipe, Flapgate, and headwall on WS toe.

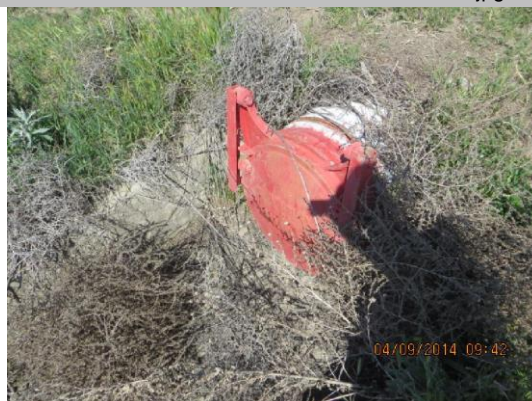
Photo 2 of 3 : UCIP_FA_2018_39246_60855.jpg

Pipe, Flapgate, and headwall on WS toe.

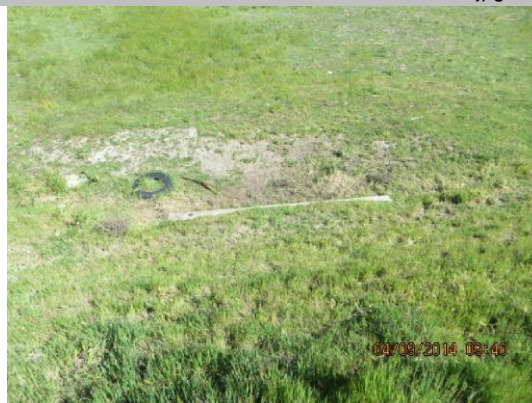
Photo 3 of 3 : UCIP_FA_2018_39246_60853.jpg

Pipe and headwall at LS toe.

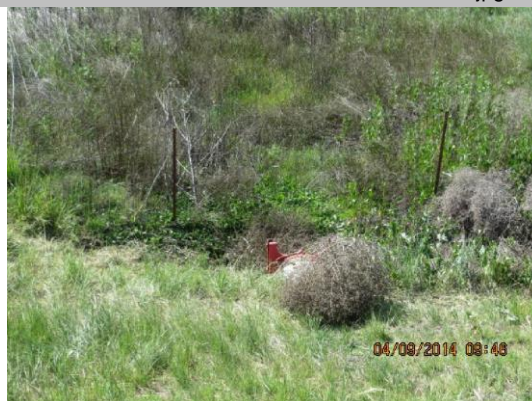
Photo 1 of 3 : UCIP_FA_2018_39247_60859.jpg

Comment Code						
Inspector Comment						
FS_ID:39247						
DS_ID:19623						
EP_NO: N/A						
Repair Type: Non-Urgent						
Crossing Status: Found						
UCIP Comments: 04/09/2014 Dense vegetation limits the inspector's visibility to identify signs of pipe failure (leaks) along the slope. Recommend removing vegetation along pipe alignment to conduct proper inspection of structure. (DWR UCIP - W. Wylie)						
FIELD_STRUCT_DESC: 24-inch corrugated metal gravity drainage pipe through the levee, 9.1 feet below the crown. Flap gate on the waterside (WS) end. Brass cap No. 80 bench mark (BM) on the headwall on the landside (LS). [Additional Reference(s): DWR Levee Log, 2002. USACE San Joaquin O&M Manual 601.1, 1967, (HLM 8.93)].						
FS Date: 4/9/2014

Pipe, flapgate, and headwall on WS toe.

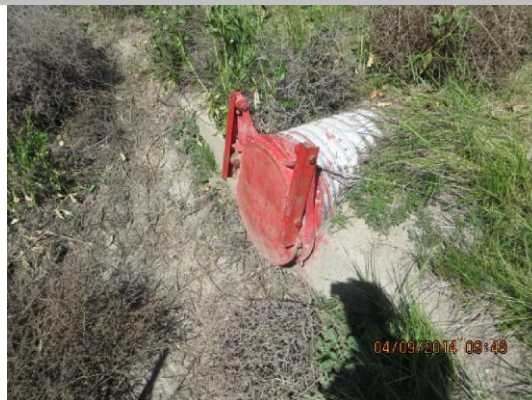
Photo 2 of 3 : UCIP_FA_2018_39247_60860.jpg

Pipe, flapgate, and headwall on WS toe.

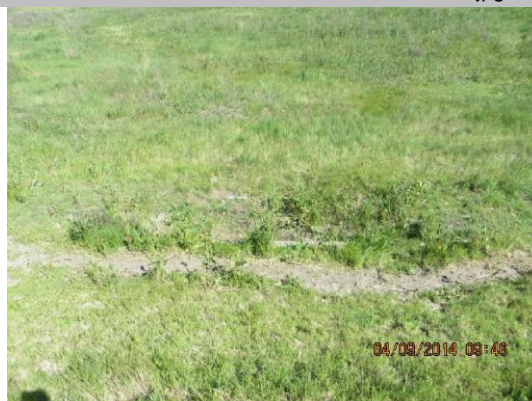
Photo 3 of 3 : UCIP_FA_2018_39247_60858.jpg

Comment Code						
Inspector Comment						
FS_ID:39247						
DS_ID:19623						
EP_NO: N/A						
Repair Type: Non-Urgent						
Crossing Status: Found						
UCIP Comments: 04/09/2014 Dense vegetation limits the inspector's visibility to identify signs of pipe failure (leaks) along the slope. Recommend removing vegetation along pipe alignment to conduct proper inspection of structure. (DWR UCIP - W. Wylie)						
FIELD_STRUCT_DESC: 24-inch corrugated metal gravity drainage pipe through the levee, 9.1 feet below the crown. Flap gate on the waterside (WS) end. Brass cap No. 80 bench mark (BM) on the headwall on the landside (LS). [Additional Reference(s): DWR Levee Log, 2002. USACE San Joaquin O&M Manual 601.1, 1967, (HLM 8.93)].						
FS Date: 4/9/2014

Pipe and headwall visible on LS toe.

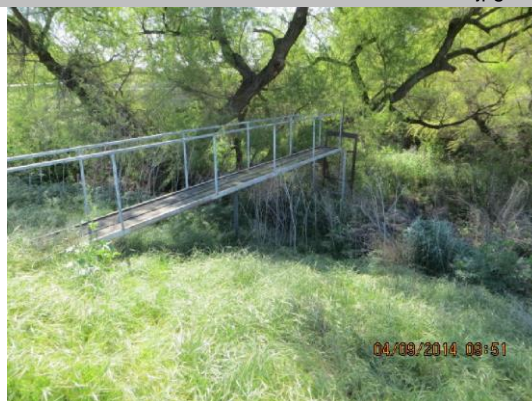
Photo 1 of 3 : UCIP_FA_2018_53190_60864.jpg

UCIP Comments: 11/01/2018 Dense vegetation prevented a full inspection of this crossing. Assumed crossing remains the same as the 2016 inspection. Crossing remains Urgent due to signs of pipe being rusted through visible from the WS. Need to contact owner to clear the dense vegetation on both the WS and the LS to be able to perform proper inspection of crossing. (O. Magana - DWR UCIP)7/19/2016 same as previous inspection--pipe rusted through. Sediment visible inside LS pipe; walkway wood panels have dry rot and appears to be unsafe to use. (DWR UCIP - O. Magana)4/09/2014 Slide gate rusted through and open on WS toe. Inlet appears to be obscured or covered in soil at LS toe. Also dense vegetation on waterward and landward sides. Need to contact owner to contact CVFPB to address issue. (DWR UCIP - W. Wylie)

Metal walkway to slidegate operator on WS toe.

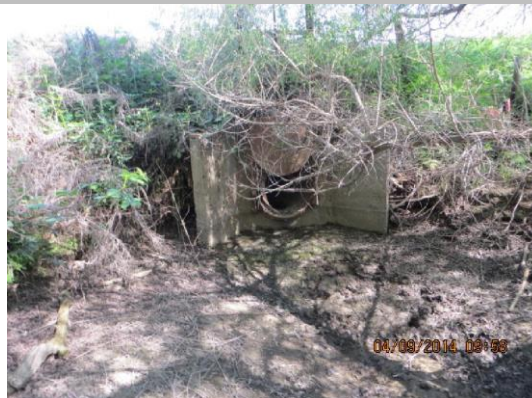
Photo 2 of 3 : UCIP_FA_2018_53190_60862.jpg

Comment Code						
Inspector Comment						
FS_ID:53190 DS_ID:19624 EP_NO: 12156 Repair Type: Urgent Crossing Status: Found UCIP Comments: 11/01/2018 Dense vegetation prevented a full inspection of this crossing. Assumed crossing remains the same as the 2016 inspection. Crossing remains Urgent due to signs of pipe being rusted through visible from the WS. Need to contact owner to clear the dense vegetation on both the WS and the LS to be able to perform proper inspection of crossing. (O. Magana - DWR UCIP)7/19/2016 same as previous inspection--pipe rusted through. Sediment visible inside LS pipe; walkway wood panels have dry rot and appears to be unsafe to use. (DWR UCIP - O. Magana)4/09/2014 Slide gate rusted through and open on WS toe. Inlet appears to be obscured or covered in soil at LS toe. Also dense vegetation on waterward and landward sides. Need to contact owner to contact CVFPB to address issue. (DWR UCIP - W. Wylie) FIELD_STRUCT_DESC: 26-inch steel pipe sleeved through a 30-inch reinforced concrete gravity drainage pipe through the levee, 7.3 feet below the crown. Annular space grouted between the two pipes. Two concrete cutoff walls in the center of the levee. Slide gate with elevated walkway access on the waterside (WS) end. 6-inch thick concrete headwall on the WS end. Concrete wing walls on each end. (Plans to install a 30-inch storm drainage pipe with a valve through the levee authorized under Permit No. 12156, 1977 - Merquin County Water District). (Additional Related Permit(s): Permit No. 12156-A, 1978 - Merquin County Water District). [Additional Reference(s): DWR Levee Log, 2002]. FS Date: 11/1/2018 12:50:00 PM

Slidegate and headwall at WS toe.

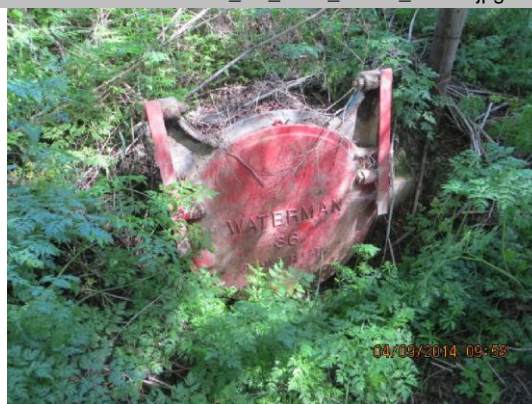
Photo 2 of 3 : UCIP_FA_2018_39249_60869.jpg

Pipe and flapgate visible on WS toe.

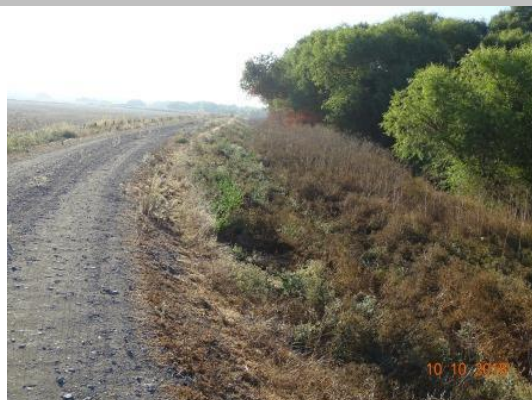
Photo 1 of 2 : FA_2018_NA0010_118_92_20181022_00282.jpg

LM Start	8.99	Rating **	U	Issue No.	92
LM End	9.08	Issue Type +	Ma	Location *	WS
Category	Earthen Levee			GPS Latitude/Longitude	
				Start	End
Item	Vegetation			37.297497 °	37.296978 °
				-120.851068 °	-120.849805 °
DWR ID	DWR_NA0010_01_s_2017_92				
Comment Code					
V2 : Remove the wild growth other than native grasses from the levee slopes.					
Inspector Comment					
Dense vegetation along waterside slope.

Looking upstream along waterside slope. (Fall 2018)

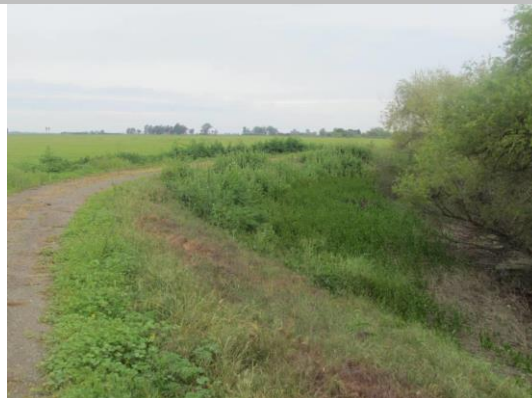
Photo 2 of 2 : FA_2018_NA0010_118_92_20180911_00018.jpg

LM Start	8.99	Rating **	U	Issue No.	92 (cont)	
LM End	9.08	Issue Type +	Ma	Location *	WS	
Category	Earthen Levee			GPS Latitude/Longitude		
				Start		End
Item	Vegetation			37.297497 °		37.296978 °
				-120.851068 °		-120.849805 °
DWR ID	DWR_NA0010_01_s_2017_92					
Comment Code						
V2 : Remove the wild growth other than native grasses from the levee slopes.						
Inspector Comment						
Dense vegetation along waterside slope.

Looking southwest at dense veg on waterward slope.

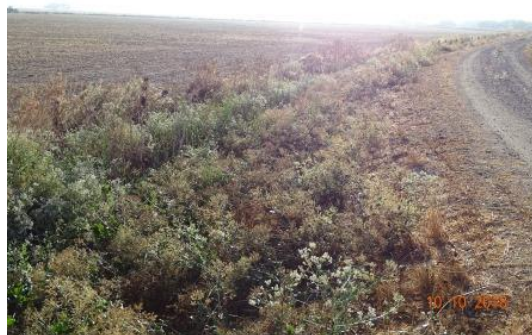
Photo 1 of 3 : FA_2018_NA0010_118_6_20181022_00283.jpg

LM Start	8.99	Rating **	U	Issue No.	6
LM End	9.61	Issue Type +	Ma	Location *	LS
Category	Earthen Levee			GPS Latitude/Longitude	
				Start	End
Item	Vegetation			37.297497 °	37.295138 °
				-120.851068 °	-120.840857 °
DWR ID	DWR_NA0010_01_s_2017_6				
Comment Code					
V2 : Remove the wild growth other than native grasses from the levee slopes.					
Inspector Comment					
Dense vegetation along landside slope.

Looking upstream at vegetation along landside slope. (Fall 2018)

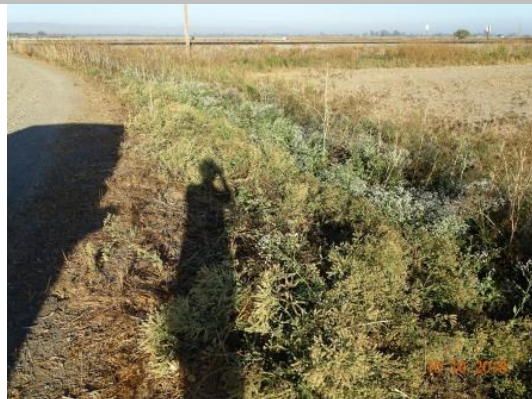
Photo 2 of 3 : FA_2018_NA0010_118_6_20181022_00284.jpg

Looking downstream at vegetation along landside slope. (Fall 2018)

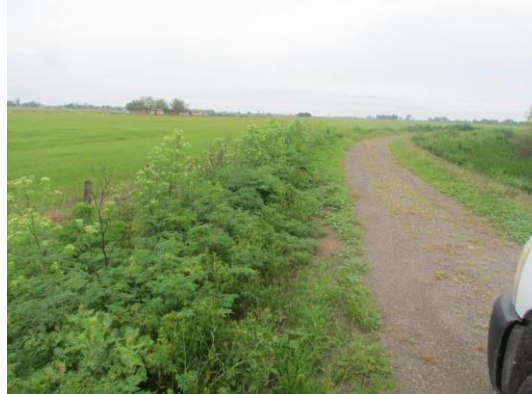
Photo 3 of 3 : FA_2018_NA0010_118_6_20180911_00004.jpg

LM Start	8.99	Rating **	U	Issue No.	6 (cont)	
LM End	9.61	Issue Type +	Ma	Location *	LS	
Category	Earthen Levee			GPS Latitude/Longitude		
				Start		End
Item	Vegetation			37.297497 °		37.295138 °
				-120.851068 °		-120.840857 °
DWR ID	DWR_NA0010_01_s_2017_6					
Comment Code						
V2 : Remove the wild growth other than native grasses from the levee slopes.						
Inspector Comment						
Dense vegetation along landside slope.

Looking south at dense veg on landward slope.

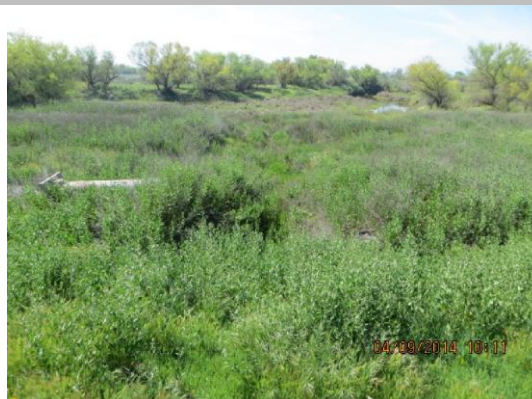
Photo 1 of 3 : UCIP_FA_2018_39251_60875.jpg

Comment Code						
Inspector Comment						
FS_ID:39251						
DS_ID:19627						
EP_NO: N/A						
Repair Type: Non-Urgent						
Crossing Status: Found						
UCIP Comments: 04/09/2014 Dense vegetation limits the inspector's visibility to identify signs of pipe failure (leaks) along the slope.						
Recommend removing vegetation along pipe alignment to conduct proper inspection of structure. (DWR UCIP - W. Wylie)						
FIELD_STRUCT_DESC: 24-inch corrugated metal gravity drainage pipe through the levee, 8.6 feet below the crown. Concrete drop inlet at the landside (LS) toe. Flap gate on the waterside (WS) end. Brass cap No. 80 bench mark (BM) on the headwall on the LS. [Additional Reference(s): DWR Levee Log, 2002. USACE San Joaquin O&M Manual 601.1, 1967, (HLM 9.37)].						
FS Date: 4/9/2014

Pipe and flapgate on WS toe.

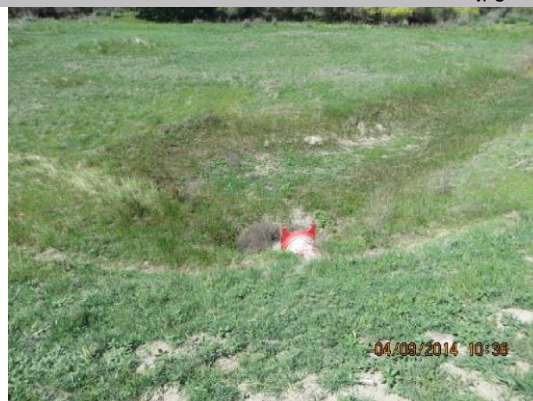
Photo 1 of 3 : UCIP_FA_2018_39253_60884.jpg

Comment Code						
Inspector Comment						
FS_ID:39253						
DS_ID:19629						
EP_NO: N/A						
Repair Type: Non-Urgent						
Crossing Status: Found						
UCIP Comments: 04/09/2014 Dense vegetation blocks waterward and landward toes Recommend removing vegetation from both toes. Also sediment buildup in pipe visible from landward side. (DWR UCIP - W. Wylie)						
FIELD_STRUCT_DESC: 24-inch corrugated metal gravity drainage pipe through the levee, 9 feet below the crown. Flap gate on the waterside (WS) end. Brass cap No. 69 bench mark (BM) on the headwall on the landside (LS). [Additional Reference(s): DWR Levee Log, 2002. USACE San Joaquin O&M Manual 601.1, 1967, (HLM 10.23)].						
FS Date: 4/9/2014

Pipe, headwall, and flapgate on WS toe.

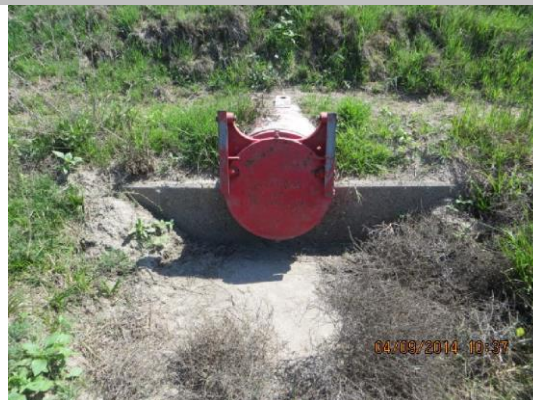
Photo 2 of 3 : UCIP_FA_2018_39253_60886.jpg

Pipe, headwall, and flapgate at WS toe.

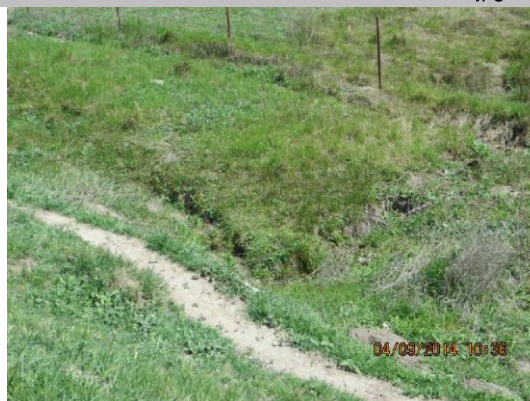
Photo 3 of 3 : UCIP_FA_2018_39253_60885.jpg

Item	DWR UCIP LMA Responsibility			37.287511 °		37.287511 °
				-120.840251 °		-120.840251 °
DWR ID	19629					
Comment Code						
Inspector Comment						
FS_ID:39253 DS_ID:19629 EP_NO: N/A Repair Type: Non-Urgent Crossing Status: Found UCIP Comments: 04/09/2014 Dense vegetation blocks waterward and landward toes Recommend removing vegetation from both toes. Also sediment buildup in pipe visible from landward side. (DWR UCIP - W. Wylie) FIELD_STRUCT_DESC: 24-inch corrugated metal gravity drainage pipe through the levee, 9 feet below the crown. Flap gate on the waterside (WS) end. Brass cap No. 69 bench mark (BM) on the headwall on the landside (LS). [Additional Reference(s): DWR Levee Log, 2002. USACE San Joaquin O&M Manual 601.1, 1967, (HLM 10.23)]. FS Date: 4/9/2014

Pipe and headwall at LS toe.

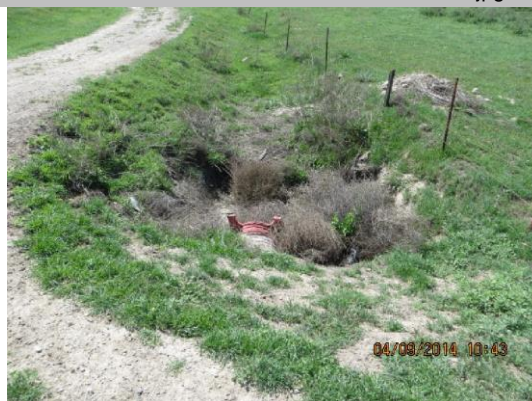
Photo 1 of 3 : UCIP_FA_2018_33687_60890.jpg

LM Start	10.68	Rating **	A/W	Issue No.	1228	
LM End	10.68	Issue Type +	Ma	Location *		
Category	Supplemental			GPS Latitude/Longitude		
				Start	End	
Item	DWR UCIP LMA Responsibility			37.283740 °	37.283740 °	
				-120.833452 °	-120.833452 °	
DWR ID	19630					
Comment Code						
Inspector Comment						
FS_ID:33687						
DS_ID:19630						
EP_NO: N/A						
Repair Type: No Action Needed						
Crossing Status: Found						
UCIP Comments:						
FIELD_STRUCT_DESC: 24-inch corrugated metal gravity drainage pipe through the levee, 7 feet below the crown. Flap gate on the waterside (WS) end. Brass cap No. 68 bench mark (BM) on the headwall on the landside (LS). [Additional Reference(s): DWR Levee Log, 2002. USACE San Joaquin O&M Manual 601.1, 1967, (HLM 10.72)].						
FS Date: 4/9/2014

Pipe and flapgate on Ws toe.

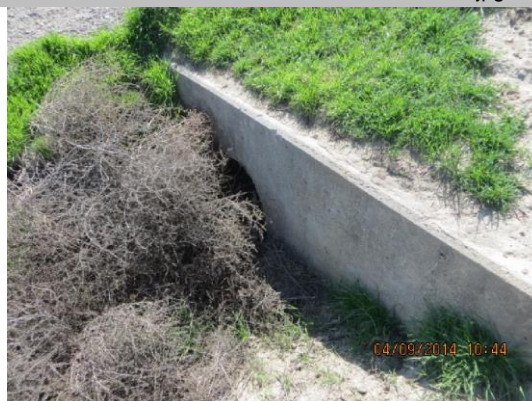
Photo 3 of 3 : UCIP_FA_2018_33687_60888.jpg

LM Start	10.68	Rating **	A/W	Issue No.	1228 (cont)	
LM End	10.68	Issue Type +	Ma	Location *		
Category	Supplemental			GPS Latitude/Longitude		
				Start	End	
Item	DWR UCIP LMA Responsibility			37.283740 °	37.283740 °	
				-120.833452 °	-120.833452 °	
DWR ID	19630					
Comment Code						
Inspector Comment						
FS_ID:33687						
DS_ID:19630						
EP_NO: N/A						
Repair Type: No Action Needed						
Crossing Status: Found						
UCIP Comments:						
FIELD_STRUCT_DESC: 24-inch corrugated metal gravity drainage pipe through the levee, 7 feet below the crown. Flap gate on the waterside (WS) end. Brass cap No. 68 bench mark (BM) on the headwall on the landside (LS). [Additional Reference(s): DWR Levee Log, 2002. USACE San Joaquin O&M Manual 601.1, 1967, (HLM 10.72)].						
FS Date: 4/9/2014

Pipe and headwall on LS toe.

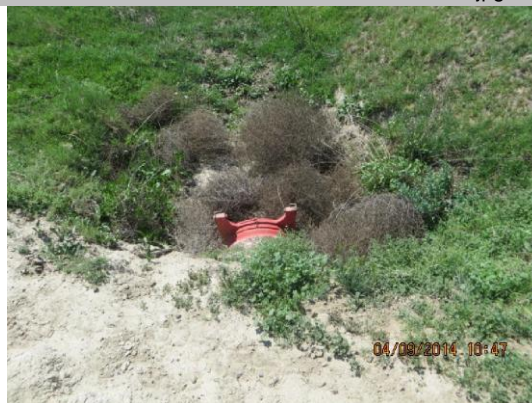
Photo 1 of 3 : UCIP_FA_2018_39254_60894.jpg

LM Start	10.69	Rating **	A/W	Issue No.	1229
LM End	10.69	Issue Type +	Ma	Location *	
Category	Supplemental			GPS Latitude/Longitude	
				Start	End
Item	DWR UCIP LMA Responsibility			37.283710 °	37.283710 °
				-120.833329 °	-120.833329 °
DWR ID	19631				
Comment Code					
Inspector Comment					
FS_ID:39254					
DS_ID:19631					
EP_NO: N/A					
Repair Type: No Action Needed					
Crossing Status: Found					
UCIP Comments:					
FIELD_STRUCT_DESC: 24-inch corrugated metal gravity drainage pipe through the levee, 7 feet below the crown. Flap gate on the waterside (WS) end. Brass cap No. 67 bench mark (BM) on the headwall on the landside (LS). [Additional Reference(s): DWR Levee Log, 2002. USACE San Joaquin O&M Manual 601.1, 1967, (HLM 10.72)].					
FS Date: 4/9/2014

Headwall, pipe, and flapgate on WS toe.

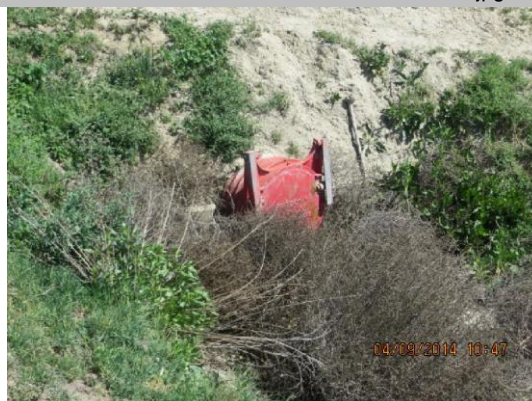
Photo 2 of 3 : UCIP_FA_2018_39254_60893.jpg

LM Start	10.69	Rating **	A/W	Issue No.	1229 (cont)	
LM End	10.69	Issue Type +	Ma	Location *		
Category	Supplemental			GPS Latitude/Longitude		
				Start	End	
Item	DWR UCIP LMA Responsibility			37.283710 °	37.283710 °	
				-120.833329 °	-120.833329 °	
DWR ID	19631					
Comment Code						
Inspector Comment						
FS_ID:39254						
DS_ID:19631						
EP_NO: N/A						
Repair Type: No Action Needed						
Crossing Status: Found						
UCIP Comments:						
FIELD_STRUCT_DESC: 24-inch corrugated metal gravity drainage pipe						
through the levee, 7 feet below the crown. Flap gate on the waterside						
(WS) end. Brass cap No. 67 bench mark (BM) on the headwall on the						
landside (LS). [Additional Reference(s): DWR Levee Log, 2002. USACE						
San Joaquin O&M Manual 601.1, 1967, (HLM 10.72)].						
FS Date: 4/9/2014

Headwall, pipe, and flapgate on WS toe.

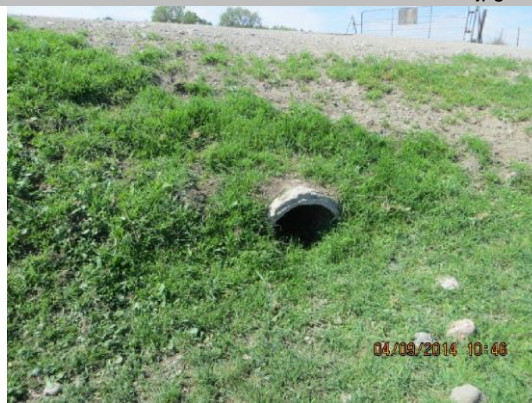
Photo 3 of 3 : UCIP_FA_2018_39254_60895.jpg

Concrete pipe visible on LS slope.

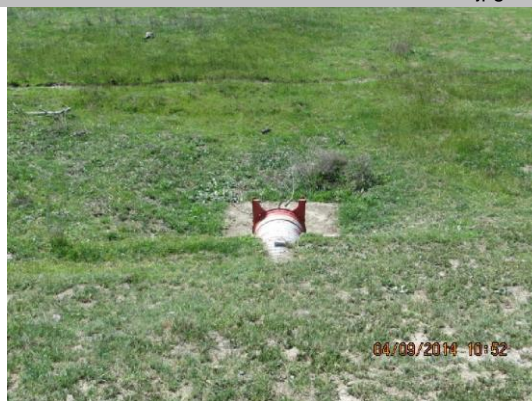
Photo 1 of 3 : UCIP_FA_2018_39255_60897.jpg

Comment Code						
Inspector Comment						
FS_ID:39255						
DS_ID:19632						
EP_NO: N/A						
Repair Type: Non-Urgent						
Crossing Status: Found						
UCIP Comments: 04/09/2014 Dense vegetation blocks landward headwall. Recommend removing excess vegetation on landward toe. (DWR UCIP - W. Wylie)						
FIELD_STRUCT_DESC: 24-inch corrugated metal gravity drainage pipe through the levee, 6 feet below the crown. Flap gate on the waterside (WS) end. Brass cap No. 66 bench mark (BM) on the headwall on the landside (LS). [Additional Reference(s): DWR Levee Log, 2002. USACE San Joaquin O&M Manual 601.1, 1967, (HLM 11.00)].						
FS Date: 4/9/2014

Pipe, headwall, and flapgate on WS toe.

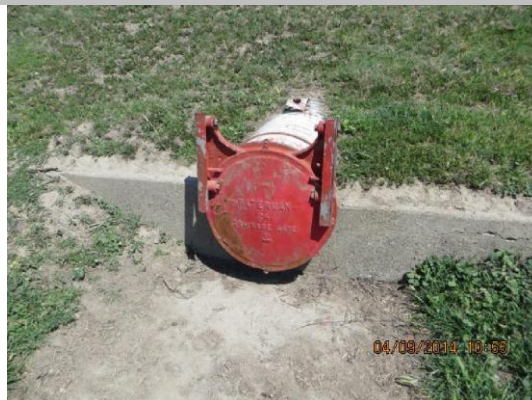
Photo 2 of 3 : UCIP_FA_2018_39255_60899.jpg

Pipe, headwall, and flapgate on WS toe.

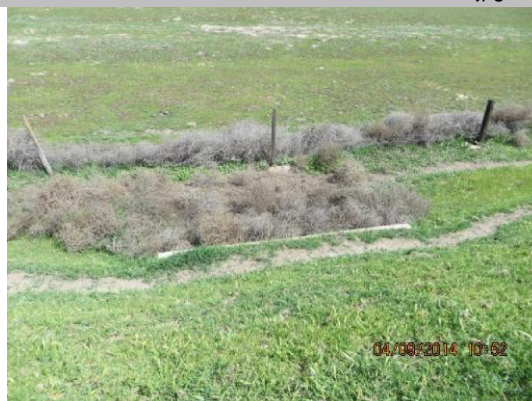
Photo 3 of 3 : UCIP_FA_2018_39255_60898.jpg

LM Start	10.98	Rating **	M	Issue No.	1230 (cont)	
LM End	10.98	Issue Type +	Ma	Location *		
Category	Supplemental			GPS Latitude/Longitude		
				Start	End	
Item	DWR UCIP LMA Responsibility			37.282627 °	37.282627 °	
				-120.828233 °	-120.828233 °	
DWR ID	19632					
Comment Code						
Inspector Comment						
FS_ID:39255 DS_ID:19632 EP_NO: N/A Repair Type: Non-Urgent Crossing Status: Found UCIP Comments: 04/09/2014 Dense vegetation blocks landward headwall. Recommend removing excess vegetation on landward toe. (DWR UCIP - W. Wylie) FIELD_STRUCT_DESC: 24-inch corrugated metal gravity drainage pipe through the levee, 6 feet below the crown. Flap gate on the waterside (WS) end. Brass cap No. 66 bench mark (BM) on the headwall on the landside (LS). [Additional Reference(s): DWR Levee Log, 2002. USACE San Joaquin O&M Manual 601.1, 1967, (HLM 11.00)]. FS Date: 4/9/2014

Pipe and headwall on LS toe.

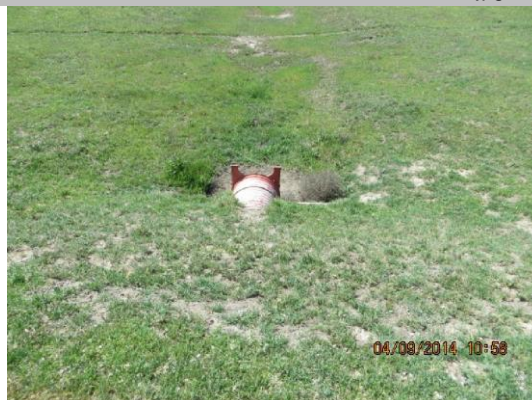
Photo 1 of 3 : UCIP_FA_2018_33690_60903.jpg

LM Start	11.14	Rating **	A/W	Issue No.	1231
LM End	11.14	Issue Type +	Ma	Location *	
Category	Supplemental			GPS Latitude/Longitude	
				Start	End
Item	DWR UCIP LMA Responsibility			37.281813 °	37.281813 °
				-120.825409 °	-120.825409 °
DWR ID	19633				
Comment Code					
Inspector Comment					
FS_ID:33690					
DS_ID:19633					
EP_NO: N/A					
Repair Type: No Action Needed					
Crossing Status: Found					
UCIP Comments:					
FIELD_STRUCT_DESC: 24-inch corrugated metal gravity drainage pipe through the levee, 5 feet below the crown. Flap gate on the waterside (WS) end. Brass cap No. 65 bench mark (BM) on the headwall on the landside (LS). [Additional Reference(s): DWR Levee Log, 2002. USACE San Joaquin O&M Manual 601.1, 1967, (HLM 11.18)].					
FS Date: 4/9/2014

Pipe, headwall, and flapgate on WS toe.

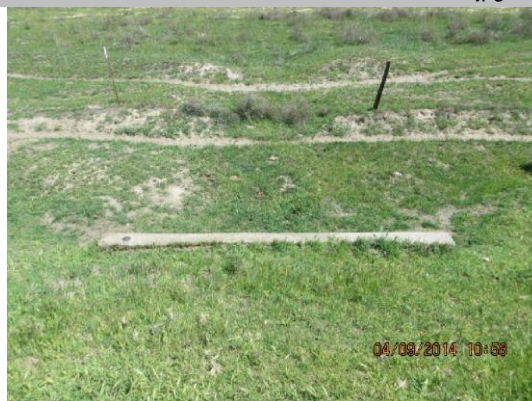
Photo 2 of 3 : UCIP_FA_2018_33690_60902.jpg

LM Start	11.14	Rating **	A/W	Issue No.	1231 (cont)	
LM End	11.14	Issue Type +	Ma	Location *		
Category	Supplemental			GPS Latitude/Longitude		
				Start	End	
Item	DWR UCIP LMA Responsibility			37.281813 °	37.281813 °	
				-120.825409 °	-120.825409 °	
DWR ID	19633					
Comment Code						
Inspector Comment						
FS_ID:33690						
DS_ID:19633						
EP_NO: N/A						
Repair Type: No Action Needed						
Crossing Status: Found						
UCIP Comments:						
FIELD_STRUCT_DESC: 24-inch corrugated metal gravity drainage pipe through the levee, 5 feet below the crown. Flap gate on the waterside (WS) end. Brass cap No. 65 bench mark (BM) on the headwall on the landside (LS). [Additional Reference(s): DWR Levee Log, 2002. USACE San Joaquin O&M Manual 601.1, 1967, (HLM 11.18)].						
FS Date: 4/9/2014

Pipe and headwall at LS toe.

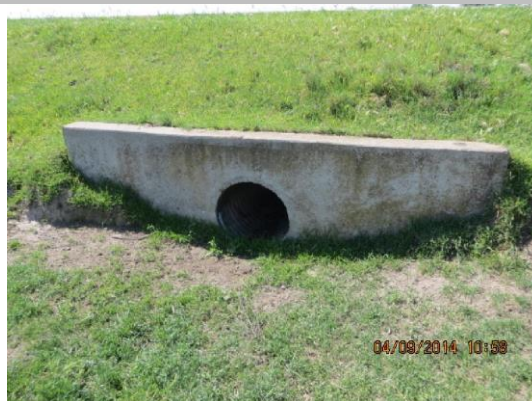
Photo 3 of 3 : UCIP_FA_2018_33690_60901.jpg

Pipe and headwall at LS toe.

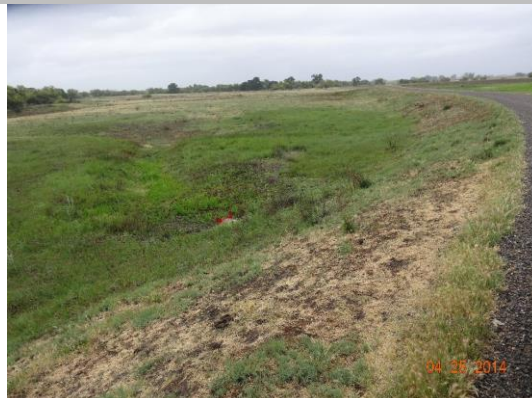
Photo 1 of 3 : UCIP_FA_2018_36103_65362.jpg

Comment Code					
Inspector Comment					
FS_ID:36103 DS_ID:19634 EP_NO: N/A Repair Type: Non-Urgent Crossing Status: Found UCIP Comments: 04/25/2014 Need to contact owner--landward side has been buried. It appears that soil was removed from levee toe, immediately upstream, and used to pile soil at landward side at crossing. (DWR UCIP - O. Magana) FIELD_STRUCT_DESC: 24-inch corrugated metal gravity drainage pipe through the levee, 10 feet below the crown. Flap gate on the waterside (WS) end. Brass cap No. 62 bench mark (BM) on the headwall on the landside (LS). [Additional Reference(s): DWR Levee Log, 2002. USACE San Joaquin O&M Manual 601.1, 1967, (HLM 11.48)]. FS Date: 4/25/2014

View of waterward side.

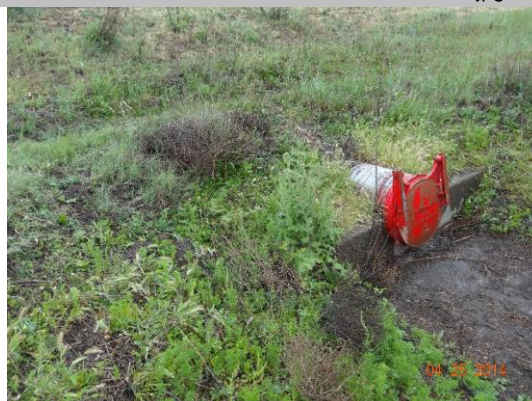
Photo 2 of 3 : UCIP_FA_2018_36103_65364.jpg

Item	DWR UCIP LMA Responsibility			37.273787 °	37.273787 °	
				-120.825519 °	-120.825519 °	
DWR ID	19634					
Comment Code						
Inspector Comment						
FS_ID:36103 DS_ID:19634 EP_NO: N/A Repair Type: Non-Urgent Crossing Status: Found UCIP Comments: 04/25/2014 Need to contact owner--landward side has been buried. It appears that soil was removed from levee toe, immediately upstream, and used to pile soil at landward side at crossing. (DWR UCIP - O. Magana) FIELD_STRUCT_DESC: 24-inch corrugated metal gravity drainage pipe through the levee, 10 feet below the crown. Flap gate on the waterside (WS) end. Brass cap No. 62 bench mark (BM) on the headwall on the landside (LS). [Additional Reference(s): DWR Levee Log, 2002. USACE San Joaquin O&M Manual 601.1, 1967, (HLM 11.48)]. FS Date: 4/25/2014

View of concrete headwall and flap gate visible on waterward side.

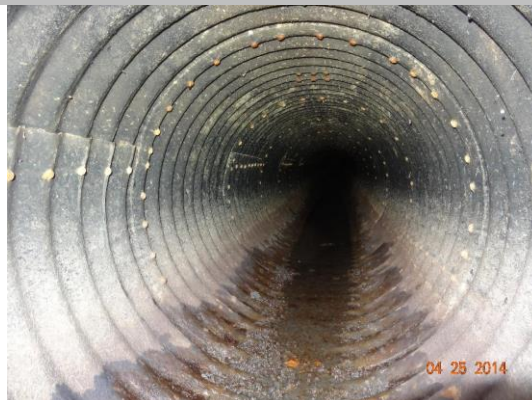
Photo 3 of 3 : UCIP_FA_2018_36103_65363.jpg

Inside view of pipe from waterward side.

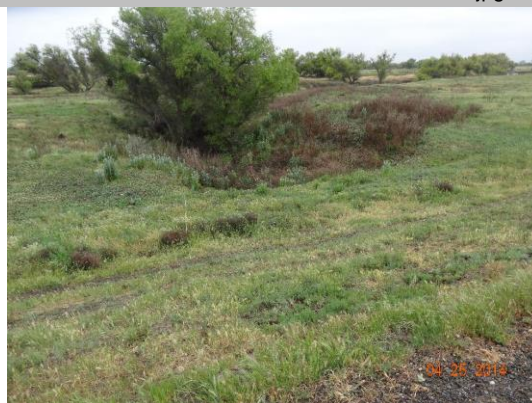
Photo 1 of 3 : UCIP_FA_2018_36105_65372.jpg

Comment Code						
Inspector Comment						
FS_ID:36105 DS_ID:19635 EP_NO: N/A Repair Type: Non-Urgent Crossing Status: Found UCIP Comments: 04/25/2014 Crossing is non-functional --landward side is buried. Debris found on landward side (channel). Dense vegetation found on waterward slope. Recommend contacting owner to determine status of crossing. If crossing is no longer used need to coordinate with CVFPB for proper abandonment. (DWR UCIP - O. Magana) FIELD_STRUCT_DESC: 24-inch corrugated metal gravity drainage pipe through the levee, 17 feet below the crown. Flap gate on the waterside (WS) end. Brass cap No. 61 bench mark (BM) on the headwall on the landside (LS). [Additional Reference(s): DWR Levee Log, 2002. USACE San Joaquin O&M Manual 601.1, 1967, (HLM 11.76)]. FS Date: 4/25/2014

View of waterward side.

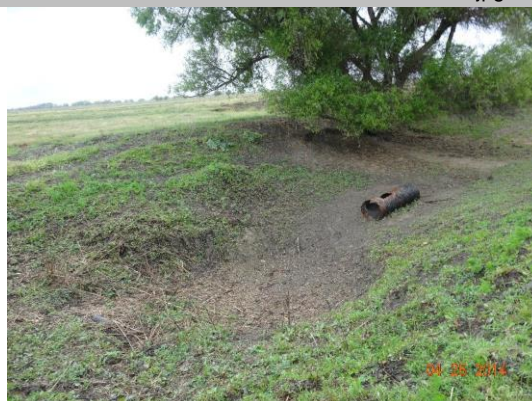
Photo 2 of 3 : UCIP_FA_2018_36105_65371.jpg

Item	DWR UCIP LMA Responsibility			37.269701 °	37.269701 °	
				-120.826450 °	-120.826450 °	
DWR ID	19635					
Comment Code						
Inspector Comment						
FS_ID:36105 DS_ID:19635 EP_NO: N/A Repair Type: Non-Urgent Crossing Status: Found UCIP Comments: 04/25/2014 Crossing is non-functional --landward side is buried. Debris found on landward side (channel). Dense vegetation found on waterward slope. Recommend contacting owner to determine status of crossing. If crossing is no longer used need to coordinate with CVFPB for proper abandonment. (DWR UCIP - O. Magana) FIELD_STRUCT_DESC: 24-inch corrugated metal gravity drainage pipe through the levee, 17 feet below the crown. Flap gate on the waterside (WS) end. Brass cap No. 61 bench mark (BM) on the headwall on the landside (LS). [Additional Reference(s): DWR Levee Log, 2002. USACE San Joaquin O&M Manual 601.1, 1967, (HLM 11.76)]. FS Date: 4/25/2014

Landward side of crossing buried--damage pipe section visible on landward side.

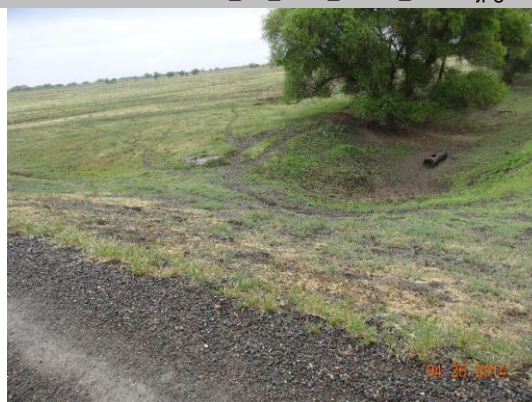
Photo 3 of 3 : UCIP_FA_2018_36105_65373.jpg

View of landward side.

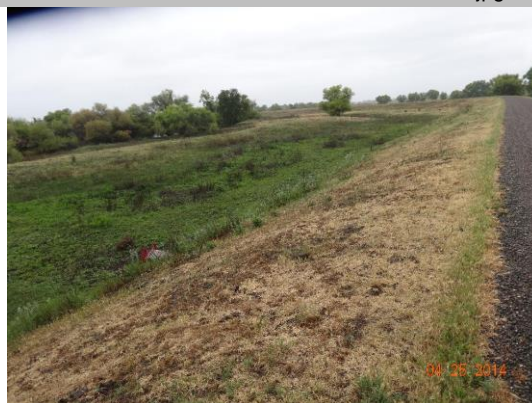
Photo 1 of 3 : UCIP_FA_2018_36106_65378.jpg

Comment Code						
Inspector Comment						
FS_ID:36106 DS_ID:19636 EP_NO: N/A Repair Type: Non-Urgent Crossing Status: Found UCIP Comments: 04/25/2014 Crossing is non-functional --landward side is buried. Dense vegetation found on waterward slope. Recommend contacting owner to determine status of crossing. If crossing is no longer used need to coordinate with CVFPB for proper abandonment. (DWR UCIP - O. Magana) FIELD_STRUCT_DESC: 24-inch corrugated metal gravity drainage pipe through the levee, 12.4 feet below the crown. Flap gate on the waterside (WS) end. Brass cap No. 60 bench mark (BM) on the headwall on the landside (LS). [Additional Reference(s): DWR Levee Log, 2002. USACE San Joaquin O&M Manual 601.1, 1967, (HLM 12.11)]. FS Date: 4/25/2014

View of waterward side--flap gate visible on waterward toe.

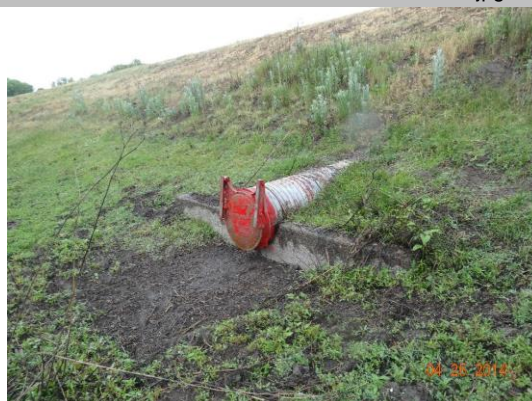
Photo 2 of 3 : UCIP_FA_2018_36106_65379.jpg

Item	DWR UCIP LMA Responsibility			37.265336 °	37.265336 °	
				-120.826591 °	-120.826591 °	
DWR ID	19636					
Comment Code						
Inspector Comment						
FS_ID:36106 DS_ID:19636 EP_NO: N/A Repair Type: Non-Urgent Crossing Status: Found UCIP Comments: 04/25/2014 Crossing is non-functional --landward side is buried. Dense vegetation found on waterward slope. Recommend contacting owner to determine status of crossing. If crossing is no longer used need to coordinate with CVFPB for proper abandonment. (DWR UCIP - O. Magana) FIELD_STRUCT_DESC: 24-inch corrugated metal gravity drainage pipe through the levee, 12.4 feet below the crown. Flap gate on the waterside (WS) end. Brass cap No. 60 bench mark (BM) on the headwall on the landside (LS). [Additional Reference(s): DWR Levee Log, 2002. USACE San Joaquin O&M Manual 601.1, 1967, (HLM 12.11)]. FS Date: 4/25/2014

Flap gate and concrete headwall visible on waterward side.

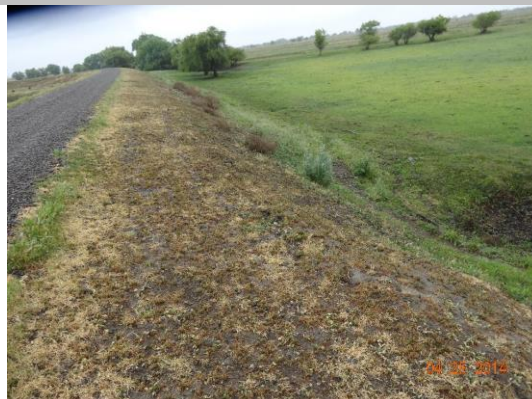
Photo 3 of 3 : UCIP_FA_2018_36106_65377.jpg

View of landward side.

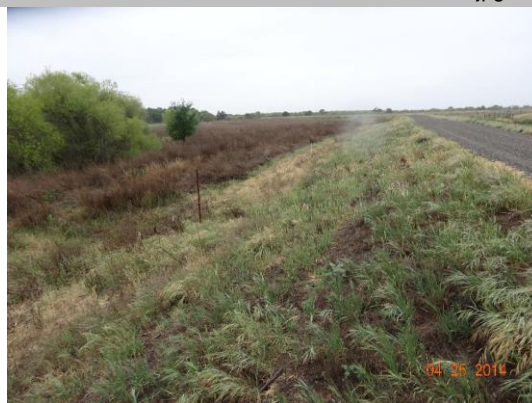
Photo 1 of 3 : UCIP_FA_2018_36146_65412.jpg

Comment Code						
Inspector Comment						
FS_ID:36146						
DS_ID:19637						
EP_NO: N/A						
Repair Type: Non-Urgent						
Crossing Status: Found						
UCIP Comments: 04/25/2014 Concrete headwall on landward side blocked by debris. Dense vegetation limits the inspector's visibility to identify signs of pipe failure (leaks) along the landward slope. Recommend removing vegetation along pipe alignment to conduct proper inspection of crossing. (DWR UCIP - O. Magana)						
FIELD_STRUCT_DESC: 24-inch corrugated metal gravity drainage pipe through the levee, 9.5 feet below the crown. Flap gate on the waterside (WS) end. Brass cap No. 60 bench mark (BM) on the headwall on the landside (LS). [Additional Reference(s): DWR Levee Log, 2002. USACE San Joaquin O&M Manual 601.1, 1967, (HLM 12.94)].						
FS Date: 4/25/2014

View of waterward side.

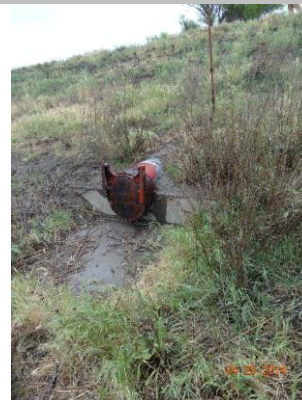
Photo 2 of 3 : UCIP_FA_2018_36146_65411.jpg

Item	DWR UCIP LMA Responsibility			37.256873 °	37.256873 °	
				-120.821277 °	-120.821277 °	
DWR ID	19637					
Comment Code						
Inspector Comment						
FS_ID:36146						
DS_ID:19637						
EP_NO: N/A						
Repair Type: Non-Urgent						
Crossing Status: Found						
UCIP Comments: 04/25/2014 Concrete headwall on landward side blocked by debris. Dense vegetation limits the inspector's visibility to identify signs of pipe failure (leaks) along the landward slope. Recommend removing vegetation along pipe alignment to conduct proper inspection of crossing. (DWR UCIP - O. Magana)						
FIELD_STRUCT_DESC: 24-inch corrugated metal gravity drainage pipe through the levee, 9.5 feet below the crown. Flap gate on the waterside (WS) end. Brass cap No. 60 bench mark (BM) on the headwall on the landside (LS). [Additional Reference(s): DWR Levee Log, 2002. USACE San Joaquin O&M Manual 601.1, 1967, (HLM 12.94)].

Flap gate and concrete headwall visible on waterward side.

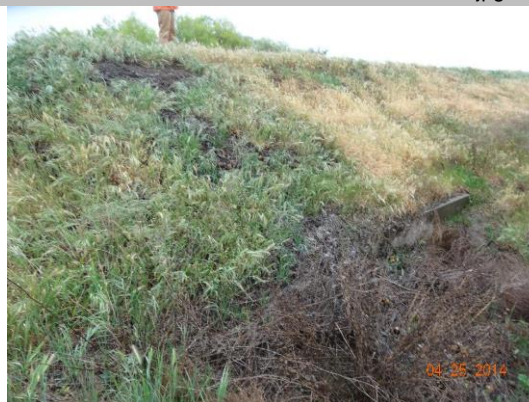
Photo 3 of 3 : UCIP_FA_2018_36146_65410.jpg

View of landward side--concrete headwall visible covered by dense vegetation.

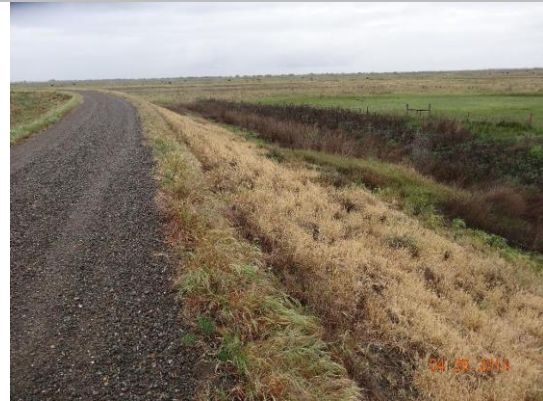
Photo 3 of 3 : UCIP_FA_2018_36109_65388.jpg

Item	DWR UCIP LMA Responsibility			37.251590 °	37.251590 °	
				-120.814354 °	-120.814354 °	
DWR ID	19638					
Comment Code						
Inspector Comment						
FS_ID:36109						
DS_ID:19638						
EP_NO: N/A						
Repair Type: Non-Urgent						
Crossing Status: Found						
UCIP Comments: 04/25/2014 Dense vegetation limits the inspector's visibility to identify signs of pipe failure (leaks) along the landward slope.						
Concrete headwall blocked by debris located on landward toe.						
Recommend clearing debris from landward slope and toe. (DWR UCIP - O. Magana)						
FIELD_STRUCT_DESC: 24-inch corrugated metal gravity drainage pipe through the levee, 14.2 feet below the crown. Flap gate on the waterside (WS) end. Brass cap No. 60 bench mark (BM) on the headwall on the landside (LS). [Additional Reference(s): DWR Levee Log, 2002. USACE San Joaquin O&M Manual 601.1, 1967, (HLM 13.48)].						
FS Date: 4/25/2014

View of landward side.

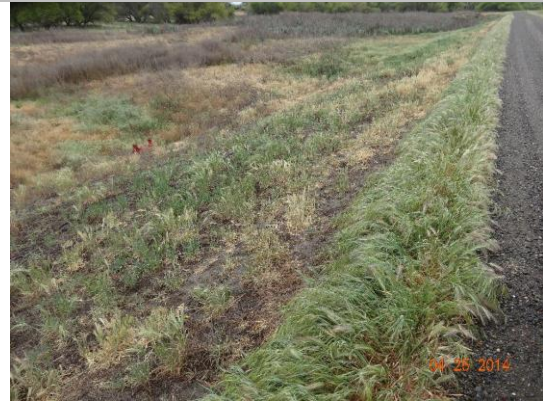
Photo 1 of 3 : UCIP_FA_2018_36167_65455.jpg

Comment Code					
Inspector Comment					
FS_ID:36167 DS_ID:19642 EP_NO: N/A Repair Type: Non-Urgent Crossing Status: Found UCIP Comments: 04/25/2014 Dense vegetation limits the inspector's visibility to identify signs of pipe failure (leaks) along the landward slope and toe. Recommend removing vegetation along pipe alignment to conduct proper inspection of structure. (DWR UCIP - O. Magana) FIELD_STRUCT_DESC: 24-inch corrugated metal gravity drainage pipe through the levee, 9.7 feet below the crown. Flap gate on the waterside (WS) end. Brass cap No. 60 bench mark (BM) on the headwall on the landside (LS). [Additional Reference(s): DWR Levee Log, 2002. USACE San Joaquin O&M Manual 601.1, 1967, (HLM 14.65)]. FS Date: 4/25/2014

View of waterward side.

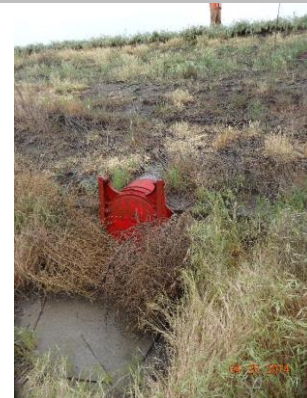
Photo 2 of 3 : UCIP_FA_2018_36167_65454.jpg

Flap gate, concrete headwall, and concrete apron located on waterward toe.

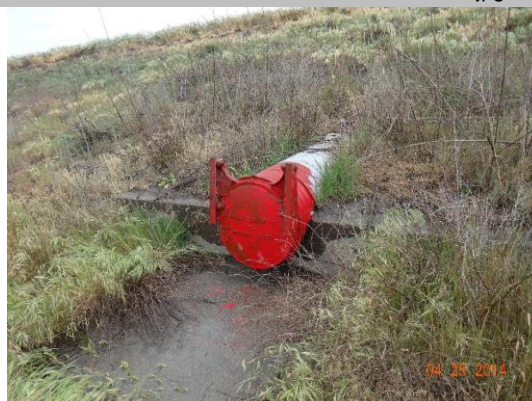
Photo 2 of 3 : UCIP_FA_2018_36168_65457.jpg

Item	DWR UCIP LMA Responsibility			37.231428 °		37.231428 °
				-120.805543 °		-120.805543 °
DWR ID	19643					
Comment Code						
Inspector Comment						
FS_ID:36168 DS_ID:19643 EP_NO: N/A Repair Type: Non-Urgent Crossing Status: Found UCIP Comments: 04/25/2014 Dense vegetation limits the inspector's visibility to identify signs of pipe failure (leaks) along the landward slope. Recommend removing vegetation along pipe alignment to conduct proper inspection of structure. (DWR UCIP - O. Magana) FIELD_STRUCT_DESC: 24-inch corrugated metal gravity drainage pipe through the levee, 9.2 feet below the crown. Flap gate on the waterside (WS) end. Brass cap No. 60 bench mark (BM) on the headwall on the landside (LS). [Additional Reference(s): DWR Levee Log, 2002. USACE San Joaquin O&M Manual 601.1, 1967, (HLM 15.29)]. FS Date: 4/25/2014

Concrete headwall, flap gate, and concrete apron located on waterward side.

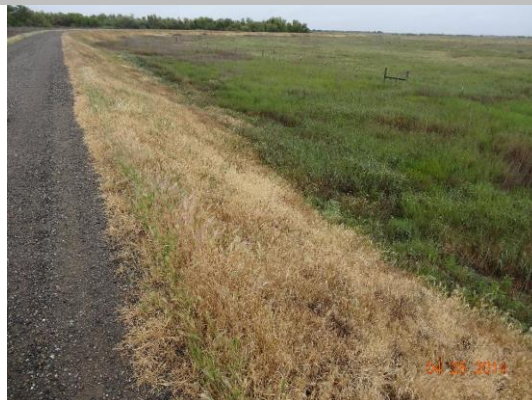
Photo 3 of 3 : UCIP_FA_2018_36168_65458.jpg

View of landward side.

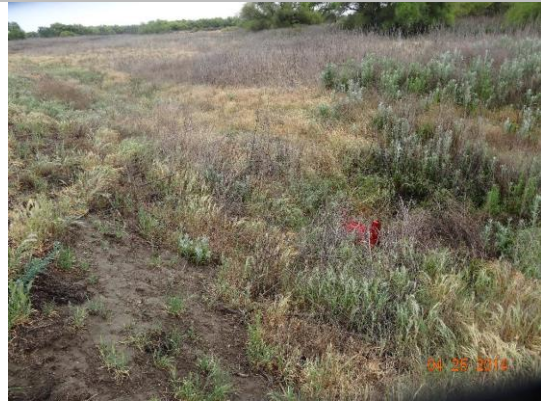
Photo 1 of 3 : UCIP_FA_2018_36169_65464.jpg

Comment Code					
Inspector Comment					
FS_ID:36169 DS_ID:19644 EP_NO: N/A Repair Type: Non-Urgent Crossing Status: Found UCIP Comments: 04/25/2014 Dense vegetation limits the inspector's visibility to identify signs of pipe failure (leaks) along the waterward and landward slopes. Recommend removing vegetation along pipe alignment to conduct proper inspection of structure. (DWR UCIP - O. Magana) FIELD_STRUCT_DESC: 24-inch corrugated metal gravity drainage pipe through the levee, 8.5 feet below the crown. Flap gate on the waterside (WS) end. Brass cap No. 60 bench mark (BM) on the headwall on the landside (LS). [Additional Reference(s): DWR Levee Log, 2002. USACE San Joaquin O&M Manual 601.1, 1967, (HLM 15.57)]. FS Date: 4/25/2014

View of waterward side--flap gate visible through dense vegetation.

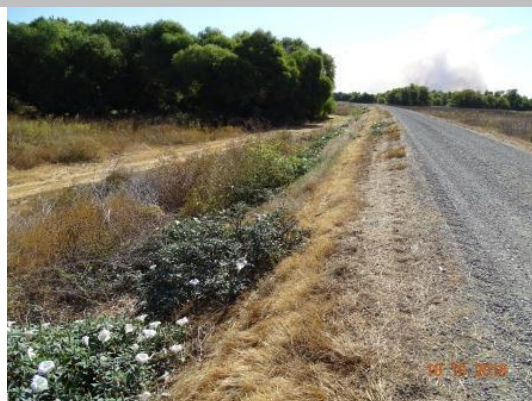
Photo 1 of 1 : FA_2018_NA0010_118_128_20181022_00287.jpg

LM Start	15.90	Rating **	M	Issue No.	128
LM End	15.97	Issue Type +	Ma	Location *	LS
Category	Earthen Levee			GPS Latitude/Longitude	
				Start	End
Item	Vegetation			37.225235°	37.224488°
				-120.798128°	-120.797226°
DWR ID	DWR_NA0010_01_f_2018_128				
Comment Code					
V1 : Control annual grass and weeds on the levee slopes and easements.					
Inspector Comment					
Vegetation on landside slope and blocking the landside toe

View of vegetation looking upstream. (Fall 2018)

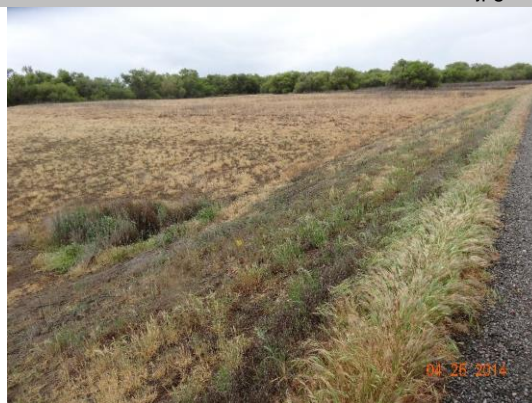
Photo 1 of 3 : UCIP_FA_2018_36172_65476.jpg

Comment Code					
Inspector Comment					
FS_ID:36172 DS_ID:19646 EP_NO: N/A Repair Type: Non-Urgent Crossing Status: Found UCIP Comments: 04/25/2014 Dense vegetation limits the inspector's visibility to identify signs of pipe failure (leaks) along the waterward and landward slopes. Recommend removing vegetation along pipe alignment to conduct proper inspection of structure and appurtenances. (DWR UCIP - O. Magana) FIELD_STRUCT_DESC: 24-inch corrugated metal gravity drainage pipe through the levee, 11.3 feet below the crown. Flap gate on the waterside (WS) end. Brass cap No. 50 bench mark (BM) on the headwall on the landside (LS). [Additional Reference(s): DWR Levee Log, 2002. USACE San Joaquin O&M Manual 601.1, 1967, (HLM 16.09)]. FS Date: 4/25/2014

View of waterward side.

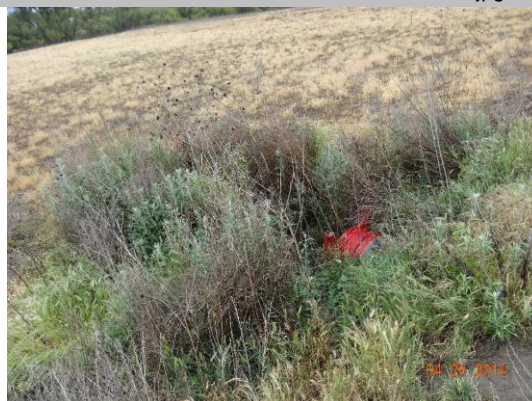
Photo 2 of 3 : UCIP_FA_2018_36172_65475.jpg

Item	DWR UCIP LMA Responsibility			37.224157 °	37.224157 °	
				-120.795250 °	-120.795250 °	
DWR ID	19646					
Comment Code						
Inspector Comment						
FS_ID:36172 DS_ID:19646 EP_NO: N/A Repair Type: Non-Urgent Crossing Status: Found UCIP Comments: 04/25/2014 Dense vegetation limits the inspector's visibility to identify signs of pipe failure (leaks) along the waterward and landward slopes. Recommend removing vegetation along pipe alignment to conduct proper inspection of structure and appurtenances. (DWR UCIP - O. Magana) FIELD_STRUCT_DESC: 24-inch corrugated metal gravity drainage pipe through the levee, 11.3 feet below the crown. Flap gate on the waterside (WS) end. Brass cap No. 50 bench mark (BM) on the headwall on the landside (LS). [Additional Reference(s): DWR Levee Log, 2002. USACE San Joaquin O&M Manual 601.1, 1967, (HLM 16.09)]. FS Date: 4/25/2014

Flap gate visible on waterward toe.

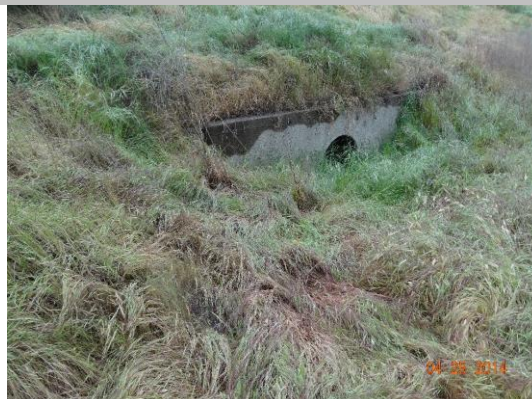
Photo 3 of 3 : UCIP_FA_2018_36172_65474.jpg

View of landward side.

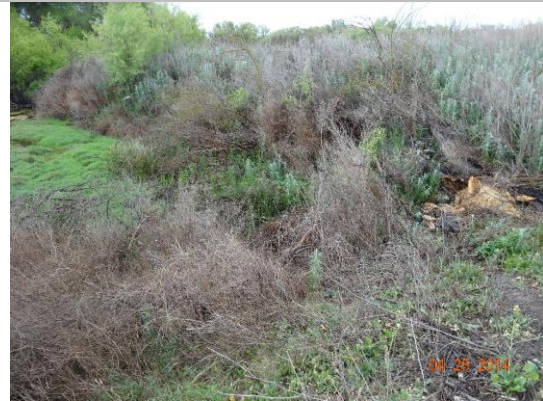
Photo 1 of 3 : UCIP_FA_2018_39257_65480.jpg

Comment Code						
Inspector Comment						
FS_ID:39257						
DS_ID:19647						
EP_NO: N/A						
Repair Type: Non-Urgent						
Crossing Status: Found						
UCIP Comments: 04/25/2014 Dense vegetation limits the inspector's visibility to identify signs of pipe failure (leaks) along the waterward and landward slopes. Recommend removing vegetation along pipe alignment to conduct proper inspection of structure. Unable to find pipe on landward side. (DWR UCIP - O. Magana)						
FIELD_STRUCT_DESC: 24-inch corrugated metal gravity drainage pipe through the levee, 14.7 feet below the crown. Flap gate on the waterside (WS) end. Brass cap No. 50 bench mark (BM) on the headwall on the landside (LS). [Additional Reference(s): DWR Levee Log, 2002. USACE San Joaquin O&M Manual 601.1, 1967, (HLM 16.15)].						
FS Date: 4/25/2014

View of waterward side.

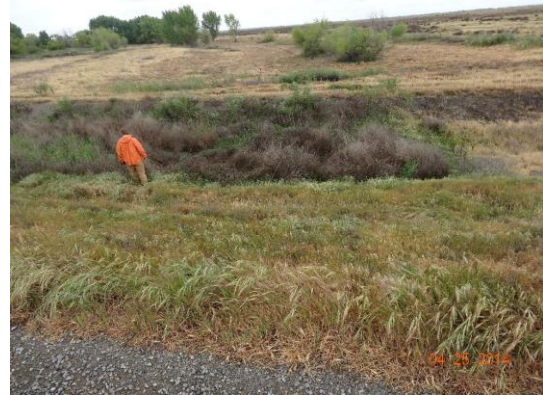
Photo 3 of 3 : UCIP_FA_2018_39257_65478.jpg

Item	DWR UCIP LMA Responsibility			37.224120°	37.224120°	
				-120.794002°	-120.794002°	
DWR ID	19647					
Comment Code						
Inspector Comment						
FS_ID:39257						
DS_ID:19647						
EP_NO: N/A						
Repair Type: Non-Urgent						
Crossing Status: Found						
UCIP Comments: 04/25/2014 Dense vegetation limits the inspector's visibility to identify signs of pipe failure (leaks) along the waterward and landward slopes. Recommend removing vegetation along pipe alignment to conduct proper inspection of structure. Unable to find pipe on landward side. (DWR UCIP - O. Magana)						
FIELD_STRUCT_DESC: 24-inch corrugated metal gravity drainage pipe through the levee, 14.7 feet below the crown. Flap gate on the waterside (WS) end. Brass cap No. 50 bench mark (BM) on the headwall on the landside (LS). [Additional Reference(s): DWR Levee Log, 2002. USACE San Joaquin O&M Manual 601.1, 1967, (HLM 16.15)].						
FS Date: 4/25/2014

View of landward side.

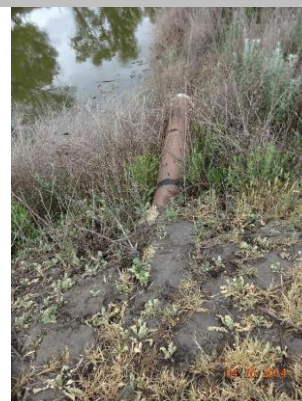
Photo 1 of 2 : UCIP_FA_2018_39360_71487.jpg

LM Start	16.72	Rating **	M	Issue No.	1248	
LM End	16.72	Issue Type +	En	Location *		
Category	Supplemental			GPS Latitude/Longitude		
				Start	End	
Item	DWR UCIP Field Study			37.224223 °	37.224223 °	
				-120.783806 °	-120.783806 °	
DWR ID	24870					
Comment Code						
Inspector Comment						
FS_ID:39360						
DS_ID:24870						
EP_NO: N/A						
Repair Type: Non-Urgent						
Crossing Status: Found						
UCIP Comments: 04/25/2014 Need to contact owner to determine status and reason for crossing. (DWR UCIP - O. Magana)						
FIELD_STRUCT_DESC: 12-inch steel gravity drainage pipe through the levee, at an unknown depth. Concrete standpipe visible on the landside (LS). This pipe was field discovered.						
FS Date: 4/25/2014

View of pipe located on waterward side.

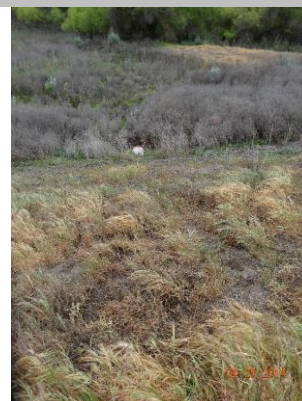
Photo 1 of 3 : UCIP_FA_2018_39260_65525.jpg

Comment Code					
Inspector Comment					
FS_ID:39260 DS_ID:19578 EP_NO: N/A Repair Type: Non-Urgent Crossing Status: Found UCIP Comments: 04/25/2014 Dense vegetation limits the inspector's visibility to identify signs of pipe failure (leaks) along the waterward and landward slopes. Recommend removing vegetation along pipe alignment to conduct proper inspection of structure. Sediment buildup inside pipe visible from landward side. Recommend clearing pipe. (DWR UCIP - O. Magana) FIELD_STRUCT_DESC: 24-inch corrugated metal gravity drainage pipe through the levee, 11.5 feet below the crown. Flap gate on the waterside (WS) end. Brass cap No. 50 bench mark (BM) on the headwall on the landside (LS). [Additional Reference(s): DWR Levee Log, 2002. USACE San Joaquin O&M Manual 601.1, 1967, (HLM 17.19)]. FS Date: 4/25/2014

View of waterward side.

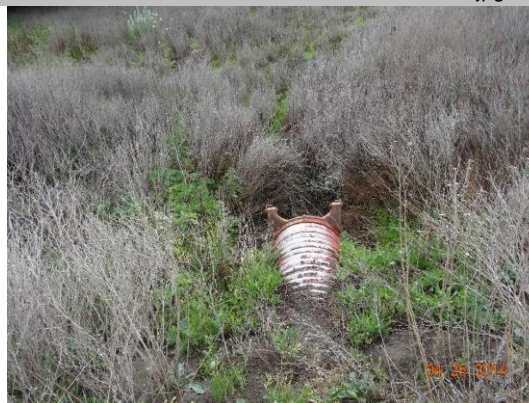
Photo 2 of 3 : UCIP_FA_2018_39260_65521.jpg

Pipe visible on waterward side.
