**Flood Control Project Maintenance
Levee Inspections**

Fall 2018 Levee Maintenance Deficiency Summary Report

San Joaquin River Basin

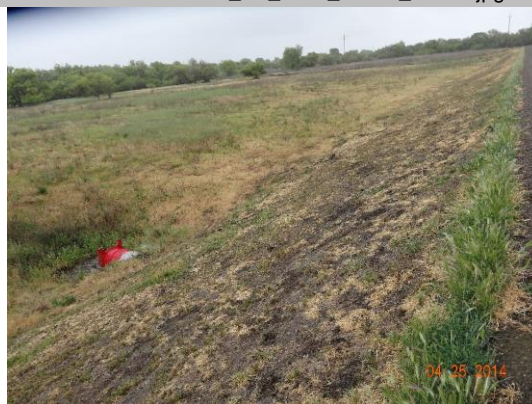
Photo 1 of 3 : UCIP_FA_2018_36204_65547.jpg

Comment Code						
Inspector Comment						
FS_ID:36204						
DS_ID:19580						
EP_NO: N/A						
Repair Type: Non-Urgent						
Crossing Status: Found						
UCIP Comments: 04/25/2014 Dense vegetation limits the inspector's visibility to identify signs of pipe failure (leaks) along the landward slope. Recommend removing vegetation along pipe alignment to conduct proper inspection of structure. (DWR UCIP - O. Magana)						
FIELD_STRUCT_DESC: 24-inch corrugated metal gravity drainage pipe through the levee, 9.5 feet below the crown. Flap gate on the waterside (WS) end. Brass cap No. 50 bench mark (BM) on the headwall on the landside (LS). [Additional Reference(s): DWR Levee Log, 2002. USACE San Joaquin O&M Manual 601.1, 1967, (HLM 17.53)].						
FS Date: 4/25/2014

View of waterward side.

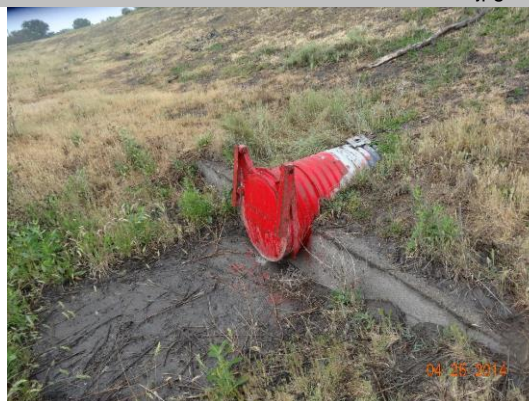
Photo 2 of 3 : UCIP_FA_2018_36204_65546.jpg

Flap gate visible on waterward side.

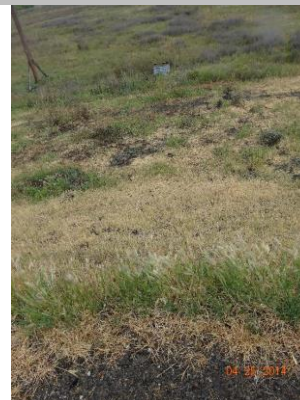
Photo 3 of 3 : UCIP_FA_2018_36204_65545.jpg

View of landward side--riser at levee toe.

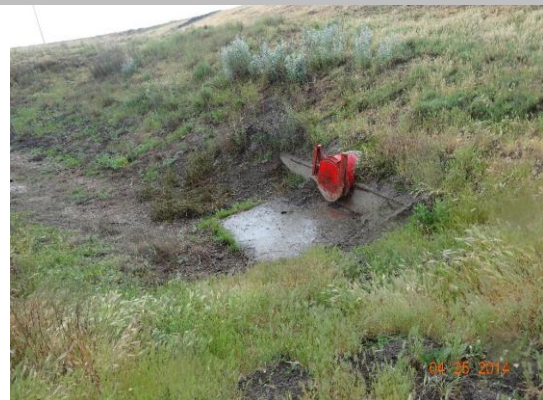
Photo 2 of 3 : UCIP_FA_2018_39261_65556.jpg

Flap gate visible on waterward side.

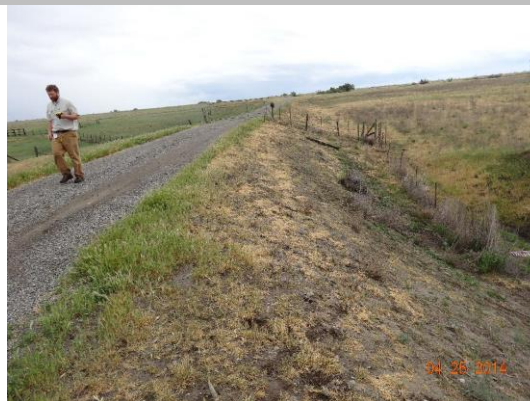
Photo 1 of 3 : UCIP_FA_2018_36246_65627.jpg

Comment Code						
Inspector Comment						
FS_ID:36246						
DS_ID:19593						
EP_NO: N/A						
Repair Type: Non-Urgent						
Crossing Status: Found						
UCIP Comments: 04/25/2014 Dense vegetation limits the inspector's						
visibility to identify signs of pipe failure (leaks) along the landward						
slope. Recommend removing vegetation along pipe alignment to						
conduct proper inspection of structure. (DWR UCIP - O. Magana)						
FIELD_STRUCT_DESC: 24-inch corrugated metal gravity drainage pipe						
through the levee, 12 feet below the crown. Flap gate on the waterside						
(WS) end. Brass cap No. 50 bench mark (BM) on the headwall on the						
landside (LS). [Additional Reference(s): DWR Levee Log, 2002. USACE						
San Joaquin O&M Manual 601.1, 1967, (HLM 18.79)].						
FS Date: 4/25/2014

Overview of levee crown and waterward slope.

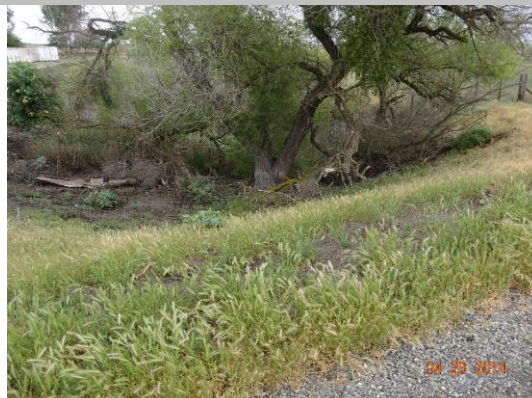
Photo 3 of 3 : UCIP_FA_2018_36246_65626.jpg

Item	DWR UCIP LMA Responsibility			37.204966 °		37.204966 °
				-120.762511 °		-120.762511 °
DWR ID	19593					
Comment Code						
Inspector Comment						
FS_ID:36246						
DS_ID:19593						
EP_NO: N/A						
Repair Type: Non-Urgent						
Crossing Status: Found						
UCIP Comments: 04/25/2014 Dense vegetation limits the inspector's visibility to identify signs of pipe failure (leaks) along the landward slope. Recommend removing vegetation along pipe alignment to conduct proper inspection of structure. (DWR UCIP - O. Magana)						
FIELD_STRUCT_DESC: 24-inch corrugated metal gravity drainage pipe through the levee, 12 feet below the crown. Flap gate on the waterside (WS) end. Brass cap No. 50 bench mark (BM) on the headwall on the landside (LS). [Additional Reference(s): DWR Levee Log, 2002. USACE San Joaquin O&M Manual 601.1, 1967, (HLM 18.79)].						
FS Date: 4/25/2014

Overview of landward side.

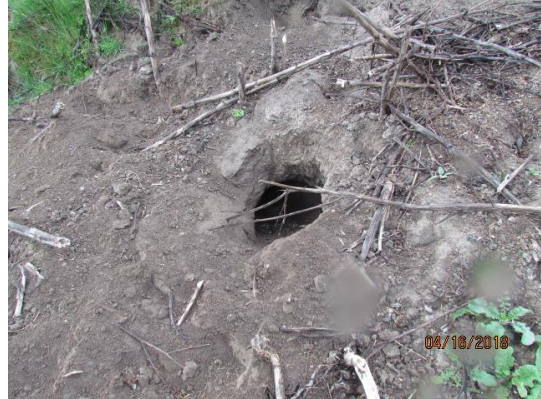
Photo 1 of 2 : FA_2018_NA0010_118_94_20180911_00019.jpg

Looking at large rodent hole on landward slope. (Spring 2018)

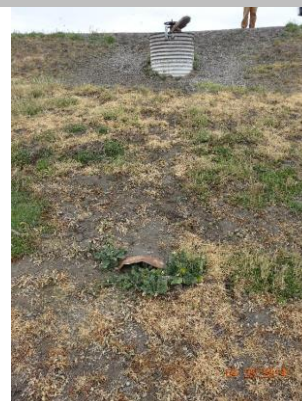
Photo 1 of 3 : UCIP_FA_2018_39263_65631.jpg

Comment Code						
Inspector Comment						
FS_ID:39263						
DS_ID:19594						
EP_NO: N/A						
Repair Type: Non-Urgent						
Crossing Status: Found						
UCIP Comments: 04/25/2014 Non-functional crossing--pipe is buried on waterward side. Sediment buildup in pipe visible from landward side. Need to coordinate with owner to determine status. If crossing is no longer in use, owner will need to coordinate with DWR Inspector and CVFPB to properly abandon. (DWR UCIP - O. Magana)						
FIELD_STRUCT_DESC: 24-inch corrugated metal gravity drainage pipe through the levee, 13 feet below the crown. Flap gate on the waterside (WS) end. Brass cap No. 40 bench mark (BM) on the headwall on the landside (LS). [Additional Reference(s): DWR Levee Log, 2002. USACE San Joaquin O&M Manual 601.1, 1967, (HLM 19.17)].						
FS Date: 4/25/2014

View of waterward slope. CMP riser and pipe visible.

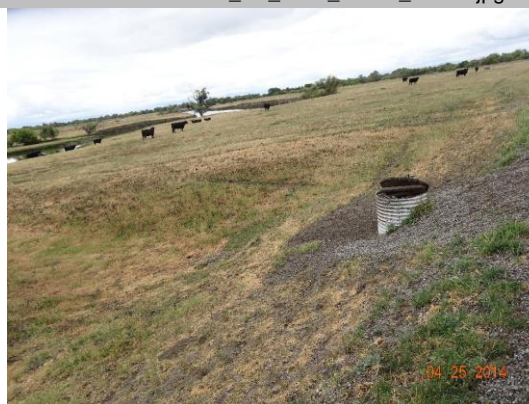
Photo 2 of 3 : UCIP_FA_2018_39263_65630.jpg

View of waterward side.

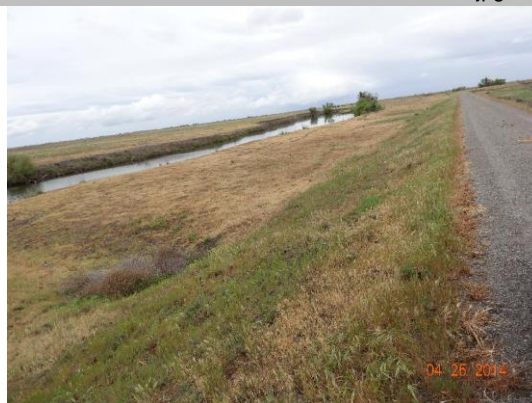
Photo 1 of 3 : UCIP_FA_2018_39268_65641.jpg

Comment Code					
Inspector Comment					
FS_ID:39268					
DS_ID:19596					
EP_NO: N/A					
Repair Type: Non-Urgent					
Crossing Status: Found					
UCIP Comments: 04/25/2014 Dense vegetation limits the inspector's visibility to identify signs of pipe failure (leaks) along the waterward slope. Recommend removing vegetation along pipe alignment to conduct proper inspection of structure. Dense vegetation blocks both waterward and landward headwalls. Sediment buildup in pipe visible from landward side. (DWR UCIP - O. Magana)					
FIELD_STRUCT_DESC: 24-inch corrugated metal gravity drainage pipe through the levee, 8 feet below the crown. Flap gate on the waterside (WS) end. Brass cap No. 40 bench mark (BM) on the headwall on the landside (LS). [Additional Reference(s): DWR Levee Log, 2002. USACE San Joaquin O&M Manual 601.1, 1967, (HLM 19.54)].					
FS Date: 4/25/2014

View of waterward side.

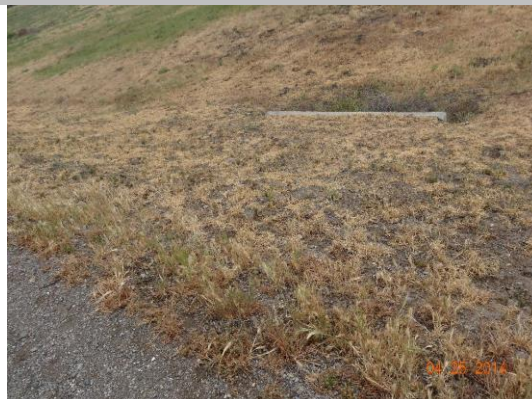
Photo 3 of 3 : UCIP_FA_2018_39268_65639.jpg

View of landward slope.

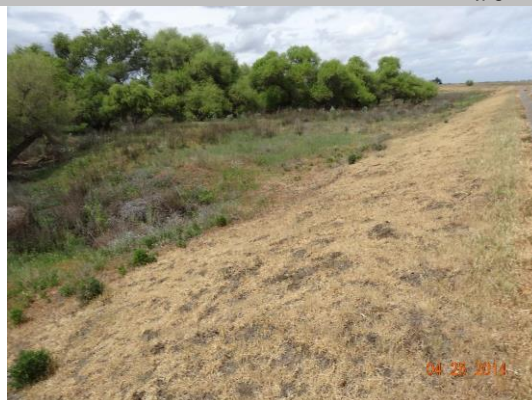
Photo 1 of 3 : UCIP_FA_2018_39269_65648.jpg

LM Start	20.18	Rating **	M	Issue No.	1261	
LM End	20.18	Issue Type +	Ma	Location *		
Category	Supplemental			GPS Latitude/Longitude		
				Start		End
Item	DWR UCIP LMA Responsibility			37.194669 °		37.194669 °
				-120.759736 °		-120.759736 °
DWR ID	19598					
Comment Code						
Inspector Comment						
FS_ID:39269 DS_ID:19598 EP_NO: N/A Repair Type: Non-Urgent Crossing Status: Found UCIP Comments: 04/25/2014 Recommend removing vegetation and sediment buildup from both waterward and landward concrete headwalls. (DWR UCIP - O. Magana) FIELD_STRUCT_DESC: 24-inch corrugated metal gravity drainage pipe through the levee, 8.5 feet below the crown. Flap gate on the waterside (WS) end. Brass cap No. 40 bench mark (BM) on the headwall on the landside (LS). [Additional Reference(s): DWR Levee Log, 2002. USACE San Joaquin O&M Manual 601.1, 1967, (HLM 20.18)]. FS Date: 4/25/2014

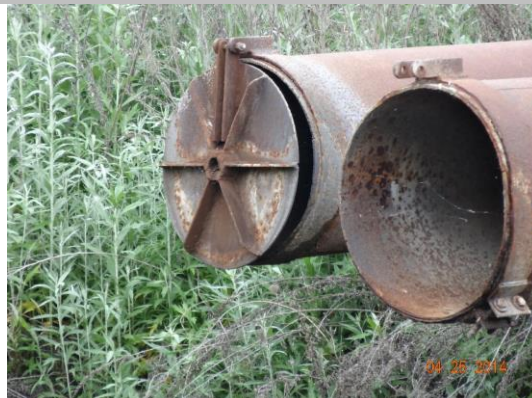
Photo 1 of 3 : UCIP_FA_2018_39285_71446.jpg

LM Start	20.26	Rating **	M	Issue No.	1262
LM End	20.26	Issue Type +	En	Location *	
Category	Supplemental			GPS Latitude/Longitude	
				Start	End
Item	DWR UCIP Field Study			37.193550 °	37.193550 °
				-120.760284 °	-120.760284 °
DWR ID	24873				
Comment Code					
Inspector Comment					
FS_ID:39285 DS_ID:24873 EP_NO: N/A Repair Type: Non-Urgent Crossing Status: Found UCIP Comments: 04/25/2014 Dense vegetation limits the inspector's visibility to identify signs of pipe failure (leaks) along the waterward slope. Recommend removing vegetation along pipe alignment to conduct proper inspection of structure. (DWR UCIP - O. Magana) FIELD_STRUCT_DESC: 12-inch steel drainage discharge pipe sleeved through a 24-inch steel pipe through levee, at an unknown depth. FS Date: 4/25/2014

Outlet visible on waterward side.

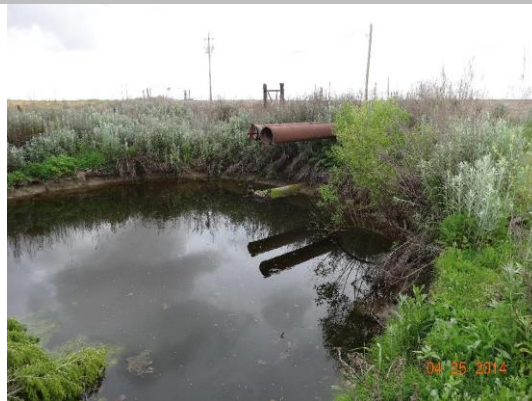
Photo 2 of 3 : UCIP_FA_2018_39285_71445.jpg

View of waterward side.

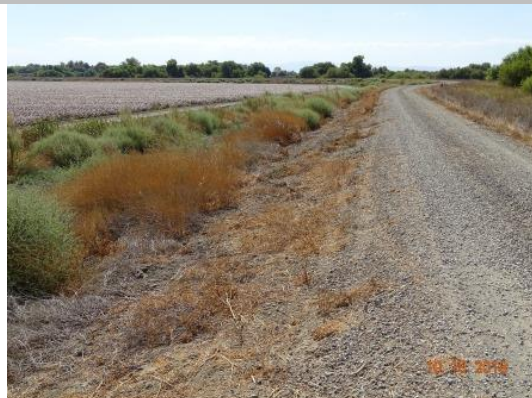
Photo 1 of 1 : FA_2018_NA0010_118_129_20181022_00289.jpg

LM Start	20.65	Rating **	M	Issue No.	129
LM End	20.96	Issue Type +	Ma	Location *	LS
Category	Earthen Levee			GPS Latitude/Longitude	
				Start	End
Item	Vegetation			37.188408 °	37.184743 °
				-120.763406 °	-120.764719 °
DWR ID	DWR_NA0010_01_f_2018_129				
Comment Code					
V1 : Control annual grass and weeds on the levee slopes and easements.					
Inspector Comment					
vegetation along landside slope and dense vegetation along the toe

View of vegetation on landside slope looking upstream. (Fall 2018)

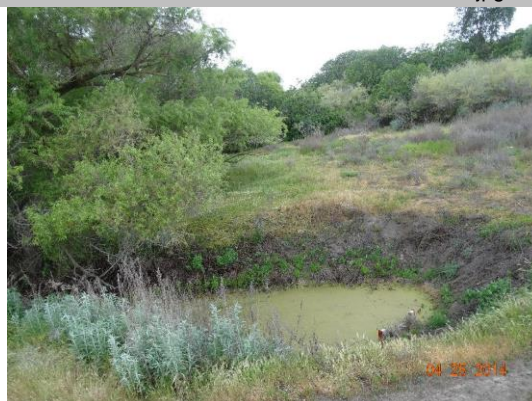
Photo 1 of 3 : UCIP_FA_2018_39271_66312.jpg

Comment Code					
Inspector Comment					
FS_ID:39271 DS_ID:19603 EP_NO: N/A Repair Type: Non-Urgent Crossing Status: Found UCIP Comments: 04/25/2014 Crossing is non-functional--crossing buried on landward side. Need to contact owner to determine status of crossing. If crossing is no longer used need to coordinate with CVFPB for proper abandonment. (DWR UCIP - O. Magana) FIELD_STRUCT_DESC: 36-inch corrugated metal gravity drainage pipe through the levee, 11.5 feet below the crown. Flap gate on the waterside (WS) end. Brass cap No. 40 bench mark (BM) on the headwall on the landside (LS). [Additional Reference(s): DWR Levee Log, 2002. USACE San Joaquin O&M Manual 601.1, 1967, (HLM 21.40)]. FS Date: 4/25/2014

View of waterward side.

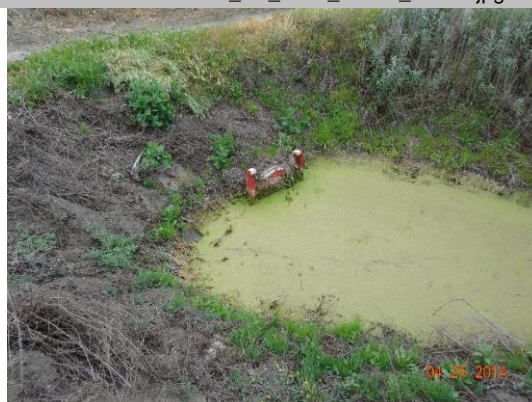
Photo 2 of 3 : UCIP_FA_2018_39271_66313.jpg

Flap gate half way submerged located on waterward side.

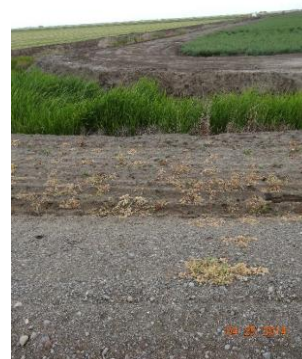
Photo 3 of 3 : UCIP_FA_2018_39271_66311.jpg

Item	DWR UCIP LMA Responsibility			37.179065 °	37.179065 °	
				-120.761567 °	-120.761567 °	
DWR ID	19603					
Comment Code						
Inspector Comment						
FS_ID:39271						
DS_ID:19603						
EP_NO: N/A						
Repair Type: Non-Urgent						
Crossing Status: Found						
UCIP Comments: 04/25/2014 Crossing is non-functional--crossing buried on landward side. Need to contact owner to determine status of crossing. If crossing is no longer used need to coordinate with CVFPB for proper abandonment. (DWR UCIP - O. Magana)						
FIELD_STRUCT_DESC: 36-inch corrugated metal gravity drainage pipe through the levee, 11.5 feet below the crown. Flap gate on the waterside (WS) end. Brass cap No. 40 bench mark (BM) on the headwall on the landside (LS). [Additional Reference(s): DWR Levee Log, 2002. USACE San Joaquin O&M Manual 601.1, 1967, (HLM 21.40)].						
FS Date: 4/25/2014

View of landward side.

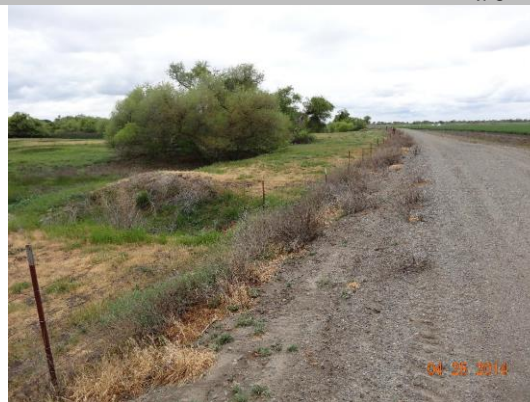
Photo 1 of 3 : UCIP_FA_2018_39272_65697.jpg

Comment Code					
Inspector Comment					
FS_ID:39272					
DS_ID:19604					
EP_NO: N/A					
Repair Type: Non-Urgent					
Crossing Status: Found					
UCIP Comments: 04/25/2014 Non-functional crossing-landward side is buried. Need to contact owner to determine status of crossing. If crossing is no longer used need to coordinate with CVFPB for proper abandonment. (DWR UCIP - O. Magana)					
FIELD_STRUCT_DESC: 24-inch corrugated metal gravity drainage pipe through the levee, 9 feet below the crown. Flap gate on the waterside (WS) end. Brass cap No. 40 bench mark (BM) on the headwall on the landside (LS). [Additional Reference(s): DWR Levee Log, 2002. USACE San Joaquin O&M Manual 601.1, 1967, (HLM 21.76)].					
FS Date: 4/25/2014

View of waterward side.

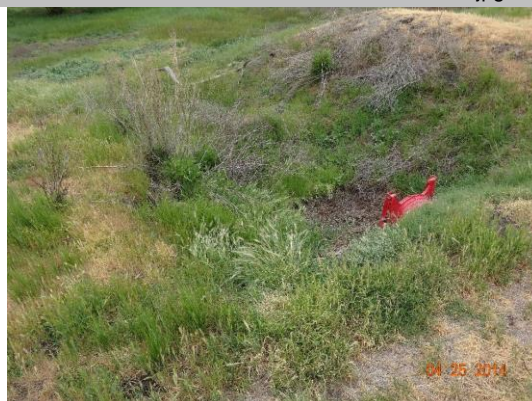
Photo 2 of 3 : UCIP_FA_2018_39272_65695.jpg

Item	DWR UCIP LMA Responsibility			37.176106 °		37.176106 °
				-120.756768 °		-120.756768 °
DWR ID	19604					
Comment Code						
Inspector Comment						
FS_ID:39272						
DS_ID:19604						
EP_NO: N/A						
Repair Type: Non-Urgent						
Crossing Status: Found						
UCIP Comments: 04/25/2014 Non-functional crossing-landward side is buried. Need to contact owner to determine status of crossing. If crossing is no longer used need to coordinate with CVFPB for proper abandonment. (DWR UCIP - O. Magana)						
FIELD_STRUCT_DESC: 24-inch corrugated metal gravity drainage pipe through the levee, 9 feet below the crown. Flap gate on the waterside (WS) end. Brass cap No. 40 bench mark (BM) on the headwall on the landside (LS). [Additional Reference(s): DWR Levee Log, 2002. USACE San Joaquin O&M Manual 601.1, 1967, (HLM 21.76)].						
FS Date: 4/25/2014

Flap gate visible on waterward side.

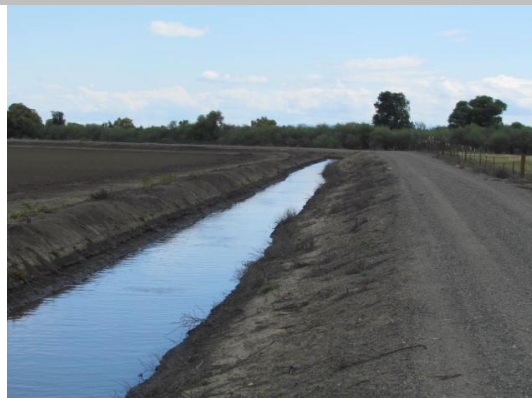
Photo 3 of 3 : FA_2018_NA0010_118_22_20180911_00016.jpg

Looking upstream at irrigation at landside toe.

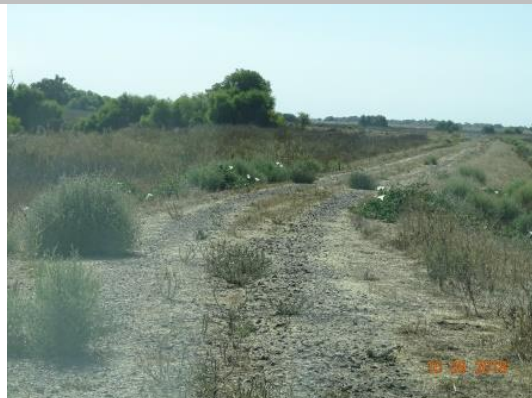
Photo 1 of 2 : FA_2018_NA0010_119_23_20181029_00069.jpg

LM Start	0.00	Rating **	M	Issue No.	23
LM End	1.02	Issue Type +	Ma	Location *	CR
Category	Earthen Levee			GPS Latitude/Longitude	
				Start	End
Item	Vegetation			37.296270 °	37.284950 °
				-120.880690 °	-120.871212 °
DWR ID	DWR_NA0010_02A_s_2017_23				
Comment Code					
V9 : Keep the crown roadway free of vegetation.					
Inspector Comment					
Control veg on levee crown and add additional base on levee crown.

Vegetation on crown and shoulders. (Fall 2018)

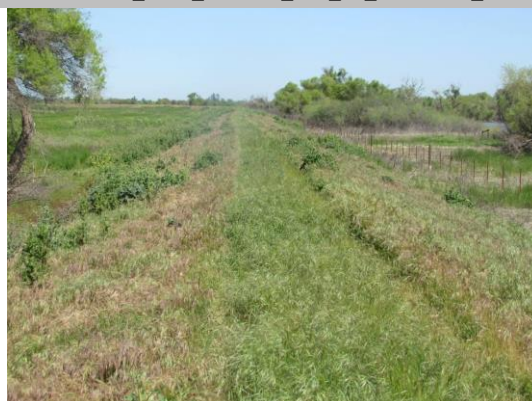
Photo 2 of 2 : FA_2018_NA0010_119_23_20180911_00011.jpg

Looking downstream at overgrown levee crown. (Spring 2018)

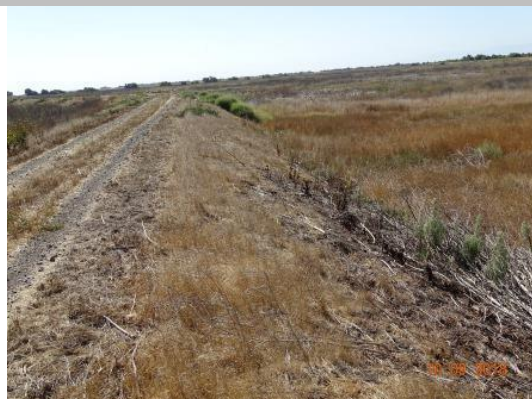
Photo 1 of 1 : FA_2018_NA0010_119_25_20181029_00072.jpg

LM Start	0.06	Rating **	M	Issue No.	25
LM End	0.42	Issue Type +	Ma	Location *	LS
Category	Earthen Levee			GPS Latitude/Longitude	
				Start	End
Item	Vegetation			37.295638 °	37.291242 °
				-120.880063 °	-120.876919 °
DWR ID	DWR_NA0010_02A_f _ 2018_25				
Comment Code					
V1 : Control annual grass and weeds on the levee slopes and easements.					
Inspector Comment					
control vegetation along toe. Sparse dense vegetation along slope.

View of vegetation on landside slope and toe (Fall 2018)

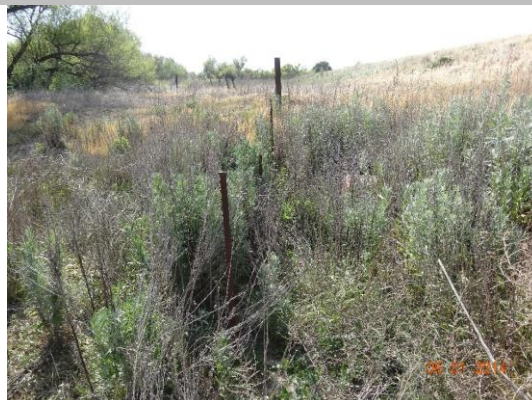
Photo 2 of 3 : UCIP_FA_2018_36503_66101.jpg

Fence along waterward side. No headwall was found on waterward side.

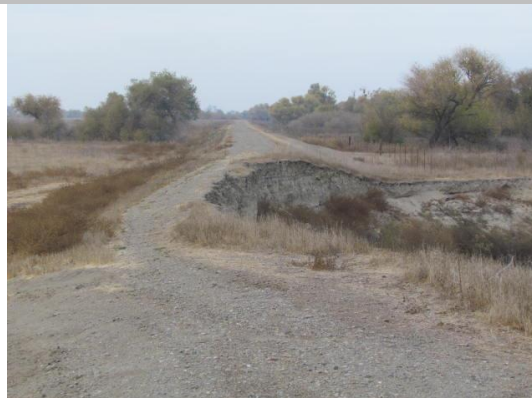
Photo 2 of 4 : FA_2018_NA0010_119_5_20180911_00006.jpg

Looking north at large erosion on waterward slope. (Fall 2013)

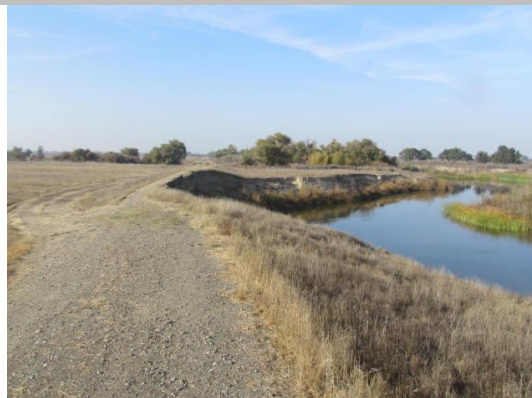
Photo 3 of 4 : FA_2018_NA0010_119_5_20180911_00007.jpg

Looking north at erosion on waterward slope. (Fall 2014)

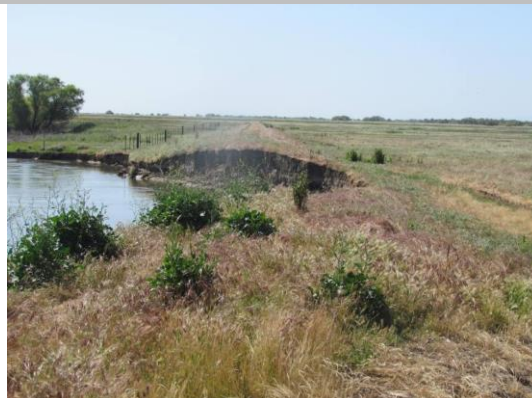
Photo 4 of 4 : FA_2018_NA0010_119_5_20180911_00008.jpg

Looking upstream at erosion fall 2017.

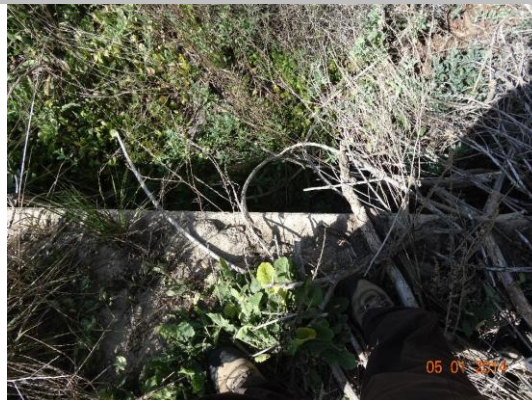
Photo 3 of 3 : UCIP_FA_2018_36504_66104.jpg

Comment Code						
Inspector Comment						
FS_ID:36504 DS_ID:19653 EP_NO: N/A Repair Type: Non-Urgent Crossing Status: Found UCIP Comments: 05/01/2014 Dense vegetation limits the inspector's visibility to identify signs of pipe failure (leaks) along the slope. Recommend removing vegetation along pipe alignment to conduct proper inspection of structure. (DWR UCIP - O. Magana) FIELD_STRUCT_DESC: 24-inch corrugated metal gravity drainage pipe through the levee, 14.8 feet below the crown. Flap gate on the waterside (WS) end. Brass cap No. 138 bench mark (BM) on the headwall on the landside (LS). [Additional Reference(s): DWR Levee Log, 2002. USACE San Joaquin O&M Manual 601.1, 1967, (HLM 0.67)]. FS Date: 5/1/2014

Concrete headwall found on landward side.

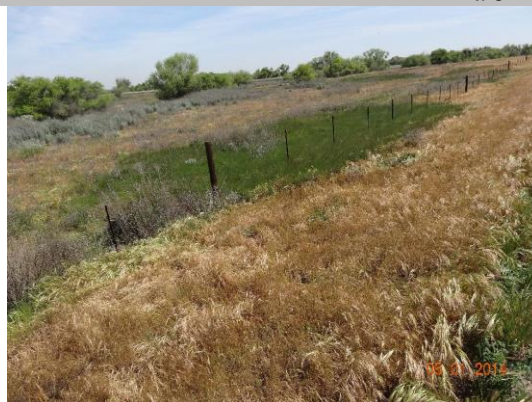
Photo 1 of 3 : UCIP_FA_2018_39363_66113.jpg

Comment Code					
Inspector Comment					
FS_ID:39363 DS_ID:19654 EP_NO: N/A Repair Type: Non-Urgent Crossing Status: Found UCIP Comments: 05/01/2014 Dense vegetation limits the inspector's visibility to identify signs of pipe failure (leaks) along the slope. Recommend removing vegetation along pipe alignment to conduct proper inspection of structure. Sediment buildup in pipe recommend clearing. (DWR UCIP - O. Magana) FIELD_STRUCT_DESC: 24-inch corrugated metal gravity drainage pipe through the levee, 8.6 feet below the crown. Flap gate on the waterside (WS) end. Brass cap No. 137 bench mark (BM) on the headwall on the landside (LS). [Additional Reference(s): DWR Levee Log, 2002. USACE San Joaquin O&M Manual 601.1, 1967, (HLM 1.02)]. FS Date: 5/1/2014

View of waterward side.

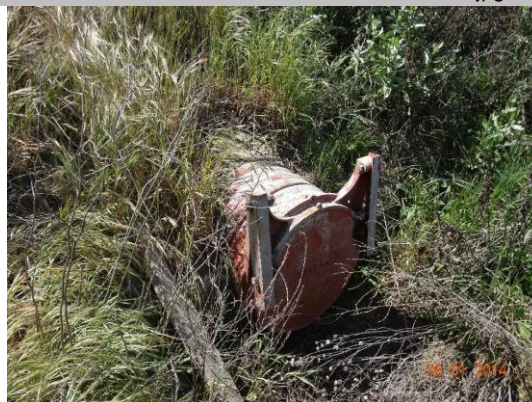
Photo 3 of 3 : UCIP_FA_2018_39363_66111.jpg

Flap gate visible on waterward side.

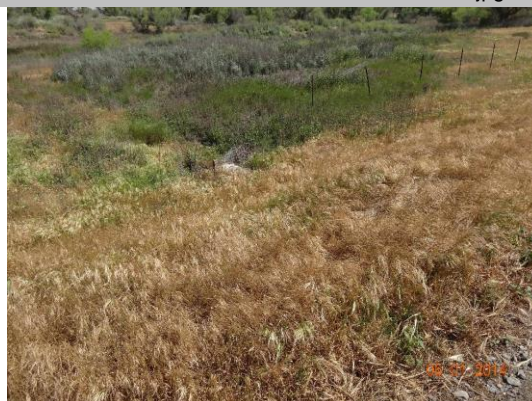
Photo 1 of 3 : UCIP_FA_2018_36506_66114.jpg

Comment Code						
Inspector Comment						
FS_ID:36506 DS_ID:19655 EP_NO: N/A Repair Type: Non-Urgent Crossing Status: Found UCIP Comments: 05/01/2014 Dense vegetation limits the inspector's visibility to identify signs of pipe failure (leaks) along the slope. Recommend removing vegetation along pipe alignment to conduct proper inspection of structure. (DWR UCIP - O. Magana) FIELD_STRUCT_DESC: 24-inch corrugated metal gravity drainage pipe through the levee, 8.6 feet below the crown. Flap gate on the waterside (WS) end. Brass cap No. 136 bench mark (BM) on the headwall on the landside (LS). [Additional Reference(s): DWR Levee Log, 2002. USACE San Joaquin O&M Manual 601.1, 1967, (HLM 1.22)]. FS Date: 5/1/2014

Overview of waterward side.

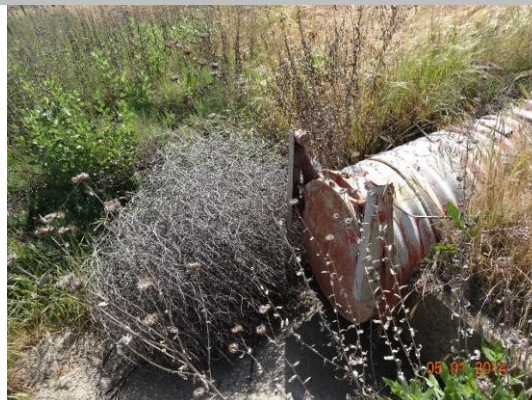
Photo 2 of 3 : UCIP_FA_2018_36506_66117.jpg

Flap gate visible on waterward side.

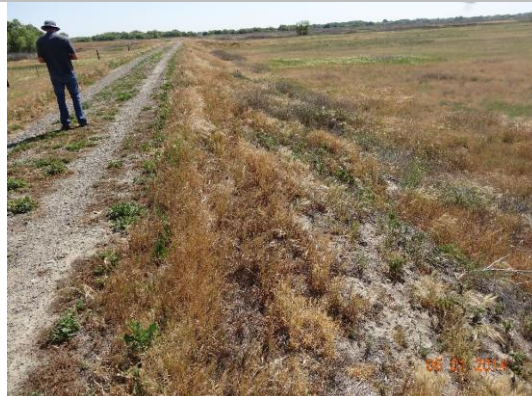
Photo 3 of 3 : UCIP_FA_2018_36506_66116.jpg

View of landward side.

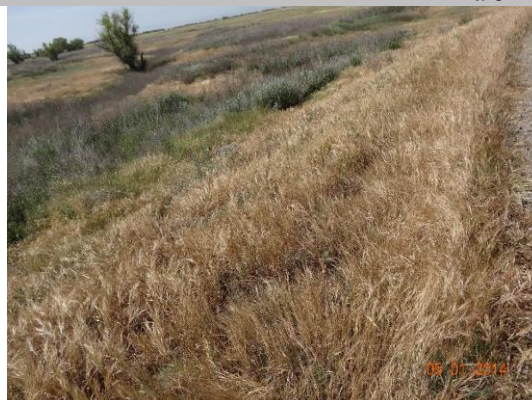
Photo 1 of 3 : UCIP_FA_2018_36507_66120.jpg

Comment Code						
Inspector Comment						
FS_ID:36507						
DS_ID:19656						
EP_NO: N/A						
Repair Type: Non-Urgent						
Crossing Status: Found						
UCIP Comments: 05/01/2014 Dense vegetation limits the inspector's						
visibility to identify signs of pipe failure (leaks) along the slope.						
Recommend removing vegetation along pipe alignment to conduct						
proper inspection of structure. (DWR UCIP - O. Magana)						
FIELD_STRUCT_DESC: 36-inch corrugated metal gravity drainage pipe						
through the levee, 14.6 feet below the crown. Flap gate on the						
waterside (WS) end. Brass cap No. 135 bench mark (BM) on the						
headwall on the landside (LS). [Additional Reference(s): DWR Levee						
Log, 2002. USACE San Joaquin O&M Manual 601.1, 1967, (HLM 1.34)].						
FS Date: 5/1/2014

View of landward side.

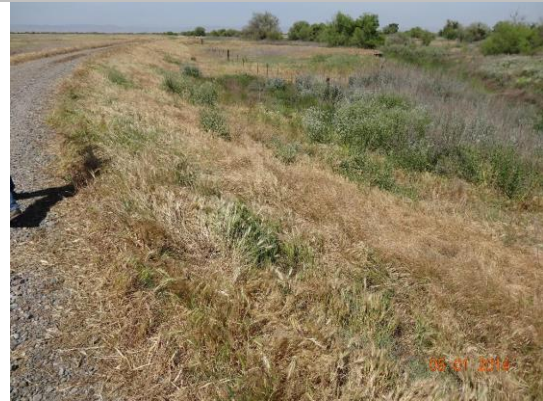
Photo 2 of 3 : UCIP_FA_2018_36507_66119.jpg

View of waterward side.

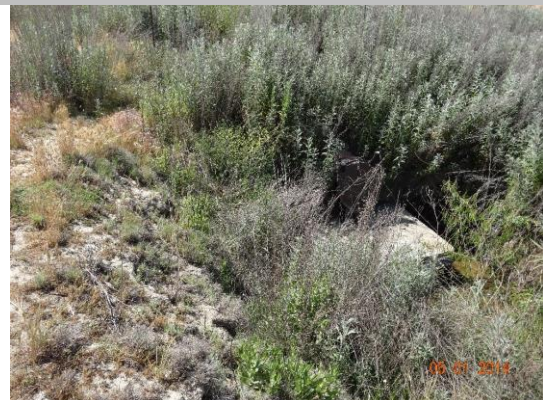
Photo 3 of 3 : UCIP_FA_2018_36507_66118.jpg

Flap gate and concrete apron visible on waterward side.

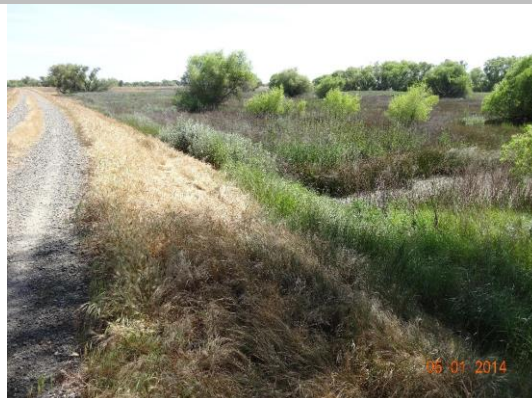
Photo 1 of 3 : UCIP_FA_2018_36508_66124.jpg

Comment Code					
Inspector Comment					
FS_ID:36508 DS_ID:19657 EP_NO: N/A Repair Type: Non-Urgent Crossing Status: Found UCIP Comments: 05/01/2014 Dense vegetation limits the inspector's visibility to identify signs of pipe failure (leaks) along the slope. Recommend removing vegetation along pipe alignment to conduct proper inspection of structure. (DWR UCIP - O. Magana) FIELD_STRUCT_DESC: 24-inch corrugated metal gravity drainage pipe through the levee, 10.2 feet below the crown. Flap gate on the waterside (WS) end. Brass cap No. 135 bench mark (BM) on the headwall on the landside (LS). [Additional Reference(s): DWR Levee Log, 2002. USACE San Joaquin O&M Manual 601.1, 1967, (HLM 1.62)]. FS Date: 5/1/2014

Overview of landward side.

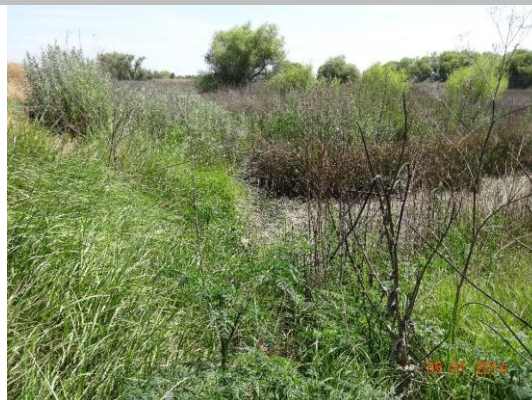
Photo 2 of 3 : UCIP_FA_2018_36508_66123.jpg

Dense vegetation along levee slope and toe.

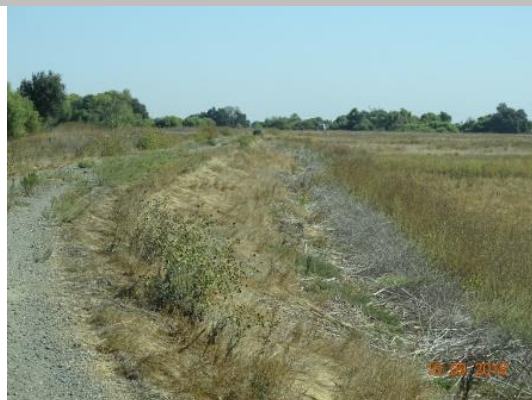
Photo 1 of 1 : FA_2018_NA0010_119_26_20181029_00074.jpg

LM Start	1.78	Rating **	M	Issue No.	26
LM End	1.91	Issue Type +	Ma	Location *	LS
Category	Earthen Levee			GPS Latitude/Longitude	
				Start	End
Item	Vegetation			37.290474 °	37.291119 °
				-120.859955 °	-120.857835 °
DWR ID	DWR_NA0010_02A_f_2018_26				
Comment Code					
V1 : Control annual grass and weeds on the levee slopes and easements.					
Inspector Comment

View of vegetation on landside slope. (Fall 2018)

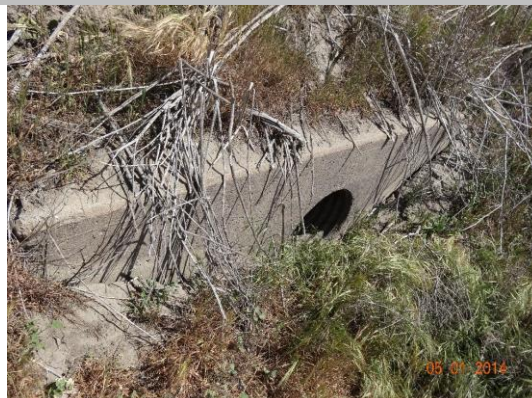
Photo 2 of 3 : UCIP_FA_2018_36509_66128.jpg

Concrete headwall visible on landward side.

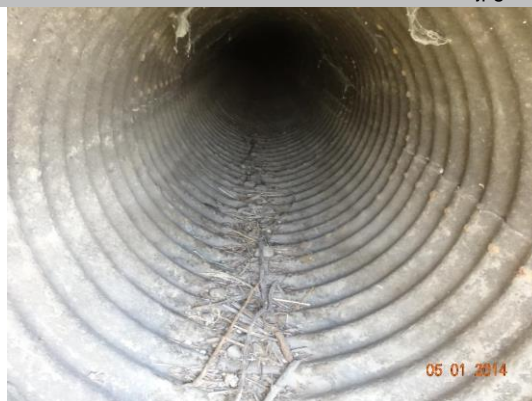
Photo 3 of 3 : UCIP_FA_2018_36509_66127.jpg

Inside view of pipe from landward side.

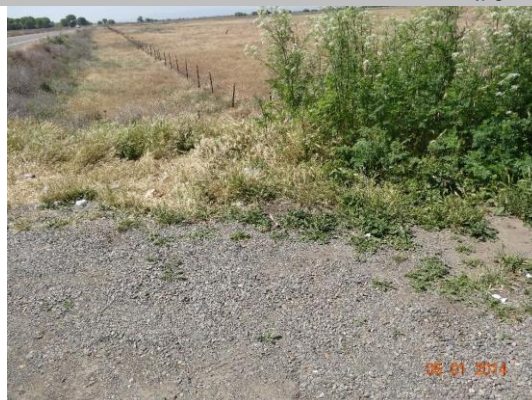
Photo 1 of 3 : UCIP_FA_2018_36510_66133.jpg

Comment Code					
Inspector Comment					
FS_ID:36510 DS_ID:19659 EP_NO: N/A Repair Type: Non-Urgent Crossing Status: Found UCIP Comments: 05/01/2014 Dense vegetation limits the inspector's visibility to identify signs of pipe failure (leaks) along the slope. Recommend removing vegetation along pipe alignment to conduct proper inspection of structure. (DWR UCIP - O. Magana) FIELD_STRUCT_DESC: 24-inch corrugated metal gravity drainage pipe through the levee, 7 feet below the crown. Flap gate on the waterside (WS) end. Brass cap No. 135 bench mark (BM) on the headwall on the landside (LS). [Additional Reference(s): DWR Levee Log, 2002. USACE San Joaquin O&M Manual 601.1, 1967, (HLM 2.30)]. FS Date: 5/1/2014

View of landward side.

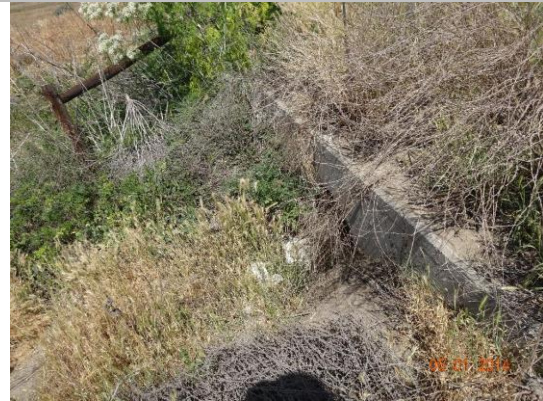
Photo 2 of 3 : UCIP_FA_2018_36510_66132.jpg

Concrete headwall visible on landward side.

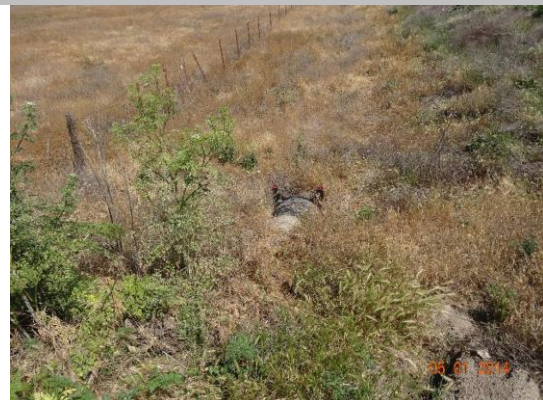
Photo 3 of 3 : UCIP_FA_2018_36510_66131.jpg

View of pipe through levee visible on waterward side.

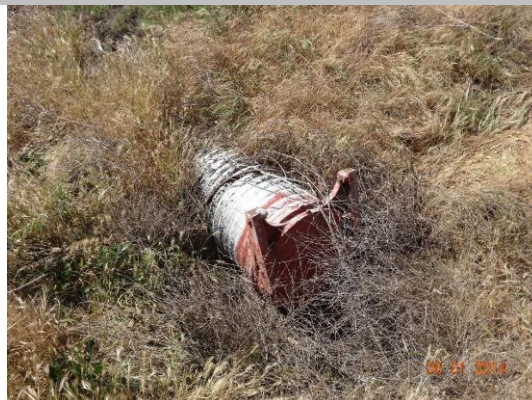
Photo 2 of 3 : UCIP_FA_2018_36511_66136.jpg

Flap gate visible on waterward side.

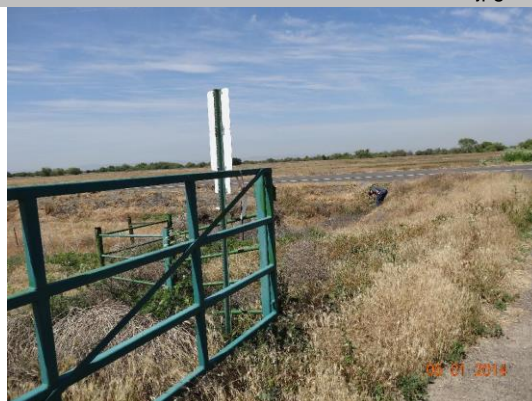
Photo 3 of 3 : UCIP_FA_2018_36511_66138.jpg

Overview of landward slope.

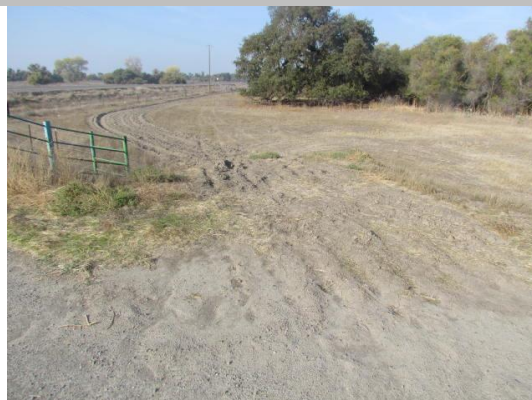
Photo 1 of 4 : FA_2018_NA0010_119_2_20180911_00001.jpg

LM Start	2.32	Rating **	M	Issue No.	2
LM End	2.32	Issue Type +	En	Location *	LS
Category	Earthen Levee			GPS Latitude/Longitude	
				Start	End
Item	Encroachments			37.291433 °	37.291433 °
				-120.850917 °	-120.850917 °
DWR ID	DWR_NA0010_02A_s_2012_2				
Comment Code					
RA : Ramp					
Inspector Comment					
Unauthorized ramp on landside and waterside slope.

Looking northeast at unauthorized ramp on landward slope.

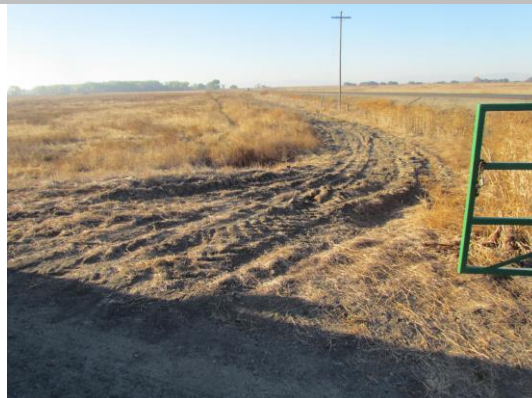
Photo 2 of 4 : FA_2018_NA0010_119_2_20180911_00002.jpg

LM Start	2.32	Rating **	M	Issue No.	2 (cont)	
LM End	2.32	Issue Type +	En	Location *	LS	
Category	Earthen Levee			GPS Latitude/Longitude		
				Start		End
Item	Encroachments			37.291433 °		37.291433 °
				-120.850917 °		-120.850917 °
DWR ID	DWR_NA0010_02A_s_2012_2					
Comment Code						
RA : Ramp						
Inspector Comment						
Unauthorized ramp on landside and waterside slope.

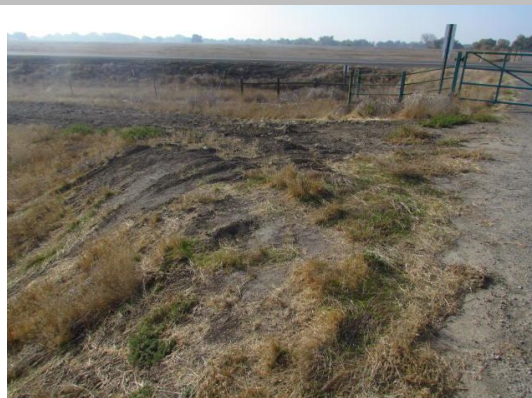
Photo 3 of 4 : FA_2018_NA0010_119_2_20180911_00003.jpg

Looking northwest at unauthorized ramp on waterward slope.

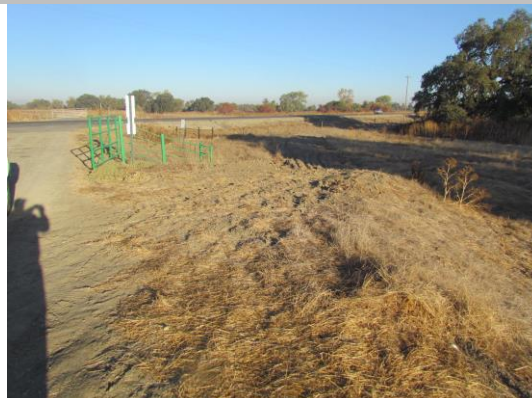
Photo 4 of 4 : FA_2018_NA0010_119_2_20180911_00004.jpg

Looking at ramp on landward slope. (Fall 2016)

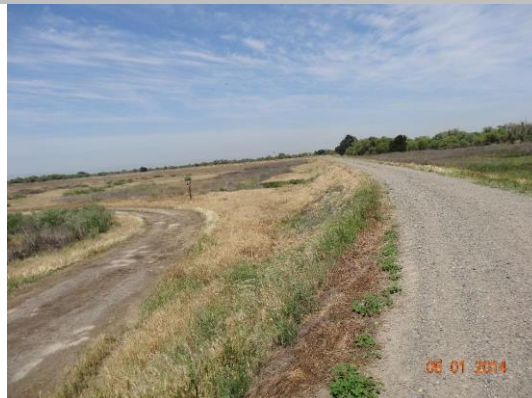
Photo 1 of 3 : UCIP_FA_2018_36512_66142.jpg

Comment Code						
Inspector Comment						
FS_ID:36512 DS_ID:19661 EP_NO: N/A Repair Type: Non-Urgent Crossing Status: Found UCIP Comments: 05/01/2014 Dense vegetation limits the inspector's visibility to identify signs of pipe failure (leaks) along the slope. Recommend removing vegetation along pipe alignment to conduct proper inspection of structure. (DWR UCIP - O. Magana) FIELD_STRUCT_DESC: 24-inch corrugated metal gravity drainage pipe through the levee, 10 feet below the crown. Flap gate on the waterside (WS) end. Brass cap No. 130 bench mark (BM) on the headwall on the landside (LS). [Additional Reference(s): DWR Levee Log, 2002. USACE San Joaquin O&M Manual 601.1, 1967, (HLM 2.59)]. FS Date: 5/1/2014

View of landward side.

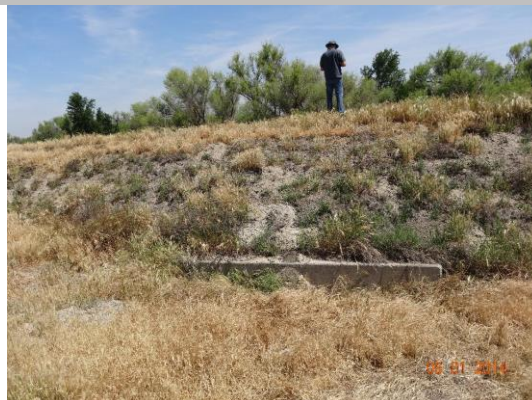
Photo 2 of 3 : UCIP_FA_2018_36512_66141.jpg

Concrete headwall visible on landward side.

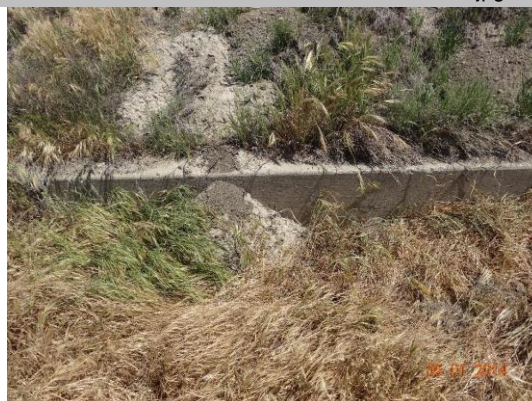
Photo 3 of 3 : UCIP_FA_2018_36512_66140.jpg

Comment Code						
Inspector Comment						
FS_ID:36512 DS_ID:19661 EP_NO: N/A Repair Type: Non-Urgent Crossing Status: Found UCIP Comments: 05/01/2014 Dense vegetation limits the inspector's visibility to identify signs of pipe failure (leaks) along the slope. Recommend removing vegetation along pipe alignment to conduct proper inspection of structure. (DWR UCIP - O. Magana) FIELD_STRUCT_DESC: 24-inch corrugated metal gravity drainage pipe through the levee, 10 feet below the crown. Flap gate on the waterside (WS) end. Brass cap No. 130 bench mark (BM) on the headwall on the landside (LS). [Additional Reference(s): DWR Levee Log, 2002. USACE San Joaquin O&M Manual 601.1, 1967, (HLM 2.59)]. FS Date: 5/1/2014

Non-functional crossing concrete headwall and inlet buried on landside side.

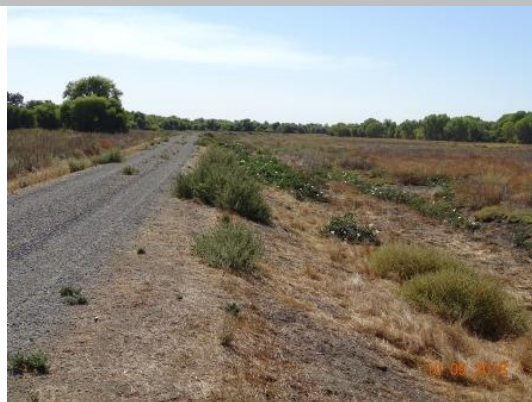
Photo 1 of 1 : FA_2018_NA0010_119_13_20181029_00075.jpg

LM Start	2.87	Rating **	M	Issue No.	13
LM End	3.00	Issue Type +	Ma	Location *	LS
Category	Earthen Levee			GPS Latitude/Longitude	
				Start	End
Item	Vegetation			37.285467 °	37.283567 °
				-120.845545 °	-120.844964 °
DWR ID	DWR_NA0010_02A_f_2018_13				
Comment Code					
V1 : Control annual grass and weeds on the levee slopes and easements.					
Inspector Comment

View of landside slope. (Fall 2018)

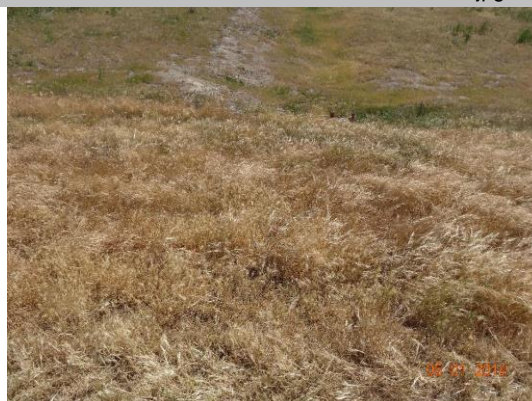
Photo 1 of 3 : UCIP_FA_2018_36513_66145.jpg

Comment Code					
Inspector Comment					
FS_ID:36513					
DS_ID:19662					
EP_NO: N/A					
Repair Type: Non-Urgent					
Crossing Status: Found					
UCIP Comments: 05/01/2014 Dense vegetation limits the inspector's visibility to identify signs of pipe failure (leaks) along the slope. Recommend removing vegetation along pipe alignment to conduct proper inspection of structure. (DWR UCIP - O. Magana)					
FIELD_STRUCT_DESC: 24-inch corrugated metal gravity drainage pipe through the levee, 10 feet below the crown. Flap gate on the waterside (WS) end. Brass cap No. 130 bench mark (BM) on the headwall on the landside (LS). [Additional Reference(s): DWR Levee Log, 2002. USACE San Joaquin O&M Manual 601.1, 1967, (HLM 2.96)].					
FS Date: 5/1/2014

View of waterward side.

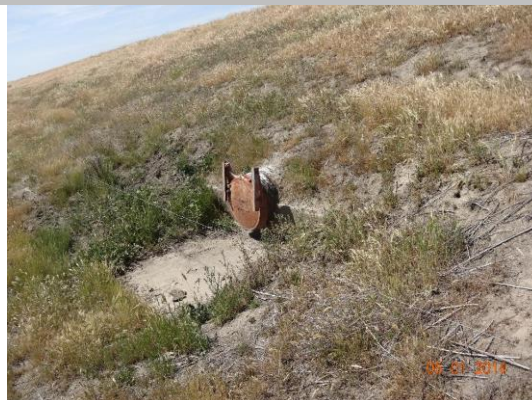
Photo 2 of 3 : UCIP_FA_2018_36513_66144.jpg

Flap gate visible on waterward side.

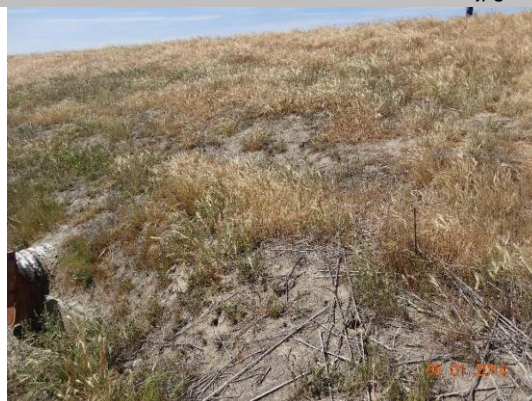
Photo 3 of 3 : UCIP_FA_2018_36513_66149.jpg

Comment Code						
Inspector Comment						
FS_ID:36513 DS_ID:19662 EP_NO: N/A Repair Type: Non-Urgent Crossing Status: Found UCIP Comments: 05/01/2014 Dense vegetation limits the inspector's visibility to identify signs of pipe failure (leaks) along the slope. Recommend removing vegetation along pipe alignment to conduct proper inspection of structure. (DWR UCIP - O. Magana) FIELD_STRUCT_DESC: 24-inch corrugated metal gravity drainage pipe through the levee, 10 feet below the crown. Flap gate on the waterside (WS) end. Brass cap No. 130 bench mark (BM) on the headwall on the landside (LS). [Additional Reference(s): DWR Levee Log, 2002. USACE San Joaquin O&M Manual 601.1, 1967, (HLM 2.96)]. FS Date: 5/1/2014

View of slope on waterward side.

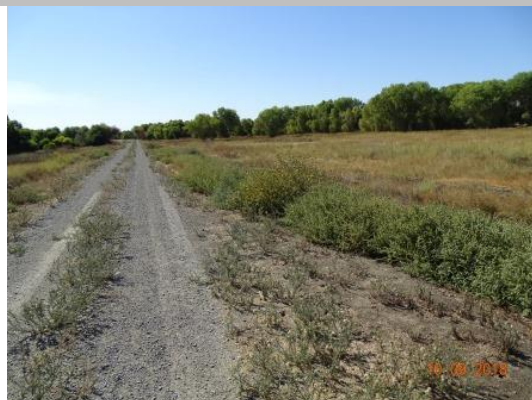
Photo 1 of 1 : FA_2018_NA0010_119_30_20181029_00077.jpg

LM Start	3.13	Rating **	U	Issue No.	30
LM End	3.18	Issue Type +	Ma	Location *	LS
Category	Earthen Levee			GPS Latitude/Longitude	
				Start	End
Item	Vegetation			37.281709 °	37.281049 °
				-120.844603 °	-120.844677 °
DWR ID	DWR_NA0010_02A_f_2018_30				
Comment Code					
V1 : Control annual grass and weeds on the levee slopes and easements.					
Inspector Comment					
Vegetation blocking view of lower section of slope and toe.

Dense vegetation blocking view of lower half of slope and toe. (Fall 2018)

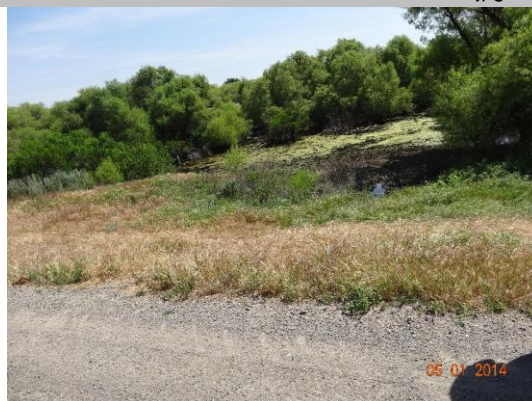
Photo 1 of 3 : UCIP_FA_2018_36514_66151.jpg

Comment Code						
Inspector Comment						
FS_ID:36514 DS_ID:19665 EP_NO: N/A Repair Type: Non-Urgent Crossing Status: Found UCIP Comments: 05/01/2014 Dense vegetation limits the inspector's visibility to identify signs of pipe failure (leaks) along the slope. Recommend removing vegetation along pipe alignment to conduct proper inspection of structure. (DWR UCIP - O. Magana) FIELD_STRUCT_DESC: 24-inch corrugated metal gravity drainage pipe through the levee, 12.4 feet below the crown. Flap gate on the waterside (WS) end. Brass cap No. 130 bench mark (BM) on the headwall on the landside (LS). [Additional Reference(s): DWR Levee Log, 2002. USACE San Joaquin O&M Manual 601.1, 1967, (HLM 3.29)]. FS Date: 5/1/2014

View of waterward side.

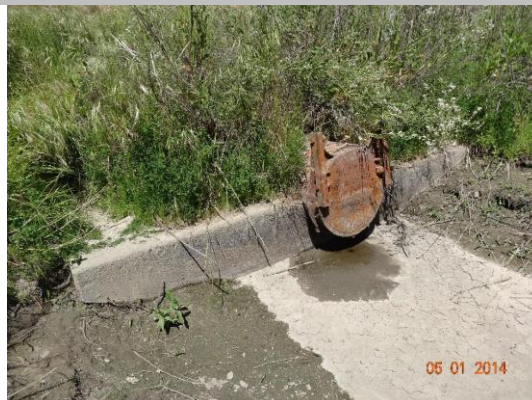
Photo 2 of 3 : UCIP_FA_2018_36514_66153.jpg

Flap gate visible on waterward side.

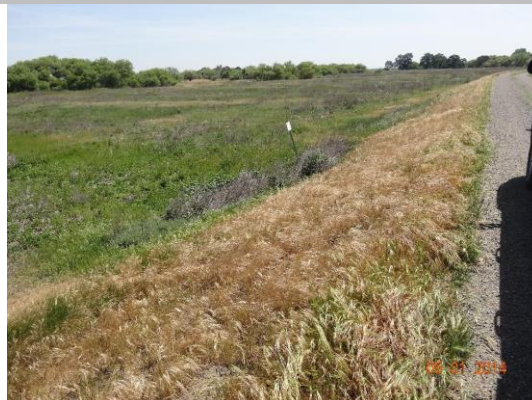
Photo 2 of 3 : UCIP_FA_2018_39364_66160.jpg

View of waterward side.

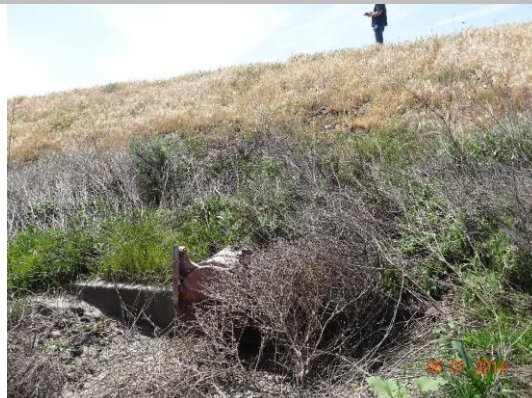
Photo 3 of 3 : UCIP_FA_2018_39364_66159.jpg

Comment Code						
Inspector Comment						
FS_ID:39364 DS_ID:19667 EP_NO: N/A Repair Type: Non-Urgent Crossing Status: Found UCIP Comments: 05/01/2014 Signs of erosion or sink hole present on landward toe--Need to contact owner. Dense vegetation limits the inspector's visibility to identify signs of pipe failure (leaks) along the slope. Recommend removing vegetation along pipe alignment to conduct proper inspection of structure. (DWR UCIP - O. Magana) FIELD_STRUCT_DESC: 24-inch corrugated metal gravity drainage pipe through the levee, 8.6 feet below the crown. Flap gate on the waterside (WS) end. Brass cap No. 130 bench mark (BM) on the headwall on the landside (LS). [Additional Reference(s): DWR Levee Log, 2002. USACE San Joaquin O&M Manual 601.1, 1967, (HLM 3.95)]. FS Date: 5/1/2014

Flap gate and concrete headwall visible through dense vegetation.

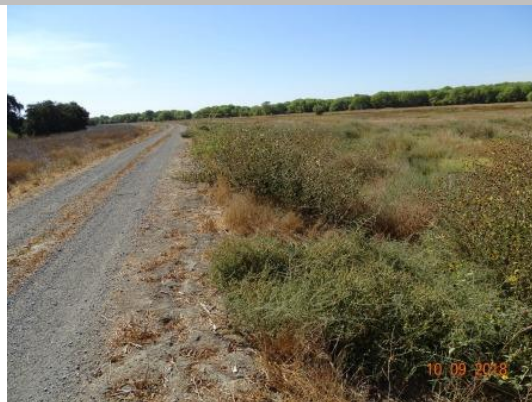
Photo 1 of 1 : FA_2018_NA0010_119_17_20181029_00079.jpg

LM Start	4.63	Rating **	U	Issue No.	17
LM End	4.69	Issue Type +	Ma	Location *	LS
Category	Earthen Levee			GPS Latitude/Longitude	
				Start	End
Item	Vegetation			37.271088 °	37.270269 °
				-120.832656 °	-120.832977 °
DWR ID	DWR_NA0010_02A_f_2018_17				
Comment Code					
V1 : Control annual grass and weeds on the levee slopes and easements.					
Inspector Comment					
Heavy vegetation on landside slope

View of vegetation on landside slope. (Fall 2018)

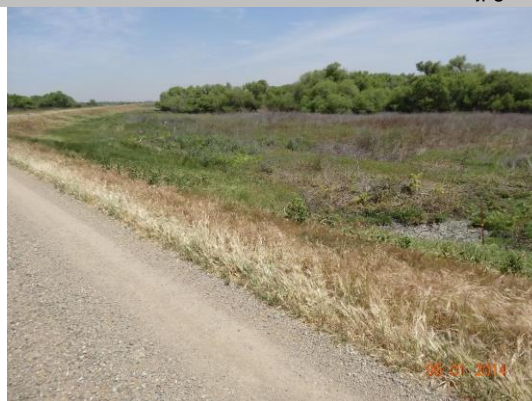
Photo 1 of 3 : UCIP_FA_2018_36517_66167.jpg

Comment Code						
Inspector Comment						
FS_ID:36517 DS_ID:19668 EP_NO: N/A Repair Type: Non-Urgent Crossing Status: Found UCIP Comments: 05/01/2014 Dense vegetation limits the inspector's visibility to identify signs of pipe failure (leaks) along the slope. Recommend removing vegetation along pipe alignment to conduct proper inspection of structure. (DWR UCIP - O. Magana) FIELD_STRUCT_DESC: 24-inch corrugated metal gravity drainage pipe through the levee, 8 feet below the crown. Flap gate on the waterside (WS) end. Brass cap No. 125 bench mark (BM) on the headwall on the landside (LS). [Additional Reference(s): DWR Levee Log, 2002. USACE San Joaquin O&M Manual 601.1, 1967, (HLM 5.43)]. FS Date: 5/1/2014

View of waterward side.

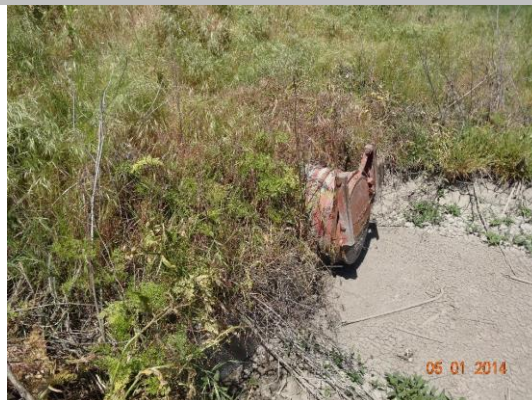
Photo 2 of 3 : UCIP_FA_2018_36517_66166.jpg

Flap gate visible on waterward side.

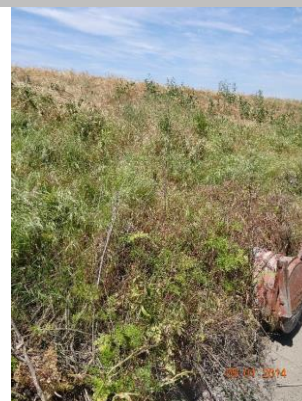
Photo 3 of 3 : UCIP_FA_2018_36517_66165.jpg

Comment Code						
Inspector Comment						
FS_ID:36517 DS_ID:19668 EP_NO: N/A Repair Type: Non-Urgent Crossing Status: Found UCIP Comments: 05/01/2014 Dense vegetation limits the inspector's visibility to identify signs of pipe failure (leaks) along the slope. Recommend removing vegetation along pipe alignment to conduct proper inspection of structure. (DWR UCIP - O. Magana) FIELD_STRUCT_DESC: 24-inch corrugated metal gravity drainage pipe through the levee, 8 feet below the crown. Flap gate on the waterside (WS) end. Brass cap No. 125 bench mark (BM) on the headwall on the landside (LS). [Additional Reference(s): DWR Levee Log, 2002. USACE San Joaquin O&M Manual 601.1, 1967, (HLM 5.43)]. FS Date: 5/1/2014

View of waterward slope covered by vegetation.

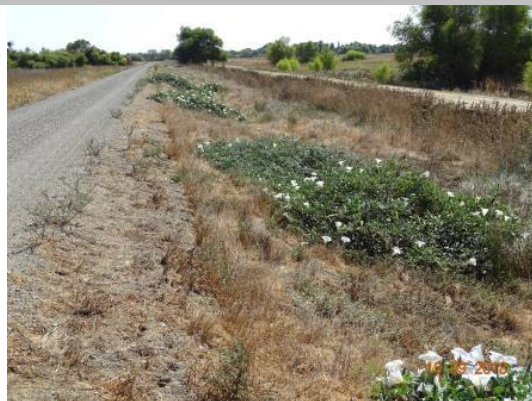
Photo 1 of 1 : FA_2018_NA0010_119_33_20181029_00078.jpg

LM Start	5.90	Rating **	M	Issue No.	33
LM End	6.00	Issue Type +	Ma	Location *	LS
Category	Earthen Levee			GPS Latitude/Longitude	
				Start	End
Item	Vegetation			37.254809 °	37.253856 °
				-120.825772 °	-120.824458 °
DWR ID	DWR_NA0010_02A_f_2018_33				
Comment Code					
V1 : Control annual grass and weeds on the levee slopes and easements.					
Inspector Comment					
Patches of dense vegetation along landside slope

View of vegetation on landside slope. (Fall 2018)
