**Flood Control Project Maintenance
Levee Inspections**

Fall 2018 Levee Maintenance Deficiency Summary Report

San Joaquin River Basin

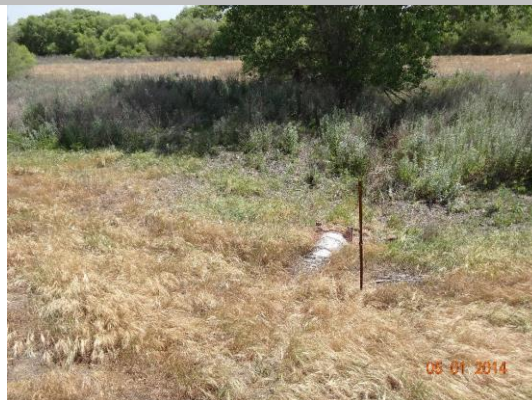
Photo 2 of 3 : UCIP_FA_2018_36519_66172.jpg

Crossing and flap gate visible on waterward side.

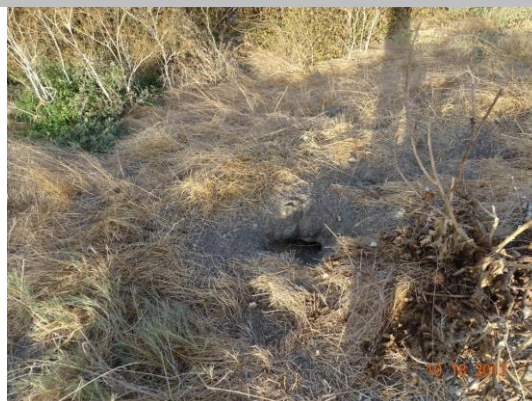
Photo 1 of 1 : FA_2018_NA0010_119_28_20180911_00012.jpg

LM Start	6.97	Rating **	M	Issue No.	28
LM End	6.97	Issue Type +	Ma	Location *	LS
Category	Earthen Levee			GPS Latitude/Longitude	
				Start	End
Item	Animal Control			37.241125°	37.241125°
				-120.821747°	-120.821747°
DWR ID	DWR_NA0010_02A_f_2017_28				
Comment Code					
A3 : No rodents visible, but rodent burrows visible; need to backfill and compact or grout burrows.					
Inspector Comment

Looking northwest at landside slope.

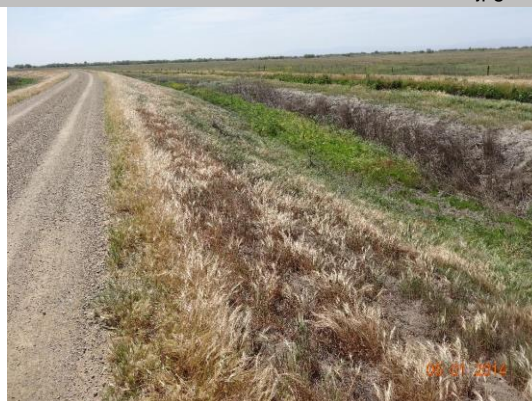
Photo 1 of 3 : UCIP_FA_2018_39365_66178.jpg

Comment Code					
Inspector Comment					
FS_ID:39365 DS_ID:19671 EP_NO: N/A Repair Type: Non-Urgent Crossing Status: Found UCIP Comments: 05/01/2014 Dense vegetation limits the inspector's visibility to identify signs of pipe failure (leaks) along the slope. Recommend removing vegetation along pipe alignment to conduct proper inspection of structure. Pipe extension visible on landward side-- need to contact owner for additional information about extension/modification. (DWR UCIP - O. Magana) FIELD_STRUCT_DESC: 24-inch corrugated metal gravity drainage pipe through the levee, 12.6 feet below the crown. Flap gate on the waterside (WS) end. Brass cap No. 125 bench mark (BM) on the headwall on the landside (LS). [Additional Reference(s): DWR Levee Log, 2002. USACE San Joaquin O&M Manual 601.1, 1967, (HLM 7.05)]. FS Date: 5/1/2014

View of landward side.

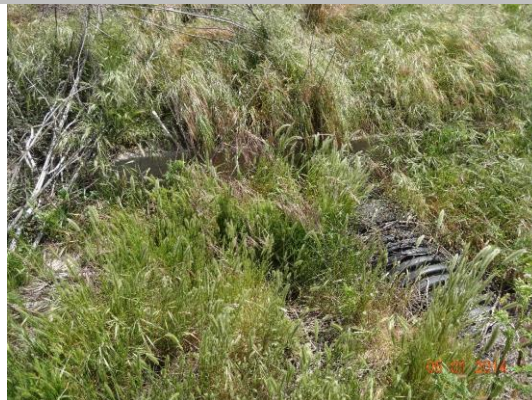
Photo 2 of 3 : UCIP_FA_2018_39365_66177.jpg

FS_ID:39365
DS_ID:19671
EP_NO: N/A
Repair Type: Non-Urgent
Crossing Status: Found
UCIP Comments: 05/01/2014 Dense vegetation limits the inspector's visibility to identify signs of pipe failure (leaks) along the slope. Recommend removing vegetation along pipe alignment to conduct proper inspection of structure. Pipe extension visible on landward side-- need to contact owner for additional information about extension/modification. (DWR UCIP - O. Magana)
FIELD_STRUCT_DESC: 24-inch corrugated metal gravity drainage pipe through the levee, 12.6 feet below the crown. Flap gate on the waterside (WS) end. Brass cap No. 125 bench mark (BM) on the headwall on the landside (LS). [Additional Reference(s): DWR Levee Log, 2002. USACE San Joaquin O&M Manual 601.1, 1967, (HLM 7.05)].
FS Date: 5/1/2014

Pipe extension visible on landward side attached to inlet at concrete headwall.

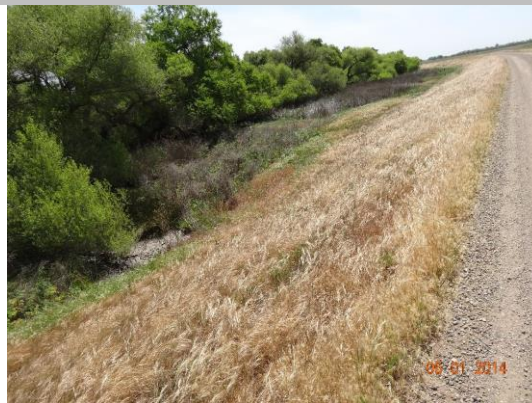
Photo 3 of 3 : UCIP_FA_2018_39365_66176.jpg

View of waterward side.

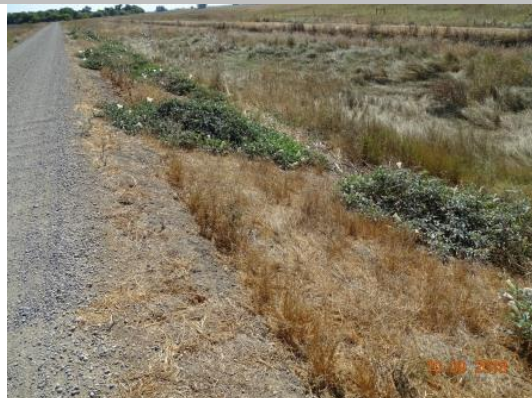
Photo 1 of 1 : FA_2018_NA0010_119_34_20181029_00081.jpg

LM Start	7.18	Rating **	M	Issue No.	34
LM End	7.31	Issue Type +	Ma	Location *	LS
Category	Earthen Levee			GPS Latitude/Longitude	
				Start	End
Item	Vegetation			37.238491°	37.237181°
				-120.819977°	-120.818299°
DWR ID	DWR_NA0010_02A_f_2018_34				
Comment Code					
V1 : Control annual grass and weeds on the levee slopes and easements.					
Inspector Comment					
Patches of dense vegetation along landside slope.

Patches of dense vegetation on landward slope. (Fall 2018)

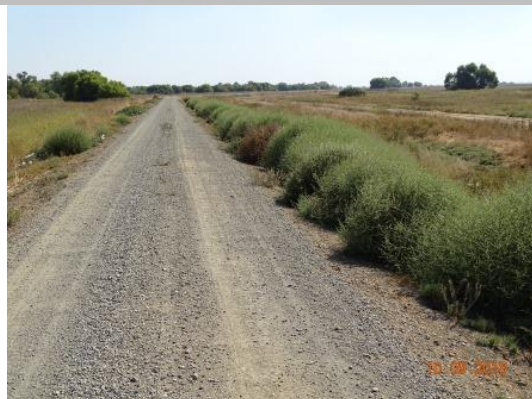
Photo 1 of 1 : FA_2018_NA0010_119_35_20181029_00082.jpg

LM Start	7.61	Rating **	U	Issue No.	35
LM End	7.67	Issue Type +	Ma	Location *	LS
Category	Earthen Levee			GPS Latitude/Longitude	
				Start	End
Item	Vegetation			37.233515 °	37.233128 °
				-120.815418 °	-120.814530 °
DWR ID	DWR_NA0010_02A_f _ 2018_35				
Comment Code					
V1 : Control annual grass and weeds on the levee slopes and easements.					
Inspector Comment					
Heavy vegetation blocking view of landside slope.

view of landside slope blocked by vegetation. (Fall 2018)

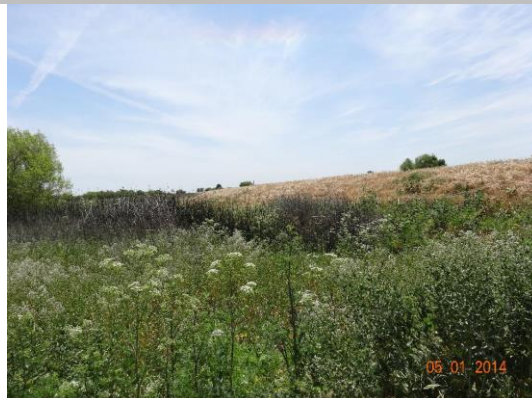
Photo 3 of 3 : UCIP_FA_2018_36521_66181.jpg

Comment Code						
Inspector Comment						
FS_ID:36521						
DS_ID:19673						
EP_NO: N/A						
Repair Type: Non-Urgent						
Crossing Status: Found						
UCIP Comments: 05/01/2014 Dense vegetation limits the inspector's visibility to identify signs of pipe failure (leaks) along the slope. Recommend removing vegetation along pipe alignment to conduct proper inspection of structure. (DWR UCIP - O. Magana)						
FIELD_STRUCT_DESC: 24-inch corrugated metal gravity drainage pipe through the levee, 8 feet below the crown. Flap gate on the waterside (WS) end. Brass cap No. 125 bench mark (BM) on the headwall on the landside (LS). [Additional Reference(s): DWR Levee Log, 2002. USACE San Joaquin O&M Manual 601.1, 1967, (HLM 7.77)].						
FS Date: 5/1/2014

View of waterward side--photo taken from levee toe looking towards alignment of crossing.

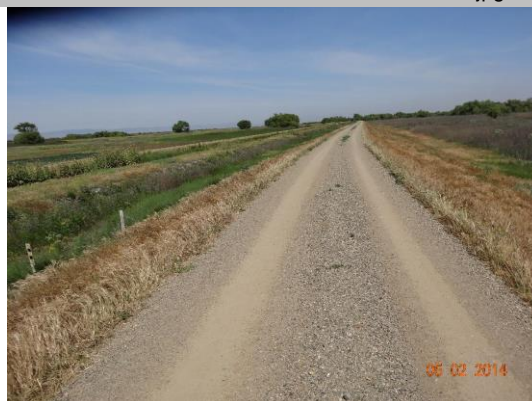
Photo 2 of 3 : UCIP_FA_2018_39366_66185.jpg

Comment Code						
Inspector Comment						
FS_ID:39366 DS_ID:19674 EP_NO: N/A Repair Type: Non-Urgent Crossing Status: Found UCIP Comments: 05/14/2014 Dense vegetation limits the inspector's visibility to identify signs of pipe failure (leaks) along the slope and landward headwall. Recommend removing vegetation along pipe alignment and toe to conduct proper inspection of structure. Sediment buildup in pipe visible from landward side--recommend clearing. (DWR UCIP - O. Magana) FIELD_STRUCT_DESC: 24-inch corrugated metal gravity drainage pipe through the levee, 9 feet below the crown. Flap gate on the waterside (WS) end. Brass cap No. 120 bench mark (BM) on the headwall on the landside (LS). [Additional Reference(s): DWR Levee Log, 2002. USACE San Joaquin O&M Manual 601.1, 1967, (HLM 8.16)]. FS Date: 5/14/2014

Overview of levee crown at crossing.

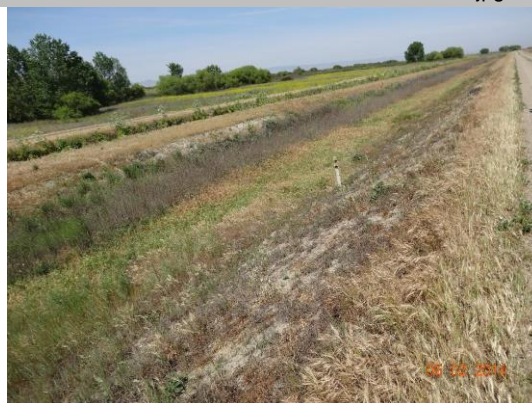
Photo 1 of 3 : UCIP_FA_2018_39367_66195.jpg

Comment Code						
Inspector Comment						
FS_ID:39367 DS_ID:19675 EP_NO: N/A Repair Type: Non-Urgent Crossing Status: Found UCIP Comments: 05/14/2014 Dense vegetation on landward toe. Also dense vegetation limits the inspector's visibility to identify signs of pipe failure (leaks) along waterward slope. Recommend removing vegetation along pipe alignment toe to conduct proper inspection of structure. Sediment buildup in pipe--recommend clearing. (DWR UCIP - O. Magana) FIELD_STRUCT_DESC: 24-inch corrugated metal gravity drainage pipe through the levee, 9.4 feet below the crown. Flap gate on the waterside (WS) end. Brass cap No. 120 bench mark (BM) on the headwall on the landside (LS). [Additional Reference(s): DWR Levee Log, 2002. USACE San Joaquin O&M Manual 601.1, 1967, (HLM 8.48)]. FS Date: 5/14/2014

View of landward side.

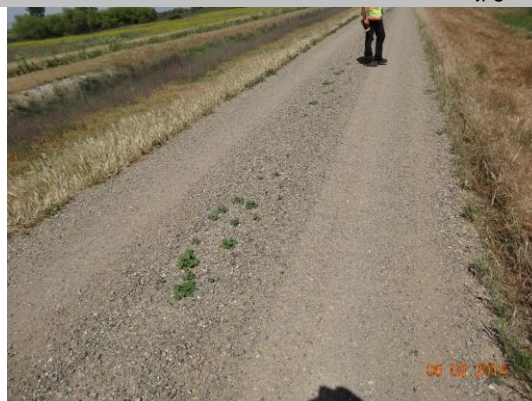
Photo 2 of 3 : UCIP_FA_2018_39367_66193.jpg

Comment Code						
Inspector Comment						
FS_ID:39367 DS_ID:19675 EP_NO: N/A Repair Type: Non-Urgent Crossing Status: Found UCIP Comments: 05/14/2014 Dense vegetation on landward toe. Also dense vegetation limits the inspector's visibility to identify signs of pipe failure (leaks) along waterward slope. Recommend removing vegetation along pipe alignment toe to conduct proper inspection of structure. Sediment buildup in pipe--recommend clearing. (DWR UCIP - O. Magana) FIELD_STRUCT_DESC: 24-inch corrugated metal gravity drainage pipe through the levee, 9.4 feet below the crown. Flap gate on the waterside (WS) end. Brass cap No. 120 bench mark (BM) on the headwall on the landside (LS). [Additional Reference(s): DWR Levee Log, 2002. USACE San Joaquin O&M Manual 601.1, 1967, (HLM 8.48)]. FS Date: 5/14/2014

Overview of levee crown at crossing.

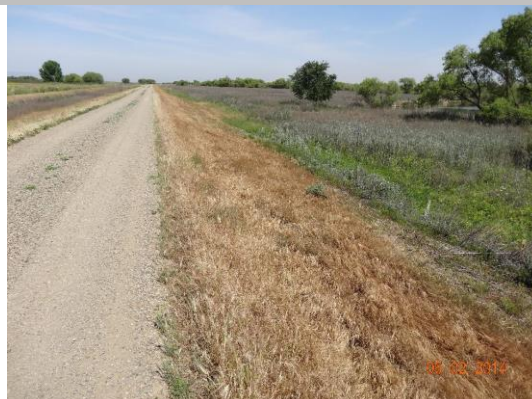
Photo 3 of 3 : UCIP_FA_2018_39367_66194.jpg

View of waterward side.

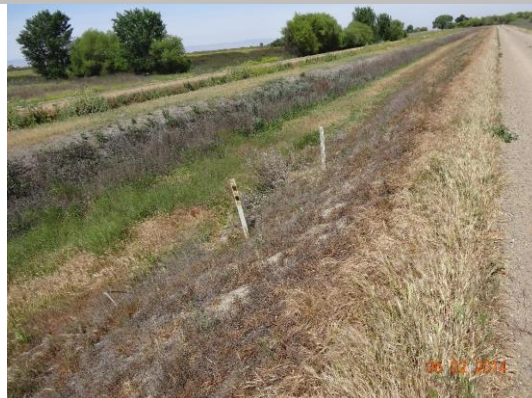
Photo 1 of 3 : UCIP_FA_2018_42503_66200.jpg

Comment Code					
Inspector Comment					
FS_ID:42503 DS_ID:19676 EP_NO: N/A Repair Type: Non-Urgent Crossing Status: Found UCIP Comments: 05/14/2014 Dense vegetation limits the inspector's visibility to identify signs of pipe failure (leaks) along the slope. Recommend removing vegetation along pipe alignment to conduct proper inspection of structure. Burrow activity presen on waterward slope. (DWR UCIP - O. Magana) FIELD_STRUCT_DESC: 24-inch corrugated metal gravity drainage pipe through the levee, 8.8 feet below the crown. Flap gate on the waterside (WS) end. Brass cap No. 120 bench mark (BM) on the headwall on the landside (LS). [Additional Reference(s): DWR Levee Log, 2002. USACE San Joaquin O&M Manual 601.1, 1967, (recorded as HLM 9.86 should be 8.86)]. FS Date: 5/14/2014

View of landward side.

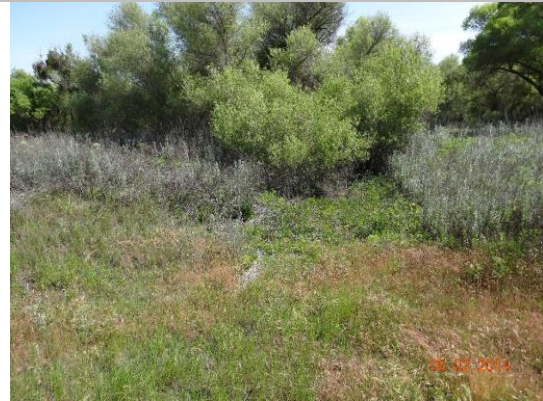
Photo 3 of 3 : UCIP_FA_2018_42503_66201.jpg

Comment Code						
Inspector Comment						
FS_ID:42503 DS_ID:19676 EP_NO: N/A Repair Type: Non-Urgent Crossing Status: Found UCIP Comments: 05/14/2014 Dense vegetation limits the inspector's visibility to identify signs of pipe failure (leaks) along the slope. Recommend removing vegetation along pipe alignment to conduct proper inspection of structure. Burrow activity presen on waterward slope. (DWR UCIP - O. Magana) FIELD_STRUCT_DESC: 24-inch corrugated metal gravity drainage pipe through the levee, 8.8 feet below the crown. Flap gate on the waterside (WS) end. Brass cap No. 120 bench mark (BM) on the headwall on the landside (LS). [Additional Reference(s): DWR Levee Log, 2002. USACE San Joaquin O&M Manual 601.1, 1967, (recorded as HLM 9.86 should be 8.86)]. FS Date: 5/14/2014

View of waterward toe.

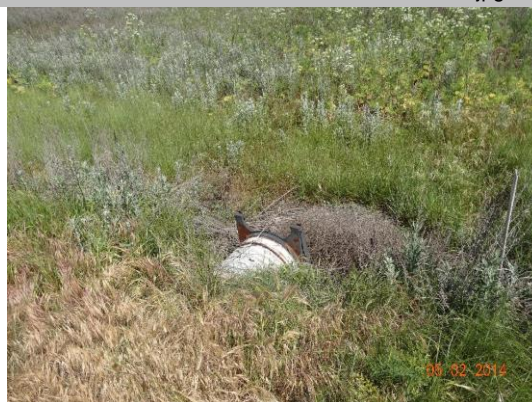
Photo 3 of 3 : UCIP_FA_2018_40443_66209.jpg

Comment Code						
Inspector Comment						
FS_ID:40443 DS_ID:19678 EP_NO: N/A Repair Type: Non-Urgent Crossing Status: Found UCIP Comments: 05/14/2014 Dense vegetation limits the inspector's visibility to identify signs of pipe failure (leaks) along the slope. Recommend removing vegetation along pipe alignment to conduct proper inspection of structure. (DWR UCIP - O. Magana) FIELD_STRUCT_DESC: 24-inch corrugated metal gravity drainage pipe through the levee, 8 feet below the crown. Flap gate on the waterside (WS) end. Brass cap No. 120 bench mark (BM) on the headwall on the landside (LS). [Additional Reference(s): DWR Levee Log, 2002. USACE San Joaquin O&M Manual 601.1, 1967, (HLM 9.20)]. FS Date: 5/14/2014

Pipe visible on waterward side.

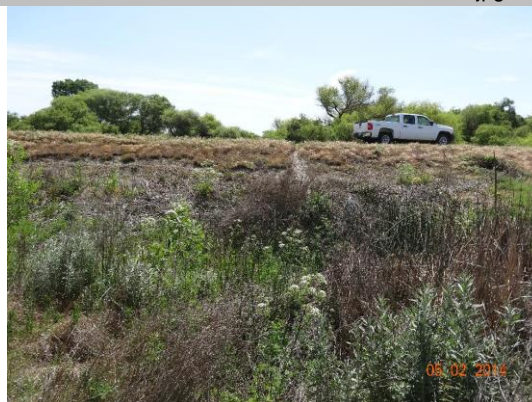
Photo 2 of 3 : UCIP_FA_2018_36528_66226.jpg

Comment Code						
Inspector Comment						
FS_ID:36528						
DS_ID:19687						
EP_NO: N/A						
Repair Type: Non-Urgent						
Crossing Status: Found						
UCIP Comments: 05/14/2014 Dense vegetation limits the inspector's visibility to identify signs of pipe failure (leaks) along the slope.						
Recommend removing vegetation along pipe alignment to conduct proper inspection of structure. (DWR UCIP - O. Magana)						
FIELD_STRUCT_DESC: 24-inch corrugated metal gravity drainage pipe through the levee, 11.7 feet below the crown. Flap gate on the waterside (WS) end. Brass cap No. 115 bench mark (BM) on the headwall on the landside (LS). [Additional Reference(s): DWR Levee Log, 2002. USACE San Joaquin O&M Manual 601.1, 1967, (HLM 10.12)].						
FS Date: 5/14/2014

View of waterward slope.

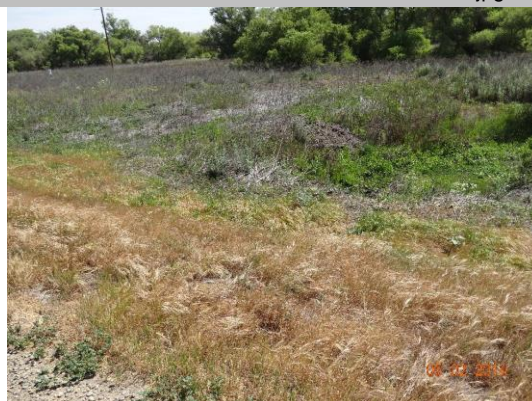
Photo 3 of 3 : UCIP_FA_2018_36528_66222.jpg

Item	DWR UCIP LMA Responsibility			37.214229 °	37.214229 °	
				-120.784350 °	-120.784350 °	
DWR ID	19687					
Comment Code						
Inspector Comment						
FS_ID:36528						
DS_ID:19687						
EP_NO: N/A						
Repair Type: Non-Urgent						
Crossing Status: Found						
UCIP Comments: 05/14/2014 Dense vegetation limits the inspector's visibility to identify signs of pipe failure (leaks) along the slope.						
Recommend removing vegetation along pipe alignment to conduct proper inspection of structure. (DWR UCIP - O. Magana)						
FIELD_STRUCT_DESC: 24-inch corrugated metal gravity drainage pipe through the levee, 11.7 feet below the crown. Flap gate on the waterside (WS) end. Brass cap No. 115 bench mark (BM) on the headwall on the landside (LS). [Additional Reference(s): DWR Levee Log, 2002. USACE San Joaquin O&M Manual 601.1, 1967, (HLM 10.12)].						
FS Date: 5/14/2014

View of waterward side.

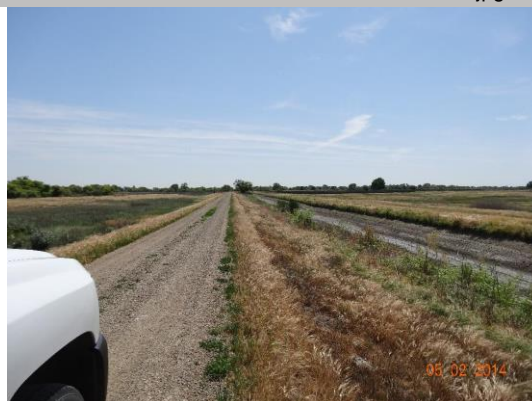
Photo 1 of 3 : UCIP_FA_2018_42504_66231.jpg

Comment Code						
Inspector Comment						
FS_ID:42504						
DS_ID:19688						
EP_NO: N/A						
Repair Type: Non-Urgent						
Crossing Status: Found						
UCIP Comments: 05/14/2014 Dense vegetation limits the inspector's						
visibility to identify signs of pipe failure (leaks) along the slope.						
Recommend removing vegetation along pipe alignment to conduct						
proper inspection of structure. Sediment buildup in pipe visible on						
landward side--recommend clearing. (DWR UCIP - O. Magana)						
FIELD_STRUCT_DESC: 24-inch corrugated metal gravity drainage pipe						
through the levee, 8 feet below the crown. Flap gate on the waterside						
(WS) end. Brass cap No. 115 bench mark (BM) on the headwall on the						
landside (LS). [Additional Reference(s): DWR Levee Log, 2002. USACE						
San Joaquin O&M Manual 601.1, 1967, (HLM 10.81)].						
FS Date: 5/14/2014

View of landward side.

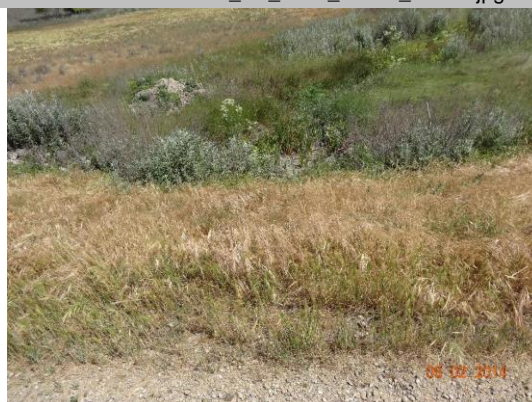
Photo 2 of 3 : UCIP_FA_2018_42504_66232.jpg

View of waterward side.

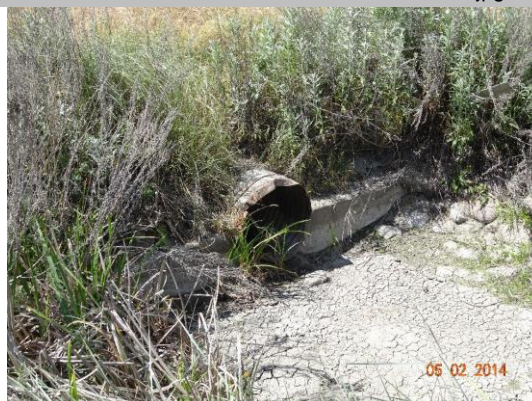
Photo 3 of 3 : UCIP_FA_2018_42504_66234.jpg

Item	DWR UCIP LMA Responsibility			37.206352 °	37.206352 °	
				-120.777634 °	-120.777634 °	
DWR ID	19688					
Comment Code						
Inspector Comment						
FS_ID:42504						
DS_ID:19688						
EP_NO: N/A						
Repair Type: Non-Urgent						
Crossing Status: Found						
UCIP Comments: 05/14/2014 Dense vegetation limits the inspector's visibility to identify signs of pipe failure (leaks) along the slope.						
Recommend removing vegetation along pipe alignment to conduct proper inspection of structure. Sediment buildup in pipe visible on landward side--recommend clearing. (DWR UCIP - O. Magana)						
FIELD_STRUCT_DESC: 24-inch corrugated metal gravity drainage pipe through the levee, 8 feet below the crown. Flap gate on the waterside (WS) end. Brass cap No. 115 bench mark (BM) on the headwall on the landside (LS). [Additional Reference(s): DWR Levee Log, 2002. USACE San Joaquin O&M Manual 601.1, 1967, (HLM 10.81)].

View of pipe visible on waterward side.

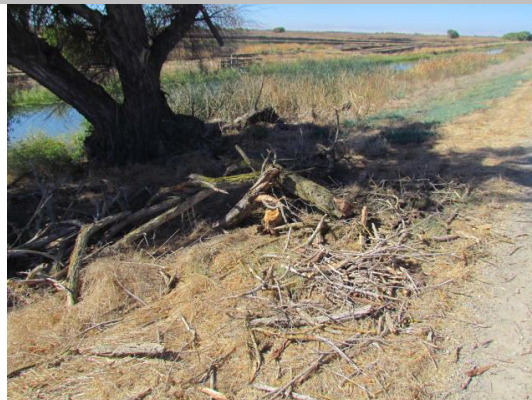
Photo 2 of 2 : FA_2018_NA0010_120_14_20180911_00003.jpg

LM Start	10.94	Rating **	M	Issue No.	14 (cont)	
LM End	10.94	Issue Type +	Ma	Location *	LS	
Category	Earthen Levee			GPS Latitude/Longitude		
				Start		End
Item	Encroachments			37.205711 °	37.205711 °	
				-120.774741 °	-120.774741 °	
DWR ID	DWR_NA0010_02B_f _ 2015_14					
Comment Code						
PR : Prunings						
Inspector Comment						
Prunings on landside toe.

Looking at prunings on landward slope. (Spring 2018)

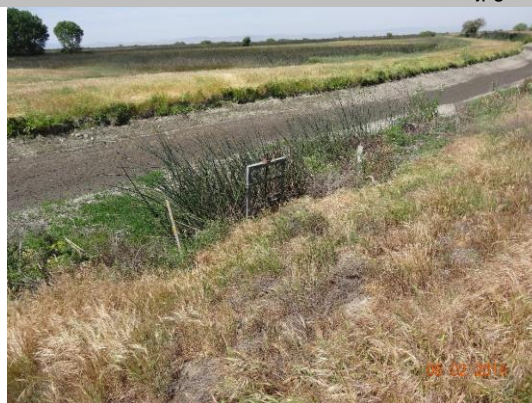
Photo 1 of 3 : UCIP_FA_2018_36530_66236.jpg

Comment Code						
Inspector Comment						
FS_ID:36530						
DS_ID:19689						
EP_NO: N/A						
Repair Type: Non-Urgent						
Crossing Status: Found						
UCIP Comments: 05/14/2014 Dense vegetation limits the inspector's visibility to identify signs of pipe failure (leaks) along the slope. Recommend removing vegetation along pipe alignment to conduct proper inspection of structure. (DWR UCIP - O. Magana)						
FIELD_STRUCT_DESC: 24-inch corrugated metal gravity drainage pipe through the levee, 8 feet below the crown. Flap gate on the waterside (WS) end. Brass cap No. 115 bench mark (BM) on the headwall on the landside (LS). [Additional Reference(s): DWR Levee Log, 2002. USACE San Joaquin O&M Manual 601.1, 1967, (HLM 11.17)].						
FS Date: 5/14/2014

View of landward slope.

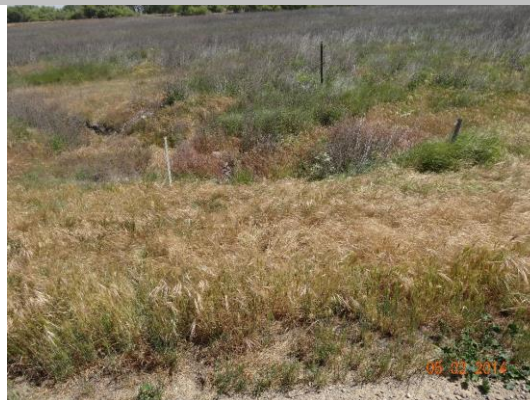
Photo 3 of 3 : UCIP_FA_2018_36530_66238.jpg

Item	DWR UCIP LMA Responsibility			37.204640 °		37.204640 °
				-120.771564 °		-120.771564 °
DWR ID	19689					
Comment Code						
Inspector Comment						
FS_ID:36530 DS_ID:19689 EP_NO: N/A Repair Type: Non-Urgent Crossing Status: Found UCIP Comments: 05/14/2014 Dense vegetation limits the inspector's visibility to identify signs of pipe failure (leaks) along the slope. Recommend removing vegetation along pipe alignment to conduct proper inspection of structure. (DWR UCIP - O. Magana) FIELD_STRUCT_DESC: 24-inch corrugated metal gravity drainage pipe through the levee, 8 feet below the crown. Flap gate on the waterside (WS) end. Brass cap No. 115 bench mark (BM) on the headwall on the landside (LS). [Additional Reference(s): DWR Levee Log, 2002. USACE San Joaquin O&M Manual 601.1, 1967, (HLM 11.17)]. FS Date: 5/14/2014

View of waterward side.

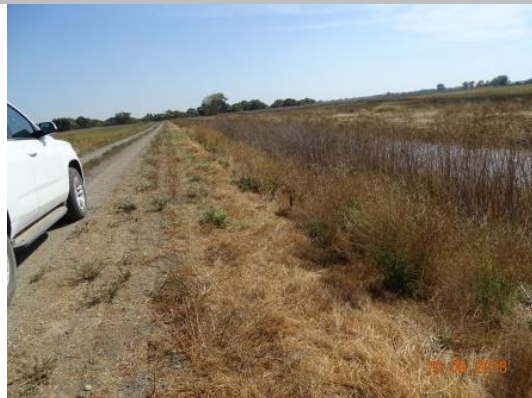
Photo 1 of 1 : FA_2018_NA0010_120_11_20181029_00051.jpg

LM Start	11.20	Rating **	M	Issue No.	11
LM End	11.33	Issue Type +	Ma	Location *	LS
Category	Earthen Levee			GPS Latitude/Longitude	
				Start	End
Item	Vegetation			37.203920 °	37.202568 °
				-120.770750 °	-120.769226 °
DWR ID	DWR_NA0010_02B_f_2018_11				
Comment Code					
V1 : Control annual grass and weeds on the levee slopes and easements.					
Inspector Comment

Dense vegetation on landside toe. (Fall 2018)

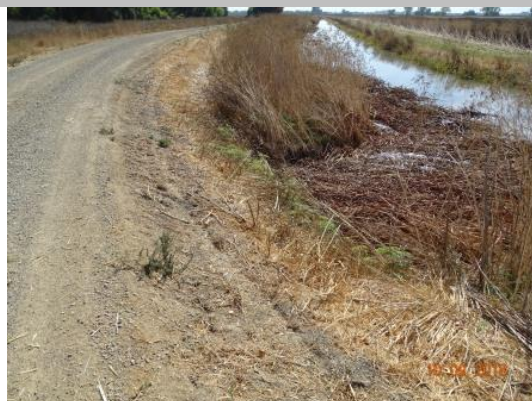
Photo 1 of 2 : FA_2018_NA0010_120_21_20181029_00052.jpg

LM Start	11.39	Rating **	U	Issue No.	21
LM End	11.39	Issue Type +	Ma	Location *	LS
Category	Earthen Levee			GPS Latitude/Longitude	
				Start	End
Item	Erosion / Bank Caving			37.201839 °	37.201839 °
				-120.768489 °	-120.768489 °
DWR ID	DWR_NA0010_02B_f_2018_21				
Comment Code					
E2 : Schedule repair of erosion site prior to the next inspection.					
Inspector Comment					
Erosion into landside slope of levee

Erosion into landside slope. Looking upstream. (Fall 2018)

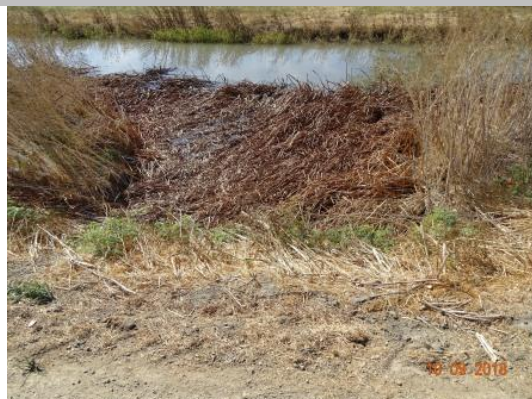
Photo 2 of 2 : FA_2018_NA0010_120_21_20181029_00053.jpg

view of erosion site looking down landside slope. (Fall 2018)

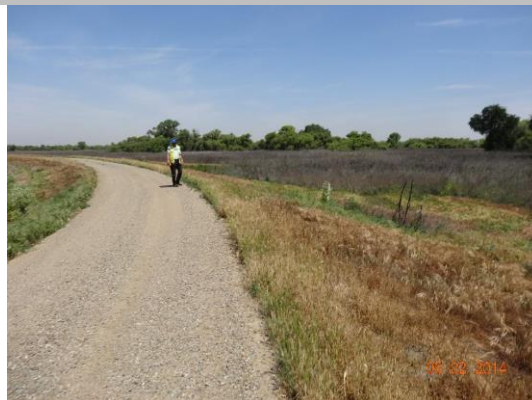
Photo 2 of 3 : UCIP_FA_2018_36531_66240.jpg

Comment Code						
Inspector Comment						
FS_ID:36531						
DS_ID:19690						
EP_NO: N/A						
Repair Type: Non-Urgent						
Crossing Status: Found						
UCIP Comments: 05/14/2014 Dense vegetation limits the inspector's visibility to identify signs of pipe failure (leaks) along the slope. Recommend removing vegetation along pipe alignment to conduct proper inspection of structure. (DWR UCIP - O. Magana)						
FIELD_STRUCT_DESC: 24-inch corrugated metal gravity drainage pipe through the levee, 8 feet below the crown. Flap gate on the waterside (WS) end. Screw gate on the landside (LS). [Additional Reference(s): DWR Levee Log, 2002. USACE San Joaquin O&M Manual 601.1, 1967, (HLM 11.43)].						
FS Date: 5/14/2014

View of waterward side.

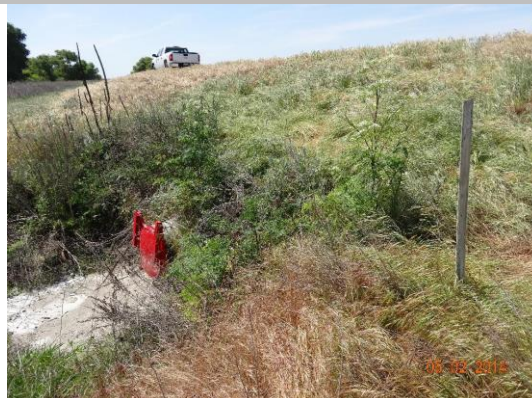
Photo 3 of 3 : UCIP_FA_2018_36531_66239.jpg

Item	DWR UCIP LMA Responsibility			37.201792 °		37.201792 °
				-120.768462 °		-120.768462 °
DWR ID	19690					
Comment Code						
Inspector Comment						
FS_ID:36531 DS_ID:19690 EP_NO: N/A Repair Type: Non-Urgent Crossing Status: Found UCIP Comments: 05/14/2014 Dense vegetation limits the inspector's visibility to identify signs of pipe failure (leaks) along the slope. Recommend removing vegetation along pipe alignment to conduct proper inspection of structure. (DWR UCIP - O. Magana) FIELD_STRUCT_DESC: 24-inch corrugated metal gravity drainage pipe through the levee, 8 feet below the crown. Flap gate on the waterside (WS) end. Screw gate on the landside (LS). [Additional Reference(s): DWR Levee Log, 2002. USACE San Joaquin O&M Manual 601.1, 1967, (HLM 11.43)]. FS Date: 5/14/2014

Flap gate visible on waterward toe.

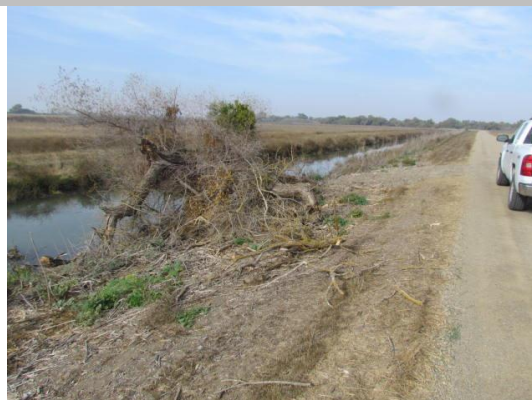
Photo 1 of 2 : FA_2018_NA0010_120_1_20180911_00001.jpg

LM Start	12.21	Rating **	M	Issue No.	1
LM End	12.21	Issue Type +	Ma	Location *	LS
Category	Earthen Levee			GPS Latitude/Longitude	
				Start	End
Item	Encroachments			37.191528 °	37.191528 °
				-120.764541 °	-120.764541 °
DWR ID	DWR_NA0010_02B_f_2014_1				
Comment Code					
TR : Tree or limb					
Inspector Comment					
Fallen tree limbs on landside slope.

Looking northwest at tree limb on waterward slope.

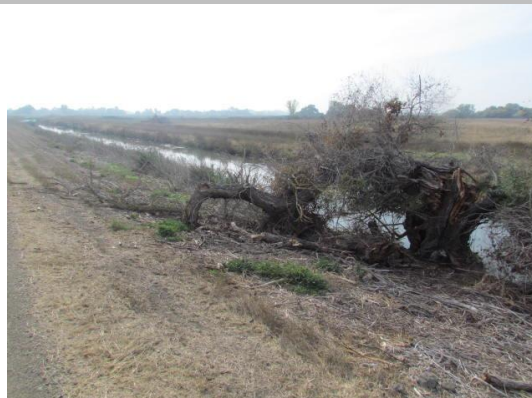
Photo 2 of 2 : FA_2018_NA0010_120_1_20180911_00002.jpg

LM Start	12.21	Rating **	M	Issue No.	1 (cont)	
LM End	12.21	Issue Type +	Ma	Location *	LS	
Category	Earthen Levee			GPS Latitude/Longitude		
				Start		End
Item	Encroachments			37.191528 °	37.191528 °	
				-120.764541 °	-120.764541 °	
DWR ID	DWR_NA0010_02B_f_2014_1					
Comment Code						
TR : Tree or limb						
Inspector Comment						
Fallen tree limbs on landside slope.

Looking southwest at tree limb on waterward slope.

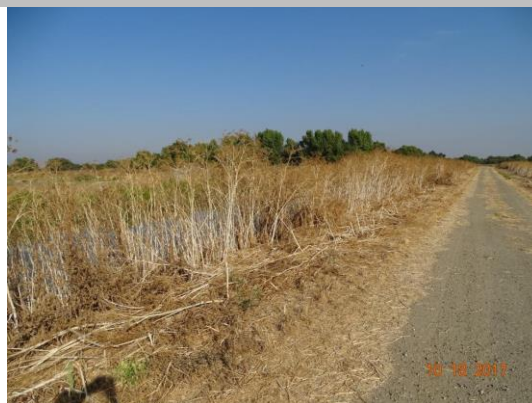
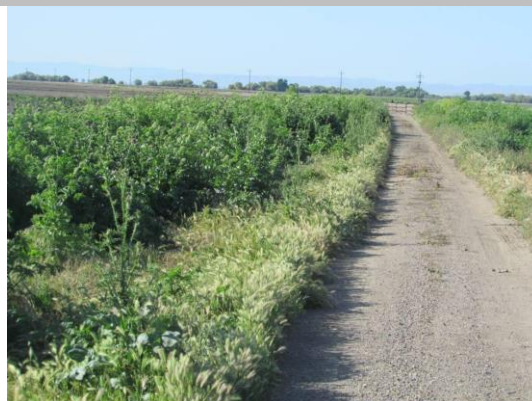
LM Start	13.64	Rating **	U	Issue No.	19
LM End	13.75	Issue Type +	Ma	Location *	LS
Category	Earthen Levee			GPS Latitude/Longitude	
				Start	End
Item	Vegetation			37.173767°	37.172157°
				-120.761018°	-120.761200°
DWR ID	DWR_NA0010_02B_s_2017_19				
Comment Code					
V2 : Remove the wild growth other than native grasses from the levee slopes.					
Inspector Comment

Looking north at landside slope.

Looking northwest at dense veg on landward slope.

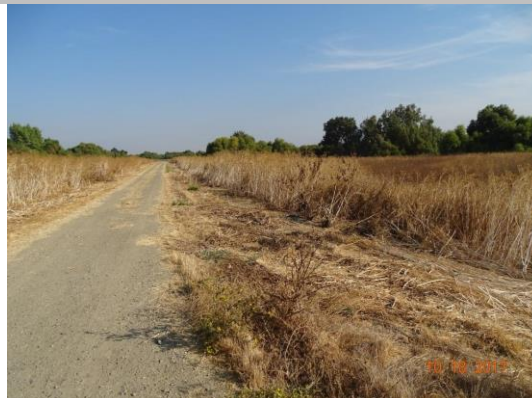
LM Start	13.64	Rating **	M	Issue No.	20
LM End	13.75	Issue Type +	Ma	Location *	WS
Category	Earthen Levee			GPS Latitude/Longitude	
				Start	End
Item	Vegetation			37.173767°	37.172157°
				-120.761018°	-120.761200°
DWR ID	DWR_NA0010_02B_s_2017_20				
Comment Code					
V2 : Remove the wild growth other than native grasses from the levee slopes.					
Inspector Comment

Looking north at waterside slope.

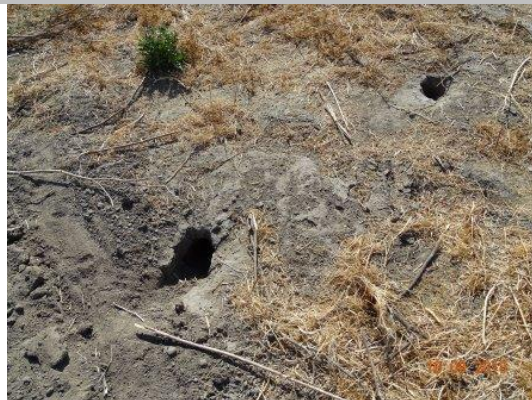
LM Start	13.73	Rating **	M	Issue No.	22 (cont)	
LM End	13.73	Issue Type +	Ma	Location *	WS	
Category	Earthen Levee			GPS Latitude/Longitude		
				Start		End
Item	Animal Control			37.172387°		37.172387°
				-120.761190°		-120.761190°
DWR ID	DWR_NA0010_02B_f_2018_22					
Comment Code						
A3 : No rodents visible, but rodent burrows visible; need to backfill and compact or grout burrows.						
Inspector Comment						
Several rodent burrows observed at this location

Representative view of rodent burrows. (Fall 2018)

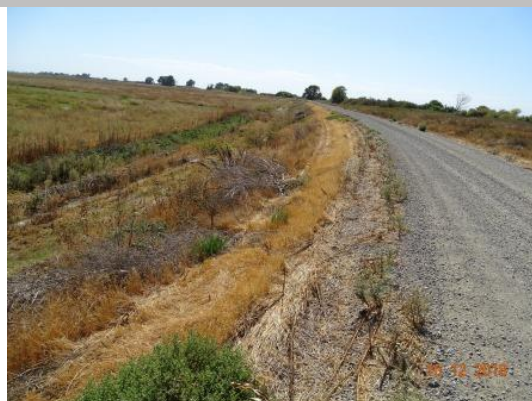
LM Start	0.03	Rating **	U	Issue No.	8
LM End	0.31	Issue Type +	Ma	Location *	LS
Category	Earthen Levee			GPS Latitude/Longitude	
				Start	End
Item	Vegetation			37.111385 °	37.107479 °
				-120.587746 °	-120.587075 °
DWR ID	DWR_NA0010_03_f_2018_8				
Comment Code					
V1 : Control annual grass and weeds on the levee slopes and easements.					
Inspector Comment					
dense grass and brush on landside slope and toe.

View of vegetation on landside slope and toe. (Fall 2018)

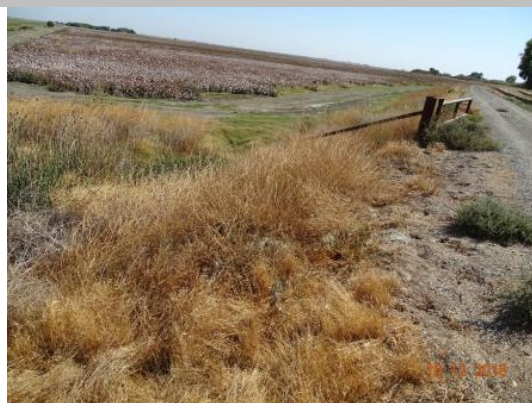
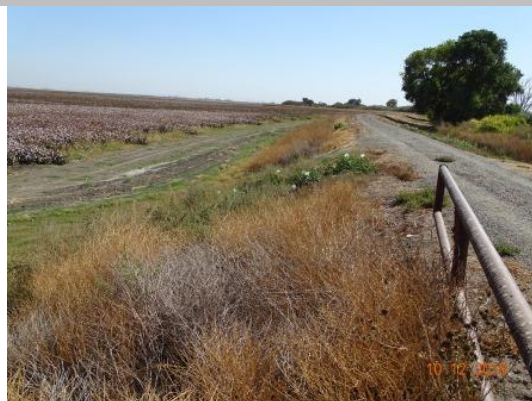
LM Start	0.41	Rating **	U	Issue No.	10
LM End	1.25	Issue Type +	Ma	Location *	LS
Category	Earthen Levee			GPS Latitude/Longitude	
				Start	End
Item	Vegetation			37.106291 °	37.097388 °
				-120.585867 °	-120.576644 °
DWR ID	DWR_NA0010_03_f_2018_10				
Comment Code					
V1 : Control annual grass and weeds on the levee slopes and easements.					
Inspector Comment					
landside slope only first 20 ft. mowed.

view vegetation on landside slope and toe. (Fall 2018)

view of landside slope and toe looking upstream. (Fall 2018)

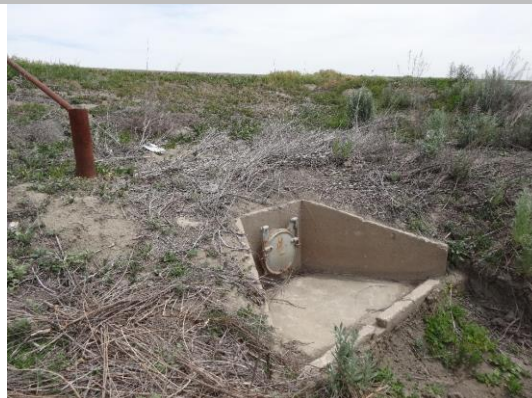
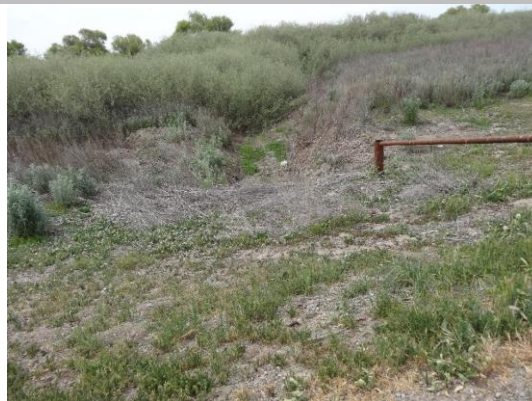
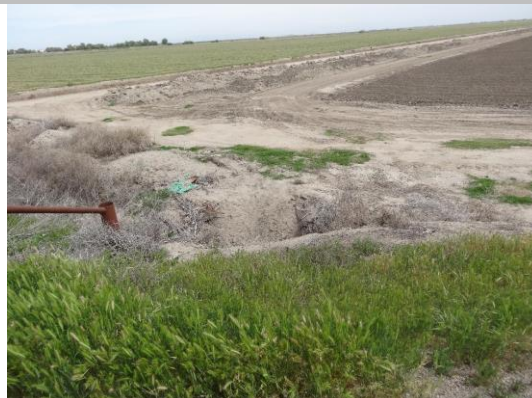
Concrete structure and flap gate visible on waterward side.

View of waterward side.

LM Start	0.42	Rating **	M	Issue No.	68 (cont)	
LM End	0.42	Issue Type +	Ma	Location *		
Category	Supplemental			GPS Latitude/Longitude		
				Start	End	
Item	DWR UCIP LMA Responsibility			37.106233 °	37.106233 °	
				-120.585797 °	-120.585797 °	
DWR ID	19691					
Comment Code						
Inspector Comment						
FS_ID:34083 DS_ID:19691 EP_NO: N/A Repair Type: Non-Urgent Crossing Status: Found UCIP Comments: 04/17/2014 Need to contact owner. Recommend removing tall grass on landward slope and clearing sediment build up inside pipe. (DWR UCIP - O. Magana) FIELD_STRUCT_DESC: 24-inch corrugated metal gravity drainage pipe through the levee, 11.3 feet below the crown. Flap gate on the waterside (WS) end. [Additional Reference(s): DWR Levee Log, 2002. USACE San Joaquin O&M Manual 601.1, 1967, (HLM 0.43)]. FS Date: 4/17/2014

View of landward side.

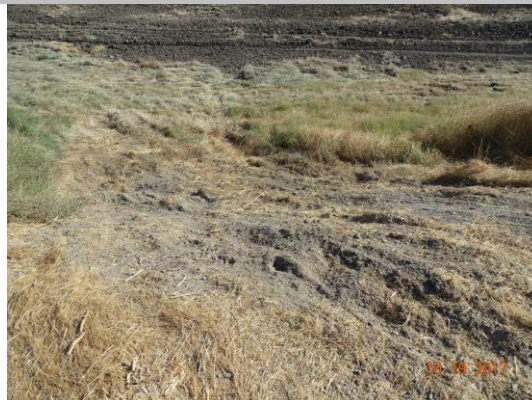
LM Start	0.43	Rating **	M	Issue No.	6
LM End	0.43	Issue Type +	Ma	Location *	LS
Category	Earthen Levee			GPS Latitude/Longitude	
				Start	End
Item	Slope Stability			37.106121 °	37.106121 °
				-120.585680 °	-120.585680 °
DWR ID	DWR_NA0010_03_f_2017_6				
Comment Code					
S3 : Repair the levee slope damaged by vehicle traffic and prevent access where possible.					
Inspector Comment

Looking east at the landside slope.

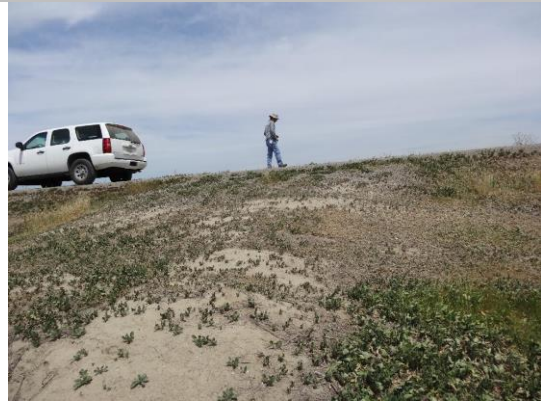
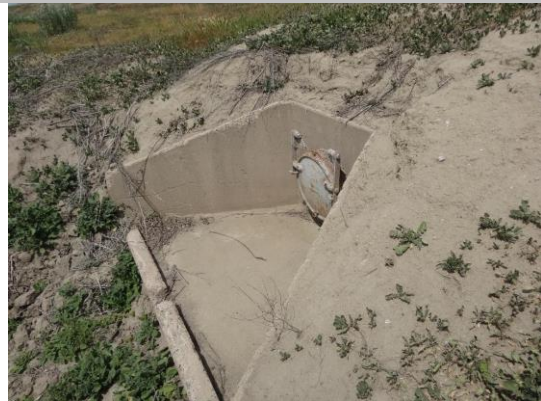
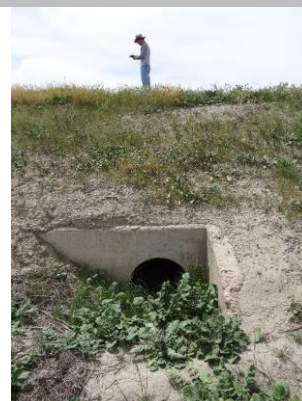
View of waterward slope.

Concrete structure located on waterward side.

LM Start	0.76	Rating **	A/W	Issue No.	69 (cont)	
LM End	0.76	Issue Type +	Ma	Location *		
Category	Supplemental			GPS Latitude/Longitude		
				Start	End	
Item	DWR UCIP LMA Responsibility			37.102964 °	37.102964 °	
				-120.581421 °	-120.581421 °	
DWR ID	19692					
Comment Code						
Inspector Comment						
FS_ID:36534						
DS_ID:19692						
EP_NO: N/A						
Repair Type: No Action Needed						
Crossing Status: Found						
UCIP Comments:						
FIELD_STRUCT_DESC: 24-inch corrugated metal gravity drainage pipe through the levee, 9.3 feet below the crown. Flap gate on the waterside (WS) end. [Additional Reference(s): DWR Levee Log, 2002. USACE San Joaquin O&M Manual 601.1, 1967, (HLM 0.77)].						
FS Date: 4/17/2014

View of landward slope.

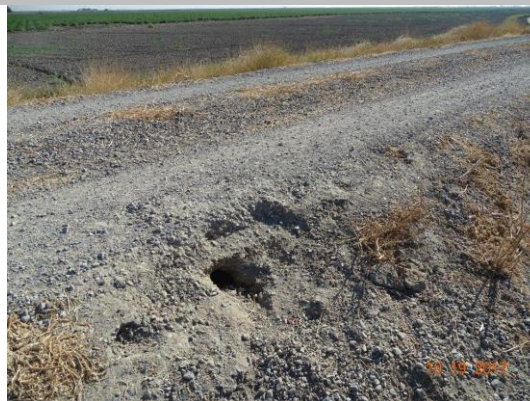
LM Start	0.83	Rating **	M	Issue No.	7
LM End	0.83	Issue Type +	Ma	Location *	CR
Category	Earthen Levee			GPS Latitude/Longitude	
				Start	End
Item	Animal Control			37.102190 °	37.102190 °
				-120.580717 °	-120.580717 °
DWR ID	DWR_NA0010_03_f_2017_7				
Comment Code					
A1 : Exterminate rodents and backfill and compact or grout burrows.					
Inspector Comment

Looking southeast at the waterside shoulder.

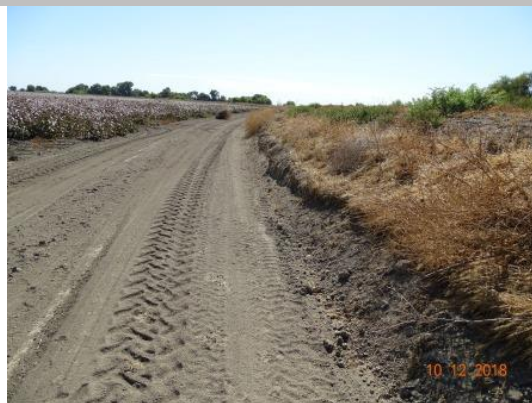
LM Start	1.74	Rating **	M	Issue No.	13
LM End	1.87	Issue Type +	En	Location *	LS
Category	Earthen Levee			GPS Latitude/Longitude	
				Start	End
Item	Encroachments			37.091698 °	37.090338 °
				-120.572058 °	-120.570537 °
DWR ID	DWR_NA0010_03_f_2018_13				
Comment Code					
AT : Agricultural tilling					
Inspector Comment					
Landside slope has been cut in to by farming equipment

view of landside slope at toe where levee has been cut in. (Fall 2018)

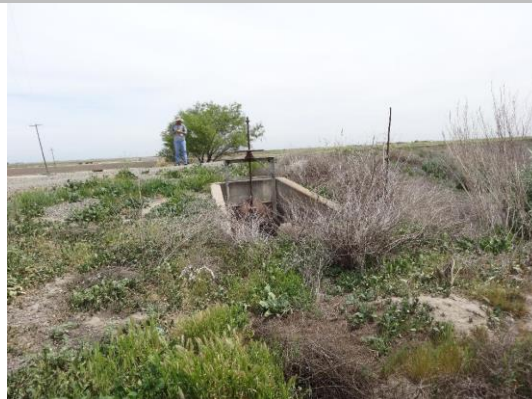
Comment Code					
Inspector Comment					
FS_ID:36543 DS_ID:19694 EP_NO: N/A Repair Type: Non-Urgent Crossing Status: Found UCIP Comments: 04/17/2014 Need to contact owner--additional appurtenances found on waterward side not part of original description. Unable to determine if walkway, pump, and pipe through waterward berm is if part of original crossing. (DWR UCIP - O. Magana) FIELD_STRUCT_DESC: 36-inch corrugated metal irrigation discharge pipe through the levee, 6.6 feet below the crown. Pump on the riverbank. Slide gate on the waterside (WS) end. [Additional Reference(s): DWR Levee Log, 2002. USACE San Joaquin O&M Manual 601.1, 1967, (HLM 2.05)]. FS Date: 4/17/2014

Slide gate and concrete structure located on waterward slope.

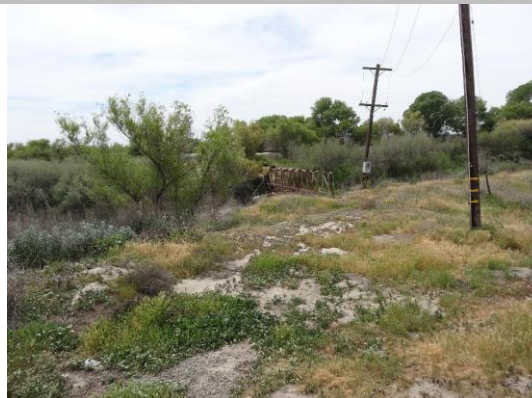
Photo 2 of 3 : UCIP_FA_2018_36543_66282.jpg

Comment Code						
Inspector Comment						
FS_ID:36543 DS_ID:19694 EP_NO: N/A Repair Type: Non-Urgent Crossing Status: Found UCIP Comments: 04/17/2014 Need to contact owner--additional appurtenances found on waterward side not part of original description. Unable to determine if walkway, pump, and pipe through waterward berm is if part of original crossing. (DWR UCIP - O. Magana) FIELD_STRUCT_DESC: 36-inch corrugated metal irrigation discharge pipe through the levee, 6.6 feet below the crown. Pump on the riverbank. Slide gate on the waterside (WS) end. [Additional Reference(s): DWR Levee Log, 2002. USACE San Joaquin O&M Manual 601.1, 1967, (HLM 2.05)]. FS Date: 4/17/2014

View of walkway and berm on waterward side.

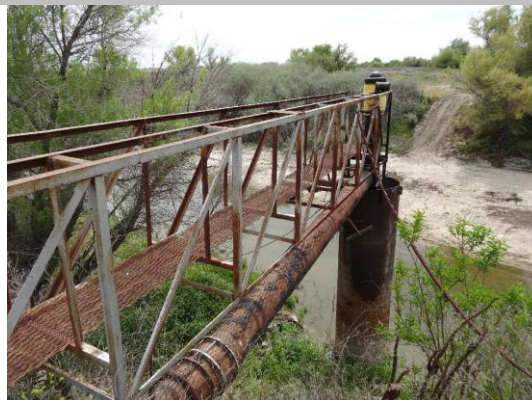
Photo 3 of 3 : UCIP_FA_2018_36543_66280.jpg

Pump and damage walkway located on waterward side.

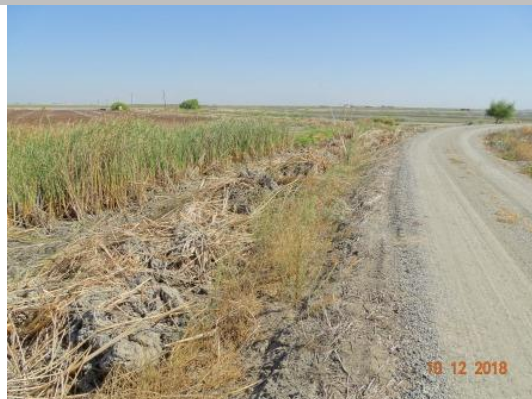
Photo 1 of 1 : FA_2018_NA0010_121_14_20181101_00021.jpg

LM Start	2.07	Rating **	U	Issue No.	14
LM End	2.09	Issue Type +	En	Location *	LS
Category	Earthen Levee			GPS Latitude/Longitude	
				Start	End
Item	Encroachments			37.089177 °	37.089070 °
				-120.567126 °	-120.566977 °
DWR ID	DWR_NA0010_03_f_2018_14				
Comment Code					
DE : Debris					
Inspector Comment					
debris from ditch

View of dredge from ditch left on landside slope. (Fall 2018)

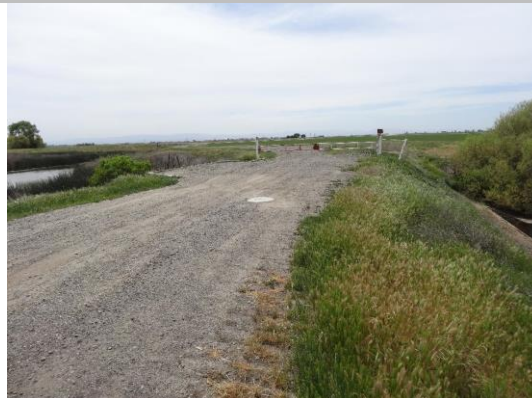
Photo 2 of 3 : UCIP_FA_2018_40529_61968.jpg

View of levee crown.

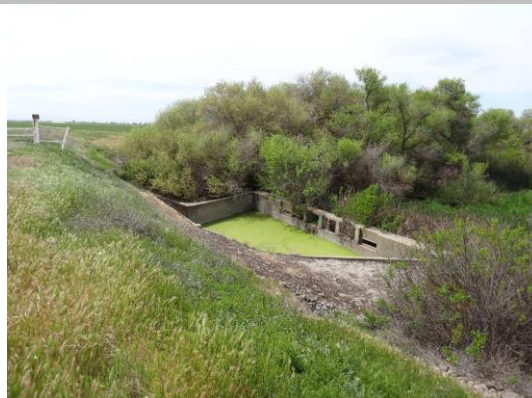
Photo 1 of 3 : UCIP_FA_2018_36875_67308.jpg

Comment Code					
Inspector Comment					
FS_ID:36875					
DS_ID:24856					
EP_NO: 5024					
Repair Type: Non-Urgent					
Crossing Status: Found					
UCIP Comments: 04/17/2014 Slide gates blocked by sediment.					
Recommend contacting owner to determine status of crossing.					
Crossing appears to be abandoned. (DWR UCIP - O. Magana)					
FIELD_STRUCT_DESC: [San Joaquin River Diversion Structure] 2 of 4:					
72-inch by 60-inch reinforced concrete box gravity drainage culvert					
through the levee, 21 feet below the crown. Slide gate on the waterside					
(WS). Concrete headwall on each end. Landside (LS) slope cobble					
revetted. Flashboards on the downstream side of the structure.					
FS Date: 4/17/2014

View of concrete structure located on landward side.

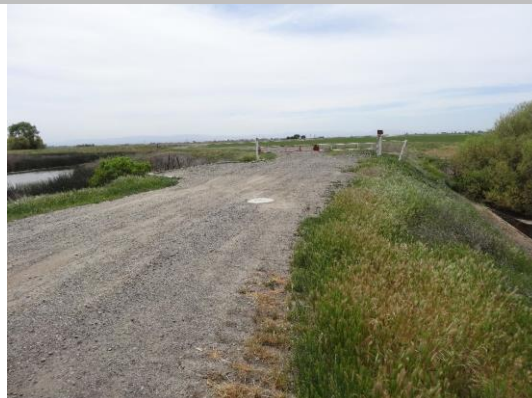
Photo 2 of 3 : UCIP_FA_2018_36875_67307.jpg

View of levee crown.

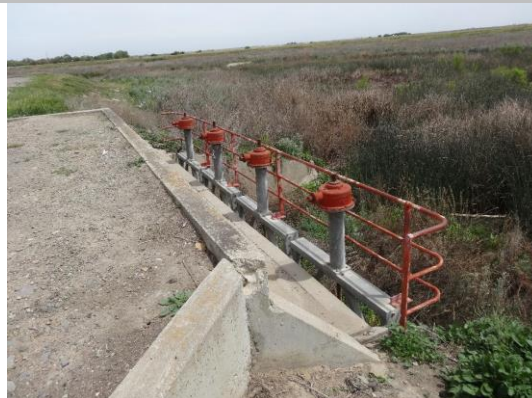
Photo 3 of 3 : UCIP_FA_2018_36875_67306.jpg

Comment Code						
Inspector Comment						
FS_ID:36875						
DS_ID:24856						
EP_NO: 5024						
Repair Type: Non-Urgent						
Crossing Status: Found						
UCIP Comments: 04/17/2014 Slide gates blocked by sediment.						
Recommend contacting owner to determine status of crossing.						
Crossing appears to be abandoned. (DWR UCIP - O. Magana)						
FIELD_STRUCT_DESC: [San Joaquin River Diversion Structure] 2 of 4:						
72-inch by 60-inch reinforced concrete box gravity drainage culvert						
through the levee, 21 feet below the crown. Slide gate on the waterside						
(WS). Concrete headwall on each end. Landside (LS) slope cobble						
revetted. Flashboards on the downstream side of the structure.						
FS Date: 4/17/2014

Concrete headwall located on waterward side.

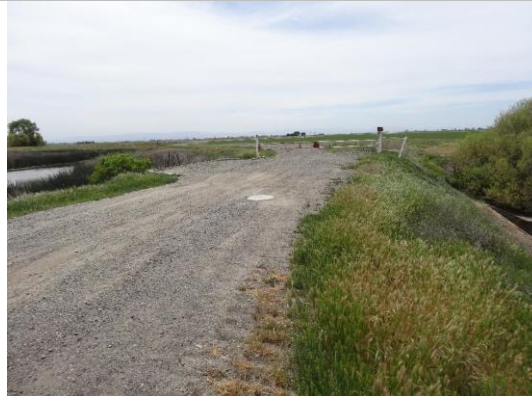
Photo 2 of 3 : UCIP_FA_2018_36876_67317.jpg

View of levee crown.

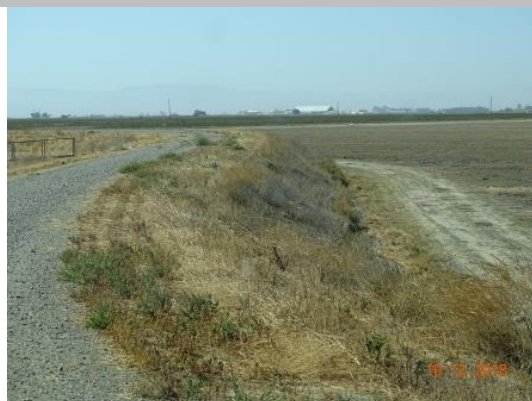
Photo 1 of 1 : FA_2018_NA0010_122_9_20181101_00023.jpg

LM Start	0.06	Rating **	M	Issue No.	9
LM End	0.30	Issue Type +	Ma	Location *	LS
Category	Earthen Levee			GPS Latitude/Longitude	
				Start	End
Item	Vegetation			37.112129°	37.109036°
				-120.589946°	-120.590809°
DWR ID	DWR_NA0010_04_f_2018_9				
Comment Code					
V1 : Control annual grass and weeds on the levee slopes and easements.					
Inspector Comment					
Patches of heavy vegetation on landside slope

View of vegetation on landside slope looking upstream. (Fall 2018)

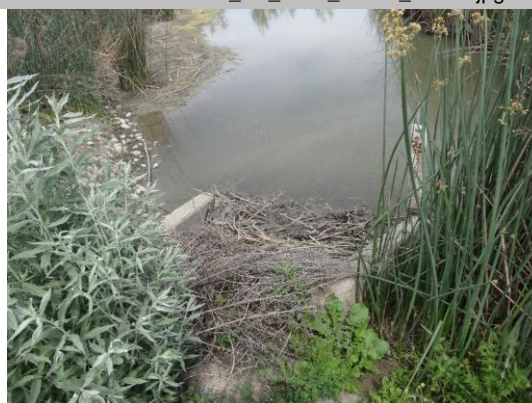
Photo 1 of 3 : UCIP_FA_2018_34093_61982.jpg

Comment Code						
Inspector Comment						
FS_ID:34093 DS_ID:19695 EP_NO: N/A Repair Type: Non-Urgent Crossing Status: Found UCIP Comments: 04/17/2014 Sediment and debris blocking concrete headwall located on waterward side. During inspection water was flowing from landward side to waterward side. Recommend removing sediment to confirm condition of flap gate and pipe. (DWR UCIP - O. Magana) FIELD_STRUCT_DESC: 36-inch corrugated metal gravity drainage pipe through the levee, 18 feet below the crown. Flap gate on the waterside (WS) end. Concrete headwall on each end. [Additional Reference(s): DWR Levee Log, 2002. USACE San Joaquin O&M Manual 601.1, 1967, (HLM 0.27)]. FS Date: 4/17/2014

View of dense vegetation near concrete headwall located on waterward side.

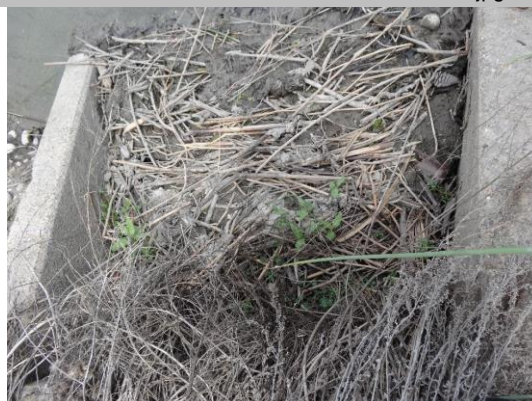
Photo 2 of 3 : UCIP_FA_2018_34093_61981.jpg

Comment Code						
Inspector Comment						
FS_ID:34093						
DS_ID:19695						
EP_NO: N/A						
Repair Type: Non-Urgent						
Crossing Status: Found						
UCIP Comments: 04/17/2014 Sediment and debris blocking concrete headwall located on waterward side. During inspection water was flowing from landward side to waterward side. Recommend removing sediment to confirm condition of flap gate and pipe. (DWR UCIP - O. Magana)						
FIELD_STRUCT_DESC: 36-inch corrugated metal gravity drainage pipe through the levee, 18 feet below the crown. Flap gate on the waterside (WS) end. Concrete headwall on each end. [Additional Reference(s): DWR Levee Log, 2002. USACE San Joaquin O&M Manual 601.1, 1967, (HLM 0.27)].						
FS Date: 4/17/2014

Sediment blocking flap gate located on waterward side.

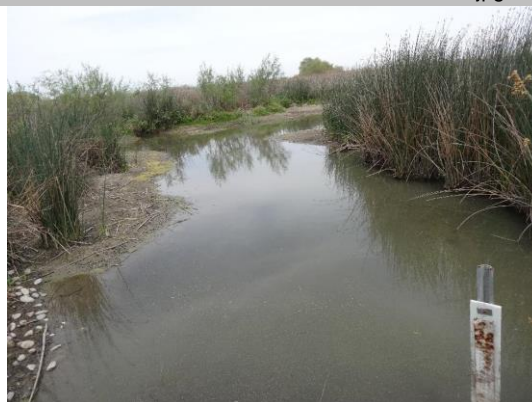
Photo 3 of 3 : UCIP_FA_2018_34093_61980.jpg

View of waterward side.

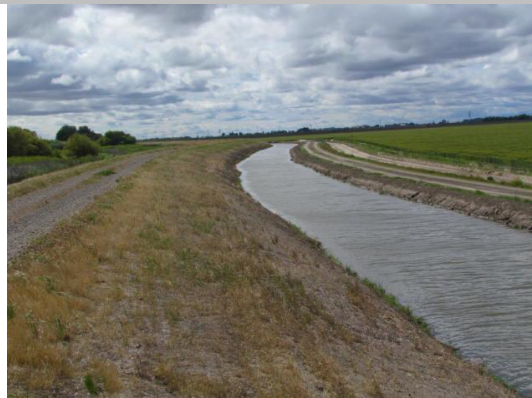
Photo 1 of 3 : FA_2018_NA0010_122_3_20180911_00001.jpg

LM Start	0.32	Rating **	M	Issue No.	3
LM End	1.41	Issue Type +	En	Location *	LS
Category	Earthen Levee			GPS Latitude/Longitude	
				Start	End
Item	Encroachments			37.108822°	37.097556°
				-120.590718°	-120.578130°
DWR ID	DWR_NA0010_04_s_2012_3				
Comment Code					
DT : Ditch					
Inspector Comment					
Agricultural ditch within 10' easement.

Looking north at irrigation ditch at landside toe.

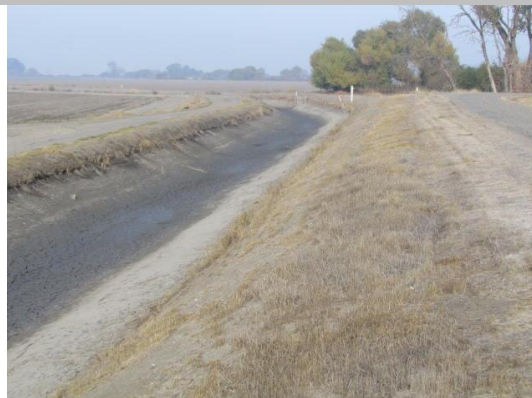
Photo 2 of 3 : FA_2018_NA0010_122_3_20180911_00002.jpg

Looking north at irrigation ditch at landward toe. (Fall 2013)

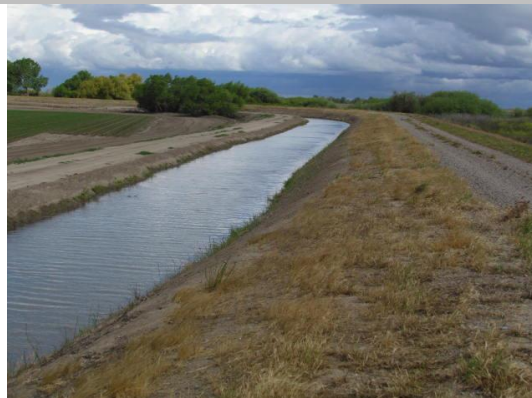
Photo 3 of 3 : FA_2018_NA0010_122_3_20180911_00003.jpg

Looking north at irrigation ditch at landside toe.

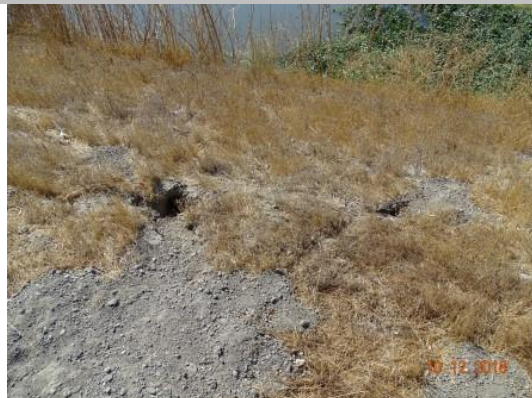
Photo 1 of 1 : FA_2018_NA0010_122_11_20181101_00024.jpg

LM Start	0.48	Rating **	M	Issue No.	11
LM End	0.48	Issue Type +	Ma	Location *	LS
Category	Earthen Levee			GPS Latitude/Longitude	
				Start	End
Item	Animal Control			37.106754 °	37.106754 °
				-120.589459 °	-120.589459 °
DWR ID	DWR_NA0010_04_f_2018_11				
Comment Code					
A3 : No rodents visible, but rodent burrows visible; need to backfill and compact or grout burrows.					
Inspector Comment					
several rodent holes in landside shoulder and slope.

Rodent burrows in landside shoulder and slope. (Fall 2018)
