**Flood Control Project Maintenance
Levee Inspections**

Fall 2018 Levee Maintenance Deficiency Summary Report

San Joaquin River Basin

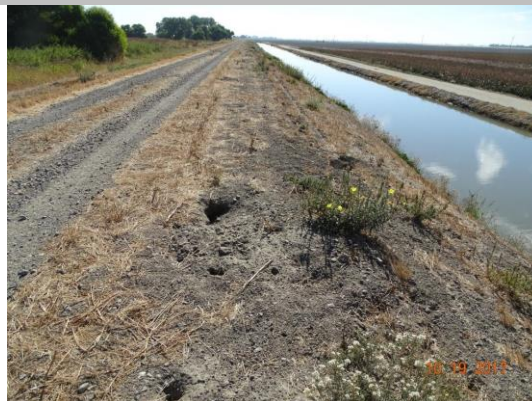
Photo 1 of 1 : FA_2018_NA0010_122_8_20180911_00004.jpg

LM Start	0.55	Rating **	M	Issue No.	8
LM End	0.55	Issue Type +	Ma	Location *	LS
Category	Earthen Levee			GPS Latitude/Longitude	
				Start	End
Item	Animal Control			37.105957 °	37.105957 °
				-120.588684 °	-120.588684 °
DWR ID	DWR_NA0010_04_f_2017_8				
Comment Code					
A3 : No rodents visible, but rodent burrows visible; need to backfill and compact or grout burrows.					
Inspector Comment

Looking south at landside slope.

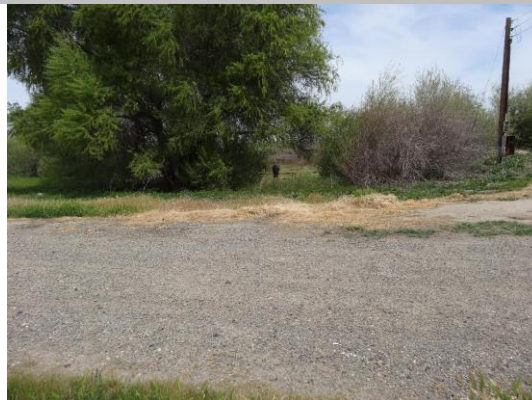
Photo 1 of 3 : UCIP_FA_2018_40530_61987.jpg

LM Start	1.34	Rating **	M	Issue No.	17	
LM End	1.34	Issue Type +	En	Location *		
Category	Supplemental			GPS Latitude/Longitude		
				Start	End	
Item	DWR UCIP Field Study			37.095274 °	37.095274 °	
				-120.577959 °	-120.577959 °	
DWR ID	19975					
Comment Code						
Inspector Comment						
FS_ID:40530						
DS_ID:19975						
EP_NO: 3416						
Repair Type: Non-Urgent						
Crossing Status: Found						
UCIP Comments: Unable to confirm if crossing is still in use. Need to contact owner to confirm status.						
FIELD_STRUCT_DESC: 12-inch steel irrigation pipe, encased in 6-inches of reinforced concrete through the levee. Concrete cutoff wall at center of levee. Pumping plant on the waterward bank. Pump and irrigation pipe retained under Permit No. 3416 (1964).						
FS Date: 4/17/2014

View of waterward side.

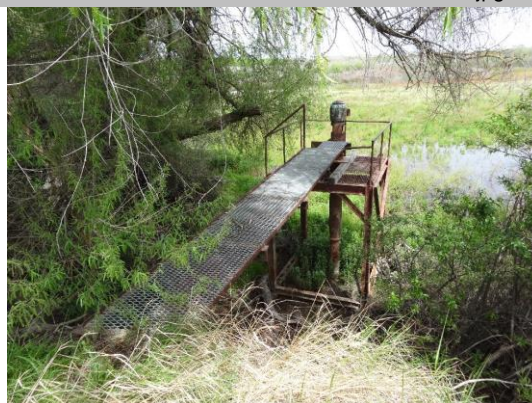
Photo 3 of 3 : UCIP_FA_2018_40530_61986.jpg

LM Start	1.34	Rating **	M	Issue No.	17 (cont)	
LM End	1.34	Issue Type +	En	Location *		
Category	Supplemental			GPS Latitude/Longitude		
				Start	End	
Item	DWR UCIP Field Study			37.095274 °	37.095274 °	
				-120.577959 °	-120.577959 °	
DWR ID	19975					
Comment Code						
Inspector Comment						
FS_ID:40530						
DS_ID:19975						
EP_NO: 3416						
Repair Type: Non-Urgent						
Crossing Status: Found						
UCIP Comments: Unable to confirm if crossing is still in use. Need to contact owner to confirm status.						
FIELD_STRUCT_DESC: 12-inch steel irrigation pipe, encased in 6-inches of reinforced concrete through the levee. Concrete cutoff wall at center of levee. Pumping plant on the waterward bank. Pump and irrigation pipe retained under Permit No. 3416 (1964).						
FS Date: 4/17/2014

Pump and walkway located on waterward side.

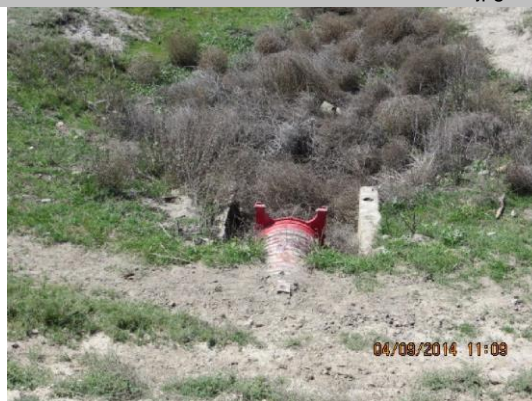
Photo 1 of 3 : UCIP_FA_2018_39563_60921.jpg

LM Start	0.08	Rating **	M	Issue No.	1310
LM End	0.08	Issue Type +	Ma	Location *	
Category	Supplemental			GPS Latitude/Longitude	
				Start	End
Item	DWR UCIP LMA Responsibility			37.278174 °	37.278174 °
				-120.823465 °	-120.823465 °
DWR ID	19756				
Comment Code					
Inspector Comment					
FS_ID:39563 DS_ID:19756 EP_NO: N/A Repair Type: Non-Urgent Crossing Status: Found UCIP Comments: 04/09/2014 Debris blocking landward headwall-- recommend clearing. (DWR UCIP - W. Wylie) FIELD_STRUCT_DESC: 24-inch corrugated metal gravity drainage pipe through the levee, 8.6 feet below the crown. Concrete U-shaped headwall and flap gate on the waterside (WS) end. Concrete headwall on the landside (LS) end. [Additional Reference(s): DWR Levee Log, 2002. USACE San Joaquin O&M Manual 601.1, 1967, (HLM 0.07)]. FS Date: 4/9/2014

Pipe, flapgate, and concrete headwall on WS toe.

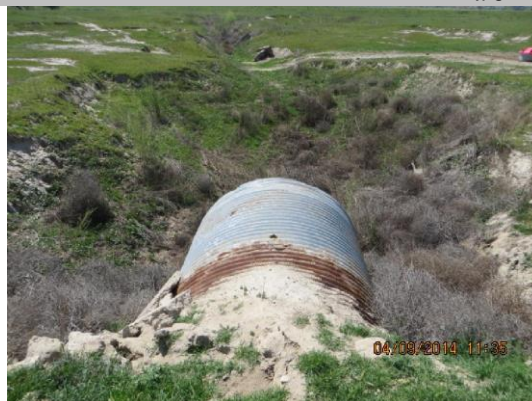
Photo 2 of 3 : UCIP_FA_2018_53185_71467.jpg

Pipe on WS toe.

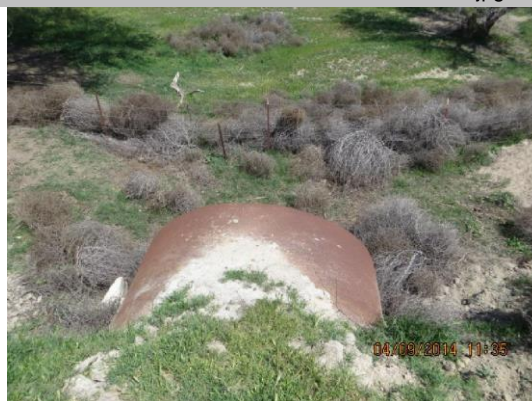
Photo 3 of 3 : UCIP_FA_2018_53185_71468.jpg

Pipe on LS toe.

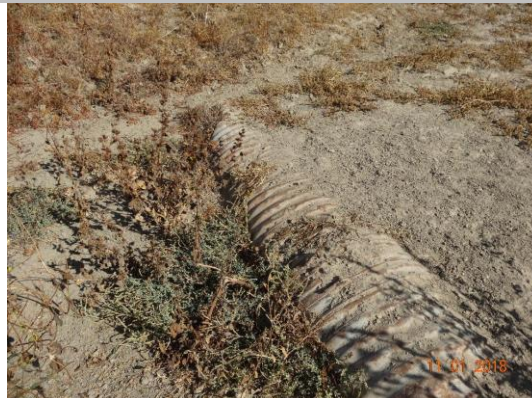
Photo 2 of 3 : UCIP_FA_2018_53194_78593.jpg

LS view: CMP section found on LS.

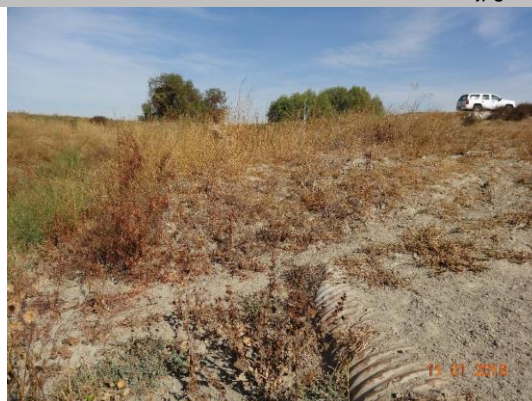
Photo 3 of 3 : UCIP_FA_2018_53194_78594.jpg

LS view: 24-inch pipe section found west of LS toe.

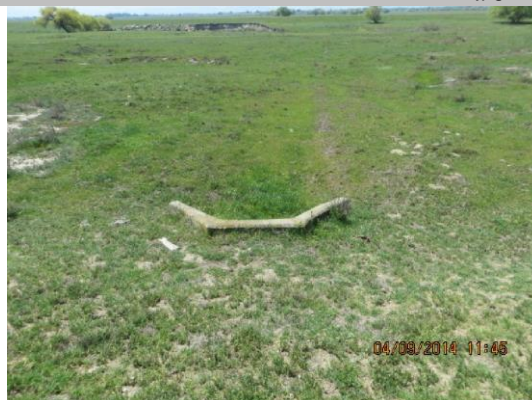
Photo 1 of 3 : UCIP_FA_2018_39584_60926.jpg

Concrete headwall, pipe, and flapgate on WS toe.

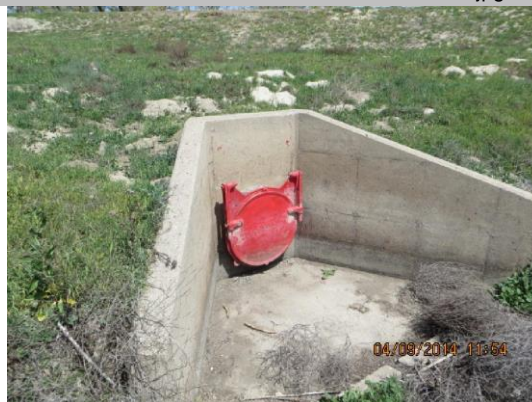
Photo 2 of 3 : UCIP_FA_2018_39585_60929.jpg

Pipe, flapgate, and headwall at WS toe.

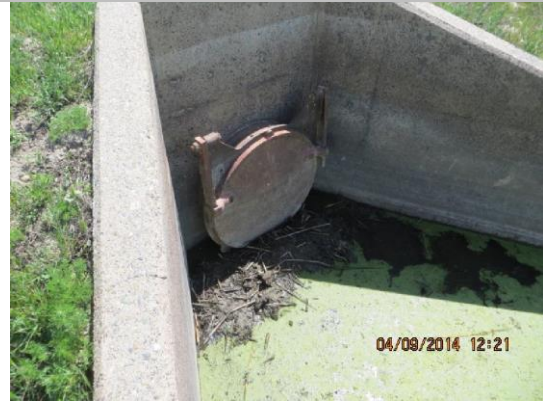
Photo 2 of 3 : UCIP_FA_2018_33708_60938.jpg

Flapgate on concrete headwall at WS toe.

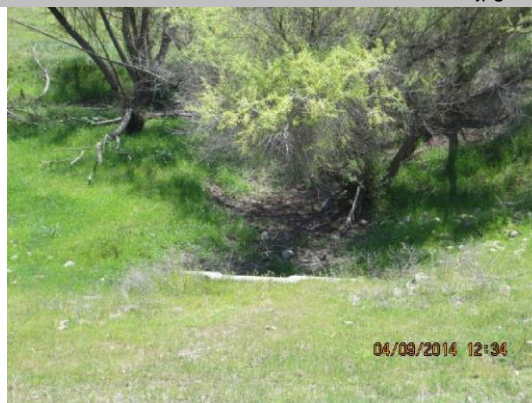
Photo 1 of 3 : UCIP_FA_2018_33709_60943.jpg

Concrete headwall at outlet on WS toe.

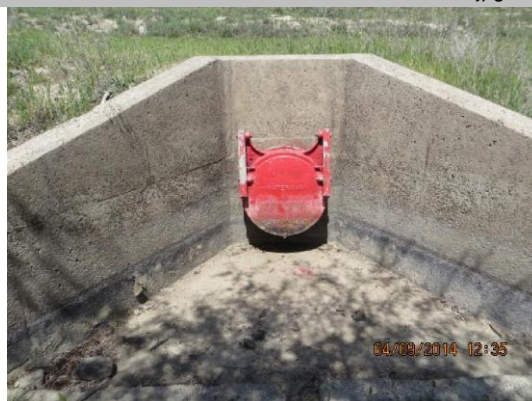
Photo 2 of 3 : UCIP_FA_2018_33709_60941.jpg

Headwall, pipe, and flapgate on WS toe.

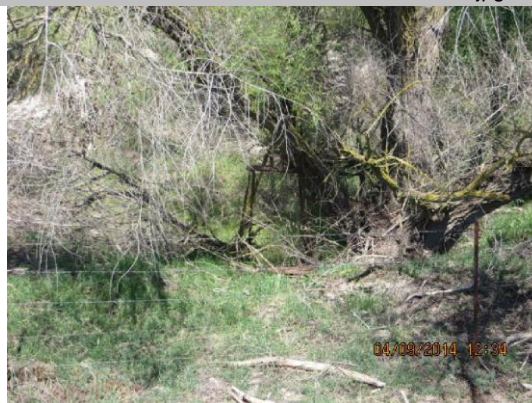
Photo 3 of 3 : UCIP_FA_2018_33709_60942.jpg

Concrete headwall and metal gate hoist on LS toe.

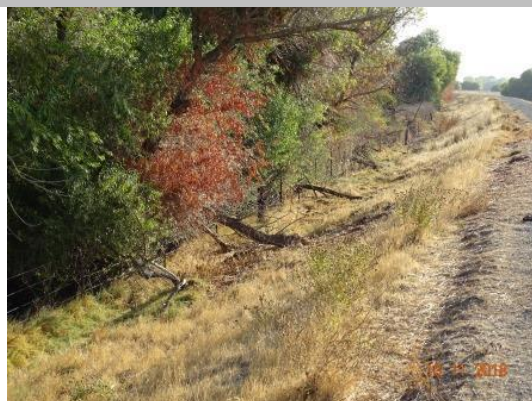
Photo 1 of 1 : FA_2018_NA0010_123_126_20181101_00309.jpg

LM Start	2.85	Rating **	M	Issue No.	126
LM End	2.85	Issue Type +	Ma	Location *	LS
Category	Earthen Levee			GPS Latitude/Longitude	
				Start	End
Item	Encroachments			37.256821 °	37.256821 °
				-120.784924 °	-120.784924 °
DWR ID	DWR_NA0010_05_f_2018_126				
Comment Code					
TR : Tree or limb					
Inspector Comment					
Several fallen tree limbs on landside slope and toe

Several tree limbs on landside slope and toe. (Fall 2018)

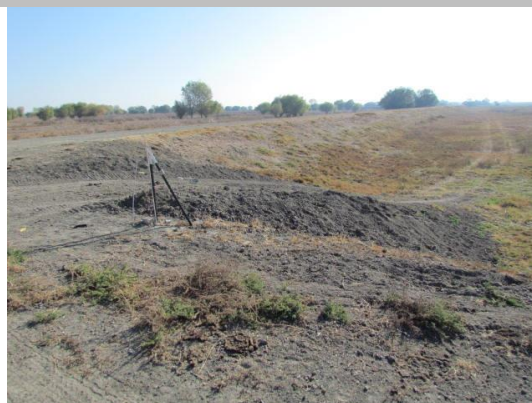
Photo 1 of 3 : FA_2018_NA0010_123_7_20180911_00007.jpg

LM Start	3.20	Rating **	M	Issue No.	7
LM End	3.20	Issue Type +	En	Location *	WS
Category	Earthen Levee			GPS Latitude/Longitude	
				Start	End
Item	Encroachments			37.256554 °	37.256554 °
				-120.778847 °	-120.778847 °
DWR ID	DWR_NA0010_05_f_2012_7				
Comment Code					
RA : Ramp					
Inspector Comment					
Unauthorized ramp on waterside slope.

Looking south at unauthorized ramp on waterside slope.

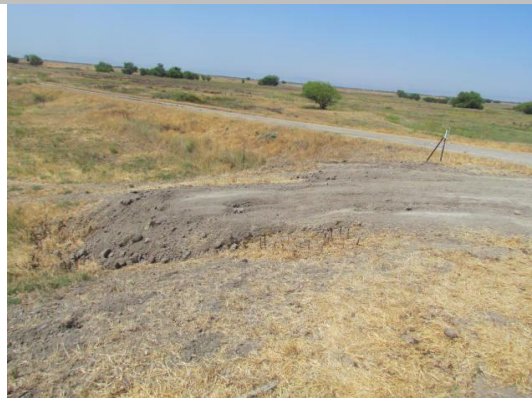
Photo 2 of 3 : FA_2018_NA0010_123_7_20180911_00008.jpg

Looking northwest at unauthorized ramp on waterward slope.

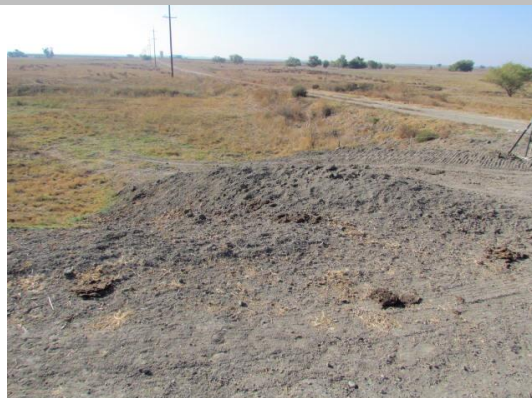
Photo 3 of 3 : FA_2018_NA0010_123_7_20180911_00009.jpg

Looking northwest at unauthorized ramp on waterside slope.

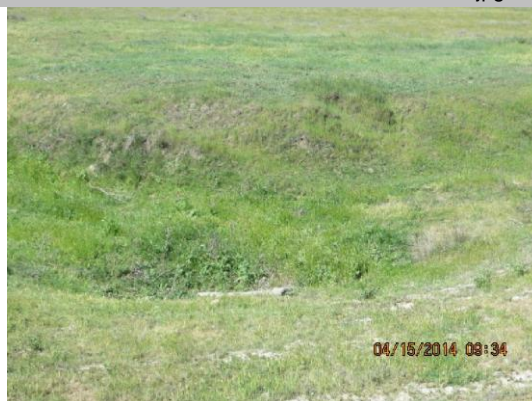
Photo 1 of 3 : UCIP_FA_2018_43055_60948.jpg

Concrete headwall at WS toe.

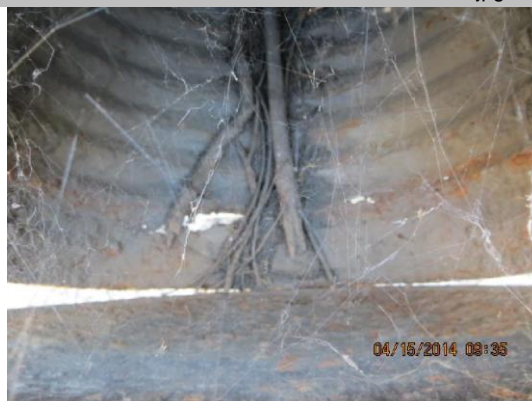
Photo 3 of 3 : UCIP_FA_2018_43055_60951.jpg

LM Start	3.34	Rating **	M	Issue No.	1318 (cont)
LM End	3.34	Issue Type +	Ma	Location *	
Category	Supplemental			GPS Latitude/Longitude	
				Start	End
Item	DWR UCIP LMA Responsibility			37.255258°	37.255258°
				-120.776996°	-120.776996°
DWR ID	19810				
Comment Code					
Inspector Comment					
FS_ID:43055 DS_ID:19810 EP_NO: N/A Repair Type: Non-Urgent Crossing Status: Found UCIP Comments: 04/15/2014 Pipe corroded through at flapgate on WS toe. (DWR UCIP - W. Wylie) FIELD_STRUCT_DESC: 24-inch corrugated metal gravity drainage pipe through the levee, 14.7 feet below the crown. Flap gate on the waterside (WS) end. Concrete U-shaped headwall on each end. [Additional Reference(s): DWR Levee Log, 2002. USACE San Joaquin O&M Manual 601.1, 1967, (HLM 3.33)]. FS Date: 4/15/2014

Pipe corroded through just behind flapgate at WS toe.

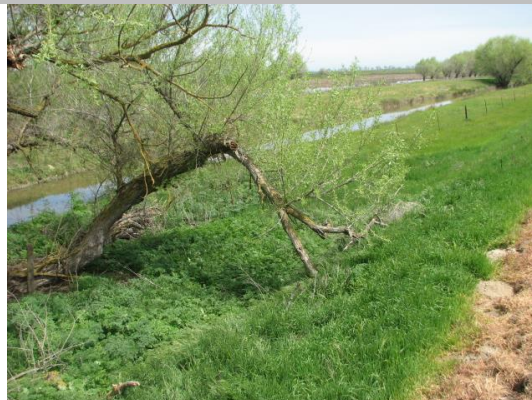
Photo 1 of 2 : FA_2018_NA0010_123_114_20180911_00022.jpg

LM Start	3.54	Rating **	M	Issue No.	114
LM End	3.54	Issue Type +	Ma	Location *	LS
Category	Earthen Levee			GPS Latitude/Longitude	
				Start	End
Item	Encroachments			37.255191°	37.255191°
				-120.773667°	-120.773667°
DWR ID	DWR_NA0010_05_f_2017_114				
Comment Code					
TR : Tree or limb					
Inspector Comment					
Broken tree branch on landward slope and toe.

Looking upstream at broken tree limb on landward slope. (Spring 2018)

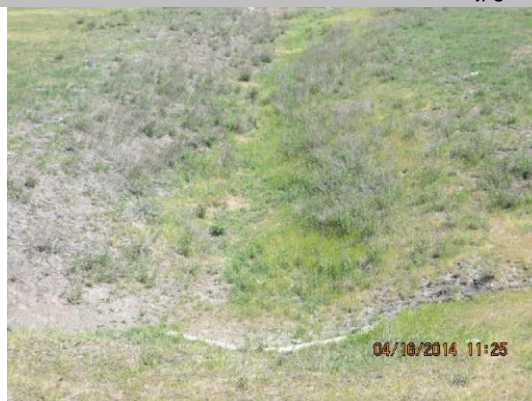
Photo 1 of 3 : UCIP_FA_2018_39586_61137.jpg

Comment Code						
Inspector Comment						
FS_ID:39586						
DS_ID:19811						
EP_NO: N/A						
Repair Type: Non-Urgent						
Crossing Status: Found						
UCIP Comments: 04/16/2014 Sediment buildup in pipe visible from						
landward side--recommend contacting owner to clear pipe. (DWR						
UCIP - W. Wylie)						
FIELD_STRUCT_DESC: 24-inch corrugated metal gravity drainage pipe						
through the levee, 15 feet below the crown. Flap gate on the waterside						
(WS) end. Concrete headwall on the landside (LS) end. Concrete U-						
shaped headwall on the WS end. [Additional Reference(s): DWR Levee						
Log, 2002. USACE San Joaquin O&M Manual 601.1, 1967, (HLM 3.67)].						
FS Date: 4/16/2014

Pipe, headwall, and flapgate on WS toe.

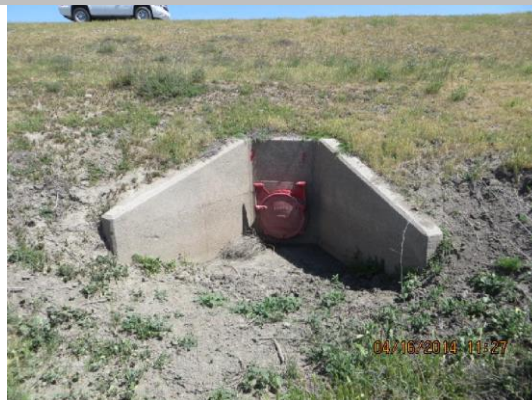
Photo 2 of 3 : UCIP_FA_2018_39586_61138.jpg

Pipe, headwall, and flapgate on WS toe.

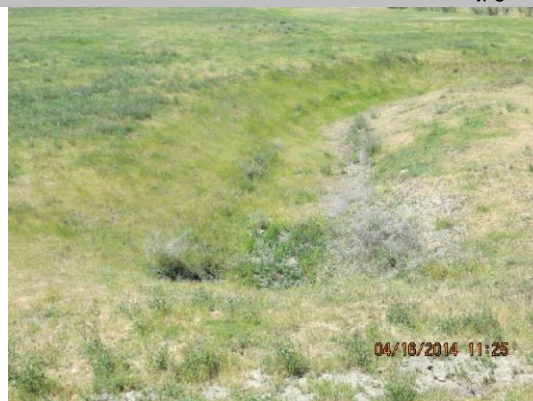
Photo 3 of 3 : UCIP_FA_2018_39586_61136.jpg

LM Start	3.68	Rating **	M	Issue No.	1319 (cont)
LM End	3.68	Issue Type +	Ma	Location *	
Category	Supplemental			GPS Latitude/Longitude	
				Start	End
Item	DWR UCIP LMA Responsibility			37.252308 °	37.252308 °
				-120.768038 °	-120.768038 °
DWR ID	19811				
Comment Code					
Inspector Comment					
FS_ID:39586 DS_ID:19811 EP_NO: N/A Repair Type: Non-Urgent Crossing Status: Found UCIP Comments: 04/16/2014 Sediment buildup in pipe visible from landward side--recommend contacting owner to clear pipe. (DWR UCIP - W. Wylie) FIELD_STRUCT_DESC: 24-inch corrugated metal gravity drainage pipe through the levee, 15 feet below the crown. Flap gate on the waterside (WS) end. Concrete headwall on the landside (LS) end. Concrete U-shaped headwall on the WS end. [Additional Reference(s): DWR Levee Log, 2002. USACE San Joaquin O&M Manual 601.1, 1967, (HLM 3.67)]. FS Date: 4/16/2014

Pipe and headwall on LS toe.

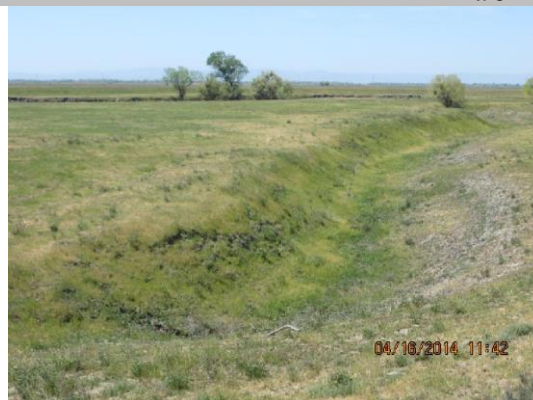
Photo 1 of 3 : UCIP_FA_2018_39880_61142.jpg

LM Start	4.02	Rating **	M	Issue No.	1320
LM End	4.02	Issue Type +	Ma	Location *	
Category	Supplemental			GPS Latitude/Longitude	
				Start	End
Item	DWR UCIP LMA Responsibility			37.248432 °	37.248432 °
				-120.764066 °	-120.764066 °
DWR ID	19769				
Comment Code					
Inspector Comment					
FS_ID:39880					
DS_ID:19769					
EP_NO: N/A					
Repair Type: Non-Urgent					
Crossing Status: Found					
UCIP Comments: 04/16/2014 Sediment buildup in pipe visible from landward side--recommend contacting owner to clear pipe. (DWR UCIP - W. Wylie)					
FIELD_STRUCT_DESC: 24-inch corrugated metal gravity drainage pipe through the levee, 16 feet below the crown. Flap gate on the waterside (WS) end. Concrete U-shaped headwall on each end. [Additional Reference(s): DWR Levee Log, 2002. USACE San Joaquin O&M Manual 601.1, 1967, (HLM 4.02)].					
FS Date: 4/16/2014

Pipe, headwall, and flapgate on WS toe.

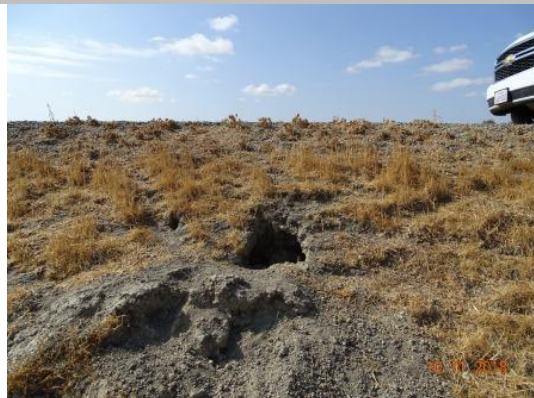
Photo 1 of 2 : FA_2018_NA0010_123_131_20181101_00310.jpg

LM Start	4.33	Rating **	U	Issue No.	131
LM End	4.33	Issue Type +	Ma	Location *	LS
Category	Earthen Levee			GPS Latitude/Longitude	
				Start	End
Item	Animal Control			37.245406 °	37.245406 °
				-120.759971 °	-120.759971 °
DWR ID	DWR_NA0010_05_f_2018_131				
Comment Code					
A3 : No rodents visible, but rodent burrows visible; need to backfill and compact or grout burrows.					
Inspector Comment					
several large rodent holes in both sides of levee

View of a large rodent hole in landward slope. (Fall 2018)

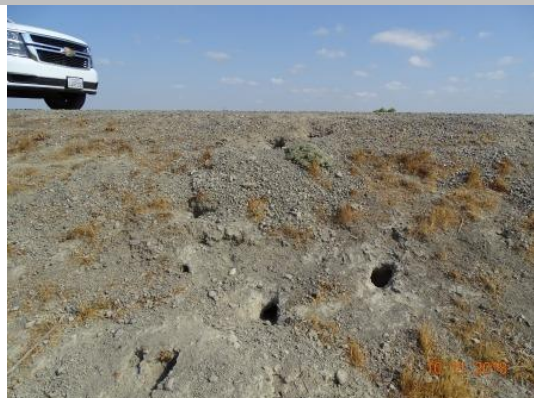
Photo 2 of 2 : FA_2018_NA0010_123_131_20181101_00312.jpg

View of several rodent burrows in landward slope. (Fall 2018)

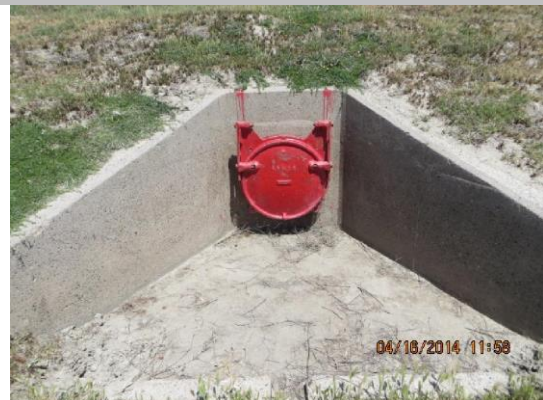
Photo 2 of 3 : UCIP_FA_2018_39589_62083.jpg

Pipe, flapgate, and headwall on WS toe.

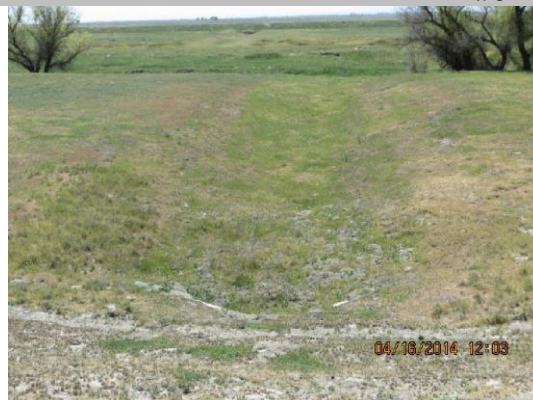
Photo 1 of 3 : UCIP_FA_2018_39590_62087.jpg

Comment Code					
Inspector Comment					
FS_ID:39590					
DS_ID:19772					
EP_NO: N/A					
Repair Type: Non-Urgent					
Crossing Status: Found					
UCIP Comments: 04/16/2014 Heavy sediment buildup in pipe visible from landward side--recommend contacting owner to clear pipe. (DWR UCIP - W. Wylie)					
FIELD_STRUCT_DESC: 24-inch corrugated metal gravity drainage pipe through the levee, 12.3 feet below the crown. Flap gate on the waterside (WS) end. Concrete headwall on the landside (LS) end. Concrete U-shaped headwall on the WS end. [Additional Reference(s): DWR Levee Log, 2002. USACE San Joaquin O&M Manual 601.1, 1967, (HLM 4.89)].					
FS Date: 4/16/2014

Headwall, flapgate, and pipe on WS toe.

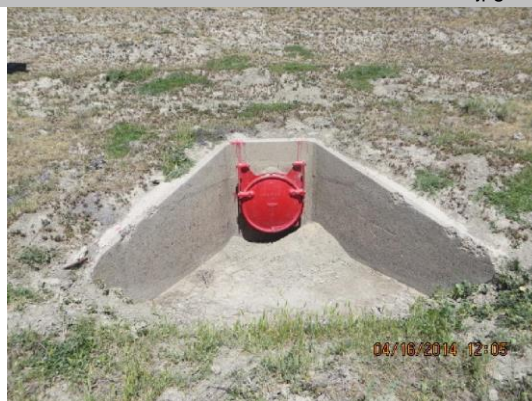
Photo 2 of 3 : UCIP_FA_2018_39590_62088.jpg

Item	DWR UCIP LMA Responsibility			37.240978	°	37.240978	°
				-120.751613	°	-120.751613	°
DWR ID	19772						
Comment Code							
Inspector Comment							
FS_ID:39590							
DS_ID:19772							
EP_NO: N/A							
Repair Type: Non-Urgent							
Crossing Status: Found							
UCIP Comments: 04/16/2014 Heavy sediment buildup in pipe visible from landward side--recommend contacting owner to clear pipe. (DWR UCIP - W. Wylie)							
FIELD_STRUCT_DESC: 24-inch corrugated metal gravity drainage pipe through the levee, 12.3 feet below the crown. Flap gate on the waterside (WS) end. Concrete headwall on the landside (LS) end. Concrete U-shaped headwall on the WS end. [Additional Reference(s): DWR Levee Log, 2002. USACE San Joaquin O&M Manual 601.1, 1967, (HLM 4.89)].							
FS Date: 4/16/2014

Headwall, flapgate, and pipe on WS toe.

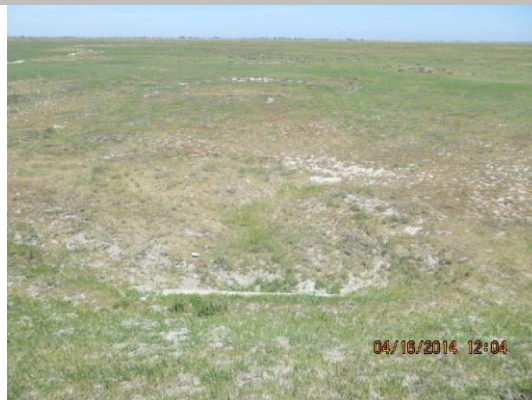
Photo 3 of 3 : UCIP_FA_2018_39590_62086.jpg

Headwall and pipe on LS toe.

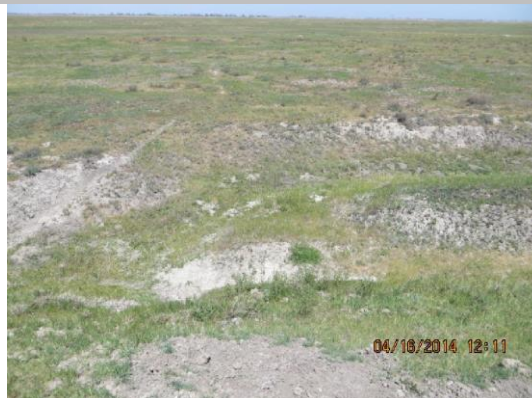
Photo 3 of 3 : UCIP_FA_2018_39591_62092.jpg

Comment Code						
Inspector Comment						
FS_ID:39591						
DS_ID:19773						
EP_NO: N/A						
Repair Type: Non-Urgent						
Crossing Status: Found						
UCIP Comments: 04/16/2014 Heavy sediment buildup in pipe visible from landward side--recommend contacting owner to clear pipe. (DWR UCIP - W. Wylie)						
FIELD_STRUCT_DESC: 24-inch corrugated metal gravity drainage pipe through the levee, 12.2 feet below the crown. Flap gate on the waterside (WS) end. Concrete headwall on the landside (LS) end. Concrete U-shaped headwall on the WS end. [Additional Reference(s): DWR Levee Log, 2002. USACE San Joaquin O&M Manual 601.1, 1967, (HLM 5.15)].						
FS Date: 4/16/2014

Headwall and pipe on LS toe.

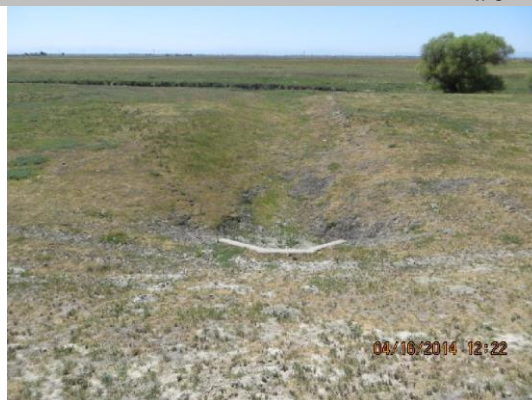
Photo 1 of 3 : UCIP_FA_2018_34151_62096.jpg

LM Start	5.58	Rating **	A/W	Issue No.	1325	
LM End	5.58	Issue Type +	Ma	Location *		
Category	Supplemental			GPS Latitude/Longitude		
				Start		End
Item	DWR UCIP LMA Responsibility			37.238879 °		37.238879 °
				-120.739719 °		-120.739719 °
DWR ID	19774					
Comment Code						
Inspector Comment						
FS_ID:34151						
DS_ID:19774						
EP_NO: N/A						
Repair Type: No Action Needed						
Crossing Status: Found						
UCIP Comments:						
FIELD_STRUCT_DESC: 24-inch corrugated metal gravity drainage pipe through the levee, 9.5 feet below the crown. Flap gate on the waterside (WS) end. Concrete headwall on the landside (LS) end. Concrete U-shaped headwall on the WS end. [Additional Reference(s): DWR Levee Log, 2002. USACE San Joaquin O&M Manual 601.1, 1967, (HLM 5.58)].						
FS Date: 4/16/2014

Headwall, flapgate, and pipe on WS toe.

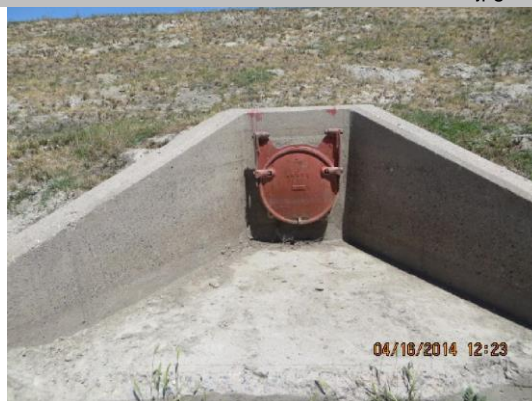
Photo 2 of 3 : UCIP_FA_2018_34151_62095.jpg

LM Start	5.58	Rating **	A/W	Issue No.	1325 (cont)	
LM End	5.58	Issue Type +	Ma	Location *		
Category	Supplemental			GPS Latitude/Longitude		
				Start	End	
Item	DWR UCIP LMA Responsibility			37.238879 °	37.238879 °	
				-120.739719 °	-120.739719 °	
DWR ID	19774					
Comment Code						
Inspector Comment						
FS_ID:34151						
DS_ID:19774						
EP_NO: N/A						
Repair Type: No Action Needed						
Crossing Status: Found						
UCIP Comments:						
FIELD_STRUCT_DESC: 24-inch corrugated metal gravity drainage pipe through the levee, 9.5 feet below the crown. Flap gate on the waterside (WS) end. Concrete headwall on the landside (LS) end. Concrete U-shaped headwall on the WS end. [Additional Reference(s): DWR Levee Log, 2002. USACE San Joaquin O&M Manual 601.1, 1967, (HLM 5.58)].						
FS Date: 4/16/2014

Headwall, flapgate, and pipe on WS toe.

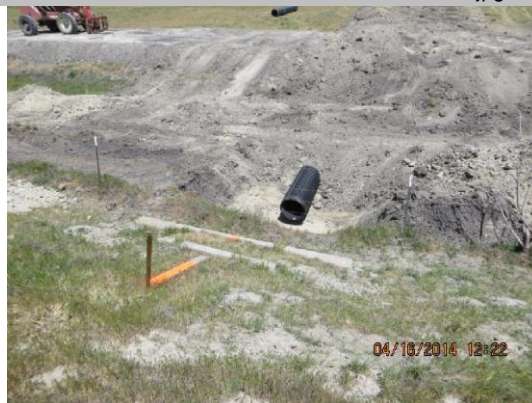
Photo 3 of 3 : UCIP_FA_2018_34151_62097.jpg

Headwall and pipe on LS toe with HDPE drain pipe being installed off LS toe.

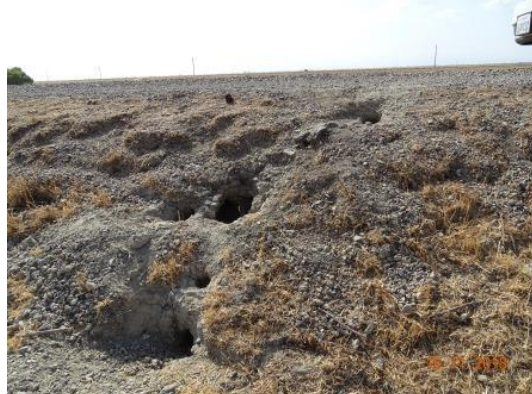
Photo 1 of 2 : FA_2018_NA0010_123_138_20181101_00313.jpg

LM Start	5.94	Rating **	U	Issue No.	138
LM End	5.94	Issue Type +	Ma	Location *	LS
Category	Earthen Levee			GPS Latitude/Longitude	
				Start	End
Item	Animal Control			37.236387°	37.236387°
				-120.734164°	-120.734164°
DWR ID	DWR_NA0010_05_f_2018_138				
Comment Code					
A1 : Exterminate rodents and backfill and compact or grout burrows.					
Inspector Comment					
Several large rodent holes at this location.

View of large rodent holes in landside slope. (Fall 2018)

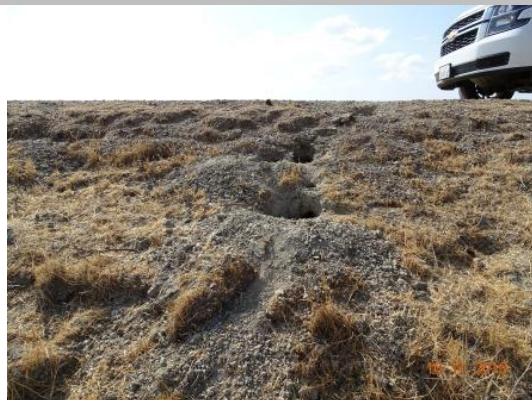
Photo 2 of 2 : FA_2018_NA0010_123_138_20181101_00314.jpg

View of large rodent holes in landside slope. (Fall 2018)

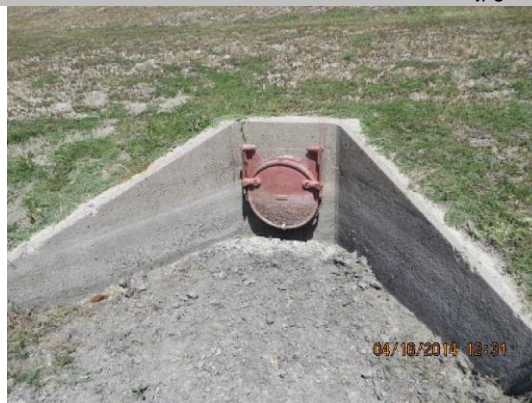
Photo 2 of 3 : UCIP_FA_2018_34163_62101.jpg

Headwall, flapgate, and pipe on WS toe.

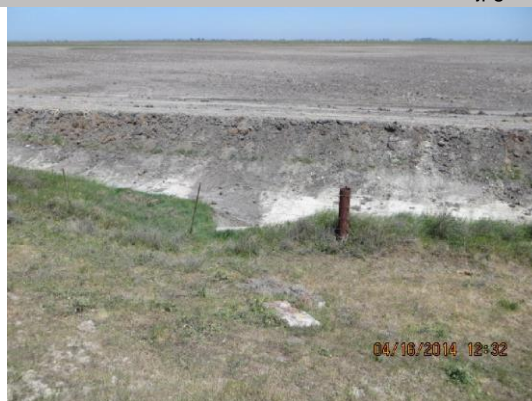
Photo 3 of 3 : UCIP_FA_2018_34163_62100.jpg

LM Start	6.35	Rating **	A/W	Issue No.	1326 (cont)	
LM End	6.35	Issue Type +	Ma	Location *		
Category	Supplemental			GPS Latitude/Longitude		
				Start	End	
Item	DWR UCIP LMA Responsibility			37.232589 °	37.232589 °	
				-120.728822 °	-120.728822 °	
DWR ID	19775					
Comment Code						
Inspector Comment						
FS_ID:34163						
DS_ID:19775						
EP_NO: N/A						
Repair Type: No Action Needed						
Crossing Status: Found						
UCIP Comments:						
FIELD_STRUCT_DESC: 24-inch corrugated metal gravity drainage pipe through the levee, 13 feet below the crown. Flap gate on the waterside (WS) end. Concrete headwall on the landside (LS) end. Concrete U-shaped headwall on the WS end. [Additional Reference(s): DWR Levee Log, 2002. USACE San Joaquin O&M Manual 601.1, 1967, (HLM 6.35)].						
FS Date: 4/16/2014

Headwall and pipe on LS toe.

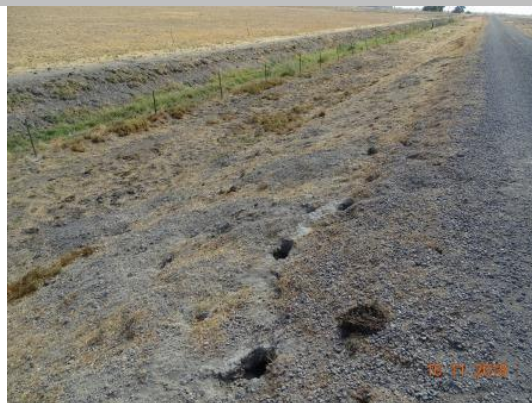
Photo 1 of 2 : FA_2018_NA0010_123_139_20181101_00315.jpg

View of rodent holes on landside shoulder. (Fall 2018)

LM Start	6.40	Rating **	M	Issue No.	139
LM End	6.40	Issue Type +	Ma	Location *	LS
Category	Earthen Levee			GPS Latitude/Longitude	
				Start	End
Item	Animal Control			37.231900 °	37.231900 °
				-120.728345 °	-120.728345 °
DWR ID	DWR_NA0010_05_f_2018_139				
Comment Code					
A1 : Exterminate rodents and backfill and compact or grout burrows.					
Inspector Comment

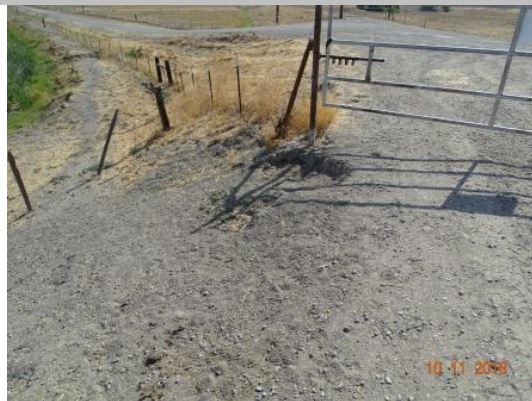
Photo 1 of 1 : FA_2018_NA0010_123_140_20181101_00317.jpg

Erosion on landward slope caused by foot traffic. (Fall 2018)

LM Start	6.56	Rating **	M	Issue No.	140
LM End	6.56	Issue Type +	Ma	Location *	LS
Category	Earthen Levee			GPS Latitude/Longitude	
				Start	End
Item	Slope Stability			37.230013 °	37.230013 °
				-120.726832 °	-120.726832 °
DWR ID	DWR_NA0010_05_f_2018_140				
Comment Code					
S2 : Repair the levee slope damaged by foot traffic and prevent access where possible.					
Inspector Comment					
Erosion on landward slope near gate.

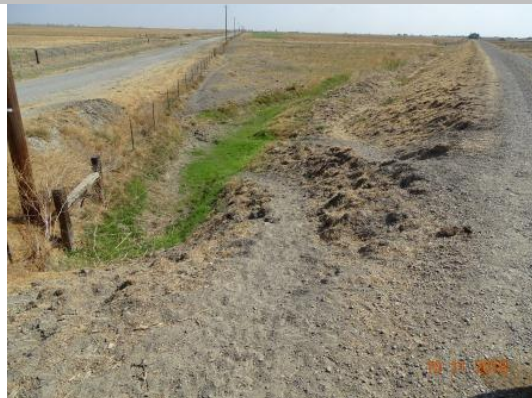
Photo 1 of 3 : FA_2018_NA0010_123_1309_20181101_00318.jpg

LM Start	6.59	Rating **	M	Issue No.	1309
LM End	6.59	Issue Type +	Ma	Location *	LS
Category	Earthen Levee			GPS Latitude/Longitude	
				Start	End
Item	Slope Stability			37.229682 °	37.229682 °
				-120.726305 °	-120.726305 °
DWR ID	DWR_NA0010_05_s_2015_1309				
Comment Code					
S2 : Repair the levee slope damaged by foot traffic and prevent access where possible.					
Inspector Comment					
Landside slope damage caused by animal foot traffic.

Looking upstream at damaged landside slope. (Fall 2018)

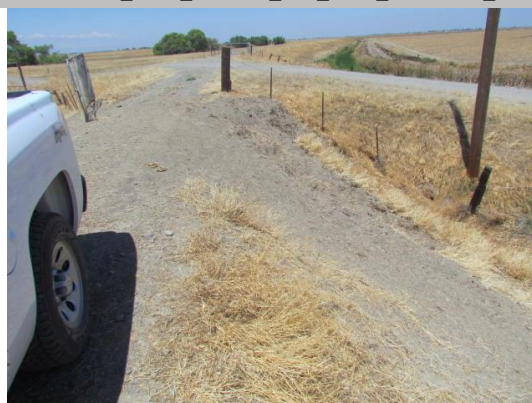
Photo 2 of 3 : FA_2018_NA0010_123_1309_20180911_00038.jpg

Looking north at damaged landward slope.

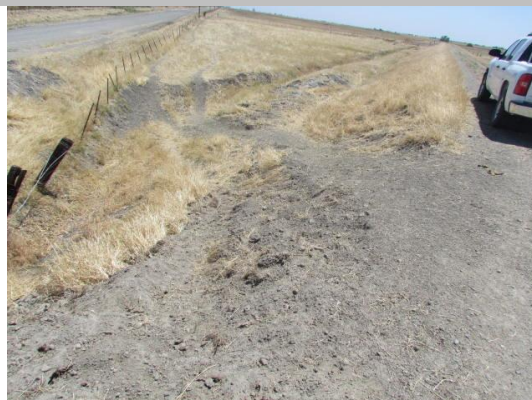
Photo 3 of 3 : FA_2018_NA0010_123_1309_20180911_00039.jpg

Looking east at damaged landward slope.

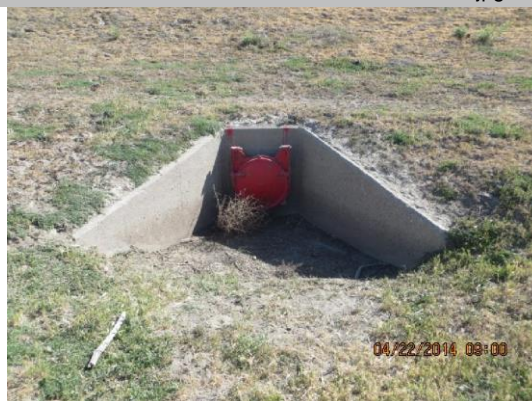
Photo 2 of 3 : UCIP_FA_2018_39592_62113.jpg

Comment Code						
Inspector Comment						
FS_ID:39592						
DS_ID:19761						
EP_NO: N/A						
Repair Type: Non-Urgent						
Crossing Status: Found						
UCIP Comments: 04/22/2014 Sediment buildup in pipe visible from landward side--recommend contacting owner to clear pipe. (DWR UCIP - W. Wylie)						
FIELD_STRUCT_DESC: 24-inch corrugated metal gravity drainage pipe through the levee, 12 feet below the crown. Flap gate on the waterside (WS) end. Concrete headwall on the landside (LS) end. Concrete U-shaped headwall on the waterside (WS) end. [Additional Reference(s): DWR Levee Log, 2002. USACE San Joaquin O&M Manual 601.1, 1967, (HLM 7.36)].						
FS Date: 4/22/2014

Headwall, flapgate, and pipe on WS toe.

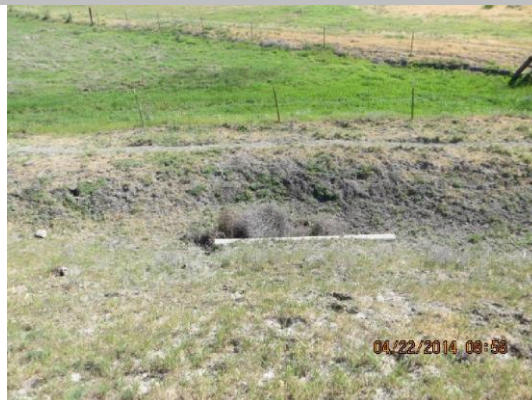
Photo 3 of 3 : UCIP_FA_2018_39592_62112.jpg

Headwall and pipe on LS toe.

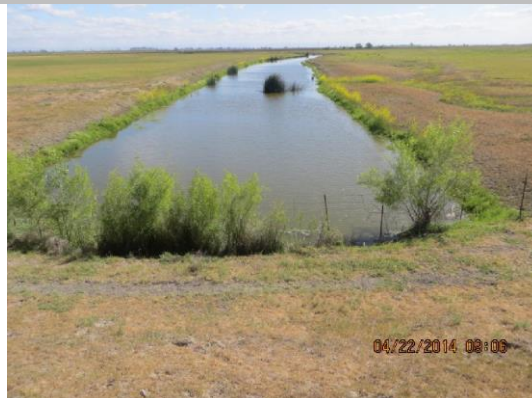
Photo 1 of 2 : UCIP_FA_2018_34170_62116.jpg

Comment Code						
Inspector Comment						
FS_ID:34170						
DS_ID:19762						
EP_NO: N/A						
Repair Type: Non-Urgent						
Crossing Status: Indicator Found						
UCIP Comments: 04/22/2014 Appears abandoned and if so should be done so properly. Slide gate rusted shut on WS slope. Unable to locate inlet or outlet. (DWR UCIP - W. Wylie)						
FIELD_STRUCT_DESC: 24-inch corrugated metal gravity drainage pipe through the levee, 20.4 feet below the crown. Slide gate in 36-inch corrugated metal pipe (CMP) riser on the waterside (WS) slope. Concrete U-shaped headwall on each end. Not found in 2014. [Additional Reference(s): DWR Levee Log, 2002. USACE San Joaquin O&M Manual 601.1, 1967, (HLM 7.58)].						
FS Date: 4/22/2014

Likely inlet on LS toe. No pipe or headwall can be seen at current water level.

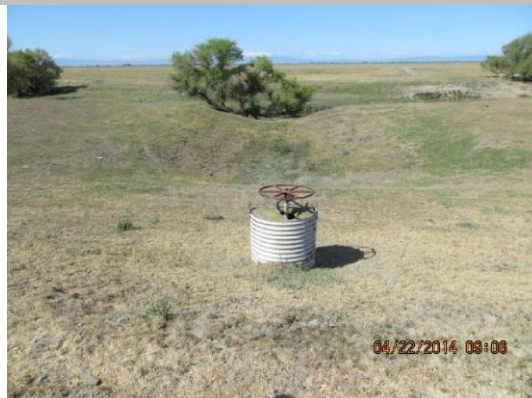
Photo 2 of 2 : UCIP_FA_2018_34170_62115.jpg

Slide gate in CMP riser on WS slope. No outlet or pipe found on WS toe.

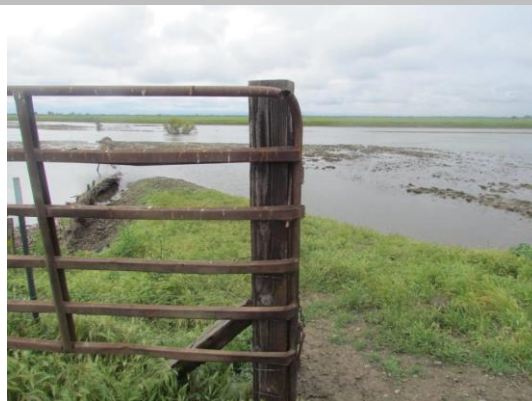
Photo 1 of 1 : FA_2018_NA0010_123_104_20180911_00016.jpg

LM Start	8.09	Rating **	M	Issue No.	104
LM End	8.09	Issue Type +	Ma	Location *	CR
Category	Earthen Levee			GPS Latitude/Longitude	
				Start	End
Item	Repair Gates			37.213580 °	37.213580 °
				-120.706550 °	-120.706550 °
DWR ID	DWR_NA0010_05_s_2017_104				
Comment Code					
Inspector Comment					
The gate is not opening correctly due to a bent fence post. Gate was previously repaired to allow opening.

Looking at a bend in the gate near the hinge point.

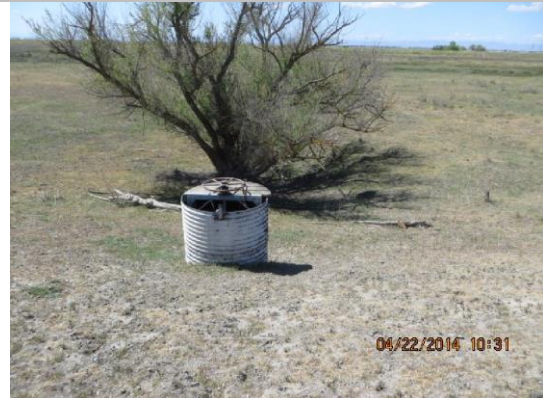
Photo 1 of 3 : UCIP_FA_2018_34272_62196.jpg

Slide gate in 48-inch CMP riser on WS slope.

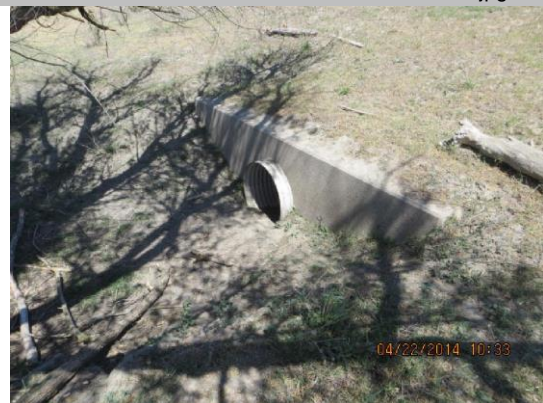
Photo 2 of 3 : UCIP_FA_2018_34272_62198.jpg

Headwall and pipe at WS toe.

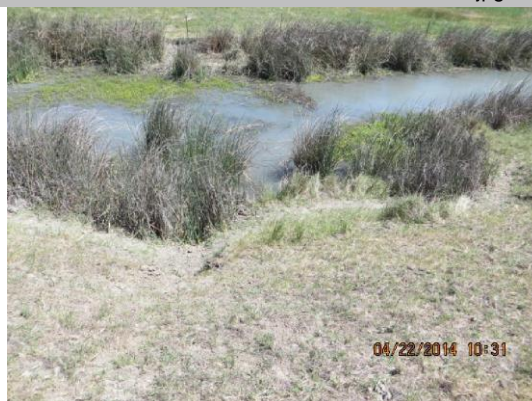
Photo 3 of 3 : UCIP_FA_2018_34272_62197.jpg

FS_ID:34272
DS_ID:19766
EP_NO: N/A
Repair Type: No Action Needed
Crossing Status: Found
UCIP Comments:
FIELD_STRUCT_DESC: 36-inch corrugated metal gravity drainage pipe through the levee, 14.8 feet below the crown. Slide gate in a 48-inch corrugated metal pipe (CMP) riser on the waterside (WS) slope. Concrete headwall on each end. [Additional Reference(s): DWR Levee Log, 2002. USACE San Joaquin O&M Manual 601.1, 1967, (HLM 9.26)].
FS Date: 4/22/2014

Headwall and pipe at LS toe.

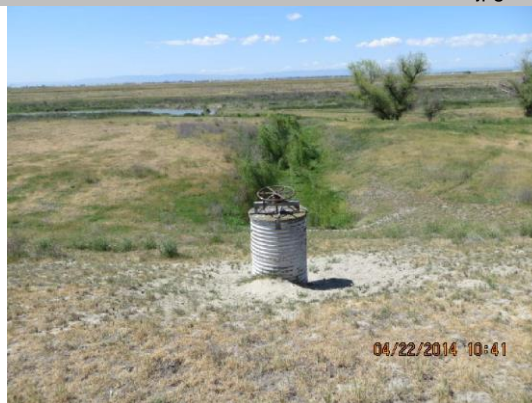
Photo 1 of 3 : UCIP_FA_2018_34273_62201.jpg

FS_ID:34273
DS_ID:19767
EP_NO: N/A
Repair Type: Non-Urgent
Crossing Status: Found
UCIP Comments: 04/22/2014 Slidegate actuator appears bent and may not work properly (WS slope). (DWR UCIP - W. Wylie)
FIELD_STRUCT_DESC: 24-inch corrugated metal gravity drainage pipe through the levee, 15 feet below the crown. Slide gate in a 36-inch corrugated metal pipe (CMP) riser on the waterside (WS) slope. Concrete headwall on each end. [Additional Reference(s): DWR Levee Log, 2002. USACE San Joaquin O&M Manual 601.1, 1967, (HLM 10.05)].
FS Date: 4/22/2014

Slidegate in CMP riser on WS slope.

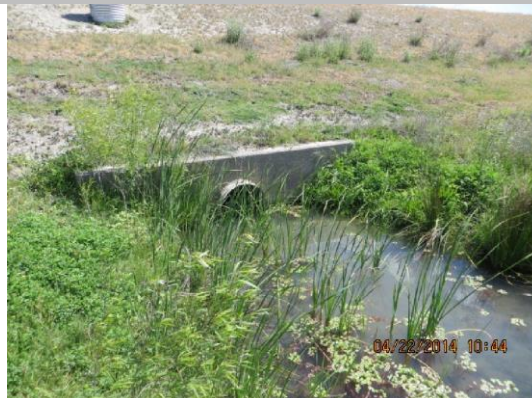
Photo 2 of 3 : UCIP_FA_2018_34273_62202.jpg

Item	DWR UCIP LMA Responsibility			37.194736 °		37.194736 °
				-120.680116 °		-120.680116 °
DWR ID	19767					
Comment Code						
Inspector Comment						
FS_ID:34273						
DS_ID:19767						
EP_NO: N/A						
Repair Type: Non-Urgent						
Crossing Status: Found						
UCIP Comments: 04/22/2014 Slidegate actuator appears bent and may not work properly (WS slope). (DWR UCIP - W. Wylie)						
FIELD_STRUCT_DESC: 24-inch corrugated metal gravity drainage pipe through the levee, 15 feet below the crown. Slide gate in a 36-inch corrugated metal pipe (CMP) riser on the waterside (WS) slope. Concrete headwall on each end. [Additional Reference(s): DWR Levee Log, 2002. USACE San Joaquin O&M Manual 601.1, 1967, (HLM 10.05)].						
FS Date: 4/22/2014

Concrete headwall and pipe on WS toe.

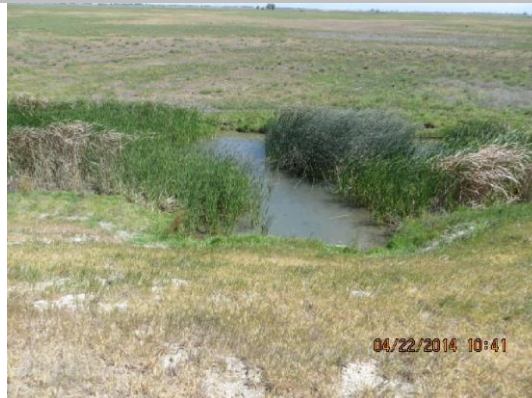
Photo 3 of 3 : UCIP_FA_2018_34273_62200.jpg

Concrete headwall and pipe on LS toe.

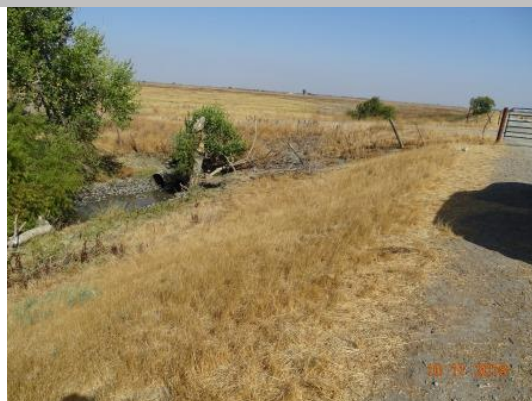
Photo 1 of 1 : FA_2018_NA0010_123_142_20181101_00319.jpg

LM Start	10.66	Rating **	M	Issue No.	142
LM End	10.66	Issue Type +	Ma	Location *	LS
Category	Earthen Levee			GPS Latitude/Longitude	
				Start	End
Item	Encroachments			37.190286 °	37.190286 °
				-120.671207 °	-120.671207 °
DWR ID	DWR_NA0010_05_f_2018_142				
Comment Code					
TR : Tree or limb					
Inspector Comment					
Fallen tree on landside toe and slope.

Fallen tree on landside toe and slope. (Fall 2018)

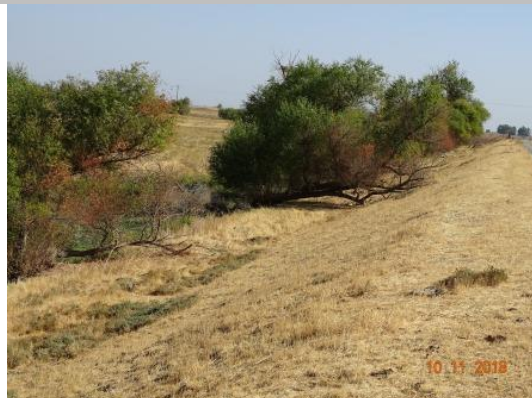
Photo 1 of 1 : FA_2018_NA0010_123_144_20181101_00320.jpg

LM Start	11.37	Rating **	M	Issue No.	144	
LM End	11.37	Issue Type +	Ma	Location *	LS	
Category	Earthen Levee			GPS Latitude/Longitude		
				Start		End
Item	Trim / Thin Trees			37.187792 °		37.187792 °
				-120.659454 °		-120.659454 °
DWR ID	DWR_NA0010_05_f_2018_144					
Comment Code						
T2 : Thin trees to allow visibility of the ground and room to flood fight.						
Inspector Comment						
tree limbs on levee slope should be trimmed to allow access

View of tree limbs on levee slope. (Fall 2018)

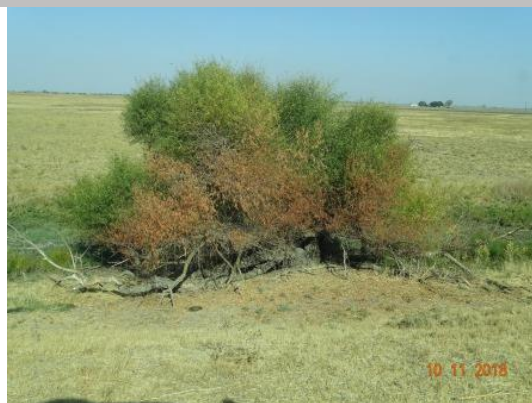
Photo 1 of 1 : FA_2018_NA0010_123_146_20181101_00322.jpg

LM Start	11.44	Rating **	M	Issue No.	146
LM End	11.44	Issue Type +	Ma	Location *	LS
Category	Earthen Levee			GPS Latitude/Longitude	
				Start	End
Item	Trim / Thin Trees			37.187021 °	37.187021 °
				-120.658564 °	-120.658564 °
DWR ID	DWR_NA0010_05_f_2018_146				
Comment Code					
T2 : Thin trees to allow visibility of the ground and room to flood fight.					
Inspector Comment					
fallen tree limbs on levee toe

tree limbs and trunk on levee toe. (Fall 2018)

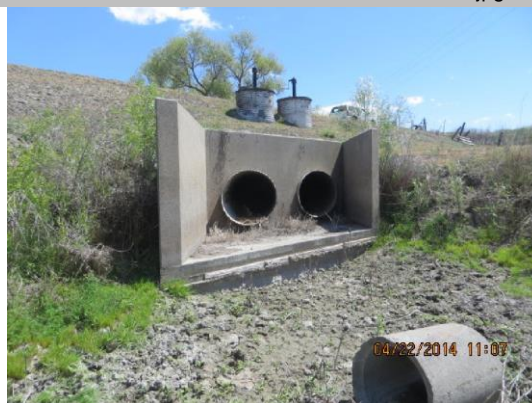
Photo 1 of 3 : UCIP_FA_2018_34281_62219.jpg

LM Start	11.49	Rating **	A/W	Issue No.	1333
LM End	11.49	Issue Type +	Ma	Location *	
Category	Supplemental			GPS Latitude/Longitude	
				Start	End
Item	DWR UCIP LMA Responsibility			37.186471 °	37.186471 °
				-120.657915 °	-120.657915 °
DWR ID	19768				
Comment Code					
Inspector Comment					
FS_ID:34281 DS_ID:19768 EP_NO: N/A Repair Type: No Action Needed Crossing Status: Found UCIP Comments: FIELD_STRUCT_DESC: [Deadman Drainage Structure] 1 of 2: 48-inch corrugated metal gravity drainage pipe through the levee, 16 feet below the crown. Slide gate in a 60-inch corrugated metal pipe (CMP) riser on the waterside (WS) slope. Concrete U-shaped headwall on each end. Stairs on the landside (LS) slope. [Additional Reference(s): DWR Levee Log, 2002. USACE San Joaquin O&M Manual 601.1, 1967, (HLM 11.48)]. FS Date: 4/22/2014

Slidegate in CMP riser, concrete headwall and pipe visible on WS slope.

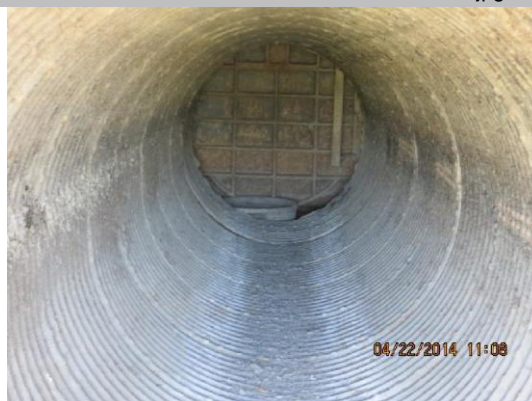
Photo 3 of 3 : UCIP_FA_2018_34280_62215.jpg

Inside pipe on WS toe.

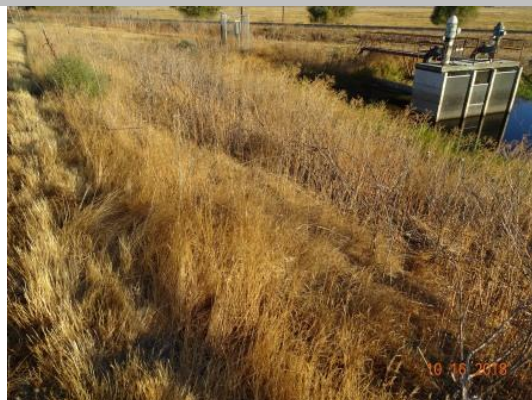
Photo 1 of 1 : FA_2018_NA0010_123_148_20181101_00324.jpg

LM Start	11.54	Rating **	U	Issue No.	148
LM End	11.61	Issue Type +	Ma	Location *	LS
Category	Earthen Levee			GPS Latitude/Longitude	
				Start	End
Item	Vegetation			37.185946 °	37.185245 °
				-120.657349 °	-120.656495 °
DWR ID	DWR_NA0010_05_f_2018_148				
Comment Code					
V1 : Control annual grass and weeds on the levee slopes and easements.					
Inspector Comment

Tall heavy grass vegetation along landside slope looking downstream.
(Fall 2018)

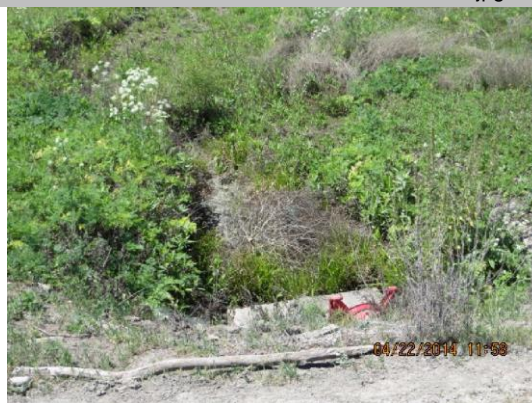
Photo 1 of 3 : UCIP_FA_2018_34284_62225.jpg

LM Start	12.01	Rating **	A/W	Issue No.	1336
LM End	12.01	Issue Type +	Ma	Location *	
Category	Supplemental			GPS Latitude/Longitude	
				Start	End
Item	DWR UCIP LMA Responsibility			37.180291 °	37.180291 °
				-120.653931 °	-120.653931 °
DWR ID	19705				
Comment Code					
Inspector Comment					
FS_ID:34284 DS_ID:19705 EP_NO: N/A Repair Type: No Action Needed Crossing Status: Found UCIP Comments: FIELD_STRUCT_DESC: 24-inch corrugated metal gravity drainage pipe through the levee, 12.5 feet below the crown. Flap gate on the waterside (WS) end. Concrete headwall on the landside (LS) end. Concrete saddle and apron on the waterside (WS) end. Flashboard attachment on the LS end. [Additional Reference(s): DWR Levee Log, 2002. USACE San Joaquin O&M Manual 601.1, 1967, (HLM 11.99)]. FS Date: 4/22/2014

Headwall, flapgate, and pipe on WS toe.

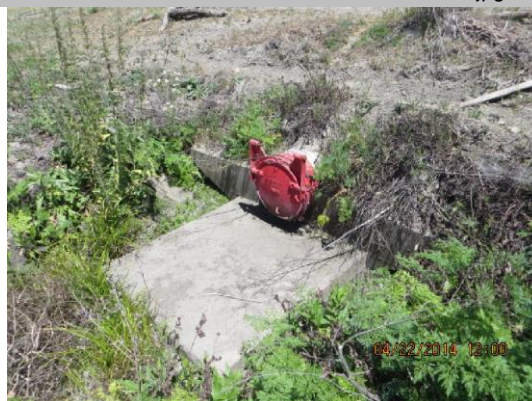
Photo 2 of 3 : UCIP_FA_2018_34284_62227.jpg

Headwall, flapgate, and pipe on WS toe.

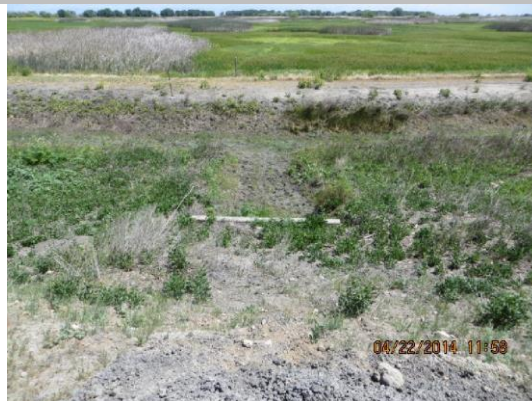
Photo 3 of 3 : UCIP_FA_2018_34284_62226.jpg

Headwall and pipe on LS toe.

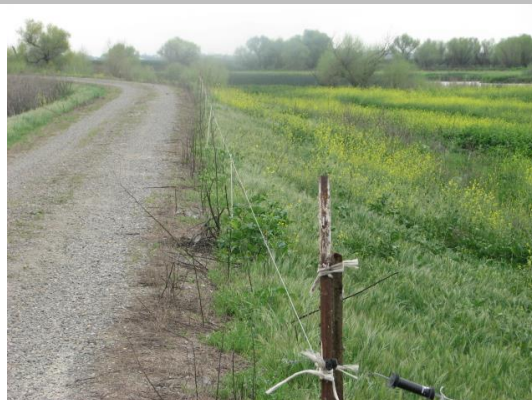
Photo 1 of 1 : FA_2018_NA0010_123_135_20180911_00035.jpg

LM Start	12.25	Rating **	M	Issue No.	135
LM End	13.76	Issue Type +	En	Location *	WS
Category	Earthen Levee			GPS Latitude/Longitude	
				Start	End
Item	Encroachments			37.177671°	37.167749°
				-120.651350°	-120.629438°
DWR ID	DWR_NA0010_05_s_2018_135				
Comment Code					
FE : Fence					
Inspector Comment					
Electric fence on waterward shoulder.

Looking upstream at electric fence along waterward shoulder. (Spring 2018)

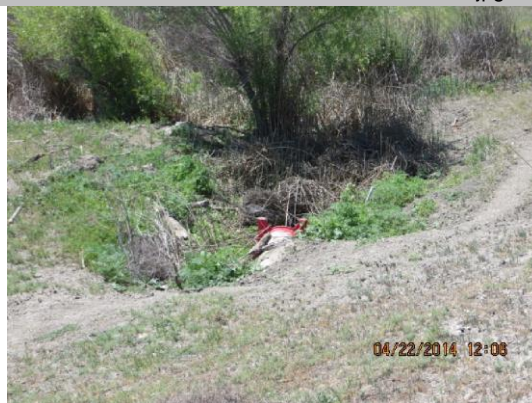
Photo 1 of 3 : UCIP_FA_2018_34285_62230.jpg

LM Start	12.40	Rating **	A/W	Issue No.	1337
LM End	12.40	Issue Type +	Ma	Location *	
Category	Supplemental			GPS Latitude/Longitude	
				Start	End
Item	DWR UCIP LMA Responsibility			37.175958 °	37.175958 °
				-120.649798 °	-120.649798 °
DWR ID	19706				
Comment Code					
Inspector Comment					
FS_ID:34285					
DS_ID:19706					
EP_NO: N/A					
Repair Type: No Action Needed					
Crossing Status: Found					
UCIP Comments:					
FIELD_STRUCT_DESC: 24-inch corrugated metal gravity drainage pipe through the levee, 10.2 feet below the crown. Flap gate on the waterside (WS) end. Concrete headwall on the landside (LS) end. Concrete saddle and apron on the WS end. Flashboard attachment on the LS end. Pipe crosses levee at 45 degrees to crown alignment. [Additional Reference(s): DWR Levee Log, 2002. USACE San Joaquin O&M Manual 601.1, 1967, (HLM 12.38)].					
FS Date: 4/22/2014

Headwall, flapgate, and pipe on WS toe.

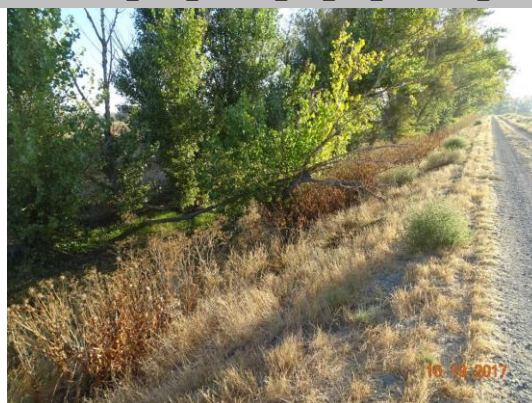
Photo 2 of 2 : FA_2018_NA0010_123_108_20180911_00017.jpg

Looking east at the landside slope. (Fall 2017)

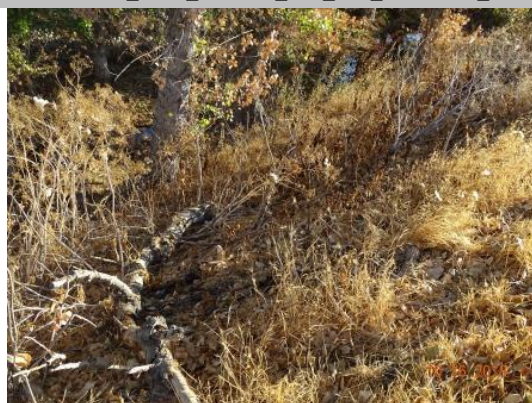
Photo 1 of 1 : FA_2018_NA0010_123_151_20181101_00326.jpg

LM Start	12.85	Rating **	M	Issue No.	151
LM End	12.85	Issue Type +	Ma	Location *	LS
Category	Earthen Levee			GPS Latitude/Longitude	
				Start	End
Item	Encroachments			37.175799 °	°
				-120.641595 °	1.000000 °
DWR ID	DWR_NA0010_05_f _ 2018_151				
Comment Code					
TR : Tree or limb					
Inspector Comment

Tree limb discarded on landside slope. (Fall 2018)
