**Flood Control Project Maintenance
Levee Inspections**

Fall 2018 Levee Maintenance Deficiency Summary Report

San Joaquin River Basin

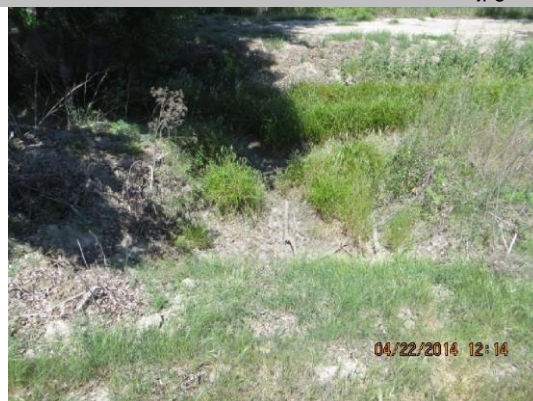
Photo 3 of 3 : UCIP_FA_2018_39593_62239.jpg

Item	DWR UCIP LMA Responsibility			37.175816 °		37.175816 °
				-120.640865 °		-120.640865 °
DWR ID	19707					
Comment Code						
Inspector Comment						
FS_ID:39593 DS_ID:19707 EP_NO: N/A Repair Type: Non-Urgent Crossing Status: Found UCIP Comments: 04/22/2014 Sediment buildup in pipe visible from landward side--recommend contacting owner to clear pipe. (DWR UCIP - W. Wylie) FIELD_STRUCT_DESC: 24-inch corrugated metal gravity drainage pipe through the levee, 10.2 feet below the crown. Concrete headwall on the landside (LS) end with flashboards. Concrete saddle and apron on the waterside (WS) end with a flap gate. Metal screen at LS toe inlet. [Additional Reference(s): DWR Levee Log, 2002. USACE San Joaquin O&M Manual 601.1, 1967, (HLM 12.87)]. FS Date: 4/22/2014

Headwall and pipe on LS toe.

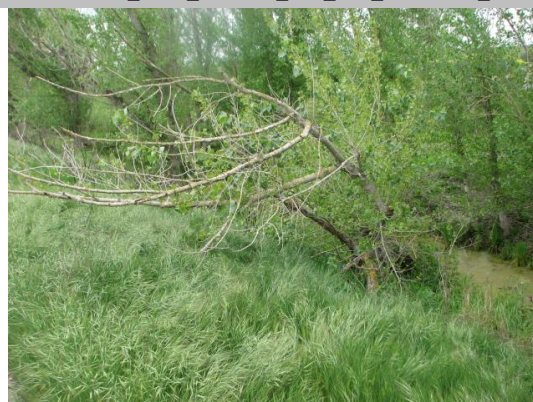
Photo 1 of 1 : FA_2018_NA0010_123_109_20180911_00018.jpg

LM Start	12.93	Rating **	M	Issue No.	109
LM End	12.93	Issue Type +	Ma	Location *	LS
Category	Earthen Levee			GPS Latitude/Longitude	
				Start	End
Item	Encroachments			37.175780 °	37.175780 °
				-120.640195 °	-120.640195 °
DWR ID	DWR_NA0010_05_s_2017_109				
Comment Code					
TR : Tree or limb					
Inspector Comment					
Fallen tree on landside toe.

Looking at broken tree on landward toe. (Spring 2018)

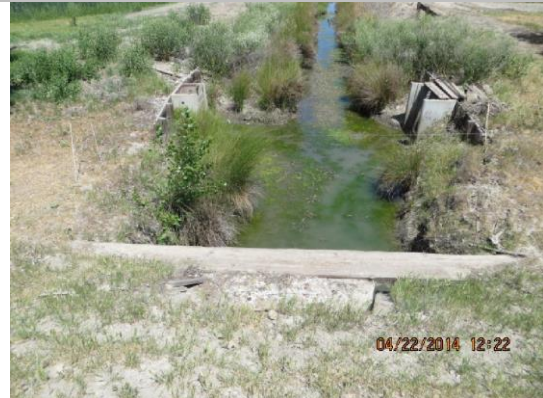
Photo 1 of 3 : UCIP_FA_2018_34288_62244.jpg

Comment Code						
Inspector Comment						
FS_ID:34288 DS_ID:19708 EP_NO: N/A Repair Type: Non-Urgent Crossing Status: Found UCIP Comments: 04/22/2014 Some erosion around headwall on the WS toe and there are animal burrows on both slopes. (DWR UCIP - W. Wylie) FIELD_STRUCT_DESC: 48-inch corrugated metal gravity drainage pipe through the levee, 10 feet below the crown. Flap gate on the waterside (WS) end. Flashboard attachment in concrete U-shaped headwall on the landside (LS) end. Concrete U-shaped headwall on the WS end. [Additional Reference(s): DWR Levee Log, 2002. USACE San Joaquin O&M Manual 601.1, 1967, (HLM 13.40)]. FS Date: 4/22/2014

Headwall and pipe on LS toe.

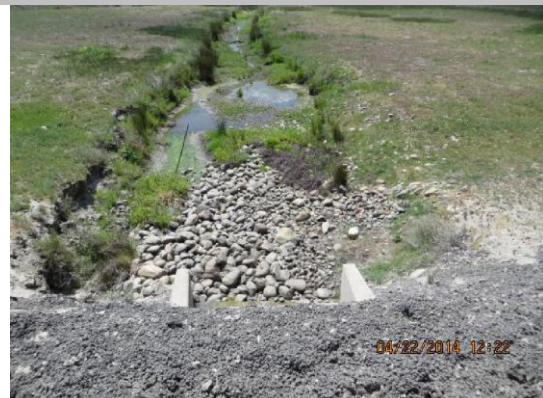
Photo 2 of 3 : UCIP_FA_2018_34288_62243.jpg

Headwall, flapgate, and pipe on WS toe.

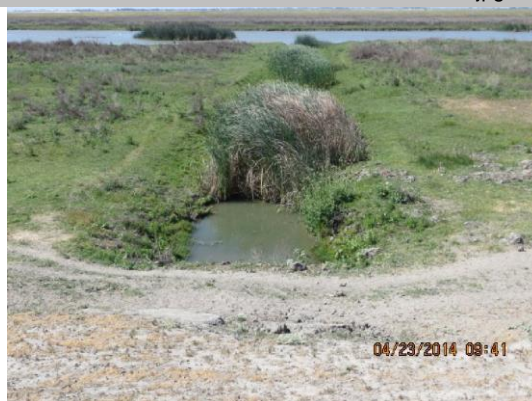
Photo 1 of 3 : UCIP_FA_2018_34656_62446.jpg

Headwall, pipe, and flapgate on WS toe.

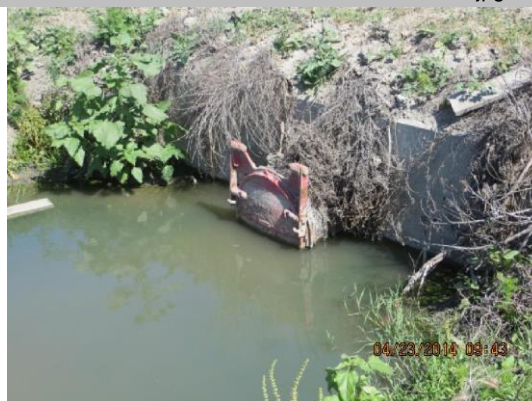
Photo 2 of 3 : UCIP_FA_2018_34656_62447.jpg

Headwall, pipe, and flapgate on WS toe.

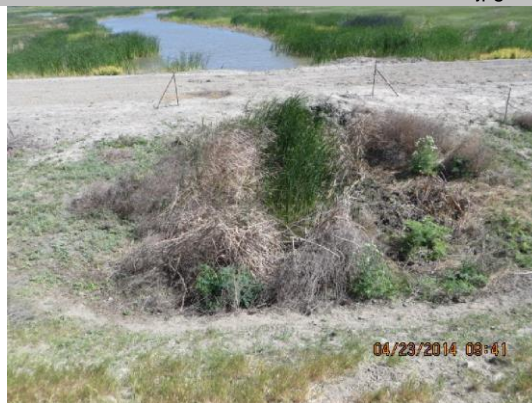
Photo 3 of 3 : UCIP_FA_2018_34656_62445.jpg

Concrete weir inlet at LS toe.

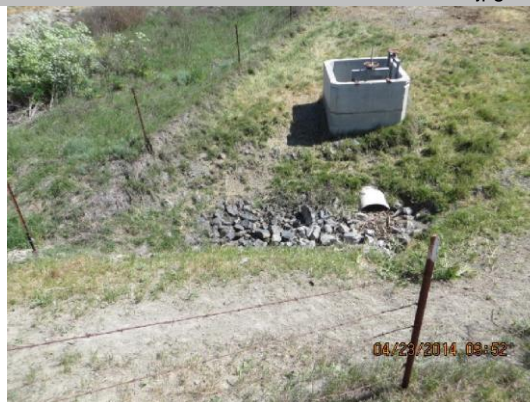
Photo 1 of 3 : UCIP_FA_2018_34664_62454.jpg

LM Start	15.11	Rating **	M	Issue No.	1343
LM End	15.11	Issue Type +	Ma	Location *	
Category	Supplemental			GPS Latitude/Longitude	
				Start	End
Item	DWR UCIP LMA Responsibility			37.156805 °	37.156805 °
				-120.609513 °	-120.609513 °
DWR ID	19712				
Comment Code					
Inspector Comment					
FS_ID:34664					
DS_ID:19712					
EP_NO: N/A					
Repair Type: Non-Urgent					
Crossing Status: Found					
UCIP Comments: 04/23/2014 Minor erosion at headwall on WS toe.					
(DWR UCIP - W. Wylie)					
FIELD_STRUCT_DESC: 36-inch corrugated metal gravity drainage pipe					
through the levee, 11.9 feet below the crown. Flap gate on the					
waterside (WS) end. Concrete headwall on each end. [Additional					
Reference(s): DWR Levee Log, 2002. USACE San Joaquin O&M					
Manual 601.1, 1967, (HLM 15.09)].					
FS Date: 4/23/2014

Headwall and inlet on LS toe.

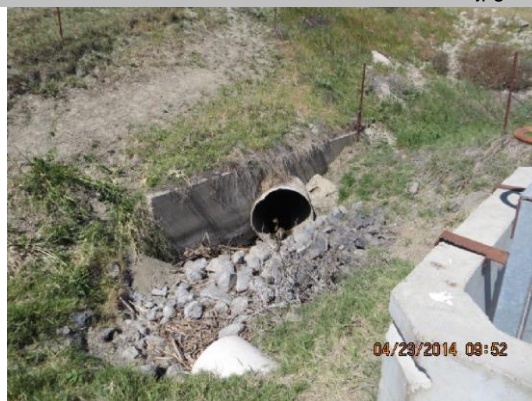
Photo 2 of 3 : UCIP_FA_2018_34664_62453.jpg

Headwall and inlet on LS toe.

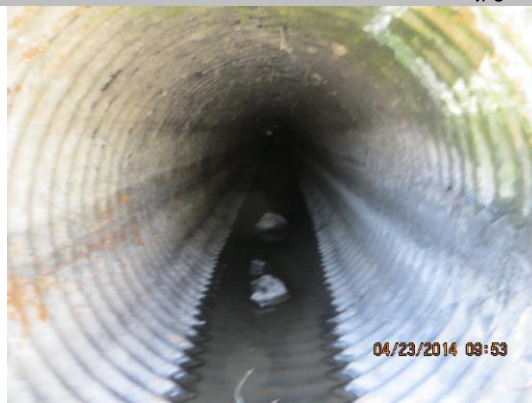
Photo 3 of 3 : UCIP_FA_2018_34664_62452.jpg

Inside pipe at LS toe.

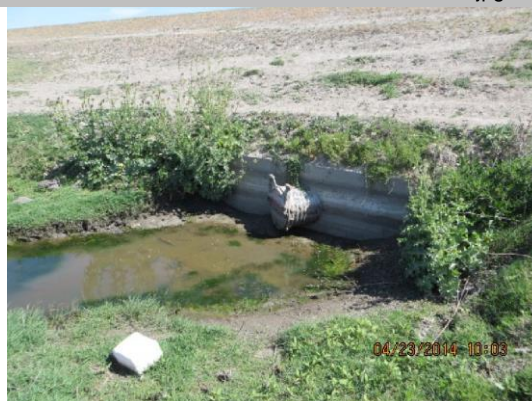
Photo 1 of 3 : UCIP_FA_2018_39595_62459.jpg

LM Start	15.76	Rating **	M	Issue No.	1344	
LM End	15.76	Issue Type +	Ma	Location *		
Category	Supplemental			GPS Latitude/Longitude		
				Start		End
Item	DWR UCIP LMA Responsibility			37.150012 °		37.150012 °
				-120.601330 °		-120.601330 °
DWR ID	19713					
Comment Code						
Inspector Comment						
FS_ID:39595 DS_ID:19713 EP_NO: N/A Repair Type: Non-Urgent Crossing Status: Found UCIP Comments: 04/23/2014 Sediment buildup in pipe visible from landward side--recommend contacting owner to clear pipe. (DWR UCIP - W. Wylie) FIELD_STRUCT_DESC: 24-inch corrugated metal gravity drainage pipe through the levee, 11 feet below the crown. Flap gate on the waterside (WS) end. Concrete headwall on each end. [Additional Reference(s): DWR Levee Log, 2002. USACE San Joaquin O&M Manual 601.1, 1967, (HLM 15.74)]. FS Date: 4/23/2014

Headwall, pipe, and flapgate on WS toe.

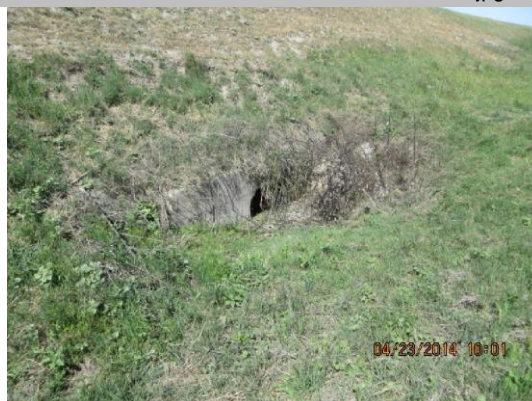
Photo 3 of 3 : UCIP_FA_2018_39595_62458.jpg

Headwall and pipe at LS toe.

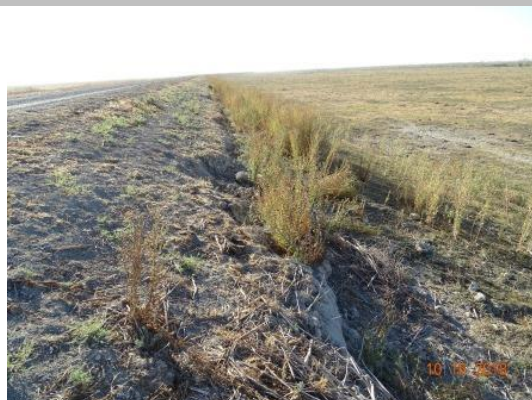
Photo 1 of 1 : FA_2018_NA0010_123_1_20181101_00330.jpg

LM Start	16.11	Rating **	M	Issue No.	1
LM End	16.12	Issue Type +	Ma	Location *	WS
Category	Supplemental			GPS Latitude/Longitude	
				Start	End
Item	DWR Erosion Survey			37.145965 °	37.145965 °
				-120.597597 °	-120.597597 °
DWR ID	NA0010U05RM13.85				
Comment Code					
Inspector Comment					
09/20/2017: The erosion was discovered during spring levee inspection. The site is covered by dense vegetation and the measurements of the erosion are estimated. [2017 Site ID:NA0010U05RM13.85]

View of erosion looking upstream. (Fall 2018)

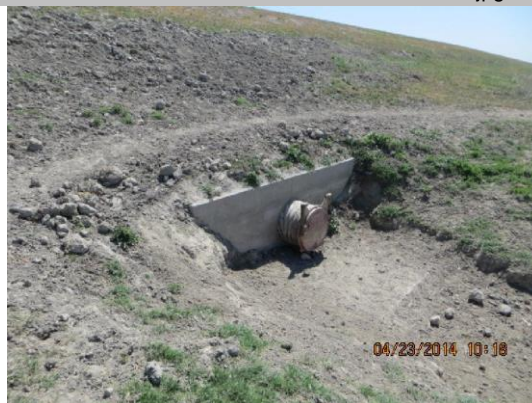
LM Start	16.68	Rating **	M	Issue No.	1346
LM End	16.68	Issue Type +	Ma	Location *	
Category	Supplemental			GPS Latitude/Longitude	
				Start	End
Item	DWR UCIP LMA Responsibility			37.138760 °	37.138760 °
				-120.592393 °	-120.592393 °
DWR ID	19716				
Comment Code					
Inspector Comment					
FS_ID:34725 DS_ID:19716 EP_NO: N/A Repair Type: Non-Urgent Crossing Status: Found UCIP Comments: 04/23/2014 Pipe heavily silted on LS toe. (DWR UCIP - W. Wylie) FIELD_STRUCT_DESC: 24-inch corrugated metal gravity drainage pipe through the levee, 10.5 feet below the crown. Flap gate on the waterside (WS) end. Concrete headwall on each end. [Additional Reference(s): DWR Levee Log, 2002. USACE San Joaquin O&M Manual 601.1, 1967, (HLM 16.67)]. FS Date: 4/23/2014

Headwall, flapgate, and pipe visible on WS toe.

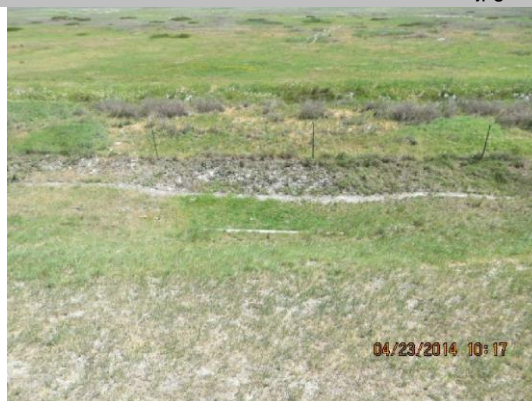
LM Start	16.68	Rating **	M	Issue No.	1346 (cont)	
LM End	16.68	Issue Type +	Ma	Location *		
Category	Supplemental			GPS Latitude/Longitude		
				Start	End	
Item	DWR UCIP LMA Responsibility			37.138760 °	37.138760 °	
				-120.592393 °	-120.592393 °	
DWR ID	19716					
Comment Code						
Inspector Comment						
FS_ID:34725 DS_ID:19716 EP_NO: N/A Repair Type: Non-Urgent Crossing Status: Found UCIP Comments: 04/23/2014 Pipe heavily silted on LS toe. (DWR UCIP - W. Wylie) FIELD_STRUCT_DESC: 24-inch corrugated metal gravity drainage pipe through the levee, 10.5 feet below the crown. Flap gate on the waterside (WS) end. Concrete headwall on each end. [Additional Reference(s): DWR Levee Log, 2002. USACE San Joaquin O&M Manual 601.1, 1967, (HLM 16.67)]. FS Date: 4/23/2014

Concrete headwall and pipe visible on LS toe.

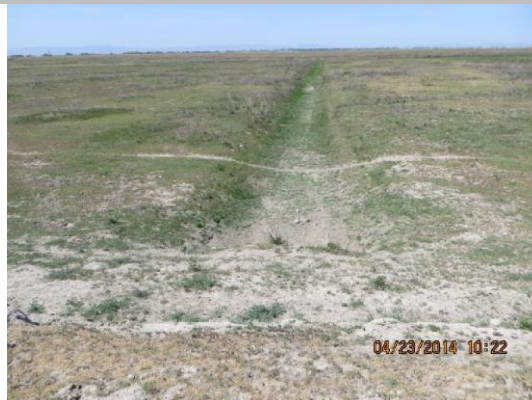
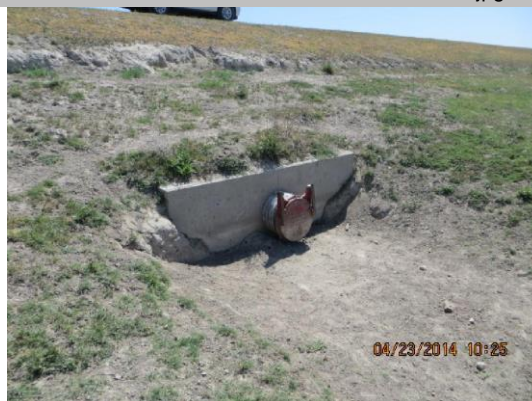
LM Start	17.22	Rating **	M	Issue No.	1347	
LM End	17.22	Issue Type +	Ma	Location *		
Category	Supplemental			GPS Latitude/Longitude		
				Start		End
Item	DWR UCIP LMA Responsibility			37.132211 °		37.132211 °
				-120.587106 °		-120.587106 °
DWR ID	19717					
Comment Code						
Inspector Comment						
FS_ID:39597 DS_ID:19717 EP_NO: N/A Repair Type: Non-Urgent Crossing Status: Found UCIP Comments: 04/23/2014 Sediment buildup in pipe visible from landward side--recommend contacting owner to clear pipe. (DWR UCIP - W. Wylie) FIELD_STRUCT_DESC: 24-inch corrugated metal gravity drainage pipe through the levee, 12 feet below the crown. Flap gate on the waterside (WS) end. Concrete headwall on each end. [Additional Reference(s): DWR Levee Log, 2002. USACE San Joaquin O&M Manual 601.1, 1967, (HLM 17.20)]. FS Date: 4/23/2014

Headwall, flapgate, and pipe visible on WS toe.

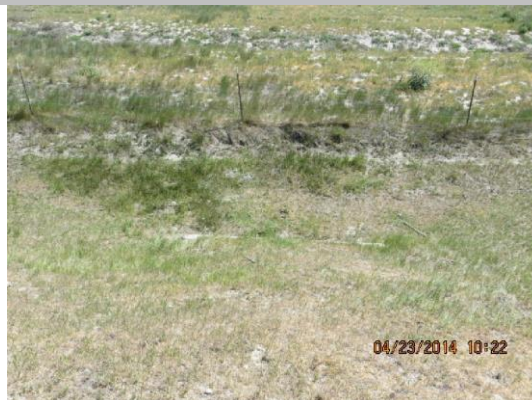
Headwall and pipe visible on LS toe.

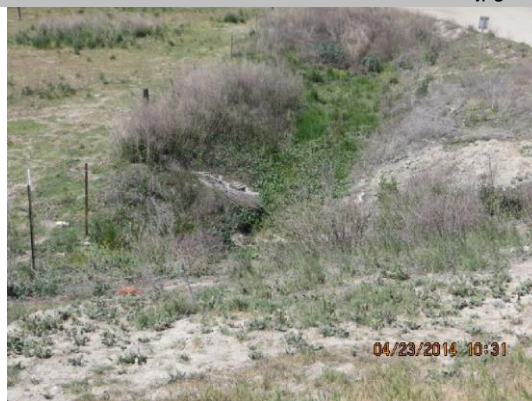
LM Start	17.54	Rating **	M	Issue No.	1348
LM End	17.54	Issue Type +	Ma	Location *	
Category	Supplemental			GPS Latitude/Longitude	
				Start	End
Item	DWR UCIP LMA Responsibility			37.127843 °	37.127843 °
				-120.585245 °	-120.585245 °
DWR ID	19743				
Comment Code					
Inspector Comment					
FS_ID:39599 DS_ID:19743 EP_NO: N/A Repair Type: Non-Urgent Crossing Status: Found UCIP Comments: 04/23/2014 Sediment buildup in pipe visible from landward side--recommend contacting owner to clear pipe. (DWR UCIP - W. Wylie) FIELD_STRUCT_DESC: 24-inch corrugated metal gravity drainage pipe through the levee, 9.8 feet below the crown. Flap gate on the waterside (WS) end. Concrete headwall on each end. [Additional Reference(s): DWR Levee Log, 2002. USACE San Joaquin O&M Manual 601.1, 1967, (HLM 17.52)]. FS Date: 4/23/2014

Headwall, pipe, and flapgate visible on WS toe.

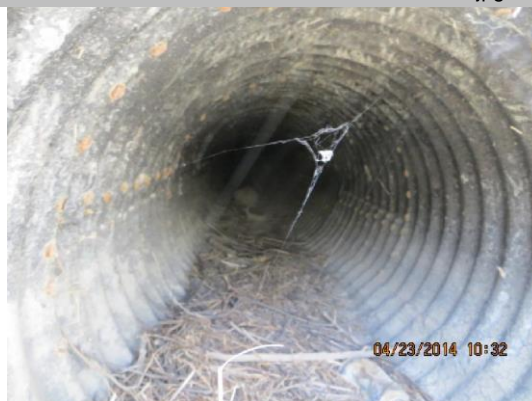
LM Start	17.54	Rating **	M	Issue No.	1348 (cont)	
LM End	17.54	Issue Type +	Ma	Location *		
Category	Supplemental			GPS Latitude/Longitude		
				Start		End
Item	DWR UCIP LMA Responsibility			37.127843 °		37.127843 °
				-120.585245 °		-120.585245 °
DWR ID	19743					
Comment Code						
Inspector Comment						
FS_ID:39599						
DS_ID:19743						
EP_NO: N/A						
Repair Type: Non-Urgent						
Crossing Status: Found						
UCIP Comments: 04/23/2014 Sediment buildup in pipe visible from landward side--recommend contacting owner to clear pipe. (DWR UCIP - W. Wylie)						
FIELD_STRUCT_DESC: 24-inch corrugated metal gravity drainage pipe through the levee, 9.8 feet below the crown. Flap gate on the waterside (WS) end. Concrete headwall on each end. [Additional Reference(s): DWR Levee Log, 2002. USACE San Joaquin O&M Manual 601.1, 1967, (HLM 17.52)].						
FS Date: 4/23/2014

Inside pipe on LS toe.

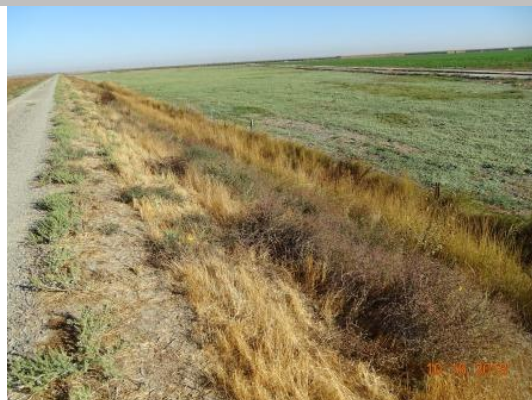
LM Start	17.64	Rating **	U	Issue No.	156
LM End	18.94	Issue Type +	Ma	Location *	LS
Category	Earthen Levee			GPS Latitude/Longitude	
				Start	End
Item	Vegetation			37.126490 °	37.115461 °
				-120.584682 °	-120.569400 °
DWR ID	DWR_NA0010_05_f_2018_156				
Comment Code					
V1 : Control annual grass and weeds on the levee slopes and easements.					
Inspector Comment					
Tall dense vegetation on slope and toe

Dense vegetation on landside slope and toe. (Fall 2018)

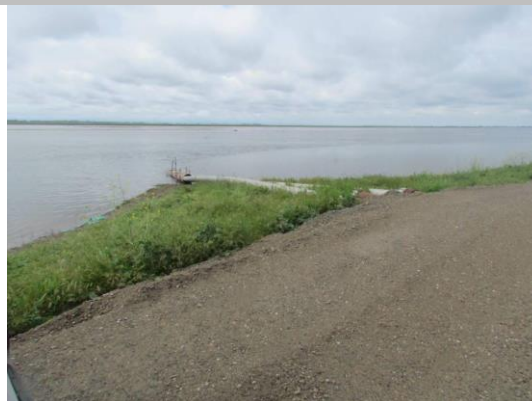
LM Start	18.06	Rating **	U	Issue No.	112
LM End	18.06	Issue Type +	En	Location *	CR
Category	Earthen Levee			GPS Latitude/Longitude	
				Start	End
Item	Encroachments			37.120690 °	37.120690 °
				-120.582218 °	-120.582218 °
DWR ID	DWR_NA0010_05_s_2017_112				
Comment Code					
PI : Pipe					
Inspector Comment					
Temporary eight inch (3) pipes across levee crown on both slopes.

Looking at temporary pipe on waterward slope.

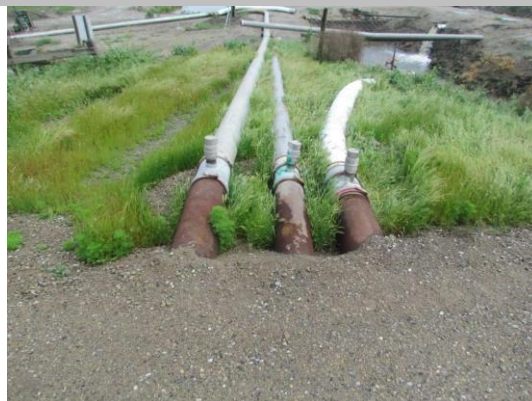
Looking at three temporary pipes on landward slope.

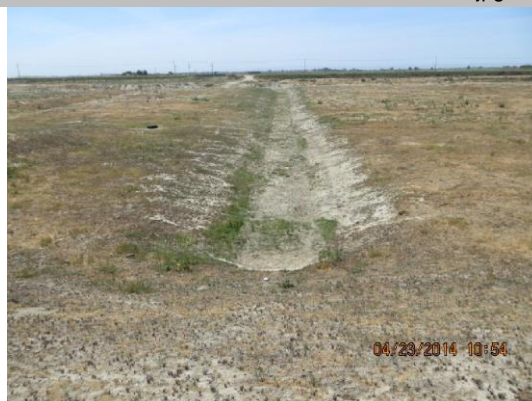
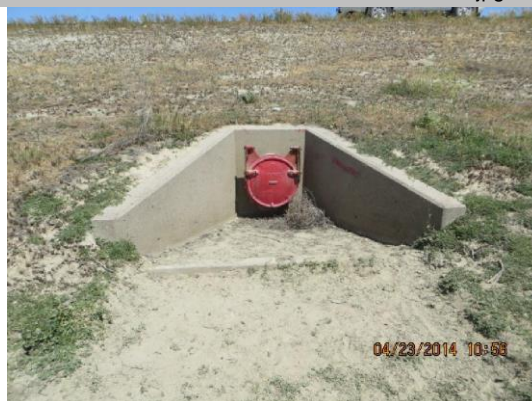
Comment Code						
Inspector Comment						
FS_ID:39601						
DS_ID:19747						
EP_NO: N/A						
Repair Type: Non-Urgent						
Crossing Status: Found						
UCIP Comments: 04/23/2014 Sediment buildup in pipe visible from landward side--recommend contacting owner to clear pipe. (DWR UCIP - W. Wylie)						
FIELD_STRUCT_DESC: 24-inch corrugated metal gravity drainage pipe through the levee, 10 feet below the crown. Flap gate on the waterside (WS) end. Concrete headwall on the landside (LS) end. Concrete U-shaped headwall on the WS end. [Additional Reference(s): DWR Levee Log, 2002. USACE San Joaquin O&M Manual 601.1, 1967, (HLM 19.11)].						
FS Date: 4/23/2014

Headwall, pipe, and flapgate visible on WS toe.

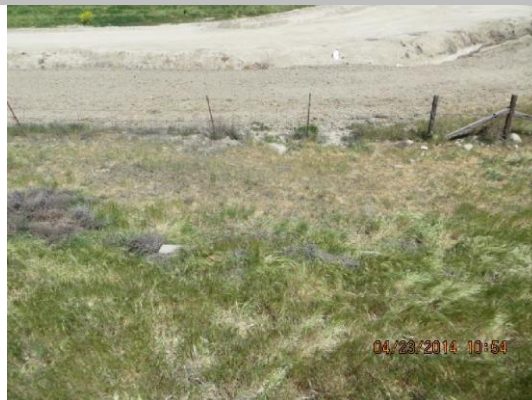
Item	DWR UCIP LMA Responsibility			37.115466 °	37.115466 °	
				-120.565467 °	-120.565467 °	
DWR ID	19747					
Comment Code						
Inspector Comment						
FS_ID:39601						
DS_ID:19747						
EP_NO: N/A						
Repair Type: Non-Urgent						
Crossing Status: Found						
UCIP Comments: 04/23/2014 Sediment buildup in pipe visible from landward side--recommend contacting owner to clear pipe. (DWR UCIP - W. Wylie)						
FIELD_STRUCT_DESC: 24-inch corrugated metal gravity drainage pipe through the levee, 10 feet below the crown. Flap gate on the waterside (WS) end. Concrete headwall on the landside (LS) end. Concrete U-shaped headwall on the WS end. [Additional Reference(s): DWR Levee Log, 2002. USACE San Joaquin O&M Manual 601.1, 1967, (HLM 19.11)].						
FS Date: 4/23/2014

Headwall and pipe visible on LS toe.

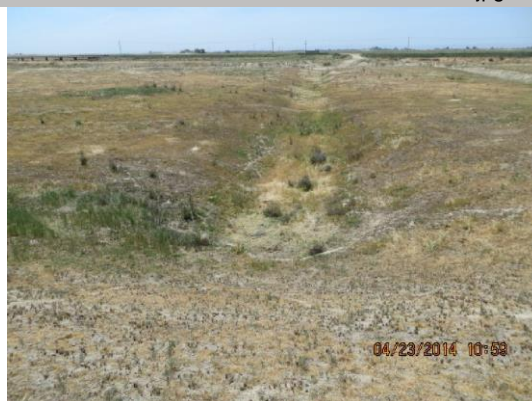
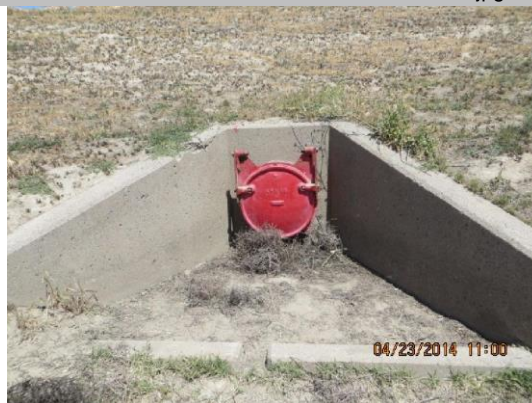
LM Start	19.17	Rating **	A/W	Issue No.	1352
LM End	19.17	Issue Type +	Ma	Location *	
Category	Supplemental			GPS Latitude/Longitude	
				Start	End
Item	DWR UCIP LMA Responsibility			37.115463 °	37.115463 °
				-120.565086 °	-120.565086 °
DWR ID	19776				
Comment Code					
Inspector Comment					
FS_ID:34751 DS_ID:19776 EP_NO: N/A Repair Type: No Action Needed Crossing Status: Found UCIP Comments: FIELD_STRUCT_DESC: 24-inch corrugated metal gravity drainage pipe through the levee, 10.3 feet below the crown. Flap gate on the waterside (WS) end. Concrete headwall on the landside (LS) end. Concrete U-shaped headwall on the WS end. [Additional Reference(s): DWR Levee Log, 2002. USACE San Joaquin O&M Manual 601.1, 1967, (HLM 19.15)]. FS Date: 4/23/2014

Headwall, pipe, and flapgate visible on WS toe.

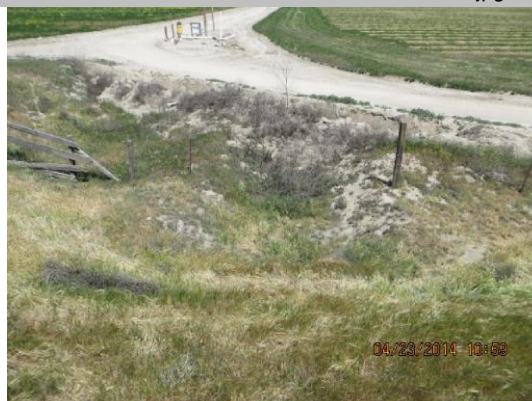
LM Start	19.17	Rating **	A/W	Issue No.	1352 (cont)	
LM End	19.17	Issue Type +	Ma	Location *		
Category	Supplemental			GPS Latitude/Longitude		
				Start		End
Item	DWR UCIP LMA Responsibility			37.115463 °		37.115463 °
				-120.565086 °		-120.565086 °
DWR ID	19776					
Comment Code						
Inspector Comment						
FS_ID:34751 DS_ID:19776 EP_NO: N/A Repair Type: No Action Needed Crossing Status: Found UCIP Comments: FIELD_STRUCT_DESC: 24-inch corrugated metal gravity drainage pipe through the levee, 10.3 feet below the crown. Flap gate on the waterside (WS) end. Concrete headwall on the landside (LS) end. Concrete U-shaped headwall on the WS end. [Additional Reference(s): DWR Levee Log, 2002. USACE San Joaquin O&M Manual 601.1, 1967, (HLM 19.15)]. FS Date: 4/23/2014

Headwall and pipe visible on LS toe.

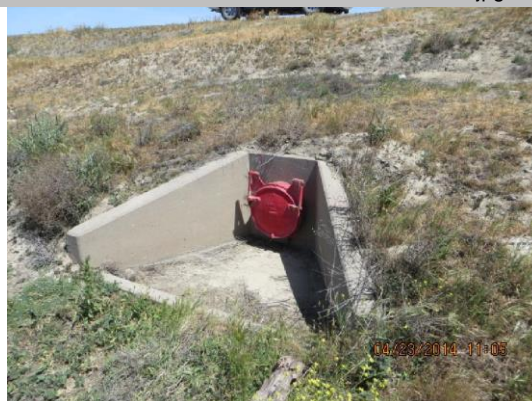
LM Start	19.48	Rating **	M	Issue No.	1353	
LM End	19.48	Issue Type +	Ma	Location *		
Category	Supplemental			GPS Latitude/Longitude		
				Start		End
Item	DWR UCIP LMA Responsibility			37.113542 °		37.113542 °
				-120.560389 °		-120.560389 °
DWR ID	19777					
Comment Code						
Inspector Comment						
FS_ID:39602 DS_ID:19777 EP_NO: N/A Repair Type: Non-Urgent Crossing Status: Found UCIP Comments: 04/23/2014 Sediment buildup in pipe visible from landward side--recommend contacting owner to clear pipe. (DWR UCIP - W. Wylie) FIELD_STRUCT_DESC: 24-inch corrugated metal gravity drainage pipe through the levee, 9 feet below the crown. Flap gate on the waterside (WS) end. Concrete headwall on the landside (LS) end. Concrete U-shaped headwall on the WS end. [Additional Reference(s): DWR Levee Log, 2002. USACE San Joaquin O&M Manual 601.1, 1967, (HLM 19.46)]. FS Date: 4/23/2014

Headwall, pipe, and flapgate visible on WS toe.

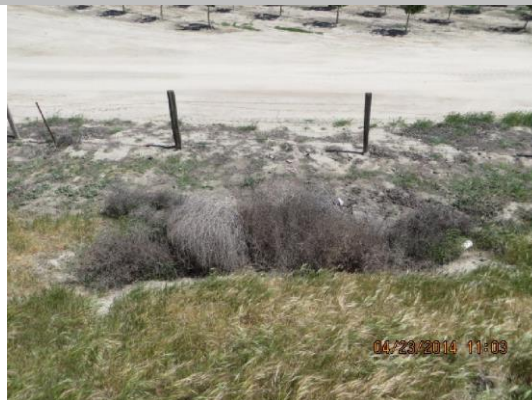
Photo 3 of 3 : UCIP_FA_2018_39602_62515.jpg

LM Start	19.48	Rating **	M	Issue No.	1353 (cont)
LM End	19.48	Issue Type +	Ma	Location *	
Category	Supplemental			GPS Latitude/Longitude	
				Start	End
Item	DWR UCIP LMA Responsibility			37.113542°	37.113542°
				-120.560389°	-120.560389°
DWR ID	19777				
Comment Code					
Inspector Comment					
FS_ID:39602 DS_ID:19777 EP_NO: N/A Repair Type: Non-Urgent Crossing Status: Found UCIP Comments: 04/23/2014 Sediment buildup in pipe visible from landward side--recommend contacting owner to clear pipe. (DWR UCIP - W. Wylie) FIELD_STRUCT_DESC: 24-inch corrugated metal gravity drainage pipe through the levee, 9 feet below the crown. Flap gate on the waterside (WS) end. Concrete headwall on the landside (LS) end. Concrete U-shaped headwall on the WS end. [Additional Reference(s): DWR Levee Log, 2002. USACE San Joaquin O&M Manual 601.1, 1967, (HLM 19.46)]. FS Date: 4/23/2014

Headwall and pipe visible on LS toe.

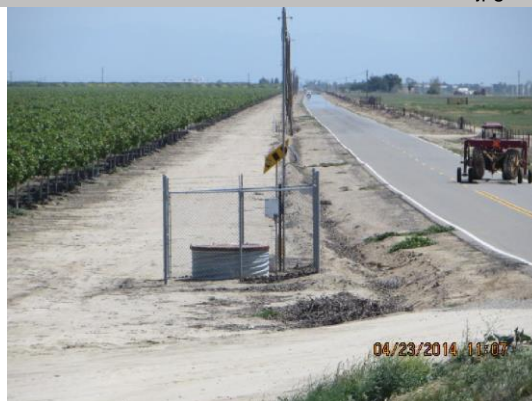
Photo 1 of 2 : UCIP_FA_2018_39345_71477.jpg

FS_ID:39345
DS_ID:24868
EP_NO: N/A
Repair Type: Non-Urgent
Crossing Status: Indicator Found
UCIP Comments: 04/23/2014 Markers closer to the levee may be necessary to properly mark pipe crossing location. (DWR UCIP - W. Wylie)
FIELD_STRUCT_DESC: Steel natural gas pipeline of an unknown size through the levee, at an unknown depth. Corrugated metal pipe (CMP) riser and gas line marker off the landside (LS) toe.
FS Date: 4/22/2014

Gasline marker off LS toe.

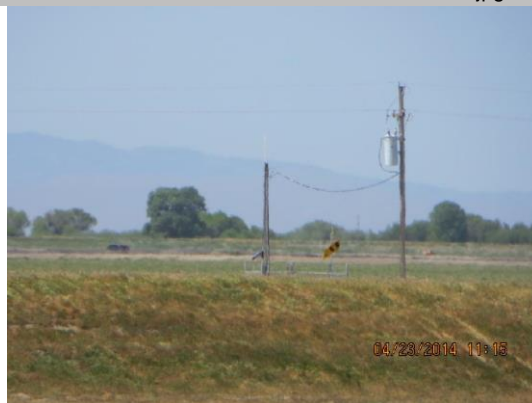
Photo 2 of 2 : UCIP_FA_2018_39345_71476.jpg

Gasline marker off LS of opposite bank.

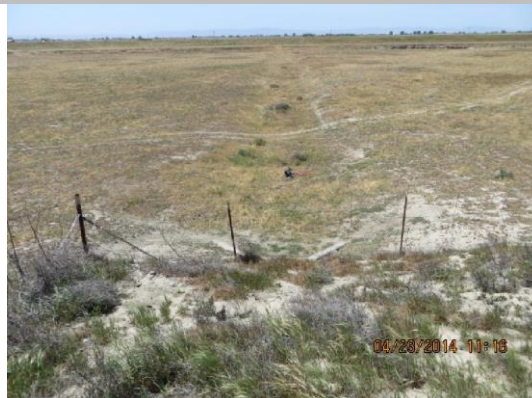
Photo 1 of 3 : UCIP_FA_2018_39603_62519.jpg

Comment Code						
Inspector Comment						
FS_ID:39603 DS_ID:19778 EP_NO: N/A Repair Type: Non-Urgent Crossing Status: Found UCIP Comments: 04/23/2014 Dense vegetation limits the inspector's visibility to identify signs of pipe failure (leaks) along the landward slope. Recommend removing vegetation along pipe alignment to conduct proper inspection of structure. Sediment buildup in pipe visible from landward side--recommend contacting owner to clear pipe. (DWR UCIP - W. Wylie) FIELD_STRUCT_DESC: 24-inch corrugated metal gravity drainage pipe through the levee, 9.7 feet below the crown. Flap gate on the waterside (WS) end. Concrete headwall on the landside (LS) end. Concrete U-shaped headwall on the WS end. [Additional Reference(s): DWR Levee Log, 2002. USACE San Joaquin O&M Manual 601.1, 1967, (HLM 19.50)]. FS Date: 4/23/2014

Headwall, pipe, and flapgate visible on WS toe.

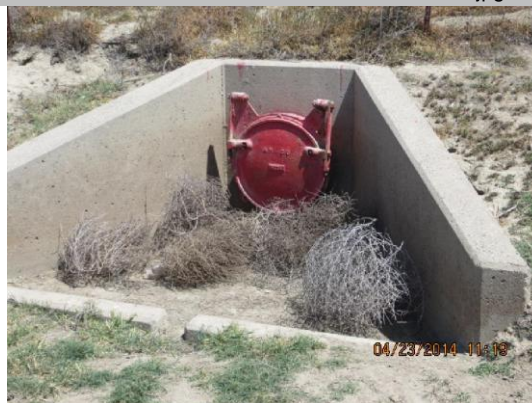
Photo 2 of 3 : UCIP_FA_2018_39603_62521.jpg

Headwall, pipe, and flapgate visible on WS toe.

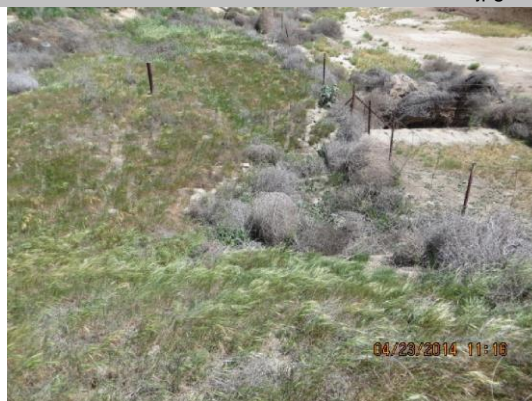
Photo 3 of 3 : UCIP_FA_2018_39603_62520.jpg

Item	DWR UCIP LMA Responsibility			37.112953°	37.112953°	
				-120.559943°	-120.559943°	
DWR ID	19778					
Comment Code						
Inspector Comment						
FS_ID:39603 DS_ID:19778 EP_NO: N/A Repair Type: Non-Urgent Crossing Status: Found UCIP Comments: 04/23/2014 Dense vegetation limits the inspector's visibility to identify signs of pipe failure (leaks) along the landward slope. Recommend removing vegetation along pipe alignment to conduct proper inspection of structure. Sediment buildup in pipe visible from landward side--recommend contacting owner to clear pipe. (DWR UCIP - W. Wylie) FIELD_STRUCT_DESC: 24-inch corrugated metal gravity drainage pipe through the levee, 9.7 feet below the crown. Flap gate on the waterside (WS) end. Concrete headwall on the landside (LS) end. Concrete U-shaped headwall on the WS end. [Additional Reference(s): DWR Levee Log, 2002. USACE San Joaquin O&M Manual 601.1, 1967, (HLM 19.50)]. FS Date: 4/23/2014

Headwall and pipe visible on LS toe.

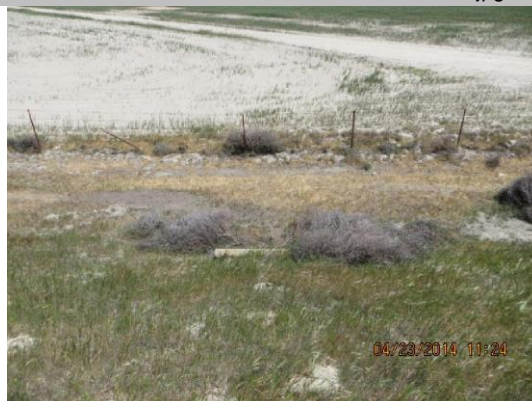
Photo 1 of 3 : UCIP_FA_2018_34754_62525.jpg

LM Start	19.86	Rating **	A/W	Issue No.	1356
LM End	19.86	Issue Type +	Ma	Location *	
Category	Supplemental			GPS Latitude/Longitude	
				Start	End
Item	DWR UCIP LMA Responsibility			37.109284 °	37.109284 °
				-120.555948 °	-120.555948 °
DWR ID	19779				
Comment Code					
Inspector Comment					
FS_ID:34754 DS_ID:19779 EP_NO: N/A Repair Type: No Action Needed Crossing Status: Found UCIP Comments: FIELD_STRUCT_DESC: 24-inch corrugated metal gravity drainage pipe through the levee, 10.3 feet below the crown. Flap gate on the waterside (WS) end. Concrete headwall on the landside (LS) end. Concrete U-shaped headwall on the WS end. [Additional Reference(s): DWR Levee Log, 2002. USACE San Joaquin O&M Manual 601.1, 1967, (HLM 19.84)]. FS Date: 4/23/2014

Headwall and pipe visible on LS toe.

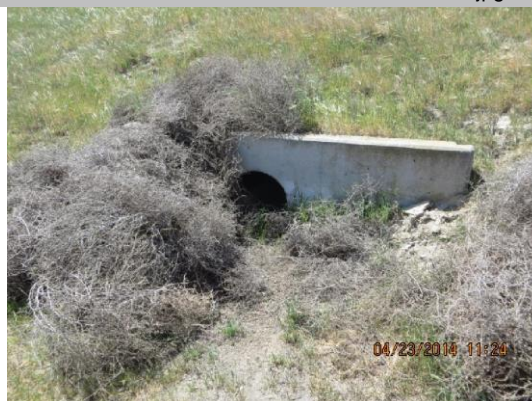
Photo 2 of 3 : UCIP_FA_2018_34754_62524.jpg

Headwall and pipe visible on LS toe.

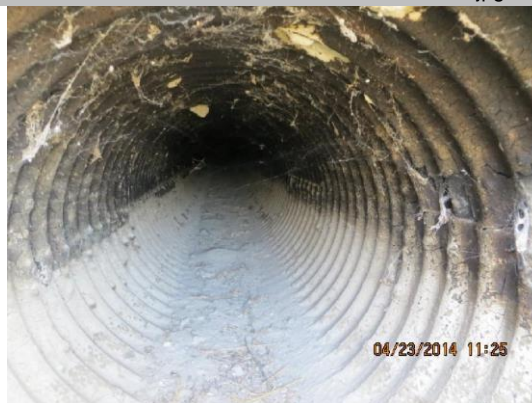
Photo 3 of 3 : UCIP_FA_2018_34754_62523.jpg

Inside pipe on LS toe.

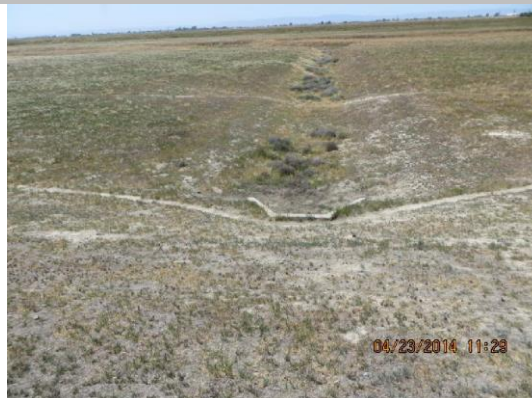
Photo 1 of 3 : UCIP_FA_2018_34755_62529.jpg

LM Start	19.94	Rating **	A/W	Issue No.	1357
LM End	19.94	Issue Type +	Ma	Location *	
Category	Supplemental			GPS Latitude/Longitude	
				Start	End
Item	DWR UCIP LMA Responsibility			37.108426 °	37.108426 °
				-120.554990 °	-120.554990 °
DWR ID	19780				
Comment Code					
Inspector Comment					
FS_ID:34755 DS_ID:19780 EP_NO: N/A Repair Type: No Action Needed Crossing Status: Found UCIP Comments: FIELD_STRUCT_DESC: 36-inch corrugated metal gravity drainage pipe through the levee, 9.8 feet below the crown. Flap gate on the waterside (WS) end. Concrete headwall on the landside (LS) end. Concrete U-shaped headwall on the WS end. [Additional Reference(s): DWR Levee Log, 2002. USACE San Joaquin O&M Manual 601.1, 1967, (HLM 19.92)]. FS Date: 4/23/2014

Headwall, pipe, and flapgate visible on WS toe.

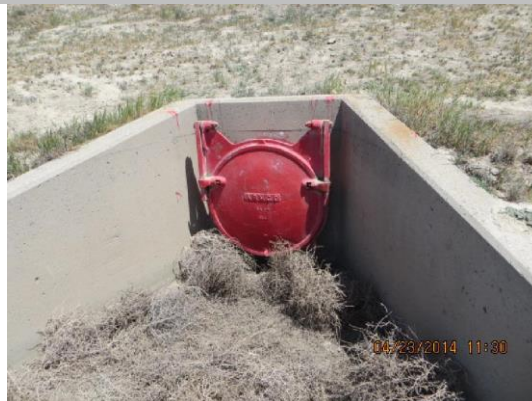
Photo 2 of 3 : UCIP_FA_2018_34755_62530.jpg

Headwall, pipe, and flapgate visible on WS toe.

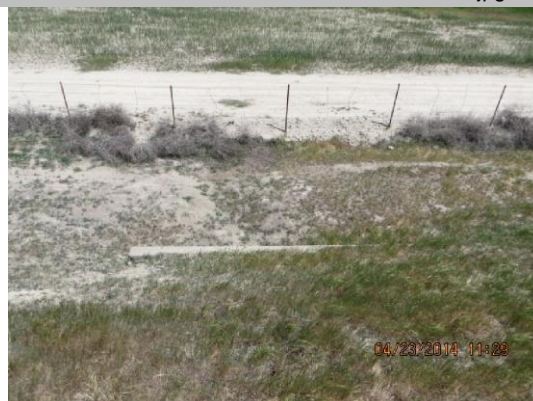
Photo 3 of 3 : UCIP_FA_2018_34755_62528.jpg

LM Start	19.94	Rating **	A/W	Issue No.	1357 (cont)
LM End	19.94	Issue Type +	Ma	Location *	
Category	Supplemental			GPS Latitude/Longitude	
				Start	End
Item	DWR UCIP LMA Responsibility			37.108426 °	37.108426 °
				-120.554990 °	-120.554990 °
DWR ID	19780				
Comment Code					
Inspector Comment					
FS_ID:34755 DS_ID:19780 EP_NO: N/A Repair Type: No Action Needed Crossing Status: Found UCIP Comments: FIELD_STRUCT_DESC: 36-inch corrugated metal gravity drainage pipe through the levee, 9.8 feet below the crown. Flap gate on the waterside (WS) end. Concrete headwall on the landside (LS) end. Concrete U-shaped headwall on the WS end. [Additional Reference(s): DWR Levee Log, 2002. USACE San Joaquin O&M Manual 601.1, 1967, (HLM 19.92)]. FS Date: 4/23/2014

Headwall and pipe visible on LS toe.

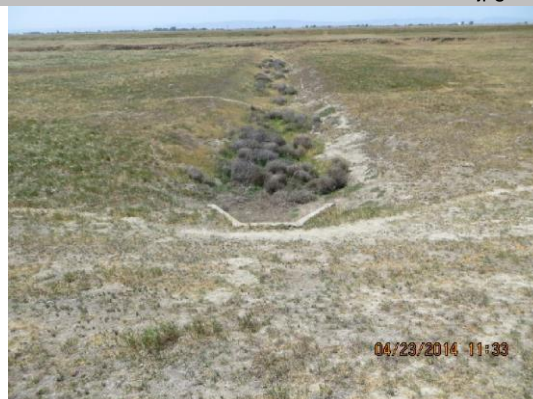
Photo 1 of 3 : UCIP_FA_2018_34757_62533.jpg

LM Start	20.10	Rating **	A/W	Issue No.	1358
LM End	20.10	Issue Type +	Ma	Location *	
Category	Supplemental			GPS Latitude/Longitude	
				Start	End
Item	DWR UCIP LMA Responsibility			37.107091 °	37.107091 °
				-120.553503 °	-120.553503 °
DWR ID	19781				
Comment Code					
Inspector Comment					
FS_ID:34757 DS_ID:19781 EP_NO: N/A Repair Type: No Action Needed Crossing Status: Found UCIP Comments: FIELD_STRUCT_DESC: 36-inch corrugated metal gravity drainage pipe through the levee, 9.9 feet below the crown. Flap gate on the waterside (WS) end. Concrete headwall on the landside (LS) end. Concrete U-shaped headwall on the WS end. [Additional Reference(s): DWR Levee Log, 2002. USACE San Joaquin O&M Manual 601.1, 1967, (HLM 20.05)]. FS Date: 4/23/2014

Headwall, pipe, and flapgate visible on WS toe.

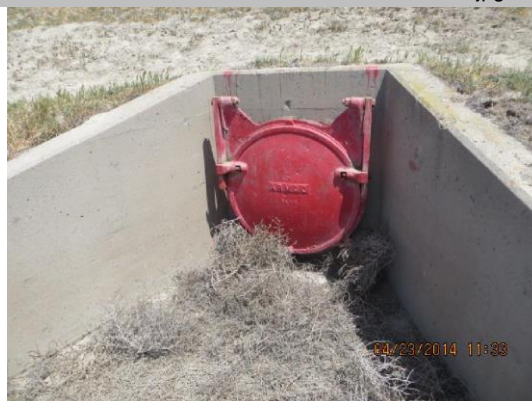
Photo 2 of 3 : UCIP_FA_2018_34757_62532.jpg

Headwall, pipe, and flapgate visible on WS toe.

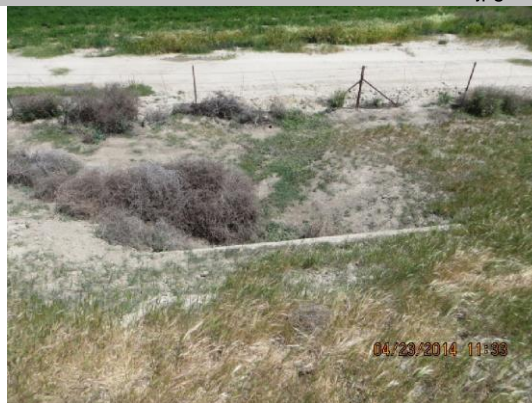
Photo 3 of 3 : UCIP_FA_2018_34757_62534.jpg

Headwall and pipe visible on LS toe.

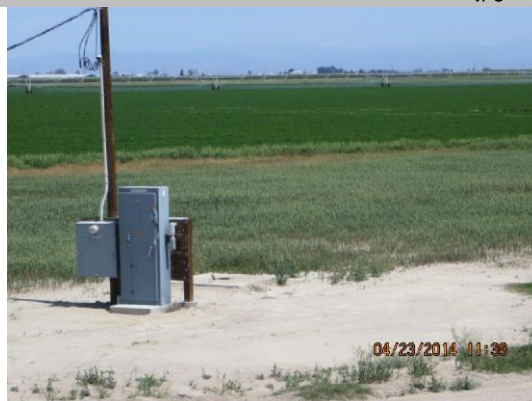
Photo 1 of 1 : UCIP_FA_2018_34759_62537.jpg

LM Start	20.19	Rating **	M	Issue No.	1359	
LM End	20.19	Issue Type +	En	Location *		
Category	Supplemental			GPS Latitude/Longitude		
				Start	End	
Item	DWR UCIP Field Study			37.106149°	37.106149°	
				-120.552538°	-120.552538°	
DWR ID	19782					
Comment Code						
Inspector Comment						
FS_ID:34759 DS_ID:19782 EP_NO: 13828 Repair Type: Non-Urgent Crossing Status: Not Found UCIP Comments: FIELD_STRUCT_DESC: *DELETE* NOT INSTALLED THROUGH THE LEVEE. 24-inch steel irrigation pipe through the levee, 4.0 feet below the crown. Pump missing from pad on the landward side. Steel cutoff wall around pipe at center of levee. Siphon breaker on apex of pipe on landward shoulder. Pre-existing ditch runs from waterward toe to channel. Pipe extends from pump to the channel. Rock revetment on the cut slopes of the inlet channel. (Permit No. 13828-1988) FS Date: 4/23/2014

Well head visible off LS toe.

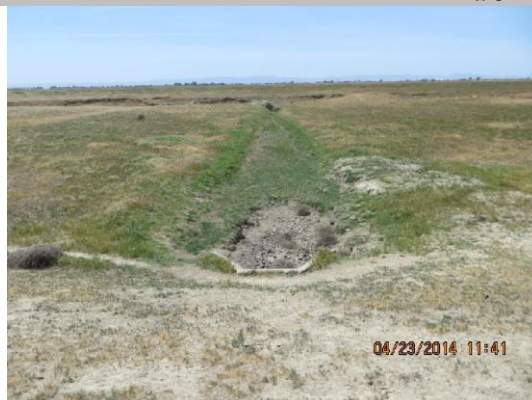
Photo 1 of 3 : UCIP_FA_2018_34760_62539.jpg

LM Start	20.24	Rating **	A/W	Issue No.	1360
LM End	20.24	Issue Type +	Ma	Location *	
Category	Supplemental			GPS Latitude/Longitude	
				Start	End
Item	DWR UCIP LMA Responsibility			37.105489 °	37.105489 °
				-120.551886 °	-120.551886 °
DWR ID	19783				
Comment Code					
Inspector Comment					
FS_ID:34760					
DS_ID:19783					
EP_NO: N/A					
Repair Type: No Action Needed					
Crossing Status: Found					
UCIP Comments:					
FIELD_STRUCT_DESC: 36-inch corrugated metal gravity drainage pipe					
through the levee, 10.6 feet below the crown. Flap gate on the					
waterside (WS) end. Concrete headwall on each end. [Additional					
Reference(s): DWR Levee Log, 2002. USACE San Joaquin O&M					
Manual 601.1, 1967, (HLM 20.18)].					
FS Date: 4/23/2014

Headwall, pipe, and flapgate visible on WS toe.

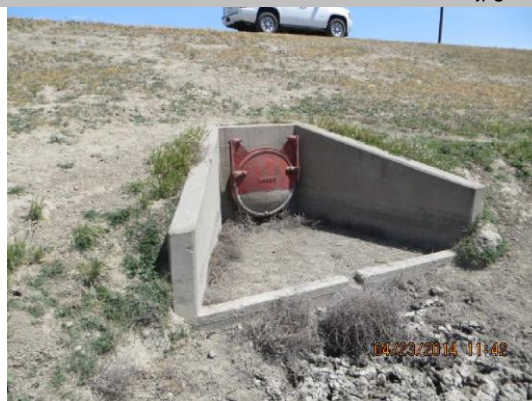
Photo 2 of 3 : UCIP_FA_2018_34760_62541.jpg

Headwall, pipe, and flapgate visible on WS toe.

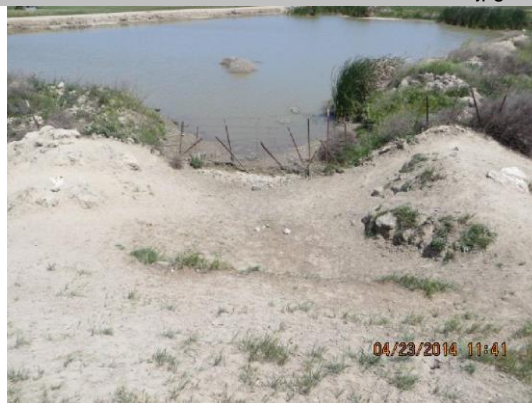
Photo 3 of 3 : UCIP_FA_2018_34760_62540.jpg

Headwall and pipe visible on LS toe.

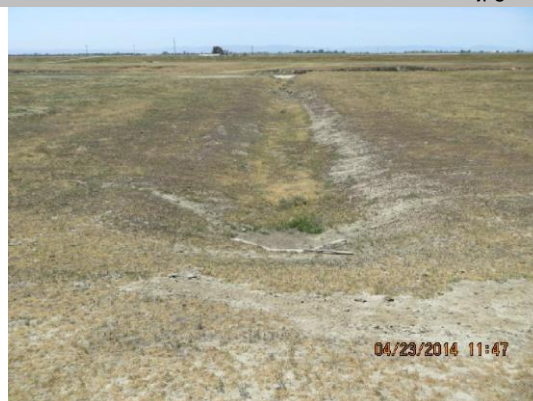
Photo 1 of 3 : UCIP_FA_2018_39605_62544.jpg

Comment Code					
Inspector Comment					
FS_ID:39605 DS_ID:19784 EP_NO: N/A Repair Type: Non-Urgent Crossing Status: Found UCIP Comments: 04/23/2014 Dense vegetation limits the inspector's visibility to identify signs of pipe failure (leaks) along the landward slope. Recommend removing vegetation along pipe alignment to conduct proper inspection of structure. (DWR UCIP - W. Wylie) FIELD_STRUCT_DESC: 24-inch corrugated metal gravity drainage pipe through the levee, 10.5 feet below the crown. Flap gate on the waterside (WS) end. Concrete headwall on the landside (LS) end. Concrete U-shaped headwall on the WS end. [Additional Reference(s): DWR Levee Log, 2002. USACE San Joaquin O&M Manual 601.1, 1967, (HLM 20.59)]. FS Date: 4/23/2014

Headwall, pipe, and flapgate visible on WS toe.

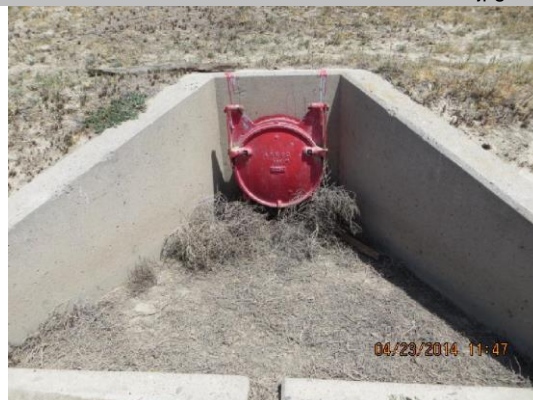
Photo 2 of 3 : UCIP_FA_2018_39605_62543.jpg

Headwall, pipe, and flapgate visible on WS toe.

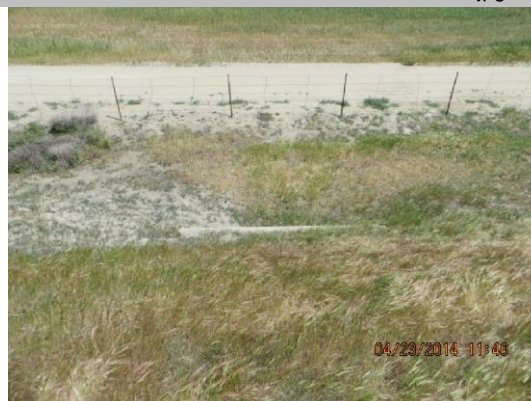
Photo 3 of 3 : UCIP_FA_2018_39605_62545.jpg

Item	DWR UCIP LMA Responsibility			37.100903 °	37.100903 °	
				-120.547282 °	-120.547282 °	
DWR ID	19784					
Comment Code						
Inspector Comment						
FS_ID:39605 DS_ID:19784 EP_NO: N/A Repair Type: Non-Urgent Crossing Status: Found UCIP Comments: 04/23/2014 Dense vegetation limits the inspector's visibility to identify signs of pipe failure (leaks) along the landward slope. Recommend removing vegetation along pipe alignment to conduct proper inspection of structure. (DWR UCIP - W. Wylie) FIELD_STRUCT_DESC: 24-inch corrugated metal gravity drainage pipe through the levee, 10.5 feet below the crown. Flap gate on the waterside (WS) end. Concrete headwall on the landside (LS) end. Concrete U-shaped headwall on the WS end. [Additional Reference(s): DWR Levee Log, 2002. USACE San Joaquin O&M Manual 601.1, 1967, (HLM 20.59)]. FS Date: 4/23/2014

Headwall and pipe visible on LS toe.

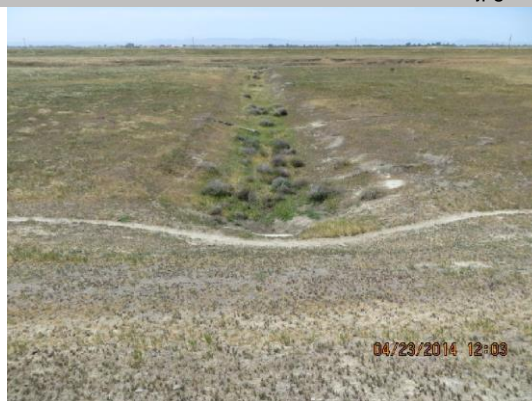
Photo 1 of 3 : UCIP_FA_2018_39606_62549.jpg

Comment Code						
Inspector Comment						
FS_ID:39606						
DS_ID:19785						
EP_NO: N/A						
Repair Type: Non-Urgent						
Crossing Status: Found						
UCIP Comments: 04/23/2014 Dense vegetation limits the inspector's visibility to identify signs of pipe failure (leaks) along the landward slope. Recommend removing vegetation along pipe alignment to conduct proper inspection of structure. (DWR UCIP - W. Wylie)						
FIELD_STRUCT_DESC: 24-inch corrugated metal gravity drainage pipe through the levee, 11.8 feet below the crown. Flap gate on the waterside (WS) end. Concrete headwall on the landside (LS) end. Concrete U-shaped headwall on the WS end. [Additional Reference(s): DWR Levee Log, 2002. USACE San Joaquin O&M Manual 601.1, 1967, (HLM 21.08)].						
FS Date: 4/23/2014

Headwall, pipe, and flapgate visible on WS toe.

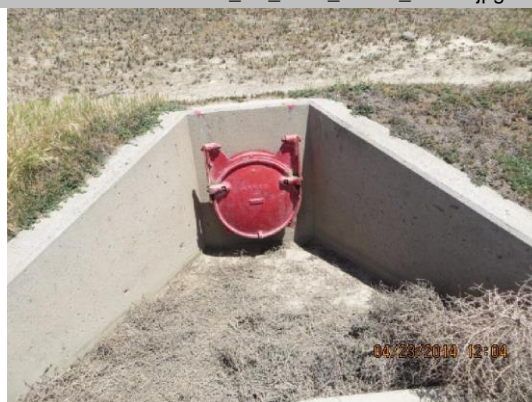
Photo 2 of 3 : UCIP_FA_2018_39606_62551.jpg

Headwall, pipe, and flapgate visible on WS toe.

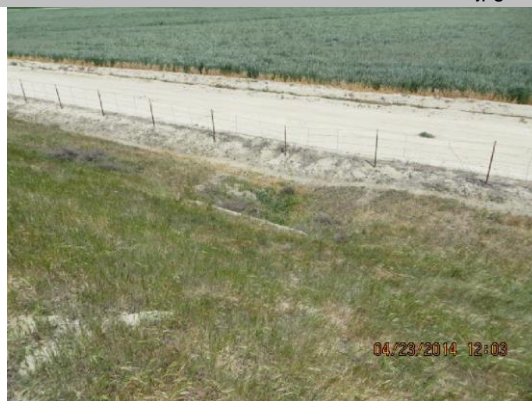
Photo 3 of 3 : UCIP_FA_2018_39606_62550.jpg

Item	DWR UCIP LMA Responsibility			37.095603°	37.095603°	
				-120.541593°	-120.541593°	
DWR ID	19785					
Comment Code						
Inspector Comment						
FS_ID:39606						
DS_ID:19785						
EP_NO: N/A						
Repair Type: Non-Urgent						
Crossing Status: Found						
UCIP Comments: 04/23/2014 Dense vegetation limits the inspector's visibility to identify signs of pipe failure (leaks) along the landward slope. Recommend removing vegetation along pipe alignment to conduct proper inspection of structure. (DWR UCIP - W. Wylie)						
FIELD_STRUCT_DESC: 24-inch corrugated metal gravity drainage pipe through the levee, 11.8 feet below the crown. Flap gate on the waterside (WS) end. Concrete headwall on the landside (LS) end. Concrete U-shaped headwall on the WS end. [Additional Reference(s): DWR Levee Log, 2002. USACE San Joaquin O&M Manual 601.1, 1967, (HLM 21.08)].						
FS Date: 4/23/2014

Headwall and pipe visible on LS toe.

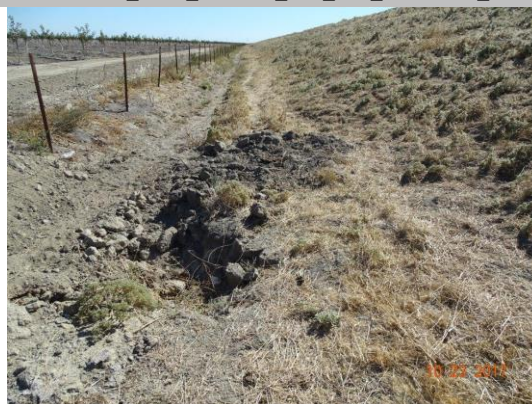
Photo 1 of 1 : FA_2018_NA0010_123_120_20180911_00024.jpg

LM Start	21.45	Rating **	M	Issue No.	120
LM End	21.45	Issue Type +	Ma	Location *	LS
Category	Earthen Levee			GPS Latitude/Longitude	
				Start	End
Item	Erosion / Bank Caving			37.092064°	37.092064°
				-120.537750°	-120.537750°
DWR ID	DWR_NA0010_05_f_2017_120				
Comment Code					
E2 : Schedule repair of erosion site prior to the next inspection.					
Inspector Comment					
Repair holes dug at the landside toe.

Looking southeast at the landside toe.

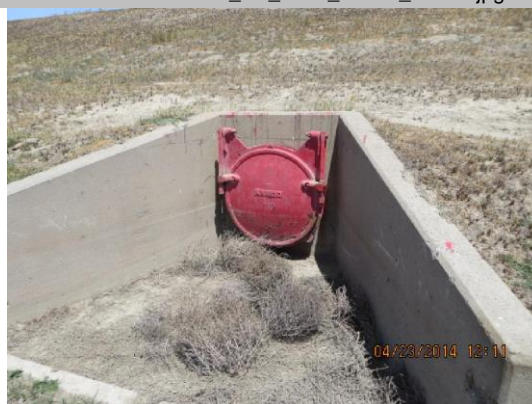
Photo 2 of 3 : UCIP_FA_2018_39614_62556.jpg

Headwall, pipe, and flapgate visible on WS toe.

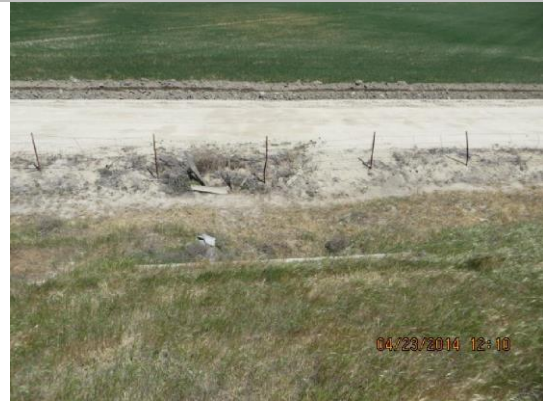
Photo 3 of 3 : UCIP_FA_2018_39614_62554.jpg

Item	DWR UCIP LMA Responsibility			37.091755°	37.091755°	
				-120.537414°	-120.537414°	
DWR ID	19786					
Comment Code						
Inspector Comment						
FS_ID:39614 DS_ID:19786 EP_NO: N/A Repair Type: Non-Urgent Crossing Status: Found UCIP Comments: 04/23/2014 Dense vegetation limits the inspector's visibility to identify signs of pipe failure (leaks) along the landward slope. Recommend removing vegetation along pipe alignment to conduct proper inspection of structure. (DWR UCIP - W. Wylie) FIELD_STRUCT_DESC: 36-inch corrugated metal gravity drainage pipe through the levee, 12.7 feet below the crown. Flap gate on the waterside (WS) end. Concrete headwall on the landside (LS) end. Concrete U-shaped headwall on the WS end. [Additional Reference(s): DWR Levee Log, 2002. USACE San Joaquin O&M Manual 601.1, 1967, (HLM 21.42)]. FS Date: 4/23/2014

Headwall and pipe visible on LS toe.

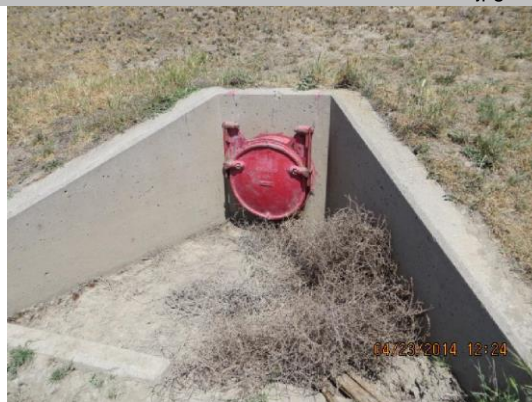
Photo 2 of 3 : UCIP_FA_2018_39883_62558.jpg

Headwall, pipe, and flapgate visible on WS toe.

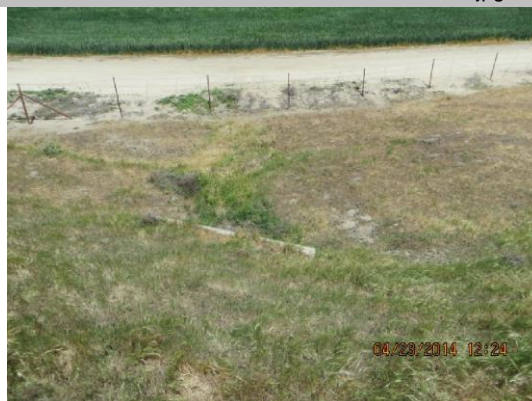
Photo 3 of 3 : UCIP_FA_2018_39883_62560.jpg

Item	DWR UCIP LMA Responsibility			37.087525 °	37.087525 °	
				-120.532827 °	-120.532827 °	
DWR ID	19787					
Comment Code						
Inspector Comment						
FS_ID:39883 DS_ID:19787 EP_NO: N/A Repair Type: Non-Urgent Crossing Status: Found UCIP Comments: 04/23/2014 Dense vegetation limits the inspector's visibility to identify signs of pipe failure (leaks) along the landward slope. Recommend removing vegetation along pipe alignment to conduct proper inspection of structure. (DWR UCIP - W. Wylie) FIELD_STRUCT_DESC: 24-inch corrugated metal gravity drainage pipe through the levee, 12.4 feet below the crown. Flap gate on the waterside (WS) end. Concrete headwall on the landside (LS) end. Concrete U-shaped headwall on the WS end. [Additional Reference(s): DWR Levee Log, 2002. USACE San Joaquin O&M Manual 601.1, 1967, (HLM 21.81)]. FS Date: 4/23/2014

Headwall and pipe visible on LS toe.

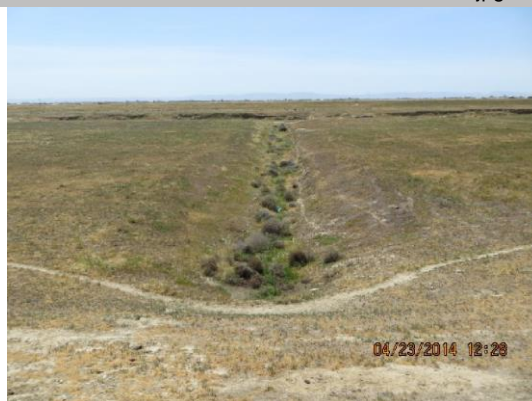
Photo 1 of 3 : UCIP_FA_2018_39610_62586.jpg

Comment Code					
Inspector Comment					
FS_ID:39610 DS_ID:19788 EP_NO: N/A Repair Type: Non-Urgent Crossing Status: Found UCIP Comments: 04/23/2014 Dense vegetation limits the inspector's visibility to identify signs of pipe failure (leaks) along the landward slope. Recommend removing vegetation along pipe alignment to conduct proper inspection of structure. (DWR UCIP - W. Wylie) FIELD_STRUCT_DESC: 24-inch corrugated metal gravity drainage pipe through the levee, 10.7 feet below the crown. Flap gate on the waterside (WS) end. Concrete headwall on the landside (LS) end. Concrete U-shaped headwall on the WS end. [Additional Reference(s): DWR Levee Log, 2002. USACE San Joaquin O&M Manual 601.1, 1967, (HLM 21.85)]. FS Date: 4/23/2014

Headwall, pipe, and flapgate visible on WS toe.

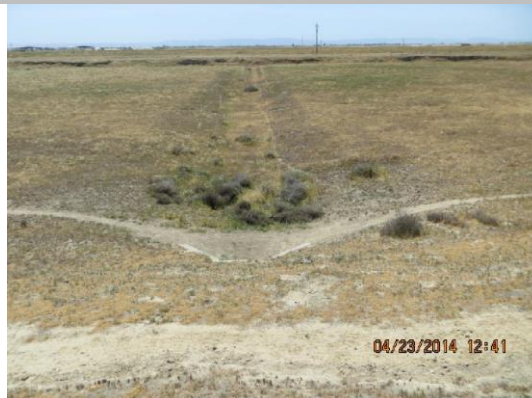
Photo 1 of 3 : UCIP_FA_2018_39611_62591.jpg

Comment Code					
Inspector Comment					
FS_ID:39611 DS_ID:19789 EP_NO: N/A Repair Type: Non-Urgent Crossing Status: Found UCIP Comments: 04/23/2014 Dense vegetation limits the inspector's visibility to identify signs of pipe failure (leaks) along the landward slope. Recommend removing vegetation along pipe alignment to conduct proper inspection of structure. Sediment buildup in pipe visible from landward side--recommend contacting owner to clear pipe. (DWR UCIP - W. Wylie) FIELD_STRUCT_DESC: 24-inch corrugated metal gravity drainage pipe through the levee, 10.2 feet below the crown. Flap gate on the waterside (WS) end. Concrete headwall on the landside (LS) end. Concrete U-shaped headwall on the WS end. [Additional Reference(s): DWR Levee Log, 2002. USACE San Joaquin O&M Manual 601.1, 1967, (HLM 22.19)]. FS Date: 4/23/2014

Headwall, pipe, and flapgate visible on WS toe.

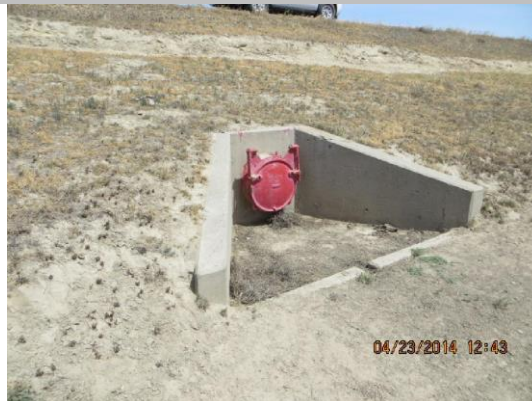
Photo 2 of 3 : UCIP_FA_2018_39611_62593.jpg

Headwall, pipe, and flapgate visible on WS toe.
