**Flood Control Project Maintenance
Levee Inspections**

Fall 2018 Levee Maintenance Deficiency Summary Report

San Joaquin River Basin

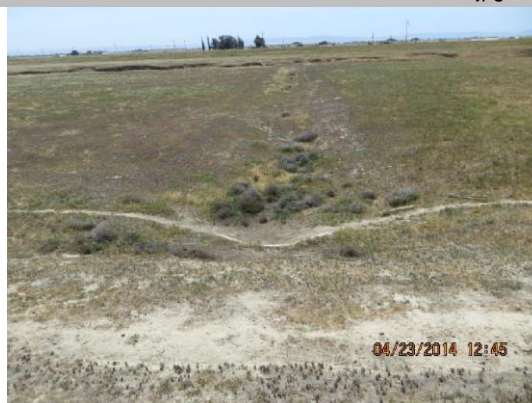
Photo 1 of 3 : UCIP_FA_2018_39613_62596.jpg

Comment Code						
Inspector Comment						
FS_ID:39613 DS_ID:19790 EP_NO: N/A Repair Type: Non-Urgent Crossing Status: Found UCIP Comments: 04/23/2014 Dense vegetation limits the inspector's visibility to identify signs of pipe failure (leaks) along the landward slope. Recommend removing vegetation along pipe alignment to conduct proper inspection of structure. Sediment buildup in pipe visible from landward side--recommend contacting owner to clear pipe. (DWR UCIP - W. Wylie) FIELD_STRUCT_DESC: 24-inch corrugated metal gravity drainage pipe through the levee, 10.4 feet below the crown. Flap gate on the waterside (WS) end. Concrete headwall on the landside (LS) end. Concrete U-shaped headwall on the WS end. [Additional Reference(s): DWR Levee Log, 2002. USACE San Joaquin O&M Manual 601.1, 1967, (HLM 22.46)]. FS Date: 4/23/2014

Headwall, pipe, and flapgate visible on WS toe.

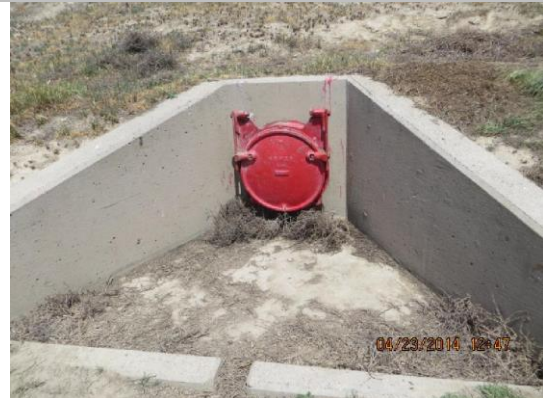
Photo 2 of 3 : UCIP_FA_2018_39613_62598.jpg

Item	DWR UCIP LMA Responsibility			37.080486 °	37.080486 °	
				-120.525180 °	-120.525180 °	
DWR ID	19790					
Comment Code						
Inspector Comment						
FS_ID:39613 DS_ID:19790 EP_NO: N/A Repair Type: Non-Urgent Crossing Status: Found UCIP Comments: 04/23/2014 Dense vegetation limits the inspector's visibility to identify signs of pipe failure (leaks) along the landward slope. Recommend removing vegetation along pipe alignment to conduct proper inspection of structure. Sediment buildup in pipe visible from landward side--recommend contacting owner to clear pipe. (DWR UCIP - W. Wylie) FIELD_STRUCT_DESC: 24-inch corrugated metal gravity drainage pipe through the levee, 10.4 feet below the crown. Flap gate on the waterside (WS) end. Concrete headwall on the landside (LS) end. Concrete U-shaped headwall on the WS end. [Additional Reference(s): DWR Levee Log, 2002. USACE San Joaquin O&M Manual 601.1, 1967, (HLM 22.46)]. FS Date: 4/23/2014

Headwall, pipe, and flapgate visible on WS toe.

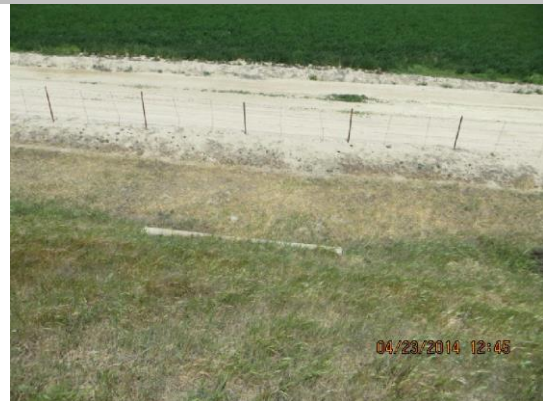
Photo 3 of 3 : UCIP_FA_2018_39613_62597.jpg

Headwall and pipe visible on LS toe.

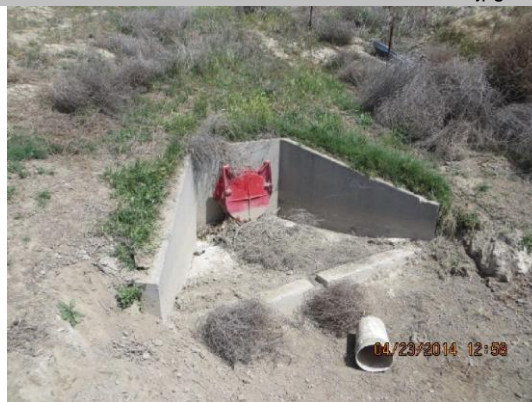
Photo 2 of 3 : UCIP_FA_2018_39618_62610.jpg

Headwall, pipe, and flapgate visible on WS toe.

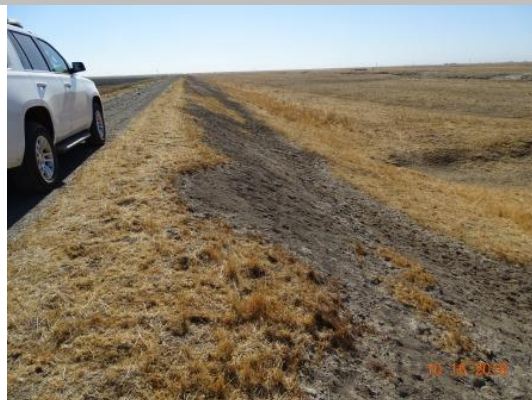
Photo 1 of 1 : FA_2018_NA0010_123_160_20181101_00331.jpg

LM Start	23.24	Rating **	A/W	Issue No.	160
LM End	23.25	Issue Type +	Ma	Location *	WS
Category	Earthen Levee			GPS Latitude/Longitude	
				Start	End
Item	Slope Stability			37.073064 °	37.072946 °
				-120.516771 °	-120.516634 °
DWR ID	DWR_NA0010_05_f_2018_160				
Comment Code					
S2 : Repair the levee slope damaged by foot traffic and prevent access where possible.					
Inspector Comment					
Slope damage caused by livestock

slope damage cause by livestock foot traffic. (Fall 2018)

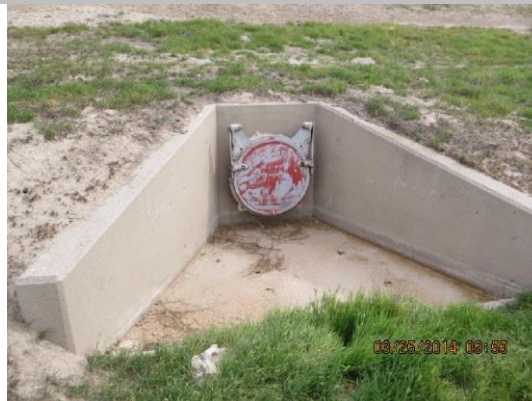
Photo 2 of 3 : UCIP_FA_2018_32763_59263.jpg

Flapgate and concrete headwall on WS toe.

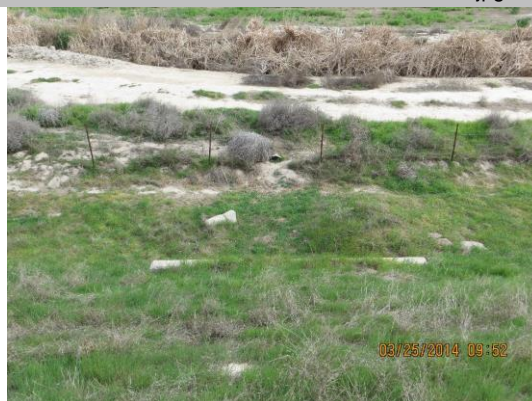
Photo 3 of 3 : UCIP_FA_2018_32763_59261.jpg

LM Start	23.25	Rating **	A/W	Issue No.	1371 (cont)	
LM End	23.25	Issue Type +	Ma	Location *		
Category	Supplemental			GPS Latitude/Longitude		
				Start		End
Item	DWR UCIP LMA Responsibility			37.072989 °		37.072989 °
				-120.516687 °		-120.516687 °
DWR ID	19794					
Comment Code						
Inspector Comment						
FS_ID:32763 DS_ID:19794 EP_NO: N/A Repair Type: No Action Needed Crossing Status: Found UCIP Comments: FIELD_STRUCT_DESC: 30-inch corrugated metal gravity drainage pipe through the levee, 11.6 feet below the crown. Flap gate on the waterside (WS) end. Concrete headwall on the landside (LS) end. Concrete U-shaped headwall on the WS end. [Additional Reference(s): DWR Levee Log, 2002. USACE San Joaquin O&M Manual 601.1, 1967, (HLM 23.15)]. FS Date: 3/25/2014 9:04:45 AM

Concrete headwall on LS toe.

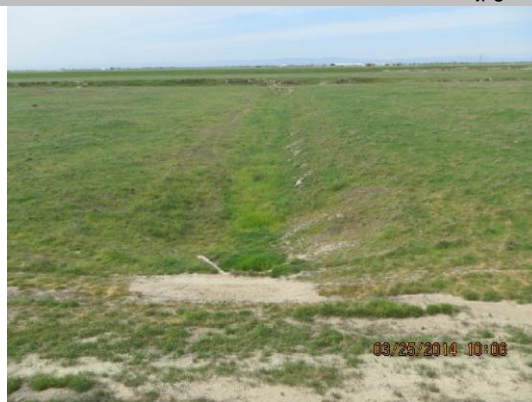
Photo 1 of 3 : UCIP_FA_2018_39621_59272.jpg

LM Start	23.72	Rating **	M	Issue No.	1372
LM End	23.72	Issue Type +	Ma	Location *	
Category	Supplemental			GPS Latitude/Longitude	
				Start	End
Item	DWR UCIP LMA Responsibility			37.067799 °	37.067799 °
				-120.511093 °	-120.511093 °
DWR ID	19796				
Comment Code					
Inspector Comment					
FS_ID:39621 DS_ID:19796 EP_NO: N/A Repair Type: Non-Urgent Crossing Status: Found UCIP Comments: 03/25/2014 Sediment buildup in pipe visible from landward side--recommend contacting owner to clear pipe. (DWR UCIP - W. Wylie) FIELD_STRUCT_DESC: 30-inch corrugated metal gravity drainage pipe through the levee, 12.1 feet below the crown. Flap gate on the waterside (WS) end. Concrete U-shaped headwall on the WS end. [Additional Reference(s): DWR Levee Log, 2002. USACE San Joaquin O&M Manual 601.1, 1967, (HLM 23.62)]. FS Date: 3/25/2014

Concrete headwall on WS toe.

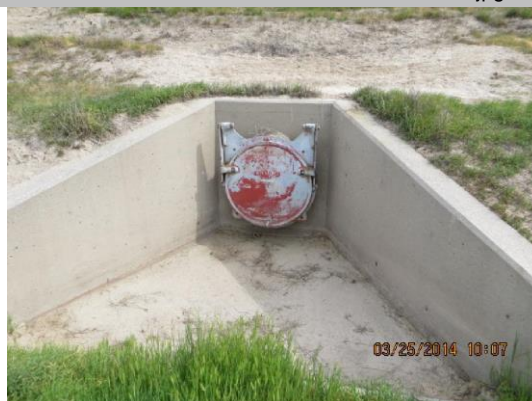
Photo 2 of 3 : UCIP_FA_2018_39621_59270.jpg

Flapgate on Concrete headwall on WS toe.

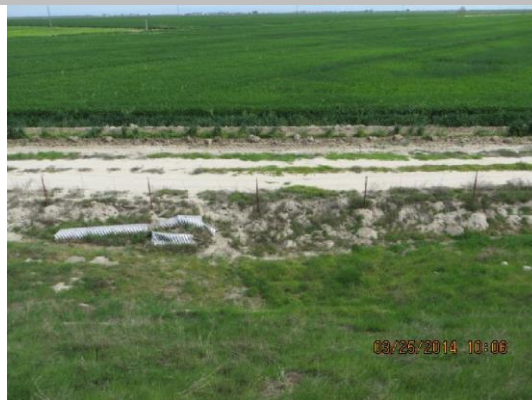
Photo 3 of 3 : UCIP_FA_2018_39621_59271.jpg

Concrete headwall on LS toe.

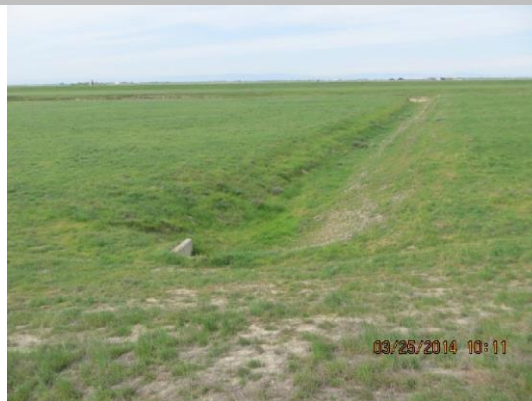
Photo 1 of 3 : UCIP_FA_2018_39620_59282.jpg

LM Start	24.02	Rating **	M	Issue No.	1373
LM End	24.02	Issue Type +	Ma	Location *	
Category	Supplemental			GPS Latitude/Longitude	
				Start	End
Item	DWR UCIP LMA Responsibility			37.064494 °	37.064494 °
				-120.507531 °	-120.507531 °
DWR ID	19797				
Comment Code					
Inspector Comment					
FS_ID:39620 DS_ID:19797 EP_NO: N/A Repair Type: Non-Urgent Crossing Status: Found UCIP Comments: 03/25/2014 Minor sediment/debris buildup in pipe visible from landward side--recommend contacting owner to clear pipe. (DWR UCIP - W. Wylie) FIELD_STRUCT_DESC: 36-inch corrugated metal gravity drainage pipe through the levee, 12.1 feet below the crown. Flap gate on the waterside (WS) end. Concrete headwall on the landside (LS) end. Concrete U-shaped headwall on the WS end. [Additional Reference(s): DWR Levee Log, 2002. USACE San Joaquin O&M Manual 601.1, 1967, (HLM 23.85)]. FS Date: 3/25/2014

Concrete headwall on WS toe.

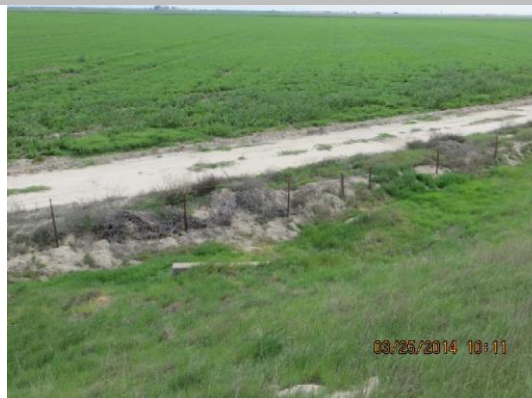
Photo 3 of 3 : UCIP_FA_2018_39620_59281.jpg

Concrete headwall on LS toe.

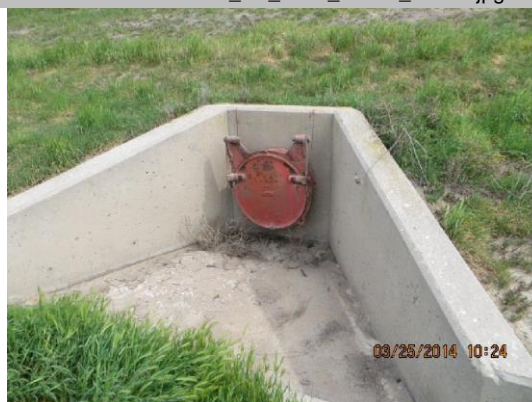
Photo 2 of 3 : UCIP_FA_2018_46850_59285.jpg

Flapgate at concrete headwall at WS toe.

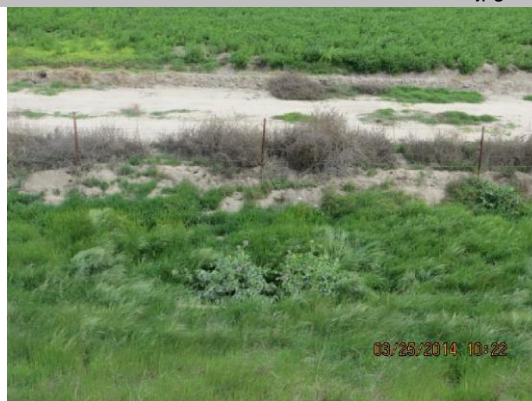
Photo 3 of 3 : UCIP_FA_2018_46850_59286.jpg

Item	DWR UCIP LMA Responsibility			37.061724 °	37.061724 °	
				-120.504512 °	-120.504512 °	
DWR ID	19798					
Comment Code						
Inspector Comment						
FS_ID:46850 DS_ID:19798 EP_NO: N/A Repair Type: Non-Urgent Crossing Status: Found UCIP Comments: 03/25/2014 Dense vegetation limits the inspector's visibility to identify signs of pipe failure (leaks) along the landward slope. Recommend removing vegetation along pipe alignment to conduct proper inspection of structure. (DWR UCIP - W. Wylie) FIELD_STRUCT_DESC: 24-inch corrugated metal gravity drainage pipe through the levee, 11.2 feet below the crown. Flap gate on the waterside (WS) end. Concrete headwall on the landside (LS) end. Concrete U-shaped headwall on the WS end. [Additional Reference(s): DWR Levee Log, 2002. USACE San Joaquin O&M Manual 601.1, 1967, (HLM 24.18)]. FS Date: 3/25/2014

Concrete headwall at LS toe.

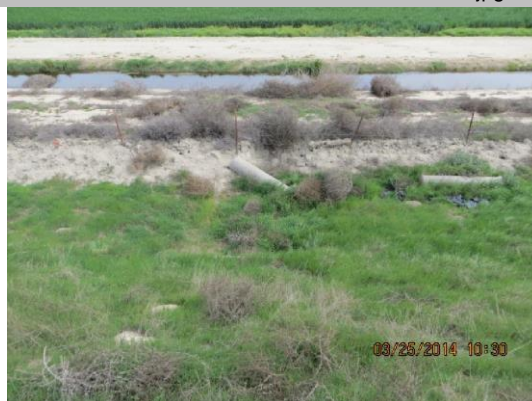
Photo 3 of 3 : UCIP_FA_2018_39623_59291.jpg

Item	DWR UCIP LMA Responsibility			37.058673 °	37.058673 °	
				-120.501238 °	-120.501238 °	
DWR ID	19799					
Comment Code						
Inspector Comment						
FS_ID:39623 DS_ID:19799 EP_NO: N/A Repair Type: Non-Urgent Crossing Status: Found UCIP Comments: 03/25/2014 Dense vegetation limits the inspector's visibility to identify signs of pipe failure (leaks) along the landward slope. Recommend removing vegetation along pipe alignment to conduct proper inspection of structure. (DWR UCIP - W. Wylie) FIELD_STRUCT_DESC: 24-inch corrugated metal gravity drainage pipe through the levee, 11.2 feet below the crown. Flap gate on the waterside (WS) end. Concrete headwall on the landside (LS) end. Concrete U-shaped headwall on the WS end. [Additional Reference(s): DWR Levee Log, 2002. USACE San Joaquin O&M Manual 601.1, 1967, (HLM 24.46)]. FS Date: 3/25/2014

Concrete headwall on LS toe.

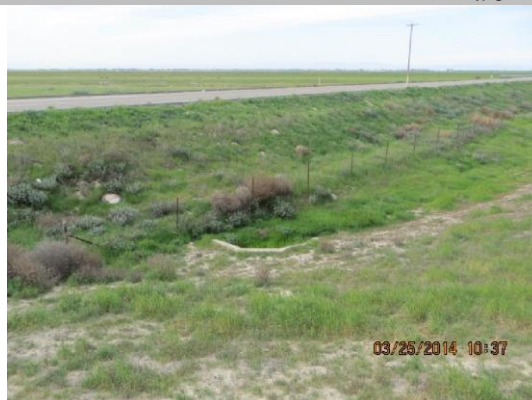
Photo 1 of 3 : UCIP_FA_2018_32786_59297.jpg

LM Start	24.93	Rating **	A/W	Issue No.	1376
LM End	24.93	Issue Type +	Ma	Location *	
Category	Supplemental			GPS Latitude/Longitude	
				Start	End
Item	DWR UCIP LMA Responsibility			37.054481 °	37.054481 °
				-120.496798 °	-120.496798 °
DWR ID	19800				
Comment Code					
Inspector Comment					
FS_ID:32786 DS_ID:19800 EP_NO: N/A Repair Type: No Action Needed Crossing Status: Found UCIP Comments: FIELD_STRUCT_DESC: 24-inch corrugated metal gravity drainage pipe through the levee, 10.7 feet below the crown. Flap gate on the waterside (WS) end. Concrete headwall on the landside (LS) end. Concrete U-shaped headwall on the WS end. [Additional Reference(s): DWR Levee Log, 2002. USACE San Joaquin O&M Manual 601.1, 1967, (HLM 24.82)]. FS Date: 3/25/2014

Concrete headwall on WS toe.

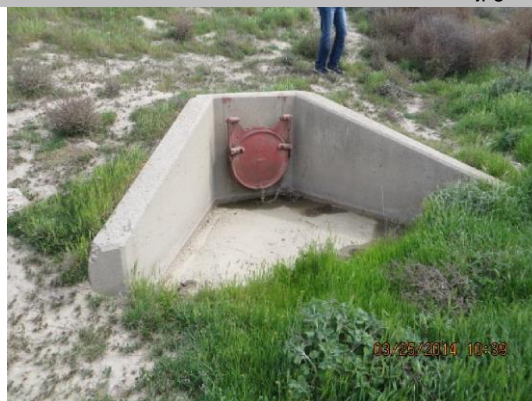
Photo 2 of 3 : UCIP_FA_2018_32786_59295.jpg

Flapgate on concrete headwall on WS toe.

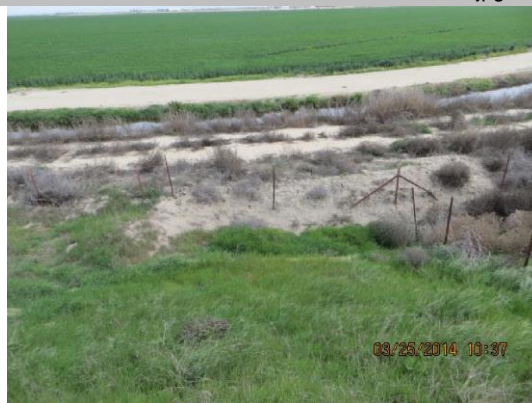
Photo 3 of 3 : UCIP_FA_2018_32786_59296.jpg

Concrete headwall on LS toe.

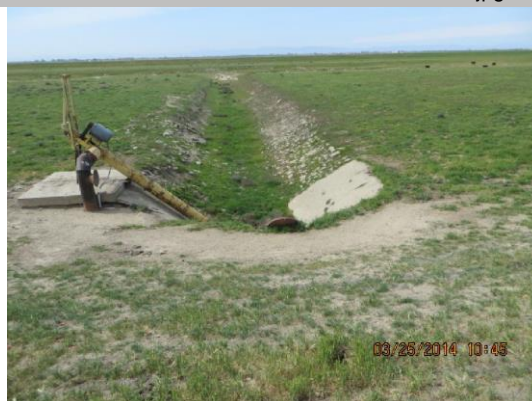
Photo 1 of 3 : UCIP_FA_2018_39624_59302.jpg

LM Start	24.96	Rating **	A/W	Issue No.	1377
LM End	24.96	Issue Type +	Ma	Location *	
Category	Supplemental			GPS Latitude/Longitude	
				Start	End
Item	DWR UCIP LMA Responsibility			37.054344 °	37.054344 °
				-120.496214 °	-120.496214 °
DWR ID	19801				
Comment Code					
Inspector Comment					
FS_ID:39624 DS_ID:19801 EP_NO: N/A Repair Type: No Action Needed Crossing Status: Found UCIP Comments: FIELD_STRUCT_DESC: 30-inch corrugated metal gravity drainage pipe through the levee, 10.9 feet below the crown. Flap gate on the waterside (WS) end. Concrete headwall on the landside (LS) end. Concrete U-shaped headwall on the WS end. [Additional Reference(s): DWR Levee Log, 2002. USACE San Joaquin O&M Manual 601.1, 1967, (HLM 24.87)]. FS Date: 3/25/2014

Flapgate and channel off WS toe.

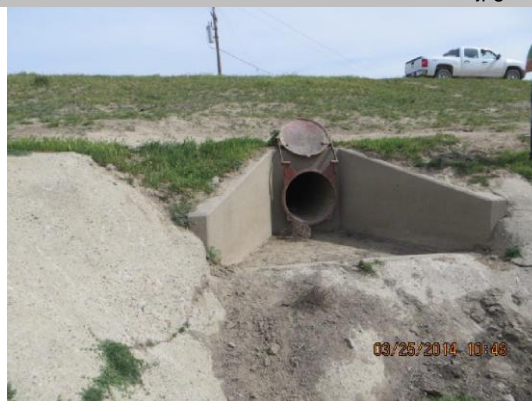
Photo 3 of 3 : UCIP_FA_2018_39624_59303.jpg

LM Start	24.96	Rating **	A/W	Issue No.	1377 (cont)
LM End	24.96	Issue Type +	Ma	Location *	
Category	Supplemental			GPS Latitude/Longitude	
				Start	End
Item	DWR UCIP LMA Responsibility			37.054344 °	37.054344 °
				-120.496214 °	-120.496214 °
DWR ID	19801				
Comment Code					
Inspector Comment					
FS_ID:39624 DS_ID:19801 EP_NO: N/A Repair Type: No Action Needed Crossing Status: Found UCIP Comments: FIELD_STRUCT_DESC: 30-inch corrugated metal gravity drainage pipe through the levee, 10.9 feet below the crown. Flap gate on the waterside (WS) end. Concrete headwall on the landside (LS) end. Concrete U-shaped headwall on the WS end. [Additional Reference(s): DWR Levee Log, 2002. USACE San Joaquin O&M Manual 601.1, 1967, (HLM 24.87)]. FS Date: 3/25/2014

Flapgate on headwall at WS toe.

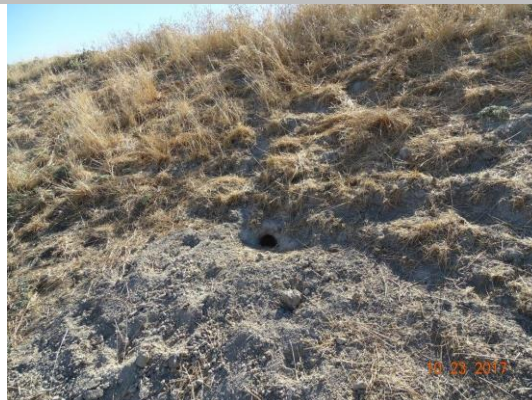
Photo 1 of 1 : FA_2018_NA0010_123_123_20180911_00027.jpg

LM Start	24.98	Rating **	M	Issue No.	123
LM End	25.26	Issue Type +	Ma	Location *	LS
Category	Earthen Levee			GPS Latitude/Longitude	
				Start	End
Item	Animal Control			37.054150 °	37.051252 °
				-120.495964 °	-120.492368 °
DWR ID	DWR_NA0010_05_f_2017_123				
Comment Code					
A3 : No rodents visible, but rodent burrows visible; need to backfill and compact or grout burrows.					
Inspector Comment

Looking southwest at the landside slope.

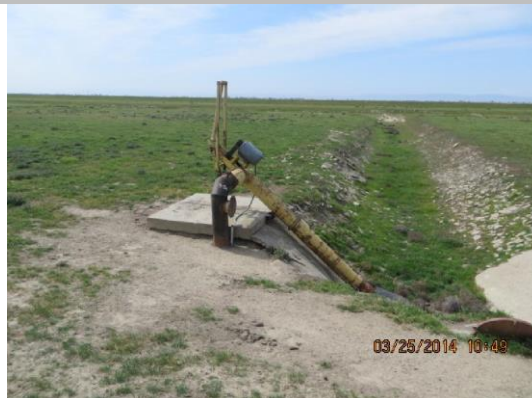
Photo 1 of 3 : UCIP_FA_2018_41716_59306.jpg

Comment Code						
Inspector Comment						
FS_ID:41716 DS_ID:19802 EP_NO: 12873 Repair Type: Non-Urgent Crossing Status: Found UCIP Comments: 03/25/2014 Clear soil from siphon breaker and install a protective riser. (DWR UCIP - W. Wylie) FIELD_STRUCT_DESC: 16-inch coated steel irrigation discharge pipe through the levee, 2 feet below the crown. Slant pump at the channel on the waterside (WS) toe. Siphon breaker on the WS shoulder. Gate valve on the landside (LS) toe. A preexisting ditch runs from the WS toe to the channel. Riprap placed around the intake. 2-inch polyvinyl chloride (PVC) electrical conduit at the same location. (Plans to install a pump with a discharge pipe through the levee authorized under Permit No. 12873, 1980 - Bowles Farming Company). [Additional Reference(s): DWR Levee Log, 2002]. FS Date: 3/25/2014

Slant pump at channel on WS toe.

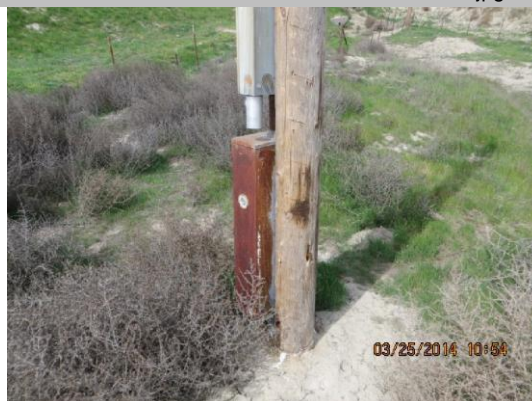
Photo 3 of 3 : UCIP_FA_2018_41716_59304.jpg

Item	DWR UCIP Field Study			37.054146 °	37.054146 °	
				-120.495968 °	-120.495968 °	
DWR ID	19802					
Comment Code						
Inspector Comment						
FS_ID:41716 DS_ID:19802 EP_NO: 12873 Repair Type: Non-Urgent Crossing Status: Found UCIP Comments: 03/25/2014 Clear soil from siphon breaker and install a protective riser. (DWR UCIP - W. Wylie) FIELD_STRUCT_DESC: 16-inch coated steel irrigation discharge pipe through the levee, 2 feet below the crown. Slant pump at the channel on the waterside (WS) toe. Siphon breaker on the WS shoulder. Gate valve on the landside (LS) toe. A preexisting ditch runs from the WS toe to the channel. Riprap placed around the intake. 2-inch polyvinyl chloride (PVC) electrical conduit at the same location. (Plans to install a pump with a discharge pipe through the levee authorized under Permit No. 12873, 1980 - Bowles Farming Company). [Additional Reference(s): DWR Levee Log, 2002]. FS Date: 3/25/2014

Power pole, meter, and electrical panel off LS toe.

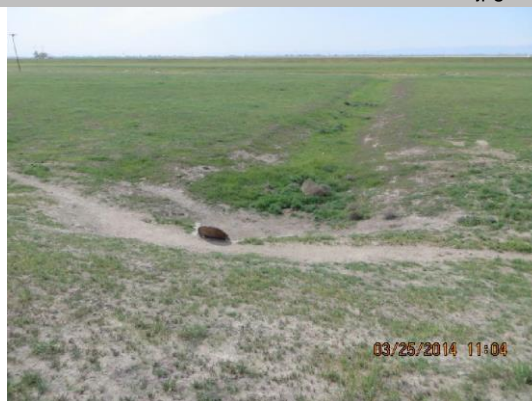
Photo 1 of 3 : UCIP_FA_2018_32789_59311.jpg

LM Start	25.24	Rating **	M	Issue No.	1379
LM End	25.24	Issue Type +	Ma	Location *	
Category	Supplemental			GPS Latitude/Longitude	
				Start	End
Item	DWR UCIP LMA Responsibility			37.051477 °	37.051477 °
				-120.492650 °	-120.492650 °
DWR ID	19803				
Comment Code					
Inspector Comment					
FS_ID:32789					
DS_ID:19803					
EP_NO: N/A					
Repair Type: Non-Urgent					
Crossing Status: Found					
UCIP Comments: 03/25/2014 Flapgate propped open during flood season. (DWR UCIP - W. Wylie)					
FIELD_STRUCT_DESC: 30-inch corrugated metal gravity drainage pipe through the levee, 11.3 feet below the crown. Flap gate on the waterside (WS) end. Concrete headwall on the landside (LS) end. Concrete U-shaped headwall on the WS end. [Additional Reference(s): DWR Levee Log, 2002. USACE San Joaquin O&M Manual 601.1, 1967, (HLM 25.43)].					
FS Date: 3/25/2014

Concrete headwall and flapgate on WS toe.

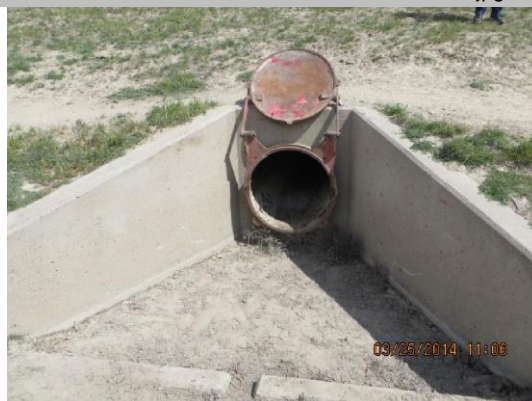
Photo 2 of 3 : UCIP_FA_2018_32789_59312.jpg

LM Start	25.24	Rating **	M	Issue No.	1379 (cont)	
LM End	25.24	Issue Type +	Ma	Location *		
Category	Supplemental			GPS Latitude/Longitude		
				Start		End
Item	DWR UCIP LMA Responsibility			37.051477 °		37.051477 °
				-120.492650 °		-120.492650 °
DWR ID	19803					
Comment Code						
Inspector Comment						
FS_ID:32789 DS_ID:19803 EP_NO: N/A Repair Type: Non-Urgent Crossing Status: Found UCIP Comments: 03/25/2014 Flapgate propped open during flood season. (DWR UCIP - W. Wylie) FIELD_STRUCT_DESC: 30-inch corrugated metal gravity drainage pipe through the levee, 11.3 feet below the crown. Flap gate on the waterside (WS) end. Concrete headwall on the landside (LS) end. Concrete U-shaped headwall on the WS end. [Additional Reference(s): DWR Levee Log, 2002. USACE San Joaquin O&M Manual 601.1, 1967, (HLM 25.43)]. FS Date: 3/25/2014

Concrete headwall and flapgate on WS toe.

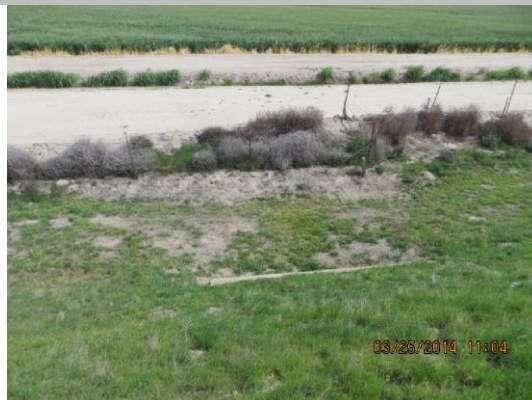
Photo 3 of 3 : UCIP_FA_2018_32789_59310.jpg

Concrete headwall on LS toe.

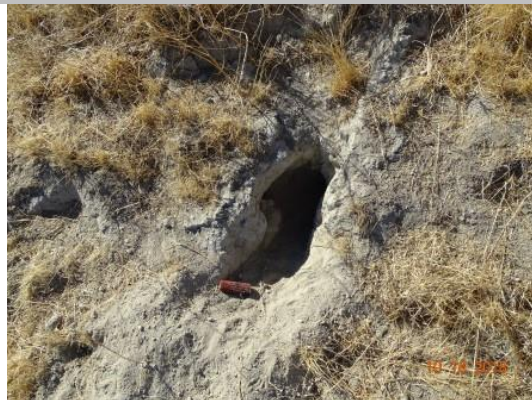
Photo 1 of 1 : FA_2018_NA0010_123_9_20181101_00332.jpg

LM Start	25.28	Rating **	M	Issue No.	9
LM End	25.64	Issue Type +	Ma	Location *	LS
Category	Earthen Levee			GPS Latitude/Longitude	
				Start	End
Item	Animal Control			37.051076 °	37.047042 °
				-120.492153 °	-120.488092 °
DWR ID	DWR_NA0010_05_s_2012_9				
Comment Code					
A3 : No rodents visible, but rodent burrows visible; need to backfill and compact or grout burrows.					
Inspector Comment					
Several rodent holes noted along this section.

view of representative rodent burrow. (Fall 2018)

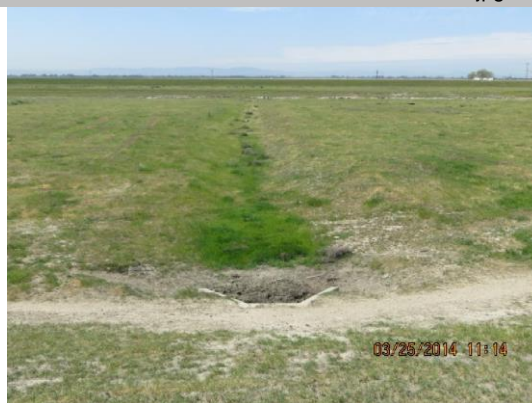
Photo 1 of 3 : UCIP_FA_2018_39625_59316.jpg

Comment Code					
Inspector Comment					
FS_ID:39625 DS_ID:19804 EP_NO: N/A Repair Type: Non-Urgent Crossing Status: Found UCIP Comments: 03/25/2014 Dense vegetation limits the inspector's visibility to identify signs of pipe failure (leaks) along the landward slope. Recommend removing vegetation along pipe alignment to conduct proper inspection of structure. Sediment buildup in pipe visible from landward side--recommend contacting owner to clear pipe. (DWR UCIP - W. Wylie) FIELD_STRUCT_DESC: 30-inch corrugated metal gravity drainage pipe through the levee, 12 feet below the crown. Flap gate on the waterside (WS) end. Concrete headwall on the landside (LS) end. Concrete U-shaped headwall on the WS end. [Additional Reference(s): DWR Levee Log, 2002. USACE San Joaquin O&M Manual 601.1, 1967, (HLM 25.51)]. FS Date: 3/25/2014

Concrete headwall on WS toe.

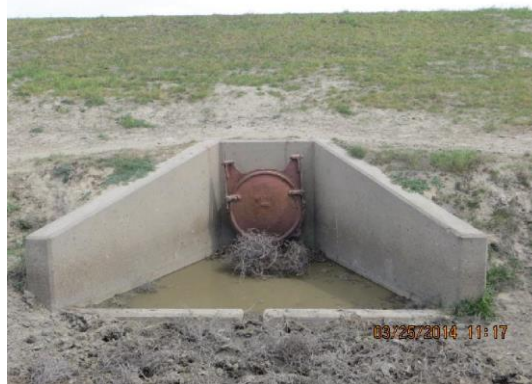
Photo 2 of 3 : UCIP_FA_2018_39625_59317.jpg

Flapgate on concrete headwall at WS toe.

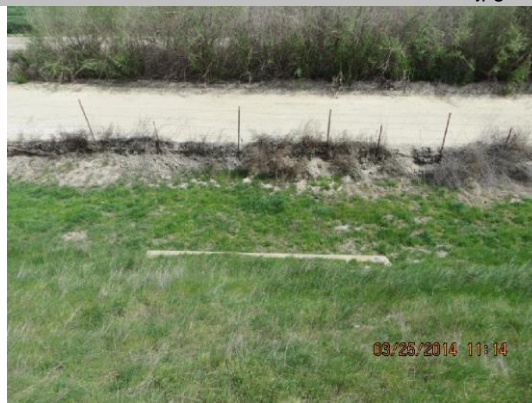
Photo 3 of 3 : UCIP_FA_2018_39625_59315.jpg

Concrete headwall on LS toe.

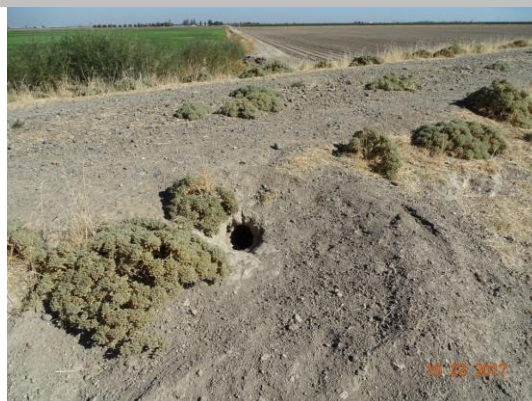
Photo 1 of 1 : FA_2018_NA0010_123_124_20180911_00028.jpg

LM Start	25.61	Rating **	M	Issue No.	124
LM End	25.61	Issue Type +	Ma	Location *	WS
Category	Earthen Levee			GPS Latitude/Longitude	
				Start	End
Item	Animal Control			37.047416 °	37.047416 °
				-120.488411 °	-120.488411 °
DWR ID	DWR_NA0010_05_f_2017_124				
Comment Code					
A3 : No rodents visible, but rodent burrows visible; need to backfill and compact or grout burrows.					
Inspector Comment

Looking east at the waterside slope.

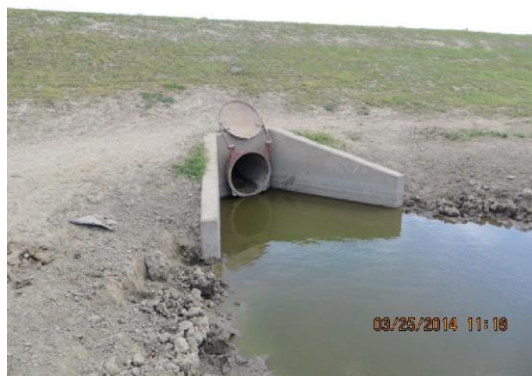
Photo 1 of 3 : UCIP_FA_2018_39626_59321.jpg

LM Start	25.63	Rating **	M	Issue No.	1381	
LM End	25.63	Issue Type +	Ma	Location *		
Category	Supplemental			GPS Latitude/Longitude		
				Start		End
Item	DWR UCIP LMA Responsibility			37.047170 °		37.047170 °
				-120.488222 °		-120.488222 °
DWR ID	19805					
Comment Code						
Inspector Comment						
FS_ID:39626 DS_ID:19805 EP_NO: N/A Repair Type: Non-Urgent Crossing Status: Found UCIP Comments: 03/25/2014 Sediment buildup in pipe visible from landward side--recommend contacting owner to clear pipe. (DWR UCIP - W. Wylie) FIELD_STRUCT_DESC: 30-inch corrugated metal gravity drainage pipe through the levee, 12.1 feet below the crown. Flap gate on the waterside (WS) end. Concrete headwall on the landside (LS) end. Concrete U-shaped headwall on the WS end. [Additional Reference(s): DWR Levee Log, 2002. USACE San Joaquin O&M Manual 601.1, 1967, (HLM 25.53)]. FS Date: 3/25/2014

Flapgate on headwall at WS toe.

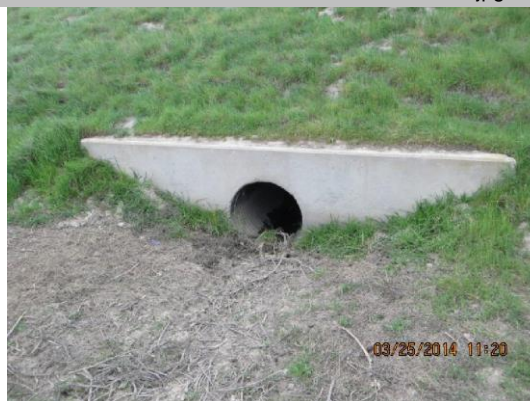
Photo 2 of 3 : UCIP_FA_2018_39626_59320.jpg

Item	DWR UCIP LMA Responsibility			37.047170 °		37.047170 °
				-120.488222 °		-120.488222 °
DWR ID	19805					
Comment Code						
Inspector Comment						
FS_ID:39626						
DS_ID:19805						
EP_NO: N/A						
Repair Type: Non-Urgent						
Crossing Status: Found						
UCIP Comments: 03/25/2014 Sediment buildup in pipe visible from landward side--recommend contacting owner to clear pipe. (DWR UCIP - W. Wylie)						
FIELD_STRUCT_DESC: 30-inch corrugated metal gravity drainage pipe through the levee, 12.1 feet below the crown. Flap gate on the waterside (WS) end. Concrete headwall on the landside (LS) end. Concrete U-shaped headwall on the WS end. [Additional Reference(s): DWR Levee Log, 2002. USACE San Joaquin O&M Manual 601.1, 1967, (HLM 25.53)].						
FS Date: 3/25/2014

Concrete headwall on LS toe.

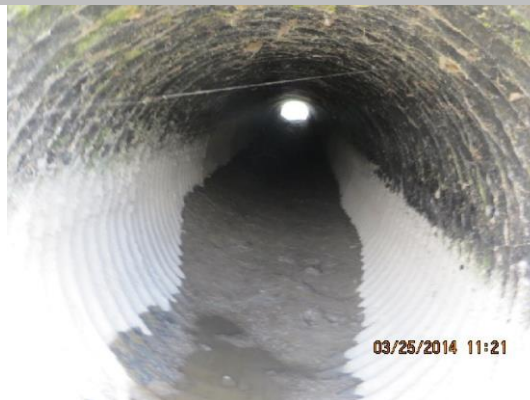
Photo 3 of 3 : UCIP_FA_2018_39626_59319.jpg

Inside pipe on LS toe.

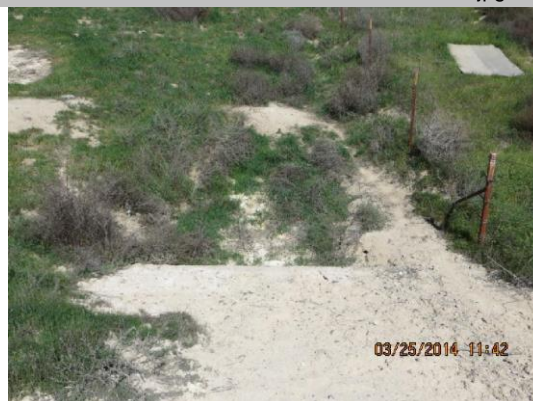
Photo 1 of 3 : UCIP_FA_2018_39628_59350.jpg

LM Start	26.95	Rating **	M	Issue No.	1384
LM End	26.95	Issue Type +	Ma	Location *	
Category	Supplemental			GPS Latitude/Longitude	
				Start	End
Item	DWR UCIP LMA Responsibility			37.032669 °	37.032669 °
				-120.473901 °	-120.473901 °
DWR ID	19808				
Comment Code					
Inspector Comment					
FS_ID:39628 DS_ID:19808 EP_NO: N/A Repair Type: Non-Urgent Crossing Status: Found UCIP Comments: 03/25/2014 Pipe has heavy silt buildup visible from landward side--recommend contacting owner to clear pipe. (DWR UCIP - W. Wylie) FIELD_STRUCT_DESC: 24-inch corrugated metal gravity drainage pipe through the levee, 11.4 feet below the crown. Flap gate on the waterside (WS) end. Concrete headwall on the landside (LS) end. Concrete U-shaped headwall on the WS end. [Additional Reference(s): DWR Levee Log, 2002. USACE San Joaquin O&M Manual 601.1, 1967, (HLM 26.85)]. FS Date: 3/25/2014

Concrete headwall on LS toe.

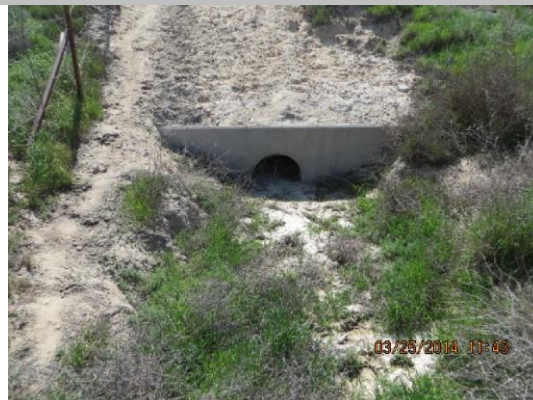
Photo 2 of 3 : UCIP_FA_2018_39628_59349.jpg

Concrete headwall on LS toe.

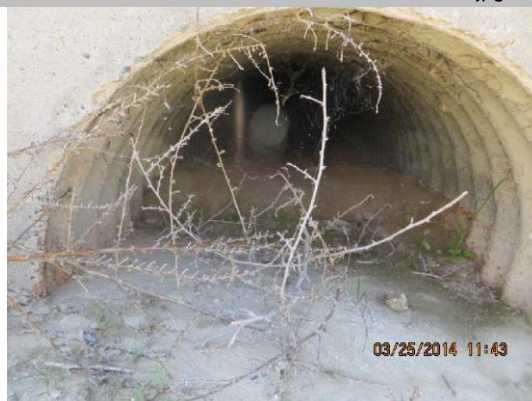
Photo 3 of 3 : UCIP_FA_2018_39628_59348.jpg

LM Start	26.95	Rating **	M	Issue No.	1384 (cont)	
LM End	26.95	Issue Type +	Ma	Location *		
Category	Supplemental			GPS Latitude/Longitude		
				Start		End
Item	DWR UCIP LMA Responsibility			37.032669 °		37.032669 °
				-120.473901 °		-120.473901 °
DWR ID	19808					
Comment Code						
Inspector Comment						
FS_ID:39628 DS_ID:19808 EP_NO: N/A Repair Type: Non-Urgent Crossing Status: Found UCIP Comments: 03/25/2014 Pipe has heavy silt buildup visible from landward side--recommend contacting owner to clear pipe. (DWR UCIP - W. Wylie) FIELD_STRUCT_DESC: 24-inch corrugated metal gravity drainage pipe through the levee, 11.4 feet below the crown. Flap gate on the waterside (WS) end. Concrete headwall on the landside (LS) end. Concrete U-shaped headwall on the WS end. [Additional Reference(s): DWR Levee Log, 2002. USACE San Joaquin O&M Manual 601.1, 1967, (HLM 26.85)]. FS Date: 3/25/2014

Silt buildup in pipe at LS toe.

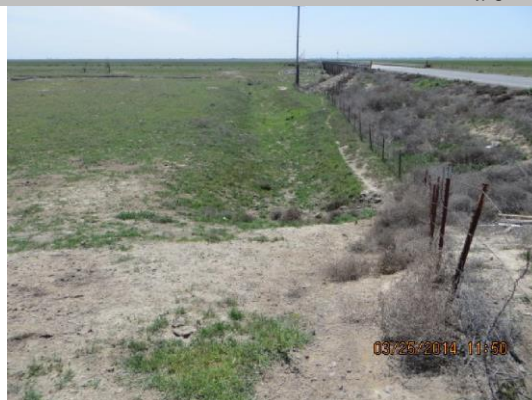
Photo 1 of 3 : UCIP_FA_2018_32806_59353.jpg

LM Start	26.97	Rating **	M	Issue No.	1385
LM End	26.97	Issue Type +	Ma	Location *	
Category	Supplemental			GPS Latitude/Longitude	
				Start	End
Item	DWR UCIP LMA Responsibility			37.032680 °	37.032680 °
				-120.473454 °	-120.473454 °
DWR ID	19748				
Comment Code					
Inspector Comment					
FS_ID:32806 DS_ID:19748 EP_NO: N/A Repair Type: Non-Urgent Crossing Status: Found UCIP Comments: 03/25/2014 Tumble weed buildup at inlet mat create blockage and should be removed. (DWR UCIP - W. Wylie) FIELD_STRUCT_DESC: 24-inch corrugated metal gravity drainage pipe through the levee, 11.3 feet below the crown. Flap gate on the waterside (WS) end. Concrete headwall on the landside (LS) end. Concrete U-shaped headwall on the WS end. [Additional Reference(s): DWR Levee Log, 2002. USACE San Joaquin O&M Manual 601.1, 1967, (HLM 26.87)]. FS Date: 3/25/2014

Concrete headwall at WS toe.

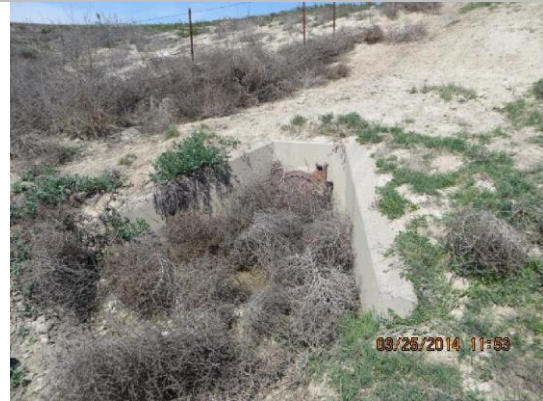
Photo 2 of 3 : UCIP_FA_2018_32806_59355.jpg

Flapgate and Concrete headwall at WS toe.

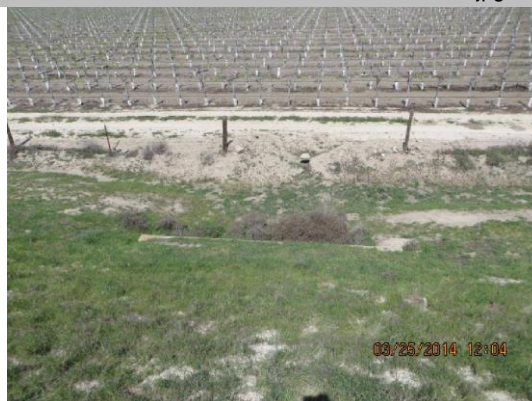
Photo 3 of 3 : UCIP_FA_2018_32807_59357.jpg

LM Start	27.31	Rating **	A/W	Issue No.	1386 (cont)	
LM End	27.31	Issue Type +	Ma	Location *		
Category	Supplemental			GPS Latitude/Longitude		
				Start		End
Item	DWR UCIP LMA Responsibility			37.032668 °		37.032668 °
				-120.467299 °		-120.467299 °
DWR ID	19749					
Comment Code						
Inspector Comment						
FS_ID:32807 DS_ID:19749 EP_NO: N/A Repair Type: No Action Needed Crossing Status: Found UCIP Comments: FIELD_STRUCT_DESC: 36-inch corrugated metal gravity drainage pipe through the levee, 12 feet below the crown. Flap gate on the waterside (WS) end. Concrete headwall on the landside (LS) end. Concrete U-shaped headwall on the WS end. [Additional Reference(s): DWR Levee Log, 2002. USACE San Joaquin O&M Manual 601.1, 1967, (HLM 27.22)]. FS Date: 3/25/2014

Concrete headwall on LS toe.

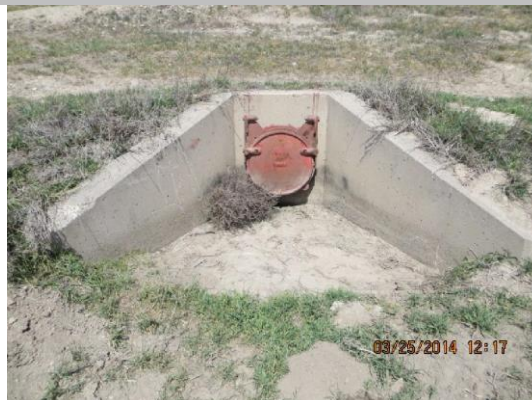
Photo 2 of 3 : UCIP_FA_2018_32823_59383.jpg

Flapgate on Concrete headwall at WS toe.

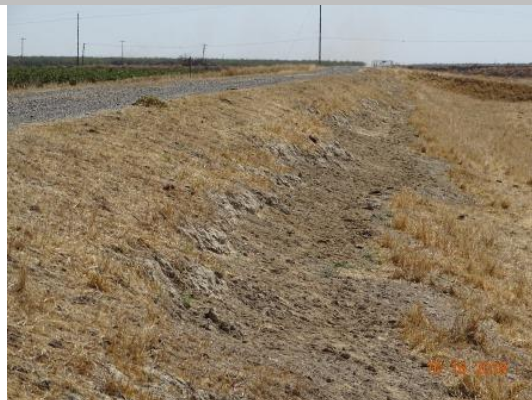
Photo 1 of 1 : FA_2018_NA0010_123_164_20181101_00335.jpg

LM Start	29.43	Rating **	M	Issue No.	164
LM End	29.59	Issue Type +	Ma	Location *	WS
Category	Earthen Levee			GPS Latitude/Longitude	
				Start	End
Item	Slope Stability			37.023481 °	37.021442 °
				-120.435960 °	-120.434564 °
DWR ID	DWR_NA0010_05_f_2018_164				
Comment Code					
S2 : Repair the levee slope damaged by foot traffic and prevent access where possible.					
Inspector Comment					
slope damage on waterside from livestock

slope damage from animal traffic. (Fall 2018)

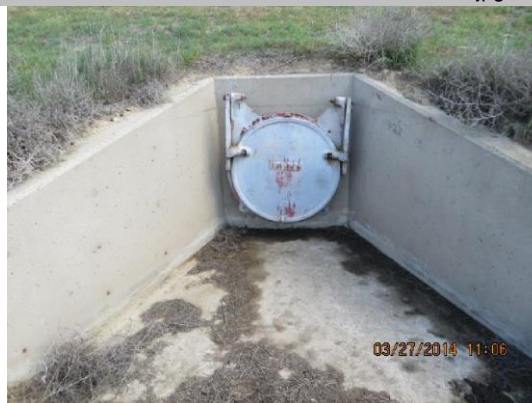
Photo 2 of 3 : UCIP_FA_2018_39884_59413.jpg

Flapgate on Concrete headwall at WS toe.

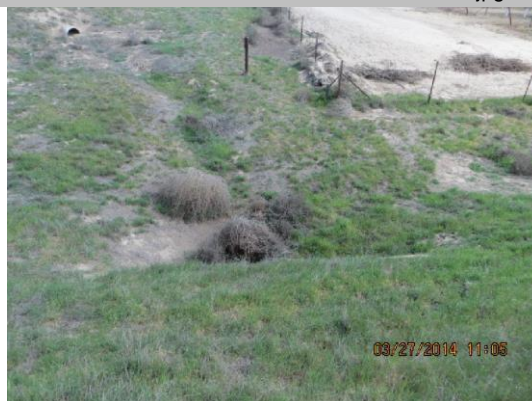
Photo 3 of 3 : UCIP_FA_2018_39884_59415.jpg

Comment Code					
Inspector Comment					
FS_ID:39884 DS_ID:19753 EP_NO: N/A Repair Type: Non-Urgent Crossing Status: Found UCIP Comments: 03/27/2014 Dense vegetation limits the inspector's visibility to identify signs of pipe failure (leaks) along the landward slope. Recommend removing vegetation along pipe alignment to conduct proper inspection of structure. Sediment buildup in pipe visible from landward side--recommend contacting owner to clear pipe. (DWR UCIP - W. Wylie) FIELD_STRUCT_DESC: 36-inch corrugated metal gravity drainage pipe through the levee, 10.2 feet below the crown. Flap gate on the waterside (WS) end. Concrete headwall on the landside (LS) end. Concrete U-shaped headwall on the WS end. [Additional Reference(s): DWR Levee Log, 2002. USACE San Joaquin O&M Manual 601.1, 1967, (HLM 29.49)]. FS Date: 3/27/2014

Concrete headwall on LS toe.

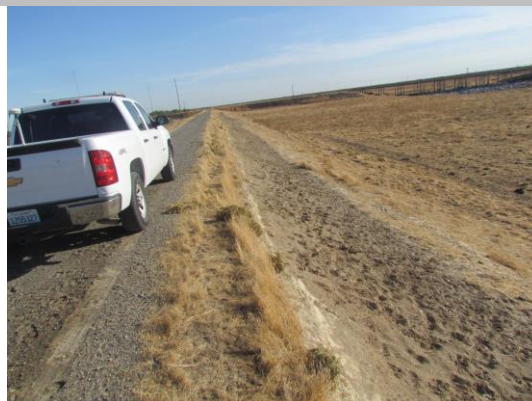
Photo 1 of 2 : FA_2018_NA0010_123_171_20180911_00036.jpg

LM Start	29.68	Rating **	M	Issue No.	171
LM End	29.80	Issue Type +	Ma	Location *	WS
Category	Earthen Levee			GPS Latitude/Longitude	
				Start	End
Item	Erosion / Bank Caving			37.020272 °	37.018712 °
				-120.433737 °	-120.432682 °
DWR ID	DWR_NA0010_05_s_2014_171				
Comment Code					
E1 : Note and monitor erosion site.					
Inspector Comment					
Waterside erosion caused by livestock.

Looking south at animal erosion on waterward slope.

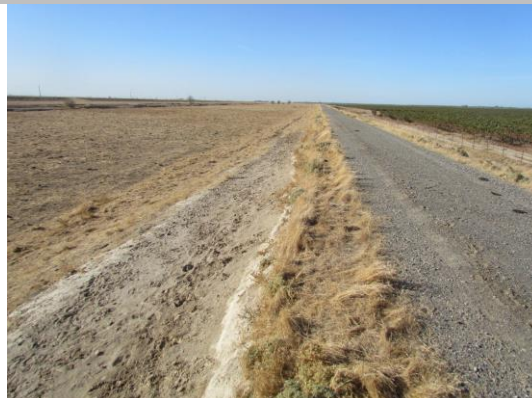
Photo 2 of 2 : FA_2018_NA0010_123_171_20180911_00037.jpg

LM Start	29.68	Rating **	M	Issue No.	171 (cont)	
LM End	29.80	Issue Type +	Ma	Location *	WS	
Category	Earthen Levee			GPS Latitude/Longitude		
				Start		End
Item	Erosion / Bank Caving			37.020272 °	37.018712 °	
				-120.433737 °	-120.432682 °	
DWR ID	DWR_NA0010_05_s_2014_171					
Comment Code						
E1 : Note and monitor erosion site.						
Inspector Comment						
Waterside erosion caused by livestock.

Looking north at animal erosion on waterward slope.

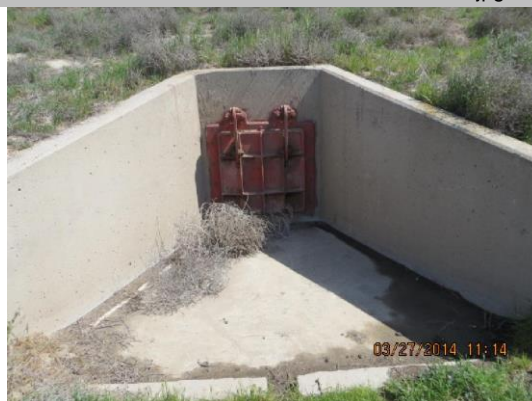
Photo 2 of 3 : UCIP_FA_2018_39631_59426.jpg

Flapgate on Concrete headwall at WS toe.

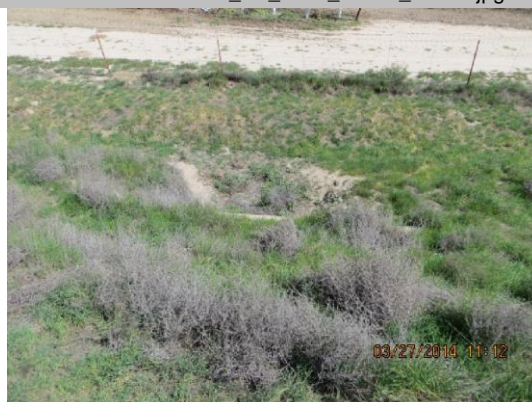
Photo 3 of 3 : UCIP_FA_2018_39631_59425.jpg

Item	DWR UCIP LMA Responsibility			37.018505 °	37.018505 °	
				-120.432544 °	-120.432544 °	
DWR ID	19754					
Comment Code						
Inspector Comment						
FS_ID:39631 DS_ID:19754 EP_NO: N/A Repair Type: Non-Urgent Crossing Status: Found UCIP Comments: 03/27/2014 Dense vegetation limits the inspector's visibility to identify signs of pipe failure (leaks) along the landward slope. Recommend removing vegetation along pipe alignment to conduct proper inspection of structure. (DWR UCIP - W. Wylie) FIELD_STRUCT_DESC: 30-inch by 30-inch reinforced concrete box gravity drainage culvert through the levee, 12 feet below the crown. Flap gate on the waterside (WS) end. Concrete headwall on the landside (LS) end. Concrete U-shaped headwall on the WS end. [Additional Reference(s): DWR Levee Log, 2002. USACE San Joaquin O&M Manual 601.1, 1967, (HLM 29.72)]. FS Date: 3/27/2014

Concrete headwall on LS toe.

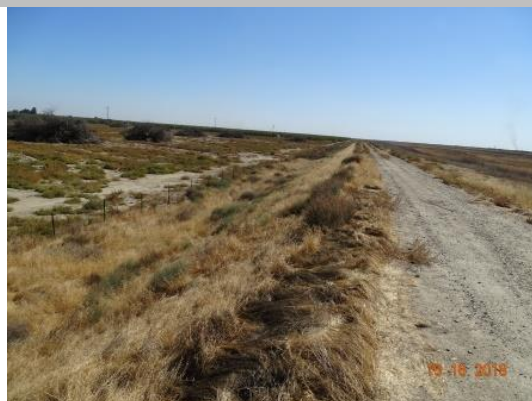
Photo 1 of 1 : FA_2018_NA0010_123_165_20181101_00336.jpg

LM Start	29.87	Rating **	U	Issue No.	165
LM End	31.70	Issue Type +	Ma	Location *	LS
Category	Earthen Levee			GPS Latitude/Longitude	
				Start	End
Item	Vegetation			37.017910 °	36.997385 °
				-120.432124 °	-120.411443 °
DWR ID	DWR_NA0010_05_f_2018_165				
Comment Code					
V1 : Control annual grass and weeds on the levee slopes and easements.					
Inspector Comment					
heavy vegetation blocking view of landside slope.

heavy grass vegetation on landside slope and toe. (Fall 2018)

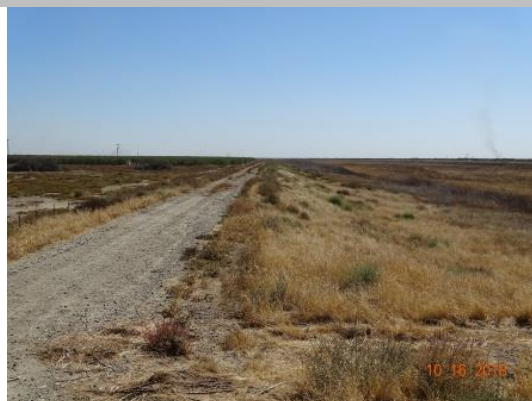
Photo 1 of 1 : FA_2018_NA0010_123_166_20181101_00337.jpg

LM Start	29.87	Rating **	M	Issue No.	166
LM End	30.22	Issue Type +	Ma	Location *	WS
Category	Earthen Levee			GPS Latitude/Longitude	
				Start	End
Item	Vegetation			37.017908 °	37.013437 °
				-120.432124 °	-120.429067 °
DWR ID	DWR_NA0010_05_f_2018_166				
Comment Code					
V1 : Control annual grass and weeds on the levee slopes and easements.					
Inspector Comment					
view of waterside slope partially obstructed by vegetation

dense grass and brush partially blocking view waterside slope. (Fall 2018)

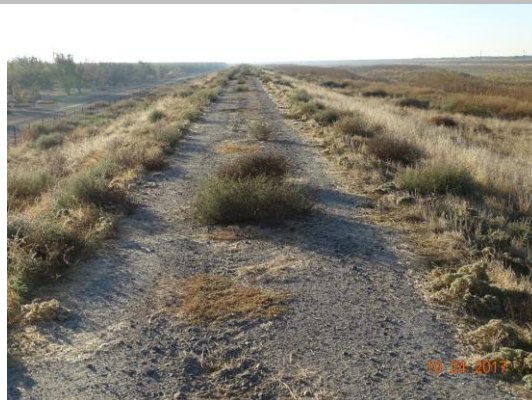
Photo 1 of 1 : FA_2018_NA0010_123_128_20180911_00030.jpg

LM Start	29.88	Rating **	A/W	Issue No.	128
LM End	31.19	Issue Type +	Ma	Location *	CR
Category	Earthen Levee			GPS Latitude/Longitude	
				Start	End
Item	Vegetation			37.017747 °	37.002885 °
				-120.432013 °	-120.417550 °
DWR ID	DWR_NA0010_05_f_2017_128				
Comment Code					
V9 : Keep the crown roadway free of vegetation.					
Inspector Comment

Looking southeast at the crown.

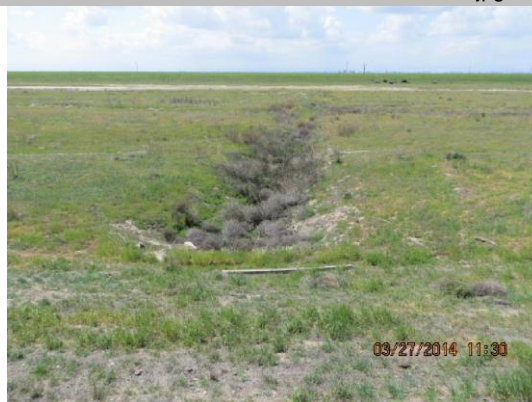
Photo 1 of 3 : UCIP_FA_2018_39633_59435.jpg

Comment Code					
Inspector Comment					
FS_ID:39633 DS_ID:19697 EP_NO: N/A Repair Type: Non-Urgent Crossing Status: Found UCIP Comments: 03/27/2014 Some debris buildup at LS toe. Dense vegetation limits the inspector's visibility to identify signs of pipe failure (leaks) along the landward slope. Recommend removing vegetation along pipe alignment to conduct proper inspection of structure. (DWR UCIP - W. Wylie) FIELD_STRUCT_DESC: 30-inch by 30-inch reinforced concrete box gravity drainage culvert through the levee, 13.3 feet below the crown. Flap gate on the waterside (WS) end. Concrete headwall on the landside (LS) end. Concrete U-shaped headwall on the WS end. [Additional Reference(s): DWR Levee Log, 2002. USACE San Joaquin O&M Manual 601.1, 1967, (HLM 30.96)]. FS Date: 3/27/2014

Concrete headwall on WS toe.

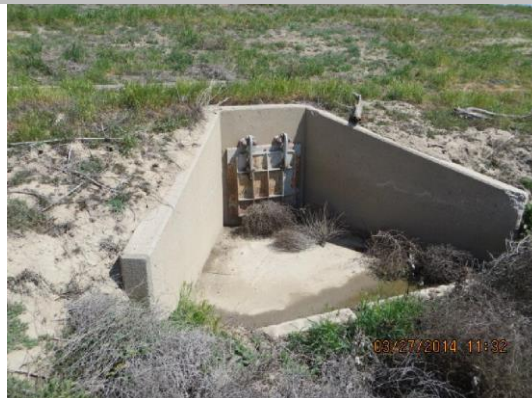
Photo 2 of 3 : UCIP_FA_2018_39633_59436.jpg

Flapgate on Concrete headwall at WS toe.

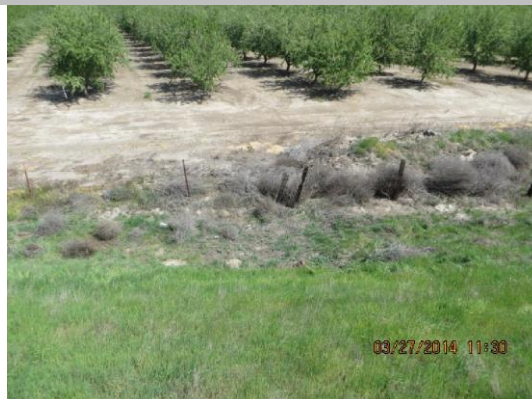
Photo 3 of 3 : UCIP_FA_2018_39633_59434.jpg

Concrete headwall on LS toe.

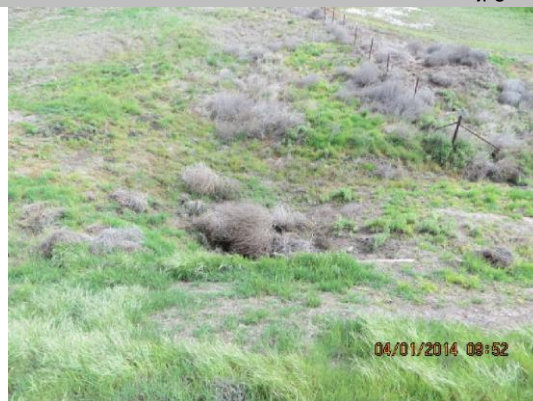
Photo 3 of 3 : UCIP_FA_2018_39645_59685.jpg

Concrete headwall on LS toe.

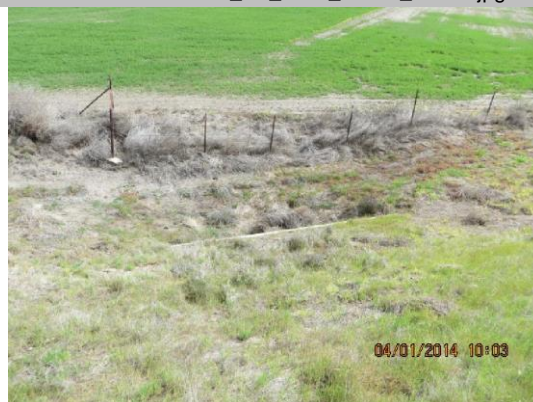
Photo 1 of 3 : UCIP_FA_2018_39646_59690.jpg

Comment Code					
Inspector Comment					
FS_ID:39646					
DS_ID:19701					
EP_NO: N/A					
Repair Type: Non-Urgent					
Crossing Status: Found					
UCIP Comments: 04/01/2014 Some silt buildup inside culvert. (DWR UCIP - W. Wylie)					
FIELD_STRUCT_DESC: 30-inch by 30-inch reinforced concrete box gravity drainage culvert through the levee, 14.2 feet below the crown. Flap gate on the waterside (WS) end. Concrete headwall on the landside (LS) end with flashboard attachment. Concrete U-shaped headwall on the WS end. [Additional Reference(s): DWR Levee Log, 2002. USACE San Joaquin O&M Manual 601.1, 1967, (HLM 32.22)].					
FS Date: 4/1/2014

Concrete headwall at inlet on LS toe.

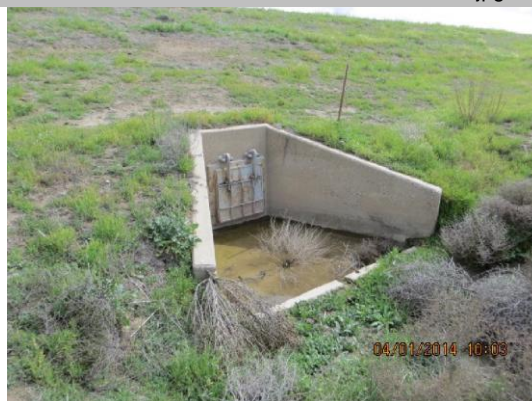
Photo 2 of 3 : UCIP_FA_2018_39646_59688.jpg

Flapgate on Concrete headwall at WS toe.

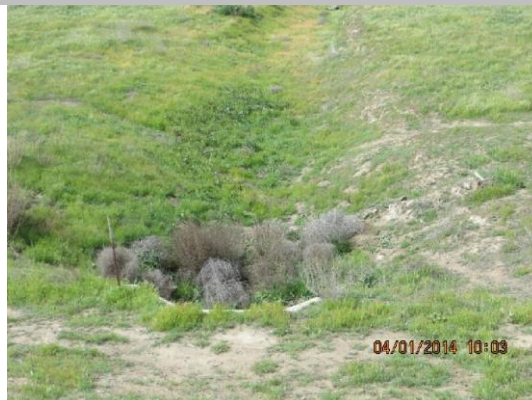
Photo 3 of 3 : UCIP_FA_2018_39646_59689.jpg

Concrete headwall at outlet on WS toe.

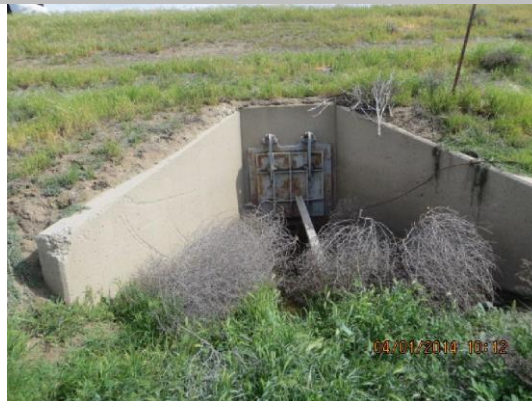
Photo 2 of 3 : UCIP_FA_2018_39647_59699.jpg

Flapgate on Concrete headwall at WS toe.

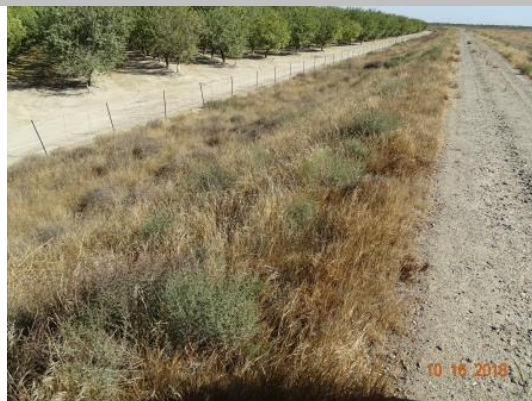
Photo 1 of 2 : FA_2018_NA0010_123_174_20181101_00340.jpg

LM Start	33.24	Rating **	U	Issue No.	174
LM End	34.77	Issue Type +	Ma	Location *	LS
Category	Earthen Levee			GPS Latitude/Longitude	
				Start	End
Item	Vegetation			36.979483 °	°
				-120.391581 °	°
DWR ID	DWR_NA0010_05_f_2018_174				
Comment Code					
V1 : Control annual grass and weeds on the levee slopes and easements.					
Inspector Comment					
heavy vegetation along landside slope and toe.

view of landside slope looking upstream. (Fall 2018)

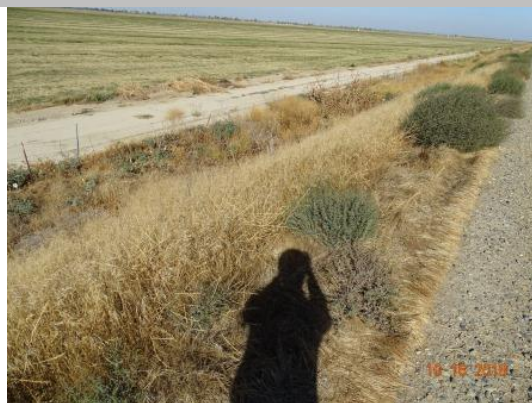
Photo 2 of 2 : FA_2018_NA0010_123_174_20181101_00341.jpg

LM Start	33.24	Rating **	U	Issue No.	174 (cont)	
LM End	34.77	Issue Type +	Ma	Location *	LS	
Category	Earthen Levee			GPS Latitude/Longitude		
				Start		End
Item	Vegetation			36.979483 °	°	
				-120.391581 °	°	
DWR ID	DWR_NA0010_05_f_2018_174					
Comment Code						
V1 : Control annual grass and weeds on the levee slopes and easements.						
Inspector Comment						
heavy vegetation along landside slope and toe.

view of vegetation along landside slope. (Fall 2018)

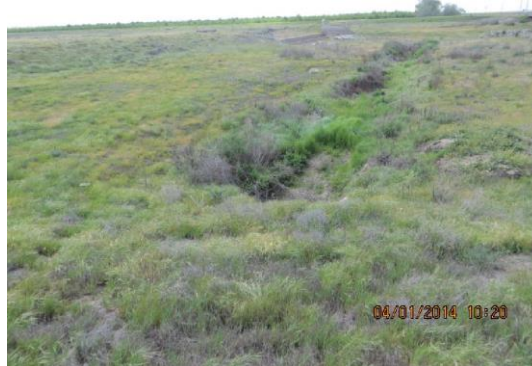
Photo 1 of 3 : UCIP_FA_2018_39648_59701.jpg

Comment Code					
Inspector Comment					
FS_ID:39648 DS_ID:19703 EP_NO: N/A Repair Type: Non-Urgent Crossing Status: Found UCIP Comments: 04/01/2014 Dense vegetation limits the inspector's visibility to identify signs of pipe failure (leaks) along the slopes. Recommend removing vegetation along pipe alignment to conduct proper inspection of structure. (DWR UCIP - W. Wylie) FIELD_STRUCT_DESC: 30-inch by 30-inch reinforced concrete box gravity drainage culvert through the levee, 13.9 feet below the crown. Flap gate on the waterside (WS) end. Concrete headwall on the landside (LS) end. Concrete U-shaped headwall on the WS end. [Additional Reference(s): DWR Levee Log, 2002. USACE San Joaquin O&M Manual 601.1, 1967, (HLM 33.72)]. FS Date: 4/1/2014

Concrete headwall at WS toe.

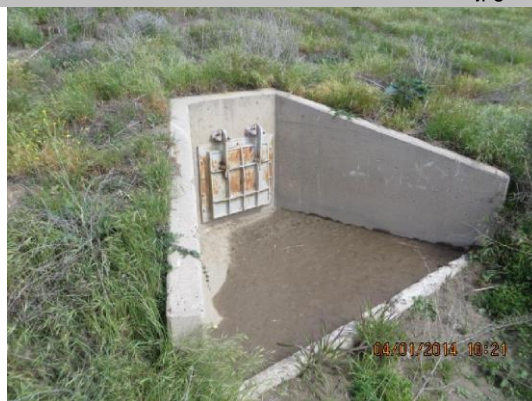
Photo 2 of 3 : UCIP_FA_2018_39648_59700.jpg

Flapgate on Concrete headwall at WS toe.
