**Flood Control Project Maintenance
Levee Inspections**

Fall 2018 Levee Maintenance Deficiency Summary Report

San Joaquin River Basin

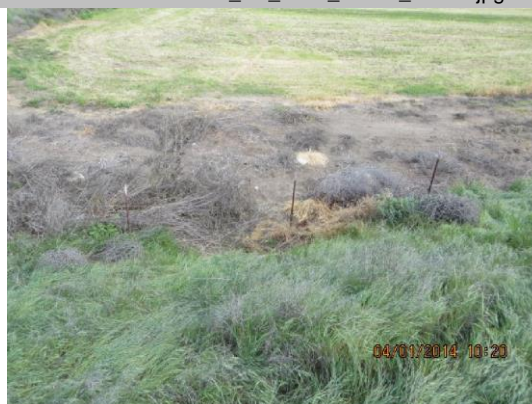
Photo 3 of 3 : UCIP_FA_2018_39648_59702.jpg

Item	DWR UCIP LMA Responsibility			36.976808 °	36.976808 °	
				-120.382593 °	-120.382593 °	
DWR ID	19703					
Comment Code						
Inspector Comment						
FS_ID:39648						
DS_ID:19703						
EP_NO: N/A						
Repair Type: Non-Urgent						
Crossing Status: Found						
UCIP Comments: 04/01/2014 Dense vegetation limits the inspector's visibility to identify signs of pipe failure (leaks) along the slopes.						
Recommend removing vegetation along pipe alignment to conduct proper inspection of structure. (DWR UCIP - W. Wylie)						
FIELD_STRUCT_DESC: 30-inch by 30-inch reinforced concrete box gravity drainage culvert through the levee, 13.9 feet below the crown.						
Flap gate on the waterside (WS) end. Concrete headwall on the landside (LS) end. Concrete U-shaped headwall on the WS end.						
[Additional Reference(s): DWR Levee Log, 2002. USACE San Joaquin O&M Manual 601.1, 1967, (HLM 33.72)].						
FS Date: 4/1/2014

Concrete headwall at LS toe.

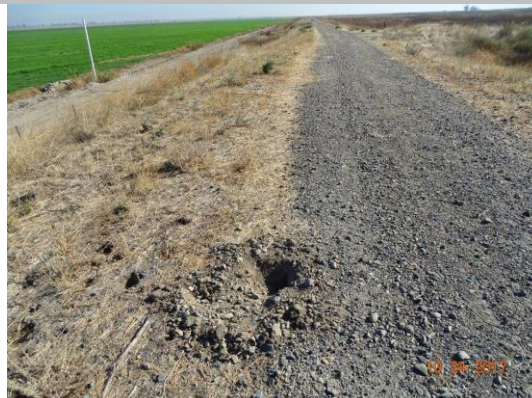
Photo 1 of 1 : FA_2018_NA0010_123_130_20180911_00031.jpg

LM Start	33.82	Rating **	M	Issue No.	130
LM End	33.82	Issue Type +	Ma	Location *	LS
Category	Earthen Levee			GPS Latitude/Longitude	
				Start	End
Item	Animal Control			36.976849 °	36.976849 °
				-120.382393 °	-120.382393 °
DWR ID	DWR_NA0010_05_f_2017_130				
Comment Code					
A3 : No rodents visible, but rodent burrows visible; need to backfill and compact or grout burrows.					
Inspector Comment

Looking east at the landside shoulder.

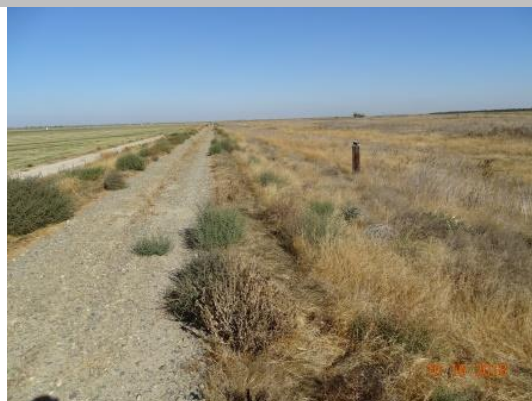
Photo 1 of 1 : FA_2018_NA0010_123_175_20181101_00342.jpg

LM Start	33.84	Rating **	U	Issue No.	175
LM End	34.77	Issue Type +	Ma	Location *	WS
Category	Earthen Levee			GPS Latitude/Longitude	
				Start	End
Item	Vegetation			36.976955 °	°
				-120.382015 °	°
DWR ID	DWR_NA0010_05_f_2018_175				
Comment Code					
V1 : Control annual grass and weeds on the levee slopes and easements.					
Inspector Comment

dense brush along waterside slope. (Fall 2018)

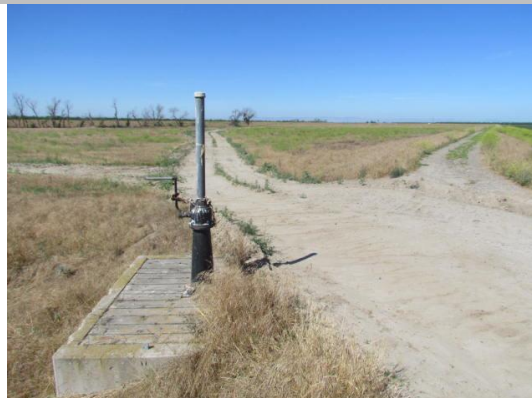
Photo 1 of 4 : FA_2018_NA0010_123_11_20180911_00010.jpg

Looking west at ramp on waterward slope.

LM Start	34.61	Rating **	M	Issue No.	11 (cont)	
LM End	34.61	Issue Type +	En	Location *	WS	
Category	Earthen Levee			GPS Latitude/Longitude		
				Start		End
Item	Encroachments			36.978523 °		36.978523 °
				-120.368520 °		-120.368520 °
DWR ID	DWR_NA0010_05_s_2012_11					
Comment Code						
RA : Ramp						
Inspector Comment						
Unauthorized ramp on waterside slope. Landowner cut unauthorized ramp on waterside slope and levee crown.

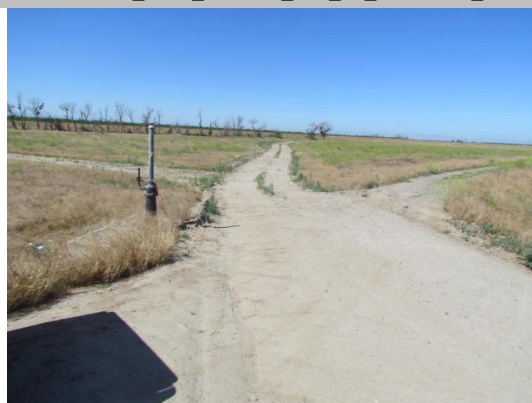
Photo 2 of 4 : FA_2018_NA0010_123_11_20180911_00011.jpg

Looking west at cut on levee crown.

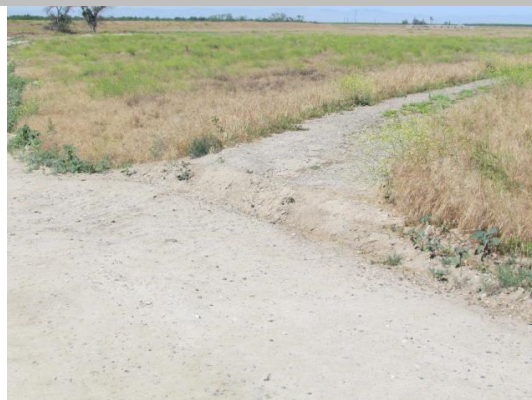
Photo 3 of 4 : FA_2018_NA0010_123_11_20180911_00012.jpg

Looking at cut on levee crown.

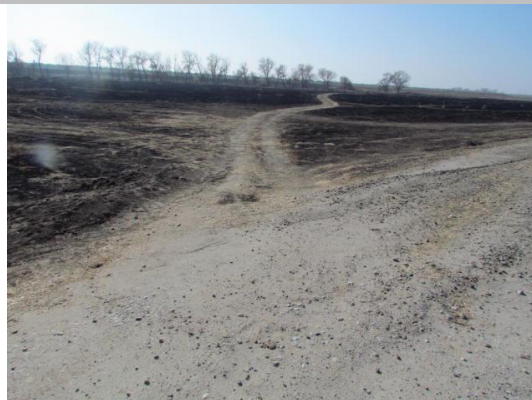
Photo 4 of 4 : FA_2018_NA0010_123_11_20180911_00013.jpg

Looking southwest at unauthorized ramp on waterward slope. (2015)

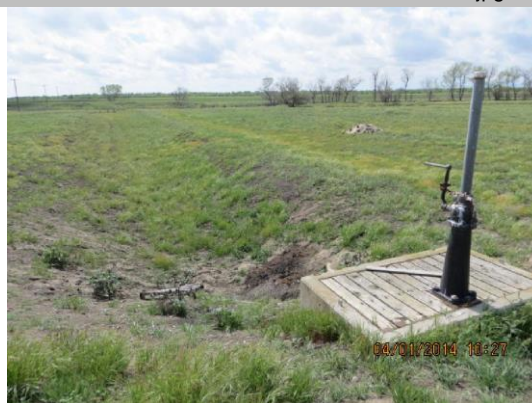
Photo 1 of 3 : UCIP_FA_2018_39649_59706.jpg

Comment Code						
Inspector Comment						
FS_ID:39649 DS_ID:19755 EP_NO: N/A Repair Type: Non-Urgent Crossing Status: Found UCIP Comments: 04/01/2014 Dense vegetation limits the inspector's visibility to identify signs of pipe failure (leaks) along the landward slope. Recommend removing vegetation along pipe alignment to conduct proper inspection of structure. Debris buildup visible on waterward headwall--recommend contacting owner to clear pipe. (DWR UCIP - W. Wylie) FIELD_STRUCT_DESC: [Chowchilla Canal Irrigation Structure] 36-inch by 36-inch reinforced concrete box gravity irrigation culvert through the levee, 9.7 feet below the crown. Slide gate in a 56-inch by 91-inch concrete riser on the waterside (WS) slope. Concrete U-shaped headwall on each end. Landside channel cobble revetted for 8 feet. [Additional Reference(s): DWR Levee Log, 2002. USACE San Joaquin O&M Manual 601.1, 1967, (HLM 34.51)]. FS Date: 4/1/2014

Slide gate in concrete riser on WS shoulder.

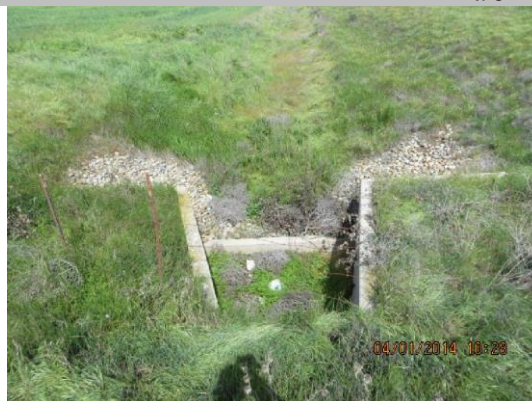
Photo 3 of 3 : UCIP_FA_2018_39649_59705.jpg

Item	DWR UCIP Field Study			36.978593 °	36.978593 °	
				-120.368511 °	-120.368511 °	
DWR ID	19755					
Comment Code						
Inspector Comment						
FS_ID:39649 DS_ID:19755 EP_NO: N/A Repair Type: Non-Urgent Crossing Status: Found UCIP Comments: 04/01/2014 Dense vegetation limits the inspector's visibility to identify signs of pipe failure (leaks) along the landward slope. Recommend removing vegetation along pipe alignment to conduct proper inspection of structure. Debris buildup visible on waterward headwall--recommend contacting owner to clear pipe. (DWR UCIP - W. Wylie) FIELD_STRUCT_DESC: [Chowchilla Canal Irrigation Structure] 36-inch by 36-inch reinforced concrete box gravity irrigation culvert through the levee, 9.7 feet below the crown. Slide gate in a 56-inch by 91-inch concrete riser on the waterside (WS) slope. Concrete U-shaped headwall on each end. Landside channel cobble revetted for 8 feet. [Additional Reference(s): DWR Levee Log, 2002. USACE San Joaquin O&M Manual 601.1, 1967, (HLM 34.51)]. FS Date: 4/1/2014

Concrete headwall at LS toe.

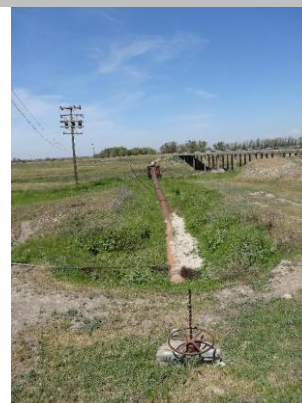
Photo 1 of 3 : UCIP_FA_2018_39463_66341.jpg

Comment Code						
Inspector Comment						
FS_ID:39463 DS_ID:19815 EP_NO: N/A Repair Type: Non-Urgent Crossing Status: Found UCIP Comments: 04/18/2014 Need to contact owner. Sediment buildup on landward side. Recommend removing sediment buildup on landward toe. (DWR UCIP - O. Magana) FIELD_STRUCT_DESC: 24-inch corrugated metal irrigation discharge pipe through the levee, 7.2 feet below the crown. Pump on concrete structure in the channel. Slide gate in a 36-inch corrugated metal pipe (CMP) riser on the waterside (WS) slope. Concrete headwall on each end. [Additional Reference(s): DWR Levee Log, 2002. USACE San Joaquin O&M Manual 601.1, 1967, (HLM 0.74)]. FS Date: 4/18/2014

View of waterward side.

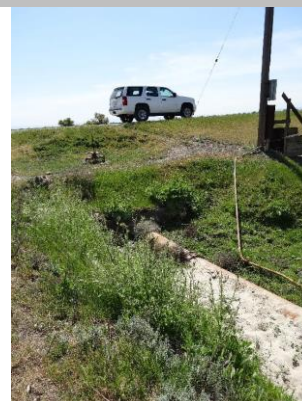
Photo 2 of 3 : UCIP_FA_2018_39463_66343.jpg

Comment Code						
Inspector Comment						
FS_ID:39463 DS_ID:19815 EP_NO: N/A Repair Type: Non-Urgent Crossing Status: Found UCIP Comments: 04/18/2014 Need to contact owner. Sediment buildup on landward side. Recommend removing sediment buildup on landward toe. (DWR UCIP - O. Magana) FIELD_STRUCT_DESC: 24-inch corrugated metal irrigation discharge pipe through the levee, 7.2 feet below the crown. Pump on concrete structure in the channel. Slide gate in a 36-inch corrugated metal pipe (CMP) riser on the waterside (WS) slope. Concrete headwall on each end. [Additional Reference(s): DWR Levee Log, 2002. USACE San Joaquin O&M Manual 601.1, 1967, (HLM 0.74)]. FS Date: 4/18/2014

View of slope on waterward side.

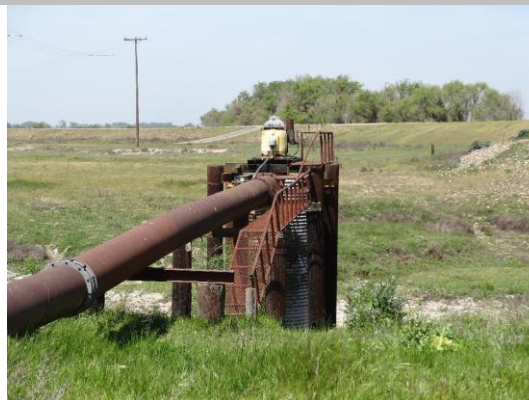
Photo 3 of 3 : UCIP_FA_2018_39463_66342.jpg

Pump station visible on waterward side.

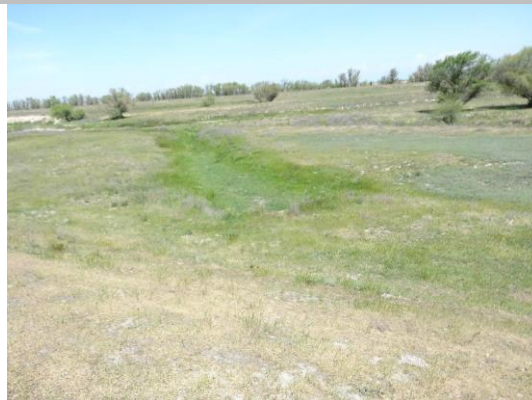
Photo 1 of 3 : UCIP_FA_2018_36565_66346.jpg

LM Start	0.78	Rating **	M	Issue No.	1214
LM End	0.78	Issue Type +	Ma	Location *	
Category	Supplemental			GPS Latitude/Longitude	
				Start	End
Item	DWR UCIP LMA Responsibility			37.270460 °	37.270460 °
				-120.814290 °	-120.814290 °
DWR ID	19816				
Comment Code					
Inspector Comment					
FS_ID:36565 DS_ID:19816 EP_NO: N/A Repair Type: Non-Urgent Crossing Status: Found UCIP Comments: 04/18/2014 Landward side blocked--need to contact owner to determine status of crossing. (DWR UCIP - O. Magana) FIELD_STRUCT_DESC: 24-inch corrugated metal gravity drainage pipe through the levee, 16.2 feet below the crown. Flap gate on the waterside (WS) end. Concrete U-shaped headwall on each end. [Additional Reference(s): DWR Levee Log, 2002. USACE San Joaquin O&M Manual 601.1, 1967, (HLM 0.86)]. FS Date: 4/18/2014

Overview of waterward side.

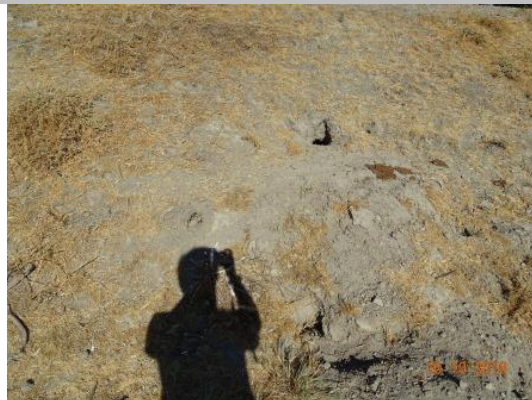
Photo 1 of 2 : FA_2018_NA0010_124_93_20181101_00183.jpg

LM Start	1.18	Rating **	U	Issue No.	93
LM End	1.18	Issue Type +	Ma	Location *	LS
Category	Earthen Levee			GPS Latitude/Longitude	
				Start	End
Item	Animal Control			37.267101 °	37.267101 °
				-120.809603 °	-120.809603 °
DWR ID	DWR_NA0010_06_f_2018_93				
Comment Code					
A3 : No rodents visible, but rodent burrows visible; need to backfill and compact or grout burrows.					
Inspector Comment					
several rodent burrow and large rodent burrows at this location

View of landside slope. (Fall 2018)

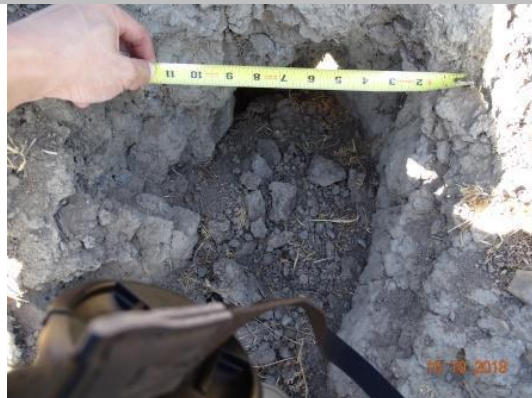
Photo 2 of 2 : FA_2018_NA0010_124_93_20181101_00185.jpg

LM Start	1.18	Rating **	U	Issue No.	93 (cont)	
LM End	1.18	Issue Type +	Ma	Location *	LS	
Category	Earthen Levee			GPS Latitude/Longitude		
				Start		End
Item	Animal Control			37.267101°		37.267101°
				-120.809603°		-120.809603°
DWR ID	DWR_NA0010_06_f_2018_93					
Comment Code						
A3 : No rodents visible, but rodent burrows visible; need to backfill and compact or grout burrows.						
Inspector Comment						
several rodent burrow and large rodent burrows at this location

View and measurement of large rodent hole found at this location. (Fall 2018)

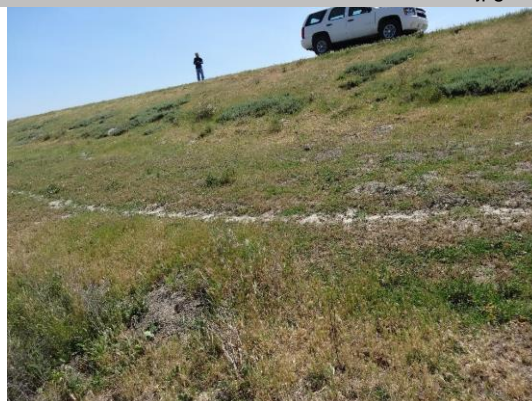
Photo 1 of 3 : UCIP_FA_2018_36566_66348.jpg

LM Start	1.87	Rating **	M	Issue No.	1215
LM End	1.87	Issue Type +	Ma	Location *	
Category	Supplemental			GPS Latitude/Longitude	
				Start	End
Item	DWR UCIP LMA Responsibility			37.259312 °	37.259312 °
				-120.802863 °	-120.802863 °
DWR ID	19817				
Comment Code					
Inspector Comment					
FS_ID:36566 DS_ID:19817 EP_NO: N/A Repair Type: Non-Urgent Crossing Status: Found UCIP Comments: 04/18/2014 No access was available to landward side due to fence. Recommend removing some of the vegetation on waterward toe. (DWR UCIP - O. Magana) FIELD_STRUCT_DESC: 24-inch corrugated metal gravity drainage pipe through the levee, 13.5 feet below the crown. Flap gate on the waterside (WS) end. Concrete headwall on each end. [Additional Reference(s): DWR Levee Log, 2002. USACE San Joaquin O&M Manual 601.1, 1967, (HLM 1.95)]. FS Date: 4/18/2014

View of waterward side.

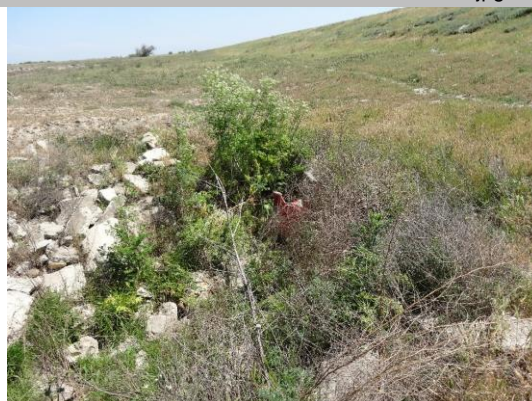
Photo 3 of 3 : UCIP_FA_2018_36566_66349.jpg

LM Start	1.87	Rating **	M	Issue No.	1215 (cont)	
LM End	1.87	Issue Type +	Ma	Location *		
Category	Supplemental			GPS Latitude/Longitude		
				Start	End	
Item	DWR UCIP LMA Responsibility			37.259312 °	37.259312 °	
				-120.802863 °	-120.802863 °	
DWR ID	19817					
Comment Code						
Inspector Comment						
FS_ID:36566 DS_ID:19817 EP_NO: N/A Repair Type: Non-Urgent Crossing Status: Found UCIP Comments: 04/18/2014 No access was available to landward side due to fence. Recommend removing some of the vegetation on waterward toe. (DWR UCIP - O. Magana) FIELD_STRUCT_DESC: 24-inch corrugated metal gravity drainage pipe through the levee, 13.5 feet below the crown. Flap gate on the waterside (WS) end. Concrete headwall on each end. [Additional Reference(s): DWR Levee Log, 2002. USACE San Joaquin O&M Manual 601.1, 1967, (HLM 1.95)]. FS Date: 4/18/2014

Flap gate visible on waterward side.

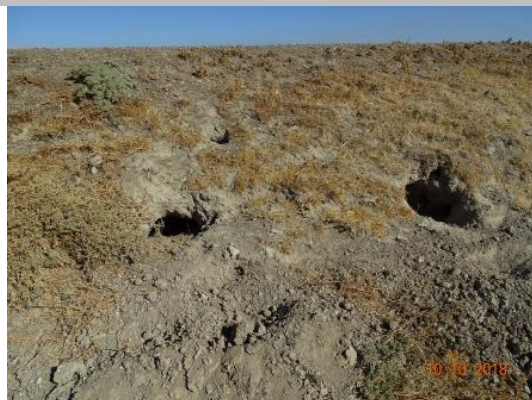
Photo 1 of 2 : FA_2018_NA0010_124_92_20181101_00186.jpg

LM Start	2.42	Rating **	U	Issue No.	92
LM End	2.42	Issue Type +	Ma	Location *	LS
Category	Earthen Levee			GPS Latitude/Longitude	
				Start	End
Item	Animal Control			37.254519 °	37.254519 °
				-120.795141 °	-120.795141 °
DWR ID	DWR_NA0010_06_f_2018_92				
Comment Code					
A3 : No rodents visible, but rodent burrows visible; need to backfill and compact or grout burrows.					
Inspector Comment

view of large rodent holes in landside slope. (Fall 2018)

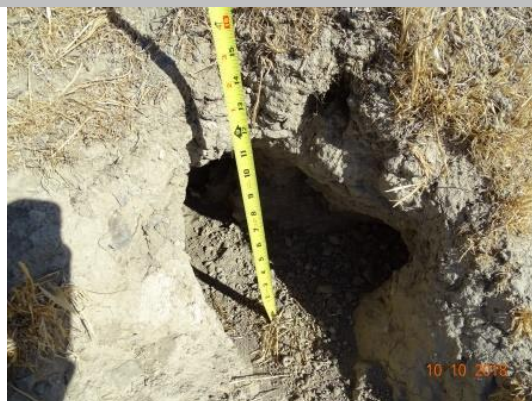
Photo 2 of 2 : FA_2018_NA0010_124_92_20181101_00187.jpg

LM Start	2.42	Rating **	U	Issue No.	92 (cont)	
LM End	2.42	Issue Type +	Ma	Location *	LS	
Category	Earthen Levee			GPS Latitude/Longitude		
				Start		End
Item	Animal Control			37.254519 °		37.254519 °
				-120.795141 °		-120.795141 °
DWR ID	DWR_NA0010_06_f_2018_92					
Comment Code						
A3 : No rodents visible, but rodent burrows visible; need to backfill and compact or grout burrows.						
Inspector Comment

measurement of large burrow. (Fall 2018)

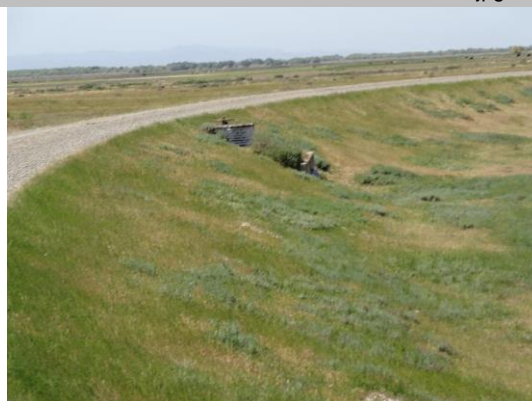
Photo 1 of 3 : UCIP_FA_2018_39464_66354.jpg

LM Start	2.53	Rating **	M	Issue No.	1216
LM End	2.53	Issue Type +	Ma	Location *	
Category	Supplemental			GPS Latitude/Longitude	
				Start	End
Item	DWR UCIP LMA Responsibility			37.252948 °	37.252948 °
				-120.794352 °	-120.794352 °
DWR ID	19818				
Comment Code					
Inspector Comment					
FS_ID:39464 DS_ID:19818 EP_NO: N/A Repair Type: Non-Urgent Crossing Status: Found UCIP Comments: 04/18/2014 Need to contact owner. Sediment buildup in pipe visible on landward side. (DWR UCIP - O. Magana) FIELD_STRUCT_DESC: 36-inch corrugated metal gravity drainage pipe through the levee, 6.9 feet below the crown. Slide gate in a 48-inch corrugated metal pipe (CMP) riser on the waterside (WS) slope. Concrete headwall on each end. [Additional Reference(s): DWR Levee Log, 2002. USACE San Joaquin O&M Manual 601.1, 1967, (HLM 2.61)]. FS Date: 4/18/2014

View of waterward side.

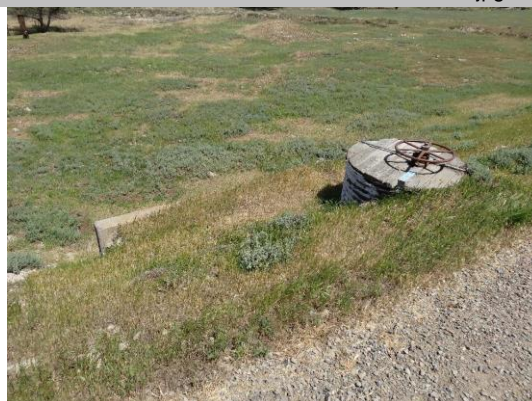
Photo 2 of 3 : UCIP_FA_2018_39464_66357.jpg

LM Start	2.53	Rating **	M	Issue No.	1216 (cont)
LM End	2.53	Issue Type +	Ma	Location *	
Category	Supplemental			GPS Latitude/Longitude	
				Start	End
Item	DWR UCIP LMA Responsibility			37.252948 °	37.252948 °
				-120.794352 °	-120.794352 °
DWR ID	19818				
Comment Code					
Inspector Comment					
FS_ID:39464 DS_ID:19818 EP_NO: N/A Repair Type: Non-Urgent Crossing Status: Found UCIP Comments: 04/18/2014 Need to contact owner. Sediment buildup in pipe visible on landward side. (DWR UCIP - O. Magana) FIELD_STRUCT_DESC: 36-inch corrugated metal gravity drainage pipe through the levee, 6.9 feet below the crown. Slide gate in a 48-inch corrugated metal pipe (CMP) riser on the waterside (WS) slope. Concrete headwall on each end. [Additional Reference(s): DWR Levee Log, 2002. USACE San Joaquin O&M Manual 601.1, 1967, (HLM 2.61)]. FS Date: 4/18/2014

View of waterward side.

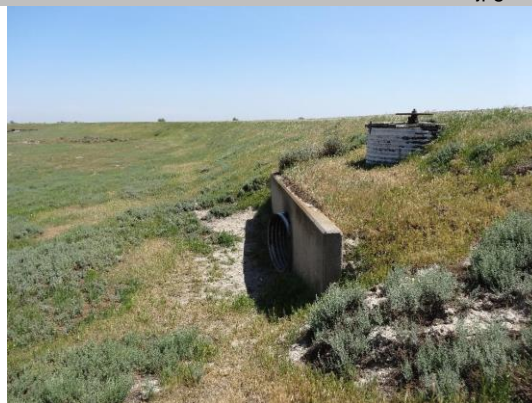
Photo 3 of 3 : UCIP_FA_2018_39464_66356.jpg

CMP riser, concrete headwall, and pipe visible on waterward side.

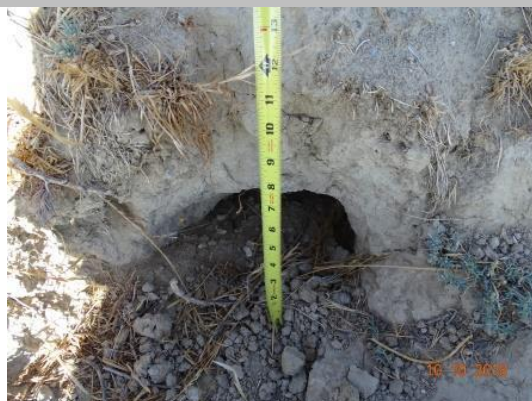
Photo 1 of 1 : FA_2018_NA0010_124_76_20181102_00203.jpg

LM Start	2.54	Rating **	M	Issue No.	76
LM End	2.54	Issue Type +	Ma	Location *	LS
Category	Earthen Levee			GPS Latitude/Longitude	
				Start	End
Item	Animal Control			37.252874 °	37.252874 °
				-120.794192 °	-120.794192 °
DWR ID	DWR_NA0010_06_f_2016_76				
Comment Code					
A3 : No rodents visible, but rodent burrows visible; need to backfill and compact or grout burrows.					
Inspector Comment					
several rodent burrow in landside slope at this location

Representative view of rodent burrow found at this section. (Fall 2018)

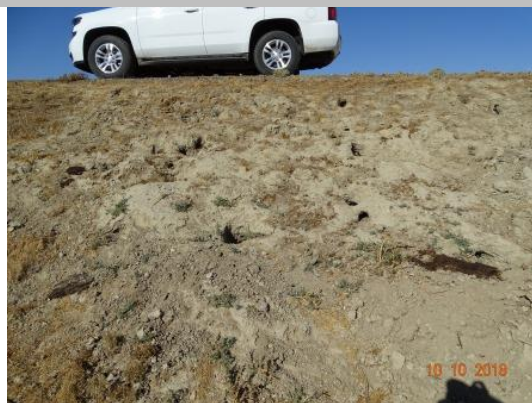
Photo 1 of 1 : FA_2018_NA0010_124_91_20181101_00188.jpg

LM Start	2.55	Rating **	M	Issue No.	91
LM End	2.55	Issue Type +	Ma	Location *	LS
Category	Earthen Levee			GPS Latitude/Longitude	
				Start	End
Item	Animal Control			37.252818 °	37.252818 °
				-120.794053 °	-120.794053 °
DWR ID	DWR_NA0010_06_f_2018_91				
Comment Code					
A3 : No rodents visible, but rodent burrows visible; need to backfill and compact or grout burrows.					
Inspector Comment					
several rodent holes at this location

view of landside levee from toe. (Fall 2018)

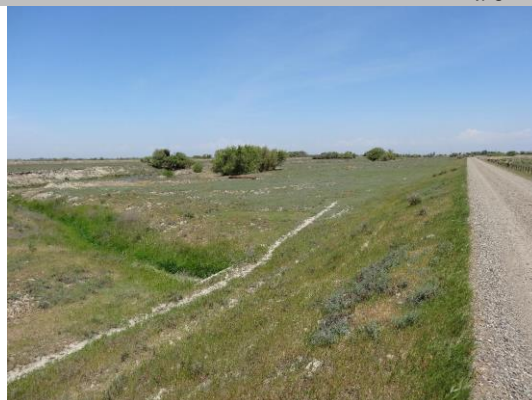
Photo 1 of 3 : UCIP_FA_2018_36569_66369.jpg

Comment Code					
Inspector Comment					
FS_ID:36569					
DS_ID:19820					
EP_NO: N/A					
Repair Type: Non-Urgent					
Crossing Status: Found					
UCIP Comments: 04/18/2014 Dense vegetation limits the inspector's visibility to identify signs of pipe condition on landward toe--headwall blocked by dense vegetation. Recommend removing vegetation from landward toe. (DWR UCIP - O. Magana)					
FIELD_STRUCT_DESC: 24-inch corrugated metal gravity drainage pipe through the levee, 10.5 feet below the crown. Flap gate on the waterside (WS) end. Concrete headwall on each end. [Additional Reference(s): DWR Levee Log, 2002. USACE San Joaquin O&M Manual 601.1, 1967, (HLM 2.85)].					
FS Date: 4/18/2014

View of waterward side.

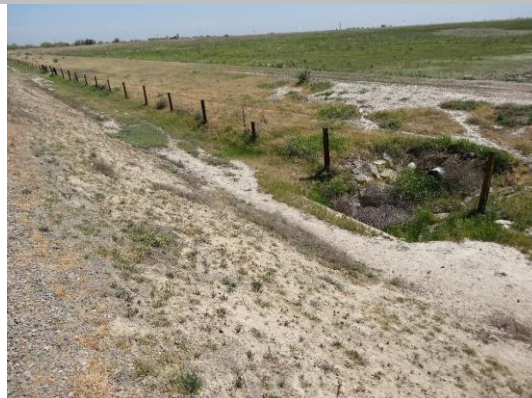
Photo 3 of 3 : UCIP_FA_2018_36583_66383.jpg

Comment Code						
Inspector Comment						
FS_ID:36583 DS_ID:19821 EP_NO: N/A Repair Type: Non-Urgent Crossing Status: Found UCIP Comments: 04/18/2014 Dense vegetation limits the inspector's visibility to identify signs of pipe condition on landward toe--headwall blocked by dense vegetation. Recommend removing vegetation from landward toe. (DWR UCIP - O. Magana) FIELD_STRUCT_DESC: 24-inch corrugated metal gravity drainage pipe through the levee, 11.2 feet below the crown. Flap gate on the waterside (WS) end. Concrete headwall on each end. [Additional Reference(s): DWR Levee Log, 2002. USACE San Joaquin O&M Manual 601.1, 1967, (HLM 3.09)]. FS Date: 4/18/2014

View of landward side.

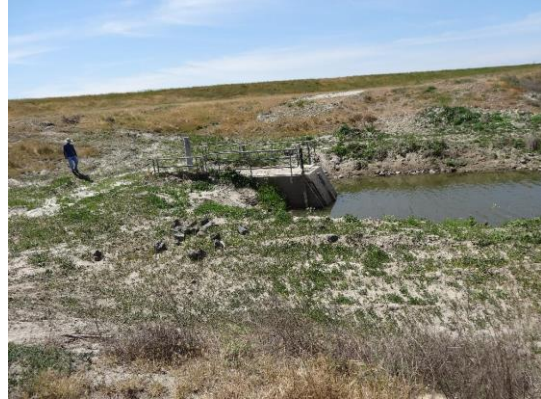
Photo 1 of 3 : UCIP_FA_2018_39482_71643.jpg

Comment Code						
Inspector Comment						
FS_ID:39482 DS_ID:19824 EP_NO: 6965 Repair Type: Non-Urgent Crossing Status: Indicator Found UCIP Comments: 04/18/2014 Description of structure does not match. Need to contact owner. Current description includes concrete platform, trash screen, and gage reading on waterward side. Metal box located on waterward shoulder. Large plant facility locate on landward side. (DWR UCIP - O. Magana) FIELD_STRUCT_DESC: 16-inch coated steel irrigation discharge pipe through the levee, 7.4 feet below the crown. Corrugated metal cutoff wall around the pipe in the center of the levee. Pump on the waterside (WS) with a timber platform on the berm for support. Siphon breaker on the apex of the pipe on the landside (LS) shoulder. Pipe exposed on both slopes. (Plans to place a 20-inch irrigation pipe through the levee authorized under Permit No. 6965, 1971 - Scarborough, Robinson, and Associates). [Additional Reference(s): DWR Levee Log, 2002]. FS Date: 4/10/2014

View of structure located on waterward side.

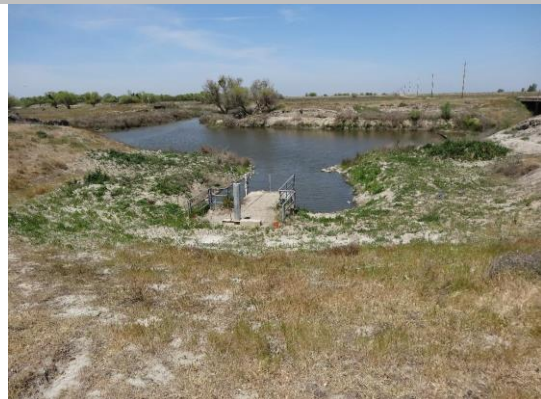
Photo 2 of 3 : UCIP_FA_2018_39482_71644.jpg

View of waterward side.

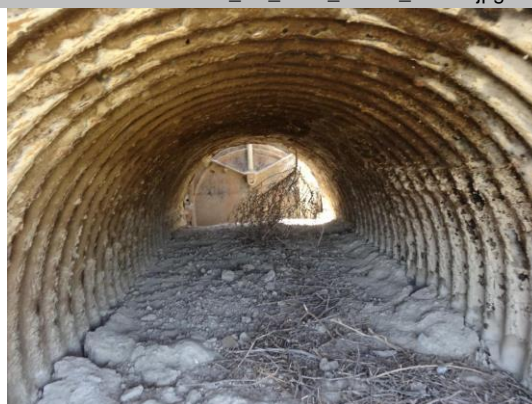
**Flood Control Project Maintenance
Levee Inspections**

Lower San Joaquin Levee District

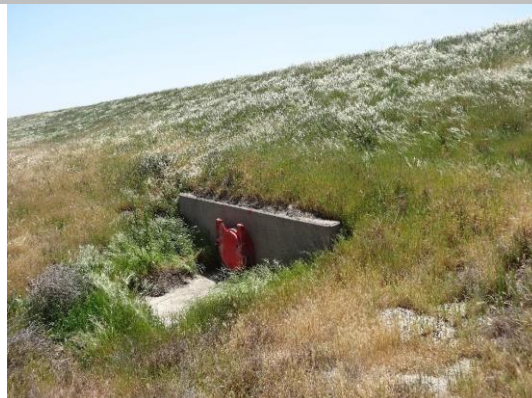
Photo 3 of 3 : UCIP_FA_2018_39092_60612.jpg

LM Start	0.60	Rating **	M	Issue No.	1187
LM End	0.60	Issue Type +	Ma	Location *	
Category	Supplemental			GPS Latitude/Longitude	
				Start	End
Item	DWR UCIP LMA Responsibility			37.341507 °	37.341507 °
				-120.961283 °	-120.961283 °
DWR ID	19583				
Comment Code					
Inspector Comment					
FS_ID:39095 DS_ID:19583 EP_NO: N/A Repair Type: Non-Urgent Crossing Status: Found UCIP Comments: 04/08/2014 Recommend removing vegetation pile through the levee, 8.5 feet below the crown. Flap gate on the waterside (WS) end. Brass cap No. 108 bench mark (BM) on the headwall on the landside (LS). [Additional Reference(s): DWR Levee Log, 2002. USACE San Joaquin O&M Manual 601.1, 1967, (HLM 0.62)]. FS Date: 4/8/2014

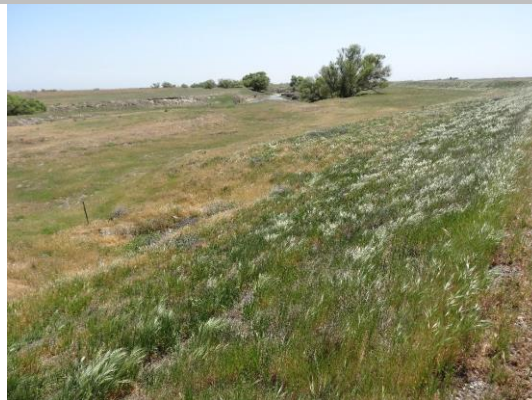
Flapgate and headwall visible on WS toe.

Photo 3 of 3 : UCIP_FA_2018_39095_60621.jpg

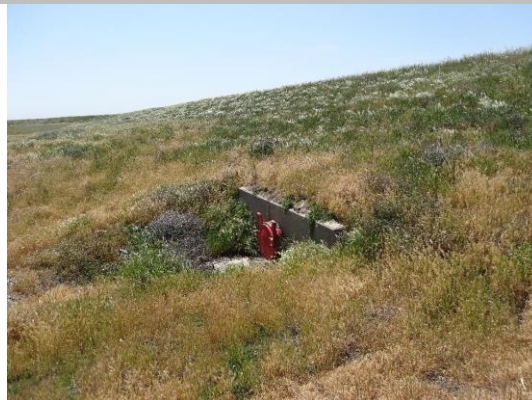
Pipe and headwall visible on LS toe.

**Flood Control Project Maintenance
Levee Inspections**

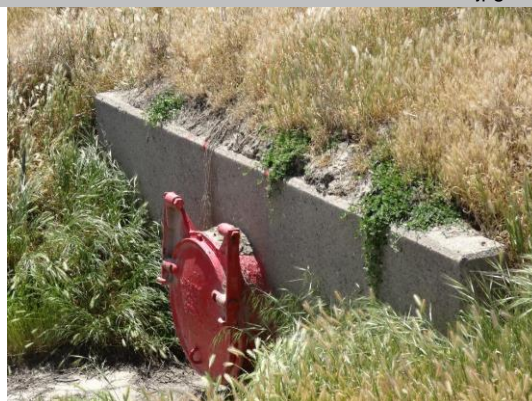
LM Start	0.85	Rating **	A/W	Issue No.	1188 (cont)
LM End	0.85	Issue Type +	Ma	Location *

Pipe, flapgate, and headwall visible on WS toe.

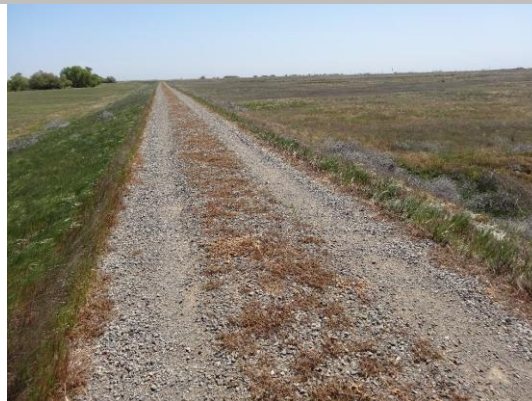
Photo 1 of 3 : UCIP_FA_2018_39096_60632.jpg

Flapgate, pipe, and headwall on WS toe.

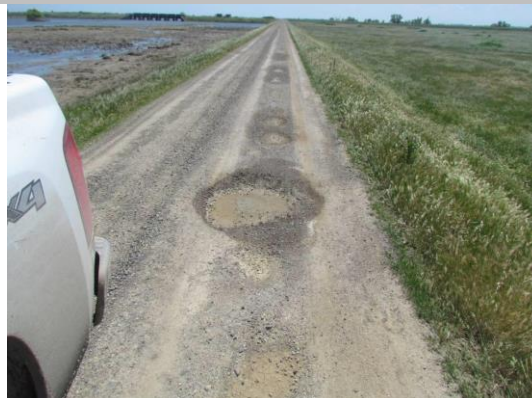
Photo 1 of 2 : FA_2018_NA0010_124_6_20180911_00011.jpg

LM Start	6.44	Rating **	M	Issue No.	6
LM End	11.00	Issue Type +	Ma	Location *	CR
Category	Earthen Levee			GPS Latitude/Longitude	
				Start	End
Item	Crown Surface / Depressions / Rutting			37.233587 °	37.187645 °
				-120.732480 °	-120.676996 °
DWR ID	DWR_NA0010_06_s_2012_6				
Comment Code					
C2 : Repair depressions or ruts in the crown or slope.					
Inspector Comment					
Levee crown should be regraded due to excessive rutting and potholes on levee crown..

Looking upstream at large pot hole on levee crown.

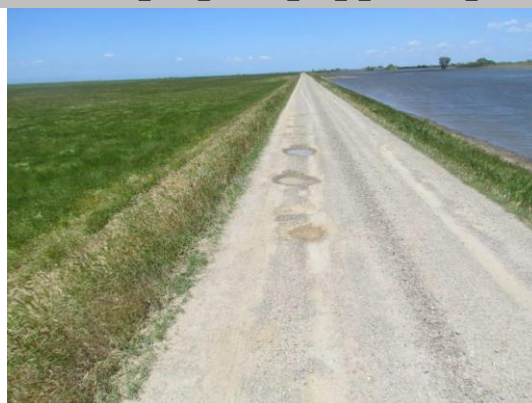
Photo 2 of 2 : FA_2018_NA0010_124_6_20180911_00012.jpg

Looking downstream at typical view of rutting and pot holes on levee crown.

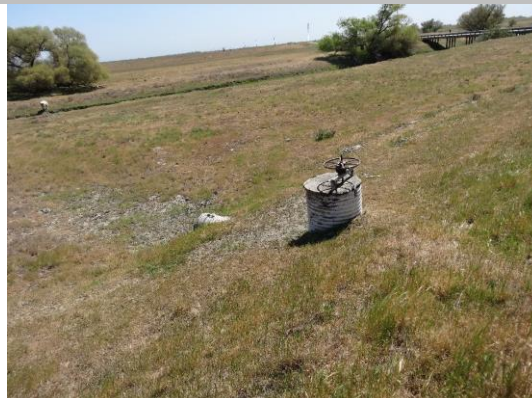
Photo 1 of 3 : UCIP_FA_2018_33984_61628.jpg

LM Start	6.70	Rating **	A/W	Issue No.	1234
LM End	6.70	Issue Type +	Ma	Location *	
Category	Supplemental			GPS Latitude/Longitude	
				Start	End
Item	DWR UCIP LMA Responsibility			37.230508 °	37.230508 °
				-120.729634 °	-120.729634 °
DWR ID	19866				
Comment Code					
Inspector Comment					
FS_ID:33984 DS_ID:19866 EP_NO: N/A Repair Type: No Action Needed Crossing Status: Found UCIP Comments: FIELD_STRUCT_DESC: 24-inch corrugated metal gravity drainage pipe through the levee, 7 feet below the crown. Slide gate in a 36-inch corrugated metal pipe (CMP) riser on the waterside (WS) slope. Concrete headwall on the landside (LS) end. Concrete saddle and apron on the WS end. [Additional Reference(s): DWR Levee Log, 2002. USACE San Joaquin O&M Manual 601.1, 1967, (HLM 6.79)]. FS Date: 4/18/2014

Slide gate inside CMP riser and pipe visible on waterward side.

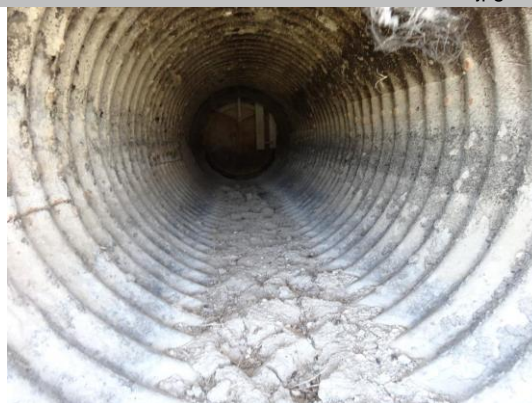
Photo 3 of 3 : UCIP_FA_2018_33984_61626.jpg

LM Start	6.70	Rating **	A/W	Issue No.	1234 (cont)
LM End	6.70	Issue Type +	Ma	Location *	
Category	Supplemental			GPS Latitude/Longitude	
				Start	End
Item	DWR UCIP LMA Responsibility			37.230508 °	37.230508 °
				-120.729634 °	-120.729634 °
DWR ID	19866				
Comment Code					
Inspector Comment					
FS_ID:33984 DS_ID:19866 EP_NO: N/A Repair Type: No Action Needed Crossing Status: Found UCIP Comments: FIELD_STRUCT_DESC: 24-inch corrugated metal gravity drainage pipe through the levee, 7 feet below the crown. Slide gate in a 36-inch corrugated metal pipe (CMP) riser on the waterside (WS) slope. Concrete headwall on the landside (LS) end. Concrete saddle and apron on the WS end. [Additional Reference(s): DWR Levee Log, 2002. USACE San Joaquin O&M Manual 601.1, 1967, (HLM 6.79)]. FS Date: 4/18/2014

Inside view pipe from waterward side.

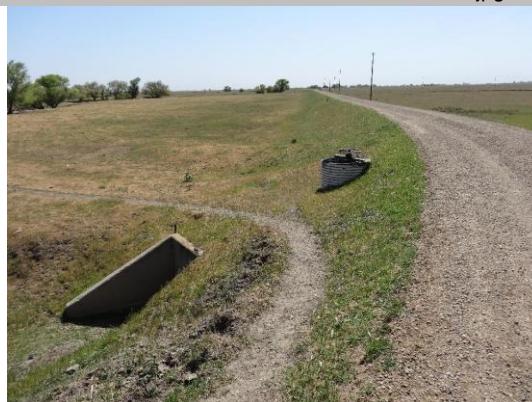
Photo 1 of 3 : UCIP_FA_2018_33985_61640.jpg

LM Start	6.89	Rating **	A/W	Issue No.	1235
LM End	6.89	Issue Type +	Ma	Location *	
Category	Supplemental			GPS Latitude/Longitude	
				Start	End
Item	DWR UCIP LMA Responsibility			37.228253 °	37.228253 °
				-120.727865 °	-120.727865 °
DWR ID	19867				
Comment Code					
Inspector Comment					
FS_ID:33985 DS_ID:19867 EP_NO: N/A Repair Type: No Action Needed Crossing Status: Found UCIP Comments: FIELD_STRUCT_DESC: 36-inch corrugated metal gravity drainage pipe through the levee, 10.7 feet below the crown. Slide gate in a 48-inch corrugated metal pipe (CMP) riser on the waterside (WS) slope. Concrete headwall on the landside (LS) end. Concrete U-shaped headwall on the WS end. [Additional Reference(s): DWR Levee Log, 2002. USACE San Joaquin O&M Manual 601.1, 1967, (HLM 6.97)]. FS Date: 4/18/2014

View of waterward side.

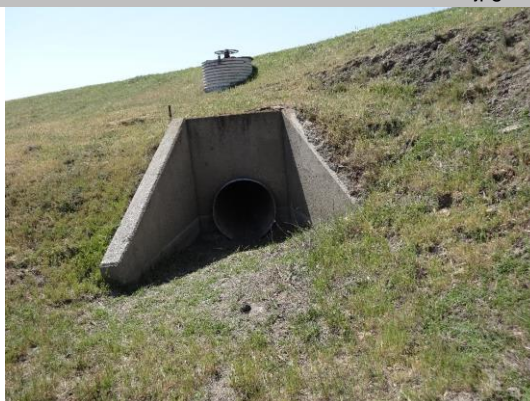
Photo 2 of 3 : UCIP_FA_2018_33985_61639.jpg

LM Start	6.89	Rating **	A/W	Issue No.	1235 (cont)
LM End	6.89	Issue Type +	Ma	Location *	
Category	Supplemental			GPS Latitude/Longitude	
				Start	End
Item	DWR UCIP LMA Responsibility			37.228253 °	37.228253 °
				-120.727865 °	-120.727865 °
DWR ID	19867				
Comment Code					
Inspector Comment					
FS_ID:33985 DS_ID:19867 EP_NO: N/A Repair Type: No Action Needed Crossing Status: Found UCIP Comments: FIELD_STRUCT_DESC: 36-inch corrugated metal gravity drainage pipe through the levee, 10.7 feet below the crown. Slide gate in a 48-inch corrugated metal pipe (CMP) riser on the waterside (WS) slope. Concrete headwall on the landside (LS) end. Concrete U-shaped headwall on the WS end. [Additional Reference(s): DWR Levee Log, 2002. USACE San Joaquin O&M Manual 601.1, 1967, (HLM 6.97)]. FS Date: 4/18/2014

Concrete headwall and CMP riser visible on waterward side.

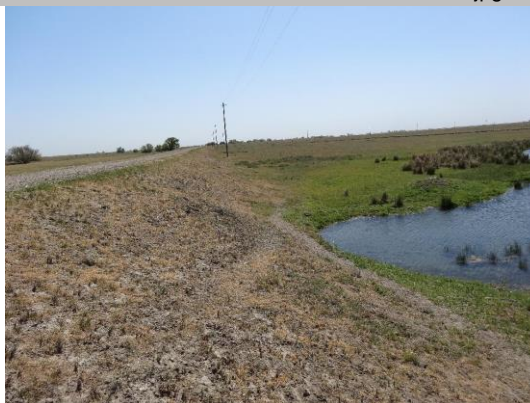
Photo 3 of 3 : UCIP_FA_2018_33985_61638.jpg

View of landward side.

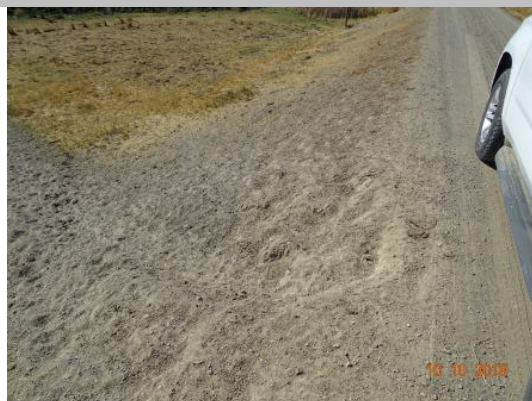
Photo 1 of 1 : FA_2018_NA0010_124_79_20181101_00192.jpg

LM Start	6.92	Rating **	M	Issue No.	79
LM End	6.92	Issue Type +	Ma	Location *	LS
Category	Earthen Levee			GPS Latitude/Longitude	
				Start	End
Item	Slope Stability			37.228054 °	37.228054 °
				-120.727428 °	-120.727428 °
DWR ID	DWR_NA0010_06_f_2018_79				
Comment Code					
S2 : Repair the levee slope damaged by foot traffic and prevent access where possible.					
Inspector Comment					
livestock damage to slope and shoulder of levee

damage to slope and shoulder from livestock. (Fall 2018)

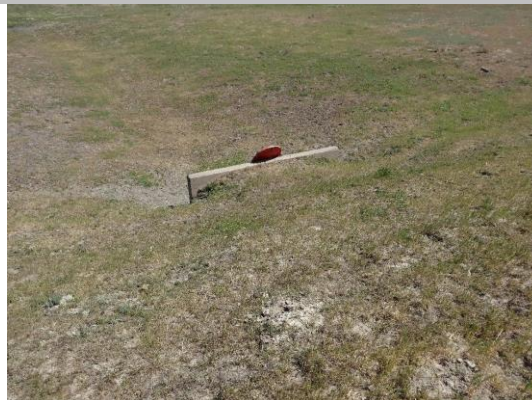
Photo 1 of 3 : UCIP_FA_2018_39471_61650.jpg

LM Start	7.21	Rating **	M	Issue No.	1236	
LM End	7.21	Issue Type +	Ma	Location *		
Category	Supplemental			GPS Latitude/Longitude		
				Start	End	
Item	DWR UCIP LMA Responsibility			37.226102 °	37.226102 °	
				-120.722739 °	-120.722739 °	
DWR ID	19868					
Comment Code						
Inspector Comment						
FS_ID:39471 DS_ID:19868 EP_NO: N/A Repair Type: Non-Urgent Crossing Status: Found UCIP Comments: 04/18/2014 Need to contact owner. Clear animal from waterward side. Some sediment buildup in pipe visible landward side--recommend clearing. (DWR UCIP - O. Magana) FIELD_STRUCT_DESC: 24-inch corrugated metal gravity drainage pipe through the levee, 10.6 feet below the crown. Flap gate on the waterside (WS) end. Concrete headwall on each end. [Additional Reference(s): DWR Levee Log, 2002. USACE San Joaquin O&M Manual 601.1, 1967, (HLM 7.29)]. FS Date: 4/18/2014

View of waterward side.

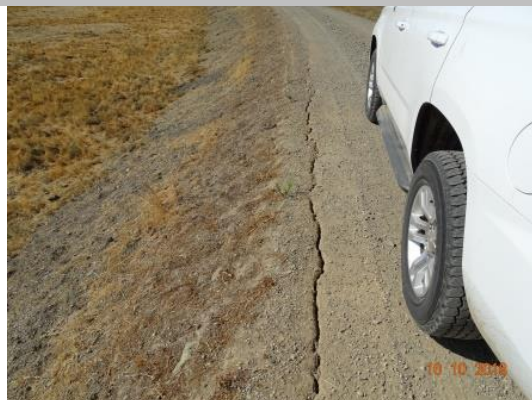
Photo 1 of 2 : FA_2018_NA0010_124_78_20181101_00193.jpg

LM Start	7.56	Rating **	A/W	Issue No.	78
LM End	7.56	Issue Type +	Ma	Location *	CR
Category	Earthen Levee			GPS Latitude/Longitude	
				Start	End
Item	Cracking			37.224113 °	37.224113 °
				-120.716887 °	-120.716887 °
DWR ID	DWR_NA0010_06_f_2018_78				
Comment Code					
CR1 : Monitor and have inspected by geotechnical engineer.					
Inspector Comment					
cracking on landside shoulder of crown

View of crack along crown looking downstream.

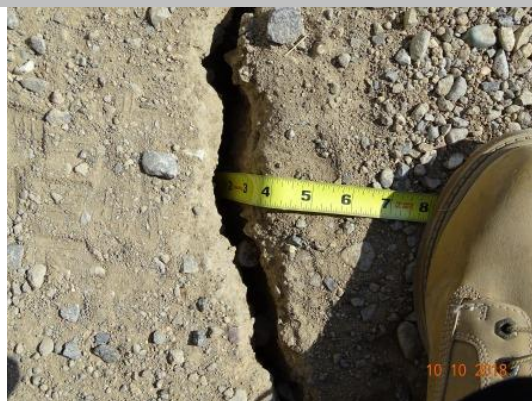
Photo 2 of 2 : FA_2018_NA0010_124_78_20181101_00194.jpg

LM Start	7.56	Rating **	A/W	Issue No.	78 (cont)	
LM End	7.56	Issue Type +	Ma	Location *	CR	
Category	Earthen Levee			GPS Latitude/Longitude		
				Start		End
Item	Cracking			37.224113 °		37.224113 °
				-120.716887 °		-120.716887 °
DWR ID	DWR_NA0010_06_f_2018_78					
Comment Code						
CR1 : Monitor and have inspected by geotechnical engineer.						
Inspector Comment						
cracking on landside shoulder of crown

view of average depth of crack. (Fall 2018)

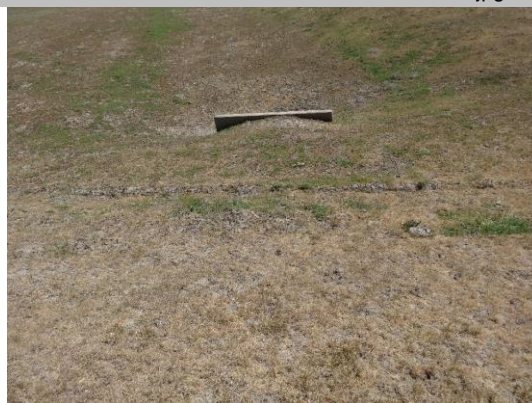
Photo 1 of 3 : UCIP_FA_2018_39472_66462.jpg

LM Start	7.66	Rating **	M	Issue No.	1237
LM End	7.66	Issue Type +	Ma	Location *	
Category	Supplemental			GPS Latitude/Longitude	
				Start	End
Item	DWR UCIP LMA Responsibility			37.222743 °	37.222743 °
				-120.716416 °	-120.716416 °
DWR ID	19869				
Comment Code					
Inspector Comment					
FS_ID:39472					
DS_ID:19869					
EP_NO: N/A					
Repair Type: Non-Urgent					
Crossing Status: Found					
UCIP Comments: 04/18/2014 Some sediment buildup in pipe visible on landward side--recommend clearing. (DWR UCIP - O. Magana)					
FIELD_STRUCT_DESC: 24-inch corrugated metal gravity drainage pipe through the levee, 11.8 feet below the crown. Flap gate on the waterside (WS) end. Concrete headwall on each end. Skewed crossing.					
[Additional Reference(s): DWR Levee Log, 2002. USACE San Joaquin O&M Manual 601.1, 1967, (HLM 7.74)].					
FS Date: 4/18/2014

View of waterward side.

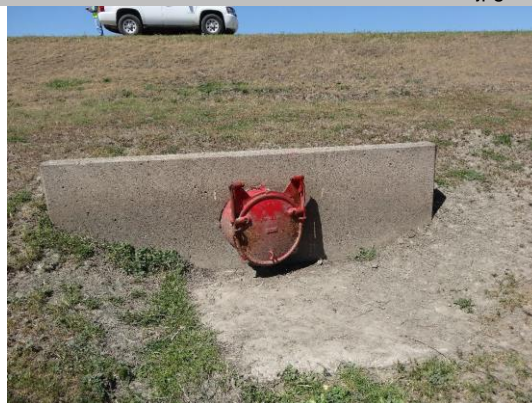
Photo 3 of 3 : UCIP_FA_2018_39472_66460.jpg

Concrete headwall and flap gate visible on waterward side.

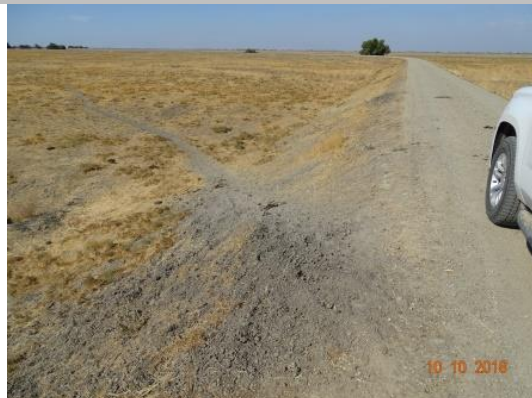
Photo 1 of 1 : FA_2018_NA0010_124_74_20181101_00195.jpg

LM Start	7.66	Rating **	M	Issue No.	74
LM End	7.66	Issue Type +	Ma	Location *	LS
Category	Earthen Levee			GPS Latitude/Longitude	
				Start	End
Item	Slope Stability			37.222689°	37.222689°
				-120.716400°	-120.716400°
DWR ID	DWR_NA0010_06_f_2018_74				
Comment Code					
S2 : Repair the levee slope damaged by foot traffic and prevent access where possible.					
Inspector Comment					
livestock damage to slope

slope damage from livestock. (Fall 2018)

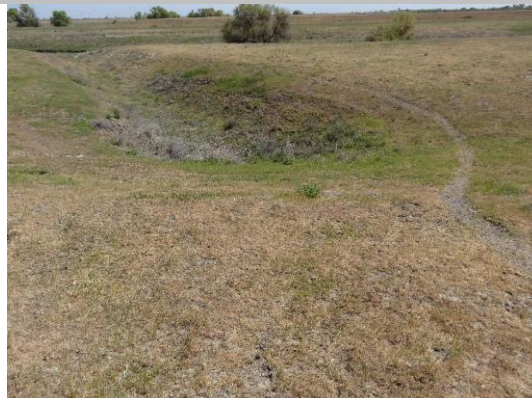
Photo 1 of 3 : UCIP_FA_2018_39473_61674.jpg

LM Start	8.13	Rating **	M	Issue No.	1238
LM End	8.13	Issue Type +	Ma	Location *	
Category	Supplemental			GPS Latitude/Longitude	
				Start	End
Item	DWR UCIP LMA Responsibility			37.216547 °	37.216547 °
				-120.713000 °	-120.713000 °
DWR ID	19870				
Comment Code					
Inspector Comment					
FS_ID:39473 DS_ID:19870 EP_NO: N/A Repair Type: Non-Urgent Crossing Status: Found UCIP Comments: 04/18/2014 Sediment buildup in pipe--recommend contacting owner to clear sediment. (DWR UCIP - O. Magana) FIELD_STRUCT_DESC: 24-inch corrugated metal gravity drainage pipe through the levee, 16.5 feet below the crown. Flap gate on the waterside (WS) end. Concrete headwall on each end. [Additional Reference(s): DWR Levee Log, 2002. USACE San Joaquin O&M Manual 601.1, 1967, (HLM 8.21)]. FS Date: 4/18/2014

View of waterward side.

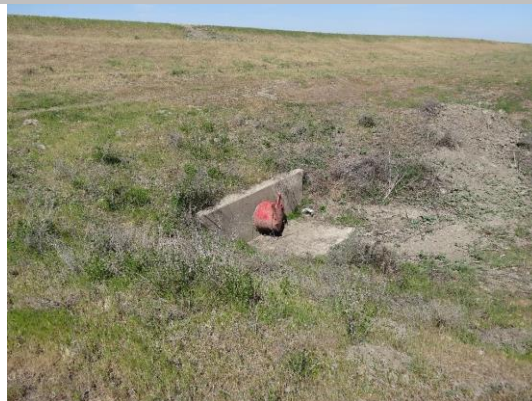
Photo 2 of 3 : UCIP_FA_2018_39473_61673.jpg

Pipe crosses levee at an angle.

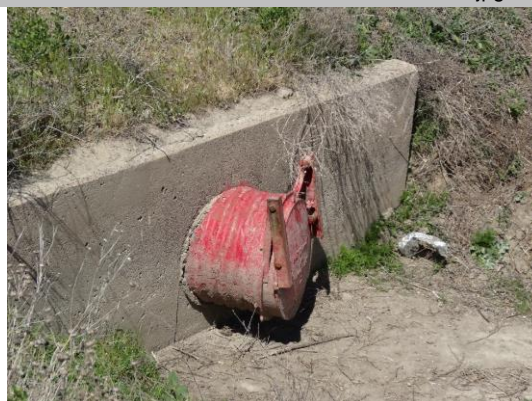
Photo 3 of 3 : UCIP_FA_2018_39473_61672.jpg

LM Start	8.13	Rating **	M	Issue No.	1238 (cont)	
LM End	8.13	Issue Type +	Ma	Location *		
Category	Supplemental			GPS Latitude/Longitude		
				Start	End	
Item	DWR UCIP LMA Responsibility			37.216547 °	37.216547 °	
				-120.713000 °	-120.713000 °	
DWR ID	19870					
Comment Code						
Inspector Comment						
FS_ID:39473 DS_ID:19870 EP_NO: N/A Repair Type: Non-Urgent Crossing Status: Found UCIP Comments: 04/18/2014 Sediment buildup in pipe--recommend contacting owner to clear sediment. (DWR UCIP - O. Magana) FIELD_STRUCT_DESC: 24-inch corrugated metal gravity drainage pipe through the levee, 16.5 feet below the crown. Flap gate on the waterside (WS) end. Concrete headwall on each end. [Additional Reference(s): DWR Levee Log, 2002. USACE San Joaquin O&M Manual 601.1, 1967, (HLM 8.21)]. FS Date: 4/18/2014

Concrete headwall and flap gate visible on waterward side.

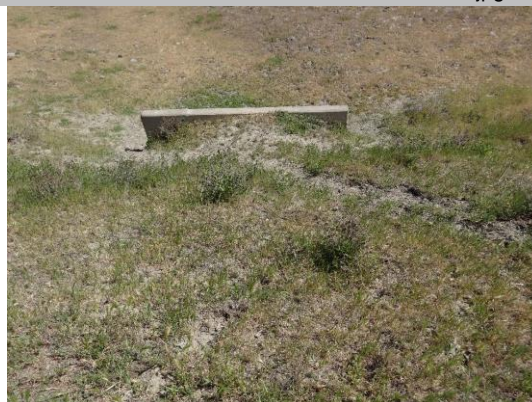
Photo 1 of 3 : UCIP_FA_2018_39474_61685.jpg

Comment Code					
Inspector Comment					
FS_ID:39474					
DS_ID:19871					
EP_NO: N/A					
Repair Type: Non-Urgent					
Crossing Status: Found					
UCIP Comments: 04/18/2014 Need to contact owner. Sediment buildup in pipe visible on landward side--recommend clearing. Good candidate for pressure test or video inspection due to signs of heavy corrosion. If no leaks after tests this crossing would be a good candidate for rehabilitation. (DWR UCIP - O. Magana)					
FIELD_STRUCT_DESC: 24-inch corrugated metal gravity drainage pipe through the levee, 9.2 feet below the crown. Flap gate on the waterside (WS) end. Concrete headwall on each end. [Additional Reference(s): DWR Levee Log, 2002. USACE San Joaquin O&M Manual 601.1, 1967, (HLM 8.51)].					
FS Date: 4/18/2014

View of waterward side.

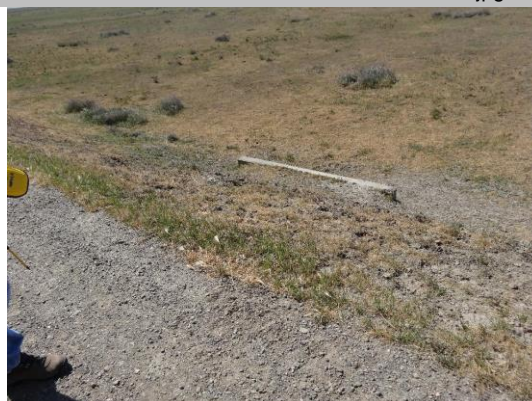
Photo 2 of 3 : UCIP_FA_2018_39474_61684.jpg

Comment Code						
Inspector Comment						
FS_ID:39474						
DS_ID:19871						
EP_NO: N/A						
Repair Type: Non-Urgent						
Crossing Status: Found						
UCIP Comments: 04/18/2014 Need to contact owner. Sediment buildup in pipe visible on landward side--recommend clearing. Good candidate for pressure test or video inspection due to signs of heavy corrosion. If no leaks after tests this crossing would be a good candidate for rehabilitation. (DWR UCIP - O. Magana)						
FIELD_STRUCT_DESC: 24-inch corrugated metal gravity drainage pipe through the levee, 9.2 feet below the crown. Flap gate on the waterside (WS) end. Concrete headwall on each end. [Additional Reference(s): DWR Levee Log, 2002. USACE San Joaquin O&M Manual 601.1, 1967, (HLM 8.51)].						
FS Date: 4/18/2014

View of landward side.

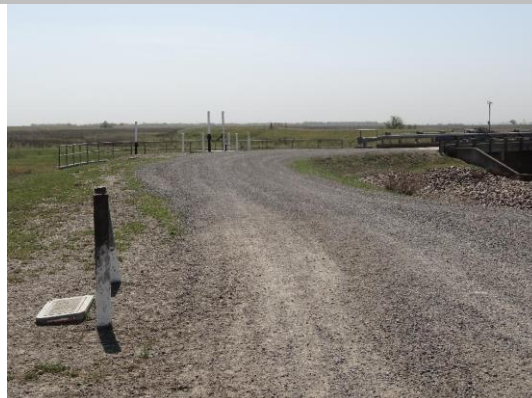
Photo 1 of 2 : UCIP_FA_2018_42525_72925.jpg

Comment Code						
Inspector Comment						
FS_ID:42525 DS_ID:19872 EP_NO: N/A Repair Type: Non-Urgent Crossing Status: Indicator Found UCIP Comments: 12/05/2014 Accidentally missed updating record. Photos have been added and coordinates have been updated. Unable to confirm if crossing is the same cable line originally identified in desk study at levee mile 6.43. Recommend contacting owner to confirm alignment, size of conduit, and permit issued. (DWR UCIP - O. Magana) FIELD_STRUCT_DESC: Telephone cable of an unknown size or material under crown of roadway, at an unknown depth. [Additional Reference(s): DWR Levee Log, 2002]. FS Date: 4/18/2014

Service box located on waterward levee shoulder.

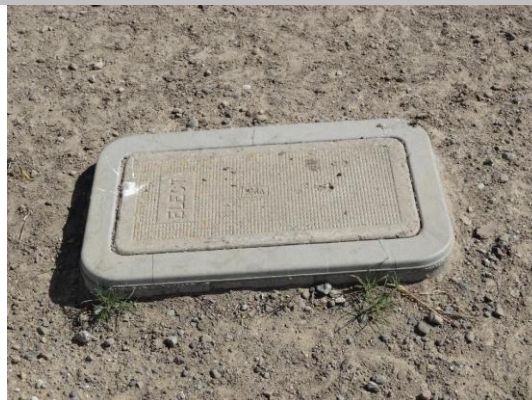
Photo 2 of 2 : UCIP_FA_2018_42525_72924.jpg

Service box is for electrical conduit.

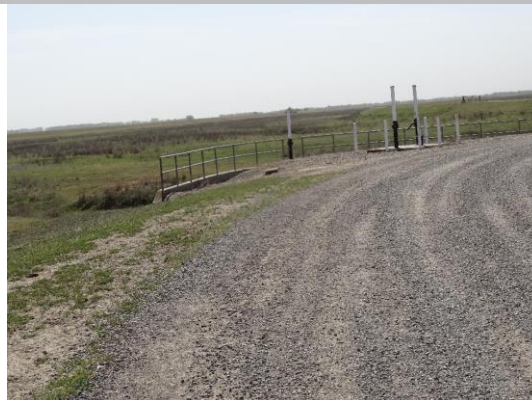
Photo 1 of 3 : UCIP_FA_2018_42524_72922.jpg

LM Start	9.56	Rating **	M	Issue No.	1241
LM End	9.56	Issue Type +	En	Location *	
Category	Supplemental			GPS Latitude/Longitude	
				Start	End
Item	DWR UCIP Field Study			37.202014 °	37.202014 °
				-120.694820 °	-120.694820 °
DWR ID	19873				
Comment Code					
Inspector Comment					
FS_ID:42524 DS_ID:19873 EP_NO: N/A Repair Type: Non-Urgent Crossing Status: Found UCIP Comments: 12/05/2014 Accidentally missed entry. Photos have been added and coordinates have been updated by Olivia Magana. Unable to determine condition of crossing due to limited access. Recommend contacting owner to provide condition of crossing. (DWR UCIP - O. Magana) FIELD_STRUCT_DESC: 36-inch corrugated metal gravity drainage pipe through the levee, 14 feet below the crown. Slide gate in a concrete diversion box on the waterside (WS) shoulder. [Additional Reference(s): DWR Levee Log, 2002]. FS Date: 4/18/2014

Overview of levee crown looking upstream.

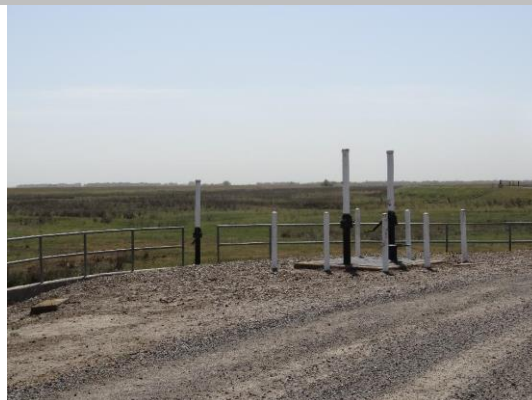
Photo 2 of 3 : UCIP_FA_2018_42524_72921.jpg

Concrete box located on waterward side.

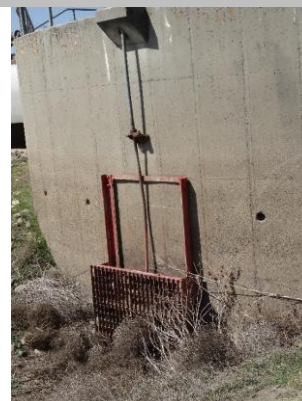
Photo 3 of 3 : UCIP_FA_2018_42524_72920.jpg

Comment Code						
Inspector Comment						
FS_ID:42524 DS_ID:19873 EP_NO: N/A Repair Type: Non-Urgent Crossing Status: Found UCIP Comments: 12/05/2014 Accidentally missed entry. Photos have been added and coordinates have been updated by Olivia Magana. Unable to determine condition of crossing due to limited access. Recommend contacting owner to provide condition of crossing. (DWR UCIP - O. Magana) FIELD_STRUCT_DESC: 36-inch corrugated metal gravity drainage pipe through the levee, 14 feet below the crown. Slide gate in a concrete diversion box on the waterside (WS) shoulder. [Additional Reference(s): DWR Levee Log, 2002]. FS Date: 4/18/2014

Trash gate visible on waterward side.

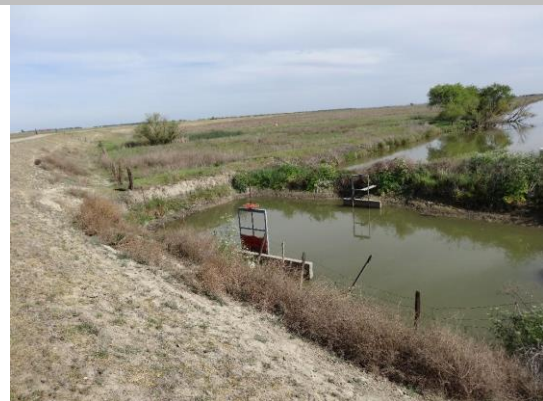
Photo 1 of 2 : UCIP_FA_2018_39475_61691.jpg

LM Start	9.66	Rating **	M	Issue No.	1247
LM End	9.66	Issue Type +	En	Location *	
Category	Supplemental			GPS Latitude/Longitude	
				Start	End
Item	DWR UCIP Field Study			37.200948 °	37.200948 °
				-120.694362 °	-120.694362 °
DWR ID	19874				
Comment Code					
Inspector Comment					
FS_ID:39475 DS_ID:19874 EP_NO: N/A Repair Type: Non-Urgent Crossing Status: Found UCIP Comments: 04/17/2014 Waterward side not visible--need to determine alignment. (DWR UCIP - O. Magana) FIELD_STRUCT_DESC: 36-inch corrugated metal gravity drainage pipe through the levee, 14 feet below the crown. Slide gate in a concrete diversion box on the waterside (WS) shoulder. [Additional Reference(s): DWR Levee Log, 2002]. FS Date: 4/17/2014

View of landward side.

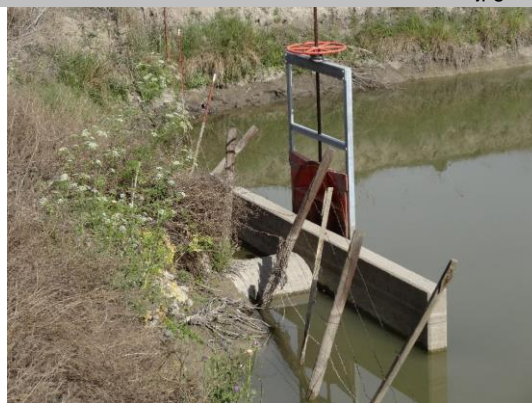
Photo 2 of 2 : UCIP_FA_2018_39475_61690.jpg

Pipe, slide gate, and concrete headwall visible on landward side.
