**Flood Control Project Maintenance
Levee Inspections**

Fall 2018 Levee Maintenance Deficiency Summary Report

San Joaquin River Basin

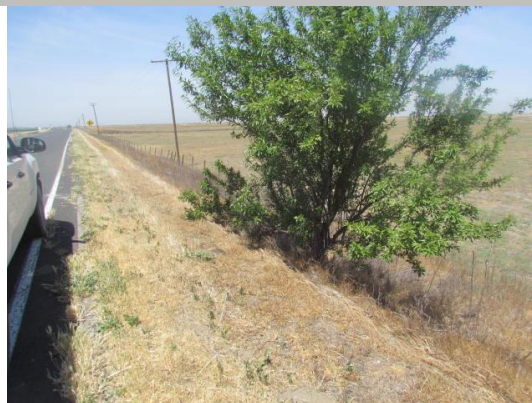
Photo 1 of 1 : FA_2018_NA0010_124_14_20180911_00015.jpg

LM Start	11.49	Rating **	M	Issue No.	14
LM End	11.49	Issue Type +	Ma	Location *	WS
Category	Earthen Levee			GPS Latitude/Longitude	
				Start	End
Item	Trim / Thin Trees			37.186189°	37.186189°
				-120.668476°	-120.668476°
DWR ID	DWR_NA0010_06_s_2015_14				
Comment Code					
T1 : Trim trees to at least five feet above ground level.					
Inspector Comment					
Almond tree located along Sandy Mush Rd. on waterside slope.

Looking west at tree on waterward slope.

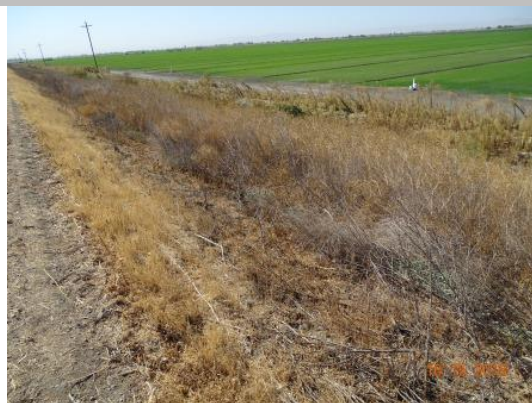
Photo 1 of 1 : FA_2018_NA0010_124_96_20181101_00196.jpg

LM Start	12.10	Rating **	U	Issue No.	96
LM End	12.46	Issue Type +	Ma	Location *	LS
Category	Earthen Levee			GPS Latitude/Longitude	
				Start	End
Item	Vegetation			37.180246 °	37.175089 °
				-120.664577 °	-120.664617 °
DWR ID	DWR_NA0010_06_f_2018_96				
Comment Code					
V1 : Control annual grass and weeds on the levee slopes and easements.					
Inspector Comment					
Dense vegetation obstructs view of lower portion of slope and toe.

View of landside slope and toe. (Fall 2018)

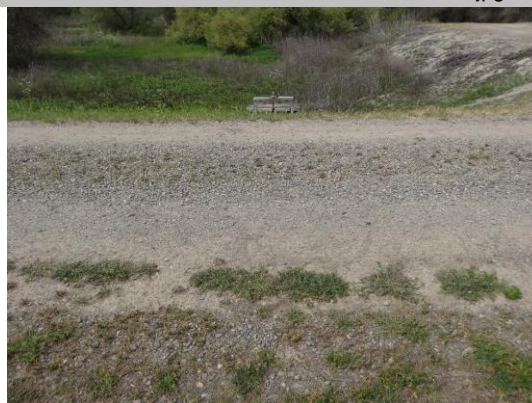
Photo 1 of 3 : UCIP_FA_2018_39477_66492.jpg

LM Start	13.22	Rating **	M	Issue No.	1250
LM End	13.22	Issue Type +	Ma	Location *	
Category	Supplemental			GPS Latitude/Longitude	
				Start	End
Item	DWR UCIP LMA Responsibility			37.171675 °	37.171675 °
				-120.655064 °	-120.655064 °
DWR ID	19877				
Comment Code					
Inspector Comment					
FS_ID:39477					
DS_ID:19877					
EP_NO: N/A					
Repair Type: Non-Urgent					
Crossing Status: Found					
UCIP Comments: 04/17/2014 Not accessible--crossing is buried on landward side. Need to contact owner to determine status. (DWR UCIP - O. Magana)					
FIELD_STRUCT_DESC: 24-inch corrugated metal gravity drainage pipe through the levee, 10.8 feet below the crown. Flap gate on the waterside (WS) end. [Additional Reference(s): DWR Levee Log, 2002. USACE San Joaquin O&M Manual 601.1, 1967, (HLM 13.30)].					
FS Date: 4/17/2014

View of levee crown at crossing.

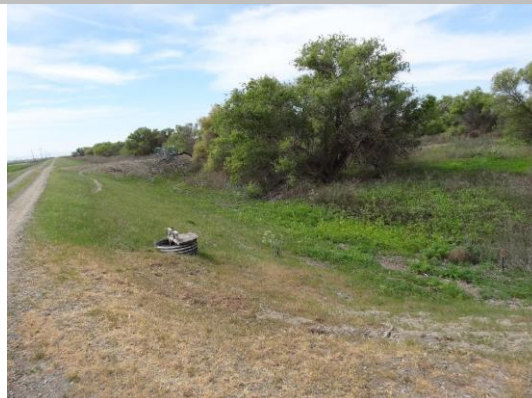
Photo 2 of 3 : UCIP_FA_2018_39477_66494.jpg

View of waterward slope.

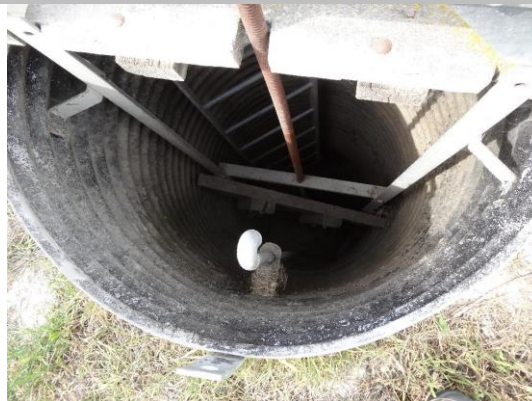
Photo 3 of 3 : UCIP_FA_2018_39477_66495.jpg

Inside view of CMP riser located on waterward slope.

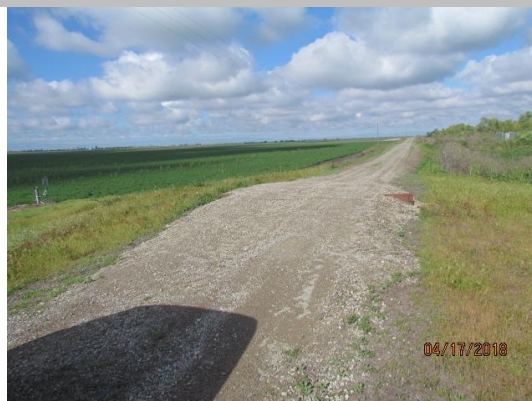
Photo 1 of 2 : FA_2018_NA0010_124_88_20180911_00035.jpg

LM Start	13.23	Rating **	U	Issue No.	88
LM End	13.23	Issue Type +	En	Location *	CR
Category	Earthen Levee			GPS Latitude/Longitude	
				Start	End
Item	Encroachments			37.171678 °	37.171678 °
				-120.654920 °	-120.654920 °
DWR ID	DWR_NA0010_06_s_2018_88				
Comment Code					
PI : Pipe					
Inspector Comment					
Landowner or Farmer installed a temporary 4-inch pipe across levee crown.

Looking north at pipe across levee crown. (Spring 2018)

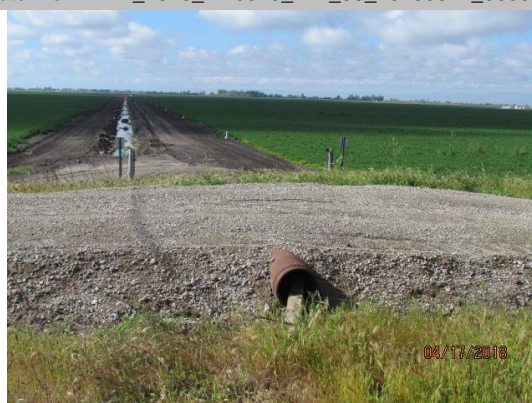
Photo 2 of 2 : FA_2018_NA0010_124_88_20180911_00036.jpg

Looking east at pipe across levee crown. (Spring 2018)

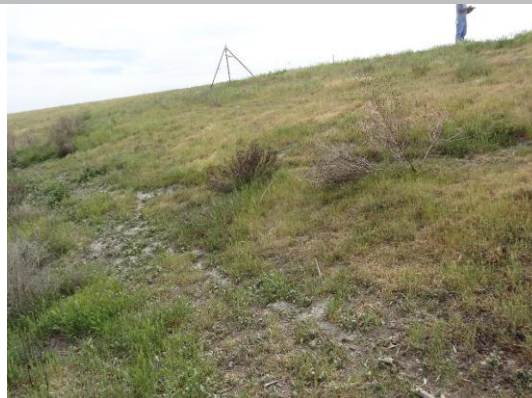
Photo 1 of 3 : UCIP_FA_2018_39478_66496.jpg

LM Start	14.36	Rating **	M	Issue No.	1251
LM End	14.36	Issue Type +	Ma	Location *	
Category	Supplemental			GPS Latitude/Longitude	
				Start	End
Item	DWR UCIP LMA Responsibility			37.167888 °	37.167888 °
				-120.636419 °	-120.636419 °
DWR ID	19878				
Comment Code					
Inspector Comment					
FS_ID:39478 DS_ID:19878 EP_NO: N/A Repair Type: Non-Urgent Crossing Status: Found UCIP Comments: 04/17/2014 Not accessible--crossing is buried on landward side. Need to contact owner to determine status. (DWR UCIP - O. Magana) FIELD_STRUCT_DESC: 24-inch corrugated metal gravity drainage pipe through the levee, 12.3 feet below the crown. Flap gate on the waterside (WS) end. [Additional Reference(s): DWR Levee Log, 2002. USACE San Joaquin O&M Manual 601.1, 1967, (HLM 14.44)]. FS Date: 4/17/2014

View of waterward slope.

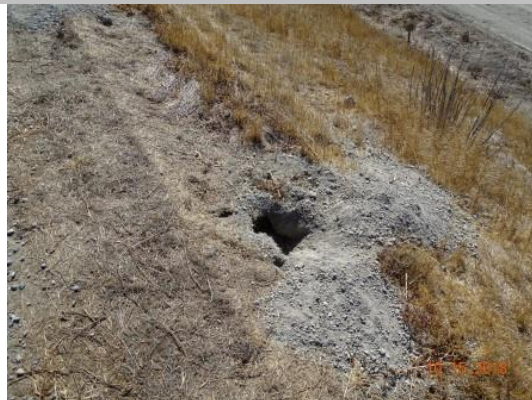
Photo 1 of 1 : FA_2018_NA0010_124_101_20181101_00197.jpg

LM Start	14.63	Rating **	M	Issue No.	101
LM End	14.64	Issue Type +	Ma	Location *	LS
Category	Earthen Levee			GPS Latitude/Longitude	
				Start	End
Item	Animal Control			37.164871 °	37.164824 °
				-120.633222 °	-120.633167 °
DWR ID	DWR_NA0010_06_f_2018_101				
Comment Code					
A3 : No rodents visible, but rodent burrows visible; need to backfill and compact or grout burrows.					
Inspector Comment					
burrows along landside shoulder

representative rodent hole on landside shoulder. (Fall 2018)

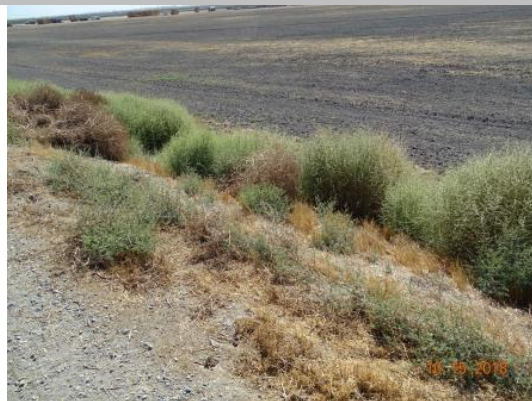
Photo 1 of 1 : FA_2018_NA0010_124_103_20181101_00198.jpg

LM Start	15.29	Rating **	U	Issue No.	103
LM End	15.46	Issue Type +	Ma	Location *	LS
Category	Earthen Levee		GPS Latitude/Longitude		
			Start	End	
Item	Vegetation		37.159974°	37.158926°	
			-120.623008°	-120.620324°	
DWR ID	DWR_NA0010_06_f_2018_103				
Comment Code					
V1 : Control annual grass and weeds on the levee slopes and easements.					
Inspector Comment					
vegetation blocking view of slope and toe.

Dense brush blocking view of lower section of levee slope and toe. (Fall 2018)

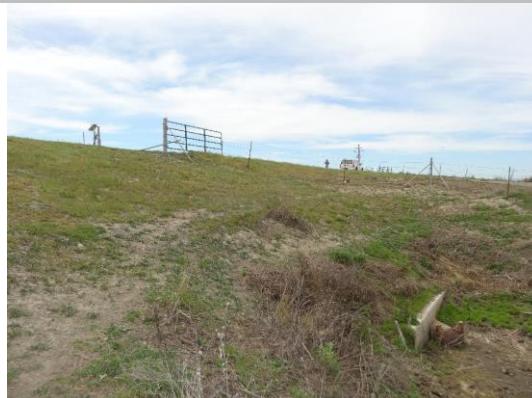
Photo 2 of 3 : UCIP_FA_2018_39480_66506.jpg

View of waterward side.

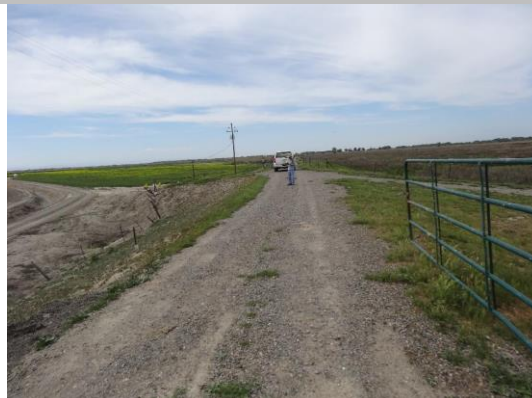
Photo 3 of 3 : UCIP_FA_2018_39480_66505.jpg

Item	DWR UCIP LMA Responsibility			37.156934 °		37.156934 °
				-120.617210 °		-120.617210 °
DWR ID	19884					
Comment Code						
Inspector Comment						
FS_ID:39480 DS_ID:19884 EP_NO: N/A Repair Type: Non-Urgent Crossing Status: Found UCIP Comments: 04/17/2014 Need to contact owner. Sediment buildup on both the waterward and landward side. Recommend removing sediment buildup from both side. Also recommend clearing excess sediment inside crossing. (DWR UCIP - O. Magana) FIELD_STRUCT_DESC: 24-inch corrugated metal gravity drainage pipe through the levee, 14 feet below the crown. Flap gate on the waterside (WS) end. [Additional Reference(s): DWR Levee Log, 2002. USACE San Joaquin O&M Manual 601.1, 1967, (HLM 15.76)]. FS Date: 4/17/2014

Overview of levee crown at crossing.

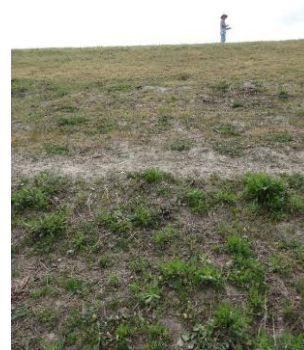
Photo 1 of 3 : UCIP_FA_2018_36663_66530.jpg

Comment Code					
Inspector Comment					
FS_ID:36663					
DS_ID:19885					
EP_NO: N/A					
Repair Type: Non-Urgent					
Crossing Status: Found					
UCIP Comments: 04/17/2014 Need to contact owner to determine status of crossing. Waterward side is buried and not accessible. Landward side headwall is blocked by dense vegetation. Recommend confirming status of flap gate on waterward side and removing dense vegetation form landward side. (DWR UCIP - O. Magana)					
FIELD_STRUCT_DESC: 36-inch corrugated metal gravity drainage pipe through the levee, 16.6 feet below the crown. Flap gate on the waterside (WS) end. [Additional Reference(s): DWR Levee Log, 2002. USACE San Joaquin O&M Manual 601.1, 1967, (HLM 15.91)].					
FS Date: 4/17/2014

View of waterward side, Photo 1 of 3.

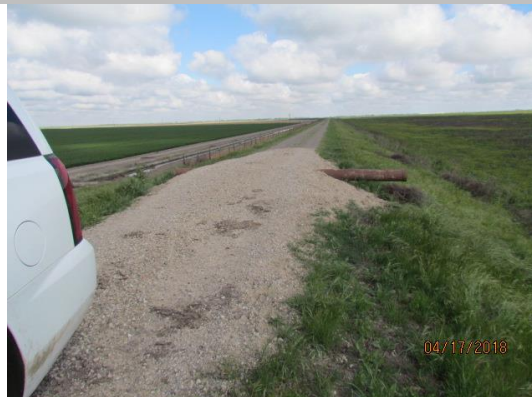
Photo 1 of 1 : FA_2018_NA0010_124_70_20180911_00022.jpg

LM Start	18.46	Rating **	U	Issue No.	70
LM End	18.46	Issue Type +	En	Location *	CR
Category	Earthen Levee			GPS Latitude/Longitude	
				Start	End
Item	Encroachments			37.124088°	37.124088°
				-120.589249°	-120.589249°
DWR ID	DWR_NA0010_06_s_2018_70				
Comment Code					
PI : Pipe					
Inspector Comment					
Landowner or Farmer installed pipe across levee crown.

Looking south at pipe across levee crown. (Spring 2018)

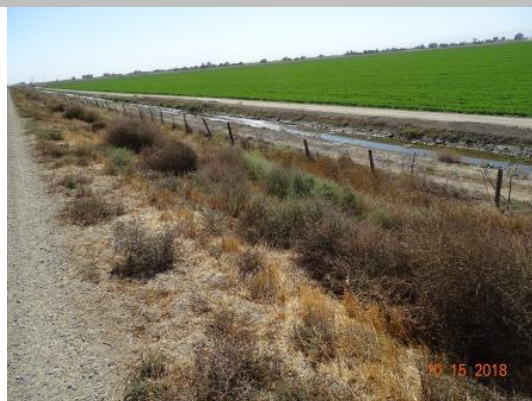
Photo 1 of 1 : FA_2018_NA0010_124_106_20181101_00199.jpg

LM Start	18.47	Rating **	U	Issue No.	106
LM End	19.52	Issue Type +	Ma	Location *	LS
Category	Earthen Levee			GPS Latitude/Longitude	
				Start	End
Item	Vegetation			37.123989 °	37.113133 °
				-120.589222 °	-120.586485 °
DWR ID	DWR_NA0010_06_f_2018_106				
Comment Code					
V1 : Control annual grass and weeds on the levee slopes and easements.					
Inspector Comment					
dense brush blocking lower slope and toe of levee

Dense brush blocking lower slope and toe. (Fall 2018)

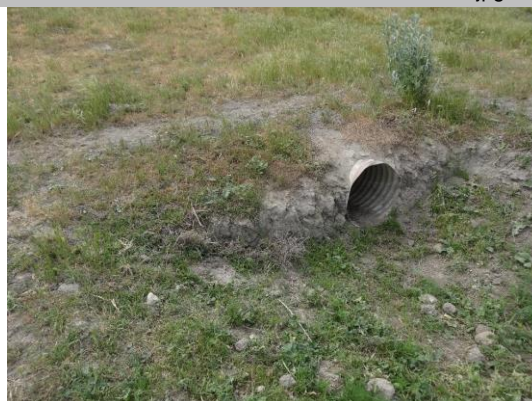
Photo 3 of 3 : UCIP_FA_2018_36687_66581.jpg

Item	DWR UCIP LMA Responsibility			37.118178 °		37.118178 °
				-120.586783 °		-120.586783 °
DWR ID	19889					
Comment Code						
Inspector Comment						
FS_ID:36687						
DS_ID:19889						
EP_NO: N/A						
Repair Type: Non-Urgent						
Crossing Status: Found						
UCIP Comments: 04/17/2014 Dense vegetation limits the inspector's visibility to identify signs of pipe failure (leaks) along the landward slope. Recommend removing vegetation along pipe alignment to conduct proper inspection of structure. (DWR UCIP - O. Magana)						
FIELD_STRUCT_DESC: 24-inch corrugated metal gravity drainage pipe through the levee, 10.2 feet below the crown. Slide gate in a pipe riser on the waterside (WS) slope. [Additional Reference(s): DWR Levee Log, 2002. USACE San Joaquin O&M Manual 601.1, 1967, (HLM 18.97)].						
FS Date: 4/17/2014

Pipe daylight on waterward side.

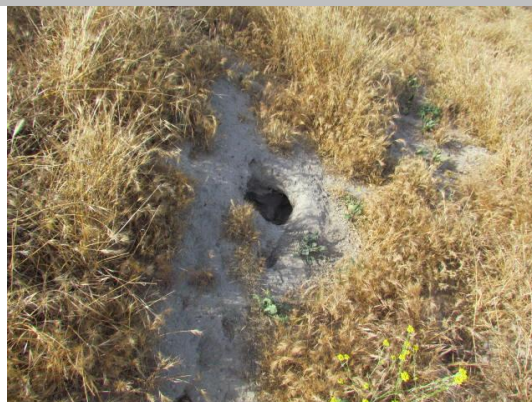
Photo 1 of 5 : FA_2018_NA0010_124_1211_20180911_00044.jpg

LM Start	19.14	Rating **	U	Issue No.	1211
LM End	19.14	Issue Type +	Ma	Location *	WS
Category	Earthen Levee			GPS Latitude/Longitude	
				Start	End
Item	Animal Control			37.114793 °	37.114793 °
				-120.587582 °	-120.587582 °
DWR ID	DWR_NA0010_06_s_2015_1211				
Comment Code					
A1 : Exterminate rodents and backfill and compact or grout burrows.					
Inspector Comment					
Several large rodent holes with more than 2 cubic feet of material were noted on the waterside slope.

Looking at rodent hole on waterward slope. Spring 2016

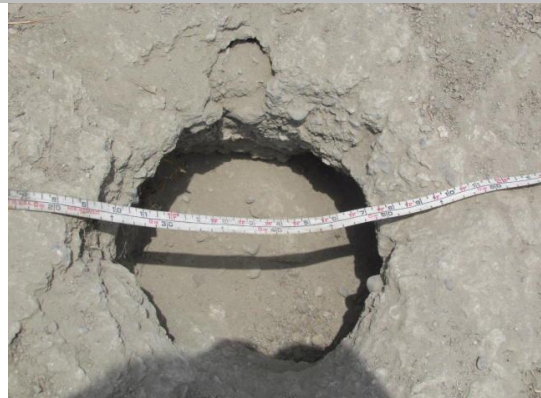
Photo 3 of 5 : FA_2018_NA0010_124_1211_20180911_00046.jpg

Looking at close-up view of large rodent hole on waterward slope. (Spring 2015)

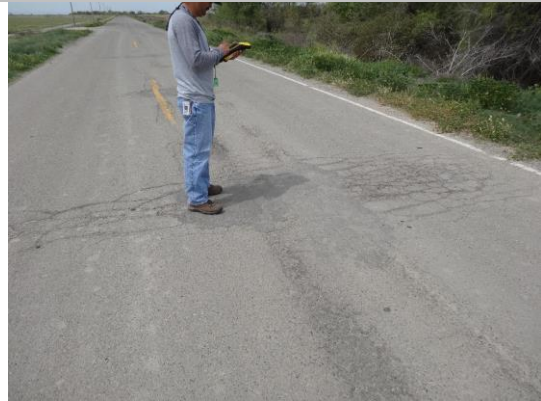
Photo 1 of 3 : UCIP_FA_2018_36689_66591.jpg

Comment Code						
Inspector Comment						
FS_ID:36689						
DS_ID:19891						
EP_NO: N/A						
Repair Type: Non-Urgent						
Crossing Status: Found						
UCIP Comments: 04/17/2014 Dense vegetation limits the inspector's visibility to identify signs of pipe failure (leaks) along the slopes. Recommend removing vegetation along pipe alignment to conduct proper inspection of structure. (DWR UCIP - O. Magana)						
FIELD_STRUCT_DESC: 30-inch by 30-inch reinforced concrete box gravity drainage culvert through the levee, 14 feet below the crown. Flap gate on the waterside (WS) end. [Additional Reference(s): DWR Levee Log, 2002. USACE San Joaquin O&M Manual 601.1, 1967, (HLM 19.85)].						
FS Date: 4/17/2014

Overview of levee crown looking downstream.

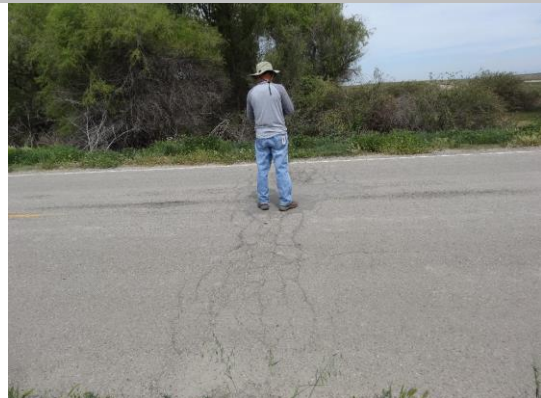
Photo 2 of 3 : UCIP_FA_2018_36689_66592.jpg

View of levee crown at crossing.

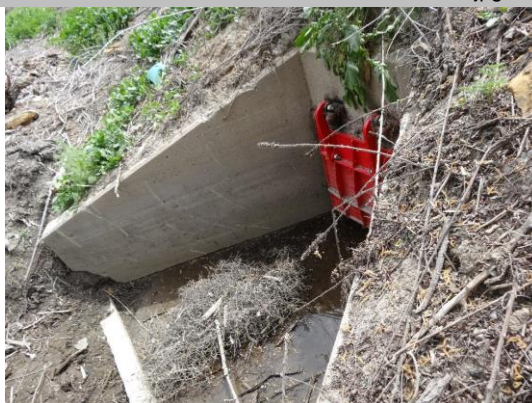
Photo 3 of 3 : UCIP_FA_2018_36689_66590.jpg

Item	DWR UCIP LMA Responsibility			37.113304 °		37.113304 °
				-120.579102 °		-120.579102 °
DWR ID	19891					
Comment Code						
Inspector Comment						
FS_ID:36689						
DS_ID:19891						
EP_NO: N/A						
Repair Type: Non-Urgent						
Crossing Status: Found						
UCIP Comments: 04/17/2014 Dense vegetation limits the inspector's visibility to identify signs of pipe failure (leaks) along the slopes. Recommend removing vegetation along pipe alignment to conduct proper inspection of structure. (DWR UCIP - O. Magana)						
FIELD_STRUCT_DESC: 30-inch by 30-inch reinforced concrete box gravity drainage culvert through the levee, 14 feet below the crown. Flap gate on the waterside (WS) end. [Additional Reference(s): DWR Levee Log, 2002. USACE San Joaquin O&M Manual 601.1, 1967, (HLM 19.85)].						
FS Date: 4/17/2014

View of "U" concrete headwall located on waterward side.

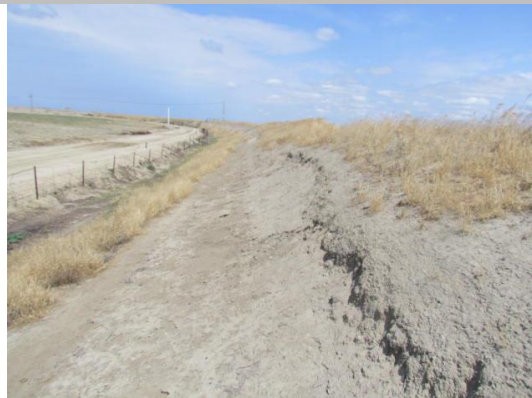
Photo 1 of 2 : FA_2018_NA0010_124_1209_20180911_00042.jpg

LM Start	20.79	Rating **	M	Issue No.	1209
LM End	21.10	Issue Type +	Ma	Location *	LS
Category	Earthen Levee			GPS Latitude/Longitude	
				Start	End
Item	Erosion / Bank Caving			37.113107°	37.109735°
				-120.563782°	-120.560079°
DWR ID	DWR_NA0010_06_s_2015_1209				
Comment Code					
E1 : Note and monitor erosion site.					
Inspector Comment					
Erosion on landside slope greater than 3 inches. Erosion caused by livestock.

Looking north at livestock erosion on landward slope.

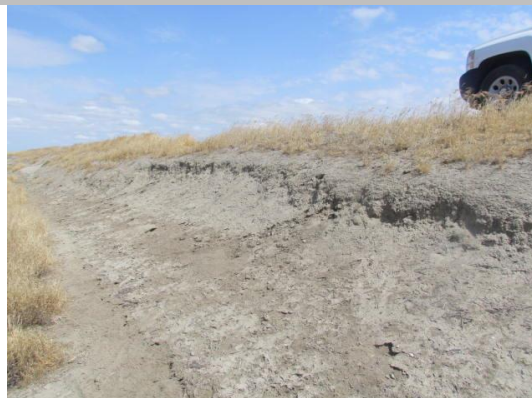
Photo 2 of 2 : FA_2018_NA0010_124_1209_20180911_00043.jpg

Looking northeast at livestock erosion on landward slope.

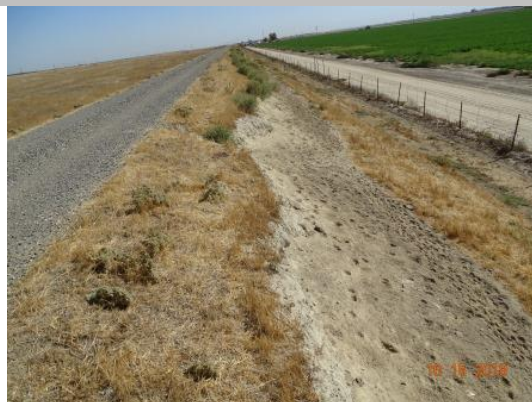
Photo 1 of 1 : FA_2018_NA0010_124_107_20181101_00200.jpg

LM Start	21.71	Rating **	M	Issue No.	107
LM End	21.78	Issue Type +	Ma	Location *	LS
Category	Earthen Levee			GPS Latitude/Longitude	
				Start	End
Item	Erosion / Bank Caving			37.102844 °	37.102002 °
				-120.553160 °	-120.552314 °
DWR ID	DWR_NA0010_06_f_2018_107				
Comment Code					
E1 : Note and monitor erosion site.					
Inspector Comment					
erosion into levee prism due to livestock

erosion into levee prism from livestock. (Fall 2018)

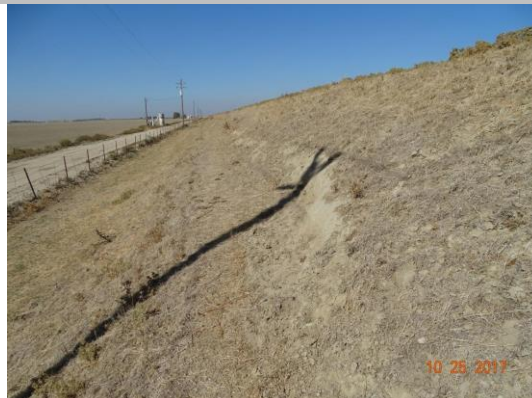
Photo 1 of 1 : FA_2018_NA0010_124_86_20180911_00034.jpg

LM Start	22.41	Rating **	M	Issue No.	86
LM End	22.46	Issue Type +	Ma	Location *	LS
Category	Earthen Levee			GPS Latitude/Longitude	
				Start	End
Item	Slope Stability			37.094969 °	37.094479 °
				-120.544964 °	-120.544435 °
DWR ID	DWR_NA0010_06_f_2017_86				
Comment Code					
S2 : Repair the levee slope damaged by foot traffic and prevent access where possible.					
Inspector Comment					
Erosion greater than 3 inches on landside slope caused by livestock.

Looking northwest at the landside slope.

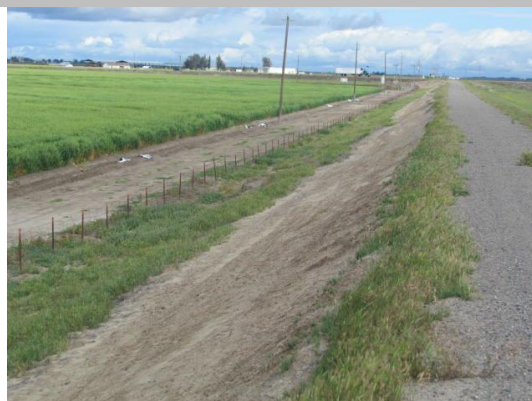
Photo 4 of 4 : FA_2018_NA0010_124_5_20180911_00010.jpg

LM Start	24.51	Rating **	M	Issue No.	5 (cont)	
LM End	25.01	Issue Type +	Ma	Location *	LS	
Category	Earthen Levee			GPS Latitude/Longitude		
				Start		End
Item	Slope Stability			37.072048 °		37.066501 °
				-120.520180 °		-120.514193 °
DWR ID	DWR_NA0010_06_s_2012_5					
Comment Code						
S2 : Repair the levee slope damaged by foot traffic and prevent access where possible.						
Inspector Comment						
Landside erosion caused by livestock extends into landward shoulder.

Looking north at livestock erosion on landside slope. (Fall 2014)

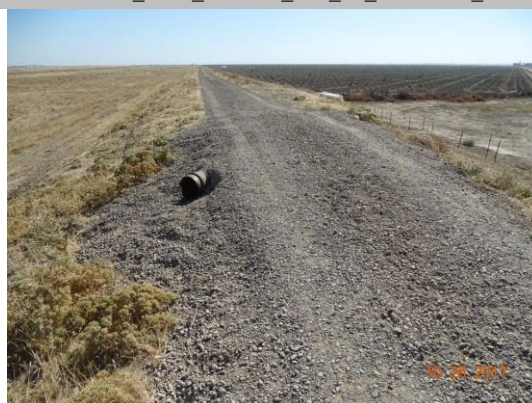
Photo 1 of 1 : FA_2018_NA0010_124_83_20180911_00033.jpg

LM Start	24.98	Rating **	M	Issue No.	83
LM End	24.98	Issue Type +	En	Location *	CR
Category	Earthen Levee			GPS Latitude/Longitude	
				Start	End
Item	Encroachments			37.066893 °	37.066893 °
				-120.514623 °	-120.514623 °
DWR ID	DWR_NA0010_06_f_2017_83				
Comment Code					
PI : Pipe					
Inspector Comment					
Landowner has a temporary pipe across the crown.

Looking southeast at the pipe on the levee crown.

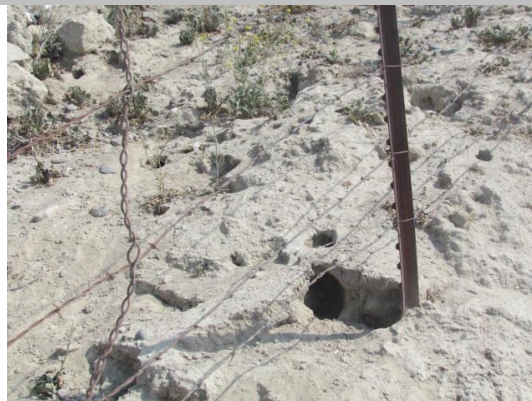
Photo 1 of 1 : FA_2018_NA0010_124_1208_20180911_00041.jpg

LM Start	26.13	Rating **	M	Issue No.	1208
LM End	26.13	Issue Type +	Ma	Location *	LS
Category	Earthen Levee			GPS Latitude/Longitude	
				Start	End
Item	Animal Control			37.054222 °	37.054222 °
				-120.500862 °	-120.500862 °
DWR ID	DWR_NA0010_06_s_2015_1208				
Comment Code					
A1 : Exterminate rodents and backfill and compact or grout burrows.					
Inspector Comment					
Noted several rodent holes next to and within rock revetment on landside slope.

Rodent holes on landward slope.

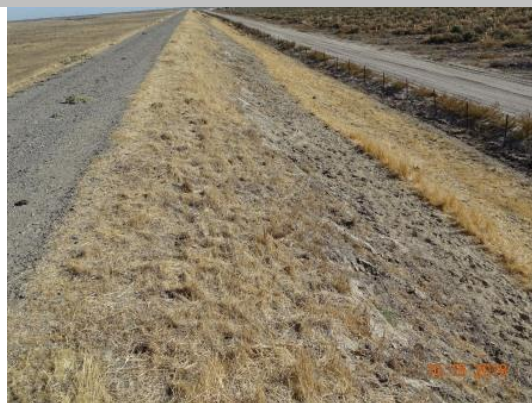
Photo 1 of 5 : FA_2018_NA0010_124_3_20181102_00201.jpg

LM Start	27.43	Rating **	M	Issue No.	3
LM End	27.97	Issue Type +	Ma	Location *	LS
Category	Earthen Levee			GPS Latitude/Longitude	
				Start	End
Item	Slope Stability			37.036955 °	37.032887 °
				-120.484395 °	-120.481225 °
DWR ID	DWR_NA0010_06_s_2012_3				
Comment Code					
S2 : Repair the levee slope damaged by foot traffic and prevent access where possible.					
Inspector Comment					
Landside erosion caused by livestock. Erosion greater than 3" in depth on landside slope. Levee crown has narrowed within this reach.

Looking south at livestock erosion on landside slope. (Fall 2018)

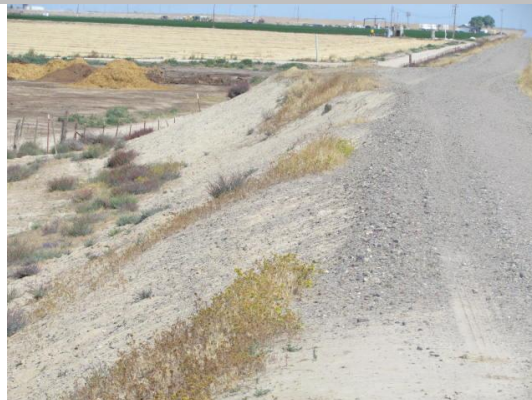
Photo 3 of 5 : FA_2018_NA0010_124_3_20180911_00004.jpg

LM Start	27.43	Rating **	M	Issue No.	3 (cont)	
LM End	27.97	Issue Type +	Ma	Location *	LS	
Category	Earthen Levee			GPS Latitude/Longitude		
				Start		End
Item	Slope Stability			37.036955 °		37.032887 °
				-120.484395 °		-120.481225 °
DWR ID	DWR_NA0010_06_s_2012_3					
Comment Code						
S2 : Repair the levee slope damaged by foot traffic and prevent access where possible.						
Inspector Comment						
Landside erosion caused by livestock. Erosion greater than 3" in depth on landside slope. Levee crown has narrowed within this reach.

Looking north at livestock erosion on landward shoulder and slope.(Spring 2015)

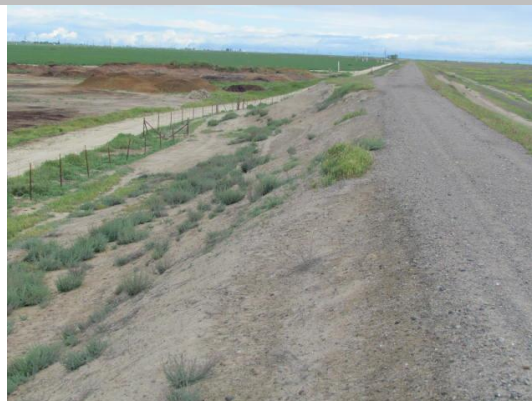
Photo 4 of 5 : FA_2018_NA0010_124_3_20180911_00005.jpg

Looking north at livestock erosion on landside shoulder and slope. (Fall 2014)

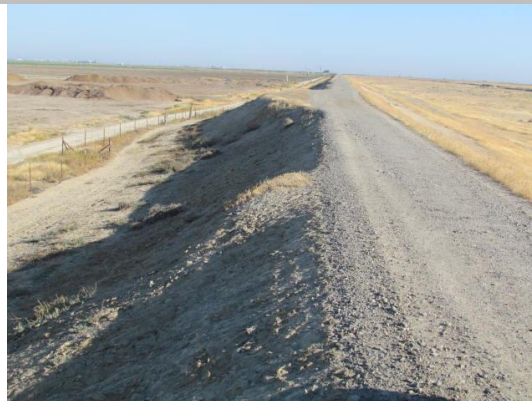
Photo 5 of 5 : FA_2018_NA0010_124_3_20180911_00006.jpg

Looking north at livestock erosion on landward slope. (Spring 2013)

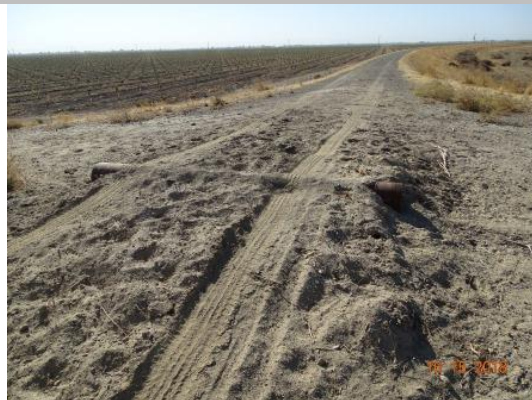
Photo 1 of 1 : FA_2018_NA0010_124_110_20181102_00202.jpg

LM Start	28.43	Rating **	M	Issue No.	110
LM End	28.43	Issue Type +	En	Location *	CR
Category	Earthen Levee			GPS Latitude/Longitude	
				Start	End
Item	Encroachments			37.029935 °	37.029935 °
				-120.474057 °	-120.474057 °
DWR ID	DWR_NA0010_06_f_2018_110				
Comment Code					
PI : Pipe					
Inspector Comment					
Landowner has installed a temporary pipe across the levee.

Landowner has installed a temporary pipe across levee crown. (Fall 2018)

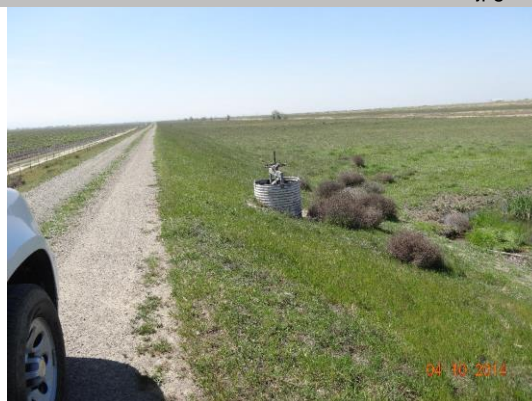
Photo 1 of 3 : UCIP_FA_2018_39886_66600.jpg

Comment Code					
Inspector Comment					
FS_ID:39886 DS_ID:19881 EP_NO: N/A Repair Type: Non-Urgent Crossing Status: Found UCIP Comments: 04/10/2014 Dense vegetation limits the inspector's visibility to identify signs of pipe failure (leaks) along the slopes. Recommend removing vegetation along pipe alignment to conduct proper inspection of structure. (DWR UCIP - O. Magana) FIELD_STRUCT_DESC: 36-inch corrugated metal gravity irrigation pipe through the levee, 12.4 feet below the crown. Slide gate in a 48-inch corrugated metal pipe (CMP) riser on the waterside (WS) slope. Concrete U-shaped headwall on each end. Cobble pad on the landside (LS). [Additional Reference(s): DWR Levee Log, 2002. USACE San Joaquin O&M Manual 601.1, 1967, (HLM 29.34)]. FS Date: 4/10/2014

View of waterward side--slide gate inside CMP riser located on waterward slope.

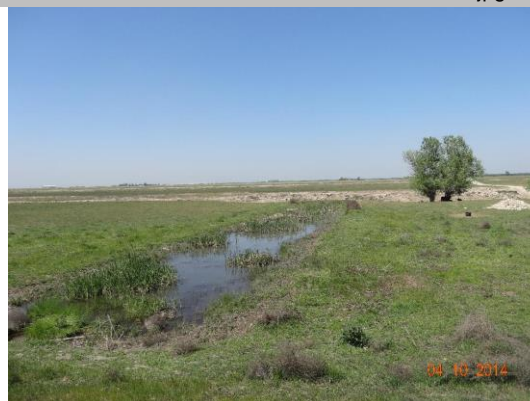
Photo 3 of 3 : UCIP_FA_2018_39886_66599.jpg

Comment Code					
Inspector Comment					
FS_ID:39886 DS_ID:19881 EP_NO: N/A Repair Type: Non-Urgent Crossing Status: Found UCIP Comments: 04/10/2014 Dense vegetation limits the inspector's visibility to identify signs of pipe failure (leaks) along the slopes. Recommend removing vegetation along pipe alignment to conduct proper inspection of structure. (DWR UCIP - O. Magana) FIELD_STRUCT_DESC: 36-inch corrugated metal gravity irrigation pipe through the levee, 12.4 feet below the crown. Slide gate in a 48-inch corrugated metal pipe (CMP) riser on the waterside (WS) slope. Concrete U-shaped headwall on each end. Cobble pad on the landside (LS). [Additional Reference(s): DWR Levee Log, 2002. USACE San Joaquin O&M Manual 601.1, 1967, (HLM 29.34)]. FS Date: 4/10/2014

View of waterward side.

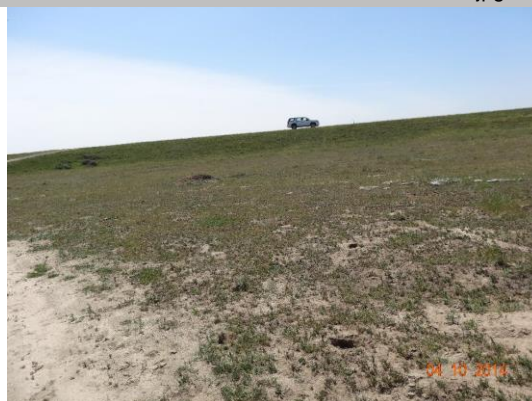
Photo 1 of 3 : UCIP_FA_2018_36693_66607.jpg

Comment Code					
Inspector Comment					
FS_ID:36693 DS_ID:19882 EP_NO: N/A Repair Type: Non-Urgent Crossing Status: Found UCIP Comments: 04/10/2014 Altered crossing--steel pipe section on landward side and concrete pipe section on waterward side. Joints on waterward side seperated. Need to contact owner to determine status. (DWR UCIP - O. Magana) FIELD_STRUCT_DESC: [Rodunder Siphon Structure] 48-inch reinforced concrete irrigation siphon pipe through the levee, 14.5 feet below the crown. Concrete U-shaped headwall on the outlet structure on the landside (LS) end. Slide gate mounted on the headwall. [Additional Reference(s): DWR Levee Log, 2002. USACE San Joaquin O&M Manual 601.1, 1967, (HLM 30.27)]. FS Date: 4/10/2014

Overview of waterward side.

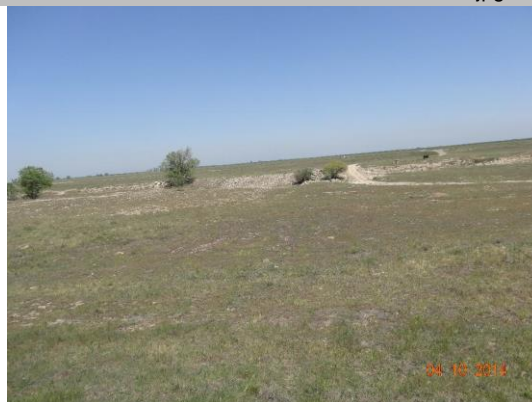
Photo 2 of 3 : UCIP_FA_2018_36693_66604.jpg

Overview of Eastside Bypass at crossing.

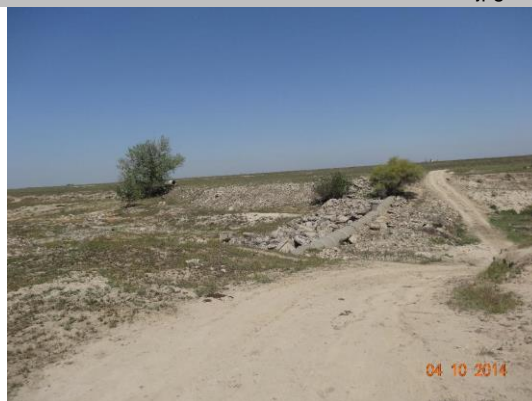
Photo 3 of 3 : UCIP_FA_2018_36693_66609.jpg

Item	DWR UCIP Field Study			37.027330 °	37.027330 °	
				-120.441498 °	-120.441498 °	
DWR ID	19882					
Comment Code						
Inspector Comment						
FS_ID:36693 DS_ID:19882 EP_NO: N/A Repair Type: Non-Urgent Crossing Status: Found UCIP Comments: 04/10/2014 Altered crossing--steel pipe section on landward side and concrete pipe section on waterward side. Joints on waterward side seperated. Need to contact owner to determine status. (DWR UCIP - O. Magana) FIELD_STRUCT_DESC: [Rodunder Siphon Structure] 48-inch reinforced concrete irrigation siphon pipe through the levee, 14.5 feet below the crown. Concrete U-shaped headwall on the outlet structure on the landside (LS) end. Slide gate mounted on the headwall. [Additional Reference(s): DWR Levee Log, 2002. USACE San Joaquin O&M Manual 601.1, 1967, (HLM 30.27)]. FS Date: 4/10/2014

Concrete pipe through Eastside Bypass exposed.

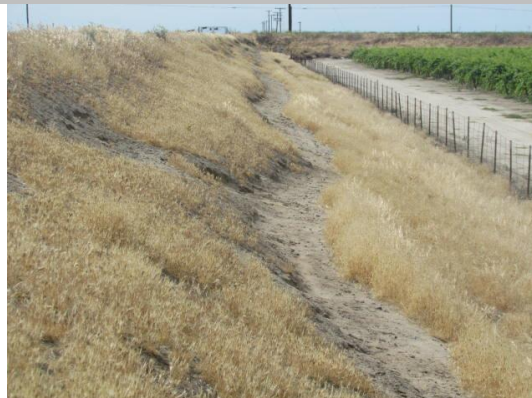
Photo 2 of 2 : FA_2018_NA0010_124_1207_20180911_00040.jpg

LM Start	30.81	Rating **	M	Issue No.	1207 (cont)	
LM End	31.06	Issue Type +	Ma	Location *	LS	
Category	Earthen Levee			GPS Latitude/Longitude		
				Start		End
Item	Erosion / Bank Caving			37.021615 °	37.018428 °	
				-120.437587 °	-120.435378 °	
DWR ID	DWR_NA0010_06_s_2015_1207					
Comment Code						
E1 : Note and monitor erosion site.						
Inspector Comment						
Landside erosion greater than 1" in depth and greater than 3" in length.						
Erosion caused by livestock traffic.

Looking south at livestock erosion on landward slope.

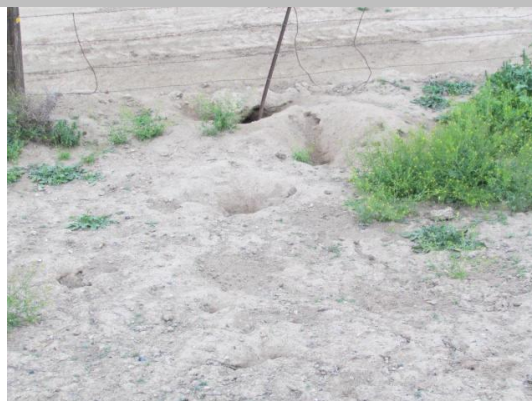
Photo 1 of 2 : FA_2018_NA0010_124_2_20180911_00001.jpg

LM Start	31.10	Rating **	U	Issue No.	2
LM End	31.10	Issue Type +	Ma	Location *	LS
Category	Earthen Levee			GPS Latitude/Longitude	
				Start	End
Item	Animal Control			37.017955 °	37.017955 °
				-120.435017 °	-120.435017 °
DWR ID	DWR_NA0010_06_s_2012_2				
Comment Code					
A1 : Exterminate rodents and backfill and compact or grout burrows.					
Inspector Comment

Looking west at rodent holes on landside slope and toe near fence line.

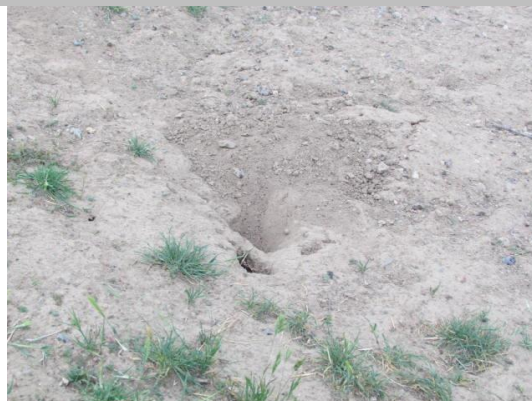
Photo 2 of 2 : FA_2018_NA0010_124_2_20180911_00002.jpg

Looking at typical rodent hole on landside slope.

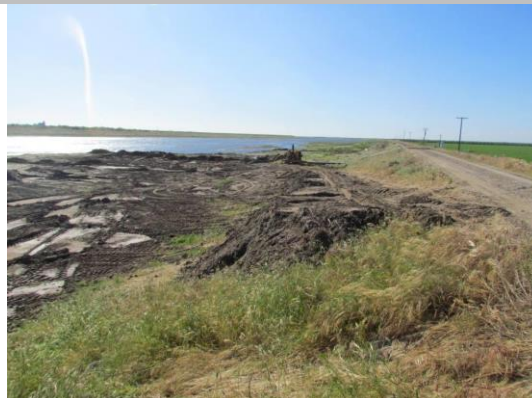
Photo 1 of 1 : FA_2018_NA0010_124_80_20180911_00030.jpg

LM Start	31.10	Rating **	U	Issue No.	80
LM End	31.10	Issue Type +	En	Location *	WS
Category	Earthen Levee			GPS Latitude/Longitude	
				Start	End
Item	Encroachments			37.017907 °	37.017907 °
				-120.434970 °	-120.434970 °
DWR ID	DWR_NA0010_06_s_2017_80				
Comment Code					
RA : Ramp					
Inspector Comment					
Farmer installed ramp on waterside slope.

Looking upstream at new ramp on waterward slope.

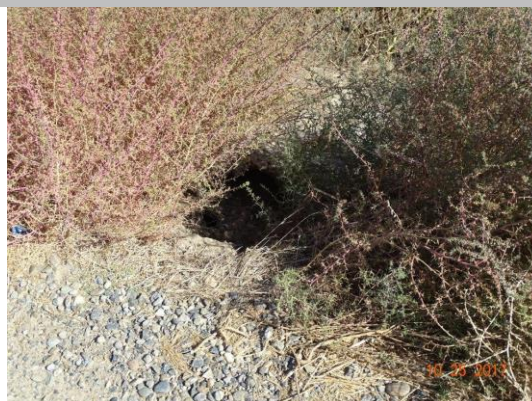
Photo 1 of 1 : FA_2018_NA0010_124_82_20180911_00032.jpg

LM Start	31.14	Rating **	U	Issue No.	82
LM End	31.14	Issue Type +	Ma	Location *	WS
Category	Earthen Levee			GPS Latitude/Longitude	
				Start	End
Item	Animal Control			37.017445 °	37.017445 °
				-120.434713 °	-120.434713 °
DWR ID	DWR_NA0010_06_f_2017_82				
Comment Code					
A3 : No rodents visible, but rodent burrows visible; need to backfill and compact or grout burrows.					
Inspector Comment

Looking east at the waterside slope.

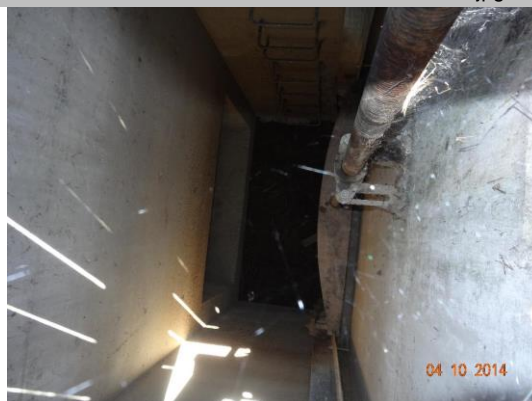
Photo 3 of 3 : UCIP_FA_2018_39481_66629.jpg

Item	DWR UCIP Field Study			36.974509 °	36.974509 °	
				-120.382056 °	-120.382056 °	
DWR ID	19813					
Comment Code						
Inspector Comment						
FS_ID:39481 DS_ID:19813 EP_NO: N/A Repair Type: Non-Urgent Crossing Status: Found UCIP Comments: 04/10/2014 Dense vegetation limits the inspector's visibility to identify signs of pipe failure (leaks) along the slope. Recommend removing vegetation along pipe alignment to conduct proper inspection of structure and appurtenances. High vegetation along crossing alignment--recommend removing vegetation along pipe crossing. (DWR UCIP - O. Magana) FIELD_STRUCT_DESC: [Fresno River Irrigation Structure] 48-inch by 72-inch reinforced concrete box gravity irrigation culvert through the levee, 15.1 feet below the crown. Slide gate in a concrete riser in the waterside (WS) slope. Concrete U-shaped headwall on each end. Landside (LS) channel cobble revetted for 8 feet. [Additional Reference(s): DWR Levee Log, 2002. USACE San Joaquin O&M Manual 601.1, 1967, (HLM 35.33)]. FS Date: 4/10/2014

Inside view of concrete box located on waterward slope.

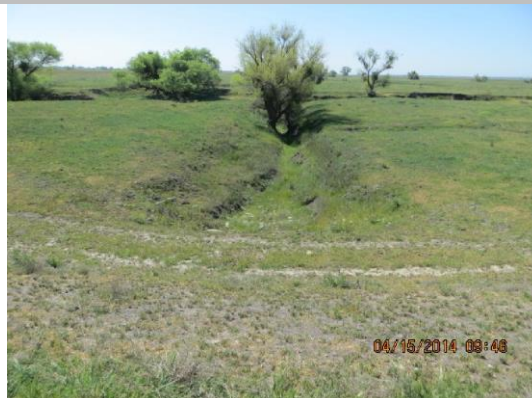
Photo 1 of 3 : UCIP_FA_2018_49966_60954.jpg

Comment Code					
Inspector Comment					
FS_ID:49966					
DS_ID:19892					
EP_NO: N/A					
Repair Type: Non-Urgent					
Crossing Status: Found					
UCIP Comments: 07/20/2016 Inlet blocked off by wooden board. Dense vegetation limits the inspector's visibility to identify signs of pipe failure (leaks) along WS and LS. Crossing downgraded from Urgent to Non-Urgent. (DWR UCIP - omagana)04/15/2014 Flapgate partially blocked by soil buildup at WS toe. (DWR UCIP - W. Wylie)					
FIELD_STRUCT_DESC: 24-inch corrugated metal gravity drainage pipe through the levee, 10.8 feet below the crown. Flap gate on the waterside (WS) end. Concrete headwall on the landside (LS) end. Concrete U-shaped headwall on the WS end. [Additional Reference(s): DWR Levee Log, 2002. USACE San Joaquin O&M Manual 601.1, 1967, (HLM 0.07)].					
FS Date: 7/20/2016

Pipe and headwall at WS toe.

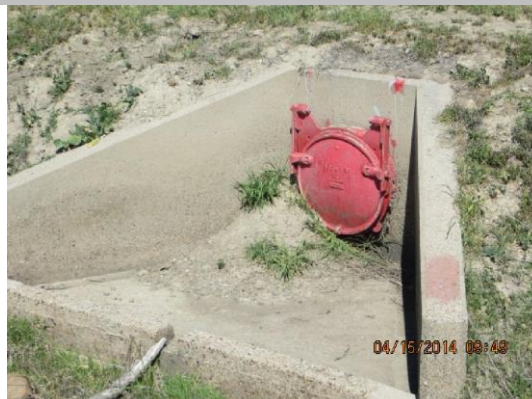
Photo 2 of 3 : UCIP_FA_2018_49966_60955.jpg

Pipe, headwall, and flapgate at WS toe. Soil buildup partially blocking flapgate.

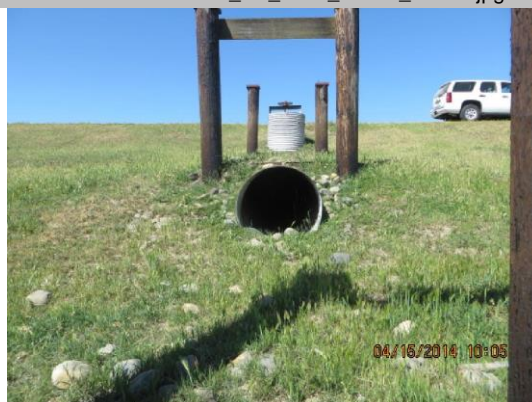
Photo 2 of 3 : UCIP_FA_2018_33713_60965.jpg

Outlet on WS slope.

Comment Code						
Inspector Comment						
FS_ID:33713						
DS_ID:19894						
EP_NO: N/A						
Repair Type: Non-Urgent						
Crossing Status: Found						
UCIP Comments: 04/15/2014 Slide gate not operable, but left in closed position. Need to reinstall covers over slide gate standpipe. (DWR UCIP - W. Wylie)						
FIELD_STRUCT_DESC: 36-inch corrugated metal gravity drainage pipe through the levee, 9.7 feet below the crown. Slide gate in a 48-inch corrugated metal pipe (CMP) riser on the landside (LS) slope. Concrete U-shaped headwall on the LS end. Inlet channel cobble revetted. Dilapidated wooden pier on the waterside (WS). WS slope and outlet ditch cobble revetted. [Additional Reference(s): DWR Levee Log, 2002. USACE San Joaquin O&M Manual 601.1, 1967, (HLM 0.49)].						
FS Date: 4/15/2014

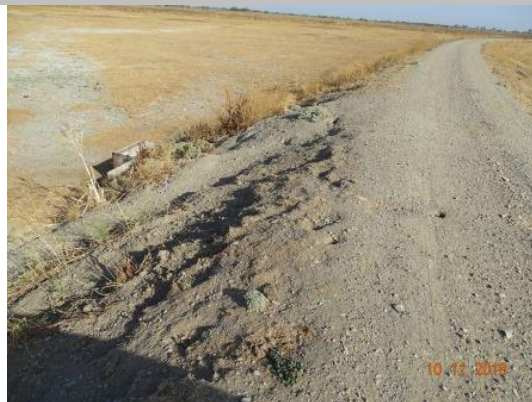
Photo 1 of 2 : FA_2018_NA0010_125_18_20181102_00044.jpg

LM Start	0.53	Rating **	M	Issue No.	18
LM End	0.53	Issue Type +	Ma	Location *	LS
Category	Earthen Levee			GPS Latitude/Longitude	
				Start	End
Item	Slope Stability			37.259097°	37.259097°
				-120.764846°	-120.764846°
DWR ID	DWR_NA0010_07_f_2018_18				
Comment Code					
S2 : Repair the levee slope damaged by foot traffic and prevent access where possible.					
Inspector Comment					
livestock damage to landside slope.

view of damage from livestock looking upstream. (Fall 2018)

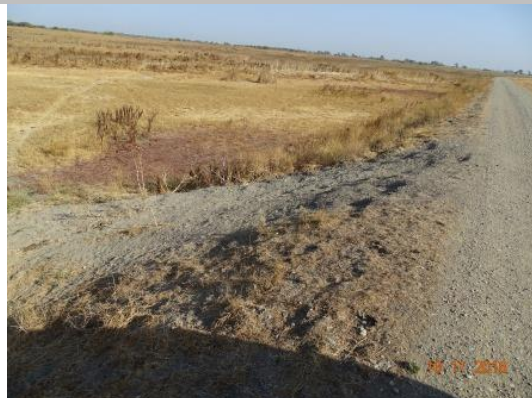
Photo 1 of 1 : FA_2018_NA0010_125_19_20181102_00047.jpg

LM Start	0.70	Rating **	M	Issue No.	19
LM End	0.70	Issue Type +	Ma	Location *	LS
Category	Earthen Levee			GPS Latitude/Longitude	
				Start	End
Item	Slope Stability			37.261337°	37.261337°
				-120.763303°	-120.763303°
DWR ID	DWR_NA0010_07_f_2018_19				
Comment Code					
S2 : Repair the levee slope damaged by foot traffic and prevent access where possible.					
Inspector Comment					
livestock damage to the landside slope

damage to landside slope from livestock. (Fall 2018)

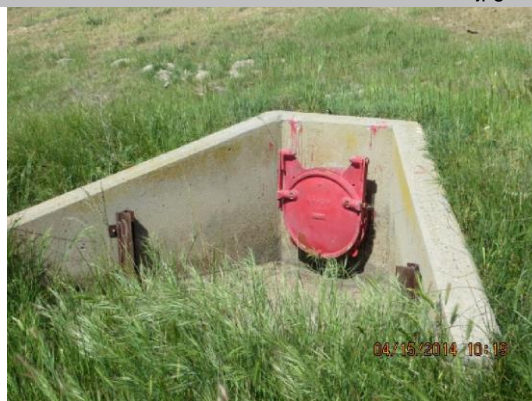
Photo 2 of 3 : UCIP_FA_2018_39507_60988.jpg

Comment Code						
Inspector Comment						
FS_ID:39507						
DS_ID:19896						
EP_NO: N/A						
Repair Type: Non-Urgent						
Crossing Status: Found						
UCIP Comments: 04/15/2014 Need to contact owner. Heavy sediment buildup at inlet due to animal activity should be cleared. (DWR UCIP - W. Wylie)						
FIELD_STRUCT_DESC: 24-inch corrugated metal gravity drainage pipe through the levee, 9.8 feet below the crown. Flap gate on the waterside (WS) end. Wooden weir on concrete headwall at the landside (LS) toe. 36-inch concrete riser at the LS toe. Concrete U-shaped headwall on the WS end. Concrete standpipe on the LS. [Additional Reference(s): DWR Levee Log, 2002. USACE San Joaquin O&M Manual 601.1, 1967, (HLM 0.85)].						
FS Date: 4/15/2014

Headwall and flapgate on WS toe.

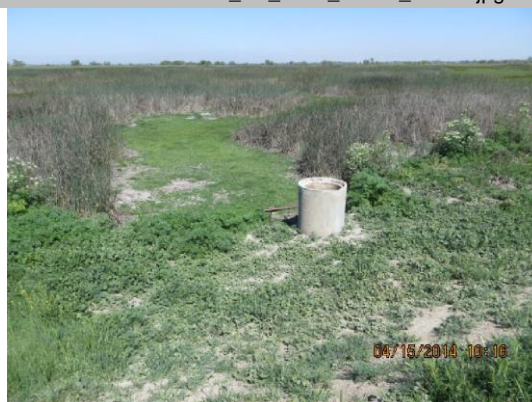
Photo 3 of 3 : UCIP_FA_2018_39507_60987.jpg

Concrete riser, concrete headwall, weir, and pipe at LS toe.

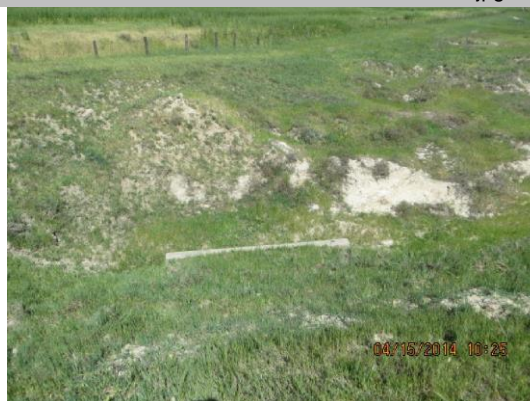
Photo 3 of 3 : UCIP_FA_2018_33725_60992.jpg

LM Start	0.94	Rating **	A/W	Issue No.	35 (cont)	
LM End	0.94	Issue Type +	Ma	Location *		
Category	Supplemental			GPS Latitude/Longitude		
				Start		End
Item	DWR UCIP LMA Responsibility			37.263950 °		37.263950 °
				-120.760572 °		-120.760572 °
DWR ID	19897					
Comment Code						
Inspector Comment						
FS_ID:33725 DS_ID:19897 EP_NO: N/A Repair Type: No Action Needed Crossing Status: Found UCIP Comments: FIELD_STRUCT_DESC: 24-inch corrugated metal gravity drainage pipe through the levee, 11.5 feet below the crown. Flap gate on the waterside (WS) end. Concrete headwall on the landside (LS) end. Concrete U-shaped headwall on the WS end. [Additional Reference(s): DWR Levee Log, 2002. USACE San Joaquin O&M Manual 601.1, 1967, (HLM 0.94)]. FS Date: 4/15/2014

Concrete headwall and pipe on LS toe.

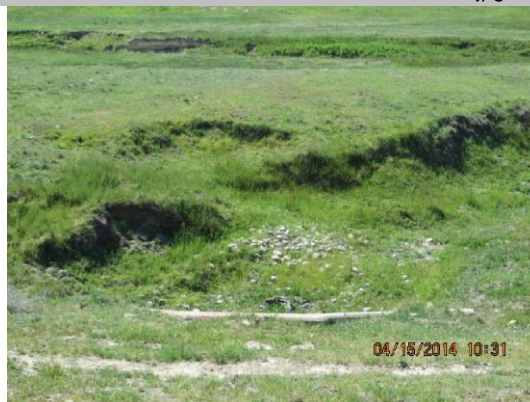
Photo 1 of 3 : UCIP_FA_2018_33726_60996.jpg

LM Start	1.17	Rating **	A/W	Issue No.	36
LM End	1.17	Issue Type +	Ma	Location *	
Category	Supplemental			GPS Latitude/Longitude	
				Start	End
Item	DWR UCIP LMA Responsibility			37.264421 °	37.264421 °
				-120.756683 °	-120.756683 °
DWR ID	19898				
Comment Code					
Inspector Comment					
FS_ID:33726					
DS_ID:19898					
EP_NO: N/A					
Repair Type: No Action Needed					
Crossing Status: Found					
UCIP Comments:					
FIELD_STRUCT_DESC: 48-inch corrugated metal gravity drainage pipe					
through the levee, 14.6 feet below the crown. Flap gate on the					
waterside (WS) end. Concrete U-shaped headwall on each end.					
[Additional Reference(s): DWR Levee Log, 2002. USACE San Joaquin					
O&M Manual 601.1, 1967, (HLM 1.17)].					
FS Date: 4/15/2014

Pipe, flapgate, and headwall on WS toe.

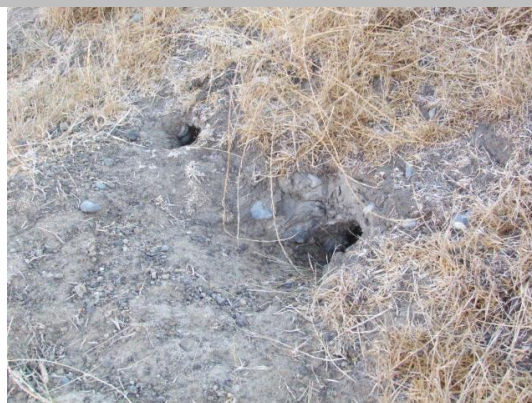
Photo 1 of 2 : FA_2018_NA0010_125_1_20180911_00001.jpg

LM Start	1.22	Rating **	M	Issue No.	1
LM End	1.22	Issue Type +	Ma	Location *	LS
Category	Earthen Levee			GPS Latitude/Longitude	
				Start	End
Item	Animal Control			37.264387°	37.264387°
				-120.755805°	-120.755805°
DWR ID	DWR_NA0010_07_f_2012_1				
Comment Code					
A1 : Exterminate rodents and backfill and compact or grout burrows.					
Inspector Comment

Looking north at several rodent holes on landward slope.

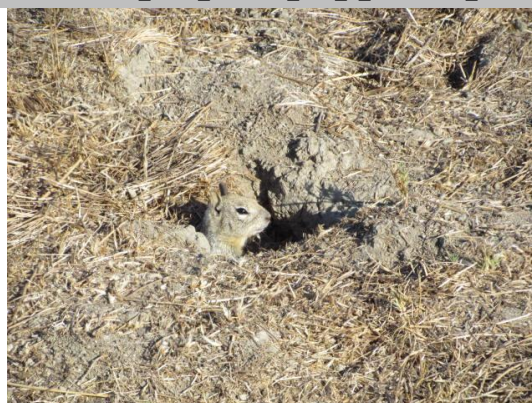
Photo 2 of 2 : FA_2018_NA0010_125_1_20180911_00002.jpg

Looking at east at active rodent holes on landside berm.

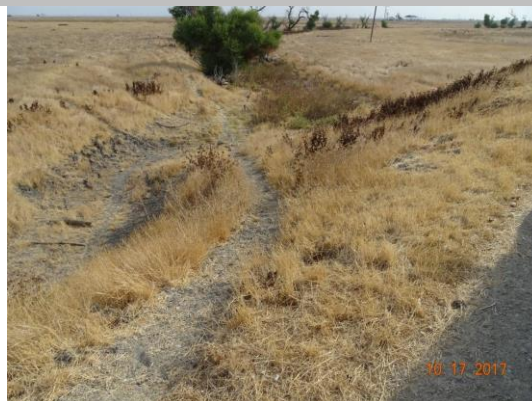
Photo 1 of 1 : FA_2018_NA0010_125_16_20180911_00007.jpg

LM Start	1.49	Rating **	M	Issue No.	16
LM End	1.49	Issue Type +	Ma	Location *	LS
Category	Earthen Levee			GPS Latitude/Longitude	
				Start	End
Item	Slope Stability			37.263999 °	37.263999 °
				-120.750854 °	-120.750854 °
DWR ID	DWR_NA0010_07_f_2017_16				
Comment Code					
S2 : Repair the levee slope damaged by foot traffic and prevent access where possible.					
Inspector Comment					
Repair slope damaged by animal traffic.

Looking east at landside slope.

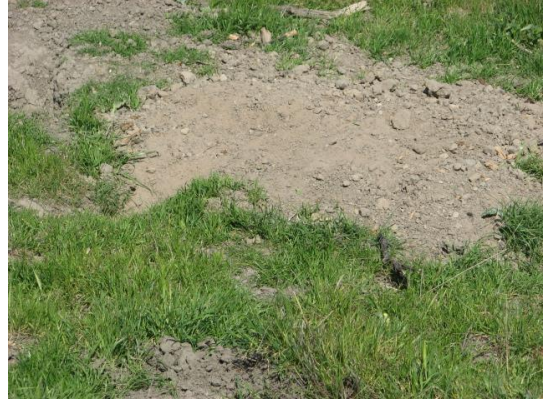
Photo 1 of 2 : FA_2018_NA0010_125_6_20180911_00003.jpg

Looking at typical view of rodent holes within this section. (Spring 2018)

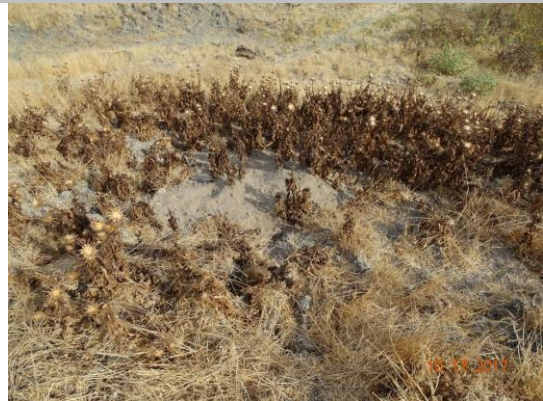
Photo 2 of 2 : FA_2018_NA0010_125_6_20180911_00004.jpg

Looking northwest at landside slope.

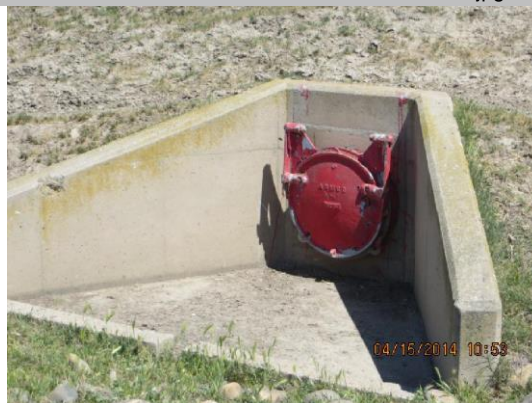
Photo 2 of 3 : UCIP_FA_2018_33728_61008.jpg

Concrete headwall and flapgate at WS toe.

LM Start	2.48	Rating **	A/W	Issue No.	38 (cont)	
LM End	2.48	Issue Type +	Ma	Location *		
Category	Supplemental			GPS Latitude/Longitude		
				Start	End	
Item	DWR UCIP LMA Responsibility			37.255803°	37.255803°	
				-120.737246°	-120.737246°	
DWR ID	19899					
Comment Code						
Inspector Comment						
FS_ID:33728						
DS_ID:19899						
EP_NO: N/A						
Repair Type: No Action Needed						
Crossing Status: Found						
UCIP Comments:						
FIELD_STRUCT_DESC: 24-inch corrugated metal gravity drainage pipe through the levee, 9.5 feet below the crown. Flap gate on the waterside (WS) end. Concrete headwall on the landside (LS) end. Concrete U-shaped headwall on the WS end. [Additional Reference(s): DWR Levee Log, 2002. USACE San Joaquin O&M Manual 601.1, 1967, (HLM 2.48)].						
FS Date: 4/15/2014

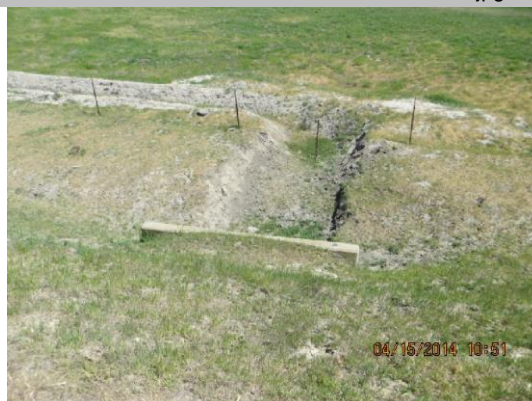
Photo 3 of 3 : UCIP_FA_2018_33728_61007.jpg

Concrete headwall and pipe on LS toe.

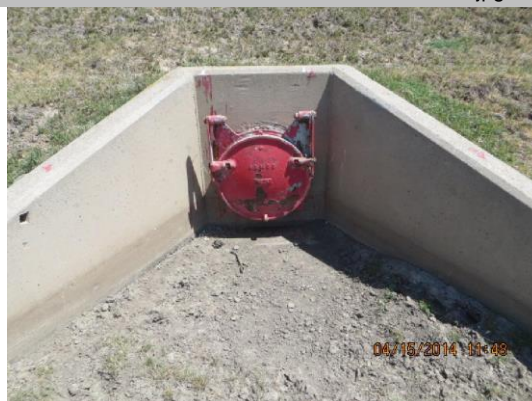
Photo 2 of 3 : UCIP_FA_2018_33729_61010.jpg

Concrete headwall and flapgate on WS toe.

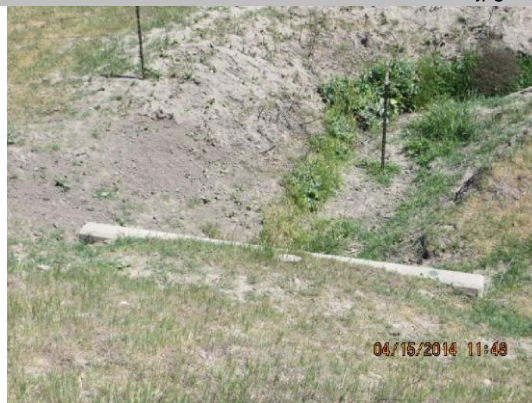
Photo 3 of 3 : UCIP_FA_2018_33729_61012.jpg

Concrete headwall and pipe at LS toe.

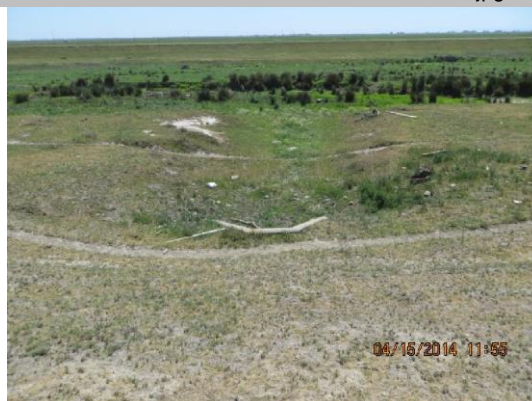
Photo 1 of 3 : UCIP_FA_2018_39508_61016.jpg

Comment Code						
Inspector Comment						
FS_ID:39508						
DS_ID:19901						
EP_NO: N/A						
Repair Type: Non-Urgent						
Crossing Status: Found						
UCIP Comments: 04/15/2014 Some sediment buildup at landward toe and inside pipe--recommend clearing. (DWR UCIP - W. Wylie)						
FIELD_STRUCT_DESC: 24-inch corrugated metal gravity drainage pipe through the levee, 10.4 feet below the crown. Flap gate on the waterside (WS) end. Concrete headwall on the landside (LS) end.						
Concrete U-shaped headwall on the WS end. [Additional Reference(s): DWR Levee Log, 2002. USACE San Joaquin O&M Manual 601.1, 1967, (HLM 3.09)].						
FS Date: 4/15/2014

Headwall, pipe, and flapgate on WS toe.
