**Flood Control Project Maintenance
Levee Inspections**

Fall 2018 Levee Maintenance Deficiency Summary Report

San Joaquin River Basin

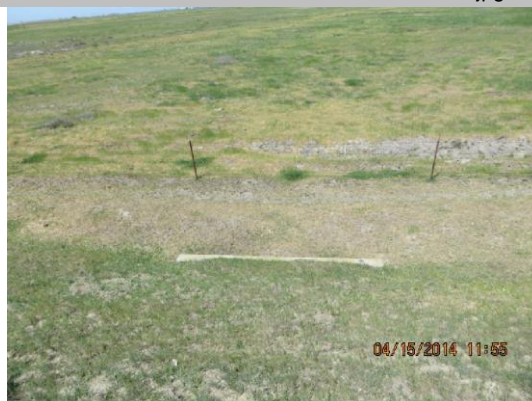
Photo 3 of 3 : UCIP_FA_2018_39508_61017.jpg

Comment Code						
Inspector Comment						
FS_ID:39508						
DS_ID:19901						
EP_NO: N/A						
Repair Type: Non-Urgent						
Crossing Status: Found						
UCIP Comments: 04/15/2014 Some sediment buildup at landward toe and inside pipe--recommend clearing. (DWR UCIP - W. Wylie)						
FIELD_STRUCT_DESC: 24-inch corrugated metal gravity drainage pipe through the levee, 10.4 feet below the crown. Flap gate on the waterside (WS) end. Concrete headwall on the landside (LS) end.						
Concrete U-shaped headwall on the WS end. [Additional Reference(s): DWR Levee Log, 2002. USACE San Joaquin O&M Manual 601.1, 1967, (HLM 3.09)].						
FS Date: 4/15/2014

Headwall and pipe on LS toe.

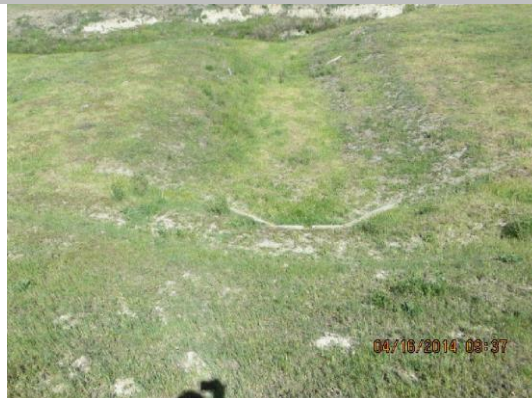
Photo 1 of 3 : UCIP_FA_2018_33751_61068.jpg

LM Start	0.23	Rating **	A/W	Issue No.	23
LM End	0.23	Issue Type +	Ma	Location *	
Category	Supplemental			GPS Latitude/Longitude	
				Start	End
Item	DWR UCIP LMA Responsibility			37.256092 °	37.256092 °
				-120.767873 °	-120.767873 °
DWR ID	19903				
Comment Code					
Inspector Comment					
FS_ID:33751					
DS_ID:19903					
EP_NO: N/A					
Repair Type: No Action Needed					
Crossing Status: Found					
UCIP Comments:					
FIELD_STRUCT_DESC: 24-inch corrugated metal gravity drainage pipe through the levee, 9.6 feet below the crown. Flap gate on the waterside (WS) end. Concrete headwall on the landside (LS) end. Concrete U-shaped headwall on the WS end. [Additional Reference(s): DWR Levee Log, 2002. USACE San Joaquin O&M Manual 601.1, 1967, (HLM 0.23)].					
FS Date: 4/16/2014

Headwall and flapgate on WS toe.

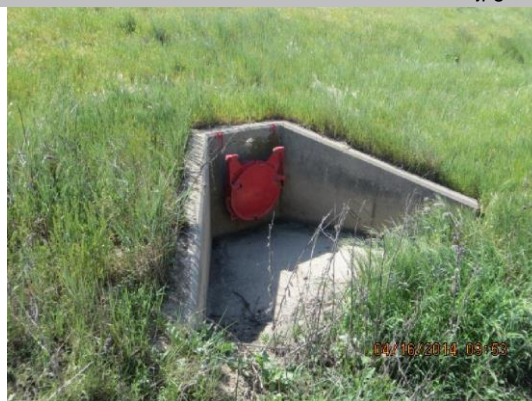
Photo 2 of 3 : UCIP_FA_2018_33753_61080.jpg

LM Start	0.72	Rating **	A/W	Issue No.	25 (cont)	
LM End	0.72	Issue Type +	Ma	Location *		
Category	Supplemental			GPS Latitude/Longitude		
				Start	End	
Item	DWR UCIP LMA Responsibility			37.260306 °	37.260306 °	
				-120.762127 °	-120.762127 °	
DWR ID	19905					
Comment Code						
Inspector Comment						
FS_ID:33753						
DS_ID:19905						
EP_NO: N/A						
Repair Type: No Action Needed						
Crossing Status: Found						
UCIP Comments:						
FIELD_STRUCT_DESC: 24-inch corrugated metal gravity drainage pipe						
through the levee, 10 feet below the crown. Flap gate on the waterside						
(WS) end. Concrete headwall on each end. [Additional Reference(s):						
DWR Levee Log, 2002. USACE San Joaquin O&M Manual 601.1, 1967,						
(HLM 0.72)].						
FS Date: 4/16/2014

Headwall and flapgate at WS toe.

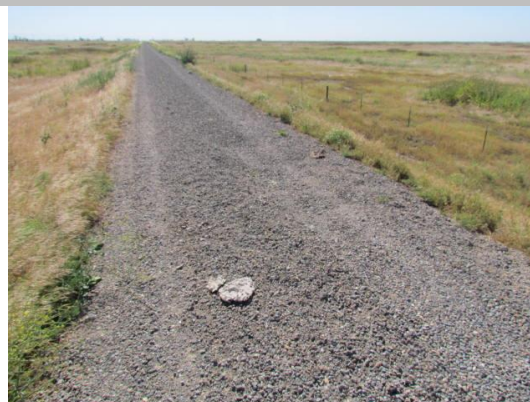
Photo 1 of 1 : FA_2018_NA0010_126_5_20180911_00004.jpg

LM Start	1.16	Rating **	A/W	Issue No.	5
LM End	3.18	Issue Type +	Ma	Location *	CR
Category	Earthen Levee			GPS Latitude/Longitude	
				Start	End
Item	Crown Surface / Depressions / Rutting			37.263243 °	37.251737 °
				-120.756372 °	-120.726246 °
DWR ID	DWR_NA0010_08_s_2016_5				
Comment Code					
C2 : Repair depressions or ruts in the crown or slope.					
Inspector Comment					
Depression noted on levee crown.

Looking west at depression on toward landward shoulder.

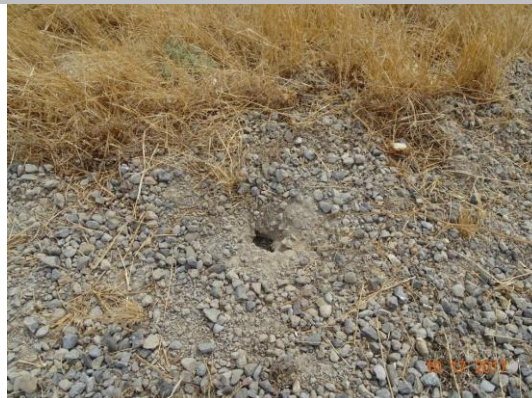
Photo 1 of 1 : FA_2018_NA0010_126_2_20180911_00001.jpg

LM Start	1.20	Rating **	M	Issue No.	2
LM End	1.20	Issue Type +	Ma	Location *	LS
Category	Earthen Levee			GPS Latitude/Longitude	
				Start	End
Item	Animal Control			37.263182°	37.263183°
				-120.755650°	-120.755637°
DWR ID	DWR_NA0010_08_s_2012_2				
Comment Code					
A3 : No rodents visible, but rodent burrows visible; need to backfill and compact or grout burrows.					
Inspector Comment

Looking south at the landside shoulder.

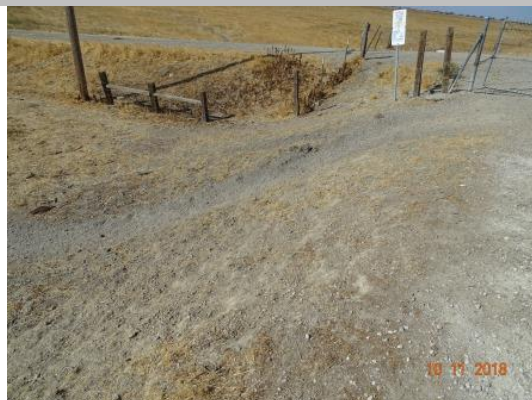
Photo 1 of 1 : FA_2018_NA0010_126_22_20181102_00042.jpg

LM Start	2.07	Rating **	M	Issue No.	22
LM End	2.07	Issue Type +	Ma	Location *	LS
Category	Earthen Levee			GPS Latitude/Longitude	
				Start	End
Item	Slope Stability			37.258076 °	37.258076 °
				-120.742439 °	-120.742439 °
DWR ID	DWR_NA0010_08_f_2018_22				
Comment Code					
Inspector Comment					
damage to slope and shoulder from livestock

slope and shoulder damage from livestock. (Fall 2018)

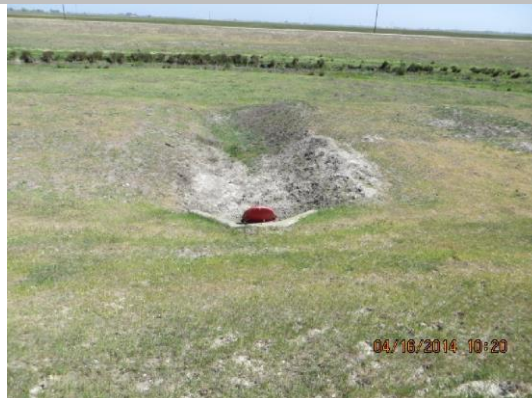
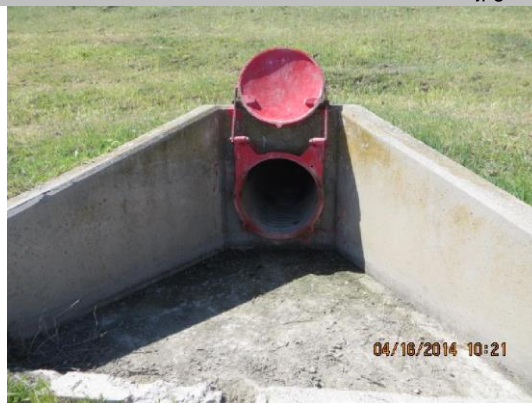
Photo 1 of 3 : UCIP_FA_2018_39512_61102.jpg

LM Start	2.12	Rating **	M	Issue No.	30
LM End	2.12	Issue Type +	Ma	Location *	
Category	Supplemental			GPS Latitude/Longitude	
				Start	End
Item	DWR UCIP LMA Responsibility			37.257800 °	37.257800 °
				-120.741604 °	-120.741604 °
DWR ID	19836				
Comment Code					
Inspector Comment					
FS_ID:39512 DS_ID:19836 EP_NO: N/A Repair Type: Non-Urgent Crossing Status: Found UCIP Comments: 04/16/2014 Sediment buildup in pipe visible from landward side. (DWR UCIP - W. Wylie) FIELD_STRUCT_DESC: 24-inch corrugated metal gravity drainage pipe through the levee, 9.5 feet below the crown. Flap gate on the waterside (WS) end. Concrete headwall on each end. [Additional Reference(s): DWR Levee Log, 2002. USACE San Joaquin O&M Manual 601.1, 1967, (HLM 2.12)]. FS Date: 4/16/2014

Pipe, headwall, and flapgate on WS toe.

Pipe and headwall on LS toe.

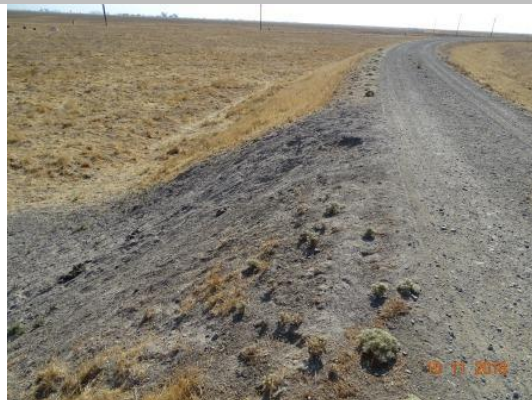
Photo 1 of 1 : FA_2018_NA0010_126_20_20181102_00043.jpg

LM Start	2.74	Rating **	A/W	Issue No.	20
LM End	2.74	Issue Type +	Ma	Location *	LS
Category	Earthen Levee			GPS Latitude/Longitude	
				Start	End
Item	Slope Stability			37.252503°	37.252503°
				-120.733282°	-120.733282°
DWR ID	DWR_NA0010_08_f_2018_20				
Comment Code					
S2 : Repair the levee slope damaged by foot traffic and prevent access where possible.					
Inspector Comment					
minor erosion to slope and shoulder

minor erosion to shoulder and slope from livestock. (Fall 2018)

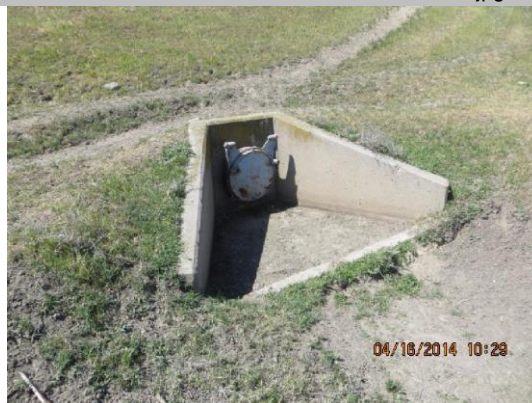
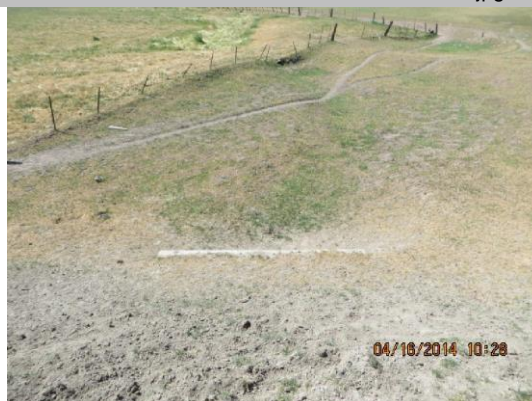
Photo 1 of 3 : UCIP_FA_2018_33760_61107.jpg

LM Start	2.77	Rating **	A/W	Issue No.	31
LM End	2.77	Issue Type +	Ma	Location *	
Category	Supplemental			GPS Latitude/Longitude	
				Start	End
Item	DWR UCIP LMA Responsibility			37.252228 °	37.252228 °
				-120.732890 °	-120.732890 °
DWR ID	19837				
Comment Code					
Inspector Comment					
FS_ID:33760					
DS_ID:19837					
EP_NO: N/A					
Repair Type: No Action Needed					
Crossing Status: Found					
UCIP Comments:					
FIELD_STRUCT_DESC: 24-inch corrugated metal gravity drainage pipe through the levee, 10.5 feet below the crown. Flap gate on the waterside (WS) end. Concrete headwall on each end. [Additional Reference(s): DWR Levee Log, 2002. USACE San Joaquin O&M Manual 601.1, 1967, (HLM 2.77)].					
FS Date: 4/16/2014

Pipe, headwall, and flapgate on Ws toe.

Pipe and headwall on LS toe.

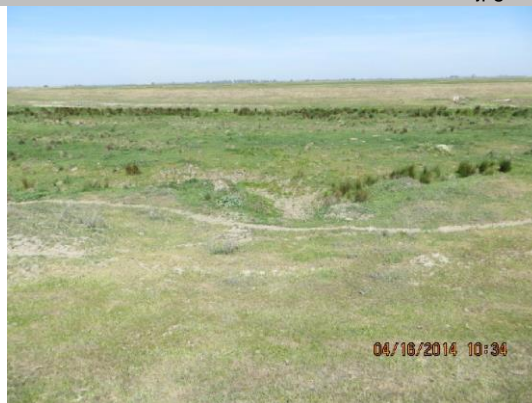
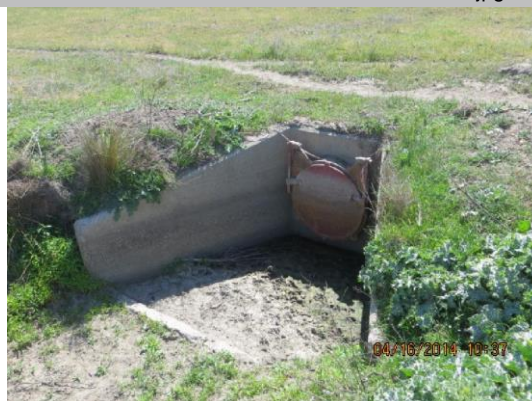
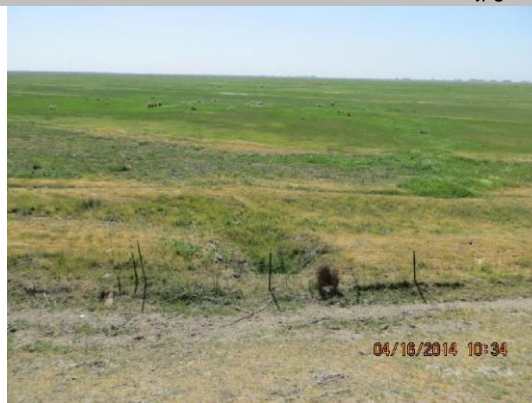
Photo 1 of 3 : UCIP_FA_2018_49969_61112.jpg

Comment Code						
Inspector Comment						
FS_ID:49969 DS_ID:19838 EP_NO: N/A Repair Type: Non-Urgent Crossing Status: Found UCIP Comments: 7/20/2016 LS inlet buried under dense vegetation. Dense vegetation limits the inspector's visibility to identify signs of pipe failure (leaks) along the WS and LS slope. Recommend removing vegetation along pipe alignment to conduct proper inspection of structure and appurtenances. (DWR UCIP - omagana)4/16/2014 Pipe blocked by silt on LS toe. Flapgate rusty and does not operate correctly. (DWR UCIP - wwylie) FIELD_STRUCT_DESC: 36-inch corrugated metal gravity drainage pipe through the levee, 13.4 feet below the crown. Flap gate on the waterside (WS) end. Concrete headwall on each end. [Additional Reference(s): DWR Levee Log, 2002. USACE San Joaquin O&M Manual 601.1, 1967, (HLM 3.06)]. FS Date: 7/20/2016

Pipe, headwall, and flapgate on WS toe.

Pipe and headwall on LS toe.

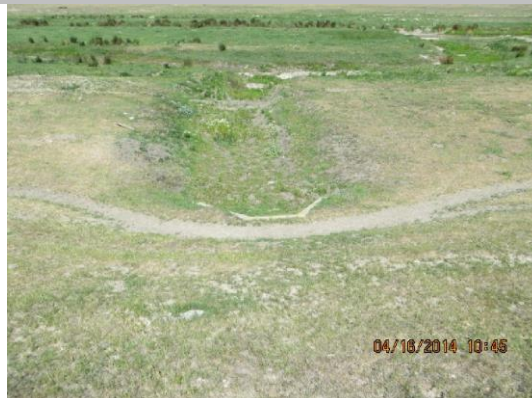
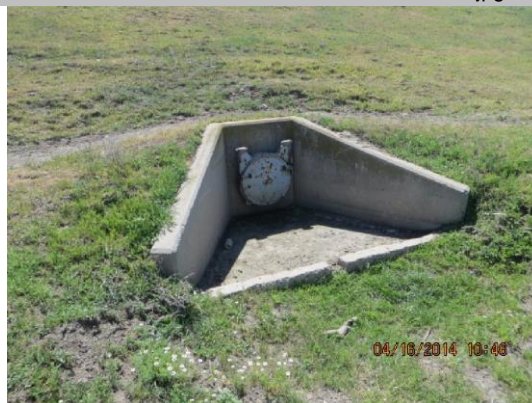
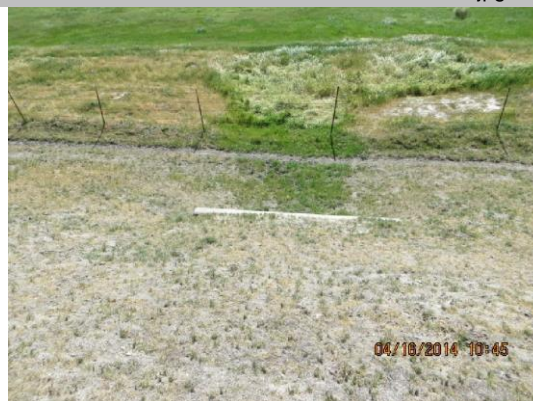
Photo 1 of 3 : UCIP_FA_2018_33764_61128.jpg

LM Start	3.24	Rating **	A/W	Issue No.	33	
LM End	3.24	Issue Type +	Ma	Location *		
Category	Supplemental			GPS Latitude/Longitude		
				Start	End	
Item	DWR UCIP LMA Responsibility			37.252230 °	37.252230 °	
				-120.725504 °	-120.725504 °	
DWR ID	19839					
Comment Code						
Inspector Comment						
FS_ID:33764						
DS_ID:19839						
EP_NO: N/A						
Repair Type: No Action Needed						
Crossing Status: Found						
UCIP Comments:						
FIELD_STRUCT_DESC: 24-inch corrugated metal gravity drainage pipe						
through the levee, 10 feet below the crown. Flap gate on the waterside						
(WS) end. Concrete headwall on each end. [Additional Reference(s):						
DWR Levee Log, 2002. USACE San Joaquin O&M Manual 601.1, 1967,						
(HLM 3.24)].						
FS Date: 4/16/2014

Pipe, flapgate, and headwall on WS toe.

Pipe and headwall on LS toe.

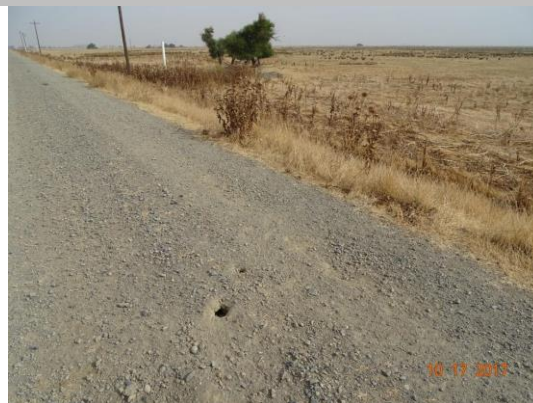
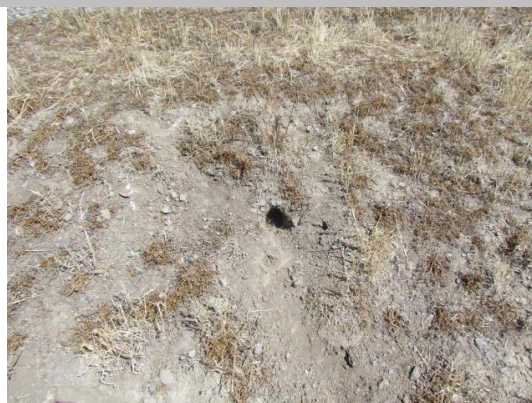
Photo 1 of 2 : FA_2018_NA0010_126_3_20180911_00002.jpg

LM Start	3.40	Rating **	M	Issue No.	3
LM End	3.54	Issue Type +	Ma	Location *	LS
Category	Earthen Levee			GPS Latitude/Longitude	
				Start	End
Item	Animal Control			37.253052 °	37.253600 °
				-120.722647 °	-120.720198 °
DWR ID	DWR_NA0010_08_s_2012_3				
Comment Code					
A3 : No rodents visible, but rodent burrows visible; need to backfill and compact or grout burrows.					
Inspector Comment					
Noted several rodent holes on landside slope within this reach.

Looking east at the crown towards the landside.

Looking at typical view of rodent holes on landward slope.

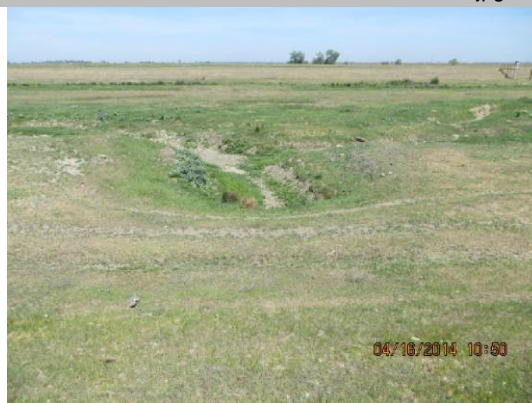
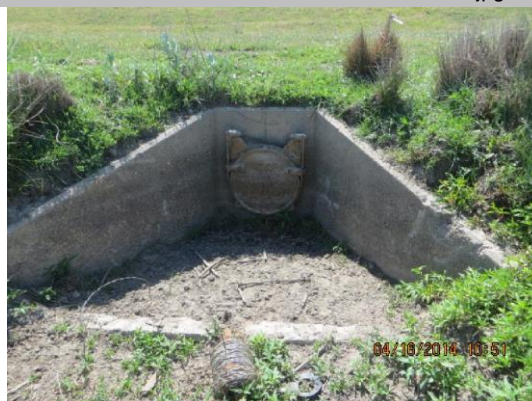
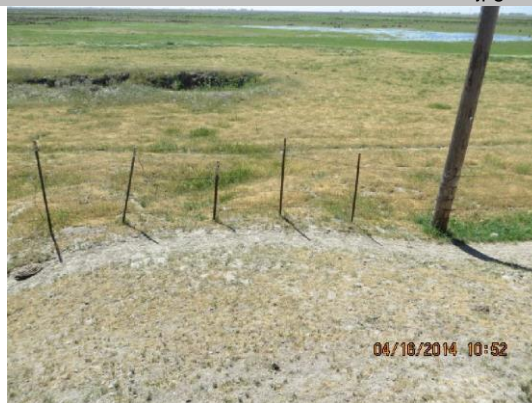
Photo 1 of 3 : UCIP_FA_2018_39513_61134.jpg

LM Start	3.43	Rating **	M	Issue No.	34
LM End	3.43	Issue Type +	Ma	Location *	
Category	Supplemental			GPS Latitude/Longitude	
				Start	End
Item	DWR UCIP LMA Responsibility			37.253151°	37.253151°
				-120.722182°	-120.722182°
DWR ID	19840				
Comment Code					
Inspector Comment					
FS_ID:39513 DS_ID:19840 EP_NO: N/A Repair Type: Non-Urgent Crossing Status: Found UCIP Comments: 04/16/2014 No access available on landward side. Need to confirm status of crossing. (DWR UCIP - W. Wylie) FIELD_STRUCT_DESC: 24-inch corrugated metal gravity drainage pipe through the levee, 13 feet below the crown. Flap gate on the waterside (WS) end. Concrete headwall on each end. [Additional Reference(s): DWR Levee Log, 2002. USACE San Joaquin O&M Manual 601.1, 1967, (HLM 3.43)]. FS Date: 4/16/2014

Pipe, headwall, and flapgate on WS toe.

Pipe likely at drainage swale off LS toe.

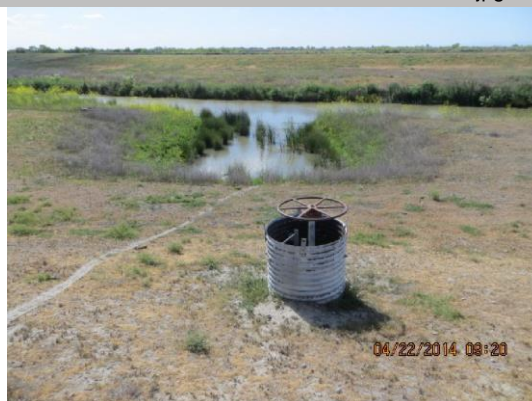
Photo 1 of 3 : UCIP_FA_2018_39888_62119.jpg

Comment Code						
Inspector Comment						
FS_ID:39888						
DS_ID:19841						
EP_NO: N/A						
Repair Type: Non-Urgent						
Crossing Status: Found						
UCIP Comments: 04/22/2014 Concrete headwalls on landward and waterward under water. Need photo to confirm condition of concrete headwalls, pipe, and gate on both toes. (DWR UCIP - W. Wylie)						
FIELD_STRUCT_DESC: 24-inch corrugated metal gravity drainage pipe through the levee, 18.7 feet below the crown. Slide gate in a 36-inch corrugated metal pipe (CMP) riser on the waterside (WS) slope.						
Concrete U-shaped headwall on each end. [Additional Reference(s): DWR Levee Log, 2002. USACE San Joaquin O&M Manual 601.1, 1967, (HLM 0.47)].						
FS Date: 4/22/2014

Slide gate in CMP riser on WS slope with outlet visible in background.

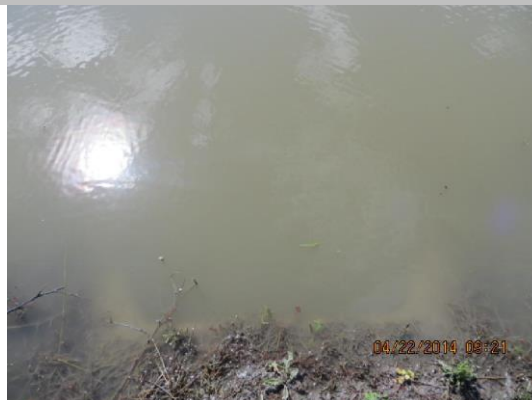
Photo 2 of 3 : UCIP_FA_2018_39888_62117.jpg

Concrete headwall visible under water on WS toe.

Comment Code						
Inspector Comment						
FS_ID:39888						
DS_ID:19841						
EP_NO: N/A						
Repair Type: Non-Urgent						
Crossing Status: Found						
UCIP Comments: 04/22/2014 Concrete headwalls on landward and waterward under water. Need photo to confirm condition of concrete headwalls, pipe, and gate on both toes. (DWR UCIP - W. Wylie)						
FIELD_STRUCT_DESC: 24-inch corrugated metal gravity drainage pipe through the levee, 18.7 feet below the crown. Slide gate in a 36-inch corrugated metal pipe (CMP) riser on the waterside (WS) slope.						
Concrete U-shaped headwall on each end. [Additional Reference(s): DWR Levee Log, 2002. USACE San Joaquin O&M Manual 601.1, 1967, (HLM 0.47)].						
FS Date: 4/22/2014

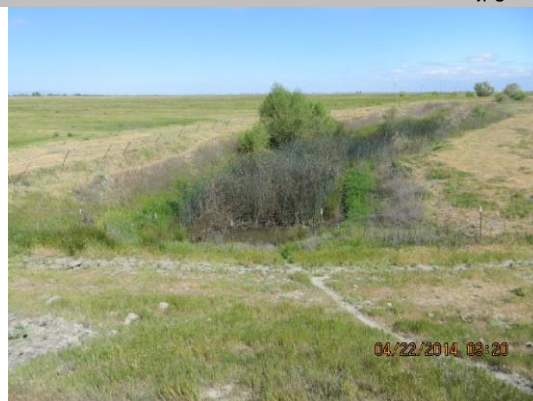
Photo 3 of 3 : UCIP_FA_2018_39888_62118.jpg

Concrete headwall visible at inlet on LS toe.

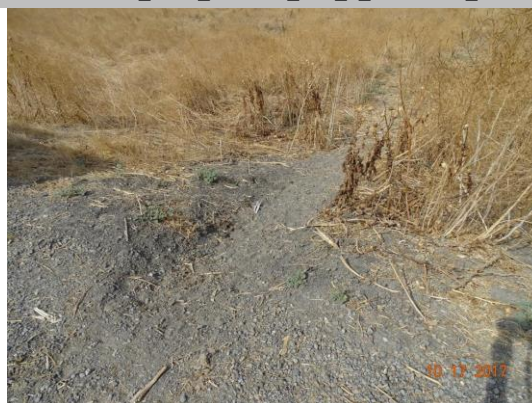
Photo 2 of 2 : FA_2018_NA0010_127_4_20180911_00001.jpg

Looking northwest at landside slope. (Fall 2017)

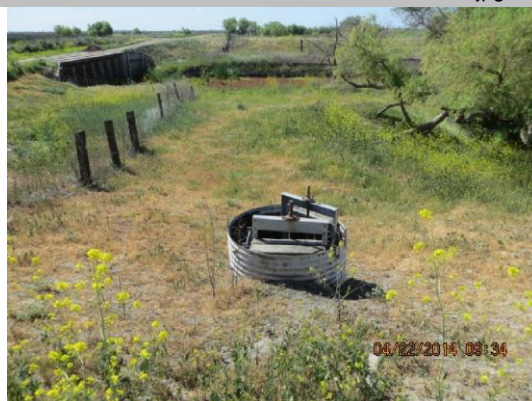
Photo 1 of 3 : UCIP_FA_2018_34186_62134.jpg

LM Start	0.87	Rating **	A/W	Issue No.	7
LM End	0.87	Issue Type +	Ma	Location *	
Category	Supplemental			GPS Latitude/Longitude	
				Start	End
Item	DWR UCIP LMA Responsibility			37.220051°	37.220051°
				-120.698374°	-120.698374°
DWR ID	19843				
Comment Code					
Inspector Comment					
FS_ID:34186 DS_ID:19843 EP_NO: N/A Repair Type: No Action Needed Crossing Status: Found UCIP Comments: FIELD_STRUCT_DESC: [Crane Irrigation Structure] 24-inch corrugated metal gravity drainage pipe through the levee, 9.7 feet below the crown. Two slide gates in a 48-inch corrugated metal pipe (CMP) riser on the waterside (WS) slope. Concrete U-shaped headwall on the landside (LS) end. WS end cobble revetted on the bank and in the outlet drain. [Additional Reference(s): DWR Levee Log, 2002. USACE San Joaquin O&M Manual 601.1, 1967, (HLM 0.87)]. FS Date: 4/22/2014

48-inch CMP riser with slide gates on WS slope.

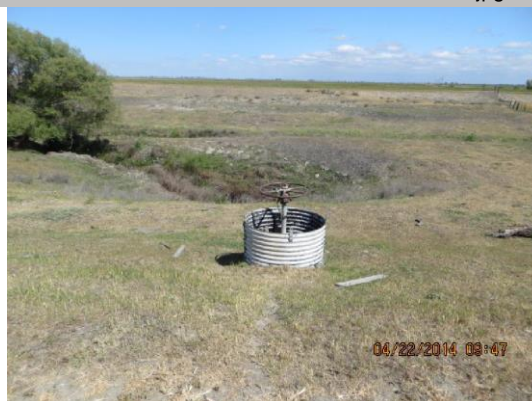
Photo 1 of 3 : UCIP_FA_2018_39516_62144.jpg

LM Start	0.30	Rating **	M	Issue No.	5	
LM End	0.30	Issue Type +	Ma	Location *		
Category	Supplemental			GPS Latitude/Longitude		
				Start	End	
Item	DWR UCIP LMA Responsibility			37.219116 °	37.219116 °	
				-120.706652 °	-120.706652 °	
DWR ID	19845					
Comment Code						
Inspector Comment						
FS_ID:39516 DS_ID:19845 EP_NO: N/A Repair Type: Non-Urgent Crossing Status: Found UCIP Comments: 04/22/2014 Inlet blocked at LS toe by wooden gate. Need to contact owner to determine status. (DWR UCIP - W. Wylie) FIELD_STRUCT_DESC: 36-inch corrugated metal gravity drainage pipe through the levee, 19.6 feet below the crown. Slide gate in a 48-inch corrugated metal pipe (CMP) riser on the waterside (WS) slope. Concrete U-shaped headwall on each end. [Additional Reference(s): DWR Levee Log, 2002. USACE San Joaquin O&M Manual 601.1, 1967, (HLM 0.31)]. FS Date: 4/22/2014

Headwall and pipe visible on LS toe. Slide gate inside 48-inch CMP riser on WS slope.

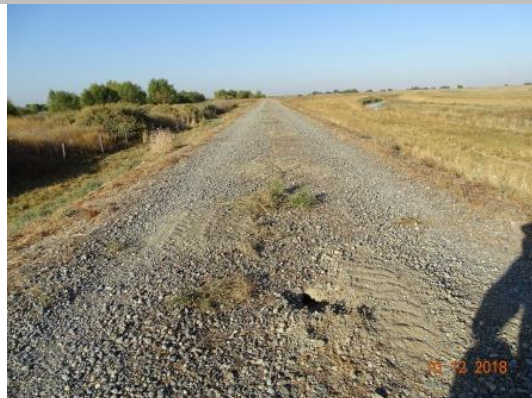
Photo 1 of 1 : FA_2018_NA0010_128_4_20181102_00005.jpg

LM Start	0.74	Rating **	A/W	Issue No.	4
LM End	0.76	Issue Type +	Ma	Location *	CR
Category	Earthen Levee			GPS Latitude/Longitude	
				Start	End
Item	Animal Control			37.219200 °	37.219258 °
				-120.699013 °	-120.698629 °
DWR ID	DWR_NA0010_10_f_2018_4				
Comment Code					
A3 : No rodents visible, but rodent burrows visible; need to backfill and compact or grout burrows.					
Inspector Comment					
rodent holes in crown

View of rodent holes in crown of the levee (Fall 2018)

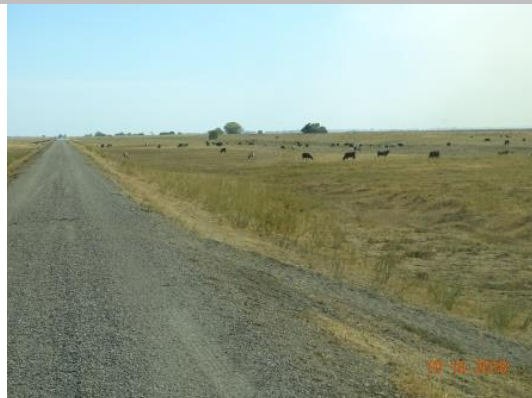
Photo 2 of 2 : FA_2018_NA0010_129_11_20181102_00026.jpg

LM Start	0.21	Rating **	M	Issue No.	11 (cont)	
LM End	0.21	Issue Type +	Ma	Location *	LS	
Category	Earthen Levee			GPS Latitude/Longitude		
				Start		End
Item	Slope Stability			37.202731°		37.202731°
				-120.751389°		-120.751389°
DWR ID	DWR_NA0010_11_f_2018_11					
Comment Code						
S2 : Repair the levee slope damaged by foot traffic and prevent access where possible.						
Inspector Comment						
damage from livestock on land and water side

View of damage on waterside. (Fall 2018)

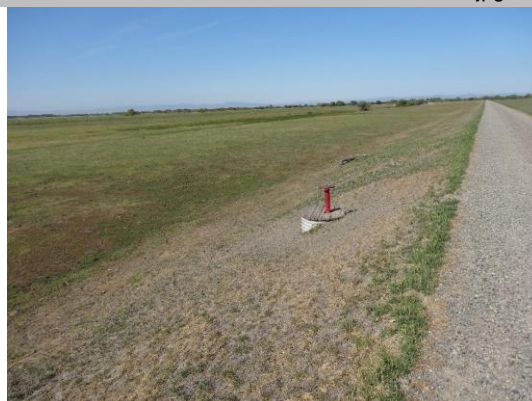
Photo 1 of 3 : UCIP_FA_2018_39517_66644.jpg

LM Start	0.42	Rating **	M	Issue No.	13
LM End	0.42	Issue Type +	Ma	Location *	
Category	Supplemental			GPS Latitude/Longitude	
				Start	End
Item	DWR UCIP LMA Responsibility			37.202754 °	37.202754 °
				-120.747689 °	-120.747689 °
DWR ID	19846				
Comment Code					
Inspector Comment					
FS_ID:39517 DS_ID:19846 EP_NO: N/A Repair Type: Non-Urgent Crossing Status: Found UCIP Comments: 04/18/2014 Need to contact owner. Recommend clearing sediment deposit inside pipe. (DWR UCIP - O. Magana) FIELD_STRUCT_DESC: 24-inch corrugated metal gravity drainage pipe through the levee, 11 feet below the crown. Slide gate in a corrugated metal pipe (CMP) riser on the waterside (WS) end. [Additional Reference(s): DWR Levee Log, 2002. USACE San Joaquin O&M Manual 601.1, 1967, (HLM 0.42)]. FS Date: 4/18/2014

View of slide gate inside CMP riser located on waterward slope.

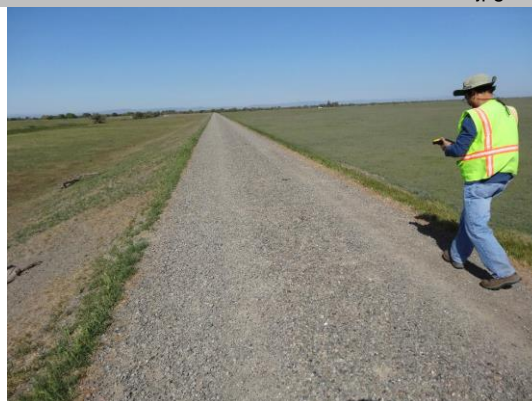
Photo 2 of 3 : UCIP_FA_2018_39517_66643.jpg

View of levee crown at crossing.

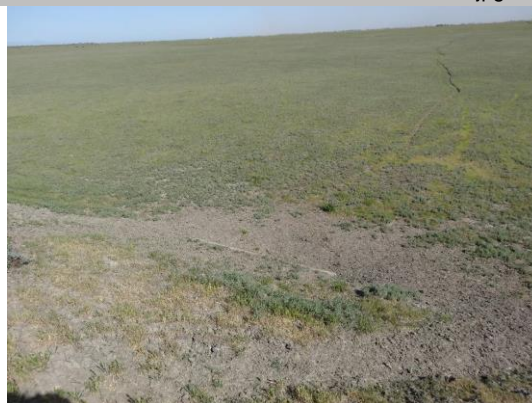
Photo 3 of 3 : UCIP_FA_2018_39517_66642.jpg

View of landward side.

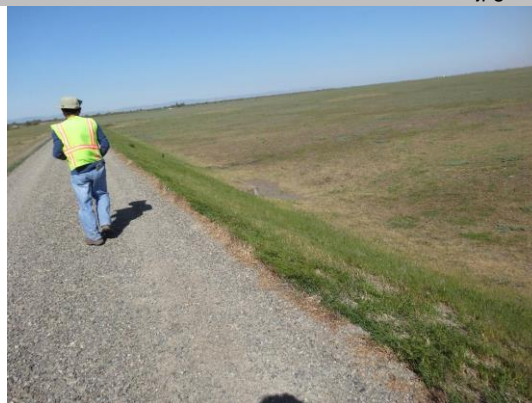
Photo 2 of 3 : UCIP_FA_2018_39518_61996.jpg

View of landward side.

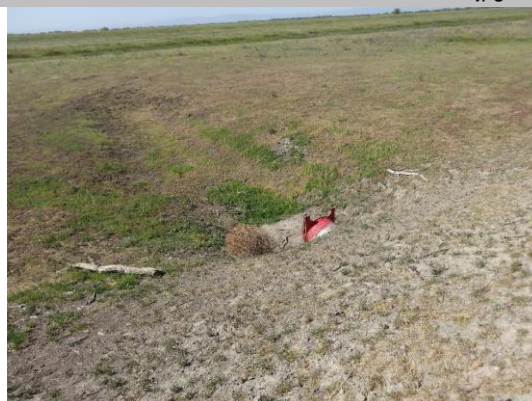
Photo 3 of 3 : UCIP_FA_2018_39518_61999.jpg

LM Start	0.65	Rating **	M	Issue No.	14 (cont)	
LM End	0.65	Issue Type +	Ma	Location *		
Category	Supplemental			GPS Latitude/Longitude		
				Start	End	
Item	DWR UCIP LMA Responsibility			37.202751 °	37.202751 °	
				-120.743474 °	-120.743474 °	
DWR ID	19847					
Comment Code						
Inspector Comment						
FS_ID:39518						
DS_ID:19847						
EP_NO: N/A						
Repair Type: Non-Urgent						
Crossing Status: Found						
UCIP Comments: 04/18/2014 Need to contact owner. Recommend clearing sediment deposit inside pipe. (DWR UCIP - O. Magana)						
FIELD_STRUCT_DESC: 24-inch corrugated metal gravity drainage pipe through the levee, 10 feet below the crown. Flap gate on the waterside (WS) end. [Additional Reference(s): DWR Levee Log, 2002. USACE San Joaquin O&M Manual 601.1, 1967, (HLM 0.65)].						
FS Date: 4/18/2014

Flap gate and concrete apron located on waterward side.

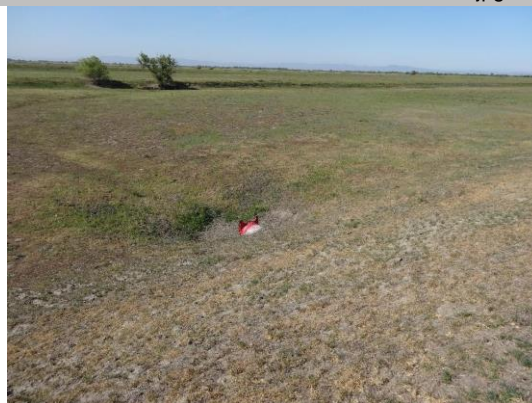
Photo 1 of 3 : UCIP_FA_2018_39519_62003.jpg

LM Start	0.84	Rating **	M	Issue No.	15
LM End	0.84	Issue Type +	Ma	Location *	
Category	Supplemental			GPS Latitude/Longitude	
				Start	End
Item	DWR UCIP LMA Responsibility			37.202745 °	37.202745 °
				-120.739935 °	-120.739935 °
DWR ID	19848				
Comment Code					
Inspector Comment					
FS_ID:39519					
DS_ID:19848					
EP_NO: N/A					
Repair Type: Non-Urgent					
Crossing Status: Found					
UCIP Comments: 04/18/2014 Need to contact owner. Recommend clearing sediment deposit inside pipe. (DWR UCIP - O. Magana)					
FIELD_STRUCT_DESC: 24-inch corrugated metal gravity drainage pipe through the levee, 10.3 feet below the crown. Flap gate on the waterside (WS) end. [Additional Reference(s): DWR Levee Log, 2002. USACE San Joaquin O&M Manual 601.1, 1967, (HLM 0.84)].					
FS Date: 4/18/2014

Overview of waterward side.

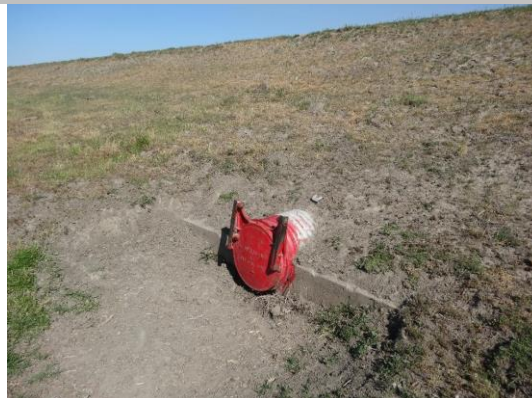
Photo 2 of 3 : UCIP_FA_2018_39519_62002.jpg

FS_ID:39519
DS_ID:19848
EP_NO: N/A
Repair Type: Non-Urgent
Crossing Status: Found
UCIP Comments: 04/18/2014 Need to contact owner. Recommend clearing sediment deposit inside pipe. (DWR UCIP - O. Magana)
FIELD_STRUCT_DESC: 24-inch corrugated metal gravity drainage pipe through the levee, 10.3 feet below the crown. Flap gate on the waterside (WS) end. [Additional Reference(s): DWR Levee Log, 2002. USACE San Joaquin O&M Manual 601.1, 1967, (HLM 0.84)].
FS Date: 4/18/2014

Concrete headwall and flap gate visible on waterward side.

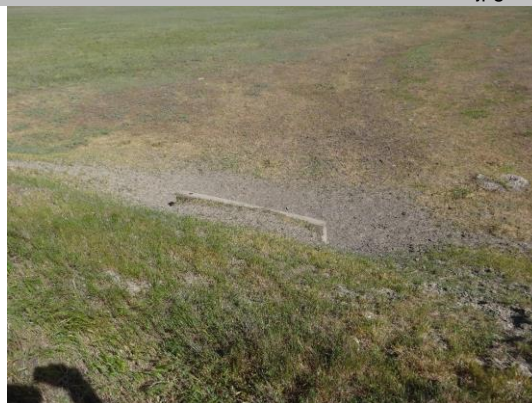
Photo 3 of 3 : UCIP_FA_2018_39519_62001.jpg

View of landward side.

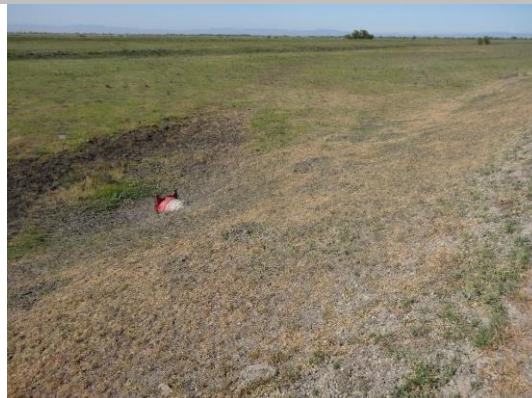
Photo 1 of 3 : UCIP_FA_2018_39520_62008.jpg

LM Start	1.13	Rating **	M	Issue No.	16
LM End	1.13	Issue Type +	Ma	Location *	
Category	Supplemental			GPS Latitude/Longitude	
				Start	End
Item	DWR UCIP LMA Responsibility			37.202748 °	37.202748 °
				-120.734796 °	-120.734796 °
DWR ID	19849				
Comment Code					
Inspector Comment					
FS_ID:39520					
DS_ID:19849					
EP_NO: N/A					
Repair Type: Non-Urgent					
Crossing Status: Found					
UCIP Comments: 04/18/2014 Need to contact owner. Recommend clearing sediment deposit inside pipe. (DWR UCIP - O. Magana)					
FIELD_STRUCT_DESC: 24-inch corrugated metal gravity drainage pipe through the levee, 9 feet below the crown. Flap gate on the waterside (WS) end. [Additional Reference(s): DWR Levee Log, 2002. USACE San Joaquin O&M Manual 601.1, 1967, (HLM 1.13)].					
FS Date: 4/18/2014

View of waterward side--flap gate visible at levee toe.

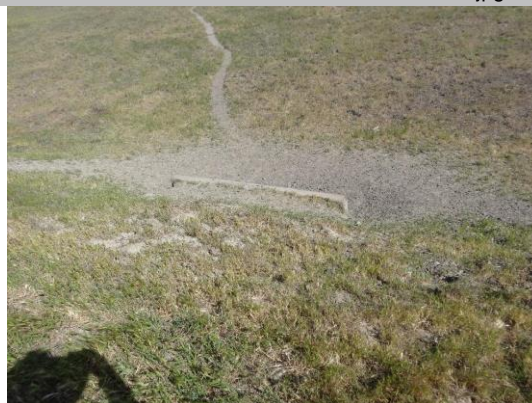
Photo 2 of 3 : UCIP_FA_2018_39520_62007.jpg

View of landward side.

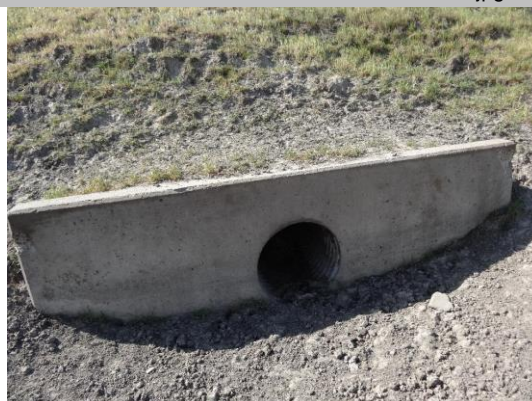
Photo 3 of 3 : UCIP_FA_2018_39520_62006.jpg

LM Start	1.13	Rating **	M	Issue No.	16 (cont)	
LM End	1.13	Issue Type +	Ma	Location *		
Category	Supplemental			GPS Latitude/Longitude		
				Start	End	
Item	DWR UCIP LMA Responsibility			37.202748 °	37.202748 °	
				-120.734796 °	-120.734796 °	
DWR ID	19849					
Comment Code						
Inspector Comment						
FS_ID:39520						
DS_ID:19849						
EP_NO: N/A						
Repair Type: Non-Urgent						
Crossing Status: Found						
UCIP Comments: 04/18/2014 Need to contact owner. Recommend clearing sediment deposit inside pipe. (DWR UCIP - O. Magana)						
FIELD_STRUCT_DESC: 24-inch corrugated metal gravity drainage pipe through the levee, 9 feet below the crown. Flap gate on the waterside (WS) end. [Additional Reference(s): DWR Levee Log, 2002. USACE San Joaquin O&M Manual 601.1, 1967, (HLM 1.13)].						
FS Date: 4/18/2014

Concrete headwall located on landward side.

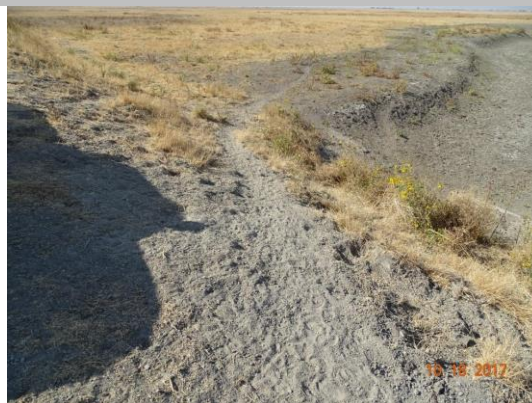
Photo 1 of 1 : FA_2018_NA0010_129_9_20180911_00001.jpg

LM Start	1.49	Rating **	M	Issue No.	9
LM End	1.49	Issue Type +	Ma	Location *	LS
Category	Earthen Levee			GPS Latitude/Longitude	
				Start	End
Item	Slope Stability			37.202748°	37.202748°
				-120.728182°	-120.728182°
DWR ID	DWR_NA0010_11_f_2017_9				
Comment Code					
S2 : Repair the levee slope damaged by foot traffic and prevent access where possible.					
Inspector Comment

Looking northwest at landside slope.

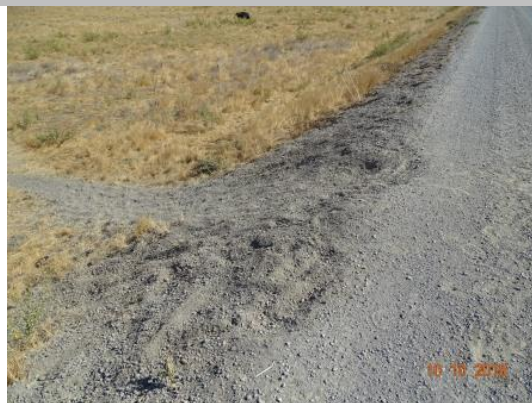
Photo 1 of 2 : FA_2018_NA0010_129_12_20181102_00027.jpg

LM Start	2.46	Rating **	M	Issue No.	12
LM End	2.46	Issue Type +	Ma	Location *	LS
Category	Earthen Levee			GPS Latitude/Longitude	
				Start	End
Item	Slope Stability			37.202712 °	37.202712 °
				-120.710633 °	-120.710633 °
DWR ID	DWR_NA0010_11_f_2018_12				
Comment Code					
S2 : Repair the levee slope damaged by foot traffic and prevent access where possible.					
Inspector Comment					
damage from livestock to both landside and waterside slope

View of landside slope. (Fall 2018)

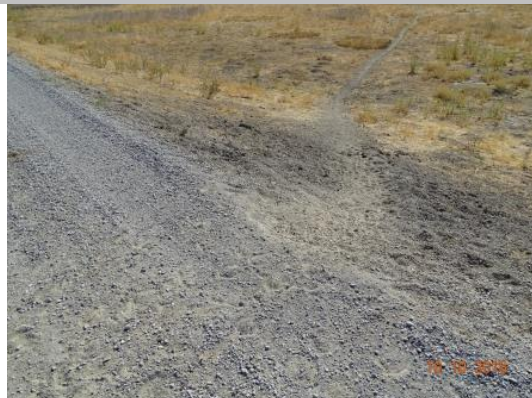
Photo 2 of 2 : FA_2018_NA0010_129_12_20181102_00028.jpg

LM Start	2.46	Rating **	M	Issue No.	12 (cont)	
LM End	2.46	Issue Type +	Ma	Location *	LS	
Category	Earthen Levee			GPS Latitude/Longitude		
				Start		End
Item	Slope Stability			37.202712 °		37.202712 °
				-120.710633 °		-120.710633 °
DWR ID	DWR_NA0010_11_f_2018_12					
Comment Code						
S2 : Repair the levee slope damaged by foot traffic and prevent access where possible.						
Inspector Comment						
damage from livestock to both landside and waterside slope

view of waterside slope. (Fall 2018)

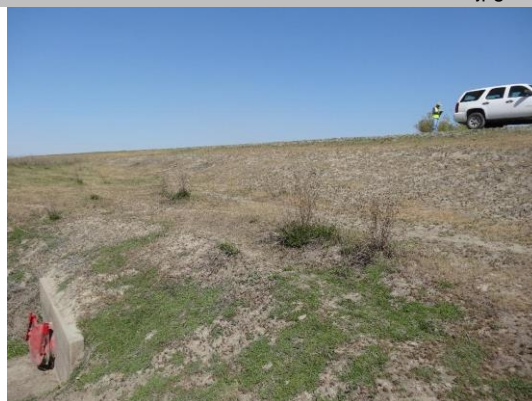
Photo 1 of 3 : UCIP_FA_2018_39523_62028.jpg

LM Start	3.04	Rating **	M	Issue No.	19
LM End	3.04	Issue Type +	Ma	Location *	
Category	Supplemental			GPS Latitude/Longitude	
				Start	End
Item	DWR UCIP LMA Responsibility			37.202494 °	37.202494 °
				-120.700153 °	-120.700153 °
DWR ID	19852				
Comment Code					
Inspector Comment					
FS_ID:39523					
DS_ID:19852					
EP_NO: N/A					
Repair Type: Non-Urgent					
Crossing Status: Found					
UCIP Comments: 04/18/2014 Need to contact owner. Recommend clearing sediment deposit inside pipe. (DWR UCIP - O. Magana)					
FIELD_STRUCT_DESC: 24-inch corrugated metal gravity drainage pipe through the levee, 15 feet below the crown. Flap gate on the waterside (WS) end. [Additional Reference(s): DWR Levee Log, 2002. USACE San Joaquin O&M Manual 601.1, 1967, (HLM 3.04)].					
FS Date: 4/18/2014

Overview of waterward side--flap gate, concrete headwall and apron visible on levee toe.

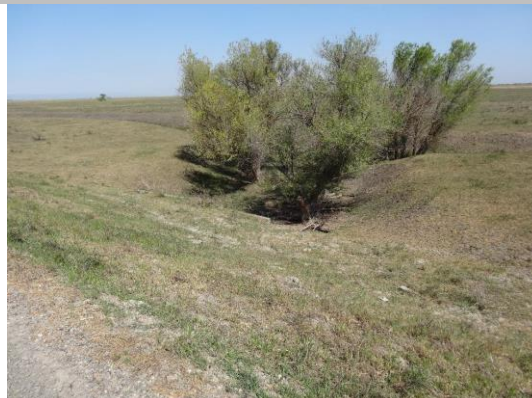
Photo 2 of 3 : UCIP_FA_2018_39523_62027.jpg

View of landward side.

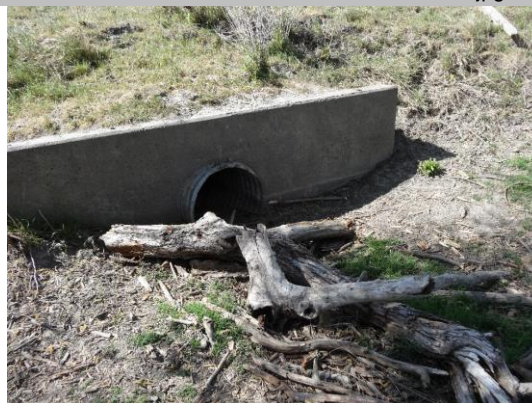
Photo 3 of 3 : UCIP_FA_2018_39523_62030.jpg

Concrete headwall located on landward side--debris in front of headwall.

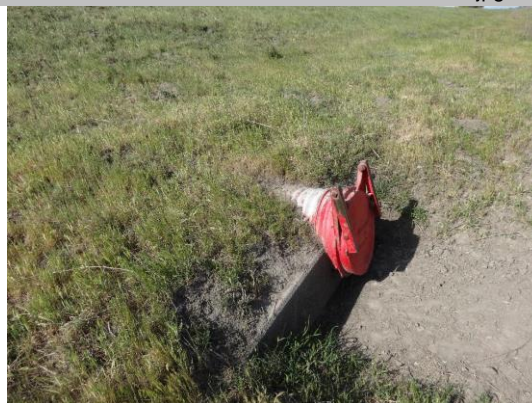
Photo 2 of 3 : UCIP_FA_2018_39889_62049.jpg

Concrete headwall and flap gate visible on waterward side.

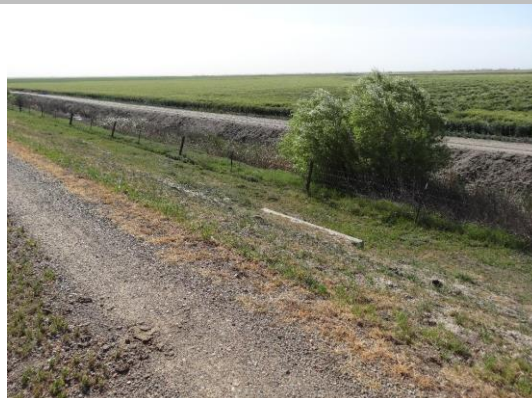
Photo 3 of 3 : UCIP_FA_2018_39889_62047.jpg

LM Start	1.06	Rating **	M	Issue No.	16 (cont)	
LM End	1.06	Issue Type +	Ma	Location *		
Category	Supplemental			GPS Latitude/Longitude		
				Start	End	
Item	DWR UCIP LMA Responsibility			37.200922°	37.200922°	
				-120.736012°	-120.736012°	
DWR ID	19856					
Comment Code						
Inspector Comment						
FS_ID:39889						
DS_ID:19856						
EP_NO: N/A						
Repair Type: Non-Urgent						
Crossing Status: Found						
UCIP Comments: 04/18/2014 Need to contact owner. Recommend clearing sediment deposit inside pipe. (DWR UCIP - O. Magana)						
FIELD_STRUCT_DESC: 24-inch corrugated metal gravity drainage pipe through the levee, 10.5 feet below the crown. Flap gate on the waterside (WS) end. [Additional Reference(s): DWR Levee Log, 2002. USACE San Joaquin O&M Manual 601.1, 1967, (HLM 1.06)].						
FS Date: 4/18/2014

View of landward side.

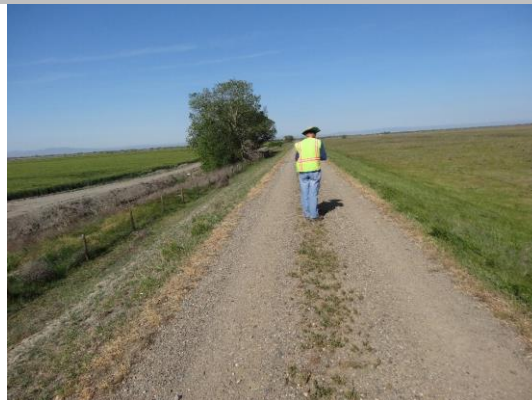
Photo 1 of 3 : UCIP_FA_2018_36705_66654.jpg

Comment Code						
Inspector Comment						
FS_ID:36705						
DS_ID:19857						
EP_NO: N/A						
Repair Type: Non-Urgent						
Crossing Status: Found						
UCIP Comments: 04/18/2014 Landward side not accessible due to dense vegetation and fence. Concrete headwall and flap gate under water therefore not able to evaluate condition. Will need to coordinate with owner to evaluate condition of crossing on waterward side and obtain access to evaluate landward side. (DWR UCIP - O. Magana)						
FIELD_STRUCT_DESC: 24-inch corrugated metal gravity drainage pipe through the levee, 17.4 feet below the crown. Flap gate on the waterside (WS) end. [Additional Reference(s): DWR Levee Log, 2002. USACE San Joaquin O&M Manual 601.1, 1967, (HLM 1.27)].						
FS Date: 4/18/2014

Overview of levee crown at crossing.

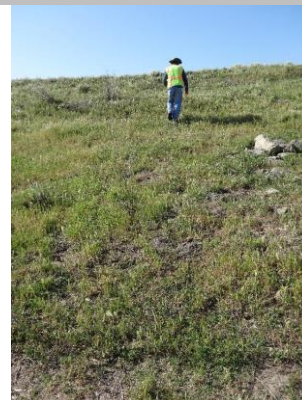
Photo 2 of 3 : UCIP_FA_2018_36705_66652.jpg

View of waterward slope.

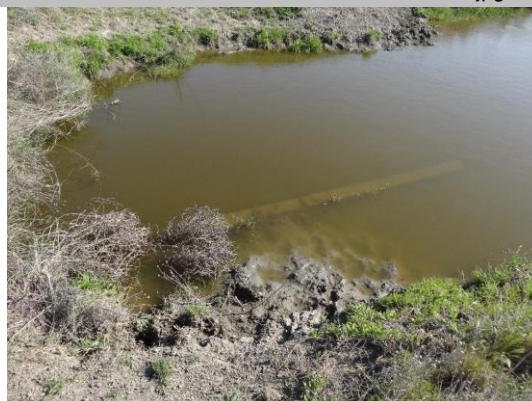
Photo 3 of 3 : UCIP_FA_2018_36705_66653.jpg

Comment Code						
Inspector Comment						
FS_ID:36705						
DS_ID:19857						
EP_NO: N/A						
Repair Type: Non-Urgent						
Crossing Status: Found						
UCIP Comments: 04/18/2014 Landward side not accessible due to dense vegetation and fence. Concrete headwall and flap gate under water therefore not able to evaluate condition. Will need to coordinate with owner to evaluate condition of crossing on waterward side and obtain access to evaluate landward side. (DWR UCIP - O. Magana)						
FIELD_STRUCT_DESC: 24-inch corrugated metal gravity drainage pipe through the levee, 17.4 feet below the crown. Flap gate on the waterside (WS) end. [Additional Reference(s): DWR Levee Log, 2002. USACE San Joaquin O&M Manual 601.1, 1967, (HLM 1.27)].						
FS Date: 4/18/2014

View of concrete wall underwater.

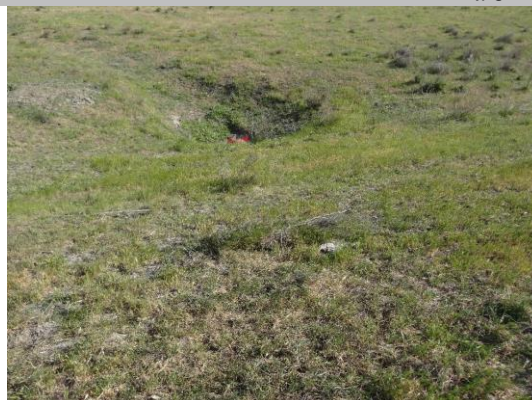
Photo 1 of 3 : UCIP_FA_2018_34126_62060.jpg

LM Start	1.53	Rating **	M	Issue No.	18
LM End	1.53	Issue Type +	Ma	Location *	
Category	Supplemental			GPS Latitude/Longitude	
				Start	End
Item	DWR UCIP LMA Responsibility			37.200913 °	37.200913 °
				-120.727496 °	-120.727496 °
DWR ID	19858				
Comment Code					
Inspector Comment					
FS_ID:34126					
DS_ID:19858					
EP_NO: N/A					
Repair Type: Non-Urgent					
Crossing Status: Found					
UCIP Comments: 04/18/2014 Limited access on landward side due to fence and dense vegetation. Recommend obtaining access to landward side and clear vegetation on landward side. (DWR UCIP - O. Magana)					
FIELD_STRUCT_DESC: 24-inch corrugated metal gravity drainage pipe through the levee, 10.7 feet below the crown. Flap gate on the waterside (WS) end. [Additional Reference(s): DWR Levee Log, 2002. USACE San Joaquin O&M Manual 601.1, 1967, (HLM 1.53)].					
FS Date: 4/18/2014

View of waterward side.

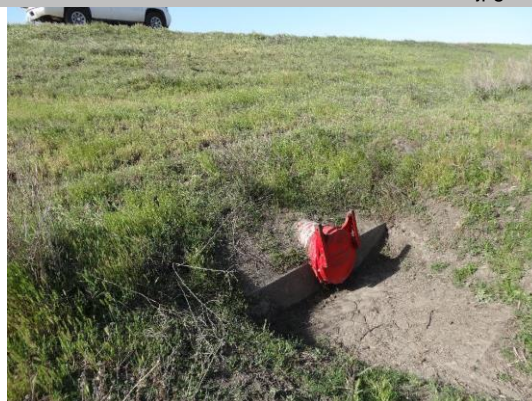
Photo 2 of 3 : UCIP_FA_2018_34126_62061.jpg

Concrete headwall and flap gate visible on waterward side.

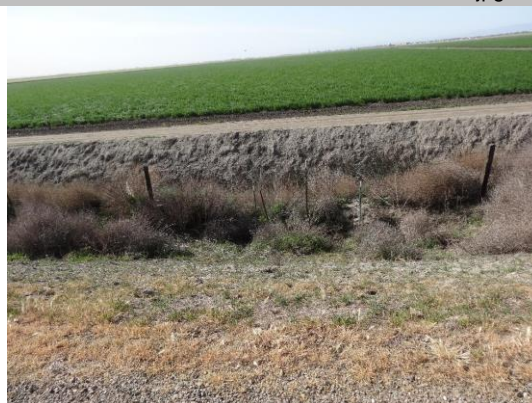
Photo 3 of 3 : UCIP_FA_2018_34126_62059.jpg

View of landward side--limited access due to fence.

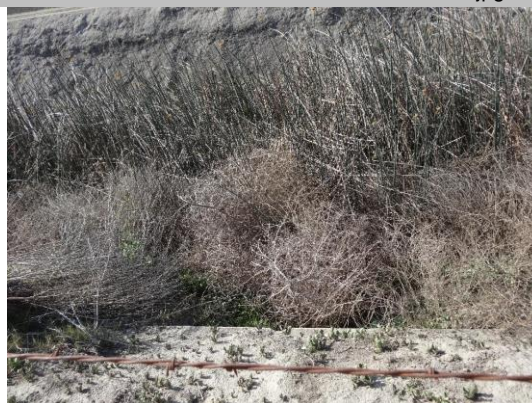
Photo 3 of 3 : UCIP_FA_2018_39506_62062.jpg

Dense vegetation on landward side--limited access due to fence along landward side.

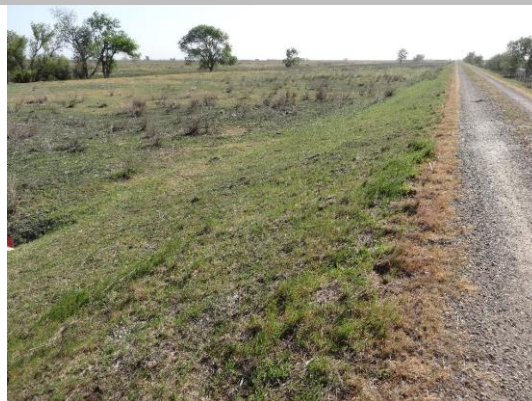
Photo 1 of 3 : UCIP_FA_2018_39890_62069.jpg

LM Start	2.70	Rating **	M	Issue No.	20
LM End	2.70	Issue Type +	Ma	Location *	
Category	Supplemental			GPS Latitude/Longitude	
				Start	End
Item	DWR UCIP LMA Responsibility			37.200906 °	37.200906 °
				-120.706316 °	-120.706316 °
DWR ID	19860				
Comment Code					
Inspector Comment					
FS_ID:39890					
DS_ID:19860					
EP_NO: N/A					
Repair Type: Non-Urgent					
Crossing Status: Found					
UCIP Comments: 04/18/2014 Need to contact owner. Recommend clearing sediment deposit inside pipe. (DWR UCIP - O. Magana)					
FIELD_STRUCT_DESC: 24-inch corrugated metal gravity drainage pipe through the levee, 10.7 feet below the crown. Flap gate on the waterside (WS) end. [Additional Reference(s): DWR Levee Log, 2002. USACE San Joaquin O&M Manual 601.1, 1967, (HLM 2.70)].					
FS Date: 4/18/2014

View of waterward side.

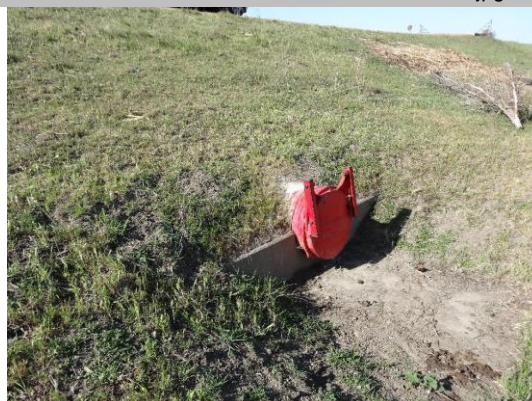
Photo 2 of 3 : UCIP_FA_2018_39890_62070.jpg

Concrete headwall and flat gate located on waterward side.

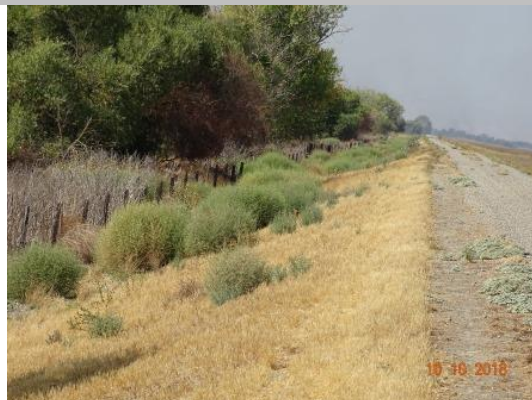
Photo 1 of 1 : FA_2018_NA0010_130_11_20181102_00025.jpg

LM Start	3.00	Rating **	M	Issue No.	11
LM End	3.24	Issue Type +	Ma	Location *	LS
Category	Earthen Levee			GPS Latitude/Longitude	
				Start	End
Item	Vegetation				37.200936 °
					-120.696452 °
DWR ID	DWR_NA0010_12_f_2018_11				
Comment Code					
V1 : Control annual grass and weeds on the levee slopes and easements.					
Inspector Comment					
patches of dense vegetation partially blocking view of levee

View of vegetation on landside slope looking downstream. (Fall 2018)

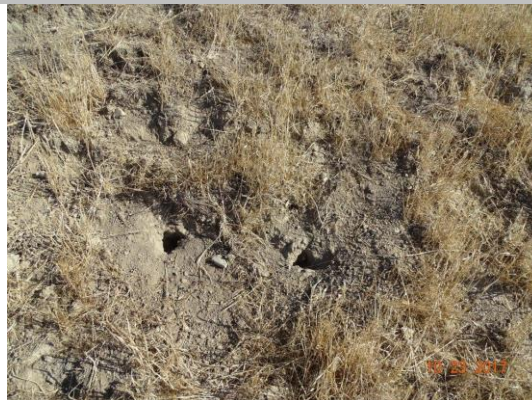
Photo 1 of 1 : FA_2018_NA0010_131_3_20180911_00001.jpg

LM Start	0.15	Rating **	M	Issue No.	3							
LM End	0.15	Issue Type +	Ma	Location *	LS							
Category	Earthen Levee		GPS Latitude/Longitude									
			Start	End								
Item	Animal Control		37.035760 °	37.035760 °								
			-120.441282 °	-120.441282 °								
DWR ID	DWR_NA0010_13_s_2012_3											
Comment Code												
A3 : No rodents visible, but rodent burrows visible; need to backfill and compact or grout burrows.												
Inspector Comment

Looking at the landside slope.

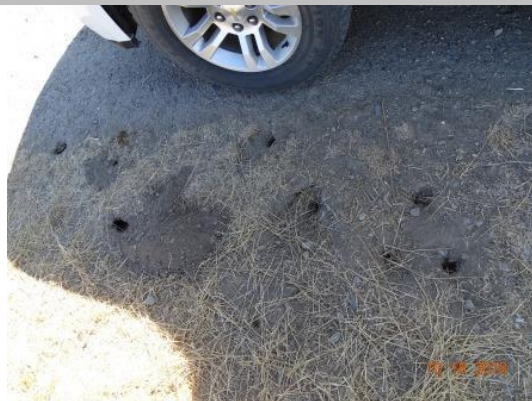
Photo 1 of 1 : FA_2018_NA0010_131_9_20181102_00018.jpg

LM Start	0.90	Rating **	M	Issue No.	9							
LM End	0.90	Issue Type +	Ma	Location *	LS							
Category	Earthen Levee		GPS Latitude/Longitude									
			Start	End								
Item	Animal Control		37.044778 °	37.044778 °								
			-120.434198 °	-120.434198 °								
DWR ID	DWR_NA0010_13_f_2018_9											
Comment Code												
A3 : No rodents visible, but rodent burrows visible; need to backfill and compact or grout burrows.												
Inspector Comment

several rodent burrows in landside shoulder. (Fall 2018)

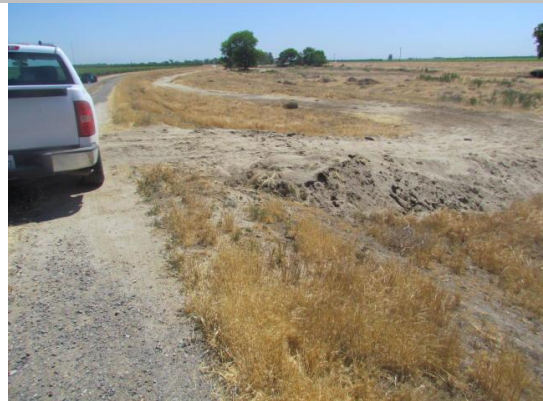
Photo 2 of 3 : FA_2018_NA0010_131_5_20180911_00004.jpg

Looking east at unauthorized ramp on waterward slope.

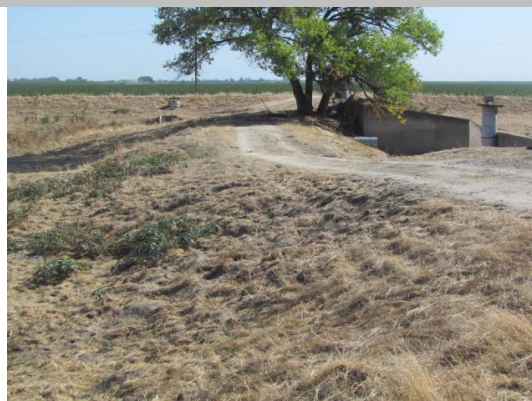
Photo 1 of 6 : FA_2018_NA0010_131_6_20180911_00005.jpg

LM Start	1.14	Rating **	U	Issue No.	6
LM End	1.14	Issue Type +	En	Location *	WS
Category	Earthen Levee			GPS Latitude/Longitude	
				Start	End
Item	Encroachments			37.045541 °	37.045541 °
				-120.430014 °	-120.430014 °
DWR ID	DWR_NA0010_13_f_2015_6				
Comment Code					
WL : Wall					
Inspector Comment					
Sand dam may have been blown out due to high flows in 2017 but has been restored.

Looking overview of sand dam.

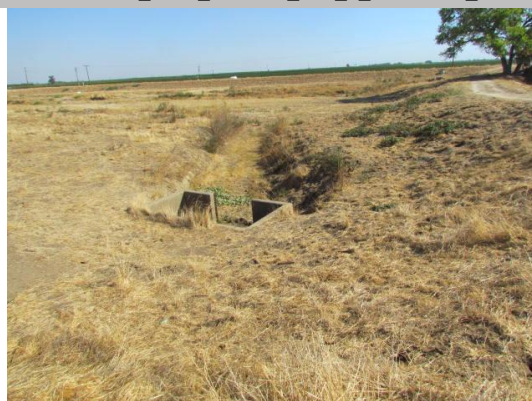
Photo 2 of 6 : FA_2018_NA0010_131_6_20180911_00006.jpg

Looking west at upstream side of sand dam on the southside of the Drop structure.

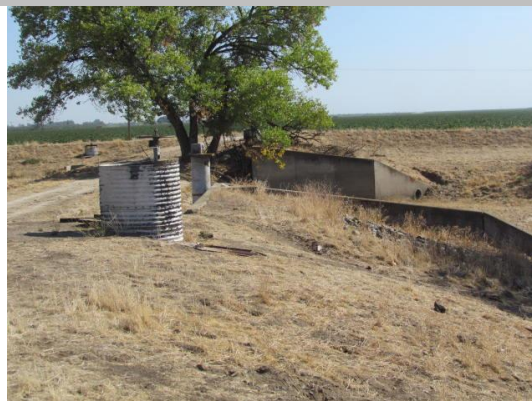
Photo 3 of 6 : FA_2018_NA0010_131_6_20180911_00007.jpg

Looking south at downstream side of structure.
