**Flood Control Project Maintenance
Levee Inspections**

Fall 2018 Levee Maintenance Deficiency Summary Report

San Joaquin River Basin

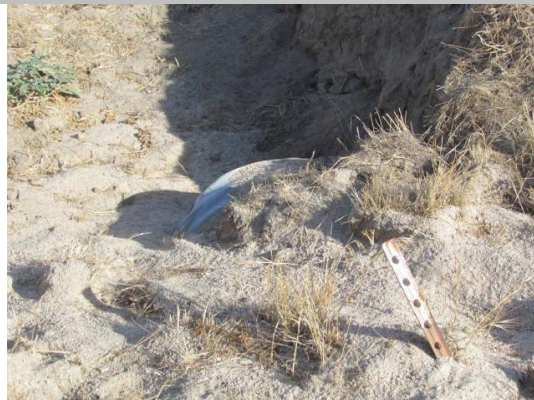
Photo 4 of 6 : FA_2018_NA0010_131_6_20180911_00008.jpg

Looking at corrugated pipe on north end on upstream side of structure.

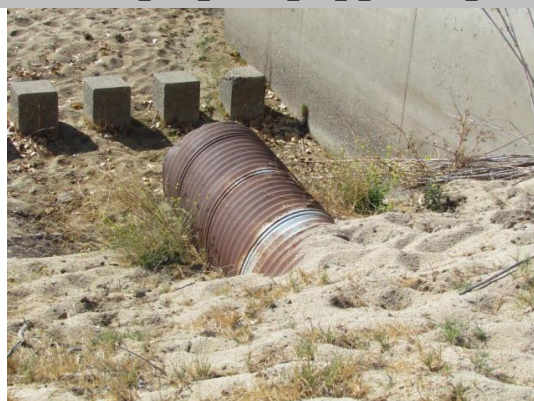
Photo 5 of 6 : FA_2018_NA0010_131_6_20180911_00009.jpg

Looking at corrugated pipe on north end on downstream side of structure.

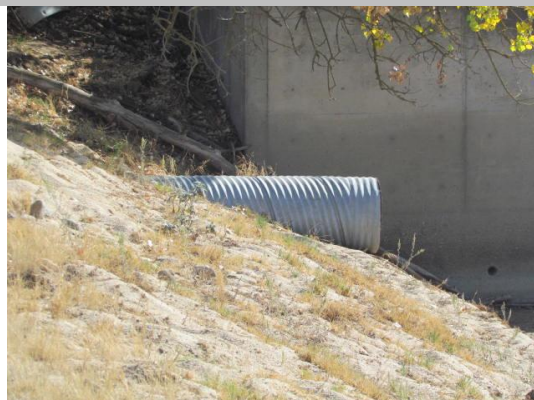
Photo 6 of 6 : FA_2018_NA0010_131_6_20180911_00010.jpg

Looking at corrugated pipe on south end on downstream side of structure.

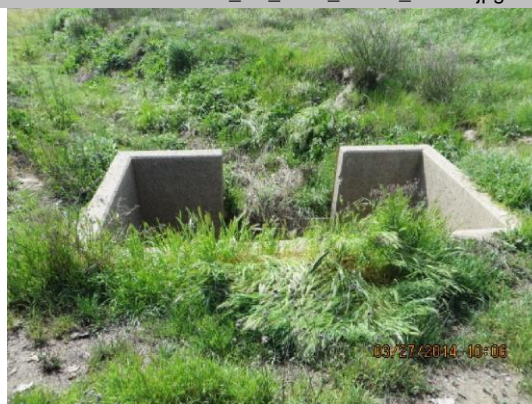
Photo 2 of 3 : UCIP_FA_2018_39877_59384.jpg

Concrete box on WS toe.

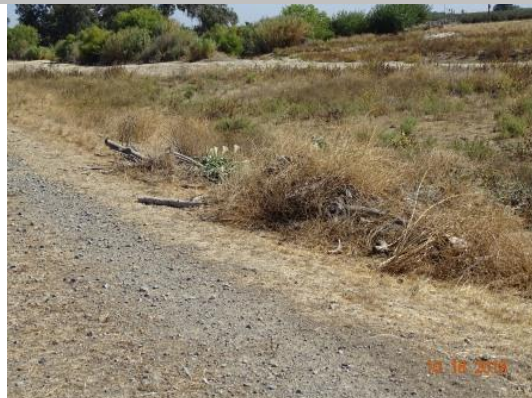
Photo 1 of 1 : FA_2018_NA0010_131_7_20181102_00020.jpg

LM Start	1.15	Rating **	M	Issue No.	7
LM End	1.15	Issue Type +	En	Location *	WS
Category	Earthen Levee			GPS Latitude/Longitude	
				Start	End
Item	Encroachments			37.045925 °	37.045925 °
				-120.429932 °	-120.429932 °
DWR ID	DWR_NA0010_13_f_2017_7				
Comment Code					
PR : Prunings					
Inspector Comment

Prunings left on waterside slope. (Fall 2018)

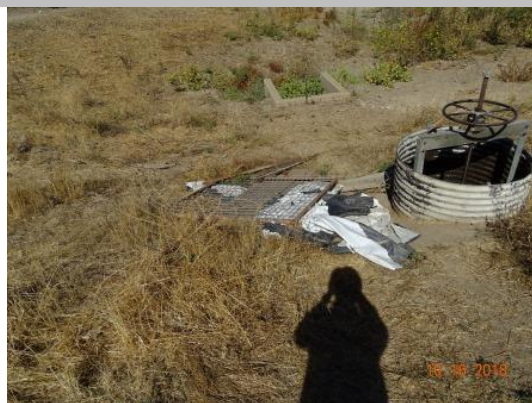
Photo 1 of 1 : FA_2018_NA0010_132_3_20181102_00010.jpg

LM Start	1.15	Rating **	M	Issue No.	3
LM End	1.15	Issue Type +	En	Location *	WS
Category	Earthen Levee			GPS Latitude/Longitude	
				Start	End
Item	Encroachments			37.044943 °	37.044943 °
				-120.429624 °	-120.429624 °
DWR ID	DWR_NA0010_14_f_2018_3				
Comment Code					
GA : Garbage					
Inspector Comment					
Garbage left on waterside slope

View of garbage left on waterside slope. (Fall 2018)

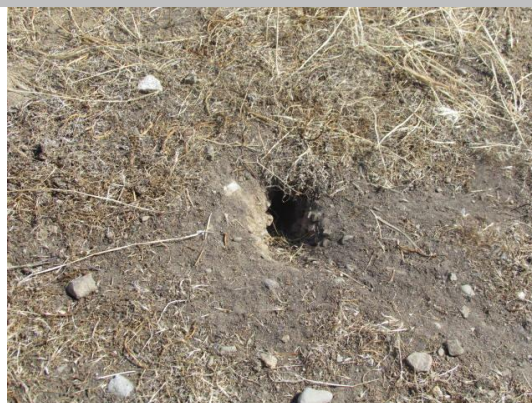
Photo 1 of 1 : FA_2018_NA0010_132_79_20180911_00003.jpg

LM Start	1.24	Rating **	M	Issue No.	79
LM End	1.24	Issue Type +	Ma	Location *	LS
Category	Earthen Levee			GPS Latitude/Longitude	
				Start	End
Item	Animal Control			37.045343 °	37.045343 °
				-120.428007 °	-120.428007 °
DWR ID	DWR_NA0010_14_s_2015_79				
Comment Code					
A3 : No rodents visible, but rodent burrows visible; need to backfill and compact or grout burrows.					
Inspector Comment					
Noted several rodent holes on landside at this location.

Looking at typical view of rodent holes on landward slope.

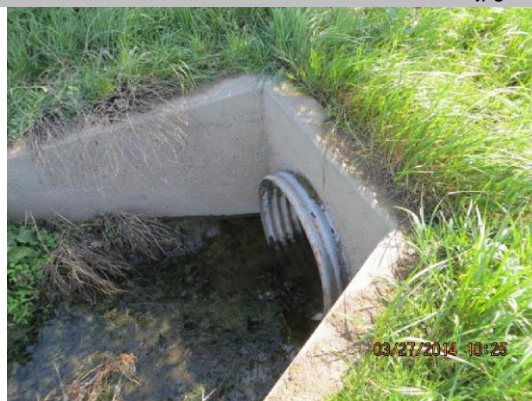
Photo 1 of 3 : UCIP_FA_2018_32828_59402.jpg

Concrete U-shaped headwall on WS toe.

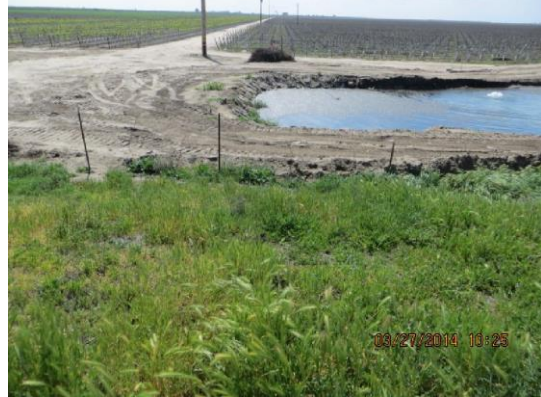
Photo 3 of 3 : UCIP_FA_2018_32828_59400.jpg

Inlet assumed to be within irrigation structure off LS toe.

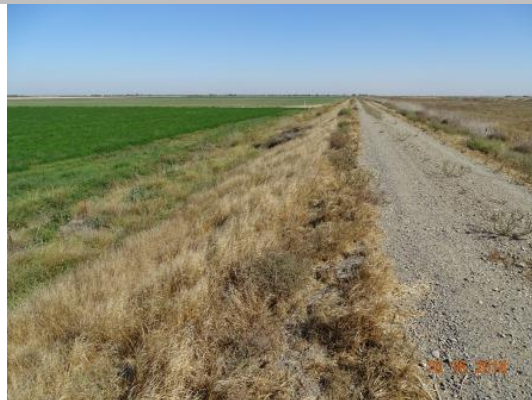
Photo 1 of 1 : FA_2018_NA0010_133_9_20181102_00013.jpg

LM Start	0.15	Rating **	U	Issue No.	9
LM End	2.03	Issue Type +	Ma	Location *	LS
Category	Earthen Levee			GPS Latitude/Longitude	
				Start	End
Item	Vegetation			36.996553 °	36.996588 °
				-120.407748 °	-120.373768 °
DWR ID	DWR_NA0010_15_f_2018_9				
Comment Code					
V1 : Control annual grass and weeds on the levee slopes and easements.					
Inspector Comment

Heavy grass obstructing view of landside slope and toe. (Fall 2018)

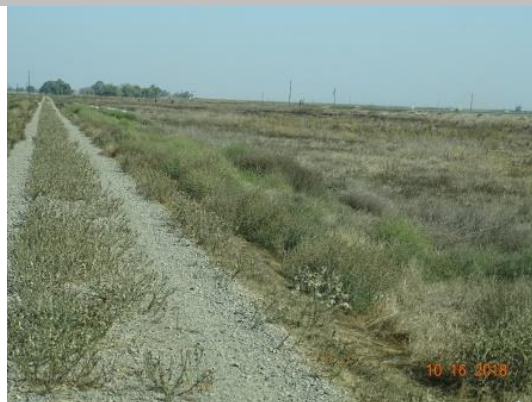
Photo 1 of 1 : FA_2018_NA0010_133_10_20181102_00014.jpg

LM Start	0.82	Rating **	U	Issue No.	10
LM End	2.03	Issue Type +	Ma	Location *	WS
Category	Earthen Levee			GPS Latitude/Longitude	
				Start	End
Item	Vegetation			36.996551 °	36.996587 °
				-120.395523 °	-120.373767 °
DWR ID	DWR_NA0010_15_f_2018_10				
Comment Code					
V1 : Control annual grass and weeds on the levee slopes and easements.					
Inspector Comment					
heavy brush on waterside slope

heavy vegetation on waterside slope. (Fall 2018)

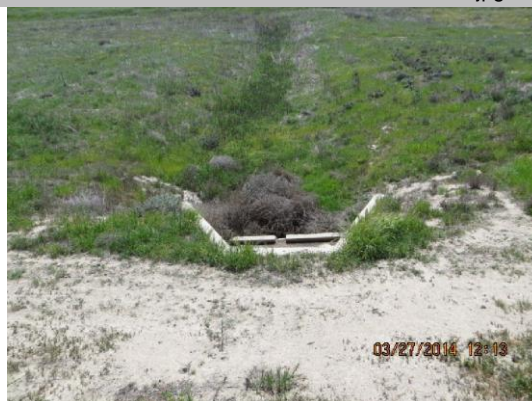
Photo 1 of 3 : UCIP_FA_2018_39527_59452.jpg

Comment Code					
Inspector Comment					
FS_ID:39527					
DS_ID:19912					
EP_NO: N/A					
Repair Type: Non-Urgent					
Crossing Status: Found					
UCIP Comments: 03/27/2014 Dense vegetation limits the inspector's visibility to identify signs of pipe failure (leaks) along the landward slope. Recommend removing vegetation along pipe alignment to conduct proper inspection of structure. (DWR UCIP - W. Wylie)					
FIELD_STRUCT_DESC: 30-inch by 30-inch square reinforced concrete box gravity drainage culvert through the levee, 8.5 feet below the crown. Flap gate on the waterside (WS) end. Concrete headwall on the landside (LS) end. Concrete U-shaped headwall on the WS end.					
[Additional Reference(s): DWR Levee Log, 2002. USACE San Joaquin O&M Manual 601.1, 1967, (HLM 1.01)].					
FS Date: 3/27/2014

Concrete headwall on WS toe.

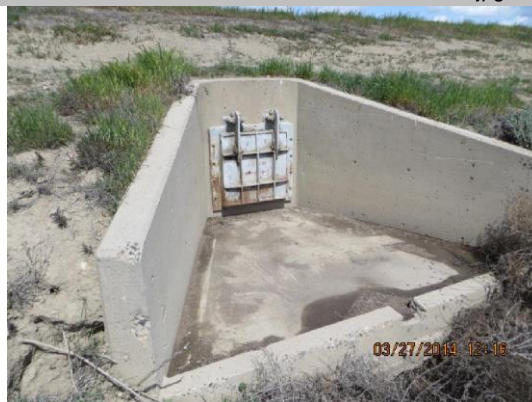
Photo 2 of 3 : UCIP_FA_2018_39527_59453.jpg

Flapgate on concrete headwall at WS toe.

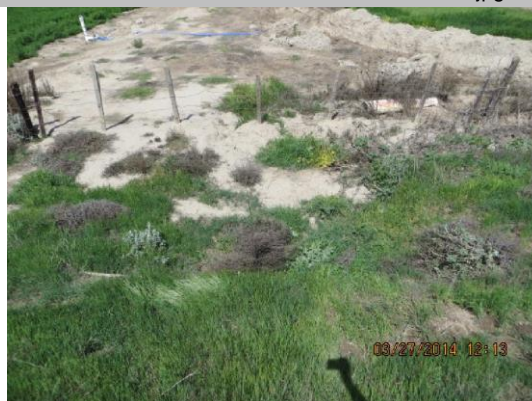
Photo 3 of 3 : UCIP_FA_2018_39527_59451.jpg

Concrete headwall on LS toe.

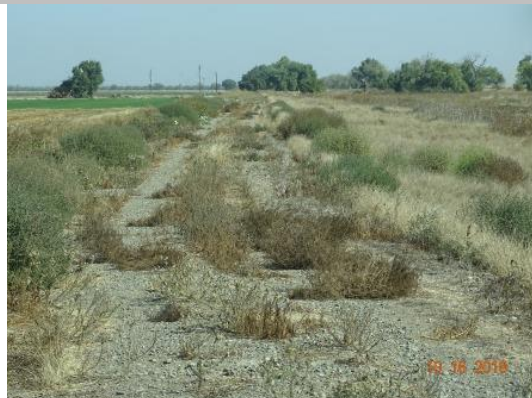
Photo 1 of 1 : FA_2018_NA0010_133_12_20181102_00015.jpg

LM Start	1.51	Rating **	M	Issue No.	12
LM End	2.02	Issue Type +	Ma	Location *	CR
Category	Earthen Levee			GPS Latitude/Longitude	
				Start	End
Item	Vegetation			36.996562 °	36.996586 °
				-120.383121 °	-120.373850 °
DWR ID	DWR_NA0010_15_f_2018_12				
Comment Code					
V9 : Keep the crown roadway free of vegetation.					
Inspector Comment					
vegetation on levee crown should be removed

moderate vegetation on levee crown. (Fall 2018)

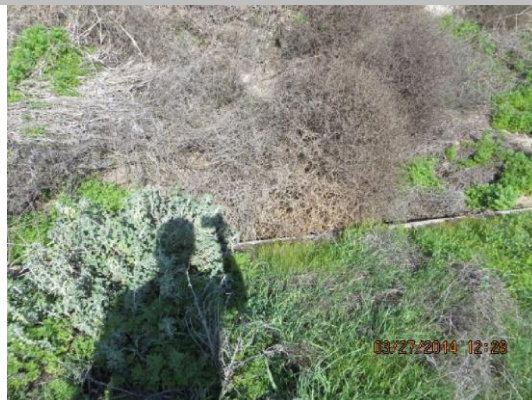
Photo 3 of 3 : UCIP_FA_2018_32840_59455.jpg

Comment Code						
Inspector Comment						
FS_ID:32840						
DS_ID:19913						
EP_NO: N/A						
Repair Type: Non-Urgent						
Crossing Status: Found						
UCIP Comments: 03/27/2014 Excessive vegetation at inlet on LS toe.						
(DWR UCIP - W. Wylie)						
FIELD_STRUCT_DESC: 30-inch by 30-inch square reinforced concrete						
box gravity drainage culvert through the levee, 8.9 feet below the crown.						
Flap gate on the waterside (WS) end. Concrete headwall on the						
landside (LS) end. Concrete U-shaped headwall on the WS end.						
[Additional Reference(s): DWR Levee Log, 2002. USACE San Joaquin						
O&M Manual 601.1, 1967, (HLM 1.53)].						
FS Date: 3/27/2014

Concrete headwall on LS toe. Note excessive vegetation buildup.

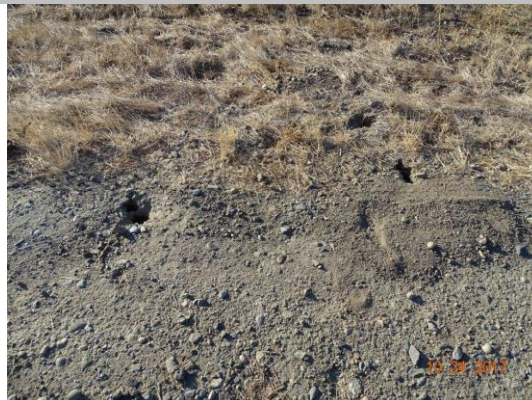
Photo 1 of 1 : FA_2018_NA0010_133_6_20180911_00002.jpg

LM Start	1.58	Rating **	M	Issue No.	6
LM End	2.01	Issue Type +	Ma	Location *	CR
Category	Earthen Levee			GPS Latitude/Longitude	
				Start	End
Item	Animal Control			36.996563 °	36.996578 °
				-120.381895 °	-120.374111 °
DWR ID	DWR_NA0010_15_f_2017_6				
Comment Code					
A3 : No rodents visible, but rodent burrows visible; need to backfill and compact or grout burrows.					
Inspector Comment

Representative picture on the crown.

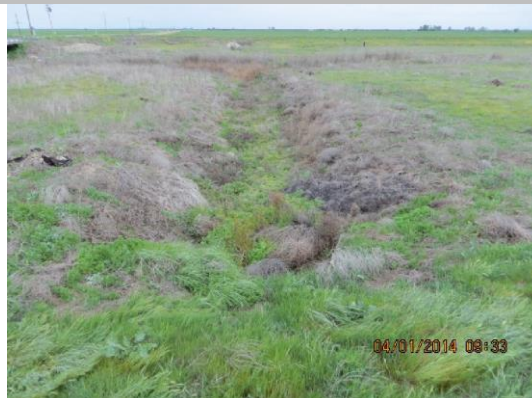
Photo 1 of 3 : UCIP_FA_2018_39529_59681.jpg

Concrete headwall on WS toe with channel.

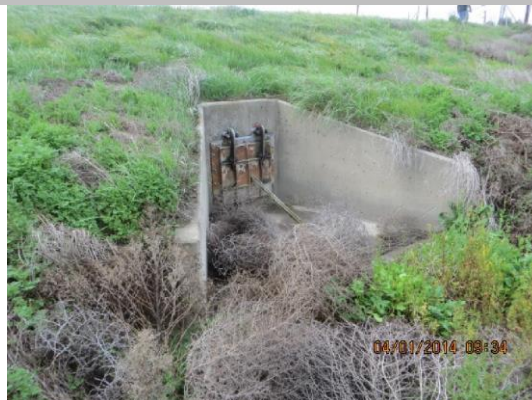
Photo 2 of 3 : UCIP_FA_2018_39529_59680.jpg

Flapgate on headwall at WS toe.

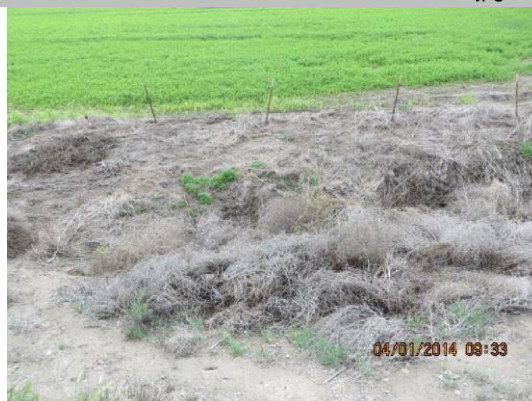
Photo 3 of 3 : UCIP_FA_2018_39529_59682.jpg

Comment Code						
Inspector Comment						
FS_ID:39529						
DS_ID:19915						
EP_NO: N/A						
Repair Type: Non-Urgent						
Crossing Status: Found						
UCIP Comments: 04/01/2014 Dense vegetation buildup at landside toe--recommend clearing. (DWR UCIP - W. Wylie)						
FIELD_STRUCT_DESC: 30-inch by 30-inch square reinforced concrete box gravity drainage culvert through the levee, 8.5 feet below the crown. Two concrete cutoff walls. Flap gate on the waterside (WS) end. Concrete headwall on the landside (LS) end. Concrete U-shaped headwall on the WS end. [Additional Reference(s): DWR Levee Log, 2002. USACE San Joaquin O&M Manual 601.1, 1967, (HLM 1.46)].						
FS Date: 4/1/2014 8:12:00 AM

Concrete headwall on LS toe covered in vegetation/tumble weeds.

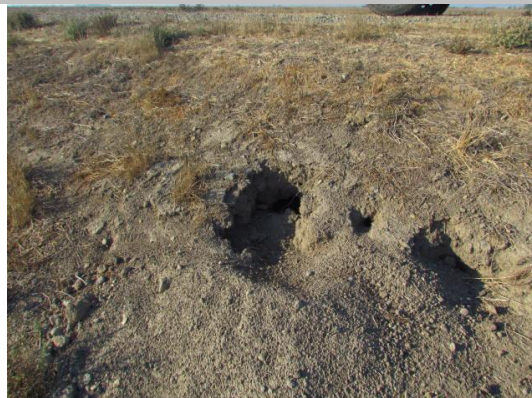
Photo 1 of 2 : FA_2018_NA0010_134_2_20180911_00001.jpg

LM Start	1.77	Rating **	U	Issue No.	2
LM End	1.77	Issue Type +	Ma	Location *	LS
Category	Earthen Levee			GPS Latitude/Longitude	
				Start	End
Item	Animal Control			36.995487°	36.995487°
				-120.377054°	-120.377054°
DWR ID	DWR_NA0010_16_f_2014_2				
Comment Code					
A3 : No rodents visible, but rodent burrows visible; need to backfill and compact or grout burrows.					
Inspector Comment					
Large rodent holes on landside slope.

Looking at large rodent holes on landward slope.

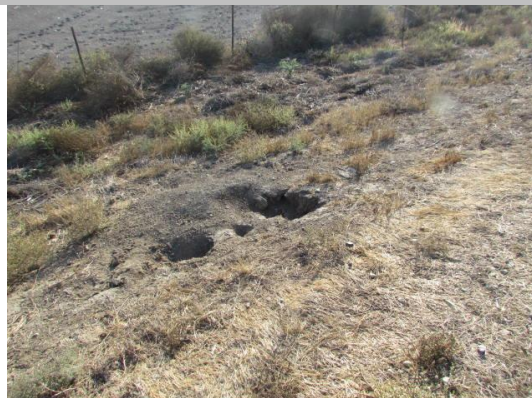
Photo 2 of 2 : FA_2018_NA0010_134_2_20180911_00002.jpg

Looking southwest at several rodent holes on landward slope.

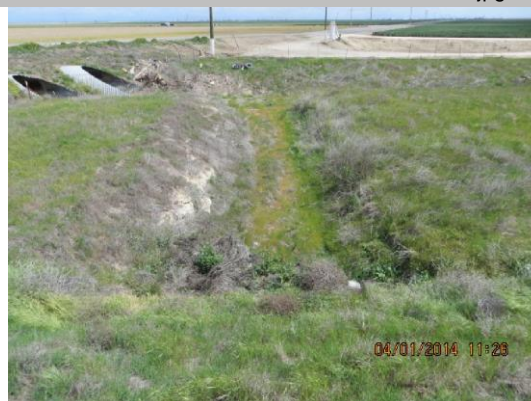
Photo 3 of 3 : UCIP_FA_2018_39531_59709.jpg

Comment Code						
Inspector Comment						
FS_ID:39531 DS_ID:19916 EP_NO: N/A Repair Type: Non-Urgent Crossing Status: Found UCIP Comments: 04/01/2014 Dense vegetation limits the inspector's visibility to identify signs of pipe failure (leaks) along the landward slope. Recommend removing vegetation along pipe alignment to conduct proper inspection of structure. (DWR UCIP - W. Wylie) FIELD_STRUCT_DESC: 48-inch by 60-inch reinforced concrete box gravity drainage culvert through the levee, 14.6 feet below the crown. Flap gate on the waterside (WS) end. Concrete headwall on the landside (LS) end. Concrete U-shaped headwall on the WS end. [Additional Reference(s): DWR Levee Log, 2002. USACE San Joaquin O&M Manual 601.1, 1967, (HLM 2.58)]. FS Date: 4/1/2014

Concrete headwall at LS toe.

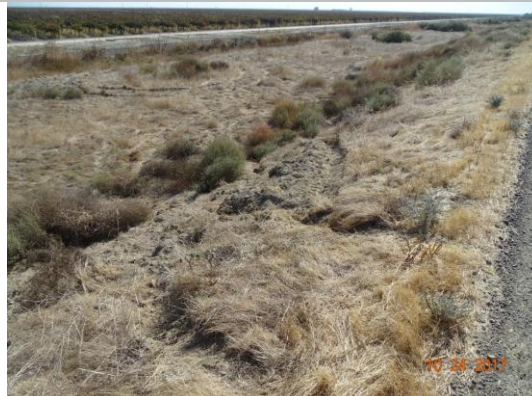
Photo 1 of 1 : FA_2018_NA0010_135_22_20180911_00008.jpg

LM Start	4.74	Rating **	M	Issue No.	22
LM End	4.74	Issue Type +	Ma	Location *	LS
Category	Earthen Levee			GPS Latitude/Longitude	
				Start	End
Item	Slope Stability			36.922526 °	36.922526 °
				-120.336227 °	-120.336227 °
DWR ID	DWR_NA0010_17_f_2017_22				
Comment Code					
S3 : Repair the levee slope damaged by vehicle traffic and prevent access where possible.					
Inspector Comment

Looking southeast at the landside slope.

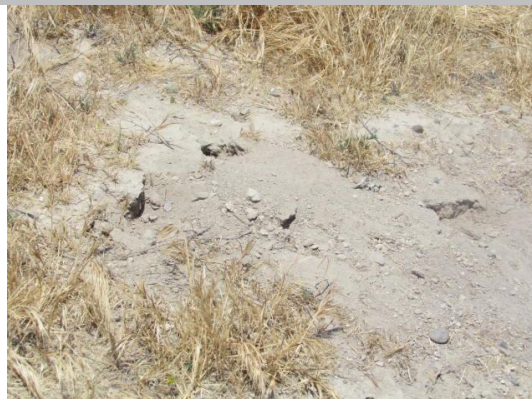
Photo 1 of 2 : FA_2018_NA0010_135_8_20180911_00005.jpg

LM Start	5.75	Rating **	M	Issue No.	8
LM End	5.90	Issue Type +	Ma	Location *	LS
Category	Earthen Levee			GPS Latitude/Longitude	
				Start	End
Item	Animal Control			36.908605 °	36.906507 °
				-120.331112 °	-120.330353 °
DWR ID	DWR_NA0010_17_s_2012_8				
Comment Code					
A1 : Exterminate rodents and backfill and compact or grout burrows.					
Inspector Comment					
Multiple rodent holes noted on landside slope.

Looking at several rodent holes on landward slope. (Spring 2015)

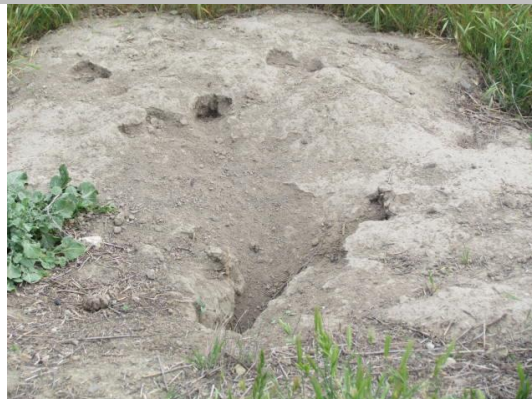
Photo 2 of 2 : FA_2018_NA0010_135_8_20180911_00006.jpg

Looking at several rodent holes on landside slope. (Fall 2014)

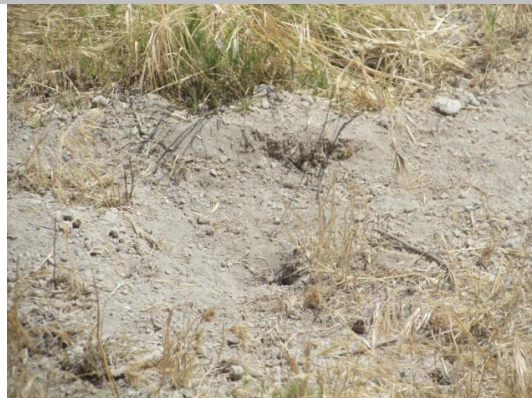
Photo 1 of 1 : FA_2018_NA0010_135_5_20180911_00004.jpg

LM Start	7.27	Rating **	M	Issue No.	5
LM End	7.38	Issue Type +	Ma	Location *	LS
Category	Earthen Levee			GPS Latitude/Longitude	
				Start	End
Item	Animal Control			36.887852 °	36.886388 °
				-120.321668 °	-120.320950 °
DWR ID	DWR_NA0010_17_s_2012_5				
Comment Code					
A3 : No rodents visible, but rodent burrows visible; need to backfill and compact or grout burrows.					
Inspector Comment					
Several rodent holes identified within this reach.

Looking at typical view of rodent holes on landward slope.

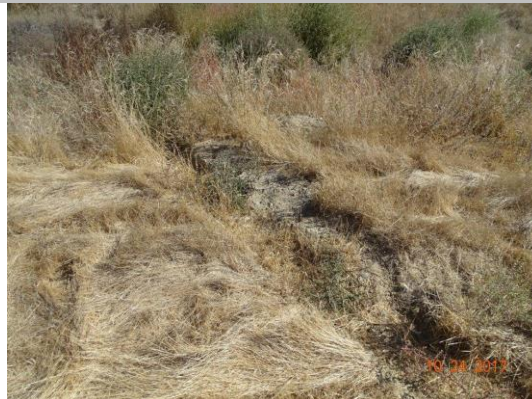
Photo 1 of 1 : FA_2018_NA0010_135_24_20180911_00010.jpg

LM Start	8.15	Rating **	M	Issue No.	24
LM End	8.15	Issue Type +	Ma	Location *	LS
Category	Earthen Levee			GPS Latitude/Longitude	
				Start	End
Item	Animal Control			36.875525 °	36.875525 °
				-120.317788 °	-120.317788 °
DWR ID	DWR_NA0010_17_f_2017_24				
Comment Code					
A3 : No rodents visible, but rodent burrows visible; need to backfill and compact or grout burrows.					
Inspector Comment					
Rodent holes on landside and crown of levee. Rodent holes have caused some erosion on the landside slope.

Looking east at the landside slope.

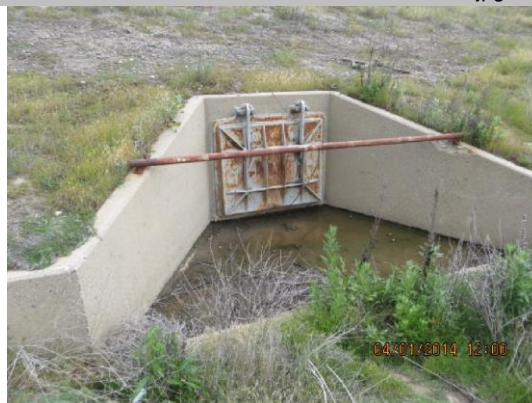
Photo 2 of 3 : UCIP_FA_2018_32999_59720.jpg

Flapgate on concrete headwall at WS toe.

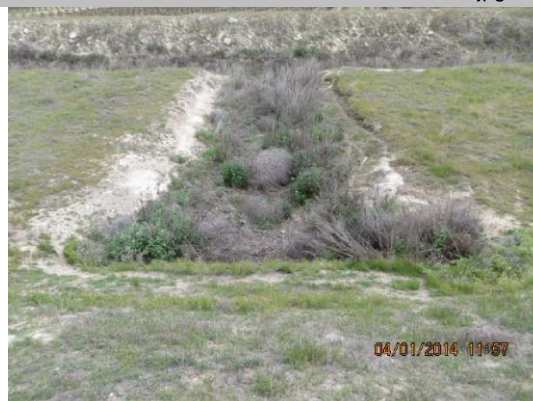
Photo 3 of 3 : UCIP_FA_2018_32999_59719.jpg

Concrete headwall and channel on LS toe.

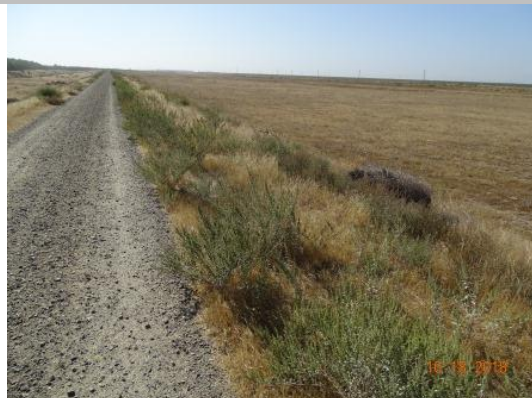
Photo 1 of 2 : FA_2018_NA0010_135_30_20181105_00046.jpg

LM Start	9.06	Rating **	U	Issue No.	30
LM End	10.56	Issue Type +	Ma	Location *	WS
Category	Earthen Levee			GPS Latitude/Longitude	
				Start	End
Item	Vegetation			36.862592°	36.841603°
				-120.315283°	-120.311313°
DWR ID	DWR_NA0010_17_f_2018_30				
Comment Code					
V1 : Control annual grass and weeds on the levee slopes and easements.					
Inspector Comment

heavy brush on waterside shoulder and slope. (Fall 2018)

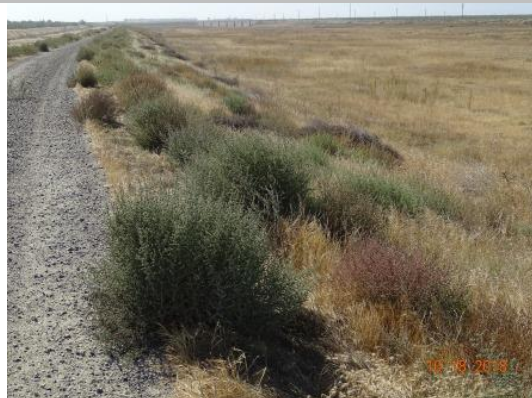
Photo 2 of 2 : FA_2018_NA0010_135_30_20181105_00047.jpg

Dense brush on waterside slope blocking view. (Fall 2018)

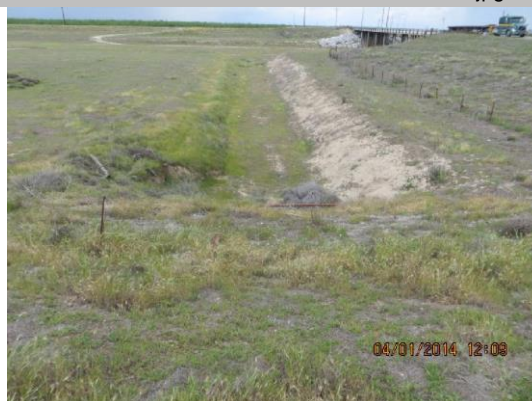
Photo 1 of 3 : UCIP_FA_2018_39532_59723.jpg

Concrete headwall and channel on WS toe.

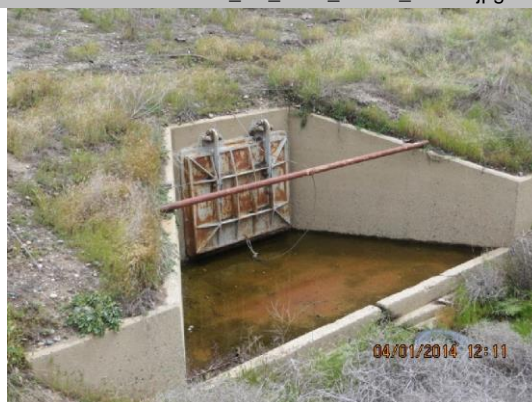
Photo 2 of 3 : UCIP_FA_2018_39532_59724.jpg

Flapgate on Concrete headwall at WS toe.

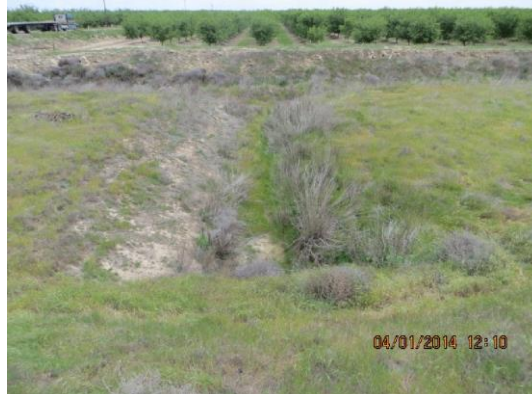
Photo 3 of 3 : UCIP_FA_2018_39532_59722.jpg

Comment Code						
Inspector Comment						
FS_ID:39532 DS_ID:19917 EP_NO: N/A Repair Type: Non-Urgent Crossing Status: Found UCIP Comments: 04/01/2014 Dense vegetation limits the inspector's visibility to identify signs of pipe failure (leaks) along the landward slope. Recommend removing vegetation along pipe alignment to conduct proper inspection of structure. (DWR UCIP - W. Wylie) FIELD_STRUCT_DESC: 48-inch by 60-inch reinforced concrete box gravity drainage culvert through the levee, 15 feet below the crown. Concrete headwall on the landside (LS) end. Concrete U-shaped headwall on the waterside (WS) end. [Additional Reference(s): DWR Levee Log, 2002. USACE San Joaquin O&M Manual 601.1, 1967, (HLM 9.89)]. FS Date: 4/1/2014

Concrete headwall and channel on LS toe.

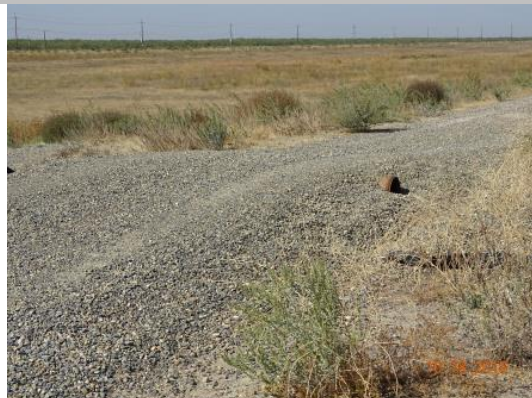
Photo 1 of 2 : FA_2018_NA0010_135_35_20181105_00050.jpg

LM Start	11.03	Rating **	M	Issue No.	35
LM End	11.03	Issue Type +	En	Location *	CR
Category	Earthen Levee			GPS Latitude/Longitude	
				Start	End
Item	Encroachments			36.836724 °	36.836724 °
				-120.305328 °	-120.305328 °
DWR ID	DWR_NA0010_17_f_2018_35				
Comment Code					
PI : Pipe					
Inspector Comment					
Landowner installed pipe across levee crown.

View of pipe encroachment looking downstream. (Fall 2018)

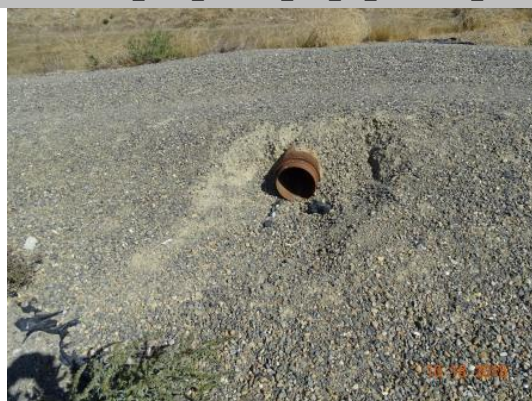
Photo 2 of 2 : FA_2018_NA0010_135_35_20181105_00051.jpg

View of pipe encroachment looking across crown. (Fall 2018)

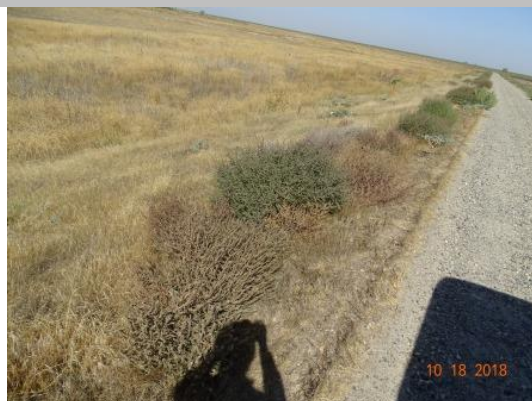
Photo 1 of 1 : FA_2018_NA0010_135_38_20181105_00052.jpg

LM Start	11.89	Rating **	U	Issue No.	38
LM End	13.81	Issue Type +	Ma	Location *	WS
Category	Earthen Levee			GPS Latitude/Longitude	
				Start	End
Item	Vegetation			36.826721 °	36.800086 °
				-120.298136 °	-120.306650 °
DWR ID	DWR_NA0010_17_f_2018_38				
Comment Code					
V1 : Control annual grass and weeds on the levee slopes and easements.					
Inspector Comment

Brush along waterside shoulder. (Fall 2018)

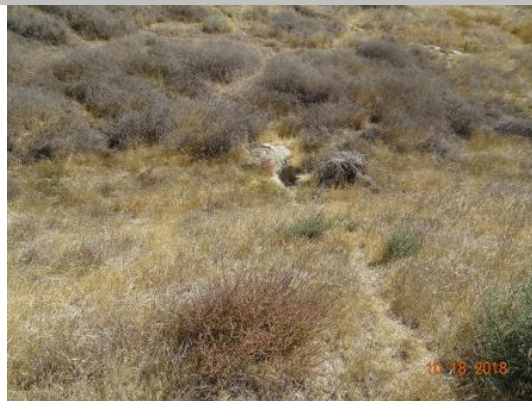
Photo 1 of 2 : FA_2018_NA0010_135_39_20181105_00053.jpg

LM Start	12.17	Rating **	U	Issue No.	39
LM End	12.17	Issue Type +	Ma	Location *	LS
Category	Earthen Levee			GPS Latitude/Longitude	
				Start	End
Item	Animal Control			36.822818 °	36.822818 °
				-120.299680 °	-120.299680 °
DWR ID	DWR_NA0010_17_f_2018_39				
Comment Code					
A3 : No rodents visible, but rodent burrows visible; need to backfill and compact or grout burrows.					
Inspector Comment					
Large hole on the landside toe

Large rodent hole at toe of levee. (Fall 2018)

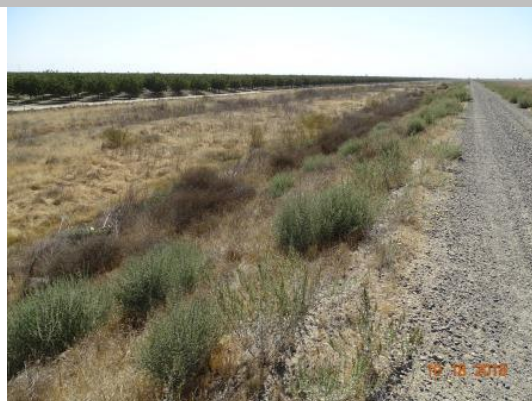
Photo 1 of 1 : FA_2018_NA0010_135_40_20181105_00055.jpg

LM Start	12.18	Rating **	U	Issue No.	40
LM End	14.71	Issue Type +	Ma	Location *	LS
Category	Earthen Levee			GPS Latitude/Longitude	
				Start	End
Item	Vegetation			36.822714 °	36.788749 °
				-120.299730 °	-120.300524 °
DWR ID	DWR_NA0010_17_f_2018_40				
Comment Code					
V1 : Control annual grass and weeds on the levee slopes and easements.					
Inspector Comment

heavy brush on landside slope and toe. (Fall 2018)

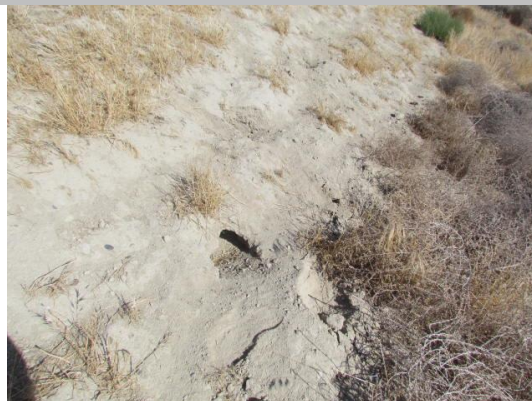
Photo 1 of 2 : FA_2018_NA0010_135_3_20180911_00001.jpg

LM Start	12.28	Rating **	M	Issue No.	3
LM End	12.38	Issue Type +	Ma	Location *	LS
Category	Earthen Levee			GPS Latitude/Longitude	
				Start	End
Item	Animal Control			36.821368 °	36.820000 °
				-120.300283 °	-120.300831 °
DWR ID	DWR_NA0010_17_s_2014_3				
Comment Code					
A3 : No rodents visible, but rodent burrows visible; need to backfill and compact or grout burrows.					
Inspector Comment					
Several rodent holes identified within this reach.

Looking at typical view of rodent holes on landward slope. Fall 2015

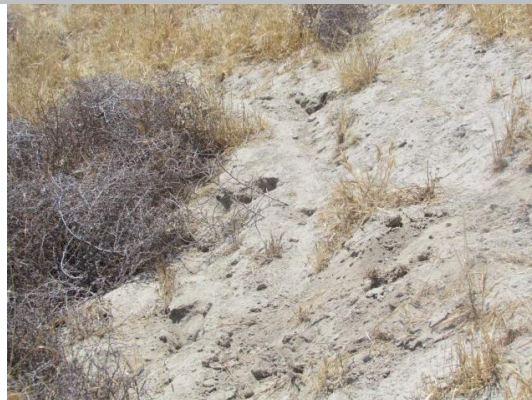
Photo 2 of 2 : FA_2018_NA0010_135_3_20180911_00002.jpg

Looking at several rodent holes on landward slope. Spring 2015

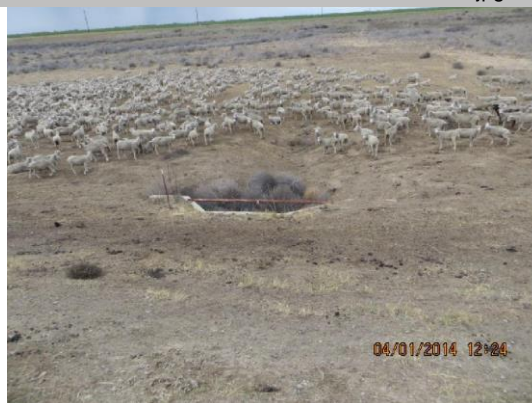
Photo 1 of 3 : UCIP_FA_2018_39533_59727.jpg

LM Start	13.29	Rating **	M	Issue No.	49
LM End	13.29	Issue Type +	Ma	Location *	
Category	Supplemental			GPS Latitude/Longitude	
				Start	End
Item	DWR UCIP LMA Responsibility			36.807509 °	36.807509 °
				-120.306231 °	-120.306231 °
DWR ID	19918				
Comment Code					
Inspector Comment					
FS_ID:39533 DS_ID:19918 EP_NO: N/A Repair Type: Non-Urgent Crossing Status: Found UCIP Comments: 04/01/2014 Some vegetation buildup at inlet--recommend clearing. (DWR UCIP - W. Wylie) FIELD_STRUCT_DESC: 48-inch by 60-inch reinforced concrete box gravity drainage culvert through the levee, 15.3 feet below the crown. Flap gate on the waterside (WS) end. Concrete headwall on the landside (LS) end. Concrete U-shaped headwall on the WS end. [Additional Reference(s): DWR Levee Log, 2002. USACE San Joaquin O&M Manual 601.1, 1967, (HLM 13.30)]. FS Date: 4/1/2014

Concrete headwall on WS toe.

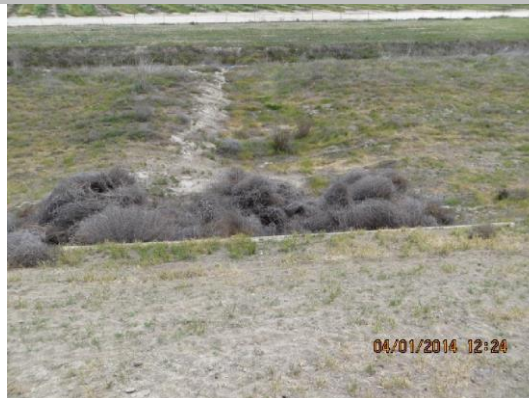
Photo 2 of 3 : UCIP_FA_2018_39533_59726.jpg

Concrete headwall on LS toe.

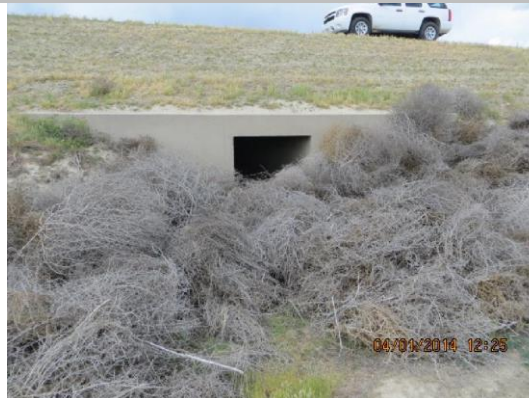
Photo 3 of 3 : UCIP_FA_2018_39533_59725.jpg

Concrete headwall on LS toe. Some vegetation buildup.

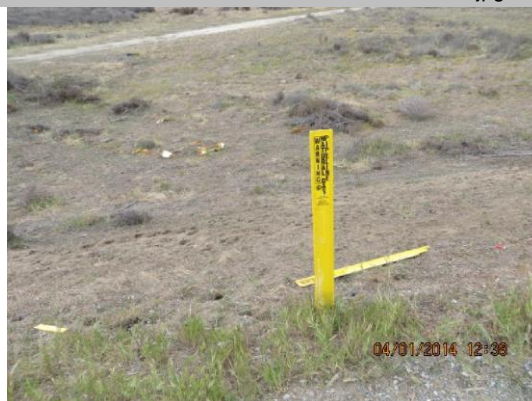
Photo 1 of 3 : UCIP_FA_2018_41406_71490.jpg

LM Start	14.38	Rating **	M	Issue No.	50
LM End	14.38	Issue Type +	En	Location *	
Category	Supplemental			GPS Latitude/Longitude	
				Start	End
Item	DWR UCIP Field Study			36.793318 °	36.793318 °
				-120.302138 °	-120.302138 °
DWR ID	24850				
Comment Code					
Inspector Comment					
FS_ID:41406					
DS_ID:24850					
EP_NO: N/A					
Repair Type: Non-Urgent					
Crossing Status: Indicator Found					
UCIP Comments: 04/01/2014 No permit identified for this crossing.					
(DWR UCIP - W. Wylie)					
FIELD_STRUCT_DESC: Natural gas pipeline of an unknown size or material through the levee, at an unknown depth. Gas line markers on both shoulders.					
FS Date: 4/1/2014

Gasline marker on WS slope..

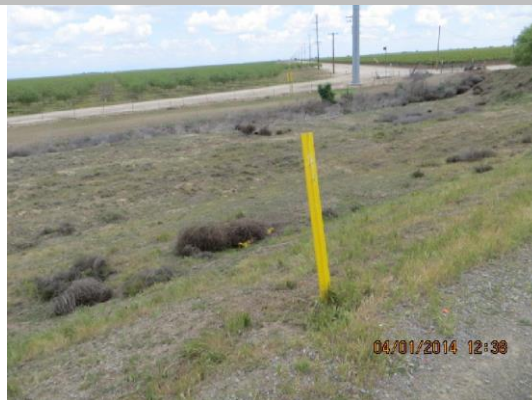
Photo 2 of 3 : UCIP_FA_2018_41406_71489.jpg

Gasline marker on LS shoulder.

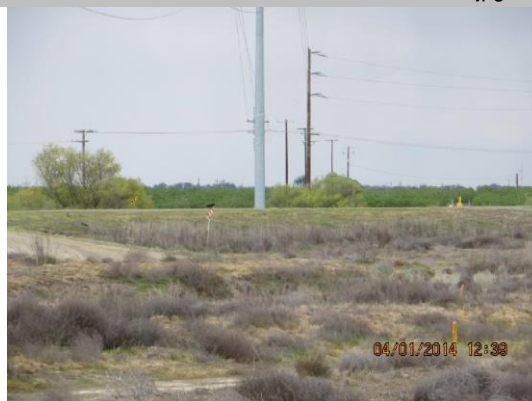
Photo 3 of 3 : UCIP_FA_2018_41406_71488.jpg

Gasline markers visible along right side of photo.

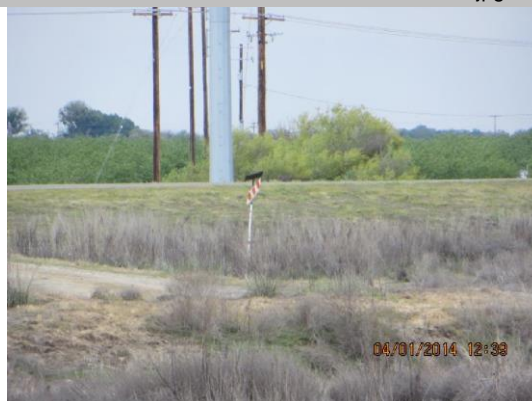
Photo 2 of 3 : UCIP_FA_2018_50067_59741.jpg

Gasline marker visible in channel off WS toe.

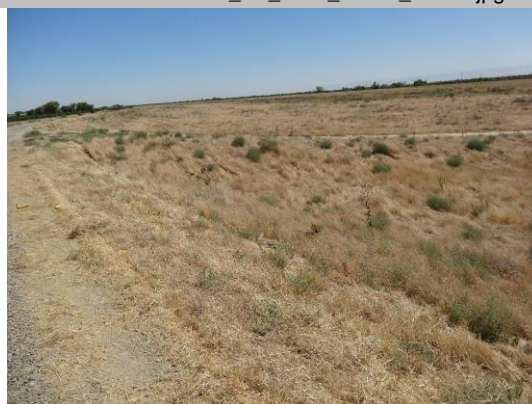
Photo 3 of 3 : UCIP_FA_2018_50067_75506.jpg

View of WS.

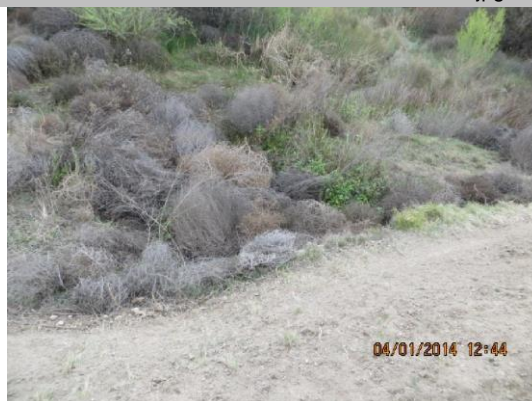
Photo 3 of 3 : UCIP_FA_2018_39535_59746.jpg

Comment Code						
Inspector Comment						
FS_ID:39535						
DS_ID:19920						
EP_NO: N/A						
Repair Type: Non-Urgent						
Crossing Status: Found						
UCIP Comments: 04/01/2014 Heavy vegetation buildup at LS toe--						
recommend clearing. (DWR UCIP - W. Wylie)						
FIELD_STRUCT_DESC: 30-inch by 30-inch square reinforced concrete						
box gravity drainage culvert through the levee, 14 feet below the crown.						
Flap gate on the waterside (WS) end. Concrete headwall on the						
landside (LS) end. Concrete U-shaped headwall on the WS end.						
[Additional Reference(s): DWR Levee Log, 2002. USACE San Joaquin						
O&M Manual 601.1, 1967, (HLM 14.69)].						
FS Date: 4/1/2014

Concrete headwall at channel on LS toe. Heavy vegetation buildup.

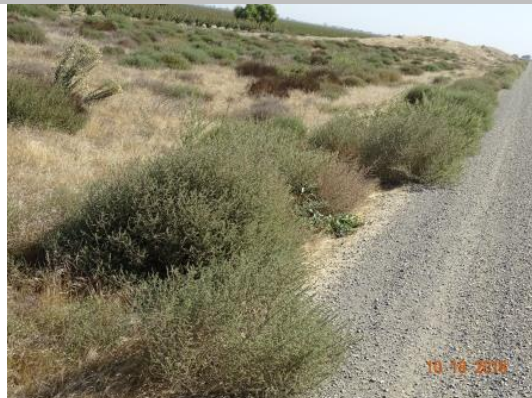
Photo 1 of 1 : FA_2018_NA0010_135_44_20181105_00057.jpg

LM Start	15.06	Rating **	U	Issue No.	44
LM End	15.57	Issue Type +	Ma	Location *	LS
Category	Earthen Levee			GPS Latitude/Longitude	
				Start	End
Item	Vegetation			36.784914 °	36.781497 °
				-120.296526 °	-120.288211 °
DWR ID	DWR_NA0010_17_f_2018_44				
Comment Code					
V1 : Control annual grass and weeds on the levee slopes and easements.					
Inspector Comment

Grass and brush blocking view of landside slope. (Fall 2018)

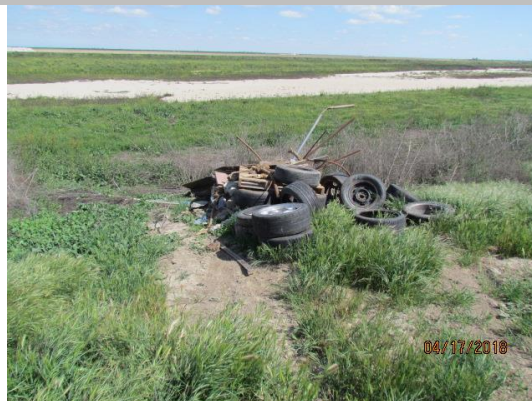
Photo 1 of 1 : FA_2018_NA0010_137_20_20180911_00009.jpg

LM Start	0.58	Rating **	M	Issue No.	20
LM End	0.58	Issue Type +	Ma	Location *	WS
Category	Earthen Levee			GPS Latitude/Longitude	
				Start	End
Item	Encroachments			36.967678 °	36.967678 °
				-120.357660 °	-120.357660 °
DWR ID	DWR_NA0010_18_s_2018_20				
Comment Code					
GA : Garbage					
Inspector Comment					
Garbage (rubber tires) stockpile on waterward slope.

Looking east at garbage (rubble tires) on waterward slope. (Spring 2018)

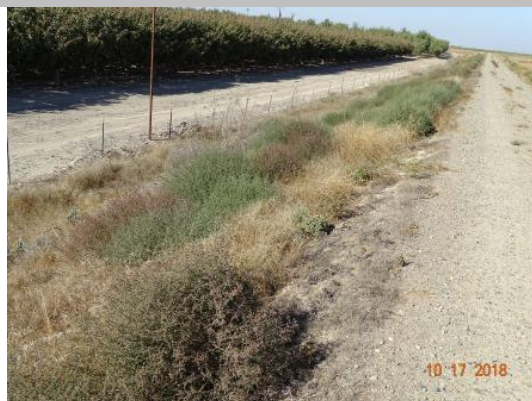
Photo 1 of 1 : FA_2018_NA0010_137_57_20181105_00022.jpg

LM Start	0.63	Rating **	U	Issue No.	57
LM End	0.74	Issue Type +	Ma	Location *	LS
Category	Earthen Levee			GPS Latitude/Longitude	
				Start	End
Item	Vegetation			36.967010 °	36.965384 °
				-120.357747 °	-120.357975 °
DWR ID	DWR_NA0010_18_f_2018_57				
Comment Code					
V1 : Control annual grass and weeds on the levee slopes and easements.					
Inspector Comment

Brush blocking view of landside slope and toe. (Fall 2018)

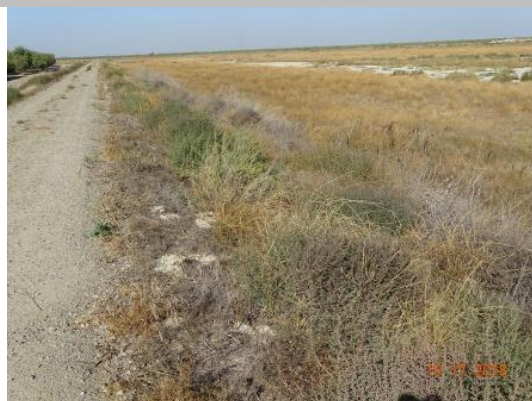
Photo 1 of 1 : FA_2018_NA0010_137_56_20181105_00023.jpg

LM Start	0.67	Rating **	U	Issue No.	56
LM End	0.75	Issue Type +	Ma	Location *	WS
Category	Earthen Levee			GPS Latitude/Longitude	
				Start	End
Item	Vegetation			36.966434°	36.965238°
				-120.357830°	-120.358000°
DWR ID	DWR_NA0010_18_f_2018_56				
Comment Code					
V1 : Control annual grass and weeds on the levee slopes and easements.					
Inspector Comment

Grass and brush blocking waterside slope. (Fall 2018)

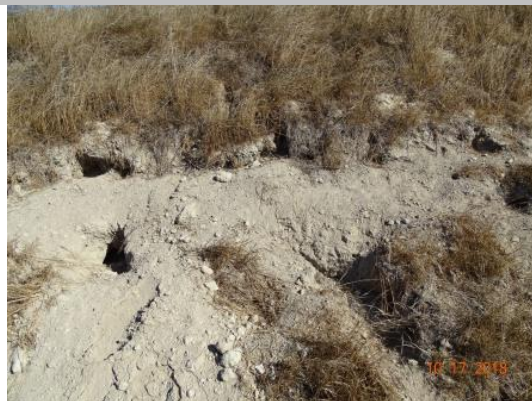
Photo 1 of 1 : FA_2018_NA0010_137_55_20181105_00024.jpg

View of rodent holes from levee toe looking towards centerline. (Fall 2018)

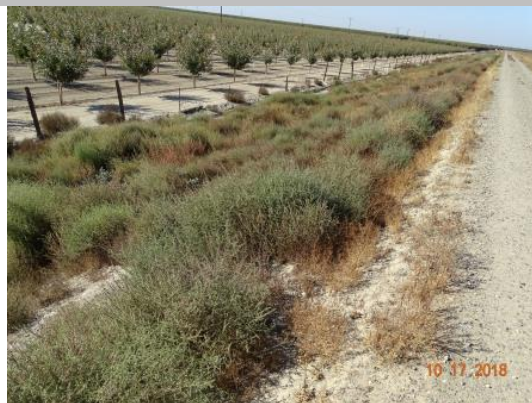
Photo 1 of 1 : FA_2018_NA0010_137_53_20181105_00025.jpg

dense vegetation along landside slope and toe. (Fall 2018)

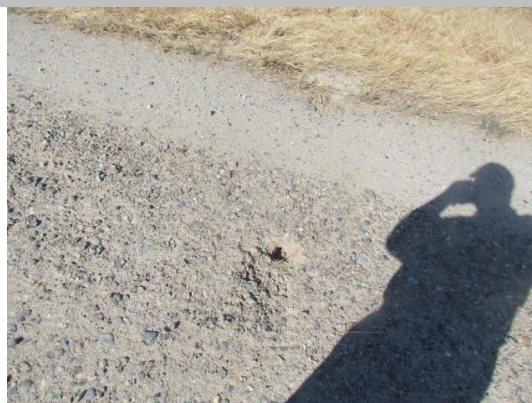
Photo 1 of 1 : FA_2018_NA0010_137_7_20180911_00002.jpg

LM Start	1.44	Rating **	M	Issue No.	7
LM End	1.44	Issue Type +	Ma	Location *	LS
Category	Earthen Levee			GPS Latitude/Longitude	
				Start	End
Item	Animal Control			36.956163 °	36.956163 °
				-120.353672 °	-120.353672 °
DWR ID	DWR_NA0010_18_f_2018_7				
Comment Code					
A3 : No rodents visible, but rodent burrows visible; need to backfill and compact or grout burrows.					
Inspector Comment					
Several holes identified on landside slope and on the levee crown.

Looking at typical view of rodent holes within this section on landward slope.

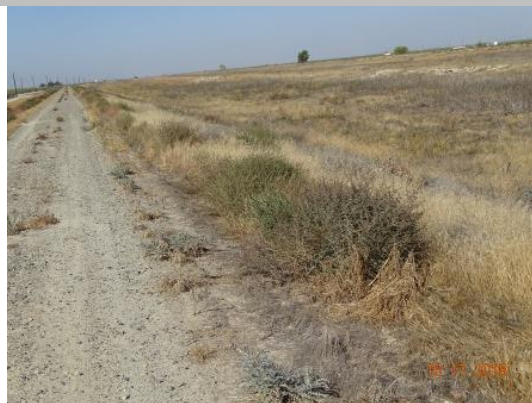
Photo 1 of 2 : FA_2018_NA0010_137_49_20181105_00026.jpg

LM Start	1.66	Rating **	U	Issue No.	49
LM End	5.64	Issue Type +	Ma	Location *	WS
Category	Earthen Levee			GPS Latitude/Longitude	
				Start	End
Item	Vegetation			36.953267 °	36.898603 °
				-120.351888 °	-120.329304 °
DWR ID	DWR_NA0010_18_f_2018_49				
Comment Code					
V1 : Control annual grass and weeds on the levee slopes and easements.					
Inspector Comment

Tall grass and brush on waterside slope. (Fall 2018)

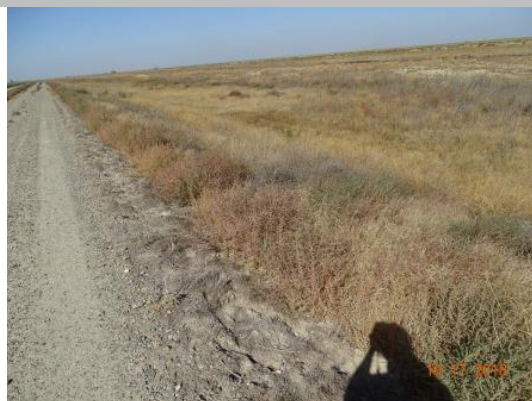
Photo 2 of 2 : FA_2018_NA0010_137_49_20181105_00027.jpg

LM Start	1.66	Rating **	U	Issue No.	49 (cont)	
LM End	5.64	Issue Type +	Ma	Location *	WS	
Category	Earthen Levee			GPS Latitude/Longitude		
				Start		End
Item	Vegetation			36.953267 °		36.898603 °
				-120.351888 °		-120.329304 °
DWR ID	DWR_NA0010_18_f_2018_49					
Comment Code						
V1 : Control annual grass and weeds on the levee slopes and easements.						
Inspector Comment

Tall grass and brush on waterside slope. (Fall 2018)

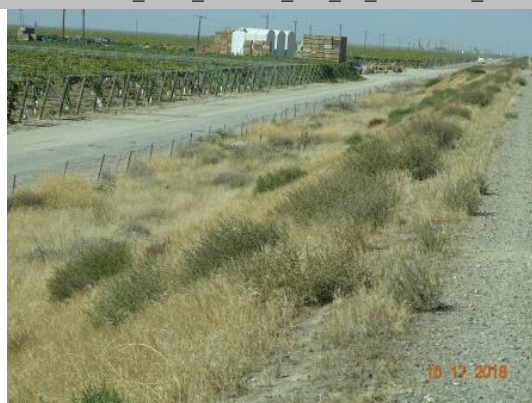
Photo 1 of 1 : FA_2018_NA0010_137_50_20181105_00029.jpg

LM Start	1.67	Rating **	U	Issue No.	50
LM End	4.78	Issue Type +	Ma	Location *	LS
Category	Earthen Levee			GPS Latitude/Longitude	
				Start	End
Item	Vegetation			36.953146 °	36.910421 °
				-120.351815 °	-120.334103 °
DWR ID	DWR_NA0010_18_f_2018_50				
Comment Code					
V1 : Control annual grass and weeds on the levee slopes and easements.					
Inspector Comment

dense grass and brush on landside slope. (Fall 2018)

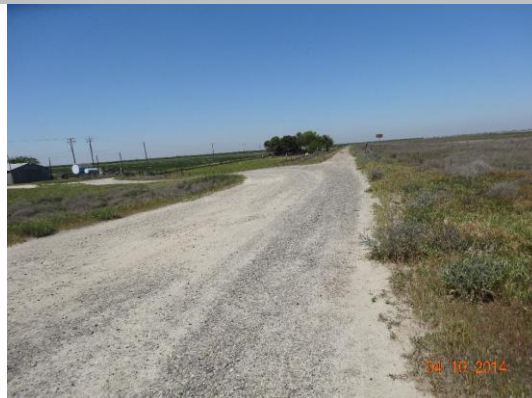
Photo 1 of 3 : UCIP_FA_2018_39503_66660.jpg

Comment Code						
Inspector Comment						
FS_ID:39503						
DS_ID:19925						
EP_NO: 6603						
Repair Type: Non-Urgent						
Crossing Status: Found						
UCIP Comments: 04/10/2014 Need to contact owner. Appears abandoned--good candidate for video or pressure inspection. This crossings is the same age as the pipe that has failed immediately upstream. (DWR UCIP - O. Magana)						
FIELD_STRUCT_DESC: 15-inch steel irrigation discharge pipe through the levee, 4.3 feet below the crown. Electrical conduit of an unknown size or material through the levee, 4.3 feet below the crown. Siphon breaker on the landside (LS) shoulder. 36-inch concrete standpipe on the LS berm. Inlet facility on the waterside (WS) bank consisting of a pump, a 42-inch concrete standpipe, and a 20-inch concrete channel with an intake pipe and a cutoff wall. (Plans to install a pump and outlet pipe at two locations on the left bank levee of the Chowchilla Bypass authorized under Permit No. 6603, 1969 - Raymond N. Costales).

Overview of levee crown at crossing.

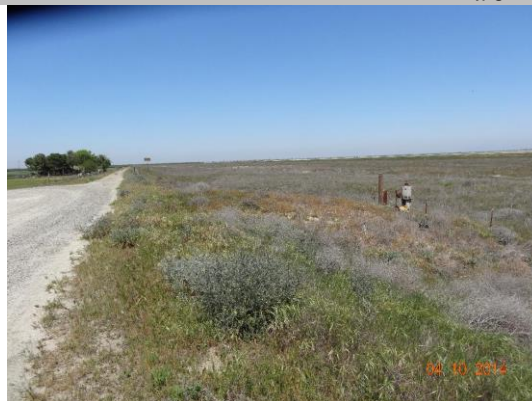
Photo 2 of 3 : UCIP_FA_2018_39503_66657.jpg

View of waterward side.

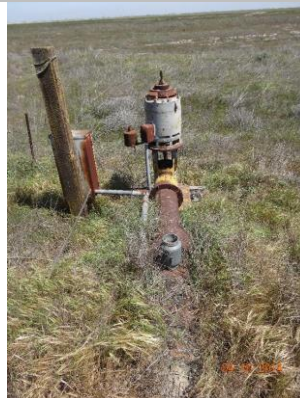
Photo 3 of 3 : UCIP_FA_2018_39503_66658.jpg

Comment Code						
Inspector Comment						
FS_ID:39503 DS_ID:19925 EP_NO: 6603 Repair Type: Non-Urgent Crossing Status: Found UCIP Comments: 04/10/2014 Need to contact owner. Appears abandoned--good candidate for video or pressure inspection. This crossings is the same age as the pipe that has failed immediately upstream. (DWR UCIP - O. Magana) FIELD_STRUCT_DESC: 15-inch steel irrigation discharge pipe through the levee, 4.3 feet below the crown. Electrical conduit of an unknown size or material through the levee, 4.3 feet below the crown. Siphon breaker on the landside (LS) shoulder. 36-inch concrete standpipe on the LS berm. Inlet facility on the waterside (WS) bank consisting of a pump, a 42-inch concrete standpipe, and a 20-inch concrete channel with an intake pipe and a cutoff wall. (Plans to install a pump and outlet pipe at two locations on the left bank levee of the Chowchilla Bypass authorized under Permit No. 6603, 1969 - Raymond N. Costales). [Additional Reference(s): DWR Levee Log, 2002]. FS Date: 4/10/2014

Pump system located on waterward slope.

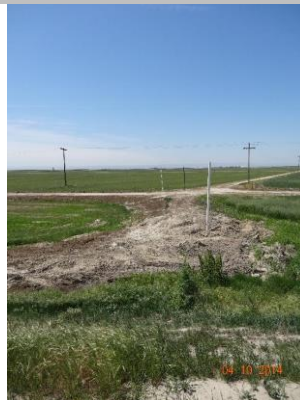
Photo 1 of 3 : UCIP_FA_2018_49968_60558.jpg

Comment Code						
Inspector Comment						
FS_ID:49968 DS_ID:19926 EP_NO: 6603 Repair Type: Non-Urgent Crossing Status: Found UCIP Comments: 7/20/2016 High burrow activity. Dense vegetation limits the inspector's visibility to identify signs of pipe failure (leaks) along the WS and LS slope. Recommend removing vegetation along pipe alignment to conduct proper inspection of structure and appurtenances. (DWR UCIP - omagana)4/10/2014 Subsidence present along pipe alignment on landward side. Modified crossing--worked done on landward side. Need to contact owner to determine permit authorizing work. Dense vegetation on landward side--tall grass. Pipe wall cut and new pipe sleeved on landward side. (DWR UCIP - omagana) FIELD_STRUCT_DESC: 15-inch steel irrigation discharge pipe and electrical conduit through the levee, 3.7 feet below the crown. Siphon breaker on the landside (LS) shoulder. 36-inch concrete standpipe on the LS berm. Inlet facility on the riverbank, consisting of a pump, a 42-inch concrete standpipe, and a 20-inch concrete channel with an intake pipe and a cutoff wall. (Plans to install a pump and outlet pipe at two locations on the left bank levee of the Chowchilla Bypass authorized under Permit No. 6603, 1969 - Raymond N. Costales). [Additional Reference(s): DWR Levee Log, 2002]. FS Date: 7/20/2016

Overview of LS--site modified.

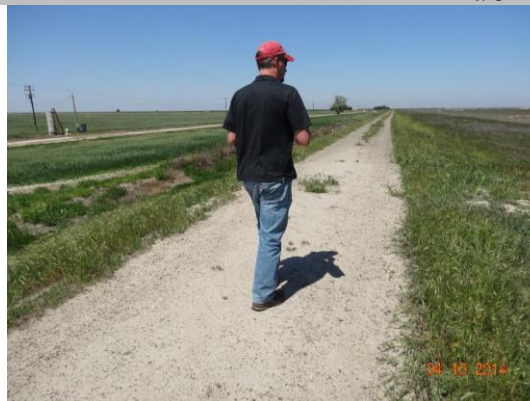
Photo 2 of 3 : UCIP_FA_2018_49968_60559.jpg

View of levee crown at crossing.

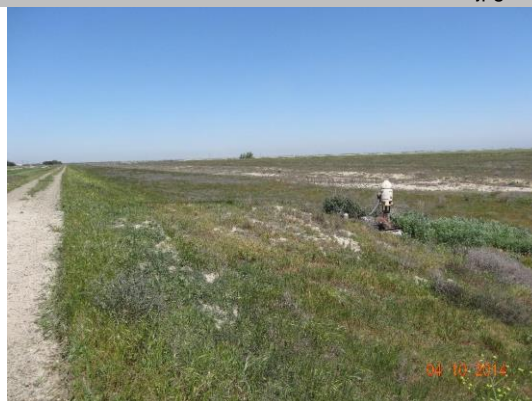
Photo 3 of 3 : UCIP_FA_2018_49968_60560.jpg

Comment Code						
Inspector Comment						
FS_ID:49968 DS_ID:19926 EP_NO: 6603 Repair Type: Non-Urgent Crossing Status: Found UCIP Comments: 7/20/2016 High burrow activity. Dense vegetation limits the inspector's visibility to identify signs of pipe failure (leaks) along the WS and LS slope. Recommend removing vegetation along pipe alignment to conduct proper inspection of structure and appurtenances. (DWR UCIP - omagana)4/10/2014 Subsidence present along pipe alignment on landward side. Modified crossing--worked done on landward side. Need to contact owner to determine permit authorizing work. Dense vegetation on landward side--tall grass. Pipe wall cut and new pipe sleeved on landward side. (DWR UCIP - omagana) FIELD_STRUCT_DESC: 15-inch steel irrigation discharge pipe and electrical conduit through the levee, 3.7 feet below the crown. Siphon breaker on the landside (LS) shoulder. 36-inch concrete standpipe on the LS berm. Inlet facility on the riverbank, consisting of a pump, a 42-inch concrete standpipe, and a 20-inch concrete channel with an intake pipe and a cutoff wall. (Plans to install a pump and outlet pipe at two locations on the left bank levee of the Chowchilla Bypass authorized under Permit No. 6603, 1969 - Raymond N. Costales). [Additional Reference(s): DWR Levee Log, 2002]. FS Date: 7/20/2016

View of WS.

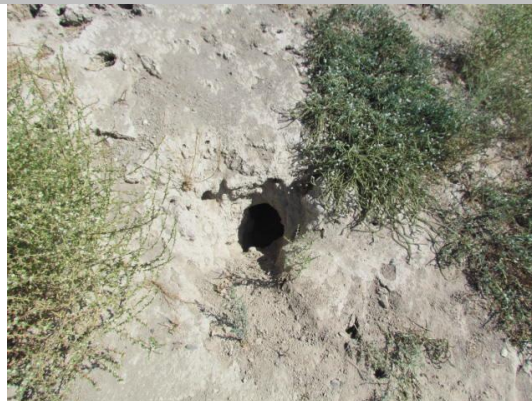
Photo 1 of 2 : FA_2018_NA0010_137_8_20180911_00003.jpg

LM Start	2.25	Rating **	U	Issue No.	8
LM End	2.25	Issue Type +	Ma	Location *	LS
Category	Earthen Levee			GPS Latitude/Longitude	
				Start	End
Item	Animal Control			36.945563 °	36.945563 °
				-120.347121 °	-120.347121 °
DWR ID	DWR_NA0010_18_f_2015_8				
Comment Code					
A3 : No rodents visible, but rodent burrows visible; need to backfill and compact or grout burrows.					
Inspector Comment					
One large rodent hole and other rodent holes within this area.

Looking at large rodent hole on landward slope.
