**Flood Control Project Maintenance
Levee Inspections**

Fall 2018 Levee Maintenance Deficiency Summary Report

San Joaquin River Basin

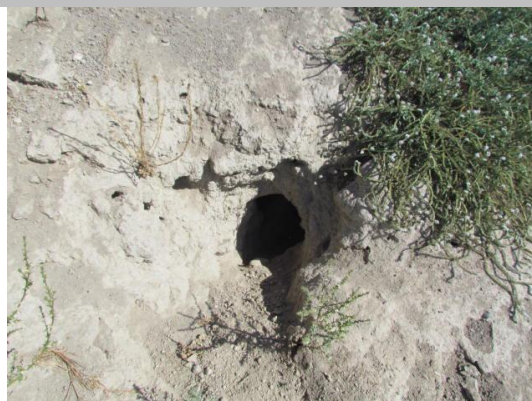
Photo 2 of 2 : FA_2018_NA0010_137_8_20180911_00004.jpg

LM Start	2.25	Rating **	U	Issue No.	8 (cont)	
LM End	2.25	Issue Type +	Ma	Location *	LS	
Category	Earthen Levee			GPS Latitude/Longitude		
				Start		End
Item	Animal Control			36.945563 °		36.945563 °
				-120.347121 °		-120.347121 °
DWR ID	DWR_NA0010_18_f_2015_8					
Comment Code						
A3 : No rodents visible, but rodent burrows visible; need to backfill and compact or grout burrows.						
Inspector Comment						
One large rodent hole and other rodent holes within this area.

Looking at close-up view of large rodent hole on landward slope.

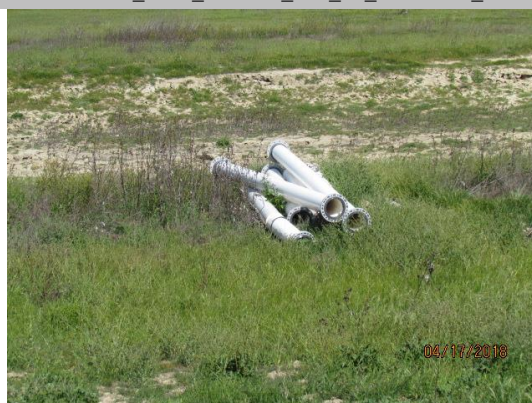
Photo 1 of 1 : FA_2018_NA0010_137_17_20180911_00008.jpg

LM Start	3.68	Rating **	M	Issue No.	17
LM End	3.68	Issue Type +	En	Location *	WS
Category	Earthen Levee			GPS Latitude/Longitude	
				Start	End
Item	Encroachments			36.925683 °	36.925683 °
				-120.339692 °	-120.339692 °
DWR ID	DWR_NA0010_18_s_2018_17				
Comment Code					
PI : Pipe					
Inspector Comment					
Remove Irrigation pipes stored in channel.

Looking east at irrigation pipe stored in channel. (Spring 2018)

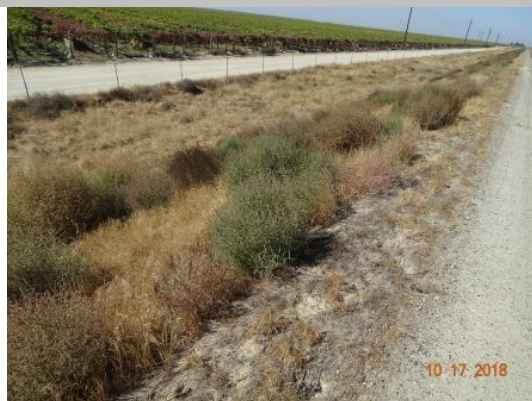
Photo 1 of 1 : FA_2018_NA0010_137_48_20181105_00030.jpg

LM Start	4.91	Rating **	U	Issue No.	48
LM End	5.64	Issue Type +	Ma	Location *	LS
Category	Earthen Levee			GPS Latitude/Longitude	
				Start	End
Item	Vegetation			36.908562 °	36.898524 °
				-120.333424 °	-120.329269 °
DWR ID	DWR_NA0010_18_f_2018_48				
Comment Code					
V1 : Control annual grass and weeds on the levee slopes and easements.					
Inspector Comment

heavy vegetation along landside slope. (Fall 2018)

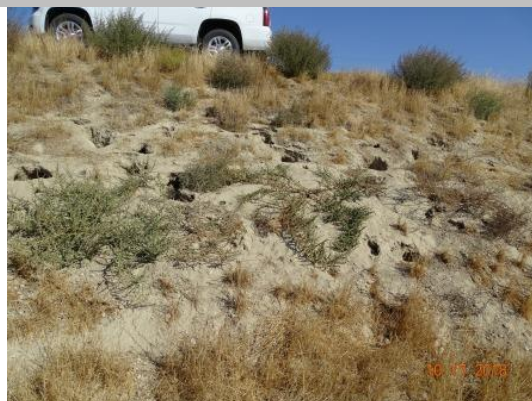
Photo 1 of 1 : FA_2018_NA0010_137_47_20181105_00032.jpg

LM Start	5.77	Rating **	M	Issue No.	47
LM End	5.77	Issue Type +	Ma	Location *	LS
Category	Earthen Levee			GPS Latitude/Longitude	
				Start	End
Item	Animal Control			36.896839 °	36.896839 °
				-120.328434 °	-120.328434 °
DWR ID	DWR_NA0010_18_f_2018_47				
Comment Code					
A3 : No rodents visible, but rodent burrows visible; need to backfill and compact or grout burrows.					
Inspector Comment

Several rodent holes in the landside slope. (Fall 2018)

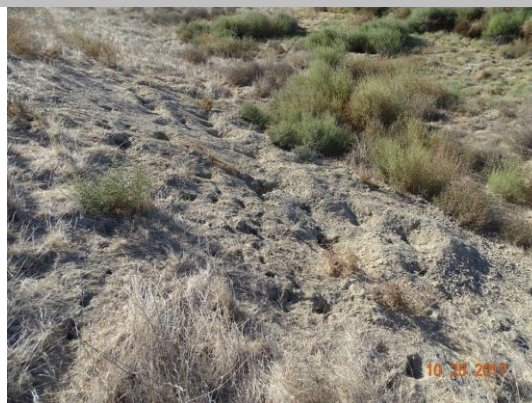
Photo 1 of 1 : FA_2018_NA0010_137_1_20180911_00001.jpg

LM Start	5.89	Rating **	U	Issue No.	1
LM End	5.89	Issue Type +	Ma	Location *	LS
Category	Earthen Levee			GPS Latitude/Longitude	
				Start	End
Item	Animal Control			36.895175 °	36.895175 °
				-120.327632 °	-120.327632 °
DWR ID	DWR_NA0010_18_s_2015_1				
Comment Code					
A3 : No rodents visible, but rodent burrows visible; need to backfill and compact or grout burrows.					
Inspector Comment					
Several large rodent holes noted on landside slope and berm within this section.

Looking at the landside slope.

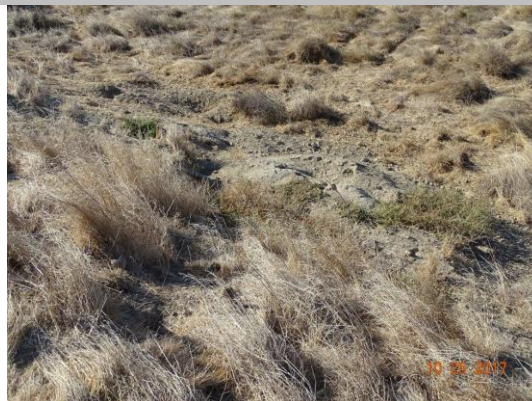
Photo 1 of 1 : FA_2018_NA0010_137_15_20180911_00007.jpg

LM Start	5.99	Rating **	U	Issue No.	15
LM End	5.99	Issue Type +	Ma	Location *	LS
Category	Earthen Levee			GPS Latitude/Longitude	
				Start	End
Item	Animal Control			36.893924 °	36.893924 °
				-120.327020 °	-120.327020 °
DWR ID	DWR_NA0010_18_f_2017_15				
Comment Code					
A3 : No rodents visible, but rodent burrows visible; need to backfill and compact or grout burrows.					
Inspector Comment					
Multiple large rodent holes at the landside toe.

Looking west at the landside slope. (Fall 2017)

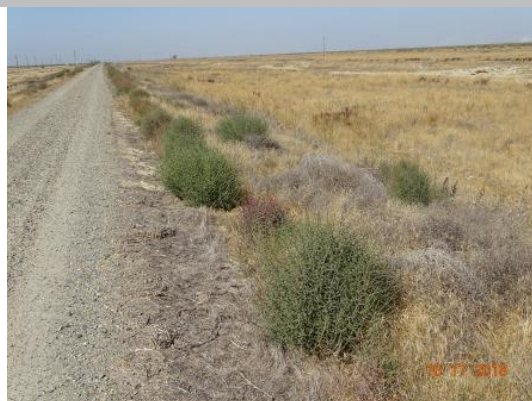
Photo 1 of 1 : FA_2018_NA0010_137_43_20181105_00033.jpg

LM Start	6.08	Rating **	U	Issue No.	43
LM End	6.75	Issue Type +	Ma	Location *	WS
Category	Earthen Levee			GPS Latitude/Longitude	
				Start	End
Item	Vegetation			36.892595 °	36.883668 °
				-120.326370 °	-120.321988 °
DWR ID	DWR_NA0010_18_f_2018_43				
Comment Code					
V1 : Control annual grass and weeds on the levee slopes and easements.					
Inspector Comment

heavy vegetation on waterside slope. (Fall 2018)

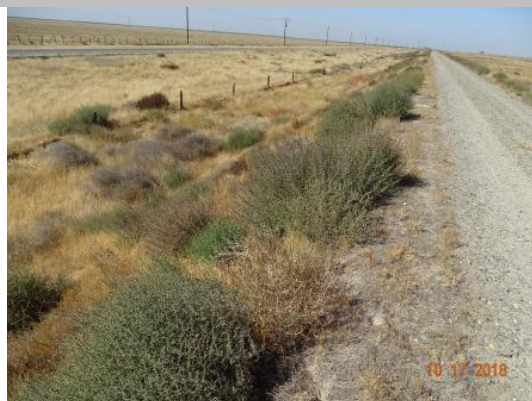
Photo 1 of 1 : FA_2018_NA0010_137_44_20181105_00034.jpg

LM Start	6.11	Rating **	U	Issue No.	44
LM End	6.75	Issue Type +	Ma	Location *	LS
Category	Earthen Levee			GPS Latitude/Longitude	
				Start	End
Item	Vegetation			36.892208°	36.883667°
				-120.326174°	-120.321988°
DWR ID	DWR_NA0010_18_f_2018_44				
Comment Code					
V1 : Control annual grass and weeds on the levee slopes and easements.					
Inspector Comment

Dense vegetation on landside slope. (Fall 2018)

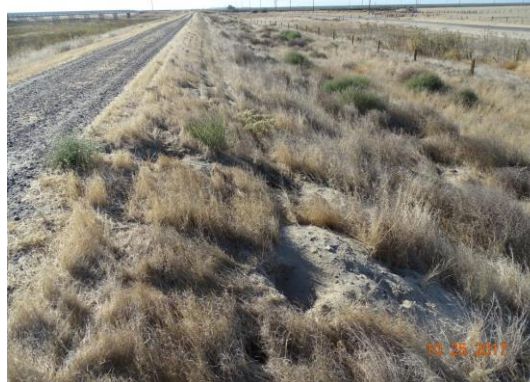
Photo 1 of 1 : FA_2018_NA0010_137_14_20180911_00006.jpg

LM Start	7.39	Rating **	U	Issue No.	14
LM End	7.53	Issue Type +	Ma	Location *	LS
Category	Earthen Levee			GPS Latitude/Longitude	
				Start	End
Item	Animal Control			36.874479 °	36.872503 °
				-120.319831 °	-120.319438 °
DWR ID	DWR_NA0010_18_f_2017_14				
Comment Code					
A3 : No rodents visible, but rodent burrows visible; need to backfill and compact or grout burrows.					
Inspector Comment					
Several rodent holes noted along landside slope in this area.

Looking south at the landside slope.

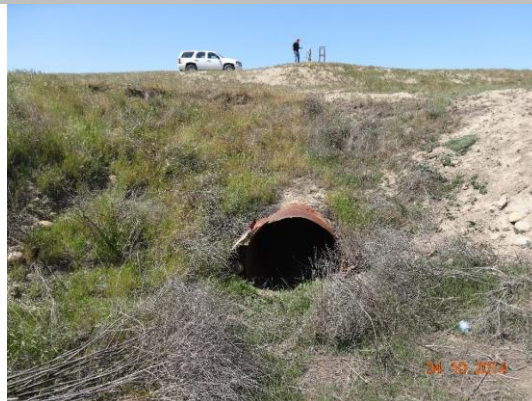
Photo 2 of 3 : UCIP_FA_2018_36843_67205.jpg

Comment Code						
Inspector Comment						
FS_ID:36843 DS_ID:19930 EP_NO: N/A Repair Type: Non-Urgent Crossing Status: Found UCIP Comments: 04/10/2014 CMP crossing is distorted on waterward side. Debris scattered on landward side. Sediment deposit inside crossing visible from landward side. Recommend removing debris from landward side. (DWR UCIP - O. Magana) FIELD_STRUCT_DESC: 42-inch reinforced concrete gravity irrigation pipe through the levee, 19 feet below the crown. Gate structure on the waterside (WS) shoulder. Pipe section on the WS is corrugated metal. Pipe section on the landside (LS) is reinforced concrete. (Plans to install a 42-inch gravity-flow concrete pipeline through the left bank levee of the Eastside Bypass to divert bypass waters for irrigation purposes authorized under Permit No. 13548, 1983 - New Stone Water District). [Additional Reference(s): DWR Levee Log, 2002]. FS Date: 4/10/2014

Pipe section distorted on waterward side.

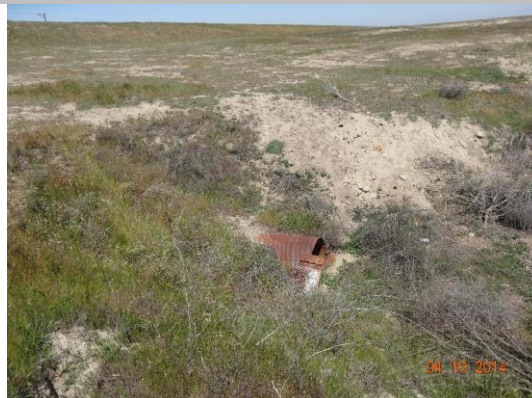
Photo 3 of 3 : UCIP_FA_2018_36843_67200.jpg

Comment Code						
Inspector Comment						
FS_ID:36843 DS_ID:19930 EP_NO: N/A Repair Type: Non-Urgent Crossing Status: Found UCIP Comments: 04/10/2014 CMP crossing is distorted on waterward side. Debris scattered on landward side. Sediment deposit inside crossing visible from landward side. Recommend removing debris from landward side. (DWR UCIP - O. Magana) FIELD_STRUCT_DESC: 42-inch reinforced concrete gravity irrigation pipe through the levee, 19 feet below the crown. Gate structure on the waterside (WS) shoulder. Pipe section on the WS is corrugated metal. Pipe section on the landside (LS) is reinforced concrete. (Plans to install a 42-inch gravity-flow concrete pipeline through the left bank levee of the Eastside Bypass to divert bypass waters for irrigation purposes authorized under Permit No. 13548, 1983 - New Stone Water District). [Additional Reference(s): DWR Levee Log, 2002]. FS Date: 4/10/2014

CMP section visible on waterward side.

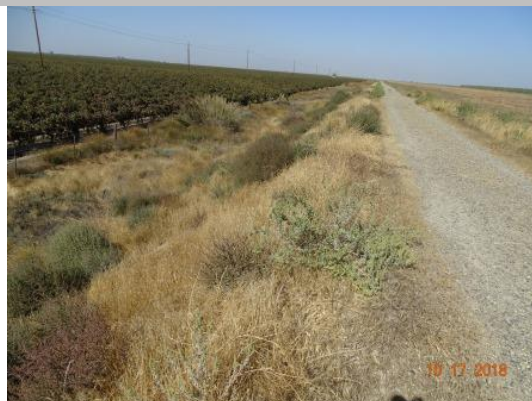
Photo 1 of 1 : FA_2018_NA0010_137_38_20181105_00036.jpg

LM Start	7.64	Rating **	U	Issue No.	38
LM End	8.97	Issue Type +	Ma	Location *	LS
Category	Earthen Levee			GPS Latitude/Longitude	
				Start	End
Item	Vegetation			36.870943 °	36.851827 °
				-120.319133 °	-120.316397 °
DWR ID	DWR_NA0010_18_f_2018_38				
Comment Code					
V1 : Control annual grass and weeds on the levee slopes and easements.					
Inspector Comment

dense vegetation on landside slope and toe. (Fall 2018)

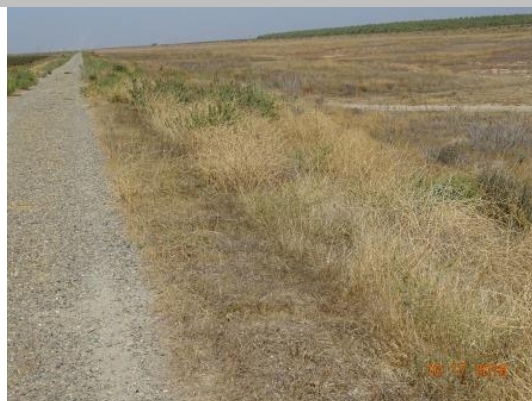
Photo 1 of 1 : FA_2018_NA0010_137_37_20181105_00037.jpg

LM Start	7.65	Rating **	U	Issue No.	37
LM End	8.99	Issue Type +	Ma	Location *	WS
Category	Earthen Levee			GPS Latitude/Longitude	
				Start	End
Item	Vegetation			36.870854 °	36.851583 °
				-120.319118 °	-120.316385 °
DWR ID	DWR_NA0010_18_f_2018_37				
Comment Code					
V1 : Control annual grass and weeds on the levee slopes and easements.					
Inspector Comment

dense vegetation on waterside slope. (Fall 2018)

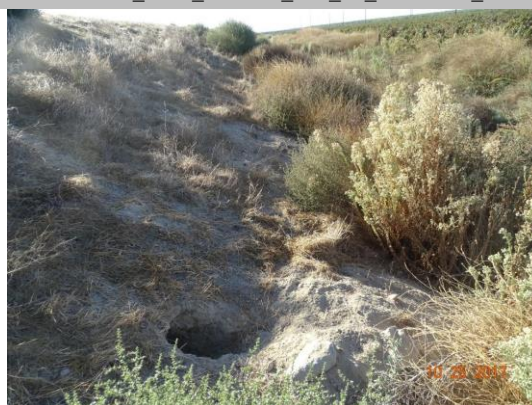
Photo 1 of 1 : FA_2018_NA0010_137_13_20180911_00005.jpg

LM Start	8.67	Rating **	U	Issue No.	13
LM End	8.67	Issue Type +	Ma	Location *	LS
Category	Earthen Levee			GPS Latitude/Longitude	
				Start	End
Item	Animal Control			36.856115 °	36.856115 °
				-120.316595 °	-120.316595 °
DWR ID	DWR_NA0010_18_f_2017_13				
Comment Code					
A3 : No rodents visible, but rodent burrows visible; need to backfill and compact or grout burrows.					
Inspector Comment

Looking south at the landside slope.

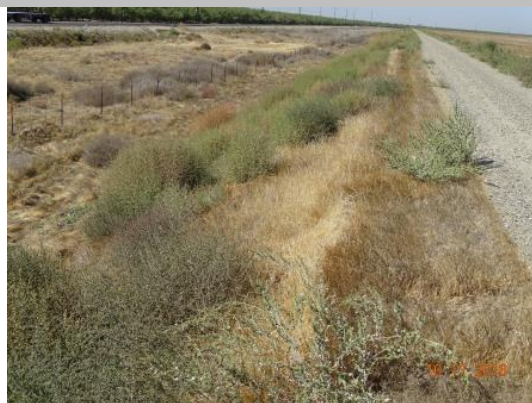
Photo 1 of 1 : FA_2018_NA0010_137_34_20181105_00038.jpg

LM Start	9.70	Rating **	U	Issue No.	34
LM End	10.10	Issue Type +	Ma	Location *	LS
Category	Earthen Levee			GPS Latitude/Longitude	
				Start	End
Item	Vegetation			36.841736 °	36.837512 °
				-120.314524 °	-120.309365 °
DWR ID	DWR_NA0010_18_f_2018_34				
Comment Code					
V1 : Control annual grass and weeds on the levee slopes and easements.					
Inspector Comment					
heavy vegetation on slope and toe

Heavy vegetation on landside slope. (Fall 2018)

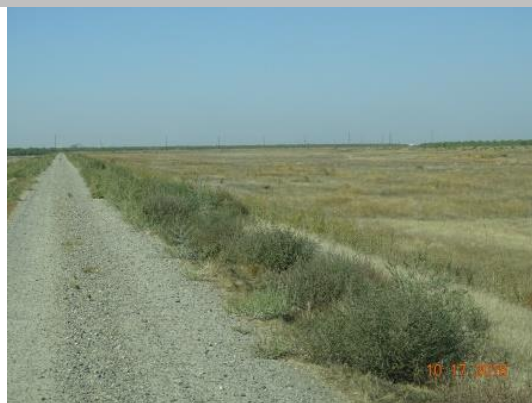
Photo 1 of 1 : FA_2018_NA0010_137_33_20181106_00039.jpg

LM Start	9.90	Rating **	U	Issue No.	33
LM End	10.14	Issue Type +	Ma	Location *	WS
Category	Earthen Levee			GPS Latitude/Longitude	
				Start	End
Item	Vegetation			36.839617 °	36.837166 °
				-120.311952 °	-120.308942 °
DWR ID	DWR_NA0010_18_f_2018_33				
Comment Code					
V1 : Control annual grass and weeds on the levee slopes and easements.					
Inspector Comment					
dense vegetation on shoulder

Dense vegetation on waterside shoulder. (Fall 2018)

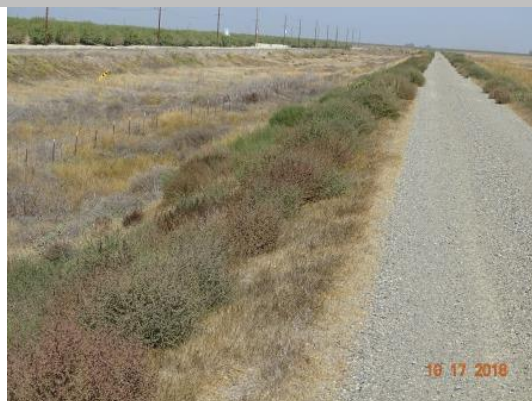
Photo 1 of 1 : FA_2018_NA0010_137_29_20181107_00040.jpg

LM Start	11.01	Rating **	U	Issue No.	29
LM End	11.80	Issue Type +	Ma	Location *	LS
Category	Earthen Levee			GPS Latitude/Longitude	
				Start	End
Item	Vegetation			36.827408°	36.816427°
				-120.300196°	-120.304655°
DWR ID	DWR_NA0010_18_f_2018_29				
Comment Code					
V1 : Control annual grass and weeds on the levee slopes and easements.					
Inspector Comment

Heavy brush on landside slope and toe. (Fall 2018)

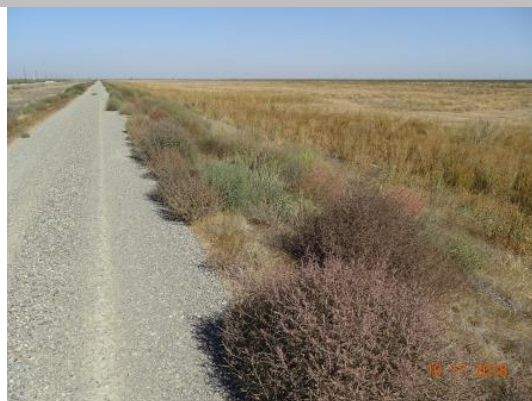
Photo 1 of 1 : FA_2018_NA0010_137_28_20181107_00041.jpg

LM Start	11.20	Rating **	U	Issue No.	28
LM End	11.93	Issue Type +	Ma	Location *	WS
Category	Earthen Levee			GPS Latitude/Longitude	
				Start	End
Item	Vegetation			36.824720°	36.814683°
				-120.301218°	-120.305377°
DWR ID	DWR_NA0010_18_f_2018_28				
Comment Code					
V1 : Control annual grass and weeds on the levee slopes and easements.					
Inspector Comment

Vegetation on shoulder and slope blocking view of waterside slope. (Fall 2018)

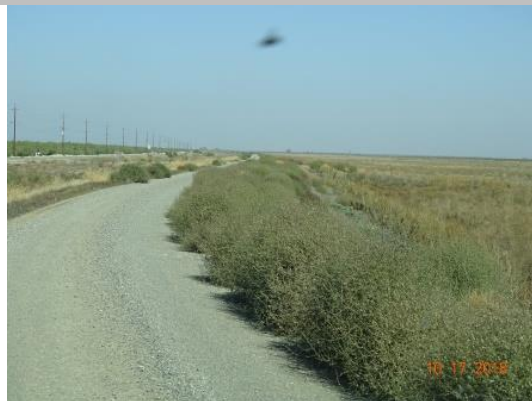
Photo 1 of 1 : FA_2018_NA0010_137_24_20181107_00042.jpg

LM Start	12.51	Rating **	U	Issue No.	24
LM End	12.63	Issue Type +	Ma	Location *	WS
Category	Earthen Levee			GPS Latitude/Longitude	
				Start	End
Item	Vegetation			36.806723 °	36.805148 °
				-120.308940 °	-120.309574 °
DWR ID	DWR_NA0010_18_f_2018_24				
Comment Code					
V1 : Control annual grass and weeds on the levee slopes and easements.					
Inspector Comment

Tall brush along waterside shoulder and slope. (Fall 2018)

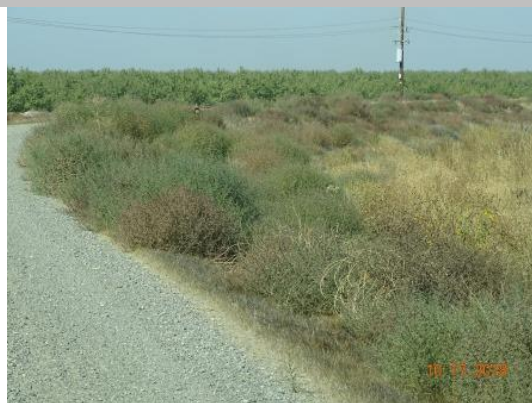
Photo 1 of 1 : FA_2018_NA0010_137_21_20181107_00043.jpg

LM Start	12.78	Rating **	U	Issue No.	21
LM End	13.41	Issue Type +	Ma	Location *	WS
Category	Earthen Levee			GPS Latitude/Longitude	
				Start	End
Item	Vegetation			36.802955 °	36.794182 °
				-120.309352 °	-120.307238 °
DWR ID	DWR_NA0010_18_f_2018_21				
Comment Code					
V1 : Control annual grass and weeds on the levee slopes and easements.					
Inspector Comment

dense vegetation on waterside shoulder and slope. (Fall 2018)

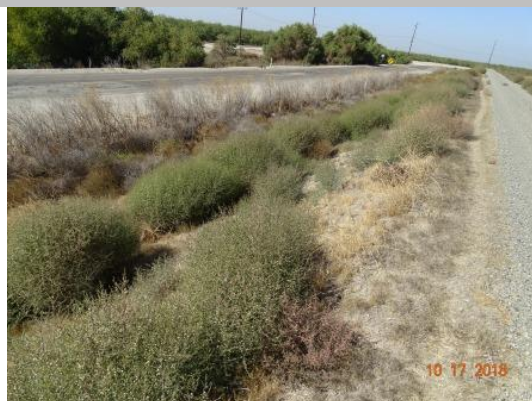
Photo 1 of 1 : FA_2018_NA0010_137_19_20181107_00044.jpg

LM Start	13.31	Rating **	U	Issue No.	19
LM End	13.49	Issue Type +	Ma	Location *	LS
Category	Earthen Levee			GPS Latitude/Longitude	
				Start	End
Item	Vegetation			36.795278 °	36.793455 °
				-120.308199 °	-120.306126 °
DWR ID	DWR_NA0010_18_f_2018_19				
Comment Code					
V1 : Control annual grass and weeds on the levee slopes and easements.					
Inspector Comment

Dense brush along landside slope. (Fall 2018)

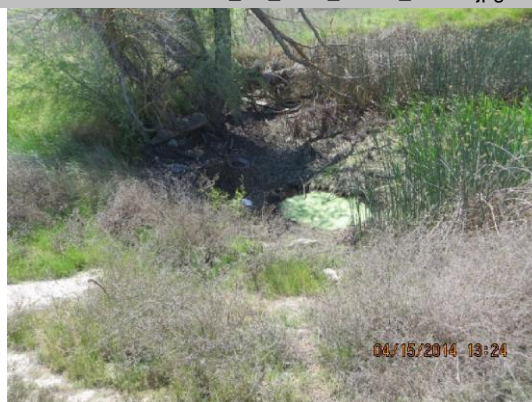
Photo 2 of 3 : UCIP_FA_2018_49959_61061.jpg

Concrete headwall at toe of LS slope.

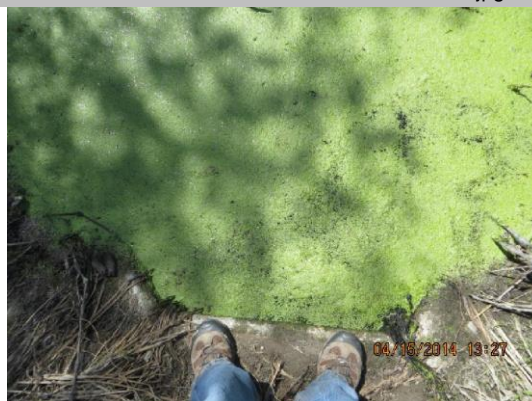
Photo 3 of 3 : UCIP_FA_2018_49959_61059.jpg

Comment Code						
Inspector Comment						
FS_ID:49959 DS_ID:19933 EP_NO: N/A Repair Type: Non-Urgent Crossing Status: Found UCIP Comments: 07/19/2016 Gate inside riser appears operable--riser lid damage. Crossing is not visible on LS due to dense vegetation. Recommend clearing dense vegetation along WS and LS slope and repairing riser cover. (DWR UCIP - omagana)04/15/2014 No actuator wheel on slide gate at WS shoulder. (DWR UCIP - wwylie) FIELD_STRUCT_DESC: 24-inch corrugated metal gravity drainage pipe through the levee, 14.8 feet below the crown. Slide gate in a 36-inch corrugated metal pipe (CMP) riser on the waterside (WS) slope. Concrete U-shaped headwall on each end. [Additional Reference(s): DWR Levee Log, 2002. USACE San Joaquin O&M Manual 601.1, 1967, (HLM 0.10)]. FS Date: 7/19/2016

Concrete headwall at LS toe.

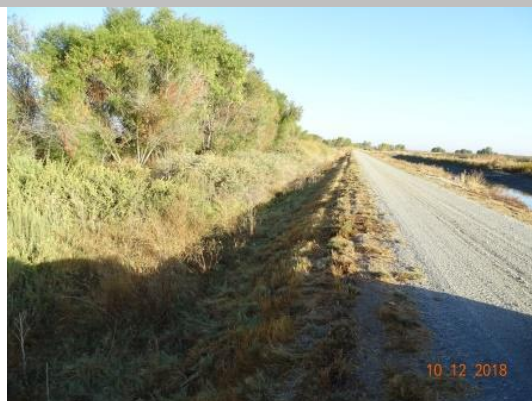
Photo 1 of 2 : FA_2018_NA0010_138_21_20181107_00037.jpg

LM Start	0.53	Rating **	U	Issue No.	21
LM End	0.63	Issue Type +	Ma	Location *	LS
Category	Earthen Levee			GPS Latitude/Longitude	
				Start	End
Item	Vegetation			37.212980 °	37.214418 °
				-120.698027 °	-120.698173 °
DWR ID	DWR_NA0010_22A_f_2014_21				
Comment Code					
V2 : Remove the wild growth other than native grasses from the levee slopes.					
Inspector Comment					
Clear vegetation 10 feet off of landside toe.

Dense vegetation on landside slope. (Fall 2018)

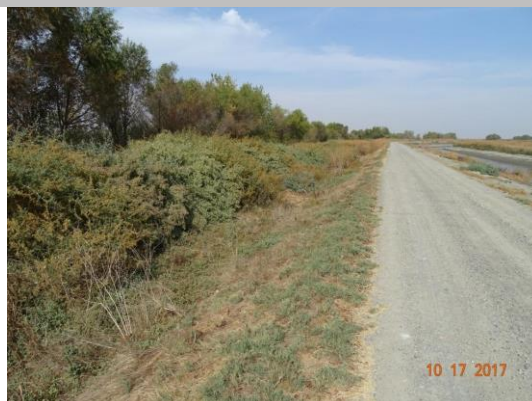
Photo 2 of 2 : FA_2018_NA0010_138_21_20180911_00020.jpg

LM Start	0.53	Rating **	U	Issue No.	21 (cont)	
LM End	0.63	Issue Type +	Ma	Location *	LS	
Category	Earthen Levee			GPS Latitude/Longitude		
				Start		End
Item	Vegetation			37.212980 °		37.214418 °
				-120.698027 °		-120.698173 °
DWR ID	DWR_NA0010_22A_f_2014_21					
Comment Code						
V2 : Remove the wild growth other than native grasses from the levee slopes.						
Inspector Comment						
Clear vegetation 10 feet off of landside toe.

Looking northwest at the landside slope.

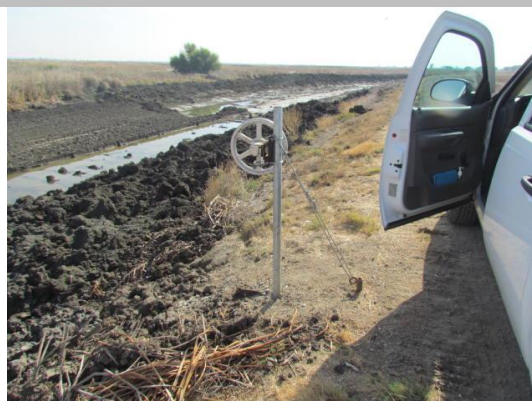
Photo 1 of 1 : FA_2018_NA0010_138_23_20180911_00023.jpg

LM Start	0.87	Rating **	M	Issue No.	23
LM End	0.87	Issue Type +	En	Location *	WS
Category	Earthen Levee			GPS Latitude/Longitude	
				Start	End
Item	Encroachments			37.217802°	37.217802°
				-120.697416°	-120.697416°
DWR ID	DWR_NA0010_22A_f_2014_23				
Comment Code					
SI : Sign					
Inspector Comment					
Pulley on waterside shouder without board permit.

Looking south at pulley on waterward shoulder.

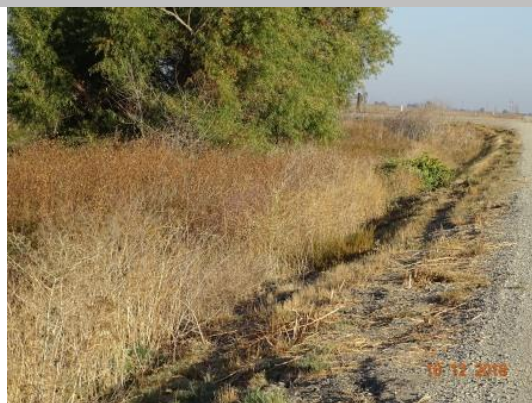
Photo 1 of 1 : FA_2018_NA0010_138_19_20181107_00038.jpg

LM Start	0.87	Rating **	M	Issue No.	19
LM End	0.93	Issue Type +	Ma	Location *	LS
Category	Earthen Levee			GPS Latitude/Longitude	
				Start	End
Item	Vegetation			37.217887 °	37.218624 °
				-120.697461 °	-120.697691 °
DWR ID	DWR_NA0010_22A_f_2018_19				
Comment Code					
V1 : Control annual grass and weeds on the levee slopes and easements.					
Inspector Comment					
tall grass blocking landside toe.

view of landside slope and toe. (Fall 2018)

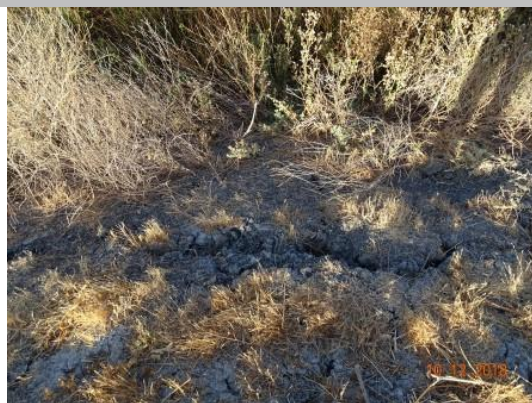
Photo 1 of 2 : FA_2018_NA0010_138_20_20181107_00039.jpg

LM Start	0.90	Rating **	A/W	Issue No.	20
LM End	0.90	Issue Type +	Ma	Location *	LS
Category	Earthen Levee			GPS Latitude/Longitude	
				Start	End
Item	Cracking			37.218269 °	37.218270 °
				-120.697563 °	-120.697565 °
DWR ID	DWR_NA0010_22A_f _ 2018_20				
Comment Code					
CR1 : Monitor and have inspected by geotechnical engineer.					
Inspector Comment					
cracking along landside slope about 50' in length

View of crack along landside shoulder. (Fall 2018)

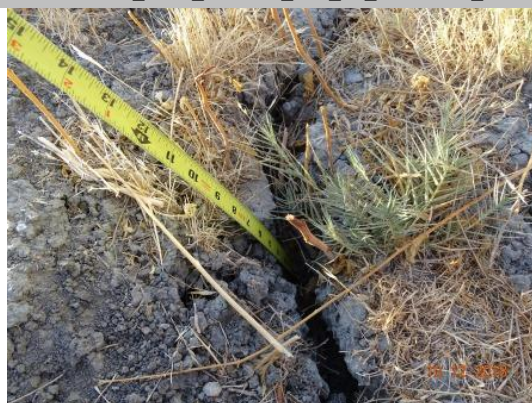
Photo 2 of 2 : FA_2018_NA0010_138_20_20181107_00040.jpg

view of average depth of crack. (Fall 2018)

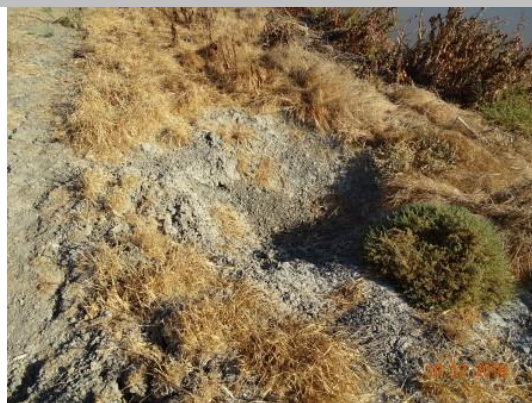
Photo 1 of 1 : FA_2018_NA0010_138_22_20181107_00042.jpg

LM Start	1.04	Rating **	M	Issue No.	22
LM End	1.04	Issue Type +	Ma	Location *	WS
Category	Earthen Levee			GPS Latitude/Longitude	
				Start	End
Item	Erosion / Bank Caving			37.220281 °	37.220281 °
				-120.698287 °	-120.698287 °
DWR ID	DWR_NA0010_22A_f_2018_22				
Comment Code					
E1 : Note and monitor erosion site.					
Inspector Comment					
depressions in waterside slope

View of depression on waterside slope. (Fall 2018)

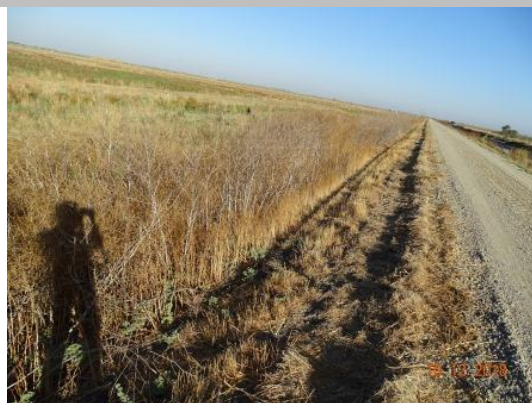
Photo 1 of 1 : FA_2018_NA0010_138_25_20181107_00043.jpg

LM Start	1.39	Rating **	M	Issue No.	25
LM End	1.44	Issue Type +	Ma	Location *	LS
Category	Earthen Levee			GPS Latitude/Longitude	
				Start	End
Item	Vegetation			37.225088 °	37.225781 °
				-120.700055 °	-120.700305 °
DWR ID	DWR_NA0010_22A_f_2018_25				
Comment Code					
V1 : Control annual grass and weeds on the levee slopes and easements.					
Inspector Comment					
Tall grass blocking landside toe

tall grass on landside toe. (Fall 2018)

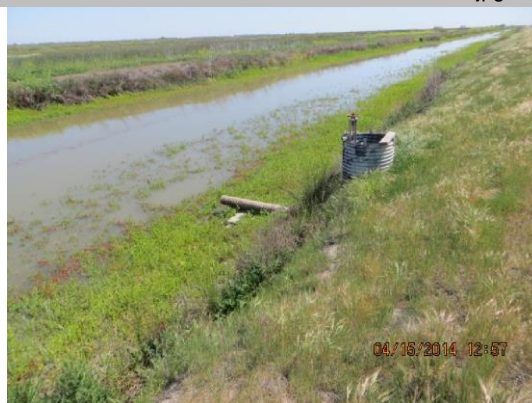
Photo 1 of 3 : UCIP_FA_2018_33733_61030.jpg

Comment Code						
Inspector Comment						
FS_ID:33733						
DS_ID:19936						
EP_NO: N/A						
Repair Type: Non-Urgent						
Crossing Status: Found						
UCIP Comments: 04/15/2014 Slide gate rusted and does not function.						
Headwall burried at LS toe. Pipe appears abandoned and if so should be done so properly. (DWR UCIP - W. Wylie)						
FIELD_STRUCT_DESC: 8-inch corrugated metal gravity irrigation pipe through the levee, 7 feet below the crown. Slide gate in a 36-inch corrugated metal pipe (CMP) riser on the waterside (WS) slope.						
Concrete headwall on the landside (LS) end. [Additional Reference(s): DWR Levee Log, 2002. USACE San Joaquin O&M Manual 601.1, 1967, (HLM 1.57)].						
FS Date: 4/15/2014

Pipe and CMP riser with slide gate visible on WS slope.

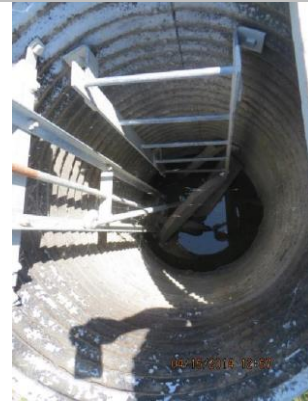
Photo 2 of 3 : UCIP_FA_2018_33733_61029.jpg

Inside CMP riser on WS shoulder.

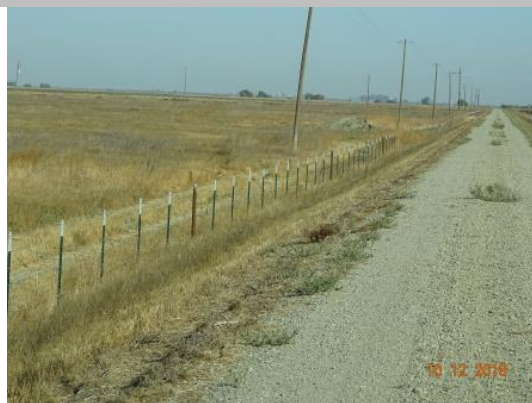
Photo 1 of 1 : FA_2018_NA0010_138_28_20181107_00044.jpg

LM Start	1.75	Rating **	M	Issue No.	28
LM End	2.60	Issue Type +	En	Location *	LS
Category	Earthen Levee			GPS Latitude/Longitude	
				Start	End
Item	Encroachments			37.230585 °	37.242371 °
				-120.702045 °	-120.706371 °
DWR ID	DWR_NA0010_22A_f_2018_28				
Comment Code					
FE : Fence					
Inspector Comment					
Fence along landside toe

View of fence along landside toe. (Fall 2018)

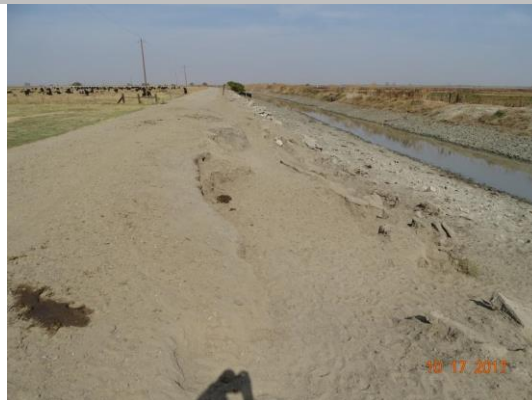
Photo 2 of 3 : FA_2018_NA0010_138_7_20180911_00005.jpg

LM Start	2.65	Rating **	U	Issue No.	7 (cont)	
LM End	2.65	Issue Type +	Ma	Location *	WS	
Category	Earthen Levee			GPS Latitude/Longitude		
				Start		End
Item	Erosion / Bank Caving			37.242595°	37.242595°	
				-120.706470°	-120.706470°	
DWR ID	DWR_NA0010_22A_s_2017_7					
Comment Code						
E2 : Schedule repair of erosion site prior to the next inspection.						
Inspector Comment						
Erosion cutting into crown

Looking northwest at the waterside shoulder. (Fall 2017)

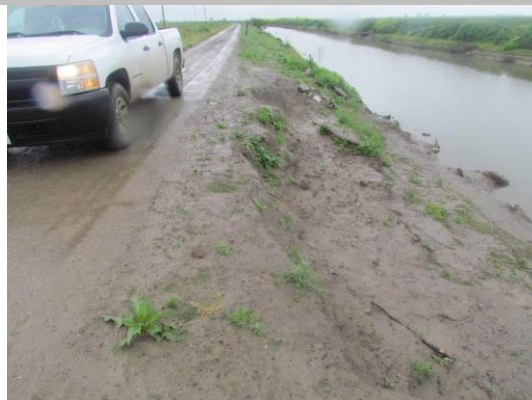
Photo 3 of 3 : FA_2018_NA0010_138_7_20180911_00006.jpg

Looking downstream at erosion on waterward shoulder and slope.

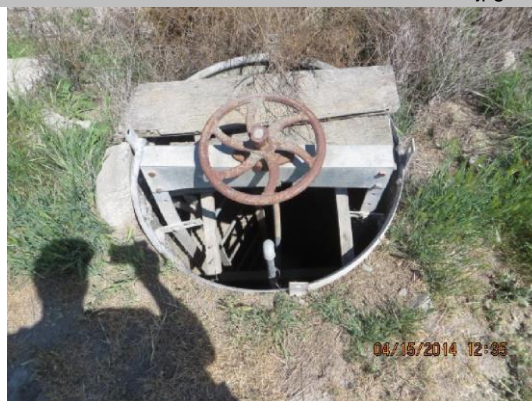
Photo 1 of 3 : UCIP_FA_2018_33732_61026.jpg

Comment Code						
Inspector Comment						
FS_ID:33732						
DS_ID:19937						
EP_NO: N/A						
Repair Type: Non-Urgent						
Crossing Status: Found						
UCIP Comments: 04/15/2014 Slide gate does not function and should be repaired. Headwall at LS toe not found. (DWR UCIP - W. Wylie)						
FIELD_STRUCT_DESC: 24-inch corrugated metal irrigation siphon pipe through the levee, 7.5 feet below the crown. Slide gate in a 36-inch corrugated metal pipe (CMP) riser on the waterside (WS) slope.						
Concrete U-shaped headwall on the landside (LS) end. [Additional Reference(s): DWR Levee Log, 2002. USACE San Joaquin O&M Manual 601.1, 1967, (HLM 2.72)].						
FS Date: 4/15/2014

Slidegate in CMP riser on WS shoulder. (Note: actuator does not work).

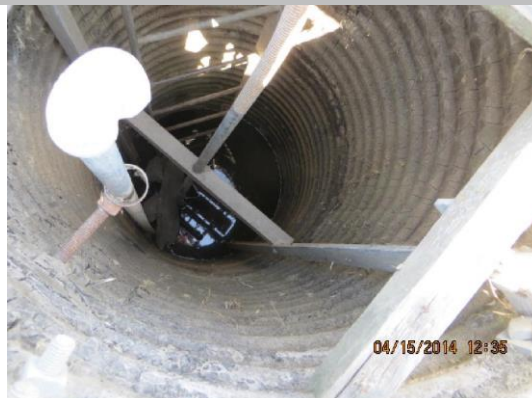
Photo 2 of 3 : UCIP_FA_2018_33732_61024.jpg

Inside CMP riser on WS shoulder.

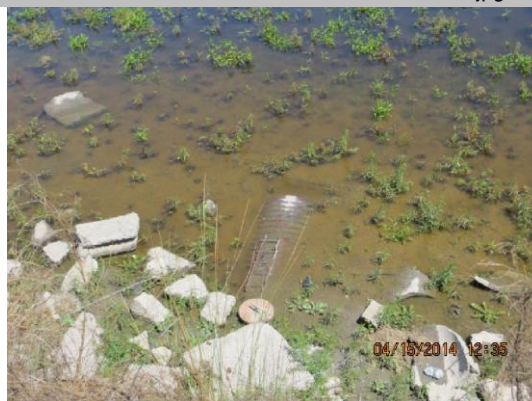
Photo 3 of 3 : UCIP_FA_2018_33732_61025.jpg

Pipe visible on WS toe.

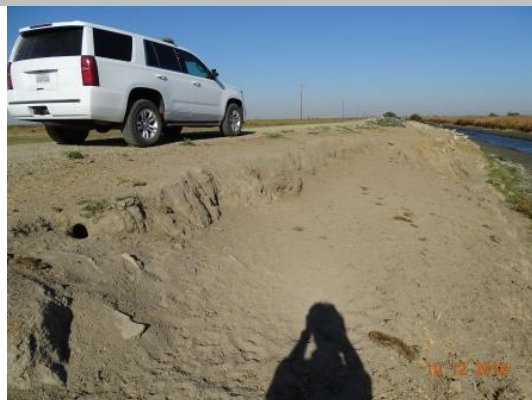
Photo 1 of 2 : FA_2018_NA0010_138_30_20181107_00048.jpg

LM Start	2.82	Rating **	U	Issue No.	30
LM End	2.83	Issue Type +	Ma	Location *	WS
Category	Earthen Levee			GPS Latitude/Longitude	
				Start	End
Item	Erosion / Bank Caving			37.244940 °	37.245050 °
				-120.707467 °	-120.707567 °
DWR ID	DWR_NA0010_22A_f_2018_30				
Comment Code					
E2 : Schedule repair of erosion site prior to the next inspection.					
Inspector Comment					
erosion into waterside bank

View of erosion in waterside slope. (Fall 2018)

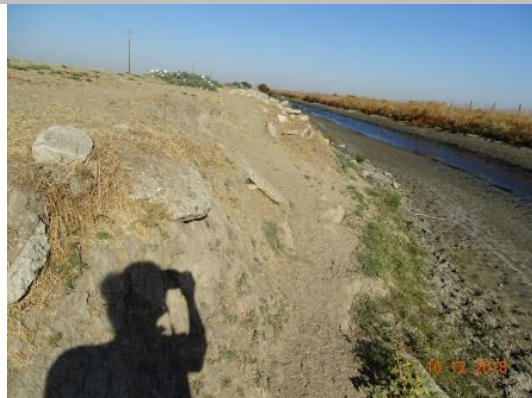
Photo 2 of 2 : FA_2018_NA0010_138_30_20181107_00049.jpg

LM Start	2.82	Rating **	U	Issue No.	30 (cont)	
LM End	2.83	Issue Type +	Ma	Location *	WS	
Category	Earthen Levee			GPS Latitude/Longitude		
				Start		End
Item	Erosion / Bank Caving			37.244940 °		37.245050 °
				-120.707467 °		-120.707567 °
DWR ID	DWR_NA0010_22A_f _ 2018_30					
Comment Code						
E2 : Schedule repair of erosion site prior to the next inspection.						
Inspector Comment						
erosion into waterside bank

View along waterside slope. (Fall 2018)

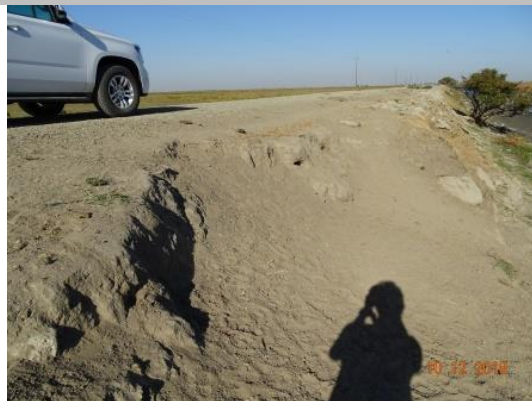
Photo 1 of 1 : FA_2018_NA0010_138_31_20181107_00050.jpg

LM Start	2.87	Rating **	U	Issue No.	31
LM End	2.87	Issue Type +	Ma	Location *	WS
Category	Earthen Levee			GPS Latitude/Longitude	
				Start	End
Item	Erosion / Bank Caving			37.245536 °	37.245536 °
				-120.708119 °	-120.708119 °
DWR ID	DWR_NA0010_22A_f_2018_31				
Comment Code					
E1 : Note and monitor erosion site.					
Inspector Comment					
erosion into waterside shoulder

View of waterside slope looking downstream. (Fall 2018)

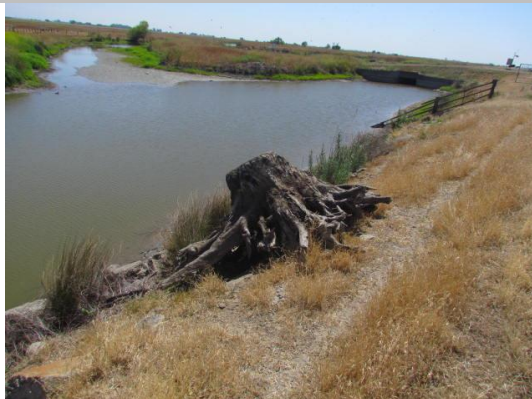
Photo 1 of 1 : FA_2018_NA0010_138_259_20180911_00024.jpg

Looking east at dead stump on waterward slope.

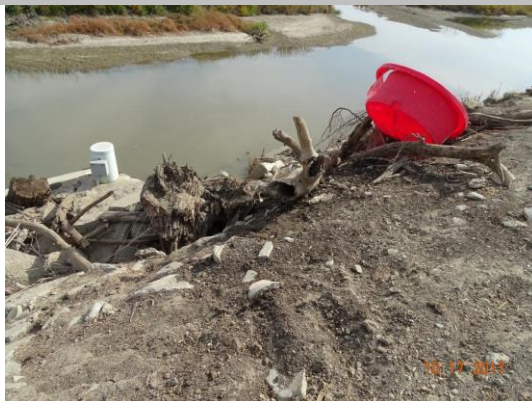
Photo 1 of 1 : FA_2018_NA0010_138_13_20180911_00015.jpg

Looking northeast at the waterside slope.

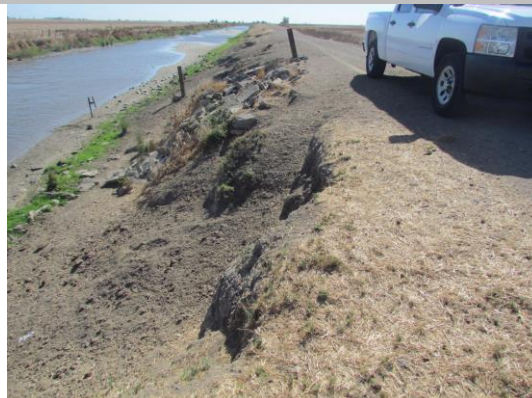
Photo 2 of 4 : FA_2018_NA0010_138_8_20180911_00008.jpg

LM Start	4.87	Rating **	A/W	Issue No.	8 (cont)	
LM End	4.87	Issue Type +	Ma	Location *	WS	
Category	Earthen Levee			GPS Latitude/Longitude		
				Start		End
Item	Slope Stability			37.265813 °		37.265813 °
				-120.733748 °		-120.733748 °
DWR ID	DWR_NA0010_22A_f _ 2016_8					
Comment Code						
S1 : Repair slope instability.						
Inspector Comment						
Levee damage caused by animal traffic. Several site repaired with broken concrete. But other sites still need repairing.

Looking downstream at animal erosion on waterward slope.

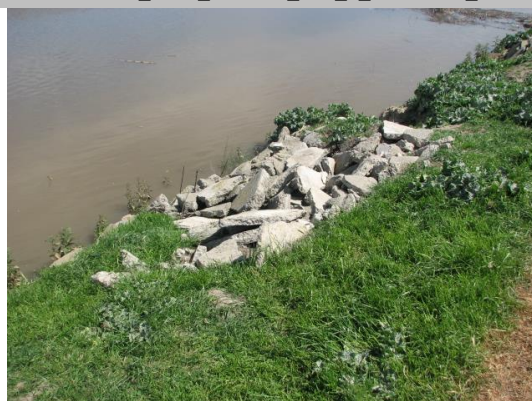
Photo 3 of 4 : FA_2018_NA0010_138_8_20180911_00009.jpg

Looking downstream at repaired site with concrete rubble on waterward slope. (Spring 2018)

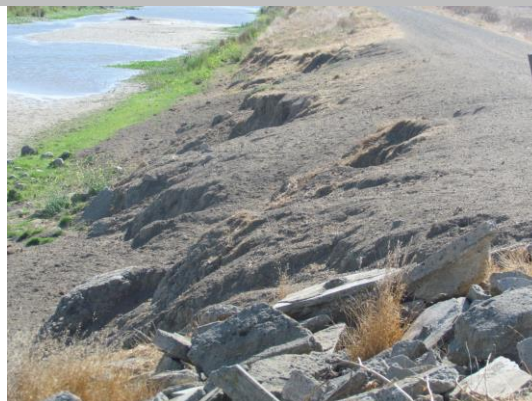
Photo 4 of 4 : FA_2018_NA0010_138_8_20180911_00010.jpg

Looking downstream at animal erosion on waterward slope.

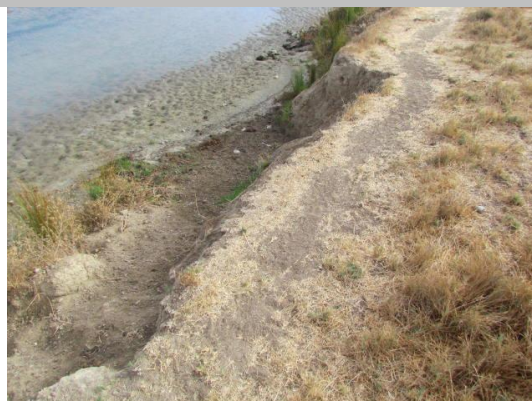
Photo 1 of 2 : FA_2018_NA0010_138_4_20180911_00001.jpg

LM Start	5.05	Rating **	M	Issue No.	4
LM End	5.05	Issue Type +	Ma	Location *	WS
Category	Earthen Levee			GPS Latitude/Longitude	
				Start	End
Item	Erosion / Bank Caving			37.267516 °	37.267516 °
				-120.736401 °	-120.736401 °
DWR ID	DWR_NA0010_22A_f _ 2013_4				
Comment Code					
E2 : Schedule repair of erosion site prior to the next inspection.					
Inspector Comment					
Erosion caused by animal traffic.

Looking southeast at livestock erosion on waterward toe.

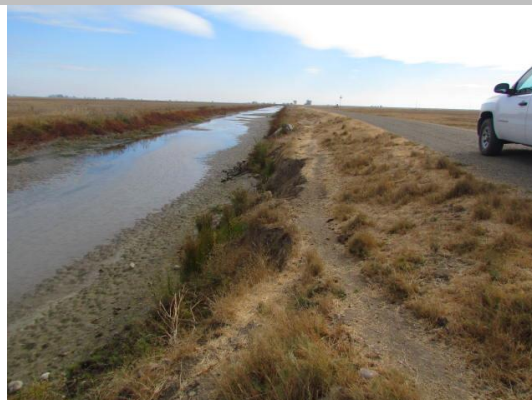
Photo 2 of 2 : FA_2018_NA0010_138_4_20180911_00002.jpg

Looking southeast at livestock erosion on waterward toe.

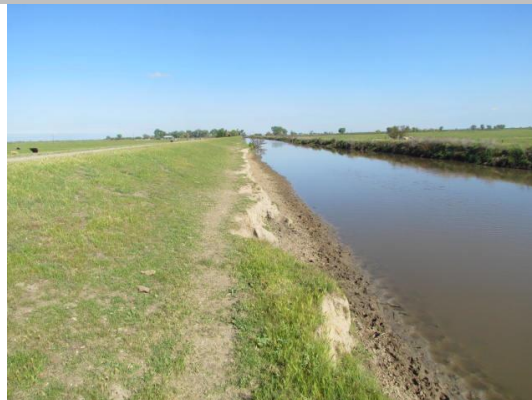
Photo 2 of 2 : FA_2018_NA0010_138_6_20180911_00004.jpg

LM Start	5.12	Rating **	M	Issue No.	6 (cont)	
LM End	5.20	Issue Type +	Ma	Location *	WS	
Category	Earthen Levee			GPS Latitude/Longitude		
				Start		End
Item	Slope Stability			37.268236 °		37.269124 °
				-120.737210 °		-120.738200 °
DWR ID	DWR_NA0010_22A_s_2012_6					
Comment Code						
S2 : Repair the levee slope damaged by foot traffic and prevent access where possible.						
Inspector Comment						
Slope damage caused by livestock on waterside toe.

Looking northwest at livestock erosion along waterside slope and toe.

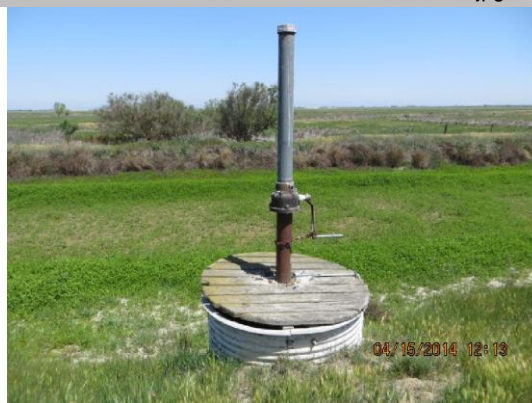
Photo 1 of 3 : UCIP_FA_2018_39536_61022.jpg

Comment Code						
Inspector Comment						
FS_ID:39536						
DS_ID:19938						
EP_NO: N/A						
Repair Type: Non-Urgent						
Crossing Status: Found						
UCIP Comments: 04/15/2014 Need to contact owner. Pipe silted in on						
LS toe. Appears abandoned and if so should be done so properly.						
(DWR UCIP - W. Wylie)						
FIELD_STRUCT_DESC: 48-inch corrugated metal irrigation siphon pipe						
through the levee, 10 feet below the crown. Slide gate in a 60-inch						
corrugated metal pipe (CMP) riser on the waterside (WS) slope.						
Concrete headwall on the landside (LS) end. WS end capped with a

Slidegate inside riser on WS shoulder.

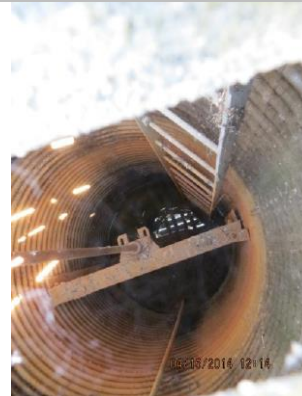
Photo 2 of 3 : UCIP_FA_2018_39536_61021.jpg

Inside riser on WS shoulder.

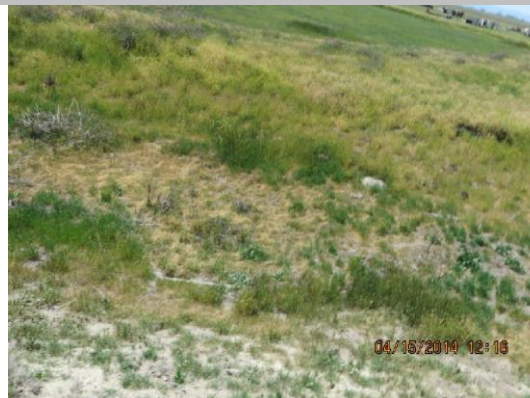
Photo 3 of 3 : UCIP_FA_2018_39536_61020.jpg

Buried headwall on LS toe.

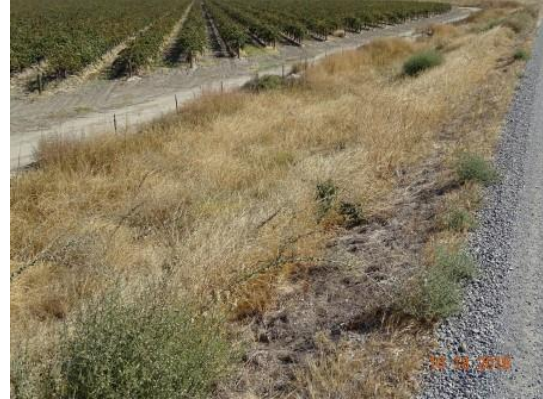
Photo 1 of 1 : FA_2018_NA0010_139_30_20181107_00041.jpg

LM Start	0.07	Rating **	U	Issue No.	30
LM End	0.60	Issue Type +	Ma	Location *	LS
Category	Earthen Levee			GPS Latitude/Longitude	
				Start	End
Item	Vegetation			36.773755 °	36.774357 °
				-120.282757 °	-120.274986 °
DWR ID	DWR_NA0010_23_f _ 2018_30				
Comment Code					
V1 : Control annual grass and weeds on the levee slopes and easements.					
Inspector Comment

Tall grass along landside slope. (Fall 2018)

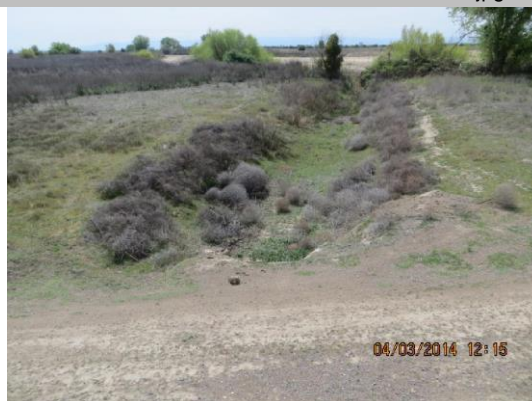
Photo 1 of 3 : UCIP_FA_2018_39537_59860.jpg

Comment Code					
Inspector Comment					
FS_ID:39537 DS_ID:19945 EP_NO: N/A Repair Type: Non-Urgent Crossing Status: Found UCIP Comments: 04/03/2014 Excessive vegetation at inlet--recommend clearing. (DWR UCIP - W. Wylie) FIELD_STRUCT_DESC: 30-inch by 30-inch square reinforced concrete box gravity drainage culvert through the levee, 13 feet below the crown. Flap gate on the waterside (WS) end. Concrete headwall on the landside (LS) end. Concrete U-shaped headwall on the WS end. (Plans to construct a new discharge structure and to rehabilitate one existing diversion structure to return intercepted seepage to the San Joaquin River authorized under Permit No. 13085, 1981 - Diener, Dry River Farms). [Additional Reference(s): DWR Levee Log, 2002. USACE San Joaquin O&M Manual 601.1, 1967, (HLM 0.21)]. FS Date: 4/3/2014

Concrete headwall on WS toe at channel.

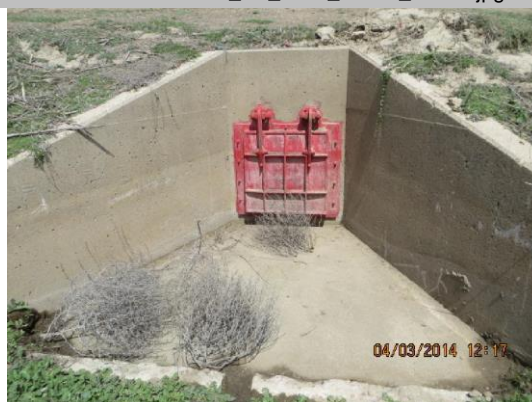
Photo 2 of 3 : UCIP_FA_2018_39537_59859.jpg

Flapgate on Concrete headwall at WS toe.

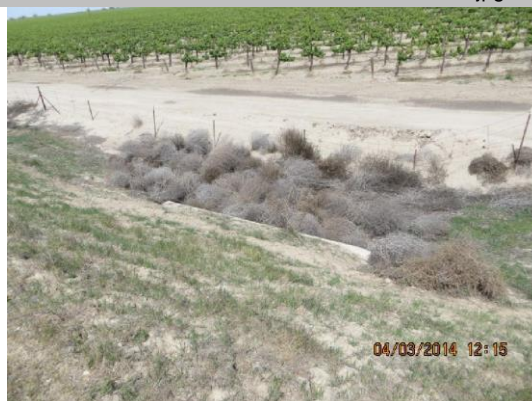
Photo 3 of 3 : UCIP_FA_2018_39537_59861.jpg

Comment Code						
Inspector Comment						
FS_ID:39537						
DS_ID:19945						
EP_NO: N/A						
Repair Type: Non-Urgent						
Crossing Status: Found						
UCIP Comments: 04/03/2014 Excessive vegetation at inlet--						
recommend clearing. (DWR UCIP - W. Wylie)						
FIELD_STRUCT_DESC: 30-inch by 30-inch square reinforced concrete						
box gravity drainage culvert through the levee, 13 feet below the crown.						
Flap gate on the waterside (WS) end. Concrete headwall on the						
landside (LS) end. Concrete U-shaped headwall on the WS end. (Plans						
to construct a new discharge structure and to rehabilitate one existing						
diversion structure to return intercepted seepage to the San Joaquin						
River authorized under Permit No. 13085, 1981 - Diener, Dry River						
Farms). [Additional Reference(s): DWR Levee Log, 2002. USACE San						
Joaquin O&M Manual 601.1, 1967, (HLM 0.21)].						
FS Date: 4/3/2014

Concrete headwall at LS toe. Excess vegetation buildup at inlet.

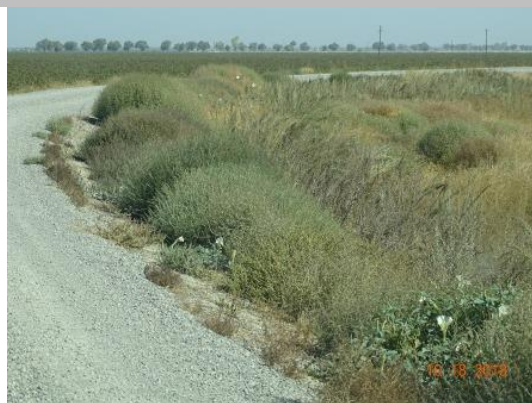
Photo 1 of 1 : FA_2018_NA0010_139_40_20181107_00043.jpg

LM Start	0.60	Rating **	U	Issue No.	40
LM End	4.16	Issue Type +	Ma	Location *	WS
Category	Earthen Levee			GPS Latitude/Longitude	
				Start	End
Item	Vegetation			36.774405 °	36.784276 °
				-120.274904 °	-120.228374 °
DWR ID	DWR_NA0010_23_f_2018_40				
Comment Code					
V1 : Control annual grass and weeds on the levee slopes and easements.					
Inspector Comment

Heavy vegetation on waterside slope. (Fall 2018)

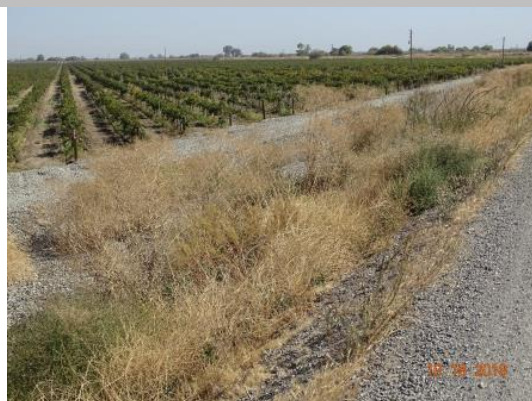
Photo 1 of 1 : FA_2018_NA0010_139_42_20181107_00044.jpg

LM Start	0.76	Rating **	U	Issue No.	42
LM End	3.02	Issue Type +	Ma	Location *	LS
Category	Earthen Levee			GPS Latitude/Longitude	
				Start	End
Item	Vegetation			36.774539 °	36.771551 °
				-120.272288 °	-120.240577 °
DWR ID	DWR_NA0010_23_f_2018_42				
Comment Code					
V1 : Control annual grass and weeds on the levee slopes and easements.					
Inspector Comment

Tall dense vegetation on landside slope. (Fall 2018)

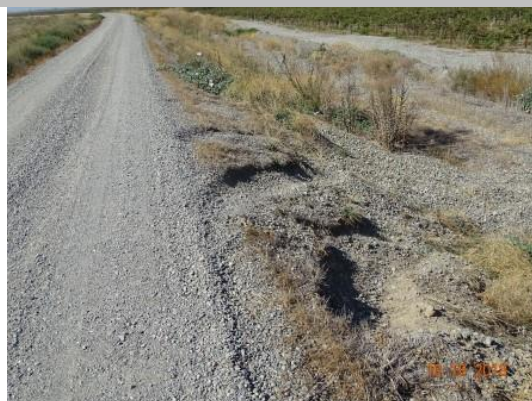
Photo 1 of 1 : FA_2018_NA0010_139_43_20181107_00045.jpg

LM Start	0.81	Rating **	M	Issue No.	43
LM End	0.81	Issue Type +	Ma	Location *	LS
Category	Earthen Levee			GPS Latitude/Longitude	
				Start	End
Item	Slope Stability			36.774170 °	36.774170 °
				-120.271461 °	-120.271461 °
DWR ID	DWR_NA0010_23_f_2018_43				
Comment Code					
S1 : Repair slope instability.					
Inspector Comment

damage to landside slope. (Fall 2018)

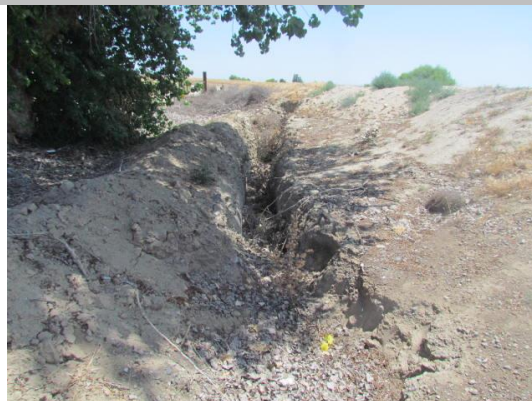
Photo 1 of 3 : FA_2018_NA0010_139_29_20180911_00011.jpg

LM Start	1.53	Rating **	U	Issue No.	29
LM End	1.53	Issue Type +	En	Location *	LS
Category	Earthen Levee			GPS Latitude/Longitude	
				Start	End
Item	Encroachments			36.772041 °	36.772041 °
				-120.259549 °	-120.259549 °
DWR ID	DWR_NA0010_23_f_2014_29				
Comment Code					
DT : Ditch					
Inspector Comment					
Trench at landside toe. Trench is ten to twelve inches wide and twenty feet long.

Looking southeast at trench at landward toe. (Spring 2015)

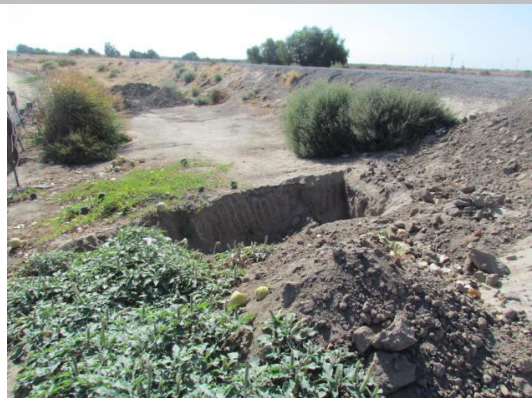
Photo 2 of 3 : FA_2018_NA0010_139_24_20180911_00005.jpg

LM Start	1.54	Rating **	U	Issue No.	24 (cont)	
LM End	1.54	Issue Type +	En	Location *	LS	
Category	Earthen Levee			GPS Latitude/Longitude		
				Start		End
Item	Encroachments			36.771922 °	36.771922 °	
				-120.259321 °	-120.259321 °	
DWR ID	DWR_NA0010_23_f_2015_24					
Comment Code						
DT : Ditch						
Inspector Comment						
Landowner digging at landside berm.

Looking southeast at large pot hole on landward berm.

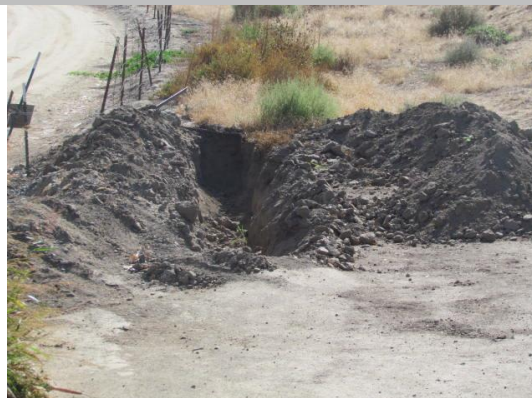
Photo 3 of 3 : FA_2018_NA0010_139_24_20180911_00006.jpg

Looking southeast at trench on landward berm.

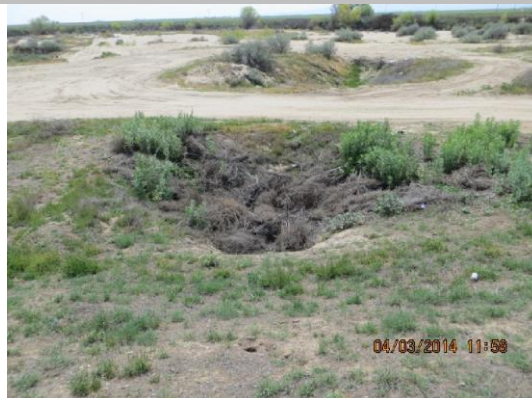
Photo 1 of 3 : UCIP_FA_2018_39538_59855.jpg

Comment Code						
Inspector Comment						
FS_ID:39538						
DS_ID:19948						
EP_NO: N/A						
Repair Type: Non-Urgent						
Crossing Status: Found						
UCIP Comments: 04/03/2014 Appears abandoned and if so should be done properly. Discharge channel is blocked by sand and soil making drain ineffective. Soil buildup at inlet on LS toe. Need to contact owner. (DWR UCIP - W. Wylie)						
FIELD_STRUCT_DESC: 30-inch by 30-inch square reinforced concrete box gravity drainage culvert through the levee, 11 feet below the crown. Flap gate on the waterside (WS) end. Concrete headwall on the landside (LS) end. Concrete U-shaped headwall on the WS end. [Additional Reference(s): DWR Levee Log, 2002].						
FS Date: 4/3/2014

Concrete headwall on WS toe.

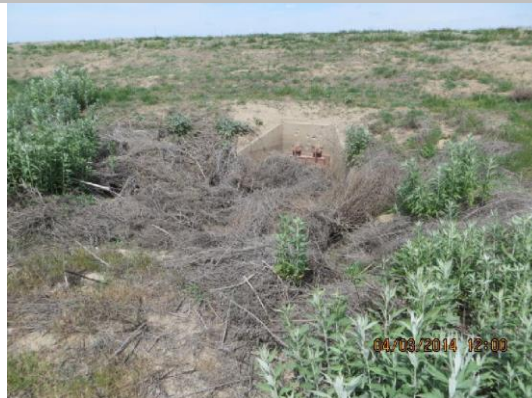
Photo 2 of 3 : UCIP_FA_2018_39538_59857.jpg

Flapgate on Concrete headwall at WS toe.

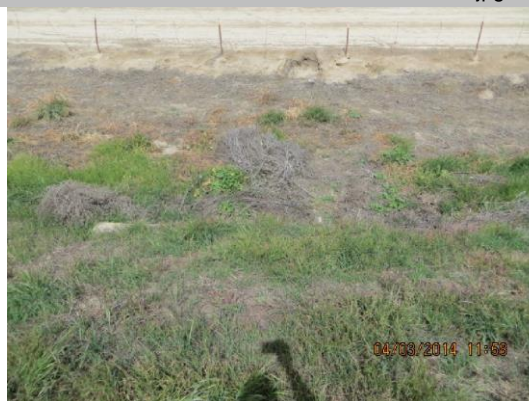
Photo 3 of 3 : UCIP_FA_2018_39538_59856.jpg

Comment Code						
Inspector Comment						
FS_ID:39538 DS_ID:19948 EP_NO: N/A Repair Type: Non-Urgent Crossing Status: Found UCIP Comments: 04/03/2014 Appears abandoned and if so should be done properly. Discharge channel is blocked by sand and soil making drain ineffective. Soil buildup at inlet on LS toe. Need to contact owner. (DWR UCIP - W. Wylie) FIELD_STRUCT_DESC: 30-inch by 30-inch square reinforced concrete box gravity drainage culvert through the levee, 11 feet below the crown. Flap gate on the waterside (WS) end. Concrete headwall on the landside (LS) end. Concrete U-shaped headwall on the WS end. [Additional Reference(s): DWR Levee Log, 2002]. FS Date: 4/3/2014

Concrete headwall on LS toe.
