**Flood Control Project Maintenance
Levee Inspections**

Fall 2018 Levee Maintenance Deficiency Summary Report

San Joaquin River Basin

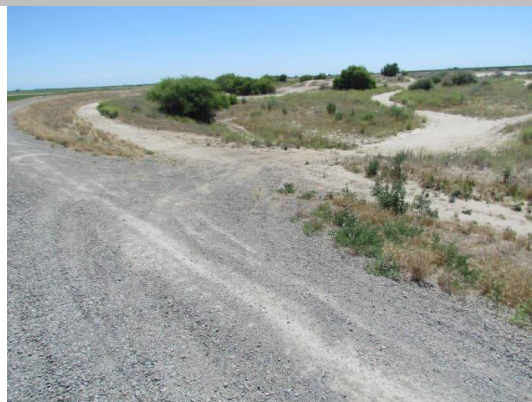
Photo 1 of 1 : FA_2018_NA0010_139_16_20180911_00003.jpg

LM Start	2.12	Rating **	M	Issue No.	16
LM End	2.12	Issue Type +	Ma	Location *	WS
Category	Earthen Levee			GPS Latitude/Longitude	
				Start	End
Item	Slope Stability			36.775507 °	36.775507 °
				-120.251670 °	-120.251672 °
DWR ID	DWR_NA0010_23_s_2013_16				
Comment Code					
S3 : Repair the levee slope damaged by vehicle traffic and prevent access where possible.					
Inspector Comment					
Several damaged sites within this reach. Damage caused by vehicle traffic. At. LM. 2.12, 2.21, 2.37, 2.41, & 2.47

Looking west at one of several slope damaged cause by vehicle traffic.

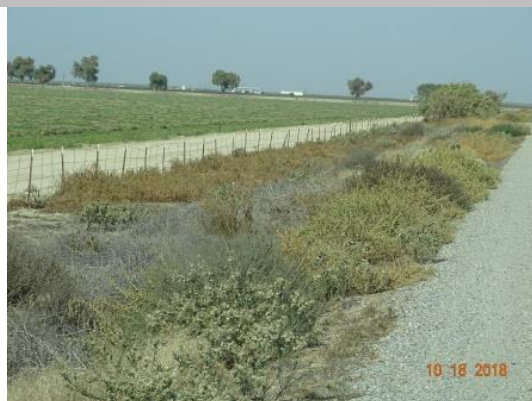
Photo 1 of 1 : FA_2018_NA0010_139_45_20181107_00046.jpg

LM Start	3.31	Rating **	U	Issue No.	45
LM End	4.22	Issue Type +	Ma	Location *	LS
Category	Earthen Levee			GPS Latitude/Longitude	
				Start	End
Item	Vegetation			36.774513 °	36.784144 °
				-120.234694 °	-120.227177 °
DWR ID	DWR_NA0010_23_f_2018_45				
Comment Code					
V1 : Control annual grass and weeds on the levee slopes and easements.					
Inspector Comment

vegetation blocking view of landside slope and toe. (Fall 2018)

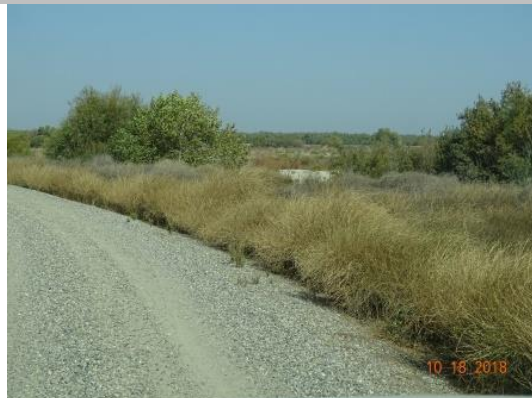
Photo 1 of 1 : FA_2018_NA0010_139_46_20181107_00047.jpg

LM Start	4.55	Rating **	U	Issue No.	46
LM End	4.97	Issue Type +	Ma	Location *	WS
Category	Earthen Levee			GPS Latitude/Longitude	
				Start	End
Item	Vegetation			36.785449 °	36.790609 °
				-120.221887 °	-120.218767 °
DWR ID	DWR_NA0010_23_f_2018_46				
Comment Code					
V1 : Control annual grass and weeds on the levee slopes and easements.					
Inspector Comment					
Shoulder is clear of vegetation but tall vegetation on slope blocking view.

tall brush on waterside slope. (Fall 2018)

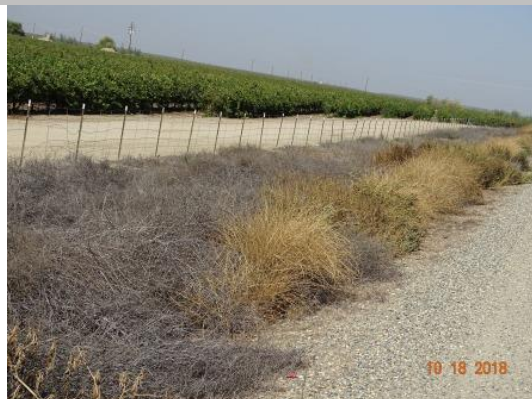
Photo 1 of 1 : FA_2018_NA0010_139_48_20181107_00048.jpg

LM Start	4.59	Rating **	U	Issue No.	48
LM End	5.25	Issue Type +	Ma	Location *	LS
Category	Earthen Levee			GPS Latitude/Longitude	
				Start	End
Item	Vegetation			36.785881°	36.791432°
				-120.221680°	-120.213875°
DWR ID	DWR_NA0010_23_f_2018_48				
Comment Code					
V1 : Control annual grass and weeds on the levee slopes and easements.					
Inspector Comment

heavy vegetation on landside slope and toe. (Fall 2018)

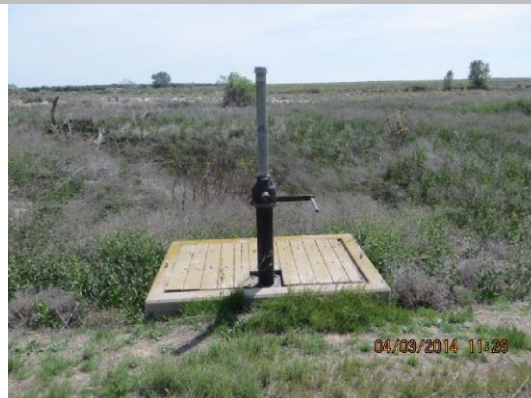
Photo 1 of 3 : UCIP_FA_2018_39540_59848.jpg

LM Start	4.85	Rating **	M	Issue No.	62
LM End	4.85	Issue Type +	En	Location *	
Category	Supplemental			GPS Latitude/Longitude	
				Start	End
Item	DWR UCIP Field Study			36.789550 °	36.789550 °
				-120.220367 °	-120.220367 °
DWR ID	19953				
Comment Code					
Inspector Comment					
FS_ID:39540 DS_ID:19953 EP_NO: N/A Repair Type: Non-Urgent Crossing Status: Found UCIP Comments: 04/03/2014 Heavy vegetation at inlet and outlet-- recommend clearing. (DWR UCIP - W. Wylie) FIELD_STRUCT_DESC: 30-inch by 30-inch square reinforced concrete box gravity irrigation culvert through the levee, 10.7 feet below the crown. 4.5-foot by 7-foot concrete riser with slide gate on the waterside (WS) slope. Concrete U-shaped headwall on each end. 15-foot-long cobble revetted inlet channel. [Additional Reference(s): DWR Levee Log, 2002]. FS Date: 4/3/2014

Slide gate in concrete riser on WS shoulder.

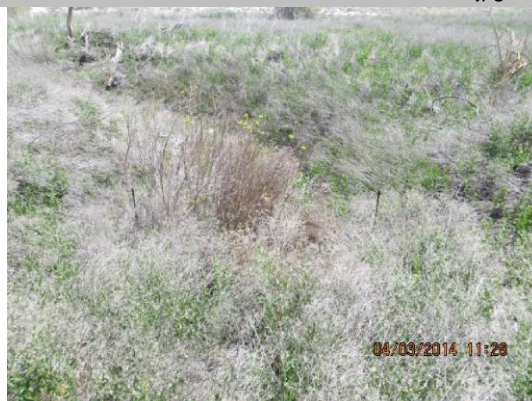
Photo 2 of 3 : UCIP_FA_2018_39540_59847.jpg

Heavy vegetation in outlet/channel on WS toe.

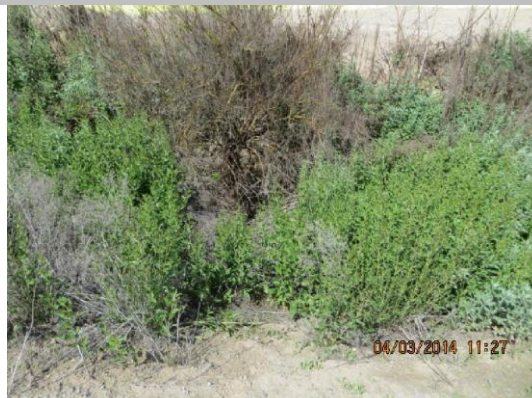
Photo 3 of 3 : UCIP_FA_2018_39540_59849.jpg

Heavy vegetation at concrete inlet on LS toe.

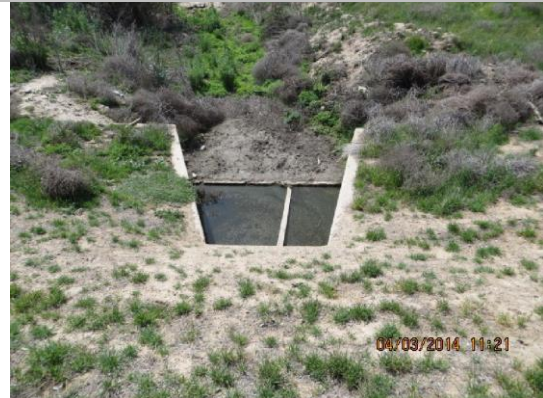
Photo 1 of 3 : UCIP_FA_2018_39542_59830.jpg

Comment Code						
Inspector Comment						
FS_ID:39542 DS_ID:19954 EP_NO: N/A Repair Type: Non-Urgent Crossing Status: Found UCIP Comments: 04/03/2014 Dense vegetation limits the inspector's visibility to identify signs of pipe failure (leaks) along the landward slope. Recommend removing vegetation along pipe alignment to conduct proper inspection of structure. (DWR UCIP - W. Wylie) FIELD_STRUCT_DESC: 36-inch by 36-inch square reinforced concrete box gravity drainage culvert through the levee, 9 feet below the crown. Flap gate on the waterside (WS) end. Concrete U-shaped headwall on each end. 5-foot-long cobble revetted outlet channel. [Additional Reference(s): DWR Levee Log, 2002. USACE San Joaquin O&M Manual 601.1, 1967, (HLM 5.71)]. FS Date: 4/3/2014

Concrete headwall on WS toe.

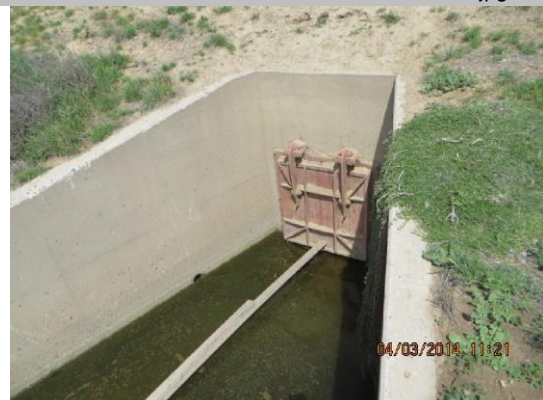
Photo 2 of 3 : UCIP_FA_2018_39542_59829.jpg

Flapgate on Concrete headwall on WS toe.

Comment Code						
Inspector Comment						
FS_ID:39542						
DS_ID:19954						
EP_NO: N/A						
Repair Type: Non-Urgent						
Crossing Status: Found						
UCIP Comments: 04/03/2014 Dense vegetation limits the inspector's visibility to identify signs of pipe failure (leaks) along the landward slope. Recommend removing vegetation along pipe alignment to conduct proper inspection of structure. (DWR UCIP - W. Wylie)						
FIELD_STRUCT_DESC: 36-inch by 36-inch square reinforced concrete box gravity drainage culvert through the levee, 9 feet below the crown. Flap gate on the waterside (WS) end. Concrete U-shaped headwall on each end. 5-foot-long cobble revetted outlet channel. [Additional Reference(s): DWR Levee Log, 2002. USACE San Joaquin O&M Manual 601.1, 1967, (HLM 5.71)].						
FS Date: 4/3/2014

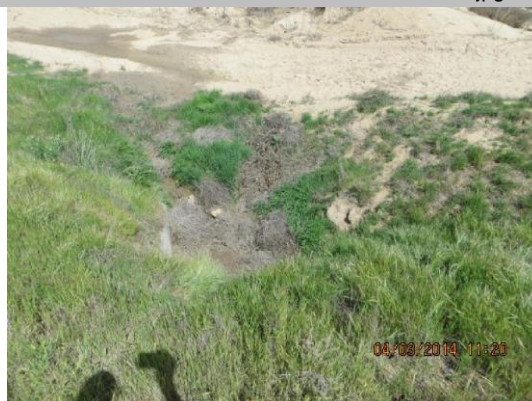
Photo 3 of 3 : UCIP_FA_2018_39542_59831.jpg

Concrete headwall at LS toe.

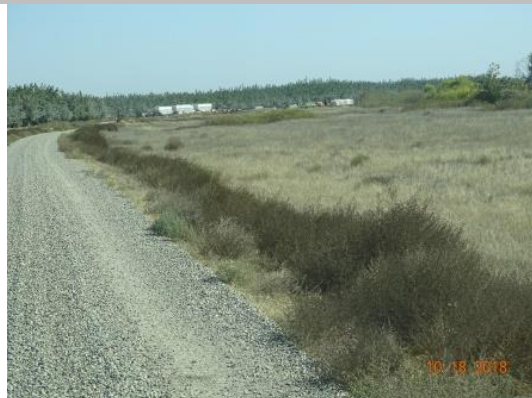
Photo 1 of 1 : FA_2018_NA0010_139_52_20181107_00050.jpg

LM Start	5.74	Rating **	U	Issue No.	52
LM End	6.63	Issue Type +	Ma	Location *	WS
Category	Earthen Levee			GPS Latitude/Longitude	
				Start	End
Item	Vegetation			36.791727 °	36.781470 °
				-120.205249 °	-120.199231 °
DWR ID	DWR_NA0010_23_f_2018_52				
Comment Code					
V1 : Control annual grass and weeds on the levee slopes and easements.					
Inspector Comment

dense brush and grass on waterside slope. (Fall 2018)

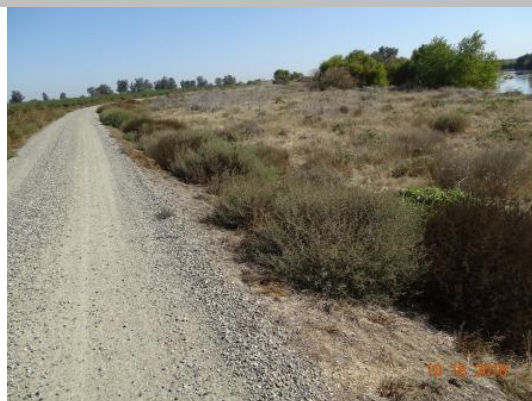
Photo 1 of 1 : FA_2018_NA0010_139_53_20181107_00051.jpg

LM Start	6.82	Rating **	U	Issue No.	53
LM End	7.49	Issue Type +	Ma	Location *	WS
Category	Earthen Levee			GPS Latitude/Longitude	
				Start	End
Item	Vegetation			36.780413 °	36.781556 °
				-120.195988 °	-120.186480 °
DWR ID	DWR_NA0010_23_f_2018_53				
Comment Code					
V1 : Control annual grass and weeds on the levee slopes and easements.					
Inspector Comment

dense brush on waterside slope. (Fall 2018)

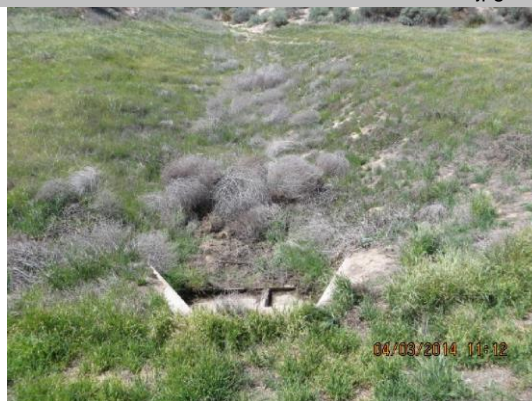
Photo 1 of 3 : UCIP_FA_2018_39543_59826.jpg

Comment Code						
Inspector Comment						
FS_ID:39543 DS_ID:19939 EP_NO: N/A Repair Type: Non-Urgent Crossing Status: Found UCIP Comments: 04/03/2014 Dense vegetation limits the inspector's visibility to identify signs of pipe failure (leaks) along the landward slope. Recommend removing vegetation along pipe alignment to conduct proper inspection of structure. (DWR UCIP - W. Wylie) FIELD_STRUCT_DESC: 30-inch by 30-inch square reinforced concrete box gravity drainage culvert through the levee, 8.5 feet below the crown. Flap gate on the waterside (WS) end. Concrete headwall on the landside (LS) end. Concrete U-shaped headwall on the WS end. [Additional Reference(s): DWR Levee Log, 2002]. FS Date: 4/3/2014

Concrete headwall on WS toe.

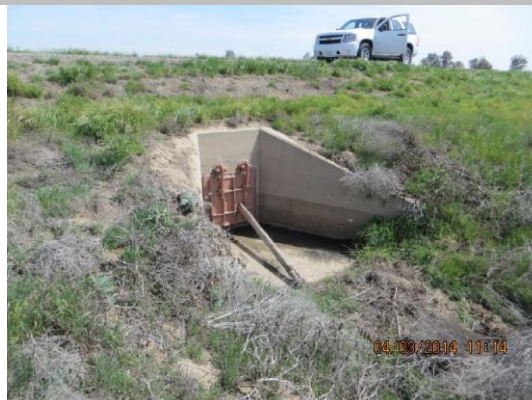
Photo 2 of 3 : UCIP_FA_2018_39543_59828.jpg

Flapgate on Concrete headwall at WS toe.

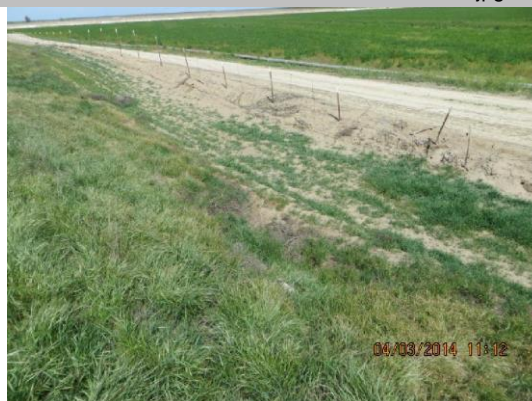
Photo 3 of 3 : UCIP_FA_2018_39543_59827.jpg

Comment Code						
Inspector Comment						
FS_ID:39543						
DS_ID:19939						
EP_NO: N/A						
Repair Type: Non-Urgent						
Crossing Status: Found						
UCIP Comments: 04/03/2014 Dense vegetation limits the inspector's visibility to identify signs of pipe failure (leaks) along the landward slope. Recommend removing vegetation along pipe alignment to conduct proper inspection of structure. (DWR UCIP - W. Wylie)						
FIELD_STRUCT_DESC: 30-inch by 30-inch square reinforced concrete box gravity drainage culvert through the levee, 8.5 feet below the crown. Flap gate on the waterside (WS) end. Concrete headwall on the landside (LS) end. Concrete U-shaped headwall on the WS end. [Additional Reference(s): DWR Levee Log, 2002].						
FS Date: 4/3/2014

Concrete headwall on LS toe.

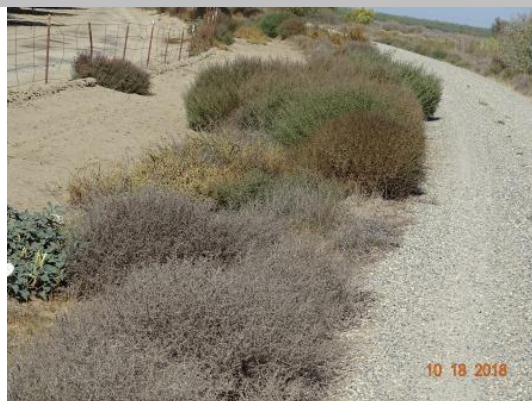
Photo 1 of 1 : FA_2018_NA0010_139_56_20181107_00052.jpg

LM Start	7.82	Rating **	U	Issue No.	56
LM End	9.71	Issue Type +	Ma	Location *	LS
Category	Earthen Levee			GPS Latitude/Longitude	
				Start	End
Item	Vegetation			36.785492°	36.807148°
				-120.183018°	-120.168830°
DWR ID	DWR_NA0010_23_f_2018_56				
Comment Code					
V1 : Control annual grass and weeds on the levee slopes and easements.					
Inspector Comment

heavy vegetation on landside shoulder and slope. (Fall 2018)

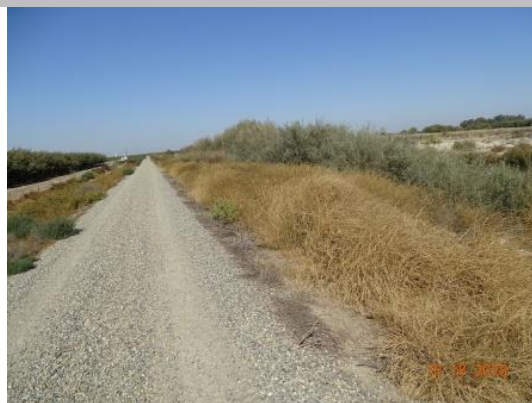
Photo 1 of 1 : FA_2018_NA0010_139_57_20181107_00053.jpg

LM Start	7.97	Rating **	U	Issue No.	57
LM End	9.69	Issue Type +	Ma	Location *	WS
Category	Earthen Levee			GPS Latitude/Longitude	
				Start	End
Item	Vegetation			36.787536 °	36.806918 °
				-120.182531 °	-120.168830 °
DWR ID	DWR_NA0010_23_f_2018_57				
Comment Code					
V1 : Control annual grass and weeds on the levee slopes and easements.					
Inspector Comment

Tall dense vegetation on waterside slope. (Fall 2018)

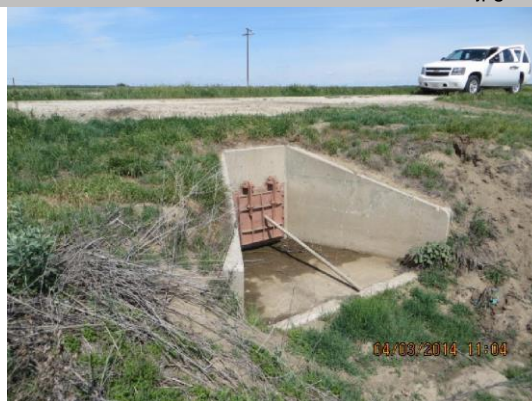
Photo 1 of 3 : UCIP_FA_2018_39544_59823.jpg

Comment Code						
Inspector Comment						
FS_ID:39544 DS_ID:19940 EP_NO: N/A Repair Type: Non-Urgent Crossing Status: Found UCIP Comments: 04/03/2014 Some sediment buildup at inlet at LS toe. Also dense vegetation limits the inspector's visibility to identify signs of pipe failure (leaks) along the landward slope. Recommend removing vegetation along pipe alignment to conduct proper inspection of structure. (DWR UCIP - W. Wylie) FIELD_STRUCT_DESC: 30-inch by 30-inch square reinforced concrete box gravity drainage culvert through the levee, 5.2 feet below the crown. Flap gate on the waterside (WS) end. Concrete headwall on the landside (LS) end. Concrete U-shaped headwall on the WS end. [Additional Reference(s): DWR Levee Log, 2002. USACE San Joaquin O&M Manual 601.1, 1967, (HLM 8.33)]. FS Date: 4/3/2014

Flapgate on WS toe.

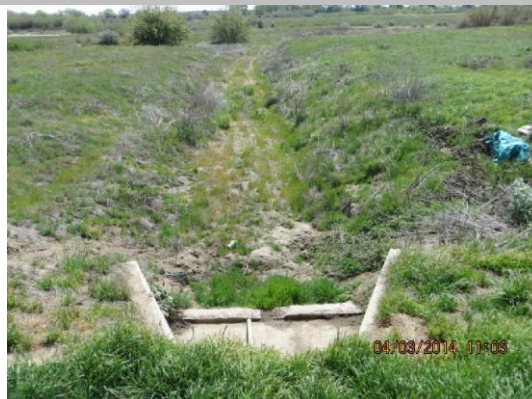
Photo 2 of 3 : UCIP_FA_2018_39544_59821.jpg

concrete headwall at drainage ditch on WS toe.

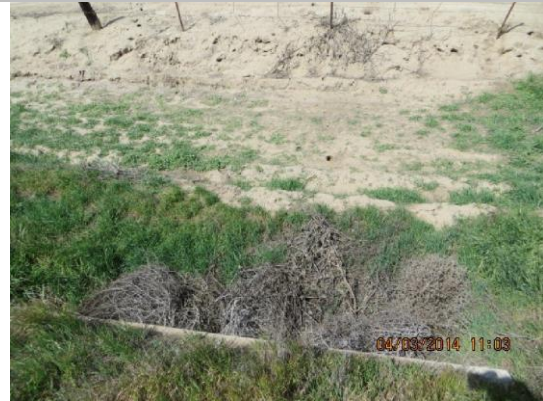
Photo 3 of 3 : UCIP_FA_2018_39544_59822.jpg

Comment Code						
Inspector Comment						
FS_ID:39544 DS_ID:19940 EP_NO: N/A Repair Type: Non-Urgent Crossing Status: Found UCIP Comments: 04/03/2014 Some sediment buildup at inlet at LS toe. Also dense vegetation limits the inspector's visibility to identify signs of pipe failure (leaks) along the landward slope. Recommend removing vegetation along pipe alignment to conduct proper inspection of structure. (DWR UCIP - W. Wylie) FIELD_STRUCT_DESC: 30-inch by 30-inch square reinforced concrete box gravity drainage culvert through the levee, 5.2 feet below the crown. Flap gate on the waterside (WS) end. Concrete headwall on the landside (LS) end. Concrete U-shaped headwall on the WS end. [Additional Reference(s): DWR Levee Log, 2002. USACE San Joaquin O&M Manual 601.1, 1967, (HLM 8.33)]. FS Date: 4/3/2014

Concrete headwall on LS toe.

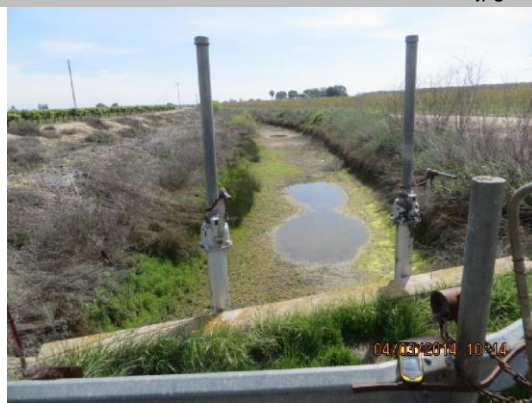
Photo 1 of 3 : UCIP_FA_2018_53192_59810.jpg

Comment Code					
Inspector Comment					
FS_ID:53192 DS_ID:19943 EP_NO: N/A Repair Type: Non-Urgent Crossing Status: Found UCIP Comments: 11/01/2018 Limited access to both LS and WS; assumed slide gates are still non-functional; Crossing has been downgraded from Urgent to Non-Urgent due to re-classification of damage slide gates. (O. Magana - DWR UCIP)07/20/2016 No change--same as previous inspection. (DWR UCIP - omagana)04/03/2014 Slide gate not functional. Slide gate channels heavily corroded (exfoliated) and likely impact functionality/structural integrity of gate. (DWR UCIP - wwylie) FIELD_STRUCT_DESC: [Gravelly Ford Canal Irrigation Structure] 1 of 2: 48-inch by 63-inch reinforced concrete box gravity irrigation culvert through the levee, 10 feet below the crown. Concrete U-shaped headwall on each end. Gear pedestal slide gate with wall bracket on the waterside (WS) headwall. 10-foot-long cobble revetted outlet channel. Guardrail on each shoulder. Slide gates on the WS. [Additional Reference(s): DWR Levee Log, 2002. USACE San Joaquin O&M Manual 601.1, 1967, (HLM 9.76)]. FS Date: 11/1/2018 12:50:00 PM

Slide gate actuator visible on WS shoulder with concrete headwall.

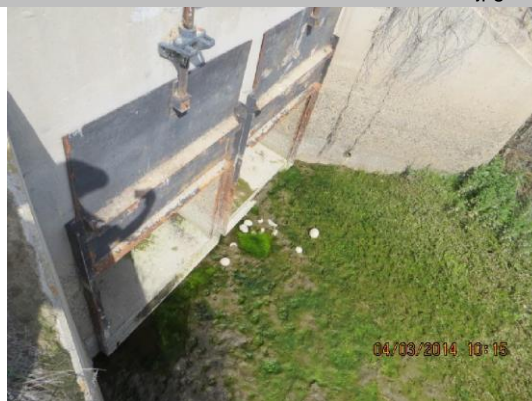
Photo 2 of 3 : UCIP_FA_2018_53192_59809.jpg

Comment Code						
Inspector Comment						
FS_ID:53192 DS_ID:19943 EP_NO: N/A Repair Type: Non-Urgent Crossing Status: Found UCIP Comments: 11/01/2018 Limited access to both LS and WS; assumed slide gates are still non-functional; Crossing has been downgraded from Urgent to Non-Urgent due to re-classification of damage slide gates. (O. Magana - DWR UCIP)07/20/2016 No change--same as previous inspection. (DWR UCIP - omagana)04/03/2014 Slide gate not functional. Slide gate channels heavily corroded (exfoliated) and likely impact functionality/structural integrity of gate. (DWR UCIP - wwylie) FIELD_STRUCT_DESC: [Gravelly Ford Canal Irrigation Structure] 1 of 2: 48-inch by 63-inch reinforced concrete box gravity irrigation culvert through the levee, 10 feet below the crown. Concrete U-shaped headwall on each end. Gear pedestal slide gate with wall bracket on the waterside (WS) headwall. 10-foot-long cobble revetted outlet channel. Guardrail on each shoulder. Slide gates on the WS. [Additional Reference(s): DWR Levee Log, 2002. USACE San Joaquin O&M Manual 601.1, 1967, (HLM 9.76)]. FS Date: 11/1/2018 12:50:00 PM

Slide gate on concrete headwall at WS toe.

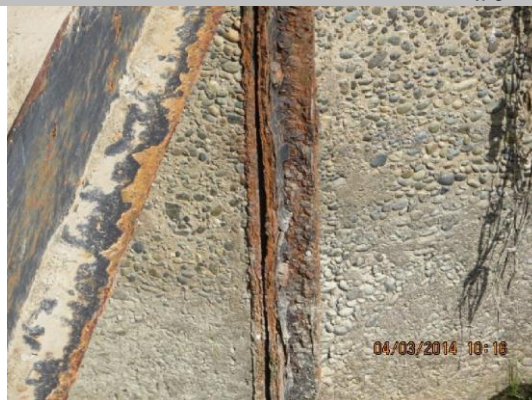
Photo 3 of 3 : UCIP_FA_2018_53192_59808.jpg

Heavy corrosion in slide gate tracks on WS toe.

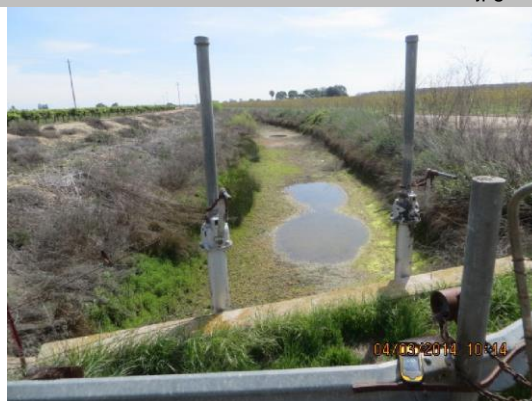
Photo 1 of 3 : UCIP_FA_2018_53193_59802.jpg

Comment Code						
Inspector Comment						
FS_ID:53193 DS_ID:19980 EP_NO: N/A Repair Type: Non-Urgent Crossing Status: Found UCIP Comments: 11/01/2018 Limited access to both LS and WS; assumed slide gates are still non-functional; Crossing has been downgraded from Urgent to Non-Urgent due to re-classification of damage slide gates. (O. Magana - DWR UCIP)07/20/2016 No change--same as previous inspection. (DWR UCIP - omagana)04/03/2014 Slide gate not functional. Slide gate channels heavily corroded (exfoliated) and likely impact functionality/structural integrity of gate. (DWR UCIP - wwylie) FIELD_STRUCT_DESC: [Gravelly Ford Canal Irrigation Structure] 2 of 2: 48-inch by 63-inch reinforced concrete box gravity irrigation culvert through the levee, 10 feet below the crown. Concrete U-shaped headwall on each end. Gear pedestal slide gate with wall bracket on the waterside (WS) headwall. 10-foot-long cobble revetted outlet channel. Guardrail on each shoulder. [Additional Reference(s): DWR Levee Log, 2002]. FS Date: 11/1/2018 12:51:00 PM

Slide gate actuators on Concrete headwall at WS shoulder.

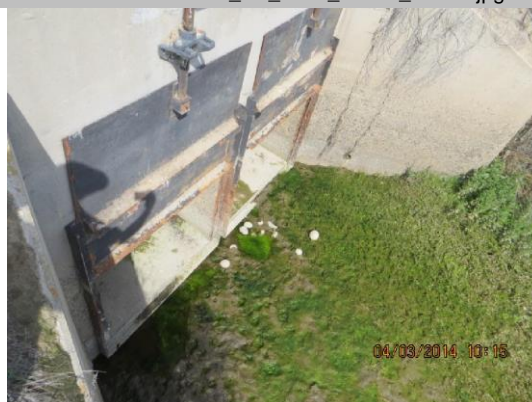
Photo 2 of 3 : UCIP_FA_2018_53193_59801.jpg

Slide gates on WS toe.

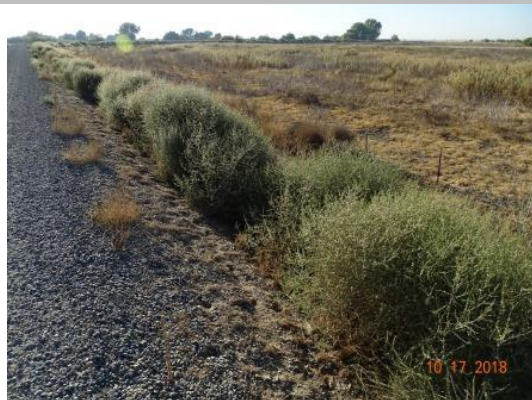
Photo 1 of 1 : FA_2018_NA0010_140_21_20181107_00033.jpg

LM Start	0.05	Rating **	U	Issue No.	21
LM End	0.95	Issue Type +	Ma	Location *	LS
Category	Earthen Levee			GPS Latitude/Longitude	
				Start	End
Item	Vegetation			36.772383°	36.768276°
				-120.285156°	-120.277410°
DWR ID	DWR_NA0010_24_f_2018_21				
Comment Code					
V1 : Control annual grass and weeds on the levee slopes and easements.					
Inspector Comment					
Tall dense vegetation on shoulder blocking view of slope and toe

tall dense brush on shoulder blocking view of slope. (Fall 2018)

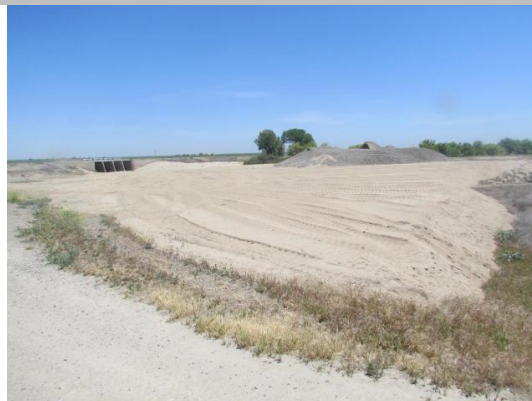
Photo 1 of 2 : FA_2018_NA0010_140_47_20180911_00010.jpg

LM Start	0.06	Rating **	M	Issue No.	47
LM End	0.06	Issue Type +	En	Location *	WS
Category	Earthen Levee			GPS Latitude/Longitude	
				Start	End
Item	Encroachments			36.772328 °	36.772328 °
				-120.285117 °	-120.285117 °
DWR ID	DWR_NA0010_24_s_2014_47				
Comment Code					
MA : Material					
Inspector Comment					
District constructed a berm on waterside slope. Berm is being used for staging of earthen material.

Looking northeast at berm on waterward slope.

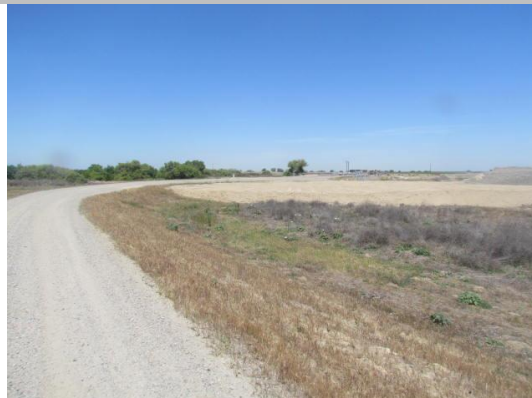
Photo 2 of 2 : FA_2018_NA0010_140_47_20180911_00011.jpg

LM Start	0.06	Rating **	M	Issue No.	47 (cont)	
LM End	0.06	Issue Type +	En	Location *	WS	
Category	Earthen Levee			GPS Latitude/Longitude		
				Start	End	
Item	Encroachments			36.772328 °	36.772328 °	
				-120.285117 °	-120.285117 °	
DWR ID	DWR_NA0010_24_s_2014_47					
Comment Code						
MA : Material						
Inspector Comment						
District constructed a berm on waterside slope. Berm is being used for staging of earthen material.

Looking north at berm on waterward slope.

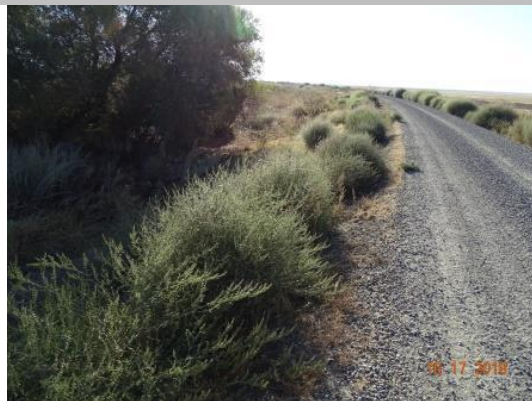
Photo 1 of 1 : FA_2018_NA0010_140_22_20181107_00034.jpg

LM Start	0.49	Rating **	U	Issue No.	22
LM End	0.56	Issue Type +	Ma	Location *	WS
Category	Earthen Levee			GPS Latitude/Longitude	
				Start	End
Item	Vegetation			36.766925 °	36.766103 °
				-120.283240 °	-120.282514 °
DWR ID	DWR_NA0010_24_f_2018_22				
Comment Code					
V1 : Control annual grass and weeds on the levee slopes and easements.					
Inspector Comment

dense vegetation on waterside shoulder and slope. (Fall 2018)

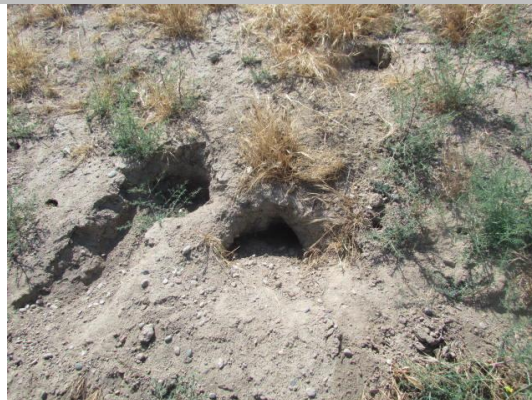
Photo 1 of 1 : FA_2018_NA0010_140_6_20180911_00002.jpg

LM Start	0.82	Rating **	M	Issue No.	6
LM End	0.84	Issue Type +	Ma	Location *	LS
Category	Earthen Levee			GPS Latitude/Longitude	
				Start	End
Item	Animal Control			36.766775 °	36.766962 °
				-120.278757 °	-120.278602 °
DWR ID	DWR_NA0010_24_s_2013_6				
Comment Code					
A1 : Exterminate rodents and backfill and compact or grout burrows.					
Inspector Comment					
Several rodent holes identified within this section.

Looking at several rodent holes on landward slope.

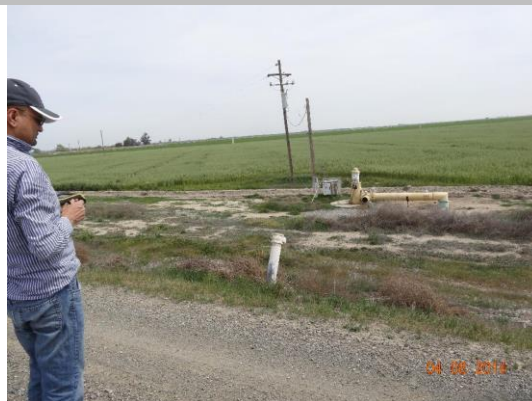
Photo 1 of 2 : UCIP_FA_2018_33265_60065.jpg

Comment Code						
Inspector Comment						
FS_ID:33265 DS_ID:19961 EP_NO: 13735 Repair Type: Non-Urgent Crossing Status: Found UCIP Comments: 04/08/2014 Unable to determine status of crossing. Need to contact owner to determine status of crossing. (DWR UCIP - O. Magana) FIELD_STRUCT_DESC: 24-inch coated steel drainage discharge pipe through the levee, 2 feet below the crown. Crown roadway has been padded 1 foot. Steel cutoff wall around the pipe at the centerline of the levee. Pump on the landside (LS). Siphon breaker on the apex of the pipe on the LS shoulder. Galvanized siphon vent pipe on the LS shoulder. (Plans to install two 24-inch steel discharge pipelines through the levee to dispose of seepage water collected in farm sumps Nos. 8 and 12 authorized under Permit No. 13735, 1983 - Rio Seco Farm). [Additional Reference(s): DWR Levee Log, 2002]. FS Date: 4/8/2014

View of landward side.

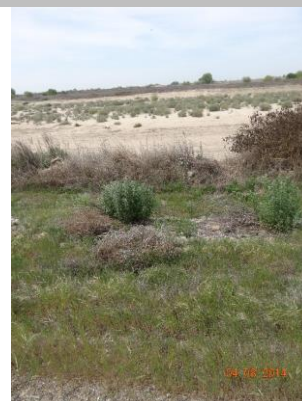
Photo 2 of 2 : UCIP_FA_2018_33265_60064.jpg

Comment Code						
Inspector Comment						
FS_ID:33265 DS_ID:19961 EP_NO: 13735 Repair Type: Non-Urgent Crossing Status: Found UCIP Comments: 04/08/2014 Unable to determine status of crossing. Need to contact owner to determine status of crossing. (DWR UCIP - O. Magana) FIELD_STRUCT_DESC: 24-inch coated steel drainage discharge pipe through the levee, 2 feet below the crown. Crown roadway has been padded 1 foot. Steel cutoff wall around the pipe at the centerline of the levee. Pump on the landside (LS). Siphon breaker on the apex of the pipe on the LS shoulder. Galvanized siphon vent pipe on the LS shoulder. (Plans to install two 24-inch steel discharge pipelines through the levee to dispose of seepage water collected in farm sumps Nos. 8 and 12 authorized under Permit No. 13735, 1983 - Rio Seco Farm). [Additional Reference(s): DWR Levee Log, 2002]. FS Date: 4/8/2014

View of waterward side.

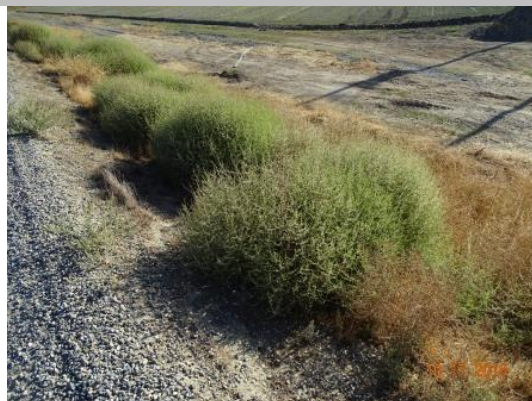
Photo 1 of 1 : FA_2018_NA0010_140_28_20181107_00035.jpg

LM Start	1.06	Rating **	U	Issue No.	28
LM End	3.33	Issue Type +	Ma	Location *	LS
Category	Earthen Levee			GPS Latitude/Longitude	
				Start	End
Item	Vegetation			36.769573 °	36.769524 °
				-120.276237 °	-120.240670 °
DWR ID	DWR_NA0010_24_f_2018_28				
Comment Code					
V1 : Control annual grass and weeds on the levee slopes and easements.					
Inspector Comment

vegetation on landside slope obstructing view. (Fall 2018)

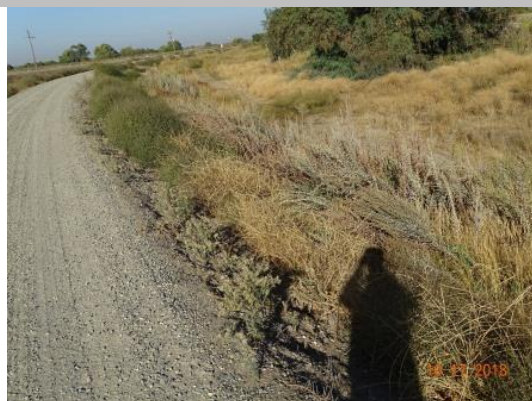
Photo 1 of 1 : FA_2018_NA0010_140_29_20181107_00036.jpg

LM Start	1.61	Rating **	U	Issue No.	29
LM End	3.21	Issue Type +	Ma	Location *	WS
Category	Earthen Levee			GPS Latitude/Longitude	
				Start	End
Item	Vegetation			36.770587 °	36.769752 °
				-120.268590 °	-120.242748 °
DWR ID	DWR_NA0010_24_f_2018_29				
Comment Code					
V1 : Control annual grass and weeds on the levee slopes and easements.					
Inspector Comment

heavy vegetation on waterside slope. (Fall 2018)

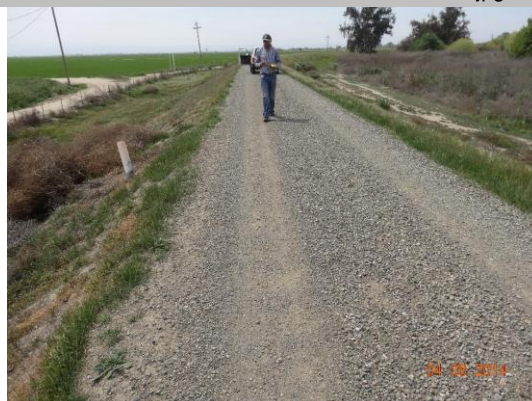
Photo 1 of 3 : UCIP_FA_2018_33266_60069.jpg

Comment Code						
Inspector Comment						
FS_ID:33266 DS_ID:19962 EP_NO: 13085 Repair Type: Non-Urgent Crossing Status: Indicator Found UCIP Comments: 04/08/2014 Need to contact owner to determine status. (DWR UCIP - O. Magana) FIELD_STRUCT_DESC: 20-inch coated steel gravity drainage pipe through the levee, 2 feet below the crown. Pipe encased in concrete through the levee crown. Steel cutoff wall around the pipe at each shoulder. Siphon breaker installed on the apex of the pipe on the landside (LS) shoulder. Vent pipe on LS shoulder. Rock riprap on the waterside (WS) slope. (Plans to construct a new discharge structure and to rehabilitate one existing diversion structure to return intercepted seepage to the San Joaquin River authorized under Permit No. 13085, 1981 - Diener, Dry River Farms). [Additional Reference(s): DWR Levee Log, 2002]. FS Date: 4/8/2014

Overview of levee crown at crossing.

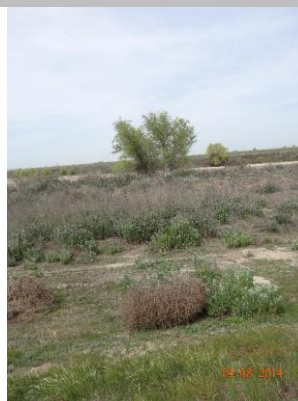
Photo 2 of 3 : UCIP_FA_2018_33266_60070.jpg

Comment Code						
Inspector Comment						
FS_ID:33266 DS_ID:19962 EP_NO: 13085 Repair Type: Non-Urgent Crossing Status: Indicator Found UCIP Comments: 04/08/2014 Need to contact owner to determine status. (DWR UCIP - O. Magana) FIELD_STRUCT_DESC: 20-inch coated steel gravity drainage pipe through the levee, 2 feet below the crown. Pipe encased in concrete through the levee crown. Steel cutoff wall around the pipe at each shoulder. Siphon breaker installed on the apex of the pipe on the landside (LS) shoulder. Vent pipe on LS shoulder. Rock riprap on the waterside (WS) slope. (Plans to construct a new discharge structure and to rehabilitate one existing diversion structure to return intercepted seepage to the San Joaquin River authorized under Permit No. 13085, 1981 - Diener, Dry River Farms). [Additional Reference(s): DWR Levee Log, 2002]. FS Date: 4/8/2014

View of waterward side.

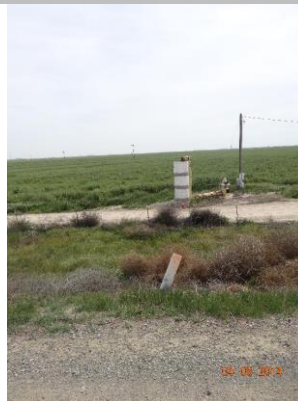
Photo 3 of 3 : UCIP_FA_2018_33266_60071.jpg

View of landward side.

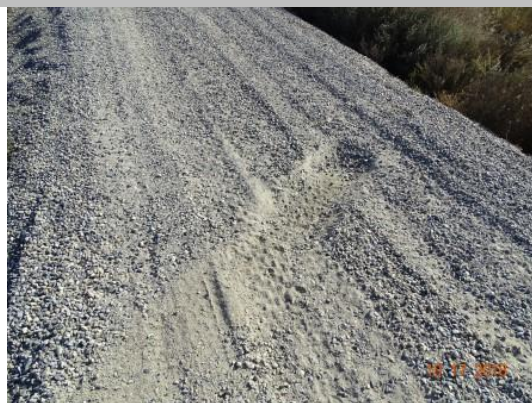
Photo 1 of 1 : FA_2018_NA0010_140_30_20181107_00047.jpg

LM Start	2.52	Rating **	A/W	Issue No.	30
LM End	2.52	Issue Type +	Ma	Location *	CR
Category	Earthen Levee			GPS Latitude/Longitude	
				Start	End
Item	Crown Surface / Depressions / Rutting			36.770298 °	36.770298 °
				-120.253468 °	-120.253468 °
DWR ID	DWR_NA0010_24_f_2018_30				
Comment Code					
C2 : Repair depressions or ruts in the crown or slope.					
Inspector Comment					
depression across the crown of the levee

depression across crown. (Fall 2018)

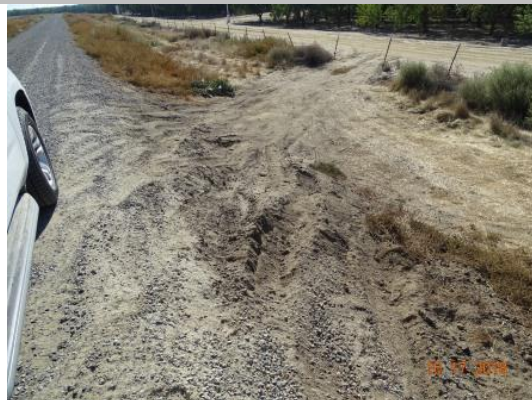
Photo 1 of 1 : FA_2018_NA0010_140_35_20181107_00039.jpg

LM Start	3.53	Rating **	M	Issue No.	35
LM End	3.53	Issue Type +	Ma	Location *	LS
Category	Earthen Levee			GPS Latitude/Longitude	
				Start	End
Item	Slope Stability			36.768873 °	36.768873 °
				-120.237161 °	-120.237161 °
DWR ID	DWR_NA0010_24_f_2018_35				
Comment Code					
S3 : Repair the levee slope damaged by vehicle traffic and prevent access where possible.					
Inspector Comment					
vehicle damage to slope. Land owner removed section of fence to allow access at this location

damage to slope from vehicle traffic. (Fall 2018)

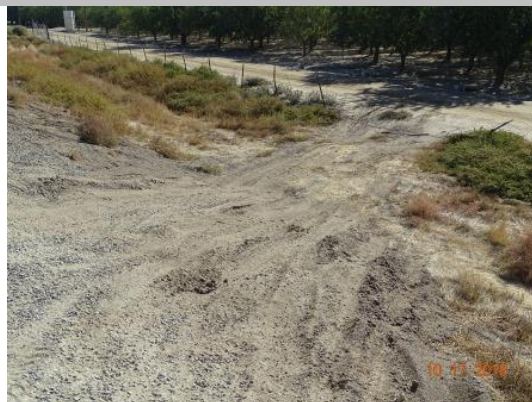
Photo 1 of 1 : FA_2018_NA0010_140_36_20181107_00041.jpg

LM Start	3.77	Rating **	M	Issue No.	36
LM End	3.77	Issue Type +	Ma	Location *	LS
Category	Earthen Levee			GPS Latitude/Longitude	
				Start	End
Item	Slope Stability			36.767784 °	36.767784 °
				-120.233252 °	-120.233252 °
DWR ID	DWR_NA0010_24_f_2018_36				
Comment Code					
S3 : Repair the levee slope damaged by vehicle traffic and prevent access where possible.					
Inspector Comment					
damage to levee slope from vehicle traffic. Landowner appears to have removed section of fencing to allow access at this location

damage to slope from vehicle traffic. (Fall 2018)

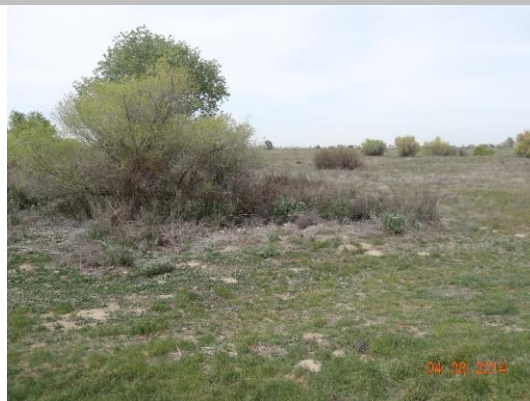
Photo 1 of 3 : UCIP_FA_2018_36849_67237.jpg

Comment Code					
Inspector Comment					
FS_ID:36849 DS_ID:19964 EP_NO: N/A Repair Type: Non-Urgent Crossing Status: Found UCIP Comments: 04/08/2014 Unable to confirm crossing alignment and appurtenances associated with this crossing. Multiple stand pipes visible on landward side. Need to contact owner to determine status of crossing and alignment. (DWR UCIP - O. Magana) FIELD_STRUCT_DESC: 30-inch by 30-inch square reinforced concrete box drainage discharge culvert through the levee, 12.5 feet below the crown. Pump on the landside (LS). Concrete riser with slide gate on the waterside (WS) slope. Screw gate on the LS shoulder. (Plans to construct a new discharge structure and to rehabilitate one existing diversion structure to return intercepted seepage to the San Joaquin River authorized under Permit No. 13085, 1981 - Diener, Dry River Farms). [Additional Reference(s): DWR Levee Log, 2002]. FS Date: 4/8/2014

View of waterwar side.

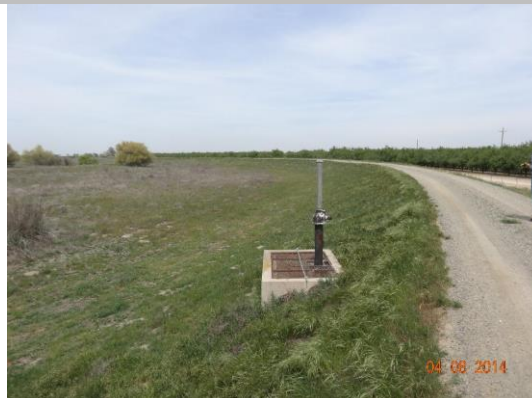
Photo 2 of 3 : UCIP_FA_2018_36849_67236.jpg

Comment Code						
Inspector Comment						
FS_ID:36849 DS_ID:19964 EP_NO: N/A Repair Type: Non-Urgent Crossing Status: Found UCIP Comments: 04/08/2014 Unable to confirm crossing alignment and appurtenances associated with this crossing. Multiple stand pipes visible on landward side. Need to contact owner to determine status of crossing and alignment. (DWR UCIP - O. Magana) FIELD_STRUCT_DESC: 30-inch by 30-inch square reinforced concrete box drainage discharge culvert through the levee, 12.5 feet below the crown. Pump on the landside (LS). Concrete riser with slide gate on the waterside (WS) slope. Screw gate on the LS shoulder. (Plans to construct a new discharge structure and to rehabilitate one existing diversion structure to return intercepted seepage to the San Joaquin River authorized under Permit No. 13085, 1981 - Diener, Dry River Farms). [Additional Reference(s): DWR Levee Log, 2002]. FS Date: 4/8/2014

Slide gate inside concrete box located on waterward side.

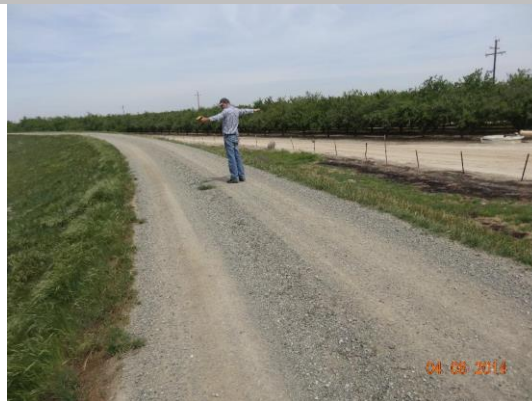
Photo 3 of 3 : UCIP_FA_2018_36849_67235.jpg

LM Start	4.06	Rating **	M	Issue No.	271 (cont)
LM End	4.06	Issue Type +	En	Location *

Overview of levee at crossing.

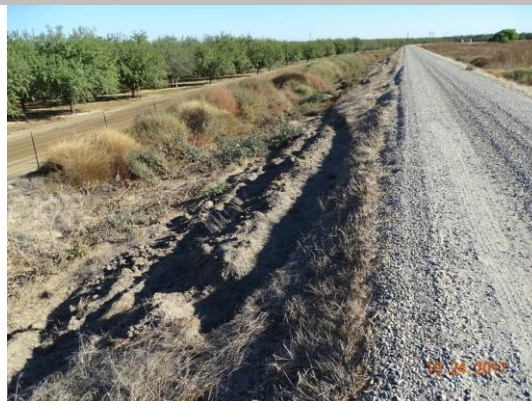
Photo 1 of 1 : FA_2018_NA0010_140_17_20180911_00006.jpg

LM Start	4.27	Rating **	M	Issue No.	17
LM End	4.27	Issue Type +	Ma	Location *	LS
Category	Earthen Levee			GPS Latitude/Longitude	
				Start	End
Item	Slope Stability			36.772003°	36.772003°
				-120.230075°	-120.230075°
DWR ID	DWR_NA0010_24_f_2017_17				
Comment Code					
S3 : Repair the levee slope damaged by vehicle traffic and prevent access where possible.					
Inspector Comment

Looking southeast at the landside slope.

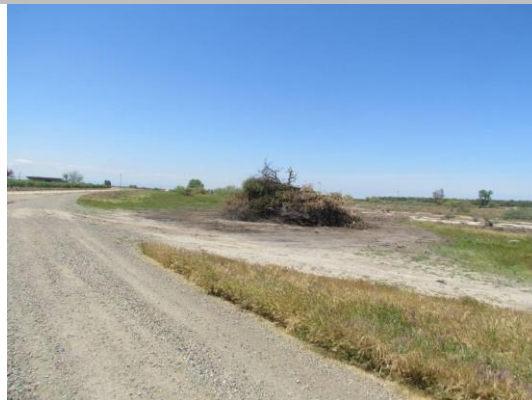
Photo 1 of 1 : FA_2018_NA0010_140_3_20180911_00001.jpg

LM Start	6.33	Rating **	A/W	Issue No.	3
LM End	6.33	Issue Type +	En	Location *	WS
Category	Earthen Levee			GPS Latitude/Longitude	
				Start	End
Item	Encroachments			36.788155 °	36.788155 °
				-120.209655 °	-120.209655 °
DWR ID	DWR_NA0010_24_s_2012_3				
Comment Code					
PR : Prunings					
Inspector Comment					
Prunings pile was burned.

Looking downstream (north) at large pruning pile on waterward berm.

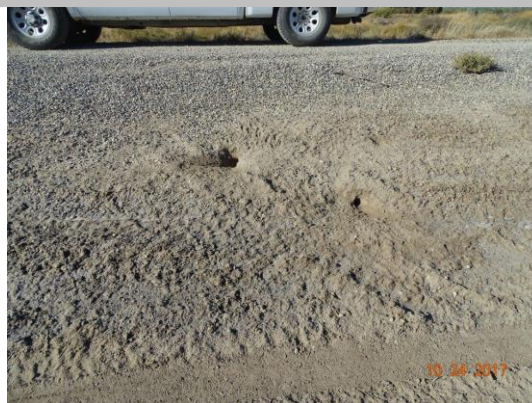
Photo 1 of 2 : FA_2018_NA0010_140_14_20180911_00004.jpg

LM Start	6.35	Rating **	M	Issue No.	14
LM End	6.35	Issue Type +	Ma	Location *	LS
Category	Earthen Levee			GPS Latitude/Longitude	
				Start	End
Item	Animal Control			36.788225 °	36.788225 °
				-120.209357 °	-120.209357 °
DWR ID	DWR_NA0010_24_s_2017_14				
Comment Code					
A3 : No rodents visible, but rodent burrows visible; need to backfill and compact or grout burrows.					
Inspector Comment					
Several rodent holes on levee landside shoulder and slope.

Looking north at the landside slope.

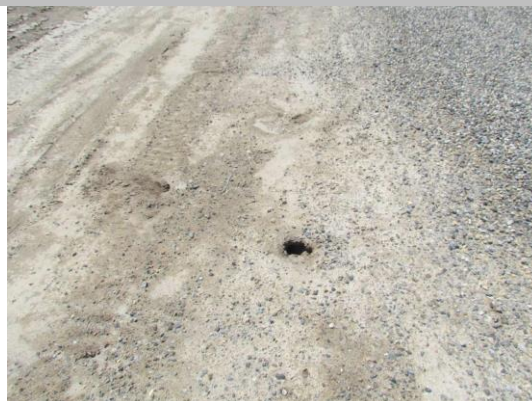
Photo 2 of 2 : FA_2018_NA0010_140_14_20180911_00005.jpg

LM Start	6.35	Rating **	M	Issue No.	14 (cont)
LM End	6.35	Issue Type +	Ma	Location *	LS

Looking at typical view of rodent holes within this section on landward shoulder and slope.

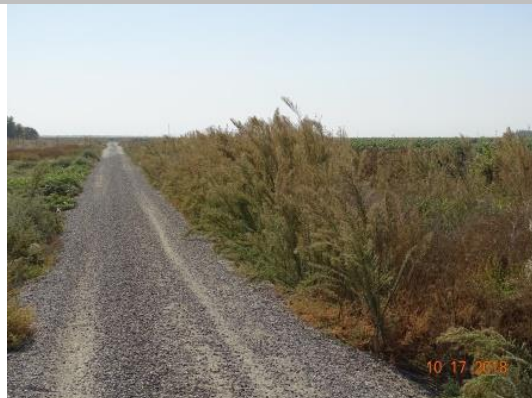
Photo 1 of 1 : FA_2018_NA0010_140_46_20181107_00046.jpg

LM Start	6.72	Rating **	U	Issue No.	46
LM End	7.36	Issue Type +	Ma	Location *	LS
Category	Earthen Levee			GPS Latitude/Longitude	
				Start	End
Item	Vegetation			36.786709 °	36.779087 °
				-120.204768 °	-120.198725 °
DWR ID	DWR_NA0010_24_f_2018_46				
Comment Code					
V1 : Control annual grass and weeds on the levee slopes and easements.					
Inspector Comment

tall dense vegetation on landside shoulder, slope, and toe. (Fall 2018)

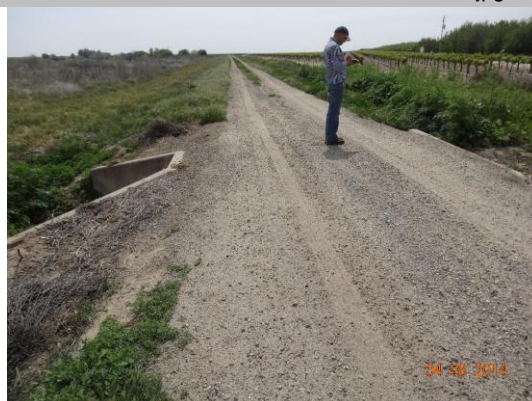
Photo 1 of 3 : UCIP_FA_2018_50056_60105.jpg

LM Start	6.73	Rating **	M	Issue No.	272
LM End	6.73	Issue Type +	En	Location *	
Category	Supplemental			GPS Latitude/Longitude	
				Start	End
Item	DWR UCIP Field Study			36.786632 °	36.786632 °
				-120.204733 °	-120.204733 °
DWR ID	19957

Comment Code					
Inspector Comment					
FS_ID:50056 DS_ID:19957 EP_NO: N/A Repair Type: Non-Urgent Crossing Status: Found UCIP Comments: 7/20/2016 same as previous inspection. Crossing has been downgraded from Urgent to Non-Urgent PVC does not prevent WS flap gate from closing. (DWR UCIP - omagana)4/08/2014 Unauthorized PVC pipe through existitng crossing. PVC distorted inside--Need to contact owner to correct issue. If crossing was allowed need to contact owner for permit number issue for crossing variance. (DWR UCIP - omagana) FIELD_STRUCT_DESC: 24-inch corrugated metal gravity drainage pipe through the levee, 3.6 feet below the crown. Flap gate on the waterside (WS) end. Concrete headwall on the landside (LS) end. Concrete U-shaped headwall on the WS end. [Additional Reference(s): DWR Levee Log, 2002]. FS Date: 7/20/2016

Overview of levee crown at crossing.

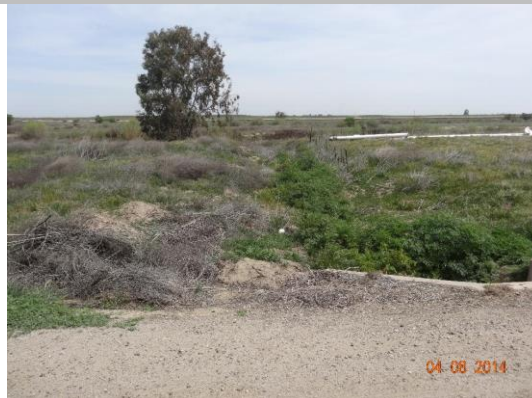
Photo 2 of 3 : UCIP_FA_2018_50056_60107.jpg

LM Start	6.73	Rating **	M	Issue No.	272 (cont)
LM End	6.73	Issue Type +	En	Location *

View of WS--debris (pipe sections) located on waterward side.

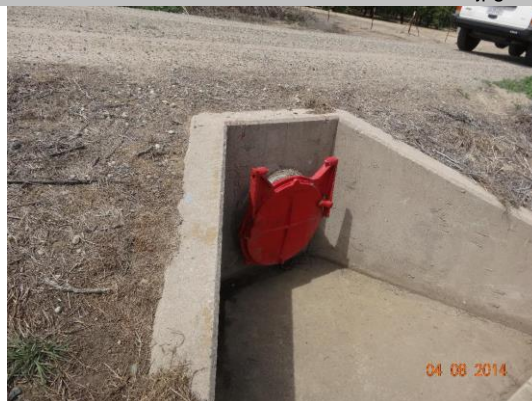
Photo 3 of 3 : UCIP_FA_2018_50056_60106.jpg

Flap gate visible on WS.

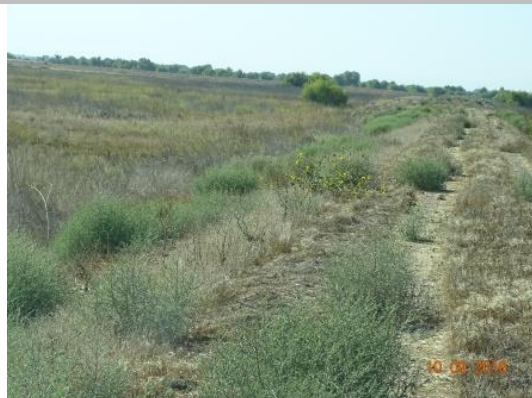
Photo 1 of 3 : FA_2018_NA0010_141_7_20181107_00027.jpg

LM Start	0.00	Rating **	U	Issue No.	7
LM End	0.49	Issue Type +	Ma	Location *	LS
Category	Earthen Levee			GPS Latitude/Longitude	
				Start	End
Item	Vegetation			37.296261°	37.281769°
				-120.880678°	-120.880745°
DWR ID	DWR_NA0010_25_f_2015_7				
Comment Code					
V2 : Remove the wild growth other than native grasses from the levee slopes.					
Inspector Comment

View of landside slope looking south. (Fall 2018)

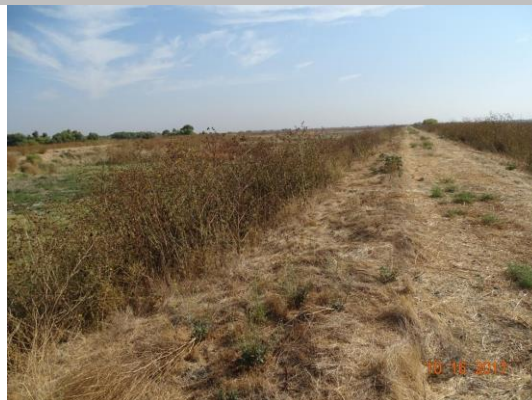
Photo 2 of 3 : FA_2018_NA0010_141_7_20180911_00001.jpg

LM Start	0.00	Rating **	U	Issue No.	7 (cont)
LM End	0.49	Issue Type +	Ma	Location *	LS

Looking south at the landside slope. (Fall 2017)

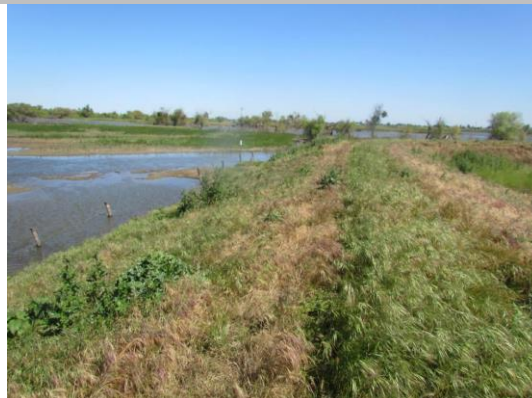
Photo 3 of 3 : FA_2018_NA0010_141_7_20180911_00002.jpg

LM Start	0.00	Rating **	U	Issue No.	7 (cont)
LM End	0.49	Issue Type +	Ma	Location *	LS

Looking at typical view of landward slope.

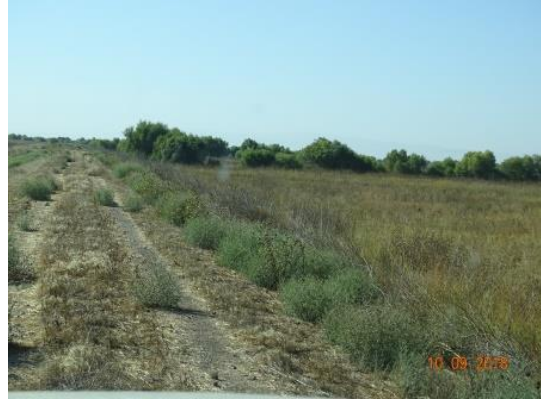
Photo 1 of 3 : FA_2018_NA0010_141_9_20181107_00029.jpg

LM Start	0.00	Rating **	M	Issue No.	9
LM End	1.41	Issue Type +	Ma	Location *	WS
Category	Earthen Levee			GPS Latitude/Longitude	
				Start	End
Item	Vegetation			37.296261 °	37.281768 °
				-120.880678 °	-120.880745 °
DWR ID	DWR_NA0010_25_f_2015_9				
Comment Code					
V2 : Remove the wild growth other than native grasses from the levee slopes.					
Inspector Comment

View of waterside slope looking south. (Fall 2018)

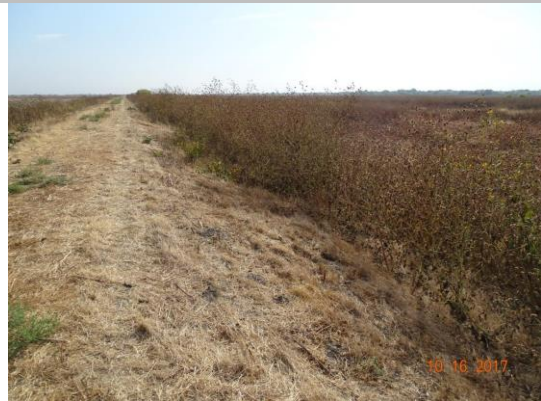
Photo 2 of 3 : FA_2018_NA0010_141_9_20180911_00005.jpg

LM Start	0.00	Rating **	M	Issue No.	9 (cont)
LM End	1.41	Issue Type +	Ma	Location *	WS

Looking south at the waterside slope. (Fall 2017)

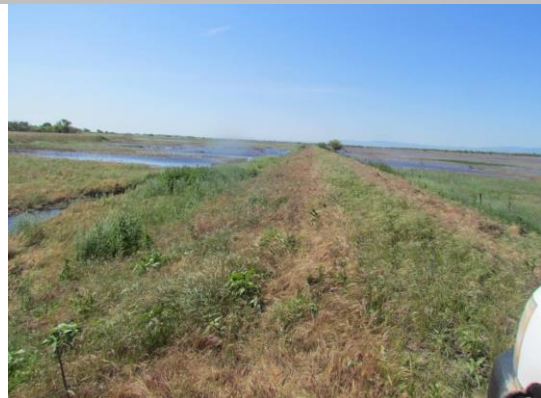
Photo 3 of 3 : FA_2018_NA0010_141_9_20180911_00006.jpg

LM Start	0.00	Rating **	M	Issue No.	9 (cont)
LM End	1.41	Issue Type +	Ma	Location *	WS

Looking typical view of waterward slope.

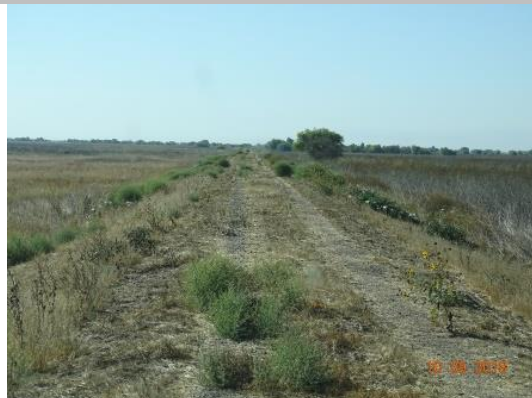
Photo 1 of 3 : FA_2018_NA0010_141_8_20181107_00026.jpg

LM Start	0.00	Rating **	M	Issue No.	8
LM End	1.76	Issue Type +	Ma	Location *	CR
Category	Earthen Levee			GPS Latitude/Longitude	
				Start	End
Item	Vegetation			37.296259 °	37.281615 °
				-120.880677 °	-120.867133 °
DWR ID	DWR_NA0010_25_s_2012_8				
Comment Code					
V2 : Remove the wild growth other than native grasses from the levee slopes.					
Inspector Comment					
Control weeds on levee crown.

looking south along the levee crown. (Fall 2018)

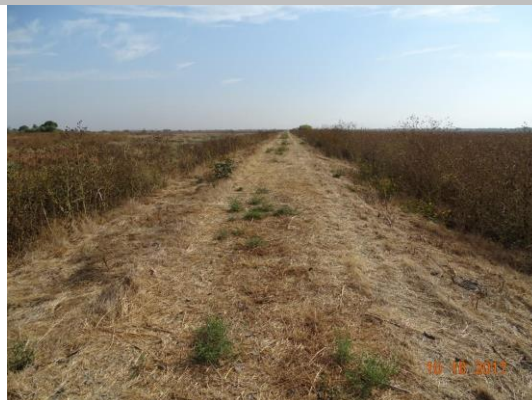
Photo 2 of 3 : FA_2018_NA0010_141_8_20180911_00003.jpg

LM Start	0.00	Rating **	M	Issue No.	8 (cont)
LM End	1.76	Issue Type +	Ma	Location *	CR

Looking south at the levee crown. (Fall 2017)

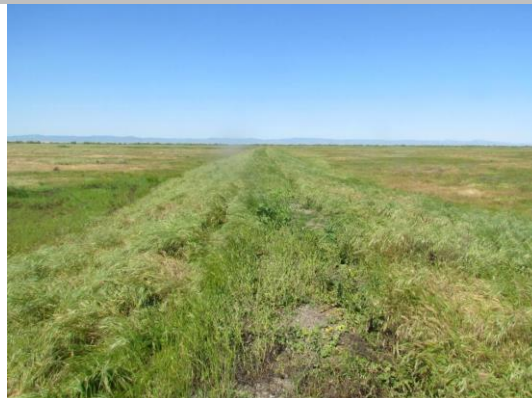
Photo 3 of 3 : FA_2018_NA0010_141_8_20180911_00004.jpg

LM Start	0.00	Rating **	M	Issue No.	8 (cont)
LM End	1.76	Issue Type +	Ma	Location *	CR

Looking at typical view of levee crown.

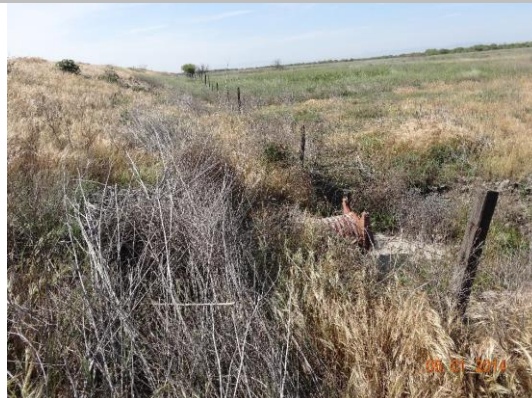
Photo 2 of 3 : UCIP_FA_2018_39501_67240.jpg

LM Start	0.02	Rating **	M	Issue No.	17 (cont)
LM End	0.02	Issue Type +	Ma	Location *

Pipe daylight visible on waterward toe.

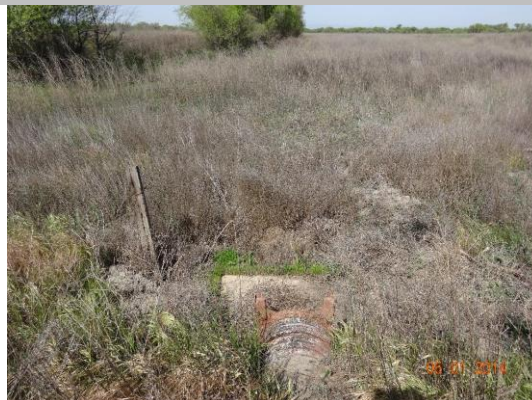
Photo 3 of 3 : UCIP_FA_2018_36852_67252.jpg

Pipe and flap gate visible on waterward side.

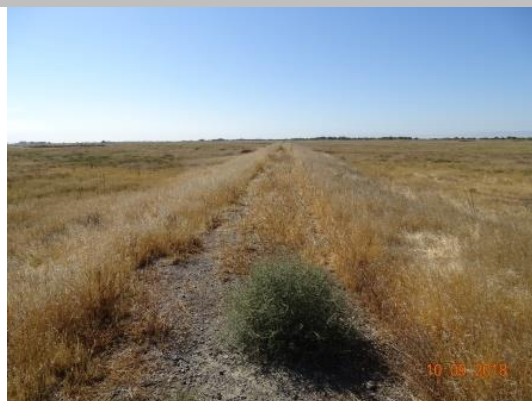
Photo 1 of 2 : FA_2018_NA0010_141_12_20181107_00030.jpg

LM Start	1.75	Rating **	U	Issue No.	12
LM End	2.49	Issue Type +	Ma	Location *	CR
Category	Earthen Levee			GPS Latitude/Longitude	
				Start	End
Item	Vegetation			37.281677°	37.271073°
				-120.867254°	-120.866562°
DWR ID	DWR_NA0010_25_f_2018_12				
Comment Code					
V2 : Remove the wild growth other than native grasses from the levee slopes.					
Inspector Comment					
Heavy vegetation along crown.

Looking east at typical view of levee crown. (Fall 2018)
