**Flood Control Project Maintenance
Levee Inspections**

Fall 2018 Levee Maintenance Deficiency Summary Report

San Joaquin River Basin

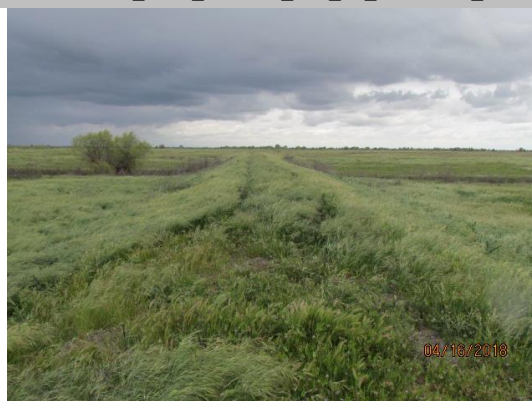
Photo 2 of 2 : FA_2018_NA0010_141_12_20180911_00007.jpg

LM Start	1.75	Rating **	U	Issue No.	12 (cont)
LM End	2.49	Issue Type +	Ma	Location *	CR

Looking east at typical view of levee crown. (Spring 2018)

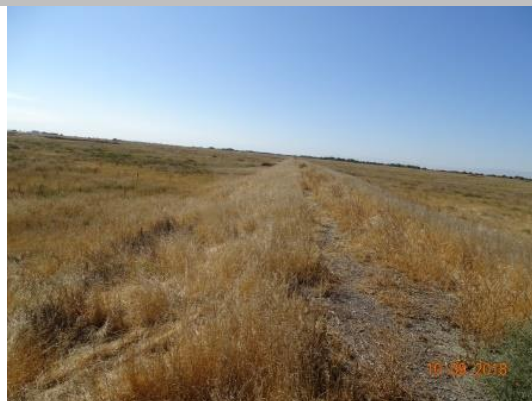
Photo 1 of 1 : FA_2018_NA0010_141_14_20181107_00032.jpg

LM Start	1.75	Rating **	U	Issue No.	14		
LM End	2.49	Issue Type +	Ma	Location *	LS		
Category	Earthen Levee			GPS Latitude/Longitude			
				Start		End	
Item	Vegetation				°		°
					°		°
DWR ID	DWR_NA0010_25_f_2018_14						
Comment Code							
V1 : Control annual grass and weeds on the levee slopes and easements.							
Inspector Comment

Looking east at typical view of landside slope. (Fall 2018)

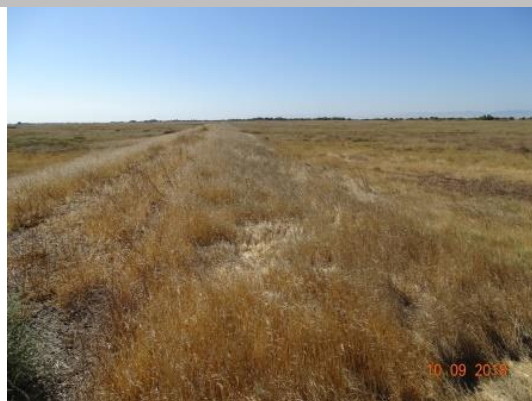
Photo 1 of 1 : FA_2018_NA0010_141_15_20181107_00031.jpg

LM Start	1.75	Rating **	U	Issue No.	15	
LM End	2.49	Issue Type +	Ma	Location *	WS	
Category	Earthen Levee			GPS Latitude/Longitude		
				Start		End
Item	Vegetation				°	
					°	
DWR ID	DWR_NA0010_25_f_2018_15					
Comment Code						
V1 : Control annual grass and weeds on the levee slopes and easements.						
Inspector Comment

Looking east at typical view of waterside slope. (Fall 2018)

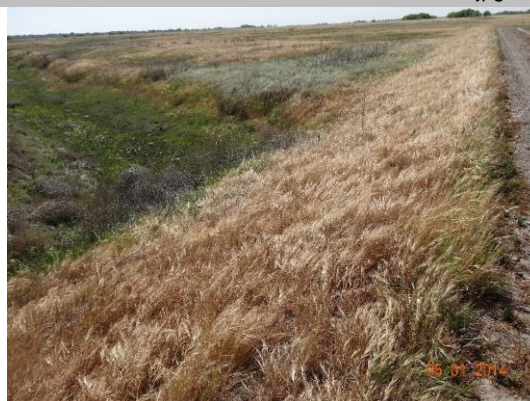
Photo 3 of 3 : UCIP_FA_2018_39502_67268.jpg

Comment Code						
Inspector Comment						
FS_ID:39502						
DS_ID:19970						
EP_NO: N/A						
Repair Type: Non-Urgent						
Crossing Status: Found						
UCIP Comments: 05/01/2014 Dense vegetation limits the inspectors visibility to identify signs of pipe failure (leaks) along the slope. Recommend removing vegetation along pipe alignment to conduct proper inspection of structure. Sediment buildup in pipe visible on landward side--recommend clearing. (DWR UCIP - O. Magana)						
FIELD_STRUCT_DESC: 24-inch corrugated metal gravity drainage pipe through the levee, 11.2 feet below the crown. Flap gate on the waterside (WS) end. [Additional Reference(s): DWR Levee Log, 2002. USACE San Joaquin O&M Manual 601.1, 1967, (HLM 2.45)].						
FS Date: 5/1/2014 4:04:00 PM

View of landward side.
