**Flood Control Project Maintenance
Levee Inspections**

Fall 2019 Levee Maintenance Deficiency Summary Report

San Joaquin River Basin

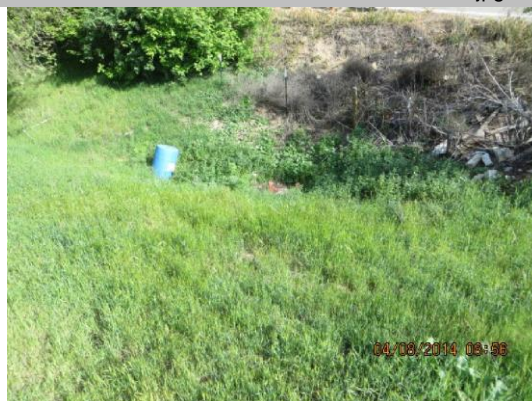
Photo 1 of 3 : UCIP_FA_2019_39091_60601.jpg

Comment Code						
Inspector Comment						
DS_ID:19650 FS_ID:39091 EP_NO: N/A Repair Type: Non-Urgent Crossing Status: Found UCIP Comments: 04/08/2014 Dense vegetation limits the inspector's visibility to identify signs of pipe failure (leaks) along the waterward slope and landward toe. Recommend removing vegetation along pipe alignment and landward toe to conduct proper inspection of structure and appurtenances. (DWR UCIP - W. Wylie) FIELD_STRUCT_DESC: 24-inch corrugated metal gravity drainage pipe through the levee, 10.5 feet below the crown. Flap gate on the waterside (WS) end. Brass cap No. 108 bench mark (BM) on the headwall on the landside (LS), elevation 65.1 feet, USGS Datum. [Additional Reference(s): DWR Levee Log, 2002. USACE San Joaquin O&M Manual 601.1, 1967, (HLM 0.02)]. FS Date: 4/8/2014 7:34:00 AM

Flapgate on WS toe.

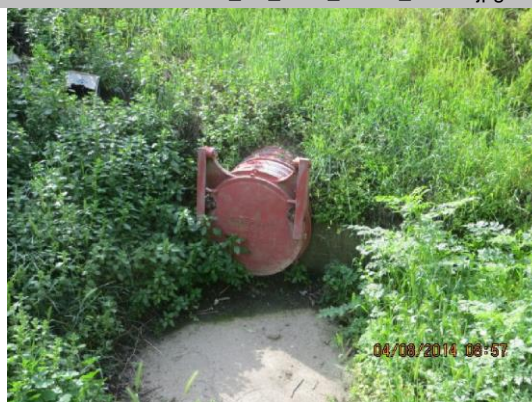
Photo 2 of 3 : UCIP_FA_2019_39091_60600.jpg

Flapgate on WS toe.

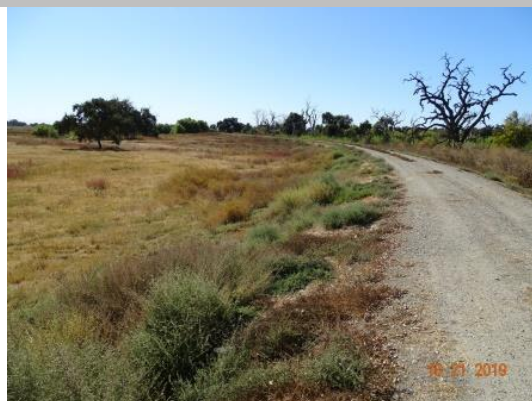
Photo 1 of 1 : FA_2019_NA0010_118_97_20191104_00276.jpg

LM Start	0.00	Rating **	U	Issue No.	97
LM End	3.49	Issue Type +	Ma	Location *	LS
Category	Earthen Levee			GPS Latitude/Longitude	
				Start	End
Item	Vegetation			37.348626 °	37.316763 °
				-120.958828 °	-120.926304 °
DWR ID	DWR_NA0010_01_f_2019_97				
Comment Code					
V1 : Control annual grass and weeds on the levee slopes and easements.					
Inspector Comment

View of landside slope and toe looking upstream. (Fall 2019)

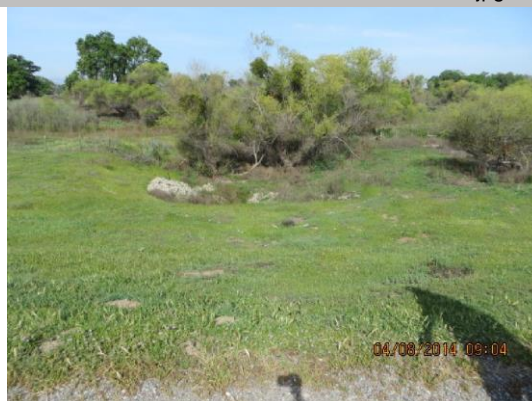
Photo 1 of 3 : UCIP_FA_2019_39092_60611.jpg

Comment Code						
Inspector Comment						
DS_ID:19651 FS_ID:39092 EP_NO: N/A Repair Type: Non-Urgent Crossing Status: Found UCIP Comments: 04/08/2014 Pipe has significant sediment buildup and shows some signs of corrosion at landward toe. Recommend cleaning sediment from inside pipe and check wall integrity. (DWR UCIP - W. Wylie) FIELD_STRUCT_DESC: 36-inch corrugated metal gravity drainage pipe through the levee, 18.5 feet below the crown. Flap gate on the waterside (WS) end. Brass cap No. 108 bench mark (BM) on the headwall on the landside (LS). [Additional Reference(s): DWR Levee Log, 2002. USACE San Joaquin O&M Manual 601.1, 1967, (HLM 0.35)]. FS Date: 4/8/2014

Flapgate and headwall visible off WS toe.

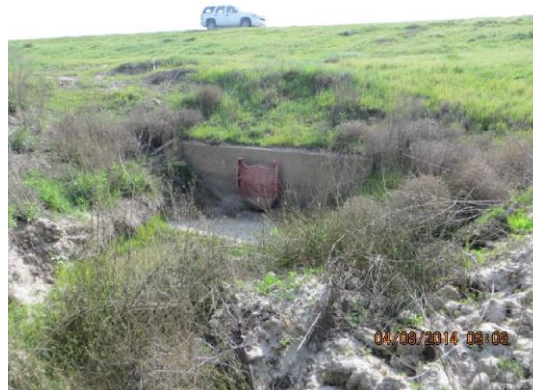
Photo 2 of 3 : UCIP_FA_2019_39092_60613.jpg

Flapgate and headwall visible off WS toe.

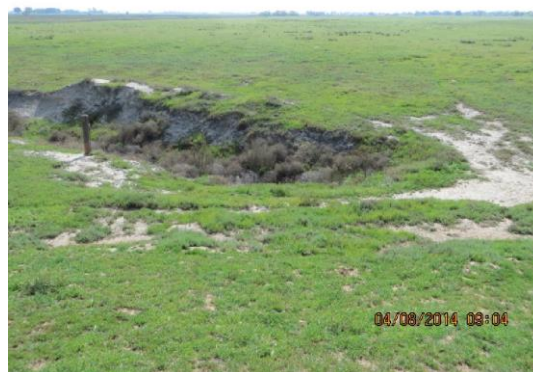
Photo 3 of 3 : UCIP_FA_2019_39092_60612.jpg

Pipe and headwall visible off LS toe.

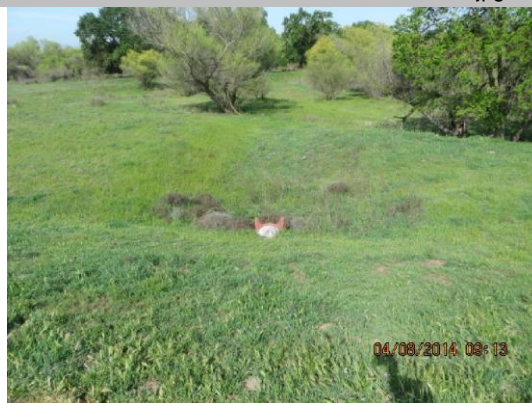
Photo 1 of 3 : UCIP_FA_2019_39095_60622.jpg

LM Start	0.60	Rating **	M	Issue No.	1187	
LM End	0.60	Issue Type +	Ma	Location *		
Category	Supplemental			GPS Latitude/Longitude		
				Start		End
Item	DRAFT DWR UCIP LMA Responsibility			37.341507 °		37.341507 °
				-120.961283 °		-120.961283 °
DWR ID	19583					
Comment Code						
Inspector Comment						
DS_ID:19583 FS_ID:39095 EP_NO: N/A Repair Type: Non-Urgent Crossing Status: Found UCIP Comments: 04/08/2014 Recommend removing vegetation pile through the levee, 8.5 feet below the crown. Flap gate on the waterside (WS) end. Brass cap No. 108 bench mark (BM) on the headwall on the landside (LS). [Additional Reference(s): DWR Levee Log, 2002. USACE San Joaquin O&M Manual 601.1, 1967, (HLM 0.62)]. FS Date: 4/8/2014

Flapgate and headwall visible on WS toe.

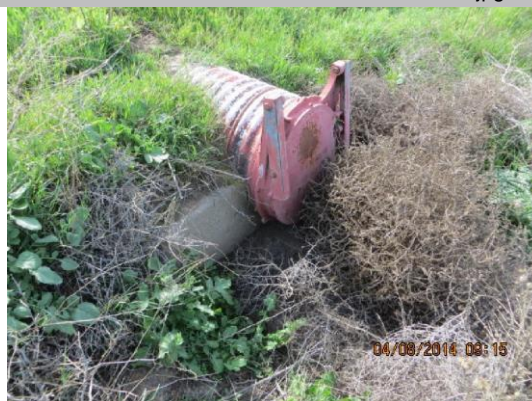
Photo 2 of 3 : UCIP_FA_2019_39095_60623.jpg

Flapgate and headwall visible on WS toe.

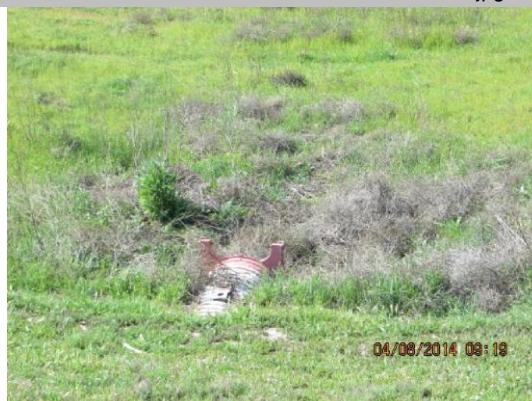
Photo 1 of 3 : UCIP_FA_2019_33524_60627.jpg

LM Start	0.85	Rating **	A/W	Issue No.	1188
LM End	0.85	Issue Type +	Ma	Location *	
Category	Supplemental			GPS Latitude/Longitude	
				Start	End
Item	DRAFT DWR UCIP LMA Responsibility			37.339829 °	37.339829 °
				-120.958621 °	-120.958621 °
DWR ID	19584				
Comment Code					
Inspector Comment					
DS_ID:19584					
FS_ID:33524					
EP_NO: N/A					
Repair Type: No Action Needed					
Crossing Status: Found					
UCIP Comments:					
FIELD_STRUCT_DESC: 24-inch corrugated metal gravity drainage pipe through the levee, 7 feet below the crown. Flap gate on the waterside (WS) end. Brass cap No. 108 bench mark (BM) on the headwall on the landside (LS). [Additional Reference(s): DWR Levee Log, 2002. USACE San Joaquin O&M Manual 601.1, 1967, (HLM 0.87)].					
FS Date: 4/8/2014

Pipe, flapgate, and headwall visible on WS toe.

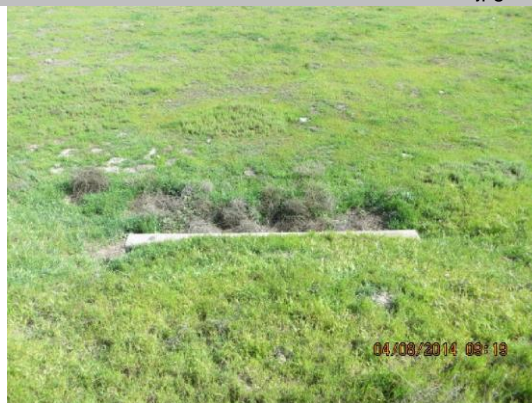
Photo 2 of 3 : UCIP_FA_2019_33524_60626.jpg

Pipe and headwall visible on LS toe.

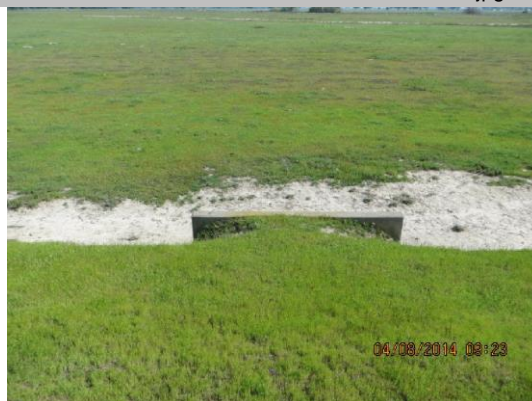
Photo 2 of 3 : UCIP_FA_2019_39096_60631.jpg

Comment Code						
Inspector Comment						
DS_ID:19585 FS_ID:39096 EP_NO: N/A Repair Type: Non-Urgent Crossing Status: Found UCIP Comments: 04/08/2014 Moderate erosion around headwall on landward toe. May or may not be an issue. Need to contact owner to determine status of crossing and to address erosion issue on landward side. (DWR UCIP - W. Wylie) FIELD_STRUCT_DESC: 24-inch corrugated metal gravity drainage pipe through the levee, 7 feet below the crown. Flap gate on the waterside (WS) end. Brass cap No. 108 bench mark (BM) on the headwall on the landside (LS). [Additional Reference(s): DWR Levee Log, 2002. USACE San Joaquin O&M Manual 601.1, 1967, (HLM 0.95)]. FS Date: 4/8/2014

Concrete headwall and pipe visible at LS toe.

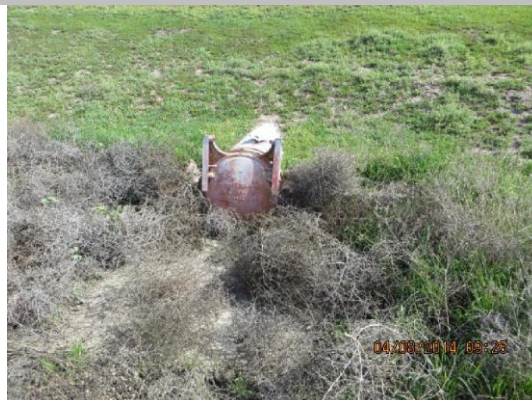
Photo 3 of 3 : UCIP_FA_2019_39096_60633.jpg

Flapgate, pipe, and headwall on WS toe.

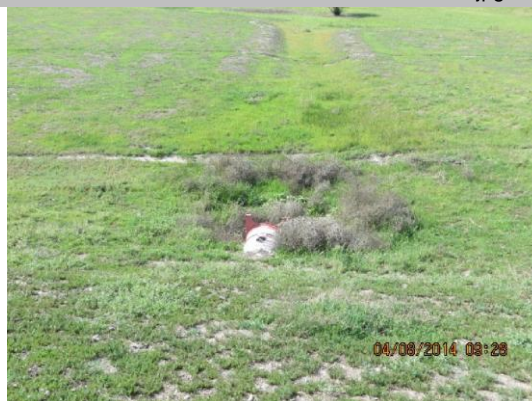
Photo 1 of 3 : UCIP_FA_2019_33543_60642.jpg

LM Start	1.15	Rating **	A/W	Issue No.	1190
LM End	1.15	Issue Type +	Ma	Location *	
Category	Supplemental			GPS Latitude/Longitude	
				Start	End
Item	DRAFT DWR UCIP LMA Responsibility			37.338005 °	37.338005 °
				-120.953921 °	-120.953921 °
DWR ID	19586				
Comment Code					
Inspector Comment					
DS_ID:19586 FS_ID:33543 EP_NO: N/A Repair Type: No Action Needed Crossing Status: Found UCIP Comments: FIELD_STRUCT_DESC: 24-inch corrugated metal gravity drainage pipe through the levee, 7.5 feet below the crown. Flap gate on the waterside (WS) end. Brass cap No. 108 bench mark (BM) on the headwall on the landside (LS). [Additional Reference(s): DWR Levee Log, 2002. USACE San Joaquin O&M Manual 601.1, 1967, (HLM 1.17)]. FS Date: 4/8/2014

Pipe, headwall, and flapgate visible on WS toe.

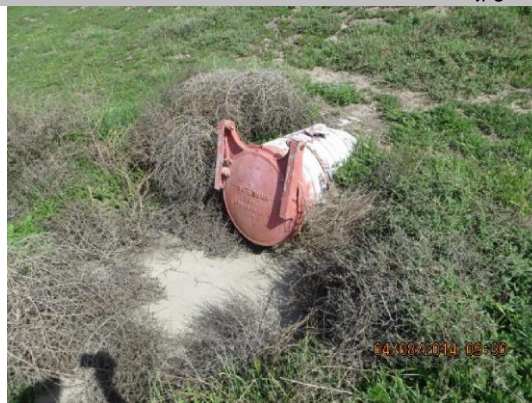
Photo 2 of 3 : UCIP_FA_2019_33543_60643.jpg

Pipe, headwall, and flapgate visible on WS toe.

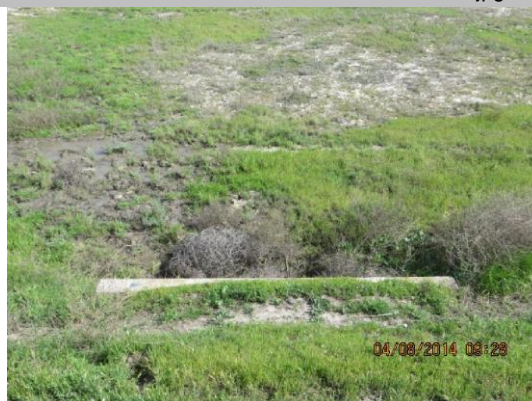
Photo 3 of 3 : UCIP_FA_2019_33543_60641.jpg

Headwall and pipe visible on LS toe.

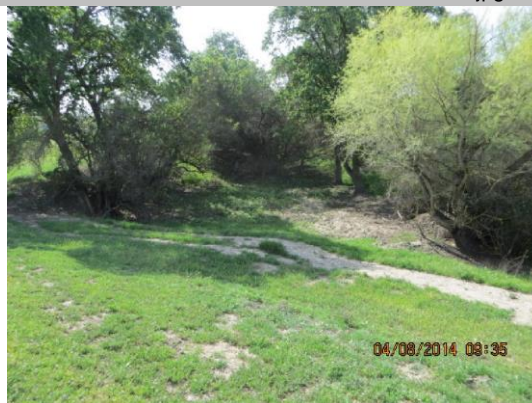
Photo 1 of 3 : UCIP_FA_2019_33544_60649.jpg

LM Start	1.32	Rating **	A/W	Issue No.	1191
LM End	1.32	Issue Type +	Ma	Location *	
Category	Supplemental			GPS Latitude/Longitude	
				Start	End
Item	DRAFT DWR UCIP LMA Responsibility			37.337361 °	37.337361 °
				-120.950879 °	-120.950879 °
DWR ID	19587				
Comment Code					
Inspector Comment					
DS_ID:19587 FS_ID:33544 EP_NO: N/A Repair Type: No Action Needed Crossing Status: Found UCIP Comments: FIELD_STRUCT_DESC: 36-inch corrugated metal gravity drainage pipe through the levee, 12.8 feet below the crown. Flap gate on the waterside (WS) end. Brass cap No. 108 bench mark (BM) on the headwall on the landside (LS). Pipe crosses through the levee at about a 45 degree angle to the crown. [Additional Reference(s): DWR Levee Log, 2002. USACE San Joaquin O&M Manual 601.1, 1967, (HLM 1.34)]. FS Date: 4/8/2014

Concrete headwall and flapgate visible at WS toe.

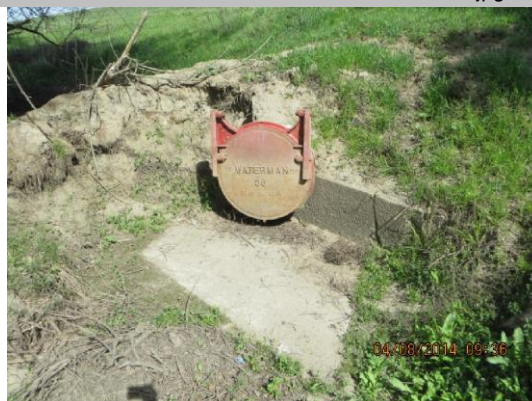
Photo 2 of 3 : UCIP_FA_2019_33544_60648.jpg

Concrete headwall and flapgate visible at WS toe.

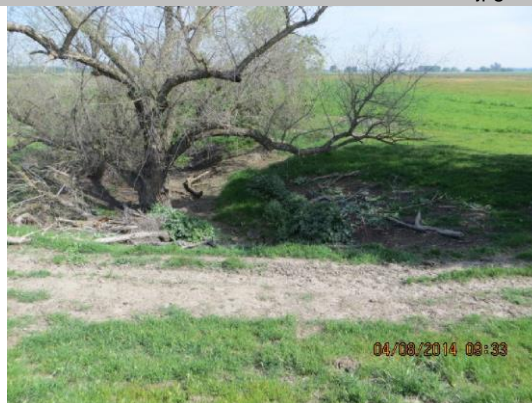
Photo 3 of 3 : UCIP_FA_2019_33544_60647.jpg

Concrete headwall and pipe visible at LS toe.

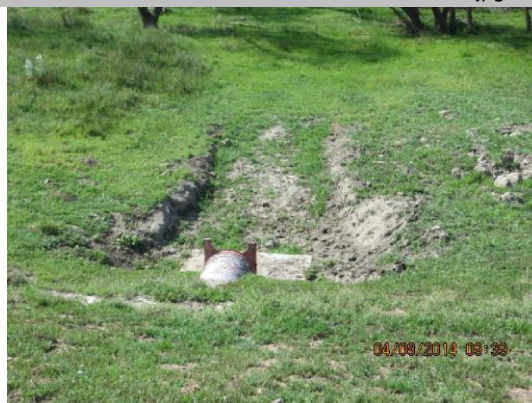
Photo 1 of 3 : UCIP_FA_2019_39099_60652.jpg

Comment Code						
Inspector Comment						
DS_ID:19588						
FS_ID:39099						
EP_NO: N/A						
Repair Type: Non-Urgent						
Crossing Status: Found						
UCIP Comments: 04/08/2014 Some sediment buildup inside pipe at LS toe. Recommend contacting owner to clear sediment buildup and check wall integrity through pipe section. (DWR UCIP - W. Wylie)						
FIELD_STRUCT_DESC: 24-inch corrugated metal gravity drainage pipe through the levee, 11 feet below the crown. Flap gate on the waterside (WS) end. Brass cap No. 108 bench mark (BM) on the headwall on the landside (LS). [Additional Reference(s): DWR Levee Log, 2002. USACE San Joaquin O&M Manual 601.1, 1967, (HLM 1.48)].						
FS Date: 4/8/2014

Pipe, flapgate, and concrete headwall visible on WS toe.

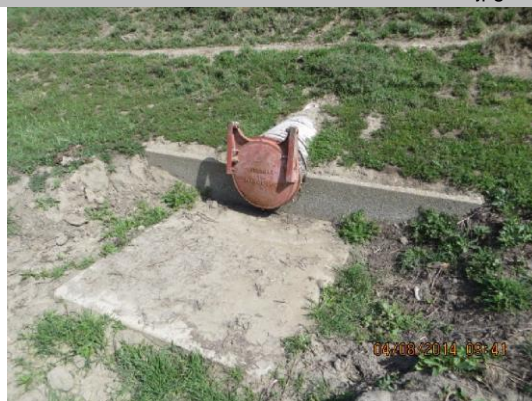
Photo 2 of 3 : UCIP_FA_2019_39099_60653.jpg

Pipe, flapgate, and concrete headwall visible on WS toe.

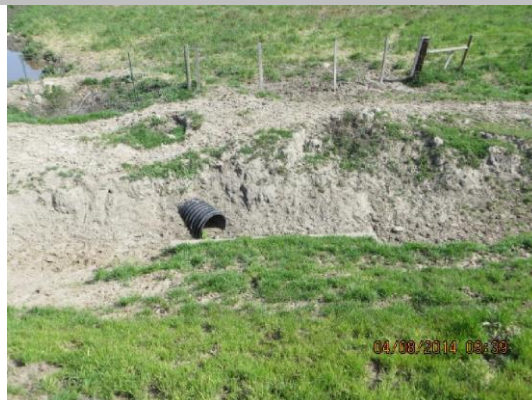
Photo 3 of 3 : UCIP_FA_2019_39099_60651.jpg

Pipe and concrete headwall visible on LS toe.

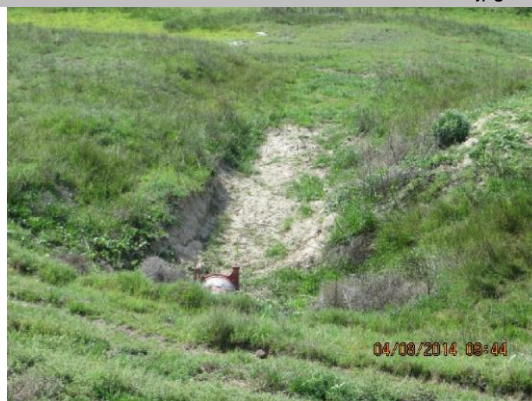
Photo 1 of 3 : UCIP_FA_2019_33563_60661.jpg

LM Start	1.67	Rating **	M	Issue No.	1193
LM End	1.67	Issue Type +	Ma	Location *	
Category	Supplemental			GPS Latitude/Longitude	
				Start	End
Item	DRAFT DWR UCIP LMA Responsibility			37.336459 °	37.336459 °
				-120.944803 °	-120.944803 °
DWR ID	19589				
Comment Code					
Inspector Comment					
DS_ID:19589 FS_ID:33563 EP_NO: N/A Repair Type: Non-Urgent Crossing Status: Found UCIP Comments: 04/08/2014 Heavy sediment buildup in pipe at LS toe. (DWR UCIP - W. Wylie) FIELD_STRUCT_DESC: 24-inch corrugated metal gravity drainage pipe through the levee, 13.6 feet below the crown. Flap gate on the waterside (WS) end. Brass cap No. 108 bench mark (BM) on the headwall on the landside (LS). [Additional Reference(s): DWR Levee Log, 2002. USACE San Joaquin O&M Manual 601.1, 1967, (HLM 1.69)]. FS Date: 4/8/2014

Pipe, headwall, and flapgate visible on WS toe.

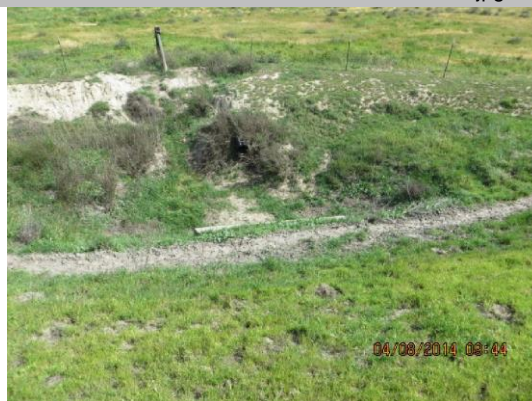
Photo 3 of 3 : UCIP_FA_2019_33563_60662.jpg

Pipe and headwall visible on LS toe.

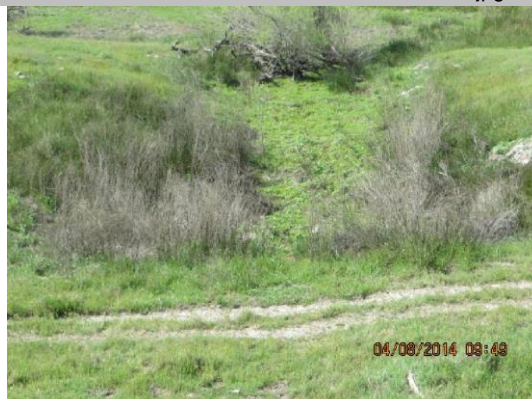
Photo 1 of 3 : UCIP_FA_2019_33564_60666.jpg

LM Start	1.81	Rating **	A/W	Issue No.	1194	
LM End	1.81	Issue Type +	Ma	Location *		
Category	Supplemental			GPS Latitude/Longitude		
				Start		End
Item	DRAFT DWR UCIP LMA Responsibility			37.335612 °		37.335612 °
				-120.942532 °		-120.942532 °
DWR ID	19590					
Comment Code						
Inspector Comment						
DS_ID:19590						
FS_ID:33564						
EP_NO: N/A						
Repair Type: No Action Needed						
Crossing Status: Found						
UCIP Comments:						
FIELD_STRUCT_DESC: 36-inch corrugated metal gravity drainage pipe through the levee, 14.2 feet below the crown. Flap gate on the waterside (WS) end. Brass cap No. 100 bench mark (BM) on the headwall on the landside (LS). [Additional Reference(s): DWR Levee Log, 2002. USACE San Joaquin O&M Manual 601.1, 1967, (HLM 1.83)].						
FS Date: 4/8/2014

Pipe, flapgate, and headwall visible at WS toe.

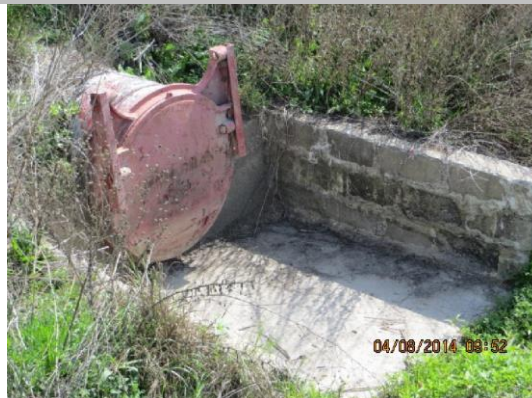
Photo 2 of 3 : UCIP_FA_2019_33564_60667.jpg

Pipe, flapgate, and headwall visible at WS toe.

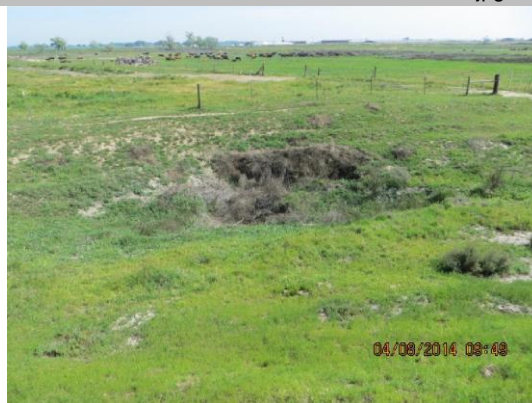
Photo 3 of 3 : UCIP_FA_2019_33564_60665.jpg

Pipe and concrete headwall visible at LS toe.

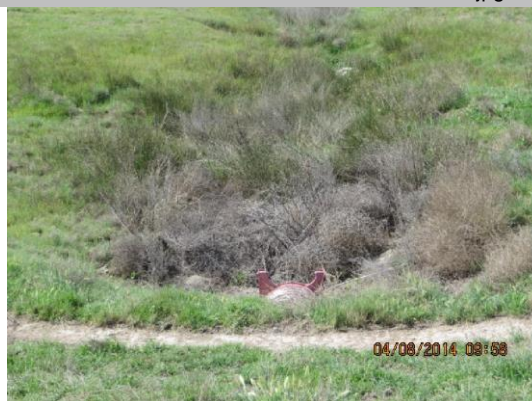
Photo 1 of 3 : UCIP_FA_2019_39100_60670.jpg

Comment Code						
Inspector Comment						
DS_ID:19591						
FS_ID:39100						
EP_NO: N/A						
Repair Type: Non-Urgent						
Crossing Status: Found						
UCIP Comments: 04/08/2014 Need to contact owner to determine crossing status. Inlet drop box silted in and needs to be cleaned out. (DWR UCIP - W. Wylie)						
FIELD_STRUCT_DESC: 24-inch corrugated metal gravity drainage pipe through the levee, 9.7 feet below the crown. Flap gate on the waterside (WS) end. Brass cap No. 100 bench mark (BM) on the headwall on the landside (LS). Wooden barrier around drop inlet on the LS toe. [Additional Reference(s): DWR Levee Log, 2002. USACE San Joaquin O&M Manual 601.1, 1967, (HLM 1.98)].						
FS Date: 4/8/2014

Concrete headwall and flapgate on WS toe.

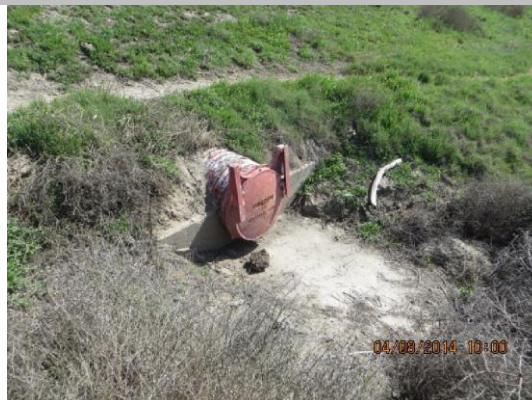
Photo 2 of 3 : UCIP_FA_2019_39100_60672.jpg

Pipe, flapgate, and headwall on WS toe.

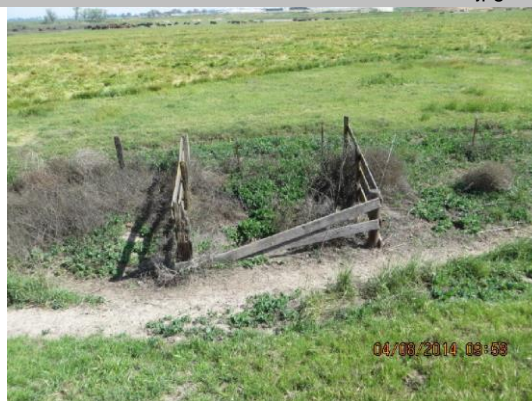
Photo 3 of 3 : UCIP_FA_2019_39100_60671.jpg

Comment Code						
Inspector Comment						
DS_ID:19591 FS_ID:39100 EP_NO: N/A Repair Type: Non-Urgent Crossing Status: Found UCIP Comments: 04/08/2014 Need to contact owner to determine crossing status. Inlet drop box silted in and needs to be cleaned out. (DWR UCIP - W. Wylie) FIELD_STRUCT_DESC: 24-inch corrugated metal gravity drainage pipe through the levee, 9.7 feet below the crown. Flap gate on the waterside (WS) end. Brass cap No. 100 bench mark (BM) on the headwall on the landside (LS). Wooden barrier around drop inlet on the LS toe. [Additional Reference(s): DWR Levee Log, 2002. USACE San Joaquin O&M Manual 601.1, 1967, (HLM 1.98)]. FS Date: 4/8/2014

Wooded barrier around drop-inlet on LS toe.

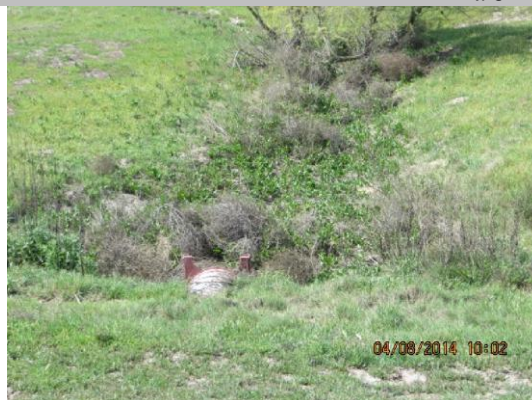
Photo 1 of 3 : UCIP_FA_2019_39123_60675.jpg

LM Start	2.06	Rating **	M	Issue No.	1196	
LM End	2.06	Issue Type +	Ma	Location *		
Category	Supplemental			GPS Latitude/Longitude		
				Start		End
Item	DRAFT DWR UCIP LMA Responsibility			37.333653 °		37.333653 °
				-120.938770 °		-120.938770 °
DWR ID	19570					
Comment Code						
Inspector Comment						
DS_ID:19570 FS_ID:39123 EP_NO: N/A Repair Type: Non-Urgent Crossing Status: Found UCIP Comments: 04/08/2014 Unable to find inlet on landward toe. Recommend clearing vegetation on landward side to properly inspect inlet. (DWR UCIP - W. Wylie) FIELD_STRUCT_DESC: 24-inch corrugated metal gravity drainage pipe through the levee, 9.8 feet below the crown. Flap gate on the waterside (WS) end. Brass cap No. 100 bench mark (BM) on the headwall on the landside (LS). [Additional Reference(s): DWR Levee Log, 2002. USACE San Joaquin O&M Manual 601.1, 1967, (HLM 2.08)]. FS Date: 4/8/2014

Pipe and flapgate visible on WS toe.

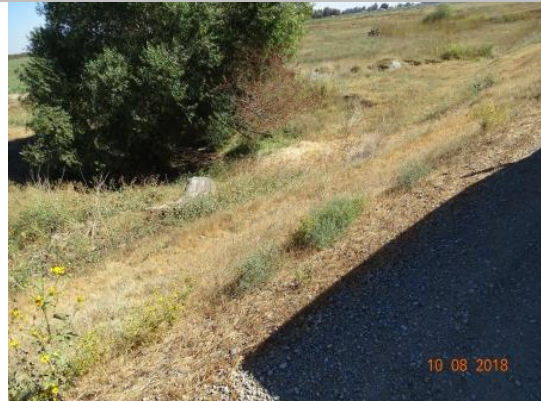
Photo 1 of 2 : FA_2019_NA0010_118_110_20190912_00020.jpg

View of tree stump on landside slope. (Fall 2018)

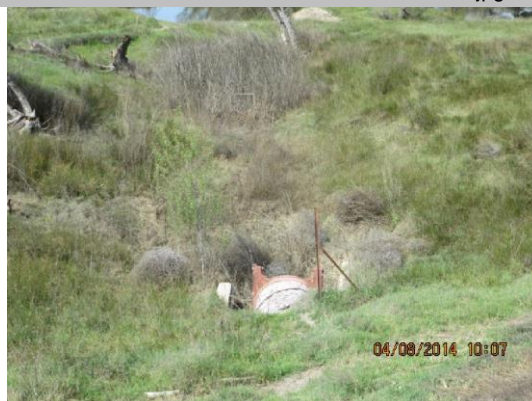
Photo 1 of 3 : UCIP_FA_2019_39125_71309.jpg

Pipe and flapgate on WS toe.

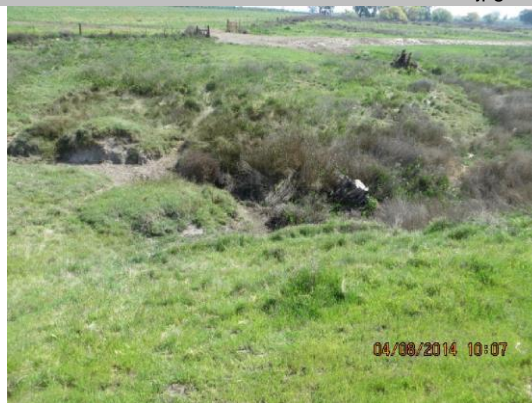
Photo 2 of 3 : UCIP_FA_2019_39125_71308.jpg

Pipe and headwall on LS toe.

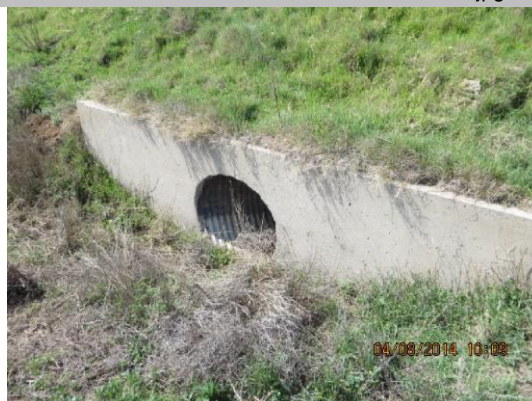
Photo 3 of 3 : UCIP_FA_2019_39125_71307.jpg

Pipe and headwall on LS toe.

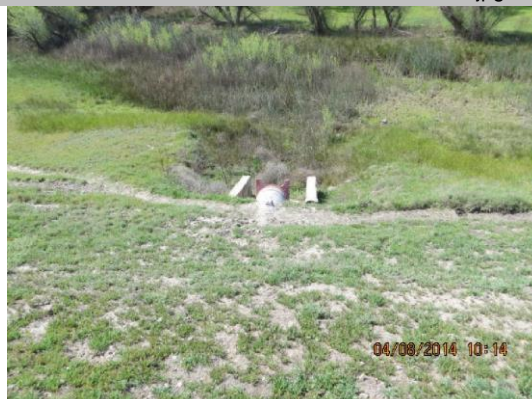
Photo 1 of 3 : UCIP_FA_2019_33568_60679.jpg

Pipe, headwall, and flapgate on WS toe.

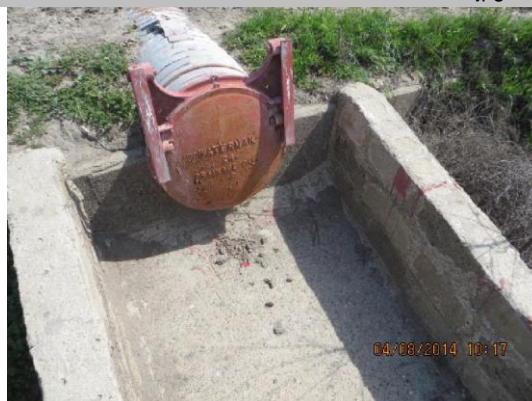
Photo 2 of 3 : UCIP_FA_2019_33568_60680.jpg

Pipe, headwall, and flapgate on WS toe.

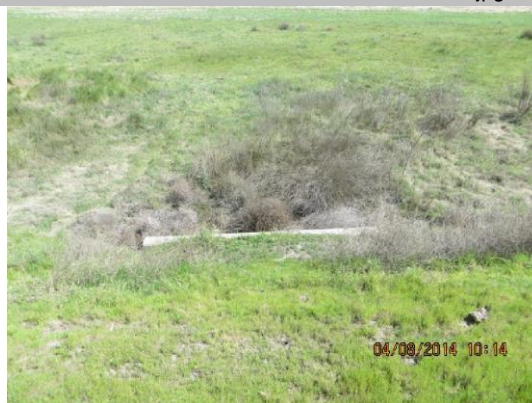
Photo 3 of 3 : UCIP_FA_2019_33568_60678.jpg

Pipe and headwall on LS toe.

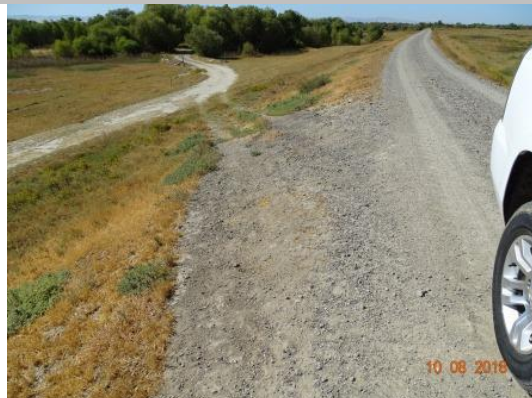
Photo 1 of 1 : FA_2019_NA0010_118_113_20190912_00023.jpg

LM Start	2.58	Rating **	A/W	Issue No.	113
LM End	2.58	Issue Type +	Ma	Location *	WS
Category	Earthen Levee			GPS Latitude/Longitude	
				Start	End
Item	Slope Stability			37.327936 °	37.327936 °
				-120.933013 °	-120.933013 °
DWR ID	DWR_NA0010_01_f_2018_113				
Comment Code					
S3 : Repair the levee slope damaged by vehicle traffic and prevent access where possible.					
Inspector Comment					
There is damage caused by vehicle traffic over the levee.

Slope damage by vehicle traffic. (Fall 2018)

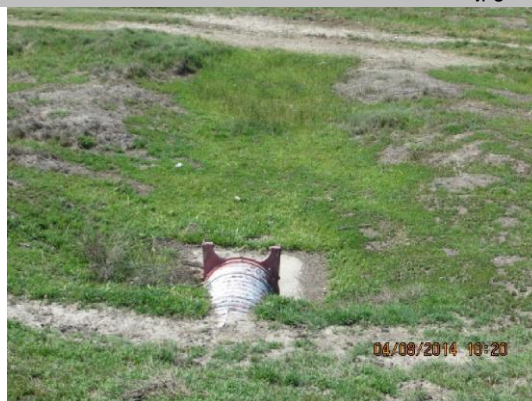
Photo 1 of 3 : UCIP_FA_2019_39127_60688.jpg

Pipe, flapgate, and headwall on WS toe.

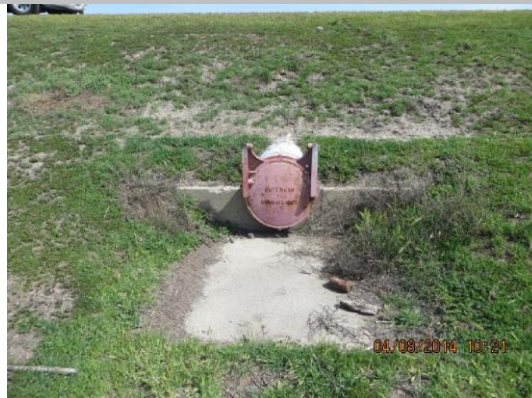
Photo 2 of 3 : UCIP_FA_2019_39127_60689.jpg

Pipe, flapgate, and headwall on WS toe.

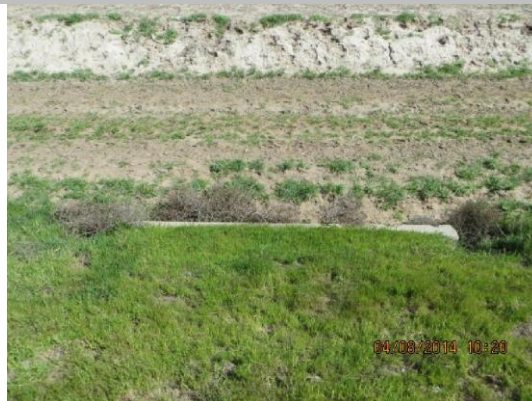
Photo 3 of 3 : UCIP_FA_2019_39127_60687.jpg

Pipe and headwall on LS toe.

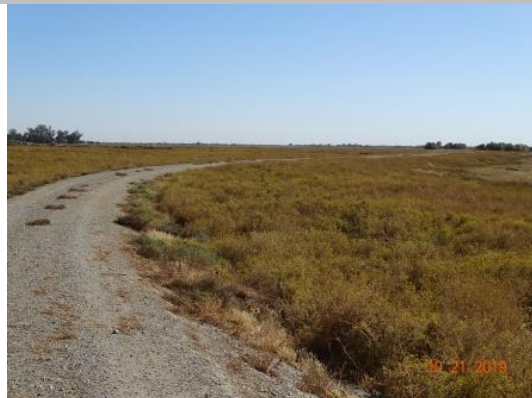
Photo 1 of 1 : FA_2019_NA0010_118_101_20191104_00277.jpg

LM Start	2.73	Rating **	U	Issue No.	101
LM End	3.28	Issue Type +	Ma	Location *	WS
Category	Earthen Levee			GPS Latitude/Longitude	
				Start	End
Item	Vegetation			37.326972 °	37.319479 °
				-120.930730 °	-120.928075 °
DWR ID	DWR_NA0010_01_f_2019_101				
Comment Code					
V1 : Control annual grass and weeds on the levee slopes and easements.					
Inspector Comment

View of waterside slope looking upstream. (Fall 2019)

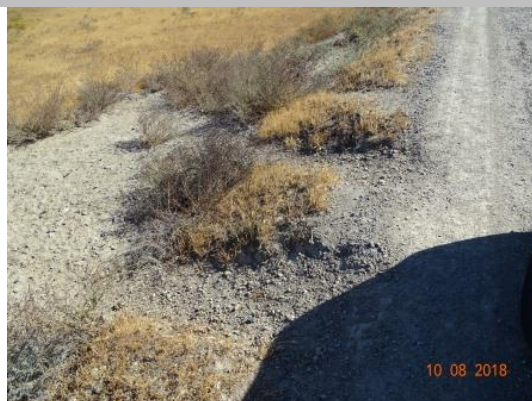
Photo 1 of 1 : FA_2019_NA0010_118_114_20190912_00024.jpg

LM Start	2.99	Rating **	M	Issue No.	114
LM End	2.99	Issue Type +	Ma	Location *	LS
Category	Earthen Levee			GPS Latitude/Longitude	
				Start	End
Item	Slope Stability			37.323328 °	37.323328 °
				-120.929521 °	-120.929521 °
DWR ID	DWR_NA0010_01_f_2018_114				
Comment Code					
S2 : Repair the levee slope damaged by foot traffic and prevent access where possible.					
Inspector Comment					
Slope damage caused by livestock.

View of slope damage caused by livestock. (Fall 2018)

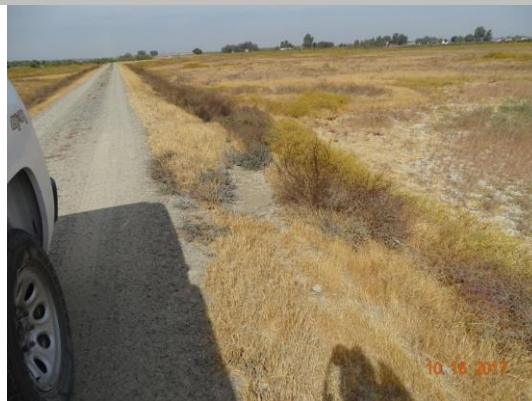
Photo 1 of 1 : FA_2019_NA0010_118_104_20190912_00018.jpg

LM Start	3.06	Rating **	M	Issue No.	104
LM End	3.06	Issue Type +	Ma	Location *	LS
Category	Earthen Levee			GPS Latitude/Longitude	
				Start	End
Item	Slope Stability			37.322499 °	37.322499 °
				-120.928986 °	-120.928986 °
DWR ID	DWR_NA0010_01_f_2017_104				
Comment Code					
S2 : Repair the levee slope damaged by foot traffic and prevent access where possible.					
Inspector Comment					
Slope damage caused by foot traffic.

Looking northeast at the landside slope. (Fall 2017)

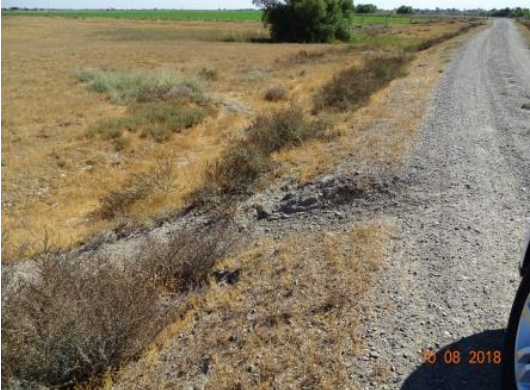
Photo 1 of 2 : FA_2019_NA0010_118_115_20190912_00025.jpg

View of erosion path looking downstream. (Fall 2018)

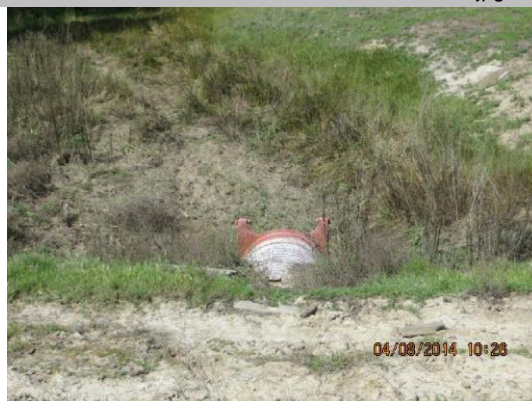
Photo 1 of 3 : UCIP_FA_2019_39128_60702.jpg

Pipe, Flapgate, and headwall on WS toe.

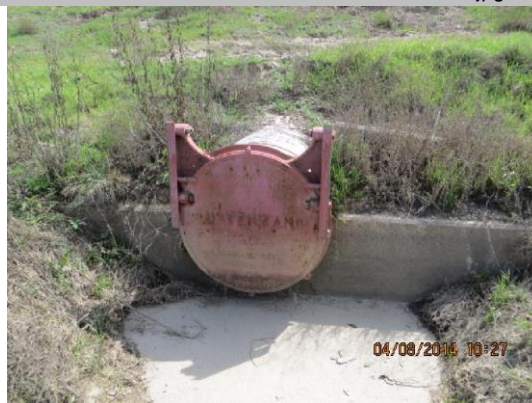
Photo 2 of 3 : UCIP_FA_2019_39128_60700.jpg

Pipe, Flapgate, and headwall on WS toe.

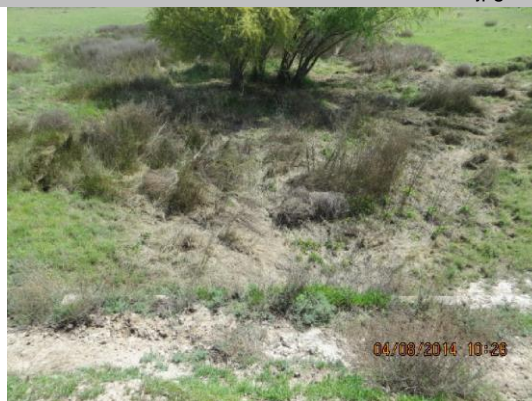
Photo 3 of 3 : UCIP_FA_2019_39128_60701.jpg

Pipe and headwall on LS toe.

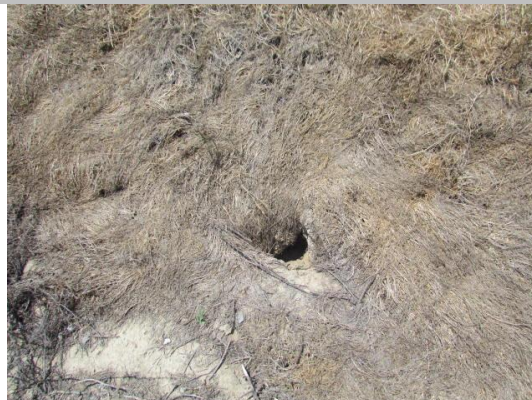
Photo 1 of 2 : FA_2019_NA0010_118_10_20190912_00009.jpg

LM Start	3.16	Rating **	M	Issue No.	10
LM End	3.16	Issue Type +	Ma	Location *	LS
Category	Earthen Levee			GPS Latitude/Longitude	
				Start	End
Item	Animal Control			37.321053 °	37.321053 °
				-120.928785 °	-120.928785 °
DWR ID	DWR_NA0010_01_s_2012_10				
Comment Code					
A3 : No rodents visible, but rodent burrows visible; need to backfill and compact or grout burrows.					
Inspector Comment					
Several rodent holes noted within this section. Rodent hole noted on landside shoulder next to fence pole.

Looking at typical view of rodent holes on landward slope.

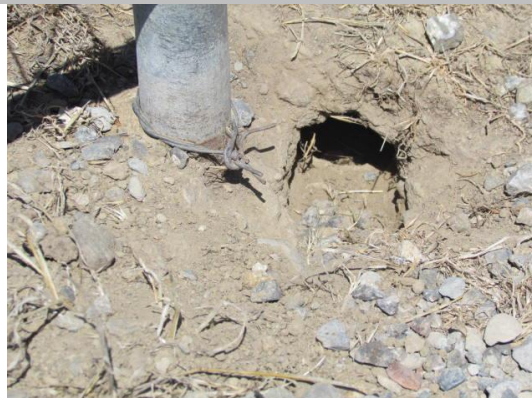
Photo 2 of 2 : FA_2019_NA0010_118_10_20190912_00010.jpg

LM Start	3.16	Rating **	M	Issue No.	10 (cont)	
LM End	3.16	Issue Type +	Ma	Location *	LS	
Category	Earthen Levee			GPS Latitude/Longitude		
				Start		End
Item	Animal Control			37.321053 °	37.321053 °	
				-120.928785 °	-120.928785 °	
DWR ID	DWR_NA0010_01_s_2012_10					
Comment Code						
A3 : No rodents visible, but rodent burrows visible; need to backfill and compact or grout burrows.						
Inspector Comment						
Several rodent holes noted within this section. Rodent hole noted on landside shoulder next to fence pole.

Looking at rodent hole next to fence pole on landward shoulder.

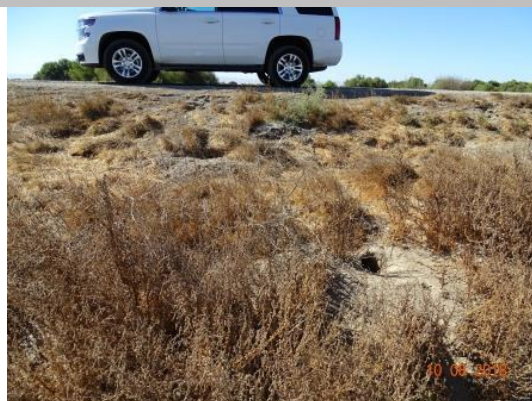
Photo 1 of 2 : FA_2019_NA0010_118_116_20190912_00027.jpg

LM Start	3.18	Rating **	M	Issue No.	116
LM End	3.18	Issue Type +	Ma	Location *	LS
Category	Earthen Levee			GPS Latitude/Longitude	
				Start	End
Item	Animal Control			37.320725 °	37.320725 °
				-120.928837 °	-120.928837 °
DWR ID	DWR_NA0010_01_f_2018_116				
Comment Code					
A3 : No rodents visible, but rodent burrows visible; need to backfill and compact or grout burrows.					
Inspector Comment					
Several rodent holes noted in this section.

View of landside slope with rodent holes. (Fall 2018)

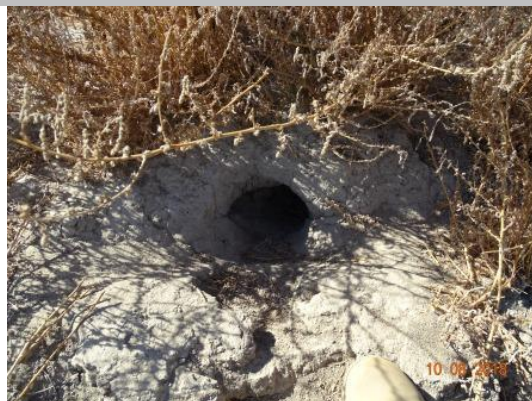
Photo 2 of 2 : FA_2019_NA0010_118_116_20190912_00028.jpg

LM Start	3.18	Rating **	M	Issue No.	116 (cont)
LM End	3.18	Issue Type +	Ma	Location *	LS

Representative view of rodent holes in this section. (Fall 2018)

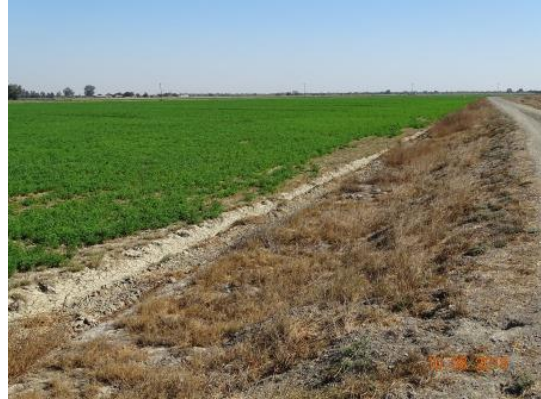
Photo 1 of 1 : FA_2019_NA0010_118_117_20190912_00029.jpg

LM Start	3.23	Rating **	M	Issue No.	117
LM End	3.90	Issue Type +	En	Location *	LS
Category	Earthen Levee			GPS Latitude/Longitude	
				Start	End
Item	Encroachments			37.320029 °	37.311311 °
				-120.928556 °	-120.927310 °
DWR ID	DWR_NA0010_01_f_2018_117				
Comment Code					
DT : Ditch					
Inspector Comment					
Earthen ditch along landside toe.

Earthen ditch along landside toe. (Fall 2018)

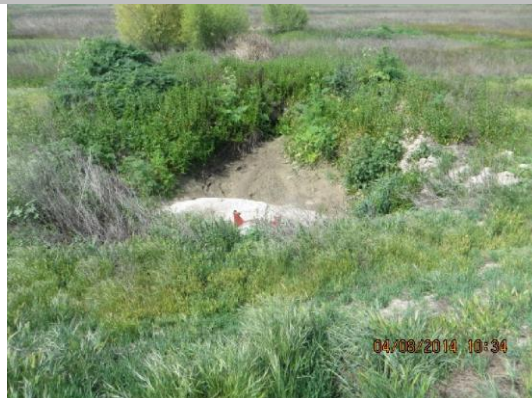
Photo 1 of 3 : UCIP_FA_2019_53188_60707.jpg

UCIP Comments: 11/01/2018 Pipe continues to rust through, causing the pipe to collapse on the LS. Sediment buildup visible from the LS inlet. Loss of soil just above the LS concrete headwall and along the LS slope. Crossing remains Urgent due to the levee slope issues and pipe failure through the levee. (O. Magana - DWR UCIP)07/19/2016 Same as previous inspection. Erosion present on LS slope. (DWR UCIP - O. Magana)04/08/2014 Pipe rusted through at Springline on LS toe. Flapgate blocked by sediment on WS toe. Heavy sediment on both ends of pipe. Need to contact owner to address issues. (DWR UCIP - W. Wylie)

LM Start	3.47	Rating **	U	Issue No.	1201 (cont)
LM End	3.47	Issue Type +	Ma	Location *

Pipe, headwall, and flapgate on WS toe.

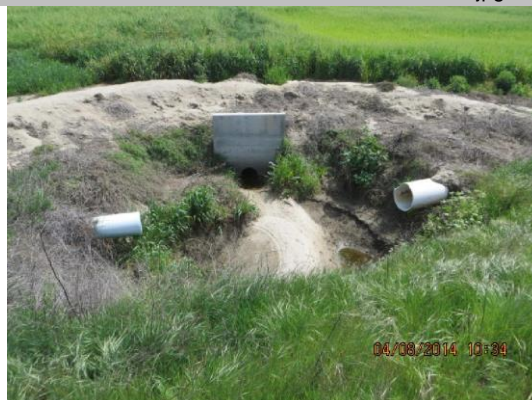
Photo 2 of 3 : UCIP_FA_2019_53188_60706.jpg

Pipe and headwall on LS toe.

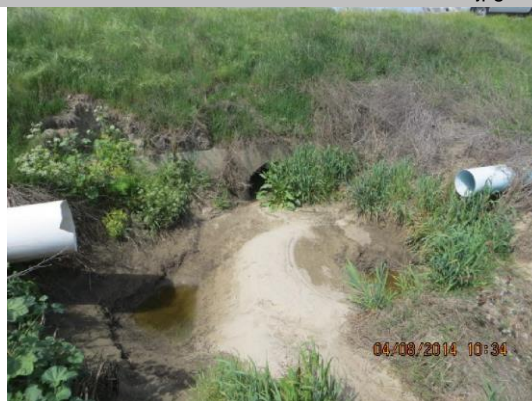
Photo 3 of 3 : UCIP_FA_2019_53188_60705.jpg

Comment Code					
Inspector Comment					
DS_ID:19575 FS_ID:53188 EP_NO: N/A Repair Type: Urgent Crossing Status: Found UCIP Comments: 11/01/2018 Pipe continues to rust through, causing the pipe to collapse on the LS. Sediment buildup visible from the LS inlet. Loss of soil just above the LS concrete headwall and along the LS slope. Crossing remains Urgent due to the levee slope issues and pipe failure through the levee. (O. Magana - DWR UCIP)07/19/2016 Same as previous inspection. Erosion present on LS slope. (DWR UCIP - O. Magana)04/08/2014 Pipe rusted through at Springline on LS toe. Flapgate blocked by sediment on WS toe. Heavy sediment on both ends of pipe. Need to contact owner to address issues. (DWR UCIP - W. Wylie) FIELD_STRUCT_DESC: 36-inch corrugated metal gravity drainage pipe through the levee, 9.7 feet below the crown. Flap gate on the waterside (WS) end. Brass cap No. 100 bench mark (BM) on the headwall on the landside (LS). [Additional Reference(s): DWR Levee Log, 2002. USACE San Joaquin O&M Manual 601.1, 1967, (HLM 3.50)]. FS Date: 11/1/2018 12:49:00 PM

Pipe and headwall on LS toe.

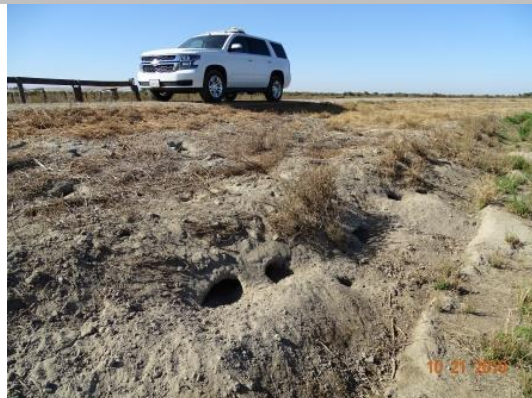
Photo 1 of 2 : FA_2019_NA0010_118_2_20191104_00278.jpg

LM Start	3.87	Rating **	U	Issue No.	2 (cont)
LM End	3.90	Issue Type +	Ma	Location *	LS

View of rodent burrows in this section looking downstream. (Fall 2019)

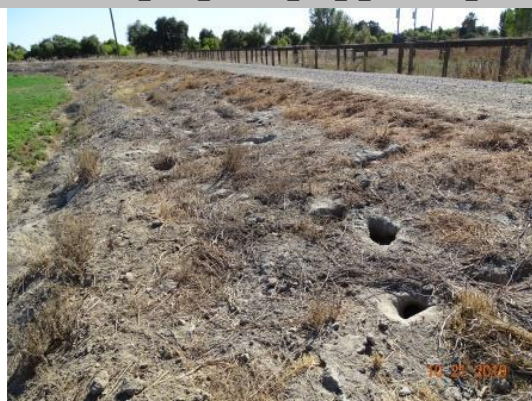
Photo 2 of 2 : FA_2019_NA0010_118_2_20191104_00279.jpg

View of rodent burrows in this section looking upstream. (Fall 2019)

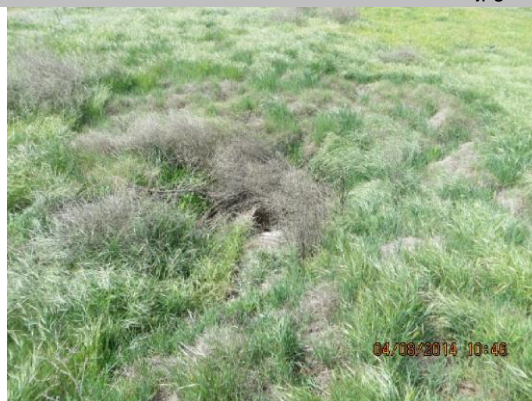
Photo 1 of 3 : UCIP_FA_2019_39132_60723.jpg

Comment Code					
Inspector Comment					
DS_ID:19576 FS_ID:39132 EP_NO: N/A Repair Type: Non-Urgent Crossing Status: Found UCIP Comments: 04/08/2014 Slide gate missing from WS. No closure device, but degrading of levee at Highway 140 is lower than pipe, so this does not appear to be a critical issue. Also dense vegetation limits the inspector's visibility to identify signs of pipe failure (leaks) along the slope. Recommend removing vegetation along pipe alignment to conduct proper inspection of structure and appurtenances. (DWR UCIP - W. Wylie) FIELD_STRUCT_DESC: 30-inch corrugated metal gravity drainage pipe through the levee, 3.5 feet below the crown. Flap gate on the waterside (WS) end. Brass cap No. 100 bench mark (BM) on the headwall on the landside (LS). [Additional Reference(s): DWR Levee Log, 2002. USACE San Joaquin O&M Manual 601.1, 1967, (HLM 3.95)]. FS Date: 4/8/2014

Slide gate missing on WS toe with heavy vegetation camouflaging pipe

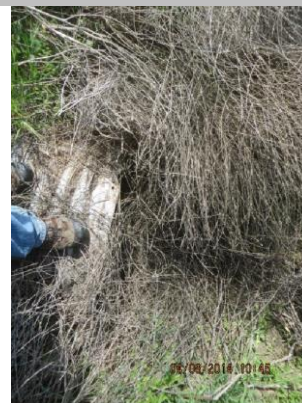
Photo 2 of 3 : UCIP_FA_2019_39132_60720.jpg

LM Start	3.92	Rating **	M	Issue No.	1202 (cont)
LM End	3.92	Issue Type +	En	Location *

Slide gate missing on WS toe with heavy vegetation camouflaging pipe

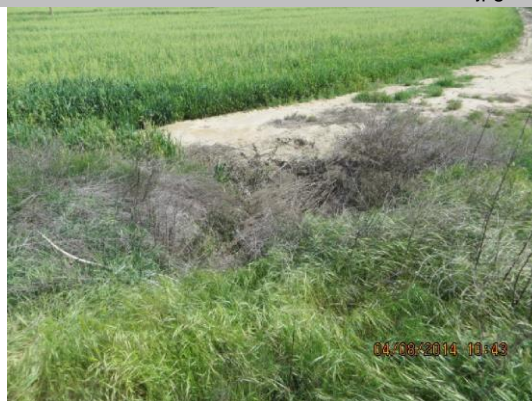
Photo 3 of 3 : UCIP_FA_2019_39132_60722.jpg

Comment Code					
Inspector Comment					
DS_ID:19576 FS_ID:39132 EP_NO: N/A Repair Type: Non-Urgent Crossing Status: Found UCIP Comments: 04/08/2014 Slide gate missing from WS. No closure device, but degrading of levee at Highway 140 is lower than pipe, so this does not appear to be a critical issue. Also dense vegetation limits the inspector's visibility to identify signs of pipe failure (leaks) along the slope. Recommend removing vegetation along pipe alignment to conduct proper inspection of structure and appurtenances. (DWR UCIP - W. Wylie) FIELD_STRUCT_DESC: 30-inch corrugated metal gravity drainage pipe through the levee, 3.5 feet below the crown. Flap gate on the waterside (WS) end. Brass cap No. 100 bench mark (BM) on the headwall on the landside (LS). [Additional Reference(s): DWR Levee Log, 2002. USACE San Joaquin O&M Manual 601.1, 1967, (HLM 3.95)]. FS Date: 4/8/2014

Concrete headwall in heavy vegetation at LS toe.

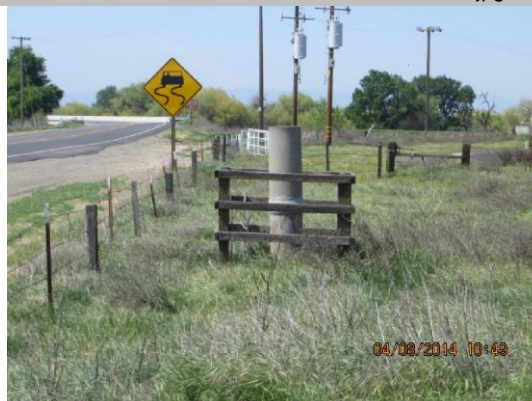
Photo 1 of 2 : UCIP_FA_2019_39133_60725.jpg

LM Start	3.93	Rating **	M	Issue No.	1203	
LM End	3.93	Issue Type +	En	Location *		
Category	Supplemental			GPS Latitude/Longitude		
				Start	End	
Item	DRAFT DWR UCIP Field Study			37.311157°	37.311157°	
				-120.926919°	-120.926919°	
DWR ID	19606					
Comment Code						
Inspector Comment						
DS_ID:19606 FS_ID:39133 EP_NO: N/A Repair Type: Non-Urgent Crossing Status: Indicator Found UCIP Comments: 04/08/2014 Need to contact owner to determine status of crossing inlet and outlet not found. (DWR UCIP - W. Wylie) FIELD_STRUCT_DESC: 12-inch reinforced concrete irrigation discharge pipe through the levee, 3.5 feet below the crown. 12-inch concrete standpipe off each side of the levee. [Additional Reference(s): DWR Levee Log, 2002]. FS Date: 4/8/2014

12-inch concrete standpipe off WS toe.

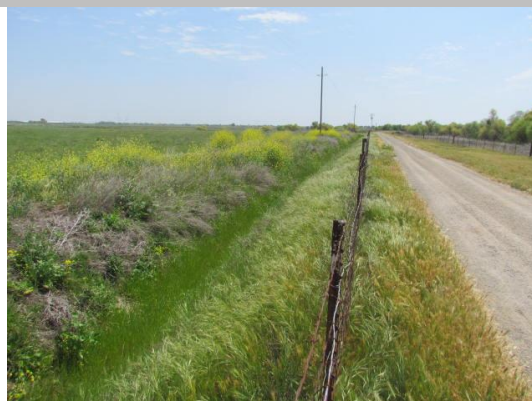
Photo 2 of 2 : FA_2019_NA0010_118_5_20190912_00002.jpg

LM Start	3.98	Rating **	U	Issue No.	5 (cont)	
LM End	4.05	Issue Type +	En	Location *	LS	
Category	Earthen Levee			GPS Latitude/Longitude		
				Start		End
Item	Encroachments			37.310837°	37.310003°	
				-120.926182°	-120.925313°	
DWR ID	DWR_NA0010_01_s_2012_5					
Comment Code						
DT : Ditch						
Inspector Comment						
Irrigation ditch at landside toe.

Looking south at irrigation ditch at landside toe.

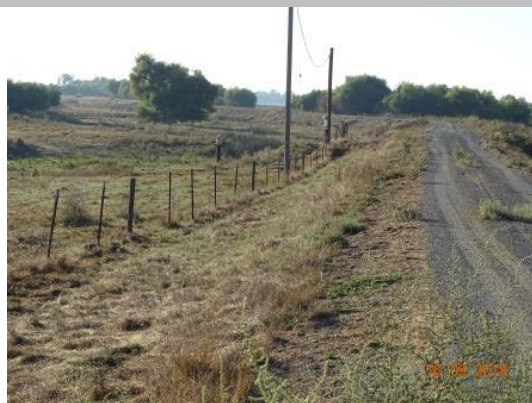
Photo 1 of 1 : FA_2019_NA0010_118_118_20190912_00030.jpg

LM Start	4.12	Rating **	U	Issue No.	118
LM End	4.15	Issue Type +	En	Location *	LS
Category	Earthen Levee			GPS Latitude/Longitude	
				Start	End
Item	Encroachments			37.309225 °	37.308817 °
				-120.924589 °	-120.924247 °
DWR ID	DWR_NA0010_01_f_2018_118				
Comment Code					
FE : Fence					
Inspector Comment					
Fence along landside toe.

View of fence along landside toe. (Fall 2018)

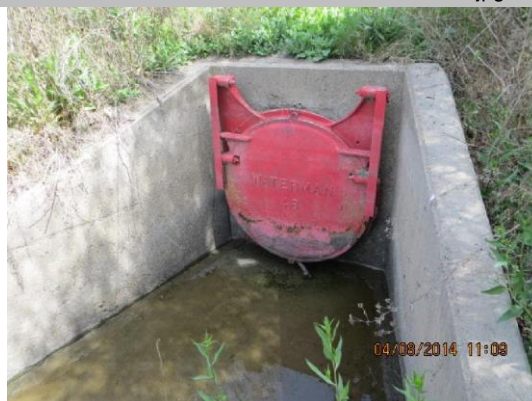
Photo 1 of 3 : UCIP_FA_2019_39134_60730.jpg

Comment Code					
Inspector Comment					
DS_ID:19607 FS_ID:39134 EP_NO: N/A Repair Type: Non-Urgent Crossing Status: Found UCIP Comments: 04/08/2014 Pipe appears sleeved with a 12-inch steel pipe with a slide gate at the LS toe. No identified authorization for changes to this crossing. Need to contact owner to obtain additional information about the modifications to crossing. (DWR UCIP - W. Wylie) FIELD_STRUCT_DESC: 48-inch corrugated metal gravity drainage pipe through the levee, 14 feet below the crown. Flap gate on the waterside (WS) end. Brass cap No. 90 bench mark (BM) on the headwall on the landside (LS). [Additional Reference(s): DWR Levee Log, 2002. USACE San Joaquin O&M Manual 601.1, 1967, (HLM 4.16)]. FS Date: 4/8/2014

Concrete headwall and 48-inch flapgate visible on WS toe.

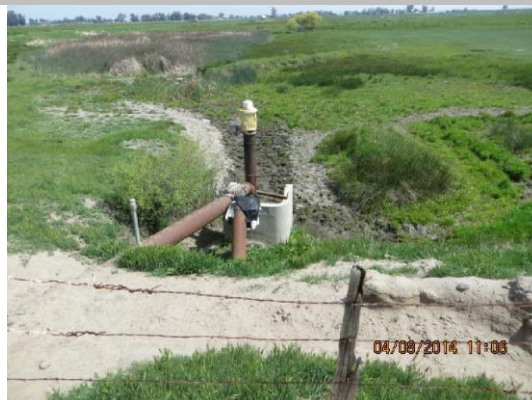
Photo 2 of 3 : UCIP_FA_2019_39134_60731.jpg

LM Start	4.13	Rating **	M	Issue No.	1204 (cont)
LM End	4.13	Issue Type +	Ma	Location *

Assumed pipe exists under pump at LS toe.

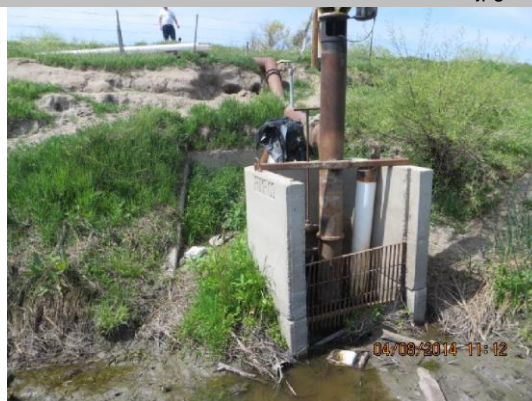
Photo 3 of 3 : UCIP_FA_2019_39134_60729.jpg

Comment Code						
Inspector Comment						
DS_ID:19607						
FS_ID:39134						
EP_NO: N/A						
Repair Type: Non-Urgent						
Crossing Status: Found						
UCIP Comments: 04/08/2014 Pipe appears sleeved with a 12-inch steel pipe with a slide gate at the LS toe. No identified authorization for changes to this crossing. Need to contact owner to obtain additional information about the modifications to crossing. (DWR UCIP - W. Wylie)						
FIELD_STRUCT_DESC: 48-inch corrugated metal gravity drainage pipe through the levee, 14 feet below the crown. Flap gate on the waterside (WS) end. Brass cap No. 90 bench mark (BM) on the headwall on the landside (LS). [Additional Reference(s): DWR Levee Log, 2002. USACE San Joaquin O&M Manual 601.1, 1967, (HLM 4.16)].						
FS Date: 4/8/2014

Concrete inlet, slidegate, and concrete headwall at LS toe.

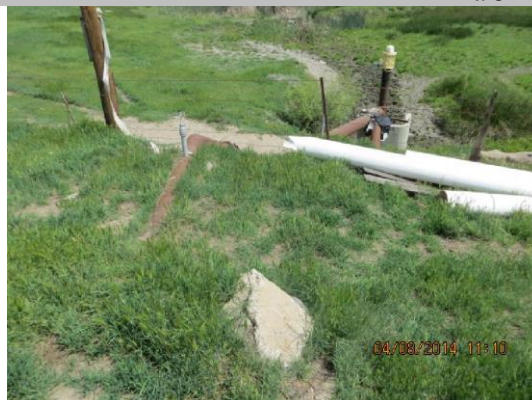
Photo 1 of 2 : UCIP_FA_2019_39138_71320.jpg

LM Start	4.13	Rating **	M	Issue No.	1205
LM End	4.13	Issue Type +	En	Location *	
Category	Supplemental			GPS Latitude/Longitude	
				Start	End
Item	DRAFT DWR UCIP Field Study			37.309063 °	37.309063 °
				-120.924449 °	-120.924449 °
DWR ID	24866				
Comment Code					
Inspector Comment					
DS_ID:24866 FS_ID:39138 EP_NO: N/A Repair Type: Non-Urgent Crossing Status: Found UCIP Comments: 04/08/2014 Need to contact owner to get details of crossing. (DWR UCIP - W. Wylie) FIELD_STRUCT_DESC: 12-inch steel drainage discharge pipe through the levee, 2.5 feet below the crown. 12-inch steel pipe, vent, and pump on stand visible on the landside (LS) slope. 10-inch polyvinyl chloride (PVC) pipe visible on the waterside (WS) slope. FS Date: 4/8/2014

View of pipe visible on landward side.
