**Flood Control Project Maintenance
Levee Inspections**

Fall 2019 Levee Maintenance Deficiency Summary Report

San Joaquin River Basin

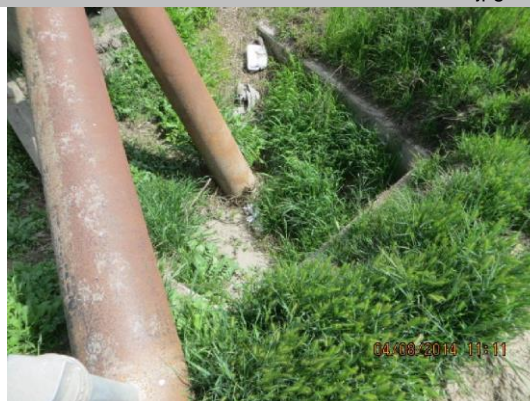
Photo 2 of 2 : UCIP_FA_2019_39138_71319.jpg

LM Start	4.13	Rating **	M	Issue No.	1205 (cont)	
LM End	4.13	Issue Type +	En	Location *		
Category	Supplemental			GPS Latitude/Longitude		
				Start	End	
Item	DRAFT DWR UCIP Field Study			37.309063 °	37.309063 °	
				-120.924449 °	-120.924449 °	
DWR ID	24866					
Comment Code						
Inspector Comment						
DS_ID:24866						
FS_ID:39138						
EP_NO: N/A						
Repair Type: Non-Urgent						
Crossing Status: Found						
UCIP Comments: 04/08/2014 Need to contact owner to get details of crossing. (DWR UCIP - W. Wylie)						
FIELD_STRUCT_DESC: 12-inch steel drainage discharge pipe through the levee, 2.5 feet below the crown. 12-inch steel pipe, vent, and pump on stand visible on the landside (LS) slope. 10-inch polyvinyl chloride (PVC) pipe visible on the waterside (WS) slope.						
FS Date: 4/8/2014

Pipe through existing 48 inch pipe.

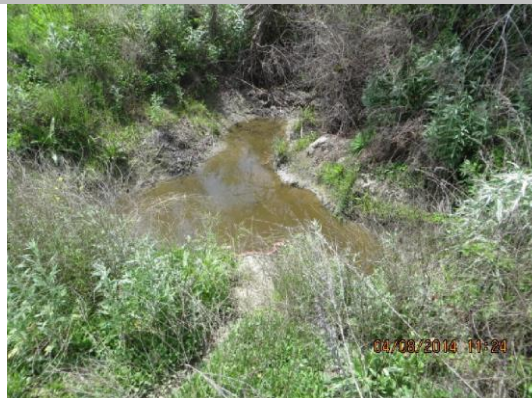
Photo 1 of 3 : UCIP_FA_2019_39140_60733.jpg

Comment Code						
Inspector Comment						
DS_ID:19608 FS_ID:39140 EP_NO: N/A Repair Type: Non-Urgent Crossing Status: Found UCIP Comments: 04/08/2014 Dense vegetation and fence limits the inspector's visibility to identify signs of pipe failure (leaks) along the landward side. Recommend obtaining access to landward toe and removing vegetation along pipe alignment to conduct proper inspection of structure and appurtenances. (DWR UCIP - W. Wylie) FIELD_STRUCT_DESC: 24-inch corrugated metal gravity drainage pipe through the levee, 11.9 feet below the crown. Flap gate on the waterside (WS) end. Brass cap No. 90 bench mark (BM) on the headwall on the landside (LS). [Additional Reference(s): DWR Levee Log, 2002. USACE San Joaquin O&M Manual 601.1, 1967, (HLM 4.27)]. FS Date: 4/8/2014

Pipe, flapgate, and headwall visible at WS toe.

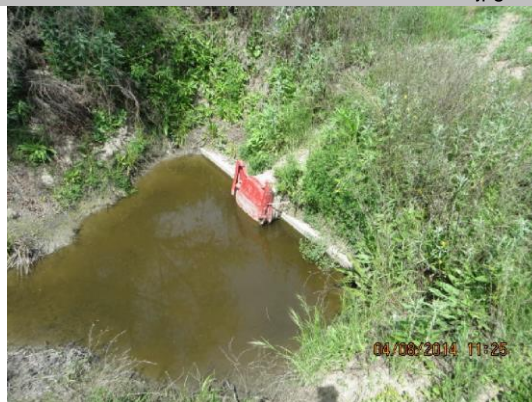
Photo 2 of 3 : UCIP_FA_2019_39140_60732.jpg

Pipe, flapgate, and headwall visible at WS toe.

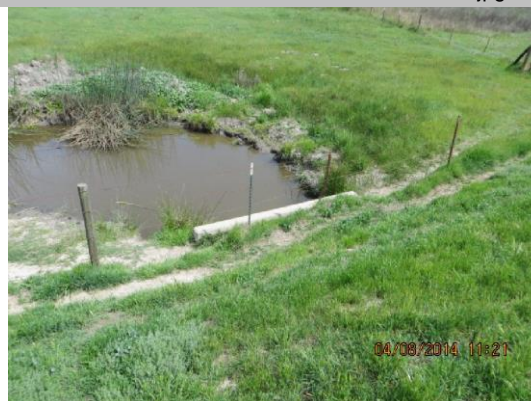
Photo 3 of 3 : UCIP_FA_2019_39140_60734.jpg

Comment Code					
Inspector Comment					
DS_ID:19608 FS_ID:39140 EP_NO: N/A Repair Type: Non-Urgent Crossing Status: Found UCIP Comments: 04/08/2014 Dense vegetation and fence limits the inspector's visibility to identify signs of pipe failure (leaks) along the landward side. Recommend obtaining access to landward toe and removing vegetation along pipe alignment to conduct proper inspection of structure and appurtenances. (DWR UCIP - W. Wylie) FIELD_STRUCT_DESC: 24-inch corrugated metal gravity drainage pipe through the levee, 11.9 feet below the crown. Flap gate on the waterside (WS) end. Brass cap No. 90 bench mark (BM) on the headwall on the landside (LS). [Additional Reference(s): DWR Levee Log, 2002. USACE San Joaquin O&M Manual 601.1, 1967, (HLM 4.27)]. FS Date: 4/8/2014

Concrete headwall at LS toe.

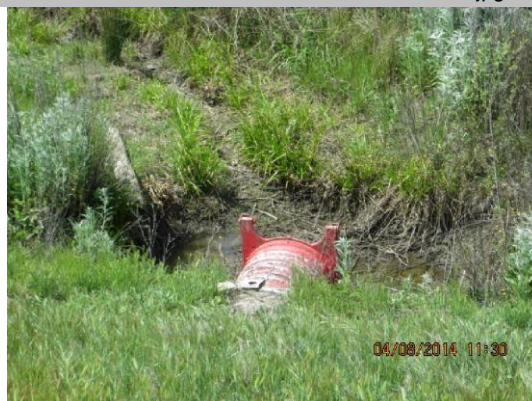
Photo 1 of 3 : UCIP_FA_2019_39141_60737.jpg

Comment Code						
Inspector Comment						
DS_ID:19609						
FS_ID:39141						
EP_NO: N/A						
Repair Type: Non-Urgent						
Crossing Status: Found						
UCIP Comments: 04/08/2014 Dense vegetation limits the inspector's visibility to identify signs of pipe failure (leaks) along the waterward side. Recommend removing vegetation along pipe alignment to conduct proper inspection of structure and appurtenances. (DWR UCIP - W. Wylie)						
FIELD_STRUCT_DESC: 24-inch corrugated metal gravity drainage pipe through the levee, 10 feet below the crown. Flap gate on the waterside (WS) end. Brass cap No. 90 bench mark (BM) on the headwall on the landside (LS). [Additional Reference(s): DWR Levee Log, 2002. USACE San Joaquin O&M Manual 601.1, 1967, (HLM 4.72)].						
FS Date: 4/8/2014

Pipe, flapgate, and headwall on WS toe.

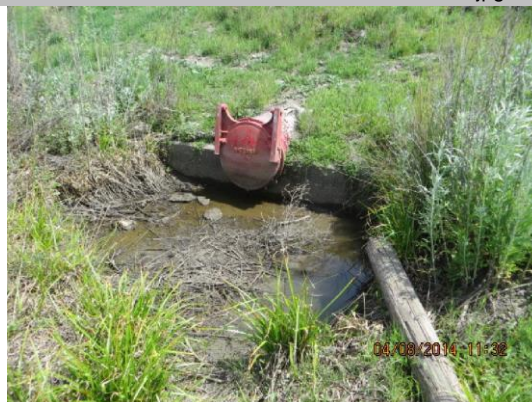
Photo 2 of 3 : UCIP_FA_2019_39141_60738.jpg

Pipe, flapgate, and headwall on WS toe.

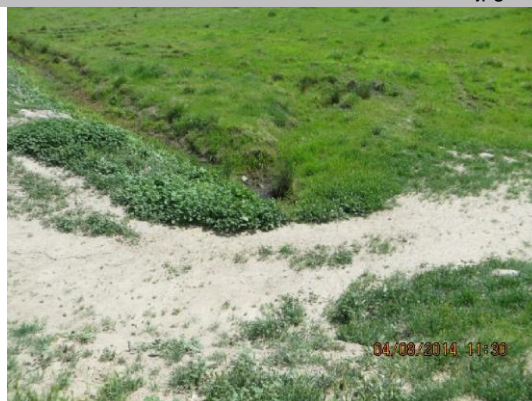
Photo 3 of 3 : UCIP_FA_2019_39141_60736.jpg

Comment Code					
Inspector Comment					
DS_ID:19609					
FS_ID:39141					
EP_NO: N/A					
Repair Type: Non-Urgent					
Crossing Status: Found					
UCIP Comments: 04/08/2014 Dense vegetation limits the inspector's visibility to identify signs of pipe failure (leaks) along the waterward side. Recommend removing vegetation along pipe alignment to conduct proper inspection of structure and appurtenances. (DWR UCIP - W. Wylie)					
FIELD_STRUCT_DESC: 24-inch corrugated metal gravity drainage pipe through the levee, 10 feet below the crown. Flap gate on the waterside (WS) end. Brass cap No. 90 bench mark (BM) on the headwall on the landside (LS). [Additional Reference(s): DWR Levee Log, 2002. USACE San Joaquin O&M Manual 601.1, 1967, (HLM 4.72)].					
FS Date: 4/8/2014

Pipe and concrete headwall on LS toe.

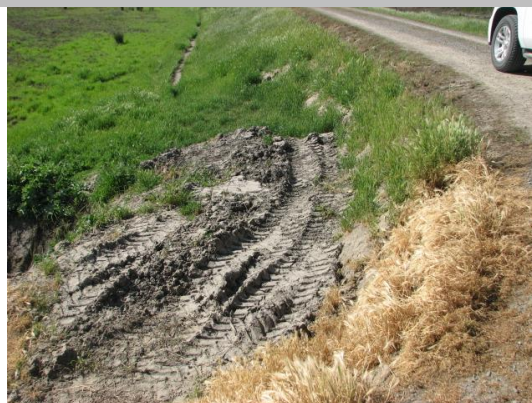
Photo 2 of 3 : FA_2019_NA0010_118_9_20190912_00006.jpg

LM Start	4.69	Rating **	M	Issue No.	9 (cont)	
LM End	4.69	Issue Type +	Ma	Location *	LS	
Category	Earthen Levee			GPS Latitude/Longitude		
				Start		End
Item	Erosion / Bank Caving			37.302398 °		37.302398 °
				-120.920920 °		-120.920920 °
DWR ID	DWR_NA0010_01_s_2013_9					
Comment Code						
E2 : Schedule repair of erosion site prior to the next inspection.						
Inspector Comment						
Levee landside toe damaged by livestock.

Looking south at fill poorly placed on landward slope and toe. (Spring 2018)

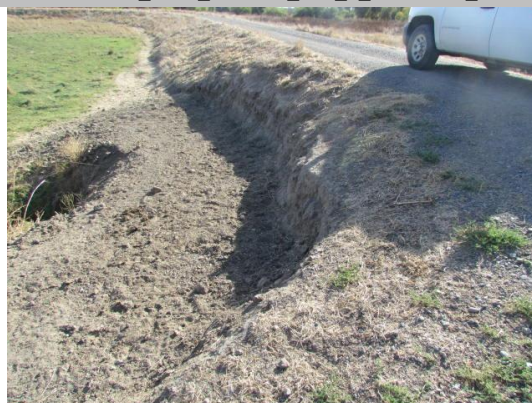
Photo 3 of 3 : FA_2019_NA0010_118_9_20190912_00008.jpg

Looking at landward slope damaged by livestock.

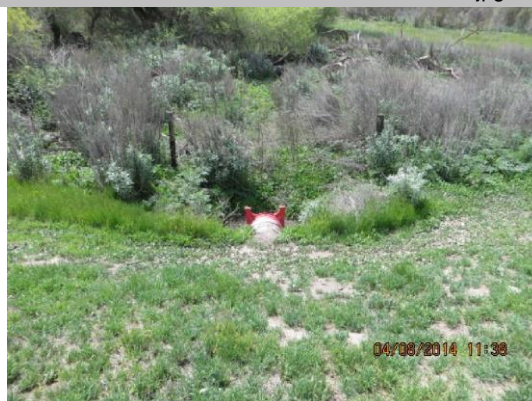
Photo 1 of 2 : UCIP_FA_2019_39143_60740.jpg

LM Start	5.02	Rating **	M	Issue No.	1208	
LM End	5.02	Issue Type +	Ma	Location *		
Category	Supplemental			GPS Latitude/Longitude		
				Start	End	
Item	DRAFT DWR UCIP LMA Responsibility			37.298917 °	37.298917 °	
				-120.917262 °	-120.917262 °	
DWR ID	19610					
Comment Code						
Inspector Comment						
DS_ID:19610 FS_ID:39143 EP_NO: N/A Repair Type: Non-Urgent Crossing Status: Found UCIP Comments: 04/08/2014 Non-functional -- sediment buildup against flapgate and inlet buried at landward side. (DWR UCIP - W. Wylie) FIELD_STRUCT_DESC: 24-inch corrugated metal gravity drainage pipe through the levee, 8 feet below the crown. Flap gate on the waterside (WS) end. Brass cap No. 90 bench mark (BM) on the headwall on the landside (LS). [Additional Reference(s): DWR Levee Log, 2002. USACE San Joaquin O&M Manual 601.1, 1967, (HLM 5.05)]. FS Date: 4/8/2014

Flapgate and headwall visible at WS toe.

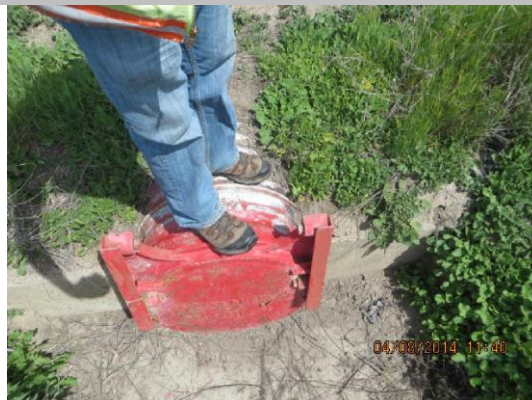
Photo 2 of 2 : UCIP_FA_2019_39143_60739.jpg

Flapgate and headwall visible at WS toe.

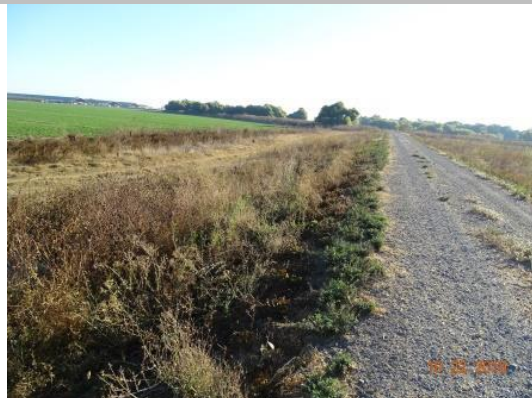
Photo 1 of 1 : FA_2019_NA0010_118_109_20191104_00281.jpg

LM Start	5.92	Rating **	U	Issue No.	109
LM End	6.74	Issue Type +	Ma	Location *	LS
Category	Earthen Levee			GPS Latitude/Longitude	
				Start	End
Item	Vegetation			37.303603 °	37.302855 °
				-120.903722 °	-120.889918 °
DWR ID	DWR_NA0010_01_f_2019_109				
Comment Code					
V1 : Control annual grass and weeds on the levee slopes and easements.					
Inspector Comment

Looking upstream along the landside slope. (Fall 2019)

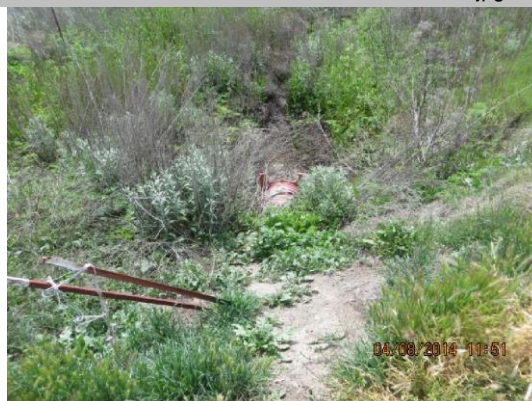
Photo 1 of 2 : UCIP_FA_2019_39151_60742.jpg

Comment Code						
Inspector Comment						
DS_ID:19611 FS_ID:39151 EP_NO: N/A Repair Type: Non-Urgent Crossing Status: Found UCIP Comments: 04/08/2014 Dense vegetation limits the inspector's visibility to identify signs of pipe failure (leaks) along waterward and landward slopes. Recommend removing vegetation along pipe alignment to conduct proper inspection of structure and appurtenances. Landward side filled in with soil. Need to contact owner. If crossing is no longer used need to coordinate with CVFPB for proper abandonment. (DWR UCIP - W. Wylie) FIELD_STRUCT_DESC: 24-inch corrugated metal gravity drainage pipe through the levee, 8.6 feet below the crown. Flap gate on the waterside (WS) end. Brass cap No. 90 bench mark (BM) on the headwall on the landside (LS). [Additional Reference(s): DWR Levee Log, 2002. USACE San Joaquin O&M Manual 601.1, 1967, (HLM 5.95)]. FS Date: 4/8/2014

Pipe, concrete headwall, and flapgate visible on WS toe.

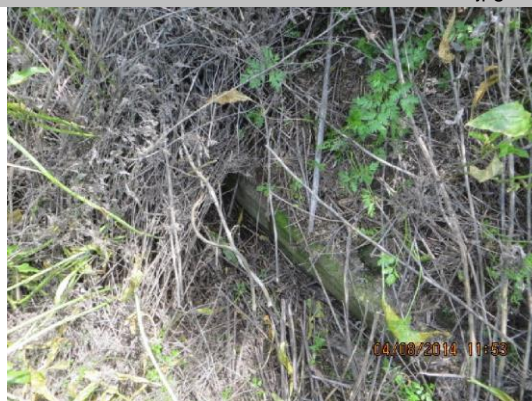
Photo 2 of 2 : UCIP_FA_2019_39151_60741.jpg

Comment Code						
Inspector Comment						
DS_ID:19611 FS_ID:39151 EP_NO: N/A Repair Type: Non-Urgent Crossing Status: Found UCIP Comments: 04/08/2014 Dense vegetation limits the inspector's visibility to identify signs of pipe failure (leaks) along waterward and landward slopes. Recommend removing vegetation along pipe alignment to conduct proper inspection of structure and appurtenances. Landward side filled in with soil. Need to contact owner. If crossing is no longer used need to coordinate with CVFPB for proper abandonment. (DWR UCIP - W. Wylie) FIELD_STRUCT_DESC: 24-inch corrugated metal gravity drainage pipe through the levee, 8.6 feet below the crown. Flap gate on the waterside (WS) end. Brass cap No. 90 bench mark (BM) on the headwall on the landside (LS). [Additional Reference(s): DWR Levee Log, 2002. USACE San Joaquin O&M Manual 601.1, 1967, (HLM 5.95)]. FS Date: 4/8/2014

Top of concrete headwall just visible on LS toe.

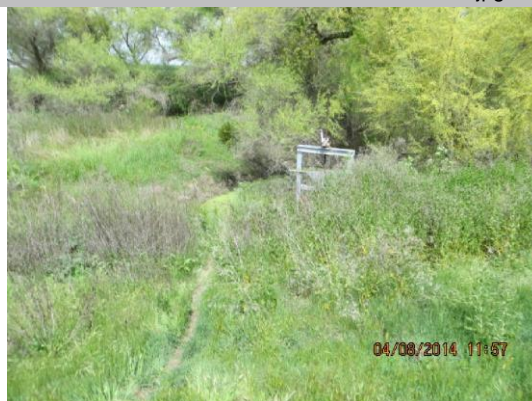
Photo 1 of 3 : UCIP_FA_2019_39152_60745.jpg

Comment Code					
Inspector Comment					
DS_ID:19612 FS_ID:39152 EP_NO: N/A Repair Type: Non-Urgent Crossing Status: Found UCIP Comments: 04/08/2014 Dense vegetation limits the inspector's visibility to identify signs of pipe failure (leaks) along waterward and landward slopes. Recommend removing vegetation along pipe alignment to conduct proper inspection of structure and appurtenances. Pipe completely blocked by soil on LS toe due to animal activity. Slide gate blocked open. (DWR UCIP - W. Wylie) FIELD_STRUCT_DESC: 48-inch corrugated metal gravity drainage pipe through the levee, 13.1 feet below the crown. Walkway to slide gate at the concrete headwall on the landside (LS) toe. Flap gate at the concrete headwall on the waterside (WS) toe. Brass cap No. 90 bench mark (BM) on the headwall on the LS. Pipe crosses the levee at an angle. [Additional Reference(s): DWR Levee Log, 2002. USACE San Joaquin O&M Manual 601.1, 1967, (HLM 6.13)]. FS Date: 4/8/2014

Slidegate at LS toe.

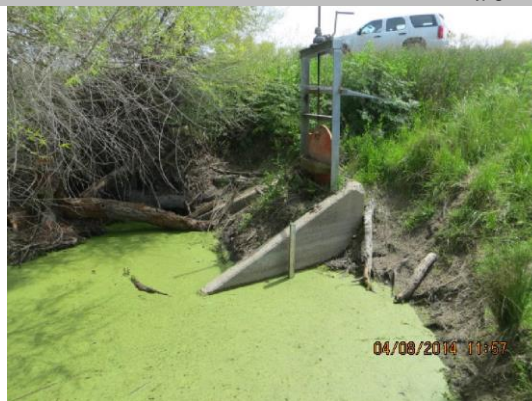
Photo 2 of 3 : UCIP_FA_2019_39152_60744.jpg

Pipe, concrete headwall, slidegate, and metal walkway on LS toe.

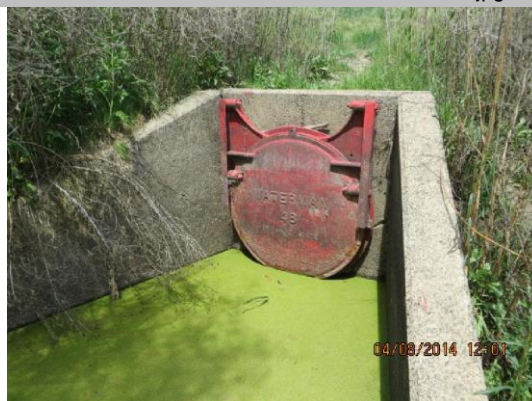
Photo 3 of 3 : UCIP_FA_2019_39152_60743.jpg

Comment Code						
Inspector Comment						
DS_ID:19612 FS_ID:39152 EP_NO: N/A Repair Type: Non-Urgent Crossing Status: Found UCIP Comments: 04/08/2014 Dense vegetation limits the inspector's visibility to identify signs of pipe failure (leaks) along waterward and landward slopes. Recommend removing vegetation along pipe alignment to conduct proper inspection of structure and appurtenances. Pipe completely blocked by soil on LS toe due to animal activity. Slide gate blocked open. (DWR UCIP - W. Wylie) FIELD_STRUCT_DESC: 48-inch corrugated metal gravity drainage pipe through the levee, 13.1 feet below the crown. Walkway to slide gate at the concrete headwall on the landside (LS) toe. Flap gate at the concrete headwall on the waterside (WS) toe. Brass cap No. 90 bench mark (BM) on the headwall on the LS. Pipe crosses the levee at an angle. [Additional Reference(s): DWR Levee Log, 2002. USACE San Joaquin O&M Manual 601.1, 1967, (HLM 6.13)]. FS Date: 4/8/2014

Flapgate on concrete headwall at WS toe.

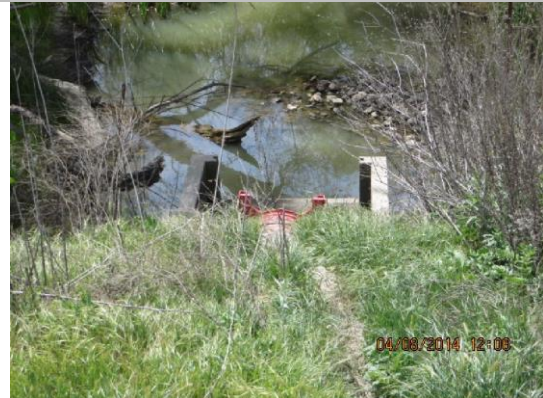
Photo 1 of 3 : UCIP_FA_2019_39154_60762.jpg

Comment Code						
Inspector Comment						
DS_ID:19613 FS_ID:39154 EP_NO: N/A Repair Type: Non-Urgent Crossing Status: Found UCIP Comments: 04/08/2014 Dense vegetation limits the inspector's visibility to identify signs of pipe failure (leaks) along the slope. Recommend removing vegetation along pipe alignment to conduct proper inspection of structure and appurtenances. (DWR UCIP - W. Wylie) FIELD_STRUCT_DESC: 24-inch corrugated metal gravity drainage pipe through the levee, 9.5 feet below the crown. Flap gate on the waterside (WS) end. Slide gate on the landside (LS) end next to a 48-inch concrete riser with walkway over the top. Brass cap No. 90 bench mark (BM) on the headwall on the LS. [Additional Reference(s): DWR Levee Log, 2002. USACE San Joaquin O&M Manual 601.1, 1967, (HLM 6.40)]. FS Date: 4/8/2014

Pipe, flapgate, and concrete headwall on WS toe.

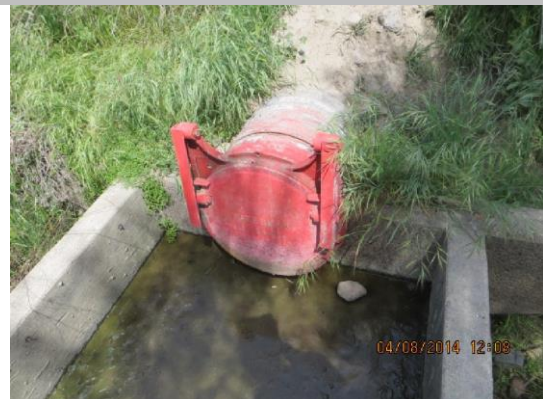
Photo 2 of 3 : UCIP_FA_2019_39154_60760.jpg

Pipe, flapgate, and concrete headwall on WS toe.

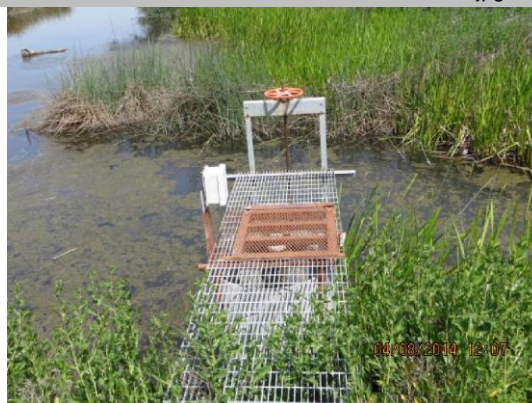
Photo 3 of 3 : UCIP_FA_2019_39154_60761.jpg

Comment Code						
Inspector Comment						
DS_ID:19613 FS_ID:39154 EP_NO: N/A Repair Type: Non-Urgent Crossing Status: Found UCIP Comments: 04/08/2014 Dense vegetation limits the inspector's visibility to identify signs of pipe failure (leaks) along the slope. Recommend removing vegetation along pipe alignment to conduct proper inspection of structure and appurtenances. (DWR UCIP - W. Wylie) FIELD_STRUCT_DESC: 24-inch corrugated metal gravity drainage pipe through the levee, 9.5 feet below the crown. Flap gate on the waterside (WS) end. Slide gate on the landside (LS) end next to a 48-inch concrete riser with walkway over the top. Brass cap No. 90 bench mark (BM) on the headwall on the LS. [Additional Reference(s): DWR Levee Log, 2002. USACE San Joaquin O&M Manual 601.1, 1967, (HLM 6.40)]. FS Date: 4/8/2014

Metal walkway over concrete standpipe next to slide gate on LS toe.

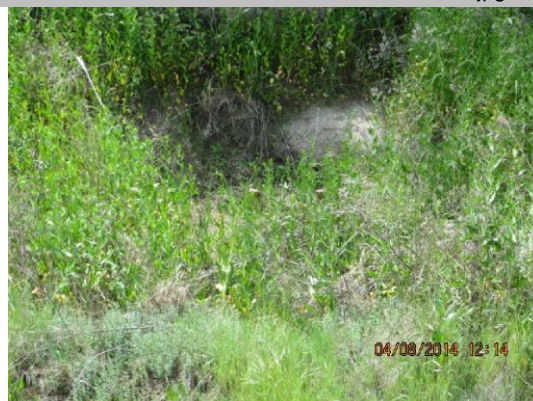
Photo 1 of 3 : UCIP_FA_2019_49962_60764.jpg

Comment Code						
Inspector Comment						
DS_ID:19614 FS_ID:49962 EP_NO: N/A Repair Type: Non-Urgent Crossing Status: Found UCIP Comments: 7/19/2016 Same as previous inspection. Outlet and inlet are under water. (DWR UCIP - O. Magana)4/08/2014 Flapgate blocked by sedimentation at WS toe. Dense vegetation limits the inspector's visibility to identify signs of pipe failure (leaks) along the slope. Recommend removing vegetation along pipe alignment to conduct proper inspection of structure and appurtenances. Also recommend clearing vegetation from both waterward and landward toe. (DWR UCIP - W. Wylie) FIELD_STRUCT_DESC: 24-inch corrugated metal gravity drainage pipe through the levee, 9.8 feet below the crown. Wooden fence around a 4-foot by 4-foot drop inlet on the landside (LS) toe. Flap gate on the waterside (WS) end. Brass cap No. 90 bench mark (BM) on the headwall on the LS. [Additional Reference(s): DWR Levee Log, 2002. USACE San Joaquin O&M Manual 601.1, 1967, (HLM 6.64)]. FS Date: 7/19/2016

Pipe and flapgate visible on WS toe.

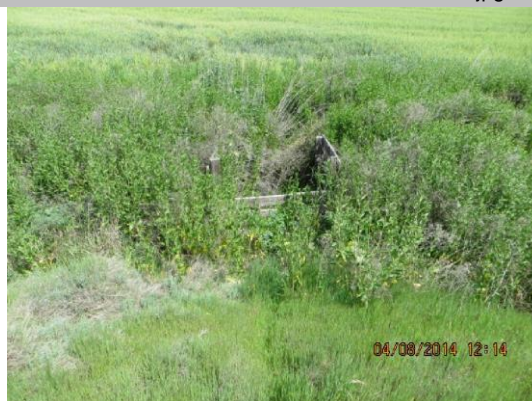
Photo 3 of 3 : UCIP_FA_2019_49962_60765.jpg

Comment Code						
Inspector Comment						
DS_ID:19614 FS_ID:49962 EP_NO: N/A Repair Type: Non-Urgent Crossing Status: Found UCIP Comments: 7/19/2016 Same as previous inspection. Outlet and inlet are under water. (DWR UCIP - O. Magana)4/08/2014 Flapgate blocked by sedimentation at WS toe. Dense vegetation limits the inspector's visibility to identify signs of pipe failure (leaks) along the slope. Recommend removing vegetation along pipe alignment to conduct proper inspection of structure and appurtenances. Also recommend clearing vegetation from both waterward and landward toe. (DWR UCIP - W. Wylie) FIELD_STRUCT_DESC: 24-inch corrugated metal gravity drainage pipe through the levee, 9.8 feet below the crown. Wooden fence around a 4-foot by 4-foot drop inlet on the landside (LS) toe. Flap gate on the waterside (WS) end. Brass cap No. 90 bench mark (BM) on the headwall on the LS. [Additional Reference(s): DWR Levee Log, 2002. USACE San Joaquin O&M Manual 601.1, 1967, (HLM 6.64)]. FS Date: 7/19/2016

Wooden barrier around drop inlet on LS toe. Excess vegetation.

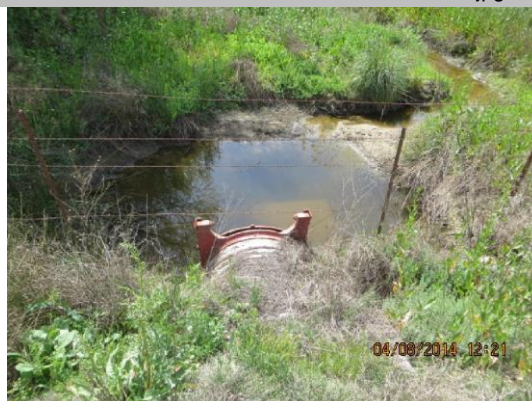
Photo 1 of 3 : UCIP_FA_2019_50077_60768.jpg

Comment Code						
Inspector Comment						
DS_ID:19615 FS_ID:50077 EP_NO: N/A Repair Type: Non-Urgent Crossing Status: Found UCIP Comments: 7/19/2016 Potential LS slope damage--difficult to determine due to dense vegetation. Limited access on WS toe due to wire fence. (DWR UCIP - O. Magana)4/08/2014 Slide gate blocked by debris at LS toe. Flapgate won't close because of debris. Dense vegetation limits the inspector's visibility to identify signs of pipe failure (leaks) along the slope. Recommend removing vegetation along pipe alignment to conduct proper inspection of structure and appurtenances. (DWR UCIP - W. Wylie) FIELD_STRUCT_DESC: 36-inch corrugated metal gravity drainage pipe through the levee, 10.3 feet below the crown. Slide gate on the landside (LS) toe. Flap gate on the waterside (WS) end. Brass cap No. 90 bench mark (BM) on the headwall on the LS. [Additional Reference(s): DWR Levee Log, 2002. USACE San Joaquin O&M Manual 601.1, 1967, (HLM 6.90)]. FS Date: 7/19/2016

Pipe, headwall, and flapgate on WS toe.

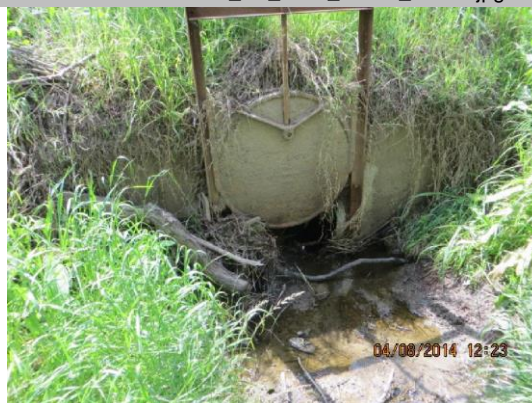
Photo 2 of 3 : UCIP_FA_2019_50077_60767.jpg

Pipe, concrete headwall, and slidegate on LS toe. Debris blocking closure of slidegate.

Comment Code						
Inspector Comment						
DS_ID:19615 FS_ID:50077 EP_NO: N/A Repair Type: Non-Urgent Crossing Status: Found UCIP Comments: 7/19/2016 Potential LS slope damage--difficult to determine due to dense vegetation. Limited access on WS toe due to wire fence. (DWR UCIP - O. Magana)4/08/2014 Slide gate blocked by debris at LS toe. Flapgate won't close because of debris. Dense vegetation limits the inspector's visibility to identify signs of pipe failure (leaks) along the slope. Recommend removing vegetation along pipe alignment to conduct proper inspection of structure and appurtenances. (DWR UCIP - W. Wylie) FIELD_STRUCT_DESC: 36-inch corrugated metal gravity drainage pipe through the levee, 10.3 feet below the crown. Slide gate on the landside (LS) toe. Flap gate on the waterside (WS) end. Brass cap No. 90 bench mark (BM) on the headwall on the LS. [Additional Reference(s): DWR Levee Log, 2002. USACE San Joaquin O&M Manual 601.1, 1967, (HLM 6.90)]. FS Date: 7/19/2016

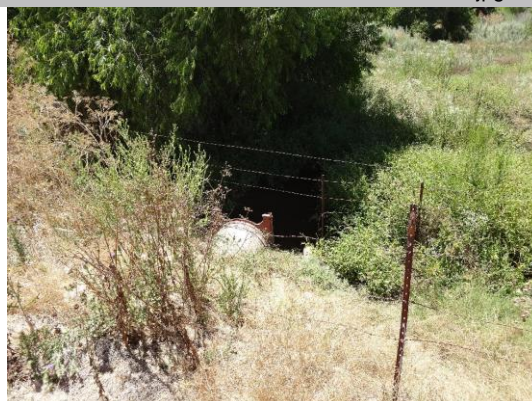
Photo 3 of 3 : UCIP_FA_2019_50077_75470.jpg

View of WS--fence limits access to flap gate.

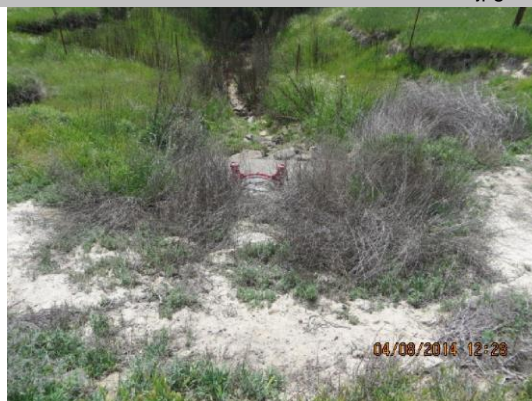
Photo 1 of 3 : UCIP_FA_2019_53412_60770.jpg

Comment Code					
Inspector Comment					
DS_ID:19616 FS_ID:53412 EP_NO: N/A Repair Type: Urgent Crossing Status: Found UCIP Comments: 11/01/2018 Pipe continues to corrode through. Voids (undermining) along pipe invert are visible from the LS. Potential undermining caused by erosion under concrete apron on the WS. Crossing remains Urgent due to the pipe failure. (O. Magana - DWR UCIP)04/08/2014 Pipe failing and corroded through at LS toe. Need to contact owner to determine status of crossing. Also dense vegetation limits the inspector's visibility to identify signs of pipe failure (leaks) along the landward slope. Recommend removing vegetation along pipe alignment to conduct proper inspection of structure. (DWR UCIP - W. Wylie) FIELD_STRUCT_DESC: 24-inch corrugated metal gravity drainage pipe through the levee, 5.1 feet below the crown. Flap gate on the waterside (WS) end. Brass cap No. 90 bench mark (BM) on the headwall on the landside (LS). [Additional Reference(s): DWR Levee Log, 2002. USACE San Joaquin O&M Manual 601.1, 1967, (HLM 7.21)]. FS Date: 11/1/2018 1:02:00 PM

Pipe, concrete headwall, and flapgate on WS toe.

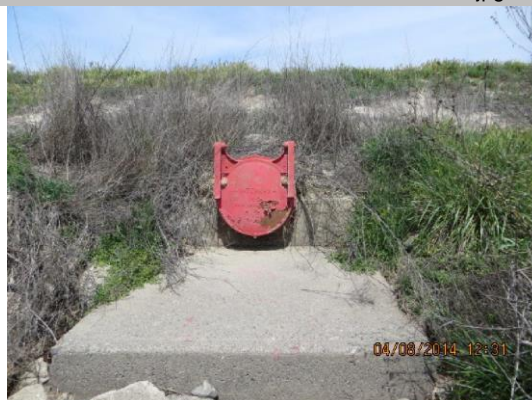
Photo 2 of 3 : UCIP_FA_2019_53412_60772.jpg

Flapgate and concrete headwall on WS toe.

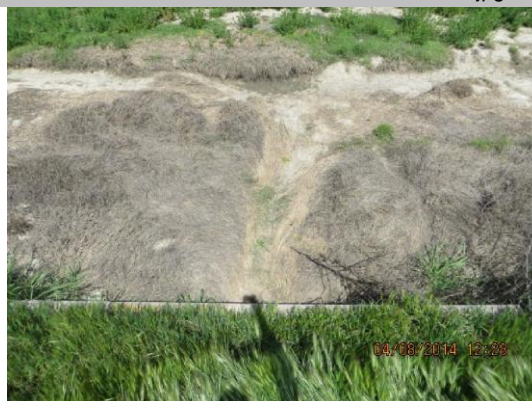
Photo 3 of 3 : UCIP_FA_2019_53412_60771.jpg

Comment Code						
Inspector Comment						
DS_ID:19616 FS_ID:53412 EP_NO: N/A Repair Type: Urgent Crossing Status: Found UCIP Comments: 11/01/2018 Pipe continues to corrode through. Voids (undermining) along pipe invert are visible from the LS. Potential undermining caused by erosion under concrete apron on the WS. Crossing remains Urgent due to the pipe failure. (O. Magana - DWR UCIP)04/08/2014 Pipe failing and corroded through at LS toe. Need to contact owner to determine status of crossing. Also dense vegetation limits the inspector's visibility to identify signs of pipe failure (leaks) along the landward slope. Recommend removing vegetation along pipe alignment to conduct proper inspection of structure. (DWR UCIP - W. Wylie) FIELD_STRUCT_DESC: 24-inch corrugated metal gravity drainage pipe through the levee, 5.1 feet below the crown. Flap gate on the waterside (WS) end. Brass cap No. 90 bench mark (BM) on the headwall on the landside (LS). [Additional Reference(s): DWR Levee Log, 2002. USACE San Joaquin O&M Manual 601.1, 1967, (HLM 7.21)]. FS Date: 11/1/2018 1:02:00 PM

Pipe and Concrete headwall visible on LS toe.

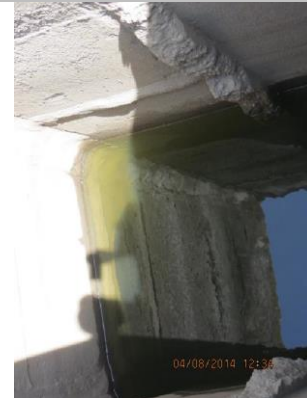
Photo 1 of 3 : UCIP_FA_2019_39160_60776.jpg

DS_ID:19617
FS_ID:39160
EP_NO: 4425
Repair Type: Non-Urgent
Crossing Status: Found
UCIP Comments: 04/08/2014 Recommend contacting owner to determine status of crossing. No pump was found on waterward side (riverbank). If crossing is no longer used need to coordinate with CVFPB for proper abandonment. (DWR UCIP - W. Wylie)
FIELD_STRUCT_DESC: 24-inch concrete encased steel irrigation discharge pipe through the levee, 13.6 feet below the crown. Pipe encased in 6-inches of concrete through the levee. 5-foot by 7-foot concrete distribution box on the waterside (WS). 20-inch concrete standpipe at the landside (LS) toe. Pump on the riverbank, accessible by walkway platform, pump not found. Concrete cutoff walls around pipe in line with the levee shoulders. Pipe extends to 36-inch concrete pipes on both sides of the levee. (Plans to install an irrigation pipeline through the levee authorized under Permit No. 4425, 1964 - James J. Stevinson, a Corporation). [Additional Reference(s): DWR Levee Log, 2002].

Pipe visible under water in concrete box riser on WS toe.

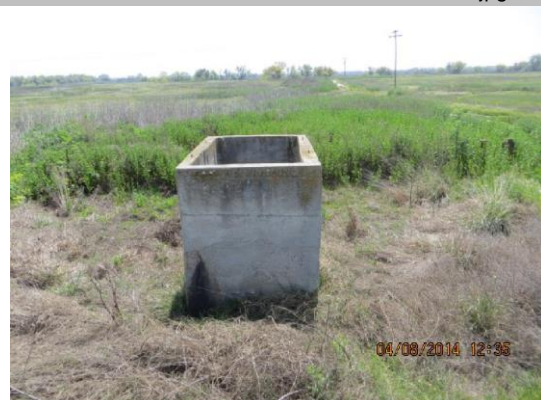
Photo 2 of 3 : UCIP_FA_2019_39160_60775.jpg

5'X7' concrete box riser on WS toe.

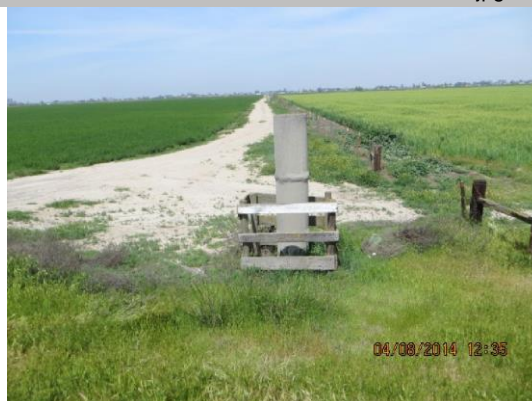
Photo 3 of 3 : UCIP_FA_2019_39160_60774.jpg

Comment Code						
Inspector Comment						
DS_ID:19617 FS_ID:39160 EP_NO: 4425 Repair Type: Non-Urgent Crossing Status: Found UCIP Comments: 04/08/2014 Recommend contacting owner to determine status of crossing. No pump was found on waterward side (riverbank). If crossing is no longer used need to coordinate with CVFPB for proper abandonment. (DWR UCIP - W. Wylie) FIELD_STRUCT_DESC: 24-inch concrete encased steel irrigation discharge pipe through the levee, 13.6 feet below the crown. Pipe encased in 6-inches of concrete through the levee. 5-foot by 7-foot concrete distribution box on the waterside (WS). 20-inch concrete standpipe at the landside (LS) toe. Pump on the riverbank, accessible by walkway platform, pump not found. Concrete cutoff walls around pipe in line with the levee shoulders. Pipe extends to 36-inch concrete pipes on both sides of the levee. (Plans to install an irrigation pipeline through the levee authorized under Permit No. 4425, 1964 - James J. Stevinson, a Corporation). [Additional Reference(s): DWR Levee Log, 2002]. FS Date: 4/8/2014

20-inch concrete standpipe off LS toe.

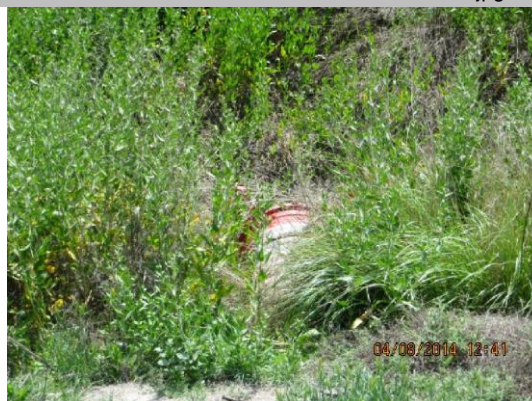
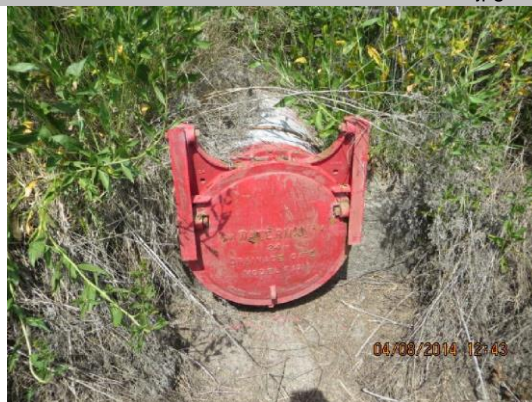
Comment Code						
Inspector Comment						
DS_ID:19618 FS_ID:39161 EP_NO: N/A Repair Type: Non-Urgent Crossing Status: Found UCIP Comments: 04/08/2014 Dense vegetation limits the inspector's visibility to identify signs of pipe failure (leaks) along the slope. Recommend removing vegetation along pipe alignment to conduct proper inspection of structure and appurtenances. (DWR UCIP - W. Wylie) FIELD_STRUCT_DESC: 24-inch corrugated metal gravity drainage pipe through the levee, 8 feet below the crown. Flap gate on the waterside (WS) end. Brass cap No. 80 bench mark (BM) on the headwall on the landside (LS). [Additional Reference(s): DWR Levee Log, 2002. USACE San Joaquin O&M Manual 601.1, 1967, (HLM 7.46)]. FS Date: 4/8/2014

Pipe and flapgate visible on WS toe.

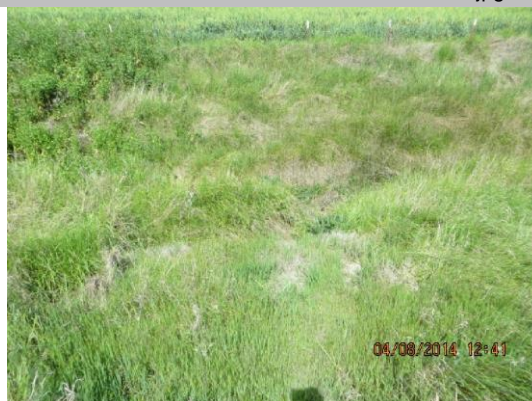
Comment Code						
Inspector Comment						
DS_ID:19618						
FS_ID:39161						
EP_NO: N/A						
Repair Type: Non-Urgent						
Crossing Status: Found						
UCIP Comments: 04/08/2014 Dense vegetation limits the inspector's visibility to identify signs of pipe failure (leaks) along the slope.						
Recommend removing vegetation along pipe alignment to conduct proper inspection of structure and appurtenances. (DWR UCIP - W. Wylie)						
FIELD_STRUCT_DESC: 24-inch corrugated metal gravity drainage pipe through the levee, 8 feet below the crown. Flap gate on the waterside (WS) end. Brass cap No. 80 bench mark (BM) on the headwall on the landside (LS). [Additional Reference(s): DWR Levee Log, 2002. USACE San Joaquin O&M Manual 601.1, 1967, (HLM 7.46)].						
FS Date: 4/8/2014

Concrete headwall and pipe visible off LS toe in heavy vegetation.

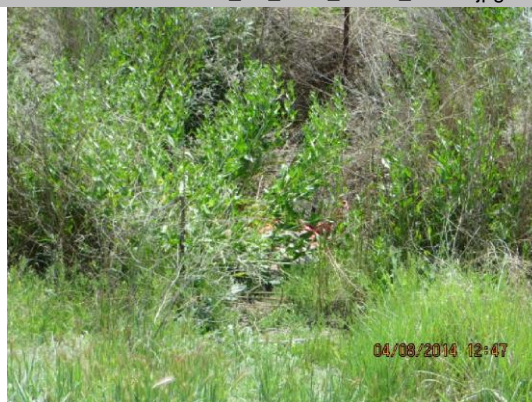
Comment Code						
Inspector Comment						
DS_ID:19619 FS_ID:39243 EP_NO: N/A Repair Type: Non-Urgent Crossing Status: Found UCIP Comments: 04/08/2014 Dense vegetation limits the inspector's visibility to identify signs of pipe failure (leaks) along the slope. Recommend removing vegetation along pipe alignment to conduct proper inspection of structure. (DWR UCIP - W. Wylie) FIELD_STRUCT_DESC: 24-inch corrugated metal gravity drainage pipe through the levee, 10 feet below the crown. Flap gate on the waterside (WS) end. Brass cap No. 80 bench mark (BM) on the headwall on the landside (LS). [Additional Reference(s): DWR Levee Log, 2002. USACE San Joaquin O&M Manual 601.1, 1967, (HLM 7.69)]. FS Date: 4/8/2014

Flapgate and headwall at WS toe. Heavy vegetation on slopes.

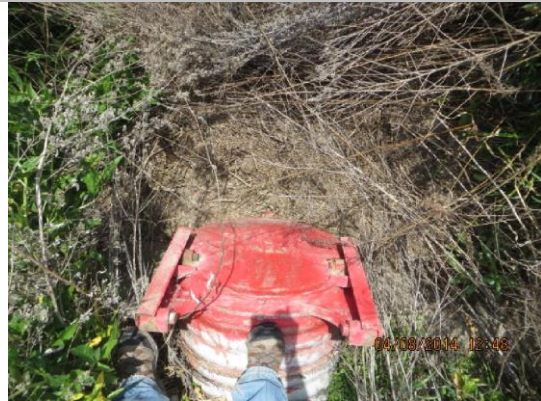
Comment Code						
Inspector Comment						
DS_ID:19619 FS_ID:39243 EP_NO: N/A Repair Type: Non-Urgent Crossing Status: Found UCIP Comments: 04/08/2014 Dense vegetation limits the inspector's visibility to identify signs of pipe failure (leaks) along the slope. Recommend removing vegetation along pipe alignment to conduct proper inspection of structure. (DWR UCIP - W. Wylie) FIELD_STRUCT_DESC: 24-inch corrugated metal gravity drainage pipe through the levee, 10 feet below the crown. Flap gate on the waterside (WS) end. Brass cap No. 80 bench mark (BM) on the headwall on the landside (LS). [Additional Reference(s): DWR Levee Log, 2002. USACE San Joaquin O&M Manual 601.1, 1967, (HLM 7.69)]. FS Date: 4/8/2014

Flapgate and headwall at WS toe.

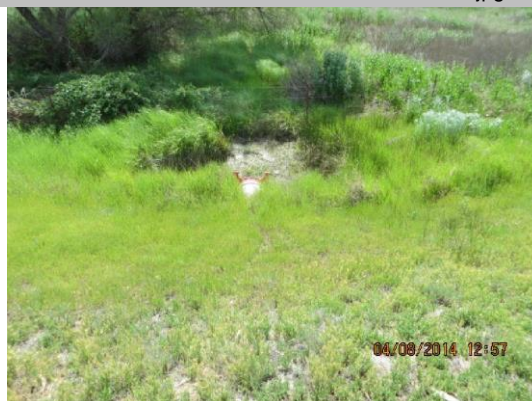
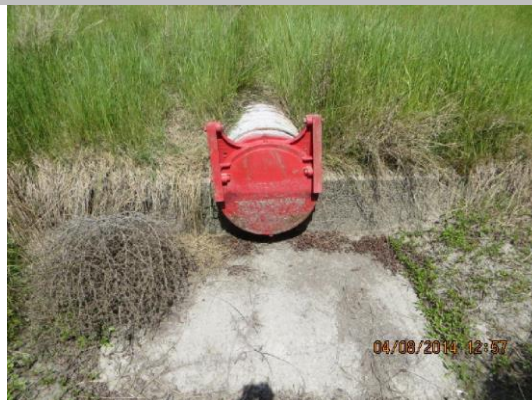
Comment Code						
Inspector Comment						
DS_ID:19620 FS_ID:39244 EP_NO: N/A Repair Type: Non-Urgent Crossing Status: Found UCIP Comments: 04/09/2014 Dense vegetation limits the inspector's visibility to identify signs of pipe failure (leaks) along the slope. Recommend removing vegetation along pipe alignment to conduct proper inspection of structure. (DWR UCIP - W. Wylie) FIELD_STRUCT_DESC: 24-inch corrugated metal gravity drainage pipe through the levee, 8 feet below the crown. Flap gate on the waterside (WS) end. Brass cap No. 80 bench mark (BM) on the headwall on the landside (LS). [Additional Reference(s): DWR Levee Log, 2002. USACE San Joaquin O&M Manual 601.1, 1967, (HLM 8.07)]. FS Date: 4/9/2014

Pipe, Headwall, and flapgate at WS toe.

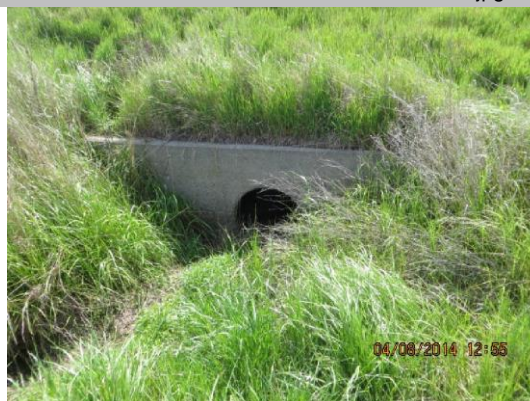
Comment Code						
Inspector Comment						
DS_ID:19620 FS_ID:39244 EP_NO: N/A Repair Type: Non-Urgent Crossing Status: Found UCIP Comments: 04/09/2014 Dense vegetation limits the inspector's visibility to identify signs of pipe failure (leaks) along the slope. Recommend removing vegetation along pipe alignment to conduct proper inspection of structure. (DWR UCIP - W. Wylie) FIELD_STRUCT_DESC: 24-inch corrugated metal gravity drainage pipe through the levee, 8 feet below the crown. Flap gate on the waterside (WS) end. Brass cap No. 80 bench mark (BM) on the headwall on the landside (LS). [Additional Reference(s): DWR Levee Log, 2002. USACE San Joaquin O&M Manual 601.1, 1967, (HLM 8.07)]. FS Date: 4/9/2014

Pipe and concrete headwall on LS toe.

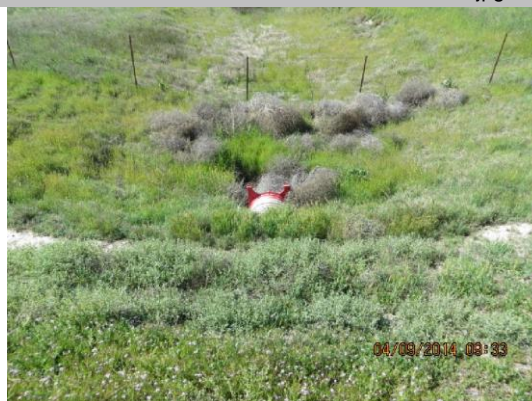
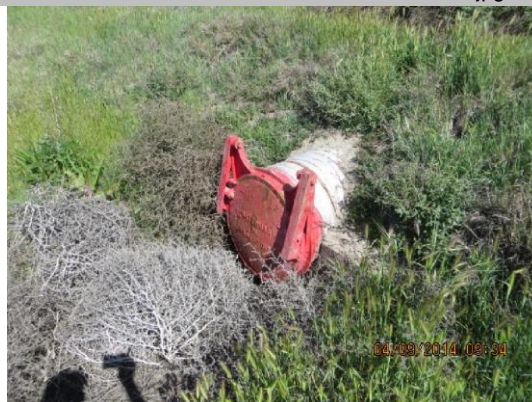
Comment Code						
Inspector Comment						
DS_ID:19621						
FS_ID:39245						
EP_NO: N/A						
Repair Type: Non-Urgent						
Crossing Status: Found						
UCIP Comments: 04/09/2014 Dense vegetation limits the inspector's visibility to identify signs of pipe failure (leaks) along the slope.						
Recommend removing vegetation along pipe alignment to conduct proper inspection of structure. Sediment buildup at landward toe. (DWR UCIP - W. Wylie)						
FIELD_STRUCT_DESC: 24-inch corrugated metal gravity drainage pipe through the levee, 9.5 feet below the crown. Flap gate on the waterside (WS) end. Brass cap No. 80 bench mark (BM) on the headwall on the landside (LS). [Additional Reference(s): DWR Levee Log, 2002. USACE San Joaquin O&M Manual 601.1, 1967, (HLM 8.41)].						
FS Date: 4/9/2014

Concrete headwall, pipe, and flapgate at WS toe.

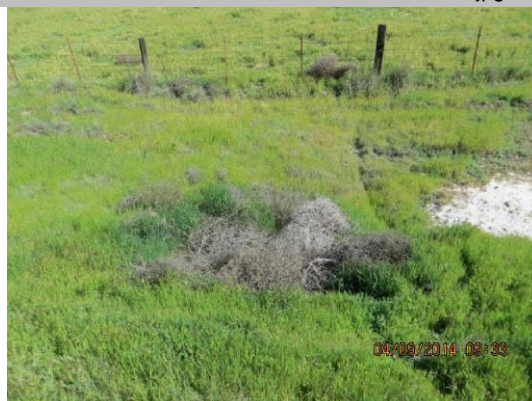
Comment Code						
Inspector Comment						
DS_ID:19621 FS_ID:39245 EP_NO: N/A Repair Type: Non-Urgent Crossing Status: Found UCIP Comments: 04/09/2014 Dense vegetation limits the inspector's visibility to identify signs of pipe failure (leaks) along the slope. Recommend removing vegetation along pipe alignment to conduct proper inspection of structure. Sediment buildup at landward toe. (DWR UCIP - W. Wylie) FIELD_STRUCT_DESC: 24-inch corrugated metal gravity drainage pipe through the levee, 9.5 feet below the crown. Flap gate on the waterside (WS) end. Brass cap No. 80 bench mark (BM) on the headwall on the landside (LS). [Additional Reference(s): DWR Levee Log, 2002. USACE San Joaquin O&M Manual 601.1, 1967, (HLM 8.41)]. FS Date: 4/9/2014

Pipe and concrete headwall at LS toe. Note heavy vegetation.

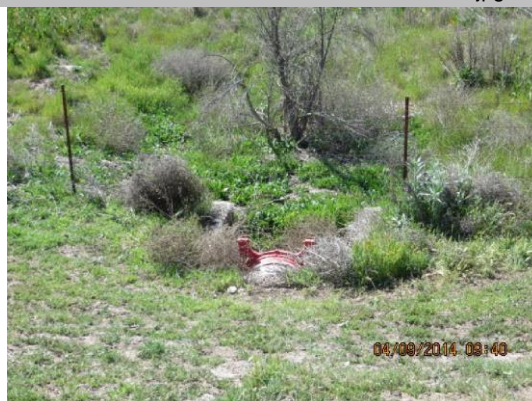
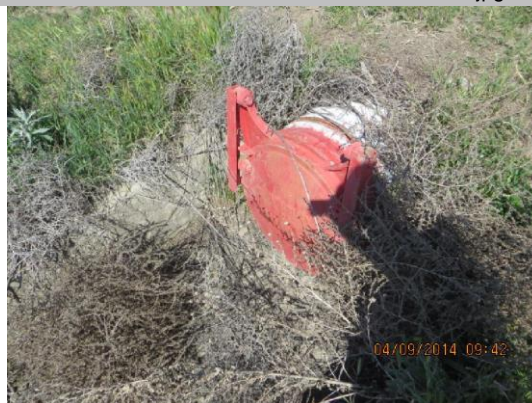
LM Start	8.57	Rating **	A/W	Issue No.	1220	
LM End	8.57	Issue Type +	Ma	Location *		
Category	Supplemental			GPS Latitude/Longitude		
				Start	End	
Item	DRAFT DWR UCIP LMA Responsibility			37.296552 °	37.296552 °	
				-120.858596 °	-120.858596 °	
DWR ID	19622					
Comment Code						
Inspector Comment						
DS_ID:19622						
FS_ID:39246						
EP_NO: N/A						
Repair Type: No Action Needed						
Crossing Status: Found						
UCIP Comments:						
FIELD_STRUCT_DESC: 24-inch corrugated metal gravity drainage pipe through the levee, 9 feet below the crown. Flap gate on the waterside (WS) end. Brass cap No. 80 bench mark (BM) on the headwall on the landside (LS). [Additional Reference(s): DWR Levee Log, 2002. USACE San Joaquin O&M Manual 601.1, 1967, (HLM 8.61)].						
FS Date: 4/9/2014

Pipe, Flapgate, and headwall on WS toe.

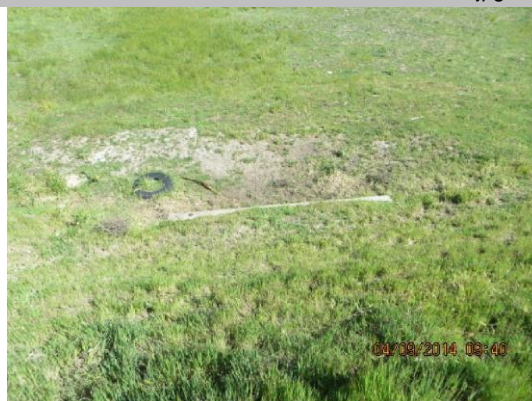
LM Start	8.57	Rating **	A/W	Issue No.	1220 (cont)	
LM End	8.57	Issue Type +	Ma	Location *		
Category	Supplemental			GPS Latitude/Longitude		
				Start	End	
Item	DRAFT DWR UCIP LMA Responsibility			37.296552 °	37.296552 °	
				-120.858596 °	-120.858596 °	
DWR ID	19622					
Comment Code						
Inspector Comment						
DS_ID:19622						
FS_ID:39246						
EP_NO: N/A						
Repair Type: No Action Needed						
Crossing Status: Found						
UCIP Comments:						
FIELD_STRUCT_DESC: 24-inch corrugated metal gravity drainage pipe through the levee, 9 feet below the crown. Flap gate on the waterside (WS) end. Brass cap No. 80 bench mark (BM) on the headwall on the landside (LS). [Additional Reference(s): DWR Levee Log, 2002. USACE San Joaquin O&M Manual 601.1, 1967, (HLM 8.61)].						
FS Date: 4/9/2014

Pipe and headwall at LS toe.

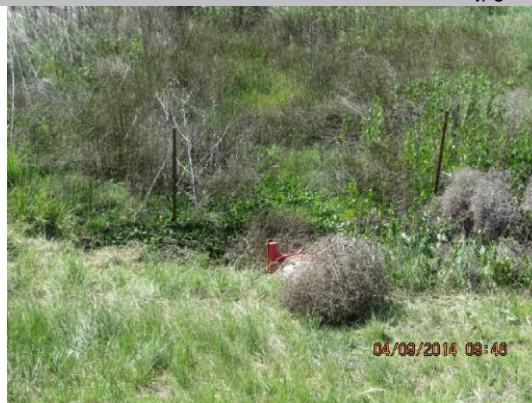
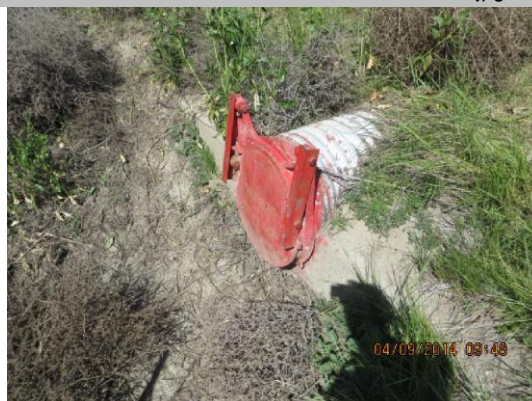
Comment Code					
Inspector Comment					
DS_ID:19623					
FS_ID:39247					
EP_NO: N/A					
Repair Type: Non-Urgent					
Crossing Status: Found					
UCIP Comments: 04/09/2014 Dense vegetation limits the inspector's visibility to identify signs of pipe failure (leaks) along the slope. Recommend removing vegetation along pipe alignment to conduct proper inspection of structure. (DWR UCIP - W. Wylie)					
FIELD_STRUCT_DESC: 24-inch corrugated metal gravity drainage pipe through the levee, 9.1 feet below the crown. Flap gate on the waterside (WS) end. Brass cap No. 80 bench mark (BM) on the headwall on the landside (LS). [Additional Reference(s): DWR Levee Log, 2002. USACE San Joaquin O&M Manual 601.1, 1967, (HLM 8.93)].					
FS Date: 4/9/2014

Pipe, flapgate, and headwall on WS toe.

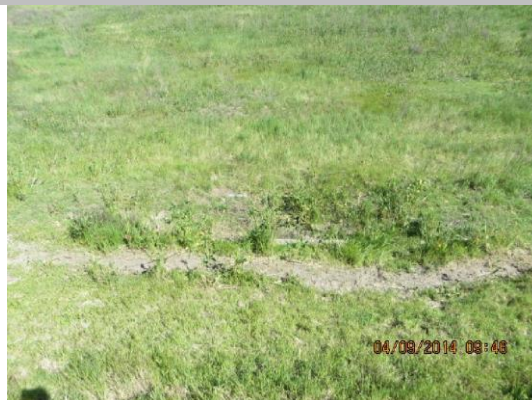
Comment Code						
Inspector Comment						
DS_ID:19623						
FS_ID:39247						
EP_NO: N/A						
Repair Type: Non-Urgent						
Crossing Status: Found						
UCIP Comments: 04/09/2014 Dense vegetation limits the inspector's visibility to identify signs of pipe failure (leaks) along the slope. Recommend removing vegetation along pipe alignment to conduct proper inspection of structure. (DWR UCIP - W. Wylie)						
FIELD_STRUCT_DESC: 24-inch corrugated metal gravity drainage pipe through the levee, 9.1 feet below the crown. Flap gate on the waterside (WS) end. Brass cap No. 80 bench mark (BM) on the headwall on the landside (LS). [Additional Reference(s): DWR Levee Log, 2002. USACE San Joaquin O&M Manual 601.1, 1967, (HLM 8.93)].						
FS Date: 4/9/2014

Pipe and headwall visible on LS toe.

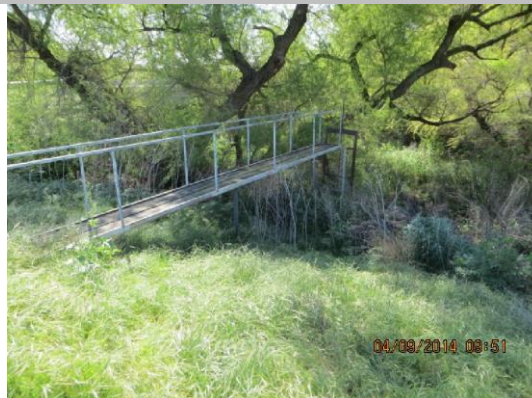
Comment Code						
Inspector Comment						
DS_ID:19624 FS_ID:53190 EP_NO: 12156 Repair Type: Urgent Crossing Status: Found UCIP Comments: 11/01/2018 Dense vegetation prevented a full inspection of this crossing. Assumed crossing remains the same as the 2016 inspection. Crossing remains Urgent due to signs of pipe being rusted through visible from the WS. Need to contact owner to clear the dense vegetation on both the WS and the LS to be able to perform proper inspection of crossing. (O. Magana - DWR UCIP)7/19/2016 same as previous inspection--pipe rusted through. Sediment visible inside LS pipe; walkway wood panels have dry rot and appears to be unsafe to use. (DWR UCIP - O. Magana)4/09/2014 Slide gate rusted through and open on WS toe. Inlet appears to be obscured or covered in soil at LS toe. Also dense vegetation on waterward and landward sides. Need to contact owner to contact CVFPB to address issue. (DWR UCIP - W. Wylie) FIELD_STRUCT_DESC: 26-inch steel pipe sleeved through a 30-inch reinforced concrete gravity drainage pipe through the levee, 7.3 feet below the crown. Annular space grouted between the two pipes. Two concrete cutoff walls in the center of the levee. Slide gate with elevated walkway access on the waterside (WS) end. 6-inch thick concrete headwall on the WS end. Concrete wing walls on each end. (Plans to install a 30-inch storm drainage pipe with a valve through the levee authorized under Permit No. 12156, 1977 - Merquin County Water District). (Additional Related Permit(s): Permit No. 12156-A, 1978 - Merquin County Water District). [Additional Reference(s): DWR Levee Log, 2002]. FS Date: 11/1/2018 12:50:00 PM

Metal walkway to slidegate operator on WS toe.

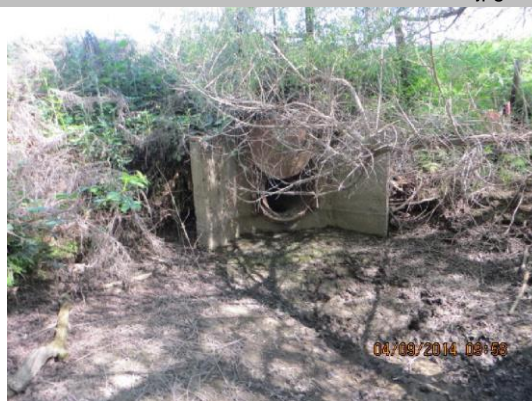
DS_ID:19624
FS_ID:53190
EP_NO: 12156
Repair Type: Urgent
Crossing Status: Found
UCIP Comments: 11/01/2018 Dense vegetation prevented a full inspection of this crossing. Assumed crossing remains the same as the 2016 inspection. Crossing remains Urgent due to signs of pipe being rusted through visible from the WS. Need to contact owner to clear the dense vegetation on both the WS and the LS to be able to perform proper inspection of crossing. (O. Magana - DWR UCIP)7/19/2016 same as previous inspection--pipe rusted through. Sediment visible inside LS pipe; walkway wood panels have dry rot and appears to be unsafe to use. (DWR UCIP - O. Magana)4/09/2014 Slide gate rusted through and open on WS toe. Inlet appears to be obscured or covered in soil at LS toe. Also dense vegetation on waterward and landward sides. Need to contact owner to contact CVFPB to address issue. (DWR UCIP - W. Wylie)
FIELD_STRUCT_DESC: 26-inch steel pipe sleeved through a 30-inch reinforced concrete gravity drainage pipe through the levee, 7.3 feet below the crown. Annular space grouted between the two pipes. Two concrete cutoff walls in the center of the levee. Slide gate with elevated walkway access on the waterside (WS) end. 6-inch thick concrete headwall on the WS end. Concrete wing walls on each end. (Plans to install a 30-inch storm drainage pipe with a valve through the levee authorized under Permit No. 12156, 1977 - Merquin County Water District). (Additional Related Permit(s): Permit No. 12156-A, 1978 - Merquin County Water District). [Additional Reference(s): DWR Levee Log, 2002].

Slidegate and headwall at WS toe.

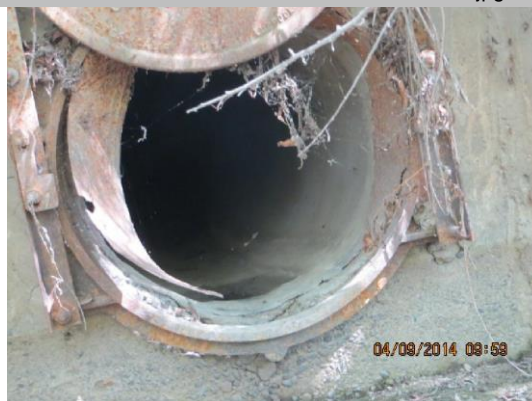
DS_ID:19624
 FS_ID:53190
 EP_NO: 12156
 Repair Type: Urgent
 Crossing Status: Found
 UCIP Comments: 11/01/2018 Dense vegetation prevented a full inspection of this crossing. Assumed crossing remains the same as the 2016 inspection. Crossing remains Urgent due to signs of pipe being rusted through visible from the WS. Need to contact owner to clear the dense vegetation on both the WS and the LS to be able to perform proper inspection of crossing. (O. Magana - DWR UCIP)7/19/2016 same as previous inspection--pipe rusted through. Sediment visible inside LS pipe; walkway wood panels have dry rot and appears to be unsafe to use. (DWR UCIP - O. Magana)4/09/2014 Slide gate rusted through and open on WS toe. Inlet appears to be obscured or covered in soil at LS toe. Also dense vegetation on waterward and landward sides. Need to contact owner to contact CVFPB to address issue. (DWR UCIP - W. Wylie)
 FIELD_STRUCT_DESC: 26-inch steel pipe sleeved through a 30-inch reinforced concrete gravity drainage pipe through the levee, 7.3 feet below the crown. Annular space grouted between the two pipes. Two concrete cutoff walls in the center of the levee. Slide gate with elevated walkway access on the waterside (WS) end. 6-inch thick concrete headwall on the WS end. Concrete wing walls on each end. (Plans to install a 30-inch storm drainage pipe with a valve through the levee authorized under Permit No. 12156, 1977 - Merquin County Water District). (Additional Related Permit(s): Permit No. 12156-A, 1978 - Merquin County Water District). [Additional Reference(s): DWR Levee Log, 2002].

Slidegate rusted through and open on WS toe.

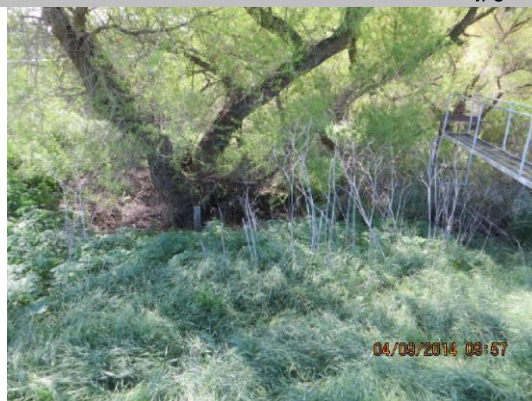
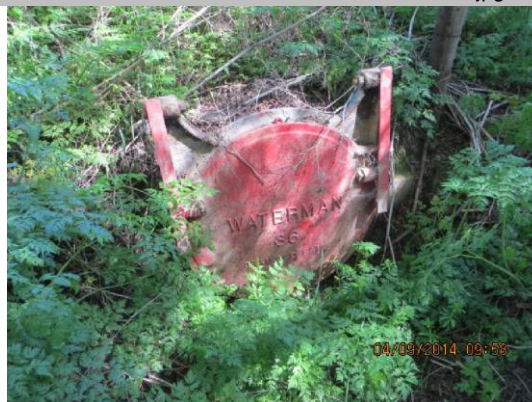
Comment Code						
Inspector Comment						
DS_ID:19625						
FS_ID:39249						
EP_NO: N/A						
Repair Type: Non-Urgent						
Crossing Status: Found						
UCIP Comments: 04/09/2014 Dense vegetation limits the inspector's visibility to identify signs of pipe failure (leaks) along the slope.						
Recommend removing vegetation along pipe alignment to conduct proper inspection of structure. Some sediment buildup in pipe. (DWR UCIP - W. Wylie)						
FIELD_STRUCT_DESC: 36-inch corrugated metal gravity drainage pipe through the levee, 10 feet below the crown. Flap gate on the waterside (WS) end. Brass cap No. 80 bench mark (BM) on the headwall on the landside (LS). [Additional Reference(s): DWR Levee Log, 2002. USACE San Joaquin O&M Manual 601.1, 1967, (HLM 9.00)].						
FS Date: 4/9/2014

Pipe and flapgate visible on WS toe.
