**Flood Control Project Maintenance
Levee Inspections**

Fall 2019 Levee Maintenance Deficiency Summary Report

San Joaquin River Basin

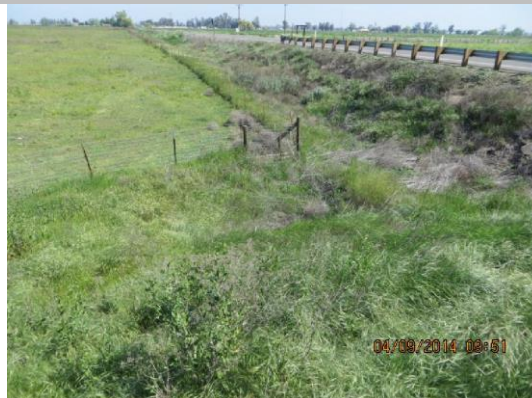
Comment Code						
Inspector Comment						
DS_ID:19625						
FS_ID:39249						
EP_NO: N/A						
Repair Type: Non-Urgent						
Crossing Status: Found						
UCIP Comments: 04/09/2014 Dense vegetation limits the inspector's visibility to identify signs of pipe failure (leaks) along the slope.						
Recommend removing vegetation along pipe alignment to conduct proper inspection of structure. Some sediment buildup in pipe. (DWR UCIP - W. Wylie)						
FIELD_STRUCT_DESC: 36-inch corrugated metal gravity drainage pipe through the levee, 10 feet below the crown. Flap gate on the waterside (WS) end. Brass cap No. 80 bench mark (BM) on the headwall on the landside (LS). [Additional Reference(s): DWR Levee Log, 2002. USACE San Joaquin O&M Manual 601.1, 1967, (HLM 9.00)].						
FS Date: 4/9/2014

Pipe and headwall visible on LS toe.

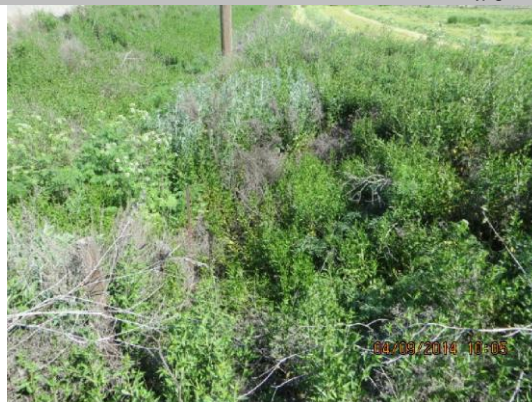
Comment Code						
Inspector Comment						
DS_ID:19626						
FS_ID:39250						
EP_NO: N/A						
Repair Type: Non-Urgent						
Crossing Status: Found						
UCIP Comments: 04/09/2014 Dense vegetation limits the inspector's visibility to identify signs of pipe failure (leaks) along the slope. Recommend removing vegetation along pipe alignment to conduct proper inspection of structure. (DWR UCIP - W. Wylie)						
FIELD_STRUCT_DESC: 24-inch corrugated metal gravity drainage pipe through the levee, 10 feet below the crown. Flap gate on the waterside (WS) end. Brass cap No. 80 bench mark (BM) on the headwall on the landside (LS). [Additional Reference(s): DWR Levee Log, 2002. USACE San Joaquin O&M Manual 601.1, 1967, (HLM 9.03)].						
FS Date: 4/9/2014

Heavy vegetation on LS toe.

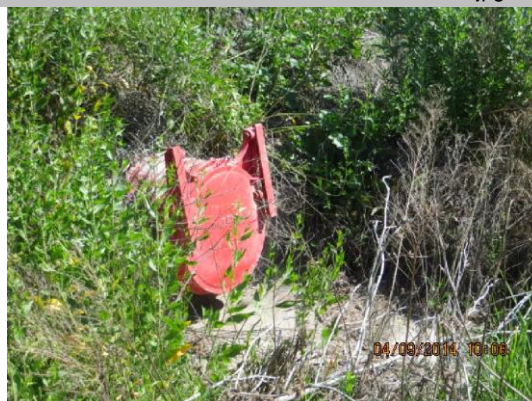
Photo 2 of 2 : UCIP_FA_2019_39250_60871.jpg

Comment Code						
Inspector Comment						
DS_ID:19626 FS_ID:39250 EP_NO: N/A Repair Type: Non-Urgent Crossing Status: Found UCIP Comments: 04/09/2014 Dense vegetation limits the inspector's visibility to identify signs of pipe failure (leaks) along the slope. Recommend removing vegetation along pipe alignment to conduct proper inspection of structure. (DWR UCIP - W. Wylie) FIELD_STRUCT_DESC: 24-inch corrugated metal gravity drainage pipe through the levee, 10 feet below the crown. Flap gate on the waterside (WS) end. Brass cap No. 80 bench mark (BM) on the headwall on the landside (LS). [Additional Reference(s): DWR Levee Log, 2002. USACE San Joaquin O&M Manual 601.1, 1967, (HLM 9.03)]. FS Date: 4/9/2014

Pipe, concrete headwall, and flapgate at WS toe.

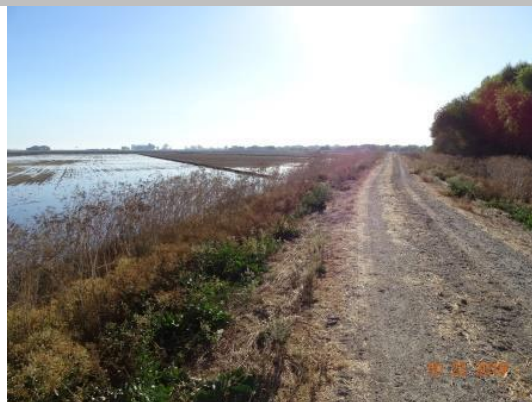
Photo 1 of 1 : FA_2019_NA0010_118_122_20191105_00282.jpg

LM Start	9.03	Rating **	U	Issue No.	122
LM End	9.94	Issue Type +	Ma	Location *	LS
Category	Earthen Levee			GPS Latitude/Longitude	
				Start	End
Item	Vegetation			37.297446 °	37.290961 °
				-120.850505 °	-120.839775 °
DWR ID	DWR_NA0010_01_f_2019_122				
Comment Code					
V1 : Control annual grass and weeds on the levee slopes and easements.					
Inspector Comment

View of vegetation along the landside slope looking upstream. (Fall 2019)

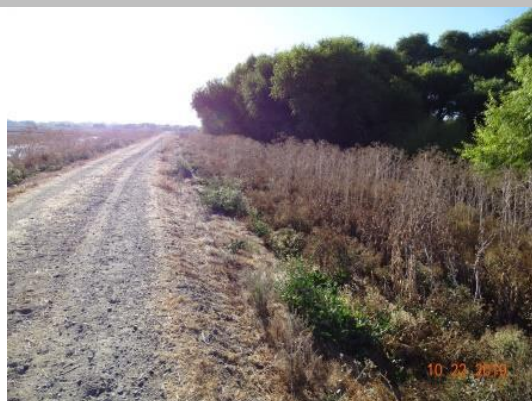
Photo 1 of 1 : FA_2019_NA0010_118_123_20191105_00283.jpg

LM Start	9.03	Rating **	U	Issue No.	123
LM End	9.94	Issue Type +	Ma	Location *	WS
Category	Earthen Levee			GPS Latitude/Longitude	
				Start	End
Item	Vegetation			37.297445 °	37.290961 °
				-120.850505 °	-120.839775 °
DWR ID	DWR_NA0010_01_f_2019_123				
Comment Code					
V1 : Control annual grass and weeds on the levee slopes and easements.					
Inspector Comment

View along the waterside slope looking upstream. (Fall 2019)

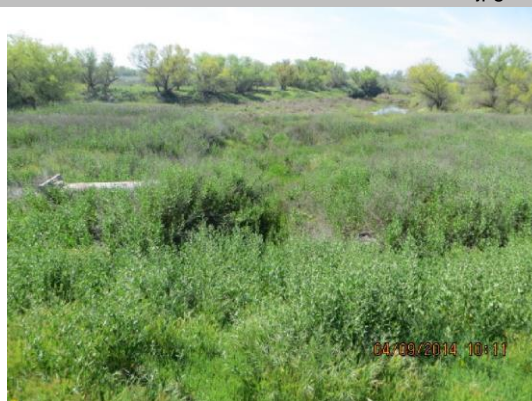
Photo 1 of 3 : UCIP_FA_2019_39251_60875.jpg

Comment Code					
Inspector Comment					
DS_ID:19627 FS_ID:39251 EP_NO: N/A Repair Type: Non-Urgent Crossing Status: Found UCIP Comments: 04/09/2014 Dense vegetation limits the inspector's visibility to identify signs of pipe failure (leaks) along the slope. Recommend removing vegetation along pipe alignment to conduct proper inspection of structure. (DWR UCIP - W. Wylie) FIELD_STRUCT_DESC: 24-inch corrugated metal gravity drainage pipe through the levee, 8.6 feet below the crown. Concrete drop inlet at the landside (LS) toe. Flap gate on the waterside (WS) end. Brass cap No. 80 bench mark (BM) on the headwall on the LS. [Additional Reference(s): DWR Levee Log, 2002. USACE San Joaquin O&M Manual 601.1, 1967, (HLM 9.37)]. FS Date: 4/9/2014

Pipe and flapgate on WS toe.

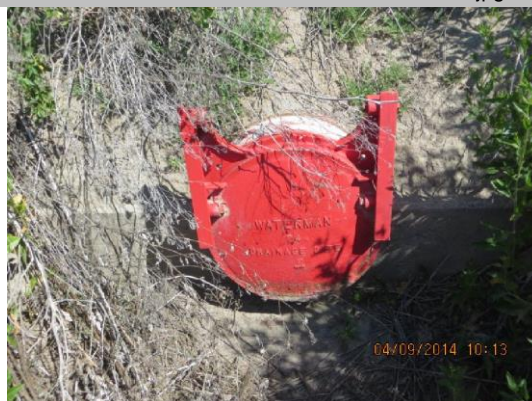
Photo 2 of 3 : UCIP_FA_2019_39251_60876.jpg

Headwall, Pipe, and flapgate on WS toe.

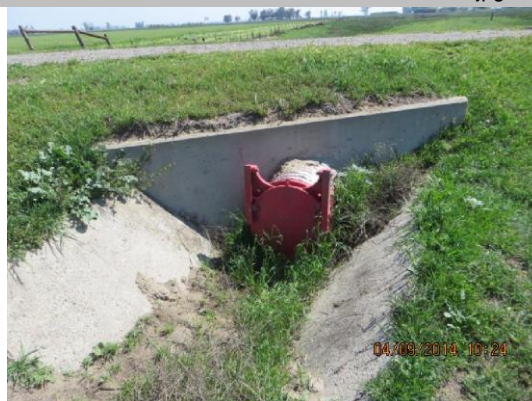
Photo 1 of 1 : UCIP_FA_2019_33683_60880.jpg

LM Start	9.64	Rating **	A/W	Issue No.	1226
LM End	9.64	Issue Type +	Ma	Location *	
Category	Supplemental			GPS Latitude/Longitude	
				Start	End
Item	DRAFT DWR UCIP LMA Responsibility			37.294845 °	37.294845 °
				-120.840580 °	-120.840580 °
DWR ID	19628				
Comment Code					
Inspector Comment					
DS_ID:19628 FS_ID:33683 EP_NO: N/A Repair Type: No Action Needed Crossing Status: Found UCIP Comments: FIELD_STRUCT_DESC: 24-inch corrugated metal gravity drainage pipe through the levee, 4.5 feet below the crown. Flap gate on the waterside (WS) end. Brass cap No. 80 bench mark (BM) on the headwall on the landside (LS). [Additional Reference(s): DWR Levee Log, 2002. USACE San Joaquin O&M Manual 601.1, 1967, (HLM 9.67)]. FS Date: 4/9/2014

Pipe, flapgate, and headwall visible on WS toe.

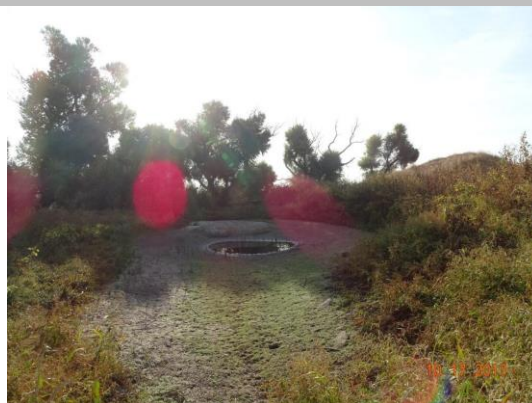
Photo 1 of 1 : FA_2019_NA0010_118_112_20190912_00022.jpg

LM Start	9.89	Rating **	A/W	Issue No.	112
LM End	9.90	Issue Type +	Ma	Location *	CR
Category	Earthen Levee			GPS Latitude/Longitude	
				Start	End
Item	Erosion / Bank Caving			37.291796 °	37.291581 °
				-120.839497 °	-120.839718 °
DWR ID	DWR_NA0010_01_f_2017_112				
Comment Code					
Inspector Comment					
Landowner degraded levee in the 1970's because water on LS was flooding his property. Landowner has prevented efforts to restore levee. LMA has stated that no water from the waterside of the levee has ever backed up through the degraded levee and caused flooding.

Looking south at the levee bank caving. (Fall 2017)

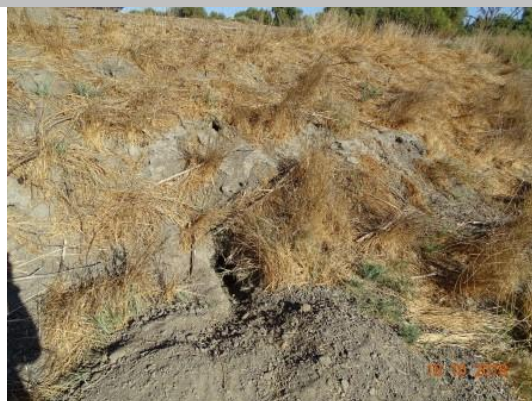
Photo 1 of 2 : FA_2019_NA0010_118_120_20190912_00031.jpg

LM Start	9.94	Rating **	U	Issue No.	120
LM End	9.97	Issue Type +	Ma	Location *	LS
Category	Earthen Levee			GPS Latitude/Longitude	
				Start	End
Item	Animal Control			37.290994 °	37.290673 °
				-120.839758 °	-120.839988 °
DWR ID	DWR_NA0010_01_f_2018_120				
Comment Code					
A3 : No rodents visible, but rodent burrows visible; need to backfill and compact or grout burrows.					
Inspector Comment					
Rodent burrows observed in this section with large amount of material displaced.

Representative view of rodent burrow. (Fall 2018)

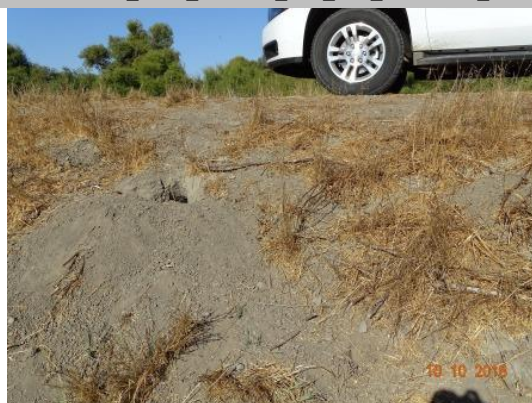
Photo 2 of 2 : FA_2019_NA0010_118_120_20190912_00032.jpg

View of another rodent burrow. (Fall 2018)

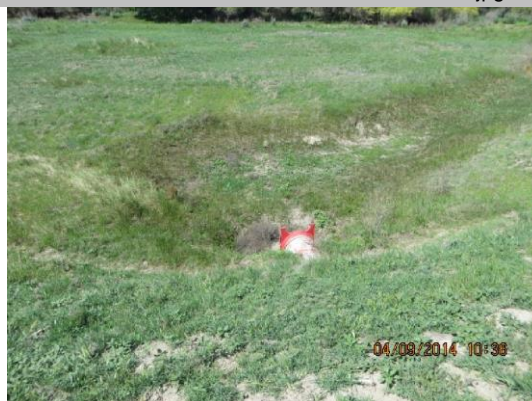
Photo 1 of 3 : UCIP_FA_2019_39253_60884.jpg

Comment Code						
Inspector Comment						
DS_ID:19629 FS_ID:39253 EP_NO: N/A Repair Type: Non-Urgent Crossing Status: Found UCIP Comments: 04/09/2014 Dense vegetation blocks waterward and landward toes Recommend removing vegetation from both toes. Also sediment buildup in pipe visible from landward side. (DWR UCIP - W. Wylie) FIELD_STRUCT_DESC: 24-inch corrugated metal gravity drainage pipe through the levee, 9 feet below the crown. Flap gate on the waterside (WS) end. Brass cap No. 69 bench mark (BM) on the headwall on the landside (LS). [Additional Reference(s): DWR Levee Log, 2002. USACE San Joaquin O&M Manual 601.1, 1967, (HLM 10.23)]. FS Date: 4/9/2014

Pipe, headwall, and flapgate on WS toe.

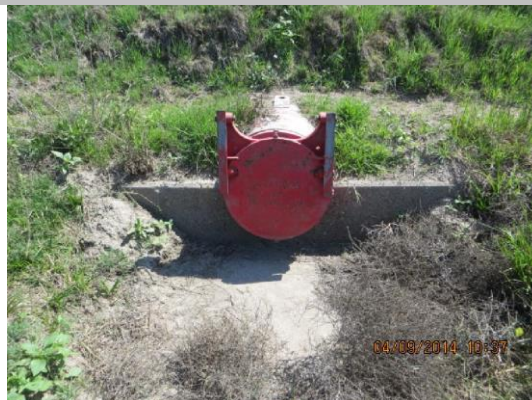
Photo 2 of 3 : UCIP_FA_2019_39253_60886.jpg

Pipe, headwall, and flapgate at WS toe.

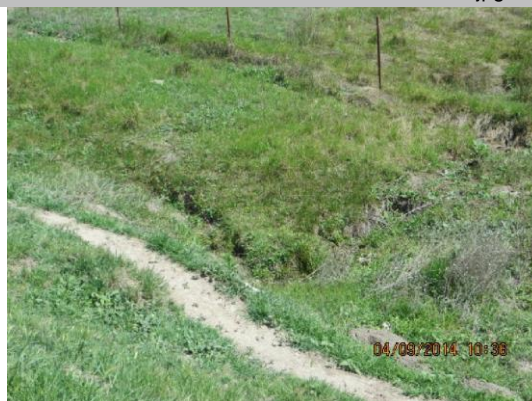
Photo 3 of 3 : UCIP_FA_2019_39253_60885.jpg

Item	DRAFT DWR UCIP LMA Responsibility			37.287511 °		37.287511 °
				-120.840251 °		-120.840251 °
DWR ID	19629					
Comment Code						
Inspector Comment						
DS_ID:19629 FS_ID:39253 EP_NO: N/A Repair Type: Non-Urgent Crossing Status: Found UCIP Comments: 04/09/2014 Dense vegetation blocks waterward and landward toes Recommend removing vegetation from both toes. Also sediment buildup in pipe visible from landward side. (DWR UCIP - W. Wylie) FIELD_STRUCT_DESC: 24-inch corrugated metal gravity drainage pipe through the levee, 9 feet below the crown. Flap gate on the waterside (WS) end. Brass cap No. 69 bench mark (BM) on the headwall on the landside (LS). [Additional Reference(s): DWR Levee Log, 2002. USACE San Joaquin O&M Manual 601.1, 1967, (HLM 10.23)]. FS Date: 4/9/2014

Pipe and headwall at LS toe.

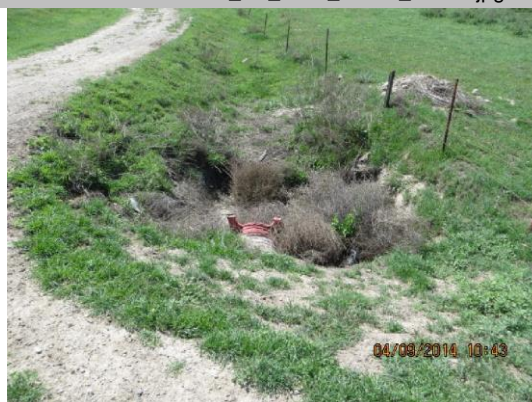
Photo 1 of 3 : UCIP_FA_2019_33687_60890.jpg

LM Start	10.68	Rating **	A/W	Issue No.	1228
LM End	10.68	Issue Type +	Ma	Location *	
Category	Supplemental			GPS Latitude/Longitude	
				Start	End
Item	DRAFT DWR UCIP LMA Responsibility			37.283740 °	37.283740 °
				-120.833452 °	-120.833452 °
DWR ID	19630				
Comment Code					
Inspector Comment					
DS_ID:19630					
FS_ID:33687					
EP_NO: N/A					
Repair Type: No Action Needed					
Crossing Status: Found					
UCIP Comments:					
FIELD_STRUCT_DESC: 24-inch corrugated metal gravity drainage pipe through the levee, 7 feet below the crown. Flap gate on the waterside (WS) end. Brass cap No. 68 bench mark (BM) on the headwall on the landside (LS). [Additional Reference(s): DWR Levee Log, 2002. USACE San Joaquin O&M Manual 601.1, 1967, (HLM 10.72)].					
FS Date: 4/9/2014

Pipe and flapgate on Ws toe.

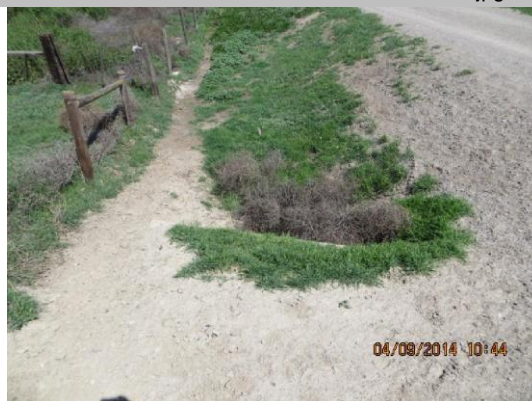
Photo 2 of 3 : UCIP_FA_2019_33687_60889.jpg

Pipe and headwall on LS toe.

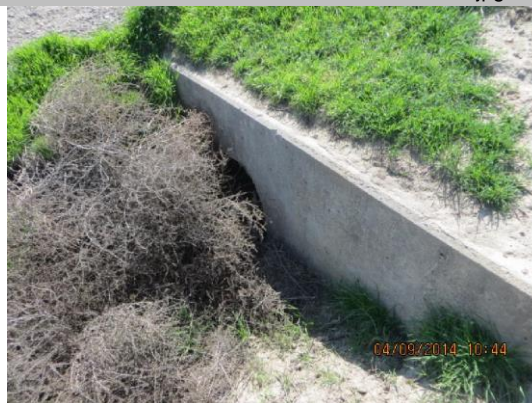
Photo 3 of 3 : UCIP_FA_2019_33687_60888.jpg

Pipe and headwall on LS toe.

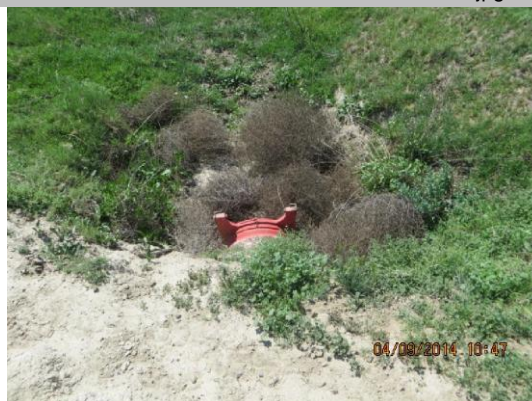
Photo 1 of 3 : UCIP_FA_2019_39254_60894.jpg

LM Start	10.69	Rating **	A/W	Issue No.	1229	
LM End	10.69	Issue Type +	Ma	Location *		
Category	Supplemental			GPS Latitude/Longitude		
				Start	End	
Item	DRAFT DWR UCIP LMA Responsibility			37.283710 °	37.283710 °	
				-120.833329 °	-120.833329 °	
DWR ID	19631					
Comment Code						
Inspector Comment						
DS_ID:19631						
FS_ID:39254						
EP_NO: N/A						
Repair Type: No Action Needed						
Crossing Status: Found						
UCIP Comments:						
FIELD_STRUCT_DESC: 24-inch corrugated metal gravity drainage pipe through the levee, 7 feet below the crown. Flap gate on the waterside (WS) end. Brass cap No. 67 bench mark (BM) on the headwall on the landside (LS). [Additional Reference(s): DWR Levee Log, 2002. USACE San Joaquin O&M Manual 601.1, 1967, (HLM 10.72)].						
FS Date: 4/9/2014

Headwall, pipe, and flapgate on WS toe.

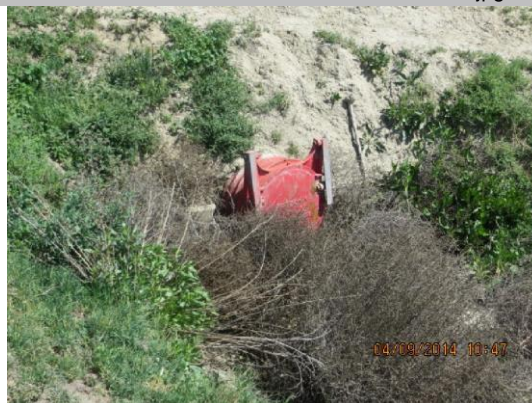
Photo 2 of 3 : UCIP_FA_2019_39254_60893.jpg

Headwall, pipe, and flapgate on WS toe.

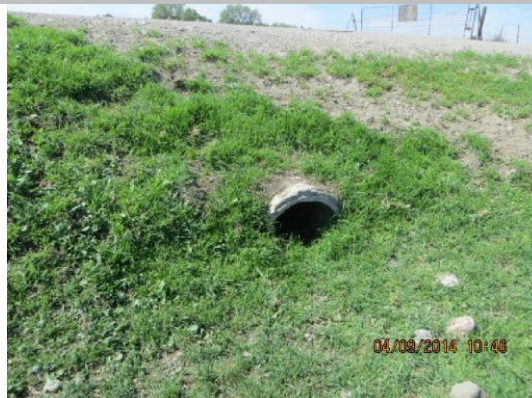
Photo 3 of 3 : UCIP_FA_2019_39254_60895.jpg

LM Start	10.69	Rating **	A/W	Issue No.	1229 (cont)	
LM End	10.69	Issue Type +	Ma	Location *		
Category	Supplemental			GPS Latitude/Longitude		
				Start	End	
Item	DRAFT DWR UCIP LMA Responsibility			37.283710°	37.283710°	
				-120.833329°	-120.833329°	
DWR ID	19631					
Comment Code						
Inspector Comment						
DS_ID:19631						
FS_ID:39254						
EP_NO: N/A						
Repair Type: No Action Needed						
Crossing Status: Found						
UCIP Comments:						
FIELD_STRUCT_DESC: 24-inch corrugated metal gravity drainage pipe						
through the levee, 7 feet below the crown. Flap gate on the waterside						
(WS) end. Brass cap No. 67 bench mark (BM) on the headwall on the						
landside (LS). [Additional Reference(s): DWR Levee Log, 2002. USACE						
San Joaquin O&M Manual 601.1, 1967, (HLM 10.72)].						
FS Date: 4/9/2014

Concrete pipe visible on LS slope.

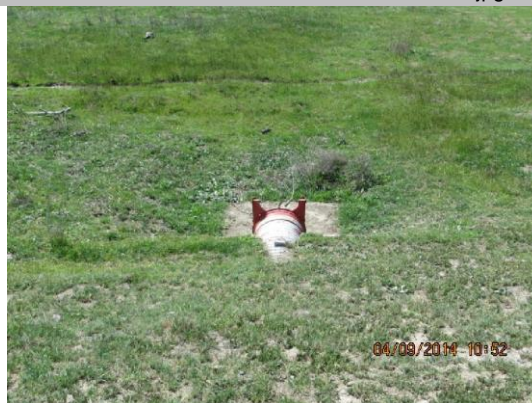
Photo 1 of 3 : UCIP_FA_2019_39255_60897.jpg

LM Start	10.98	Rating **	M	Issue No.	1230
LM End	10.98	Issue Type +	Ma	Location *	
Category	Supplemental			GPS Latitude/Longitude	
				Start	End
Item	DRAFT DWR UCIP LMA Responsibility			37.282627°	37.282627°
				-120.828233°	-120.828233°
DWR ID	19632				
Comment Code					
Inspector Comment					
DS_ID:19632					
FS_ID:39255					
EP_NO: N/A					
Repair Type: Non-Urgent					
Crossing Status: Found					
UCIP Comments: 04/09/2014 Dense vegetation blocks landward headwall. Recommend removing excess vegetation on landward toe. (DWR UCIP - W. Wylie)					
FIELD_STRUCT_DESC: 24-inch corrugated metal gravity drainage pipe through the levee, 6 feet below the crown. Flap gate on the waterside (WS) end. Brass cap No. 66 bench mark (BM) on the headwall on the landside (LS). [Additional Reference(s): DWR Levee Log, 2002. USACE San Joaquin O&M Manual 601.1, 1967, (HLM 11.00)].					
FS Date: 4/9/2014

Pipe, headwall, and flapgate on WS toe.

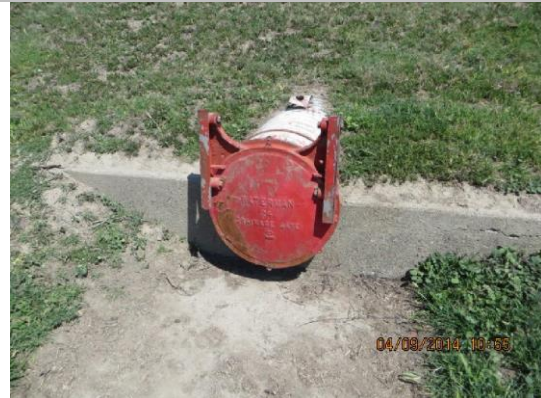
Photo 2 of 3 : UCIP_FA_2019_39255_60899.jpg

Pipe, headwall, and flapgate on WS toe.

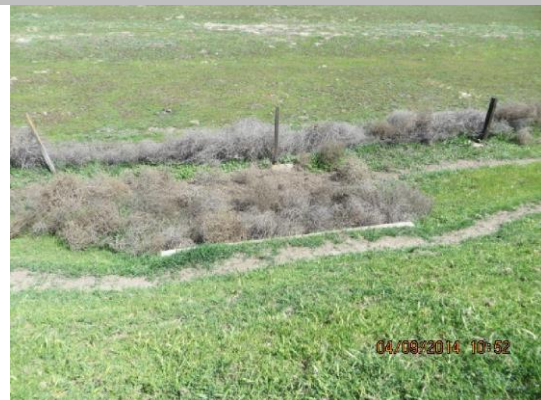
Photo 3 of 3 : UCIP_FA_2019_39255_60898.jpg

Pipe and headwall on LS toe.

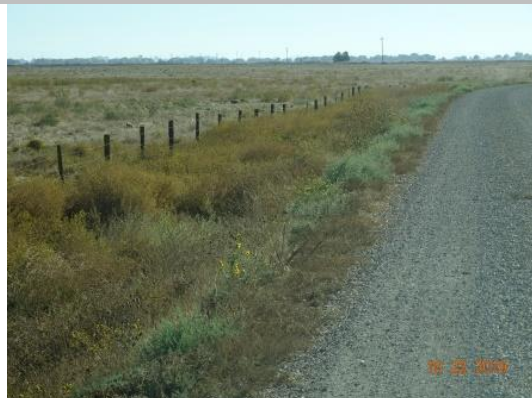
Photo 1 of 1 : FA_2019_NA0010_118_126_20191105_00284.jpg

LM Start	11.03	Rating **	U	Issue No.	126
LM End	11.68	Issue Type +	Ma	Location *	LS
Category	Earthen Levee			GPS Latitude/Longitude	
				Start	End
Item	Vegetation			37.282393 °	37.270987 °
				-120.827252 °	-120.826067 °
DWR ID	DWR_NA0010_01_f_2019_126				
Comment Code					
V1 : Control annual grass and weeds on the levee slopes and easements.					
Inspector Comment

View of landside slope looking upstream. (Fall 2019)

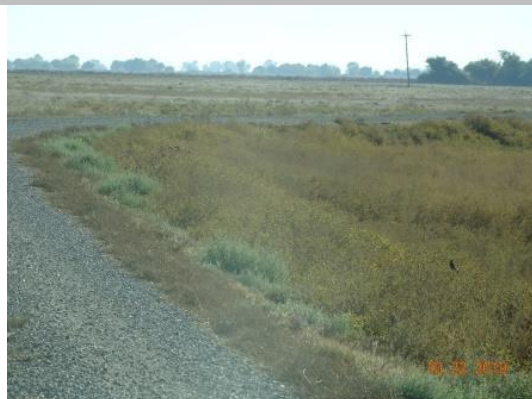
Photo 1 of 1 : FA_2019_NA0010_118_127_20191107_00285.jpg

LM Start	11.03	Rating **	U	Issue No.	127
LM End	11.69	Issue Type +	Ma	Location *	WS
Category	Earthen Levee			GPS Latitude/Longitude	
				Start	End
Item	Vegetation			37.282393 °	37.270939 °
				-120.827251 °	-120.826077 °
DWR ID	DWR_NA0010_01_f_2019_127				
Comment Code					
V1 : Control annual grass and weeds on the levee slopes and easements.					
Inspector Comment

View of the waterside slope looking upstream. (Fall 2019)

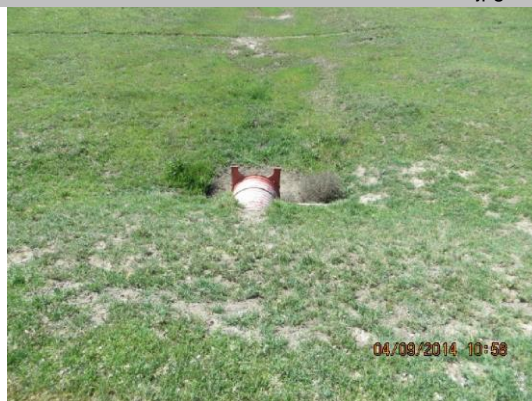
Photo 1 of 3 : UCIP_FA_2019_33690_60903.jpg

LM Start	11.14	Rating **	A/W	Issue No.	1231
LM End	11.14	Issue Type +	Ma	Location *	
Category	Supplemental			GPS Latitude/Longitude	
				Start	End
Item	DRAFT DWR UCIP LMA Responsibility			37.281813 °	37.281813 °
				-120.825409 °	-120.825409 °
DWR ID	19633				
Comment Code					
Inspector Comment					
DS_ID:19633 FS_ID:33690 EP_NO: N/A Repair Type: No Action Needed Crossing Status: Found UCIP Comments: FIELD_STRUCT_DESC: 24-inch corrugated metal gravity drainage pipe through the levee, 5 feet below the crown. Flap gate on the waterside (WS) end. Brass cap No. 65 bench mark (BM) on the headwall on the landside (LS). [Additional Reference(s): DWR Levee Log, 2002. USACE San Joaquin O&M Manual 601.1, 1967, (HLM 11.18)]. FS Date: 4/9/2014

Pipe, headwall, and flapgate on WS toe.

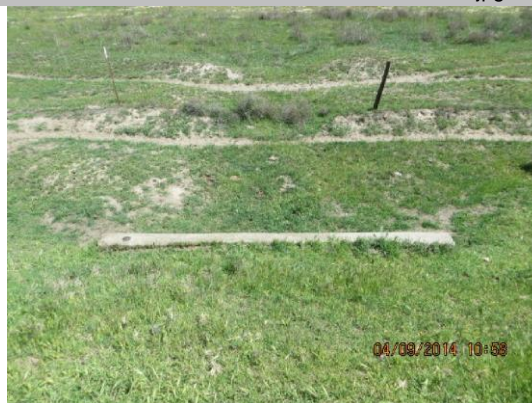
Photo 2 of 3 : UCIP_FA_2019_33690_60902.jpg

Pipe and headwall at LS toe.

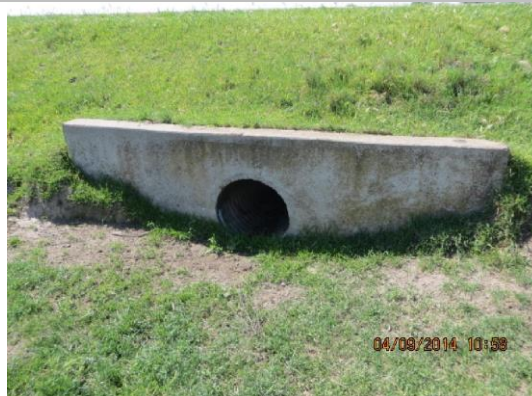
Photo 3 of 3 : UCIP_FA_2019_33690_60901.jpg

Pipe and headwall at LS toe.

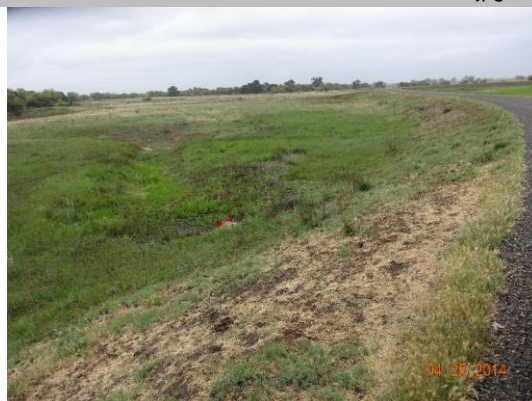
Photo 1 of 3 : UCIP_FA_2019_36103_65362.jpg

Comment Code						
Inspector Comment						
DS_ID:19634 FS_ID:36103 EP_NO: N/A Repair Type: Non-Urgent Crossing Status: Found UCIP Comments: 04/25/2014 Need to contact owner--landward side has been buried. It appears that soil was removed from levee toe, immediately upstream, and used to pile soil at landward side at crossing. (DWR UCIP - O. Magana) FIELD_STRUCT_DESC: 24-inch corrugated metal gravity drainage pipe through the levee, 10 feet below the crown. Flap gate on the waterside (WS) end. Brass cap No. 62 bench mark (BM) on the headwall on the landside (LS). [Additional Reference(s): DWR Levee Log, 2002. USACE San Joaquin O&M Manual 601.1, 1967, (HLM 11.48)]. FS Date: 4/25/2014

View of waterward side.

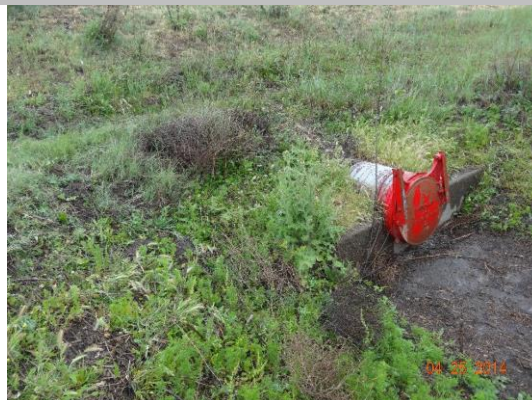
Photo 2 of 3 : UCIP_FA_2019_36103_65364.jpg

View of concrete headwall and flap gate visible on waterward side.

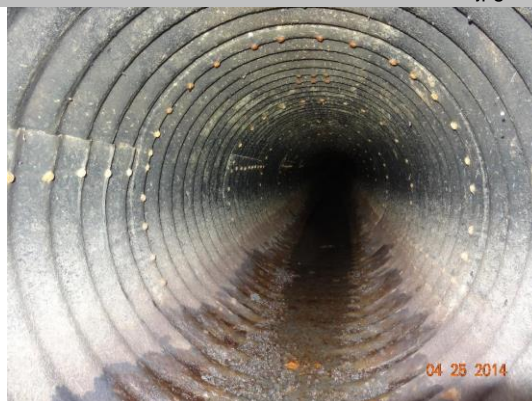
Photo 3 of 3 : UCIP_FA_2019_36103_65363.jpg

Item	DRAFT DWR UCIP LMA Responsibility			37.273787 °		37.273787 °
				-120.825519 °		-120.825519 °
DWR ID	19634					
Comment Code						
Inspector Comment						
DS_ID:19634 FS_ID:36103 EP_NO: N/A Repair Type: Non-Urgent Crossing Status: Found UCIP Comments: 04/25/2014 Need to contact owner--landward side has been buried. It appears that soil was removed from levee toe, immediately upstream, and used to pile soil at landward side at crossing. (DWR UCIP - O. Magana) FIELD_STRUCT_DESC: 24-inch corrugated metal gravity drainage pipe through the levee, 10 feet below the crown. Flap gate on the waterside (WS) end. Brass cap No. 62 bench mark (BM) on the headwall on the landside (LS). [Additional Reference(s): DWR Levee Log, 2002. USACE San Joaquin O&M Manual 601.1, 1967, (HLM 11.48)]. FS Date: 4/25/2014

Inside view of pipe from waterward side.

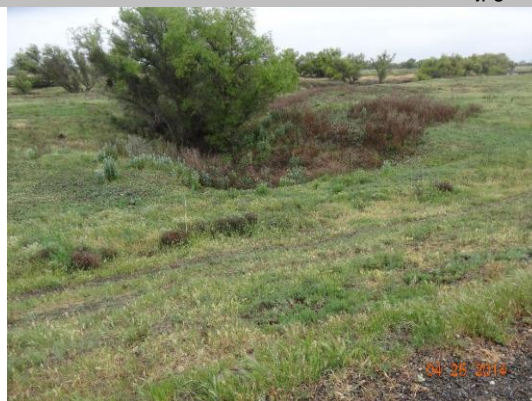
Photo 1 of 3 : UCIP_FA_2019_36105_65372.jpg

Comment Code						
Inspector Comment						
DS_ID:19635 FS_ID:36105 EP_NO: N/A Repair Type: Non-Urgent Crossing Status: Found UCIP Comments: 04/25/2014 Crossing is non-functional --landward side is buried. Debris found on landward side (channel). Dense vegetation found on waterward slope. Recommend contacting owner to determine status of crossing. If crossing is no longer used need to coordinate with CVFPB for proper abandonment. (DWR UCIP - O. Magana) FIELD_STRUCT_DESC: 24-inch corrugated metal gravity drainage pipe through the levee, 17 feet below the crown. Flap gate on the waterside (WS) end. Brass cap No. 61 bench mark (BM) on the headwall on the landside (LS). [Additional Reference(s): DWR Levee Log, 2002. USACE San Joaquin O&M Manual 601.1, 1967, (HLM 11.76)]. FS Date: 4/25/2014

View of waterward side.

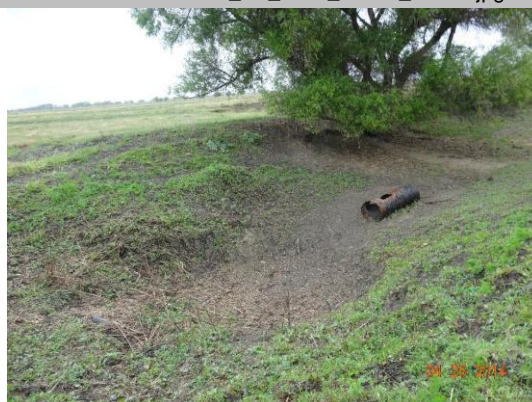
Photo 2 of 3 : UCIP_FA_2019_36105_65371.jpg

Landward side of crossing buried--damage pipe section visible on landward side.

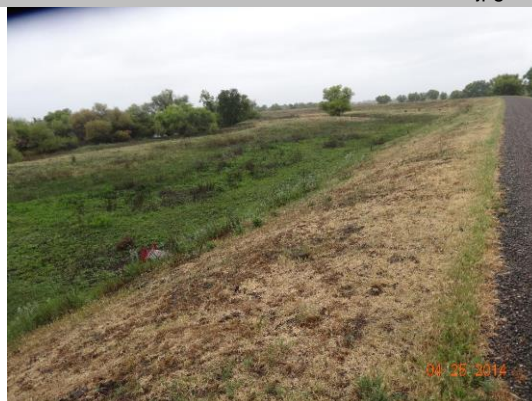
Photo 1 of 3 : UCIP_FA_2019_36106_65378.jpg

Comment Code						
Inspector Comment						
DS_ID:19636 FS_ID:36106 EP_NO: N/A Repair Type: Non-Urgent Crossing Status: Found UCIP Comments: 04/25/2014 Crossing is non-functional --landward side is buried. Dense vegetation found on waterward slope. Recommend contacting owner to determine status of crossing. If crossing is no longer used need to coordinate with CVFPB for proper abandonment. (DWR UCIP - O. Magana) FIELD_STRUCT_DESC: 24-inch corrugated metal gravity drainage pipe through the levee, 12.4 feet below the crown. Flap gate on the waterside (WS) end. Brass cap No. 60 bench mark (BM) on the headwall on the landside (LS). [Additional Reference(s): DWR Levee Log, 2002. USACE San Joaquin O&M Manual 601.1, 1967, (HLM 12.11)]. FS Date: 4/25/2014

View of waterward side--flap gate visible on waterward toe.

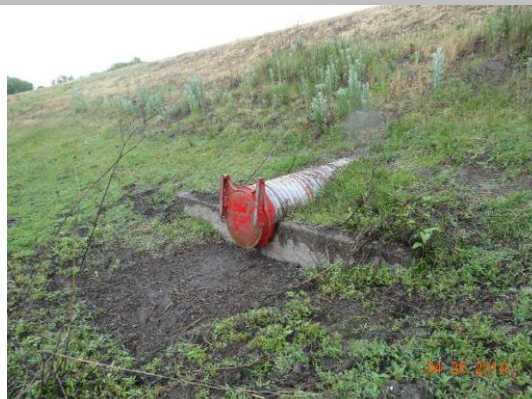
Photo 2 of 3 : UCIP_FA_2019_36106_65379.jpg

Flap gate and concrete headwall visible on waterward side.

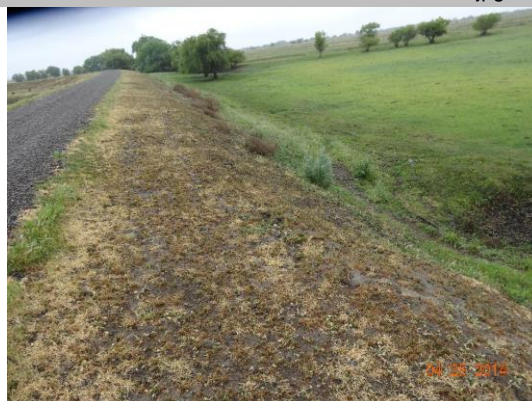
Photo 3 of 3 : UCIP_FA_2019_36106_65377.jpg

Item	DRAFT DWR UCIP LMA Responsibility			37.265336 °	37.265336 °	
				-120.826591 °	-120.826591 °	
DWR ID	19636					
Comment Code						
Inspector Comment						
DS_ID:19636 FS_ID:36106 EP_NO: N/A Repair Type: Non-Urgent Crossing Status: Found UCIP Comments: 04/25/2014 Crossing is non-functional --landward side is buried. Dense vegetation found on waterward slope. Recommend contacting owner to determine status of crossing. If crossing is no longer used need to coordinate with CVFPB for proper abandonment. (DWR UCIP - O. Magana) FIELD_STRUCT_DESC: 24-inch corrugated metal gravity drainage pipe through the levee, 12.4 feet below the crown. Flap gate on the waterside (WS) end. Brass cap No. 60 bench mark (BM) on the headwall on the landside (LS). [Additional Reference(s): DWR Levee Log, 2002. USACE San Joaquin O&M Manual 601.1, 1967, (HLM 12.11)]. FS Date: 4/25/2014

View of landward side.

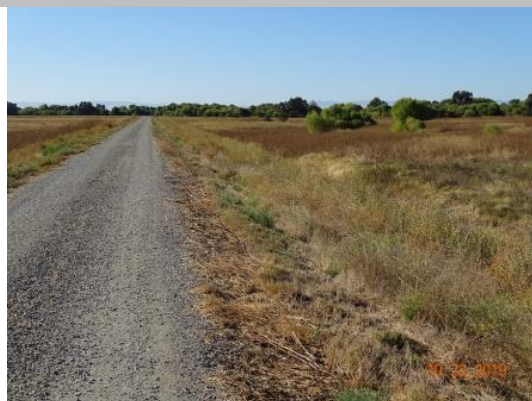
Photo 1 of 1 : FA_2019_NA0010_118_129_20191107_00291.jpg

LM Start	12.13	Rating **	M	Issue No.	129
LM End	12.63	Issue Type +	Ma	Location *	WS
Category	Earthen Levee			GPS Latitude/Longitude	
				Start	End
Item	Vegetation			37.265307 °	37.258945 °
				-120.826590 °	-120.826358 °
DWR ID	DWR_NA0010_01_f_2019_129				
Comment Code					
V1 : Control annual grass and weeds on the levee slopes and easements.					
Inspector Comment

View of waterside slope looking upstream. (Fall 2019)

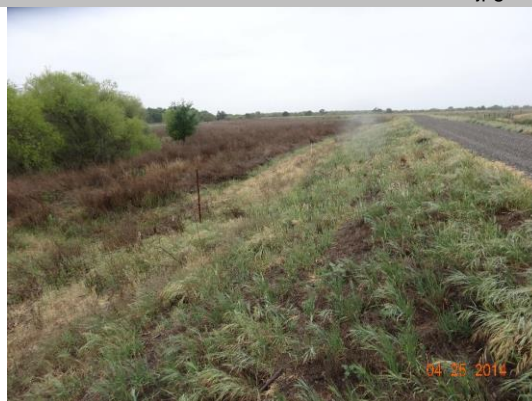
Photo 1 of 3 : UCIP_FA_2019_36146_65412.jpg

Comment Code					
Inspector Comment					
DS_ID:19637 FS_ID:36146 EP_NO: N/A Repair Type: Non-Urgent Crossing Status: Found UCIP Comments: 04/25/2014 Concrete headwall on landward side blocked by debris. Dense vegetation limits the inspector's visibility to identify signs of pipe failure (leaks) along the landward slope. Recommend removing vegetation along pipe alignment to conduct proper inspection of crossing. (DWR UCIP - O. Magana) FIELD_STRUCT_DESC: 24-inch corrugated metal gravity drainage pipe through the levee, 9.5 feet below the crown. Flap gate on the waterside (WS) end. Brass cap No. 60 bench mark (BM) on the headwall on the landside (LS). [Additional Reference(s): DWR Levee Log, 2002. USACE San Joaquin O&M Manual 601.1, 1967, (HLM 12.94)]. FS Date: 4/25/2014

View of waterward side.

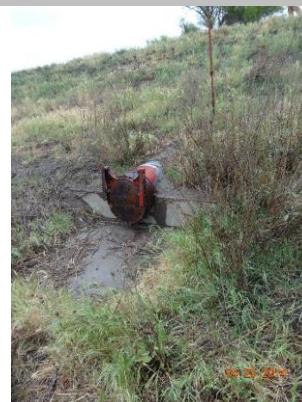
Photo 2 of 3 : UCIP_FA_2019_36146_65411.jpg

Flap gate and concrete headwall visible on waterward side.

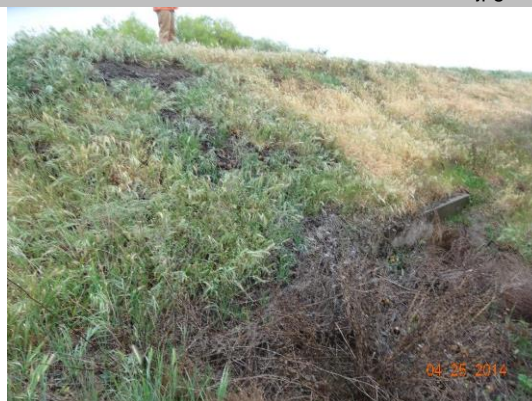
Photo 3 of 3 : UCIP_FA_2019_36146_65410.jpg

Item	DRAFT DWR UCIP LMA Responsibility			37.256873 °	37.256873 °	
				-120.821277 °	-120.821277 °	
DWR ID	19637					
Comment Code						
Inspector Comment						
DS_ID:19637						
FS_ID:36146						
EP_NO: N/A						
Repair Type: Non-Urgent						
Crossing Status: Found						
UCIP Comments: 04/25/2014 Concrete headwall on landward side blocked by debris. Dense vegetation limits the inspector's visibility to identify signs of pipe failure (leaks) along the landward slope. Recommend removing vegetation along pipe alignment to conduct proper inspection of crossing. (DWR UCIP - O. Magana)						
FIELD_STRUCT_DESC: 24-inch corrugated metal gravity drainage pipe through the levee, 9.5 feet below the crown. Flap gate on the waterside (WS) end. Brass cap No. 60 bench mark (BM) on the headwall on the landside (LS). [Additional Reference(s): DWR Levee Log, 2002. USACE San Joaquin O&M Manual 601.1, 1967, (HLM 12.94)].

View of landward side--concrete headwall visible covered by dense vegetation.

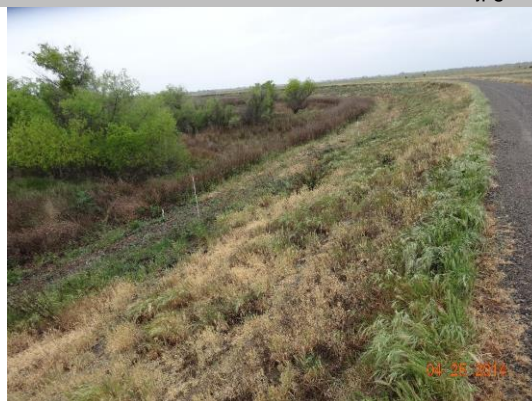
Photo 1 of 3 : UCIP_FA_2019_36109_65389.jpg

Comment Code						
Inspector Comment						
DS_ID:19638 FS_ID:36109 EP_NO: N/A Repair Type: Non-Urgent Crossing Status: Found UCIP Comments: 04/25/2014 Dense vegetation limits the inspector's visibility to identify signs of pipe failure (leaks) along the landward slope. Concrete headwall blocked by debris located on landward toe. Recommend clearing debris from landward slope and toe. (DWR UCIP - O. Magana) FIELD_STRUCT_DESC: 24-inch corrugated metal gravity drainage pipe through the levee, 14.2 feet below the crown. Flap gate on the waterside (WS) end. Brass cap No. 60 bench mark (BM) on the headwall on the landside (LS). [Additional Reference(s): DWR Levee Log, 2002. USACE San Joaquin O&M Manual 601.1, 1967, (HLM 13.48)]. FS Date: 4/25/2014

View of waterward side.

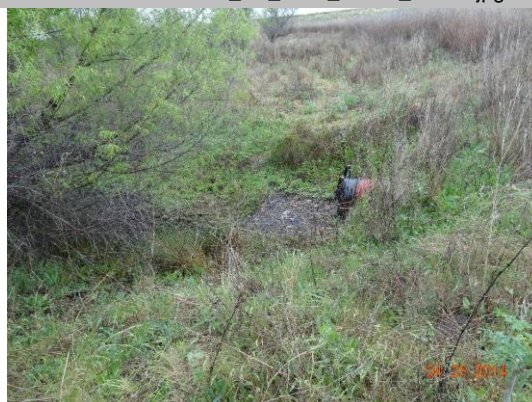
Photo 2 of 3 : UCIP_FA_2019_36109_65387.jpg

View of flap gate and pipe through levee on waterward side.

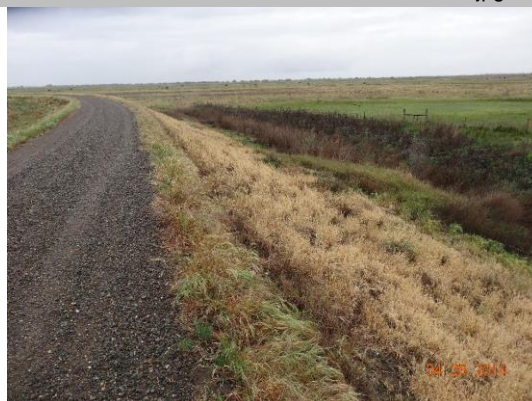
Photo 3 of 3 : UCIP_FA_2019_36109_65388.jpg

Item	DRAFT DWR UCIP LMA Responsibility			37.251590 °	37.251590 °	
				-120.814354 °	-120.814354 °	
DWR ID	19638					
Comment Code						
Inspector Comment						
DS_ID:19638 FS_ID:36109 EP_NO: N/A Repair Type: Non-Urgent Crossing Status: Found UCIP Comments: 04/25/2014 Dense vegetation limits the inspector's visibility to identify signs of pipe failure (leaks) along the landward slope. Concrete headwall blocked by debris located on landward toe. Recommend clearing debris from landward slope and toe. (DWR UCIP - O. Magana) FIELD_STRUCT_DESC: 24-inch corrugated metal gravity drainage pipe through the levee, 14.2 feet below the crown. Flap gate on the waterside (WS) end. Brass cap No. 60 bench mark (BM) on the headwall on the landside (LS). [Additional Reference(s): DWR Levee Log, 2002. USACE San Joaquin O&M Manual 601.1, 1967, (HLM 13.48)]. FS Date: 4/25/2014

View of landward side.

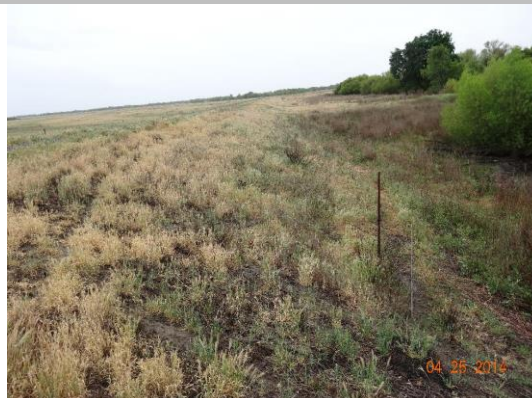
Photo 1 of 3 : UCIP_FA_2019_39256_65418.jpg

Comment Code						
Inspector Comment						
DS_ID:19639 FS_ID:39256 EP_NO: N/A Repair Type: Non-Urgent Crossing Status: Found UCIP Comments: 04/25/2014 No access to waterward toe due to fence. Unable to find the concrete headwall and flap gate on waterward side past fence. Also dense vegetation limits the inspector's visibility to identify signs of pipe failure (leaks) along the waterward slope. Recommend removing vegetation along pipe alignment to conduct proper inspection of structure. Also need access past fence on waterward side. (DWR UCIP - O. Magana) FIELD_STRUCT_DESC: 24-inch corrugated metal gravity drainage pipe through the levee, 14.5 feet below the crown. Flap gate on the waterside (WS) end. Brass cap No. 60 bench mark (BM) on the headwall on the landside (LS). [Additional Reference(s): DWR Levee Log, 2002. USACE San Joaquin O&M Manual 601.1, 1967, (HLM 13.58)]. FS Date: 4/25/2014

View of waterward side.

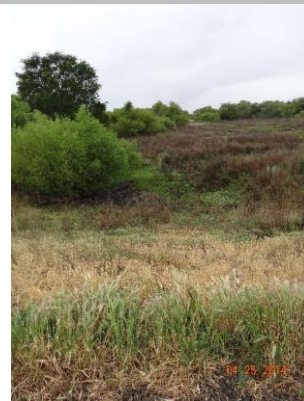
Photo 2 of 3 : UCIP_FA_2019_39256_65417.jpg

Dense vegetation on waterward side.

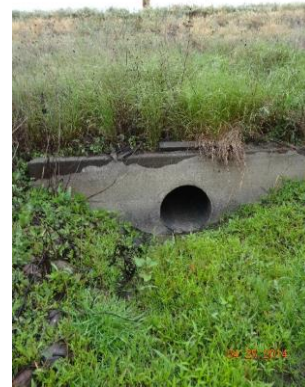
Photo 3 of 3 : UCIP_FA_2019_39256_65416.jpg

Item	DRAFT DWR UCIP LMA Responsibility			37.250138 °	37.250138 °	
				-120.814720 °	-120.814720 °	
DWR ID	19639					
Comment Code						
Inspector Comment						
DS_ID:19639 FS_ID:39256 EP_NO: N/A Repair Type: Non-Urgent Crossing Status: Found UCIP Comments: 04/25/2014 No access to waterward toe due to fence. Unable to find the concrete headwall and flap gate on waterward side past fence. Also dense vegetation limits the inspector's visibility to identify signs of pipe failure (leaks) along the waterward slope. Recommend removing vegetation along pipe alignment to conduct proper inspection of structure. Also need access past fence on waterward side. (DWR UCIP - O. Magana) FIELD_STRUCT_DESC: 24-inch corrugated metal gravity drainage pipe through the levee, 14.5 feet below the crown. Flap gate on the waterside (WS) end. Brass cap No. 60 bench mark (BM) on the headwall on the landside (LS). [Additional Reference(s): DWR Levee Log, 2002. USACE San Joaquin O&M Manual 601.1, 1967, (HLM 13.58)]. FS Date: 4/25/2014

Concrete headwall visible from landward side.

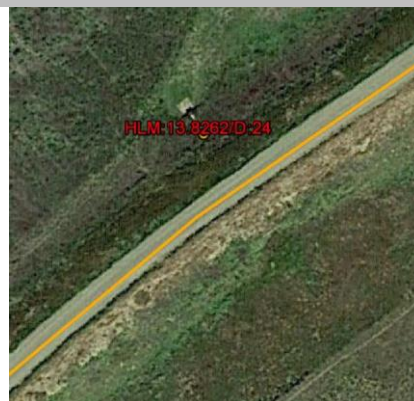
Photo 1 of 1 : UCIP_FA_2019_36544_66286.jpg

Comment Code					
Inspector Comment					
DS_ID:19640 FS_ID:36544 EP_NO: N/A Repair Type: Non-Urgent Crossing Status: Indicator Found UCIP Comments: 04/25/2014 No photos available--missed crossing. Aerial photograph indicates crossing is present. Need to confirm if crossing is still present on waterward side. (DWR UCIP - O. Magana) FIELD_STRUCT_DESC: 24-inch corrugated metal gravity drainage pipe through the levee, 11 feet below the crown. Flap gate on the waterside (WS) end. Brass cap No. 60 bench mark (BM) on the headwall on the landside (LS). [Additional Reference(s): DWR Levee Log, 2002. USACE San Joaquin O&M Manual 601.1, 1967, (HLM 13.81)]. FS Date: 4/25/2014

Indicators of crossing visible from aerial photograph.

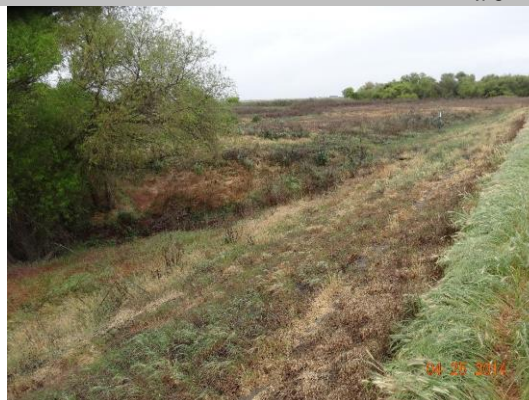
Photo 1 of 3 : UCIP_FA_2019_36166_65449.jpg

Comment Code					
Inspector Comment					
DS_ID:19641 FS_ID:36166 EP_NO: N/A Repair Type: Non-Urgent Crossing Status: Found UCIP Comments: 04/25/2014 Dense vegetation limits the inspector's visibility to identify signs of pipe failure (leaks) along the slopes. Recommend removing vegetation along pipe alignment to conduct proper inspection of structure. (DWR UCIP - O. Magana) FIELD_STRUCT_DESC: 24-inch corrugated metal gravity drainage pipe through the levee, 13 feet below the crown. Flap gate on the waterside (WS) end. Brass cap No. 60 bench mark (BM) on the headwall on the landside (LS). [Additional Reference(s): DWR Levee Log, 2002. USACE San Joaquin O&M Manual 601.1, 1967, (HLM 14.21)]. FS Date: 4/25/2014

View of waterward side.

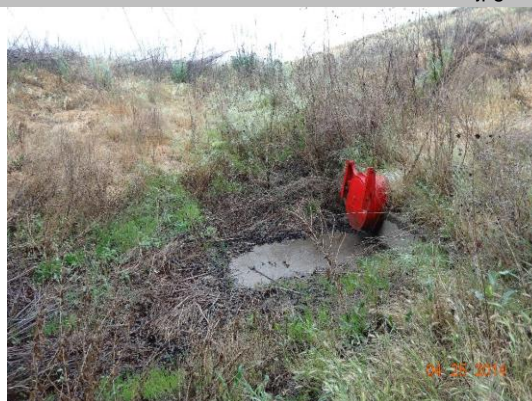
Photo 2 of 3 : UCIP_FA_2019_36166_65452.jpg

View of concrete headwall, concrete apron, and flap gate on waterward side.

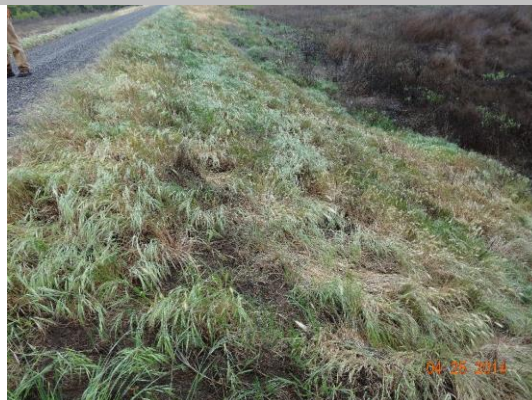
Photo 3 of 3 : UCIP_FA_2019_36166_65448.jpg

View of landward side.

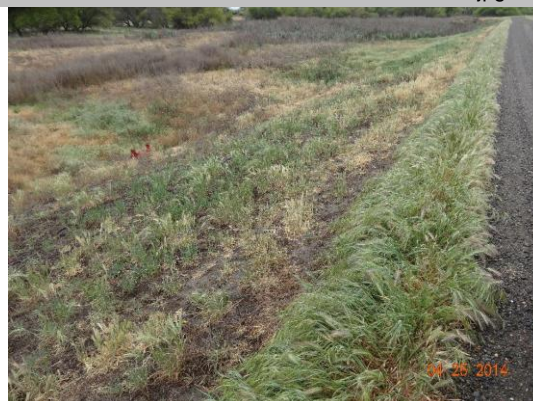
Photo 1 of 3 : UCIP_FA_2019_36167_65455.jpg

Comment Code						
Inspector Comment						
DS_ID:19642						
FS_ID:36167						
EP_NO: N/A						
Repair Type: Non-Urgent						
Crossing Status: Found						
UCIP Comments: 04/25/2014 Dense vegetation limits the inspector's visibility to identify signs of pipe failure (leaks) along the landward slope and toe. Recommend removing vegetation along pipe alignment to conduct proper inspection of structure. (DWR UCIP - O. Magana)						
FIELD_STRUCT_DESC: 24-inch corrugated metal gravity drainage pipe through the levee, 9.7 feet below the crown. Flap gate on the waterside (WS) end. Brass cap No. 60 bench mark (BM) on the headwall on the landside (LS). [Additional Reference(s): DWR Levee Log, 2002. USACE San Joaquin O&M Manual 601.1, 1967, (HLM 14.65)].						
FS Date: 4/25/2014

View of waterward side.

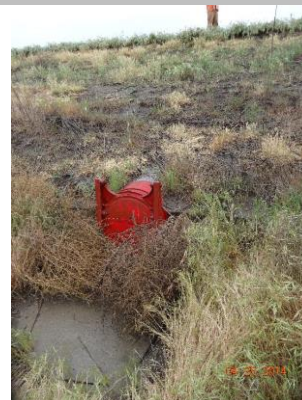
Photo 2 of 3 : UCIP_FA_2019_36167_65454.jpg

Flap gate, concrete headwall, and concrete apron located on waterward toe.

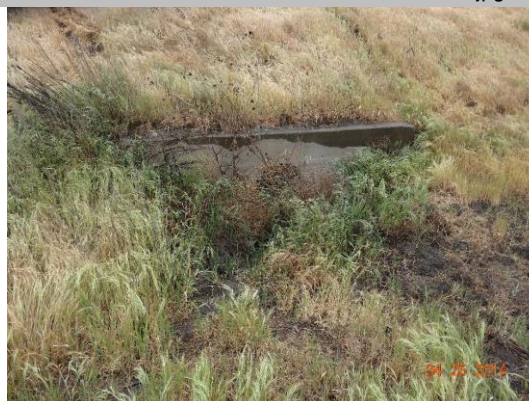
Photo 3 of 3 : UCIP_FA_2019_36167_65453.jpg

Concrete headwall located on landward toe.

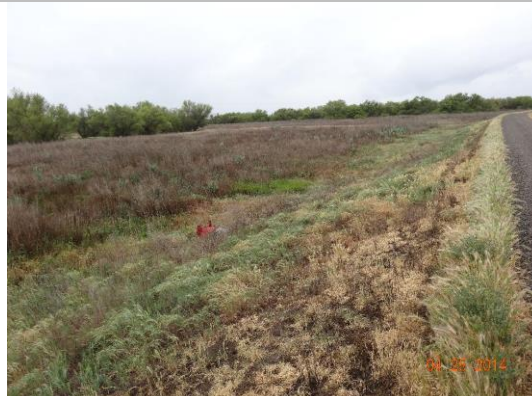
Photo 1 of 3 : UCIP_FA_2019_36168_65459.jpg

Comment Code						
Inspector Comment						
DS_ID:19643						
FS_ID:36168						
EP_NO: N/A						
Repair Type: Non-Urgent						
Crossing Status: Found						
UCIP Comments: 04/25/2014 Dense vegetation limits the inspector's visibility to identify signs of pipe failure (leaks) along the landward slope. Recommend removing vegetation along pipe alignment to conduct proper inspection of structure. (DWR UCIP - O. Magana)						
FIELD_STRUCT_DESC: 24-inch corrugated metal gravity drainage pipe through the levee, 9.2 feet below the crown. Flap gate on the waterside (WS) end. Brass cap No. 60 bench mark (BM) on the headwall on the landside (LS). [Additional Reference(s): DWR Levee Log, 2002. USACE San Joaquin O&M Manual 601.1, 1967, (HLM 15.29)].						
FS Date: 4/25/2014

View of waterward side.

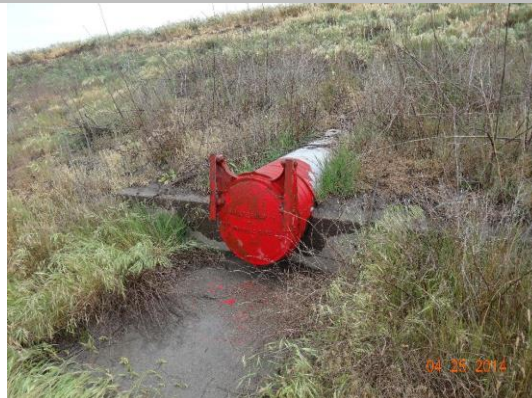
Photo 2 of 3 : UCIP_FA_2019_36168_65457.jpg

Concrete headwall, flap gate, and concrete apron located on waterward side.

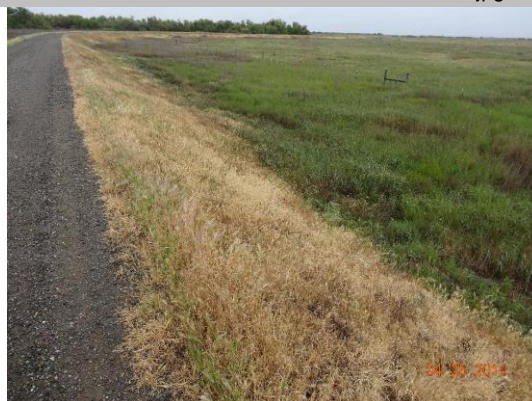
Photo 3 of 3 : UCIP_FA_2019_36168_65458.jpg

View of landward side.

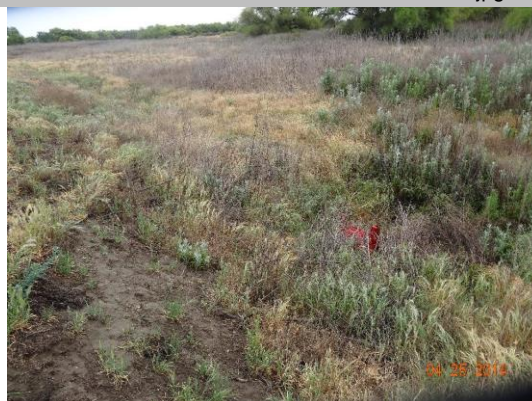
Photo 1 of 3 : UCIP_FA_2019_36169_65464.jpg

Comment Code						
Inspector Comment						
DS_ID:19644 FS_ID:36169 EP_NO: N/A Repair Type: Non-Urgent Crossing Status: Found UCIP Comments: 04/25/2014 Dense vegetation limits the inspector's visibility to identify signs of pipe failure (leaks) along the waterward and landward slopes. Recommend removing vegetation along pipe alignment to conduct proper inspection of structure. (DWR UCIP - O. Magana) FIELD_STRUCT_DESC: 24-inch corrugated metal gravity drainage pipe through the levee, 8.5 feet below the crown. Flap gate on the waterside (WS) end. Brass cap No. 60 bench mark (BM) on the headwall on the landside (LS). [Additional Reference(s): DWR Levee Log, 2002. USACE San Joaquin O&M Manual 601.1, 1967, (HLM 15.57)]. FS Date: 4/25/2014

View of waterward side--flap gate visible through dense vegetation.

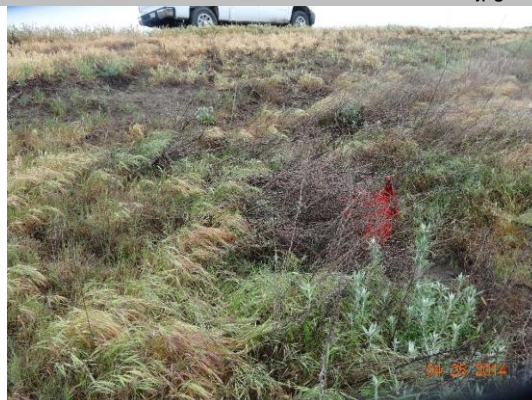
Photo 2 of 3 : UCIP_FA_2019_36169_65463.jpg

View of waterward slope covered by dense vegetation.

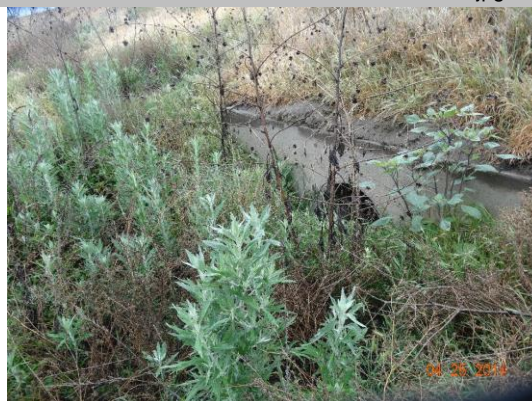
Photo 3 of 3 : UCIP_FA_2019_36169_65462.jpg

Concrete headwall visible on landward toe--dense vegetation blocking inlet.

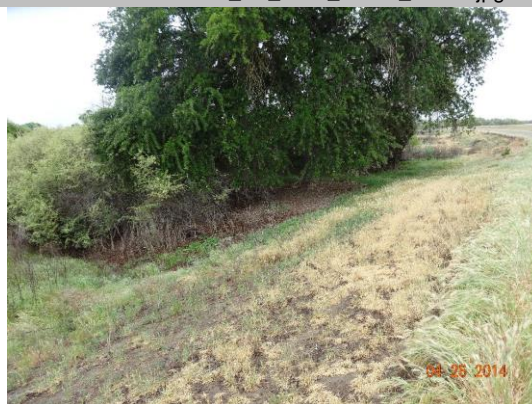
Photo 1 of 3 : UCIP_FA_2019_36171_65471.jpg

Comment Code						
Inspector Comment						
DS_ID:19645 FS_ID:36171 EP_NO: N/A Repair Type: Non-Urgent Crossing Status: Found UCIP Comments: 04/25/2014 Dense vegetation limits the inspector's visibility to identify signs of pipe failure (leaks) along the waterward and landward slope. Recommend removing vegetation along pipe alignment to conduct proper inspection of structure. (DWR UCIP - O. Magana) FIELD_STRUCT_DESC: 24-inch corrugated metal gravity drainage pipe through the levee, 11 feet below the crown. Flap gate on the waterside (WS) end. Brass cap No. 60 bench mark (BM) on the headwall on the landside (LS). [Additional Reference(s): DWR Levee Log, 2002. USACE San Joaquin O&M Manual 601.1, 1967, (HLM 15.81)]. FS Date: 4/25/2014

View of waterward side.

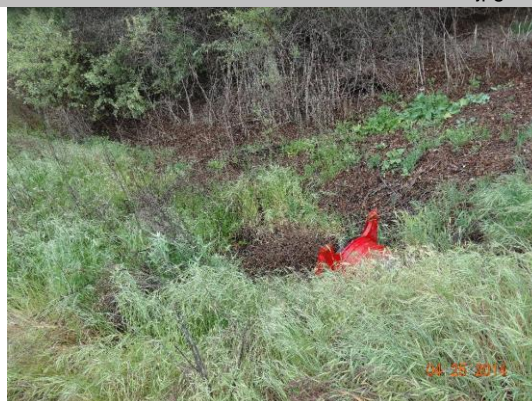
Photo 2 of 3 : UCIP_FA_2019_36171_65470.jpg

Flap gate visible on waterward side.

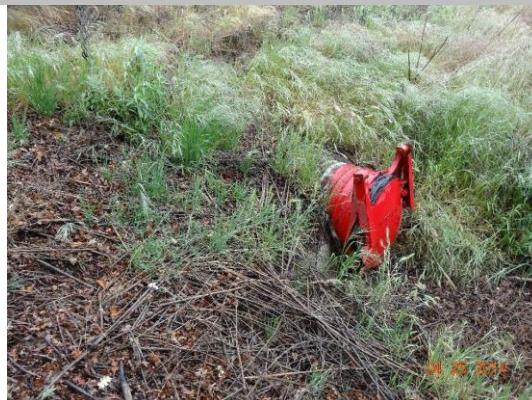
Photo 3 of 3 : UCIP_FA_2019_36171_65469.jpg

Side view of pipe and flap gate on waterward side.

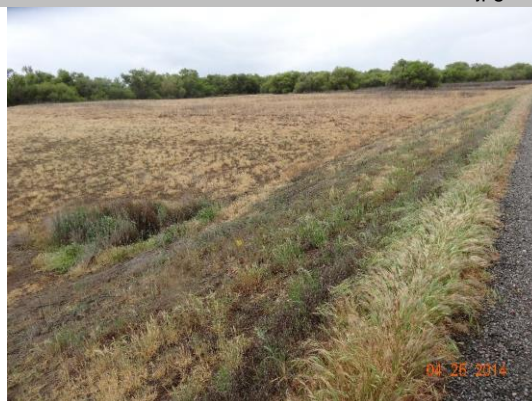
Photo 1 of 3 : UCIP_FA_2019_36172_65476.jpg

Comment Code						
Inspector Comment						
DS_ID:19646 FS_ID:36172 EP_NO: N/A Repair Type: Non-Urgent Crossing Status: Found UCIP Comments: 04/25/2014 Dense vegetation limits the inspector's visibility to identify signs of pipe failure (leaks) along the waterward and landward slopes. Recommend removing vegetation along pipe alignment to conduct proper inspection of structure and appurtenances. (DWR UCIP - O. Magana) FIELD_STRUCT_DESC: 24-inch corrugated metal gravity drainage pipe through the levee, 11.3 feet below the crown. Flap gate on the waterside (WS) end. Brass cap No. 50 bench mark (BM) on the headwall on the landside (LS). [Additional Reference(s): DWR Levee Log, 2002. USACE San Joaquin O&M Manual 601.1, 1967, (HLM 16.09)]. FS Date: 4/25/2014

View of waterward side.

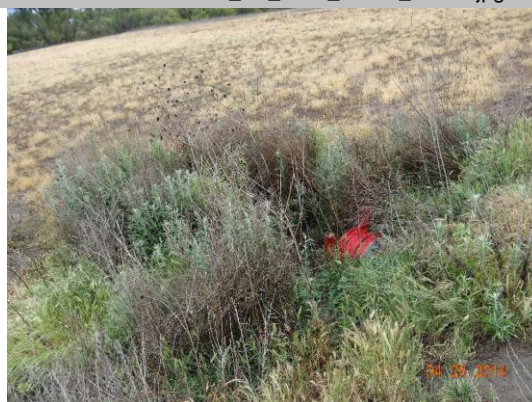
Photo 2 of 3 : UCIP_FA_2019_36172_65475.jpg

Flap gate visible on waterward toe.
