**Flood Control Project Maintenance
Levee Inspections**

Fall 2019 Levee Maintenance Deficiency Summary Report

San Joaquin River Basin

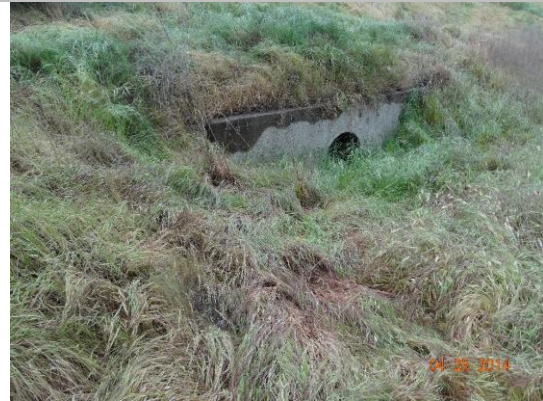
Photo 3 of 3 : UCIP_FA_2019_36172_65474.jpg

View of landward side.

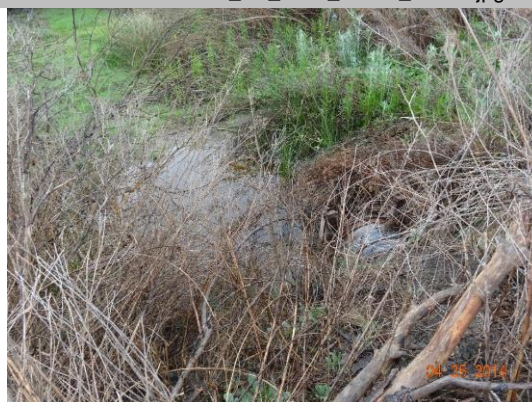
Photo 2 of 3 : UCIP_FA_2019_39257_65479.jpg

Crossing visible on waterward side under dense vegetation.

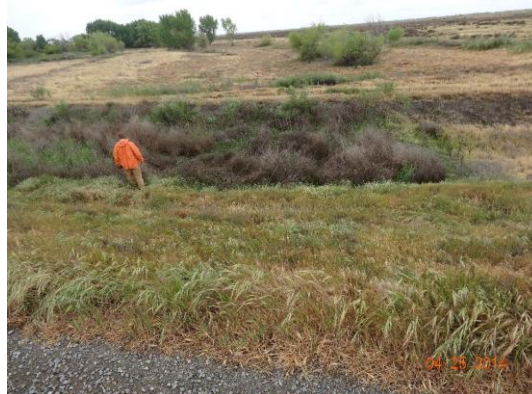
Photo 3 of 3 : UCIP_FA_2019_39257_65478.jpg

View of landward side.

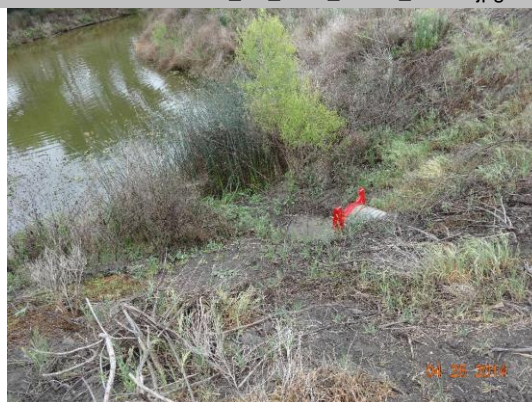
Photo 2 of 3 : UCIP_FA_2019_39258_66289.jpg

View of waterward side.

Item	DRAFT DWR UCIP LMA Responsibility			37.224223 °	37.224223 °	
				-120.783806 °	-120.783806 °	
DWR ID	19648					
Comment Code						
Inspector Comment						
DS_ID:19648 FS_ID:39258 EP_NO: N/A Repair Type: Non-Urgent Crossing Status: Found UCIP Comments: 04/25/2014 Dense vegetation limits the inspector's visibility to identify signs of pipe failure (leaks) along the waterward and landward slopes. Recommend removing vegetation along pipe alignment to conduct proper inspection of structure. Unable to find pipe on landward side. (DWR UCIP - O. Magana) FIELD_STRUCT_DESC: 24-inch corrugated metal gravity drainage pipe through the levee, 11.4 feet below the crown. Flap gate on the waterside (WS) end. Brass cap No. 50 bench mark (BM) on the headwall on the landside (LS). [Additional Reference(s): DWR Levee Log, 2002. USACE San Joaquin O&M Manual 601.1, 1967, (HLM 16.72)]. FS Date: 4/25/2014

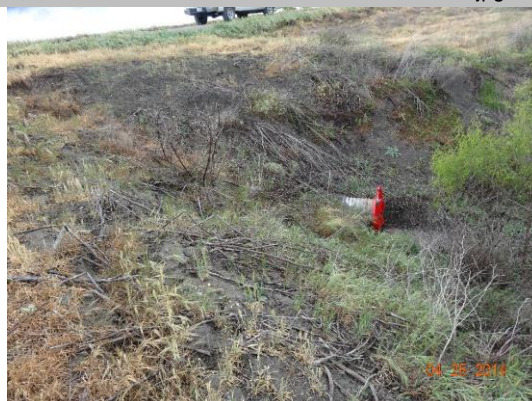
Photo 3 of 3 : UCIP_FA_2019_39258_66287.jpg

View of flap gate visible on waterward side.

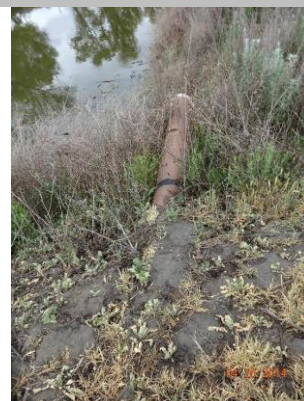
Photo 1 of 2 : UCIP_FA_2019_39360_71487.jpg

LM Start	16.72	Rating **	M	Issue No.	1248
LM End	16.72	Issue Type +	En	Location *	
Category	Supplemental			GPS Latitude/Longitude	
				Start	End
Item	DRAFT DWR UCIP Field Study			37.224223 °	37.224223 °
				-120.783806 °	-120.783806 °
DWR ID	24870				
Comment Code					
Inspector Comment					
DS_ID:24870 FS_ID:39360 EP_NO: N/A Repair Type: Non-Urgent Crossing Status: Found UCIP Comments: 04/25/2014 Need to contact owner to determine status and reason for crossing. (DWR UCIP - O. Magana) FIELD_STRUCT_DESC: 12-inch steel gravity drainage pipe through the levee, at an unknown depth. Concrete standpipe visible on the landside (LS). This pipe was field discovered. FS Date: 4/25/2014

View of pipe located on waterward side.

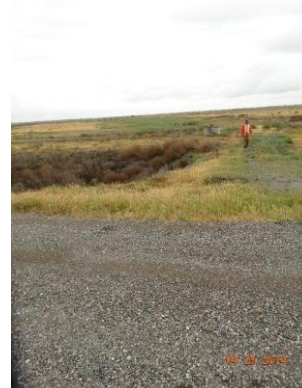
Photo 2 of 2 : UCIP_FA_2019_39360_71486.jpg

LM Start	16.72	Rating **	M	Issue No.	1248 (cont)	
LM End	16.72	Issue Type +	En	Location *		
Category	Supplemental			GPS Latitude/Longitude		
				Start	End	
Item	DRAFT DWR UCIP Field Study			37.224223 °	37.224223 °	
				-120.783806 °	-120.783806 °	
DWR ID	24870					
Comment Code						
Inspector Comment						
DS_ID:24870						
FS_ID:39360						
EP_NO: N/A						
Repair Type: Non-Urgent						
Crossing Status: Found						
UCIP Comments: 04/25/2014 Need to contact owner to determine status and reason for crossing. (DWR UCIP - O. Magana)						
FIELD_STRUCT_DESC: 12-inch steel gravity drainage pipe through the levee, at an unknown depth. Concrete standpipe visible on the landside (LS). This pipe was field discovered.						
FS Date: 4/25/2014

View of landward side.

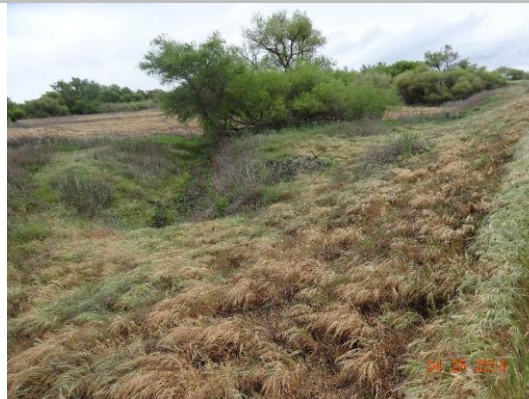
Photo 1 of 3 : UCIP_FA_2019_39259_65518.jpg

Comment Code					
Inspector Comment					
DS_ID:19577 FS_ID:39259 EP_NO: N/A Repair Type: Non-Urgent Crossing Status: Found UCIP Comments: 04/25/2014 Dense vegetation limits the inspector's visibility to identify signs of pipe failure (leaks) along the waterward and landward slopes. Concrete headwall is buried by dense vegetation. Recommend removing vegetation along pipe alignment to conduct proper inspection of structure. (DWR UCIP - O. Magana) FIELD_STRUCT_DESC: 24-inch corrugated metal gravity drainage pipe through the levee, 11.5 feet below the crown. Flap gate on the waterside (WS) end. Brass cap No. 50 bench mark (BM) on the headwall on the landside (LS). [Additional Reference(s): DWR Levee Log, 2002. USACE San Joaquin O&M Manual 601.1, 1967, (HLM 17.01)]. FS Date: 4/25/2014

View of waterward side.

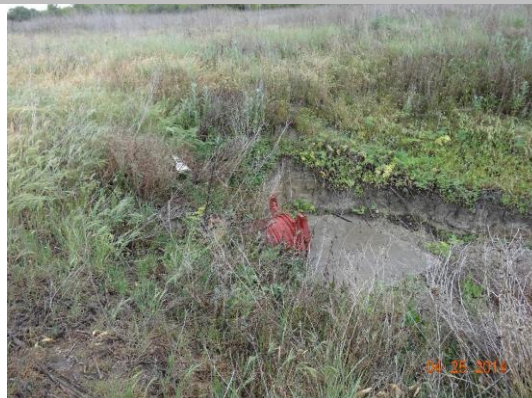
Photo 2 of 3 : UCIP_FA_2019_39259_65519.jpg

Item	DRAFT DWR UCIP LMA Responsibility			37.221838 °	37.221838 °	
				-120.780230 °	-120.780230 °	
DWR ID	19577					
Comment Code						
Inspector Comment						
DS_ID:19577 FS_ID:39259 EP_NO: N/A Repair Type: Non-Urgent Crossing Status: Found UCIP Comments: 04/25/2014 Dense vegetation limits the inspector's visibility to identify signs of pipe failure (leaks) along the waterward and landward slopes. Concrete headwall is buried by dense vegetation. Recommend removing vegetation along pipe alignment to conduct proper inspection of structure. (DWR UCIP - O. Magana) FIELD_STRUCT_DESC: 24-inch corrugated metal gravity drainage pipe through the levee, 11.5 feet below the crown. Flap gate on the waterside (WS) end. Brass cap No. 50 bench mark (BM) on the headwall on the landside (LS). [Additional Reference(s): DWR Levee Log, 2002. USACE San Joaquin O&M Manual 601.1, 1967, (HLM 17.01)]. FS Date: 4/25/2014

Flap gate visible on waterward side.

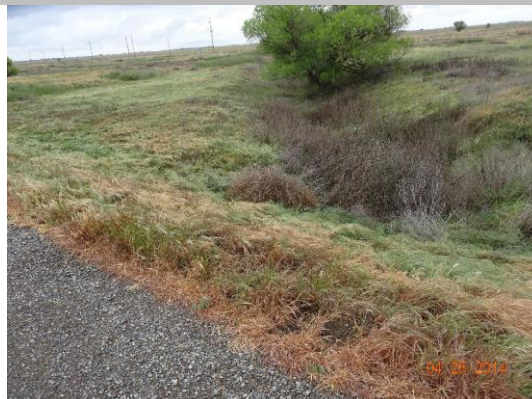
Photo 3 of 3 : UCIP_FA_2019_39259_65517.jpg

View of landward side.

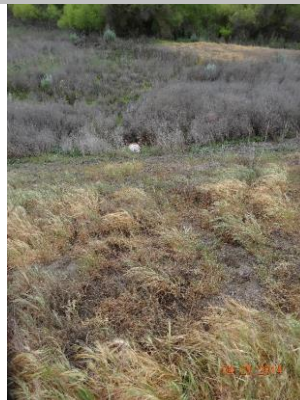
Photo 1 of 3 : UCIP_FA_2019_39260_65525.jpg

Comment Code					
Inspector Comment					
DS_ID:19578 FS_ID:39260 EP_NO: N/A Repair Type: Non-Urgent Crossing Status: Found UCIP Comments: 04/25/2014 Dense vegetation limits the inspector's visibility to identify signs of pipe failure (leaks) along the waterward and landward slopes. Recommend removing vegetation along pipe alignment to conduct proper inspection of structure. Sediment buildup inside pipe visible from landward side. Recommend clearing pipe. (DWR UCIP - O. Magana) FIELD_STRUCT_DESC: 24-inch corrugated metal gravity drainage pipe through the levee, 11.5 feet below the crown. Flap gate on the waterside (WS) end. Brass cap No. 50 bench mark (BM) on the headwall on the landside (LS). [Additional Reference(s): DWR Levee Log, 2002. USACE San Joaquin O&M Manual 601.1, 1967, (HLM 17.19)]. FS Date: 4/25/2014

View of waterward side.

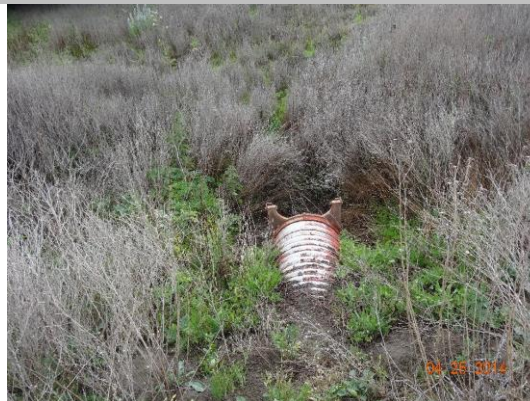
Photo 2 of 3 : UCIP_FA_2019_39260_65521.jpg

Pipe visible on waterward side.

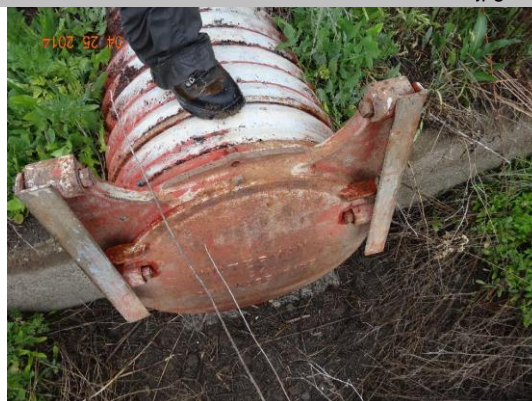
Photo 3 of 3 : UCIP_FA_2019_39260_65520.jpg

Item	DRAFT DWR UCIP LMA Responsibility			37.219302°	37.219302°	
				-120.779475°	-120.779475°	
DWR ID	19578					
Comment Code						
Inspector Comment						
DS_ID:19578 FS_ID:39260 EP_NO: N/A Repair Type: Non-Urgent Crossing Status: Found UCIP Comments: 04/25/2014 Dense vegetation limits the inspector's visibility to identify signs of pipe failure (leaks) along the waterward and landward slopes. Recommend removing vegetation along pipe alignment to conduct proper inspection of structure. Sediment buildup inside pipe visible from landward side. Recommend clearing pipe. (DWR UCIP - O. Magana) FIELD_STRUCT_DESC: 24-inch corrugated metal gravity drainage pipe through the levee, 11.5 feet below the crown. Flap gate on the waterside (WS) end. Brass cap No. 50 bench mark (BM) on the headwall on the landside (LS). [Additional Reference(s): DWR Levee Log, 2002. USACE San Joaquin O&M Manual 601.1, 1967, (HLM 17.19)]. FS Date: 4/25/2014

Flap gate visible on waterward toe.

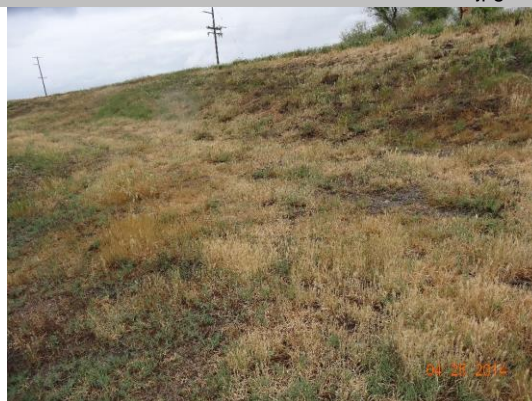
Photo 1 of 3 : UCIP_FA_2019_36203_65551.jpg

Comment Code						
Inspector Comment						
DS_ID:19579 FS_ID:36203 EP_NO: N/A Repair Type: Non-Urgent Crossing Status: Found UCIP Comments: 04/25/2014 Dense vegetation limits the inspector's visibility to identify signs of pipe failure (leaks) along the waterward and landward slope. Recommend removing vegetation along pipe alignment to conduct proper inspection of structure. (DWR UCIP - O. Magana) FIELD_STRUCT_DESC: 24-inch corrugated metal gravity drainage pipe through the levee, 15.8 feet below the crown. Flap gate on the waterside (WS) end. Brass cap No. 50 bench mark (BM) on the headwall on the landside (LS). [Additional Reference(s): DWR Levee Log, 2002. USACE San Joaquin O&M Manual 601.1, 1967, (HLM 17.26)]. FS Date: 4/25/2014

View of waterward slope.

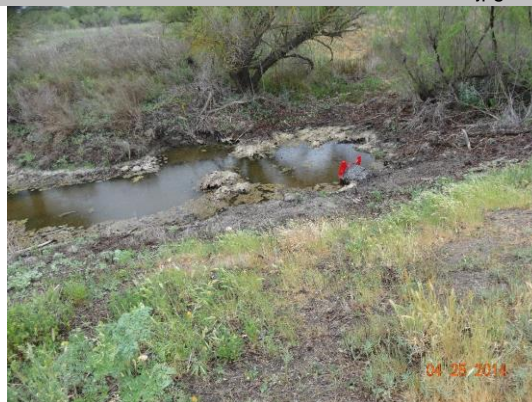
Photo 2 of 3 : UCIP_FA_2019_36203_65552.jpg

Pipe visible on waterward side.

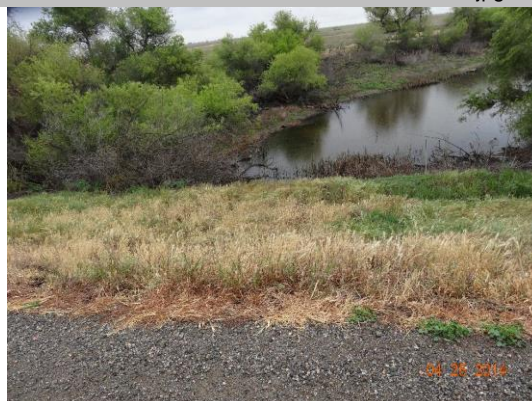
Photo 3 of 3 : UCIP_FA_2019_36203_65554.jpg

Item	DRAFT DWR UCIP LMA Responsibility			37.218332 °	37.218332 °	
				-120.779459 °	-120.779459 °	
DWR ID	19579					
Comment Code						
Inspector Comment						
DS_ID:19579						
FS_ID:36203						
EP_NO: N/A						
Repair Type: Non-Urgent						
Crossing Status: Found						
UCIP Comments: 04/25/2014 Dense vegetation limits the inspector's visibility to identify signs of pipe failure (leaks) along the waterward and landward slope. Recommend removing vegetation along pipe alignment to conduct proper inspection of structure. (DWR UCIP - O. Magana)						
FIELD_STRUCT_DESC: 24-inch corrugated metal gravity drainage pipe through the levee, 15.8 feet below the crown. Flap gate on the waterside (WS) end. Brass cap No. 50 bench mark (BM) on the headwall on the landside (LS). [Additional Reference(s): DWR Levee Log, 2002. USACE San Joaquin O&M Manual 601.1, 1967, (HLM 17.26)].						
FS Date: 4/25/2014

View of landward side.

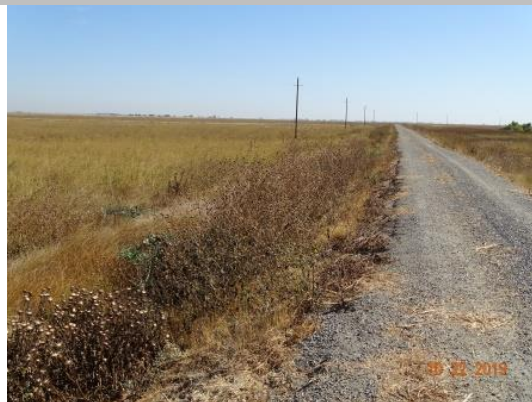
Photo 1 of 1 : FA_2019_NA0010_118_135_20191107_00287.jpg

LM Start	17.45	Rating **	U	Issue No.	135
LM End	18.82	Issue Type +	Ma	Location *	LS
Category	Earthen Levee			GPS Latitude/Longitude	
				Start	End
Item	Vegetation			37.216003 °	37.204707 °
				-120.778941 °	-120.762065 °
DWR ID	DWR_NA0010_01_f_2019_135				
Comment Code					
V1 : Control annual grass and weeds on the levee slopes and easements.					
Inspector Comment

View of vegetation on landside slope and toe looking upstream. (Fall 2019)

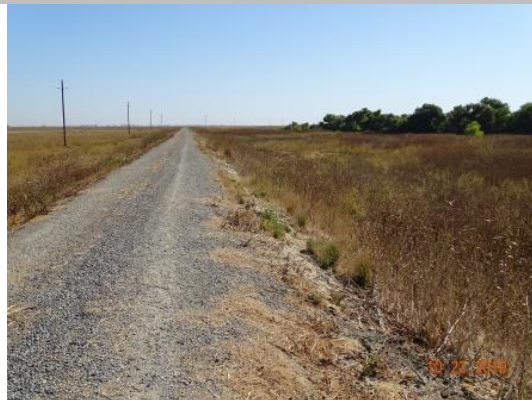
Photo 1 of 1 : FA_2019_NA0010_118_136_20191107_00288.jpg

LM Start	17.45	Rating **	U	Issue No.	136
LM End	18.82	Issue Type +	Ma	Location *	WS
Category	Earthen Levee			GPS Latitude/Longitude	
				Start	End
Item	Vegetation			37.216003 °	37.204655 °
				-120.778941 °	-120.761978 °
DWR ID	DWR_NA0010_01_f_2019_136				
Comment Code					
V1 : Control annual grass and weeds on the levee slopes and easements.					
Inspector Comment

View of vegetation on waterside slope looking upstream. (Fall 2019)

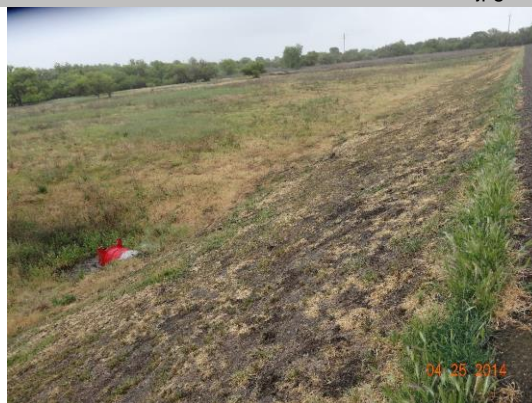
Photo 1 of 3 : UCIP_FA_2019_36204_65547.jpg

Comment Code						
Inspector Comment						
DS_ID:19580 FS_ID:36204 EP_NO: N/A Repair Type: Non-Urgent Crossing Status: Found UCIP Comments: 04/25/2014 Dense vegetation limits the inspector's visibility to identify signs of pipe failure (leaks) along the landward slope. Recommend removing vegetation along pipe alignment to conduct proper inspection of structure. (DWR UCIP - O. Magana) FIELD_STRUCT_DESC: 24-inch corrugated metal gravity drainage pipe through the levee, 9.5 feet below the crown. Flap gate on the waterside (WS) end. Brass cap No. 50 bench mark (BM) on the headwall on the landside (LS). [Additional Reference(s): DWR Levee Log, 2002. USACE San Joaquin O&M Manual 601.1, 1967, (HLM 17.53)]. FS Date: 4/25/2014

View of waterward side.

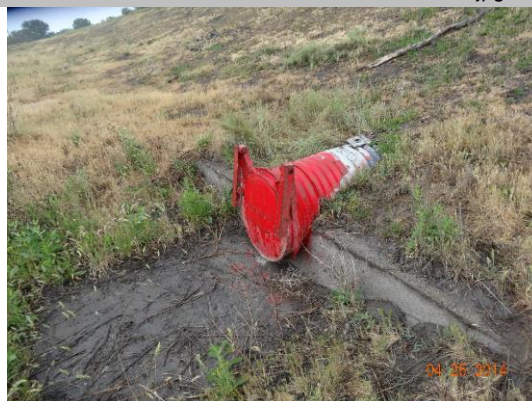
Photo 2 of 3 : UCIP_FA_2019_36204_65546.jpg

Item	DRAFT DWR UCIP LMA Responsibility			37.215976 °		37.215976 °
				-120.777615 °		-120.777615 °
DWR ID	19580					
Comment Code						
Inspector Comment						
DS_ID:19580 FS_ID:36204 EP_NO: N/A Repair Type: Non-Urgent Crossing Status: Found UCIP Comments: 04/25/2014 Dense vegetation limits the inspector's visibility to identify signs of pipe failure (leaks) along the landward slope. Recommend removing vegetation along pipe alignment to conduct proper inspection of structure. (DWR UCIP - O. Magana) FIELD_STRUCT_DESC: 24-inch corrugated metal gravity drainage pipe through the levee, 9.5 feet below the crown. Flap gate on the waterside (WS) end. Brass cap No. 50 bench mark (BM) on the headwall on the landside (LS). [Additional Reference(s): DWR Levee Log, 2002. USACE San Joaquin O&M Manual 601.1, 1967, (HLM 17.53)]. FS Date: 4/25/2014

Flap gate visible on waterward side.

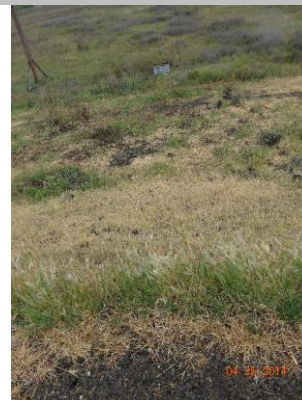
Photo 3 of 3 : UCIP_FA_2019_36204_65545.jpg

View of landward side--riser at levee toe.

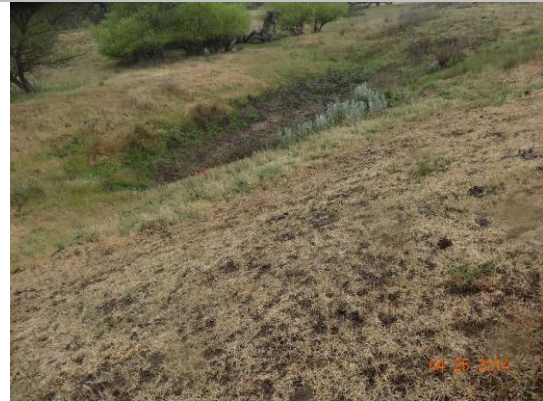
Photo 1 of 3 : UCIP_FA_2019_39261_65557.jpg

Comment Code						
Inspector Comment						
DS_ID:19581 FS_ID:39261 EP_NO: N/A Repair Type: Non-Urgent Crossing Status: Found UCIP Comments: 04/25/2014 Need to contact owner. Recommend investigating integrity of pipe wall through levee heavy corrosion visible from landward side. (DWR UCIP - O. Magana) FIELD_STRUCT_DESC: 24-inch corrugated metal gravity drainage pipe through the levee, 11.5 feet below the crown. Flap gate on the waterside (WS) end. Brass cap No. 50 bench mark (BM) on the headwall on the landside (LS). [Additional Reference(s): DWR Levee Log, 2002. USACE San Joaquin O&M Manual 601.1, 1967, (HLM 18.19)]. FS Date: 4/25/2014

View of waterward side.

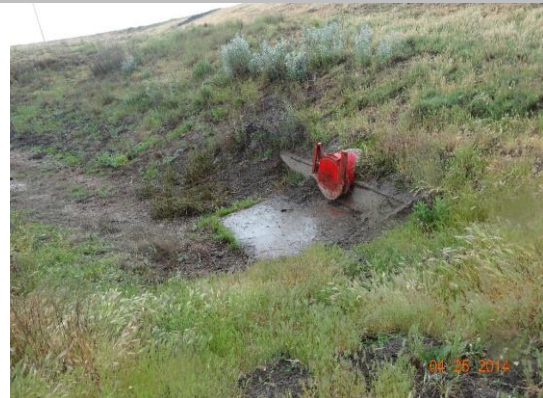
Photo 2 of 3 : UCIP_FA_2019_39261_65556.jpg

Flap gate visible on waterward side.

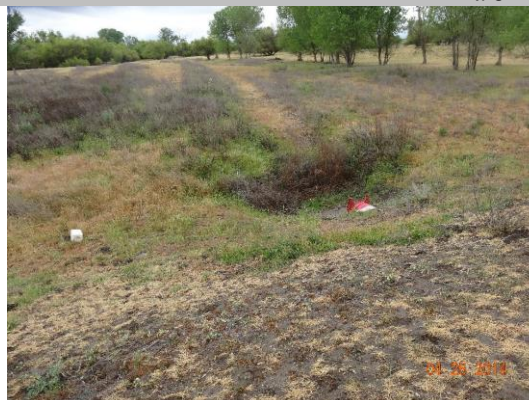
Photo 1 of 3 : UCIP_FA_2019_36206_65563.jpg

LM Start	18.45	Rating **	A/W	Issue No.	1254	
LM End	18.45	Issue Type +	Ma	Location *		
Category	Supplemental			GPS Latitude/Longitude		
				Start		End
Item	DRAFT DWR UCIP LMA Responsibility			37.207538 °		37.207538 °
				-120.767679 °		-120.767679 °
DWR ID	19582					
Comment Code						
Inspector Comment						
DS_ID:19582						
FS_ID:36206						
EP_NO: N/A						
Repair Type: No Action Needed						
Crossing Status: Found						
UCIP Comments:						
FIELD_STRUCT_DESC: 24-inch corrugated metal gravity drainage pipe through the levee, 9.4 feet below the crown. Flap gate on the waterside (WS) end. Brass cap No. 50 bench mark (BM) on the headwall on the landside (LS). [Additional Reference(s): DWR Levee Log, 2002. USACE San Joaquin O&M Manual 601.1, 1967, (HLM 18.45)].						
FS Date: 4/25/2014

View of waterward side.

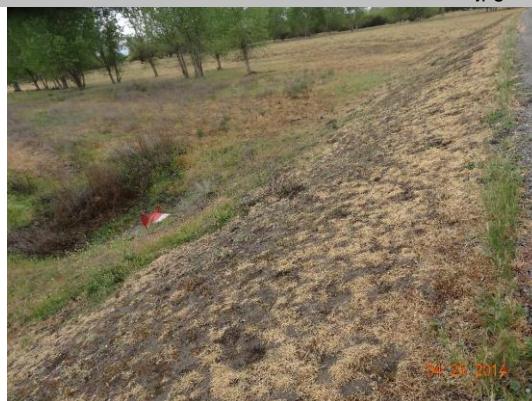
Photo 2 of 3 : UCIP_FA_2019_36206_65562.jpg

LM Start	18.45	Rating **	A/W	Issue No.	1254 (cont)	
LM End	18.45	Issue Type +	Ma	Location *		
Category	Supplemental			GPS Latitude/Longitude		
				Start	End	
Item	DRAFT DWR UCIP LMA Responsibility			37.207538 °	37.207538 °	
				-120.767679 °	-120.767679 °	
DWR ID	19582					
Comment Code						
Inspector Comment						
DS_ID:19582						
FS_ID:36206						
EP_NO: N/A						
Repair Type: No Action Needed						
Crossing Status: Found						
UCIP Comments:						
FIELD_STRUCT_DESC: 24-inch corrugated metal gravity drainage pipe through the levee, 9.4 feet below the crown. Flap gate on the waterside (WS) end. Brass cap No. 50 bench mark (BM) on the headwall on the landside (LS). [Additional Reference(s): DWR Levee Log, 2002. USACE San Joaquin O&M Manual 601.1, 1967, (HLM 18.45)].						
FS Date: 4/25/2014

View of waterward slope.

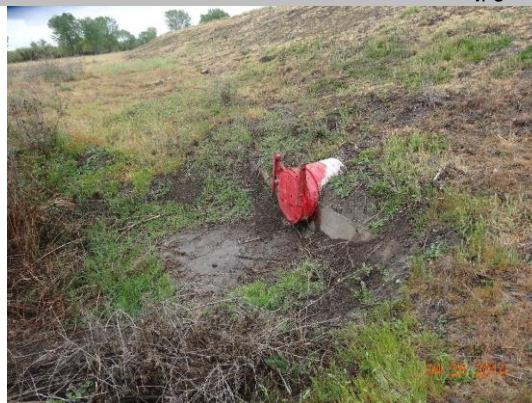
Photo 3 of 3 : UCIP_FA_2019_36206_65561.jpg

Flap gate visible on waterward side.

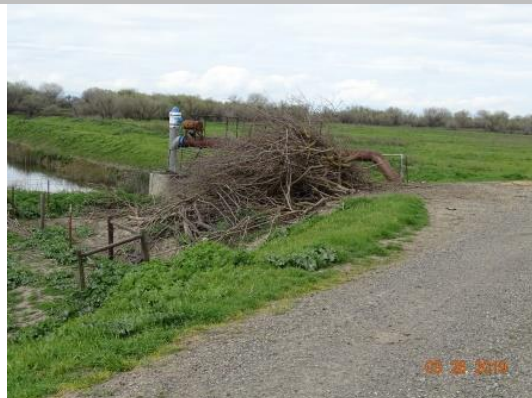
Photo 1 of 1 : FA_2019_NA0010_118_134_20190912_00035.jpg

LM Start	18.77	Rating **	U	Issue No.	134
LM End	18.77	Issue Type +	En	Location *	WS
Category	Earthen Levee			GPS Latitude/Longitude	
				Start	End
Item	Encroachments			37.205064 °	37.205064 °
				-120.762721 °	-120.762721 °
DWR ID	DWR_NA0010_01_s_2019_134				
Comment Code					
PR : Prunings					
Inspector Comment

View of prunings on waterside slope. (Spring 2019)

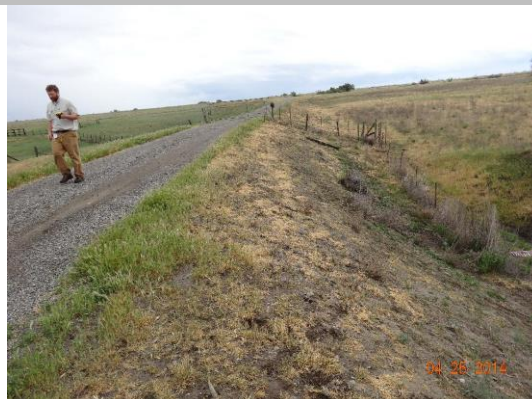
Photo 1 of 3 : UCIP_FA_2019_36246_65627.jpg

Comment Code						
Inspector Comment						
DS_ID:19593						
FS_ID:36246						
EP_NO: N/A						
Repair Type: Non-Urgent						
Crossing Status: Found						
UCIP Comments: 04/25/2014 Dense vegetation limits the inspector's visibility to identify signs of pipe failure (leaks) along the landward slope. Recommend removing vegetation along pipe alignment to conduct proper inspection of structure. (DWR UCIP - O. Magana)						
FIELD_STRUCT_DESC: 24-inch corrugated metal gravity drainage pipe through the levee, 12 feet below the crown. Flap gate on the waterside (WS) end. Brass cap No. 50 bench mark (BM) on the headwall on the landside (LS). [Additional Reference(s): DWR Levee Log, 2002. USACE San Joaquin O&M Manual 601.1, 1967, (HLM 18.79)].						
FS Date: 4/25/2014

Overview of levee crown and waterward slope.

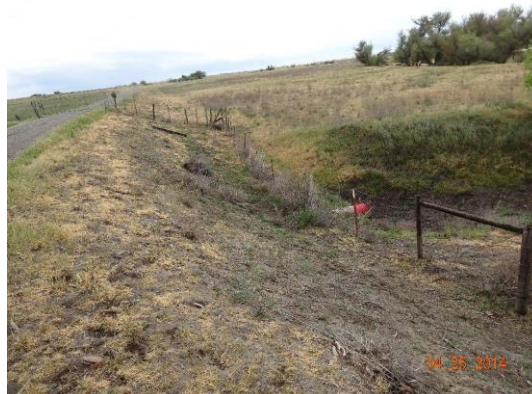
Photo 2 of 3 : UCIP_FA_2019_36246_65623.jpg

Item	DRAFT DWR UCIP LMA Responsibility			37.204966 °		37.204966 °
				-120.762511 °		-120.762511 °
DWR ID	19593					
Comment Code						
Inspector Comment						
DS_ID:19593 FS_ID:36246 EP_NO: N/A Repair Type: Non-Urgent Crossing Status: Found UCIP Comments: 04/25/2014 Dense vegetation limits the inspector's visibility to identify signs of pipe failure (leaks) along the landward slope. Recommend removing vegetation along pipe alignment to conduct proper inspection of structure. (DWR UCIP - O. Magana) FIELD_STRUCT_DESC: 24-inch corrugated metal gravity drainage pipe through the levee, 12 feet below the crown. Flap gate on the waterside (WS) end. Brass cap No. 50 bench mark (BM) on the headwall on the landside (LS). [Additional Reference(s): DWR Levee Log, 2002. USACE San Joaquin O&M Manual 601.1, 1967, (HLM 18.79)]. FS Date: 4/25/2014

View of waterward side.

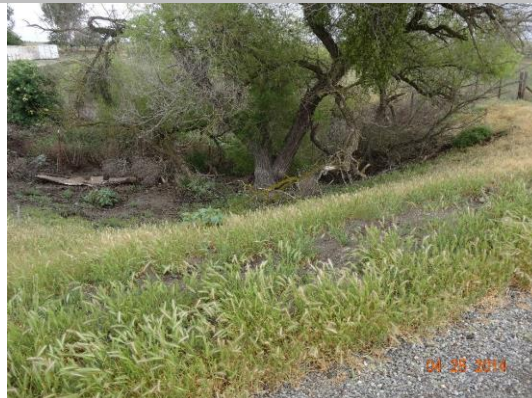
Photo 3 of 3 : UCIP_FA_2019_36246_65626.jpg

Overview of landward side.

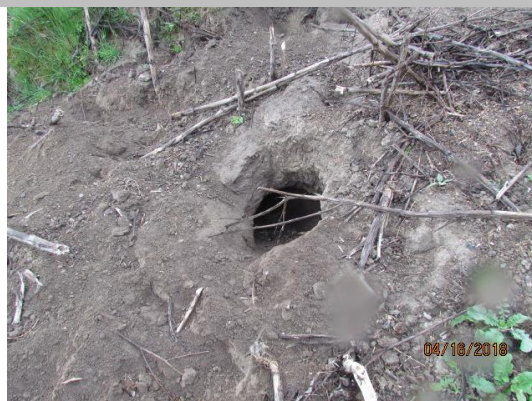
Photo 1 of 2 : FA_2019_NA0010_118_94_20190912_00016.jpg

LM Start	18.79	Rating **	U	Issue No.	94
LM End	18.79	Issue Type +	Ma	Location *	LS
Category	Earthen Levee			GPS Latitude/Longitude	
				Start	End
Item	Animal Control			37.204913 °	37.204913 °
				-120.762412 °	-120.762412 °
DWR ID	DWR_NA0010_01_s_2018_94				
Comment Code					
A3 : No rodents visible, but rodent burrows visible; need to backfill and compact or grout burrows.					
Inspector Comment					
Several large rodent holes on landward slope.

Looking at large rodent hole on landward slope. (Spring 2018)

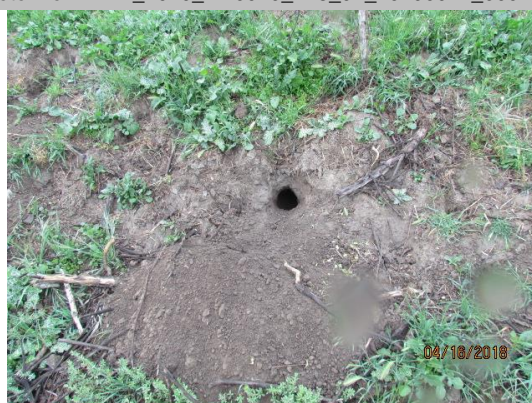
Photo 2 of 2 : FA_2019_NA0010_118_94_20190912_00017.jpg

Looking at typical view of rodent holes with this section. (Spring 2018)

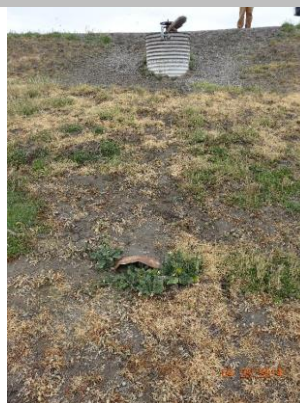
Photo 1 of 3 : UCIP_FA_2019_39263_65631.jpg

Comment Code						
Inspector Comment						
DS_ID:19594						
FS_ID:39263						
EP_NO: N/A						
Repair Type: Non-Urgent						
Crossing Status: Found						
UCIP Comments: 04/25/2014 Non-functional crossing--pipe is buried on waterward side. Sediment buildup in pipe visible from landward side. Need to coordinate with owner to determine status. If crossing is no longer in use, owner will need to coordinate with DWR Inspector and CVFPB to properly abandon. (DWR UCIP - O. Magana)						
FIELD_STRUCT_DESC: 24-inch corrugated metal gravity drainage pipe through the levee, 13 feet below the crown. Flap gate on the waterside (WS) end. Brass cap No. 40 bench mark (BM) on the headwall on the landside (LS). [Additional Reference(s): DWR Levee Log, 2002. USACE San Joaquin O&M Manual 601.1, 1967, (HLM 19.17)].						
FS Date: 4/25/2014

View of waterward slope. CMP riser and pipe visible.

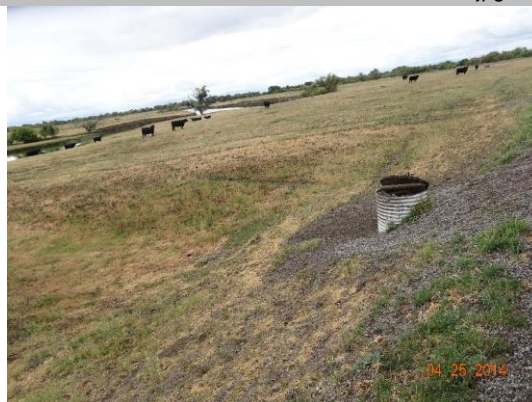
Photo 2 of 3 : UCIP_FA_2019_39263_65630.jpg

View of waterward side.

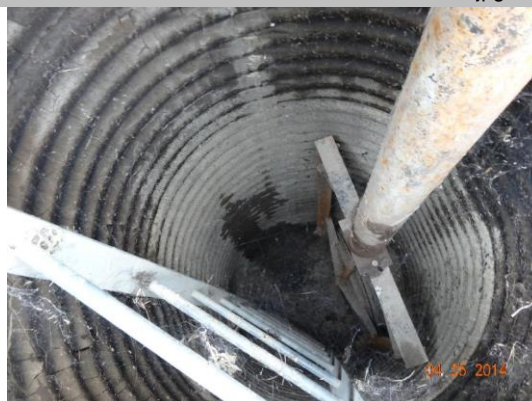
Photo 3 of 3 : UCIP_FA_2019_39263_65632.jpg

Item	DRAFT DWR UCIP LMA Responsibility			37.202801 °	37.202801 °	
				-120.756209 °	-120.756209 °	
DWR ID	19594					
Comment Code						
Inspector Comment						
DS_ID:19594						
FS_ID:39263						
EP_NO: N/A						
Repair Type: Non-Urgent						
Crossing Status: Found						
UCIP Comments: 04/25/2014 Non-functional crossing--pipe is buried on waterward side. Sediment buildup in pipe visible from landward side. Need to coordinate with owner to determine status. If crossing is no longer in use, owner will need to coordinate with DWR Inspector and CVFPB to properly abandon. (DWR UCIP - O. Magana)						
FIELD_STRUCT_DESC: 24-inch corrugated metal gravity drainage pipe through the levee, 13 feet below the crown. Flap gate on the waterside (WS) end. Brass cap No. 40 bench mark (BM) on the headwall on the landside (LS). [Additional Reference(s): DWR Levee Log, 2002. USACE San Joaquin O&M Manual 601.1, 1967, (HLM 19.17)].

Inside view of CMP riser.

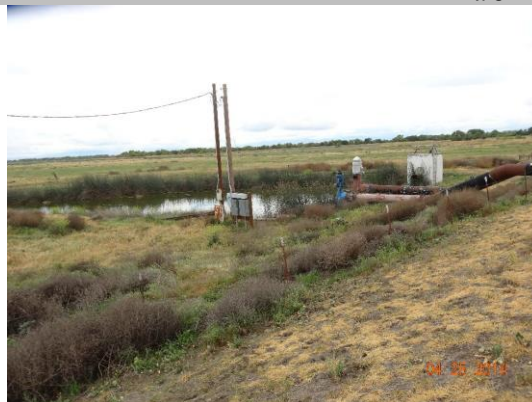
Photo 1 of 3 : UCIP_FA_2019_39266_71421.jpg

LM Start	19.32	Rating **	M	Issue No.	1257	
LM End	19.32	Issue Type +	En	Location *		
Category	Supplemental			GPS Latitude/Longitude		
				Start		End
Item	DRAFT DWR UCIP Field Study			37.200921 °		37.200921 °
				-120.756901 °		-120.756901 °
DWR ID	24871					
Comment Code						
Inspector Comment						
DS_ID:24871 FS_ID:39266 EP_NO: N/A Repair Type: Non-Urgent Crossing Status: Found UCIP Comments: 04/25/2014 New crossing found during field inspection--Need to contact owner to obtain additional information about crossing. (DWR UCIP - O. Magana) FIELD_STRUCT_DESC: 1 of 2: 20-inch steel drainage discharge pipe through the levee, at an unknown depth. Pump station and electrical panel on the landside (LS). This pipe was field discovered. FS Date: 4/25/2014

View of landward side.

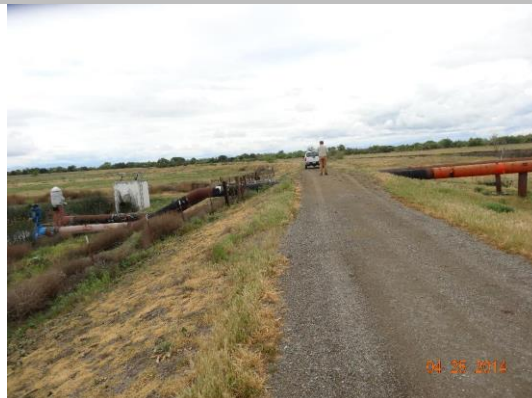
Photo 2 of 3 : UCIP_FA_2019_39266_71420.jpg

DS_ID:24871
FS_ID:39266
EP_NO: N/A
Repair Type: Non-Urgent
Crossing Status: Found
UCIP Comments: 04/25/2014 New crossing found during field inspection--Need to contact owner to obtain additional information about crossing. (DWR UCIP - O. Magana)
FIELD_STRUCT_DESC: 1 of 2: 20-inch steel drainage discharge pipe through the levee, at an unknown depth. Pump station and electrical panel on the landside (LS). This pipe was field discovered.
FS Date: 4/25/2014

Overview of levee crown at crossing.

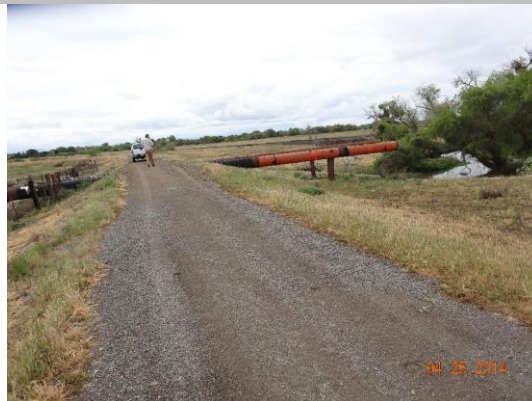
Photo 3 of 3 : UCIP_FA_2019_39266_71423.jpg

View of waterward slope.

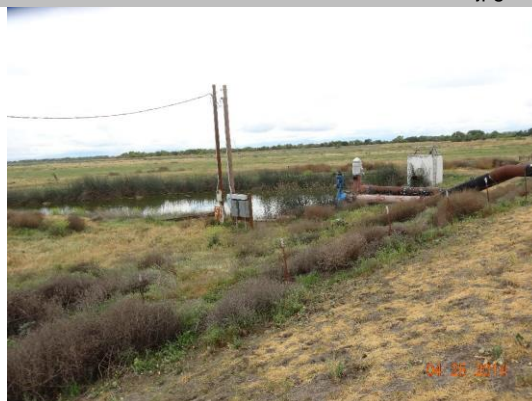
Photo 1 of 3 : UCIP_FA_2019_39267_71427.jpg

LM Start	19.32	Rating **	M	Issue No.	1258	
LM End	19.32	Issue Type +	En	Location *		
Category	Supplemental			GPS Latitude/Longitude		
				Start	End	
Item	DRAFT DWR UCIP Field Study			37.200919 °	37.200919 °	
				-120.756928 °	-120.756928 °	
DWR ID	24872					
Comment Code						
Inspector Comment						
DS_ID:24872 FS_ID:39267 EP_NO: N/A Repair Type: Non-Urgent Crossing Status: Found UCIP Comments: 04/25/2014 New crossing found during field inspection--Need to contact owner to obtain additional information about crossing. (DWR UCIP - O. Magana) FIELD_STRUCT_DESC: 2 of 2: 20-inch steel drainage discharge pipe through the levee, at an unknown depth. Pump station and electrical panel on the landside (LS). This pipe was field discovered. FS Date: 4/25/2014

View of landward side.

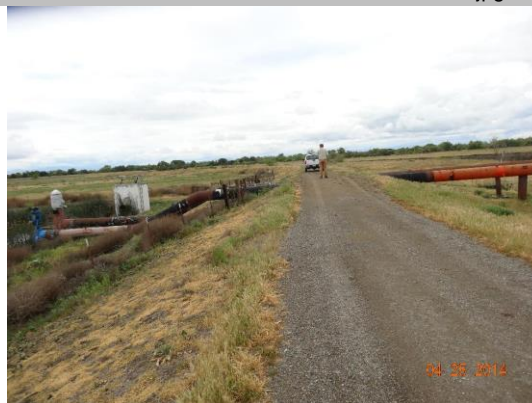
Photo 2 of 3 : UCIP_FA_2019_39267_71425.jpg

View of levee crown at crossings.

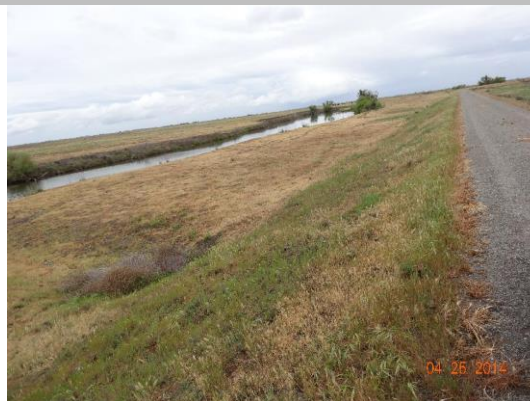
Photo 1 of 3 : UCIP_FA_2019_39268_65641.jpg

Comment Code						
Inspector Comment						
DS_ID:19596 FS_ID:39268 EP_NO: N/A Repair Type: Non-Urgent Crossing Status: Found UCIP Comments: 04/25/2014 Dense vegetation limits the inspector's visibility to identify signs of pipe failure (leaks) along the waterward slope. Recommend removing vegetation along pipe alignment to conduct proper inspection of structure. Dense vegetation blocks both waterward and landward headwalls. Sediment buildup in pipe visible from landward side. (DWR UCIP - O. Magana) FIELD_STRUCT_DESC: 24-inch corrugated metal gravity drainage pipe through the levee, 8 feet below the crown. Flap gate on the waterside (WS) end. Brass cap No. 40 bench mark (BM) on the headwall on the landside (LS). [Additional Reference(s): DWR Levee Log, 2002. USACE San Joaquin O&M Manual 601.1, 1967, (HLM 19.54)]. FS Date: 4/25/2014

View of waterward side.

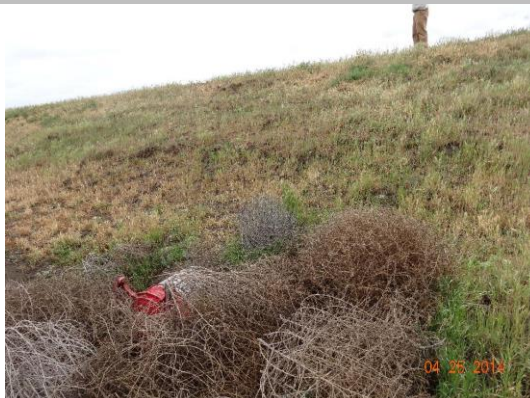
Photo 2 of 3 : UCIP_FA_2019_39268_65640.jpg

Item	DRAFT DWR UCIP LMA Responsibility			37.199427°	37.199427°	
				-120.760235°	-120.760235°	
DWR ID	19596					
Comment Code						
Inspector Comment						
DS_ID:19596 FS_ID:39268 EP_NO: N/A Repair Type: Non-Urgent Crossing Status: Found UCIP Comments: 04/25/2014 Dense vegetation limits the inspector's visibility to identify signs of pipe failure (leaks) along the waterward slope. Recommend removing vegetation along pipe alignment to conduct proper inspection of structure. Dense vegetation blocks both waterward and landward headwalls. Sediment buildup in pipe visible from landward side. (DWR UCIP - O. Magana) FIELD_STRUCT_DESC: 24-inch corrugated metal gravity drainage pipe through the levee, 8 feet below the crown. Flap gate on the waterside (WS) end. Brass cap No. 40 bench mark (BM) on the headwall on the landside (LS). [Additional Reference(s): DWR Levee Log, 2002. USACE San Joaquin O&M Manual 601.1, 1967, (HLM 19.54)]. FS Date: 4/25/2014

Flap gate visible on waterward side--potential erosion present on slope.

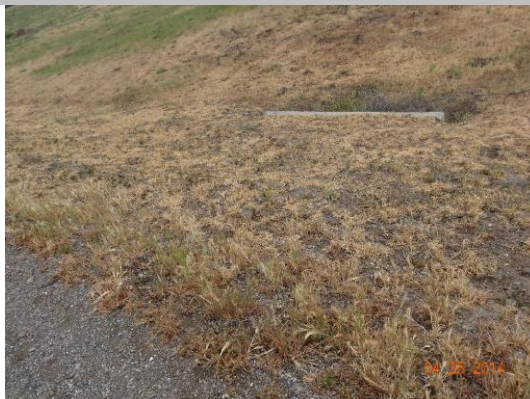
Photo 3 of 3 : UCIP_FA_2019_39268_65639.jpg

View of landward slope.

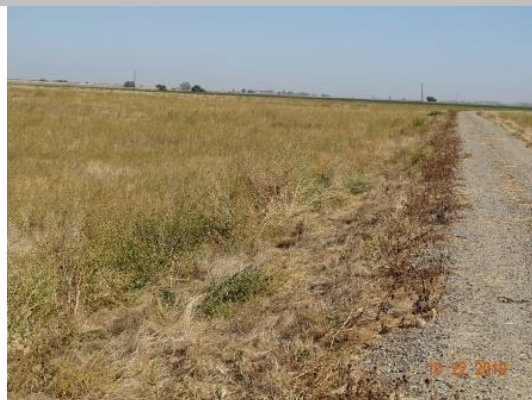
Photo 1 of 1 : FA_2019_NA0010_118_139_20191107_00289.jpg

LM Start	19.94	Rating **	U	Issue No.	139
LM End	20.26	Issue Type +	Ma	Location *	LS
Category	Earthen Levee			GPS Latitude/Longitude	
				Start	End
Item	Vegetation			37.196247 °	37.193640 °
				-120.762397 °	-120.760166 °
DWR ID	DWR_NA0010_01_f_2019_139				
Comment Code					
V1 : Control annual grass and weeds on the levee slopes and easements.					
Inspector Comment

Looking upstream along the landside slope. (Fall 2019)

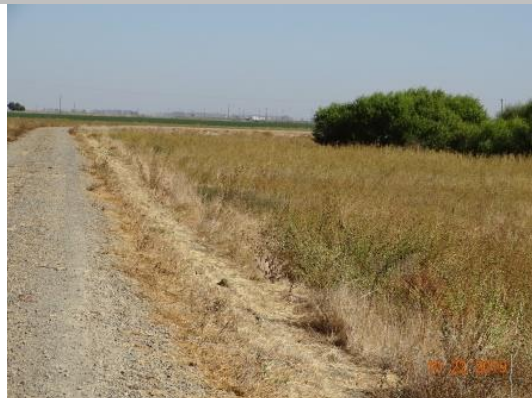
Photo 1 of 1 : FA_2019_NA0010_118_140_20191107_00290.jpg

LM Start	19.94	Rating **	U	Issue No.	140
LM End	20.43	Issue Type +	Ma	Location *	WS
Category	Earthen Levee			GPS Latitude/Longitude	
				Start	End
Item	Vegetation			37.196247 °	37.191516 °
				-120.762397 °	-120.761681 °
DWR ID	DWR_NA0010_01_f_2019_140				
Comment Code					
V1 : Control annual grass and weeds on the levee slopes and easements.					
Inspector Comment

View of the waterside slope looking upstream. (Fall 2019)

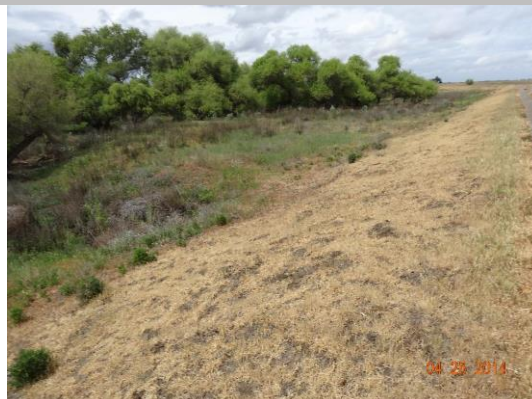
Photo 1 of 3 : UCIP_FA_2019_39269_65648.jpg

Comment Code					
Inspector Comment					
DS_ID:19598					
FS_ID:39269					
EP_NO: N/A					
Repair Type: Non-Urgent					
Crossing Status: Found					
UCIP Comments: 04/25/2014 Recommend removing vegetation and sediment buildup from both waterward and landward concrete headwalls. (DWR UCIP - O. Magana)					
FIELD_STRUCT_DESC: 24-inch corrugated metal gravity drainage pipe through the levee, 8.5 feet below the crown. Flap gate on the waterside (WS) end. Brass cap No. 40 bench mark (BM) on the headwall on the landside (LS). [Additional Reference(s): DWR Levee Log, 2002. USACE San Joaquin O&M Manual 601.1, 1967, (HLM 20.18)].					
FS Date: 4/25/2014

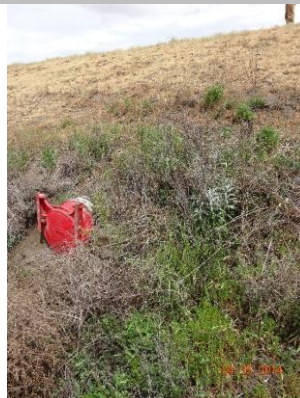
Photo 2 of 3 : UCIP_FA_2019_39269_65647.jpg

Item	DRAFT DWR UCIP LMA Responsibility			37.194669 °	37.194669 °	
				-120.759736 °	-120.759736 °	
DWR ID	19598					
Comment Code						
Inspector Comment						
DS_ID:19598						
FS_ID:39269						
EP_NO: N/A						
Repair Type: Non-Urgent						
Crossing Status: Found						
UCIP Comments: 04/25/2014 Recommend removing vegetation and sediment buildup from both waterward and landward concrete headwalls. (DWR UCIP - O. Magana)						
FIELD_STRUCT_DESC: 24-inch corrugated metal gravity drainage pipe through the levee, 8.5 feet below the crown. Flap gate on the waterside (WS) end. Brass cap No. 40 bench mark (BM) on the headwall on the landside (LS). [Additional Reference(s): DWR Levee Log, 2002. USACE San Joaquin O&M Manual 601.1, 1967, (HLM 20.18)].						
FS Date: 4/25/2014

Flap gate visible on WS toe.

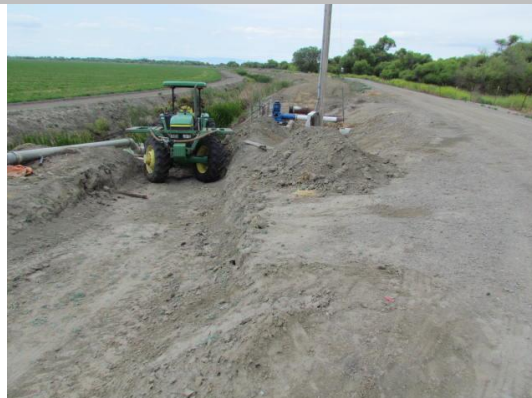
Photo 1 of 2 : FA_2019_NA0010_118_1184_20190912_00036.jpg

LM Start	20.25	Rating **	U	Issue No.	1184
LM End	20.25	Issue Type +	En	Location *	LS
Category	Earthen Levee			GPS Latitude/Longitude	
				Start	End
Item	Encroachments			37.193657°	37.193657°
				-120.760138°	-120.760138°
DWR ID	DWR_NA0010_01_s_2015_1184				
Comment Code					
RA : Ramp					
Inspector Comment					
Landowner installed unauthorized ramp on landside slope and toe.

Looking north at ramp cut into landward slope.

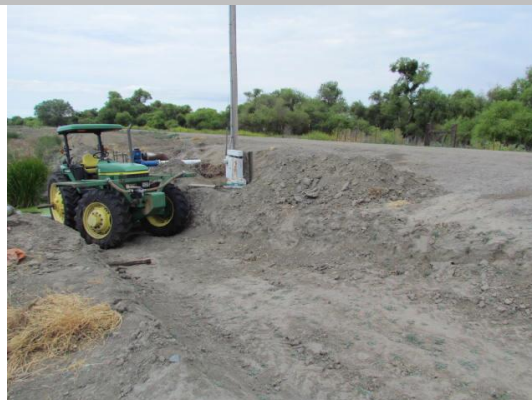
Photo 2 of 2 : FA_2019_NA0010_118_1184_20190912_00037.jpg

LM Start	20.25	Rating **	U	Issue No.	1184 (cont)
LM End	20.25	Issue Type +	En	Location *	LS

Looking east at ramp cut into landward slope.

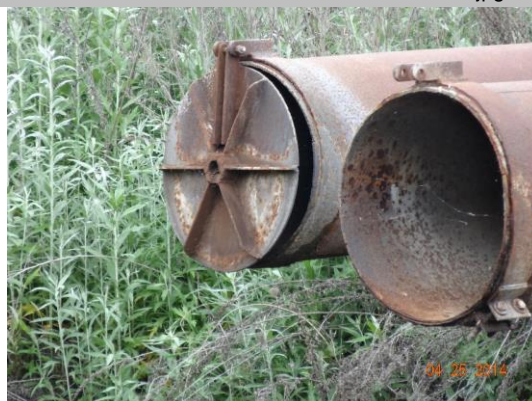
Photo 1 of 3 : UCIP_FA_2019_39285_71446.jpg

LM Start	20.26	Rating **	M	Issue No.	1262	
LM End	20.26	Issue Type +	En	Location *		
Category	Supplemental			GPS Latitude/Longitude		
				Start	End	
Item	DRAFT DWR UCIP Field Study			37.193550 °	37.193550 °	
				-120.760284 °	-120.760284 °	
DWR ID	24873					
Comment Code						
Inspector Comment						
DS_ID:24873 FS_ID:39285 EP_NO: N/A Repair Type: Non-Urgent Crossing Status: Found UCIP Comments: 04/25/2014 Dense vegetation limits the inspector's visibility to identify signs of pipe failure (leaks) along the waterward slope. Recommend removing vegetation along pipe alignment to conduct proper inspection of structure. (DWR UCIP - O. Magana) FIELD_STRUCT_DESC: 12-inch steel drainage discharge pipe sleeved through a 24-inch steel pipe through levee, at an unknown depth. FS Date: 4/25/2014

Outlet visible on waterward side.

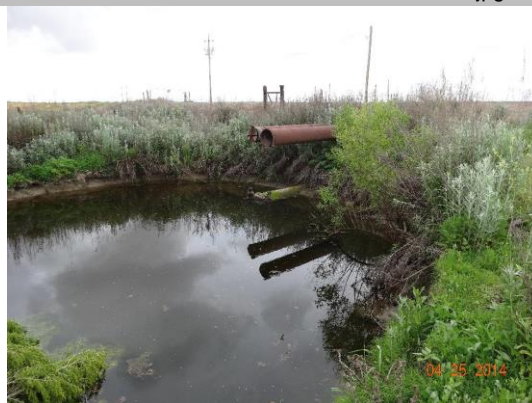
Photo 2 of 3 : UCIP_FA_2019_39285_71445.jpg

View of waterward side.

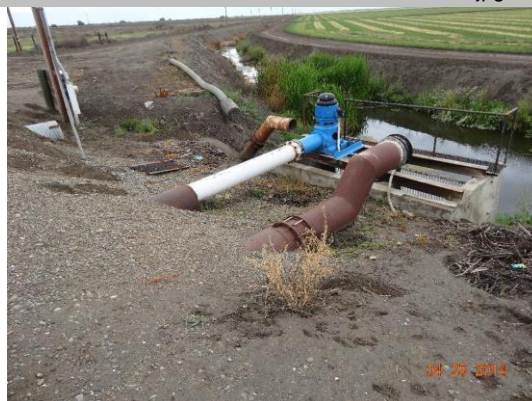
Photo 3 of 3 : UCIP_FA_2019_39285_71444.jpg

LM Start	20.26	Rating **	M	Issue No.	1262 (cont)	
LM End	20.26	Issue Type +	En	Location *		
Category	Supplemental			GPS Latitude/Longitude		
				Start	End	
Item	DRAFT DWR UCIP Field Study			37.193550 °	37.193550 °	
				-120.760284 °	-120.760284 °	
DWR ID	24873					
Comment Code						
Inspector Comment						
DS_ID:24873 FS_ID:39285 EP_NO: N/A Repair Type: Non-Urgent Crossing Status: Found UCIP Comments: 04/25/2014 Dense vegetation limits the inspector's visibility to identify signs of pipe failure (leaks) along the waterward slope. Recommend removing vegetation along pipe alignment to conduct proper inspection of structure. (DWR UCIP - O. Magana) FIELD_STRUCT_DESC: 12-inch steel drainage discharge pipe sleeved through a 24-inch steel pipe through levee, at an unknown depth. FS Date: 4/25/2014

View of landward side.

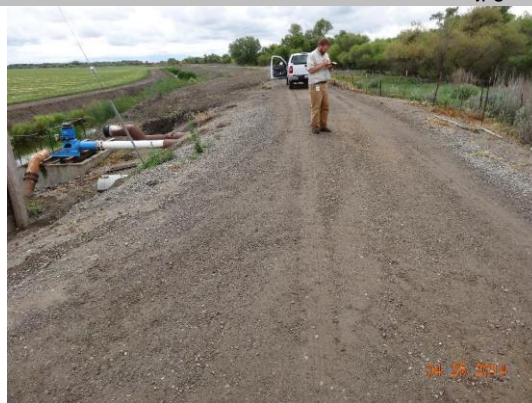
Photo 1 of 3 : UCIP_FA_2019_49965_66303.jpg

Comment Code						
Inspector Comment						
DS_ID:19599 FS_ID:49965 EP_NO: N/A Repair Type: Non-Urgent Crossing Status: Found UCIP Comments: 7/19/2016 same as previous inspection. crossing was downgraded from Urgent to Non-Urgent due to metal rod not interfering with flap gate. (DWR UCIP - omagana)4/25/2014 Unauthorized crossing through pipe. Line was pushed through existing crossing. Need to contact owner. Also sediment buildup in pipe visible from landward side--recommend clearing. (DWR UCIP - O. Magana) FIELD_STRUCT_DESC: 24-inch corrugated metal gravity drainage pipe through the levee, 5 feet below the crown. Flap gate on the waterside (WS) end. No permit for this crossing. [Additional Reference(s): DWR Levee Log, 2002]. FS Date: 7/19/2016

Overview of levee crown at crossing.

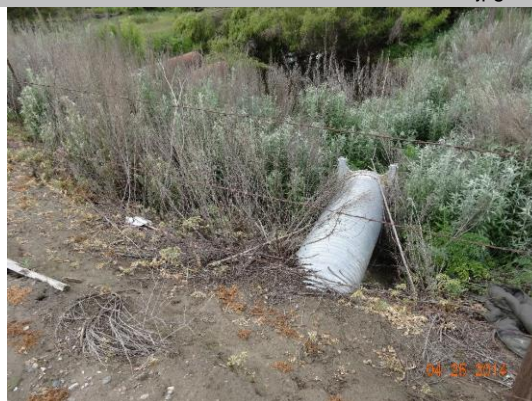
Photo 2 of 3 : UCIP_FA_2019_49965_66304.jpg

Item	DRAFT DWR UCIP Field Study			37.193542°	37.193542°	
				-120.760300°	-120.760300°	
DWR ID	19599					
Comment Code						
Inspector Comment						
DS_ID:19599						
FS_ID:49965						
EP_NO: N/A						
Repair Type: Non-Urgent						
Crossing Status: Found						
UCIP Comments: 7/19/2016 same as previous inspection. crossing was downgraded from Urgent to Non-Urgent due to metal rod not interfering with flap gate. (DWR UCIP - omagana)4/25/2014						
Unauthorized crossing through pipe. Line was pushed through existing crossing. Need to contact owner. Also sediment buildup in pipe visible from landward side--recommend clearing. (DWR UCIP - O. Magana)						
FIELD_STRUCT_DESC: 24-inch corrugated metal gravity drainage pipe through the levee, 5 feet below the crown. Flap gate on the waterside (WS) end. No permit for this crossing. [Additional Reference(s): DWR Levee Log, 2002].						
FS Date: 7/19/2016

View of WS.

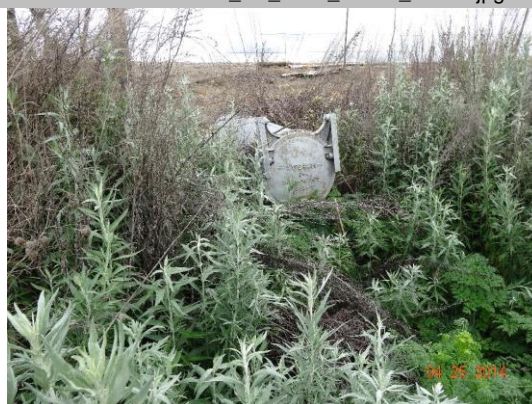
Photo 3 of 3 : UCIP_FA_2019_49965_66302.jpg

View of WS.

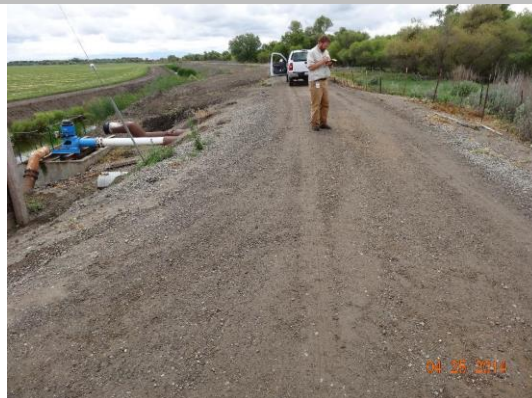
Photo 1 of 3 : UCIP_FA_2019_39878_66308.jpg

Comment Code						
Inspector Comment						
DS_ID:19600 FS_ID:39878 EP_NO: N/A Repair Type: Non-Urgent Crossing Status: Found UCIP Comments: 04/25/2014 Crossing partially submersed--no signs of failure of pipe present along pipe alignment. Recommend contacting owner to determine status of crossing and condition. (DWR UCIP - O. Magana) FIELD_STRUCT_DESC: 36-inch corrugated metal gravity drainage pipe through the levee, 10.5 feet below the crown. Flap gate on the waterside (WS) end. Brass cap No. 40 bench mark (BM) on the headwall on the landside (LS). [Additional Reference(s): DWR Levee Log, 2002. USACE San Joaquin O&M Manual 601.1, 1967, (HLM 20.27)]. FS Date: 4/25/2014

Overview of levee crown at crossing--multiple crossings at this location.

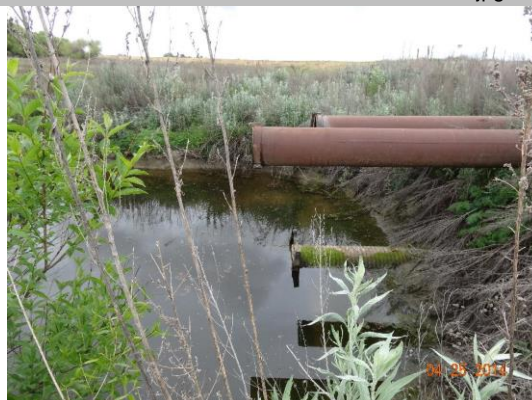
Photo 2 of 3 : UCIP_FA_2019_39878_66309.jpg

Multiple crossings visible on waterward side--36 inch CMP is submersed in water.

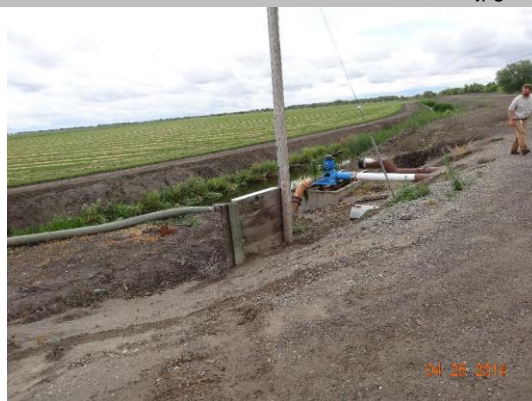
Photo 3 of 3 : UCIP_FA_2019_39878_66307.jpg

Item	DRAFT DWR UCIP LMA Responsibility			37.193542 °	37.193542 °	
				-120.760300 °	-120.760300 °	
DWR ID	19600					
Comment Code						
Inspector Comment						
DS_ID:19600 FS_ID:39878 EP_NO: N/A Repair Type: Non-Urgent Crossing Status: Found UCIP Comments: 04/25/2014 Crossing partially submersed--no signs of failure of pipe present along pipe alignment. Recommend contacting owner to determine status of crossing and condition. (DWR UCIP - O. Magana) FIELD_STRUCT_DESC: 36-inch corrugated metal gravity drainage pipe through the levee, 10.5 feet below the crown. Flap gate on the waterside (WS) end. Brass cap No. 40 bench mark (BM) on the headwall on the landside (LS). [Additional Reference(s): DWR Levee Log, 2002. USACE San Joaquin O&M Manual 601.1, 1967, (HLM 20.27)]. FS Date: 4/25/2014

View of landward side.

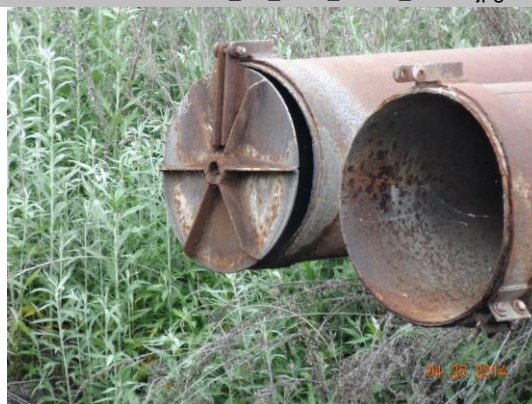
Photo 1 of 3 : UCIP_FA_2019_39286_71442.jpg

LM Start	20.27	Rating **	M	Issue No.	1265
LM End	20.27	Issue Type +	En	Location *	
Category	Supplemental			GPS Latitude/Longitude	
				Start	End
Item	DRAFT DWR UCIP Field Study			37.193542 °	37.193542 °
				-120.760300 °	-120.760300 °
DWR ID	24874				
Comment Code					
Inspector Comment					
DS_ID:24874 FS_ID:39286 EP_NO: N/A Repair Type: Non-Urgent Crossing Status: Found UCIP Comments: 04/25/2014 Dense vegetation limits the inspector's visibility to identify signs of pipe failure (leaks) along the waterward slope. Recommend removing vegetation along pipe alignment to conduct proper inspection of structure. (DWR UCIP - O. Magana) FIELD_STRUCT_DESC: 18-inch steel drainage discharge pipe sleeved through a 24-inch steel pipe through levee, at an unknown depth. FS Date: 4/25/2014

Outlets visible on waterward side.

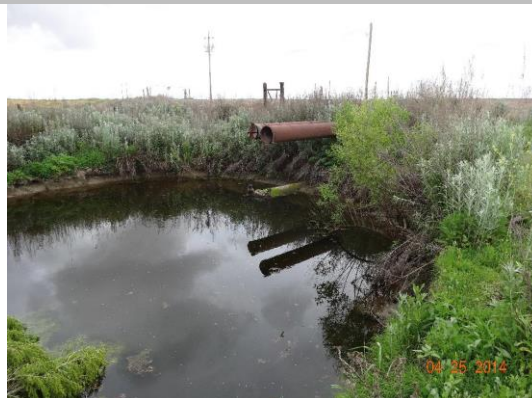
Photo 2 of 3 : UCIP_FA_2019_39286_71441.jpg

DS_ID:24874
 FS_ID:39286
 EP_NO: N/A
 Repair Type: Non-Urgent
 Crossing Status: Found
 UCIP Comments: 04/25/2014 Dense vegetation limits the inspector's visibility to identify signs of pipe failure (leaks) along the waterward slope. Recommend removing vegetation along pipe alignment to conduct proper inspection of structure. (DWR UCIP - O. Magana)
 FIELD_STRUCT_DESC: 18-inch steel drainage discharge pipe sleeved through a 24-inch steel pipe through levee, at an unknown depth.
 FS Date: 4/25/2014

View of waterward side.

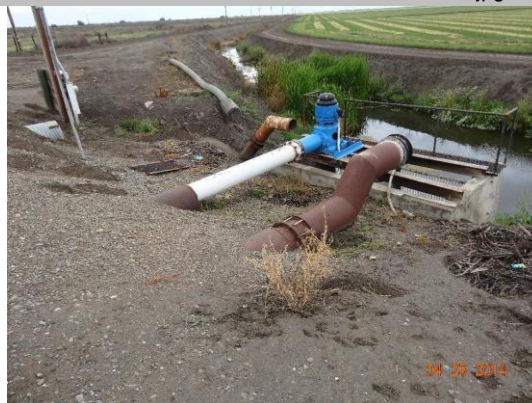
Photo 3 of 3 : UCIP_FA_2019_39286_71440.jpg

View of landward side.

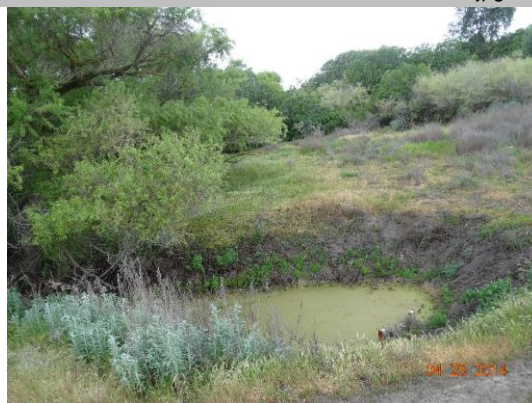
Photo 1 of 3 : UCIP_FA_2019_39271_66312.jpg

Comment Code						
Inspector Comment						
DS_ID:19603						
FS_ID:39271						
EP_NO: N/A						
Repair Type: Non-Urgent						
Crossing Status: Found						
UCIP Comments: 04/25/2014 Crossing is non-functional--crossing buried on landward side. Need to contact owner to determine status of crossing. If crossing is no longer used need to coordinate with CVFPB for proper abandonment. (DWR UCIP - O. Magana)						
FIELD_STRUCT_DESC: 36-inch corrugated metal gravity drainage pipe through the levee, 11.5 feet below the crown. Flap gate on the waterside (WS) end. Brass cap No. 40 bench mark (BM) on the headwall on the landside (LS). [Additional Reference(s): DWR Levee Log, 2002. USACE San Joaquin O&M Manual 601.1, 1967, (HLM 21.40)].						
FS Date: 4/25/2014

View of waterward side.
