**Flood Control Project Maintenance
Levee Inspections**

Fall 2019 Levee Maintenance Deficiency Summary Report

San Joaquin River Basin

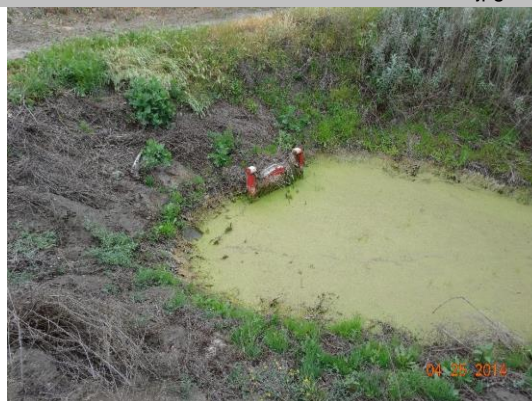
Photo 2 of 3 : UCIP_FA_2019_39271_66313.jpg

Item	DRAFT DWR UCIP LMA Responsibility			37.179065 °	37.179065 °	
				-120.761567 °	-120.761567 °	
DWR ID	19603					
Comment Code						
Inspector Comment						
DS_ID:19603						
FS_ID:39271						
EP_NO: N/A						
Repair Type: Non-Urgent						
Crossing Status: Found						
UCIP Comments: 04/25/2014 Crossing is non-functional--crossing buried on landward side. Need to contact owner to determine status of crossing. If crossing is no longer used need to coordinate with CVFPB for proper abandonment. (DWR UCIP - O. Magana)						
FIELD_STRUCT_DESC: 36-inch corrugated metal gravity drainage pipe through the levee, 11.5 feet below the crown. Flap gate on the waterside (WS) end. Brass cap No. 40 bench mark (BM) on the headwall on the landside (LS). [Additional Reference(s): DWR Levee Log, 2002. USACE San Joaquin O&M Manual 601.1, 1967, (HLM 21.40)].						
FS Date: 4/25/2014

Flap gate half way submersed located on waterward side.

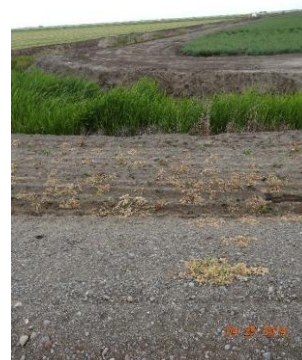
Photo 3 of 3 : UCIP_FA_2019_39271_66311.jpg

View of landward side.

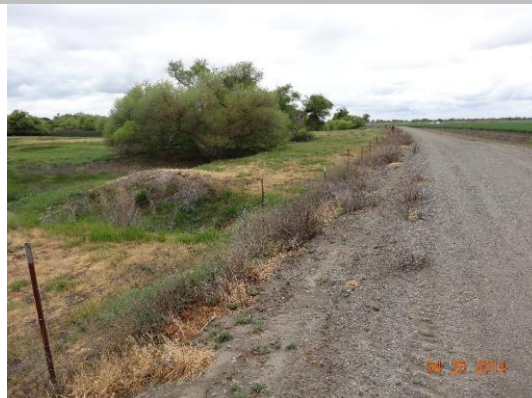
Photo 1 of 3 : UCIP_FA_2019_39272_65697.jpg

Comment Code						
Inspector Comment						
DS_ID:19604						
FS_ID:39272						
EP_NO: N/A						
Repair Type: Non-Urgent						
Crossing Status: Found						
UCIP Comments: 04/25/2014 Non-functional crossing-landward side is buried. Need to contact owner to determine status of crossing. If crossing is no longer used need to coordinate with CVFPB for proper abandonment. (DWR UCIP - O. Magana)						
FIELD_STRUCT_DESC: 24-inch corrugated metal gravity drainage pipe through the levee, 9 feet below the crown. Flap gate on the waterside (WS) end. Brass cap No. 40 bench mark (BM) on the headwall on the landside (LS). [Additional Reference(s): DWR Levee Log, 2002. USACE San Joaquin O&M Manual 601.1, 1967, (HLM 21.76)].						
FS Date: 4/25/2014

View of waterward side.

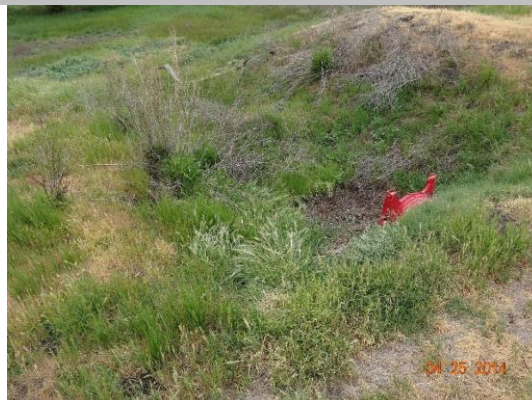
Photo 2 of 3 : UCIP_FA_2019_39272_65695.jpg

Flap gate visible on waterward side.

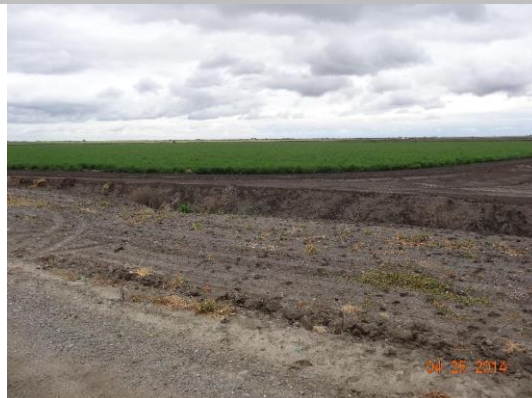
Photo 3 of 3 : UCIP_FA_2019_39272_65696.jpg

Item	DRAFT DWR UCIP LMA Responsibility			37.176106 °		37.176106 °
				-120.756768 °		-120.756768 °
DWR ID	19604					
Comment Code						
Inspector Comment						
DS_ID:19604						
FS_ID:39272						
EP_NO: N/A						
Repair Type: Non-Urgent						
Crossing Status: Found						
UCIP Comments: 04/25/2014 Non-functional crossing-landward side is buried. Need to contact owner to determine status of crossing. If crossing is no longer used need to coordinate with CVFPB for proper abandonment. (DWR UCIP - O. Magana)						
FIELD_STRUCT_DESC: 24-inch corrugated metal gravity drainage pipe through the levee, 9 feet below the crown. Flap gate on the waterside (WS) end. Brass cap No. 40 bench mark (BM) on the headwall on the landside (LS). [Additional Reference(s): DWR Levee Log, 2002. USACE San Joaquin O&M Manual 601.1, 1967, (HLM 21.76)].						
FS Date: 4/25/2014

View of landward side.

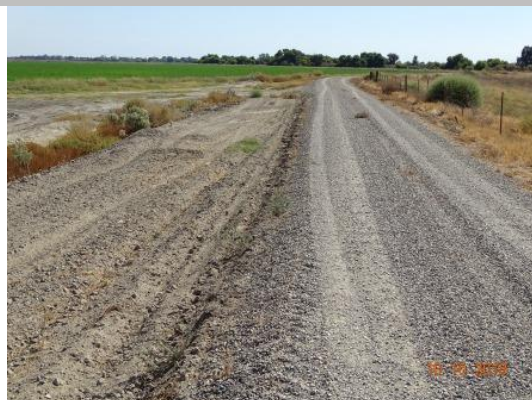
Photo 1 of 2 : FA_2019_NA0010_118_130_20190912_00033.jpg

LM Start	21.99	Rating **	M	Issue No.	130
LM End	22.01	Issue Type +	En	Location *	LS
Category	Earthen Levee			GPS Latitude/Longitude	
				Start	End
Item	Encroachments			37.173001°	37.172668°
				-120.755115°	-120.754933°
DWR ID	DWR_NA0010_01_f_2018_130				
Comment Code					
AT : Agricultural tilling					
Inspector Comment					
Tilling along landside toe partially cut into the slope.

View of tilling looking upstream. (Fall 2018)

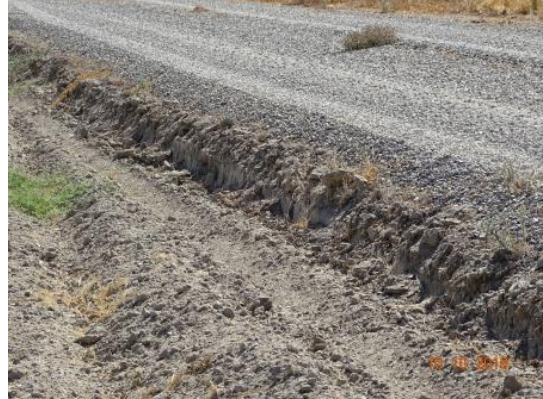
Photo 2 of 2 : FA_2019_NA0010_118_130_20190912_00034.jpg

LM Start	21.99	Rating **	M	Issue No.	130 (cont)
LM End	22.01	Issue Type +	En	Location *	LS
Category	Earthen Levee			GPS Latitude/Longitude	
				Start	End
Item	Encroachments			37.173001°	37.172668°
				-120.755115°	-120.754933°
DWR ID	DWR_NA0010_01_f_2018_130				
Comment Code					
AT : Agricultural tilling					
Inspector Comment					
Tilling along landside toe partially cut into the slope.

View of tilling from toe looking towards the levee. (Fall 2018)

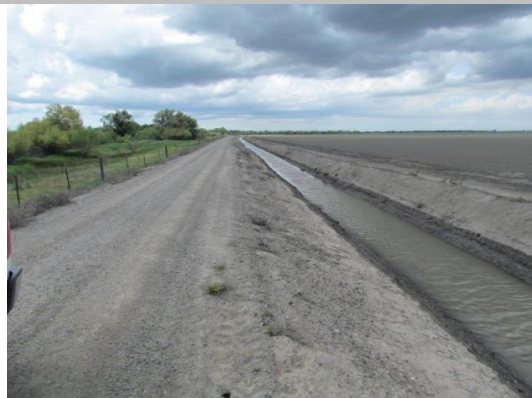
Photo 2 of 3 : FA_2019_NA0010_118_22_20190912_00012.jpg

LM Start	22.06	Rating **	U	Issue No.	22 (cont)	
LM End	22.52	Issue Type +	En	Location *	LS	
Category	Earthen Levee			GPS Latitude/Longitude		
				Start		End
Item	Encroachments			37.172074 °	37.166906 °	
				-120.754628 °	-120.749962 °	
DWR ID	DWR_NA0010_01_s_2012_22					
Comment Code						
DT : Ditch						
Inspector Comment						
Ditch has encroached into landside toe and slope.

Looking downstream at irrigation ditch at landside toe.

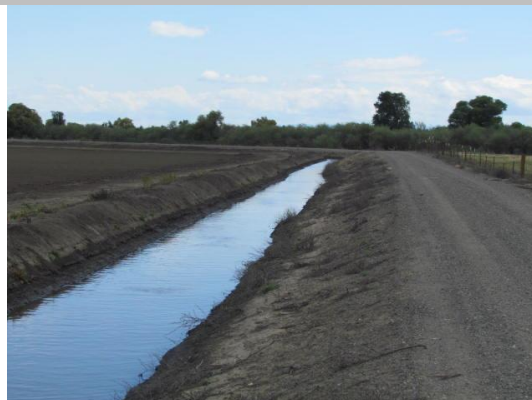
Photo 3 of 3 : FA_2019_NA0010_118_22_20190912_00013.jpg

LM Start	22.06	Rating **	U	Issue No.	22 (cont)
LM End	22.52	Issue Type +	En	Location *	LS

Looking upstream at irrigation at landside toe.

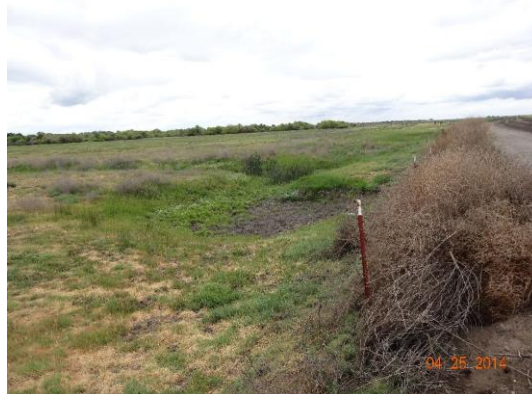
Photo 1 of 3 : UCIP_FA_2019_39273_65709.jpg

Comment Code					
Inspector Comment					
DS_ID:19605 FS_ID:39273 EP_NO: N/A Repair Type: Non-Urgent Crossing Status: Found UCIP Comments: 04/25/2014 Non-functional crossing--landward side is buried. Need to contact owner to determine status. If crossing is no longer used need to coordinate with CVFPB for proper abandonment. (DWR UCIP - O. Magana) FIELD_STRUCT_DESC: 24-inch corrugated metal gravity drainage pipe through the levee, 9 feet below the crown. Flap gate on the waterside (WS) end. Wooden headboards on the landside (LS) end. Brass cap No. 31 bench mark (BM) on the headwall on the LS. [Additional Reference(s): DWR Levee Log, 2002. USACE San Joaquin O&M Manual 601.1, 1967, (HLM 22.13)]. FS Date: 4/25/2014

View of waterward side.

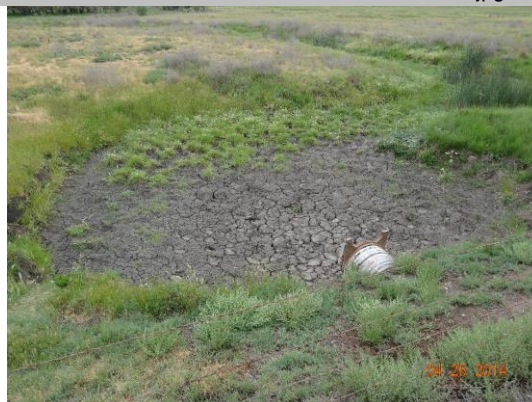
Photo 2 of 3 : UCIP_FA_2019_39273_65707.jpg

Flap gate visible on waterward side.

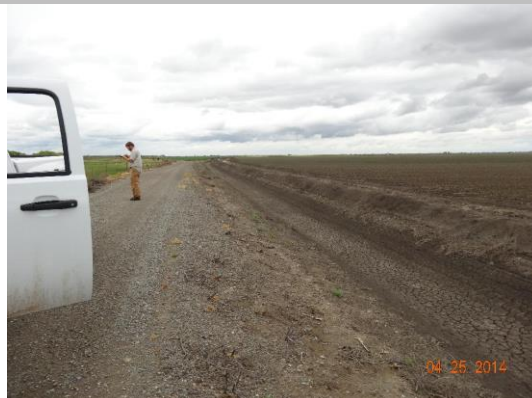
Photo 3 of 3 : UCIP_FA_2019_39273_65708.jpg

Item	DRAFT DWR UCIP LMA Responsibility			37.171181 °	37.171181 °	
				-120.754526 °	-120.754526 °	
DWR ID	19605					
Comment Code						
Inspector Comment						
DS_ID:19605 FS_ID:39273 EP_NO: N/A Repair Type: Non-Urgent Crossing Status: Found UCIP Comments: 04/25/2014 Non-functional crossing--landward side is buried. Need to contact owner to determine status. If crossing is no longer used need to coordinate with CVFPB for proper abandonment. (DWR UCIP - O. Magana) FIELD_STRUCT_DESC: 24-inch corrugated metal gravity drainage pipe through the levee, 9 feet below the crown. Flap gate on the waterside (WS) end. Wooden headboards on the landside (LS) end. Brass cap No. 31 bench mark (BM) on the headwall on the LS. [Additional Reference(s): DWR Levee Log, 2002. USACE San Joaquin O&M Manual 601.1, 1967, (HLM 22.13)]. FS Date: 4/25/2014

View of landward side.

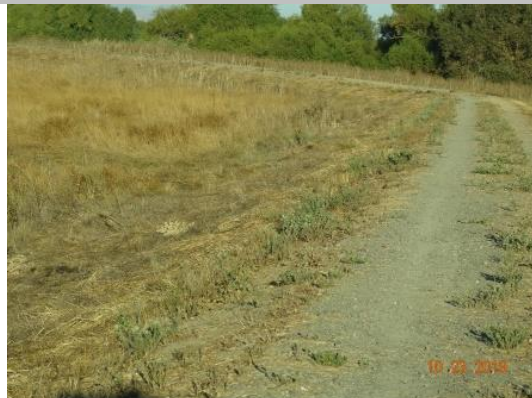
Photo 1 of 1 : FA_2019_NA0010_119_23_20191107_00066.jpg

LM Start	0.02	Rating **	M	Issue No.	23
LM End	3.00	Issue Type +	Ma	Location *	LS
Category	Earthen Levee			GPS Latitude/Longitude	
				Start	End
Item	Vegetation			37.296237 °	37.283668 °
				-120.880371 °	-120.844968 °
DWR ID	DWR_NA0010_02A_f _ 2019_23				
Comment Code					
V1 : Control annual grass and weeds on the levee slopes and easements.					
Inspector Comment

View of landside slope looking downstream. (Fall 2019)

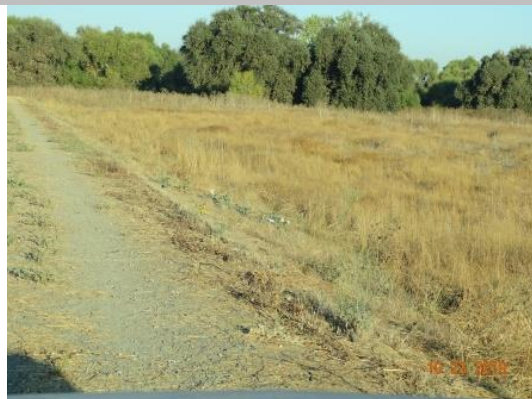
Photo 1 of 1 : FA_2019_NA0010_119_22_20191107_00067.jpg

LM Start	0.02	Rating **	M	Issue No.	22
LM End	2.27	Issue Type +	Ma	Location *	WS
Category	Earthen Levee			GPS Latitude/Longitude	
				Start	End
Item	Vegetation			37.296236 °	37.291740 °
				-120.880371 °	-120.851650 °
DWR ID	DWR_NA0010_02A_f_2019_22				
Comment Code					
V1 : Control annual grass and weeds on the levee slopes and easements.					
Inspector Comment

View of waterside slope looking downstream. (Fall 2019)

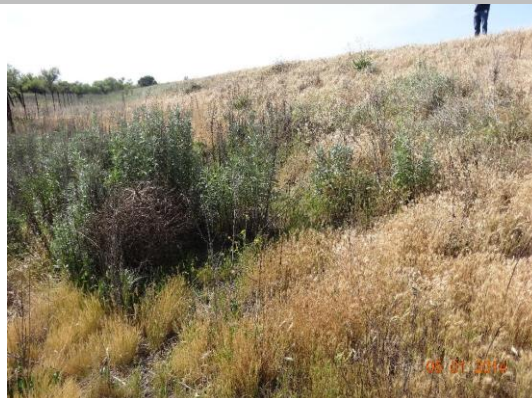
Photo 1 of 3 : UCIP_FA_2019_36503_66102.jpg

Comment Code						
Inspector Comment						
DS_ID:19652						
FS_ID:36503						
EP_NO: N/A						
Repair Type: Non-Urgent						
Crossing Status: Found						
UCIP Comments: 05/01/2014 Dense vegetation limits the inspector's visibility to identify signs of pipe failure (leaks) along the slope. Recommend removing vegetation along pipe alignment to conduct proper inspection of structure. (DWR UCIP - O. Magana)						
FIELD_STRUCT_DESC: 24-inch corrugated metal gravity drainage pipe through the levee, 11 feet below the crown. Flap gate on the waterside (WS) end. Brass cap No. 139 bench mark (BM) on the headwall on the landside (LS). [Additional Reference(s): DWR Levee Log, 2002. USACE San Joaquin O&M Manual 601.1, 1967, (HLM 0.24)].						
FS Date: 5/1/2014

View of waterward side.

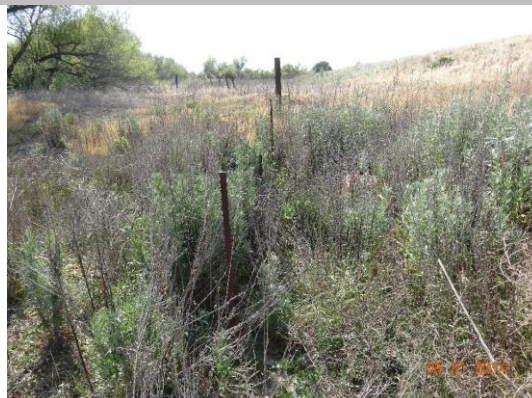
Photo 2 of 3 : UCIP_FA_2019_36503_66101.jpg

Fence along waterward side. No headwall was found on waterward side.

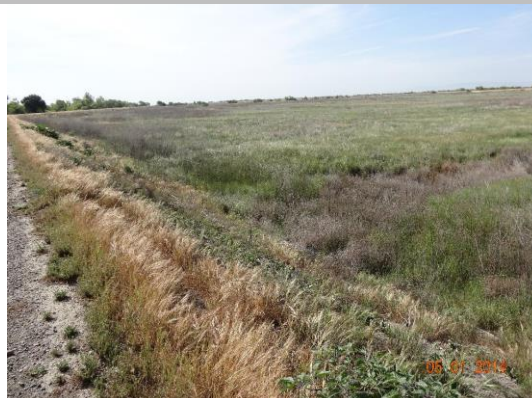
Photo 3 of 3 : UCIP_FA_2019_36503_66100.jpg

Comment Code						
Inspector Comment						
DS_ID:19652						
FS_ID:36503						
EP_NO: N/A						
Repair Type: Non-Urgent						
Crossing Status: Found						
UCIP Comments: 05/01/2014 Dense vegetation limits the inspector's visibility to identify signs of pipe failure (leaks) along the slope. Recommend removing vegetation along pipe alignment to conduct proper inspection of structure. (DWR UCIP - O. Magana)						
FIELD_STRUCT_DESC: 24-inch corrugated metal gravity drainage pipe through the levee, 11 feet below the crown. Flap gate on the waterside (WS) end. Brass cap No. 139 bench mark (BM) on the headwall on the landside (LS). [Additional Reference(s): DWR Levee Log, 2002. USACE San Joaquin O&M Manual 601.1, 1967, (HLM 0.24)].						
FS Date: 5/1/2014

View of landward side.

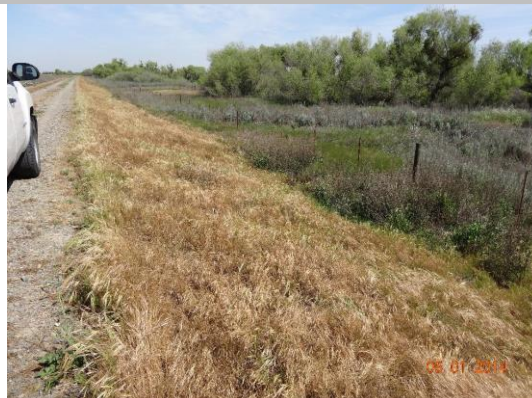
Photo 1 of 3 : UCIP_FA_2019_36504_66106.jpg

Comment Code						
Inspector Comment						
DS_ID:19653 FS_ID:36504 EP_NO: N/A Repair Type: Non-Urgent Crossing Status: Found UCIP Comments: 05/01/2014 Dense vegetation limits the inspector's visibility to identify signs of pipe failure (leaks) along the slope. Recommend removing vegetation along pipe alignment to conduct proper inspection of structure. (DWR UCIP - O. Magana) FIELD_STRUCT_DESC: 24-inch corrugated metal gravity drainage pipe through the levee, 14.8 feet below the crown. Flap gate on the waterside (WS) end. Brass cap No. 138 bench mark (BM) on the headwall on the landside (LS). [Additional Reference(s): DWR Levee Log, 2002. USACE San Joaquin O&M Manual 601.1, 1967, (HLM 0.67)]. FS Date: 5/1/2014

View of waterward side.

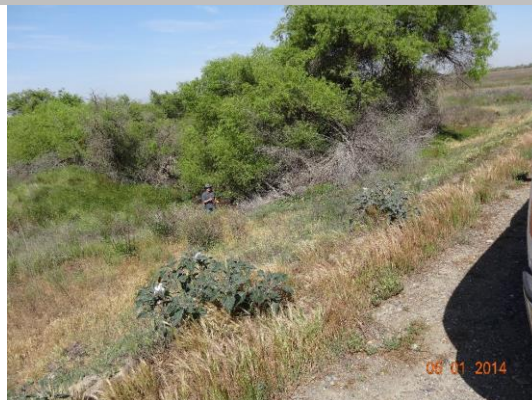
Photo 2 of 3 : UCIP_FA_2019_36504_66105.jpg

View of landward side.

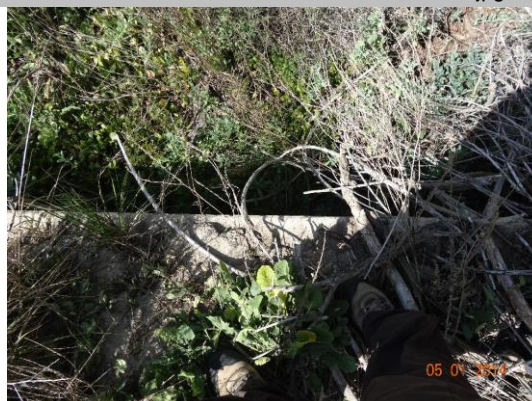
Photo 3 of 3 : UCIP_FA_2019_36504_66104.jpg

Comment Code						
Inspector Comment						
DS_ID:19653 FS_ID:36504 EP_NO: N/A Repair Type: Non-Urgent Crossing Status: Found UCIP Comments: 05/01/2014 Dense vegetation limits the inspector's visibility to identify signs of pipe failure (leaks) along the slope. Recommend removing vegetation along pipe alignment to conduct proper inspection of structure. (DWR UCIP - O. Magana) FIELD_STRUCT_DESC: 24-inch corrugated metal gravity drainage pipe through the levee, 14.8 feet below the crown. Flap gate on the waterside (WS) end. Brass cap No. 138 bench mark (BM) on the headwall on the landside (LS). [Additional Reference(s): DWR Levee Log, 2002. USACE San Joaquin O&M Manual 601.1, 1967, (HLM 0.67)]. FS Date: 5/1/2014

Concrete headwall found on landward side.

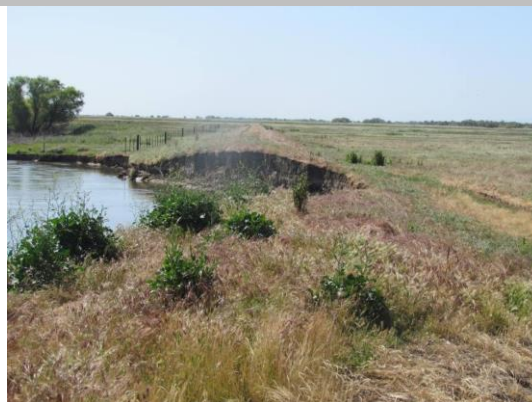
Photo 1 of 4 : FA_2019_NA0010_119_5_20190912_00008.jpg

LM Start	0.71	Rating **	U	Issue No.	5
LM End	0.78	Issue Type +	Ma	Location *	WS
Category	Earthen Levee			GPS Latitude/Longitude	
				Start	End
Item	Erosion / Bank Caving			37.287517 °	37.286543 °
				-120.874583 °	-120.873935 °
DWR ID	DWR_NA0010_02A_s_2012_5				
Comment Code					
E2 : Schedule repair of erosion site prior to the next inspection.					
Inspector Comment					
This levee unit is in the process of being turned over to State Parks.

Looking upstream at erosion Fall 2017.

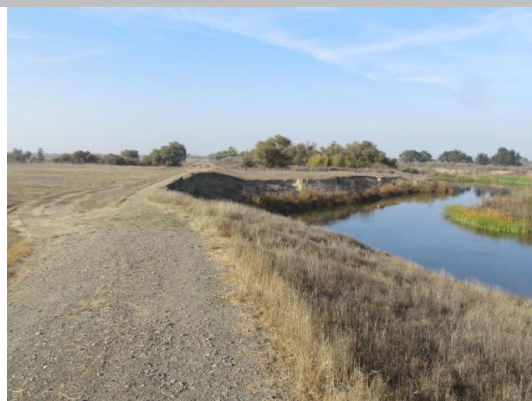
Photo 2 of 4 : FA_2019_NA0010_119_5_20190912_00007.jpg

LM Start	0.71	Rating **	U	Issue No.	5 (cont)	
LM End	0.78	Issue Type +	Ma	Location *	WS	
Category	Earthen Levee			GPS Latitude/Longitude		
				Start		End
Item	Erosion / Bank Caving			37.287517 °		37.286543 °
				-120.874583 °		-120.873935 °
DWR ID	DWR_NA0010_02A_s_2012_5					
Comment Code						
E2 : Schedule repair of erosion site prior to the next inspection.						
Inspector Comment						
This levee unit is in the process of being turned over to State Parks.

Looking north at erosion on waterward slope. (Fall 2014)

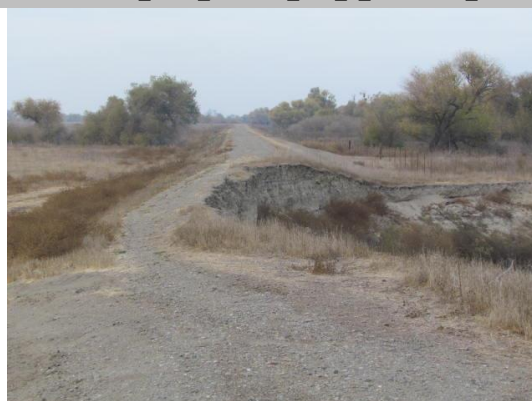
Photo 3 of 4 : FA_2019_NA0010_119_5_20190912_00006.jpg

Looking north at large erosion on waterward slope. (Fall 2013)

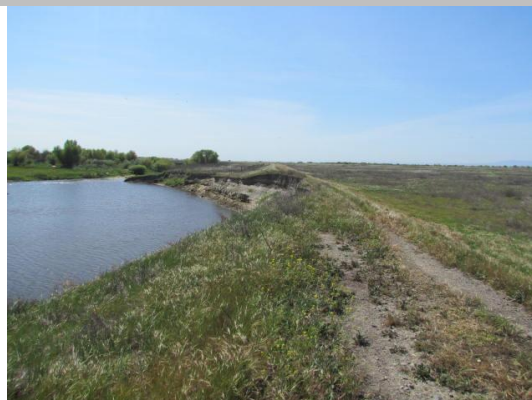
Photo 4 of 4 : FA_2019_NA0010_119_5_20190912_00005.jpg

Looking south at large erosion on waterside slope. (Spring 2012)

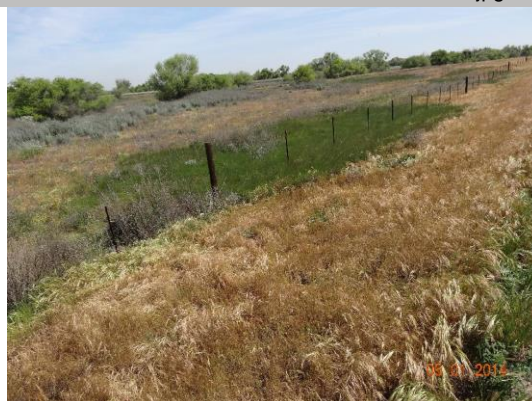
Photo 1 of 3 : UCIP_FA_2019_39363_66113.jpg

Comment Code						
Inspector Comment						
DS_ID:19654 FS_ID:39363 EP_NO: N/A Repair Type: Non-Urgent Crossing Status: Found UCIP Comments: 05/01/2014 Dense vegetation limits the inspector's visibility to identify signs of pipe failure (leaks) along the slope. Recommend removing vegetation along pipe alignment to conduct proper inspection of structure. Sediment buildup in pipe recommend clearing. (DWR UCIP - O. Magana) FIELD_STRUCT_DESC: 24-inch corrugated metal gravity drainage pipe through the levee, 8.6 feet below the crown. Flap gate on the waterside (WS) end. Brass cap No. 137 bench mark (BM) on the headwall on the landside (LS). [Additional Reference(s): DWR Levee Log, 2002. USACE San Joaquin O&M Manual 601.1, 1967, (HLM 1.02)]. FS Date: 5/1/2014

View of waterward side.

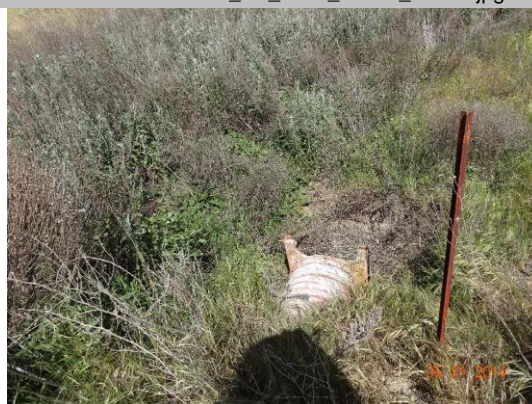
Photo 2 of 3 : UCIP_FA_2019_39363_66112.jpg

Pipe visible on waterward side.

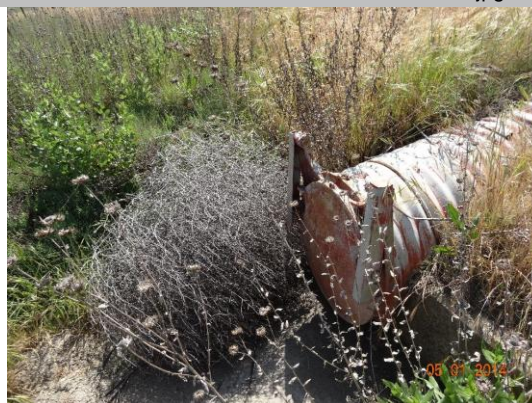
Photo 2 of 3 : UCIP_FA_2019_36506_66117.jpg

DS_ID:19655
FS_ID:36506
EP_NO: N/A
Repair Type: Non-Urgent
Crossing Status: Found
UCIP Comments: 05/01/2014 Dense vegetation limits the inspector's visibility to identify signs of pipe failure (leaks) along the slope. Recommend removing vegetation along pipe alignment to conduct proper inspection of structure. (DWR UCIP - O. Magana)
FIELD_STRUCT_DESC: 24-inch corrugated metal gravity drainage pipe through the levee, 8.6 feet below the crown. Flap gate on the waterside (WS) end. Brass cap No. 136 bench mark (BM) on the headwall on the landside (LS). [Additional Reference(s): DWR Levee Log, 2002. USACE San Joaquin O&M Manual 601.1, 1967, (HLM 1.22)].
FS Date: 5/1/2014

Flap gate visible on waterward side.

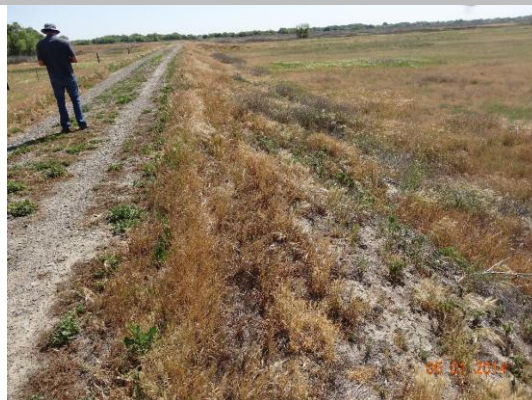
Photo 3 of 3 : UCIP_FA_2019_36506_66116.jpg

View of landward side.

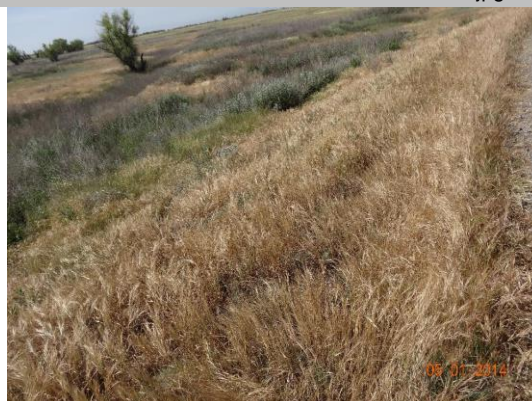
Photo 1 of 3 : UCIP_FA_2019_36507_66120.jpg

Comment Code						
Inspector Comment						
DS_ID:19656						
FS_ID:36507						
EP_NO: N/A						
Repair Type: Non-Urgent						
Crossing Status: Found						
UCIP Comments: 05/01/2014 Dense vegetation limits the inspector's visibility to identify signs of pipe failure (leaks) along the slope. Recommend removing vegetation along pipe alignment to conduct proper inspection of structure. (DWR UCIP - O. Magana)						
FIELD_STRUCT_DESC: 36-inch corrugated metal gravity drainage pipe through the levee, 14.6 feet below the crown. Flap gate on the waterside (WS) end. Brass cap No. 135 bench mark (BM) on the headwall on the landside (LS). [Additional Reference(s): DWR Levee Log, 2002. USACE San Joaquin O&M Manual 601.1, 1967, (HLM 1.34)].						
FS Date: 5/1/2014

View of landward side.

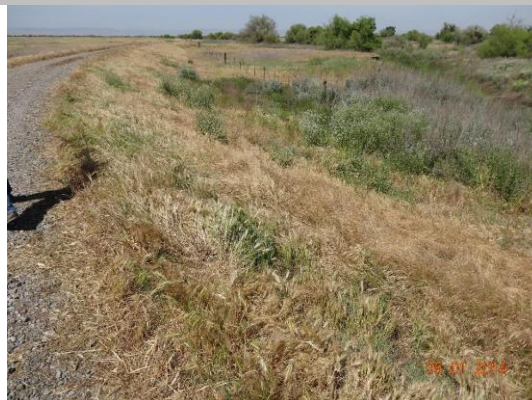
Photo 2 of 3 : UCIP_FA_2019_36507_66119.jpg

View of waterward side.

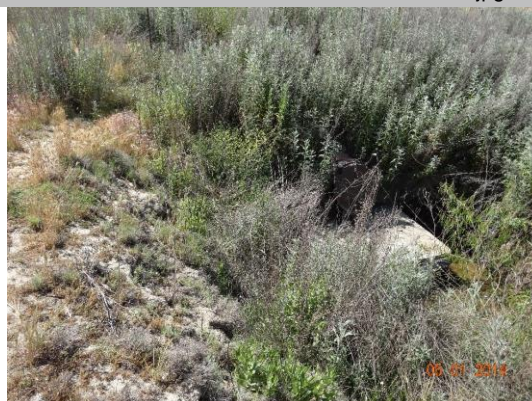
Photo 3 of 3 : UCIP_FA_2019_36507_66118.jpg

Comment Code						
Inspector Comment						
DS_ID:19656 FS_ID:36507 EP_NO: N/A Repair Type: Non-Urgent Crossing Status: Found UCIP Comments: 05/01/2014 Dense vegetation limits the inspector's visibility to identify signs of pipe failure (leaks) along the slope. Recommend removing vegetation along pipe alignment to conduct proper inspection of structure. (DWR UCIP - O. Magana) FIELD_STRUCT_DESC: 36-inch corrugated metal gravity drainage pipe through the levee, 14.6 feet below the crown. Flap gate on the waterside (WS) end. Brass cap No. 135 bench mark (BM) on the headwall on the landside (LS). [Additional Reference(s): DWR Levee Log, 2002. USACE San Joaquin O&M Manual 601.1, 1967, (HLM 1.34)]. FS Date: 5/1/2014

Flap gate and concrete apron visible on waterward side.

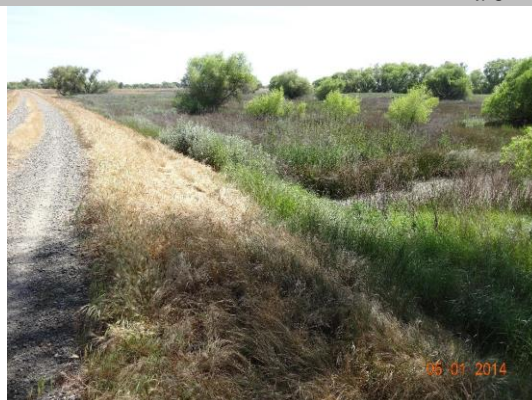
Photo 1 of 3 : UCIP_FA_2019_36508_66124.jpg

Comment Code						
Inspector Comment						
DS_ID:19657						
FS_ID:36508						
EP_NO: N/A						
Repair Type: Non-Urgent						
Crossing Status: Found						
UCIP Comments: 05/01/2014 Dense vegetation limits the inspector's						
visibility to identify signs of pipe failure (leaks) along the slope.						
Recommend removing vegetation along pipe alignment to conduct						
proper inspection of structure. (DWR UCIP - O. Magana)						
FIELD_STRUCT_DESC: 24-inch corrugated metal gravity drainage pipe						
through the levee, 10.2 feet below the crown. Flap gate on the						
waterside (WS) end. Brass cap No. 135 bench mark (BM) on the						
headwall on the landside (LS). [Additional Reference(s): DWR Levee						
Log, 2002. USACE San Joaquin O&M Manual 601.1, 1967, (HLM 1.62)].						
FS Date: 5/1/2014

Overview of landward side.

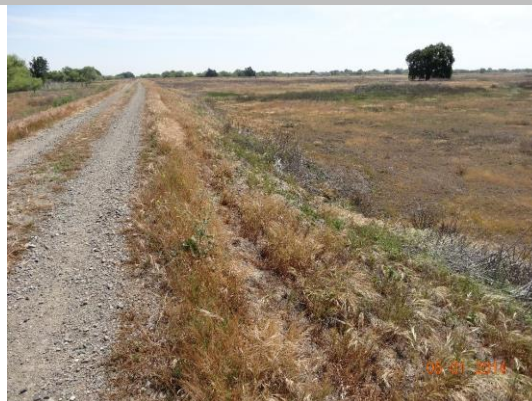
Photo 1 of 3 : UCIP_FA_2019_36509_66129.jpg

Comment Code						
Inspector Comment						
DS_ID:19658 FS_ID:36509 EP_NO: N/A Repair Type: Non-Urgent Crossing Status: Found UCIP Comments: 05/01/2014 Dense vegetation limits the inspector's visibility to identify signs of pipe failure (leaks) along the slope. Recommend removing vegetation along pipe alignment to conduct proper inspection of structure. (DWR UCIP - O. Magana) FIELD_STRUCT_DESC: 24-inch corrugated metal gravity drainage pipe through the levee, 10.7 feet below the crown. Flap gate on the waterside (WS) end. Brass cap No. 135 bench mark (BM) on the headwall on the landside (LS). [Additional Reference(s): DWR Levee Log, 2002. USACE San Joaquin O&M Manual 601.1, 1967, (HLM 1.86)]. FS Date: 5/1/2014

View of landward side.

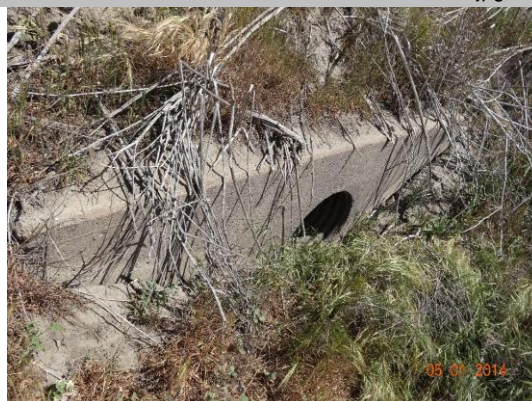
Photo 2 of 3 : UCIP_FA_2019_36509_66128.jpg

Concrete headwall visible on landward side.

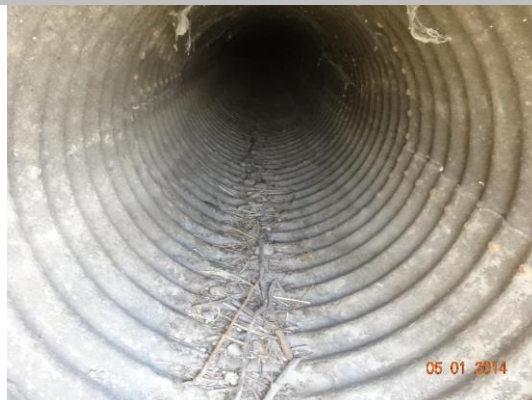
Photo 3 of 3 : UCIP_FA_2019_36509_66127.jpg

Inside view of pipe from landward side.

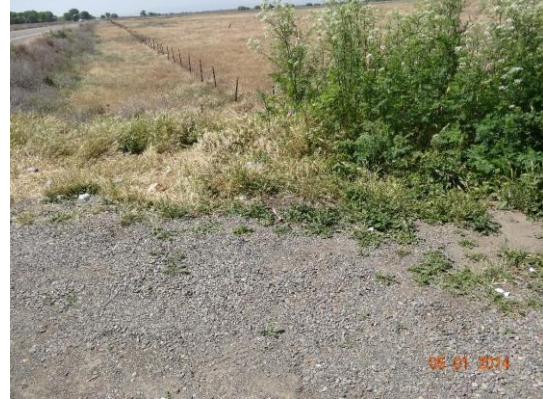
Photo 1 of 3 : UCIP_FA_2019_36510_66133.jpg

Comment Code						
Inspector Comment						
DS_ID:19659						
FS_ID:36510						
EP_NO: N/A						
Repair Type: Non-Urgent						
Crossing Status: Found						
UCIP Comments: 05/01/2014 Dense vegetation limits the inspector's visibility to identify signs of pipe failure (leaks) along the slope. Recommend removing vegetation along pipe alignment to conduct proper inspection of structure. (DWR UCIP - O. Magana)						
FIELD_STRUCT_DESC: 24-inch corrugated metal gravity drainage pipe through the levee, 7 feet below the crown. Flap gate on the waterside (WS) end. Brass cap No. 135 bench mark (BM) on the headwall on the landside (LS). [Additional Reference(s): DWR Levee Log, 2002. USACE San Joaquin O&M Manual 601.1, 1967, (HLM 2.30)].						
FS Date: 5/1/2014

View of landward side.

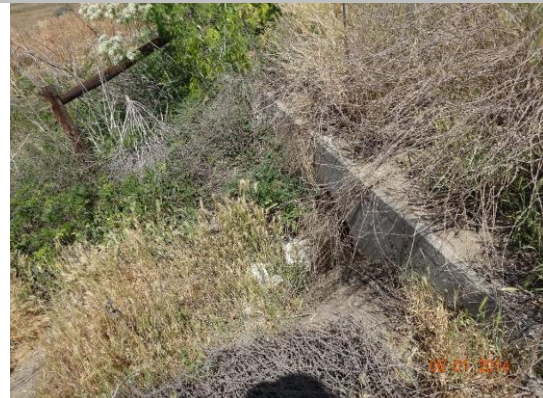
Photo 2 of 3 : UCIP_FA_2019_36510_66132.jpg

Concrete headwall visible on landward side.

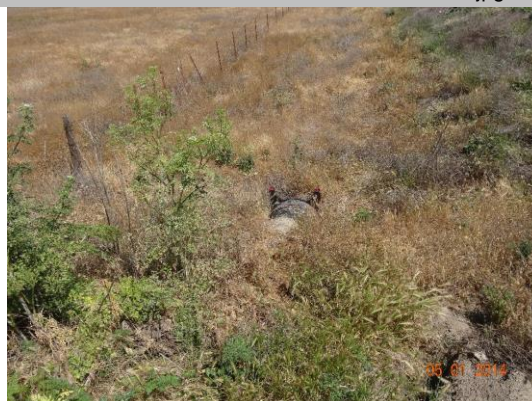
Photo 3 of 3 : UCIP_FA_2019_36510_66131.jpg

Comment Code						
Inspector Comment						
DS_ID:19659						
FS_ID:36510						
EP_NO: N/A						
Repair Type: Non-Urgent						
Crossing Status: Found						
UCIP Comments: 05/01/2014 Dense vegetation limits the inspector's visibility to identify signs of pipe failure (leaks) along the slope. Recommend removing vegetation along pipe alignment to conduct proper inspection of structure. (DWR UCIP - O. Magana)						
FIELD_STRUCT_DESC: 24-inch corrugated metal gravity drainage pipe through the levee, 7 feet below the crown. Flap gate on the waterside (WS) end. Brass cap No. 135 bench mark (BM) on the headwall on the landside (LS). [Additional Reference(s): DWR Levee Log, 2002. USACE San Joaquin O&M Manual 601.1, 1967, (HLM 2.30)].						
FS Date: 5/1/2014

View of pipe through levee visible on waterward side.

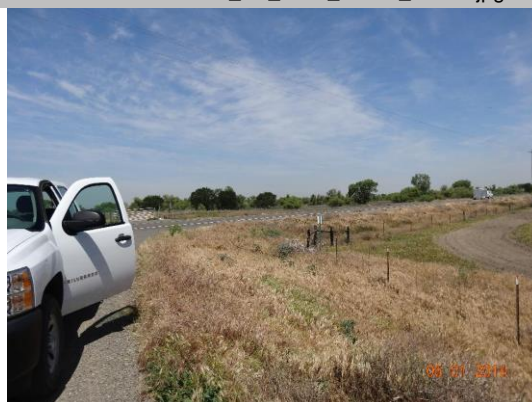
Photo 1 of 3 : UCIP_FA_2019_36511_66137.jpg

Comment Code						
Inspector Comment						
DS_ID:19660						
FS_ID:36511						
EP_NO: N/A						
Repair Type: Non-Urgent						
Crossing Status: Found						
UCIP Comments: 05/01/2014 Dense vegetation limits the inspector's visibility to identify signs of pipe failure (leaks) along the slope. Recommend removing vegetation along pipe alignment to conduct proper inspection of structure. (DWR UCIP - O. Magana)						
FIELD_STRUCT_DESC: 24-inch corrugated metal gravity drainage pipe through the levee, 7 feet below the crown. Flap gate on the waterside (WS) end. Brass cap No. 135 bench mark (BM) on the headwall on the landside (LS). [Additional Reference(s): DWR Levee Log, 2002. USACE San Joaquin O&M Manual 601.1, 1967, (HLM 2.32)].						
FS Date: 5/1/2014

View of waterward side.

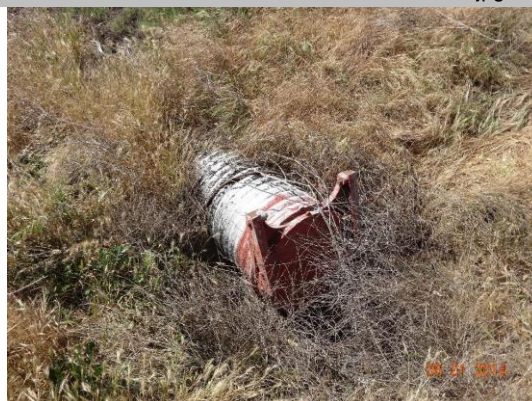
Photo 2 of 3 : UCIP_FA_2019_36511_66136.jpg

Comment Code						
Inspector Comment						
DS_ID:19660						
FS_ID:36511						
EP_NO: N/A						
Repair Type: Non-Urgent						
Crossing Status: Found						
UCIP Comments: 05/01/2014 Dense vegetation limits the inspector's visibility to identify signs of pipe failure (leaks) along the slope. Recommend removing vegetation along pipe alignment to conduct proper inspection of structure. (DWR UCIP - O. Magana)						
FIELD_STRUCT_DESC: 24-inch corrugated metal gravity drainage pipe through the levee, 7 feet below the crown. Flap gate on the waterside (WS) end. Brass cap No. 135 bench mark (BM) on the headwall on the landside (LS). [Additional Reference(s): DWR Levee Log, 2002. USACE San Joaquin O&M Manual 601.1, 1967, (HLM 2.32)].						
FS Date: 5/1/2014

Flap gate visible on waterward side.

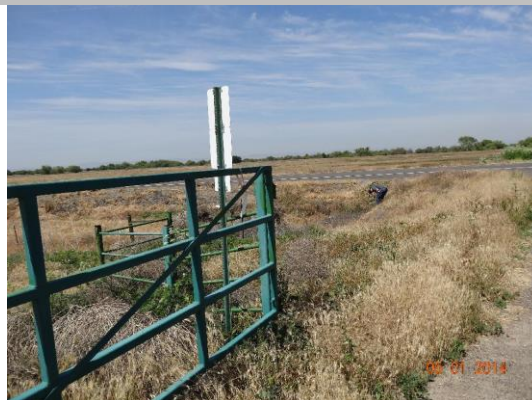
Photo 3 of 3 : UCIP_FA_2019_36511_66138.jpg

Overview of landward slope.

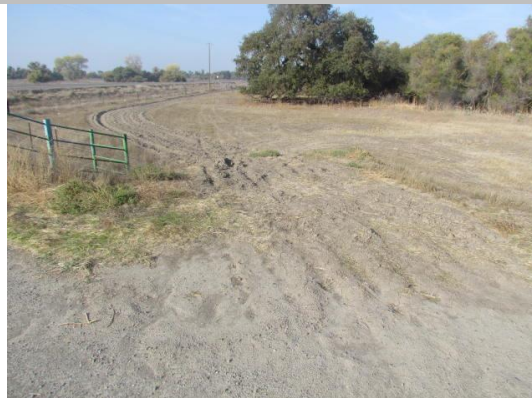
Photo 1 of 4 : FA_2019_NA0010_119_2_20190912_00001.jpg

LM Start	2.32	Rating **	M	Issue No.	2
LM End	2.32	Issue Type +	En	Location *	LS
Category	Earthen Levee			GPS Latitude/Longitude	
				Start	End
Item	Encroachments			37.291433 °	37.291433 °
				-120.850917 °	-120.850917 °
DWR ID	DWR_NA0010_02A_s_2012_2				
Comment Code					
RA : Ramp					
Inspector Comment					
Unauthorized ramps are located on the landside and waterside slopes.

Looking northeast at unauthorized ramp on landward slope.

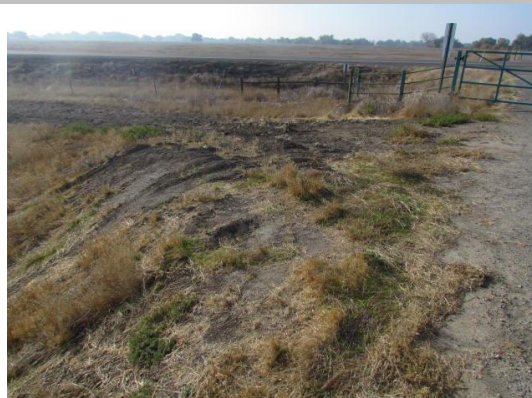
Photo 3 of 4 : FA_2019_NA0010_119_2_20190912_00003.jpg

Looking northwest at unauthorized ramp on waterward slope.

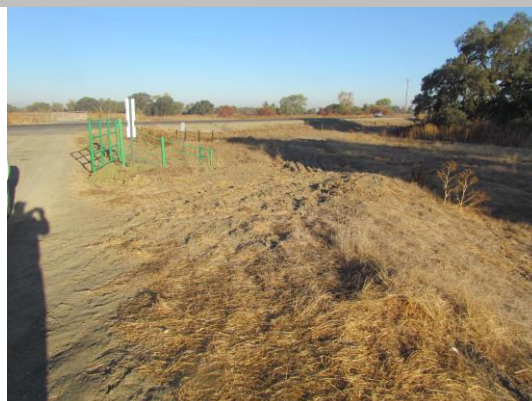
Photo 4 of 4 : FA_2019_NA0010_119_2_20190912_00004.jpg

LM Start	2.32	Rating **	M	Issue No.	2 (cont)	
LM End	2.32	Issue Type +	En	Location *	LS	
Category	Earthen Levee			GPS Latitude/Longitude		
				Start		End
Item	Encroachments			37.291433 °	37.291433 °	
				-120.850917 °	-120.850917 °	
DWR ID	DWR_NA0010_02A_s_2012_2					
Comment Code						
RA : Ramp						
Inspector Comment						
Unauthorized ramps are located on the landside and waterside slopes.

Looking at ramp on landward slope. (Fall 2016)

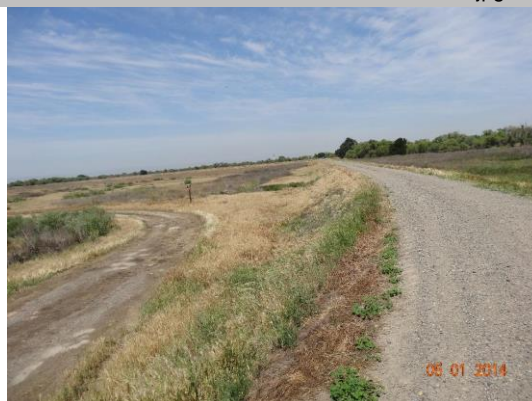
Photo 1 of 3 : UCIP_FA_2019_36512_66142.jpg

Comment Code					
Inspector Comment					
DS_ID:19661 FS_ID:36512 EP_NO: N/A Repair Type: Non-Urgent Crossing Status: Found UCIP Comments: 05/01/2014 Dense vegetation limits the inspector's visibility to identify signs of pipe failure (leaks) along the slope. Recommend removing vegetation along pipe alignment to conduct proper inspection of structure. (DWR UCIP - O. Magana) FIELD_STRUCT_DESC: 24-inch corrugated metal gravity drainage pipe through the levee, 10 feet below the crown. Flap gate on the waterside (WS) end. Brass cap No. 130 bench mark (BM) on the headwall on the landside (LS). [Additional Reference(s): DWR Levee Log, 2002. USACE San Joaquin O&M Manual 601.1, 1967, (HLM 2.59)]. FS Date: 5/1/2014

View of landward side.

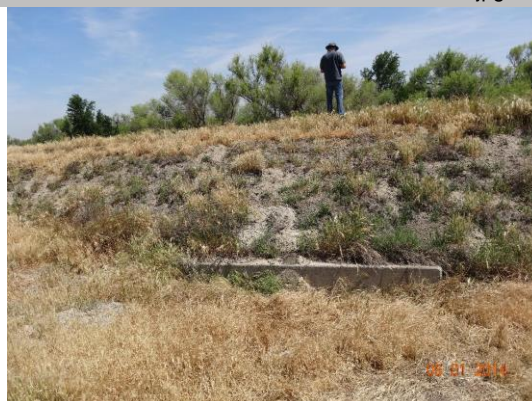
Photo 2 of 3 : UCIP_FA_2019_36512_66141.jpg

Comment Code						
Inspector Comment						
DS_ID:19661						
FS_ID:36512						
EP_NO: N/A						
Repair Type: Non-Urgent						
Crossing Status: Found						
UCIP Comments: 05/01/2014 Dense vegetation limits the inspector's visibility to identify signs of pipe failure (leaks) along the slope. Recommend removing vegetation along pipe alignment to conduct proper inspection of structure. (DWR UCIP - O. Magana)						
FIELD_STRUCT_DESC: 24-inch corrugated metal gravity drainage pipe through the levee, 10 feet below the crown. Flap gate on the waterside (WS) end. Brass cap No. 130 bench mark (BM) on the headwall on the landside (LS). [Additional Reference(s): DWR Levee Log, 2002. USACE San Joaquin O&M Manual 601.1, 1967, (HLM 2.59)].						
FS Date: 5/1/2014

Concrete headwall visible on landward side.

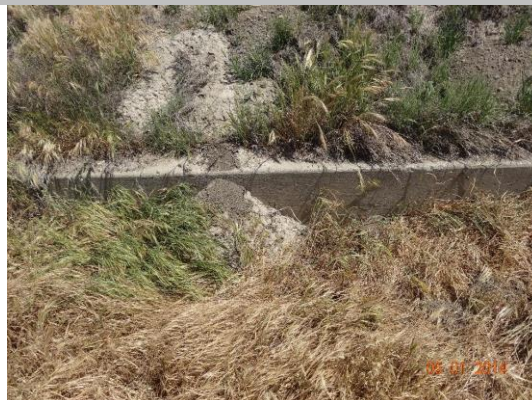
Photo 3 of 3 : UCIP_FA_2019_36512_66140.jpg

Non-functional crossing concrete headwall and inlet buried on landward side.

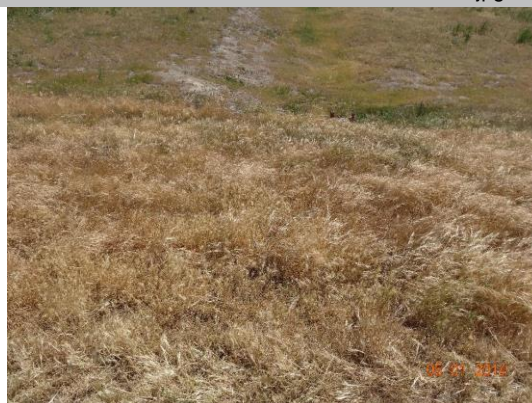
Photo 1 of 3 : UCIP_FA_2019_36513_66145.jpg

Comment Code						
Inspector Comment						
DS_ID:19662						
FS_ID:36513						
EP_NO: N/A						
Repair Type: Non-Urgent						
Crossing Status: Found						
UCIP Comments: 05/01/2014 Dense vegetation limits the inspector's visibility to identify signs of pipe failure (leaks) along the slope. Recommend removing vegetation along pipe alignment to conduct proper inspection of structure. (DWR UCIP - O. Magana)						
FIELD_STRUCT_DESC: 24-inch corrugated metal gravity drainage pipe through the levee, 10 feet below the crown. Flap gate on the waterside (WS) end. Brass cap No. 130 bench mark (BM) on the headwall on the landside (LS). [Additional Reference(s): DWR Levee Log, 2002. USACE San Joaquin O&M Manual 601.1, 1967, (HLM 2.96)].						
FS Date: 5/1/2014

View of waterward side.

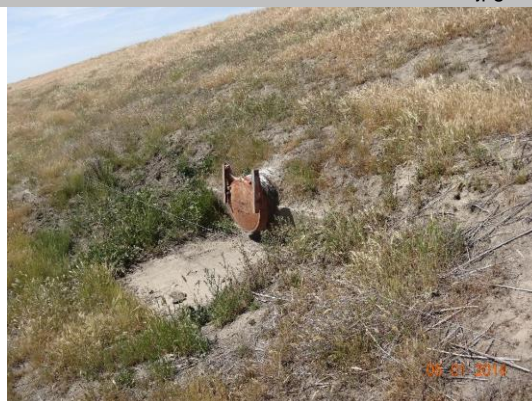
Photo 2 of 3 : UCIP_FA_2019_36513_66144.jpg

Comment Code						
Inspector Comment						
DS_ID:19662 FS_ID:36513 EP_NO: N/A Repair Type: Non-Urgent Crossing Status: Found UCIP Comments: 05/01/2014 Dense vegetation limits the inspector's visibility to identify signs of pipe failure (leaks) along the slope. Recommend removing vegetation along pipe alignment to conduct proper inspection of structure. (DWR UCIP - O. Magana) FIELD_STRUCT_DESC: 24-inch corrugated metal gravity drainage pipe through the levee, 10 feet below the crown. Flap gate on the waterside (WS) end. Brass cap No. 130 bench mark (BM) on the headwall on the landside (LS). [Additional Reference(s): DWR Levee Log, 2002. USACE San Joaquin O&M Manual 601.1, 1967, (HLM 2.96)]. FS Date: 5/1/2014

Flap gate visible on waterward side.

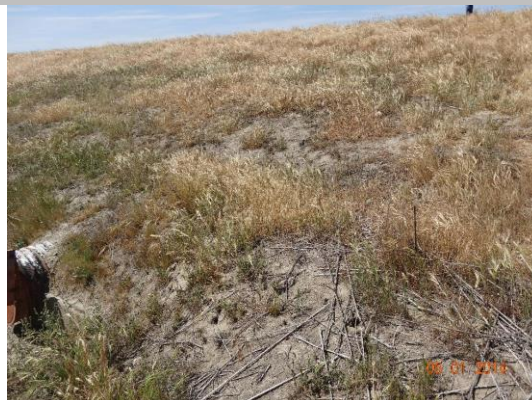
Photo 3 of 3 : UCIP_FA_2019_36513_66149.jpg

View of slope on waterward side.

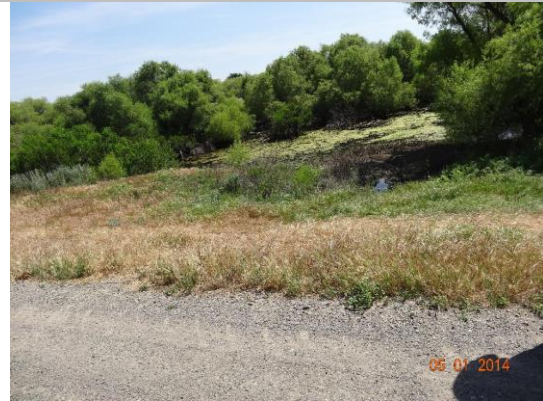
Photo 1 of 3 : UCIP_FA_2019_36514_66151.jpg

Comment Code						
Inspector Comment						
DS_ID:19665						
FS_ID:36514						
EP_NO: N/A						
Repair Type: Non-Urgent						
Crossing Status: Found						
UCIP Comments: 05/01/2014 Dense vegetation limits the inspector's visibility to identify signs of pipe failure (leaks) along the slope. Recommend removing vegetation along pipe alignment to conduct proper inspection of structure. (DWR UCIP - O. Magana)						
FIELD_STRUCT_DESC: 24-inch corrugated metal gravity drainage pipe through the levee, 12.4 feet below the crown. Flap gate on the waterside (WS) end. Brass cap No. 130 bench mark (BM) on the headwall on the landside (LS). [Additional Reference(s): DWR Levee Log, 2002. USACE San Joaquin O&M Manual 601.1, 1967, (HLM 3.29)].						
FS Date: 5/1/2014

View of waterward side.

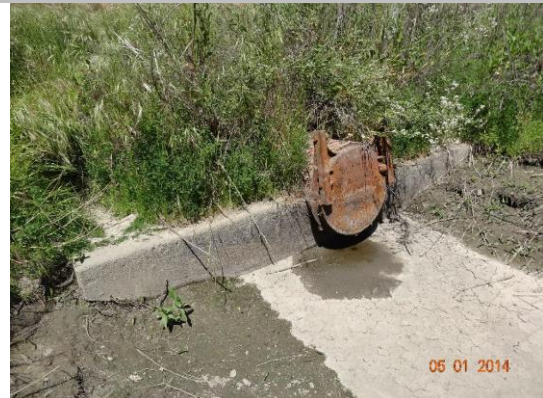
Photo 2 of 3 : UCIP_FA_2019_36514_66153.jpg

Flap gate visible on waterward side.

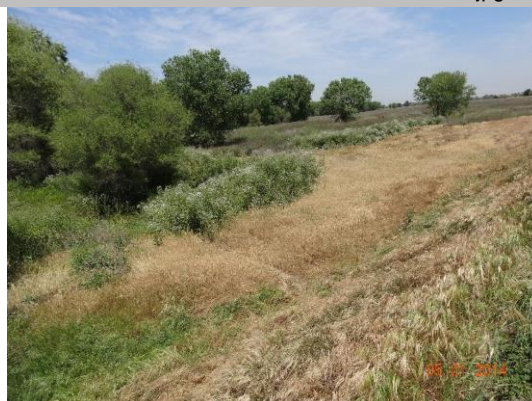
Photo 3 of 3 : UCIP_FA_2019_36514_66152.jpg

Comment Code						
Inspector Comment						
DS_ID:19665 FS_ID:36514 EP_NO: N/A Repair Type: Non-Urgent Crossing Status: Found UCIP Comments: 05/01/2014 Dense vegetation limits the inspector's visibility to identify signs of pipe failure (leaks) along the slope. Recommend removing vegetation along pipe alignment to conduct proper inspection of structure. (DWR UCIP - O. Magana) FIELD_STRUCT_DESC: 24-inch corrugated metal gravity drainage pipe through the levee, 12.4 feet below the crown. Flap gate on the waterside (WS) end. Brass cap No. 130 bench mark (BM) on the headwall on the landside (LS). [Additional Reference(s): DWR Levee Log, 2002. USACE San Joaquin O&M Manual 601.1, 1967, (HLM 3.29)]. FS Date: 5/1/2014

View of landward side.

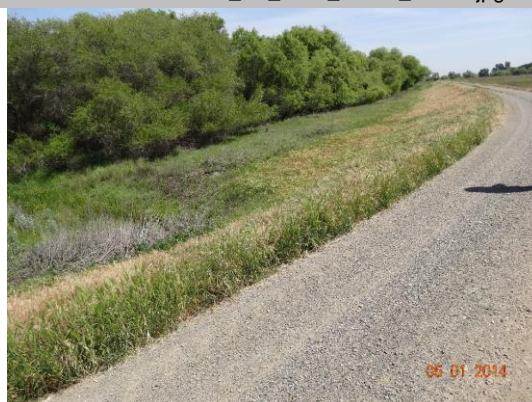
Photo 1 of 3 : UCIP_FA_2019_36515_66155.jpg

Comment Code						
Inspector Comment						
DS_ID:19666						
FS_ID:36515						
EP_NO: N/A						
Repair Type: Non-Urgent						
Crossing Status: Found						
UCIP Comments: 05/01/2014 Dense vegetation limits the inspector's visibility to identify signs of pipe failure (leaks) along the slope. Recommend removing vegetation along pipe alignment to conduct proper inspection of structure. (DWR UCIP - O. Magana)						
FIELD_STRUCT_DESC: 24-inch corrugated metal gravity drainage pipe through the levee, 10 feet below the crown. Flap gate on the waterside (WS) end. Brass cap No. 130 bench mark (BM) on the headwall on the landside (LS). [Additional Reference(s): DWR Levee Log, 2002. USACE San Joaquin O&M Manual 601.1, 1967, (HLM 3.62)].						
FS Date: 5/1/2014

View of waterward side.

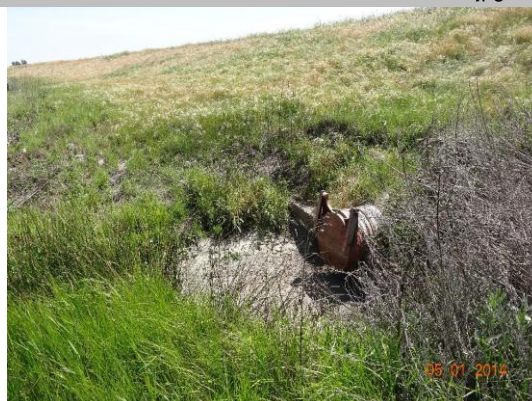
Photo 2 of 3 : UCIP_FA_2019_36515_66154.jpg

Comment Code						
Inspector Comment						
DS_ID:19666						
FS_ID:36515						
EP_NO: N/A						
Repair Type: Non-Urgent						
Crossing Status: Found						
UCIP Comments: 05/01/2014 Dense vegetation limits the inspector's visibility to identify signs of pipe failure (leaks) along the slope. Recommend removing vegetation along pipe alignment to conduct proper inspection of structure. (DWR UCIP - O. Magana)						
FIELD_STRUCT_DESC: 24-inch corrugated metal gravity drainage pipe through the levee, 10 feet below the crown. Flap gate on the waterside (WS) end. Brass cap No. 130 bench mark (BM) on the headwall on the landside (LS). [Additional Reference(s): DWR Levee Log, 2002. USACE San Joaquin O&M Manual 601.1, 1967, (HLM 3.62)].						
FS Date: 5/1/2014

Flap gate visible on waterward side.

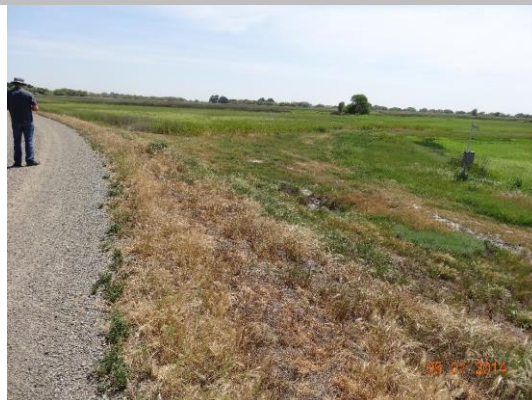
Photo 3 of 3 : UCIP_FA_2019_36515_66156.jpg

View of landward side.

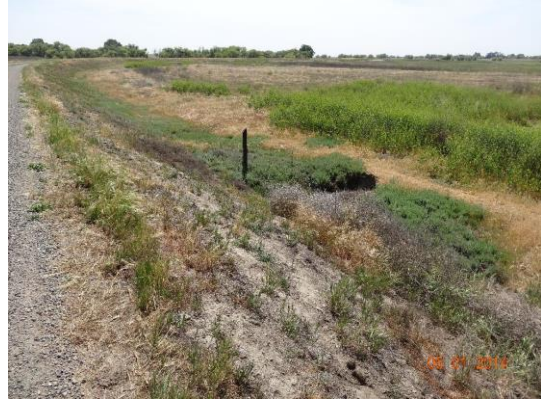
Photo 1 of 3 : UCIP_FA_2019_39364_66161.jpg

Comment Code						
Inspector Comment						
DS_ID:19667 FS_ID:39364 EP_NO: N/A Repair Type: Non-Urgent Crossing Status: Found UCIP Comments: 05/01/2014 Signs of erosion or sink hole present on landward toe--Need to contact owner. Dense vegetation limits the inspector's visibility to identify signs of pipe failure (leaks) along the slope. Recommend removing vegetation along pipe alignment to conduct proper inspection of structure. (DWR UCIP - O. Magana) FIELD_STRUCT_DESC: 24-inch corrugated metal gravity drainage pipe through the levee, 8.6 feet below the crown. Flap gate on the waterside (WS) end. Brass cap No. 130 bench mark (BM) on the headwall on the landside (LS). [Additional Reference(s): DWR Levee Log, 2002. USACE San Joaquin O&M Manual 601.1, 1967, (HLM 3.95)]. FS Date: 5/1/2014

View of landward side.

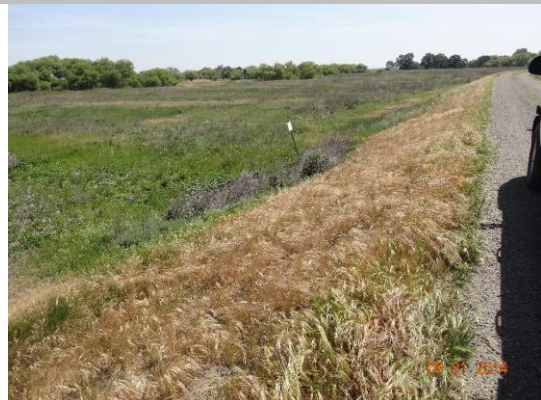
Photo 2 of 3 : UCIP_FA_2019_39364_66160.jpg

View of waterward side.

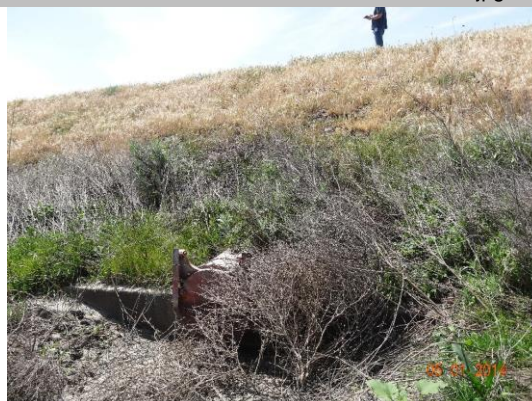
Photo 3 of 3 : UCIP_FA_2019_39364_66159.jpg

Item	DRAFT DWR UCIP LMA Responsibility		37.279704 °	37.279704 °								
			-120.834709 °	-120.834709 °								
DWR ID	19667											
Comment Code												
Inspector Comment												
DS_ID:19667 FS_ID:39364 EP_NO: N/A Repair Type: Non-Urgent Crossing Status: Found UCIP Comments: 05/01/2014 Signs of erosion or sink hole present on landward toe--Need to contact owner. Dense vegetation limits the inspector's visibility to identify signs of pipe failure (leaks) along the slope. Recommend removing vegetation along pipe alignment to conduct proper inspection of structure. (DWR UCIP - O. Magana) FIELD_STRUCT_DESC: 24-inch corrugated metal gravity drainage pipe through the levee, 8.6 feet below the crown. Flap gate on the waterside (WS) end. Brass cap No. 130 bench mark (BM) on the headwall on the landside (LS). [Additional Reference(s): DWR Levee Log, 2002. USACE San Joaquin O&M Manual 601.1, 1967, (HLM 3.95)]. FS Date: 5/1/2014

Flap gate and concrete headwall visible through dense vegetation.

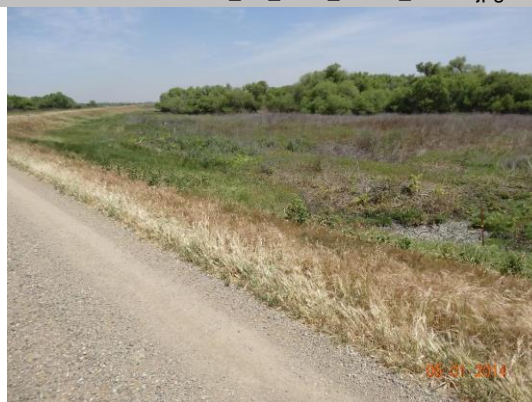
Photo 1 of 3 : UCIP_FA_2019_36517_66167.jpg

Item	DRAFT DWR UCIP LMA Responsibility		37.260069 °	37.260069 °								
			-120.831768 °	-120.831768 °								
DWR ID	19668											
Comment Code												
Inspector Comment												
DS_ID:19668 FS_ID:36517 EP_NO: N/A Repair Type: Non-Urgent Crossing Status: Found UCIP Comments: 05/01/2014 Dense vegetation limits the inspector's visibility to identify signs of pipe failure (leaks) along the slope. Recommend removing vegetation along pipe alignment to conduct proper inspection of structure. (DWR UCIP - O. Magana) FIELD_STRUCT_DESC: 24-inch corrugated metal gravity drainage pipe through the levee, 8 feet below the crown. Flap gate on the waterside (WS) end. Brass cap No. 125 bench mark (BM) on the headwall on the landside (LS). [Additional Reference(s): DWR Levee Log, 2002. USACE San Joaquin O&M Manual 601.1, 1967, (HLM 5.43)]. FS Date: 5/1/2014

View of waterward side.

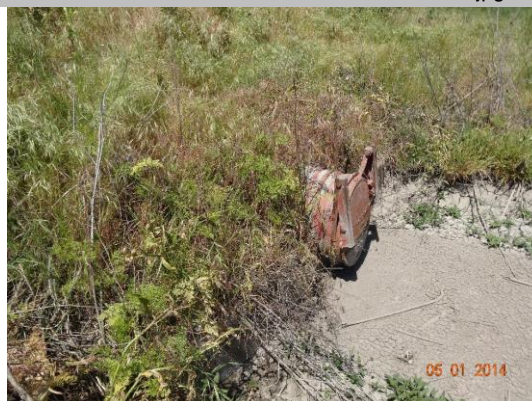
Photo 2 of 3 : UCIP_FA_2019_36517_66166.jpg

Comment Code						
Inspector Comment						
DS_ID:19668 FS_ID:36517 EP_NO: N/A Repair Type: Non-Urgent Crossing Status: Found UCIP Comments: 05/01/2014 Dense vegetation limits the inspector's visibility to identify signs of pipe failure (leaks) along the slope. Recommend removing vegetation along pipe alignment to conduct proper inspection of structure. (DWR UCIP - O. Magana) FIELD_STRUCT_DESC: 24-inch corrugated metal gravity drainage pipe through the levee, 8 feet below the crown. Flap gate on the waterside (WS) end. Brass cap No. 125 bench mark (BM) on the headwall on the landside (LS). [Additional Reference(s): DWR Levee Log, 2002. USACE San Joaquin O&M Manual 601.1, 1967, (HLM 5.43)]. FS Date: 5/1/2014

Flap gate visible on waterward side.

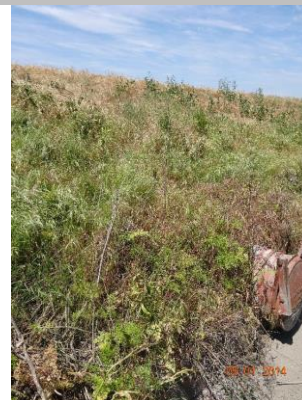
Photo 3 of 3 : UCIP_FA_2019_36517_66165.jpg

View of waterward slope covered by vegetation.
