**Flood Control Project Maintenance
Levee Inspections**

Fall 2019 Levee Maintenance Deficiency Summary Report

San Joaquin River Basin

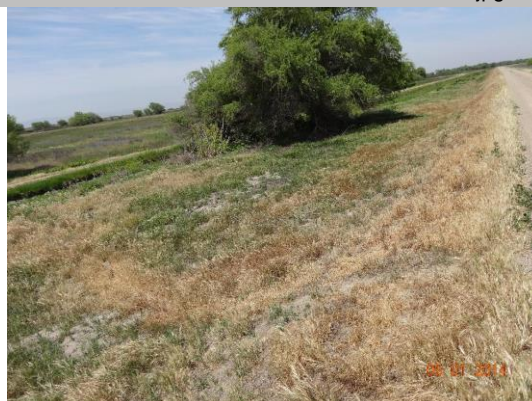
Photo 1 of 2 : UCIP_FA_2019_36518_66171.jpg

Comment Code						
Inspector Comment						
DS_ID:19669 FS_ID:36518 EP_NO: N/A Repair Type: Non-Urgent Crossing Status: Found UCIP Comments: 05/01/2014 Dense vegetation limits the inspector's visibility to identify signs of pipe failure (leaks) along the slope. Recommend removing vegetation along pipe alignment to conduct proper inspection of structure. (DWR UCIP - O. Magana) FIELD_STRUCT_DESC: 24-inch corrugated metal gravity drainage pipe through the levee, 7.7 feet below the crown. Flap gate on the waterside (WS) end. Brass cap No. 125 bench mark (BM) on the headwall on the landside (LS). [Additional Reference(s): DWR Levee Log, 2002. USACE San Joaquin O&M Manual 601.1, 1967, (HLM 6.06)]. FS Date: 5/1/2014

View of landward side.

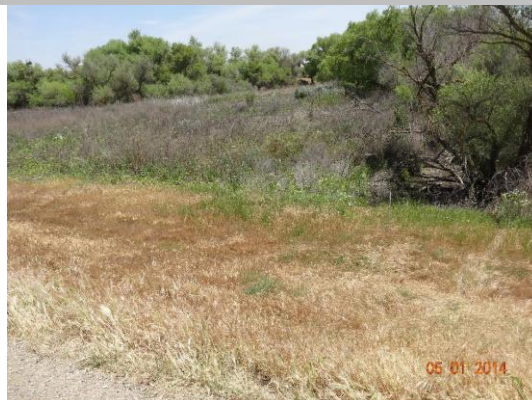
Photo 2 of 2 : UCIP_FA_2019_36518_66170.jpg

View of waterward side.

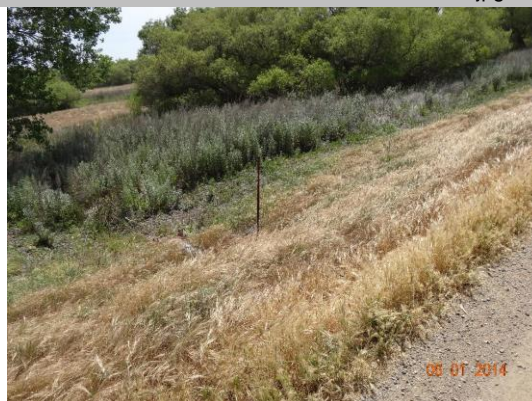
Photo 1 of 3 : UCIP_FA_2019_36519_66173.jpg

Comment Code						
Inspector Comment						
DS_ID:19670						
FS_ID:36519						
EP_NO: N/A						
Repair Type: Non-Urgent						
Crossing Status: Found						
UCIP Comments: 05/01/2014 Dense vegetation limits the inspector's visibility to identify signs of pipe failure (leaks) along the slope. Recommend removing vegetation along pipe alignment to conduct proper inspection of structure. (DWR UCIP - O. Magana)						
FIELD_STRUCT_DESC: 24-inch corrugated metal gravity drainage pipe through the levee, 7.7 feet below the crown. Flap gate on the waterside (WS) end. Brass cap No. 125 bench mark (BM) on the headwall on the landside (LS). [Additional Reference(s): DWR Levee Log, 2002. USACE San Joaquin O&M Manual 601.1, 1967, (HLM 6.50)].						
FS Date: 5/1/2014

View of waterward side.

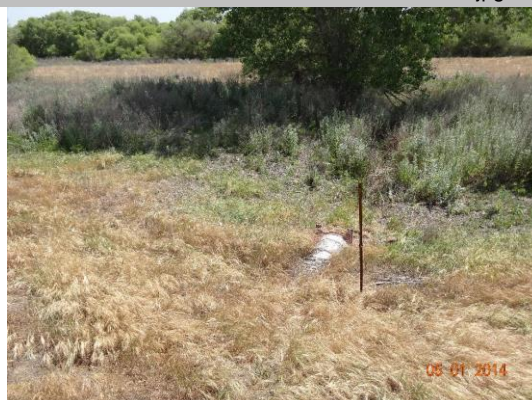
Photo 2 of 3 : UCIP_FA_2019_36519_66172.jpg

Crossing and flap gate visible on waterward side.

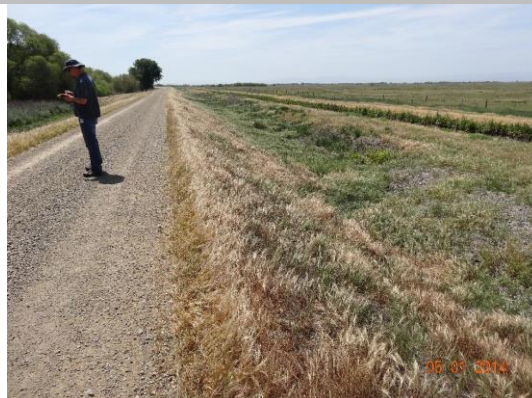
Photo 3 of 3 : UCIP_FA_2019_36519_66174.jpg

Comment Code						
Inspector Comment						
DS_ID:19670 FS_ID:36519 EP_NO: N/A Repair Type: Non-Urgent Crossing Status: Found UCIP Comments: 05/01/2014 Dense vegetation limits the inspector's visibility to identify signs of pipe failure (leaks) along the slope. Recommend removing vegetation along pipe alignment to conduct proper inspection of structure. (DWR UCIP - O. Magana) FIELD_STRUCT_DESC: 24-inch corrugated metal gravity drainage pipe through the levee, 7.7 feet below the crown. Flap gate on the waterside (WS) end. Brass cap No. 125 bench mark (BM) on the headwall on the landside (LS). [Additional Reference(s): DWR Levee Log, 2002. USACE San Joaquin O&M Manual 601.1, 1967, (HLM 6.50)]. FS Date: 5/1/2014

Overview of levee crown and landward slope.

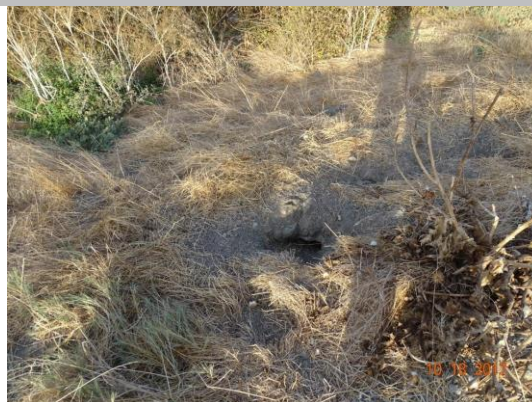
Photo 1 of 1 : FA_2019_NA0010_119_28_20190912_00009.jpg

LM Start	6.97	Rating **	M	Issue No.	28
LM End	6.97	Issue Type +	Ma	Location *	LS
Category	Earthen Levee			GPS Latitude/Longitude	
				Start	End
Item	Animal Control			37.241125 °	37.241125 °
				-120.821747 °	-120.821747 °
DWR ID	DWR_NA0010_02A_f_2017_28				
Comment Code					
A3 : No rodents visible, but rodent burrows visible; need to backfill and compact or grout burrows.					
Inspector Comment

Looking northwest at landside slope.

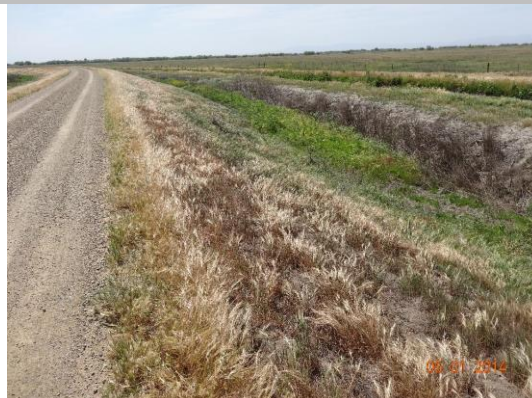
Photo 1 of 3 : UCIP_FA_2019_39365_66178.jpg

DS_ID:19671
FS_ID:39365
EP_NO: N/A
Repair Type: Non-Urgent
Crossing Status: Found
UCIP Comments: 05/01/2014 Dense vegetation limits the inspector's visibility to identify signs of pipe failure (leaks) along the slope. Recommend removing vegetation along pipe alignment to conduct proper inspection of structure. Pipe extension visible on landward side-- need to contact owner for additional information about extension/modification. (DWR UCIP - O. Magana)
FIELD_STRUCT_DESC: 24-inch corrugated metal gravity drainage pipe through the levee, 12.6 feet below the crown. Flap gate on the waterside (WS) end. Brass cap No. 125 bench mark (BM) on the headwall on the landside (LS). [Additional Reference(s): DWR Levee Log, 2002. USACE San Joaquin O&M Manual 601.1, 1967, (HLM 7.05)].
FS Date: 5/1/2014

View of landward side.

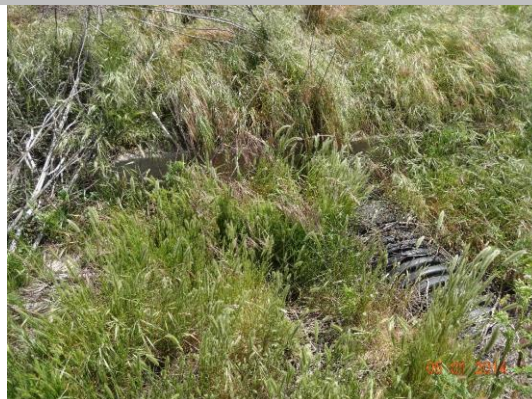
Photo 2 of 3 : UCIP_FA_2019_39365_66177.jpg

Pipe extension visible on landward side attached to inlet at concrete headwall.

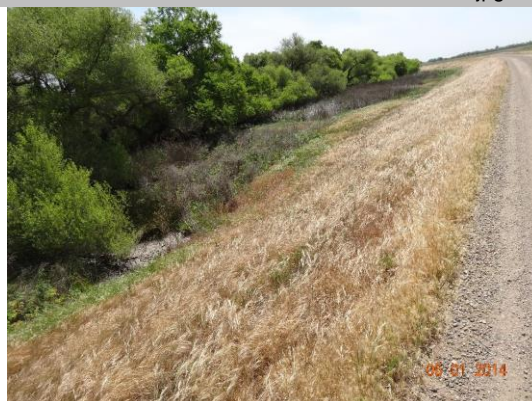
Photo 3 of 3 : UCIP_FA_2019_39365_66176.jpg

Comment Code						
Inspector Comment						
DS_ID:19671 FS_ID:39365 EP_NO: N/A Repair Type: Non-Urgent Crossing Status: Found UCIP Comments: 05/01/2014 Dense vegetation limits the inspector's visibility to identify signs of pipe failure (leaks) along the slope. Recommend removing vegetation along pipe alignment to conduct proper inspection of structure. Pipe extension visible on landward side--need to contact owner for additional information about extension/modification. (DWR UCIP - O. Magana) FIELD_STRUCT_DESC: 24-inch corrugated metal gravity drainage pipe through the levee, 12.6 feet below the crown. Flap gate on the waterside (WS) end. Brass cap No. 125 bench mark (BM) on the headwall on the landside (LS). [Additional Reference(s): DWR Levee Log, 2002. USACE San Joaquin O&M Manual 601.1, 1967, (HLM 7.05)]. FS Date: 5/1/2014

View of waterward side.

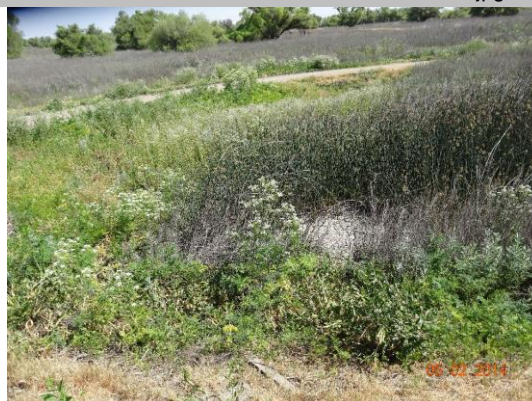
Photo 1 of 3 : UCIP_FA_2019_36521_66183.jpg

Comment Code						
Inspector Comment						
DS_ID:19673						
FS_ID:36521						
EP_NO: N/A						
Repair Type: Non-Urgent						
Crossing Status: Found						
UCIP Comments: 05/01/2014 Dense vegetation limits the inspector's visibility to identify signs of pipe failure (leaks) along the slope.						
Recommend removing vegetation along pipe alignment to conduct proper inspection of structure. (DWR UCIP - O. Magana)						
FIELD_STRUCT_DESC: 24-inch corrugated metal gravity drainage pipe through the levee, 8 feet below the crown. Flap gate on the waterside (WS) end. Brass cap No. 125 bench mark (BM) on the headwall on the landside (LS). [Additional Reference(s): DWR Levee Log, 2002. USACE San Joaquin O&M Manual 601.1, 1967, (HLM 7.77)].						
FS Date: 5/1/2014

View of waterward side.

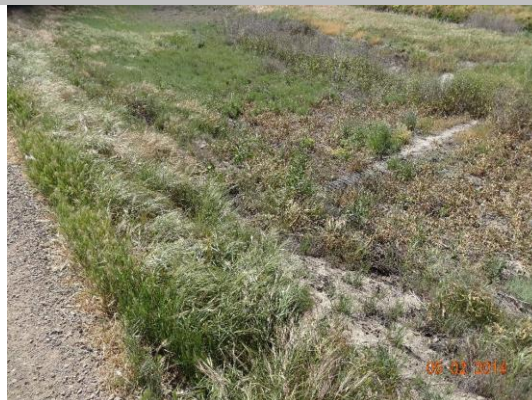
Photo 2 of 3 : UCIP_FA_2019_36521_66182.jpg

View of landward side.

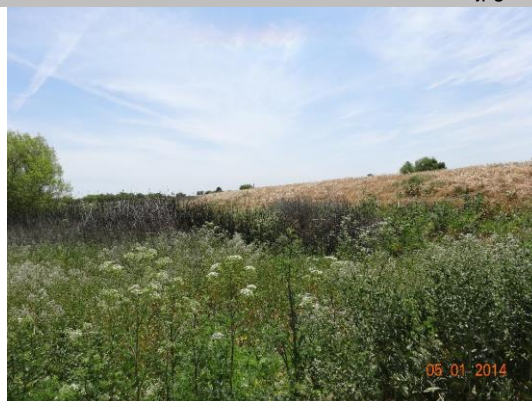
Photo 3 of 3 : UCIP_FA_2019_36521_66181.jpg

Comment Code						
Inspector Comment						
DS_ID:19673						
FS_ID:36521						
EP_NO: N/A						
Repair Type: Non-Urgent						
Crossing Status: Found						
UCIP Comments: 05/01/2014 Dense vegetation limits the inspector's visibility to identify signs of pipe failure (leaks) along the slope. Recommend removing vegetation along pipe alignment to conduct proper inspection of structure. (DWR UCIP - O. Magana)						
FIELD_STRUCT_DESC: 24-inch corrugated metal gravity drainage pipe through the levee, 8 feet below the crown. Flap gate on the waterside (WS) end. Brass cap No. 125 bench mark (BM) on the headwall on the landside (LS). [Additional Reference(s): DWR Levee Log, 2002. USACE San Joaquin O&M Manual 601.1, 1967, (HLM 7.77)].						
FS Date: 5/1/2014

View of waterward side--photo taken from levee toe looking towards alignment of crossing.

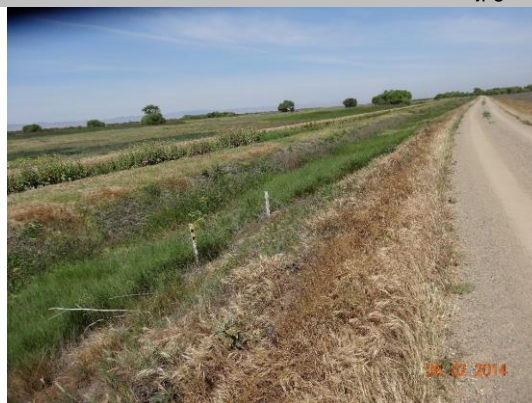
Photo 1 of 3 : UCIP_FA_2019_39366_66184.jpg

Comment Code						
Inspector Comment						
DS_ID:19674						
FS_ID:39366						
EP_NO: N/A						
Repair Type: Non-Urgent						
Crossing Status: Found						
UCIP Comments: 05/14/2014 Dense vegetation limits the inspector's visibility to identify signs of pipe failure (leaks) along the slope and landward headwall. Recommend removing vegetation along pipe alignment and toe to conduct proper inspection of structure. Sediment buildup in pipe visible from landward side--recommend clearing. (DWR UCIP - O. Magana)						
FIELD_STRUCT_DESC: 24-inch corrugated metal gravity drainage pipe through the levee, 9 feet below the crown. Flap gate on the waterside (WS) end. Brass cap No. 120 bench mark (BM) on the headwall on the landside (LS). [Additional Reference(s): DWR Levee Log, 2002. USACE San Joaquin O&M Manual 601.1, 1967, (HLM 8.16)].						
FS Date: 5/14/2014

View of landward side.

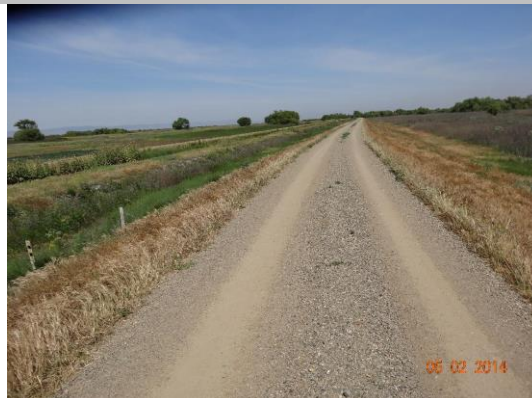
Photo 2 of 3 : UCIP_FA_2019_39366_66185.jpg

Comment Code						
Inspector Comment						
DS_ID:19674 FS_ID:39366 EP_NO: N/A Repair Type: Non-Urgent Crossing Status: Found UCIP Comments: 05/14/2014 Dense vegetation limits the inspector's visibility to identify signs of pipe failure (leaks) along the slope and landward headwall. Recommend removing vegetation along pipe alignment and toe to conduct proper inspection of structure. Sediment buildup in pipe visible from landward side--recommend clearing. (DWR UCIP - O. Magana) FIELD_STRUCT_DESC: 24-inch corrugated metal gravity drainage pipe through the levee, 9 feet below the crown. Flap gate on the waterside (WS) end. Brass cap No. 120 bench mark (BM) on the headwall on the landside (LS). [Additional Reference(s): DWR Levee Log, 2002. USACE San Joaquin O&M Manual 601.1, 1967, (HLM 8.16)]. FS Date: 5/14/2014

Overview of levee crown at crossing.

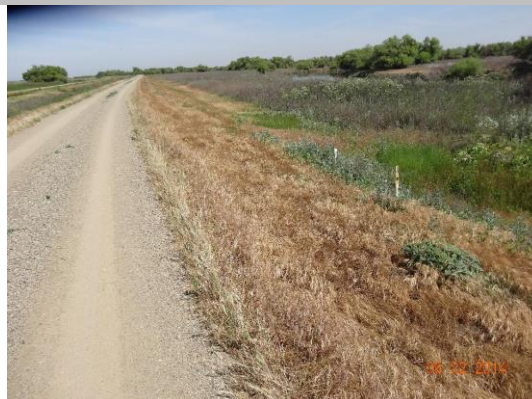
Photo 3 of 3 : UCIP_FA_2019_39366_66186.jpg

View of waterward side.

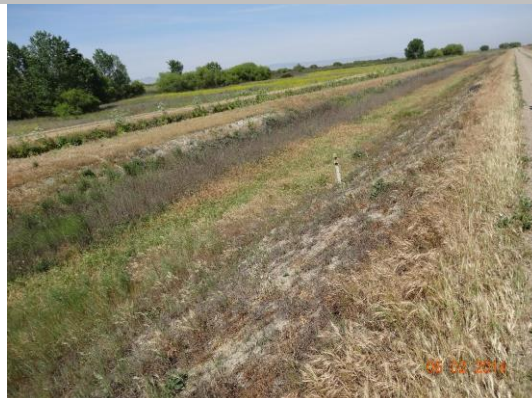
Photo 1 of 3 : UCIP_FA_2019_39367_66195.jpg

Comment Code						
Inspector Comment						
DS_ID:19675 FS_ID:39367 EP_NO: N/A Repair Type: Non-Urgent Crossing Status: Found UCIP Comments: 05/14/2014 Dense vegetation on landward toe. Also dense vegetation limits the inspector's visibility to identify signs of pipe failure (leaks) along waterward slope. Recommend removing vegetation along pipe alignment toe to conduct proper inspection of structure. Sediment buildup in pipe--recommend clearing. (DWR UCIP - O. Magana) FIELD_STRUCT_DESC: 24-inch corrugated metal gravity drainage pipe through the levee, 9.4 feet below the crown. Flap gate on the waterside (WS) end. Brass cap No. 120 bench mark (BM) on the headwall on the landside (LS). [Additional Reference(s): DWR Levee Log, 2002. USACE San Joaquin O&M Manual 601.1, 1967, (HLM 8.48)]. FS Date: 5/14/2014

View of landward side.

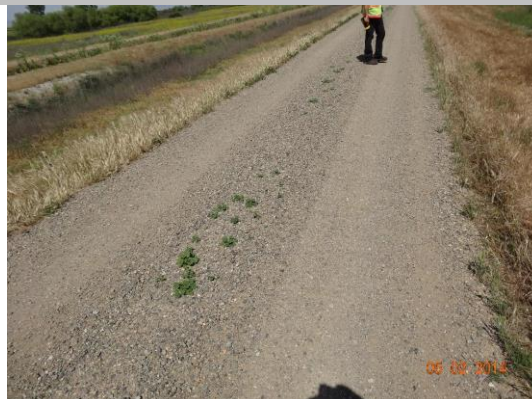
Photo 2 of 3 : UCIP_FA_2019_39367_66193.jpg

Overview of levee crown at crossing.

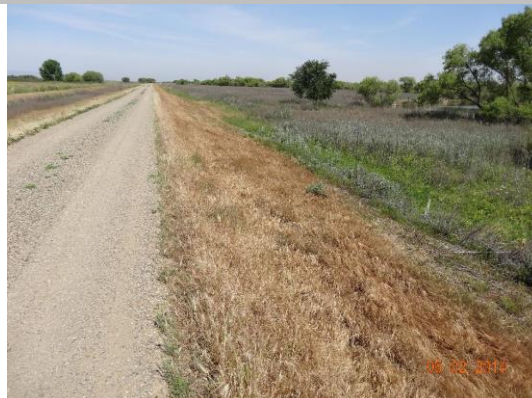
Photo 3 of 3 : UCIP_FA_2019_39367_66194.jpg

Comment Code						
Inspector Comment						
DS_ID:19675 FS_ID:39367 EP_NO: N/A Repair Type: Non-Urgent Crossing Status: Found UCIP Comments: 05/14/2014 Dense vegetation on landward toe. Also dense vegetation limits the inspector's visibility to identify signs of pipe failure (leaks) along waterward slope. Recommend removing vegetation along pipe alignment toe to conduct proper inspection of structure. Sediment buildup in pipe--recommend clearing. (DWR UCIP - O. Magana) FIELD_STRUCT_DESC: 24-inch corrugated metal gravity drainage pipe through the levee, 9.4 feet below the crown. Flap gate on the waterside (WS) end. Brass cap No. 120 bench mark (BM) on the headwall on the landside (LS). [Additional Reference(s): DWR Levee Log, 2002. USACE San Joaquin O&M Manual 601.1, 1967, (HLM 8.48)]. FS Date: 5/14/2014

View of waterward side.

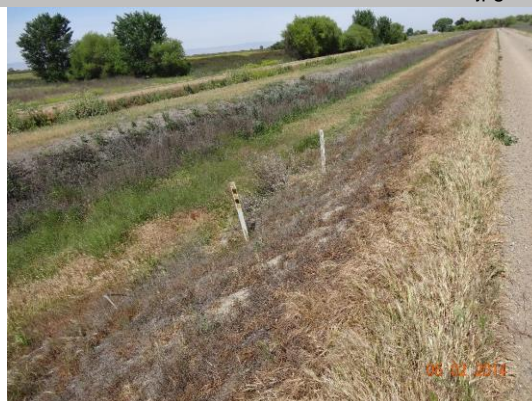
Photo 1 of 3 : UCIP_FA_2019_42503_66200.jpg

Comment Code					
Inspector Comment					
DS_ID:19676 FS_ID:42503 EP_NO: N/A Repair Type: Non-Urgent Crossing Status: Found UCIP Comments: 05/14/2014 Dense vegetation limits the inspector's visibility to identify signs of pipe failure (leaks) along the slope. Recommend removing vegetation along pipe alignment to conduct proper inspection of structure. Burrow activity presen on waterward slope. (DWR UCIP - O. Magana) FIELD_STRUCT_DESC: 24-inch corrugated metal gravity drainage pipe through the levee, 8.8 feet below the crown. Flap gate on the waterside (WS) end. Brass cap No. 120 bench mark (BM) on the headwall on the landside (LS). [Additional Reference(s): DWR Levee Log, 2002. USACE San Joaquin O&M Manual 601.1, 1967, (recorded as HLM 9.86 should be 8.86)]. FS Date: 5/14/2014

View of landward side.

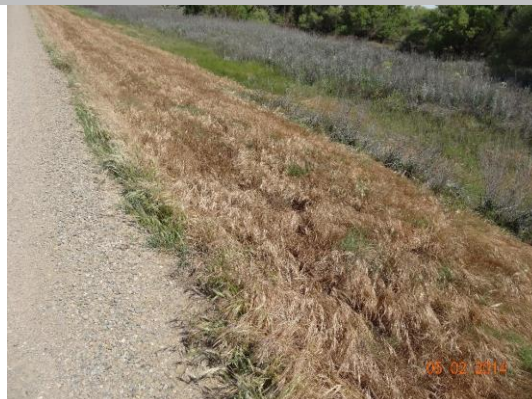
Photo 2 of 3 : UCIP_FA_2019_42503_66199.jpg

View of waterward side.

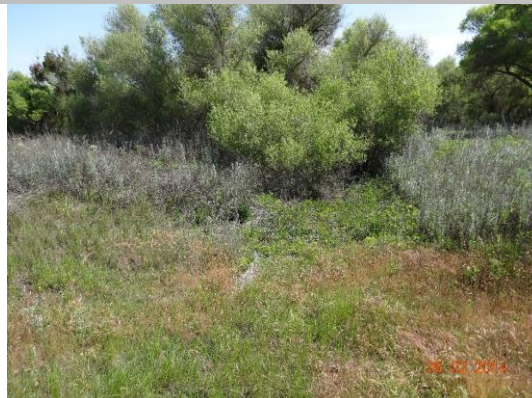
Photo 3 of 3 : UCIP_FA_2019_42503_66201.jpg

Comment Code						
Inspector Comment						
DS_ID:19676 FS_ID:42503 EP_NO: N/A Repair Type: Non-Urgent Crossing Status: Found UCIP Comments: 05/14/2014 Dense vegetation limits the inspector's visibility to identify signs of pipe failure (leaks) along the slope. Recommend removing vegetation along pipe alignment to conduct proper inspection of structure. Burrow activity presen on waterward slope. (DWR UCIP - O. Magana) FIELD_STRUCT_DESC: 24-inch corrugated metal gravity drainage pipe through the levee, 8.8 feet below the crown. Flap gate on the waterside (WS) end. Brass cap No. 120 bench mark (BM) on the headwall on the landside (LS). [Additional Reference(s): DWR Levee Log, 2002. USACE San Joaquin O&M Manual 601.1, 1967, (recorded as HLM 9.86 should be 8.86)]. FS Date: 5/14/2014

View of waterward toe.

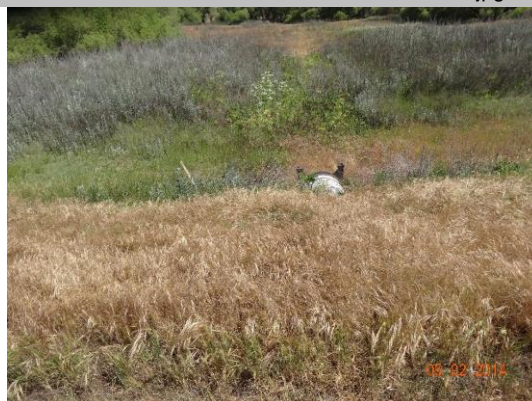
Photo 1 of 3 : UCIP_FA_2019_36525_66208.jpg

Comment Code						
Inspector Comment						
DS_ID:19677 FS_ID:36525 EP_NO: N/A Repair Type: Non-Urgent Crossing Status: Found UCIP Comments: 05/14/2014 Dense vegetation limits the inspector's visibility to identify signs of pipe failure (leaks) along the slope. Recommend removing vegetation along pipe alignment to conduct proper inspection of structure. (DWR UCIP - O. Magana) FIELD_STRUCT_DESC: 36-inch corrugated metal gravity drainage pipe through the levee, 8.8 feet below the crown. Flap gate on the waterside (WS) end. Brass cap No. 120 bench mark (BM) on the headwall on the landside (LS). [Additional Reference(s): DWR Levee Log, 2002. USACE San Joaquin O&M Manual 601.1, 1967, (HLM 9.02)]. FS Date: 5/14/2014

View of waterward side--pipe and flap gate visible.

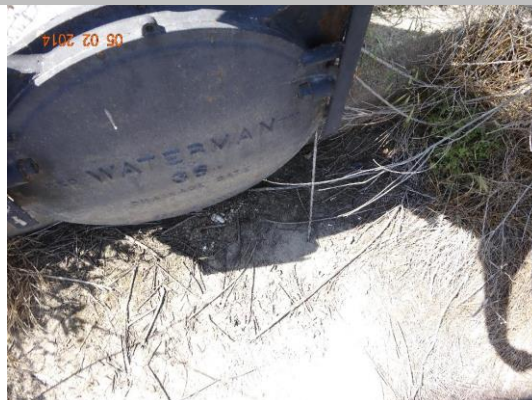
Photo 2 of 3 : UCIP_FA_2019_36525_66207.jpg

View of flap gate visible from waterward side.

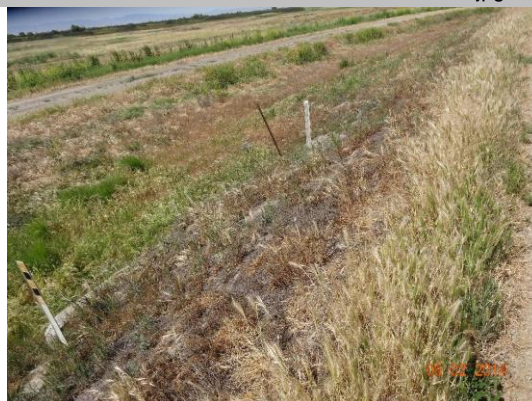
Photo 3 of 3 : UCIP_FA_2019_36525_66206.jpg

Comment Code						
Inspector Comment						
DS_ID:19677 FS_ID:36525 EP_NO: N/A Repair Type: Non-Urgent Crossing Status: Found UCIP Comments: 05/14/2014 Dense vegetation limits the inspector's visibility to identify signs of pipe failure (leaks) along the slope. Recommend removing vegetation along pipe alignment to conduct proper inspection of structure. (DWR UCIP - O. Magana) FIELD_STRUCT_DESC: 36-inch corrugated metal gravity drainage pipe through the levee, 8.8 feet below the crown. Flap gate on the waterside (WS) end. Brass cap No. 120 bench mark (BM) on the headwall on the landside (LS). [Additional Reference(s): DWR Levee Log, 2002. USACE San Joaquin O&M Manual 601.1, 1967, (HLM 9.02)]. FS Date: 5/14/2014

View of landward side.

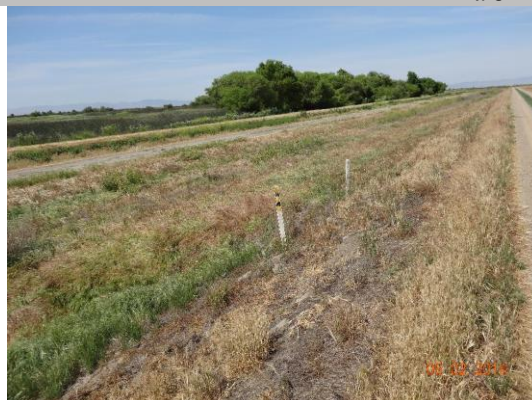
Photo 1 of 3 : UCIP_FA_2019_40443_66211.jpg

Comment Code						
Inspector Comment						
DS_ID:19678						
FS_ID:40443						
EP_NO: N/A						
Repair Type: Non-Urgent						
Crossing Status: Found						
UCIP Comments: 05/14/2014 Dense vegetation limits the inspector's						
visibility to identify signs of pipe failure (leaks) along the slope.						
Recommend removing vegetation along pipe alignment to conduct						
proper inspection of structure. (DWR UCIP - O. Magana)						
FIELD_STRUCT_DESC: 24-inch corrugated metal gravity drainage pipe						
through the levee, 8 feet below the crown. Flap gate on the waterside						
(WS) end. Brass cap No. 120 bench mark (BM) on the headwall on the						
landside (LS). [Additional Reference(s): DWR Levee Log, 2002. USACE						
San Joaquin O&M Manual 601.1, 1967, (HLM 9.20)].						
FS Date: 5/14/2014

View of landward side.

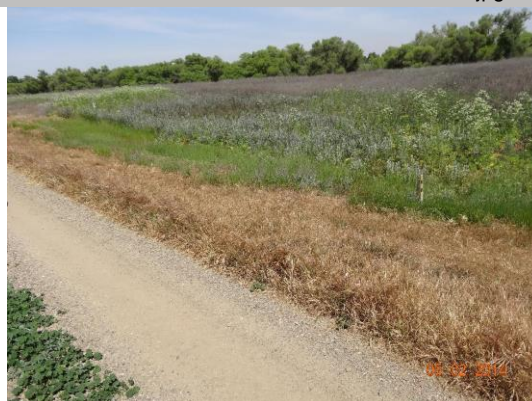
Photo 2 of 3 : UCIP_FA_2019_40443_66210.jpg

Comment Code						
Inspector Comment						
DS_ID:19678 FS_ID:40443 EP_NO: N/A Repair Type: Non-Urgent Crossing Status: Found UCIP Comments: 05/14/2014 Dense vegetation limits the inspector's visibility to identify signs of pipe failure (leaks) along the slope. Recommend removing vegetation along pipe alignment to conduct proper inspection of structure. (DWR UCIP - O. Magana) FIELD_STRUCT_DESC: 24-inch corrugated metal gravity drainage pipe through the levee, 8 feet below the crown. Flap gate on the waterside (WS) end. Brass cap No. 120 bench mark (BM) on the headwall on the landside (LS). [Additional Reference(s): DWR Levee Log, 2002. USACE San Joaquin O&M Manual 601.1, 1967, (HLM 9.20)]. FS Date: 5/14/2014

View of waterward side.

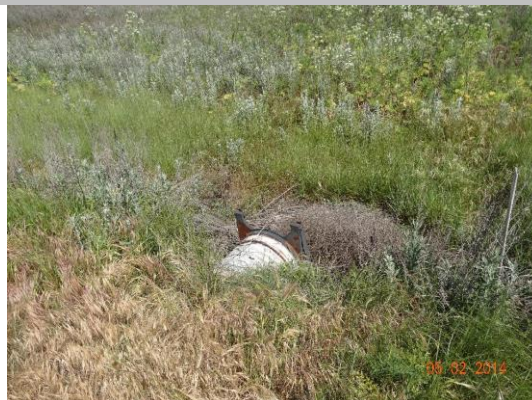
Photo 3 of 3 : UCIP_FA_2019_40443_66209.jpg

Pipe visible on waterward side.

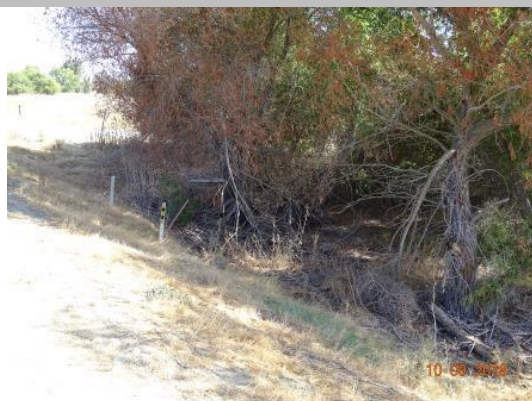
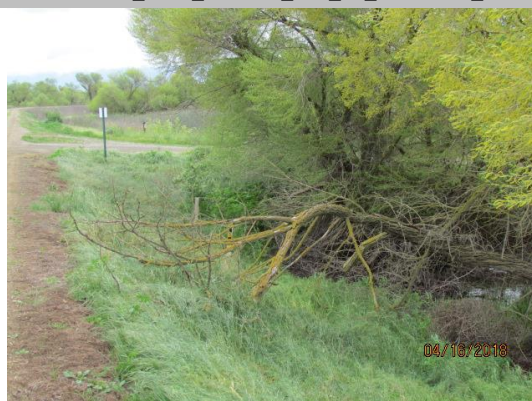
LM Start	9.42	Rating **	M	Issue No.	17
LM End	9.42	Issue Type +	Ma	Location *	LS
Category	Earthen Levee			GPS Latitude/Longitude	
				Start	End
Item	Trim / Thin Trees			37.220199°	37.220199°
				-120.788748°	-120.788748°
DWR ID	DWR_NA0010_02B_f_2016_17				
Comment Code					
T3 : Trim and thin trees to allow visibility of the ground and room to flood fight.					
Inspector Comment					
Trim back dead tree limbs on landside toe.

View of dead branches on landside toe. (Fall 2018)

Looking north at broken tree limbs and branches on landward slope. (Spring 2018)

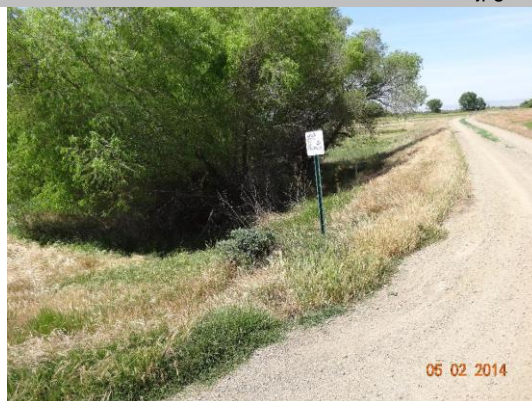
Photo 1 of 3 : UCIP_FA_2019_36527_66217.jpg

Comment Code						
Inspector Comment						
DS_ID:19686						
FS_ID:36527						
EP_NO: N/A						
Repair Type: Non-Urgent						
Crossing Status: Found						
UCIP Comments: 05/14/2014 Dense vegetation limits the inspector's visibility to identify signs of pipe failure (leaks) along the slope. Recommend removing vegetation along pipe alignment to conduct proper inspection of structure. (DWR UCIP - O. Magana)						
FIELD_STRUCT_DESC: 24-inch corrugated metal gravity drainage pipe through the levee, 9 feet below the crown. Flap gate on the waterside (WS) end. Brass cap No. 115 bench mark (BM) on the headwall on the landside (LS). [Additional Reference(s): DWR Levee Log, 2002. USACE San Joaquin O&M Manual 601.1, 1967, (HLM 9.46)].						
FS Date: 5/14/2014

View of landward side.

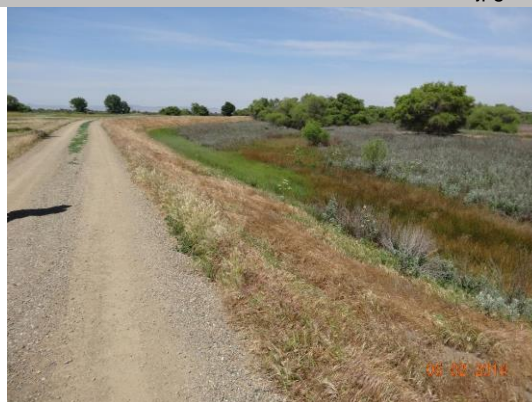
Photo 2 of 3 : UCIP_FA_2019_36527_66216.jpg

View of waterward side.

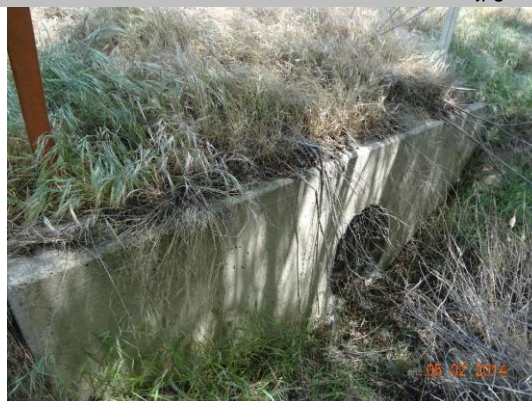
Photo 3 of 3 : UCIP_FA_2019_36527_66215.jpg

Comment Code						
Inspector Comment						
DS_ID:19686 FS_ID:36527 EP_NO: N/A Repair Type: Non-Urgent Crossing Status: Found UCIP Comments: 05/14/2014 Dense vegetation limits the inspector's visibility to identify signs of pipe failure (leaks) along the slope. Recommend removing vegetation along pipe alignment to conduct proper inspection of structure. (DWR UCIP - O. Magana) FIELD_STRUCT_DESC: 24-inch corrugated metal gravity drainage pipe through the levee, 9 feet below the crown. Flap gate on the waterside (WS) end. Brass cap No. 115 bench mark (BM) on the headwall on the landside (LS). [Additional Reference(s): DWR Levee Log, 2002. USACE San Joaquin O&M Manual 601.1, 1967, (HLM 9.46)]. FS Date: 5/14/2014

Concrete headwall visible on landward side.

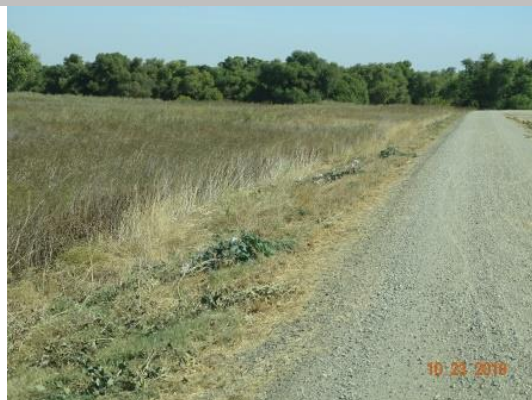
Photo 1 of 1 : FA_2019_NA0010_120_19_20191107_00050.jpg

LM Start	9.44	Rating **	M	Issue No.	19
LM End	9.76	Issue Type +	Ma	Location *	WS
Category	Earthen Levee			GPS Latitude/Longitude	
				Start	End
Item	Vegetation			37.220281 °	37.219048 °
				-120.788429 °	-120.784360 °
DWR ID	DWR_NA0010_02B_f_2019_19				
Comment Code					
V1 : Control annual grass and weeds on the levee slopes and easements.					
Inspector Comment

View of the waterside slope looking upstream. (Fall 2019)

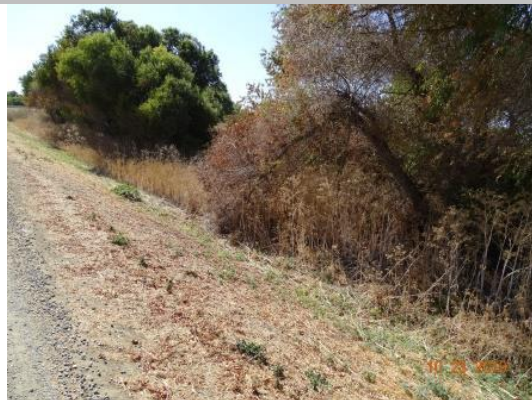
Photo 1 of 1 : FA_2019_NA0010_120_20_20191107_00048.jpg

LM Start	9.90	Rating **	M	Issue No.	20
LM End	9.90	Issue Type +	Ma	Location *	LS
Category	Earthen Levee			GPS Latitude/Longitude	
				Start	End
Item	Trim / Thin Trees			37.216923 °	37.216923 °
				-120.784007 °	-120.784007 °
DWR ID	DWR_NA0010_02B_f_2019_20				
Comment Code					
T1 : Trim trees to at least five feet above ground level.					
Inspector Comment					
Dead tree limb hanging on landside toe.

View of broken tree limb hanging over landside slope and toe. (Fall 2019)

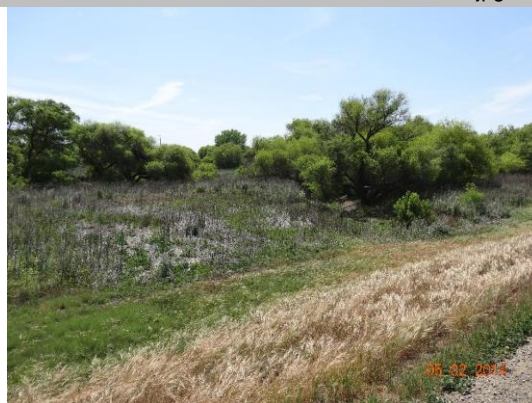
Photo 1 of 3 : UCIP_FA_2019_36528_66224.jpg

Comment Code					
Inspector Comment					
DS_ID:19687 FS_ID:36528 EP_NO: N/A Repair Type: Non-Urgent Crossing Status: Found UCIP Comments: 05/14/2014 Dense vegetation limits the inspector's visibility to identify signs of pipe failure (leaks) along the slope. Recommend removing vegetation along pipe alignment to conduct proper inspection of structure. (DWR UCIP - O. Magana) FIELD_STRUCT_DESC: 24-inch corrugated metal gravity drainage pipe through the levee, 11.7 feet below the crown. Flap gate on the waterside (WS) end. Brass cap No. 115 bench mark (BM) on the headwall on the landside (LS). [Additional Reference(s): DWR Levee Log, 2002. USACE San Joaquin O&M Manual 601.1, 1967, (HLM 10.12)]. FS Date: 5/14/2014

Overview of waterward side.

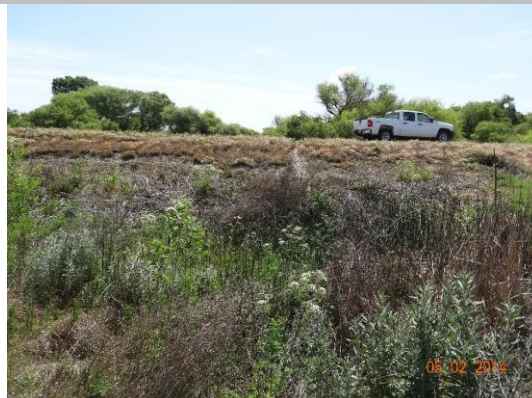
Photo 2 of 3 : UCIP_FA_2019_36528_66226.jpg

Comment Code						
Inspector Comment						
DS_ID:19687						
FS_ID:36528						
EP_NO: N/A						
Repair Type: Non-Urgent						
Crossing Status: Found						
UCIP Comments: 05/14/2014 Dense vegetation limits the inspector's visibility to identify signs of pipe failure (leaks) along the slope.						
Recommend removing vegetation along pipe alignment to conduct proper inspection of structure. (DWR UCIP - O. Magana)						
FIELD_STRUCT_DESC: 24-inch corrugated metal gravity drainage pipe through the levee, 11.7 feet below the crown. Flap gate on the waterside (WS) end. Brass cap No. 115 bench mark (BM) on the headwall on the landside (LS). [Additional Reference(s): DWR Levee Log, 2002. USACE San Joaquin O&M Manual 601.1, 1967, (HLM 10.12)].						
FS Date: 5/14/2014

View of waterward slope.

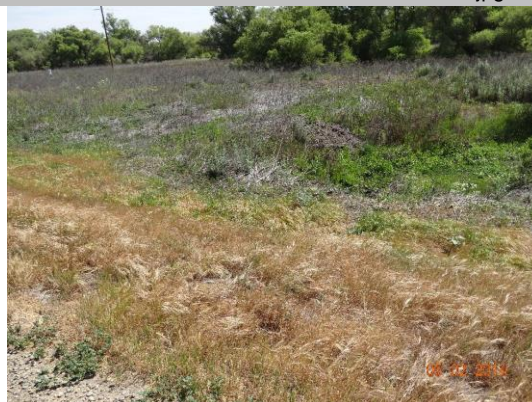
Photo 3 of 3 : UCIP_FA_2019_36528_66222.jpg

View of waterward side.

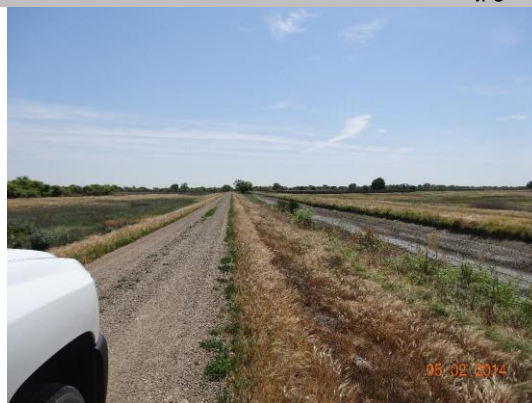
Photo 1 of 3 : UCIP_FA_2019_42504_66231.jpg

Comment Code						
Inspector Comment						
DS_ID:19688						
FS_ID:42504						
EP_NO: N/A						
Repair Type: Non-Urgent						
Crossing Status: Found						
UCIP Comments: 05/14/2014 Dense vegetation limits the inspector's						
visibility to identify signs of pipe failure (leaks) along the slope.						
Recommend removing vegetation along pipe alignment to conduct						
proper inspection of structure. Sediment buildup in pipe visible on						
landward side--recommend clearing. (DWR UCIP - O. Magana)						
FIELD_STRUCT_DESC: 24-inch corrugated metal gravity drainage pipe						
through the levee, 8 feet below the crown. Flap gate on the waterside						
(WS) end. Brass cap No. 115 bench mark (BM) on the headwall on the						
landside (LS). [Additional Reference(s): DWR Levee Log, 2002. USACE						
San Joaquin O&M Manual 601.1, 1967, (HLM 10.81)].						
FS Date: 5/14/2014

View of landward side.

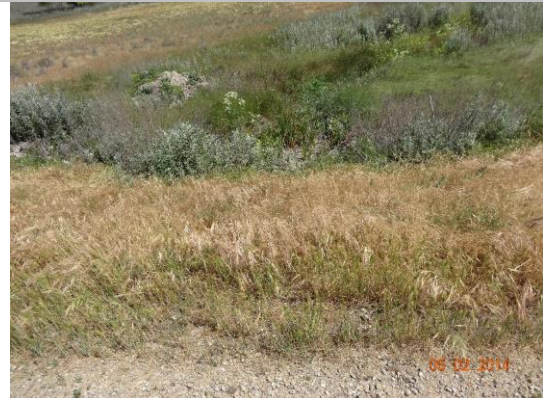
Photo 2 of 3 : UCIP_FA_2019_42504_66232.jpg

Comment Code						
Inspector Comment						
DS_ID:19688 FS_ID:42504 EP_NO: N/A Repair Type: Non-Urgent Crossing Status: Found UCIP Comments: 05/14/2014 Dense vegetation limits the inspector's visibility to identify signs of pipe failure (leaks) along the slope. Recommend removing vegetation along pipe alignment to conduct proper inspection of structure. Sediment buildup in pipe visible on landward side--recommend clearing. (DWR UCIP - O. Magana) FIELD_STRUCT_DESC: 24-inch corrugated metal gravity drainage pipe through the levee, 8 feet below the crown. Flap gate on the waterside (WS) end. Brass cap No. 115 bench mark (BM) on the headwall on the landside (LS). [Additional Reference(s): DWR Levee Log, 2002. USACE San Joaquin O&M Manual 601.1, 1967, (HLM 10.81)]. FS Date: 5/14/2014

View of waterward side.

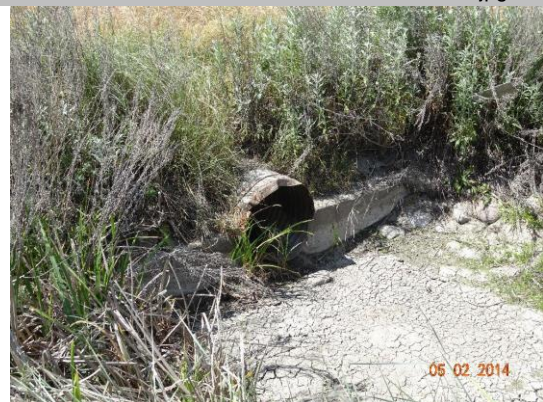
Photo 3 of 3 : UCIP_FA_2019_42504_66234.jpg

View of pipe visible on waterward side.

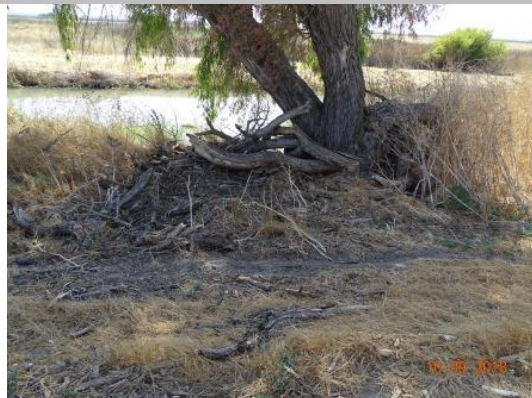
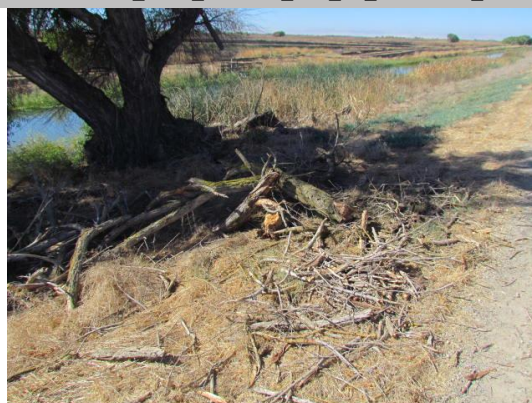
LM Start	10.94	Rating **	M	Issue No.	14
LM End	10.94	Issue Type +	Ma	Location *	LS
Category	Earthen Levee			GPS Latitude/Longitude	
				Start	End
Item	Encroachments			37.205711 °	37.205711 °
				-120.774741 °	-120.774741 °
DWR ID	DWR_NA0010_02B_f_2015_14				
Comment Code					
PR : Prunings					
Inspector Comment					
Remove prunings from landside toe.

Prunings at landside toe. (Fall 2018)

Looking at prunings on landward slope. (Spring 2018)

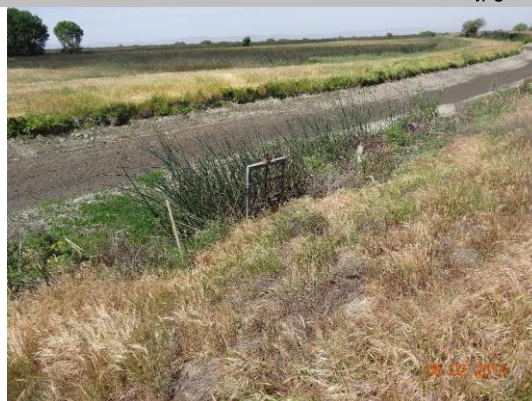
Photo 1 of 3 : UCIP_FA_2019_36530_66236.jpg

Comment Code					
Inspector Comment					
DS_ID:19689 FS_ID:36530 EP_NO: N/A Repair Type: Non-Urgent Crossing Status: Found UCIP Comments: 05/14/2014 Dense vegetation limits the inspector's visibility to identify signs of pipe failure (leaks) along the slope. Recommend removing vegetation along pipe alignment to conduct proper inspection of structure. (DWR UCIP - O. Magana) FIELD_STRUCT_DESC: 24-inch corrugated metal gravity drainage pipe through the levee, 8 feet below the crown. Flap gate on the waterside (WS) end. Brass cap No. 115 bench mark (BM) on the headwall on the landside (LS). [Additional Reference(s): DWR Levee Log, 2002. USACE San Joaquin O&M Manual 601.1, 1967, (HLM 11.17)]. FS Date: 5/14/2014

View of landward slope.

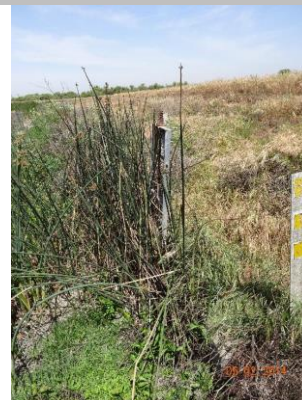
Photo 2 of 3 : UCIP_FA_2019_36530_66235.jpg

Slide gate visible on landward side blocked by vegetation.

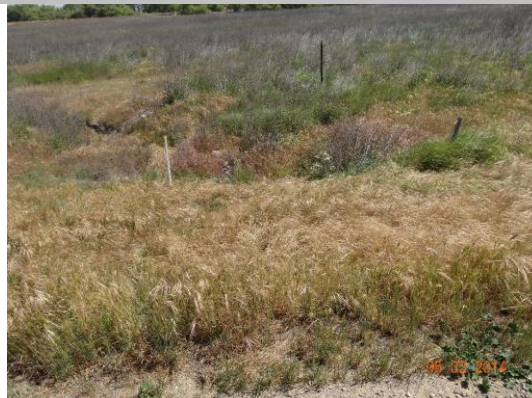
Photo 3 of 3 : UCIP_FA_2019_36530_66238.jpg

Comment Code						
Inspector Comment						
DS_ID:19689						
FS_ID:36530						
EP_NO: N/A						
Repair Type: Non-Urgent						
Crossing Status: Found						
UCIP Comments: 05/14/2014 Dense vegetation limits the inspector's visibility to identify signs of pipe failure (leaks) along the slope. Recommend removing vegetation along pipe alignment to conduct proper inspection of structure. (DWR UCIP - O. Magana)						
FIELD_STRUCT_DESC: 24-inch corrugated metal gravity drainage pipe through the levee, 8 feet below the crown. Flap gate on the waterside (WS) end. Brass cap No. 115 bench mark (BM) on the headwall on the landside (LS). [Additional Reference(s): DWR Levee Log, 2002. USACE San Joaquin O&M Manual 601.1, 1967, (HLM 11.17)].						
FS Date: 5/14/2014

View of waterward side.

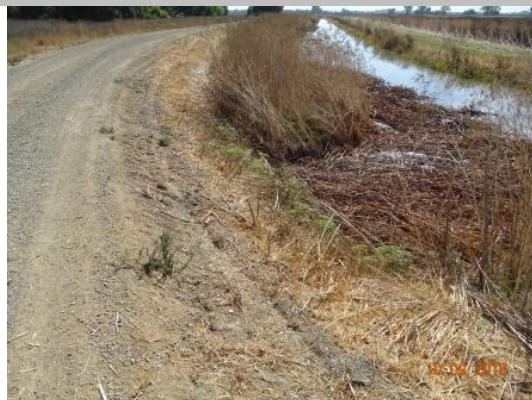
Photo 1 of 2 : FA_2019_NA0010_120_21_20190912_00007.jpg

LM Start	11.39	Rating **	U	Issue No.	21
LM End	11.39	Issue Type +	Ma	Location *	LS
Category	Earthen Levee			GPS Latitude/Longitude	
				Start	End
Item	Erosion / Bank Caving			37.201839 °	37.201839 °
				-120.768489 °	-120.768489 °
DWR ID	DWR_NA0010_02B_f_2018_21				
Comment Code					
E2 : Schedule repair of erosion site prior to the next inspection.					
Inspector Comment					
Erosion occurring into the landside slope of levee.

Erosion into landside slope. Looking upstream. (Fall 2018)

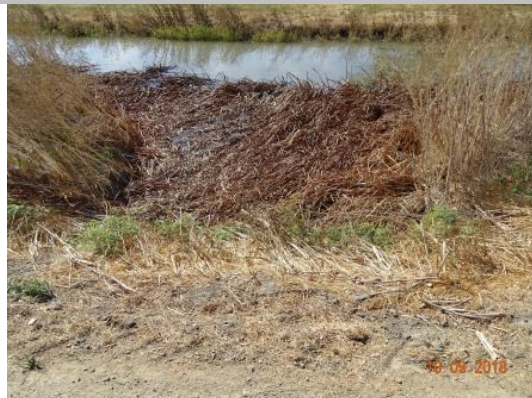
Photo 2 of 2 : FA_2019_NA0010_120_21_20190912_00008.jpg

LM Start	11.39	Rating **	U	Issue No.	21 (cont)	
LM End	11.39	Issue Type +	Ma	Location *	LS	
Category	Earthen Levee			GPS Latitude/Longitude		
				Start		End
Item	Erosion / Bank Caving			37.201839 °		37.201839 °
				-120.768489 °		-120.768489 °
DWR ID	DWR_NA0010_02B_f _ 2018_21					
Comment Code						
E2 : Schedule repair of erosion site prior to the next inspection.						
Inspector Comment						
Erosion occurring into the landside slope of levee.

View of erosion site looking down landside slope. (Fall 2018)

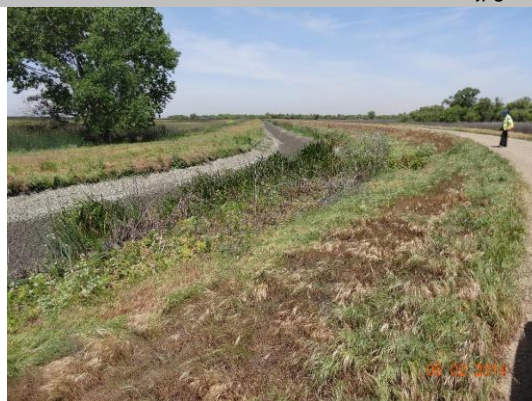
Photo 1 of 3 : UCIP_FA_2019_36531_66241.jpg

Comment Code						
Inspector Comment						
DS_ID:19690 FS_ID:36531 EP_NO: N/A Repair Type: Non-Urgent Crossing Status: Found UCIP Comments: 05/14/2014 Dense vegetation limits the inspector's visibility to identify signs of pipe failure (leaks) along the slope. Recommend removing vegetation along pipe alignment to conduct proper inspection of structure. (DWR UCIP - O. Magana) FIELD_STRUCT_DESC: 24-inch corrugated metal gravity drainage pipe through the levee, 8 feet below the crown. Flap gate on the waterside (WS) end. Screw gate on the landside (LS). [Additional Reference(s): DWR Levee Log, 2002. USACE San Joaquin O&M Manual 601.1, 1967, (HLM 11.43)]. FS Date: 5/14/2014

View of landward side.

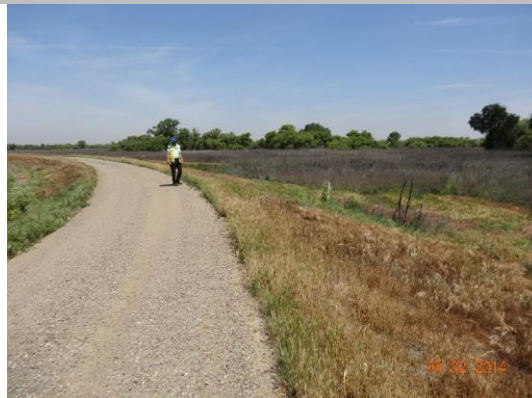
Photo 2 of 3 : UCIP_FA_2019_36531_66240.jpg

View of waterward side.

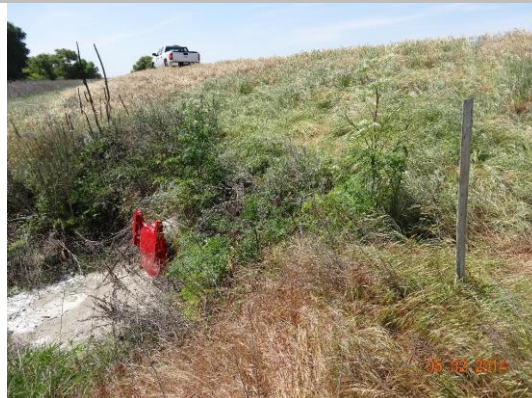
Photo 3 of 3 : UCIP_FA_2019_36531_66239.jpg

Flap gate visible on waterward toe.

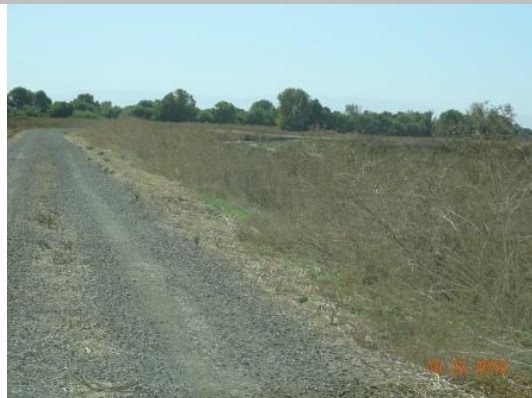
Photo 1 of 1 : FA_2019_NA0010_120_24_20191107_00049.jpg

LM Start	11.77	Rating **	M	Issue No.	24
LM End	13.15	Issue Type +	Ma	Location *	LS
Category	Earthen Levee			GPS Latitude/Longitude	
				Start	End
Item	Vegetation			37.196888 °	37.179656 °
				-120.766995 °	-120.765136 °
DWR ID	DWR_NA0010_02B_f_2019_24				
Comment Code					
V2 : Remove the wild growth other than native grasses from the levee slopes.					
Inspector Comment

View of vegetation along the landside slope looking upstream. (Fall 2019)

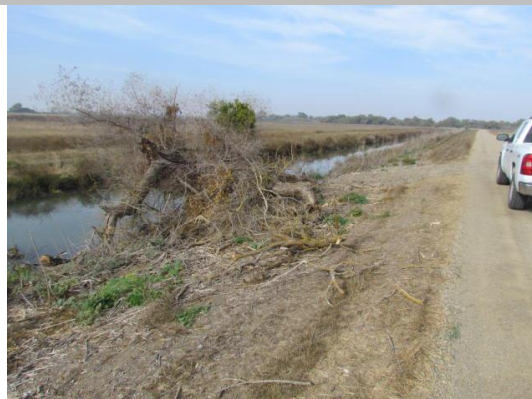
Photo 1 of 2 : FA_2019_NA0010_120_1_20190912_00001.jpg

LM Start	12.21	Rating **	M	Issue No.	1
LM End	12.21	Issue Type +	Ma	Location *	LS
Category	Earthen Levee			GPS Latitude/Longitude	
				Start	End
Item	Encroachments			37.191528 °	37.191528 °
				-120.764541 °	-120.764541 °
DWR ID	DWR_NA0010_02B_f_2014_1				
Comment Code					
TR : Tree or limb					
Inspector Comment					
Fallen tree limbs are located on the landside slope.

Looking northwest at tree limb on landward slope.

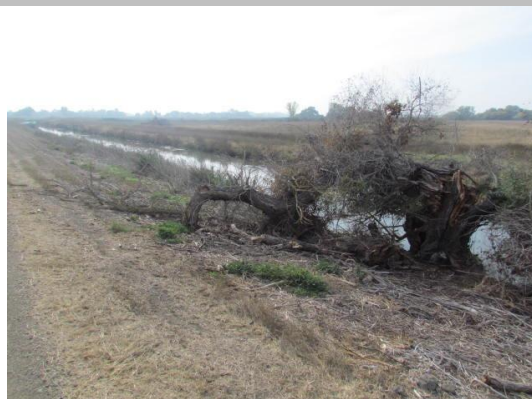
Photo 2 of 2 : FA_2019_NA0010_120_1_20190912_00002.jpg

Looking southwest at tree limb on landward slope.

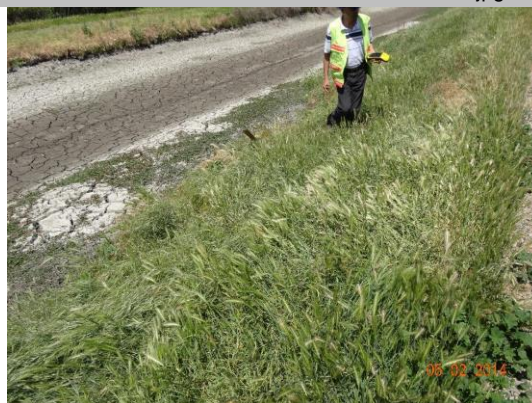
Photo 1 of 3 : UCIP_FA_2019_39370_66245.jpg

Comment Code					
Inspector Comment					
DS_ID:19663 FS_ID:39370 EP_NO: N/A Repair Type: Non-Urgent Crossing Status: Found UCIP Comments: 05/14/2014 Dense vegetation limits the inspector's visibility to identify signs of pipe failure (leaks) along the slope. Recommend removing vegetation along pipe alignment to conduct proper inspection of structure. Sediment buildup in pipe--recommend clearing. (DWR UCIP - O. Magana) FIELD_STRUCT_DESC: 24-inch corrugated metal gravity drainage pipe through the levee, 6.5 feet below the crown. Slide gate in a pipe riser on the waterside (WS) slope. [Additional Reference(s): DWR Levee Log, 2002. USACE San Joaquin O&M Manual 601.1, 1967, (recorded as HLM 13.32 should be 13.22)]. FS Date: 5/14/2014

View of landward side.

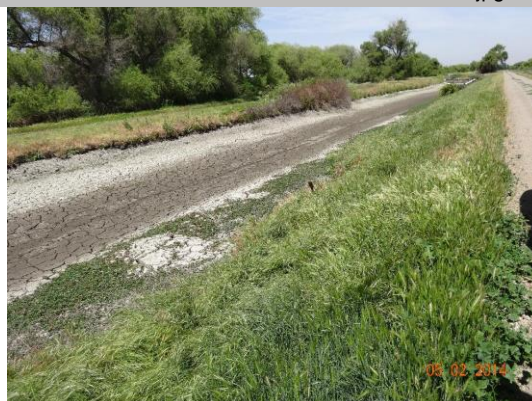
Photo 2 of 3 : UCIP_FA_2019_39370_66244.jpg

Overview of landward slope.

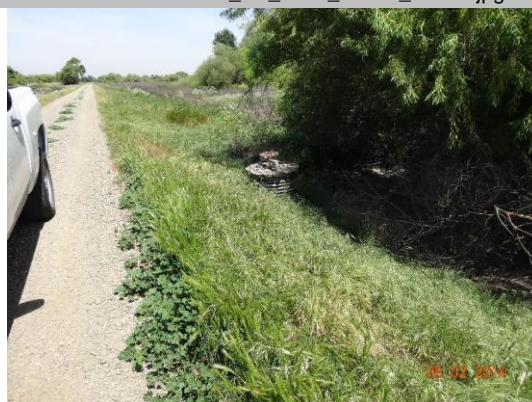
Photo 3 of 3 : UCIP_FA_2019_39370_66243.jpg

View of waterward side.

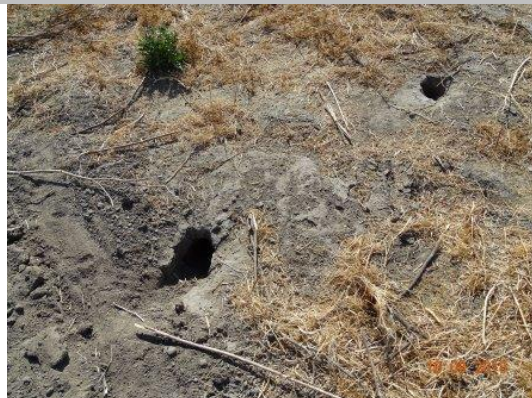
Photo 2 of 2 : FA_2019_NA0010_120_22_20190912_00010.jpg

LM Start	13.73	Rating **	M	Issue No.	22 (cont)
LM End	13.73	Issue Type +	Ma	Location *	WS
Category	Earthen Levee			GPS Latitude/Longitude	
				Start	End
Item	Animal Control			37.172387°	37.172387°
				-120.761190°	-120.761190°
DWR ID	DWR_NA0010_02B_f_2018_22				
Comment Code					
A1 : Exterminate rodents and backfill and compact or grout burrows.					
Inspector Comment					
There are several rodent burrows observed at this location.

Representative view of rodent burrows. (Fall 2018)

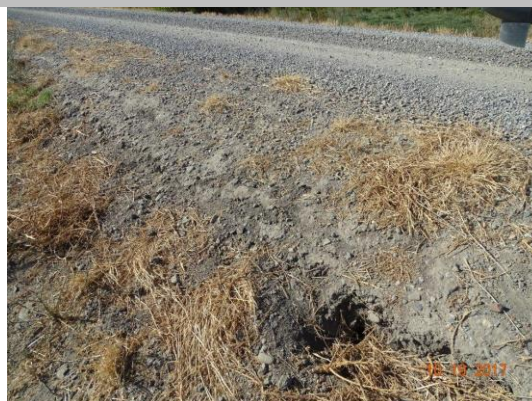
Photo 1 of 1 : FA_2019_NA0010_121_67_20190912_00006.jpg

LM Start	0.19	Rating **	M	Issue No.	67
LM End	0.19	Issue Type +	Ma	Location *	LS
Category	Earthen Levee			GPS Latitude/Longitude	
				Start	End
Item	Animal Control			37.109013 °	37.109013 °
				-120.587799 °	-120.587799 °
DWR ID	DWR_NA0010_03_s_2015_67				
Comment Code					
A3 : No rodents visible, but rodent burrows visible; need to backfill and compact or grout burrows.					
Inspector Comment					
Rodent holes are noted on the landside slope.

Looking southwest at the landside shoulder.

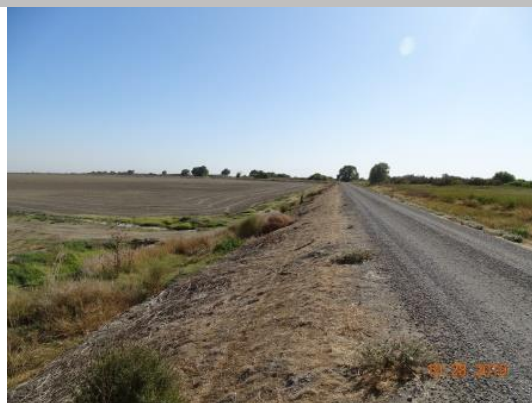
Photo 1 of 1 : FA_2019_NA0010_121_8_20191107_00019.jpg

LM Start	0.39	Rating **	M	Issue No.	8
LM End	0.53	Issue Type +	Ma	Location *	LS
Category	Earthen Levee			GPS Latitude/Longitude	
				Start	End
Item	Vegetation			37.106530 °	37.104879 °
				-120.586116 °	-120.584722 °
DWR ID	DWR_NA0010_03_f_2019_8				
Comment Code					
V1 : Control annual grass and weeds on the levee slopes and easements.					
Inspector Comment

View of the landside slope and toe looking upstream. (Fall 2019)

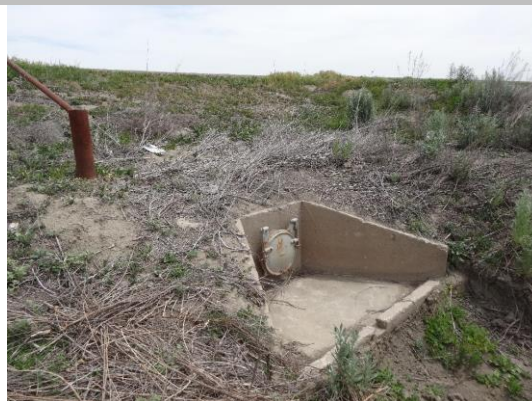
Photo 1 of 3 : UCIP_FA_2019_34083_61941.jpg

LM Start	0.42	Rating **	M	Issue No.	68
LM End	0.42	Issue Type +	Ma	Location *	
Category	Supplemental			GPS Latitude/Longitude	
				Start	End
Item	DRAFT DWR UCIP LMA Responsibility			37.106233 °	37.106233 °
				-120.585797 °	-120.585797 °
DWR ID	19691				
Comment Code					
Inspector Comment					
DS_ID:19691 FS_ID:34083 EP_NO: N/A Repair Type: Non-Urgent Crossing Status: Found UCIP Comments: 04/17/2014 Need to contact owner. Recommend removing tall grass on landward slope and clearing sediment build up inside pipe. (DWR UCIP - O. Magana) FIELD_STRUCT_DESC: 24-inch corrugated metal gravity drainage pipe through the levee, 11.3 feet below the crown. Flap gate on the waterside (WS) end. [Additional Reference(s): DWR Levee Log, 2002. USACE San Joaquin O&M Manual 601.1, 1967, (HLM 0.43)]. FS Date: 4/17/2014

Concrete structure and flap gate visible on waterward side.

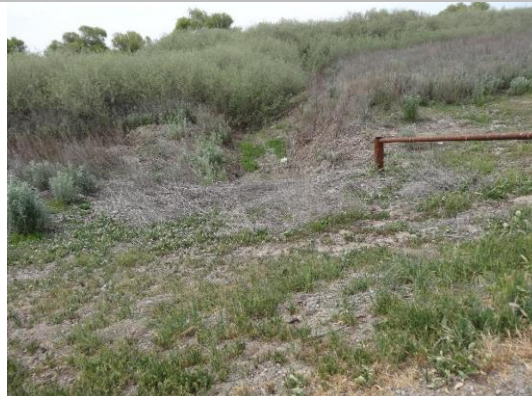
Photo 2 of 3 : UCIP_FA_2019_34083_61940.jpg

View of waterward side.

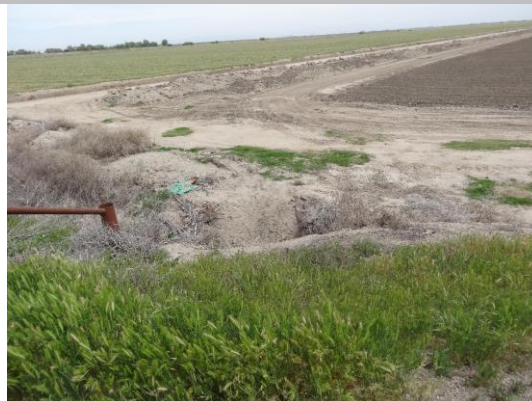
Photo 3 of 3 : UCIP_FA_2019_34083_61944.jpg

View of landward side.

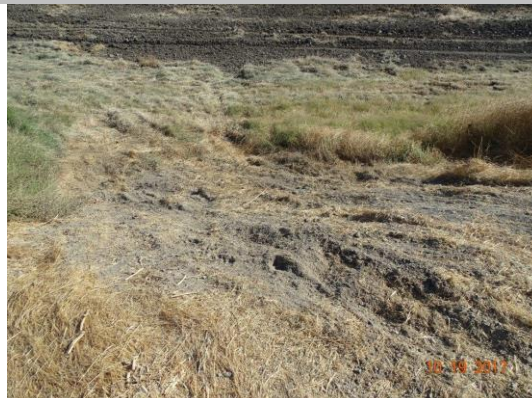
Photo 1 of 1 : FA_2019_NA0010_121_6_20190912_00002.jpg

LM Start	0.43	Rating **	M	Issue No.	6
LM End	0.43	Issue Type +	Ma	Location *	LS
Category	Earthen Levee			GPS Latitude/Longitude	
				Start	End
Item	Slope Stability			37.106121°	37.106121°
				-120.585680°	-120.585680°
DWR ID	DWR_NA0010_03_f_2017_6				
Comment Code					
S3 : Repair the levee slope damaged by vehicle traffic and prevent access where possible.					
Inspector Comment

Looking east at the landside slope.
