**Flood Control Project Maintenance
Levee Inspections**

Fall 2019 Levee Maintenance Deficiency Summary Report

San Joaquin River Basin

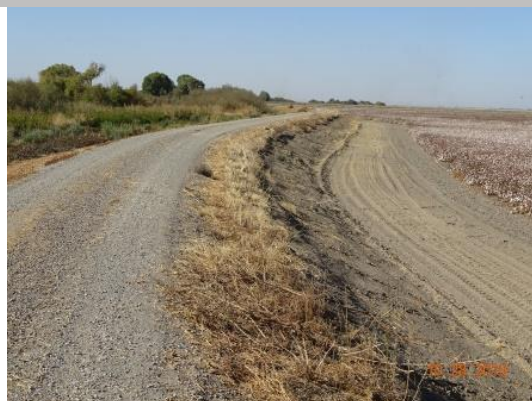
Photo 1 of 1 : FA_2019_NA0010_121_11_20191107_00020.jpg

LM Start	0.68	Rating **	M	Issue No.	11
LM End	1.42	Issue Type +	Ma	Location *	LS
Category	Earthen Levee			GPS Latitude/Longitude	
				Start	End
Item	Vegetation			37.103499 °	37.095404 °
				-120.582675 °	-120.574911 °
DWR ID	DWR_NA0010_03_f_2019_11				
Comment Code					
V1 : Control annual grass and weeds on the levee slopes and easements.					
Inspector Comment					
Keep landside shoulder free of vegetation.

View of vegetation along the landside shoulder looking downstream.
(Fall 2019)

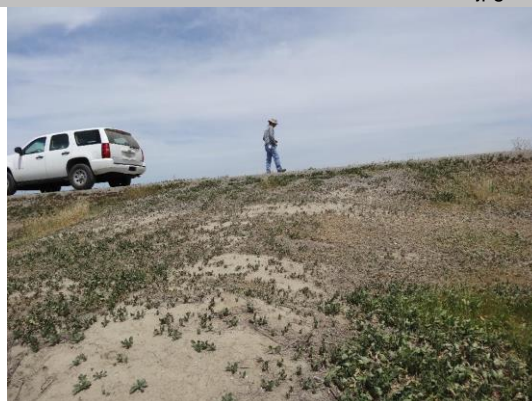
Photo 1 of 3 : UCIP_FA_2019_36534_66248.jpg

LM Start	0.76	Rating **	A/W	Issue No.	69	
LM End	0.76	Issue Type +	Ma	Location *		
Category	Supplemental			GPS Latitude/Longitude		
				Start	End	
Item	DRAFT DWR UCIP LMA Responsibility			37.102964 °	37.102964 °	
				-120.581421 °	-120.581421 °	
DWR ID	19692					
Comment Code						
Inspector Comment						
DS_ID:19692 FS_ID:36534 EP_NO: N/A Repair Type: No Action Needed Crossing Status: Found UCIP Comments: FIELD_STRUCT_DESC: 24-inch corrugated metal gravity drainage pipe through the levee, 9.3 feet below the crown. Flap gate on the waterside (WS) end. [Additional Reference(s): DWR Levee Log, 2002. USACE San Joaquin O&M Manual 601.1, 1967, (HLM 0.77)]. FS Date: 4/17/2014

View of waterward slope.

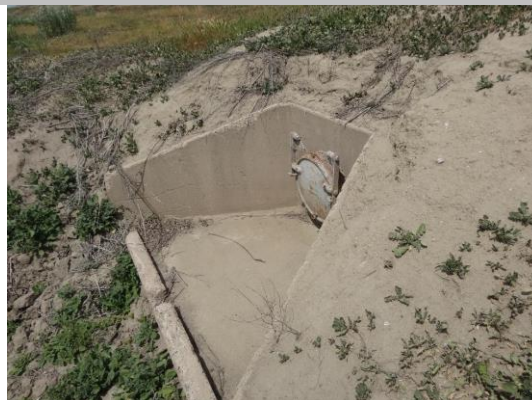
Photo 2 of 3 : UCIP_FA_2019_36534_66249.jpg

Concrete structure located on waterward side.

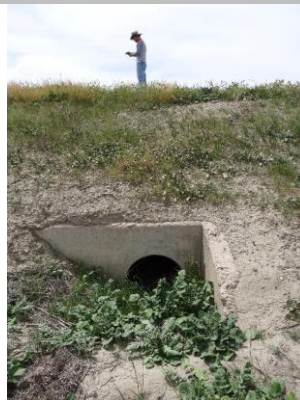
Photo 3 of 3 : UCIP_FA_2019_36534_66251.jpg

View of landward slope.

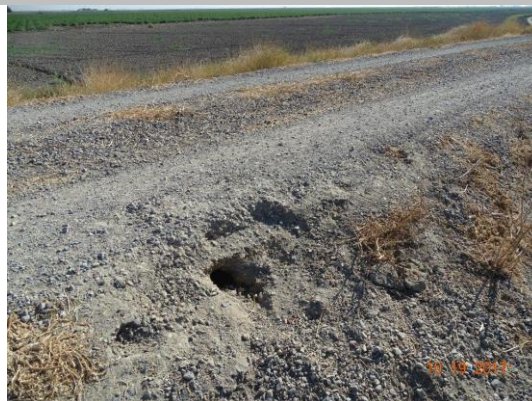
Photo 1 of 1 : FA_2019_NA0010_121_7_20190912_00003.jpg

LM Start	0.83	Rating **	M	Issue No.	7
LM End	0.83	Issue Type +	Ma	Location *	CR
Category	Earthen Levee			GPS Latitude/Longitude	
				Start	End
Item	Animal Control			37.102190 °	37.102190 °
				-120.580717 °	-120.580717 °
DWR ID	DWR_NA0010_03_f_2017_7				
Comment Code					
A1 : Exterminate rodents and backfill and compact or grout burrows.					
Inspector Comment

Looking southeast at the waterside shoulder.

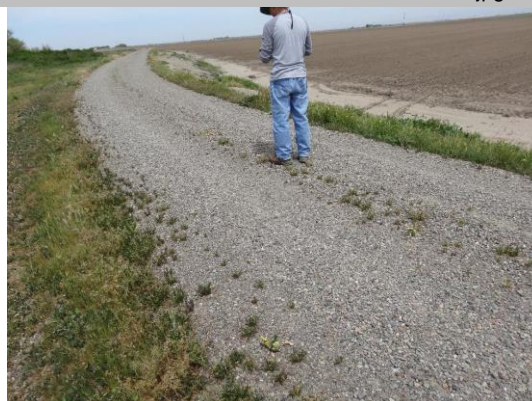
Photo 1 of 3 : UCIP_FA_2019_39371_66252.jpg

LM Start	1.71	Rating **	M	Issue No.	70	
LM End	1.71	Issue Type +	Ma	Location *		
Category	Supplemental			GPS Latitude/Longitude		
				Start	End	
Item	DRAFT DWR UCIP LMA Responsibility			37.092079 °	37.092079 °	
				-120.572316 °	-120.572316 °	
DWR ID	19693					
Comment Code						
Inspector Comment						
DS_ID:19693						
FS_ID:39371						
EP_NO: N/A						
Repair Type: Non-Urgent						
Crossing Status: Found						
UCIP Comments: 04/17/2014 Sediment buildup in pipe visible from landward side--recommend clearing. (DWR UCIP - O. Magana)						
FIELD_STRUCT_DESC: 24-inch corrugated metal gravity drainage pipe through the levee, 6.8 feet below the crown. Flap gate on the waterside (WS) end. [Additional Reference(s): DWR Levee Log, 2002. USACE San Joaquin O&M Manual 601.1, 1967, (HLM 1.72)].						
FS Date: 4/17/2014

View of levee crown at crossing.

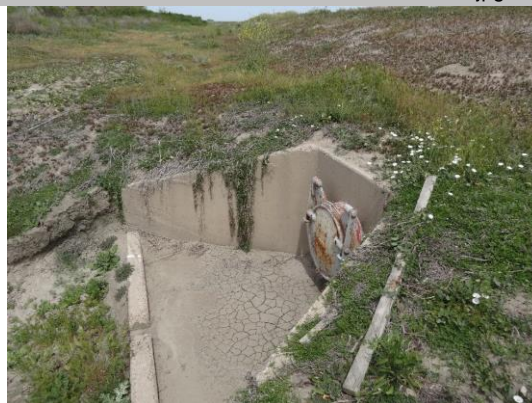
Photo 2 of 3 : UCIP_FA_2019_39371_66254.jpg

Concrete structure located on waterward side.

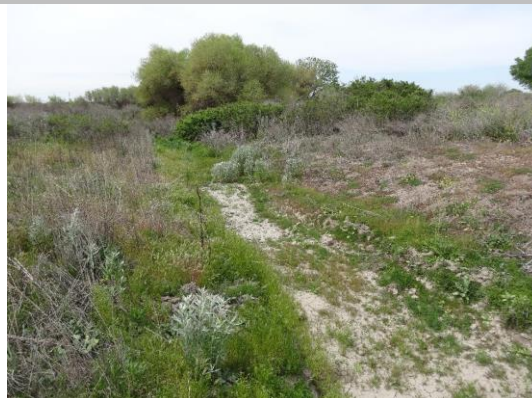
Photo 3 of 3 : UCIP_FA_2019_39371_66253.jpg

LM Start	1.71	Rating **	M	Issue No.	70 (cont)	
LM End	1.71	Issue Type +	Ma	Location *		
Category	Supplemental			GPS Latitude/Longitude		
				Start	End	
Item	DRAFT DWR UCIP LMA Responsibility			37.092079 °	37.092079 °	
				-120.572316 °	-120.572316 °	
DWR ID	19693					
Comment Code						
Inspector Comment						
DS_ID:19693						
FS_ID:39371						
EP_NO: N/A						
Repair Type: Non-Urgent						
Crossing Status: Found						
UCIP Comments: 04/17/2014 Sediment buildup in pipe visible from						
landward side--recommend clearing. (DWR UCIP - O. Magana)						
FIELD_STRUCT_DESC: 24-inch corrugated metal gravity drainage pipe						
through the levee, 6.8 feet below the crown. Flap gate on the waterside						
(WS) end. [Additional Reference(s): DWR Levee Log, 2002. USACE						
San Joaquin O&M Manual 601.1, 1967, (HLM 1.72)].						
FS Date: 4/17/2014

View of waterward side--channel.

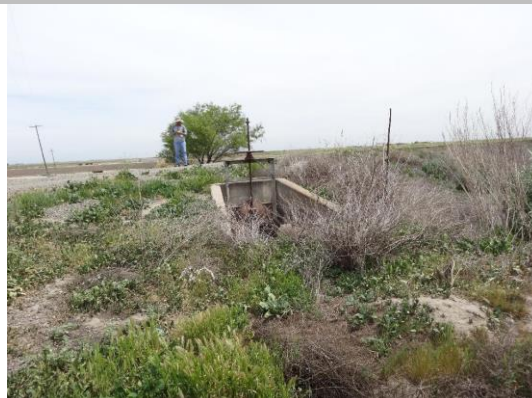
Photo 1 of 3 : UCIP_FA_2019_36543_66281.jpg

Comment Code						
Inspector Comment						
DS_ID:19694 FS_ID:36543 EP_NO: N/A Repair Type: Non-Urgent Crossing Status: Found UCIP Comments: 04/17/2014 Need to contact owner--additional appurtenances found on waterward side not part of original description. Unable to determine if walkway, pump, and pipe through waterward berm is if part of original crossing. (DWR UCIP - O. Magana) FIELD_STRUCT_DESC: 36-inch corrugated metal irrigation discharge pipe through the levee, 6.6 feet below the crown. Pump on the riverbank. Slide gate on the waterside (WS) end. [Additional Reference(s): DWR Levee Log, 2002. USACE San Joaquin O&M Manual 601.1, 1967, (HLM 2.05)]. FS Date: 4/17/2014

Slide gate and concrete structure located on waterward slope.

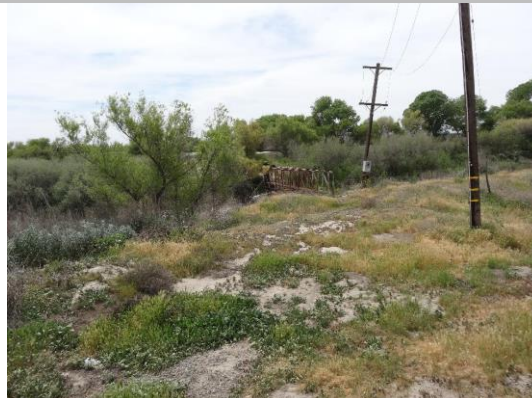
Photo 2 of 3 : UCIP_FA_2019_36543_66282.jpg

View of walkway and berm on waterward side.

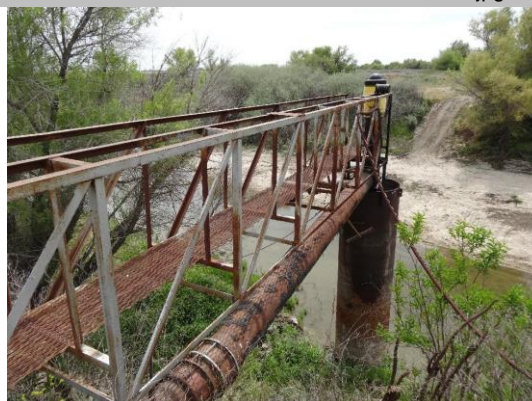
Photo 3 of 3 : UCIP_FA_2019_36543_66280.jpg

Comment Code						
Inspector Comment						
DS_ID:19694 FS_ID:36543 EP_NO: N/A Repair Type: Non-Urgent Crossing Status: Found UCIP Comments: 04/17/2014 Need to contact owner--additional appurtenances found on waterward side not part of original description. Unable to determine if walkway, pump, and pipe through waterward berm is if part of original crossing. (DWR UCIP - O. Magana) FIELD_STRUCT_DESC: 36-inch corrugated metal irrigation discharge pipe through the levee, 6.6 feet below the crown. Pump on the riverbank. Slide gate on the waterside (WS) end. [Additional Reference(s): DWR Levee Log, 2002. USACE San Joaquin O&M Manual 601.1, 1967, (HLM 2.05)]. FS Date: 4/17/2014

Pump and damage walkway located on waterward side.

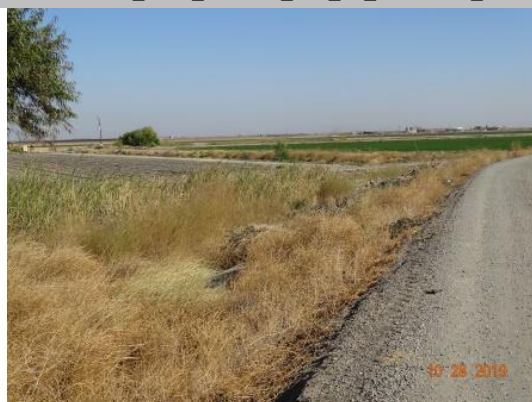
Photo 1 of 1 : FA_2019_NA0010_121_17_20191107_00021.jpg

LM Start	2.05	Rating **	U	Issue No.	17
LM End	2.09	Issue Type +	Ma	Location *	LS
Category	Earthen Levee			GPS Latitude/Longitude	
				Start	End
Item	Vegetation			37.089329 °	37.089013 °
				-120.567586 °	-120.566940 °
DWR ID	DWR_NA0010_03_f_2019_17				
Comment Code					
V1 : Control annual grass and weeds on the levee slopes and easements.					
Inspector Comment

Looking upstream along the landside slope. (Fall 2019)

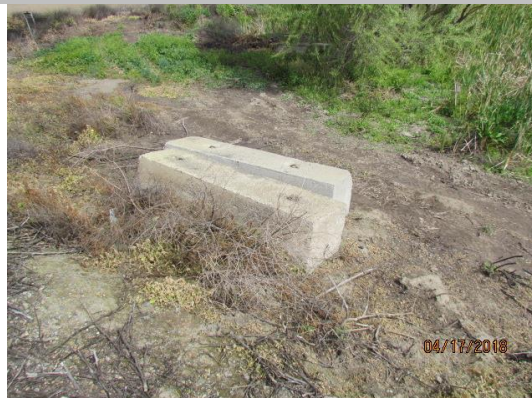
Photo 1 of 1 : FA_2019_NA0010_121_5_20190912_00001.jpg

LM Start	2.05	Rating **	U	Issue No.	5
LM End	2.05	Issue Type +	En	Location *	LS
Category	Earthen Levee			GPS Latitude/Longitude	
				Start	End
Item	Encroachments			37.089289 °	37.089289 °
				-120.567463 °	-120.567463 °
DWR ID	DWR_NA0010_03_s_2018_5				
Comment Code					
MA : Material					
Inspector Comment					
Two large concrete blocks are located on the landward toe.

Looking southwest at concrete blocks on landward toe. (Spring 2018)

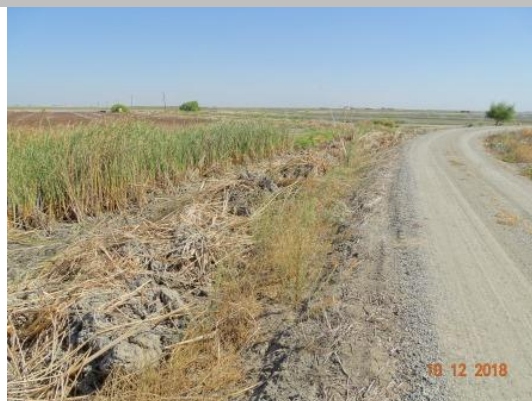
Photo 1 of 1 : FA_2019_NA0010_121_14_20190912_00005.jpg

LM Start	2.07	Rating **	U	Issue No.	14
LM End	2.09	Issue Type +	En	Location *	LS
Category	Earthen Levee			GPS Latitude/Longitude	
				Start	End
Item	Encroachments			37.089177 °	37.089070 °
				-120.567126 °	-120.566977 °
DWR ID	DWR_NA0010_03_f_2018_14				
Comment Code					
DE : Debris					
Inspector Comment					
Debris from ditch dredging left on landside slope.

View of debris from dredging left on landside slope. (Fall 2018)

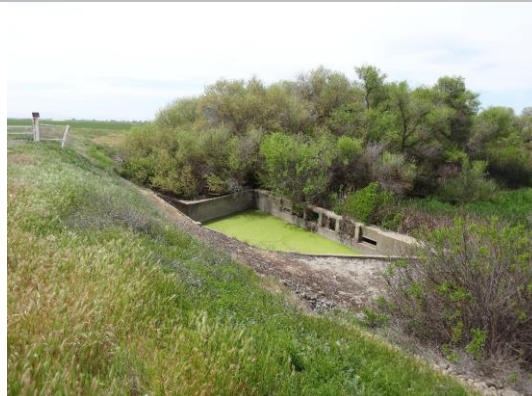
Photo 1 of 3 : UCIP_FA_2019_40529_61969.jpg

Comment Code					
Inspector Comment					
DS_ID:19977 FS_ID:40529 EP_NO: 5024 Repair Type: Non-Urgent Crossing Status: Found UCIP Comments: 10/27/2017 This structure is inspected annually under the Structure and Channel Summer Inspection (part of the Levee Inspection Program) conducted by the DWR Flood Project Integrity and Inspection Branch (FPIIB). (DWR UCIP - O. Magana) 04/17/2014 Slide gates blocked by sediment. Recommend contacting owner to determine status of crossing. Crossing appears to be abandoned. (DWR UCIP - O. Magana) FIELD_STRUCT_DESC: [San Joaquin River Diversion Structure] 1 of 4: 72-inch by 60-inch reinforced concrete box gravity drainage culvert through the levee, 21 feet below the crown. Slide gate on the waterside (WS). Concrete headwall on each end. Landside (LS) slope cobble revetted. Flashboards on the downstream side of the structure. FS Date: 4/17/2014

View of concrete structure located on landward side.

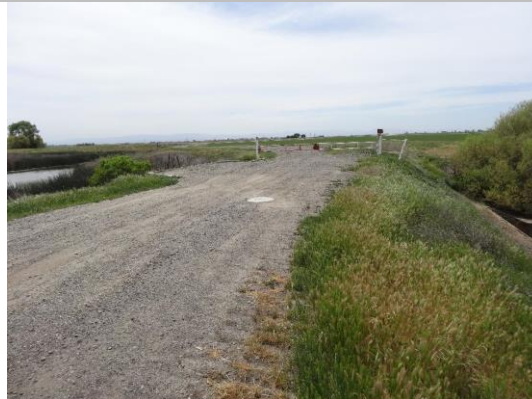
Photo 2 of 3 : UCIP_FA_2019_40529_61968.jpg

View of levee crown.

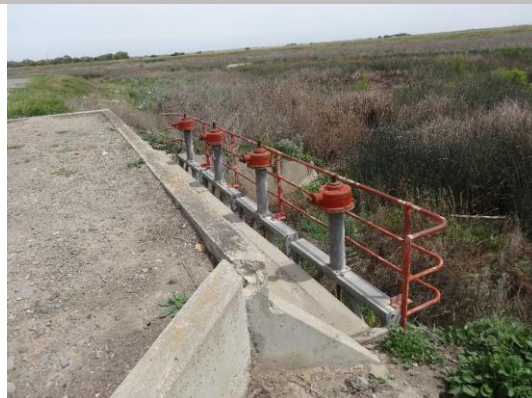
Photo 3 of 3 : UCIP_FA_2019_40529_61967.jpg

Comment Code						
Inspector Comment						
DS_ID:19977 FS_ID:40529 EP_NO: 5024 Repair Type: Non-Urgent Crossing Status: Found UCIP Comments: 10/27/2017 This structure is inspected annually under the Structure and Channel Summer Inspection (part of the Levee Inspection Program) conducted by the DWR Flood Project Integrity and Inspection Branch (FPIIB). (DWR UCIP - O. Magana) 04/17/2014 Slide gates blocked by sediment. Recommend contacting owner to determine status of crossing. Crossing appears to be abandoned. (DWR UCIP - O. Magana) FIELD_STRUCT_DESC: [San Joaquin River Diversion Structure] 1 of 4: 72-inch by 60-inch reinforced concrete box gravity drainage culvert through the levee, 21 feet below the crown. Slide gate on the waterside (WS). Concrete headwall on each end. Landside (LS) slope cobble revetted. Flashboards on the downstream side of the structure. FS Date: 4/17/2014

Concrete headwall located on waterward side.

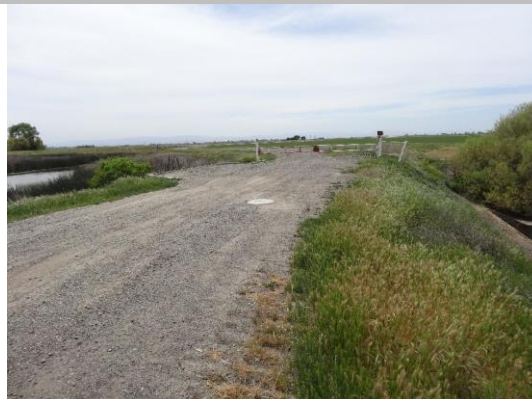
Photo 2 of 3 : UCIP_FA_2019_36876_67317.jpg

View of levee crown.

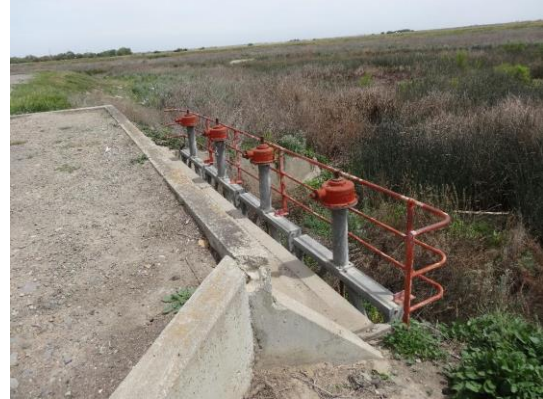
Photo 3 of 3 : UCIP_FA_2019_36876_67316.jpg

Comment Code						
Inspector Comment						
DS_ID:24857 FS_ID:36876 EP_NO: 5024 Repair Type: Non-Urgent Crossing Status: Found UCIP Comments: 10/27/2017 This structure is inspected annually under the Structure and Channel Summer Inspection (part of the Levee Inspection Program) conducted by the DWR Flood Project Integrity and Inspection Branch (FPIIB). (DWR UCIP - O. Magana) 04/17/2014 Slide gates blocked by sediment. Recommend contacting owner to determine status of crossing. Crossing appears to be abandoned. (DWR UCIP - O. Magana) FIELD_STRUCT_DESC: [San Joaquin River Diversion Structure] 3 of 4: 72-inch by 60-inch reinforced concrete box gravity drainage culvert through the levee, 21 feet below the crown. Slide gate on the waterside (WS). Concrete headwall on each end. Landside (LS) slope cobble revetted. Flashboards on the downstream side of the structure. FS Date: 4/17/2014

Concrete headwall located on waterward side.

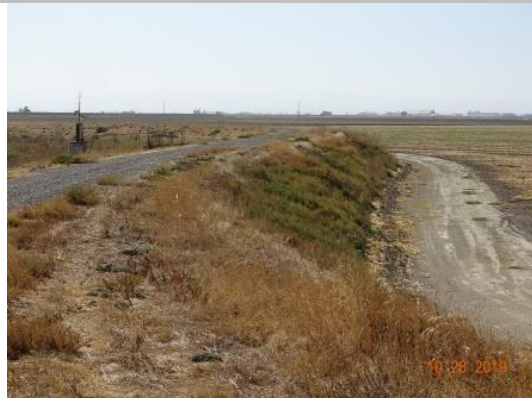
Photo 1 of 1 : FA_2019_NA0010_122_9_20191107_00024.jpg

LM Start	0.07	Rating **	U	Issue No.	9
LM End	0.31	Issue Type +	Ma	Location *	LS
Category	Earthen Levee			GPS Latitude/Longitude	
				Start	End
Item	Vegetation			37.112032 °	37.108940 °
				-120.589978 °	-120.590800 °
DWR ID	DWR_NA0010_04_f_2019_9				
Comment Code					
V1 : Control annual grass and weeds on the levee slopes and easements.					
Inspector Comment

View of the landside slope looking upstream. (Fall 2019)

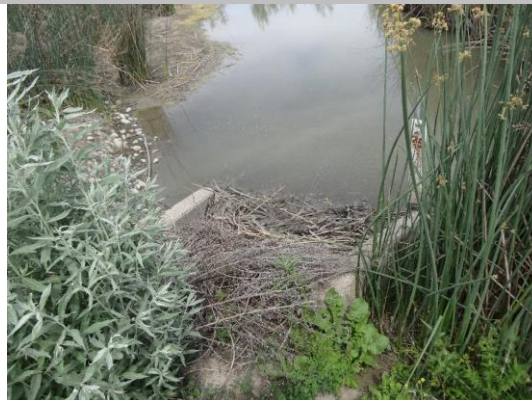
Photo 1 of 3 : UCIP_FA_2019_34093_61982.jpg

Comment Code						
Inspector Comment						
DS_ID:19695 FS_ID:34093 EP_NO: N/A Repair Type: Non-Urgent Crossing Status: Found UCIP Comments: 04/17/2014 Sediment and debris blocking concrete headwall located on waterward side. During inspection water was flowing from landward side to waterward side. Recommend removing sediment to confirm condition of flap gate and pipe. (DWR UCIP - O. Magana) FIELD_STRUCT_DESC: 36-inch corrugated metal gravity drainage pipe through the levee, 18 feet below the crown. Flap gate on the waterside (WS) end. Concrete headwall on each end. [Additional Reference(s): DWR Levee Log, 2002. USACE San Joaquin O&M Manual 601.1, 1967, (HLM 0.27)]. FS Date: 4/17/2014

View of dense vegetation near concrete headwall located on waterward side.

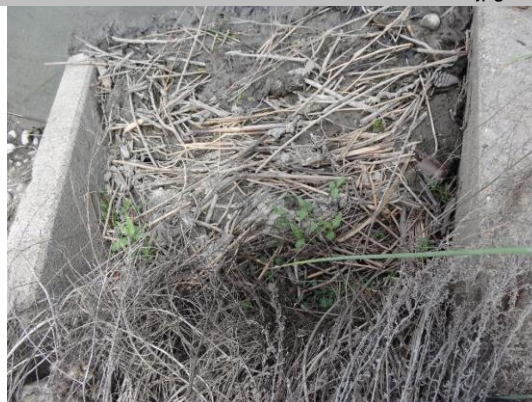
Photo 2 of 3 : UCIP_FA_2019_34093_61981.jpg

Sediment blocking flap gate located on waterward side.

Comment Code						
Inspector Comment						
DS_ID:19695 FS_ID:34093 EP_NO: N/A Repair Type: Non-Urgent Crossing Status: Found UCIP Comments: 04/17/2014 Sediment and debris blocking concrete headwall located on waterward side. During inspection water was flowing from landward side to waterward side. Recommend removing sediment to confirm condition of flap gate and pipe. (DWR UCIP - O. Magana) FIELD_STRUCT_DESC: 36-inch corrugated metal gravity drainage pipe through the levee, 18 feet below the crown. Flap gate on the waterside (WS) end. Concrete headwall on each end. [Additional Reference(s): DWR Levee Log, 2002. USACE San Joaquin O&M Manual 601.1, 1967, (HLM 0.27)]. FS Date: 4/17/2014

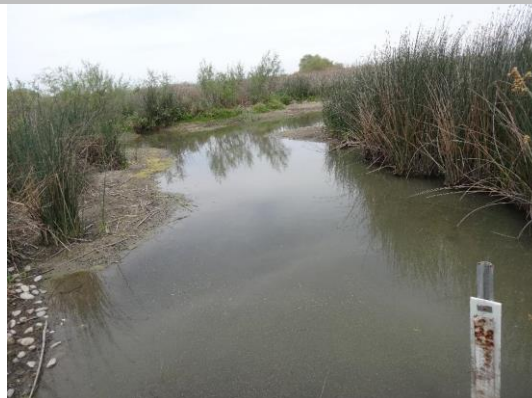
Photo 3 of 3 : UCIP_FA_2019_34093_61980.jpg

View of waterward side.

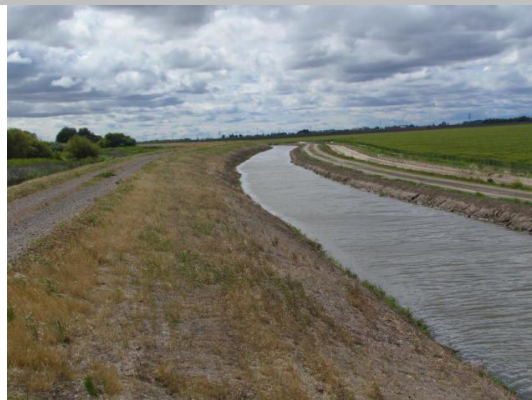
Photo 1 of 3 : FA_2019_NA0010_122_3_20190912_00001.jpg

LM Start	0.32	Rating **	M	Issue No.	3
LM End	1.41	Issue Type +	En	Location *	LS
Category	Earthen Levee			GPS Latitude/Longitude	
				Start	End
Item	Encroachments			37.108822 °	37.097556 °
				-120.590718 °	-120.578130 °
DWR ID	DWR_NA0010_04_s_2012_3				
Comment Code					
DT : Ditch					
Inspector Comment					
An irrigation ditch is within 10' easement.

Looking north at irrigation ditch at landside toe.

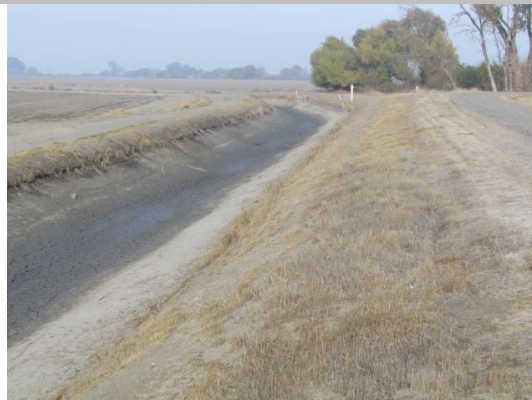
Photo 2 of 3 : FA_2019_NA0010_122_3_20190912_00002.jpg

LM Start	0.32	Rating **	M	Issue No.	3 (cont)	
LM End	1.41	Issue Type +	En	Location *	LS	
Category	Earthen Levee			GPS Latitude/Longitude		
				Start		End
Item	Encroachments			37.108822°	37.097556°	
				-120.590718°	-120.578130°	
DWR ID	DWR_NA0010_04_s_2012_3					
Comment Code						
DT : Ditch						
Inspector Comment						
An irrigation ditch is within 10' easement.

Looking north at irrigation ditch at landward toe. (Fall 2013)

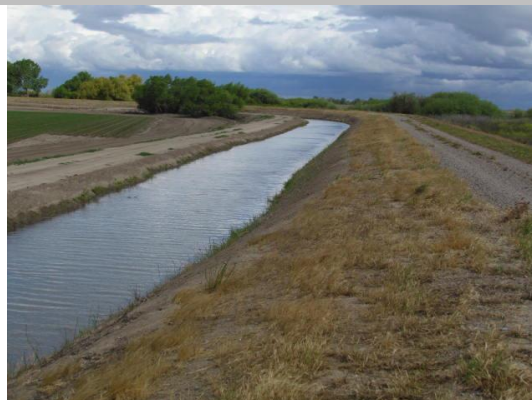
Photo 3 of 3 : FA_2019_NA0010_122_3_20190912_00003.jpg

Looking north at irrigation ditch at landside toe.

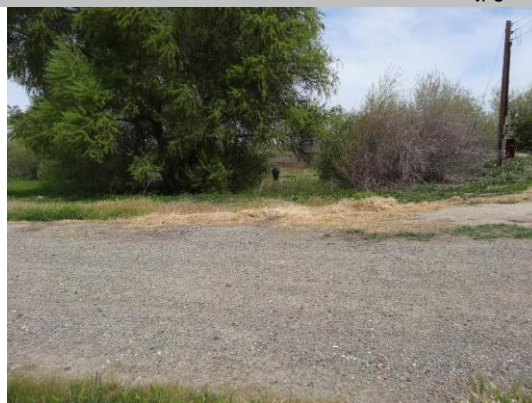
Photo 1 of 3 : UCIP_FA_2019_40530_61987.jpg

LM Start	1.34	Rating **	M	Issue No.	19
LM End	1.34	Issue Type +	En	Location *	
Category	Supplemental		GPS Latitude/Longitude		
			Start	End	
Item	DRAFT DWR UCIP Field Study		37.095274 °	37.095274 °	
			-120.577959 °	-120.577959 °	
DWR ID	19975				
Comment Code					
Inspector Comment					
DS_ID:19975 FS_ID:40530 EP_NO: 3416 Repair Type: Non-Urgent Crossing Status: Found UCIP Comments: Unable to confirm if crossing is still in use. Need to contact owner to confirm status. FIELD_STRUCT_DESC: 12-inch steel irrigation pipe, encased in 6-inches of reinforced concrete through the levee. Concrete cutoff wall at center of levee. Pumping plant on the waterward bank. Pump and irrigation pipe retained under Permit No. 3416 (1964). FS Date: 4/17/2014

View of waterward side.

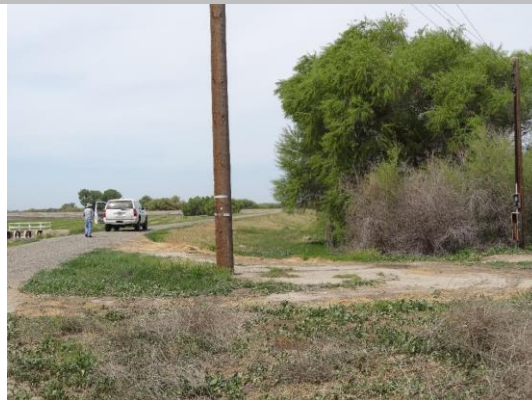
Photo 2 of 3 : UCIP_FA_2019_40530_61988.jpg

Overview of waterward side and levee crown at crossing.

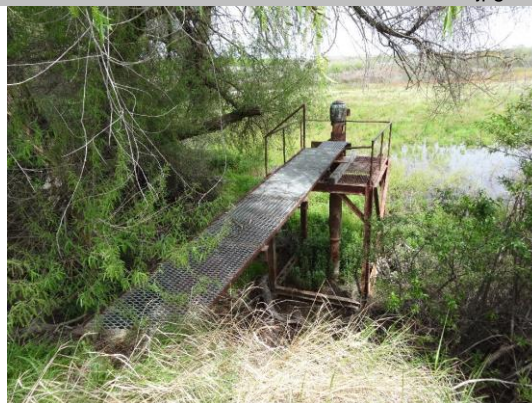
Photo 3 of 3 : UCIP_FA_2019_40530_61986.jpg

Pump and walkway located on waterward side.

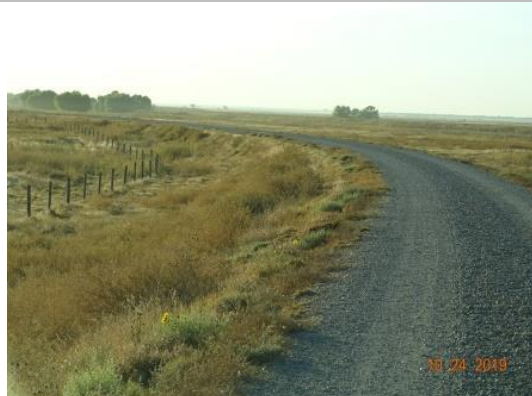
Photo 1 of 1 : FA_2019_NA0010_123_100_20191108_00323.jpg

LM Start	0.01	Rating **	U	Issue No.	100
LM End	3.64	Issue Type +	Ma	Location *	LS
Category	Earthen Levee			GPS Latitude/Longitude	
				Start	End
Item	Vegetation			37.278964 °	37.252803 °
				-120.824218 °	-120.768252 °
DWR ID	DWR_NA0010_05_f_2019_100				
Comment Code					
V1 : Control annual grass and weeds on the levee slopes and easements.					
Inspector Comment

View of the landside slope looking upstream. (Fall 2019)

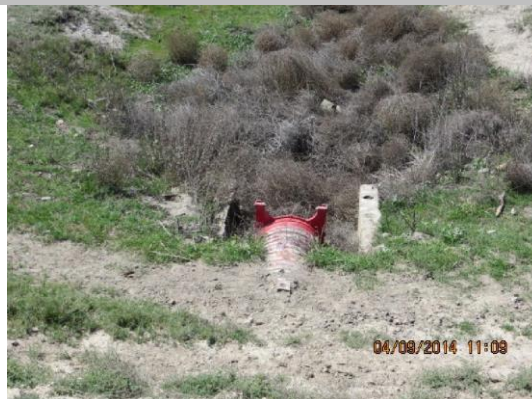
Photo 1 of 3 : UCIP_FA_2019_39563_60921.jpg

LM Start	0.08	Rating **	M	Issue No.	1310
LM End	0.08	Issue Type +	Ma	Location *	
Category	Supplemental			GPS Latitude/Longitude	
				Start	End
Item	DRAFT DWR UCIP LMA Responsibility			37.278174 °	37.278174 °
				-120.823465 °	-120.823465 °
DWR ID	19756				
Comment Code					
Inspector Comment					
DS_ID:19756 FS_ID:39563 EP_NO: N/A Repair Type: Non-Urgent Crossing Status: Found UCIP Comments: 04/09/2014 Debris blocking landward headwall-- recommend clearing. (DWR UCIP - W. Wylie) FIELD_STRUCT_DESC: 24-inch corrugated metal gravity drainage pipe through the levee, 8.6 feet below the crown. Concrete U-shaped headwall and flap gate on the waterside (WS) end. Concrete headwall on the landside (LS) end. [Additional Reference(s): DWR Levee Log, 2002. USACE San Joaquin O&M Manual 601.1, 1967, (HLM 0.07)]. FS Date: 4/9/2014

Pipe, flapgate, and concrete headwall on WS toe.

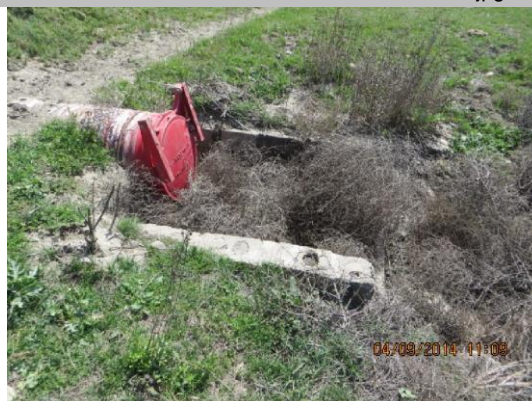
Photo 2 of 3 : UCIP_FA_2019_39563_60920.jpg

LM Start	0.08	Rating **	M	Issue No.	1310 (cont)	
LM End	0.08	Issue Type +	Ma	Location *		
Category	Supplemental			GPS Latitude/Longitude		
				Start	End	
Item	DRAFT DWR UCIP LMA Responsibility			37.278174 °	37.278174 °	
				-120.823465 °	-120.823465 °	
DWR ID	19756					
Comment Code						
Inspector Comment						
DS_ID:19756 FS_ID:39563 EP_NO: N/A Repair Type: Non-Urgent Crossing Status: Found UCIP Comments: 04/09/2014 Debris blocking landward headwall-- recommend clearing. (DWR UCIP - W. Wylie) FIELD_STRUCT_DESC: 24-inch corrugated metal gravity drainage pipe through the levee, 8.6 feet below the crown. Concrete U-shaped headwall and flap gate on the waterside (WS) end. Concrete headwall on the landside (LS) end. [Additional Reference(s): DWR Levee Log, 2002. USACE San Joaquin O&M Manual 601.1, 1967, (HLM 0.07)]. FS Date: 4/9/2014

Pipe, flapgate, and concrete headwall on WS toe.

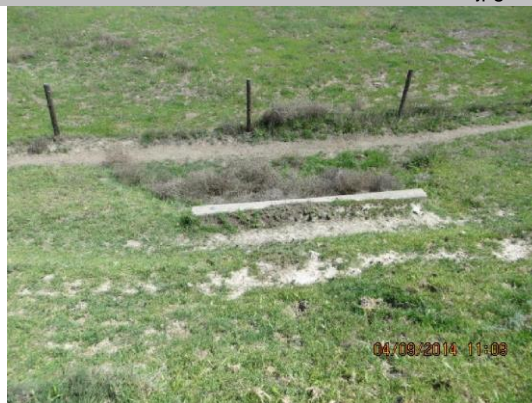
Photo 3 of 3 : UCIP_FA_2019_39563_60922.jpg

Pipe and concrete headwall on LS toe.

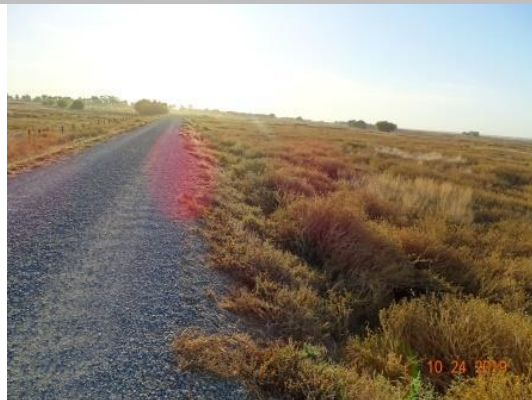
Photo 1 of 1 : FA_2019_NA0010_123_101_20191108_00324.jpg

LM Start	0.18	Rating **	U	Issue No.	101
LM End	1.79	Issue Type +	Ma	Location *	WS
Category	Earthen Levee			GPS Latitude/Longitude	
				Start	End
Item	Vegetation			37.277368 °	37.261851 °
				-120.821927 °	-120.801916 °
DWR ID	DWR_NA0010_05_f_2019_101				
Comment Code					
V1 : Control annual grass and weeds on the levee slopes and easements.					
Inspector Comment

Looking upstream along the waterside slope. (Fall 2019)

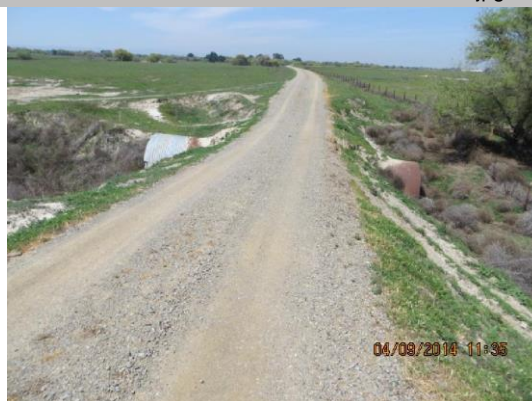
Photo 1 of 3 : UCIP_FA_2019_53185_71469.jpg

Comment Code						
Inspector Comment						
DS_ID:24867 FS_ID:53185 EP_NO: N/A Repair Type: Urgent Crossing Status: Found UCIP Comments: 11/01/2018 Same as previous inspection, 1960s levee breach; degraded levee section that drops about 4 feet within a 100-foot levee section. Crossing remains Urgent due to the levee degradation at this location. (O. Magana - DWR UCIP)07/20/2016 same as previous inspection. Levee section at crossing has been degraded. According to LMA representative, Rick, the low point at crossing has been present for over 10 years when the pipe was replaced. (DWR UCIP - O. Magana)04/09/2014 Pipe is open on both ends and levee has been degraded at this location. No permit identified for this crossing. (DWR UCIP - W. Wylie) FIELD_STRUCT_DESC: 96-inch corrugated metal gravity drainage pipe through the levee, 4.5 feet below the crown. Pipe is composed of two materials: corrugated metal pipe (CMP) on the waterside (WS) and steel pipe on the landside (LS). This section of the levee is a degraded section that drops approximately 4 feet within 100 feet of length. This section of the levee is the site of the 1960s levee breach. [Additional Reference(s): USACE Periodic Inspection Report 2014, USACE_CESPK_L05A_2014_p_0014]. FS Date: 11/1/2018 12:48:00 PM

Pipe through levee where levee has been degraded.

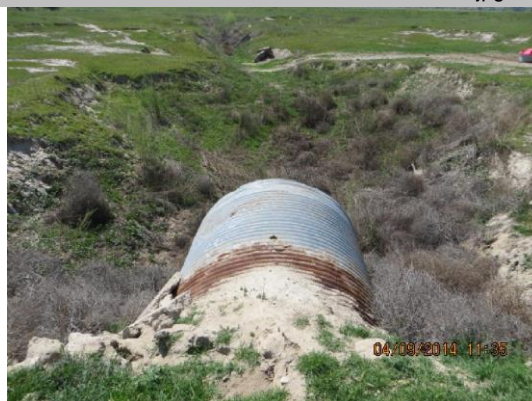
Photo 2 of 3 : UCIP_FA_2019_53185_71467.jpg

DS_ID:24867
FS_ID:53185
EP_NO: N/A
Repair Type: Urgent
Crossing Status: Found
UCIP Comments: 11/01/2018 Same as previous inspection, 1960s levee breach; degraded levee section that drops about 4 feet within a 100-foot levee section. Crossing remains Urgent due to the levee degradation at this location. (O. Magana - DWR UCIP)07/20/2016 same as previous inspection. Levee section at crossing has been degraded. According to LMA representative, Rick, the low point at crossing has been present for over 10 years when the pipe was replaced. (DWR UCIP - O. Magana)04/09/2014 Pipe is open on both ends and levee has been degraded at this location. No permit identified for this crossing. (DWR UCIP - W. Wylie)
FIELD_STRUCT_DESC: 96-inch corrugated metal gravity drainage pipe through the levee, 4.5 feet below the crown. Pipe is composed of two materials: corrugated metal pipe (CMP) on the waterside (WS) and steel pipe on the landside (LS). This section of the levee is a degraded section that drops approximately 4 feet within 100 feet of length. This section of the levee is the site of the 1960s levee breach. [Additional Reference(s): USACE Periodic Inspection Report 2014, USACE_CESPK_L05A_2014_p_0014].

Pipe on WS toe.

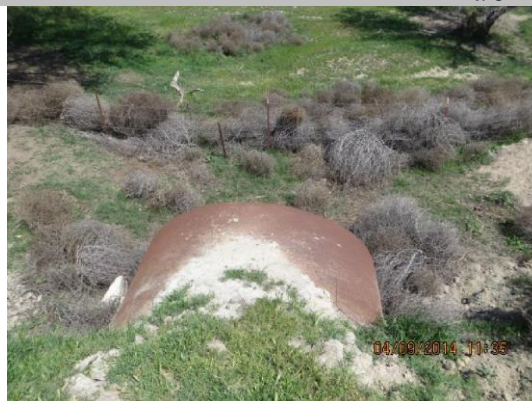
Photo 3 of 3 : UCIP_FA_2019_53185_71468.jpg

Pipe on LS toe.

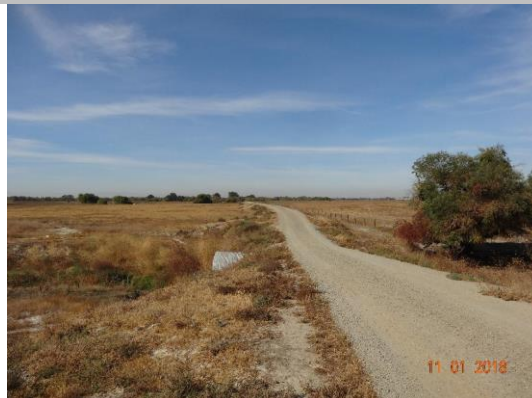
Photo 1 of 3 : UCIP_FA_2019_53194_78592.jpg

Comment Code						
Inspector Comment						
DS_ID:19557 FS_ID:53194 EP_NO: N/A Repair Type: Non-Urgent Crossing Status: Indicator Found UCIP Comments: 11/01/2018 24-inch corrugated metal pipe (CMP) section found during pipe inspection of dsid 24867 (see photos); according to LMA representative levee section is the location of levee breach from 1960s; 24-inch pipe was undersized and was replaced after levee breach with a 96-inch CMP and steel pipe. FIELD_STRUCT_DESC: 24-inch corrugated metal gravity drainage pipe through the levee, 5.6 feet below the crown. Flap gate on the waterside (WS) end. Large pipe found at this location. [Additional Reference(s): USACE San Joaquin O&M Manual 601.1, 1967, (HLM 0.30)]. FS Date: 4/9/2014

Overview of degraded levee section.

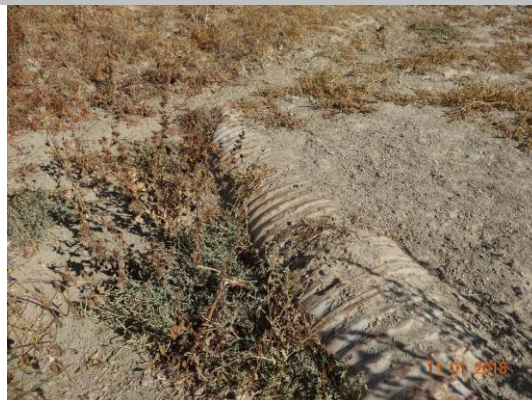
Photo 2 of 3 : UCIP_FA_2019_53194_78593.jpg

LS view: CMP section found on LS.

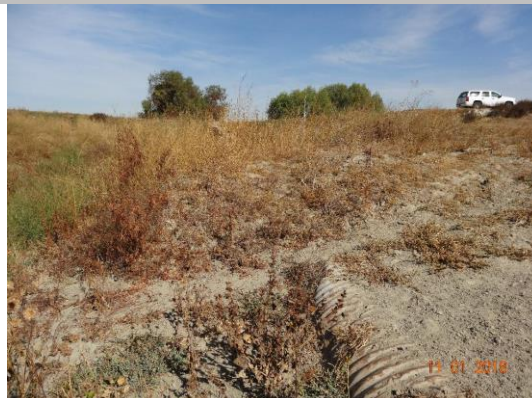
Photo 3 of 3 : UCIP_FA_2019_53194_78594.jpg

Comment Code						
Inspector Comment						
DS_ID:19557 FS_ID:53194 EP_NO: N/A Repair Type: Non-Urgent Crossing Status: Indicator Found UCIP Comments: 11/01/2018 24-inch corrugated metal pipe (CMP) section found during pipe inspection of dsid 24867 (see photos); according to LMA representative levee section is the location of levee breach from 1960s; 24-inch pipe was undersized and was replaced after levee breach with a 96-inch CMP and steel pipe. FIELD_STRUCT_DESC: 24-inch corrugated metal gravity drainage pipe through the levee, 5.6 feet below the crown. Flap gate on the waterside (WS) end. Large pipe found at this location. [Additional Reference(s): USACE San Joaquin O&M Manual 601.1, 1967, (HLM 0.30)]. FS Date: 4/9/2014

LS view: 24-inch pipe section found west of LS toe.

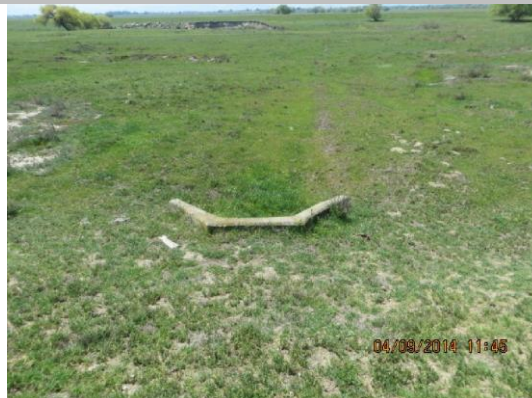
Photo 1 of 3 : UCIP_FA_2019_39584_60926.jpg

LM Start	0.60	Rating **	M	Issue No.	1313
LM End	0.60	Issue Type +	Ma	Location *	
Category	Supplemental			GPS Latitude/Longitude	
				Start	End
Item	DRAFT DWR UCIP LMA Responsibility			37.273945 °	37.273945 °
				-120.815835 °	-120.815835 °
DWR ID	19757				
Comment Code					
Inspector Comment					
DS_ID:19757 FS_ID:39584 EP_NO: N/A Repair Type: Non-Urgent Crossing Status: Found UCIP Comments: 04/09/2014 Excess debris on landward headwall--recommend clearing. (DWR UCIP - W. Wylie) FIELD_STRUCT_DESC: 30-inch corrugated metal gravity drainage pipe through the levee, 7.5 feet below the crown. Flap gate on the waterside (WS) end. Concrete headwall on the landside (LS) end. Concrete U-shaped headwall on the WS end. [Additional Reference(s): DWR Levee Log, 2002. USACE San Joaquin O&M Manual 601.1, 1967, (HLM 0.59)]. FS Date: 4/9/2014

Concrete headwall, pipe, and flapgate on WS toe.

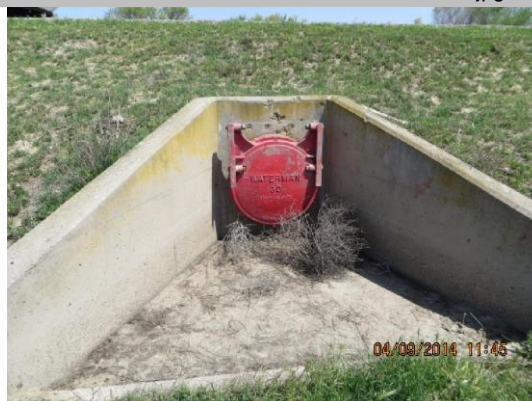
Photo 2 of 3 : UCIP_FA_2019_39584_60925.jpg

LM Start	0.60	Rating **	M	Issue No.	1313 (cont)	
LM End	0.60	Issue Type +	Ma	Location *		
Category	Supplemental			GPS Latitude/Longitude		
				Start		End
Item	DRAFT DWR UCIP LMA Responsibility			37.273945 °		37.273945 °
				-120.815835 °		-120.815835 °
DWR ID	19757					
Comment Code						
Inspector Comment						
DS_ID:19757 FS_ID:39584 EP_NO: N/A Repair Type: Non-Urgent Crossing Status: Found UCIP Comments: 04/09/2014 Excess debris on landward headwall--recommend clearing. (DWR UCIP - W. Wylie) FIELD_STRUCT_DESC: 30-inch corrugated metal gravity drainage pipe through the levee, 7.5 feet below the crown. Flap gate on the waterside (WS) end. Concrete headwall on the landside (LS) end. Concrete U-shaped headwall on the WS end. [Additional Reference(s): DWR Levee Log, 2002. USACE San Joaquin O&M Manual 601.1, 1967, (HLM 0.59)]. FS Date: 4/9/2014

Concrete headwall, pipe, and flapgate on WS toe.

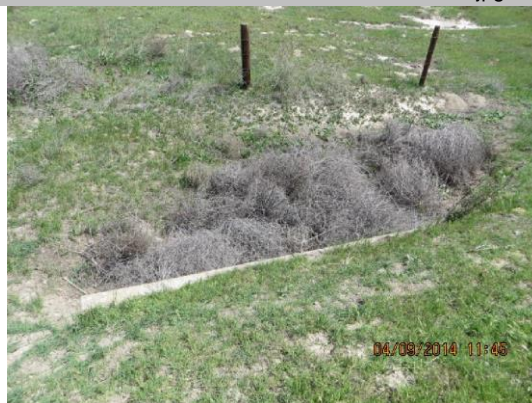
Photo 3 of 3 : UCIP_FA_2019_39584_60927.jpg

Pipe and concrete headwall on LS toe. Note vegetation buildup.

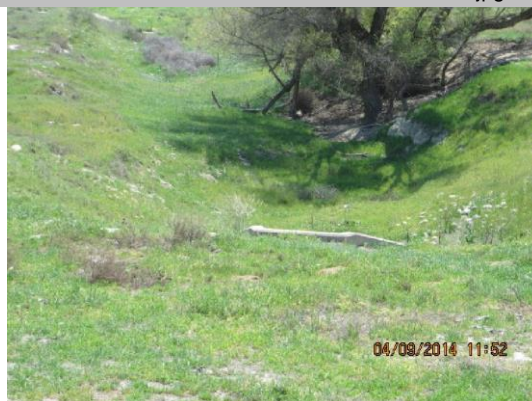
Photo 1 of 3 : UCIP_FA_2019_39585_60931.jpg

Comment Code					
Inspector Comment					
DS_ID:19758					
FS_ID:39585					
EP_NO: N/A					
Repair Type: Non-Urgent					
Crossing Status: Found					
UCIP Comments: 04/09/2014 Dense vegetation limits the inspector's visibility to identify signs of pipe failure (leaks) along the landward slope. Recommend removing vegetation along pipe alignment to conduct proper inspection of structure. (DWR UCIP - W. Wylie)					
FIELD_STRUCT_DESC: 36-inch corrugated metal gravity drainage pipe through the levee, 13.2 feet below the crown. Flap gate on the waterside (WS) end. Concrete headwall on the landside (LS) end. Concrete U-shaped headwall on the WS end. Cobble revetment around both ends. [Additional Reference(s): DWR Levee Log, 2002. USACE San Joaquin O&M Manual 601.1, 1967, (HLM 0.65)].					
FS Date: 4/9/2014

Concrete headwall visible off WS toe.

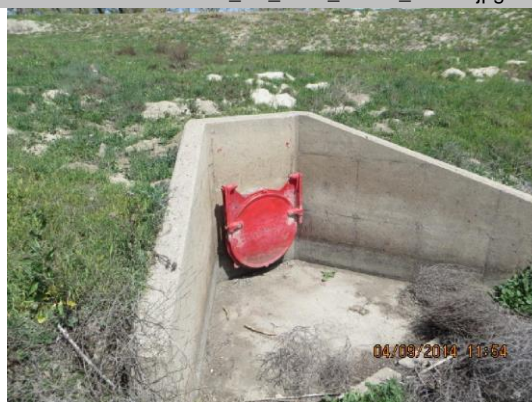
Photo 2 of 3 : UCIP_FA_2019_39585_60929.jpg

Pipe, flapgate, and headwall at WS toe.

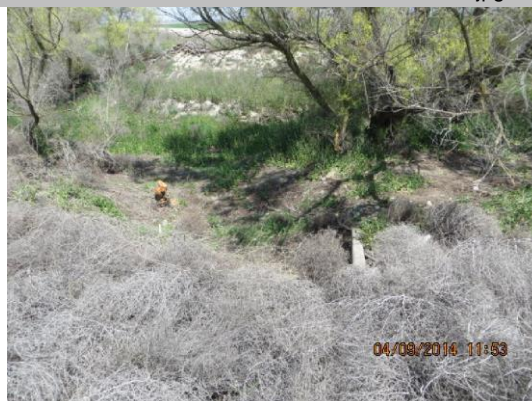
Photo 3 of 3 : UCIP_FA_2019_39585_60930.jpg

Comment Code						
Inspector Comment						
DS_ID:19758 FS_ID:39585 EP_NO: N/A Repair Type: Non-Urgent Crossing Status: Found UCIP Comments: 04/09/2014 Dense vegetation limits the inspector's visibility to identify signs of pipe failure (leaks) along the landward slope. Recommend removing vegetation along pipe alignment to conduct proper inspection of structure. (DWR UCIP - W. Wylie) FIELD_STRUCT_DESC: 36-inch corrugated metal gravity drainage pipe through the levee, 13.2 feet below the crown. Flap gate on the waterside (WS) end. Concrete headwall on the landside (LS) end. Concrete U-shaped headwall on the WS end. Cobble revetment around both ends. [Additional Reference(s): DWR Levee Log, 2002. USACE San Joaquin O&M Manual 601.1, 1967, (HLM 0.65)]. FS Date: 4/9/2014

Concrete headwall at LS toe.

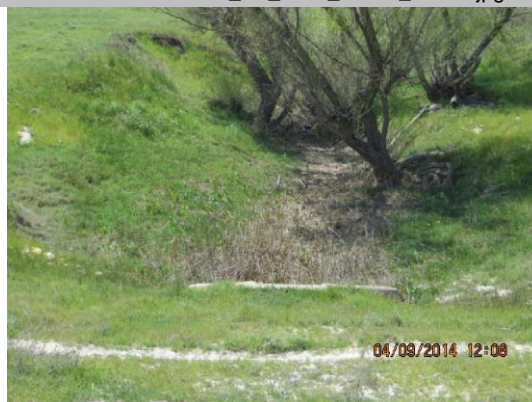
Photo 1 of 3 : UCIP_FA_2019_33707_60934.jpg

LM Start	0.85	Rating **	A/W	Issue No.	1315
LM End	0.85	Issue Type +	Ma	Location *	
Category	Supplemental			GPS Latitude/Longitude	
				Start	End
Item	DRAFT DWR UCIP LMA Responsibility			37.271894 °	37.271894 °
				-120.812224 °	-120.812224 °
DWR ID	19759				
Comment Code					
Inspector Comment					
DS_ID:19759 FS_ID:33707 EP_NO: N/A Repair Type: No Action Needed Crossing Status: Found UCIP Comments: FIELD_STRUCT_DESC: 24-inch corrugated metal gravity drainage pipe through the levee, 14.4 feet below the crown. Flap gate on the waterside (WS) end. Concrete headwall on the landside (LS) end. Concrete U-shaped headwall on the WS end. [Additional Reference(s): DWR Levee Log, 2002. USACE San Joaquin O&M Manual 601.1, 1967, (HLM 0.84)]. FS Date: 4/9/2014

Concrete headwall visible at LS toe.

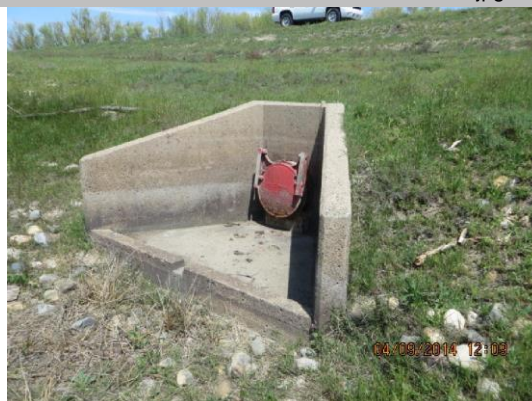
Photo 2 of 3 : UCIP_FA_2019_33707_60933.jpg

LM Start	0.85	Rating **	A/W	Issue No.	1315 (cont)	
LM End	0.85	Issue Type +	Ma	Location *		
Category	Supplemental			GPS Latitude/Longitude		
				Start	End	
Item	DRAFT DWR UCIP LMA Responsibility			37.271894 °	37.271894 °	
				-120.812224 °	-120.812224 °	
DWR ID	19759					
Comment Code						
Inspector Comment						
DS_ID:19759 FS_ID:33707 EP_NO: N/A Repair Type: No Action Needed Crossing Status: Found UCIP Comments: FIELD_STRUCT_DESC: 24-inch corrugated metal gravity drainage pipe through the levee, 14.4 feet below the crown. Flap gate on the waterside (WS) end. Concrete headwall on the landside (LS) end. Concrete U-shaped headwall on the WS end. [Additional Reference(s): DWR Levee Log, 2002. USACE San Joaquin O&M Manual 601.1, 1967, (HLM 0.84)]. FS Date: 4/9/2014

Pipe, flapgate, and headwall at WS toe.

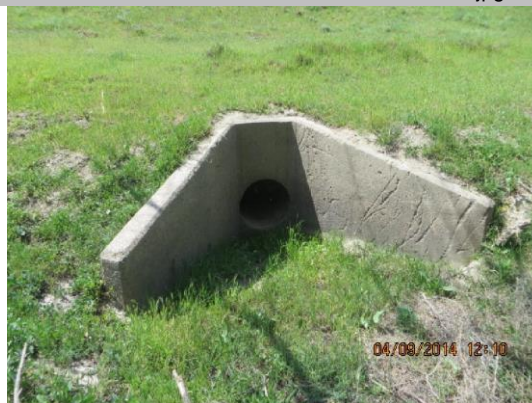
Photo 3 of 3 : UCIP_FA_2019_33707_60936.jpg

Pipe and concrete headwall at LS toe.

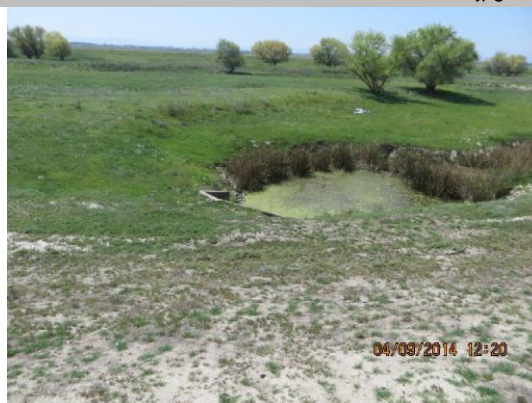
Photo 1 of 3 : UCIP_FA_2019_33708_60939.jpg

LM Start	1.45	Rating **	A/W	Issue No.	1316
LM End	1.45	Issue Type +	Ma	Location *	
Category	Supplemental			GPS Latitude/Longitude	
				Start	End
Item	DRAFT DWR UCIP LMA Responsibility			37.265804 °	37.265804 °
				-120.804955 °	-120.804955 °
DWR ID	19760				
Comment Code					
Inspector Comment					
DS_ID:19760 FS_ID:33708 EP_NO: N/A Repair Type: No Action Needed Crossing Status: Found UCIP Comments: FIELD_STRUCT_DESC: 36-inch corrugated metal gravity drainage pipe through the levee, 21 feet below the crown. Flap gate on the waterside (WS) end. Concrete headwall on the landside (LS) end. Concrete U-shaped headwall on the WS end. [Additional Reference(s): DWR Levee Log, 2002. USACE San Joaquin O&M Manual 601.1, 1967, (HLM 1.44)]. FS Date: 4/9/2014

Flapgate on concrete headwall at WS toe.

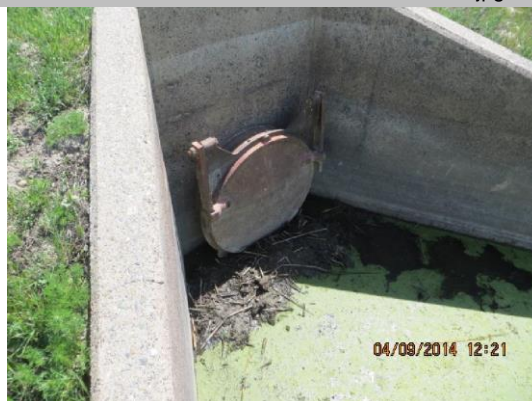
Photo 2 of 3 : UCIP_FA_2019_33708_60938.jpg

DS_ID:19760
FS_ID:33708
EP_NO: N/A
Repair Type: No Action Needed
Crossing Status: Found
UCIP Comments:
FIELD_STRUCT_DESC: 36-inch corrugated metal gravity drainage pipe through the levee, 21 feet below the crown. Flap gate on the waterside (WS) end. Concrete headwall on the landside (LS) end. Concrete U-shaped headwall on the WS end. [Additional Reference(s): DWR Levee Log, 2002. USACE San Joaquin O&M Manual 601.1, 1967, (HLM 1.44)].
FS Date: 4/9/2014

Flapgate on concrete headwall at WS toe.

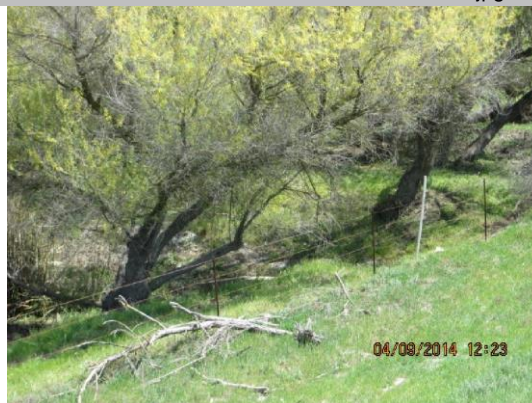
Photo 3 of 3 : UCIP_FA_2019_33708_60937.jpg

Pipe and concrete headwall on LS toe.

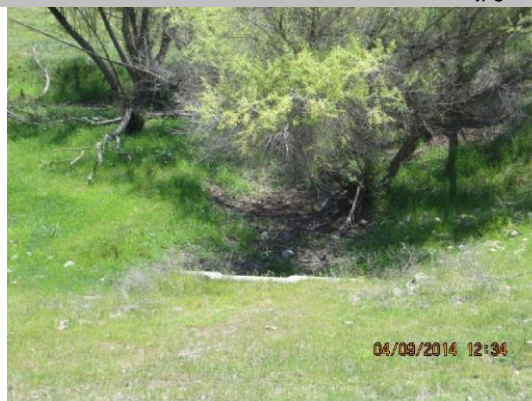
Photo 1 of 3 : UCIP_FA_2019_33709_60943.jpg

LM Start	2.84	Rating **	M	Issue No.	1317
LM End	2.84	Issue Type +	Ma	Location *	
Category	Supplemental			GPS Latitude/Longitude	
				Start	End
Item	DRAFT DWR UCIP LMA Responsibility			37.256810°	37.256810°
				-120.785113°	-120.785113°
DWR ID	19809				
Comment Code					
Inspector Comment					
DS_ID:19809 FS_ID:33709 EP_NO: N/A Repair Type: Non-Urgent Crossing Status: Found UCIP Comments: 04/09/2014 Log partially blocking inlet at LS toe. (DWR UCIP - W. Wylie) FIELD_STRUCT_DESC: 24-inch corrugated metal gravity drainage pipe through the levee, 15 feet below the crown. Flap gate on the waterside (WS) end. Concrete U-shaped headwall on each end. [Additional Reference(s): DWR Levee Log, 2002. USACE San Joaquin O&M Manual 601.1, 1967, (HLM 2.85)]. FS Date: 4/9/2014

Concrete headwall at outlet on WS toe.

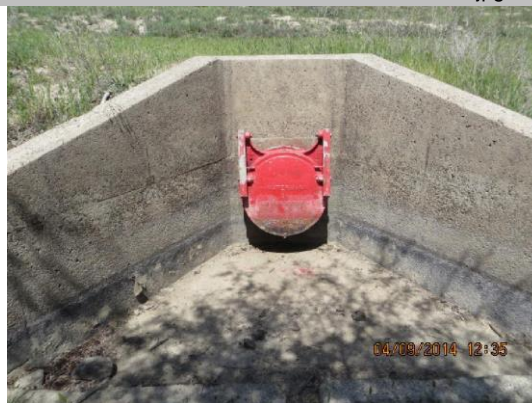
Photo 2 of 3 : UCIP_FA_2019_33709_60941.jpg

Headwall, pipe, and flapgate on WS toe.

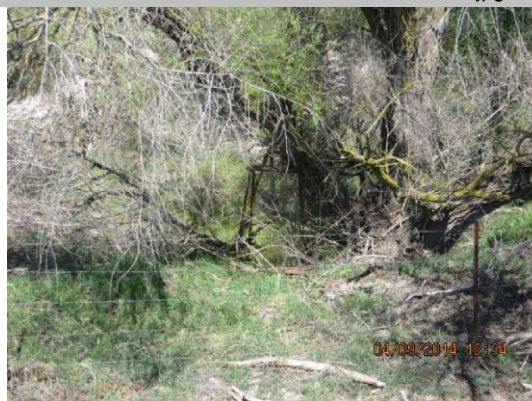
Photo 3 of 3 : UCIP_FA_2019_33709_60942.jpg

LM Start	2.84	Rating **	M	Issue No.	1317 (cont)
LM End	2.84	Issue Type +	Ma	Location *	
Category	Supplemental			GPS Latitude/Longitude	
				Start	End
Item	DRAFT DWR UCIP LMA Responsibility			37.256810 °	37.256810 °
				-120.785113 °	-120.785113 °
DWR ID	19809				
Comment Code					
Inspector Comment					
DS_ID:19809 FS_ID:33709 EP_NO: N/A Repair Type: Non-Urgent Crossing Status: Found UCIP Comments: 04/09/2014 Log partially blocking inlet at LS toe. (DWR UCIP - W. Wylie) FIELD_STRUCT_DESC: 24-inch corrugated metal gravity drainage pipe through the levee, 15 feet below the crown. Flap gate on the waterside (WS) end. Concrete U-shaped headwall on each end. [Additional Reference(s): DWR Levee Log, 2002. USACE San Joaquin O&M Manual 601.1, 1967, (HLM 2.85)]. FS Date: 4/9/2014

Concrete headwall and metal gate hoist on LS toe.

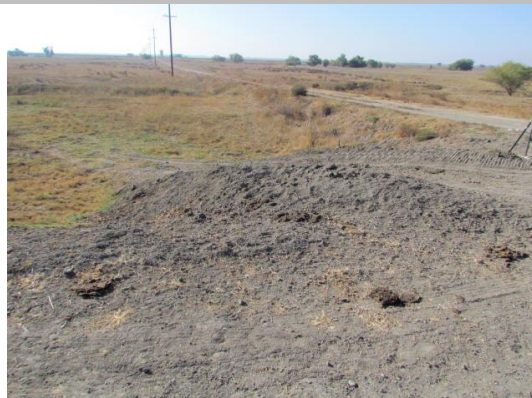
Photo 3 of 3 : FA_2019_NA0010_123_7_20190912_00005.jpg

LM Start	3.20	Rating **	M	Issue No.	7 (cont)	
LM End	3.20	Issue Type +	En	Location *	WS	
Category	Earthen Levee			GPS Latitude/Longitude		
				Start	End	
Item	Encroachments			37.256554 °	37.256554 °	
				-120.778847 °	-120.778847 °	
DWR ID	DWR_NA0010_05_f_2012_7					
Comment Code						
RA : Ramp						
Inspector Comment						
An unauthorized ramp is located on the waterside slope.

Looking northwest at unauthorized ramp on waterside slope.

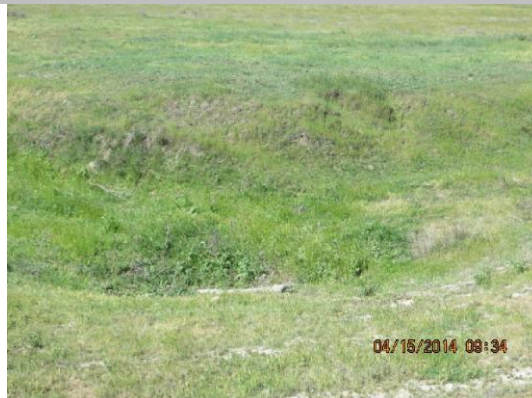
Photo 1 of 3 : UCIP_FA_2019_43055_60948.jpg

Concrete headwall at WS toe.

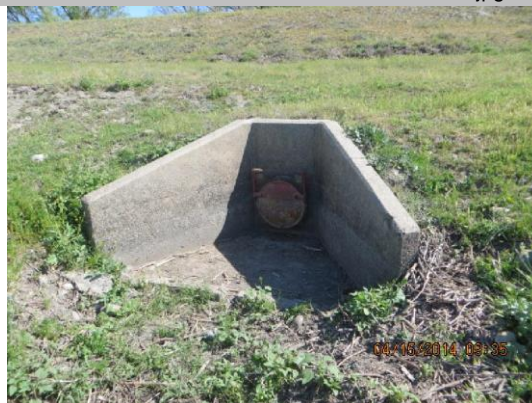
Photo 2 of 3 : UCIP_FA_2019_43055_60946.jpg

Flapgate and Concrete headwall at WS toe.

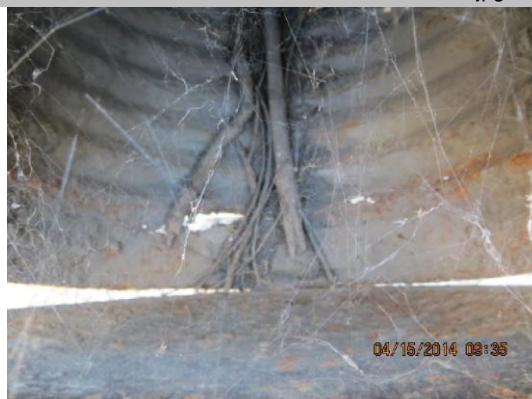
Photo 3 of 3 : UCIP_FA_2019_43055_60951.jpg

LM Start	3.34	Rating **	M	Issue No.	1318 (cont)	
LM End	3.34	Issue Type +	Ma	Location *		
Category	Supplemental			GPS Latitude/Longitude		
				Start	End	
Item	DRAFT DWR UCIP LMA Responsibility			37.255258 °	37.255258 °	
				-120.776996 °	-120.776996 °	
DWR ID	19810					
Comment Code						
Inspector Comment						
DS_ID:19810 FS_ID:43055 EP_NO: N/A Repair Type: Non-Urgent Crossing Status: Found UCIP Comments: 04/15/2014 Pipe corroded through at flapgate on WS toe. (DWR UCIP - W. Wylie) FIELD_STRUCT_DESC: 24-inch corrugated metal gravity drainage pipe through the levee, 14.7 feet below the crown. Flap gate on the waterside (WS) end. Concrete U-shaped headwall on each end. [Additional Reference(s): DWR Levee Log, 2002. USACE San Joaquin O&M Manual 601.1, 1967, (HLM 3.33)]. FS Date: 4/15/2014

Pipe corroded through just behind flapgate at WS toe.

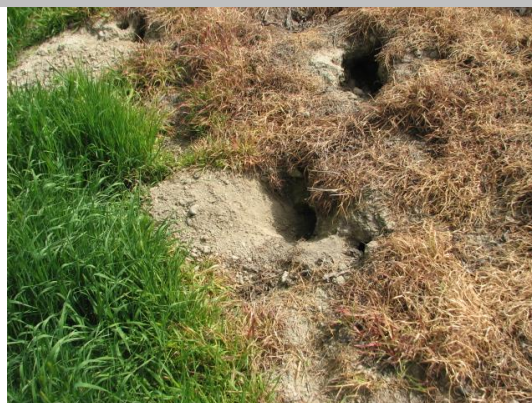
Photo 1 of 1 : FA_2019_NA0010_123_134_20190912_00032.jpg

LM Start	3.55	Rating **	M	Issue No.	134
LM End	3.55	Issue Type +	Ma	Location *	LS
Category	Earthen Levee			GPS Latitude/Longitude	
				Start	End
Item	Animal Control			37.255202 °	37.255202 °
				-120.773655 °	-120.773655 °
DWR ID	DWR_NA0010_05_f_2018_134				
Comment Code					
A3 : No rodents visible, but rodent burrows visible; need to backfill and compact or grout burrows.					
Inspector Comment					
Several rodent holes are located within this section.

Looking at typical rodent holes within this section. (Spring 2018)

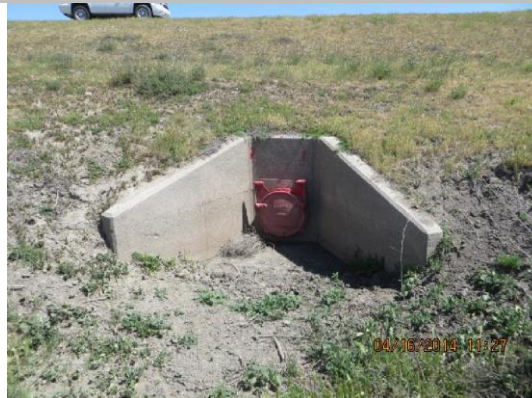
Photo 2 of 3 : UCIP_FA_2019_39586_61138.jpg

Pipe, headwall, and flapgate on WS toe.

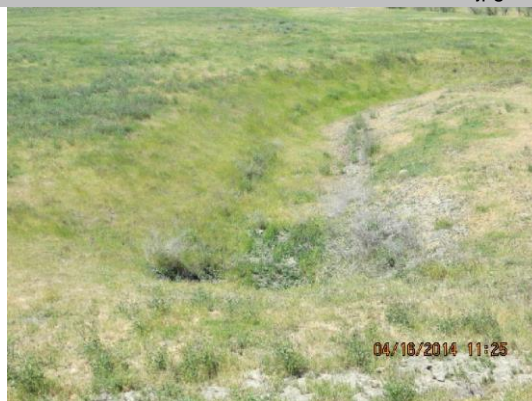
Photo 3 of 3 : UCIP_FA_2019_39586_61136.jpg

Pipe and headwall on LS toe.
