**Flood Control Project Maintenance
Levee Inspections**

Fall 2019 Levee Maintenance Deficiency Summary Report

San Joaquin River Basin

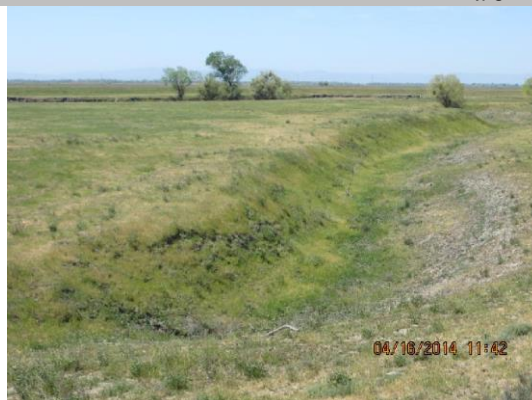
Photo 1 of 3 : UCIP_FA_2019_39880_61142.jpg

Pipe, headwall, and flapgate on WS toe.

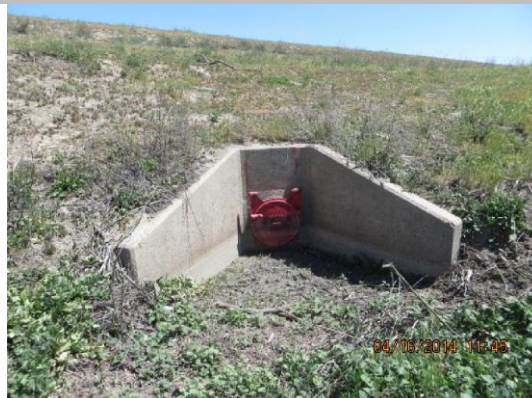
Photo 2 of 3 : UCIP_FA_2019_39880_61143.jpg

Pipe, headwall, and flapgate on WS toe.

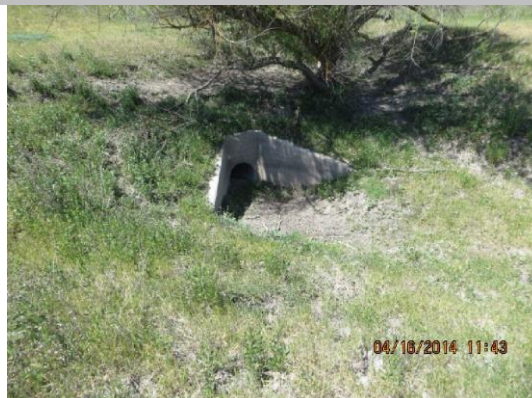
Photo 3 of 3 : UCIP_FA_2019_39880_61141.jpg

Pipe and headwall on LS toe.

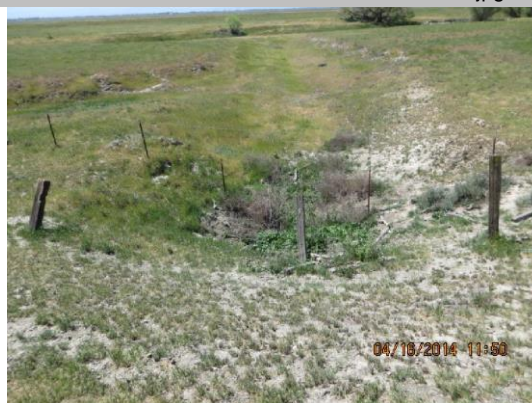
Photo 1 of 3 : UCIP_FA_2019_39588_61146.jpg

Comment Code						
Inspector Comment						
DS_ID:19770						
FS_ID:39588						
EP_NO: N/A						
Repair Type: Non-Urgent						
Crossing Status: Found						
UCIP Comments: 04/16/2014 Sediment buildup in pipe visible from landward side--recommend contacting owner to clear pipe. (DWR UCIP - W. Wylie)						
FIELD_STRUCT_DESC: 24-inch corrugated metal gravity drainage pipe through the levee, 11.6 feet below the crown. Flap gate on the waterside (WS) end. Concrete headwall on the landside (LS) end. Concrete U-shaped headwall on the WS end. [Additional Reference(s): DWR Levee Log, 2002. USACE San Joaquin O&M Manual 601.1, 1967, (HLM 4.27)].						
FS Date: 4/16/2014

Pipe, headwall, and flapgate on WS toe.

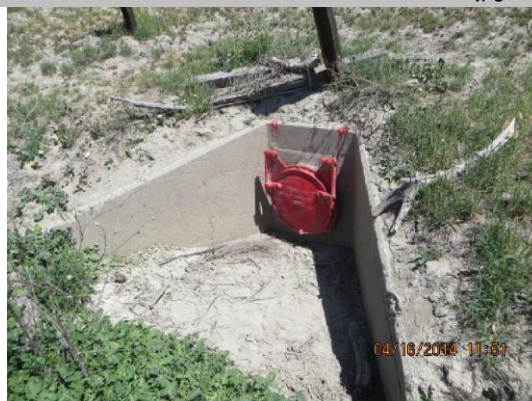
Photo 2 of 3 : UCIP_FA_2019_39588_61145.jpg

Pipe, headwall, and flapgate on WS toe.

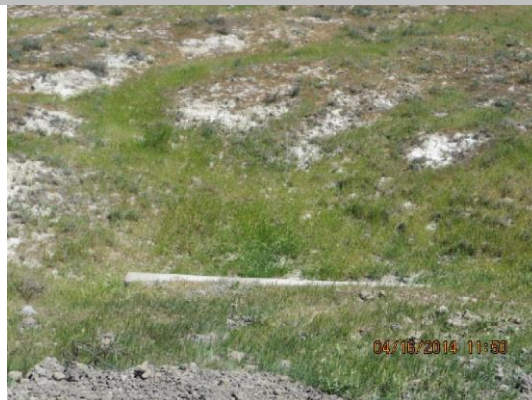
Photo 3 of 3 : UCIP_FA_2019_39588_61147.jpg

Concrete headwall and pipe on LS toe.

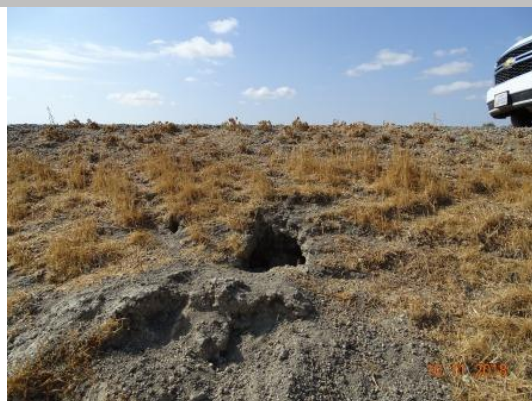
Photo 1 of 2 : FA_2019_NA0010_123_131_20190912_00028.jpg

LM Start	4.33	Rating **	U	Issue No.	131
LM End	4.33	Issue Type +	Ma	Location *	LS
Category	Earthen Levee			GPS Latitude/Longitude	
				Start	End
Item	Animal Control			37.245406 °	37.245406 °
				-120.759971 °	-120.759971 °
DWR ID	DWR_NA0010_05_f_2018_131				
Comment Code					
A3 : No rodents visible, but rodent burrows visible; need to backfill and compact or grout burrows.					
Inspector Comment					
Several large rodent holes are located on both sides of levee.

View of a large rodent hole in landward slope. (Fall 2018)

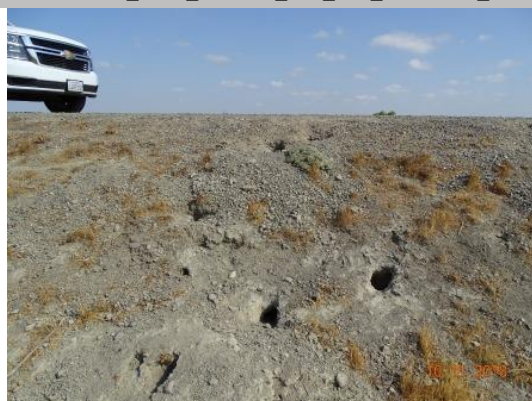
Photo 2 of 2 : FA_2019_NA0010_123_131_20190912_00029.jpg

View of several rodent burrows in landward slope. (Fall 2018)

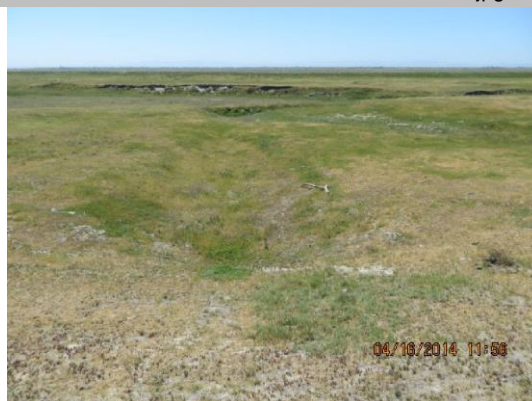
Photo 1 of 3 : UCIP_FA_2019_39589_62081.jpg

Comment Code						
Inspector Comment						
DS_ID:19771 FS_ID:39589 EP_NO: N/A Repair Type: Non-Urgent Crossing Status: Found UCIP Comments: 04/16/2014 Sediment buildup in pipe visible from landward side--recommend contacting owner to clear pipe. (DWR UCIP - W. Wylie) FIELD_STRUCT_DESC: 24-inch corrugated metal gravity drainage pipe through the levee, 12 feet below the crown. Flap gate on the waterside (WS) end. Concrete headwall on the landside (LS) end. Concrete U-shaped headwall on the WS end. [Additional Reference(s): DWR Levee Log, 2002. USACE San Joaquin O&M Manual 601.1, 1967, (HLM 4.54)]. FS Date: 4/16/2014 8:16:00 AM

Pipe, flapgate, and headwall on WS toe.

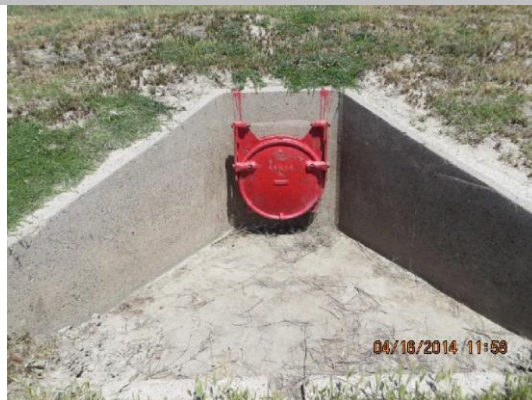
Photo 2 of 3 : UCIP_FA_2019_39589_62083.jpg

Pipe, flapgate, and headwall on WS toe.

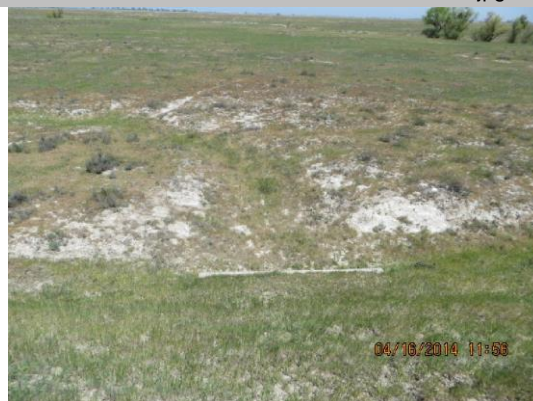
Photo 3 of 3 : UCIP_FA_2019_39589_62082.jpg

Comment Code						
Inspector Comment						
DS_ID:19771 FS_ID:39589 EP_NO: N/A Repair Type: Non-Urgent Crossing Status: Found UCIP Comments: 04/16/2014 Sediment buildup in pipe visible from landward side--recommend contacting owner to clear pipe. (DWR UCIP - W. Wylie) FIELD_STRUCT_DESC: 24-inch corrugated metal gravity drainage pipe through the levee, 12 feet below the crown. Flap gate on the waterside (WS) end. Concrete headwall on the landside (LS) end. Concrete U-shaped headwall on the WS end. [Additional Reference(s): DWR Levee Log, 2002. USACE San Joaquin O&M Manual 601.1, 1967, (HLM 4.54)]. FS Date: 4/16/2014 8:16:00 AM

Pipe and headwall on LS toe.

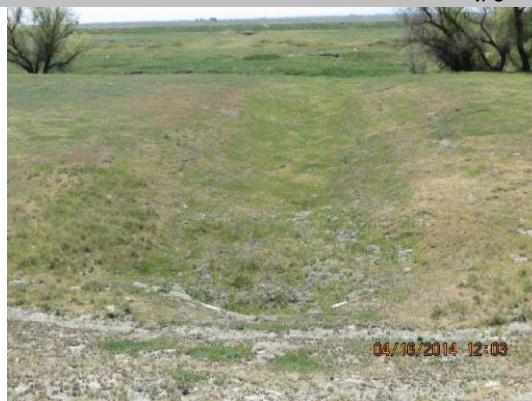
Photo 1 of 3 : UCIP_FA_2019_39590_62087.jpg

Headwall, flapgate, and pipe on WS toe.

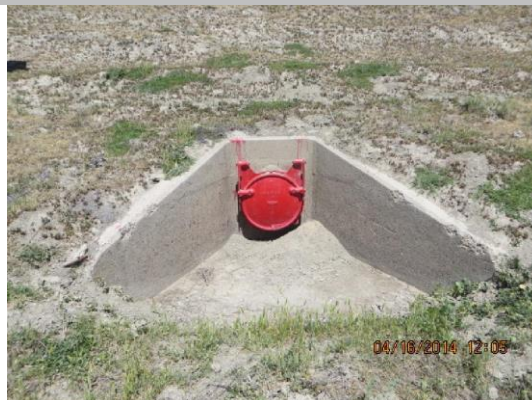
Photo 2 of 3 : UCIP_FA_2019_39590_62088.jpg

Headwall, flapgate, and pipe on WS toe.

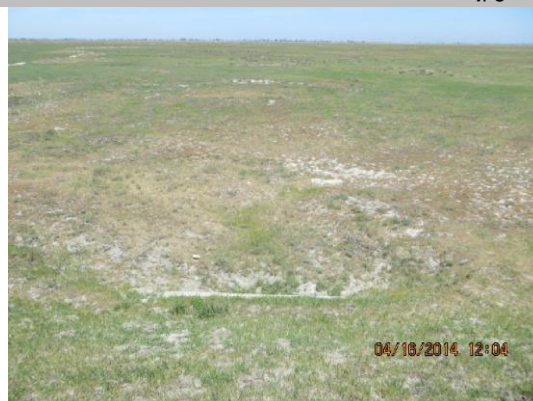
Photo 3 of 3 : UCIP_FA_2019_39590_62086.jpg

Comment Code						
Inspector Comment						
DS_ID:19772 FS_ID:39590 EP_NO: N/A Repair Type: Non-Urgent Crossing Status: Found UCIP Comments: 04/16/2014 Heavy sediment buildup in pipe visible from landward side--recommend contacting owner to clear pipe. (DWR UCIP - W. Wylie) FIELD_STRUCT_DESC: 24-inch corrugated metal gravity drainage pipe through the levee, 12.3 feet below the crown. Flap gate on the waterside (WS) end. Concrete headwall on the landside (LS) end. Concrete U-shaped headwall on the WS end. [Additional Reference(s): DWR Levee Log, 2002. USACE San Joaquin O&M Manual 601.1, 1967, (HLM 4.89)]. FS Date: 4/16/2014

Headwall and pipe on LS toe.

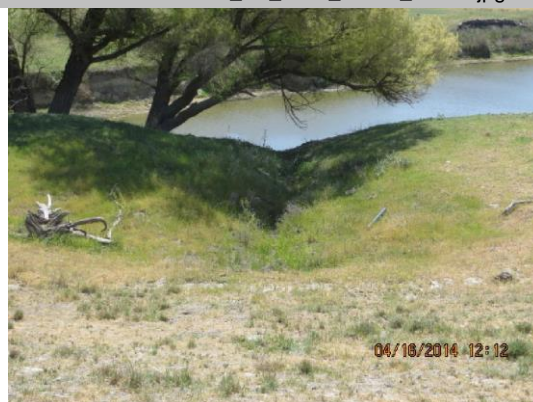
Photo 1 of 3 : UCIP_FA_2019_39591_62091.jpg

Headwall, flapgate, and pipe on WS toe.

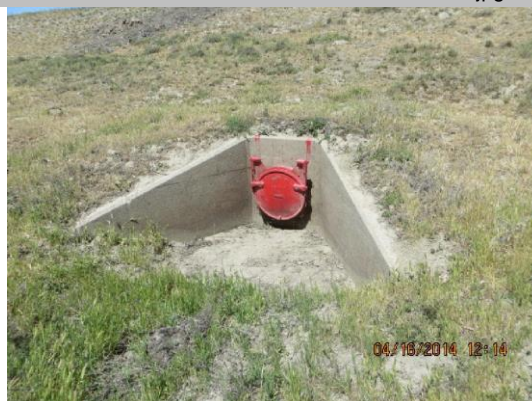
Photo 2 of 3 : UCIP_FA_2019_39591_62093.jpg

Comment Code						
Inspector Comment						
DS_ID:19773 FS_ID:39591 EP_NO: N/A Repair Type: Non-Urgent Crossing Status: Found UCIP Comments: 04/16/2014 Heavy sediment buildup in pipe visible from landward side--recommend contacting owner to clear pipe. (DWR UCIP - W. Wylie) FIELD_STRUCT_DESC: 24-inch corrugated metal gravity drainage pipe through the levee, 12.2 feet below the crown. Flap gate on the waterside (WS) end. Concrete headwall on the landside (LS) end. Concrete U-shaped headwall on the WS end. [Additional Reference(s): DWR Levee Log, 2002. USACE San Joaquin O&M Manual 601.1, 1967, (HLM 5.15)]. FS Date: 4/16/2014

Headwall, flapgate, and pipe on WS toe.

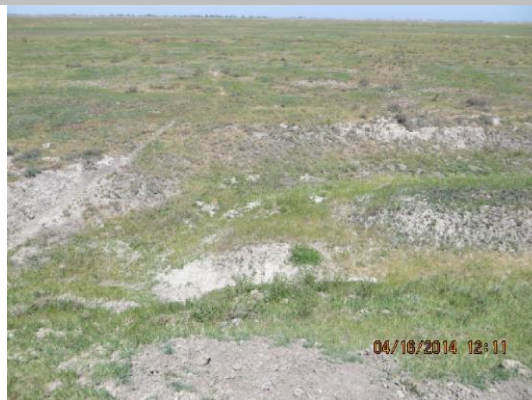
Photo 3 of 3 : UCIP_FA_2019_39591_62092.jpg

Headwall and pipe on LS toe.

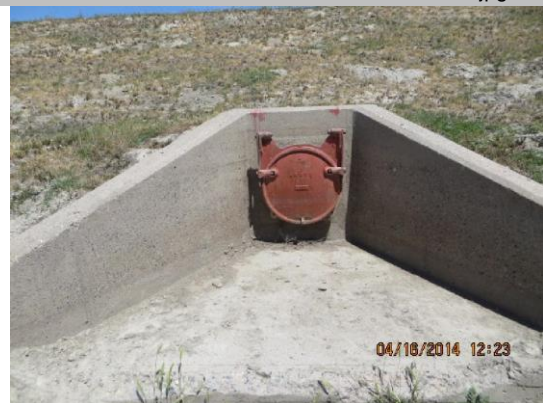
Photo 2 of 3 : UCIP_FA_2019_34151_62095.jpg

Headwall, flapgate, and pipe on WS toe.

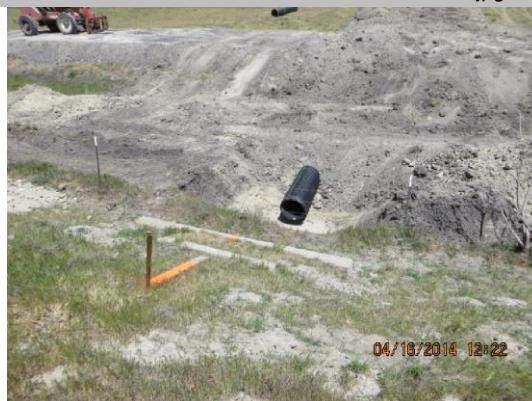
Photo 3 of 3 : UCIP_FA_2019_34151_62097.jpg

Headwall and pipe on LS toe with HDPE drain pipe being installed off LS toe.

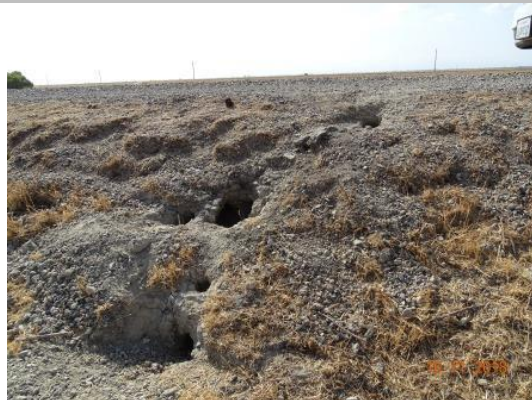
Photo 1 of 2 : FA_2019_NA0010_123_138_20190912_00033.jpg

LM Start	5.94	Rating **	U	Issue No.	138
LM End	5.94	Issue Type +	Ma	Location *	LS
Category	Earthen Levee			GPS Latitude/Longitude	
				Start	End
Item	Animal Control			37.236387 °	37.236387 °
				-120.734164 °	-120.734164 °
DWR ID	DWR_NA0010_05_f_2018_138				
Comment Code					
A1 : Exterminate rodents and backfill and compact or grout burrows.					
Inspector Comment					
Several large rodent holes are located at this location.

View of large rodent holes in landside slope. (Fall 2018)

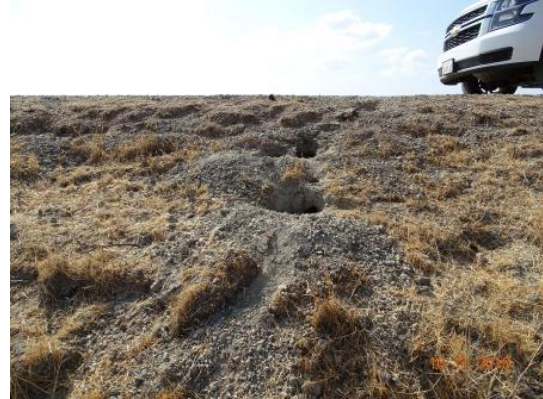
Photo 2 of 2 : FA_2019_NA0010_123_138_20190912_00034.jpg

LM Start	5.94	Rating **	U	Issue No.	138 (cont)
LM End	5.94	Issue Type +	Ma	Location *	LS
Category	Earthen Levee			GPS Latitude/Longitude	
				Start	End
Item	Animal Control			37.236387 °	37.236387 °
				-120.734164 °	-120.734164 °
DWR ID	DWR_NA0010_05_f _ 2018_138				
Comment Code					
A1 : Exterminate rodents and backfill and compact or grout burrows.					
Inspector Comment					
Several large rodent holes are located at this location.

View of large rodent holes in landside slope. (Fall 2018)

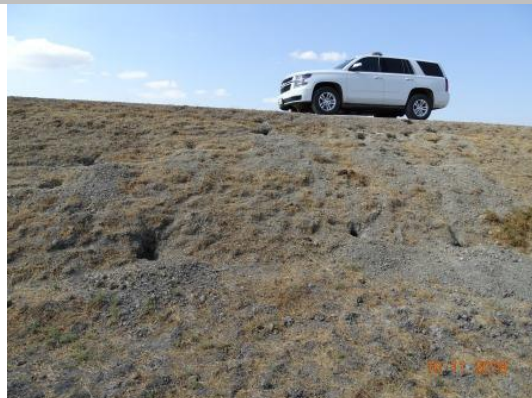
Photo 2 of 2 : FA_2019_NA0010_123_139_20190912_00036.jpg

View of rodent holes on landside slope. (Fall 2018)

LM Start	6.40	Rating **	M	Issue No.	139 (cont)	
LM End	6.40	Issue Type +	Ma	Location *	LS	
Category	Earthen Levee			GPS Latitude/Longitude		
				Start		End
Item	Animal Control			37.231900 °		37.231900 °
				-120.728345 °		-120.728345 °
DWR ID	DWR_NA0010_05_f_2018_139					
Comment Code						
A1 : Exterminate rodents and backfill and compact or grout burrows.						
Inspector Comment

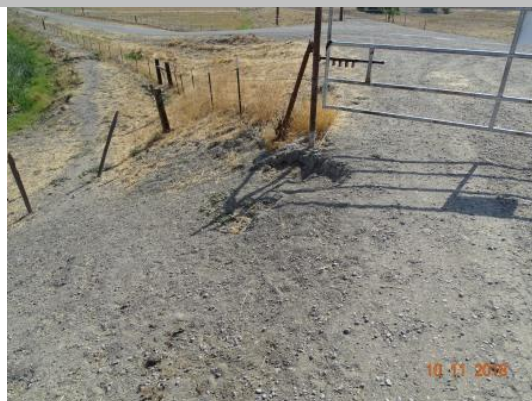
Photo 1 of 1 : FA_2019_NA0010_123_140_20190912_00037.jpg

LM Start	6.56	Rating **	M	Issue No.	140
LM End	6.56	Issue Type +	Ma	Location *	LS
Category	Earthen Levee			GPS Latitude/Longitude	
				Start	End
Item	Slope Stability			37.230013 °	37.230013 °
				-120.726832 °	-120.726832 °
DWR ID	DWR_NA0010_05_f_2018_140				
Comment Code					
S2 : Repair the levee slope damaged by foot traffic and prevent access where possible.					
Inspector Comment					
There is erosion on the landward slope near the gate.

Erosion on landward slope caused by foot traffic. (Fall 2018)

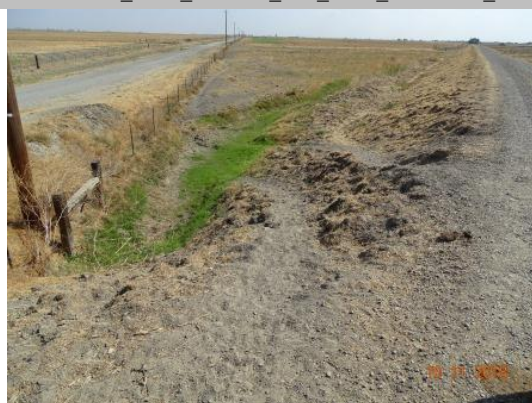
Photo 1 of 3 : FA_2019_NA0010_123_1309_20190912_00055.jpg

LM Start	6.59	Rating **	M	Issue No.	1309
LM End	6.59	Issue Type +	Ma	Location *	LS
Category	Earthen Levee			GPS Latitude/Longitude	
				Start	End
Item	Slope Stability			37.229682 °	37.229682 °
				-120.726305 °	-120.726305 °
DWR ID	DWR_NA0010_05_s_2015_1309				
Comment Code					
S2 : Repair the levee slope damaged by foot traffic and prevent access where possible.					
Inspector Comment					
The landside slope has damage caused by animal foot traffic.

Looking upstream at damaged landside slope. (Fall 2018)

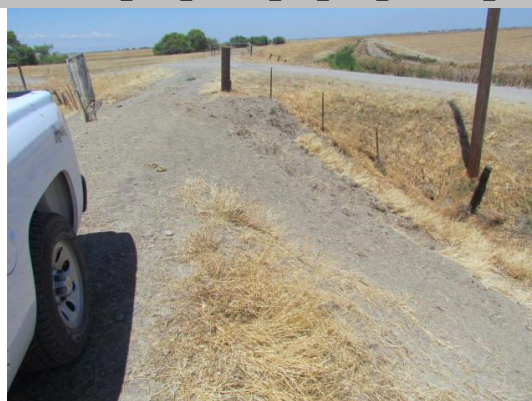
Photo 2 of 3 : FA_2019_NA0010_123_1309_20190912_00056.jpg

Looking north at damaged landward slope.

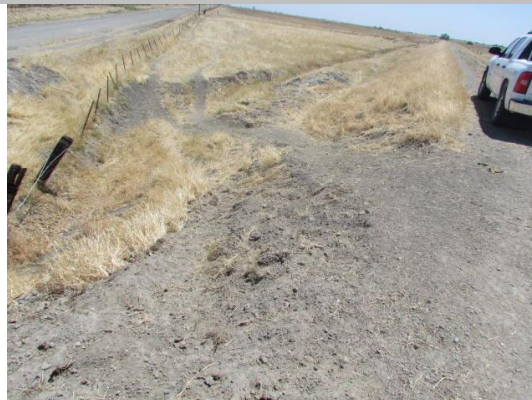
Photo 3 of 3 : FA_2019_NA0010_123_1309_20190912_00057.jpg

LM Start	6.59	Rating **	M	Issue No.	1309 (cont)
LM End	6.59	Issue Type +	Ma	Location *	LS
Category	Earthen Levee			GPS Latitude/Longitude	
				Start	End
Item	Slope Stability			37.229682 °	37.229682 °
				-120.726305 °	-120.726305 °
DWR ID	DWR_NA0010_05_s_2015_1309				
Comment Code					
S2 : Repair the levee slope damaged by foot traffic and prevent access where possible.					
Inspector Comment					
The landside slope has damage caused by animal foot traffic.

Looking east at damaged landward slope.

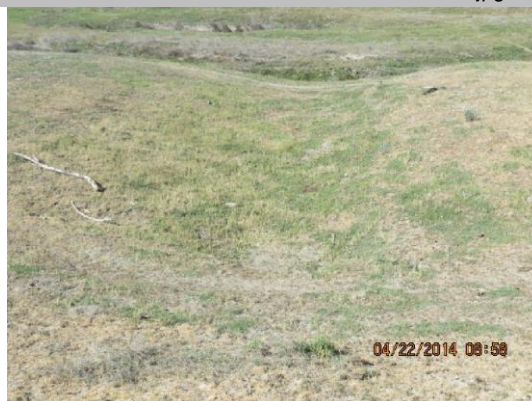
Photo 1 of 3 : UCIP_FA_2019_39592_62111.jpg

Comment Code						
Inspector Comment						
DS_ID:19761 FS_ID:39592 EP_NO: N/A Repair Type: Non-Urgent Crossing Status: Found UCIP Comments: 04/22/2014 Sediment buildup in pipe visible from landward side--recommend contacting owner to clear pipe. (DWR UCIP - W. Wylie) FIELD_STRUCT_DESC: 24-inch corrugated metal gravity drainage pipe through the levee, 12 feet below the crown. Flap gate on the waterside (WS) end. Concrete headwall on the landside (LS) end. Concrete U-shaped headwall on the waterside (WS) end. [Additional Reference(s): DWR Levee Log, 2002. USACE San Joaquin O&M Manual 601.1, 1967, (HLM 7.36)]. FS Date: 4/22/2014

Headwall, flapgate, and pipe on WS toe.

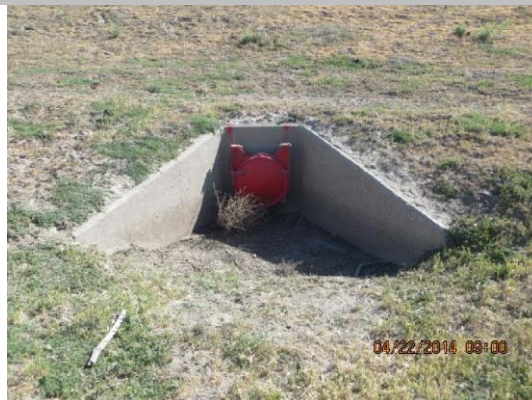
Photo 2 of 3 : UCIP_FA_2019_39592_62113.jpg

Headwall, flapgate, and pipe on WS toe.

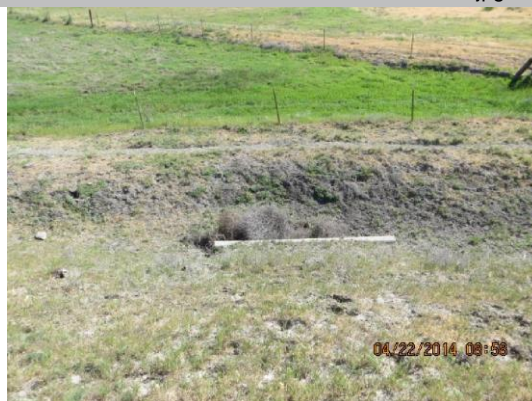
Photo 3 of 3 : UCIP_FA_2019_39592_62112.jpg

Comment Code						
Inspector Comment						
DS_ID:19761 FS_ID:39592 EP_NO: N/A Repair Type: Non-Urgent Crossing Status: Found UCIP Comments: 04/22/2014 Sediment buildup in pipe visible from landward side--recommend contacting owner to clear pipe. (DWR UCIP - W. Wylie) FIELD_STRUCT_DESC: 24-inch corrugated metal gravity drainage pipe through the levee, 12 feet below the crown. Flap gate on the waterside (WS) end. Concrete headwall on the landside (LS) end. Concrete U-shaped headwall on the waterside (WS) end. [Additional Reference(s): DWR Levee Log, 2002. USACE San Joaquin O&M Manual 601.1, 1967, (HLM 7.36)]. FS Date: 4/22/2014

Headwall and pipe on LS toe.

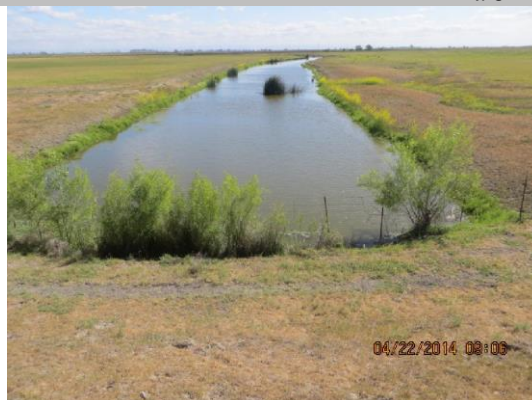
Photo 1 of 2 : UCIP_FA_2019_34170_62116.jpg

Comment Code					
Inspector Comment					
DS_ID:19762					
FS_ID:34170					
EP_NO: N/A					
Repair Type: Non-Urgent					
Crossing Status: Indicator Found					
UCIP Comments: 04/22/2014 Appears abandoned and if so should be done so properly. Slide gate rusted shut on WS slope. Unable to locate inlet or outlet. (DWR UCIP - W. Wylie)					
FIELD_STRUCT_DESC: 24-inch corrugated metal gravity drainage pipe through the levee, 20.4 feet below the crown. Slide gate in 36-inch corrugated metal pipe (CMP) riser on the waterside (WS) slope. Concrete U-shaped headwall on each end. Not found in 2014. [Additional Reference(s): DWR Levee Log, 2002. USACE San Joaquin O&M Manual 601.1, 1967, (HLM 7.58)].					
FS Date: 4/22/2014

Likely inlet on LS toe. No pipe or headwall can be seen at current water level.

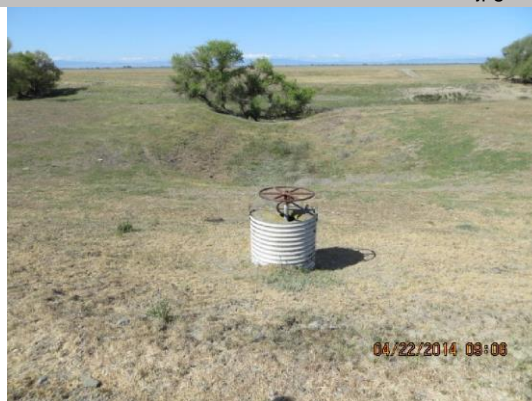
Photo 2 of 2 : UCIP_FA_2019_34170_62115.jpg

Comment Code						
Inspector Comment						
DS_ID:19762						
FS_ID:34170						
EP_NO: N/A						
Repair Type: Non-Urgent						
Crossing Status: Indicator Found						
UCIP Comments: 04/22/2014 Appears abandoned and if so should be done so properly. Slide gate rusted shut on WS slope. Unable to locate inlet or outlet. (DWR UCIP - W. Wylie)						
FIELD_STRUCT_DESC: 24-inch corrugated metal gravity drainage pipe through the levee, 20.4 feet below the crown. Slide gate in 36-inch corrugated metal pipe (CMP) riser on the waterside (WS) slope. Concrete U-shaped headwall on each end. Not found in 2014. [Additional Reference(s): DWR Levee Log, 2002. USACE San Joaquin O&M Manual 601.1, 1967, (HLM 7.58)].						
FS Date: 4/22/2014

Slide gate in CMP riser on WS slope. No outlet or pipe found on WS toe.

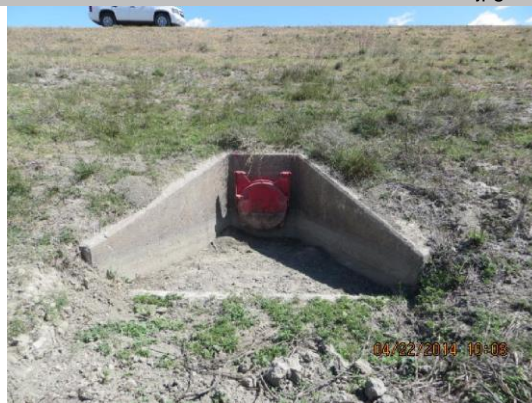
Photo 2 of 3 : UCIP_FA_2019_34265_62183.jpg

Headwall, flapgate, and pipe on WS toe

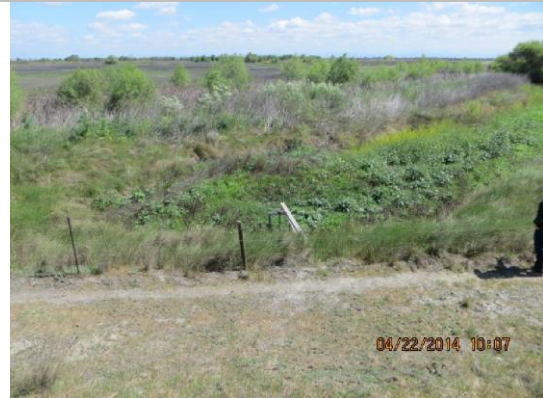
Photo 3 of 3 : UCIP_FA_2019_34265_62181.jpg

Headwall, slidegate, and pipe on LS toe.

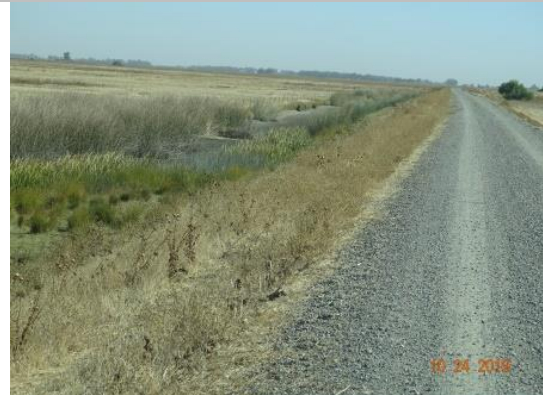
Photo 1 of 1 : FA_2019_NA0010_123_155_20191108_00327.jpg

LM Start	9.00	Rating **	U	Issue No.	155
LM End	10.74	Issue Type +	Ma	Location *	LS
Category	Earthen Levee			GPS Latitude/Longitude	
				Start	End
Item	Vegetation			37.204620°	37.190285°
				-120.694467°	-120.669748°
DWR ID	DWR_NA0010_05_f_2019_155				
Comment Code					
V1 : Control annual grass and weeds on the levee slopes and easements.					
Inspector Comment

View of the landside slope looking upstream. (Fall 2019)

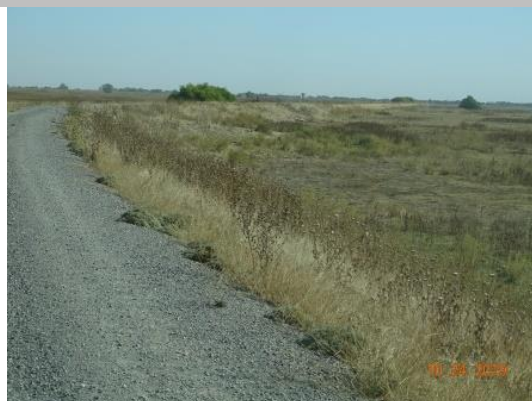
Photo 1 of 1 : FA_2019_NA0010_123_156_20191108_00328.jpg

LM Start	9.28	Rating **	U	Issue No.	156
LM End	10.70	Issue Type +	Ma	Location *	WS
Category	Earthen Levee			GPS Latitude/Longitude	
				Start	End
Item	Vegetation			37.202732°	37.190281°
				-120.690085°	-120.670589°
DWR ID	DWR_NA0010_05_f_2019_156				
Comment Code					
V1 : Control annual grass and weeds on the levee slopes and easements.					
Inspector Comment

View of the waterside slope looking upstream. (Fall 2019)

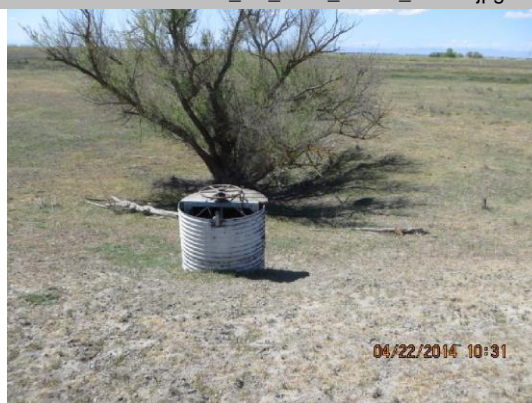
Photo 1 of 3 : UCIP_FA_2019_34272_62196.jpg

LM Start	9.28	Rating **	A/W	Issue No.	1331
LM End	9.28	Issue Type +	Ma	Location *	
Category	Supplemental			GPS Latitude/Longitude	
				Start	End
Item	DRAFT DWR UCIP LMA Responsibility			37.202742 °	37.202742 °
				-120.690064 °	-120.690064 °
DWR ID	19766				
Comment Code					
Inspector Comment					
DS_ID:19766					
FS_ID:34272					
EP_NO: N/A					
Repair Type: No Action Needed					
Crossing Status: Found					
UCIP Comments:					
FIELD_STRUCT_DESC: 36-inch corrugated metal gravity drainage pipe through the levee, 14.8 feet below the crown. Slide gate in a 48-inch corrugated metal pipe (CMP) riser on the waterside (WS) slope. Concrete headwall on each end. [Additional Reference(s): DWR Levee Log, 2002. USACE San Joaquin O&M Manual 601.1, 1967, (HLM 9.26)]. FS Date: 4/22/2014

Slide gate in 48-inch CMP riser on WS slope.

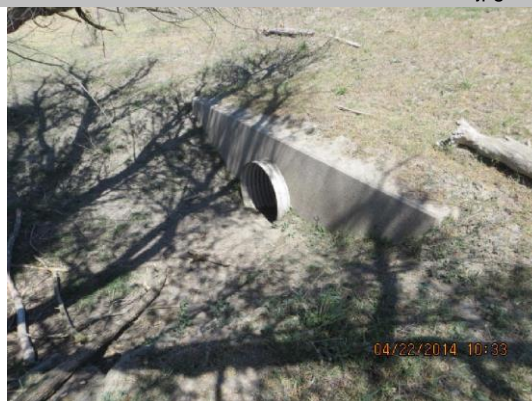
Photo 2 of 3 : UCIP_FA_2019_34272_62198.jpg

Headwall and pipe at WS toe.

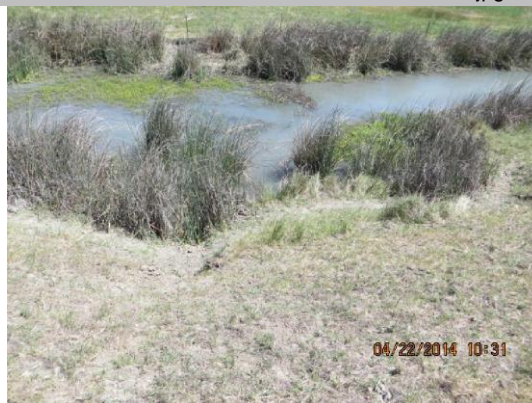
Photo 3 of 3 : UCIP_FA_2019_34272_62197.jpg

Headwall and pipe at LS toe.

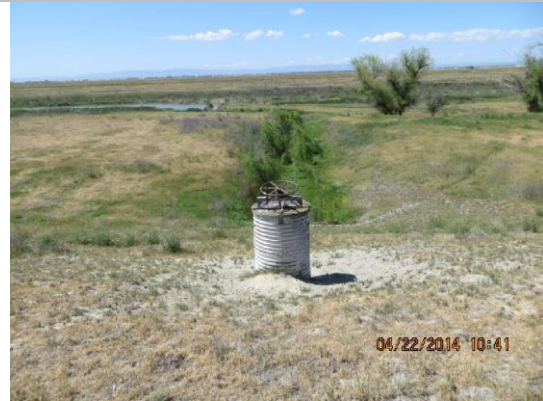
Photo 1 of 3 : UCIP_FA_2019_34273_62201.jpg

LM Start	10.06	Rating **	M	Issue No.	1332
LM End	10.06	Issue Type +	Ma	Location *	
Category	Supplemental			GPS Latitude/Longitude	
				Start	End
Item	DRAFT DWR UCIP LMA Responsibility			37.194736 °	37.194736 °
				-120.680116 °	-120.680116 °
DWR ID	19767				
Comment Code					
Inspector Comment					
DS_ID:19767 FS_ID:34273 EP_NO: N/A Repair Type: Non-Urgent Crossing Status: Found UCIP Comments: 04/22/2014 Slidegate actuator appears bent and may not work properly (WS slope). (DWR UCIP - W. Wylie) FIELD_STRUCT_DESC: 24-inch corrugated metal gravity drainage pipe through the levee, 15 feet below the crown. Slide gate in a 36-inch corrugated metal pipe (CMP) riser on the waterside (WS) slope. Concrete headwall on each end. [Additional Reference(s): DWR Levee Log, 2002. USACE San Joaquin O&M Manual 601.1, 1967, (HLM 10.05)]. FS Date: 4/22/2014

Slidegate in CMP riser on WS slope.

Item	DRAFT DWR UCIP LMA Responsibility			37.194736 °	37.194736 °	
				-120.680116 °	-120.680116 °	
DWR ID	19767					
Comment Code						
Inspector Comment						
DS_ID:19767						
FS_ID:34273						
EP_NO: N/A						
Repair Type: Non-Urgent						
Crossing Status: Found						
UCIP Comments: 04/22/2014 Slidegate actuator appears bent and may not work properly (WS slope). (DWR UCIP - W. Wylie)						
FIELD_STRUCT_DESC: 24-inch corrugated metal gravity drainage pipe through the levee, 15 feet below the crown. Slide gate in a 36-inch corrugated metal pipe (CMP) riser on the waterside (WS) slope.						
Concrete headwall on each end. [Additional Reference(s): DWR Levee Log, 2002. USACE San Joaquin O&M Manual 601.1, 1967, (HLM 10.05)].						
FS Date: 4/22/2014

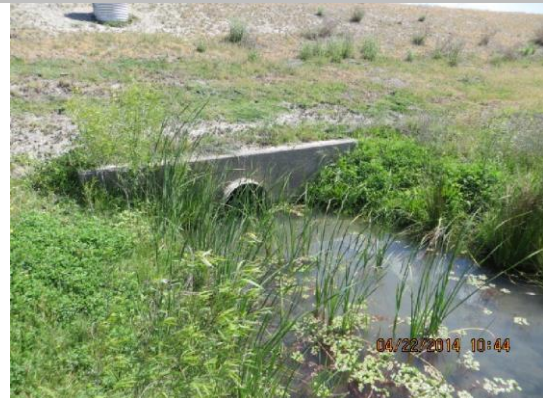
Photo 2 of 3 : UCIP_FA_2019_34273_62202.jpg

Concrete headwall and pipe on WS toe.

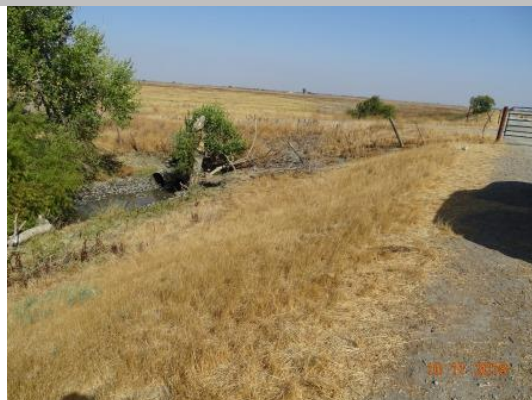
Photo 1 of 1 : FA_2019_NA0010_123_142_20190912_00038.jpg

LM Start	10.66	Rating **	M	Issue No.	142
LM End	10.66	Issue Type +	Ma	Location *	LS
Category	Earthen Levee			GPS Latitude/Longitude	
				Start	End
Item	Encroachments			37.190286 °	37.190286 °
				-120.671207 °	-120.671207 °
DWR ID	DWR_NA0010_05_f_2018_142				
Comment Code					
TR : Tree or limb					
Inspector Comment					
A fallen tree is located on the landside toe and slope.

Fallen tree on landside toe and slope. (Fall 2018)

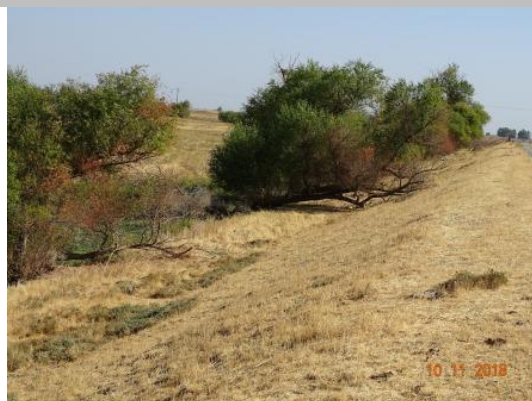
Photo 1 of 1 : FA_2019_NA0010_123_144_20190912_00039.jpg

LM Start	11.37	Rating **	M	Issue No.	144	
LM End	11.37	Issue Type +	Ma	Location *	LS	
Category	Earthen Levee			GPS Latitude/Longitude		
				Start		End
Item	Trim / Thin Trees			37.187792 °		37.187792 °
				-120.659454 °		-120.659454 °
DWR ID	DWR_NA0010_05_f_2018_144					
Comment Code						
T2 : Thin trees to allow visibility of the ground and room to flood fight.						
Inspector Comment						
Tree limbs on the levee slope should be trimmed to allow access.

View of tree limbs on levee slope. (Fall 2018)

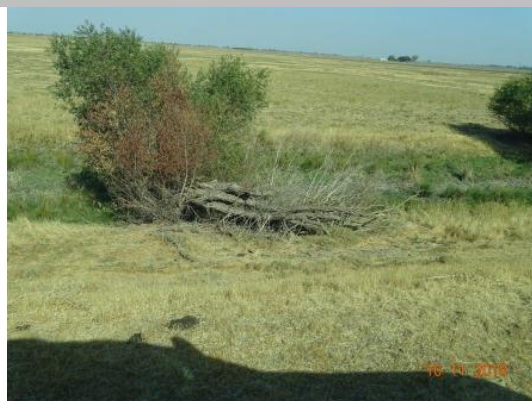
Photo 1 of 1 : FA_2019_NA0010_123_145_20190912_00040.jpg

LM Start	11.41	Rating **	M	Issue No.	145
LM End	11.41	Issue Type +	Ma	Location *	LS
Category	Earthen Levee			GPS Latitude/Longitude	
				Start	End
Item	Trim / Thin Trees			37.187404 °	37.187404 °
				-120.659005 °	-120.659005 °
DWR ID	DWR_NA0010_05_f_2018_145				
Comment Code					
T2 : Thin trees to allow visibility of the ground and room to flood fight.					
Inspector Comment					
A fallen tree trunk is located on the levee toe.

Fallen tree on levee toe. (Fall 2018)

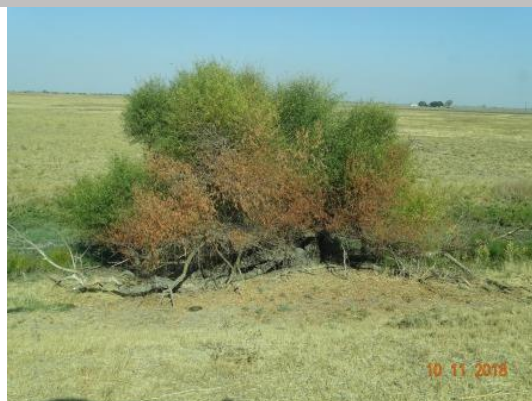
Photo 1 of 1 : FA_2019_NA0010_123_146_20190912_00041.jpg

LM Start	11.44	Rating **	M	Issue No.	146
LM End	11.44	Issue Type +	Ma	Location *	LS
Category	Earthen Levee			GPS Latitude/Longitude	
				Start	End
Item	Trim / Thin Trees			37.187021 °	37.187021 °
				-120.658564 °	-120.658564 °
DWR ID	DWR_NA0010_05_f_2018_146				
Comment Code					
T2 : Thin trees to allow visibility of the ground and room to flood fight.					
Inspector Comment					
Fallen tree limbs are located on the levee toe.

Tree limbs and trunk on levee toe. (Fall 2018)

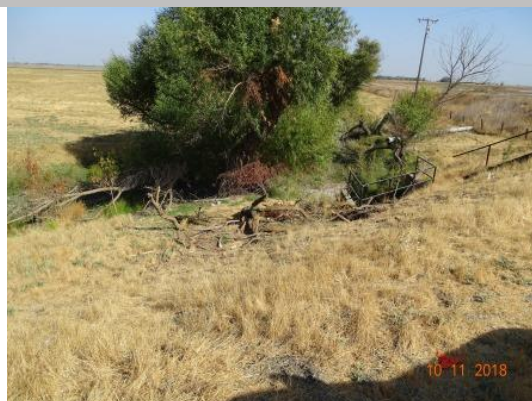
Photo 1 of 1 : FA_2019_NA0010_123_147_20190912_00042.jpg

LM Start	11.49	Rating **	M	Issue No.	147
LM End	11.49	Issue Type +	En	Location *	LS
Category	Earthen Levee			GPS Latitude/Longitude	
				Start	End
Item	Encroachments			37.186482 °	37.186482 °
				-120.657935 °	-120.657935 °
DWR ID	DWR_NA0010_05_f_2018_147				
Comment Code					
TR : Tree or limb					
Inspector Comment					
Tree limbs are located on landside slope and toe.

Tree limbs on levee toe. (Fall 2018)

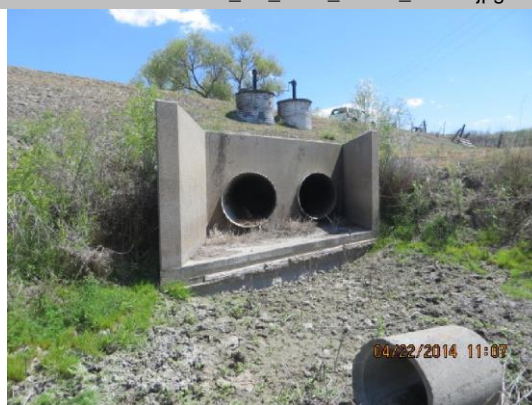
Photo 1 of 3 : UCIP_FA_2019_34281_62219.jpg

LM Start	11.49	Rating **	A/W	Issue No.	1333
LM End	11.49	Issue Type +	Ma	Location *	
Category	Supplemental			GPS Latitude/Longitude	
				Start	End
Item	DRAFT DWR UCIP LMA Responsibility			37.186471 °	37.186471 °
				-120.657915 °	-120.657915 °
DWR ID	19768				
Comment Code					
Inspector Comment					
DS_ID:19768					
FS_ID:34281					
EP_NO: N/A					
Repair Type: No Action Needed					
Crossing Status: Found					
UCIP Comments:					
FIELD_STRUCT_DESC: [Deadman Drainage Structure] 1 of 2: 48-inch corrugated metal gravity drainage pipe through the levee, 16 feet below the crown. Slide gate in a 60-inch corrugated metal pipe (CMP) riser on the waterside (WS) slope. Concrete U-shaped headwall on each end. Stairs on the landside (LS) slope. [Additional Reference(s): DWR Levee Log, 2002. USACE San Joaquin O&M Manual 601.1, 1967, (HLM 11.48)].					
FS Date: 4/22/2014

Slidegate in CMP riser, concrete headwall and pipe visible on WS slope.

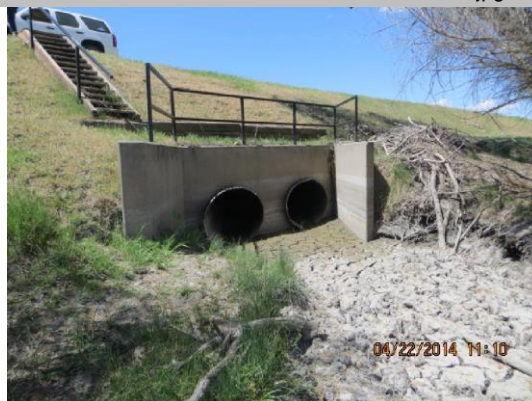
Photo 2 of 3 : UCIP_FA_2019_34281_62217.jpg

Stairs, concrete headwall, and pipe visible on LS slope.

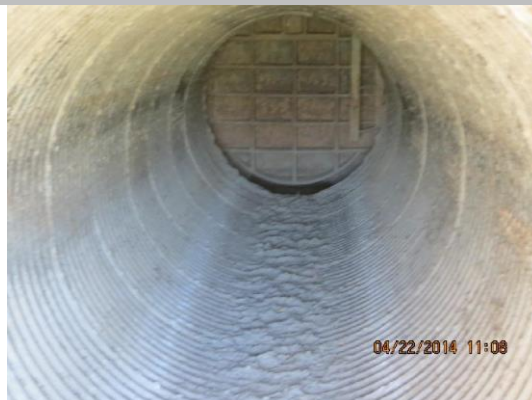
Photo 3 of 3 : UCIP_FA_2019_34281_62218.jpg

Inside pipe at LS toe.

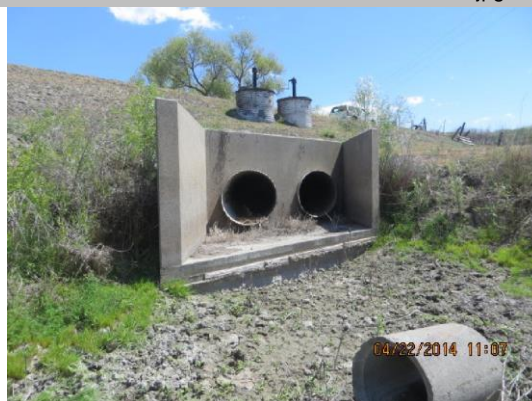
Photo 1 of 3 : UCIP_FA_2019_34280_62216.jpg

LM Start	11.50	Rating **	A/W	Issue No.	1334
LM End	11.50	Issue Type +	Ma	Location *	
Category	Supplemental			GPS Latitude/Longitude	
				Start	End
Item	DRAFT DWR UCIP LMA Responsibility			37.186458 °	37.186458 °
				-120.657903 °	-120.657903 °
DWR ID	19734				
Comment Code					
Inspector Comment					
DS_ID:19734 FS_ID:34280 EP_NO: N/A Repair Type: No Action Needed Crossing Status: Found UCIP Comments: FIELD_STRUCT_DESC: [Deadman Drainage Structure] 2 of 2: 48-inch corrugated metal gravity drainage pipe through the levee, 16 feet below the crown. Slide gate in a 60-inch corrugated metal pipe (CMP) riser on the waterside (WS) slope. Concrete U-shaped headwall on each end. Stairs on the landside (LS) slope. [Additional Reference(s): DWR Levee Log, 2002. USACE San Joaquin O&M Manual 601.1, 1967, (HLM 11.48)]. FS Date: 4/22/2014

Concrete headwall, pipe, and slidegate in CMP riser on WS of levee.

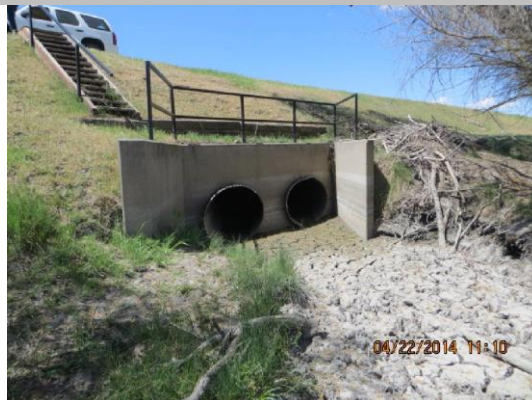
Photo 2 of 3 : UCIP_FA_2019_34280_62214.jpg

Stairs, concrete headwall and pipe on LS toe.

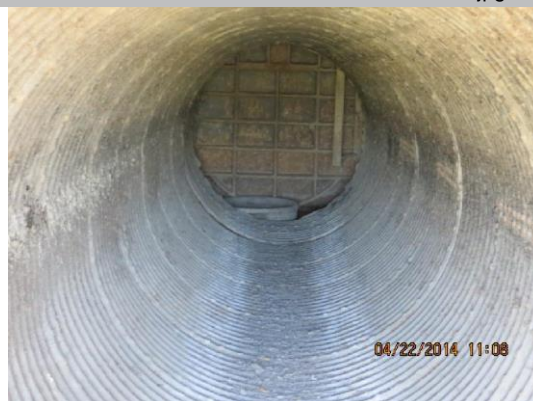
Photo 3 of 3 : UCIP_FA_2019_34280_62215.jpg

Inside pipe on WS toe.

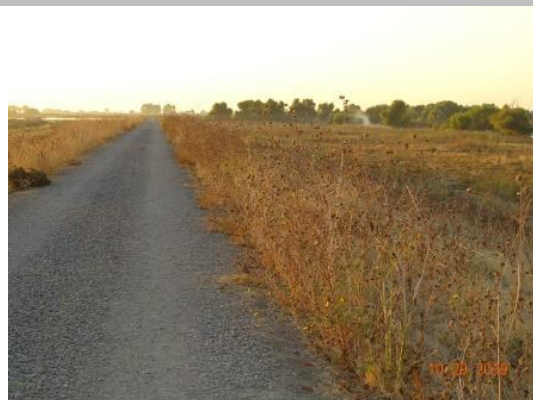
Photo 1 of 1 : FA_2019_NA0010_123_157_20191108_00329.jpg

LM Start	11.54	Rating **	U	Issue No.	157
LM End	15.12	Issue Type +	Ma	Location *	WS
Category	Earthen Levee			GPS Latitude/Longitude	
				Start	End
Item	Vegetation			37.185957 °	37.156705 °
				-120.657316 °	-120.609366 °
DWR ID	DWR_NA0010_05_f_2019_157				
Comment Code					
V1 : Control annual grass and weeds on the levee slopes and easements.					
Inspector Comment

Looking upstream along the waterside slope. (Fall 2019)

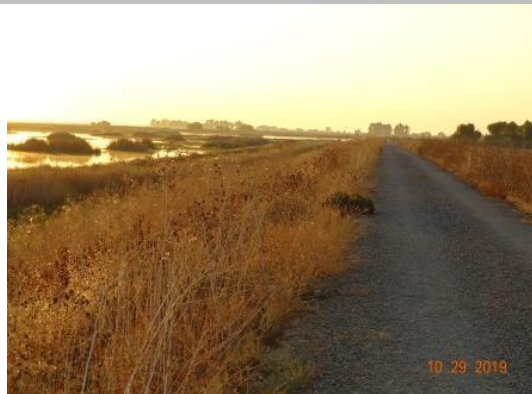
Photo 1 of 1 : FA_2019_NA0010_123_118_20191108_00330.jpg

LM Start	11.54	Rating **	U	Issue No.	118
LM End	15.12	Issue Type +	Ma	Location *	LS
Category	Earthen Levee			GPS Latitude/Longitude	
				Start	End
Item	Vegetation			37.185956 °	37.156705 °
				-120.657317 °	-120.609366 °
DWR ID	DWR_NA0010_05_f_2019_118				
Comment Code					
V1 : Control annual grass and weeds on the levee slopes and easements.					
Inspector Comment

View of the landside slope looking upstream. (Fall 2019)

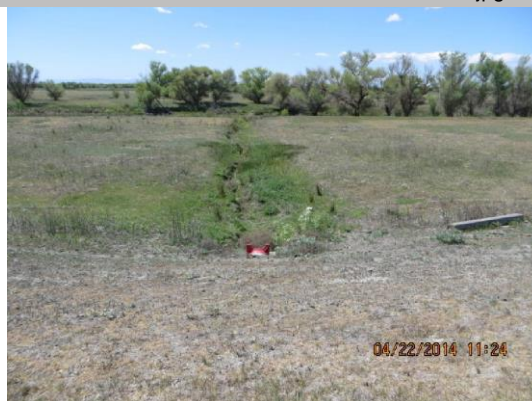
Photo 1 of 3 : UCIP_FA_2019_34283_62221.jpg

LM Start	11.65	Rating **	A/W	Issue No.	1335
LM End	11.65	Issue Type +	Ma	Location *	
Category	Supplemental			GPS Latitude/Longitude	
				Start	End
Item	DRAFT DWR UCIP LMA Responsibility			37.184830 °	37.184830 °
				-120.656016 °	-120.656016 °
DWR ID	19704				
Comment Code					
Inspector Comment					
DS_ID:19704 FS_ID:34283 EP_NO: N/A Repair Type: No Action Needed Crossing Status: Found UCIP Comments: FIELD_STRUCT_DESC: 24-inch corrugated metal gravity drainage pipe through the levee, 11.8 feet below the crown. Flap gate on the waterside (WS) end. Concrete headwall on the landside (LS) end. Concrete saddle and apron on the WS end. [Additional Reference(s): DWR Levee Log, 2002. USACE San Joaquin O&M Manual 601.1, 1967, (HLM 11.63)]. FS Date: 4/22/2014

Headwall, flapgate, and pipe at WS toe.

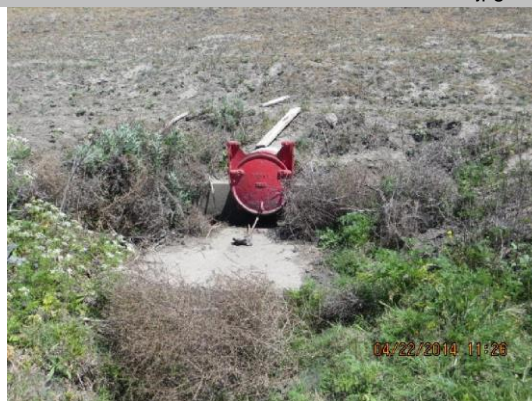
Photo 2 of 3 : UCIP_FA_2019_34283_62223.jpg

Headwall, flapgate, and pipe at WS toe.

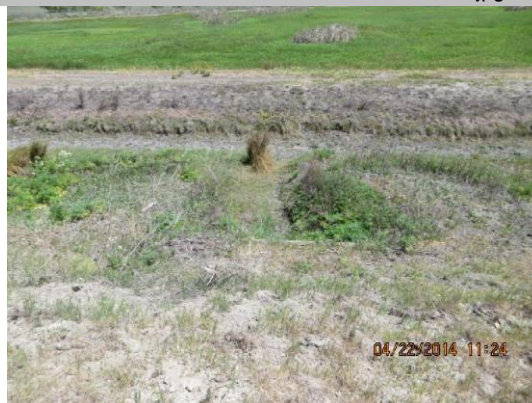
Photo 3 of 3 : UCIP_FA_2019_34283_62222.jpg

Concrete headwall and pipe at LS toe.

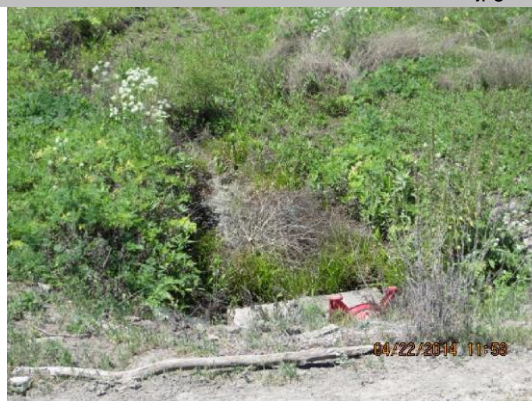
Photo 1 of 3 : UCIP_FA_2019_34284_62225.jpg

Headwall, flapgate, and pipe on WS toe.

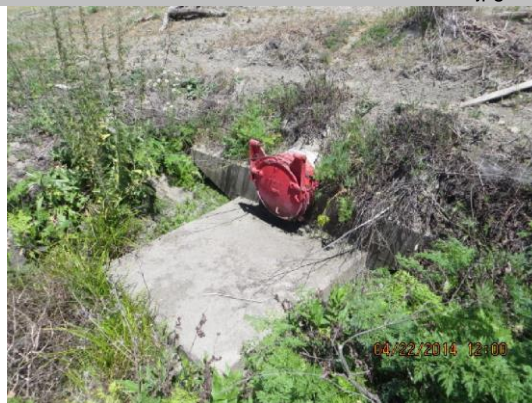
Photo 2 of 3 : UCIP_FA_2019_34284_62227.jpg

Headwall, flapgate, and pipe on WS toe.

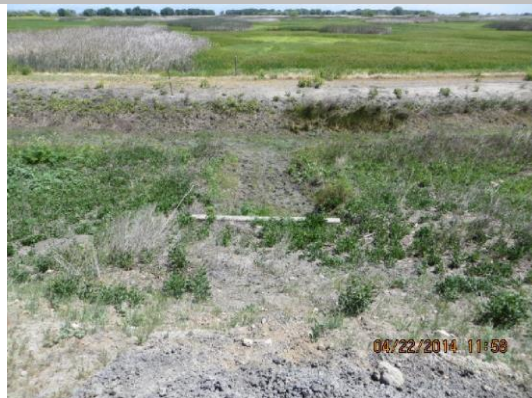
Photo 3 of 3 : UCIP_FA_2019_34284_62226.jpg

Headwall and pipe on LS toe.

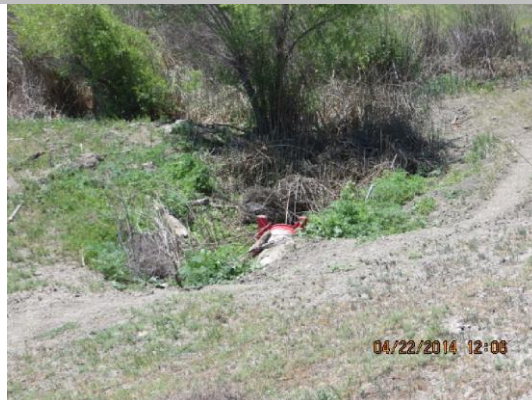
Photo 1 of 3 : UCIP_FA_2019_34285_62230.jpg

Headwall, flapgate, and pipe on WS toe.

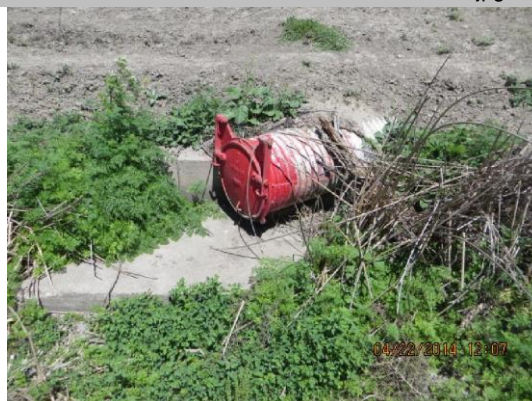
Photo 2 of 3 : UCIP_FA_2019_34285_62229.jpg

Headwall, flapgate, and pipe on WS toe.

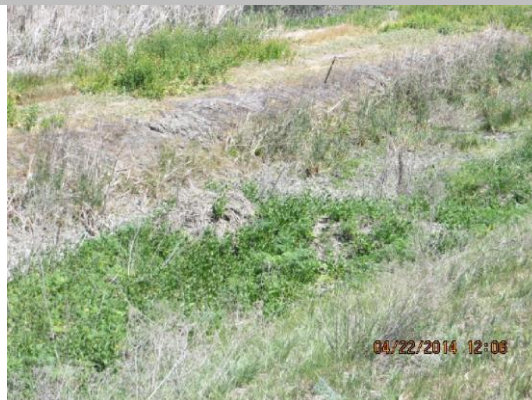
Photo 3 of 3 : UCIP_FA_2019_34285_62231.jpg

Headwall and pipe on LS toe.

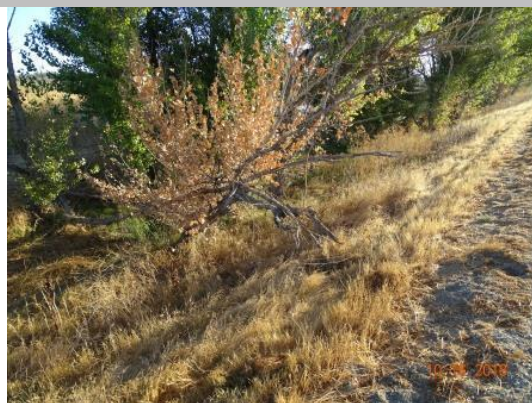
Photo 1 of 2 : FA_2019_NA0010_123_108_20190912_00015.jpg

LM Start	12.81	Rating **	M	Issue No.	108
LM End	12.81	Issue Type +	Ma	Location *	LS
Category	Earthen Levee			GPS Latitude/Longitude	
				Start	End
Item	Encroachments			37.175793 °	37.175793 °
				-120.642227 °	-120.642227 °
DWR ID	DWR_NA0010_05_s_2017_108				
Comment Code					
TR : Tree or limb					
Inspector Comment

Looking upstream at tree branch on landside slope. (Fall 2018)

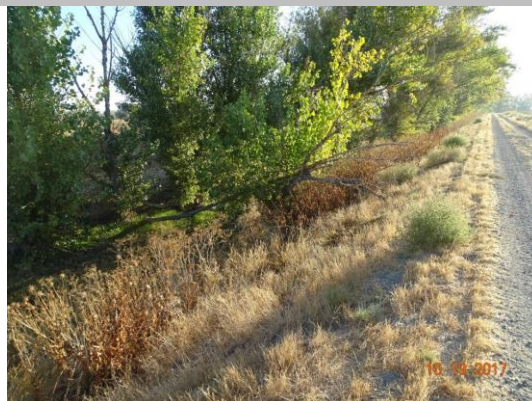
Photo 2 of 2 : FA_2019_NA0010_123_108_20190912_00016.jpg

Looking east at the landside slope. (Fall 2017)

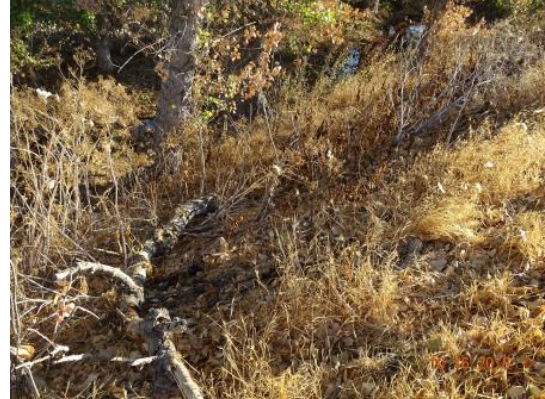
Photo 1 of 1 : FA_2019_NA0010_123_151_20190912_00044.jpg

LM Start	12.85	Rating **	M	Issue No.	151
LM End	12.85	Issue Type +	Ma	Location *	LS
Category	Earthen Levee			GPS Latitude/Longitude	
				Start	End
Item	Encroachments			37.175799°	37.175799°
				-120.641595°	-120.641595°
DWR ID	DWR_NA0010_05_f _ 2018_151				
Comment Code					
TR : Tree or limb					
Inspector Comment

Tree limb discarded on landside slope. (Fall 2018)

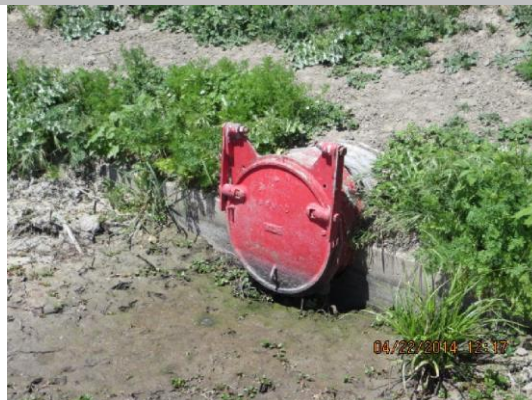
Photo 2 of 3 : UCIP_FA_2019_39593_62241.jpg

Headwall, flapgate, and pipe on WS toe.

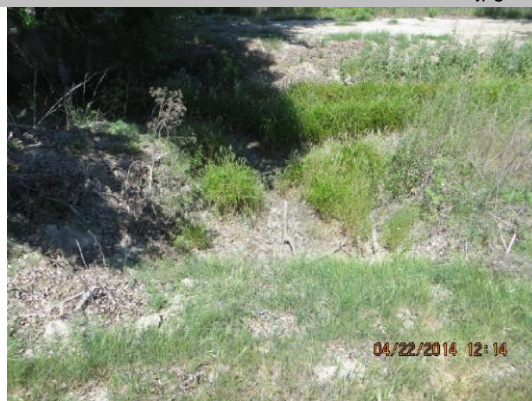
Photo 3 of 3 : UCIP_FA_2019_39593_62239.jpg

Item	DRAFT DWR UCIP LMA Responsibility			37.175816 °		37.175816 °
				-120.640865 °		-120.640865 °
DWR ID	19707					
Comment Code						
Inspector Comment						
DS_ID:19707 FS_ID:39593 EP_NO: N/A Repair Type: Non-Urgent Crossing Status: Found UCIP Comments: 04/22/2014 Sediment buildup in pipe visible from landward side--recommend contacting owner to clear pipe. (DWR UCIP - W. Wylie) FIELD_STRUCT_DESC: 24-inch corrugated metal gravity drainage pipe through the levee, 10.2 feet below the crown. Concrete headwall on the landside (LS) end with flashboards. Concrete saddle and apron on the waterside (WS) end with a flap gate. Metal screen at LS toe inlet. [Additional Reference(s): DWR Levee Log, 2002. USACE San Joaquin O&M Manual 601.1, 1967, (HLM 12.87)]. FS Date: 4/22/2014

Headwall and pipe on LS toe.

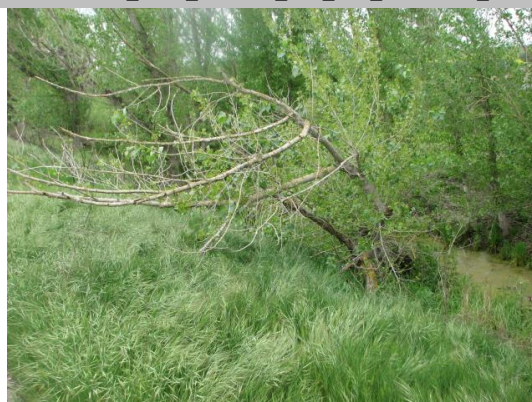
Photo 1 of 1 : FA_2019_NA0010_123_109_20190912_00017.jpg

LM Start	12.93	Rating **	M	Issue No.	109
LM End	12.93	Issue Type +	Ma	Location *	LS
Category	Earthen Levee			GPS Latitude/Longitude	
				Start	End
Item	Encroachments			37.175780 °	37.175780 °
				-120.640195 °	-120.640195 °
DWR ID	DWR_NA0010_05_s_2017_109				
Comment Code					
TR : Tree or limb					
Inspector Comment					
A fallen tree is located on the landside toe.

Looking at broken tree on landward toe. (Spring 2018)

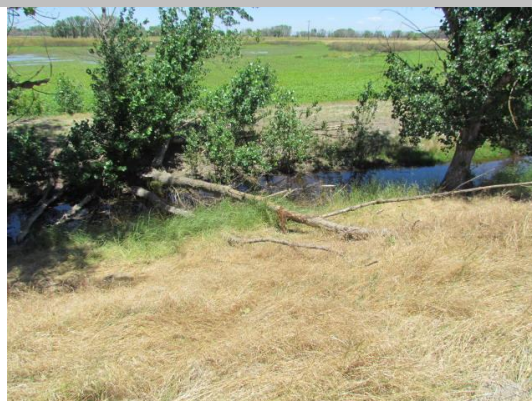
Photo 1 of 1 : FA_2019_NA0010_123_2_20190912_00002.jpg

LM Start	13.01	Rating **	M	Issue No.	2
LM End	13.01	Issue Type +	Ma	Location *	LS
Category	Earthen Levee			GPS Latitude/Longitude	
				Start	End
Item	Encroachments			37.175576 °	37.175576 °
				-120.638755 °	-120.638755 °
DWR ID	DWR_NA0010_05_s_2016_2				
Comment Code					
TR : Tree or limb					
Inspector Comment					
There is a downed tree on landside toe.

Looking west at down tree at landward toe.

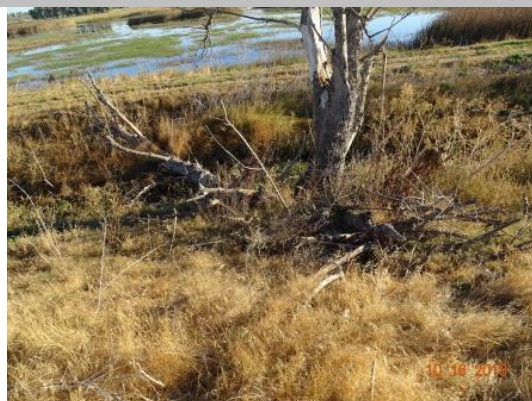
Photo 1 of 1 : FA_2019_NA0010_123_150_20190912_00043.jpg

LM Start	13.05	Rating **	M	Issue No.	150
LM End	13.05	Issue Type +	Ma	Location *	LS
Category	Earthen Levee			GPS Latitude/Longitude	
				Start	End
Item	Encroachments			37.175314 °	37.175314 °
				-120.638034 °	-120.638034 °
DWR ID	DWR_NA0010_05_f_2018_150				
Comment Code					
TR : Tree or limb					
Inspector Comment					
There are tree trimmings on the levee slope and toe.

Tree trimmings on landside slope and toe. (Fall 2018)
