**Flood Control Project Maintenance
Levee Inspections**

Fall 2019 Levee Maintenance Deficiency Summary Report

San Joaquin River Basin

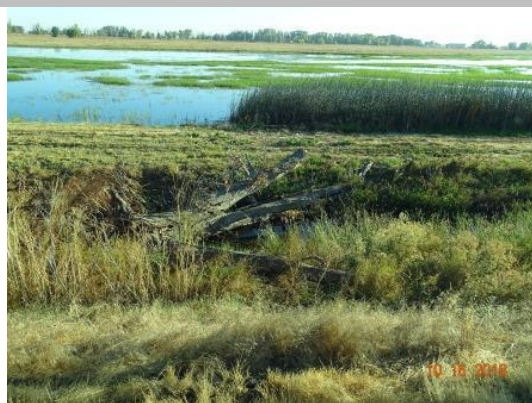
Photo 1 of 1 : FA_2019_NA0010_123_152_20190912_00045.jpg

LM Start	13.15	Rating **	M	Issue No.	152
LM End	13.15	Issue Type +	Ma	Location *	LS
Category	Earthen Levee			GPS Latitude/Longitude	
				Start	End
Item	Encroachments			37.174444 °	37.174444 °
				-120.636589 °	-120.636589 °
DWR ID	DWR_NA0010_05_f_2018_152				
Comment Code					
TR : Tree or limb					
Inspector Comment					
There is a tree trunk on landside toe.

Tree trunk on landside toe. (Fall 2018)

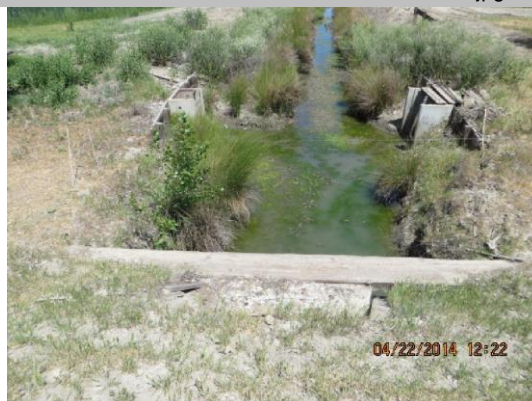
Photo 1 of 3 : UCIP_FA_2019_34288_62244.jpg

Comment Code					
Inspector Comment					
DS_ID:19708 FS_ID:34288 EP_NO: N/A Repair Type: Non-Urgent Crossing Status: Found UCIP Comments: 04/22/2014 Some erosion around headwall on the WS toe and there are animal burrows on both slopes. (DWR UCIP - W. Wylie) FIELD_STRUCT_DESC: 48-inch corrugated metal gravity drainage pipe through the levee, 10 feet below the crown. Flap gate on the waterside (WS) end. Flashboard attachment in concrete U-shaped headwall on the landside (LS) end. Concrete U-shaped headwall on the WS end. [Additional Reference(s): DWR Levee Log, 2002. USACE San Joaquin O&M Manual 601.1, 1967, (HLM 13.40)]. FS Date: 4/22/2014

Headwall and pipe on LS toe.

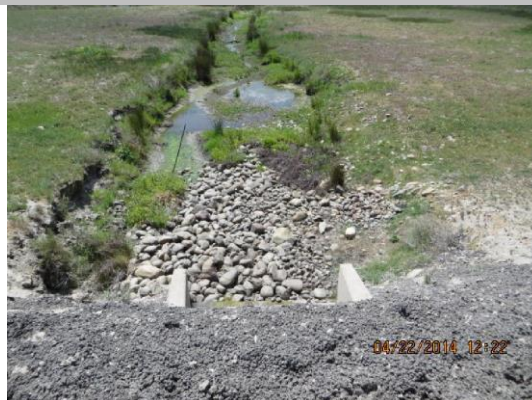
Photo 2 of 3 : UCIP_FA_2019_34288_62243.jpg

Headwall, flapgate, and pipe on WS toe.

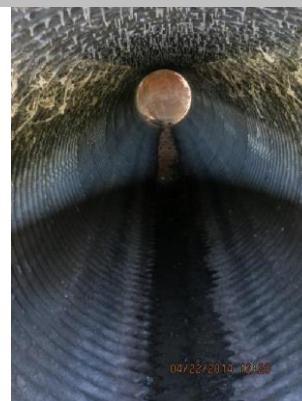
Photo 3 of 3 : UCIP_FA_2019_34288_62242.jpg

Item	DRAFT DWR UCIP LMA Responsibility			37.171523 °		37.171523 °
				-120.633442 °		-120.633442 °
DWR ID	19708					
Comment Code						
Inspector Comment						
DS_ID:19708 FS_ID:34288 EP_NO: N/A Repair Type: Non-Urgent Crossing Status: Found UCIP Comments: 04/22/2014 Some erosion around headwall on the WS toe and there are animal burrows on both slopes. (DWR UCIP - W. Wylie) FIELD_STRUCT_DESC: 48-inch corrugated metal gravity drainage pipe through the levee, 10 feet below the crown. Flap gate on the waterside (WS) end. Flashboard attachment in concrete U-shaped headwall on the landside (LS) end. Concrete U-shaped headwall on the WS end. [Additional Reference(s): DWR Levee Log, 2002. USACE San Joaquin O&M Manual 601.1, 1967, (HLM 13.40)]. FS Date: 4/22/2014

Headwall, flapgate, and pipe on WS toe.

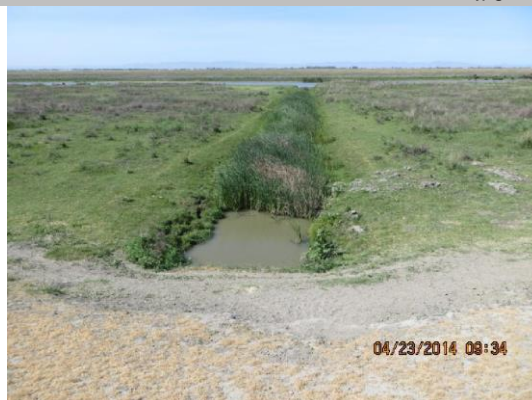
Photo 1 of 3 : UCIP_FA_2019_34657_62450.jpg

Headwall, flapgate, and pipe on WS toe.

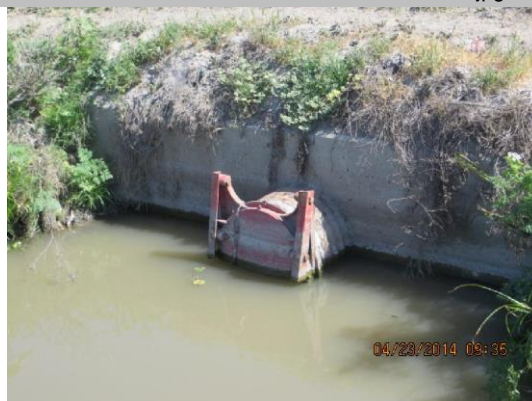
Photo 2 of 3 : UCIP_FA_2019_34657_62448.jpg

Headwall, flapgate, and pipe on WS toe.

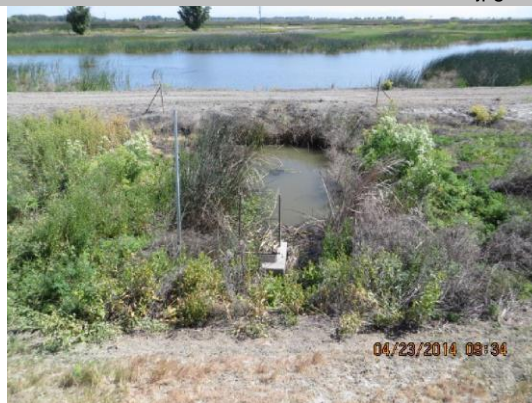
Photo 3 of 3 : UCIP_FA_2019_34657_62449.jpg

Concrete wier intake structure and pipe at LS toe.

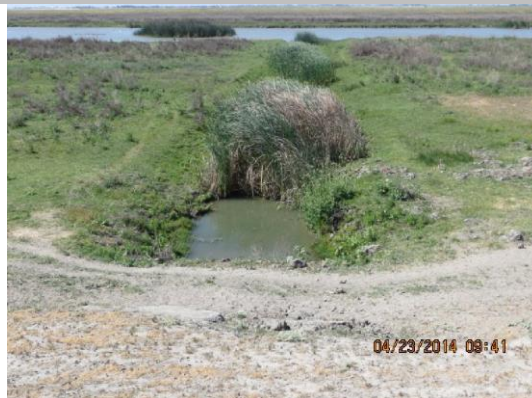
Photo 1 of 3 : UCIP_FA_2019_34656_62446.jpg

LM Start	14.46	Rating **	A/W	Issue No.	1342
LM End	14.46	Issue Type +	Ma	Location *	
Category	Supplemental			GPS Latitude/Longitude	
				Start	End
Item	DRAFT DWR UCIP LMA Responsibility			37.162722 °	37.162722 °
				-120.618571 °	-120.618571 °
DWR ID	19711				
Comment Code					
Inspector Comment					
DS_ID:19711 FS_ID:34656 EP_NO: N/A Repair Type: No Action Needed Crossing Status: Found UCIP Comments: FIELD_STRUCT_DESC: 24-inch corrugated metal gravity drainage pipe through the levee, 12.5 feet below the crown. Flap gate on the waterside (WS) end. Concrete headwall on each end. Concrete weir inlet structure on the landside (LS) toe. [Additional Reference(s): DWR Levee Log, 2002. USACE San Joaquin O&M Manual 601.1, 1967, (HLM 14.44)]. FS Date: 4/23/2014

Headwall, pipe, and flapgate on WS toe.

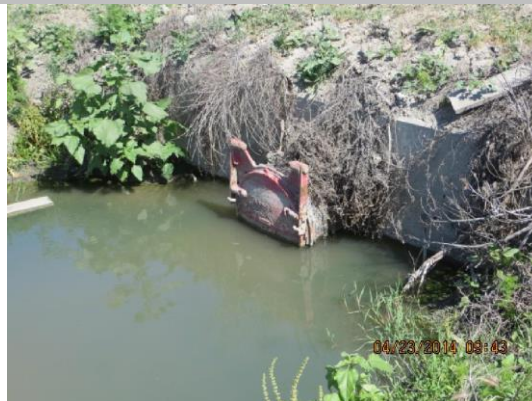
Photo 2 of 3 : UCIP_FA_2019_34656_62447.jpg

Headwall, pipe, and flapgate on WS toe.

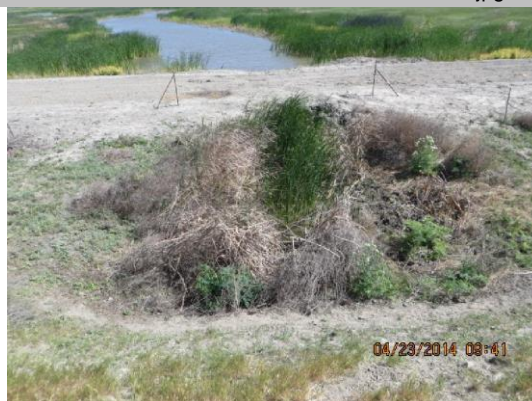
Photo 3 of 3 : UCIP_FA_2019_34656_62445.jpg

Concrete weir inlet at LS toe.

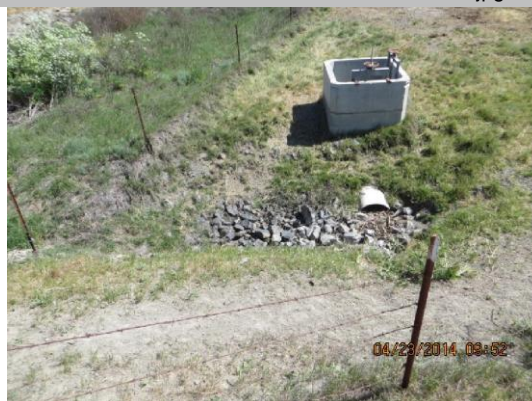
Photo 1 of 3 : UCIP_FA_2019_34664_62454.jpg

LM Start	15.11	Rating **	M	Issue No.	1343
LM End	15.11	Issue Type +	Ma	Location *	
Category	Supplemental			GPS Latitude/Longitude	
				Start	End
Item	DRAFT DWR UCIP LMA Responsibility			37.156805°	37.156805°
				-120.609513°	-120.609513°
DWR ID	19712				
Comment Code					
Inspector Comment					
DS_ID:19712 FS_ID:34664 EP_NO: N/A Repair Type: Non-Urgent Crossing Status: Found UCIP Comments: 04/23/2014 Minor erosion at headwall on WS toe. (DWR UCIP - W. Wylie) FIELD_STRUCT_DESC: 36-inch corrugated metal gravity drainage pipe through the levee, 11.9 feet below the crown. Flap gate on the waterside (WS) end. Concrete headwall on each end. [Additional Reference(s): DWR Levee Log, 2002. USACE San Joaquin O&M Manual 601.1, 1967, (HLM 15.09)]. FS Date: 4/23/2014

Headwall and inlet on LS toe.

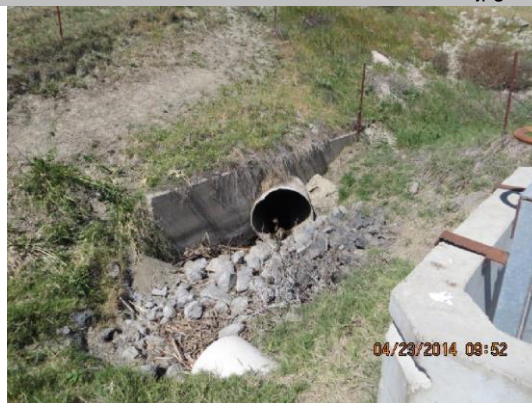
Photo 2 of 3 : UCIP_FA_2019_34664_62453.jpg

Headwall and inlet on LS toe.

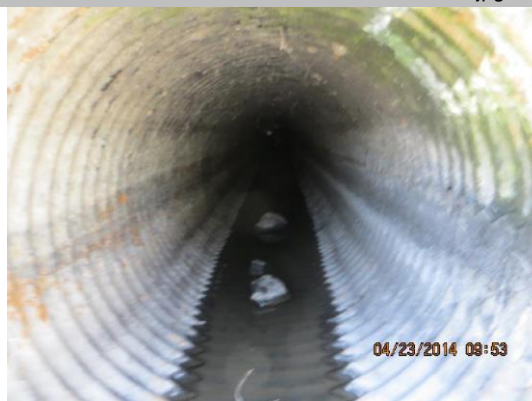
Photo 3 of 3 : UCIP_FA_2019_34664_62452.jpg

Inside pipe at LS toe.

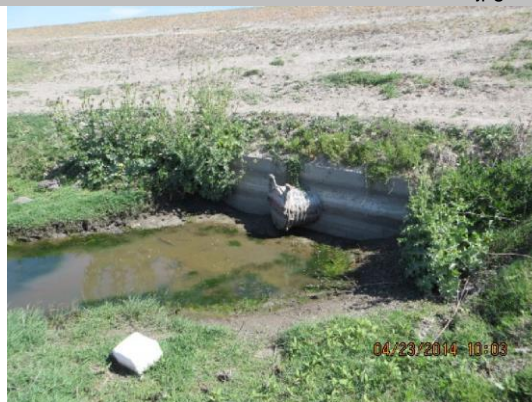
Photo 1 of 3 : UCIP_FA_2019_39595_62459.jpg

LM Start	15.76	Rating **	M	Issue No.	1344
LM End	15.76	Issue Type +	Ma	Location *	
Category	Supplemental			GPS Latitude/Longitude	
				Start	End
Item	DRAFT DWR UCIP LMA Responsibility			37.150012 °	37.150012 °
				-120.601330 °	-120.601330 °
DWR ID	19713				
Comment Code					
Inspector Comment					
DS_ID:19713 FS_ID:39595 EP_NO: N/A Repair Type: Non-Urgent Crossing Status: Found UCIP Comments: 04/23/2014 Sediment buildup in pipe visible from landward side--recommend contacting owner to clear pipe. (DWR UCIP - W. Wylie) FIELD_STRUCT_DESC: 24-inch corrugated metal gravity drainage pipe through the levee, 11 feet below the crown. Flap gate on the waterside (WS) end. Concrete headwall on each end. [Additional Reference(s): DWR Levee Log, 2002. USACE San Joaquin O&M Manual 601.1, 1967, (HLM 15.74)]. FS Date: 4/23/2014

Headwall, pipe, and flapgate on WS toe.

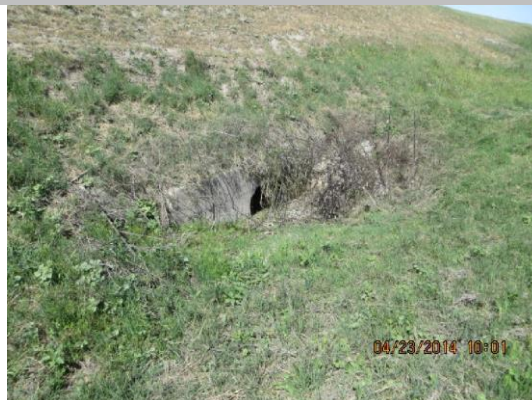
Photo 3 of 3 : UCIP_FA_2019_39595_62458.jpg

Headwall and pipe at LS toe.

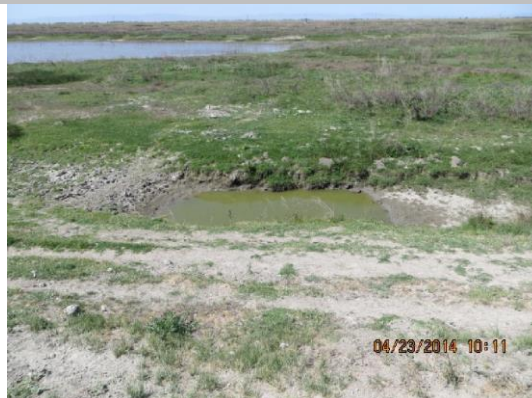
Photo 1 of 3 : UCIP_FA_2019_39596_62464.jpg

LM Start	15.81	Rating **	M	Issue No.	1345	
LM End	15.81	Issue Type +	Ma	Location *		
Category	Supplemental			GPS Latitude/Longitude		
				Start	End	
Item	DRAFT DWR UCIP LMA Responsibility			37.149381 °	37.149381 °	
				-120.600761 °	-120.600761 °	
DWR ID	19715					
Comment Code						
Inspector Comment						
DS_ID:19715 FS_ID:39596 EP_NO: N/A Repair Type: Non-Urgent Crossing Status: Found UCIP Comments: 04/23/2014 Excess vegetation at inlet on LS toe should be cleared. (DWR UCIP - W. Wylie) FIELD_STRUCT_DESC: 24-inch corrugated metal gravity drainage pipe through the levee, 12 feet below the crown. Flap gate on the waterside (WS) end. Concrete headwall on the landside (LS) end. Concrete saddle and apron on the WS end. [Additional Reference(s): DWR Levee Log, 2002. USACE San Joaquin O&M Manual 601.1, 1967, (HLM 15.80)]. FS Date: 4/23/2014

Headwall, pipe, and flapgate on WS toe.

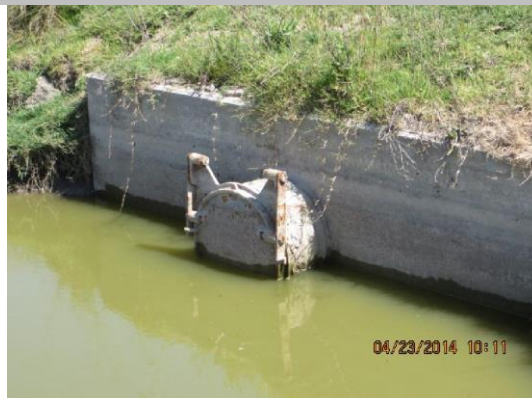
Photo 2 of 3 : UCIP_FA_2019_39596_62467.jpg

Headwall, pipe, and flapgate on WS toe.

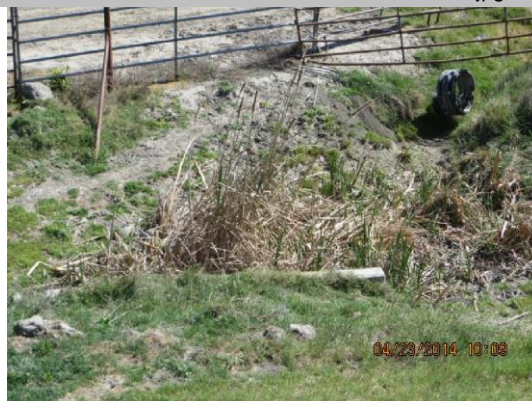
Photo 3 of 3 : UCIP_FA_2019_39596_62466.jpg

Headwall and pipe visible at LS toe.

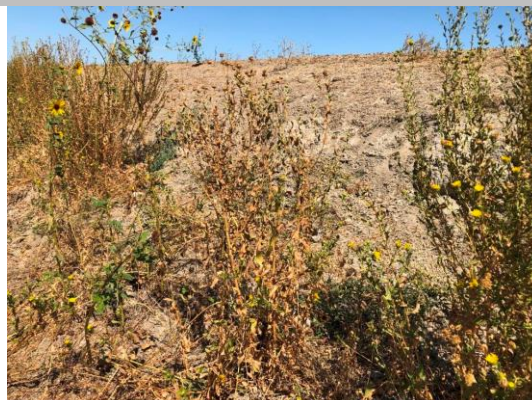
Photo 1 of 3 : SJR2019_DWR_NA0010_05_s_2017_110_5.JPG

LM Start	16.09	Rating **	M	Issue No.	1	
LM End	16.13	Issue Type +	Ma	Location *		
Category	Supplemental			GPS Latitude/Longitude		
				Start	End	
Item	DWR Erosion Survey			37.145965 °	37.145965 °	
				-120.597597 °	-120.597597 °	
DWR ID	NA0010U05RM13.85					
Comment Code						
Inspector Comment						
Site ID: NA0010U05RM13.85 09/10/2019: The erosion has become worse during the past 2 flood seasons. The erosion length has increased to approximately 200 ft from 55 ft. Signs of animal activity were observed. 09/20/2017: The erosion was discovered during spring levee inspection. The site is covered by dense vegetation and the measurements of the erosion are estimated.

Looking at the erosion from the levee toe. Note the dense vegetation.

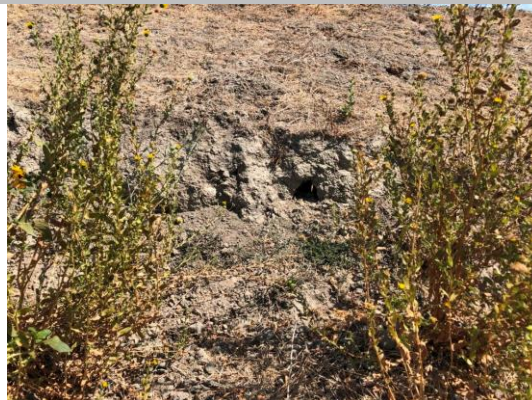
Photo 2 of 3 : SJR2019_DWR_NA0010_05_s _ 2017_110_4.JPG

Close-up view of the erosion.

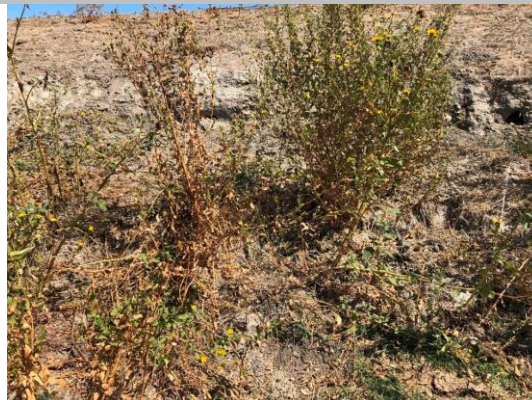
Photo 3 of 3 : SJR2019_DWR_NA0010_05_s _ 2017_110_1.JPG

Close-up view of the erosion.

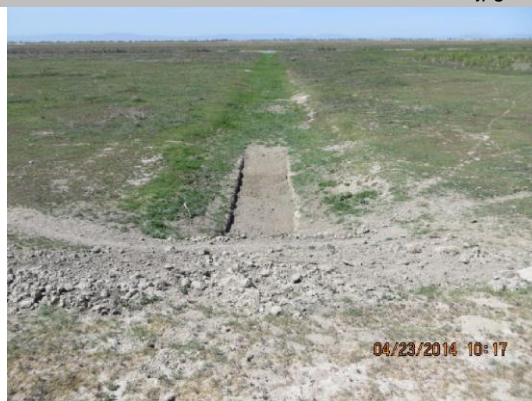
Photo 1 of 3 : UCIP_FA_2019_34725_62469.jpg

LM Start	16.68	Rating **	M	Issue No.	1346
LM End	16.68	Issue Type +	Ma	Location *	
Category	Supplemental			GPS Latitude/Longitude	
				Start	End
Item	DRAFT DWR UCIP LMA Responsibility			37.138760 °	37.138760 °
				-120.592393 °	-120.592393 °
DWR ID	19716				
Comment Code					
Inspector Comment					
DS_ID:19716 FS_ID:34725 EP_NO: N/A Repair Type: Non-Urgent Crossing Status: Found UCIP Comments: 04/23/2014 Pipe heavily silted on LS toe. (DWR UCIP - W. Wylie) FIELD_STRUCT_DESC: 24-inch corrugated metal gravity drainage pipe through the levee, 10.5 feet below the crown. Flap gate on the waterside (WS) end. Concrete headwall on each end. [Additional Reference(s): DWR Levee Log, 2002. USACE San Joaquin O&M Manual 601.1, 1967, (HLM 16.67)]. FS Date: 4/23/2014

Headwall, flapgate, and pipe visible on WS toe.

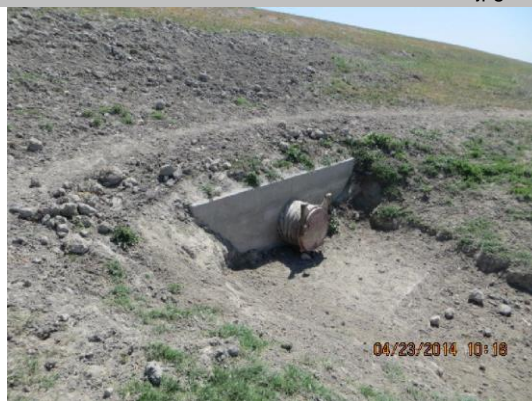
Photo 2 of 3 : UCIP_FA_2019_34725_62471.jpg

Headwall, flapgate, and pipe visible on WS toe.

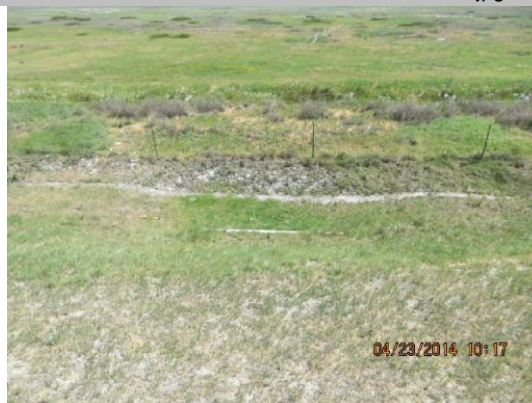
Photo 3 of 3 : UCIP_FA_2019_34725_62470.jpg

Concrete headwall and pipe visible on LS toe.

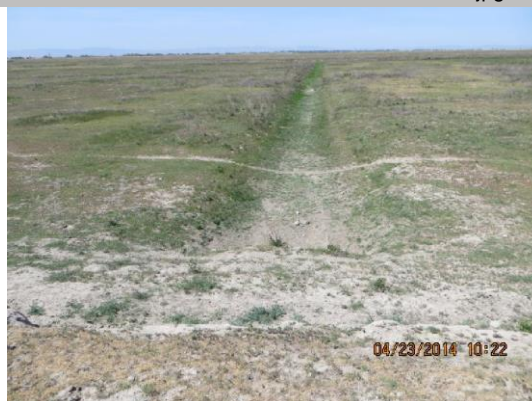
Photo 1 of 3 : UCIP_FA_2019_39597_62481.jpg

LM Start	17.22	Rating **	M	Issue No.	1347
LM End	17.22	Issue Type +	Ma	Location *	
Category	Supplemental			GPS Latitude/Longitude	
				Start	End
Item	DRAFT DWR UCIP LMA Responsibility			37.132211 °	37.132211 °
				-120.587106 °	-120.587106 °
DWR ID	19717				
Comment Code					
Inspector Comment					
DS_ID:19717					
FS_ID:39597					
EP_NO: N/A					
Repair Type: Non-Urgent					
Crossing Status: Found					
UCIP Comments: 04/23/2014 Sediment buildup in pipe visible from landward side--recommend contacting owner to clear pipe. (DWR UCIP - W. Wylie)					
FIELD_STRUCT_DESC: 24-inch corrugated metal gravity drainage pipe through the levee, 12 feet below the crown. Flap gate on the waterside (WS) end. Concrete headwall on each end. [Additional Reference(s): DWR Levee Log, 2002. USACE San Joaquin O&M Manual 601.1, 1967, (HLM 17.20)].					
FS Date: 4/23/2014

Headwall, flapgate, and pipe visible on WS toe.

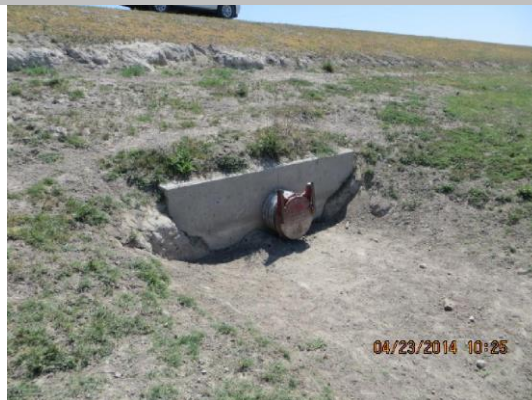
Photo 2 of 3 : UCIP_FA_2019_39597_62483.jpg

Headwall, flapgate, and pipe visible on WS toe.

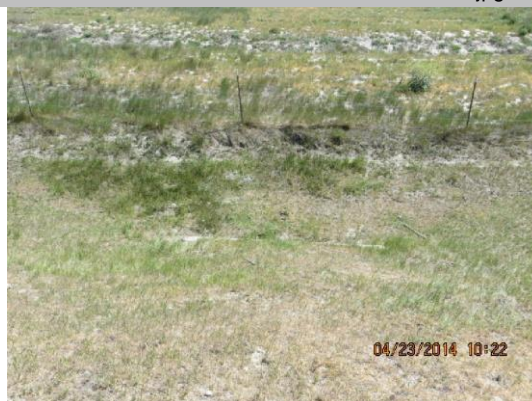
Photo 3 of 3 : UCIP_FA_2019_39597_62482.jpg

Headwall and pipe visible on LS toe.

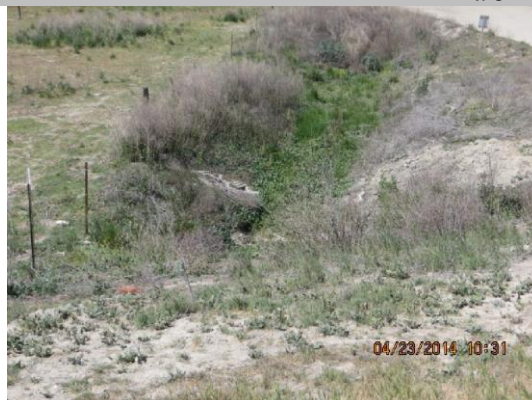
Photo 1 of 3 : UCIP_FA_2019_39599_62485.jpg

LM Start	17.54	Rating **	M	Issue No.	1348
LM End	17.54	Issue Type +	Ma	Location *	
Category	Supplemental			GPS Latitude/Longitude	
				Start	End
Item	DRAFT DWR UCIP LMA Responsibility			37.127843 °	37.127843 °
				-120.585245 °	-120.585245 °
DWR ID	19743				
Comment Code					
Inspector Comment					
DS_ID:19743 FS_ID:39599 EP_NO: N/A Repair Type: Non-Urgent Crossing Status: Found UCIP Comments: 04/23/2014 Sediment buildup in pipe visible from landward side--recommend contacting owner to clear pipe. (DWR UCIP - W. Wylie) FIELD_STRUCT_DESC: 24-inch corrugated metal gravity drainage pipe through the levee, 9.8 feet below the crown. Flap gate on the waterside (WS) end. Concrete headwall on each end. [Additional Reference(s): DWR Levee Log, 2002. USACE San Joaquin O&M Manual 601.1, 1967, (HLM 17.52)]. FS Date: 4/23/2014

Headwall, pipe, and flapgate visible on WS toe.

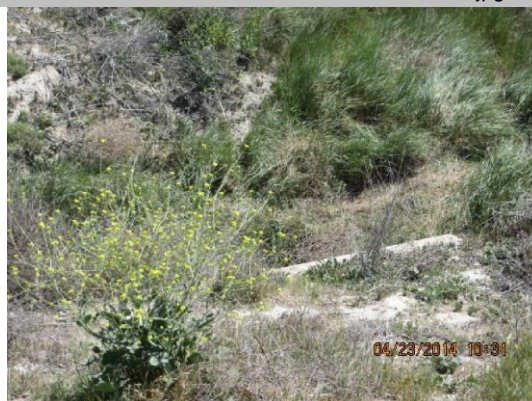
Photo 2 of 3 : UCIP_FA_2019_39599_62486.jpg

Pipe and headwall visible on LS toe.

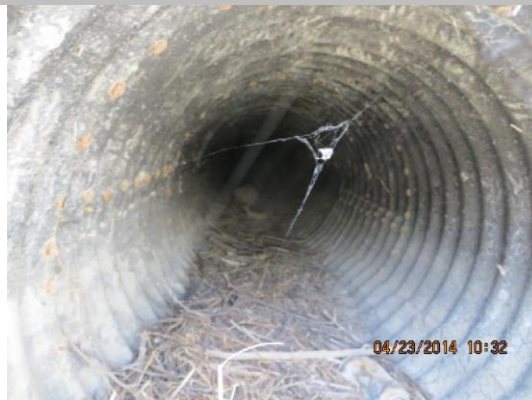
Photo 3 of 3 : UCIP_FA_2019_39599_62488.jpg

Inside pipe on LS toe.

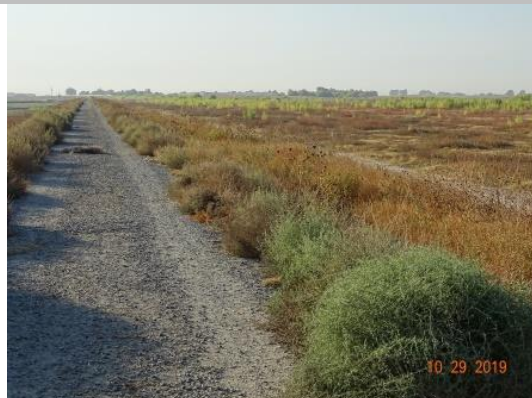
Photo 1 of 1 : FA_2019_NA0010_123_168_20191108_00332.jpg

LM Start	17.55	Rating **	U	Issue No.	168
LM End	19.58	Issue Type +	Ma	Location *	WS
Category	Earthen Levee			GPS Latitude/Longitude	
				Start	End
Item	Vegetation			37.127733 °	37.112343 °
				-120.585203 °	-120.559179 °
DWR ID	DWR_NA0010_05_f_2019_168				
Comment Code					
V1 : Control annual grass and weeds on the levee slopes and easements.					
Inspector Comment

View of the waterside slope looking upstream. (Fall 2019)

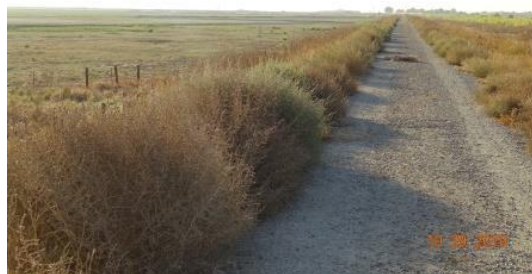
Photo 1 of 1 : FA_2019_NA0010_123_167_20191108_00334.jpg

LM Start	17.55	Rating **	U	Issue No.	167
LM End	19.60	Issue Type +	Ma	Location *	LS
Category	Earthen Levee			GPS Latitude/Longitude	
				Start	End
Item	Vegetation			37.127733 °	37.112147 °
				-120.585203 °	-120.558984 °
DWR ID	DWR_NA0010_05_f_2019_167				
Comment Code					
V1 : Control annual grass and weeds on the levee slopes and easements.					
Inspector Comment

Looking upstream along the landside slope. (Fall 2019)

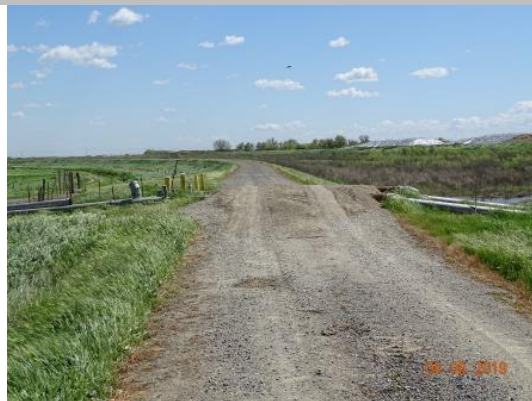
Photo 1 of 3 : FA_2019_NA0010_123_112_20190912_00018.jpg

LM Start	18.06	Rating **	U	Issue No.	112
LM End	18.06	Issue Type +	En	Location *	CR
Category	Earthen Levee			GPS Latitude/Longitude	
				Start	End
Item	Encroachments			37.120690 °	37.120690 °
				-120.582218 °	-120.582218 °
DWR ID	DWR_NA0010_05_s_2017_112				
Comment Code					
PI : Pipe					
Inspector Comment					
There are 3 temporary eight inch pipes across the levee crown going down both slopes.

View of pipe encroachment looking upstream along the levee crown. (Spring 2019)

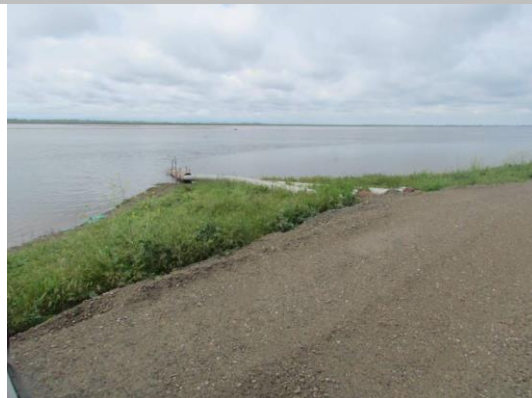
Photo 2 of 3 : FA_2019_NA0010_123_112_20190912_00019.jpg

LM Start	18.06	Rating **	U	Issue No.	112 (cont)
LM End	18.06	Issue Type +	En	Location *	CR
Category	Earthen Levee			GPS Latitude/Longitude	
				Start	End
Item	Encroachments			37.120690 °	37.120690 °
				-120.582218 °	-120.582218 °
DWR ID	DWR_NA0010_05_s_2017_112				
Comment Code					
PI : Pipe					
Inspector Comment					
There are 3 temporary eight inch pipes across the levee crown going down both slopes.

Looking at temporary pipe on waterward slope.

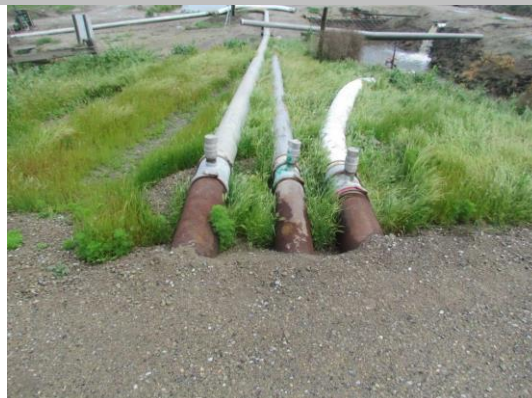
Photo 3 of 3 : FA_2019_NA0010_123_112_20190912_00020.jpg

Looking at three temporary pipes on landward slope.

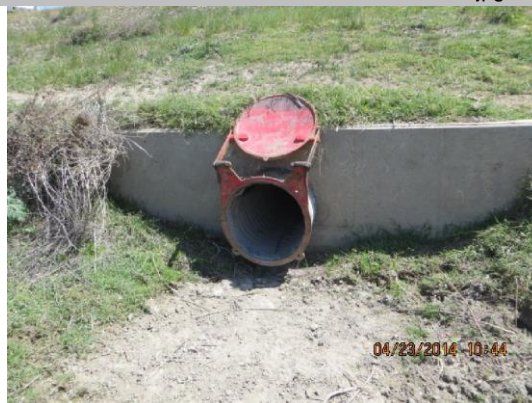
Photo 2 of 3 : UCIP_FA_2019_34747_62495.jpg

Headwall, pipe, and flapgate on WS toe.

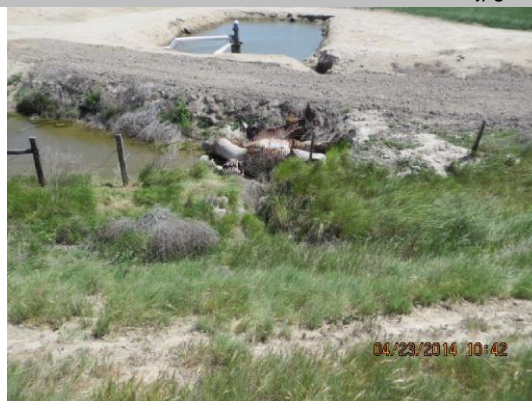
Photo 3 of 3 : UCIP_FA_2019_34747_62493.jpg

LM Start	18.09	Rating **	M	Issue No.	1349 (cont)
LM End	18.09	Issue Type +	Ma	Location *	
Category	Supplemental			GPS Latitude/Longitude	
				Start	End
Item	DRAFT DWR UCIP LMA Responsibility			37.120309 °	37.120309 °
				-120.582041 °	-120.582041 °
DWR ID	19745				
Comment Code					
Inspector Comment					
DS_ID:19745 FS_ID:34747 EP_NO: N/A Repair Type: Non-Urgent Crossing Status: Found UCIP Comments: 04/23/2014 Animal burrows in levee on both slopes. (DWR UCIP - W. Wylie) FIELD_STRUCT_DESC: 24-inch corrugated metal gravity drainage pipe through the levee, 12.4 feet below the crown. Flap gate on the waterside (WS) end. Concrete headwall on each end. [Additional Reference(s): DWR Levee Log, 2002. USACE San Joaquin O&M Manual 601.1, 1967, (HLM 18.07)]. FS Date: 4/23/2014

Headwall and pipe visible on LS toe.

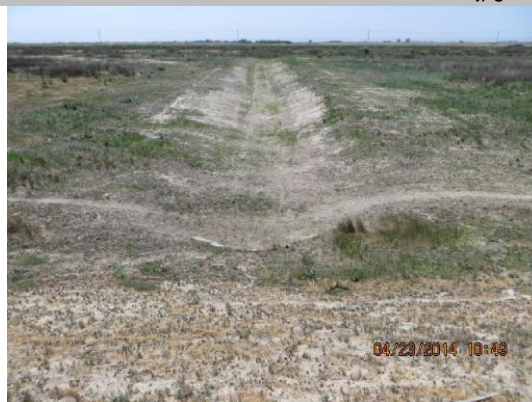
Photo 1 of 3 : UCIP_FA_2019_39600_62499.jpg

Comment Code					
Inspector Comment					
DS_ID:19746 FS_ID:39600 EP_NO: N/A Repair Type: Non-Urgent Crossing Status: Found UCIP Comments: 04/23/2014 Dense vegetation limits the inspector's visibility to identify signs of pipe failure (leaks) along the landward slope. Recommend removing vegetation along pipe alignment to conduct proper inspection of structure. (DWR UCIP - W. Wylie) FIELD_STRUCT_DESC: 24-inch corrugated metal gravity drainage pipe through the levee, 10 feet below the crown. Flap gate on the waterside (WS) end. Concrete headwall on the landside (LS) end. Concrete U-shaped headwall on the WS end. [Additional Reference(s): DWR Levee Log, 2002. USACE San Joaquin O&M Manual 601.1, 1967, (HLM 18.68)]. FS Date: 4/23/2014

Headwall, pipe and flapgate visible on WS toe.

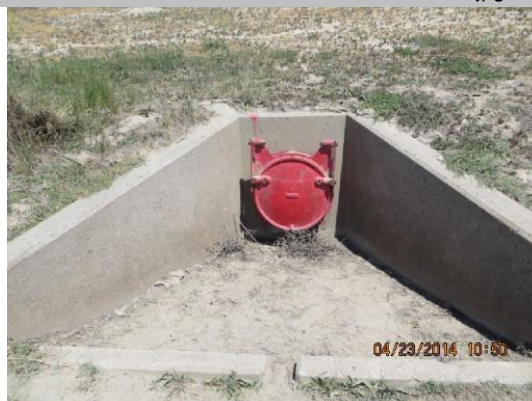
Photo 2 of 3 : UCIP_FA_2019_39600_62498.jpg

Item	DRAFT DWR UCIP LMA Responsibility			37.115472°	37.115472°	
				-120.573628°	-120.573628°	
DWR ID	19746					
Comment Code						
Inspector Comment						
DS_ID:19746 FS_ID:39600 EP_NO: N/A Repair Type: Non-Urgent Crossing Status: Found UCIP Comments: 04/23/2014 Dense vegetation limits the inspector's visibility to identify signs of pipe failure (leaks) along the landward slope. Recommend removing vegetation along pipe alignment to conduct proper inspection of structure. (DWR UCIP - W. Wylie) FIELD_STRUCT_DESC: 24-inch corrugated metal gravity drainage pipe through the levee, 10 feet below the crown. Flap gate on the waterside (WS) end. Concrete headwall on the landside (LS) end. Concrete U-shaped headwall on the WS end. [Additional Reference(s): DWR Levee Log, 2002. USACE San Joaquin O&M Manual 601.1, 1967, (HLM 18.68)]. FS Date: 4/23/2014

Headwall, pipe and flapgate visible on WS toe.

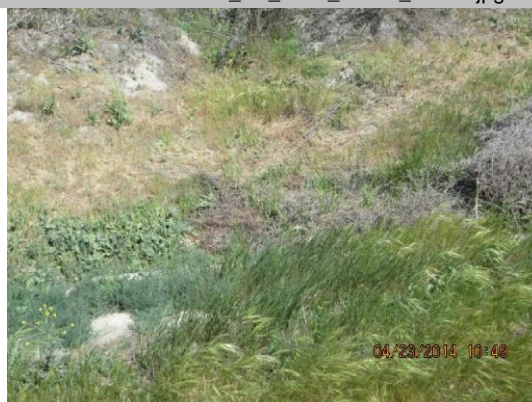
Photo 3 of 3 : UCIP_FA_2019_39600_62500.jpg

Headwall and pipe on LS toe.

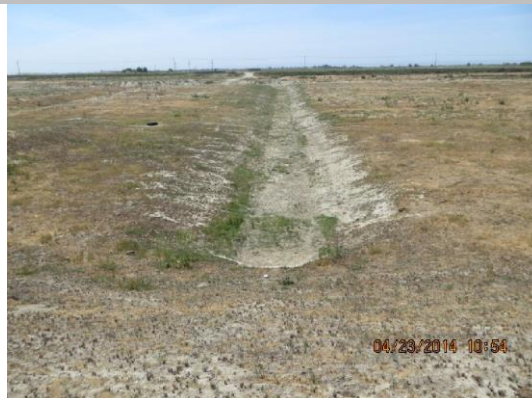
Photo 1 of 3 : UCIP_FA_2019_39601_62504.jpg

LM Start	19.15	Rating **	M	Issue No.	1351	
LM End	19.15	Issue Type +	Ma	Location *		
Category	Supplemental			GPS Latitude/Longitude		
				Start		End
Item	DRAFT DWR UCIP LMA Responsibility			37.115466 °		37.115466 °
				-120.565467 °		-120.565467 °
DWR ID	19747					
Comment Code						
Inspector Comment						
DS_ID:19747 FS_ID:39601 EP_NO: N/A Repair Type: Non-Urgent Crossing Status: Found UCIP Comments: 04/23/2014 Sediment buildup in pipe visible from landward side--recommend contacting owner to clear pipe. (DWR UCIP - W. Wylie) FIELD_STRUCT_DESC: 24-inch corrugated metal gravity drainage pipe through the levee, 10 feet below the crown. Flap gate on the waterside (WS) end. Concrete headwall on the landside (LS) end. Concrete U-shaped headwall on the WS end. [Additional Reference(s): DWR Levee Log, 2002. USACE San Joaquin O&M Manual 601.1, 1967, (HLM 19.11)]. FS Date: 4/23/2014

Headwall, pipe, and flapgate visible on WS toe.

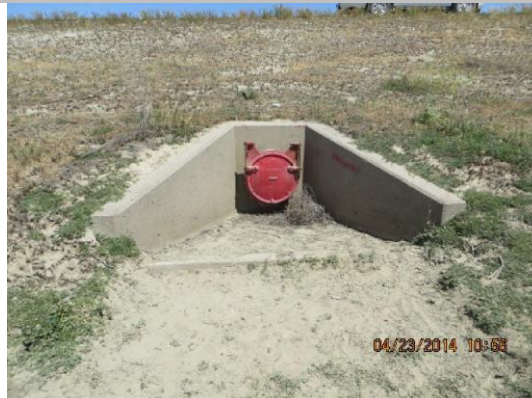
Photo 2 of 3 : UCIP_FA_2019_39601_62506.jpg

Headwall, pipe, and flapgate visible on WS toe.

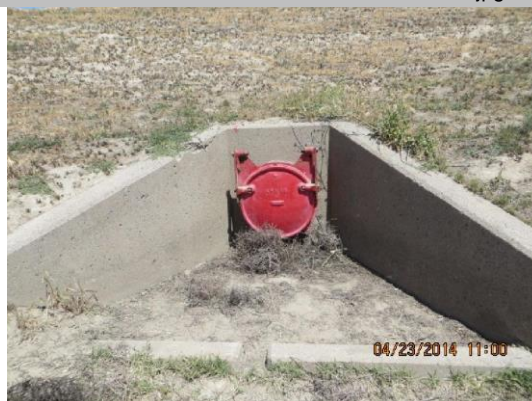
Photo 2 of 3 : UCIP_FA_2019_34751_62511.jpg

LM Start	19.17	Rating **	A/W	Issue No.	1352 (cont)	
LM End	19.17	Issue Type +	Ma	Location *		
Category	Supplemental			GPS Latitude/Longitude		
				Start	End	
Item	DRAFT DWR UCIP LMA Responsibility			37.115463 °	37.115463 °	
				-120.565086 °	-120.565086 °	
DWR ID	19776					
Comment Code						
Inspector Comment						
DS_ID:19776 FS_ID:34751 EP_NO: N/A Repair Type: No Action Needed Crossing Status: Found UCIP Comments: FIELD_STRUCT_DESC: 24-inch corrugated metal gravity drainage pipe through the levee, 10.3 feet below the crown. Flap gate on the waterside (WS) end. Concrete headwall on the landside (LS) end. Concrete U-shaped headwall on the WS end. [Additional Reference(s): DWR Levee Log, 2002. USACE San Joaquin O&M Manual 601.1, 1967, (HLM 19.15)]. FS Date: 4/23/2014

Headwall, pipe, and flapgate visible on WS toe.

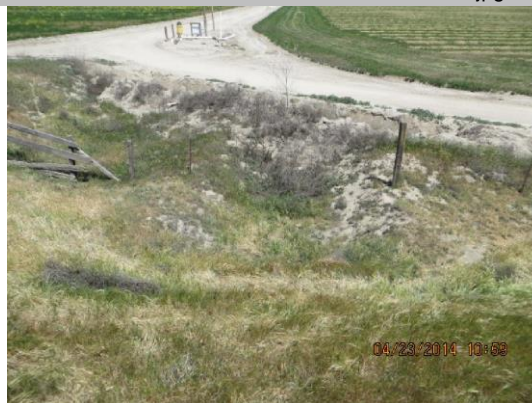
Photo 3 of 3 : UCIP_FA_2019_34751_62510.jpg

Headwall and pipe visible on LS toe.

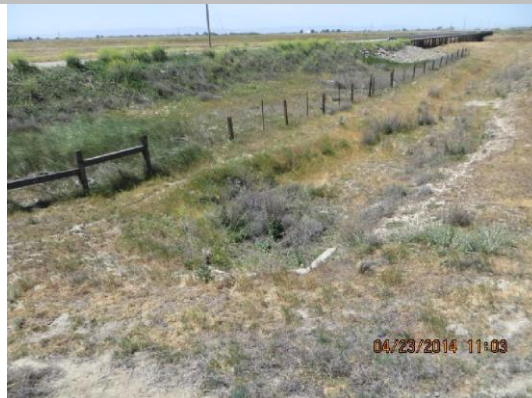
Photo 1 of 3 : UCIP_FA_2019_39602_62514.jpg

LM Start	19.48	Rating **	M	Issue No.	1353	
LM End	19.48	Issue Type +	Ma	Location *		
Category	Supplemental			GPS Latitude/Longitude		
				Start		End
Item	DRAFT DWR UCIP LMA Responsibility			37.113542 °		37.113542 °
				-120.560389 °		-120.560389 °
DWR ID	19777					
Comment Code						
Inspector Comment						
DS_ID:19777 FS_ID:39602 EP_NO: N/A Repair Type: Non-Urgent Crossing Status: Found UCIP Comments: 04/23/2014 Sediment buildup in pipe visible from landward side--recommend contacting owner to clear pipe. (DWR UCIP - W. Wylie) FIELD_STRUCT_DESC: 24-inch corrugated metal gravity drainage pipe through the levee, 9 feet below the crown. Flap gate on the waterside (WS) end. Concrete headwall on the landside (LS) end. Concrete U-shaped headwall on the WS end. [Additional Reference(s): DWR Levee Log, 2002. USACE San Joaquin O&M Manual 601.1, 1967, (HLM 19.46)]. FS Date: 4/23/2014

Headwall, pipe, and flapgate visible on WS toe.

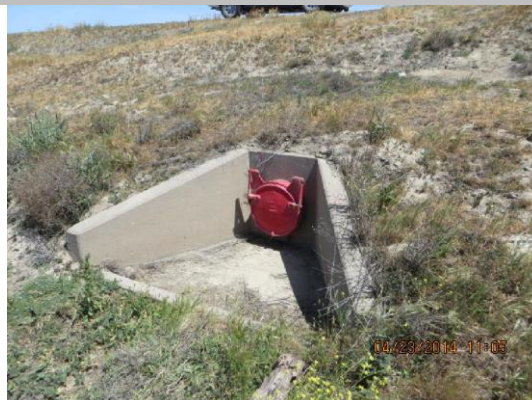
Photo 2 of 3 : UCIP_FA_2019_39602_62516.jpg

Headwall, pipe, and flapgate visible on WS toe.

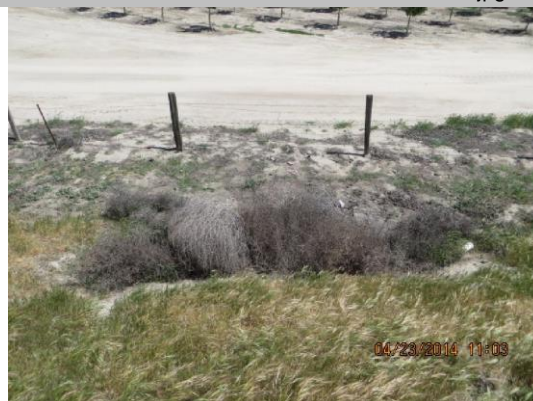
Photo 3 of 3 : UCIP_FA_2019_39602_62515.jpg

LM Start	19.48	Rating **	M	Issue No.	1353 (cont)	
LM End	19.48	Issue Type +	Ma	Location *		
Category	Supplemental			GPS Latitude/Longitude		
				Start		End
Item	DRAFT DWR UCIP LMA Responsibility			37.113542 °	37.113542 °	
				-120.560389 °	-120.560389 °	
DWR ID	19777					
Comment Code						
Inspector Comment						
DS_ID:19777 FS_ID:39602 EP_NO: N/A Repair Type: Non-Urgent Crossing Status: Found UCIP Comments: 04/23/2014 Sediment buildup in pipe visible from landward side--recommend contacting owner to clear pipe. (DWR UCIP - W. Wylie) FIELD_STRUCT_DESC: 24-inch corrugated metal gravity drainage pipe through the levee, 9 feet below the crown. Flap gate on the waterside (WS) end. Concrete headwall on the landside (LS) end. Concrete U-shaped headwall on the WS end. [Additional Reference(s): DWR Levee Log, 2002. USACE San Joaquin O&M Manual 601.1, 1967, (HLM 19.46)]. FS Date: 4/23/2014

Headwall and pipe visible on LS toe.

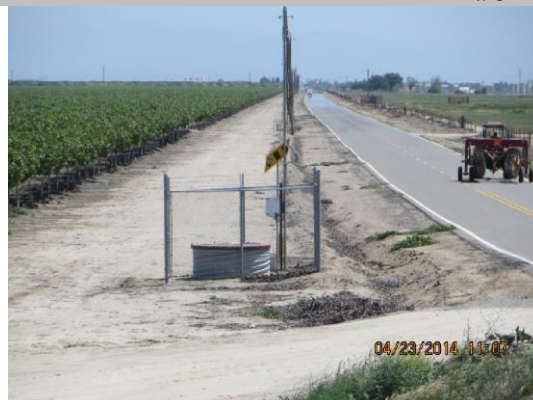
Photo 1 of 2 : UCIP_FA_2019_39345_71477.jpg

LM Start	19.51	Rating **	M	Issue No.	1354
LM End	19.51	Issue Type +	En	Location *	
Category	Supplemental			GPS Latitude/Longitude	
				Start	End
Item	DRAFT DWR UCIP Field Study			37.113172 °	37.113172 °
				-120.560014 °	-120.560014 °
DWR ID	24868				
Comment Code					
Inspector Comment					
DS_ID:24868					
FS_ID:39345					
EP_NO: N/A					
Repair Type: Non-Urgent					
Crossing Status: Indicator Found					
UCIP Comments: 04/23/2014 Markers closer to the levee may be necessary to properly mark pipe crossing location. (DWR UCIP - W. Wylie)					
FIELD_STRUCT_DESC: Steel natural gas pipeline of an unknown size through the levee, at an unknown depth. Corrugated metal pipe (CMP) riser and gas line marker off the landside (LS) toe.					
FS Date: 4/22/2014

Gasline marker off LS toe.

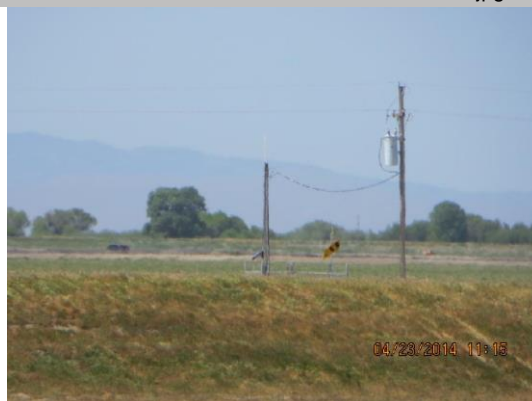
Photo 2 of 2 : UCIP_FA_2019_39345_71476.jpg

LM Start	19.51	Rating **	M	Issue No.	1354 (cont)	
LM End	19.51	Issue Type +	En	Location *		
Category	Supplemental			GPS Latitude/Longitude		
				Start	End	
Item	DRAFT DWR UCIP Field Study			37.113172 °	37.113172 °	
				-120.560014 °	-120.560014 °	
DWR ID	24868					
Comment Code						
Inspector Comment						
DS_ID:24868						
FS_ID:39345						
EP_NO: N/A						
Repair Type: Non-Urgent						
Crossing Status: Indicator Found						
UCIP Comments: 04/23/2014 Markers closer to the levee may be necessary to properly mark pipe crossing location. (DWR UCIP - W. Wylie)						
FIELD_STRUCT_DESC: Steel natural gas pipeline of an unknown size through the levee, at an unknown depth. Corrugated metal pipe (CMP) riser and gas line marker off the landside (LS) toe.						
FS Date: 4/22/2014

Gasline marker off LS of opposite bank.

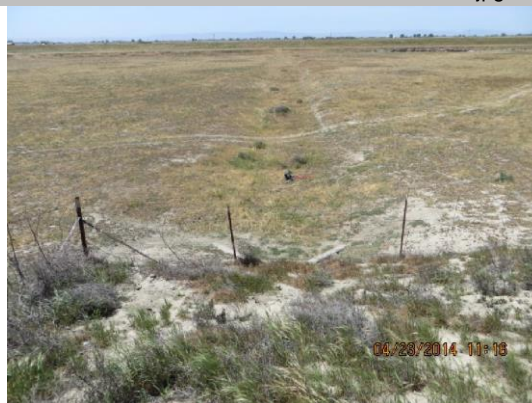
Photo 1 of 3 : UCIP_FA_2019_39603_62519.jpg

Comment Code						
Inspector Comment						
DS_ID:19778 FS_ID:39603 EP_NO: N/A Repair Type: Non-Urgent Crossing Status: Found UCIP Comments: 04/23/2014 Dense vegetation limits the inspector's visibility to identify signs of pipe failure (leaks) along the landward slope. Recommend removing vegetation along pipe alignment to conduct proper inspection of structure. Sediment buildup in pipe visible from landward side--recommend contacting owner to clear pipe. (DWR UCIP - W. Wylie) FIELD_STRUCT_DESC: 24-inch corrugated metal gravity drainage pipe through the levee, 9.7 feet below the crown. Flap gate on the waterside (WS) end. Concrete headwall on the landside (LS) end. Concrete U-shaped headwall on the WS end. [Additional Reference(s): DWR Levee Log, 2002. USACE San Joaquin O&M Manual 601.1, 1967, (HLM 19.50)]. FS Date: 4/23/2014

Headwall, pipe, and flapgate visible on WS toe.

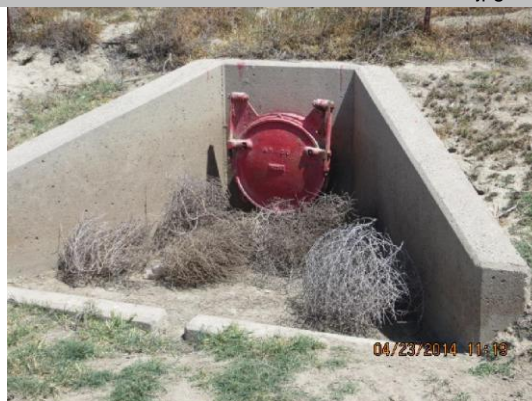
Photo 2 of 3 : UCIP_FA_2019_39603_62521.jpg

Item	DRAFT DWR UCIP LMA Responsibility			37.112953 °	37.112953 °	
				-120.559943 °	-120.559943 °	
DWR ID	19778					
Comment Code						
Inspector Comment						
DS_ID:19778 FS_ID:39603 EP_NO: N/A Repair Type: Non-Urgent Crossing Status: Found UCIP Comments: 04/23/2014 Dense vegetation limits the inspector's visibility to identify signs of pipe failure (leaks) along the landward slope. Recommend removing vegetation along pipe alignment to conduct proper inspection of structure. Sediment buildup in pipe visible from landward side--recommend contacting owner to clear pipe. (DWR UCIP - W. Wylie) FIELD_STRUCT_DESC: 24-inch corrugated metal gravity drainage pipe through the levee, 9.7 feet below the crown. Flap gate on the waterside (WS) end. Concrete headwall on the landside (LS) end. Concrete U-shaped headwall on the WS end. [Additional Reference(s): DWR Levee Log, 2002. USACE San Joaquin O&M Manual 601.1, 1967, (HLM 19.50)]. FS Date: 4/23/2014

Headwall, pipe, and flapgate visible on WS toe.

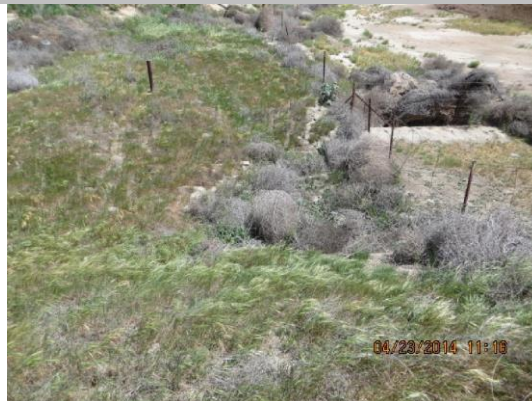
Photo 3 of 3 : UCIP_FA_2019_39603_62520.jpg

Headwall and pipe visible on LS toe.

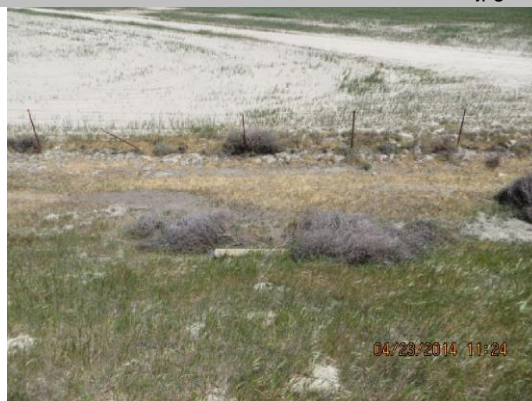
Photo 1 of 3 : UCIP_FA_2019_34754_62525.jpg

LM Start	19.86	Rating **	A/W	Issue No.	1356
LM End	19.86	Issue Type +	Ma	Location *	
Category	Supplemental			GPS Latitude/Longitude	
				Start	End
Item	DRAFT DWR UCIP LMA Responsibility			37.109284 °	37.109284 °
				-120.555948 °	-120.555948 °
DWR ID	19779				
Comment Code					
Inspector Comment					
DS_ID:19779 FS_ID:34754 EP_NO: N/A Repair Type: No Action Needed Crossing Status: Found UCIP Comments: FIELD_STRUCT_DESC: 24-inch corrugated metal gravity drainage pipe through the levee, 10.3 feet below the crown. Flap gate on the waterside (WS) end. Concrete headwall on the landside (LS) end. Concrete U-shaped headwall on the WS end. [Additional Reference(s): DWR Levee Log, 2002. USACE San Joaquin O&M Manual 601.1, 1967, (HLM 19.84)]. FS Date: 4/23/2014

Headwall and pipe visible on LS toe.

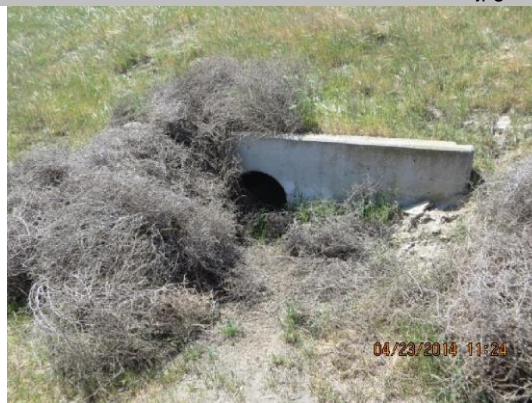
Photo 2 of 3 : UCIP_FA_2019_34754_62524.jpg

Headwall and pipe visible on LS toe.

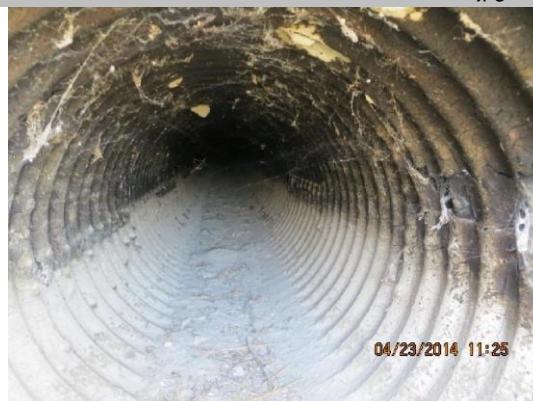
Photo 3 of 3 : UCIP_FA_2019_34754_62523.jpg

LM Start	19.86	Rating **	A/W	Issue No.	1356 (cont)	
LM End	19.86	Issue Type +	Ma	Location *		
Category	Supplemental			GPS Latitude/Longitude		
				Start		End
Item	DRAFT DWR UCIP LMA Responsibility			37.109284 °		37.109284 °
				-120.555948 °		-120.555948 °
DWR ID	19779					
Comment Code						
Inspector Comment						
DS_ID:19779						
FS_ID:34754						
EP_NO: N/A						
Repair Type: No Action Needed						
Crossing Status: Found						
UCIP Comments:						
FIELD_STRUCT_DESC: 24-inch corrugated metal gravity drainage pipe through the levee, 10.3 feet below the crown. Flap gate on the waterside (WS) end. Concrete headwall on the landside (LS) end. Concrete U-shaped headwall on the WS end. [Additional Reference(s): DWR Levee Log, 2002. USACE San Joaquin O&M Manual 601.1, 1967, (HLM 19.84)].						
FS Date: 4/23/2014

Inside pipe on LS toe.

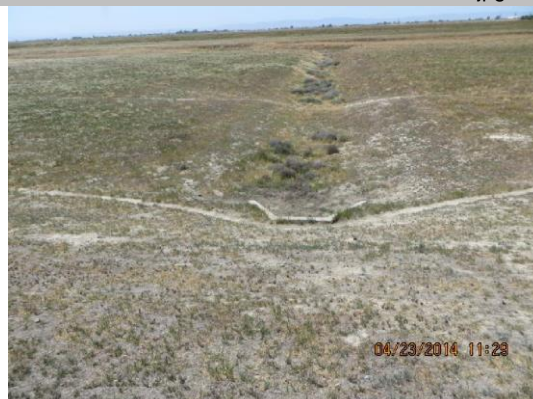
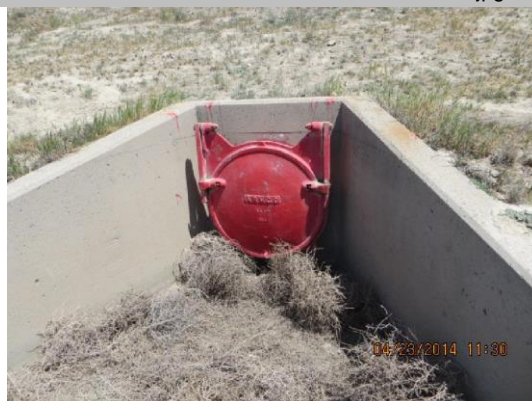
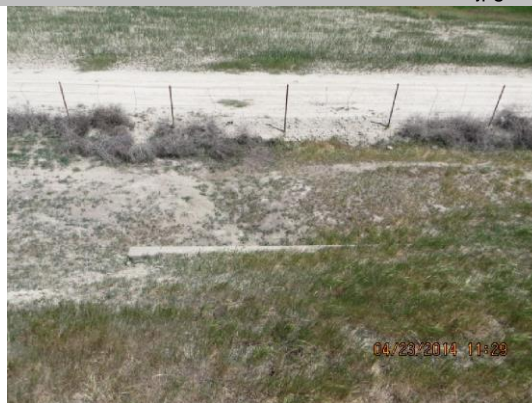
Photo 1 of 3 : UCIP_FA_2019_34755_62529.jpg

LM Start	19.94	Rating **	A/W	Issue No.	1357
LM End	19.94	Issue Type +	Ma	Location *	
Category	Supplemental			GPS Latitude/Longitude	
				Start	End
Item	DRAFT DWR UCIP LMA Responsibility			37.108426 °	37.108426 °
				-120.554990 °	-120.554990 °
DWR ID	19780				
Comment Code					
Inspector Comment					
DS_ID:19780 FS_ID:34755 EP_NO: N/A Repair Type: No Action Needed Crossing Status: Found UCIP Comments: FIELD_STRUCT_DESC: 36-inch corrugated metal gravity drainage pipe through the levee, 9.8 feet below the crown. Flap gate on the waterside (WS) end. Concrete headwall on the landside (LS) end. Concrete U-shaped headwall on the WS end. [Additional Reference(s): DWR Levee Log, 2002. USACE San Joaquin O&M Manual 601.1, 1967, (HLM 19.92)]. FS Date: 4/23/2014

Headwall, pipe, and flapgate visible on WS toe.

Headwall and pipe visible on LS toe.

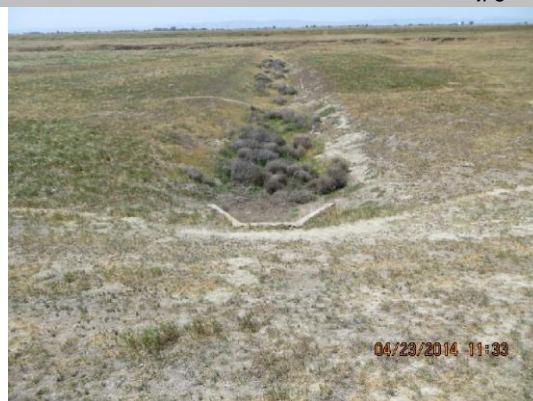
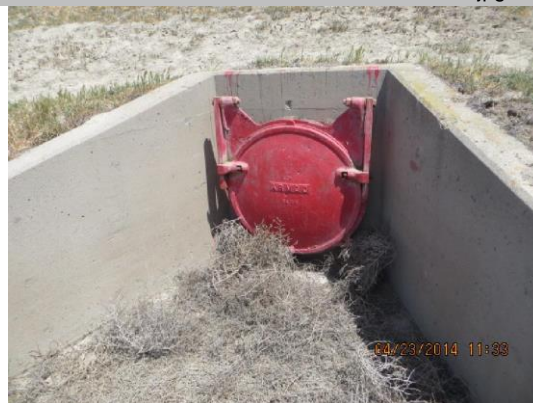
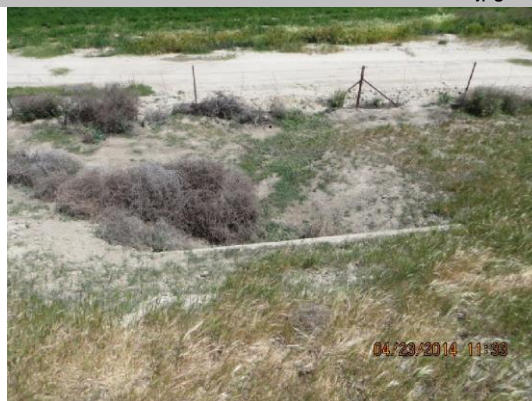
Photo 1 of 3 : UCIP_FA_2019_34757_62533.jpg

LM Start	20.10	Rating **	A/W	Issue No.	1358
LM End	20.10	Issue Type +	Ma	Location *	
Category	Supplemental			GPS Latitude/Longitude	
				Start	End
Item	DRAFT DWR UCIP LMA Responsibility			37.107091 °	37.107091 °
				-120.553503 °	-120.553503 °
DWR ID	19781				
Comment Code					
Inspector Comment					
DS_ID:19781 FS_ID:34757 EP_NO: N/A Repair Type: No Action Needed Crossing Status: Found UCIP Comments: FIELD_STRUCT_DESC: 36-inch corrugated metal gravity drainage pipe through the levee, 9.9 feet below the crown. Flap gate on the waterside (WS) end. Concrete headwall on the landside (LS) end. Concrete U-shaped headwall on the WS end. [Additional Reference(s): DWR Levee Log, 2002. USACE San Joaquin O&M Manual 601.1, 1967, (HLM 20.05)]. FS Date: 4/23/2014

Headwall, pipe, and flapgate visible on WS toe.

Headwall and pipe visible on LS toe.

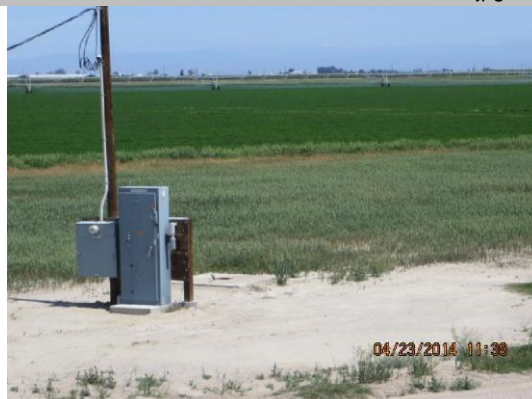
Photo 1 of 1 : UCIP_FA_2019_34759_62537.jpg

LM Start	20.19	Rating **	M	Issue No.	1359
LM End	20.19	Issue Type +	En	Location *	
Category	Supplemental			GPS Latitude/Longitude	
				Start	End
Item	DRAFT DWR UCIP Field Study			37.106149°	37.106149°
				-120.552538°	-120.552538°
DWR ID	19782				
Comment Code					
Inspector Comment					
DS_ID:19782 FS_ID:34759 EP_NO: 13828 Repair Type: Non-Urgent Crossing Status: Not Found UCIP Comments: FIELD_STRUCT_DESC: *DELETE* NOT INSTALLED THROUGH THE LEVEE. 24-inch steel irrigation pipe through the levee, 4.0 feet below the crown. Pump missing from pad on the landward side. Steel cutoff wall around pipe at center of levee. Siphon breaker on apex of pipe on landward shoulder. Pre-existing ditch runs from waterward toe to channel. Pipe extends from pump to the channel. Rock revetment on the cut slopes of the inlet channel. (Permit No. 13828-1988) FS Date: 4/23/2014

Well head visible off LS toe.

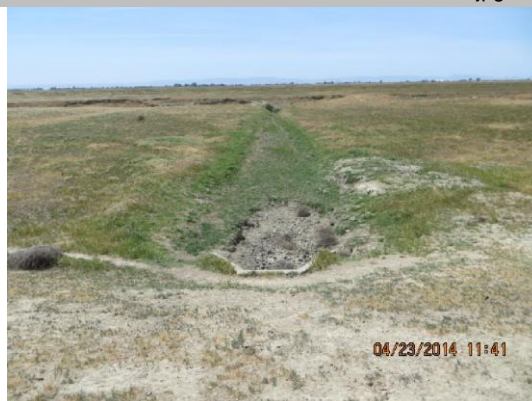
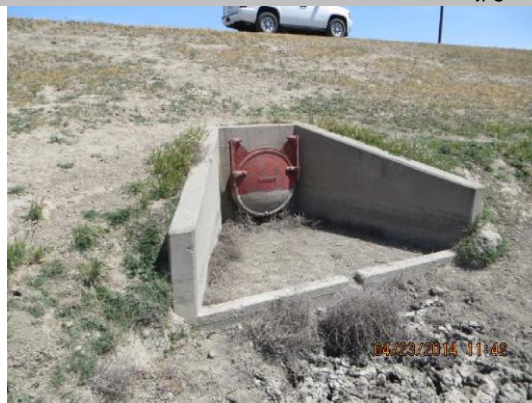
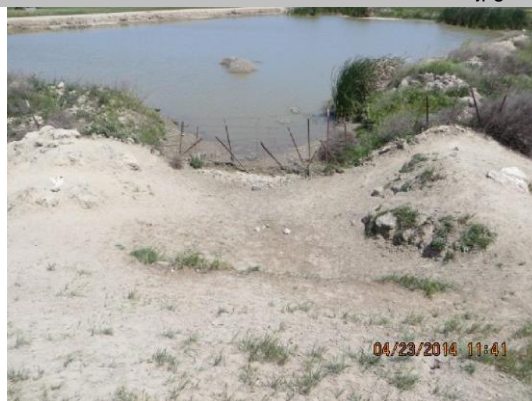
Photo 1 of 3 : UCIP_FA_2019_34760_62539.jpg

LM Start	20.24	Rating **	A/W	Issue No.	1360	
LM End	20.24	Issue Type +	Ma	Location *		
Category	Supplemental			GPS Latitude/Longitude		
				Start	End	
Item	DRAFT DWR UCIP LMA Responsibility			37.105489 °	37.105489 °	
				-120.551886 °	-120.551886 °	
DWR ID	19783					
Comment Code						
Inspector Comment						
DS_ID:19783 FS_ID:34760 EP_NO: N/A Repair Type: No Action Needed Crossing Status: Found UCIP Comments: FIELD_STRUCT_DESC: 36-inch corrugated metal gravity drainage pipe through the levee, 10.6 feet below the crown. Flap gate on the waterside (WS) end. Concrete headwall on each end. [Additional Reference(s): DWR Levee Log, 2002. USACE San Joaquin O&M Manual 601.1, 1967, (HLM 20.18)]. FS Date: 4/23/2014

Headwall, pipe, and flapgate visible on WS toe.

Headwall and pipe visible on LS toe.
