**Flood Control Project Maintenance
Levee Inspections**

Fall 2019 Levee Maintenance Deficiency Summary Report

San Joaquin River Basin

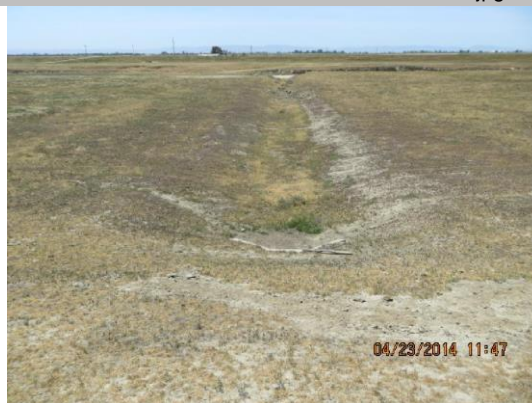
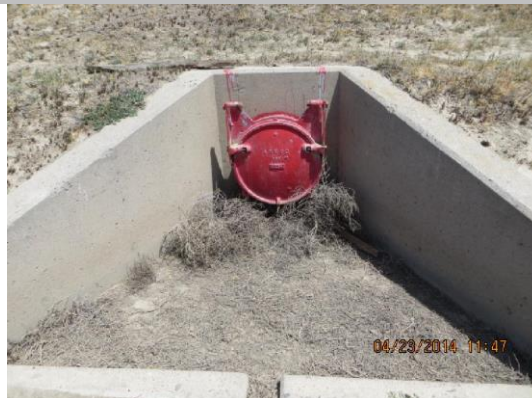
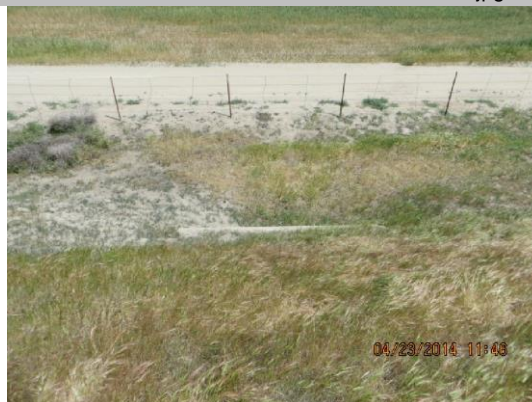
Photo 1 of 3 : UCIP_FA_2019_39605_62544.jpg

LM Start	20.65	Rating **	M	Issue No.	1361	
LM End	20.65	Issue Type +	Ma	Location *		
Category	Supplemental			GPS Latitude/Longitude		
				Start	End	
Item	DRAFT DWR UCIP LMA Responsibility			37.100903 °	37.100903 °	
				-120.547282 °	-120.547282 °	
DWR ID	19784

Comment Code						
Inspector Comment						
DS_ID:19784						
FS_ID:39605						
EP_NO: N/A						
Repair Type: Non-Urgent						
Crossing Status: Found						
UCIP Comments: 04/23/2014 Dense vegetation limits the inspector's visibility to identify signs of pipe failure (leaks) along the landward slope. Recommend removing vegetation along pipe alignment to conduct proper inspection of structure. (DWR UCIP - W. Wylie)						
FIELD_STRUCT_DESC: 24-inch corrugated metal gravity drainage pipe through the levee, 10.5 feet below the crown. Flap gate on the waterside (WS) end. Concrete headwall on the landside (LS) end. Concrete U-shaped headwall on the WS end. [Additional Reference(s): DWR Levee Log, 2002. USACE San Joaquin O&M Manual 601.1, 1967, (HLM 20.59)].						
FS Date: 4/23/2014

Headwall, pipe, and flapgate visible on WS toe.

Headwall and pipe visible on LS toe.

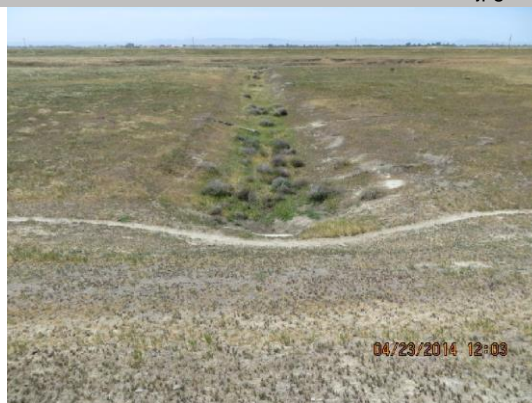
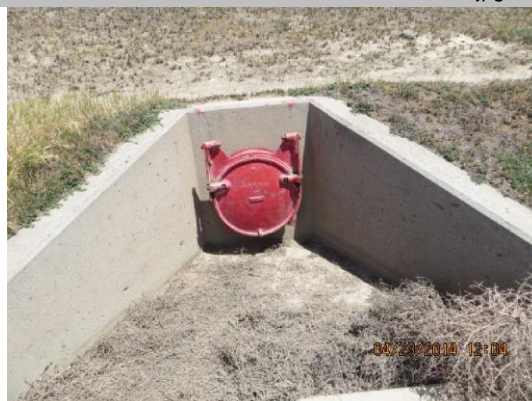
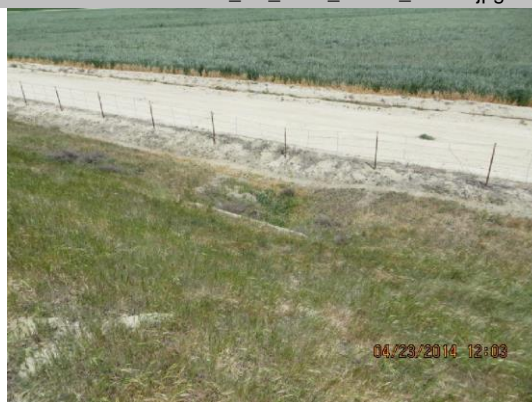
Photo 1 of 3 : UCIP_FA_2019_39606_62549.jpg

Comment Code					
Inspector Comment					
DS_ID:19785 FS_ID:39606 EP_NO: N/A Repair Type: Non-Urgent Crossing Status: Found UCIP Comments: 04/23/2014 Dense vegetation limits the inspector's visibility to identify signs of pipe failure (leaks) along the landward slope. Recommend removing vegetation along pipe alignment to conduct proper inspection of structure. (DWR UCIP - W. Wylie) FIELD_STRUCT_DESC: 24-inch corrugated metal gravity drainage pipe through the levee, 11.8 feet below the crown. Flap gate on the waterside (WS) end. Concrete headwall on the landside (LS) end. Concrete U-shaped headwall on the WS end. [Additional Reference(s): DWR Levee Log, 2002. USACE San Joaquin O&M Manual 601.1, 1967, (HLM 21.08)]. FS Date: 4/23/2014

Headwall, pipe, and flapgate visible on WS toe.

Headwall and pipe visible on LS toe.

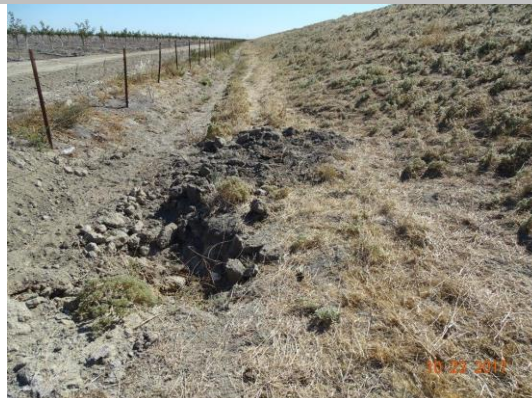
Photo 1 of 1 : FA_2019_NA0010_123_120_20190912_00021.jpg

LM Start	21.45	Rating **	M	Issue No.	120
LM End	21.45	Issue Type +	Ma	Location *	LS
Category	Earthen Levee			GPS Latitude/Longitude	
				Start	End
Item	Erosion / Bank Caving			37.092064 °	37.092064 °
				-120.537750 °	-120.537750 °
DWR ID	DWR_NA0010_05_f_2017_120				
Comment Code					
E2 : Schedule repair of erosion site prior to the next inspection.					
Inspector Comment					
Repair holes dug at the landside toe.

Looking southeast at the landside toe.

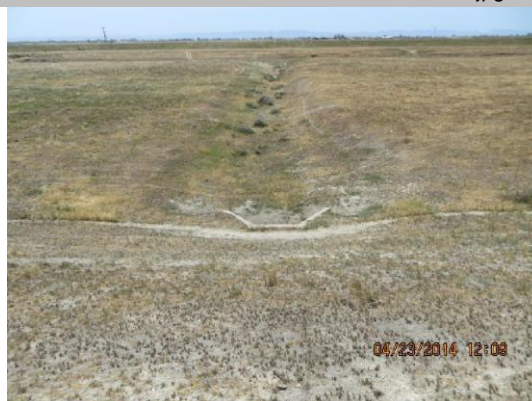
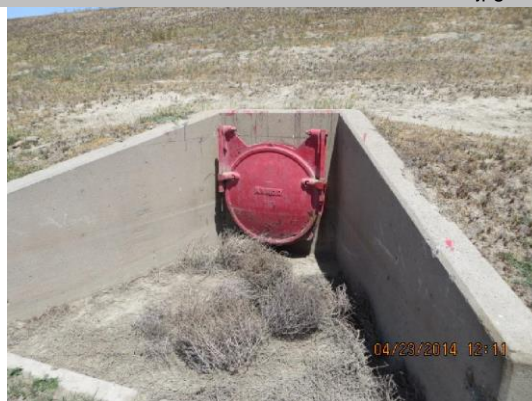
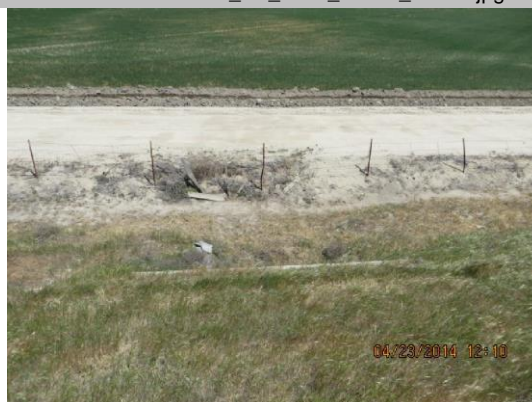
Photo 1 of 3 : UCIP_FA_2019_39614_62555.jpg

LM Start	21.48	Rating **	M	Issue No.	1363	
LM End	21.48	Issue Type +	Ma	Location *		
Category	Supplemental			GPS Latitude/Longitude		
				Start	End	
Item	DRAFT DWR UCIP LMA Responsibility			37.091755 °	37.091755 °	
				-120.537414 °	-120.537414 °	
DWR ID	19786

Comment Code						
Inspector Comment						
DS_ID:19786 FS_ID:39614 EP_NO: N/A Repair Type: Non-Urgent Crossing Status: Found UCIP Comments: 04/23/2014 Dense vegetation limits the inspector's visibility to identify signs of pipe failure (leaks) along the landward slope. Recommend removing vegetation along pipe alignment to conduct proper inspection of structure. (DWR UCIP - W. Wylie) FIELD_STRUCT_DESC: 36-inch corrugated metal gravity drainage pipe through the levee, 12.7 feet below the crown. Flap gate on the waterside (WS) end. Concrete headwall on the landside (LS) end. Concrete U-shaped headwall on the WS end. [Additional Reference(s): DWR Levee Log, 2002. USACE San Joaquin O&M Manual 601.1, 1967, (HLM 21.42)]. FS Date: 4/23/2014

Headwall, pipe, and flapgate visible on WS toe.

Headwall and pipe visible on LS toe.

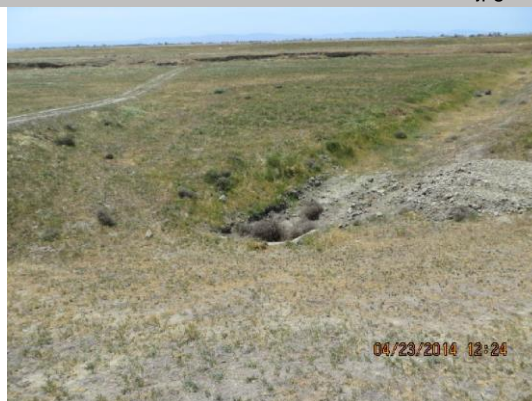
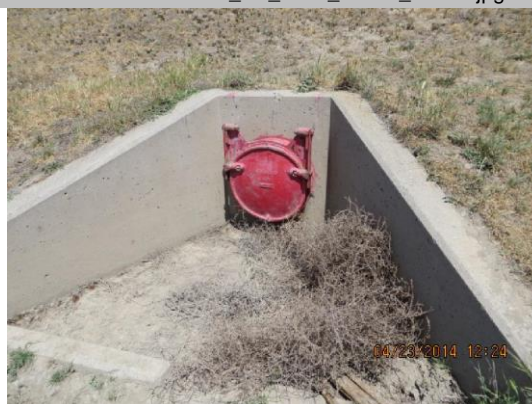
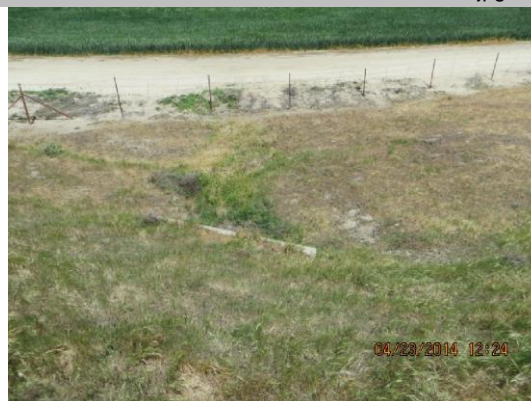
Photo 1 of 3 : UCIP_FA_2019_39883_62559.jpg

Comment Code						
Inspector Comment						
DS_ID:19787 FS_ID:39883 EP_NO: N/A Repair Type: Non-Urgent Crossing Status: Found UCIP Comments: 04/23/2014 Dense vegetation limits the inspector's visibility to identify signs of pipe failure (leaks) along the landward slope. Recommend removing vegetation along pipe alignment to conduct proper inspection of structure. (DWR UCIP - W. Wylie) FIELD_STRUCT_DESC: 24-inch corrugated metal gravity drainage pipe through the levee, 12.4 feet below the crown. Flap gate on the waterside (WS) end. Concrete headwall on the landside (LS) end. Concrete U-shaped headwall on the WS end. [Additional Reference(s): DWR Levee Log, 2002. USACE San Joaquin O&M Manual 601.1, 1967, (HLM 21.81)]. FS Date: 4/23/2014

Headwall, pipe, and flapgate visible on WS toe.

Headwall and pipe visible on LS toe.

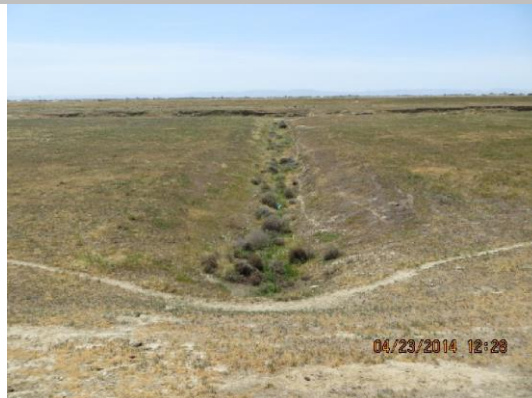
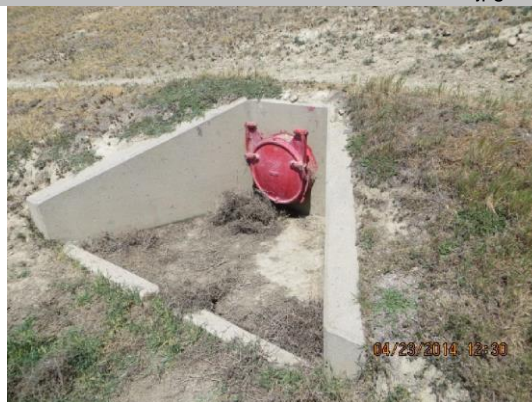
Photo 1 of 3 : UCIP_FA_2019_39610_62586.jpg

Comment Code					
Inspector Comment					
DS_ID:19788 FS_ID:39610 EP_NO: N/A Repair Type: Non-Urgent Crossing Status: Found UCIP Comments: 04/23/2014 Dense vegetation limits the inspector's visibility to identify signs of pipe failure (leaks) along the landward slope. Recommend removing vegetation along pipe alignment to conduct proper inspection of structure. (DWR UCIP - W. Wylie) FIELD_STRUCT_DESC: 24-inch corrugated metal gravity drainage pipe through the levee, 10.7 feet below the crown. Flap gate on the waterside (WS) end. Concrete headwall on the landside (LS) end. Concrete U-shaped headwall on the WS end. [Additional Reference(s): DWR Levee Log, 2002. USACE San Joaquin O&M Manual 601.1, 1967, (HLM 21.85)]. FS Date: 4/23/2014

Headwall, pipe, and flapgate visible on WS toe.

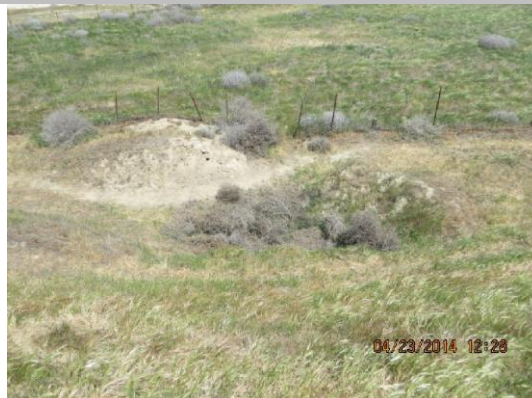
Photo 3 of 3 : UCIP_FA_2019_39610_62587.jpg

Item	DRAFT DWR UCIP LMA Responsibility			37.087108 °	37.087108 °	
				-120.532374 °	-120.532374 °	
DWR ID	19788					
Comment Code						
Inspector Comment						
DS_ID:19788 FS_ID:39610 EP_NO: N/A Repair Type: Non-Urgent Crossing Status: Found UCIP Comments: 04/23/2014 Dense vegetation limits the inspector's visibility to identify signs of pipe failure (leaks) along the landward slope. Recommend removing vegetation along pipe alignment to conduct proper inspection of structure. (DWR UCIP - W. Wylie) FIELD_STRUCT_DESC: 24-inch corrugated metal gravity drainage pipe through the levee, 10.7 feet below the crown. Flap gate on the waterside (WS) end. Concrete headwall on the landside (LS) end. Concrete U-shaped headwall on the WS end. [Additional Reference(s): DWR Levee Log, 2002. USACE San Joaquin O&M Manual 601.1, 1967, (HLM 21.85)]. FS Date: 4/23/2014

Headwall and pipe visible on LS toe.

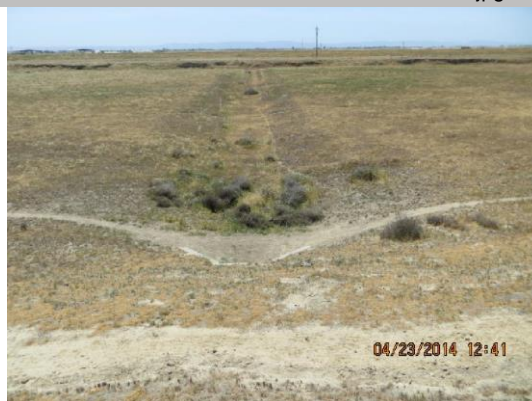
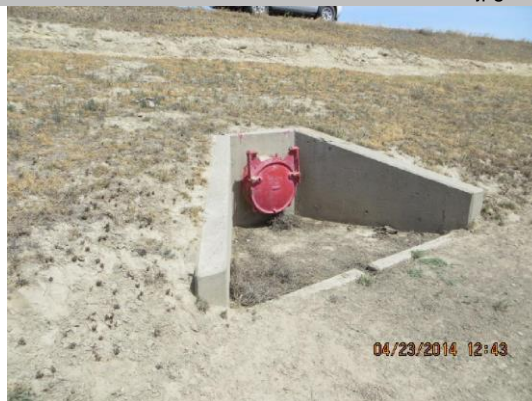
Comment Code					
Inspector Comment					
DS_ID:19789 FS_ID:39611 EP_NO: N/A Repair Type: Non-Urgent Crossing Status: Found UCIP Comments: 04/23/2014 Dense vegetation limits the inspector's visibility to identify signs of pipe failure (leaks) along the landward slope. Recommend removing vegetation along pipe alignment to conduct proper inspection of structure. Sediment buildup in pipe visible from landward side--recommend contacting owner to clear pipe. (DWR UCIP - W. Wylie) FIELD_STRUCT_DESC: 24-inch corrugated metal gravity drainage pipe through the levee, 10.2 feet below the crown. Flap gate on the waterside (WS) end. Concrete headwall on the landside (LS) end. Concrete U-shaped headwall on the WS end. [Additional Reference(s): DWR Levee Log, 2002. USACE San Joaquin O&M Manual 601.1, 1967, (HLM 22.19)]. FS Date: 4/23/2014

Headwall, pipe, and flapgate visible on WS toe.

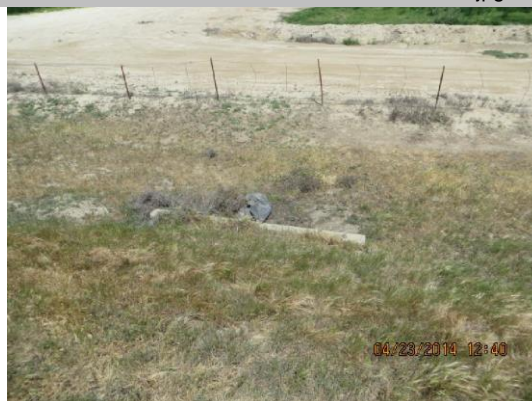
Photo 3 of 3 : UCIP_FA_2019_39611_62592.jpg

Item	DRAFT DWR UCIP LMA Responsibility			37.083410 °	37.083410 °	
				-120.528356 °	-120.528356 °	
DWR ID	19789					
Comment Code						
Inspector Comment						
DS_ID:19789 FS_ID:39611 EP_NO: N/A Repair Type: Non-Urgent Crossing Status: Found UCIP Comments: 04/23/2014 Dense vegetation limits the inspector's visibility to identify signs of pipe failure (leaks) along the landward slope. Recommend removing vegetation along pipe alignment to conduct proper inspection of structure. Sediment buildup in pipe visible from landward side--recommend contacting owner to clear pipe. (DWR UCIP - W. Wylie) FIELD_STRUCT_DESC: 24-inch corrugated metal gravity drainage pipe through the levee, 10.2 feet below the crown. Flap gate on the waterside (WS) end. Concrete headwall on the landside (LS) end. Concrete U-shaped headwall on the WS end. [Additional Reference(s): DWR Levee Log, 2002. USACE San Joaquin O&M Manual 601.1, 1967, (HLM 22.19)]. FS Date: 4/23/2014

Headwall and pipe visible on LS toe.

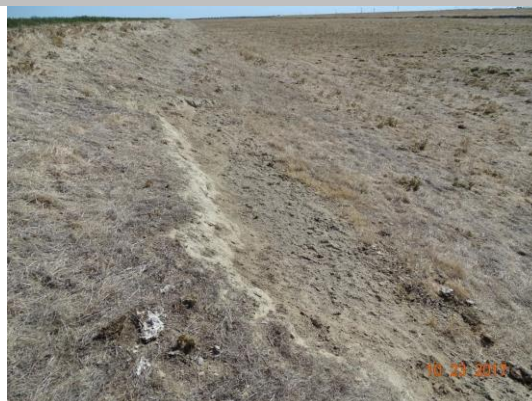
Photo 1 of 1 : FA_2019_NA0010_123_121_20190912_00022.jpg

LM Start	22.35	Rating **	M	Issue No.	121
LM End	22.35	Issue Type +	Ma	Location *	WS
Category	Earthen Levee			GPS Latitude/Longitude	
				Start	End
Item	Erosion / Bank Caving			37.082696 °	37.082696 °
				-120.527620 °	-120.527620 °
DWR ID	DWR_NA0010_05_f_2017_121				
Comment Code					
E1 : Note and monitor erosion site.					
Inspector Comment					
Waterside slope damaged by animal traffic.

Looking southeast at the waterside slope.

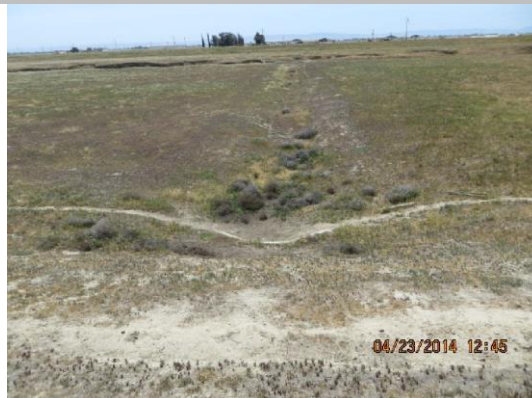
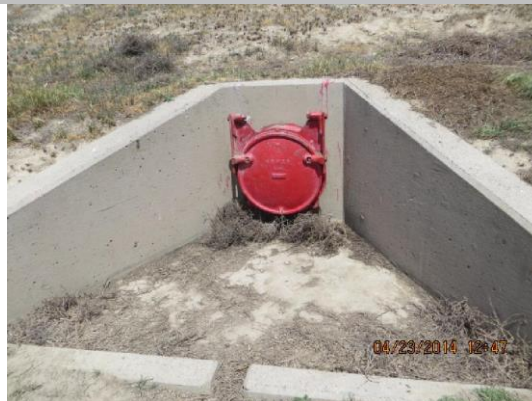
Comment Code						
Inspector Comment						
DS_ID:19790 FS_ID:39613 EP_NO: N/A Repair Type: Non-Urgent Crossing Status: Found UCIP Comments: 04/23/2014 Dense vegetation limits the inspector's visibility to identify signs of pipe failure (leaks) along the landward slope. Recommend removing vegetation along pipe alignment to conduct proper inspection of structure. Sediment buildup in pipe visible from landward side--recommend contacting owner to clear pipe. (DWR UCIP - W. Wylie) FIELD_STRUCT_DESC: 24-inch corrugated metal gravity drainage pipe through the levee, 10.4 feet below the crown. Flap gate on the waterside (WS) end. Concrete headwall on the landside (LS) end. Concrete U-shaped headwall on the WS end. [Additional Reference(s): DWR Levee Log, 2002. USACE San Joaquin O&M Manual 601.1, 1967, (HLM 22.46)]. FS Date: 4/23/2014

Headwall, pipe, and flapgate visible on WS toe.

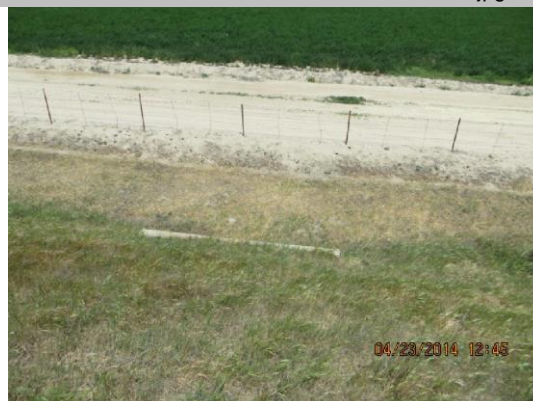
Photo 3 of 3 : UCIP_FA_2019_39613_62597.jpg

Item	DRAFT DWR UCIP LMA Responsibility			37.080486°	37.080486°	
				-120.525180°	-120.525180°	
DWR ID	19790					
Comment Code						
Inspector Comment						
DS_ID:19790 FS_ID:39613 EP_NO: N/A Repair Type: Non-Urgent Crossing Status: Found UCIP Comments: 04/23/2014 Dense vegetation limits the inspector's visibility to identify signs of pipe failure (leaks) along the landward slope. Recommend removing vegetation along pipe alignment to conduct proper inspection of structure. Sediment buildup in pipe visible from landward side--recommend contacting owner to clear pipe. (DWR UCIP - W. Wylie) FIELD_STRUCT_DESC: 24-inch corrugated metal gravity drainage pipe through the levee, 10.4 feet below the crown. Flap gate on the waterside (WS) end. Concrete headwall on the landside (LS) end. Concrete U-shaped headwall on the WS end. [Additional Reference(s): DWR Levee Log, 2002. USACE San Joaquin O&M Manual 601.1, 1967, (HLM 22.46)]. FS Date: 4/23/2014

Headwall and pipe visible on LS toe.

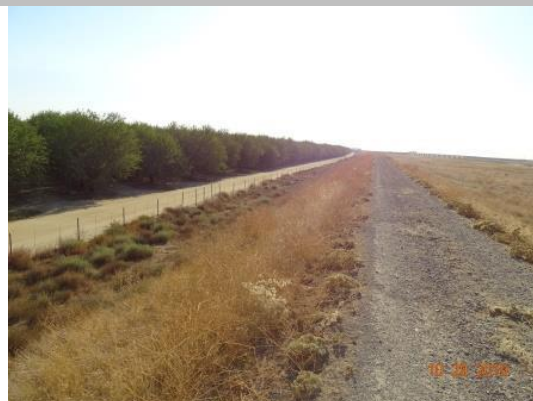
Photo 1 of 1 : FA_2019_NA0010_123_173_20191108_00335.jpg

LM Start	22.65	Rating **	U	Issue No.	173
LM End	23.25	Issue Type +	Ma	Location *	LS
Category	Earthen Levee			GPS Latitude/Longitude	
				Start	End
Item	Vegetation			37.079385°	37.072986°
				-120.524030°	-120.516656°
DWR ID	DWR_NA0010_05_f_2019_173				
Comment Code					
V1 : Control annual grass and weeds on the levee slopes and easements.					
Inspector Comment

View of the vegetation along the landside slope looking upstream. (Fall 2019)

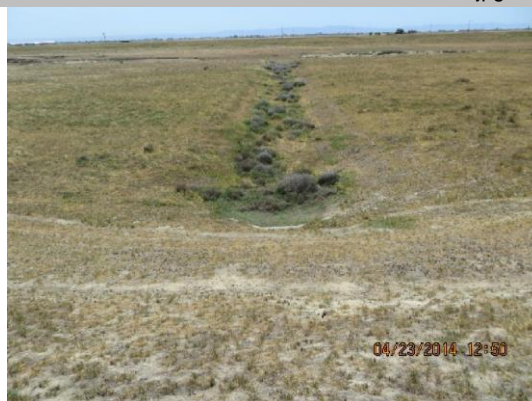
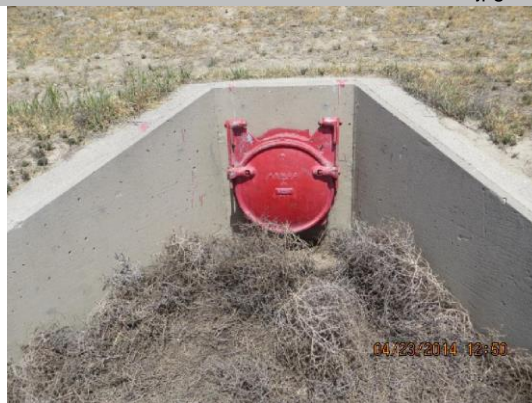
Comment Code						
Inspector Comment						
DS_ID:19791 FS_ID:39616 EP_NO: N/A Repair Type: Non-Urgent Crossing Status: Found UCIP Comments: 04/23/2014 Dense vegetation limits the inspector's visibility to identify signs of pipe failure (leaks) along the landward slope. Recommend removing vegetation along pipe alignment to conduct proper inspection of structure. Sediment buildup in pipe visible from landward side--recommend contacting owner to clear pipe. (DWR UCIP - W. Wylie) FIELD_STRUCT_DESC: 24-inch corrugated metal gravity drainage pipe through the levee, 12.2 feet below the crown. Flap gate on the waterside (WS) end. Concrete headwall on the landside (LS) end. Concrete U-shaped headwall on the WS end. [Additional Reference(s): DWR Levee Log, 2002. USACE San Joaquin O&M Manual 601.1, 1967, (HLM 22.79)]. FS Date: 4/23/2014

Headwall, pipe, and flapgate visible on WS toe.

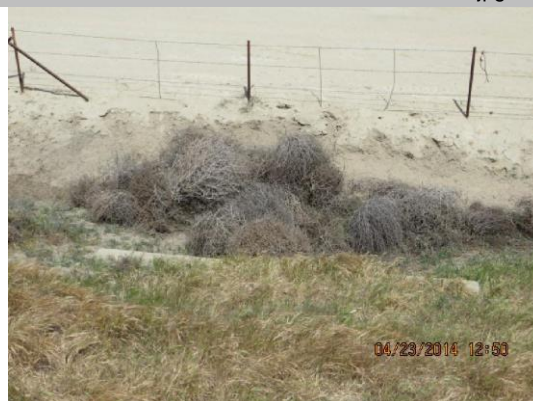
Photo 3 of 3 : UCIP_FA_2019_39616_62602.jpg

Item	DRAFT DWR UCIP LMA Responsibility			37.076830 °	37.076830 °	
				-120.521116 °	-120.521116 °	
DWR ID	19791					
Comment Code						
Inspector Comment						
DS_ID:19791 FS_ID:39616 EP_NO: N/A Repair Type: Non-Urgent Crossing Status: Found UCIP Comments: 04/23/2014 Dense vegetation limits the inspector's visibility to identify signs of pipe failure (leaks) along the landward slope. Recommend removing vegetation along pipe alignment to conduct proper inspection of structure. Sediment buildup in pipe visible from landward side--recommend contacting owner to clear pipe. (DWR UCIP - W. Wylie) FIELD_STRUCT_DESC: 24-inch corrugated metal gravity drainage pipe through the levee, 12.2 feet below the crown. Flap gate on the waterside (WS) end. Concrete headwall on the landside (LS) end. Concrete U-shaped headwall on the WS end. [Additional Reference(s): DWR Levee Log, 2002. USACE San Joaquin O&M Manual 601.1, 1967, (HLM 22.79)]. FS Date: 4/23/2014

Headwall and pipe visible on LS toe.

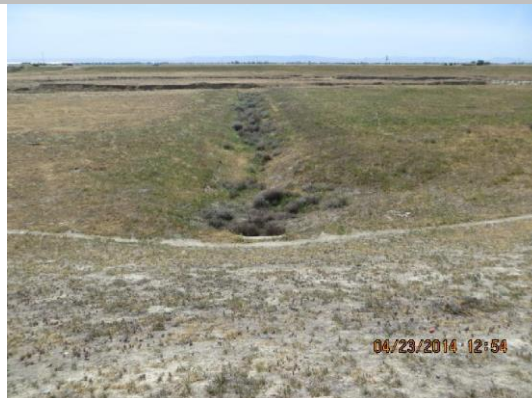
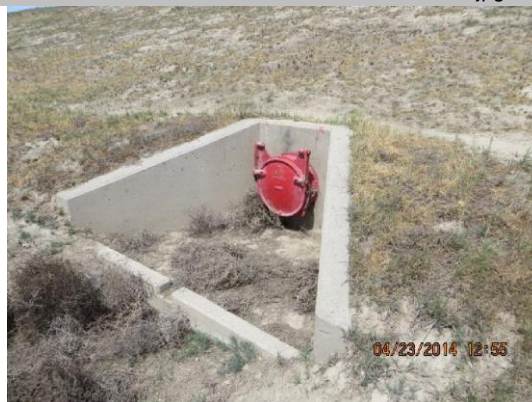
Comment Code						
Inspector Comment						
DS_ID:19792						
FS_ID:39617						
EP_NO: N/A						
Repair Type: Non-Urgent						
Crossing Status: Found						
UCIP Comments: 04/23/2014 Dense vegetation limits the inspector's visibility to identify signs of pipe failure (leaks) along the landward slope. Recommend removing vegetation along pipe alignment to conduct proper inspection of structure. (DWR UCIP - W. Wylie)						
FIELD_STRUCT_DESC: 24-inch corrugated metal gravity drainage pipe through the levee, 11.1 feet below the crown. Flap gate on the waterside (WS) end. Concrete headwall on the landside (LS) end. Concrete U-shaped headwall on the WS end. [Additional Reference(s): DWR Levee Log, 2002. USACE San Joaquin O&M Manual 601.1, 1967, (HLM 22.94)].						
FS Date: 4/23/2014

Headwall, pipe, and flapgate visible on WS toe.

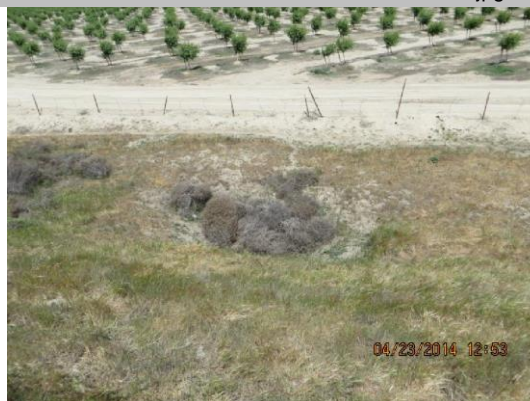
Photo 3 of 3 : UCIP_FA_2019_39617_62607.jpg

Item	DRAFT DWR UCIP LMA Responsibility			37.075387 °	37.075387 °	
				-120.519406 °	-120.519406 °	
DWR ID	19792					
Comment Code						
Inspector Comment						
DS_ID:19792 FS_ID:39617 EP_NO: N/A Repair Type: Non-Urgent Crossing Status: Found UCIP Comments: 04/23/2014 Dense vegetation limits the inspector's visibility to identify signs of pipe failure (leaks) along the landward slope. Recommend removing vegetation along pipe alignment to conduct proper inspection of structure. (DWR UCIP - W. Wylie) FIELD_STRUCT_DESC: 24-inch corrugated metal gravity drainage pipe through the levee, 11.1 feet below the crown. Flap gate on the waterside (WS) end. Concrete headwall on the landside (LS) end. Concrete U-shaped headwall on the WS end. [Additional Reference(s): DWR Levee Log, 2002. USACE San Joaquin O&M Manual 601.1, 1967, (HLM 22.94)]. FS Date: 4/23/2014

Headwall and pipe visible on LS toe.

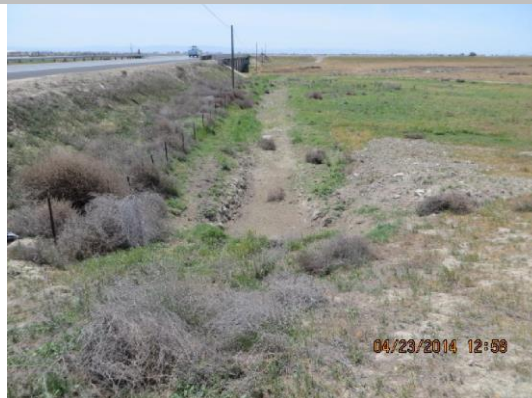
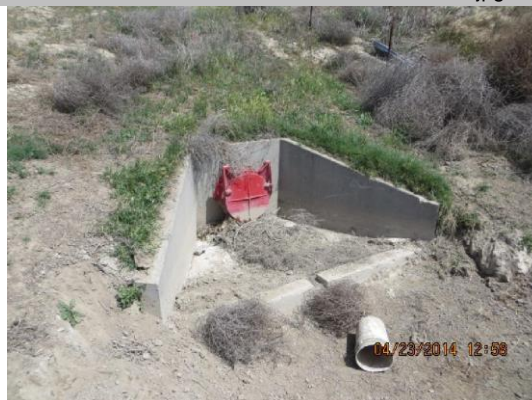
Comment Code					
Inspector Comment					
DS_ID:19793 FS_ID:39618 EP_NO: N/A Repair Type: Non-Urgent Crossing Status: Found UCIP Comments: 04/23/2014 Debris blocking closure of outlet. Dense vegetation limits the inspector's visibility to identify signs of pipe failure (leaks) along the waterward and landward slopes. Recommend removing vegetation along pipe alignment to conduct proper inspection of structure. (DWR UCIP - W. Wylie) FIELD_STRUCT_DESC: 24-inch corrugated metal gravity drainage pipe through the levee, 11.5 feet below the crown. Flap gate on the waterside (WS) end. Concrete headwall on the landside (LS) end. Concrete U-shaped headwall on the WS end. [Additional Reference(s): DWR Levee Log, 2002]. FS Date: 4/23/2014

Headwall, pipe, and flapgate visible on WS toe.

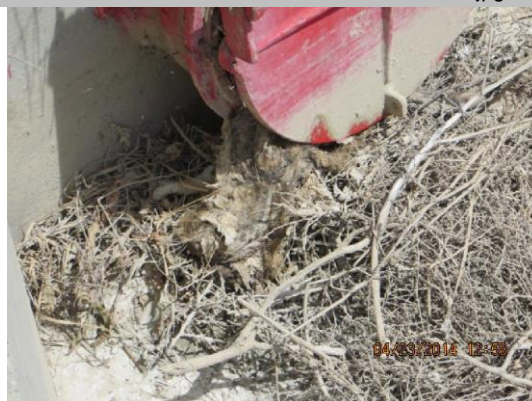
Photo 3 of 3 : UCIP_FA_2019_39618_62615.jpg

Item	DRAFT DWR UCIP Field Study			37.073901 °	37.073901 °	
				-120.517651 °	-120.517651 °	
DWR ID	19793					
Comment Code						
Inspector Comment						
DS_ID:19793 FS_ID:39618 EP_NO: N/A Repair Type: Non-Urgent Crossing Status: Found UCIP Comments: 04/23/2014 Debris blocking closure of outlet. Dense vegetation limits the inspector's visibility to identify signs of pipe failure (leaks) along the waterward and landward slopes. Recommend removing vegetation along pipe alignment to conduct proper inspection of structure. (DWR UCIP - W. Wylie) FIELD_STRUCT_DESC: 24-inch corrugated metal gravity drainage pipe through the levee, 11.5 feet below the crown. Flap gate on the waterside (WS) end. Concrete headwall on the landside (LS) end. Concrete U-shaped headwall on the WS end. [Additional Reference(s): DWR Levee Log, 2002]. FS Date: 4/23/2014

Debris blocking closure of outlet on WS toe.

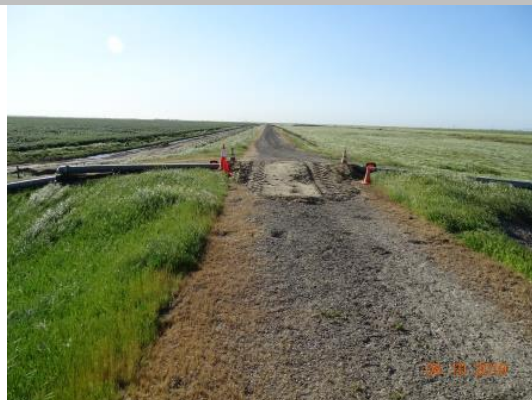
Photo 1 of 3 : FA_2019_NA0010_123_184_20190912_00052.jpg

LM Start	23.23	Rating **	M	Issue No.	184
LM End	23.23	Issue Type +	En	Location *	CR
Category	Earthen Levee			GPS Latitude/Longitude	
				Start	End
Item	Encroachments			37.073259 °	37.073259 °
				-120.516970 °	-120.516970 °
DWR ID	DWR_NA0010_05_s_2019_184				
Comment Code					
PI : Pipe					
Inspector Comment

View of pipe encroachment looking upstream along the levee crown.
(Spring 2019)

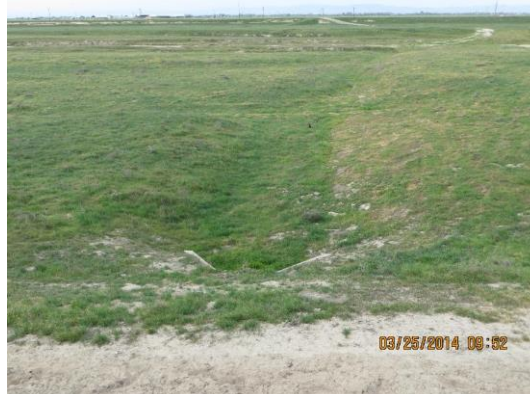
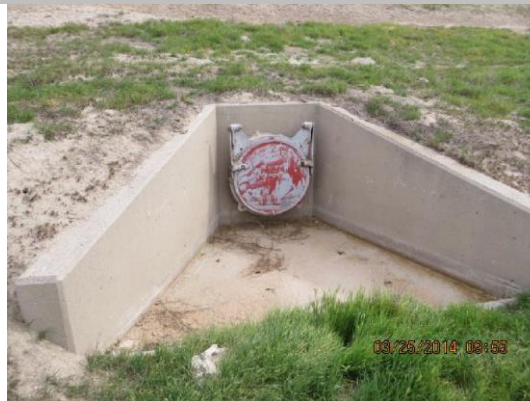
LM Start	23.25	Rating **	A/W	Issue No.	1371	
LM End	23.25	Issue Type +	Ma	Location *		
Category	Supplemental			GPS Latitude/Longitude		
				Start		End
Item	DRAFT DWR UCIP LMA Responsibility			37.072989 °		37.072989 °
				-120.516687 °		-120.516687 °
DWR ID	19794					
Comment Code						
Inspector Comment						
DS_ID:19794 FS_ID:32763 EP_NO: N/A Repair Type: No Action Needed Crossing Status: Found UCIP Comments: FIELD_STRUCT_DESC: 30-inch corrugated metal gravity drainage pipe through the levee, 11.6 feet below the crown. Flap gate on the waterside (WS) end. Concrete headwall on the landside (LS) end. Concrete U-shaped headwall on the WS end. [Additional Reference(s): DWR Levee Log, 2002. USACE San Joaquin O&M Manual 601.1, 1967, (HLM 23.15)]. FS Date: 3/25/2014 9:04:45 AM

Concrete headwall on WS toe.

Flapgate and concrete headwall on WS toe.

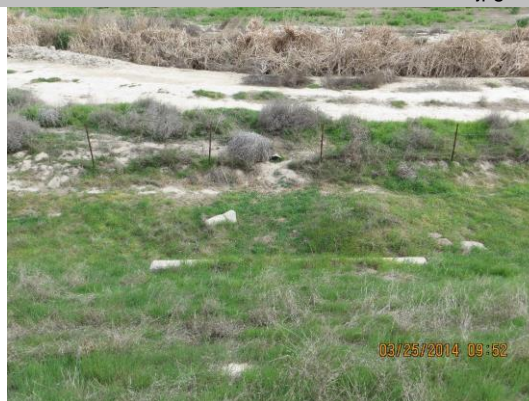
Photo 3 of 3 : UCIP_FA_2019_32763_59261.jpg

LM Start	23.25	Rating **	A/W	Issue No.	1371 (cont)	
LM End	23.25	Issue Type +	Ma	Location *		
Category	Supplemental			GPS Latitude/Longitude		
				Start	End	
Item	DRAFT DWR UCIP LMA Responsibility			37.072989 °	37.072989 °	
				-120.516687 °	-120.516687 °	
DWR ID	19794					
Comment Code						
Inspector Comment						
DS_ID:19794 FS_ID:32763 EP_NO: N/A Repair Type: No Action Needed Crossing Status: Found UCIP Comments: FIELD_STRUCT_DESC: 30-inch corrugated metal gravity drainage pipe through the levee, 11.6 feet below the crown. Flap gate on the waterside (WS) end. Concrete headwall on the landside (LS) end. Concrete U-shaped headwall on the WS end. [Additional Reference(s): DWR Levee Log, 2002. USACE San Joaquin O&M Manual 601.1, 1967, (HLM 23.15)]. FS Date: 3/25/2014 9:04:45 AM

Concrete headwall on LS toe.

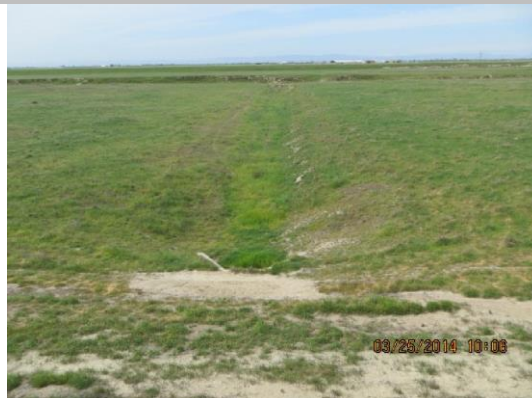
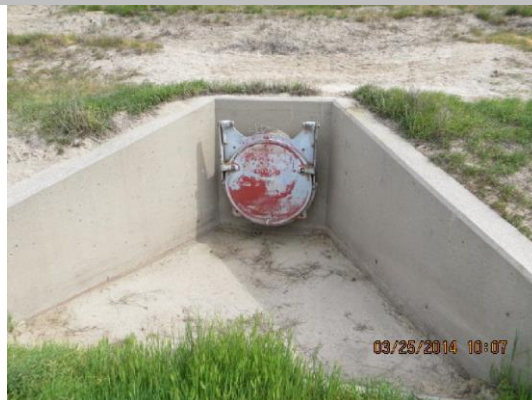
LM Start	23.72	Rating **	M	Issue No.	1372
LM End	23.72	Issue Type +	Ma	Location *	
Category	Supplemental			GPS Latitude/Longitude	
				Start	End
Item	DRAFT DWR UCIP LMA Responsibility			37.067799 °	37.067799 °
				-120.511093 °	-120.511093 °
DWR ID	19796				
Comment Code					
Inspector Comment					
DS_ID:19796 FS_ID:39621 EP_NO: N/A Repair Type: Non-Urgent Crossing Status: Found UCIP Comments: 03/25/2014 Sediment buildup in pipe visible from landward side--recommend contacting owner to clear pipe. (DWR UCIP - W. Wylie) FIELD_STRUCT_DESC: 30-inch corrugated metal gravity drainage pipe through the levee, 12.1 feet below the crown. Flap gate on the waterside (WS) end. Concrete U-shaped headwall on the WS end. [Additional Reference(s): DWR Levee Log, 2002. USACE San Joaquin O&M Manual 601.1, 1967, (HLM 23.62)]. FS Date: 3/25/2014

Concrete headwall on WS toe.

Flapgate on Concrete headwall on WS toe.

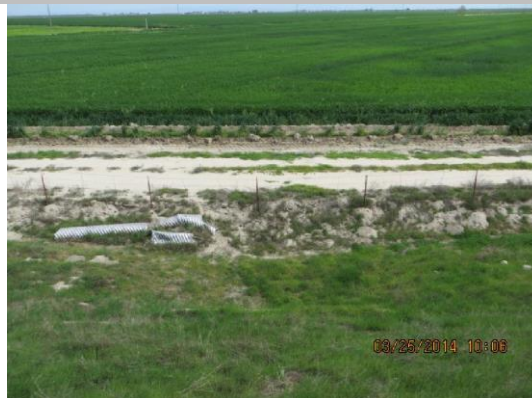
Photo 3 of 3 : UCIP_FA_2019_39621_59271.jpg

LM Start	23.72	Rating **	M	Issue No.	1372 (cont)	
LM End	23.72	Issue Type +	Ma	Location *		
Category	Supplemental			GPS Latitude/Longitude		
				Start	End	
Item	DRAFT DWR UCIP LMA Responsibility			37.067799 °	37.067799 °	
				-120.511093 °	-120.511093 °	
DWR ID	19796					
Comment Code						
Inspector Comment						
DS_ID:19796 FS_ID:39621 EP_NO: N/A Repair Type: Non-Urgent Crossing Status: Found UCIP Comments: 03/25/2014 Sediment buildup in pipe visible from landward side--recommend contacting owner to clear pipe. (DWR UCIP - W. Wylie) FIELD_STRUCT_DESC: 30-inch corrugated metal gravity drainage pipe through the levee, 12.1 feet below the crown. Flap gate on the waterside (WS) end. Concrete U-shaped headwall on the WS end. [Additional Reference(s): DWR Levee Log, 2002. USACE San Joaquin O&M Manual 601.1, 1967, (HLM 23.62)]. FS Date: 3/25/2014

Concrete headwall on LS toe.

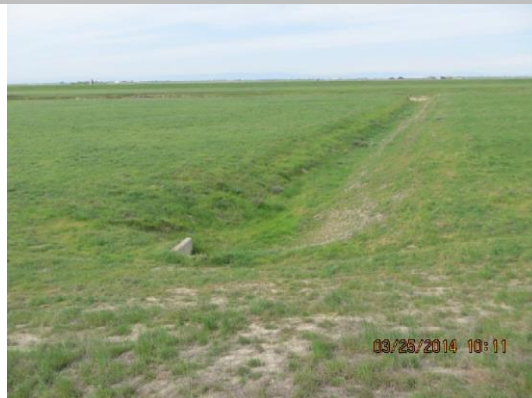
Photo 1 of 3 : UCIP_FA_2019_39620_59282.jpg

Comment Code						
Inspector Comment						
DS_ID:19797 FS_ID:39620 EP_NO: N/A Repair Type: Non-Urgent Crossing Status: Found UCIP Comments: 03/25/2014 Minor sediment/debris buildup in pipe visible from landward side--recommend contacting owner to clear pipe. (DWR UCIP - W. Wylie) FIELD_STRUCT_DESC: 36-inch corrugated metal gravity drainage pipe through the levee, 12.1 feet below the crown. Flap gate on the waterside (WS) end. Concrete headwall on the landside (LS) end. Concrete U-shaped headwall on the WS end. [Additional Reference(s): DWR Levee Log, 2002. USACE San Joaquin O&M Manual 601.1, 1967, (HLM 23.85)]. FS Date: 3/25/2014

Concrete headwall on WS toe.

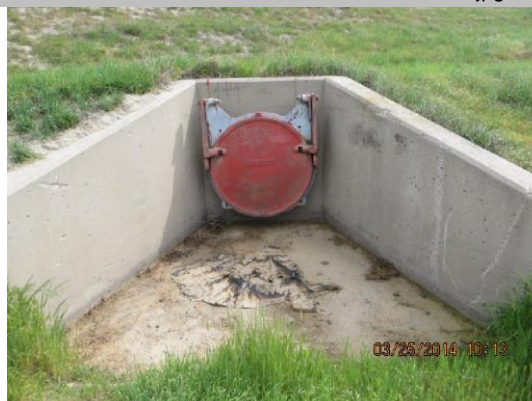
Photo 2 of 3 : UCIP_FA_2019_39620_59280.jpg

Flapgate at Concrete headwall on WS toe.

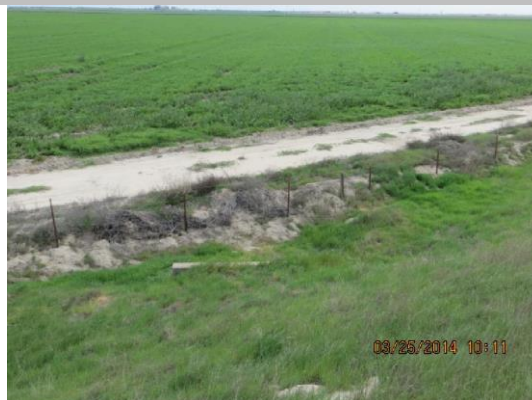
Photo 3 of 3 : UCIP_FA_2019_39620_59281.jpg

Concrete headwall on LS toe.

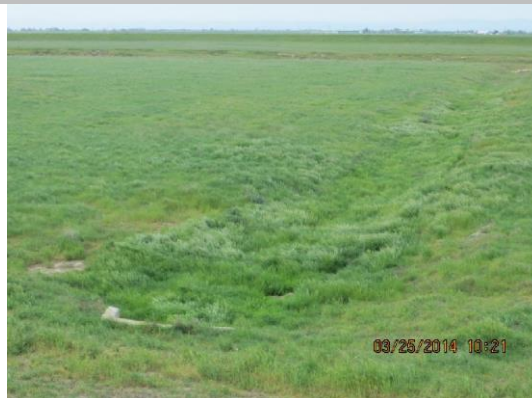
Photo 1 of 3 : UCIP_FA_2019_46850_59287.jpg

Comment Code						
Inspector Comment						
DS_ID:19798 FS_ID:46850 EP_NO: N/A Repair Type: Non-Urgent Crossing Status: Found UCIP Comments: 03/25/2014 Dense vegetation limits the inspector's visibility to identify signs of pipe failure (leaks) along the landward slope. Recommend removing vegetation along pipe alignment to conduct proper inspection of structure. (DWR UCIP - W. Wylie) FIELD_STRUCT_DESC: 24-inch corrugated metal gravity drainage pipe through the levee, 11.2 feet below the crown. Flap gate on the waterside (WS) end. Concrete headwall on the landside (LS) end. Concrete U-shaped headwall on the WS end. [Additional Reference(s): DWR Levee Log, 2002. USACE San Joaquin O&M Manual 601.1, 1967, (HLM 24.18)]. FS Date: 3/25/2014

Concrete headwall at WS toe.

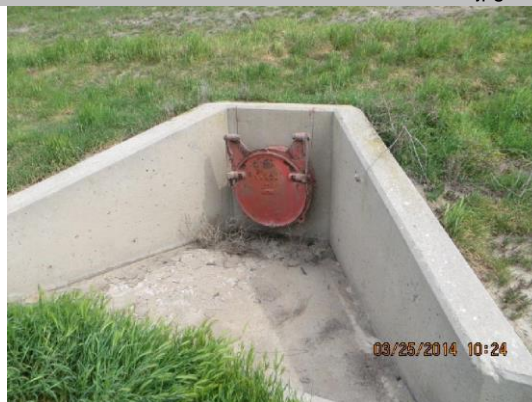
Photo 2 of 3 : UCIP_FA_2019_46850_59285.jpg

Flapgate at concrete headwall at WS toe.

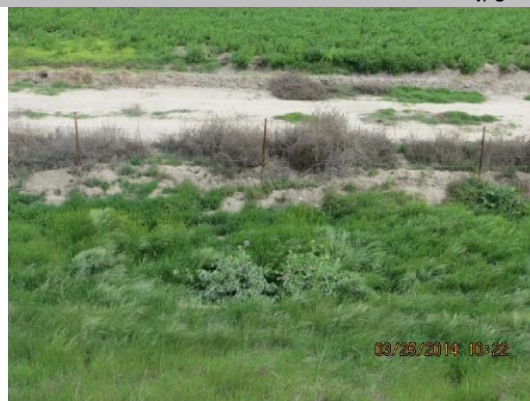
Photo 3 of 3 : UCIP_FA_2019_46850_59286.jpg

Concrete headwall at LS toe.

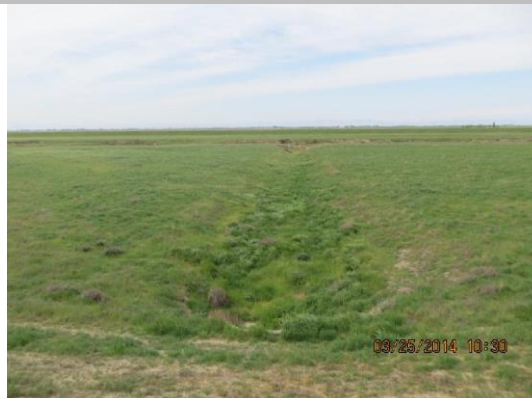
Photo 1 of 3 : UCIP_FA_2019_39623_59292.jpg

Comment Code					
Inspector Comment					
DS_ID:19799 FS_ID:39623 EP_NO: N/A Repair Type: Non-Urgent Crossing Status: Found UCIP Comments: 03/25/2014 Dense vegetation limits the inspector's visibility to identify signs of pipe failure (leaks) along the landward slope. Recommend removing vegetation along pipe alignment to conduct proper inspection of structure. (DWR UCIP - W. Wylie) FIELD_STRUCT_DESC: 24-inch corrugated metal gravity drainage pipe through the levee, 11.2 feet below the crown. Flap gate on the waterside (WS) end. Concrete headwall on the landside (LS) end. Concrete U-shaped headwall on the WS end. [Additional Reference(s): DWR Levee Log, 2002. USACE San Joaquin O&M Manual 601.1, 1967, (HLM 24.46)]. FS Date: 3/25/2014

Concrete headwall on WS toe.

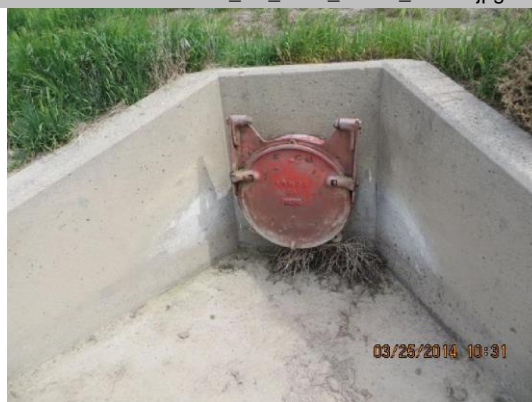
Photo 2 of 3 : UCIP_FA_2019_39623_59290.jpg

Flapgate at Concrete headwall on WS toe.

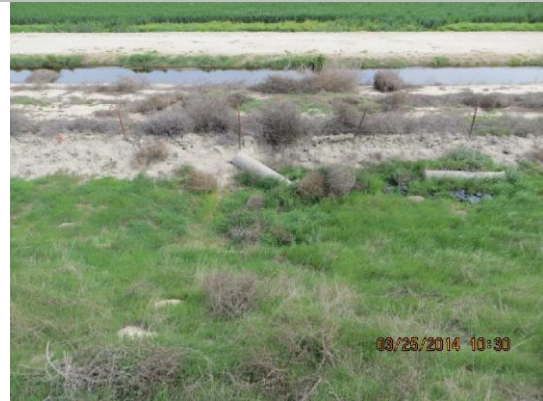
Photo 3 of 3 : UCIP_FA_2019_39623_59291.jpg

Concrete headwall on LS toe.

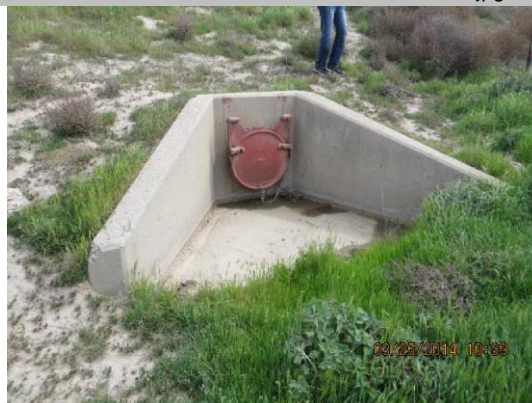
Photo 2 of 3 : UCIP_FA_2019_32786_59295.jpg

Flapgate on concrete headwall on WS toe.

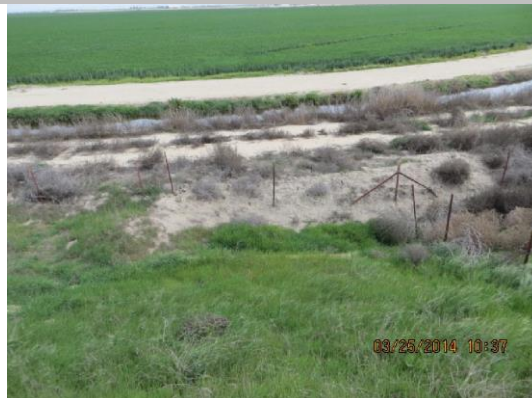
Photo 3 of 3 : UCIP_FA_2019_32786_59296.jpg

Concrete headwall on LS toe.

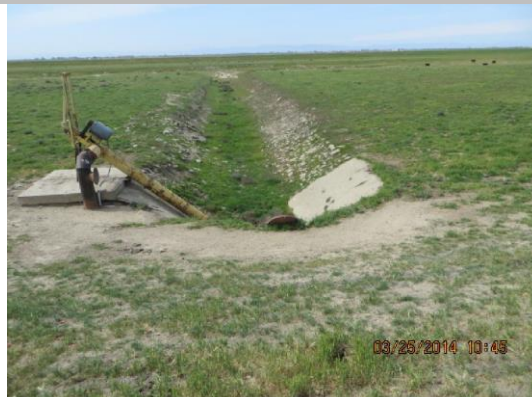
Photo 1 of 3 : UCIP_FA_2019_39624_59302.jpg

LM Start	24.96	Rating **	A/W	Issue No.	1377
LM End	24.96	Issue Type +	Ma	Location *	
Category	Supplemental			GPS Latitude/Longitude	
				Start	End
Item	DRAFT DWR UCIP LMA Responsibility			37.054344 °	37.054344 °
				-120.496214 °	-120.496214 °
DWR ID	19801				
Comment Code					
Inspector Comment					
DS_ID:19801 FS_ID:39624 EP_NO: N/A Repair Type: No Action Needed Crossing Status: Found UCIP Comments: FIELD_STRUCT_DESC: 30-inch corrugated metal gravity drainage pipe through the levee, 10.9 feet below the crown. Flap gate on the waterside (WS) end. Concrete headwall on the landside (LS) end. Concrete U-shaped headwall on the WS end. [Additional Reference(s): DWR Levee Log, 2002. USACE San Joaquin O&M Manual 601.1, 1967, (HLM 24.87)]. FS Date: 3/25/2014

Flapgate and channel off WS toe.

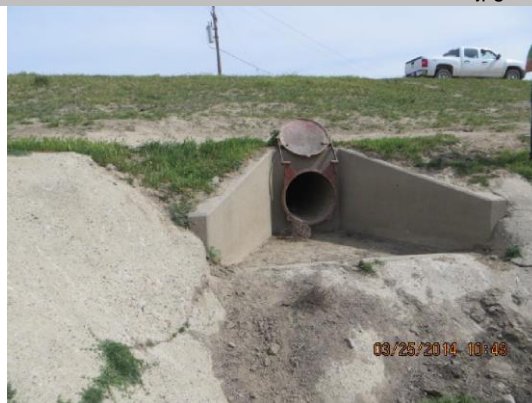
Photo 3 of 3 : UCIP_FA_2019_39624_59303.jpg

Flapgate on headwall at WS toe.

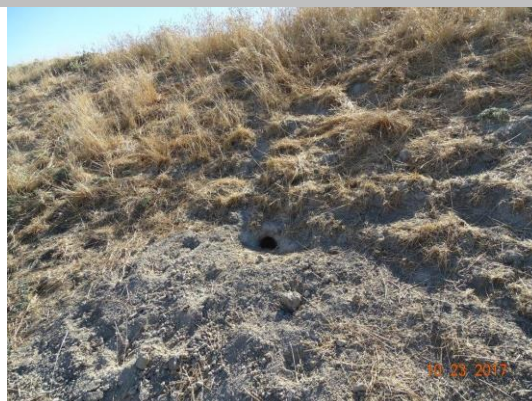
Photo 1 of 1 : FA_2019_NA0010_123_123_20190912_00023.jpg

LM Start	24.98	Rating **	M	Issue No.	123
LM End	25.26	Issue Type +	Ma	Location *	LS
Category	Earthen Levee			GPS Latitude/Longitude	
				Start	End
Item	Animal Control			37.054150 °	37.051252 °
				-120.495964 °	-120.492368 °
DWR ID	DWR_NA0010_05_f_2017_123				
Comment Code					
A3 : No rodents visible, but rodent burrows visible; need to backfill and compact or grout burrows.					
Inspector Comment

Looking southwest at the landside slope.

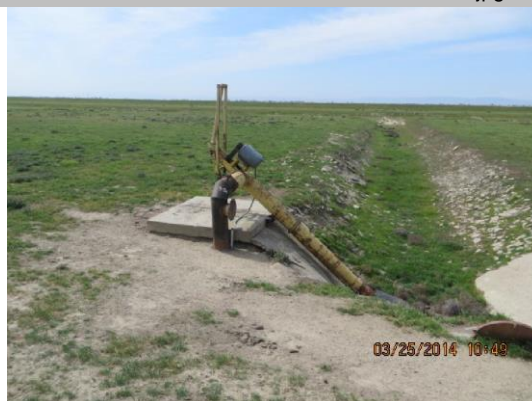
Photo 1 of 3 : UCIP_FA_2019_41716_59306.jpg

Comment Code						
Inspector Comment						
DS_ID:19802 FS_ID:41716 EP_NO: 12873 Repair Type: Non-Urgent Crossing Status: Found UCIP Comments: 03/25/2014 Clear soil from siphon breaker and install a protective riser. (DWR UCIP - W. Wylie) FIELD_STRUCT_DESC: 16-inch coated steel irrigation discharge pipe through the levee, 2 feet below the crown. Slant pump at the channel on the waterside (WS) toe. Siphon breaker on the WS shoulder. Gate valve on the landside (LS) toe. A preexisting ditch runs from the WS toe to the channel. Riprap placed around the intake. 2-inch polyvinyl chloride (PVC) electrical conduit at the same location. (Plans to install a pump with a discharge pipe through the levee authorized under Permit No. 12873, 1980 - Bowles Farming Company). [Additional Reference(s): DWR Levee Log, 2002]. FS Date: 3/25/2014

Slant pump at channel on WS toe.

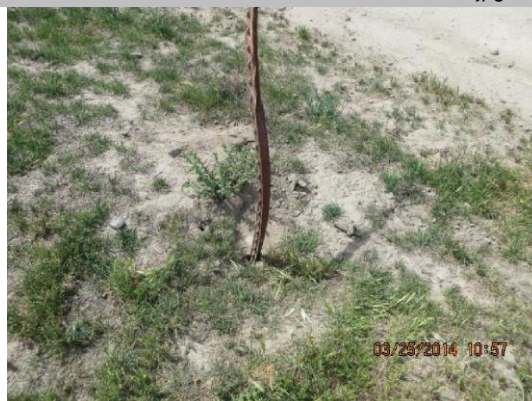
Photo 2 of 3 : UCIP_FA_2019_41716_59307.jpg

Buried Siphon breaker on WS shoulder.

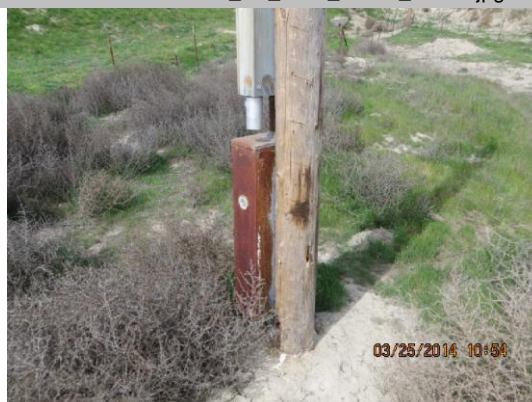
Photo 3 of 3 : UCIP_FA_2019_41716_59304.jpg

Power pole, meter, and electrical panel off LS toe.

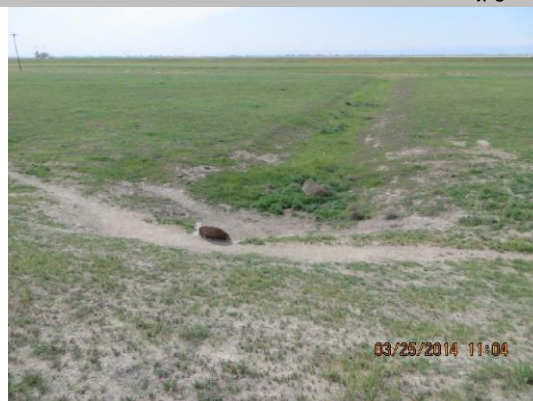
Photo 1 of 3 : UCIP_FA_2019_32789_59311.jpg

LM Start	25.24	Rating **	M	Issue No.	1379	
LM End	25.24	Issue Type +	Ma	Location *		
Category	Supplemental			GPS Latitude/Longitude		
				Start	End	
Item	DRAFT DWR UCIP LMA Responsibility			37.051477 °	37.051477 °	
				-120.492650 °	-120.492650 °	
DWR ID	19803					
Comment Code						
Inspector Comment						
DS_ID:19803 FS_ID:32789 EP_NO: N/A Repair Type: Non-Urgent Crossing Status: Found UCIP Comments: 03/25/2014 Flapgate propped open during flood season. (DWR UCIP - W. Wylie) FIELD_STRUCT_DESC: 30-inch corrugated metal gravity drainage pipe through the levee, 11.3 feet below the crown. Flap gate on the waterside (WS) end. Concrete headwall on the landside (LS) end. Concrete U-shaped headwall on the WS end. [Additional Reference(s): DWR Levee Log, 2002. USACE San Joaquin O&M Manual 601.1, 1967, (HLM 25.43)]. FS Date: 3/25/2014

Concrete headwall and flapgate on WS toe.

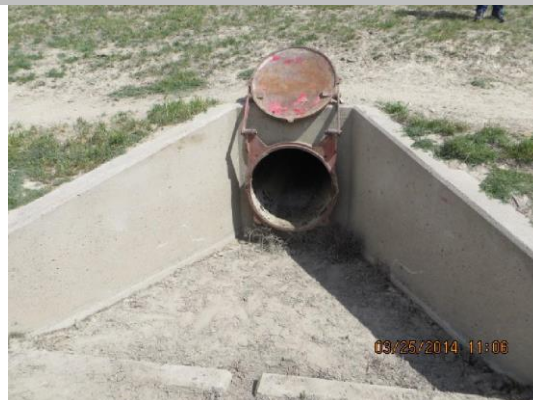
Photo 2 of 3 : UCIP_FA_2019_32789_59312.jpg

Concrete headwall and flapgate on WS toe.

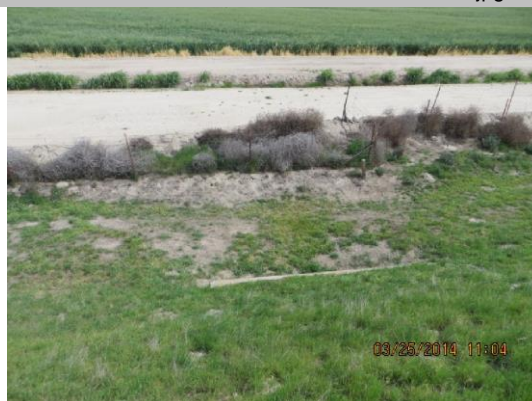
Photo 3 of 3 : UCIP_FA_2019_32789_59310.jpg

Concrete headwall on LS toe.

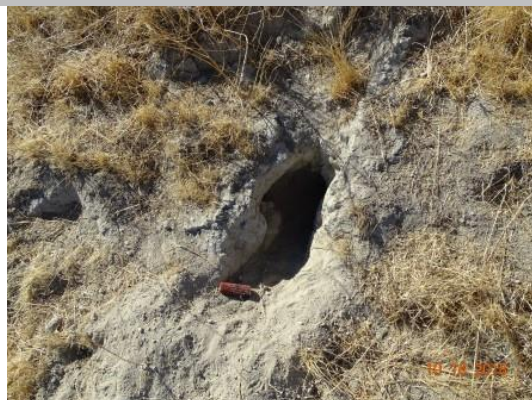
Photo 1 of 1 : FA_2019_NA0010_123_9_20190912_00006.jpg

LM Start	25.28	Rating **	M	Issue No.	9
LM End	25.64	Issue Type +	Ma	Location *	LS
Category	Earthen Levee			GPS Latitude/Longitude	
				Start	End
Item	Animal Control			37.051076 °	37.047042 °
				-120.492153 °	-120.488092 °
DWR ID	DWR_NA0010_05_s_2012_9				
Comment Code					
A3 : No rodents visible, but rodent burrows visible; need to backfill and compact or grout burrows.					
Inspector Comment					
Several rodent holes are noted along this section.

View of representative rodent burrow. (Fall 2018)

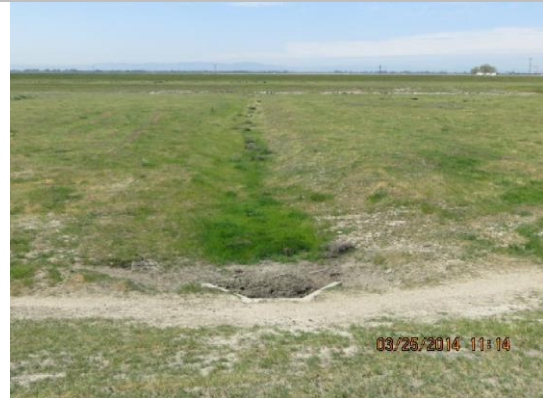
Photo 1 of 3 : UCIP_FA_2019_39625_59316.jpg

Comment Code					
Inspector Comment					
DS_ID:19804 FS_ID:39625 EP_NO: N/A Repair Type: Non-Urgent Crossing Status: Found UCIP Comments: 03/25/2014 Dense vegetation limits the inspector's visibility to identify signs of pipe failure (leaks) along the landward slope. Recommend removing vegetation along pipe alignment to conduct proper inspection of structure. Sediment buildup in pipe visible from landward side--recommend contacting owner to clear pipe. (DWR UCIP - W. Wylie) FIELD_STRUCT_DESC: 30-inch corrugated metal gravity drainage pipe through the levee, 12 feet below the crown. Flap gate on the waterside (WS) end. Concrete headwall on the landside (LS) end. Concrete U-shaped headwall on the WS end. [Additional Reference(s): DWR Levee Log, 2002. USACE San Joaquin O&M Manual 601.1, 1967, (HLM 25.51)]. FS Date: 3/25/2014

Concrete headwall on WS toe.

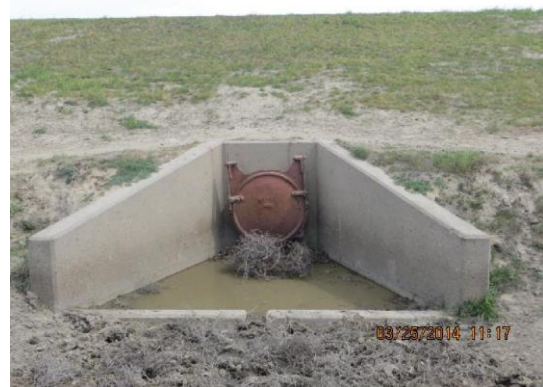
Photo 2 of 3 : UCIP_FA_2019_39625_59317.jpg

Flapgate on concrete headwall at WS toe.

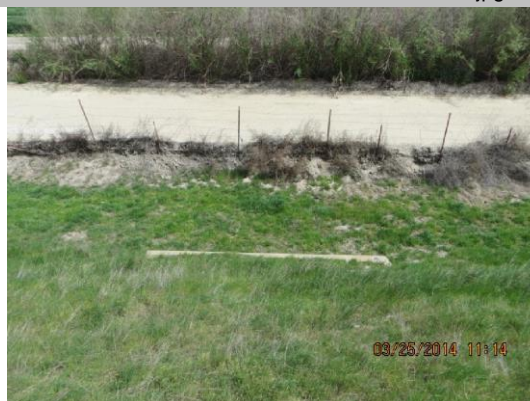
Photo 3 of 3 : UCIP_FA_2019_39625_59315.jpg

Item	DRAFT DWR UCIP LMA Responsibility			37.047455 °	37.047455 °	
				-120.488443 °	-120.488443 °	
DWR ID	19804					
Comment Code						
Inspector Comment						
DS_ID:19804 FS_ID:39625 EP_NO: N/A Repair Type: Non-Urgent Crossing Status: Found UCIP Comments: 03/25/2014 Dense vegetation limits the inspector's visibility to identify signs of pipe failure (leaks) along the landward slope. Recommend removing vegetation along pipe alignment to conduct proper inspection of structure. Sediment buildup in pipe visible from landward side--recommend contacting owner to clear pipe. (DWR UCIP - W. Wylie) FIELD_STRUCT_DESC: 30-inch corrugated metal gravity drainage pipe through the levee, 12 feet below the crown. Flap gate on the waterside (WS) end. Concrete headwall on the landside (LS) end. Concrete U-shaped headwall on the WS end. [Additional Reference(s): DWR Levee Log, 2002. USACE San Joaquin O&M Manual 601.1, 1967, (HLM 25.51)]. FS Date: 3/25/2014

Concrete headwall on LS toe.

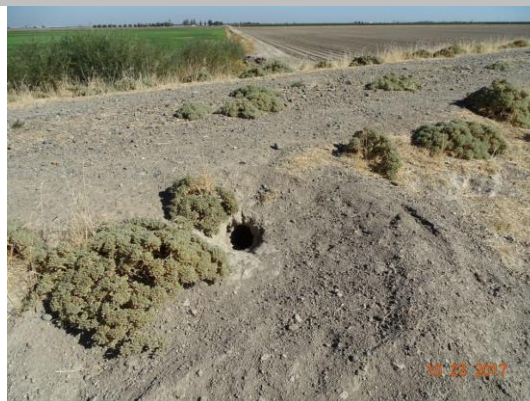
Photo 1 of 1 : FA_2019_NA0010_123_124_20190912_00024.jpg

LM Start	25.61	Rating **	M	Issue No.	124
LM End	25.61	Issue Type +	Ma	Location *	WS
Category	Earthen Levee			GPS Latitude/Longitude	
				Start	End
Item	Animal Control			37.047416 °	37.047416 °
				-120.488411 °	-120.488411 °
DWR ID	DWR_NA0010_05_f_2017_124				
Comment Code					
A3 : No rodents visible, but rodent burrows visible; need to backfill and compact or grout burrows.					
Inspector Comment

Looking east at the waterside slope.
