**Flood Control Project Maintenance
Levee Inspections**

Fall 2019 Levee Maintenance Deficiency Summary Report

San Joaquin River Basin

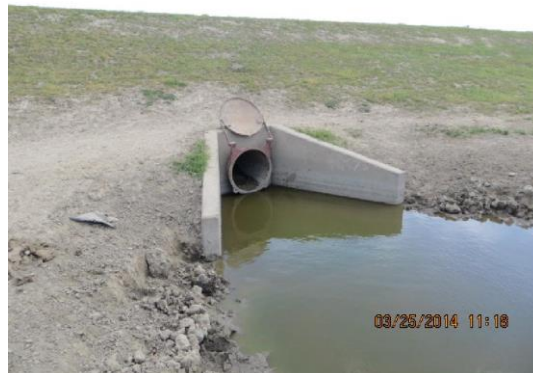
Photo 1 of 3 : UCIP_FA_2019_39626_59321.jpg

LM Start	25.63	Rating **	M	Issue No.	1381	
LM End	25.63	Issue Type +	Ma	Location *		
Category	Supplemental			GPS Latitude/Longitude		
				Start		End
Item	DRAFT DWR UCIP LMA Responsibility			37.047170 °		37.047170 °
				-120.488222 °		-120.488222 °
DWR ID	19805					
Comment Code						
Inspector Comment						
DS_ID:19805 FS_ID:39626 EP_NO: N/A Repair Type: Non-Urgent Crossing Status: Found UCIP Comments: 03/25/2014 Sediment buildup in pipe visible from landward side--recommend contacting owner to clear pipe. (DWR UCIP - W. Wylie) FIELD_STRUCT_DESC: 30-inch corrugated metal gravity drainage pipe through the levee, 12.1 feet below the crown. Flap gate on the waterside (WS) end. Concrete headwall on the landside (LS) end. Concrete U-shaped headwall on the WS end. [Additional Reference(s): DWR Levee Log, 2002. USACE San Joaquin O&M Manual 601.1, 1967, (HLM 25.53)]. FS Date: 3/25/2014

Flapgate on headwall at WS toe.

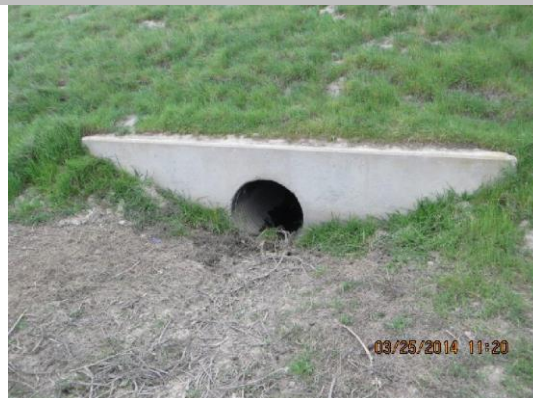
Photo 2 of 3 : UCIP_FA_2019_39626_59320.jpg

Concrete headwall on LS toe.

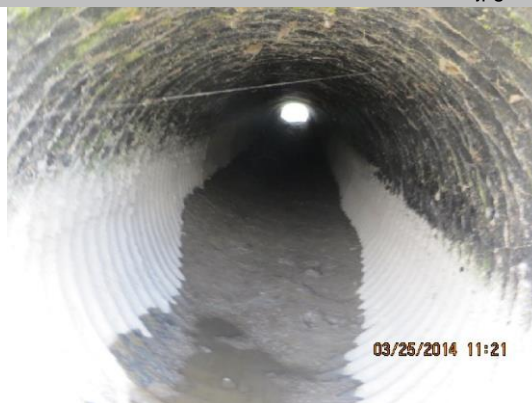
Photo 3 of 3 : UCIP_FA_2019_39626_59319.jpg

Item	DRAFT DWR UCIP LMA Responsibility			37.047170 °		37.047170 °
				-120.488222 °		-120.488222 °
DWR ID	19805					
Comment Code						
Inspector Comment						
DS_ID:19805 FS_ID:39626 EP_NO: N/A Repair Type: Non-Urgent Crossing Status: Found UCIP Comments: 03/25/2014 Sediment buildup in pipe visible from landward side--recommend contacting owner to clear pipe. (DWR UCIP - W. Wylie) FIELD_STRUCT_DESC: 30-inch corrugated metal gravity drainage pipe through the levee, 12.1 feet below the crown. Flap gate on the waterside (WS) end. Concrete headwall on the landside (LS) end. Concrete U-shaped headwall on the WS end. [Additional Reference(s): DWR Levee Log, 2002. USACE San Joaquin O&M Manual 601.1, 1967, (HLM 25.53)]. FS Date: 3/25/2014

Inside pipe on LS toe.

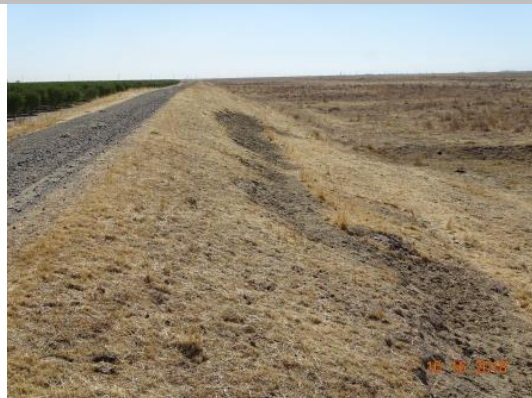
Photo 1 of 1 : FA_2019_NA0010_123_161_20190912_00047.jpg

LM Start	26.19	Rating **	M	Issue No.	161
LM End	26.21	Issue Type +	Ma	Location *	WS
Category	Earthen Levee			GPS Latitude/Longitude	
				Start	End
Item	Slope Stability			37.040289 °	37.040043 °
				-120.482988 °	-120.482795 °
DWR ID	DWR_NA0010_05_f_2018_161				
Comment Code					
S2 : Repair the levee slope damaged by foot traffic and prevent access where possible.					
Inspector Comment					
Waterside slope damage is caused by livestock foot traffic.

Slope damage on waterside. (Fall 2018)

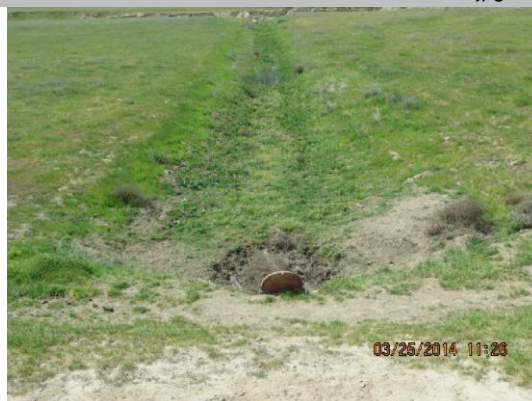
Photo 1 of 3 : UCIP_FA_2019_39627_59341.jpg

LM Start	26.20	Rating **	M	Issue No.	1382
LM End	26.20	Issue Type +	Ma	Location *	
Category	Supplemental			GPS Latitude/Longitude	
				Start	End
Item	DRAFT DWR UCIP LMA Responsibility			37.040070 °	37.040070 °
				-120.482796 °	-120.482796 °
DWR ID	19806				
Comment Code					
Inspector Comment					
DS_ID:19806 FS_ID:39627 EP_NO: N/A Repair Type: Non-Urgent Crossing Status: Found UCIP Comments: 03/25/2014 Sediment buildup in pipe visible from landward side--recommend contacting owner to clear pipe. (DWR UCIP - W. Wylie) FIELD_STRUCT_DESC: 24-inch corrugated metal gravity drainage pipe through the levee, 10 feet below the crown. Flap gate on the waterside (WS) end. Concrete headwall on the landside (LS) end. Concrete U-shaped headwall on the WS end. [Additional Reference(s): DWR Levee Log, 2002. USACE San Joaquin O&M Manual 601.1, 1967, (HLM 26.11)]. FS Date: 3/25/2014

Concrete headwall on WS toe.

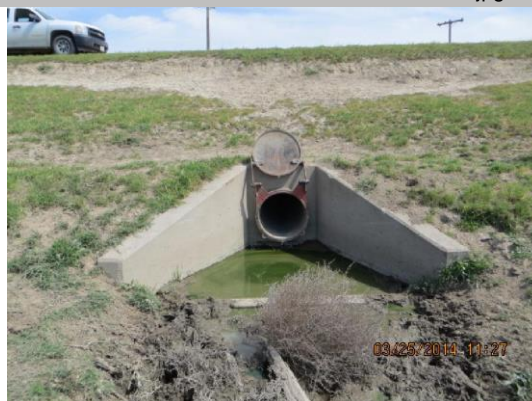
Photo 2 of 3 : UCIP_FA_2019_39627_59340.jpg

Flapgate on Concrete headwall at WS toe.

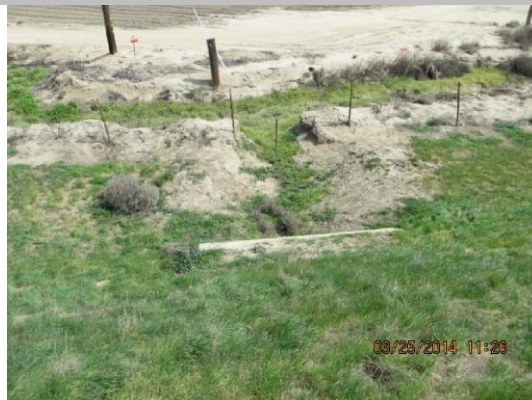
Photo 3 of 3 : UCIP_FA_2019_39627_59342.jpg

Concrete headwall on LS toe.

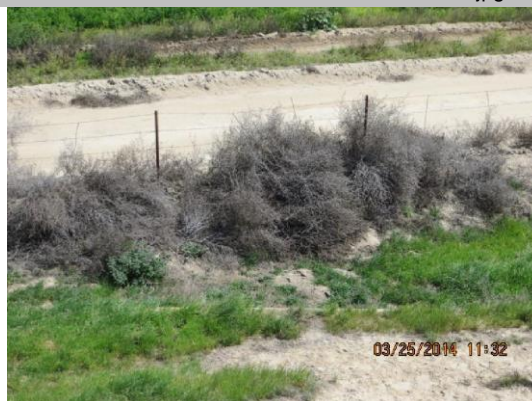
Photo 1 of 3 : UCIP_FA_2019_32804_59347.jpg

LM Start	26.39	Rating **	A/W	Issue No.	1383
LM End	26.39	Issue Type +	Ma	Location *	
Category	Supplemental			GPS Latitude/Longitude	
				Start	End
Item	DRAFT DWR UCIP LMA Responsibility			37.037772 °	37.037772 °
				-120.481028 °	-120.481028 °
DWR ID	19807				
Comment Code					
Inspector Comment					
DS_ID:19807					
FS_ID:32804					
EP_NO: N/A					
Repair Type: No Action Needed					
Crossing Status: Found					
UCIP Comments:					
FIELD_STRUCT_DESC: 36-inch corrugated metal gravity drainage pipe through the levee, 13 feet below the crown. Flap gate on the waterside (WS) end. Concrete headwall on the landside (LS) end. Concrete U-shaped headwall on the WS end. [Additional Reference(s): DWR Levee Log, 2002. USACE San Joaquin O&M Manual 601.1, 1967, (HLM 26.29)].					
FS Date: 3/25/2014

Concrete headwall on LS toe.

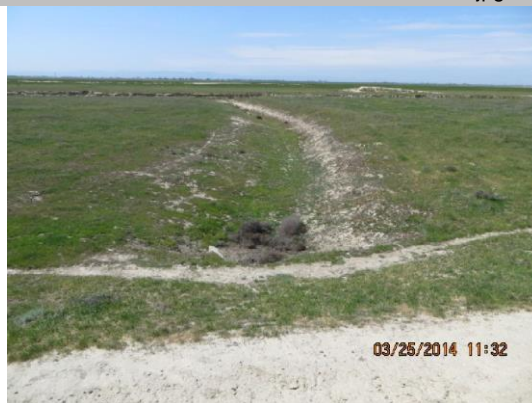
Photo 2 of 3 : UCIP_FA_2019_32804_59346.jpg

Concrete headwall on WS toe.

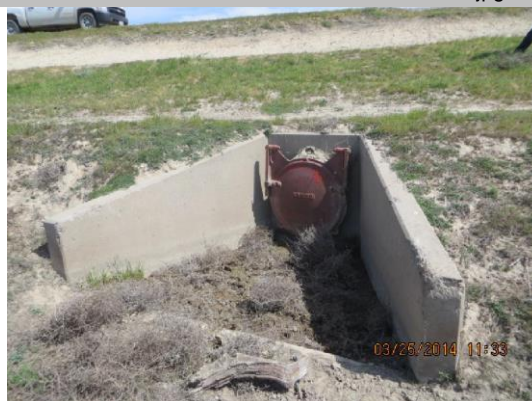
Photo 3 of 3 : UCIP_FA_2019_32804_59345.jpg

LM Start	26.39	Rating **	A/W	Issue No.	1383 (cont)
LM End	26.39	Issue Type +	Ma	Location *	
Category	Supplemental			GPS Latitude/Longitude	
				Start	End
Item	DRAFT DWR UCIP LMA Responsibility			37.037772 °	37.037772 °
				-120.481028 °	-120.481028 °
DWR ID	19807				
Comment Code					
Inspector Comment					
DS_ID:19807 FS_ID:32804 EP_NO: N/A Repair Type: No Action Needed Crossing Status: Found UCIP Comments: FIELD_STRUCT_DESC: 36-inch corrugated metal gravity drainage pipe through the levee, 13 feet below the crown. Flap gate on the waterside (WS) end. Concrete headwall on the landside (LS) end. Concrete U-shaped headwall on the WS end. [Additional Reference(s): DWR Levee Log, 2002. USACE San Joaquin O&M Manual 601.1, 1967, (HLM 26.29)]. FS Date: 3/25/2014

Flapgate on Concrete headwall at WS toe.

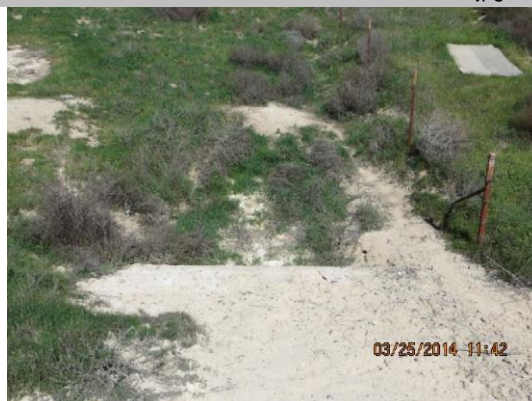
Photo 1 of 3 : UCIP_FA_2019_39628_59350.jpg

LM Start	26.95	Rating **	M	Issue No.	1384	
LM End	26.95	Issue Type +	Ma	Location *		
Category	Supplemental			GPS Latitude/Longitude		
				Start		End
Item	DRAFT DWR UCIP LMA Responsibility			37.032669 °		37.032669 °
				-120.473901 °		-120.473901 °
DWR ID	19808					
Comment Code						
Inspector Comment						
DS_ID:19808 FS_ID:39628 EP_NO: N/A Repair Type: Non-Urgent Crossing Status: Found UCIP Comments: 03/25/2014 Pipe has heavy silt buildup visible from landward side--recommend contacting owner to clear pipe. (DWR UCIP - W. Wylie) FIELD_STRUCT_DESC: 24-inch corrugated metal gravity drainage pipe through the levee, 11.4 feet below the crown. Flap gate on the waterside (WS) end. Concrete headwall on the landside (LS) end. Concrete U-shaped headwall on the WS end. [Additional Reference(s): DWR Levee Log, 2002. USACE San Joaquin O&M Manual 601.1, 1967, (HLM 26.85)]. FS Date: 3/25/2014

Concrete headwall on LS toe.

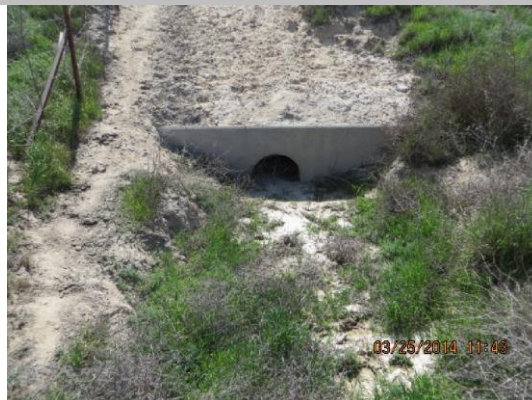
Photo 2 of 3 : UCIP_FA_2019_39628_59349.jpg

Concrete headwall on LS toe.

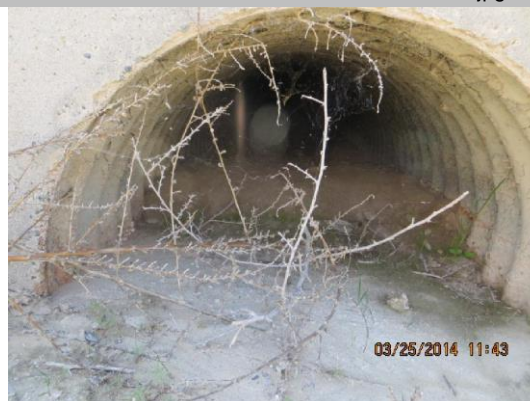
Photo 3 of 3 : UCIP_FA_2019_39628_59348.jpg

Item	DRAFT DWR UCIP LMA Responsibility			37.032669 °		37.032669 °
				-120.473901 °		-120.473901 °
DWR ID	19808					
Comment Code						
Inspector Comment						
DS_ID:19808 FS_ID:39628 EP_NO: N/A Repair Type: Non-Urgent Crossing Status: Found UCIP Comments: 03/25/2014 Pipe has heavy silt buildup visible from landward side--recommend contacting owner to clear pipe. (DWR UCIP - W. Wylie) FIELD_STRUCT_DESC: 24-inch corrugated metal gravity drainage pipe through the levee, 11.4 feet below the crown. Flap gate on the waterside (WS) end. Concrete headwall on the landside (LS) end. Concrete U-shaped headwall on the WS end. [Additional Reference(s): DWR Levee Log, 2002. USACE San Joaquin O&M Manual 601.1, 1967, (HLM 26.85)]. FS Date: 3/25/2014

Silt buildup in pipe at LS toe.

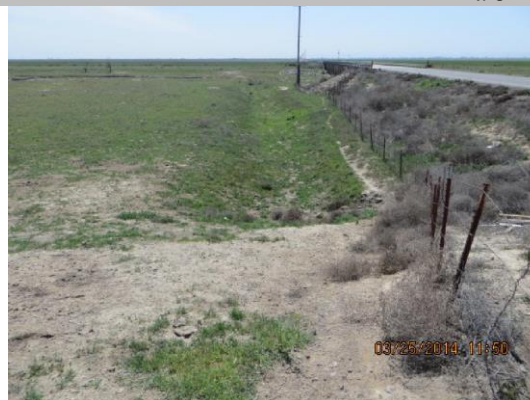
Photo 1 of 3 : UCIP_FA_2019_32806_59353.jpg

LM Start	26.97	Rating **	M	Issue No.	1385	
LM End	26.97	Issue Type +	Ma	Location *		
Category	Supplemental			GPS Latitude/Longitude		
				Start		End
Item	DRAFT DWR UCIP LMA Responsibility			37.032680 °		37.032680 °
				-120.473454 °		-120.473454 °
DWR ID	19748					
Comment Code						
Inspector Comment						
DS_ID:19748 FS_ID:32806 EP_NO: N/A Repair Type: Non-Urgent Crossing Status: Found UCIP Comments: 03/25/2014 Tumble weed buildup at inlet mat create blockage and should be removed. (DWR UCIP - W. Wylie) FIELD_STRUCT_DESC: 24-inch corrugated metal gravity drainage pipe through the levee, 11.3 feet below the crown. Flap gate on the waterside (WS) end. Concrete headwall on the landside (LS) end. Concrete U-shaped headwall on the WS end. [Additional Reference(s): DWR Levee Log, 2002. USACE San Joaquin O&M Manual 601.1, 1967, (HLM 26.87)]. FS Date: 3/25/2014

Concrete headwall at WS toe.

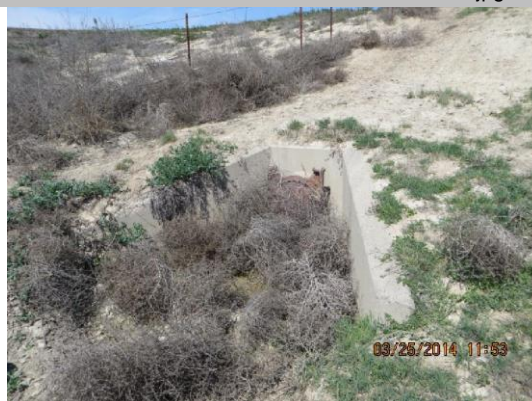
Photo 2 of 3 : UCIP_FA_2019_32806_59355.jpg

LM Start	26.97	Rating **	M	Issue No.	1385 (cont)	
LM End	26.97	Issue Type +	Ma	Location *		
Category	Supplemental			GPS Latitude/Longitude		
				Start		End
Item	DRAFT DWR UCIP LMA Responsibility			37.032680 °		37.032680 °
				-120.473454 °		-120.473454 °
DWR ID	19748					
Comment Code						
Inspector Comment						
DS_ID:19748 FS_ID:32806 EP_NO: N/A Repair Type: Non-Urgent Crossing Status: Found UCIP Comments: 03/25/2014 Tumble weed buildup at inlet mat create blockage and should be removed. (DWR UCIP - W. Wylie) FIELD_STRUCT_DESC: 24-inch corrugated metal gravity drainage pipe through the levee, 11.3 feet below the crown. Flap gate on the waterside (WS) end. Concrete headwall on the landside (LS) end. Concrete U-shaped headwall on the WS end. [Additional Reference(s): DWR Levee Log, 2002. USACE San Joaquin O&M Manual 601.1, 1967, (HLM 26.87)]. FS Date: 3/25/2014

Flapgate and Concrete headwall at WS toe.

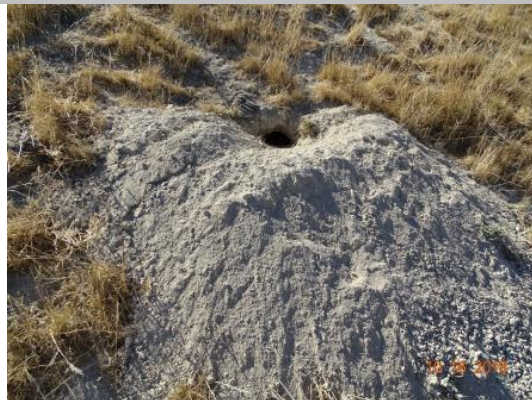
Photo 1 of 1 : FA_2019_NA0010_123_162_20190912_00048.jpg

LM Start	27.00	Rating **	U	Issue No.	162
LM End	27.04	Issue Type +	Ma	Location *	LS
Category	Earthen Levee			GPS Latitude/Longitude	
				Start	End
Item	Animal Control			37.032663 °	37.032659 °
				-120.472907 °	-120.472190 °
DWR ID	DWR_NA0010_05_f_2018_162				
Comment Code					
A3 : No rodents visible, but rodent burrows visible; need to backfill and compact or grout burrows.					
Inspector Comment					
Several rodent burrows with large quantities of material displaced noted in this section.

Rodent burrow noted with large quantity of material displaced. (Fall 2018)

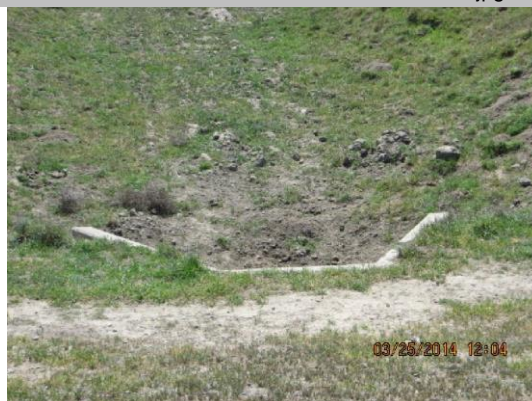
Photo 1 of 3 : UCIP_FA_2019_32807_59358.jpg

LM Start	27.31	Rating **	A/W	Issue No.	1386
LM End	27.31	Issue Type +	Ma	Location *	
Category	Supplemental			GPS Latitude/Longitude	
				Start	End
Item	DRAFT DWR UCIP LMA Responsibility			37.032668 °	37.032668 °
				-120.467299 °	-120.467299 °
DWR ID	19749				
Comment Code					
Inspector Comment					
DS_ID:19749 FS_ID:32807 EP_NO: N/A Repair Type: No Action Needed Crossing Status: Found UCIP Comments: FIELD_STRUCT_DESC: 36-inch corrugated metal gravity drainage pipe through the levee, 12 feet below the crown. Flap gate on the waterside (WS) end. Concrete headwall on the landside (LS) end. Concrete U-shaped headwall on the WS end. [Additional Reference(s): DWR Levee Log, 2002. USACE San Joaquin O&M Manual 601.1, 1967, (HLM 27.22)]. FS Date: 3/25/2014

Concrete headwall on WS toe.

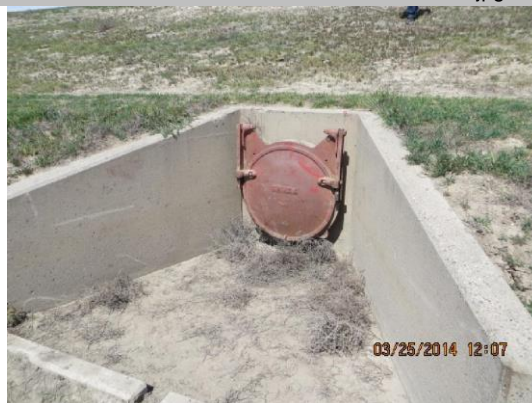
Photo 2 of 3 : UCIP_FA_2019_32807_59359.jpg

Flapgate at Concrete headwall on WS toe.

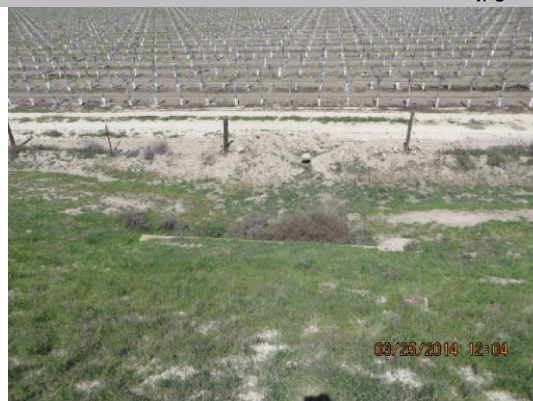
Photo 3 of 3 : UCIP_FA_2019_32807_59357.jpg

Concrete headwall on LS toe.

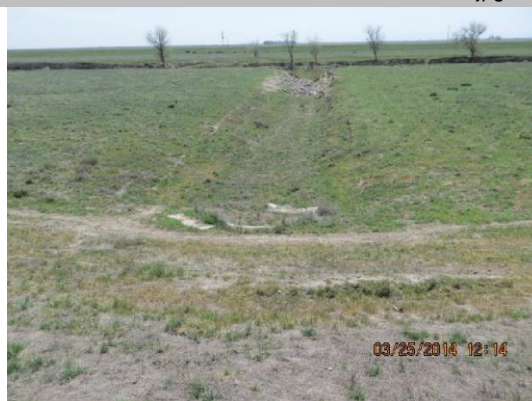
Photo 1 of 3 : UCIP_FA_2019_32823_59382.jpg

LM Start	28.27	Rating **	M	Issue No.	1387	
LM End	28.27	Issue Type +	Ma	Location *		
Category	Supplemental			GPS Latitude/Longitude		
				Start		End
Item	DRAFT DWR UCIP LMA Responsibility			37.032623 °		37.032623 °
				-120.450108 °		-120.450108 °
DWR ID	19750					
Comment Code						
Inspector Comment						
DS_ID:19750 FS_ID:32823 EP_NO: N/A Repair Type: Non-Urgent Crossing Status: Found UCIP Comments: 03/25/2014 Animal Burrowing activity at LS toe may undermine headwall. (DWR UCIP - W. Wylie) FIELD_STRUCT_DESC: 24-inch corrugated metal gravity drainage pipe through the levee, 10.8 feet below the crown. Flap gate on the waterside (WS) end. Concrete headwall on the landside (LS) end. Concrete U-shaped headwall on the WS end. [Additional Reference(s): DWR Levee Log, 2002. USACE San Joaquin O&M Manual 601.1, 1967, (HLM 28.17)]. FS Date: 3/25/2014

Concrete headwall on WS toe.

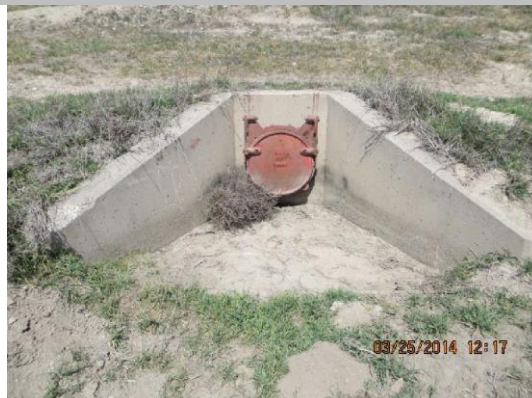
Photo 2 of 3 : UCIP_FA_2019_32823_59383.jpg

Flapgate on Concrete headwall at WS toe.

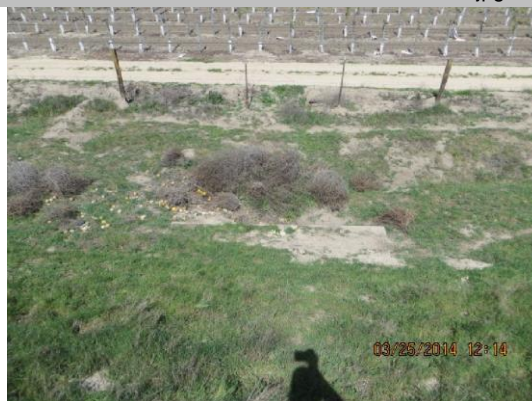
Photo 3 of 3 : UCIP_FA_2019_32823_59381.jpg

Concrete headwall on LS toe.

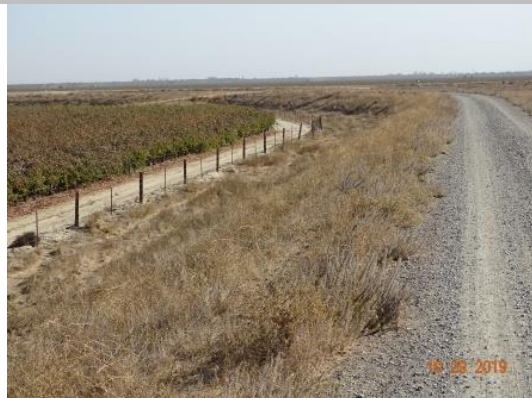
Photo 1 of 1 : FA_2019_NA0010_123_180_20191108_00337.jpg

LM Start	28.53	Rating **	U	Issue No.	180
LM End	28.74	Issue Type +	Ma	Location *	LS
Category	Earthen Levee			GPS Latitude/Longitude	
				Start	End
Item	Vegetation			37.032586 °	37.032297 °
				-120.445332 °	-120.441298 °
DWR ID	DWR_NA0010_05_f_2019_180				
Comment Code					
V1 : Control annual grass and weeds on the levee slopes and easements.					
Inspector Comment

View of the landside slope looking upstream. (Fall 2019)

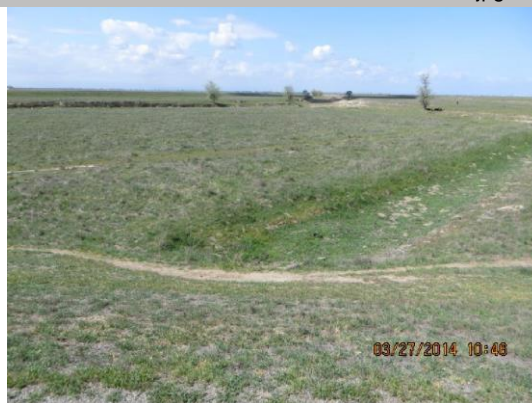
Photo 1 of 3 : UCIP_FA_2019_32832_59420.jpg

LM Start	28.79	Rating **	A/W	Issue No.	1388
LM End	28.79	Issue Type +	Ma	Location *	
Category	Supplemental			GPS Latitude/Longitude	
				Start	End
Item	DRAFT DWR UCIP LMA Responsibility			37.031640 °	37.031640 °
				-120.441389 °	-120.441389 °
DWR ID	19751				
Comment Code					
Inspector Comment					
DS_ID:19751 FS_ID:32832 EP_NO: N/A Repair Type: No Action Needed Crossing Status: Found UCIP Comments: FIELD_STRUCT_DESC: 30-inch corrugated metal gravity drainage pipe through the levee, 9.8 feet below the crown. Flap gate on the waterside (WS) end. Concrete headwall on the landside (LS) end. Concrete U-shaped headwall on the WS end. [Additional Reference(s): DWR Levee Log, 2002. USACE San Joaquin O&M Manual 601.1, 1967, (HLM 28.69)]. FS Date: 3/27/2014

Concrete headwall on WS toe.

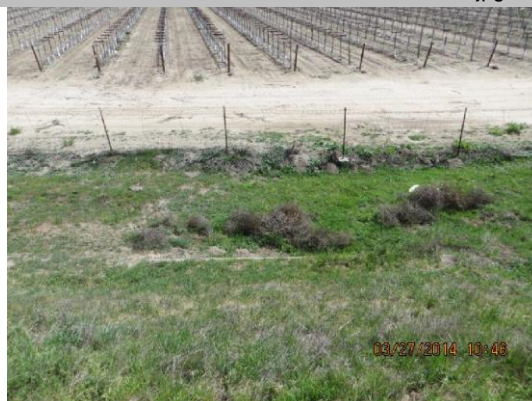
Photo 2 of 3 : UCIP_FA_2019_32832_59419.jpg

Concrete headwall on LS toe.

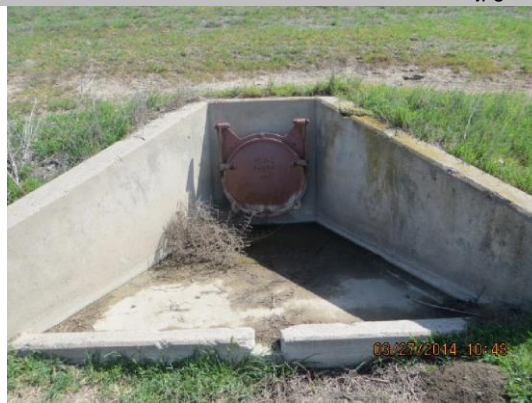
Photo 3 of 3 : UCIP_FA_2019_32832_59418.jpg

Flapgate on Concrete headwall at WS toe.

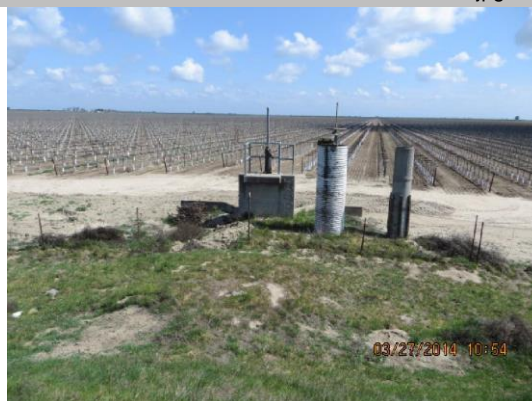
Photo 1 of 3 : UCIP_FA_2019_50055_59410.jpg

Comment Code						
Inspector Comment						
DS_ID:19752 FS_ID:50055 EP_NO: N/A Repair Type: Non-Urgent Crossing Status: Found UCIP Comments: 7/20/2016 same as previous inspection. Crossing has been downgraded from Urgent to Non-Urgent slide gate is on LS. Pipe is buried through WS. Need to coordinate with owner to determine permit used to authorized sleeved pipe. (DWR UCIP - O. Magana)3/27/2014 Slide gate will not close due to 24-inch PVC pipe sleeved through pipe. Also slide gate rails rusted beyond use. (DWR UCIP - W. Wylie) FIELD_STRUCT_DESC: [Rodunder Siphon Structure] 48-inch reinforced concrete irrigation siphon pipe through the levee, 12.1 feet below the crown. Concrete U-shaped headwall on inlet structure on the landside (LS) end. Slide gate mounted on concrete headwall on the LS. 36-inch corrugated metal pipe (CMP) riser with a slide gate on the LS, 8 feet upstream from the siphon. 24-inch pipe from this unit enters the siphon behind the inlet structure. [Additional Reference(s): DWR Levee Log, 2002. USACE San Joaquin O&M Manual 601.1, 1967, (HLM 28.95)]. FS Date: 7/20/2016

Slide gate mounted to concrete headwall on LS toe.

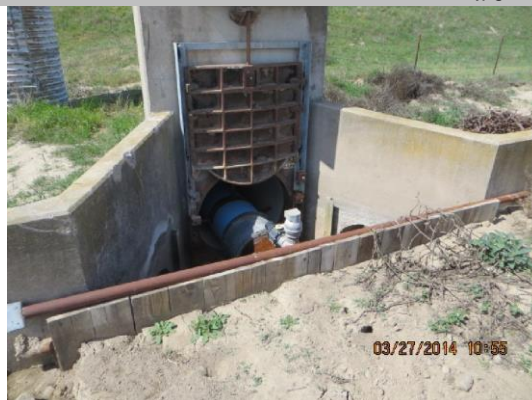
Photo 2 of 3 : UCIP_FA_2019_50055_59409.jpg

24-inch PVC pipe sleeved through 48-inch concrete pipe.

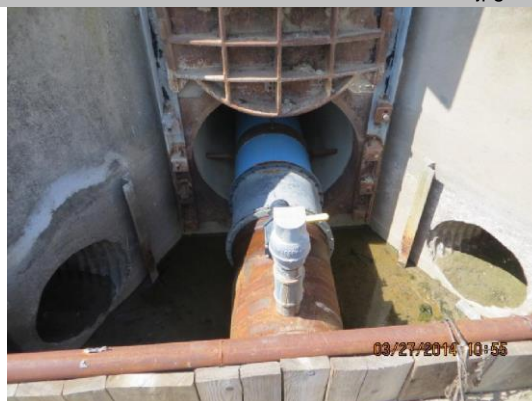
Photo 3 of 3 : UCIP_FA_2019_50055_59408.jpg

24-inch PVC pipe sleeved through 48-inch concrete pipe. Rails on Slide gate rusted beyond use.

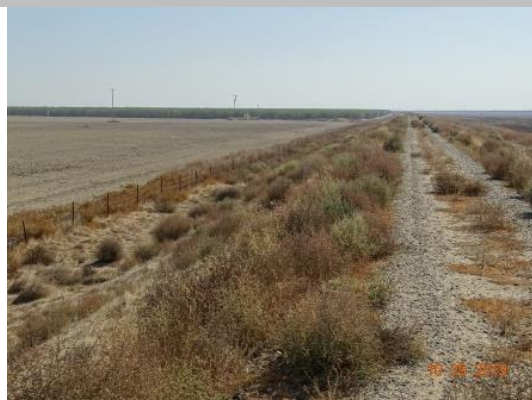
Photo 1 of 1 : FA_2019_NA0010_123_182_20191108_00339.jpg

LM Start	29.26	Rating **	U	Issue No.	182
LM End	34.77	Issue Type +	Ma	Location *	LS
Category	Earthen Levee			GPS Latitude/Longitude	
				Start	End
Item	Vegetation			37.025560 °	36.980528 °
				-120.437382 °	-120.368310 °
DWR ID	DWR_NA0010_05_f_2019_182				
Comment Code					
V1 : Control annual grass and weeds on the levee slopes and easements.					
Inspector Comment

View of the landside slope looking upstream. (Fall 2019)

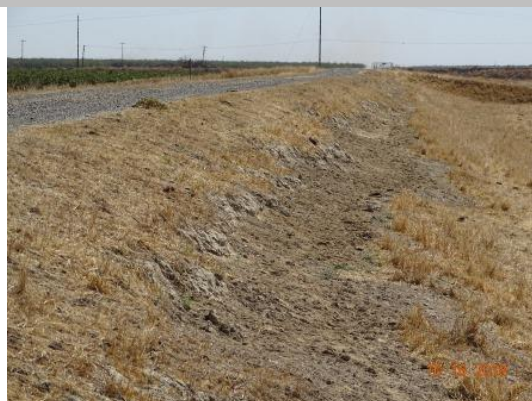
Photo 1 of 1 : FA_2019_NA0010_123_164_20190912_00049.jpg

LM Start	29.43	Rating **	M	Issue No.	164
LM End	29.59	Issue Type +	Ma	Location *	WS
Category	Earthen Levee			GPS Latitude/Longitude	
				Start	End
Item	Slope Stability			37.023481 °	37.021442 °
				-120.435960 °	-120.434564 °
DWR ID	DWR_NA0010_05_f_2018_164				
Comment Code					
S2 : Repair the levee slope damaged by foot traffic and prevent access where possible.					
Inspector Comment					
There is slope damage on waterside from livestock traffic.

Slope damage from animal traffic. (Fall 2018)

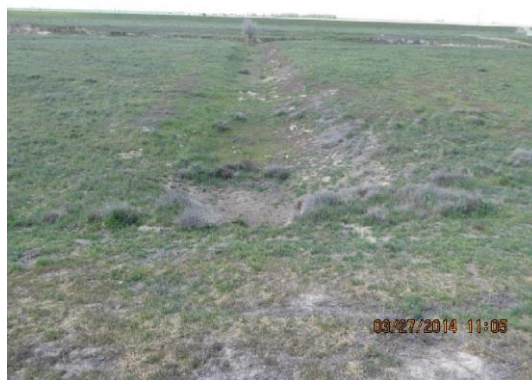
Photo 1 of 3 : UCIP_FA_2019_39884_59414.jpg

Comment Code					
Inspector Comment					
DS_ID:19753 FS_ID:39884 EP_NO: N/A Repair Type: Non-Urgent Crossing Status: Found UCIP Comments: 03/27/2014 Dense vegetation limits the inspector's visibility to identify signs of pipe failure (leaks) along the landward slope. Recommend removing vegetation along pipe alignment to conduct proper inspection of structure. Sediment buildup in pipe visible from landward side--recommend contacting owner to clear pipe. (DWR UCIP - W. Wylie) FIELD_STRUCT_DESC: 36-inch corrugated metal gravity drainage pipe through the levee, 10.2 feet below the crown. Flap gate on the waterside (WS) end. Concrete headwall on the landside (LS) end. Concrete U-shaped headwall on the WS end. [Additional Reference(s): DWR Levee Log, 2002. USACE San Joaquin O&M Manual 601.1, 1967, (HLM 29.49)]. FS Date: 3/27/2014

Concrete headwall on WS toe.

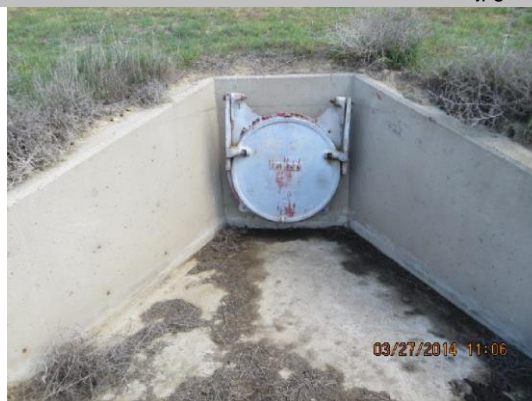
Photo 2 of 3 : UCIP_FA_2019_39884_59413.jpg

Flapgate on Concrete headwall at WS toe.

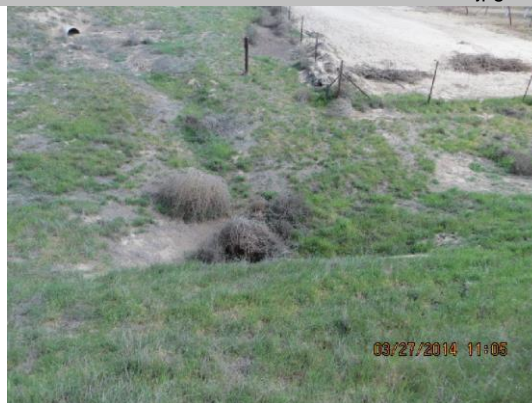
Photo 3 of 3 : UCIP_FA_2019_39884_59415.jpg

Concrete headwall on LS toe.

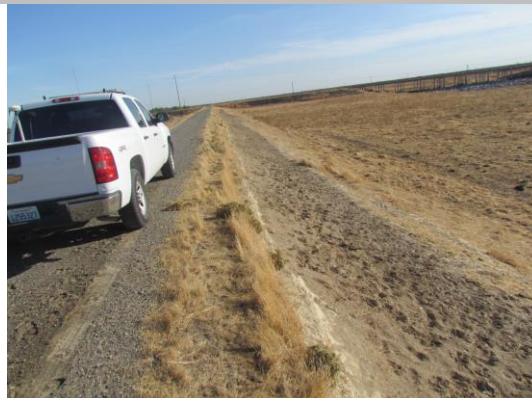
Photo 1 of 2 : FA_2019_NA0010_123_171_20190912_00050.jpg

LM Start	29.68	Rating **	M	Issue No.	171
LM End	29.80	Issue Type +	Ma	Location *	WS
Category	Earthen Levee			GPS Latitude/Longitude	
				Start	End
Item	Erosion / Bank Caving			37.020272 °	37.018712 °
				-120.433737 °	-120.432682 °
DWR ID	DWR_NA0010_05_s_2014_171				
Comment Code					
E1 : Note and monitor erosion site.					
Inspector Comment					
There is waterside erosion caused by livestock.

Looking south at animal erosion on waterward slope.

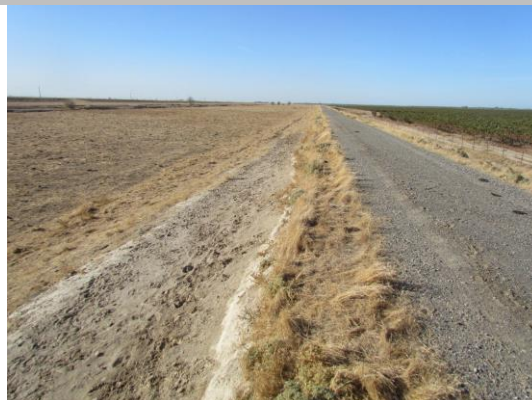
Photo 2 of 2 : FA_2019_NA0010_123_171_20190912_00051.jpg

Looking north at animal erosion on waterward slope.

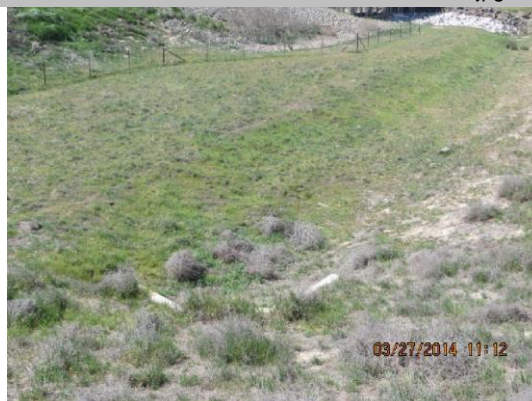
Photo 1 of 3 : UCIP_FA_2019_39631_59424.jpg

Comment Code					
Inspector Comment					
DS_ID:19754 FS_ID:39631 EP_NO: N/A Repair Type: Non-Urgent Crossing Status: Found UCIP Comments: 03/27/2014 Dense vegetation limits the inspector's visibility to identify signs of pipe failure (leaks) along the landward slope. Recommend removing vegetation along pipe alignment to conduct proper inspection of structure. (DWR UCIP - W. Wylie) FIELD_STRUCT_DESC: 30-inch by 30-inch reinforced concrete box gravity drainage culvert through the levee, 12 feet below the crown. Flap gate on the waterside (WS) end. Concrete headwall on the landside (LS) end. Concrete U-shaped headwall on the WS end. [Additional Reference(s): DWR Levee Log, 2002. USACE San Joaquin O&M Manual 601.1, 1967, (HLM 29.72)]. FS Date: 3/27/2014

Concrete headwall on WS toe.

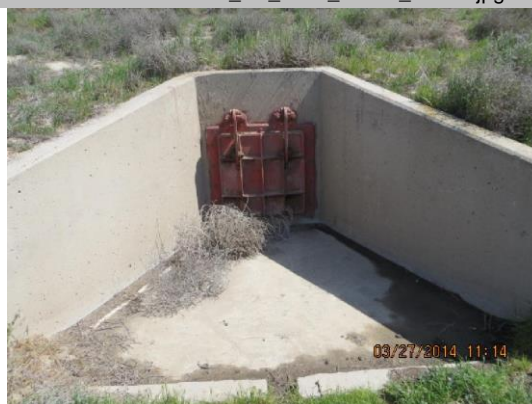
Photo 2 of 3 : UCIP_FA_2019_39631_59426.jpg

Flapgate on Concrete headwall at WS toe.

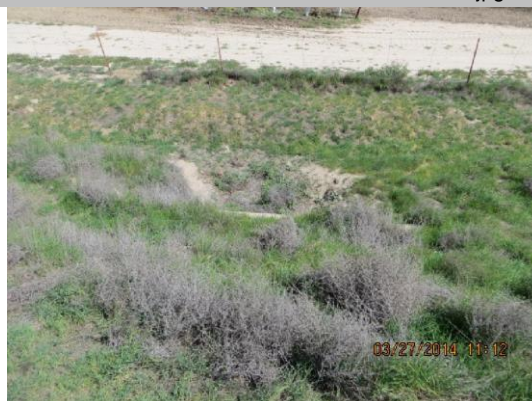
Photo 3 of 3 : UCIP_FA_2019_39631_59425.jpg

Concrete headwall on LS toe.

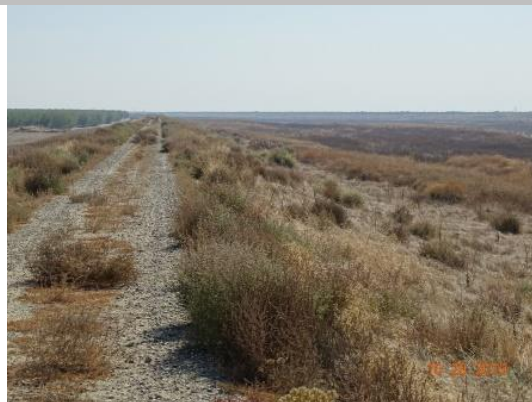
Photo 1 of 1 : FA_2019_NA0010_123_183_20191108_00340.jpg

LM Start	29.87	Rating **	U	Issue No.	183
LM End	34.24	Issue Type +	Ma	Location *	WS
Category	Earthen Levee			GPS Latitude/Longitude	
				Start	End
Item	Vegetation			37.017890 °	36.978493 °
				-120.432109 °	-120.375129 °
DWR ID	DWR_NA0010_05_f_2019_183				
Comment Code					
V1 : Control annual grass and weeds on the levee slopes and easements.					
Inspector Comment

Looking upstream along the waterside slope. (Fall 2019)

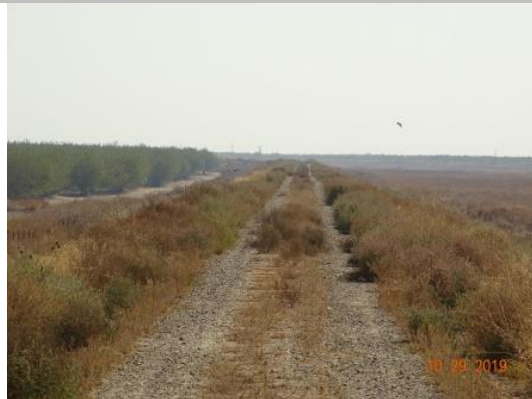
Photo 1 of 1 : FA_2019_NA0010_123_185_20191108_00341.jpg

LM Start	29.88	Rating **	U	Issue No.	185
LM End	30.69	Issue Type +	Ma	Location *	CR
Category	Earthen Levee			GPS Latitude/Longitude	
				Start	End
Item	Vegetation			37.017704 °	37.008094 °
				-120.431985 °	-120.423951 °
DWR ID	DWR_NA0010_05_f_2019_185				
Comment Code					
V9 : Keep the crown roadway free of vegetation.					
Inspector Comment

View of the levee crown looking upstream. (Fall 2019)

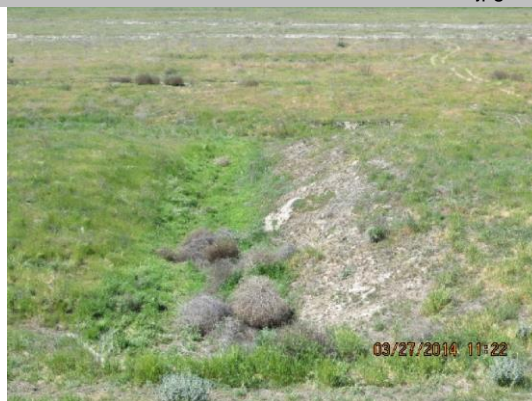
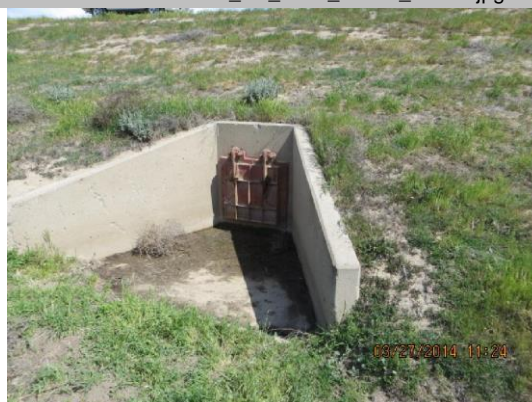
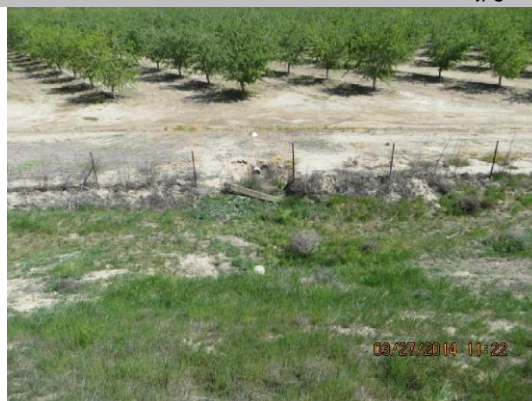
Comment Code						
Inspector Comment						
DS_ID:19696						
FS_ID:39632						
EP_NO: N/A						
Repair Type: Non-Urgent						
Crossing Status: Found						
UCIP Comments: 03/27/2014 Dense vegetation limits the inspector's visibility to identify signs of pipe failure (leaks) along the landward slope. Recommend removing vegetation along pipe alignment to conduct proper inspection of structure. (DWR UCIP - W. Wylie)						
FIELD_STRUCT_DESC: 30-inch by 30-inch reinforced concrete box gravity drainage culvert through the levee, 13.1 feet below the crown. Flap gate on the waterside (WS) end. Concrete headwall on the landside (LS) end. Concrete U-shaped headwall on the WS end.						
[Additional Reference(s): DWR Levee Log, 2002. USACE San Joaquin O&M Manual 601.1, 1967, (HLM 30.04)].						
FS Date: 3/27/2014

Concrete headwall on WS toe.

Flapgate on Concrete headwall at WS toe.

Concrete headwall on LS toe.

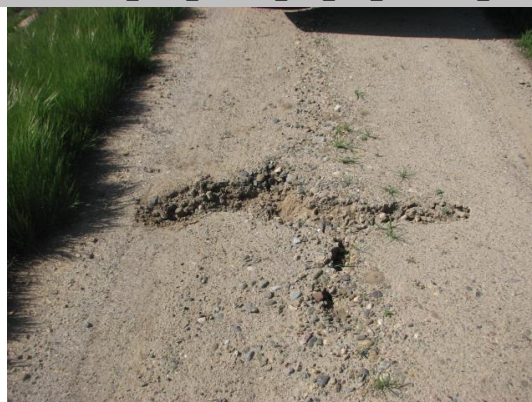
Photo 1 of 2 : FA_2019_NA0010_123_133_20190912_00030.jpg

LM Start	30.31	Rating **	M	Issue No.	133
LM End	30.31	Issue Type +	Ma	Location *	CR
Category	Earthen Levee			GPS Latitude/Longitude	
				Start	End
Item	Crown Surface / Depressions / Rutting			37.012273 °	37.012273 °
				-120.428244 °	-120.428244 °
DWR ID	DWR_NA0010_05_s_2018_133				
Comment Code					
C2 : Repair depressions or ruts in the crown or slope.					
Inspector Comment					
There is a minor depression on levee crown. Possible sink hole.

Looking north at depression on levee crown. (Spring 2018)

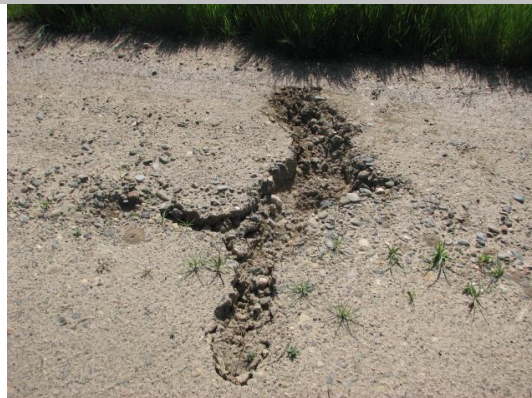
Photo 2 of 2 : FA_2019_NA0010_123_133_20190912_00031.jpg

LM Start	30.31	Rating **	M	Issue No.	133 (cont)	
LM End	30.31	Issue Type +	Ma	Location *	CR	
Category	Earthen Levee			GPS Latitude/Longitude		
				Start		End
Item	Crown Surface / Depressions / Rutting			37.012273 °		37.012273 °
				-120.428244 °		-120.428244 °
DWR ID	DWR_NA0010_05_s_2018_133					
Comment Code						
C2 : Repair depressions or ruts in the crown or slope.						
Inspector Comment						
There is a minor depression on levee crown. Possible sink hole.

Looking east at depression on levee crown. (Spring 2018)

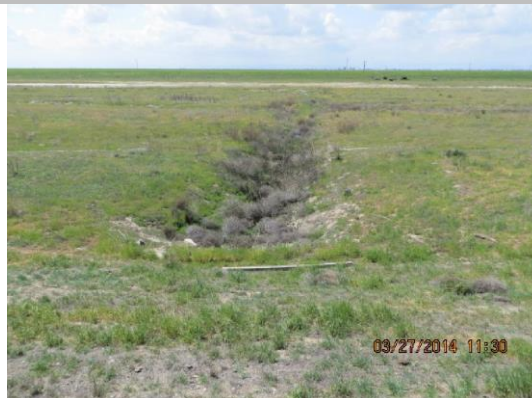
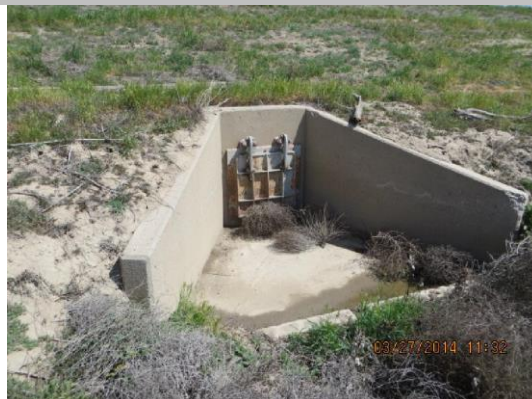
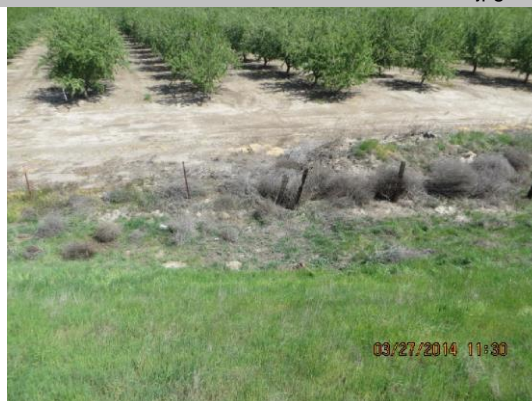
Comment Code						
Inspector Comment						
DS_ID:19697 FS_ID:39633 EP_NO: N/A Repair Type: Non-Urgent Crossing Status: Found UCIP Comments: 03/27/2014 Some debris buildup at LS toe. Dense vegetation limits the inspector's visibility to identify signs of pipe failure (leaks) along the landward slope. Recommend removing vegetation along pipe alignment to conduct proper inspection of structure. (DWR UCIP - W. Wylie) FIELD_STRUCT_DESC: 30-inch by 30-inch reinforced concrete box gravity drainage culvert through the levee, 13.3 feet below the crown. Flap gate on the waterside (WS) end. Concrete headwall on the landside (LS) end. Concrete U-shaped headwall on the WS end. [Additional Reference(s): DWR Levee Log, 2002. USACE San Joaquin O&M Manual 601.1, 1967, (HLM 30.96)]. FS Date: 3/27/2014

Concrete headwall on WS toe.

Flapgate on Concrete headwall at WS toe.

Concrete headwall on LS toe.

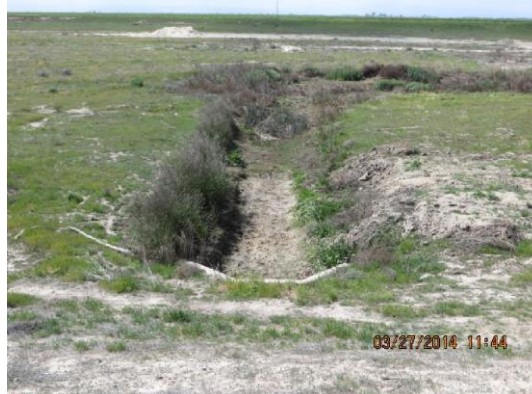
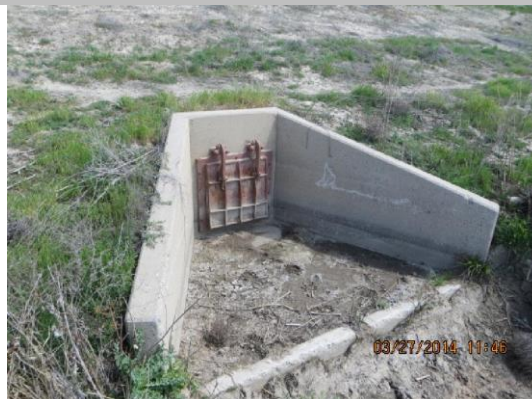
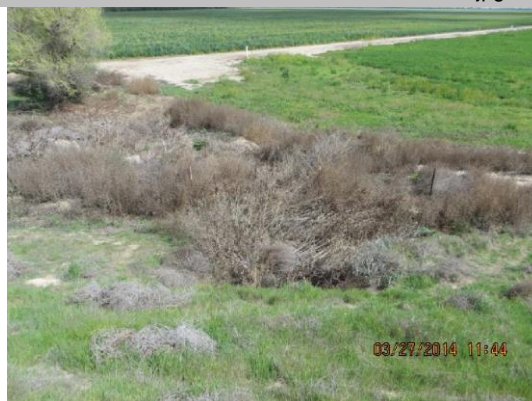
Comment Code						
Inspector Comment						
DS_ID:19698 FS_ID:39643 EP_NO: N/A Repair Type: Non-Urgent Crossing Status: Found UCIP Comments: 03/27/2014 Excess vegetation buildup at inlet on LS toe. Dense vegetation limits the inspector's visibility to identify signs of pipe failure (leaks) along the landward slope. Recommend removing vegetation along pipe alignment to conduct proper inspection of structure. (DWR UCIP - W. Wylie) FIELD_STRUCT_DESC: 30-inch by 30-inch reinforced concrete box gravity drainage culvert through the levee, 13.4 feet below the crown. Flap gate on the waterside (WS) end. Concrete headwall on the landside (LS) end. Concrete U-shaped headwall on the WS end. [Additional Reference(s): DWR Levee Log, 2002. USACE San Joaquin O&M Manual 601.1, 1967, (HLM 31.19)]. FS Date: 3/27/2014

Concrete headwall on WS toe.

Flapgate at concrete headwall on WS toe.

Concrete headwall on LS toe.

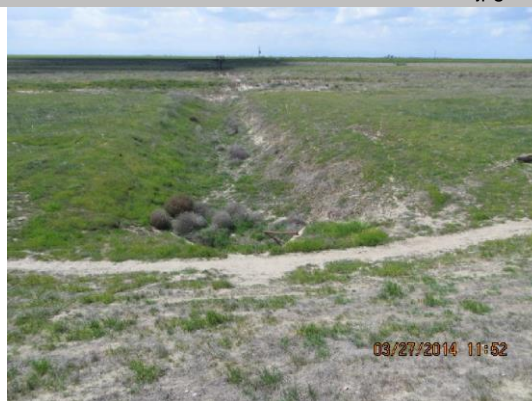
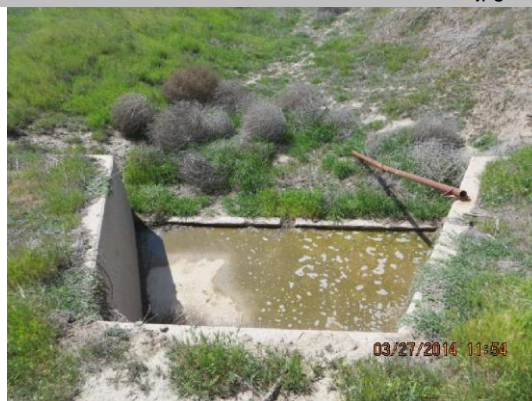
LM Start	31.74	Rating **	A/W	Issue No.	1395
LM End	31.74	Issue Type +	Ma	Location *	
Category	Supplemental			GPS Latitude/Longitude	
				Start	End
Item	DRAFT DWR UCIP LMA Responsibility			36.997001 °	36.997001 °
				-120.410991 °	-120.410991 °
DWR ID	19699				
Comment Code					
Inspector Comment					
DS_ID:19699					
FS_ID:39644					
EP_NO: N/A					
Repair Type: No Action Needed					
Crossing Status: Found					
UCIP Comments:					
FIELD_STRUCT_DESC: 48-inch by 36-inch reinforced concrete box gravity drainage culvert through the levee, 14.5 feet below the crown. Flap gate on the waterside (WS) end. Concrete U-shaped headwall on each end. [Additional Reference(s): DWR Levee Log, 2002. USACE San Joaquin O&M Manual 601.1, 1967, (HLM 31.64)].					
FS Date: 3/27/2014

Concrete headwall on WS toe.

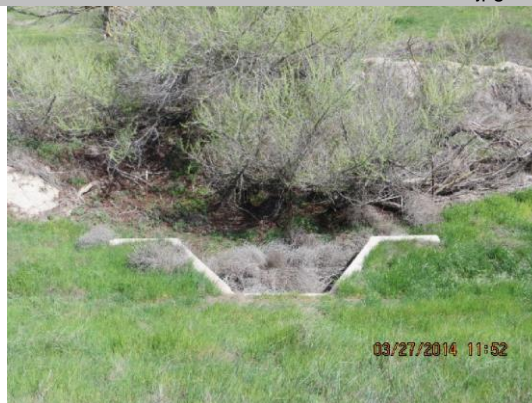
Photo 3 of 3 : UCIP_FA_2019_39644_59443.jpg

Concrete headwall on LS toe. Note tumbleweeds blocking inlet.

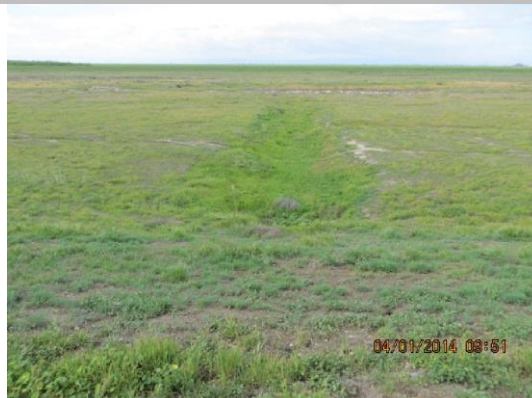
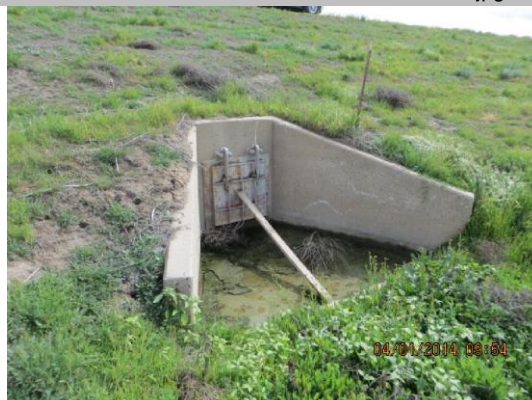
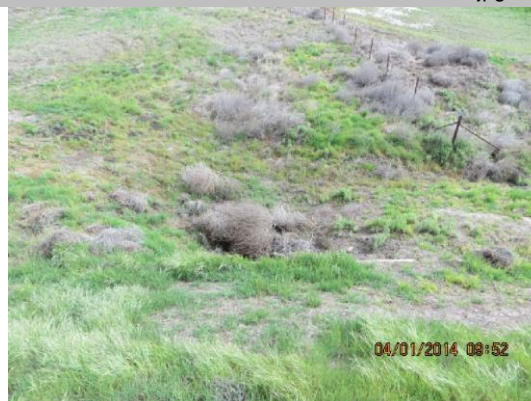
Comment Code					
Inspector Comment					
DS_ID:19700					
FS_ID:39645					
EP_NO: N/A					
Repair Type: Non-Urgent					
Crossing Status: Found					
UCIP Comments: 04/01/2014 Dense vegetation limits the inspector's visibility to identify signs of pipe failure (leaks) along the landward slope. Recommend removing vegetation along pipe alignment to conduct proper inspection of structure. (DWR UCIP - W. Wylie)					
FIELD_STRUCT_DESC: 30-inch by 30-inch reinforced concrete box gravity drainage culvert through the levee, 13 feet below the crown. Flap gate on the waterside (WS) end. Concrete headwall on the landside (LS) end with flashboard attachment. Concrete U-shaped headwall on the WS end. [Additional Reference(s): DWR Levee Log, 2002. USACE San Joaquin O&M Manual 601.1, 1967, (HLM 31.71)].					
FS Date: 4/1/2014

Concrete headwall at channel on WS toe.

Flapgate on Concrete headwall at channel on WS toe.

Concrete headwall on LS toe.

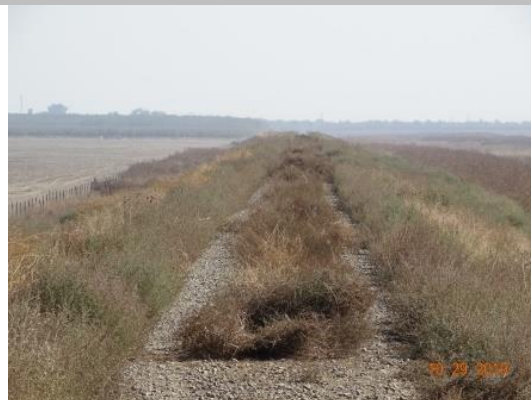
Photo 1 of 1 : FA_2019_NA0010_123_188_20191108_00343.jpg

LM Start	31.92	Rating **	U	Issue No.	188
LM End	32.24	Issue Type +	Ma	Location *	CR
Category	Earthen Levee			GPS Latitude/Longitude	
				Start	End
Item	Vegetation			36.993764 °	36.990236 °
				-120.407395 °	-120.403476 °
DWR ID	DWR_NA0010_05_f_2019_188				
Comment Code					
V9 : Keep the crown roadway free of vegetation.					
Inspector Comment

Looking upstream along the levee crown. (Fall 2019)

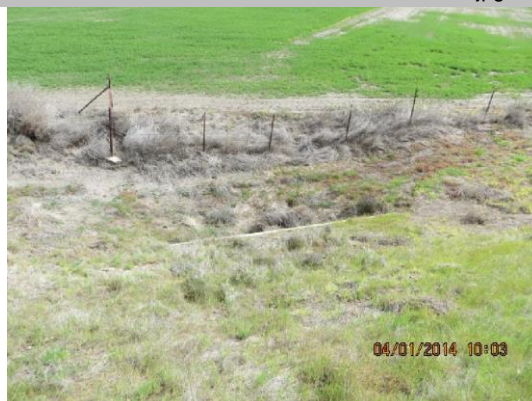
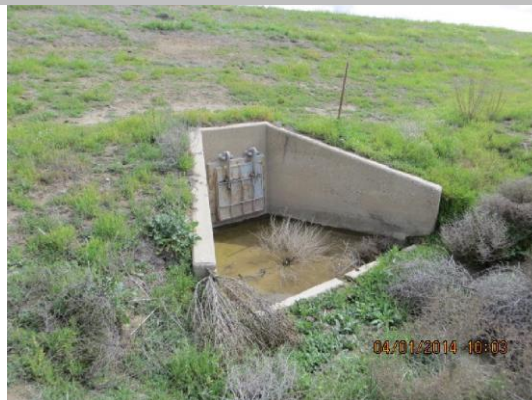
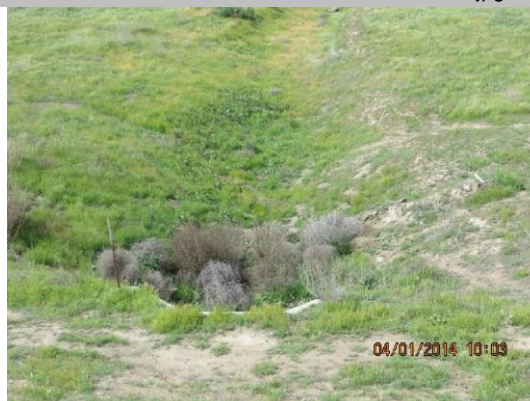
Comment Code					
Inspector Comment					
DS_ID:19701					
FS_ID:39646					
EP_NO: N/A					
Repair Type: Non-Urgent					
Crossing Status: Found					
UCIP Comments: 04/01/2014 Some silt buildup inside culvert. (DWR UCIP - W. Wylie)					
FIELD_STRUCT_DESC: 30-inch by 30-inch reinforced concrete box gravity drainage culvert through the levee, 14.2 feet below the crown. Flap gate on the waterside (WS) end. Concrete headwall on the landside (LS) end with flashboard attachment. Concrete U-shaped headwall on the WS end. [Additional Reference(s): DWR Levee Log, 2002. USACE San Joaquin O&M Manual 601.1, 1967, (HLM 32.22)].					
FS Date: 4/1/2014

Concrete headwall at inlet on LS toe.

Flapgate on Concrete headwall at WS toe.

Concrete headwall at outlet on WS toe.

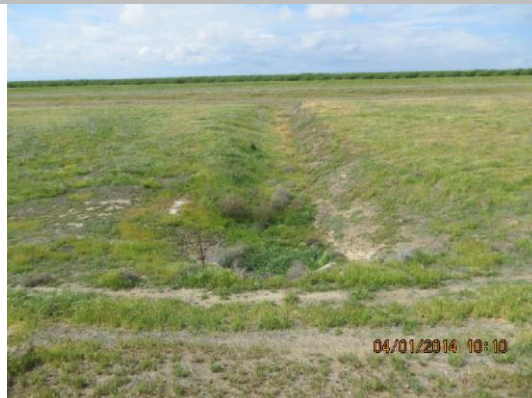
Photo 1 of 3 : UCIP_FA_2019_39647_59697.jpg

Comment Code						
Inspector Comment						
DS_ID:19702 FS_ID:39647 EP_NO: N/A Repair Type: Non-Urgent Crossing Status: Found UCIP Comments: 04/01/2014 Dense vegetation limits the inspector's visibility to identify signs of pipe failure (leaks) along the landward slope. Recommend removing vegetation along pipe alignment to conduct proper inspection of structure. Debris buildup blocking landward headwall--recommend contacting owner to clear debris. (DWR UCIP - W. Wylie) FIELD_STRUCT_DESC: 30-inch by 30-inch reinforced concrete box gravity drainage culvert through the levee, 12.2 feet below the crown. Flap gate on the waterside (WS) end. Concrete headwall on the landside (LS) end. Concrete U-shaped headwall on the WS end. [Additional Reference(s): DWR Levee Log, 2002. USACE San Joaquin O&M Manual 601.1, 1967, (HLM 33.01)]. FS Date: 4/1/2014

Concrete headwall at WS toe.

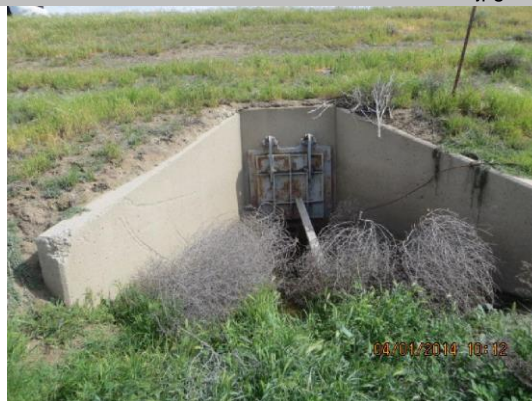
Photo 2 of 3 : UCIP_FA_2019_39647_59699.jpg

Flapgate on Concrete headwall at WS toe.

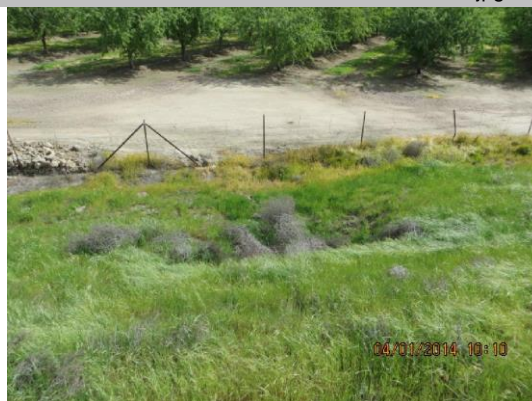
Photo 3 of 3 : UCIP_FA_2019_39647_59698.jpg

Item	DRAFT DWR UCIP LMA Responsibility			36.980861 °	36.980861 °	
				-120.393116 °	-120.393116 °	
DWR ID	19702					
Comment Code						
Inspector Comment						
DS_ID:19702 FS_ID:39647 EP_NO: N/A Repair Type: Non-Urgent Crossing Status: Found UCIP Comments: 04/01/2014 Dense vegetation limits the inspector's visibility to identify signs of pipe failure (leaks) along the landward slope. Recommend removing vegetation along pipe alignment to conduct proper inspection of structure. Debris buildup blocking landward headwall--recommend contacting owner to clear debris. (DWR UCIP - W. Wylie) FIELD_STRUCT_DESC: 30-inch by 30-inch reinforced concrete box gravity drainage culvert through the levee, 12.2 feet below the crown. Flap gate on the waterside (WS) end. Concrete headwall on the landside (LS) end. Concrete U-shaped headwall on the WS end. [Additional Reference(s): DWR Levee Log, 2002. USACE San Joaquin O&M Manual 601.1, 1967, (HLM 33.01)]. FS Date: 4/1/2014

Concrete headwall at inlet on LS toe.

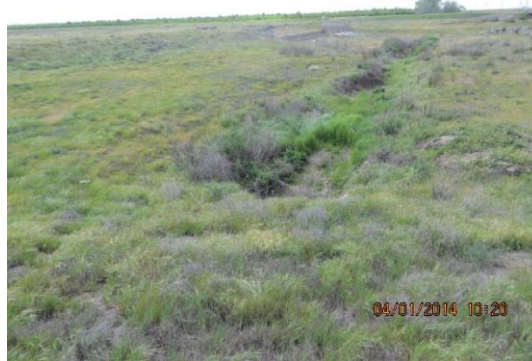
Photo 1 of 3 : UCIP_FA_2019_39648_59701.jpg

Comment Code						
Inspector Comment						
DS_ID:19703						
FS_ID:39648						
EP_NO: N/A						
Repair Type: Non-Urgent						
Crossing Status: Found						
UCIP Comments: 04/01/2014 Dense vegetation limits the inspector's visibility to identify signs of pipe failure (leaks) along the slopes.						
Recommend removing vegetation along pipe alignment to conduct proper inspection of structure. (DWR UCIP - W. Wylie)						
FIELD_STRUCT_DESC: 30-inch by 30-inch reinforced concrete box gravity drainage culvert through the levee, 13.9 feet below the crown.						
Flap gate on the waterside (WS) end. Concrete headwall on the landside (LS) end. Concrete U-shaped headwall on the WS end.						
[Additional Reference(s): DWR Levee Log, 2002. USACE San Joaquin O&M Manual 601.1, 1967, (HLM 33.72)].						
FS Date: 4/1/2014

Concrete headwall at WS toe.
