**Flood Control Project Maintenance
Levee Inspections**

Fall 2019 Levee Maintenance Deficiency Summary Report

San Joaquin River Basin

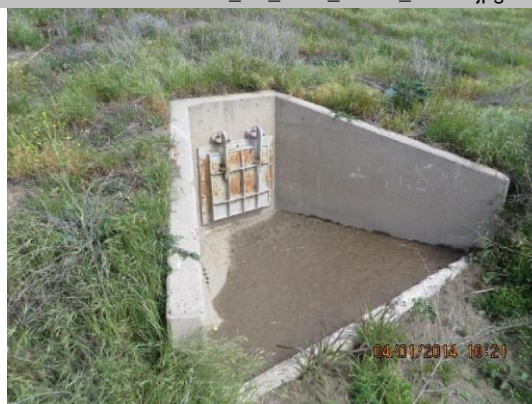
Photo 2 of 3 : UCIP_FA_2019_39648_59700.jpg

Comment Code						
Inspector Comment						
DS_ID:19703						
FS_ID:39648						
EP_NO: N/A						
Repair Type: Non-Urgent						
Crossing Status: Found						
UCIP Comments: 04/01/2014 Dense vegetation limits the inspector's visibility to identify signs of pipe failure (leaks) along the slopes.						
Recommend removing vegetation along pipe alignment to conduct proper inspection of structure. (DWR UCIP - W. Wylie)						
FIELD_STRUCT_DESC: 30-inch by 30-inch reinforced concrete box gravity drainage culvert through the levee, 13.9 feet below the crown.						
Flap gate on the waterside (WS) end. Concrete headwall on the landside (LS) end. Concrete U-shaped headwall on the WS end.						
[Additional Reference(s): DWR Levee Log, 2002. USACE San Joaquin O&M Manual 601.1, 1967, (HLM 33.72)].						
FS Date: 4/1/2014

Flapgate on Concrete headwall at WS toe.

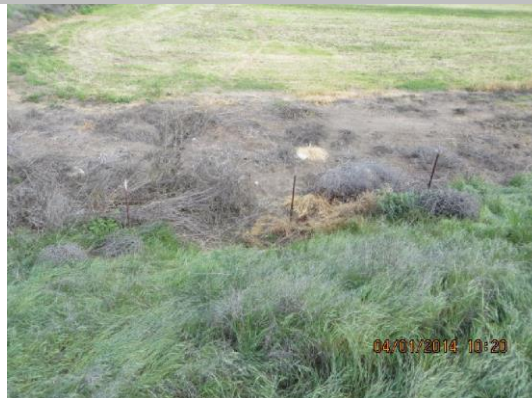
Photo 3 of 3 : UCIP_FA_2019_39648_59702.jpg

Item	DRAFT DWR UCIP LMA Responsibility			36.976808 °	36.976808 °	
				-120.382593 °	-120.382593 °	
DWR ID	19703					
Comment Code						
Inspector Comment						
DS_ID:19703						
FS_ID:39648						
EP_NO: N/A						
Repair Type: Non-Urgent						
Crossing Status: Found						
UCIP Comments: 04/01/2014 Dense vegetation limits the inspector's visibility to identify signs of pipe failure (leaks) along the slopes.						
Recommend removing vegetation along pipe alignment to conduct proper inspection of structure. (DWR UCIP - W. Wylie)						
FIELD_STRUCT_DESC: 30-inch by 30-inch reinforced concrete box gravity drainage culvert through the levee, 13.9 feet below the crown.						
Flap gate on the waterside (WS) end. Concrete headwall on the landside (LS) end. Concrete U-shaped headwall on the WS end.						
[Additional Reference(s): DWR Levee Log, 2002. USACE San Joaquin O&M Manual 601.1, 1967, (HLM 33.72)].						
FS Date: 4/1/2014

Concrete headwall at LS toe.

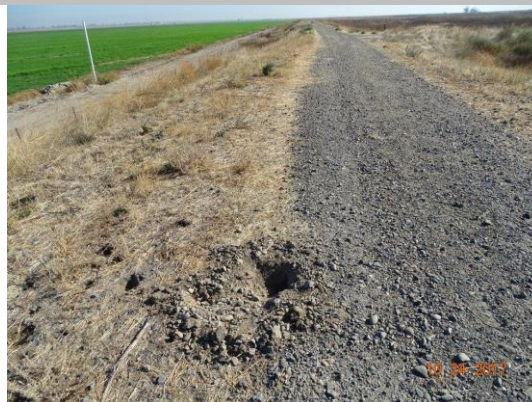
Photo 1 of 1 : FA_2019_NA0010_123_130_20190912_00027.jpg

LM Start	33.82	Rating **	M	Issue No.	130
LM End	33.82	Issue Type +	Ma	Location *	LS
Category	Earthen Levee			GPS Latitude/Longitude	
				Start	End
Item	Animal Control			36.976849°	36.976849°
				-120.382393°	-120.382393°
DWR ID	DWR_NA0010_05_f_2017_130				
Comment Code					
A3 : No rodents visible, but rodent burrows visible; need to backfill and compact or grout burrows.					
Inspector Comment

Looking east at the landside shoulder.

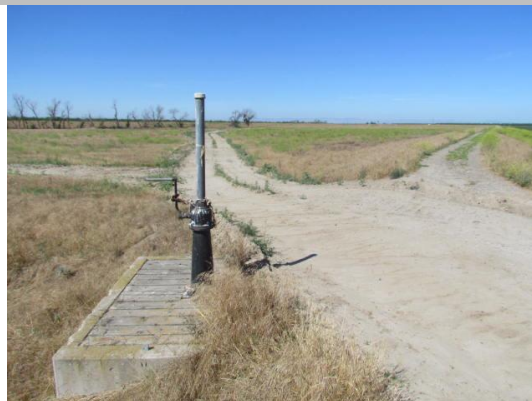
Photo 1 of 4 : FA_2019_NA0010_123_11_20190912_00007.jpg

LM Start	34.61	Rating **	M	Issue No.	11
LM End	34.61	Issue Type +	En	Location *	WS
Category	Earthen Levee			GPS Latitude/Longitude	
				Start	End
Item	Encroachments			36.978523 °	36.978523 °
				-120.368520 °	-120.368520 °
DWR ID	DWR_NA0010_05_s_2012_11				
Comment Code					
RA : Ramp					
Inspector Comment					
There is an unauthorized ramp on waterside slope. Landowner cut unauthorized ramp on waterside slope and levee crown.

Looking west at ramp on waterward slope.

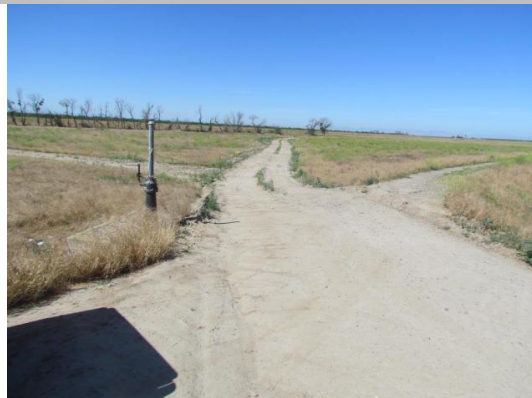
Photo 2 of 4 : FA_2019_NA0010_123_11_20190912_00008.jpg

LM Start	34.61	Rating **	M	Issue No.	11 (cont)	
LM End	34.61	Issue Type +	En	Location *	WS	
Category	Earthen Levee			GPS Latitude/Longitude		
				Start		End
Item	Encroachments			36.978523 °		36.978523 °
				-120.368520 °		-120.368520 °
DWR ID	DWR_NA0010_05_s_2012_11					
Comment Code						
RA : Ramp						
Inspector Comment						
There is an unauthorized ramp on waterside slope. Landowner cut unauthorized ramp on waterside slope and levee crown.

Looking west at cut on levee crown.

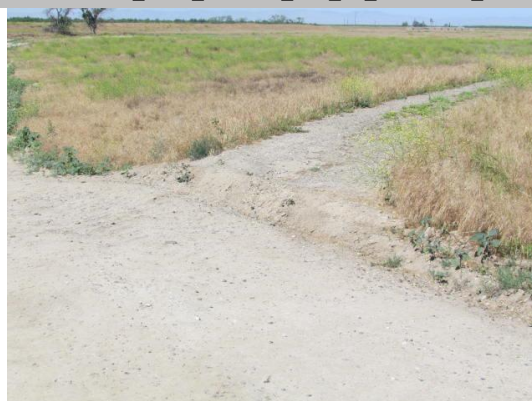
Photo 3 of 4 : FA_2019_NA0010_123_11_20190912_00009.jpg

Looking at cut on levee crown.

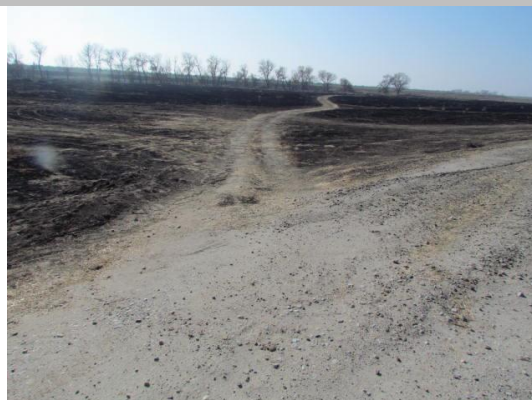
Photo 4 of 4 : FA_2019_NA0010_123_11_20190912_00010.jpg

Looking southwest at unauthorized ramp on waterward slope. (2015)

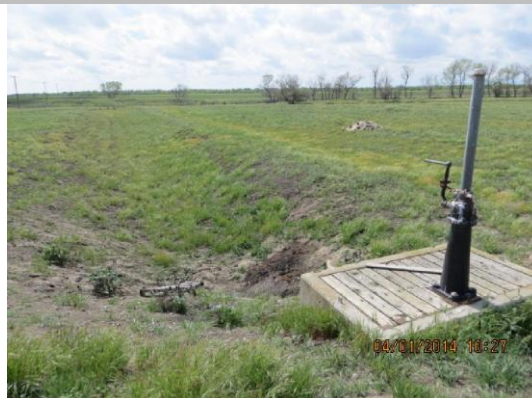
Photo 1 of 3 : UCIP_FA_2019_39649_59706.jpg

Comment Code						
Inspector Comment						
DS_ID:19755 FS_ID:39649 EP_NO: N/A Repair Type: Non-Urgent Crossing Status: Found UCIP Comments: 04/01/2014 Dense vegetation limits the inspector's visibility to identify signs of pipe failure (leaks) along the landward slope. Recommend removing vegetation along pipe alignment to conduct proper inspection of structure. Debris buildup visible on waterward headwall--recommend contacting owner to clear pipe. (DWR UCIP - W. Wylie) FIELD_STRUCT_DESC: [Chowchilla Canal Irrigation Structure] 36-inch by 36-inch reinforced concrete box gravity irrigation culvert through the levee, 9.7 feet below the crown. Slide gate in a 56-inch by 91-inch concrete riser on the waterside (WS) slope. Concrete U-shaped headwall on each end. Landside channel cobble revetted for 8 feet. [Additional Reference(s): DWR Levee Log, 2002. USACE San Joaquin O&M Manual 601.1, 1967, (HLM 34.51)]. FS Date: 4/1/2014

Slide gate in concrete riser on WS shoulder.

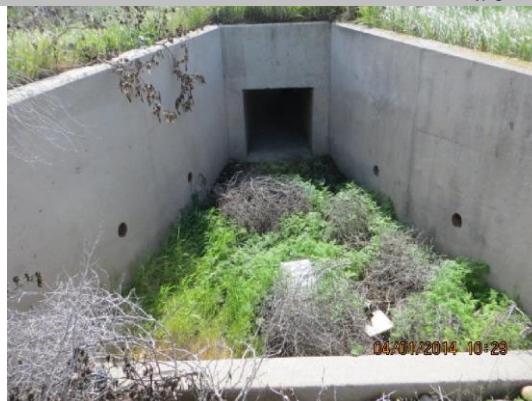
Photo 2 of 3 : UCIP_FA_2019_39649_59704.jpg

Concrete headwall at LS toe.

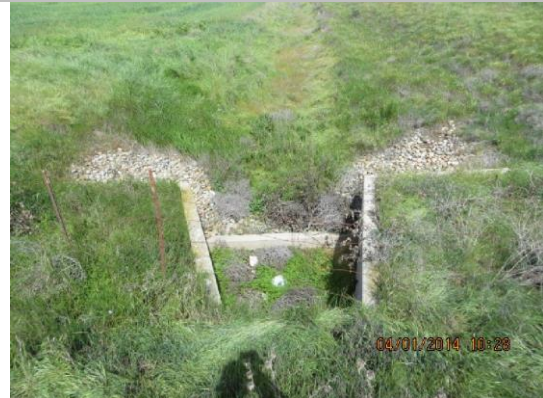
Photo 3 of 3 : UCIP_FA_2019_39649_59705.jpg

Item	DRAFT DWR UCIP Field Study			36.978593 °	36.978593 °	
				-120.368511 °	-120.368511 °	
DWR ID	19755					
Comment Code						
Inspector Comment						
DS_ID:19755 FS_ID:39649 EP_NO: N/A Repair Type: Non-Urgent Crossing Status: Found UCIP Comments: 04/01/2014 Dense vegetation limits the inspector's visibility to identify signs of pipe failure (leaks) along the landward slope. Recommend removing vegetation along pipe alignment to conduct proper inspection of structure. Debris buildup visible on waterward headwall--recommend contacting owner to clear pipe. (DWR UCIP - W. Wylie) FIELD_STRUCT_DESC: [Chowchilla Canal Irrigation Structure] 36-inch by 36-inch reinforced concrete box gravity irrigation culvert through the levee, 9.7 feet below the crown. Slide gate in a 56-inch by 91-inch concrete riser on the waterside (WS) slope. Concrete U-shaped headwall on each end. Landside channel cobble revetted for 8 feet. [Additional Reference(s): DWR Levee Log, 2002. USACE San Joaquin O&M Manual 601.1, 1967, (HLM 34.51)]. FS Date: 4/1/2014

Concrete headwall at LS toe.

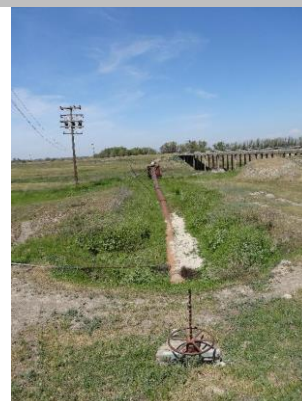
Photo 1 of 3 : UCIP_FA_2019_39463_66341.jpg

Comment Code						
Inspector Comment						
DS_ID:19815 FS_ID:39463 EP_NO: N/A Repair Type: Non-Urgent Crossing Status: Found UCIP Comments: 04/18/2014 Need to contact owner. Sediment buildup on landward side. Recommend removing sediment buildup on landward toe. (DWR UCIP - O. Magana) FIELD_STRUCT_DESC: 24-inch corrugated metal irrigation discharge pipe through the levee, 7.2 feet below the crown. Pump on concrete structure in the channel. Slide gate in a 36-inch corrugated metal pipe (CMP) riser on the waterside (WS) slope. Concrete headwall on each end. [Additional Reference(s): DWR Levee Log, 2002. USACE San Joaquin O&M Manual 601.1, 1967, (HLM 0.74)]. FS Date: 4/18/2014

View of waterward side.

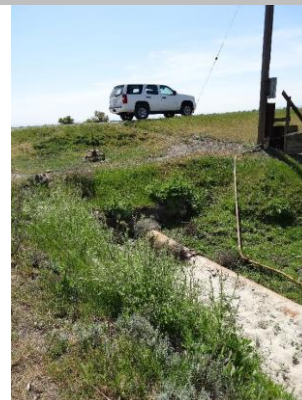
Photo 2 of 3 : UCIP_FA_2019_39463_66343.jpg

View of slope on waterward side.

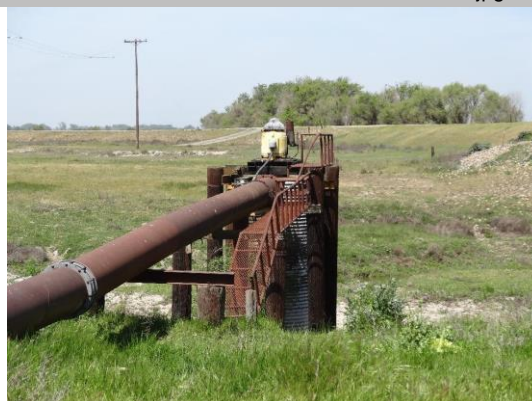
Photo 3 of 3 : UCIP_FA_2019_39463_66342.jpg

Comment Code						
Inspector Comment						
DS_ID:19815 FS_ID:39463 EP_NO: N/A Repair Type: Non-Urgent Crossing Status: Found UCIP Comments: 04/18/2014 Need to contact owner. Sediment buildup on landward side. Recommend removing sediment buildup on landward toe. (DWR UCIP - O. Magana) FIELD_STRUCT_DESC: 24-inch corrugated metal irrigation discharge pipe through the levee, 7.2 feet below the crown. Pump on concrete structure in the channel. Slide gate in a 36-inch corrugated metal pipe (CMP) riser on the waterside (WS) slope. Concrete headwall on each end. [Additional Reference(s): DWR Levee Log, 2002. USACE San Joaquin O&M Manual 601.1, 1967, (HLM 0.74)]. FS Date: 4/18/2014

Pump station visible on waterward side.

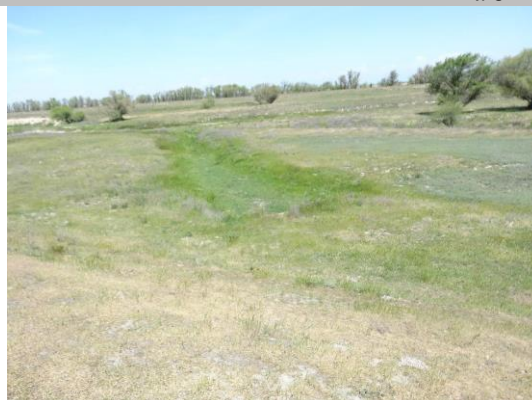
Photo 1 of 3 : UCIP_FA_2019_36565_66346.jpg

LM Start	0.78	Rating **	M	Issue No.	1213	
LM End	0.78	Issue Type +	Ma	Location *		
Category	Supplemental			GPS Latitude/Longitude		
				Start		End
Item	DRAFT DWR UCIP LMA Responsibility			37.270460 °		37.270460 °
				-120.814290 °		-120.814290 °
DWR ID	19816					
Comment Code						
Inspector Comment						
DS_ID:19816 FS_ID:36565 EP_NO: N/A Repair Type: Non-Urgent Crossing Status: Found UCIP Comments: 04/18/2014 Landward side blocked--need to contact owner to determine status of crossing. (DWR UCIP - O. Magana) FIELD_STRUCT_DESC: 24-inch corrugated metal gravity drainage pipe through the levee, 16.2 feet below the crown. Flap gate on the waterside (WS) end. Concrete U-shaped headwall on each end. [Additional Reference(s): DWR Levee Log, 2002. USACE San Joaquin O&M Manual 601.1, 1967, (HLM 0.86)]. FS Date: 4/18/2014

Overview of waterward side.

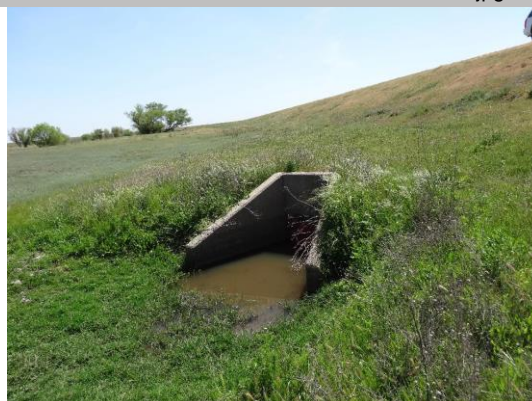
Photo 2 of 3 : UCIP_FA_2019_36565_66345.jpg

LM Start	0.78	Rating **	M	Issue No.	1213 (cont)	
LM End	0.78	Issue Type +	Ma	Location *		
Category	Supplemental			GPS Latitude/Longitude		
				Start	End	
Item	DRAFT DWR UCIP LMA Responsibility			37.270460 °	37.270460 °	
				-120.814290 °	-120.814290 °	
DWR ID	19816					
Comment Code						
Inspector Comment						
DS_ID:19816 FS_ID:36565 EP_NO: N/A Repair Type: Non-Urgent Crossing Status: Found UCIP Comments: 04/18/2014 Landward side blocked--need to contact owner to determine status of crossing. (DWR UCIP - O. Magana) FIELD_STRUCT_DESC: 24-inch corrugated metal gravity drainage pipe through the levee, 16.2 feet below the crown. Flap gate on the waterside (WS) end. Concrete U-shaped headwall on each end. [Additional Reference(s): DWR Levee Log, 2002. USACE San Joaquin O&M Manual 601.1, 1967, (HLM 0.86)]. FS Date: 4/18/2014

Concrete structure located on waterward toe.

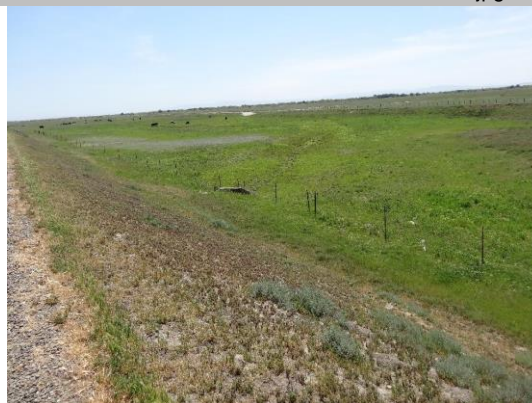
Photo 3 of 3 : UCIP_FA_2019_36565_66344.jpg

View of landward side.

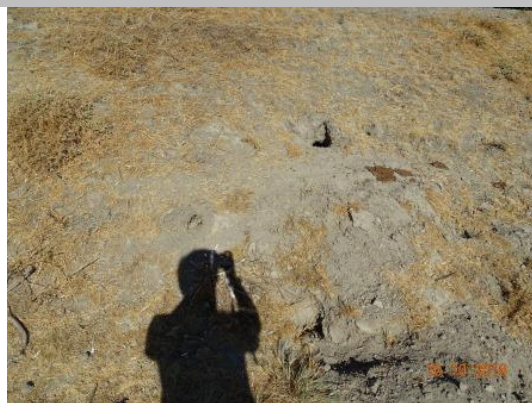
Photo 1 of 2 : FA_2019_NA0010_124_93_20190912_00035.jpg

LM Start	1.18	Rating **	U	Issue No.	93
LM End	1.18	Issue Type +	Ma	Location *	LS
Category	Earthen Levee			GPS Latitude/Longitude	
				Start	End
Item	Animal Control			37.267101 °	37.267101 °
				-120.809603 °	-120.809603 °
DWR ID	DWR_NA0010_06_f_2018_93				
Comment Code					
A3 : No rodents visible, but rodent burrows visible; need to backfill and compact or grout burrows.					
Inspector Comment					
Several rodent burrows including large burrows were observed at this location.

View of landside slope. (Fall 2018)

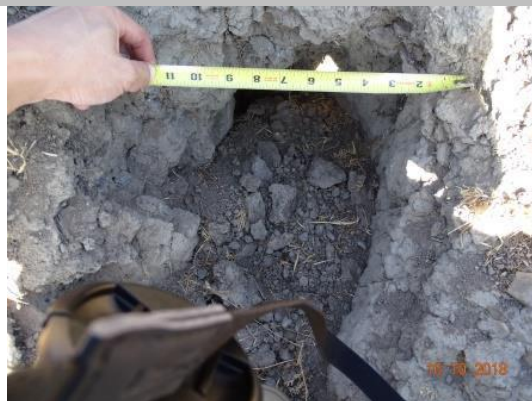
Photo 2 of 2 : FA_2019_NA0010_124_93_20190912_00036.jpg

View and measurement of large rodent hole found at this location. (Fall 2018)

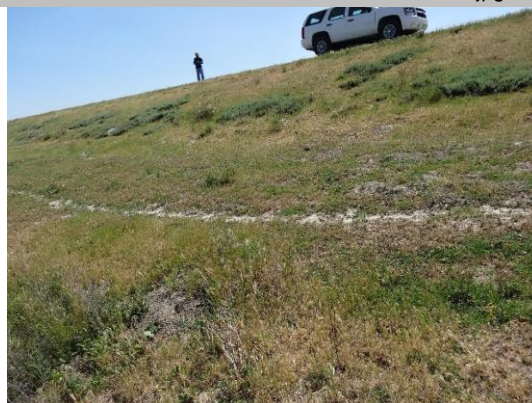
Photo 1 of 3 : UCIP_FA_2019_36566_66348.jpg

LM Start	1.87	Rating **	M	Issue No.	1214	
LM End	1.87	Issue Type +	Ma	Location *		
Category	Supplemental			GPS Latitude/Longitude		
				Start		End
Item	DRAFT DWR UCIP LMA Responsibility			37.259312 °		37.259312 °
				-120.802863 °		-120.802863 °
DWR ID	19817					
Comment Code						
Inspector Comment						
DS_ID:19817 FS_ID:36566 EP_NO: N/A Repair Type: Non-Urgent Crossing Status: Found UCIP Comments: 04/18/2014 No access was available to landward side due to fence. Recommend removing some of the vegetation on waterward toe. (DWR UCIP - O. Magana) FIELD_STRUCT_DESC: 24-inch corrugated metal gravity drainage pipe through the levee, 13.5 feet below the crown. Flap gate on the waterside (WS) end. Concrete headwall on each end. [Additional Reference(s): DWR Levee Log, 2002. USACE San Joaquin O&M Manual 601.1, 1967, (HLM 1.95)]. FS Date: 4/18/2014

View of waterward side.

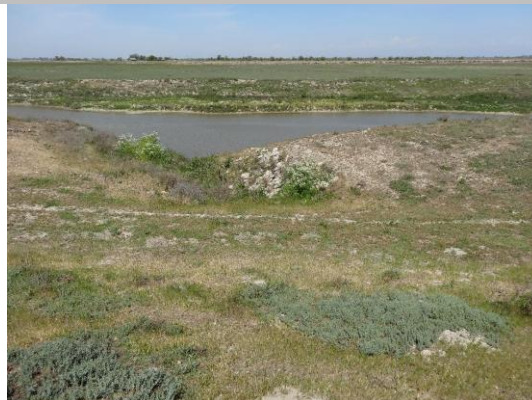
Photo 2 of 3 : UCIP_FA_2019_36566_66350.jpg

LM Start	1.87	Rating **	M	Issue No.	1214 (cont)	
LM End	1.87	Issue Type +	Ma	Location *		
Category	Supplemental			GPS Latitude/Longitude		
				Start	End	
Item	DRAFT DWR UCIP LMA Responsibility			37.259312 °	37.259312 °	
				-120.802863 °	-120.802863 °	
DWR ID	19817					
Comment Code						
Inspector Comment						
DS_ID:19817 FS_ID:36566 EP_NO: N/A Repair Type: Non-Urgent Crossing Status: Found UCIP Comments: 04/18/2014 No access was available to landward side due to fence. Recommend removing some of the vegetation on waterward toe. (DWR UCIP - O. Magana) FIELD_STRUCT_DESC: 24-inch corrugated metal gravity drainage pipe through the levee, 13.5 feet below the crown. Flap gate on the waterside (WS) end. Concrete headwall on each end. [Additional Reference(s): DWR Levee Log, 2002. USACE San Joaquin O&M Manual 601.1, 1967, (HLM 1.95)]. FS Date: 4/18/2014

View of waterward side.

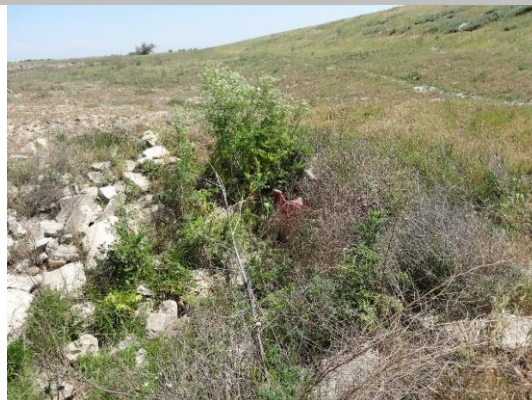
Photo 3 of 3 : UCIP_FA_2019_36566_66349.jpg

Flap gate visible on waterward side.

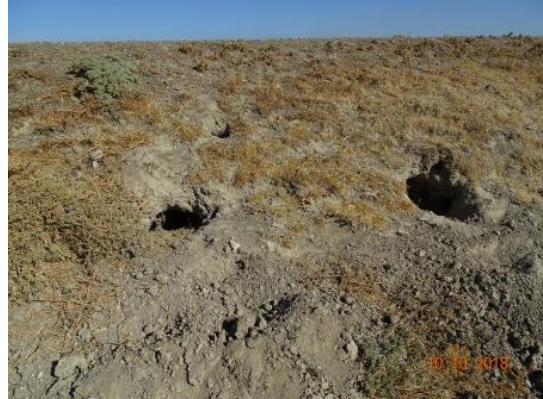
Photo 1 of 2 : FA_2019_NA0010_124_92_20190912_00033.jpg

View of large rodent holes in landside slope. (Fall 2018)

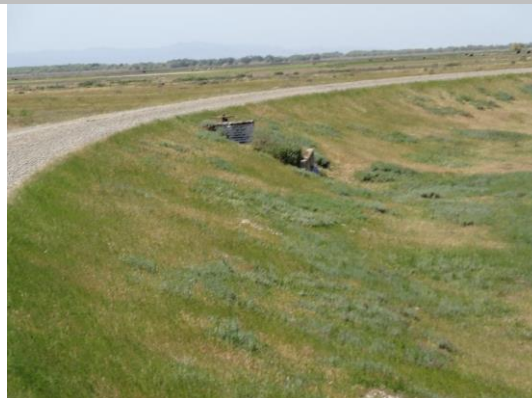
Photo 1 of 3 : UCIP_FA_2019_39464_66354.jpg

LM Start	2.53	Rating **	M	Issue No.	1215
LM End	2.53	Issue Type +	Ma	Location *	
Category	Supplemental			GPS Latitude/Longitude	
				Start	End
Item	DRAFT DWR UCIP LMA Responsibility			37.252948 °	37.252948 °
				-120.794352 °	-120.794352 °
DWR ID	19818				
Comment Code					
Inspector Comment					
DS_ID:19818 FS_ID:39464 EP_NO: N/A Repair Type: Non-Urgent Crossing Status: Found UCIP Comments: 04/18/2014 Need to contact owner. Sediment buildup in pipe visible on landward side. (DWR UCIP - O. Magana) FIELD_STRUCT_DESC: 36-inch corrugated metal gravity drainage pipe through the levee, 6.9 feet below the crown. Slide gate in a 48-inch corrugated metal pipe (CMP) riser on the waterside (WS) slope. Concrete headwall on each end. [Additional Reference(s): DWR Levee Log, 2002. USACE San Joaquin O&M Manual 601.1, 1967, (HLM 2.61)]. FS Date: 4/18/2014

View of waterward side.

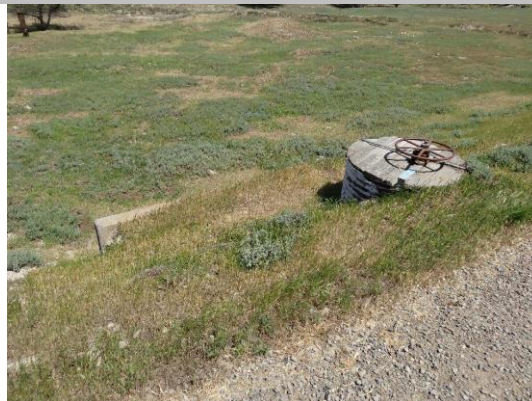
Photo 2 of 3 : UCIP_FA_2019_39464_66357.jpg

View of waterward side.

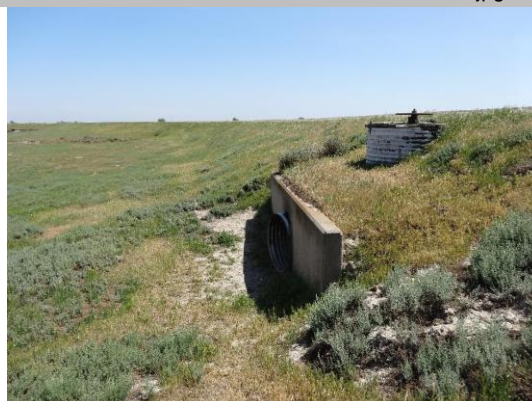
Photo 3 of 3 : UCIP_FA_2019_39464_66356.jpg

LM Start	2.53	Rating **	M	Issue No.	1215 (cont)
LM End	2.53	Issue Type +	Ma	Location *	
Category	Supplemental			GPS Latitude/Longitude	
				Start	End
Item	DRAFT DWR UCIP LMA Responsibility			37.252948 °	37.252948 °
				-120.794352 °	-120.794352 °
DWR ID	19818				
Comment Code					
Inspector Comment					
DS_ID:19818 FS_ID:39464 EP_NO: N/A Repair Type: Non-Urgent Crossing Status: Found UCIP Comments: 04/18/2014 Need to contact owner. Sediment buildup in pipe visible on landward side. (DWR UCIP - O. Magana) FIELD_STRUCT_DESC: 36-inch corrugated metal gravity drainage pipe through the levee, 6.9 feet below the crown. Slide gate in a 48-inch corrugated metal pipe (CMP) riser on the waterside (WS) slope. Concrete headwall on each end. [Additional Reference(s): DWR Levee Log, 2002. USACE San Joaquin O&M Manual 601.1, 1967, (HLM 2.61)]. FS Date: 4/18/2014

CMP riser, concrete headwall, and pipe visible on waterward side.

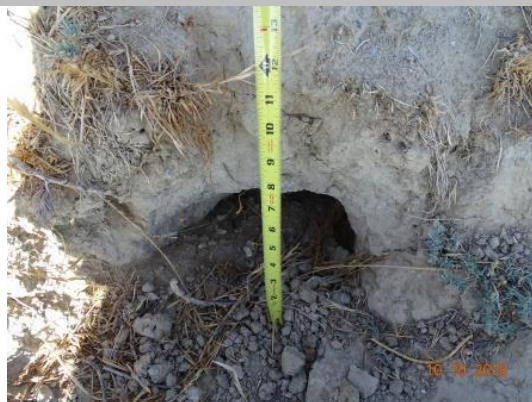
Photo 1 of 1 : FA_2019_NA0010_124_76_20190912_00020.jpg

LM Start	2.54	Rating **	M	Issue No.	76
LM End	2.54	Issue Type +	Ma	Location *	LS
Category	Earthen Levee			GPS Latitude/Longitude	
				Start	End
Item	Animal Control			37.252874 °	37.252874 °
				-120.794192 °	-120.794192 °
DWR ID	DWR_NA0010_06_f_2016_76				
Comment Code					
A3 : No rodents visible, but rodent burrows visible; need to backfill and compact or grout burrows.					
Inspector Comment					
There are several rodent burrows in the landside slope at this location.

Representative view of rodent burrow found at this section. (Fall 2018)

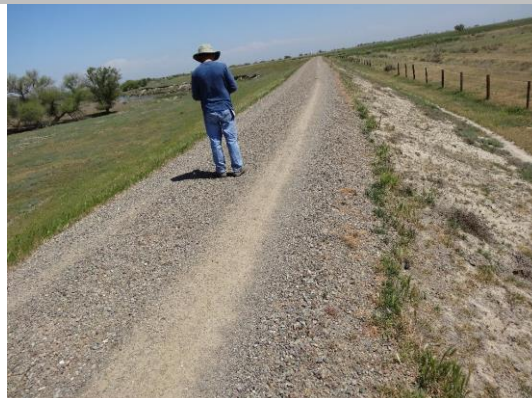
Photo 1 of 3 : UCIP_FA_2019_36568_66362.jpg

Comment Code						
Inspector Comment						
DS_ID:19819						
FS_ID:36568						
EP_NO: N/A						
Repair Type: Non-Urgent						
Crossing Status: Found						
UCIP Comments: 04/18/2014 Dense vegetation limits the inspector's visibility to identify signs of pipe condition on landward toe--headwall blocked by dense vegetation. Recommend removing vegetation from landward toe. (DWR UCIP - O. Magana)						
FIELD_STRUCT_DESC: 24-inch corrugated metal gravity drainage pipe through the levee, 9.2 feet below the crown. Flap gate on the waterside (WS) end. Concrete headwall on each end. [Additional Reference(s): DWR Levee Log, 2002. USACE San Joaquin O&M Manual 601.1, 1967, (HLM 2.65)].						
FS Date: 4/18/2014

Overview of levee crown at crossing.

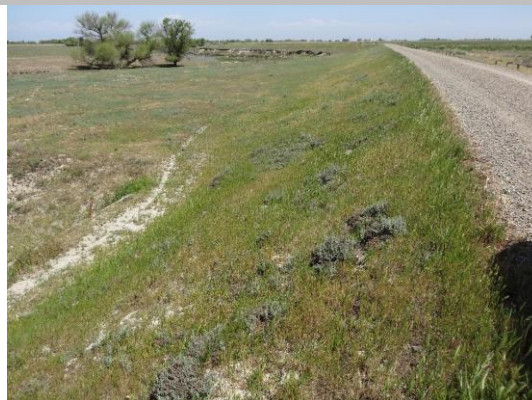
Photo 2 of 3 : UCIP_FA_2019_36568_66360.jpg

View of waterward side.

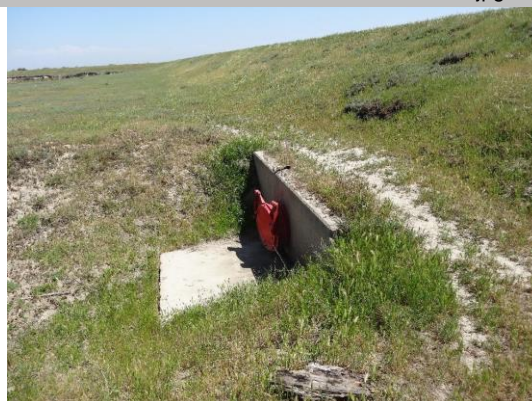
Photo 3 of 3 : UCIP_FA_2019_36568_66359.jpg

Comment Code						
Inspector Comment						
DS_ID:19819 FS_ID:36568 EP_NO: N/A Repair Type: Non-Urgent Crossing Status: Found UCIP Comments: 04/18/2014 Dense vegetation limits the inspector's visibility to identify signs of pipe condition on landward toe--headwall blocked by dense vegetation. Recommend removing vegetation from landward toe. (DWR UCIP - O. Magana) FIELD_STRUCT_DESC: 24-inch corrugated metal gravity drainage pipe through the levee, 9.2 feet below the crown. Flap gate on the waterside (WS) end. Concrete headwall on each end. [Additional Reference(s): DWR Levee Log, 2002. USACE San Joaquin O&M Manual 601.1, 1967, (HLM 2.65)]. FS Date: 4/18/2014

View of concrete headwall, flap gate, and concrete apron located on waterside side.

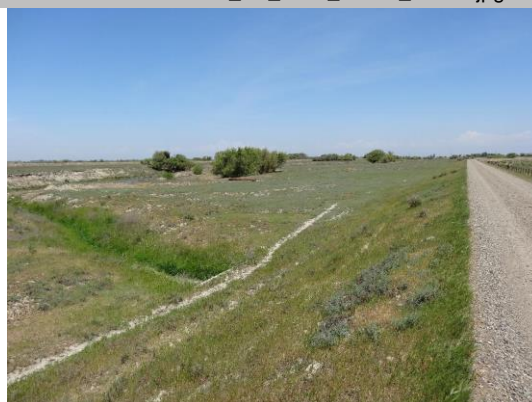
Photo 1 of 3 : UCIP_FA_2019_36569_66369.jpg

Comment Code						
Inspector Comment						
DS_ID:19820						
FS_ID:36569						
EP_NO: N/A						
Repair Type: Non-Urgent						
Crossing Status: Found						
UCIP Comments: 04/18/2014 Dense vegetation limits the inspector's visibility to identify signs of pipe condition on landward toe--headwall blocked by dense vegetation. Recommend removing vegetation from landward toe. (DWR UCIP - O. Magana)						
FIELD_STRUCT_DESC: 24-inch corrugated metal gravity drainage pipe through the levee, 10.5 feet below the crown. Flap gate on the waterside (WS) end. Concrete headwall on each end. [Additional Reference(s): DWR Levee Log, 2002. USACE San Joaquin O&M Manual 601.1, 1967, (HLM 2.85)].						
FS Date: 4/18/2014

View of waterward side.

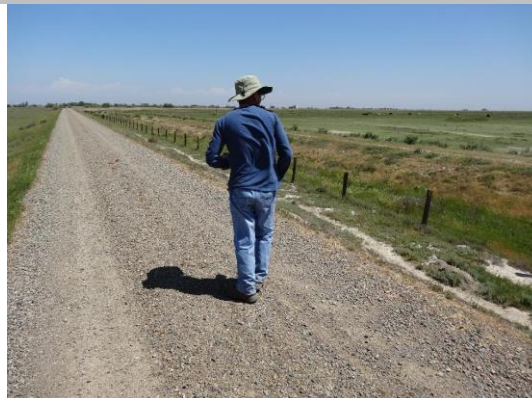
Photo 2 of 3 : UCIP_FA_2019_36569_66368.jpg

Overview of levee crown at crossing.

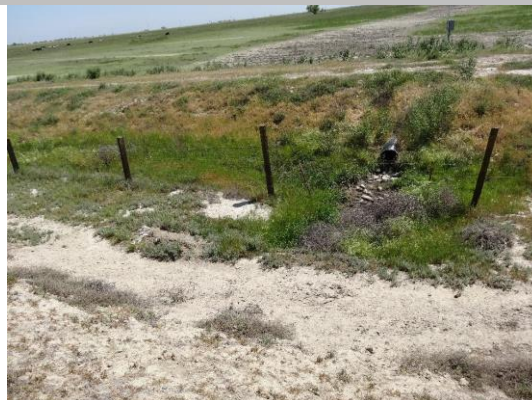
Photo 3 of 3 : UCIP_FA_2019_36569_66372.jpg

Comment Code						
Inspector Comment						
DS_ID:19820 FS_ID:36569 EP_NO: N/A Repair Type: Non-Urgent Crossing Status: Found UCIP Comments: 04/18/2014 Dense vegetation limits the inspector's visibility to identify signs of pipe condition on landward toe--headwall blocked by dense vegetation. Recommend removing vegetation from landward toe. (DWR UCIP - O. Magana) FIELD_STRUCT_DESC: 24-inch corrugated metal gravity drainage pipe through the levee, 10.5 feet below the crown. Flap gate on the waterside (WS) end. Concrete headwall on each end. [Additional Reference(s): DWR Levee Log, 2002. USACE San Joaquin O&M Manual 601.1, 1967, (HLM 2.85)]. FS Date: 4/18/2014

View of landward side.

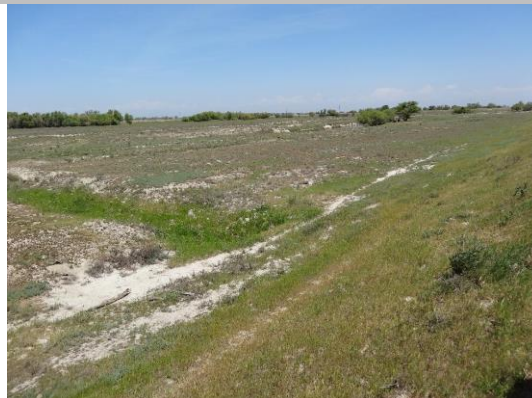
Photo 1 of 3 : UCIP_FA_2019_36583_66381.jpg

Comment Code						
Inspector Comment						
DS_ID:19821 FS_ID:36583 EP_NO: N/A Repair Type: Non-Urgent Crossing Status: Found UCIP Comments: 04/18/2014 Dense vegetation limits the inspector's visibility to identify signs of pipe condition on landward toe--headwall blocked by dense vegetation. Recommend removing vegetation from landward toe. (DWR UCIP - O. Magana) FIELD_STRUCT_DESC: 24-inch corrugated metal gravity drainage pipe through the levee, 11.2 feet below the crown. Flap gate on the waterside (WS) end. Concrete headwall on each end. [Additional Reference(s): DWR Levee Log, 2002. USACE San Joaquin O&M Manual 601.1, 1967, (HLM 3.09)]. FS Date: 4/18/2014

View of waterward side.

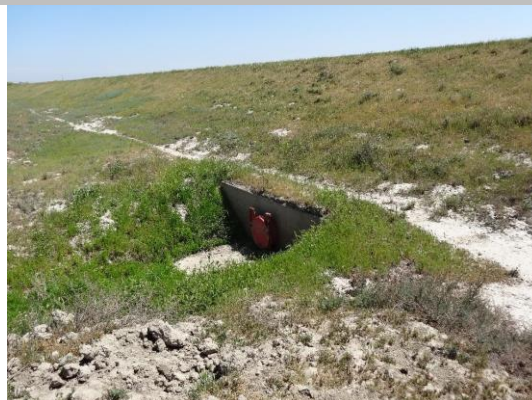
Photo 2 of 3 : UCIP_FA_2019_36583_66380.jpg

Flap gate and concrete headwall visible on waterward side.

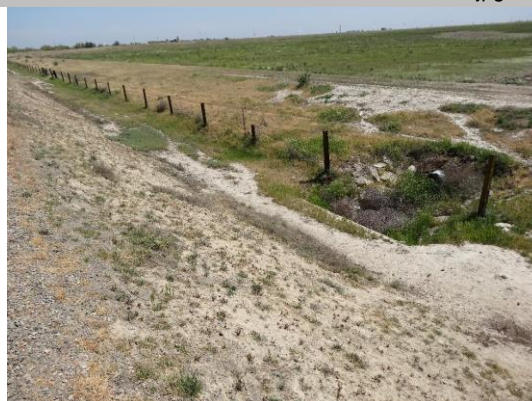
Photo 3 of 3 : UCIP_FA_2019_36583_66383.jpg

Comment Code						
Inspector Comment						
DS_ID:19821 FS_ID:36583 EP_NO: N/A Repair Type: Non-Urgent Crossing Status: Found UCIP Comments: 04/18/2014 Dense vegetation limits the inspector's visibility to identify signs of pipe condition on landward toe--headwall blocked by dense vegetation. Recommend removing vegetation from landward toe. (DWR UCIP - O. Magana) FIELD_STRUCT_DESC: 24-inch corrugated metal gravity drainage pipe through the levee, 11.2 feet below the crown. Flap gate on the waterside (WS) end. Concrete headwall on each end. [Additional Reference(s): DWR Levee Log, 2002. USACE San Joaquin O&M Manual 601.1, 1967, (HLM 3.09)]. FS Date: 4/18/2014

View of landward side.

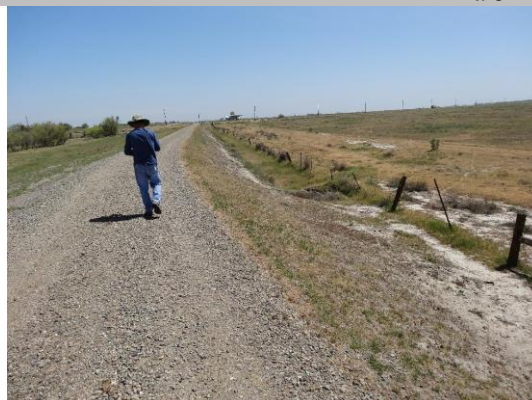
Photo 1 of 3 : UCIP_FA_2019_36584_66384.jpg

Comment Code						
Inspector Comment						
DS_ID:19822						
FS_ID:36584						
EP_NO: N/A						
Repair Type: Non-Urgent						
Crossing Status: Found						
UCIP Comments: 04/18/2014 Dense vegetation limits the inspector's visibility to identify signs of pipe condition on waterward slope and landward toe (headwall blocked by dense vegetation). Recommend removing vegetation from landward toe. (DWR UCIP - O. Magana)						
FIELD_STRUCT_DESC: 24-inch corrugated metal gravity drainage pipe through the levee, 10.4 feet below the crown. Flap gate on the waterside (WS) end. Concrete headwall on each end. [Additional Reference(s): DWR Levee Log, 2002. USACE San Joaquin O&M Manual 601.1, 1967, (HLM 3.29)].						
FS Date: 4/18/2014

Overview of levee crown and landward side.

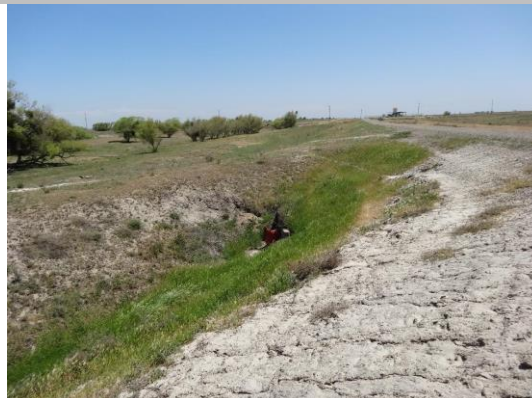
Photo 2 of 3 : UCIP_FA_2019_36584_66386.jpg

View of waterward side.

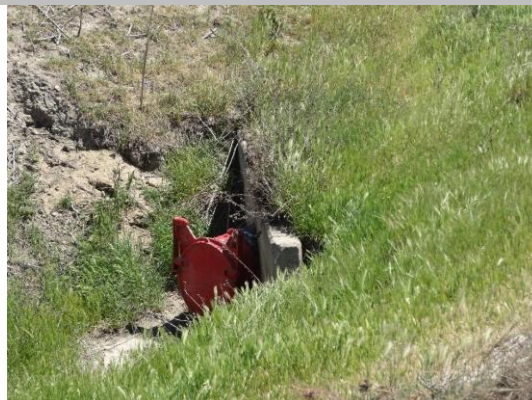
Photo 3 of 3 : UCIP_FA_2019_36584_66385.jpg

Comment Code						
Inspector Comment						
DS_ID:19822 FS_ID:36584 EP_NO: N/A Repair Type: Non-Urgent Crossing Status: Found UCIP Comments: 04/18/2014 Dense vegetation limits the inspector's visibility to identify signs of pipe condition on waterward slope and landward toe (headwall blocked by dense vegetation). Recommend removing vegetation from landward toe. (DWR UCIP - O. Magana) FIELD_STRUCT_DESC: 24-inch corrugated metal gravity drainage pipe through the levee, 10.4 feet below the crown. Flap gate on the waterside (WS) end. Concrete headwall on each end. [Additional Reference(s): DWR Levee Log, 2002. USACE San Joaquin O&M Manual 601.1, 1967, (HLM 3.29)]. FS Date: 4/18/2014

Crossing goes through the levee at an angle. Flap gate visible on waterward side.

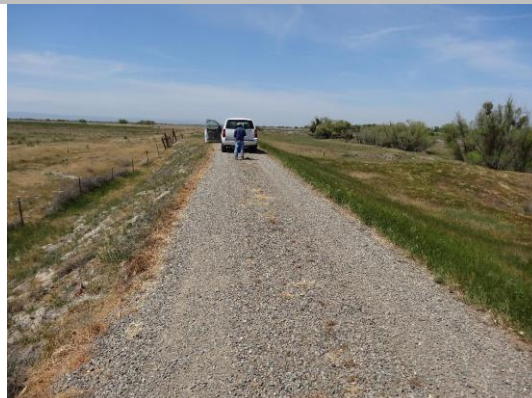
Photo 1 of 3 : UCIP_FA_2019_36585_66389.jpg

Comment Code					
Inspector Comment					
DS_ID:19823 FS_ID:36585 EP_NO: N/A Repair Type: Non-Urgent Crossing Status: Found UCIP Comments: 04/18/2014 Alignment of crossing unknown--altered crossing. No headwall found on landward side only siphon breaker found a short distance from landward toe. Tall grass observed on waterward slope and some burrow activity also noticed. Need to contact owner to determine alignment of crossing and status of crossing. (DWR UCIP - O. Magana) FIELD_STRUCT_DESC: 36-inch corrugated metal gravity drainage pipe through the levee, 15.7 feet below the crown. Flap gate on the waterside (WS) end. Concrete U-shaped headwall on each end. Bench mark (BM) stamped 9770-152 on top of the WS headwall. [Additional Reference(s): DWR Levee Log, 2002. USACE San Joaquin O&M Manual 601.1, 1967, (HLM 3.43)]. FS Date: 4/18/2014

Overview of levee crown at crossing.

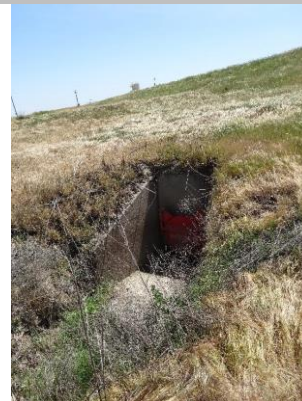
Photo 2 of 3 : UCIP_FA_2019_36585_66390.jpg

Flap gate and concrete headwall visible on waterward side.

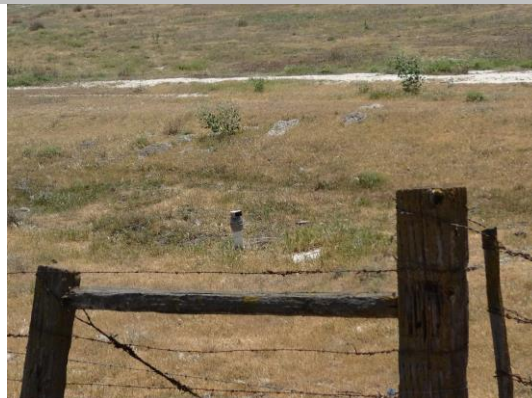
Photo 3 of 3 : UCIP_FA_2019_36585_66391.jpg

Comment Code						
Inspector Comment						
DS_ID:19823 FS_ID:36585 EP_NO: N/A Repair Type: Non-Urgent Crossing Status: Found UCIP Comments: 04/18/2014 Alignment of crossing unknown--altered crossing. No headwall found on landward side only siphon breaker found a short distance from landward toe. Tall grass observed on waterward slope and some burrow activity also noticed. Need to contact owner to determine alignment of crossing and status of crossing. (DWR UCIP - O. Magana) FIELD_STRUCT_DESC: 36-inch corrugated metal gravity drainage pipe through the levee, 15.7 feet below the crown. Flap gate on the waterside (WS) end. Concrete U-shaped headwall on each end. Bench mark (BM) stamped 9770-152 on top of the WS headwall. [Additional Reference(s): DWR Levee Log, 2002. USACE San Joaquin O&M Manual 601.1, 1967, (HLM 3.43)]. FS Date: 4/18/2014

View of landward side. No signs of concrete headwall only siphon breaker visible on landward side.

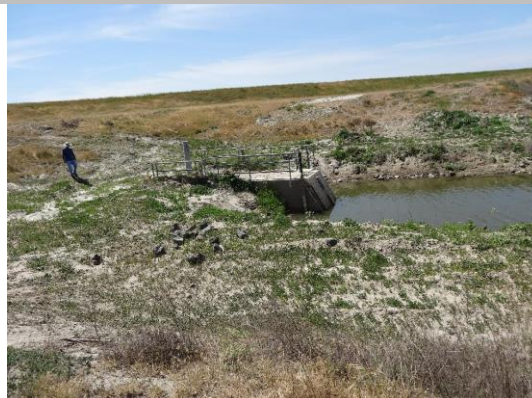
Photo 1 of 3 : UCIP_FA_2019_39482_71643.jpg

Comment Code						
Inspector Comment						
DS_ID:19824 FS_ID:39482 EP_NO: 6965 Repair Type: Non-Urgent Crossing Status: Indicator Found UCIP Comments: 04/18/2014 Description of structure does not match. Need to contact owner. Current description includes concrete platform, trash screen, and gage reading on waterward side. Metal box located on waterward shoulder. Large plant facility locate on landward side. (DWR UCIP - O. Magana) FIELD_STRUCT_DESC: 16-inch coated steel irrigation discharge pipe through the levee, 7.4 feet below the crown. Corrugated metal cutoff wall around the pipe in the center of the levee. Pump on the waterside (WS) with a timber platform on the berm for support. Siphon breaker on the apex of the pipe on the landside (LS) shoulder. Pipe exposed on both slopes. (Plans to place a 20-inch irrigation pipe through the levee authorized under Permit No. 6965, 1971 - Scarborough, Robinson, and Associates). [Additional Reference(s): DWR Levee Log, 2002]. FS Date: 4/10/2014

View of structure located on waterward side.

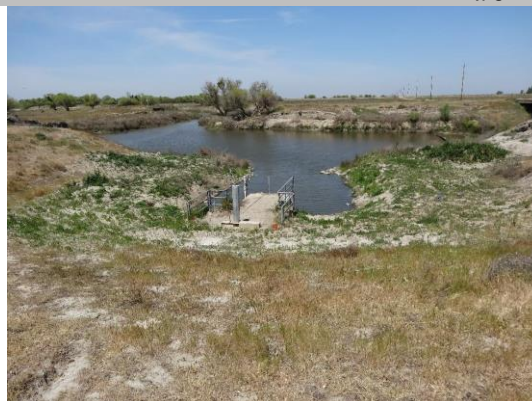
Photo 2 of 3 : UCIP_FA_2019_39482_71644.jpg

View of waterward side.

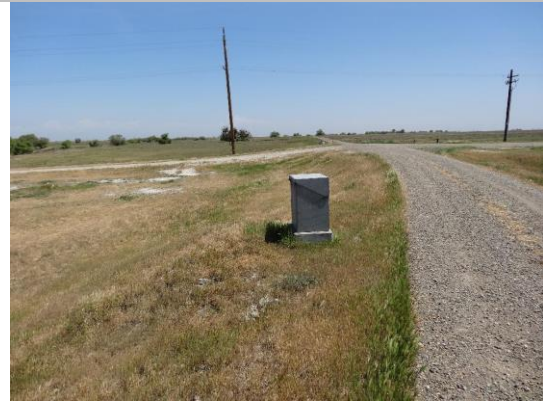
Photo 3 of 3 : UCIP_FA_2019_39482_71642.jpg

Comment Code						
Inspector Comment						
DS_ID:19824 FS_ID:39482 EP_NO: 6965 Repair Type: Non-Urgent Crossing Status: Indicator Found UCIP Comments: 04/18/2014 Description of structure does not match. Need to contact owner. Current description includes concrete platform, trash screen, and gage reading on waterward side. Metal box located on waterward shoulder. Large plant facility locate on landward side. (DWR UCIP - O. Magana) FIELD_STRUCT_DESC: 16-inch coated steel irrigation discharge pipe through the levee, 7.4 feet below the crown. Corrugated metal cutoff wall around the pipe in the center of the levee. Pump on the waterside (WS) with a timber platform on the berm for support. Siphon breaker on the apex of the pipe on the landside (LS) shoulder. Pipe exposed on both slopes. (Plans to place a 20-inch irrigation pipe through the levee authorized under Permit No. 6965, 1971 - Scarborough, Robinson, and Associates). [Additional Reference(s): DWR Levee Log, 2002]. FS Date: 4/10/2014

Metal box located on waterward shoulder.

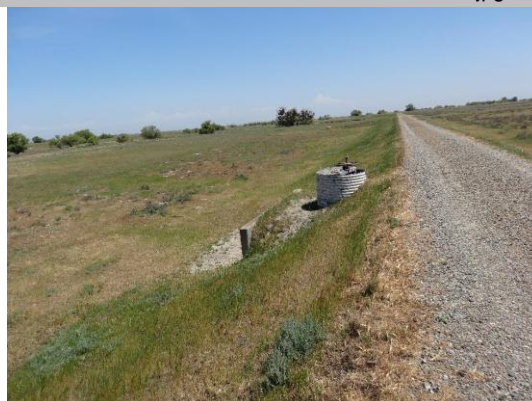
Photo 1 of 3 : UCIP_FA_2019_39465_66394.jpg

Comment Code						
Inspector Comment						
DS_ID:19825 FS_ID:39465 EP_NO: N/A Repair Type: Non-Urgent Crossing Status: Found UCIP Comments: 04/18/2014 Sediment buildup inside pipe visible from landward side. Excess soil is also present on landward toe partially blocking concrete headwall and inlet. Recommend removing soil from landward toe and clear buildup inside. (DWR UCIP - O. Magana) FIELD_STRUCT_DESC: 36-inch corrugated metal gravity drainage pipe through the levee, 6.8 feet below the crown. Slide gate in a 48-inch corrugated metal pipe (CMP) riser on the waterside (WS) slope. Concrete headwall on each end. Pipe connects to a 30-inch steel drainage pipe on the WS. Drainage pipe extends to the pump on the WS on a support platform in the channel. (Extension drainage pipe and pump installed under Permit No. 12527, 1979 - Joseph Gallo). [Additional Reference(s): DWR Levee Log, 2002. USACE San Joaquin O&M Manual 601.1, 1967, (HLM 3.54)]. FS Date: 4/18/2014

View of waterward side--cmp riser and concrete headwall visible.

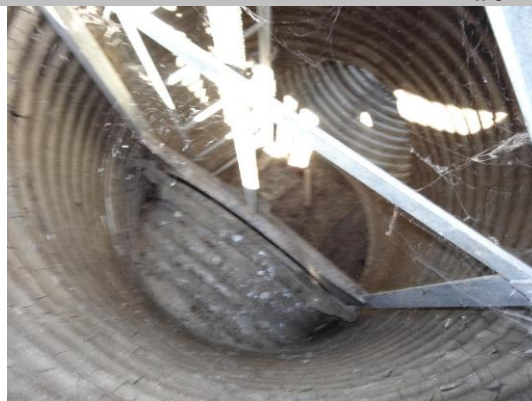
Photo 2 of 3 : UCIP_FA_2019_39465_66395.jpg

Inside view of cmp riser located on waterward slope.

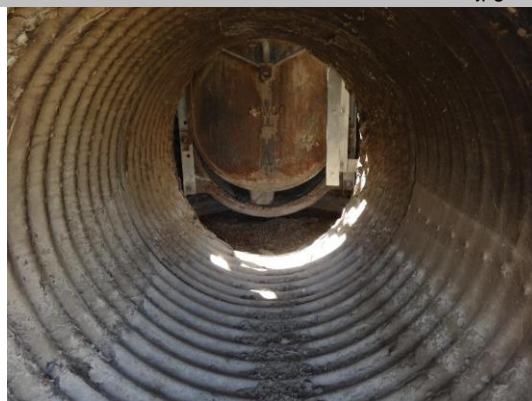
Photo 3 of 3 : UCIP_FA_2019_39465_66397.jpg

Comment Code						
Inspector Comment						
DS_ID:19825 FS_ID:39465 EP_NO: N/A Repair Type: Non-Urgent Crossing Status: Found UCIP Comments: 04/18/2014 Sediment buildup inside pipe visible from landward side. Excess soil is also present on landward toe partially blocking concrete headwall and inlet. Recommend removing soil from landward toe and clear buildup inside. (DWR UCIP - O. Magana) FIELD_STRUCT_DESC: 36-inch corrugated metal gravity drainage pipe through the levee, 6.8 feet below the crown. Slide gate in a 48-inch corrugated metal pipe (CMP) riser on the waterside (WS) slope. Concrete headwall on each end. Pipe connects to a 30-inch steel drainage pipe on the WS. Drainage pipe extends to the pump on the WS on a support platform in the channel. (Extension drainage pipe and pump installed under Permit No. 12527, 1979 - Joseph Gallo). [Additional Reference(s): DWR Levee Log, 2002. USACE San Joaquin O&M Manual 601.1, 1967, (HLM 3.54)]. FS Date: 4/18/2014

Inside view of pipe from waterward side.

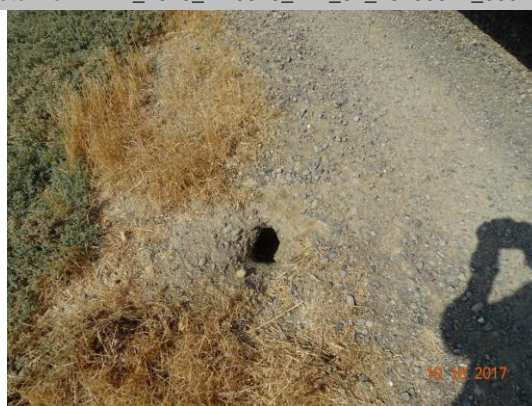
Photo 1 of 1 : FA_2019_NA0010_124_67_20190912_00013.jpg

LM Start	3.49	Rating **	M	Issue No.	67
LM End	3.49	Issue Type +	Ma	Location *	LS
Category	Earthen Levee			GPS Latitude/Longitude	
				Start	End
Item	Animal Control			37.251602°	37.251602°
				-120.778118°	-120.778118°
DWR ID	DWR_NA0010_06_f_2017_67				
Comment Code					
A3 : No rodents visible, but rodent burrows visible; need to backfill and compact or grout burrows.					
Inspector Comment

Looking east at the landside slope.

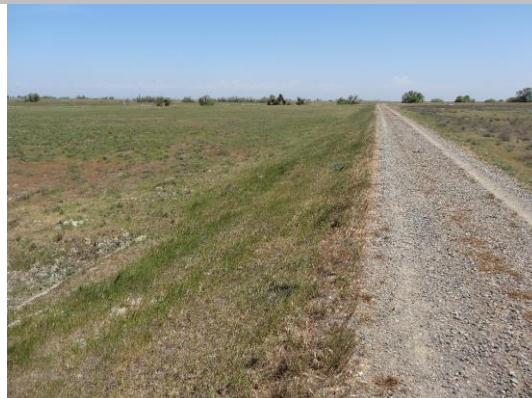
Photo 1 of 3 : UCIP_FA_2019_39466_66413.jpg

Comment Code						
Inspector Comment						
DS_ID:19826 FS_ID:39466 EP_NO: N/A Repair Type: Non-Urgent Crossing Status: Found UCIP Comments: 04/18/2014 Sediment buildup inside crossing and is visible from landward side. Recommend clearing sediment buildup inside pipe and check wall integrity to determine condition. (DWR UCIP - O. Magana) FIELD_STRUCT_DESC: 24-inch corrugated metal gravity drainage pipe through the levee, 7 feet below the crown. Flap gate on the waterside (WS) end. Concrete headwall on each end. [Additional Reference(s): DWR Levee Log, 2002. USACE San Joaquin O&M Manual 601.1, 1967, (HLM 3.77)]. FS Date: 4/18/2014

View of waterward side.

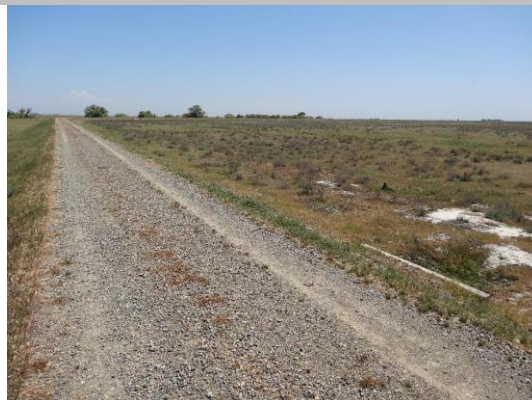
Photo 2 of 3 : UCIP_FA_2019_39466_66412.jpg

View of landward side.

Comment Code						
Inspector Comment						
DS_ID:19826 FS_ID:39466 EP_NO: N/A Repair Type: Non-Urgent Crossing Status: Found UCIP Comments: 04/18/2014 Sediment buildup inside crossing and is visible from landward side. Recommend clearing sediment buildup inside pipe and check wall integrity to determine condition. (DWR UCIP - O. Magana) FIELD_STRUCT_DESC: 24-inch corrugated metal gravity drainage pipe through the levee, 7 feet below the crown. Flap gate on the waterside (WS) end. Concrete headwall on each end. [Additional Reference(s): DWR Levee Log, 2002. USACE San Joaquin O&M Manual 601.1, 1967, (HLM 3.77)]. FS Date: 4/18/2014

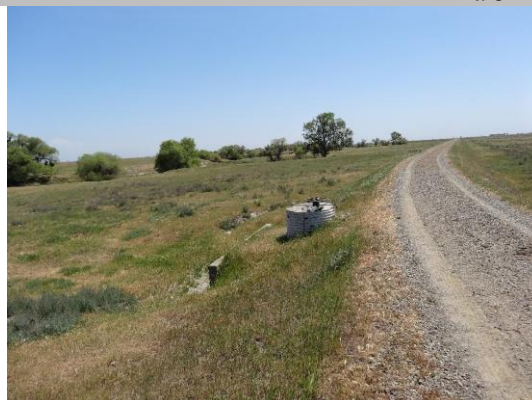
Photo 1 of 3 : UCIP_FA_2019_39467_66407.jpg

Comment Code						
Inspector Comment						
DS_ID:19827 FS_ID:39467 EP_NO: N/A Repair Type: Non-Urgent Crossing Status: Found UCIP Comments: 04/18/2014 Sediment buildup inside crossing and is visible from landward side. Recommend clearing sediment buildup inside pipe and check wall integrity to determine condition. (DWR UCIP - O. Magana) FIELD_STRUCT_DESC: 36-inch corrugated metal gravity drainage pipe through the levee, 6.7 feet below the crown. Slide gate in a 48-inch corrugated metal pipe (CMP) riser on the waterside (WS) slope. [Additional Reference(s): DWR Levee Log, 2002. USACE San Joaquin O&M Manual 601.1, 1967, (HLM 3.97)]. FS Date: 4/18/2014

View of waterward side.

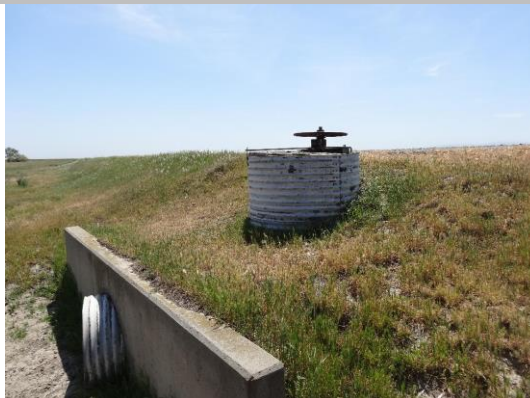
Photo 2 of 3 : UCIP_FA_2019_39467_66406.jpg

Comment Code						
Inspector Comment						
DS_ID:19827 FS_ID:39467 EP_NO: N/A Repair Type: Non-Urgent Crossing Status: Found UCIP Comments: 04/18/2014 Sediment buildup inside crossing and is visible from landward side. Recommend clearing sediment buildup inside pipe and check wall integrity to determine condition. (DWR UCIP - O. Magana) FIELD_STRUCT_DESC: 36-inch corrugated metal gravity drainage pipe through the levee, 6.7 feet below the crown. Slide gate in a 48-inch corrugated metal pipe (CMP) riser on the waterside (WS) slope. [Additional Reference(s): DWR Levee Log, 2002. USACE San Joaquin O&M Manual 601.1, 1967, (HLM 3.97)]. FS Date: 4/18/2014

Slide gate inside CMP riser visible on waterward slope.

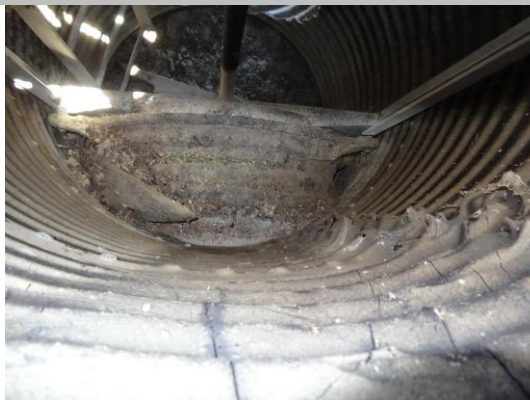
Photo 3 of 3 : UCIP_FA_2019_39467_66410.jpg

Inside view of CMP riser located on waterward side.

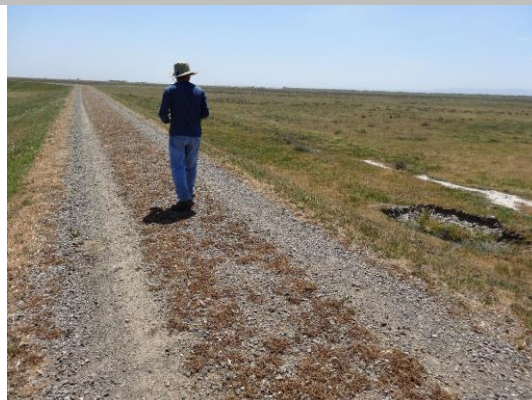
Photo 2 of 3 : UCIP_FA_2019_36606_66417.jpg

Comment Code						
Inspector Comment						
DS_ID:19828 FS_ID:36606 EP_NO: N/A Repair Type: Non-Urgent Crossing Status: Found UCIP Comments: 04/18/2014 Dense vegetation limits the inspector's visibility to identify signs of pipe condition on landward toe--headwall blocked by dense vegetation. Recommend removing vegetation from landward toe. (DWR UCIP - O. Magana) FIELD_STRUCT_DESC: 24-inch corrugated metal gravity drainage pipe through the levee, 10.8 feet below the crown. Flap gate on the waterside (WS) end. Concrete headwall on each end. [Additional Reference(s): DWR Levee Log, 2002. USACE San Joaquin O&M Manual 601.1, 1967, (HLM 4.17)]. FS Date: 4/18/2014

Overview of levee crown at crossing.

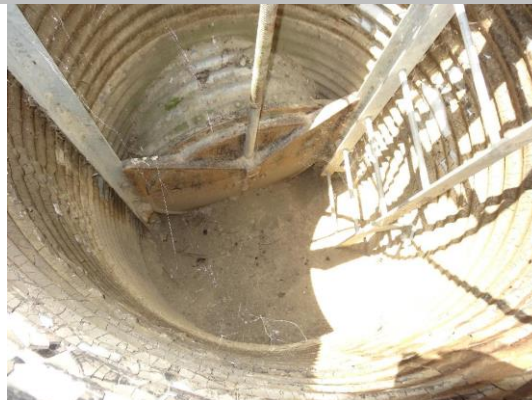
Photo 2 of 3 : UCIP_FA_2019_39468_66426.jpg

Comment Code						
Inspector Comment						
DS_ID:19830 FS_ID:39468 EP_NO: N/A Repair Type: Non-Urgent Crossing Status: Found UCIP Comments: 04/18/2014 Sediment buildup inside crossing visible from landward side. Recommend clearing sediment buildup inside pipe and check wall integrity to determine condition. (DWR UCIP - O. Magana) FIELD_STRUCT_DESC: 36-inch corrugated metal gravity drainage pipe through the levee, 6.9 feet below the crown. Slide gate in a 48-inch corrugated metal pipe (CMP) riser on the waterside (WS) slope. Concrete headwall on the landside (LS) end. Concrete saddle and apron on the WS end. [Additional Reference(s): DWR Levee Log, 2002. USACE San Joaquin O&M Manual 601.1, 1967, (HLM 4.70)]. FS Date: 4/18/2014

Inside view of CMP riser located on waterward.

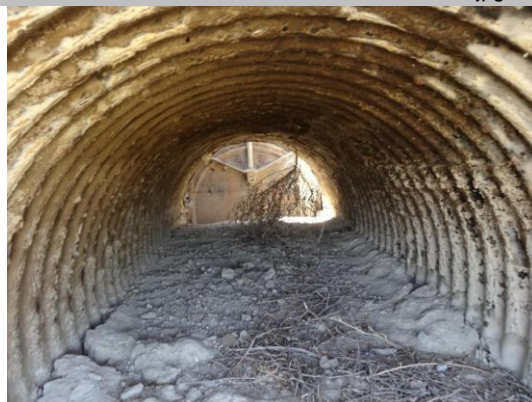
Photo 3 of 3 : UCIP_FA_2019_39468_66424.jpg

Inside view of pipe from waterward side.

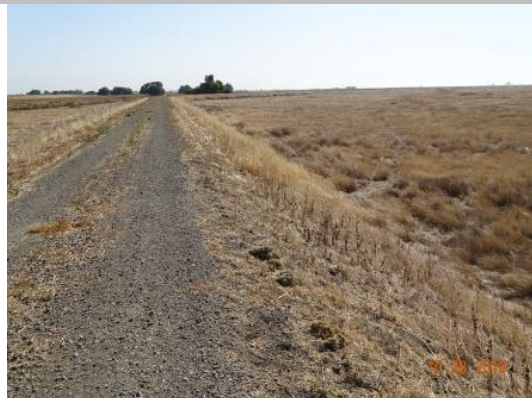
Photo 1 of 1 : FA_2019_NA0010_124_71_20191108_00194.jpg

LM Start	4.67	Rating **	U	Issue No.	71
LM End	5.78	Issue Type +	Ma	Location *	LS
Category	Earthen Levee			GPS Latitude/Longitude	
				Start	End
Item	Vegetation			37.243477°	37.238362°
				-120.760678°	-120.742356°
DWR ID	DWR_NA0010_06_f_2019_71				
Comment Code					
V1 : Control annual grass and weeds on the levee slopes and easements.					
Inspector Comment

View of the landside slope looking upstream. (Fall 2019)

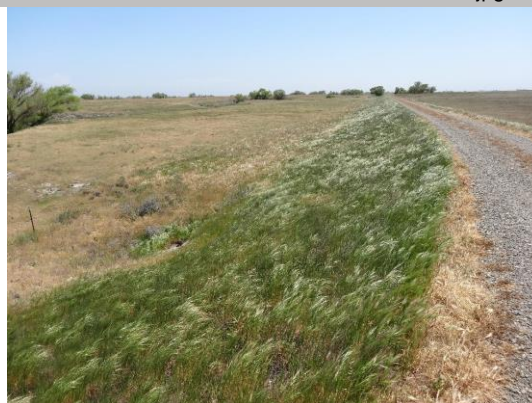
Photo 1 of 3 : UCIP_FA_2019_36609_66433.jpg

LM Start	4.67	Rating **	M	Issue No.	1228
LM End	4.67	Issue Type +	Ma	Location *	
Category	Supplemental			GPS Latitude/Longitude	
				Start	End
Item	DRAFT DWR UCIP LMA Responsibility			37.243408°	37.243408°
				-120.760564°	-120.760564°
DWR ID	19831				
Comment Code					
Inspector Comment					
DS_ID:19831					
FS_ID:36609					
EP_NO: N/A					
Repair Type: Non-Urgent					
Crossing Status: Found					
UCIP Comments: 04/18/2014 Need to contact owner. Recommend removing tall grass on landward toe to determine condition of crossing from landward side. (DWR UCIP - O. Magana)					
FIELD_STRUCT_DESC: 24-inch corrugated metal gravity drainage pipe through the levee, 11.8 feet below the crown. Flap gate on the waterside (WS) end. Concrete headwall on each end. [Additional Reference(s): DWR Levee Log, 2002. USACE San Joaquin O&M Manual 601.1, 1967, (HLM 4.75)].					
FS Date: 4/18/2014

View of waterward side.

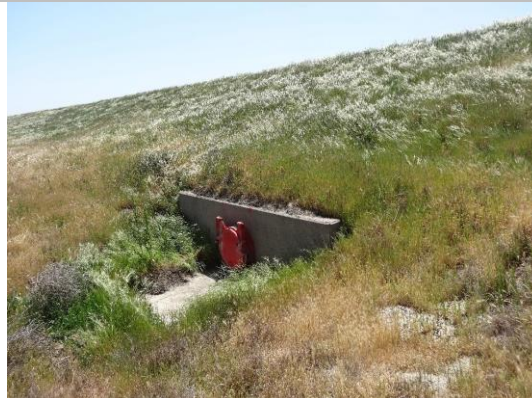
Photo 2 of 3 : UCIP_FA_2019_36609_66432.jpg

Comment Code						
Inspector Comment						
DS_ID:19831						
FS_ID:36609						
EP_NO: N/A						
Repair Type: Non-Urgent						
Crossing Status: Found						
UCIP Comments: 04/18/2014 Need to contact owner. Recommend removing tall grass on landward toe to determine condition of crossing from landward side. (DWR UCIP - O. Magana)						
FIELD_STRUCT_DESC: 24-inch corrugated metal gravity drainage pipe through the levee, 11.8 feet below the crown. Flap gate on the waterside (WS) end. Concrete headwall on each end. [Additional Reference(s): DWR Levee Log, 2002. USACE San Joaquin O&M Manual 601.1, 1967, (HLM 4.75)].						
FS Date: 4/18/2014

Flap gate, concrete headwall and apron visible on waterward toe.
